Situation Photo Log

Monday, December 17, 2012

Kalamazoo River / Enbridge Spill

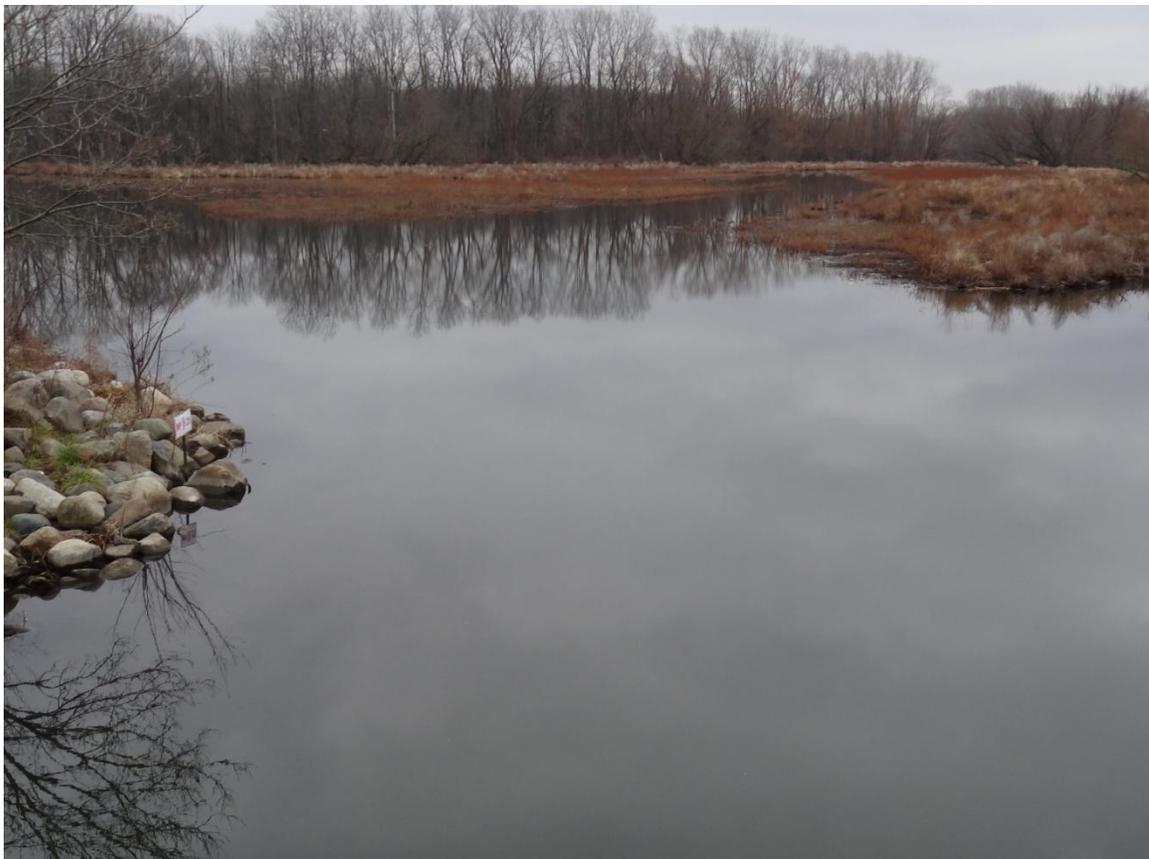
26. MP15.25 South Mill Pond sheen and tar globs observed.

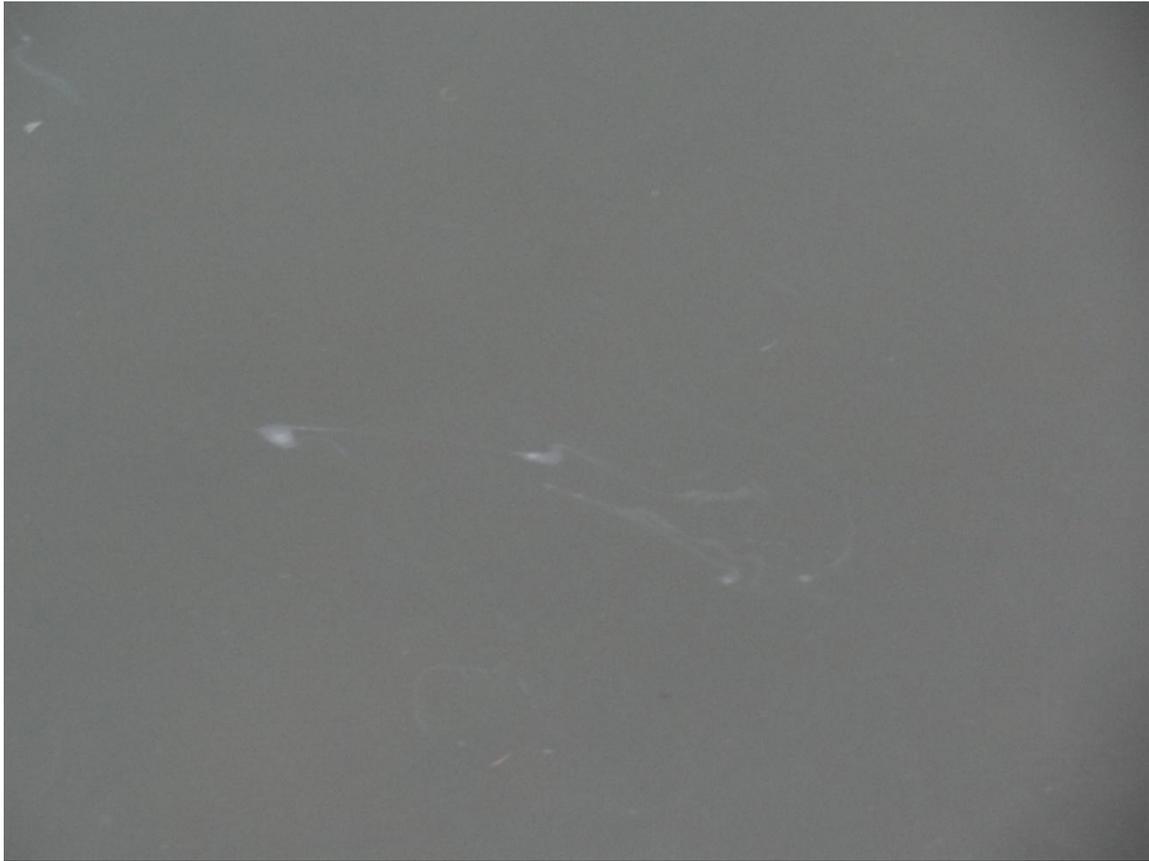
27. MP15.25 South Mill Pond sheen and tar globs observed.

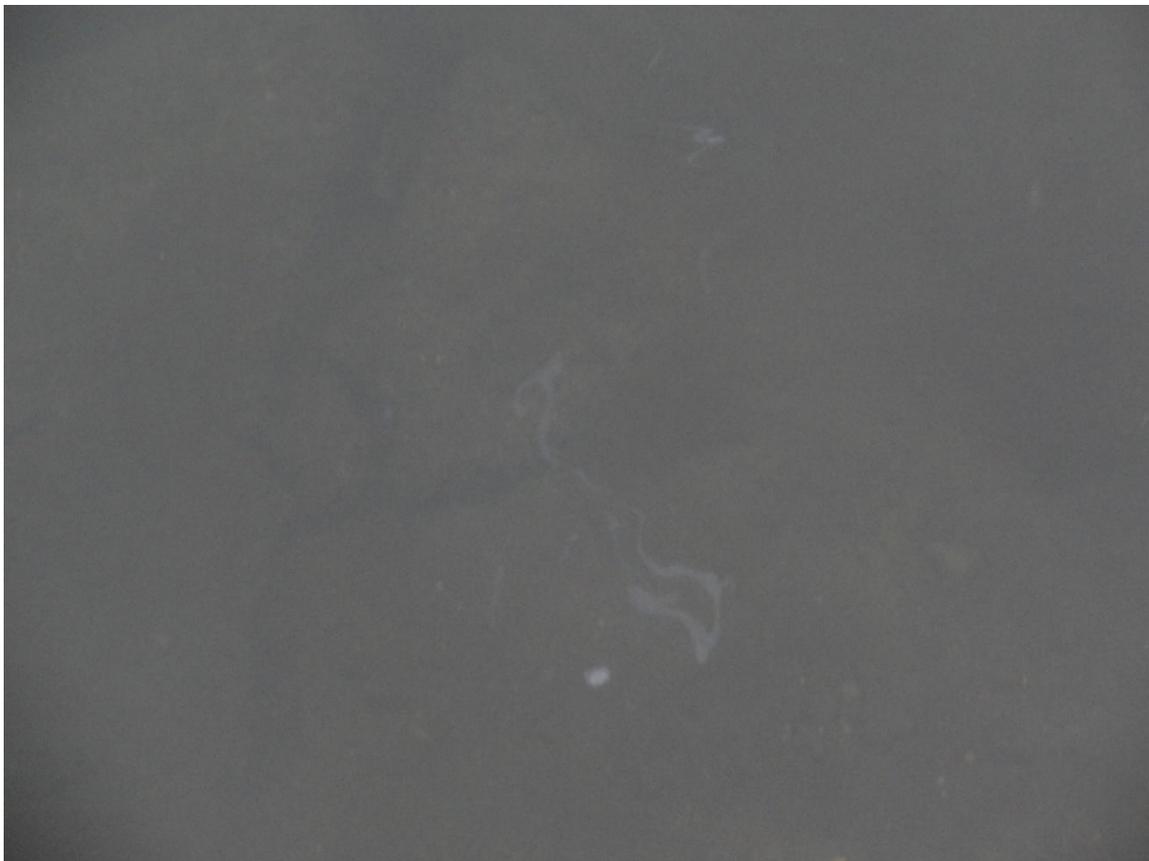
28. MP15.25 South Mill Pond sheen and tar globs observed.

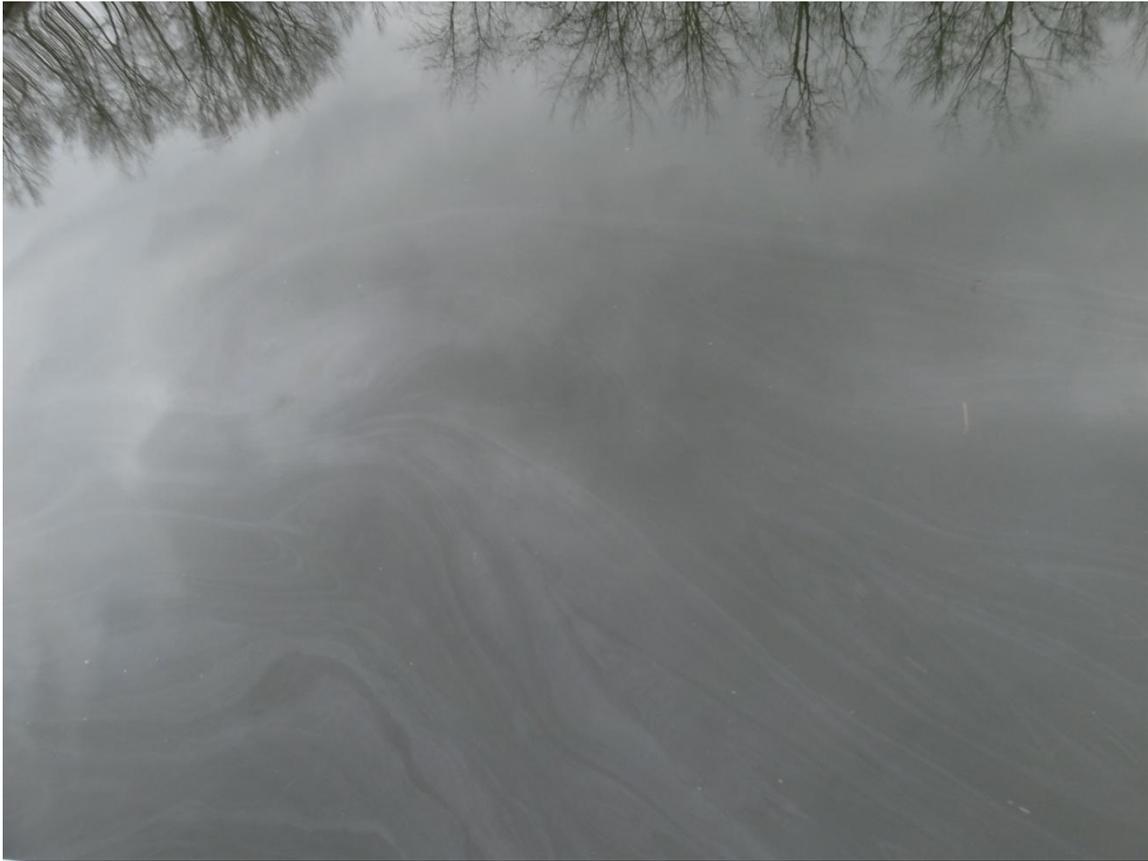
35. MP36.25 LDB sheen test conducted, results were inconclusive.

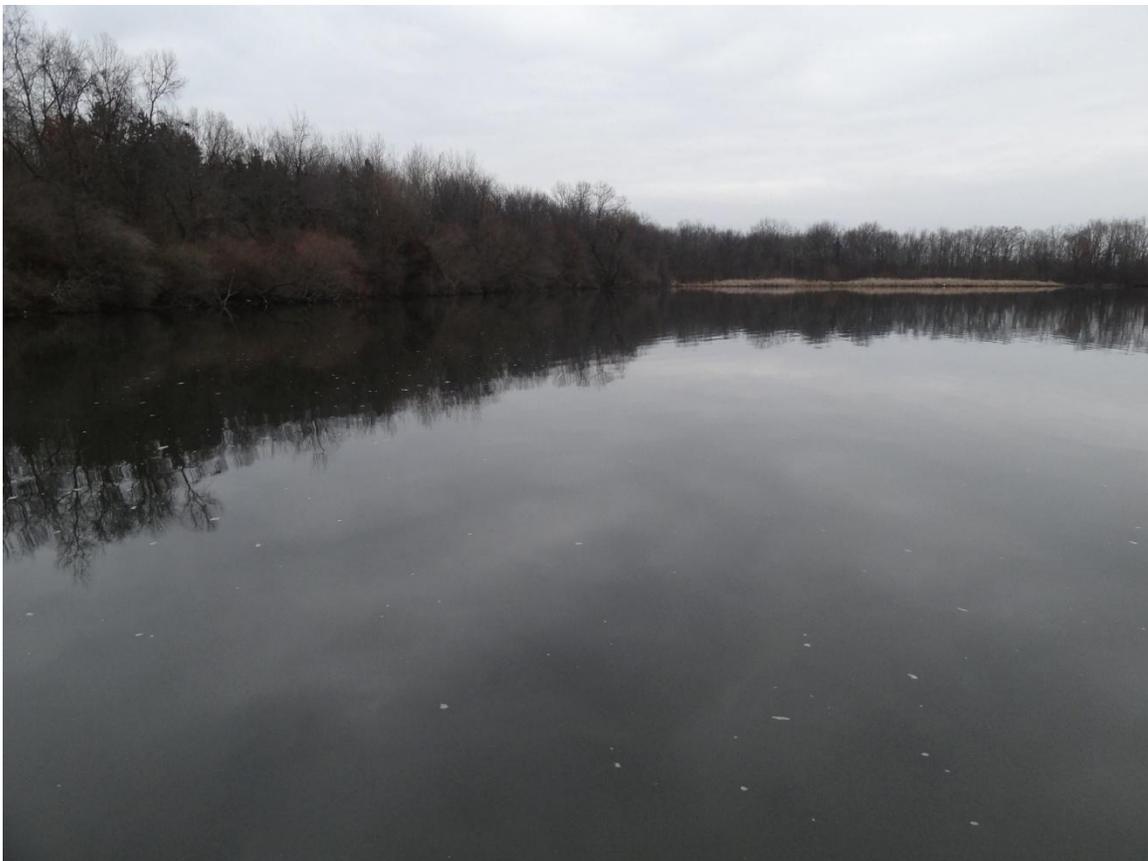
36. Morrow Lake North Cove area where sheen and tar globs were observed. Sweep boat requested.

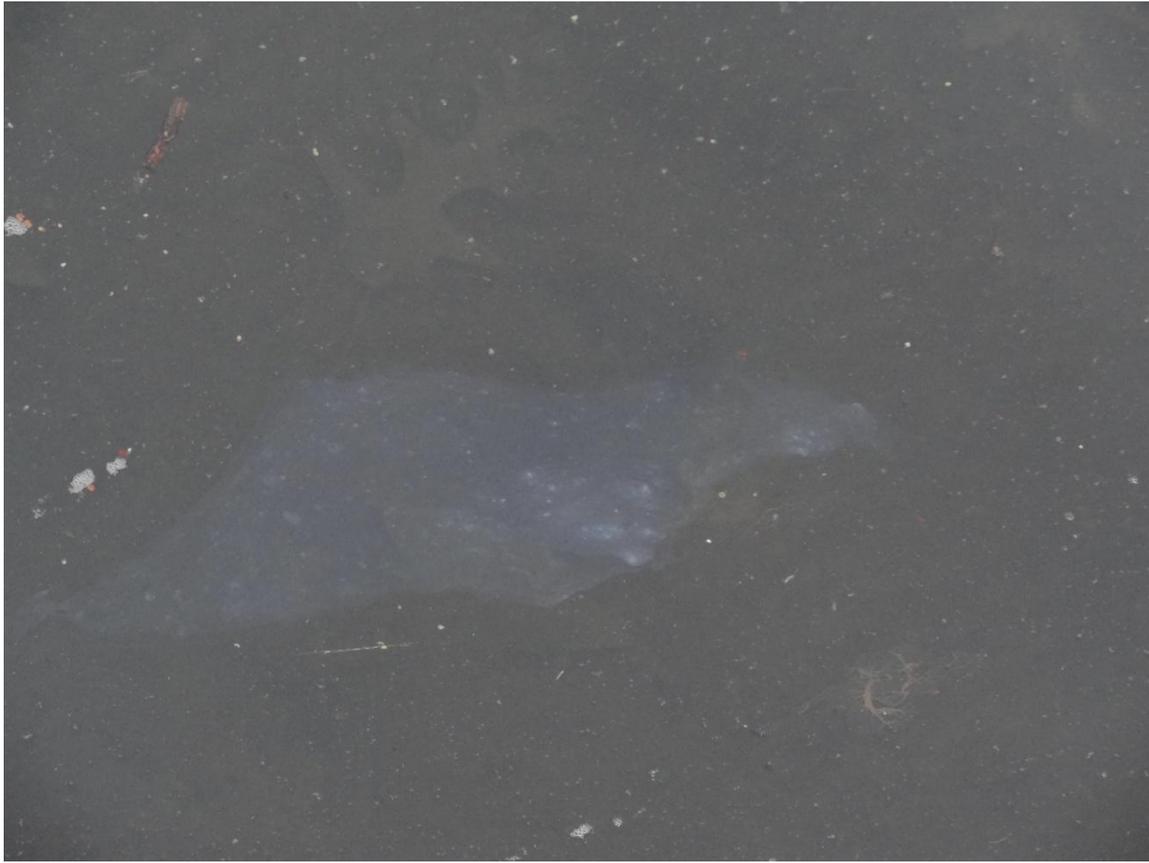
37. Morrow Lake North Cove sheen and tar globs observed.

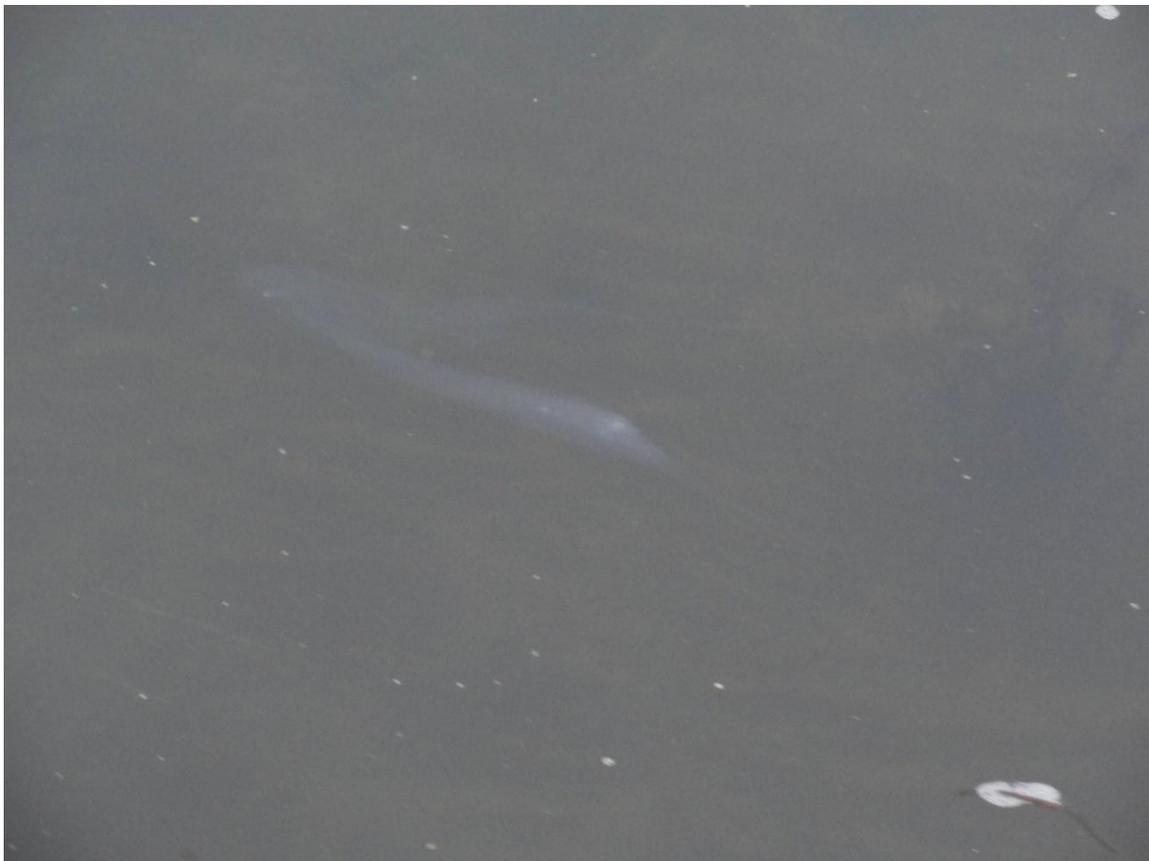
38. Morrow Lake North Cove sheen and tar globs observed.

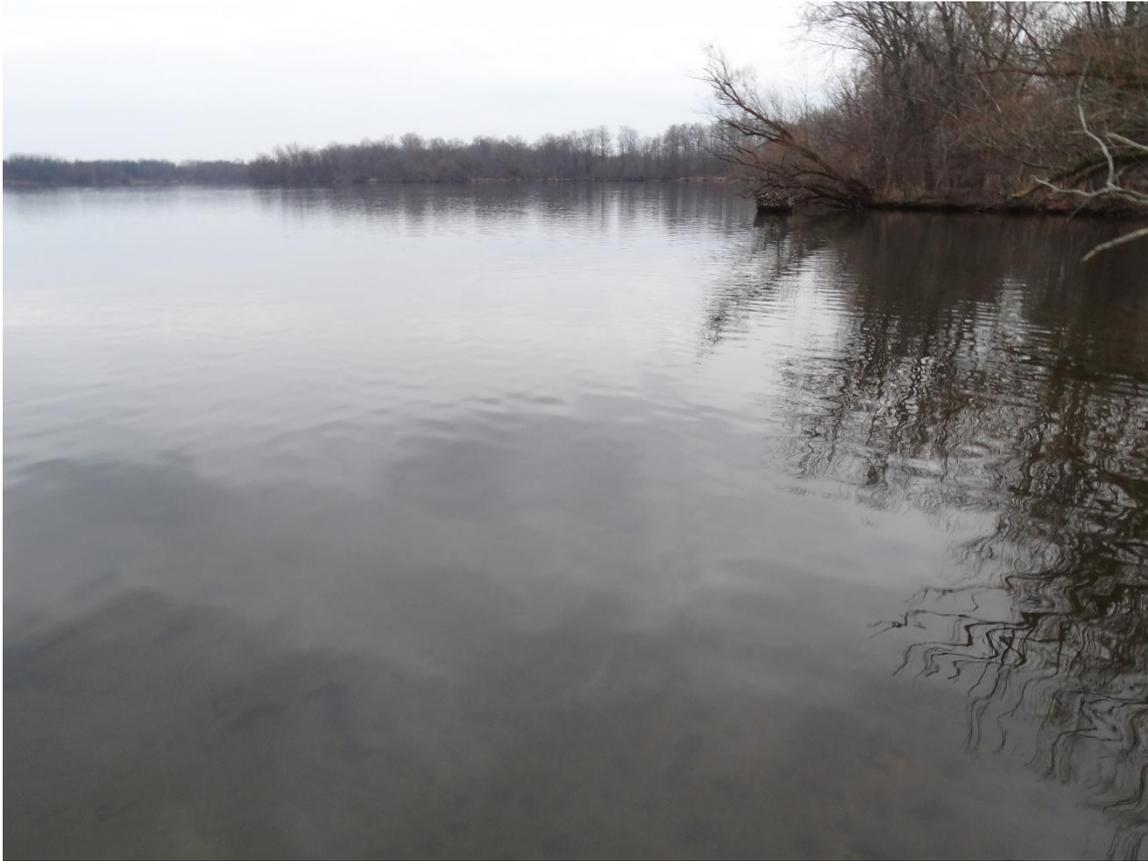
39. Morrow Lake South Cove sheen and tar globs observed. Sweep boat requested.

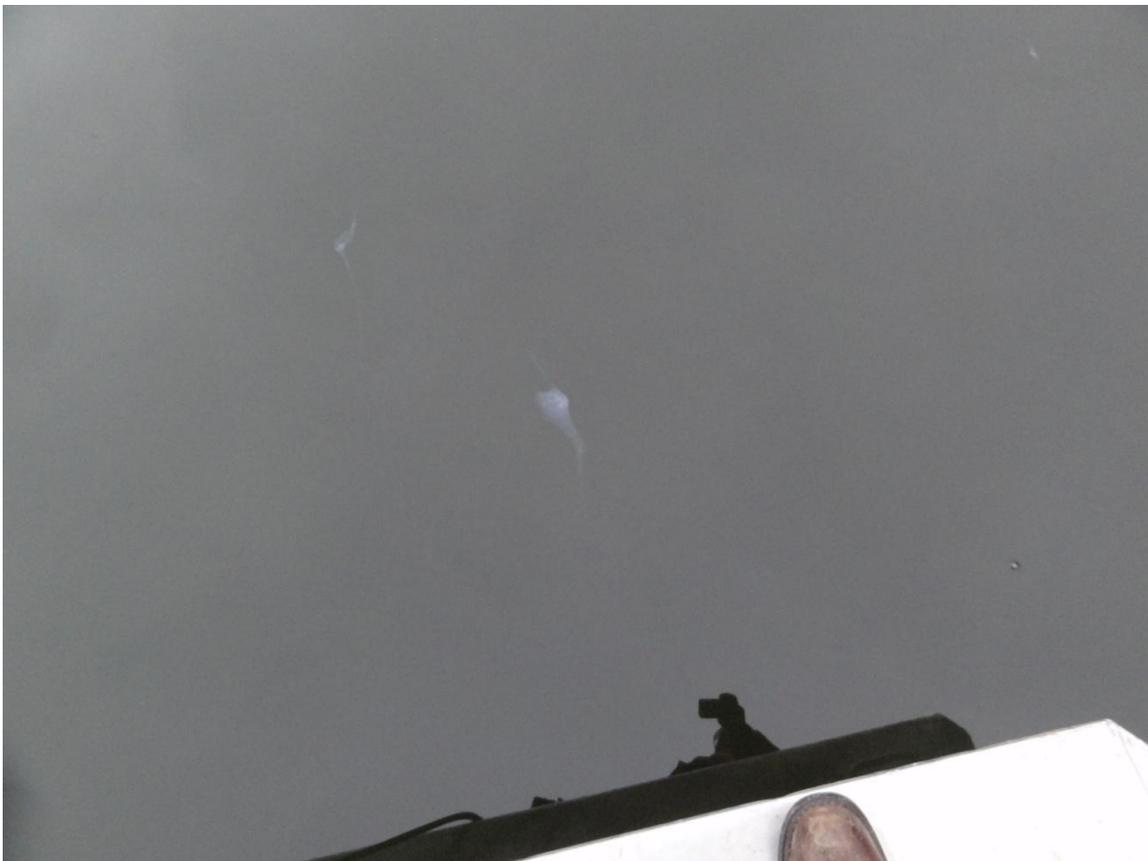
40. Morrow Lake South Cove sheen and tar globs observed.
