# Situation Photo Log

Tuesday, December 18, 2012

Kalamazoo River / Enbridge Spill

Prepared by:  
Larry Rader  
START-USEPA  
Situation Unit Leader

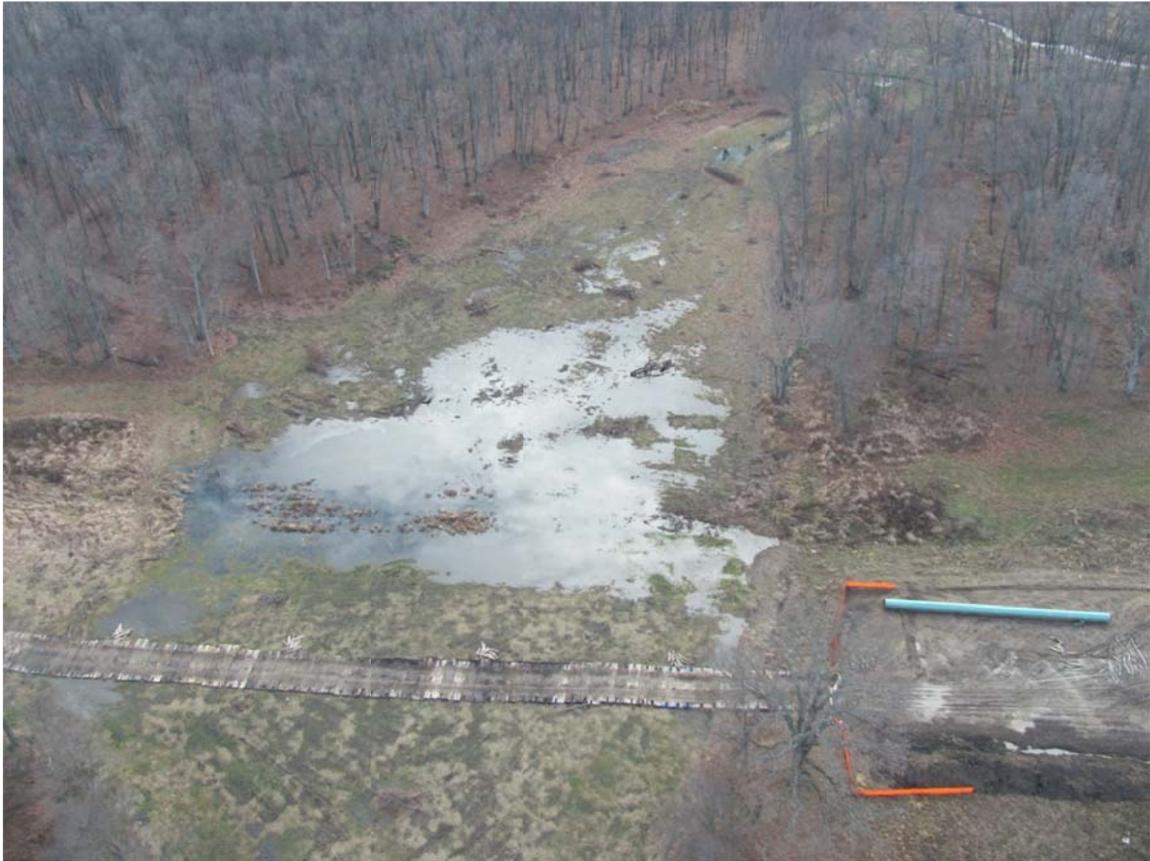
1. Source Area, no sheen observed.

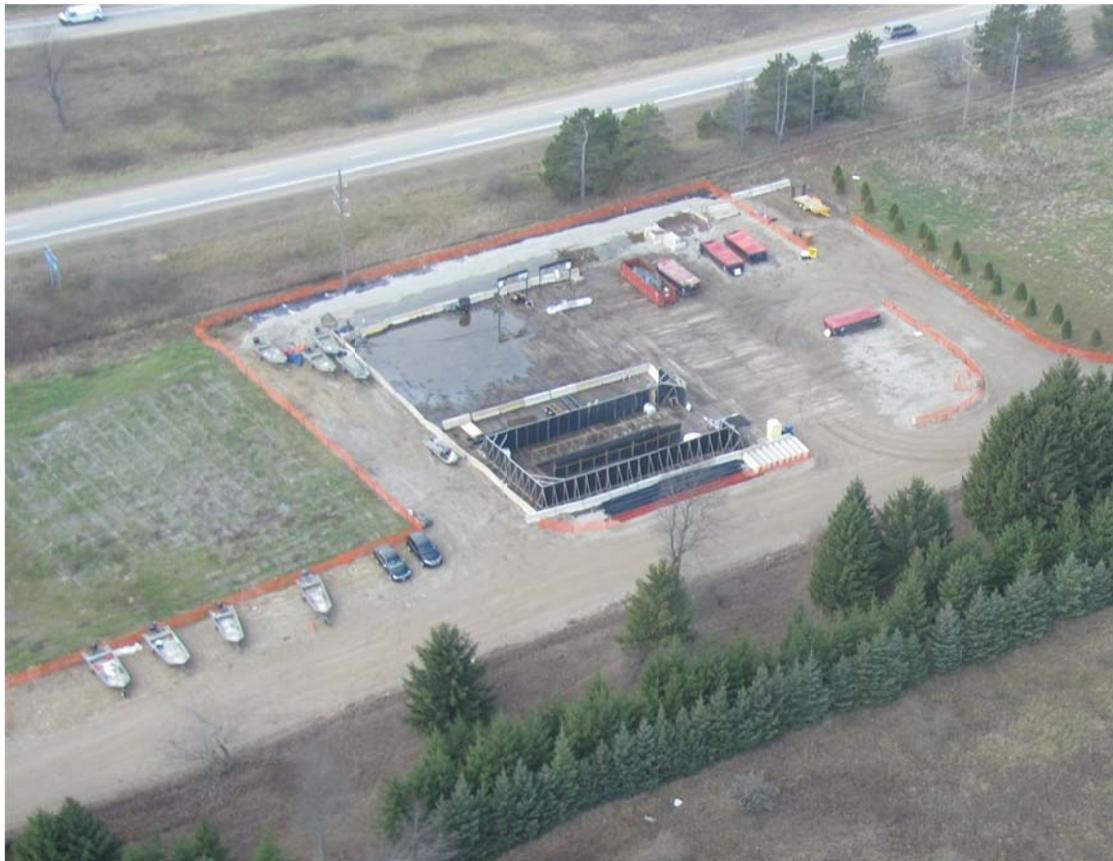
2. Frac Tank City, no decon operations observed.

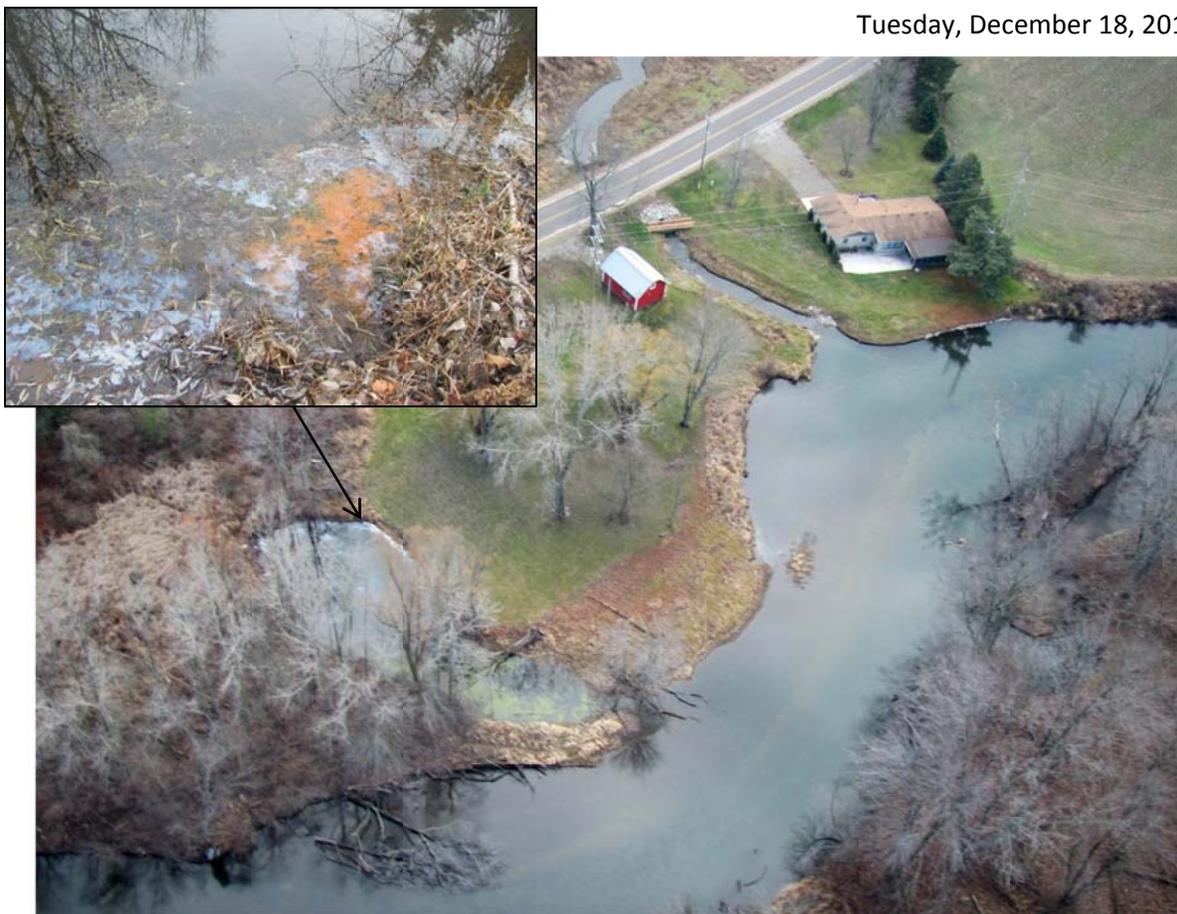
3. Confluence, sheen observed in pond north of confluence. Ground inspection determined that sheen was biogenic in origin.

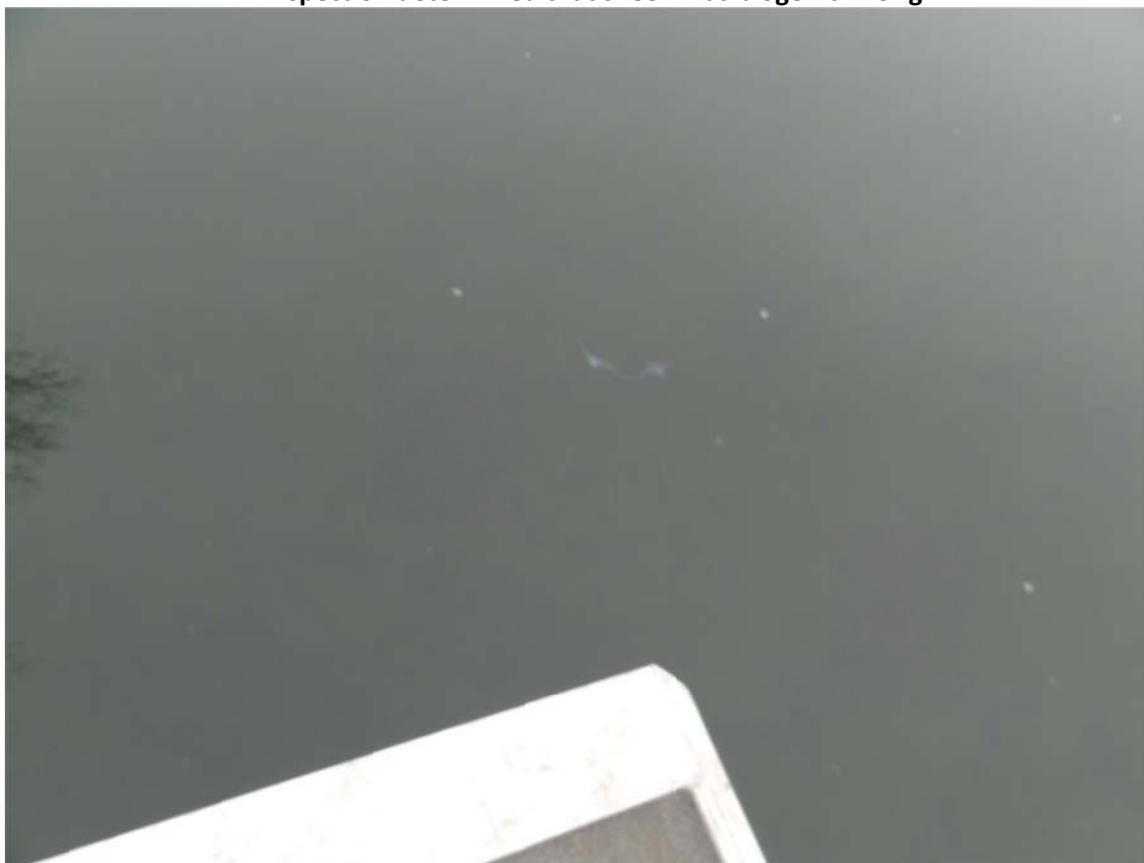
4. MP 5.25 LDB, sheen observed along southern shore. Sheen response was requested.

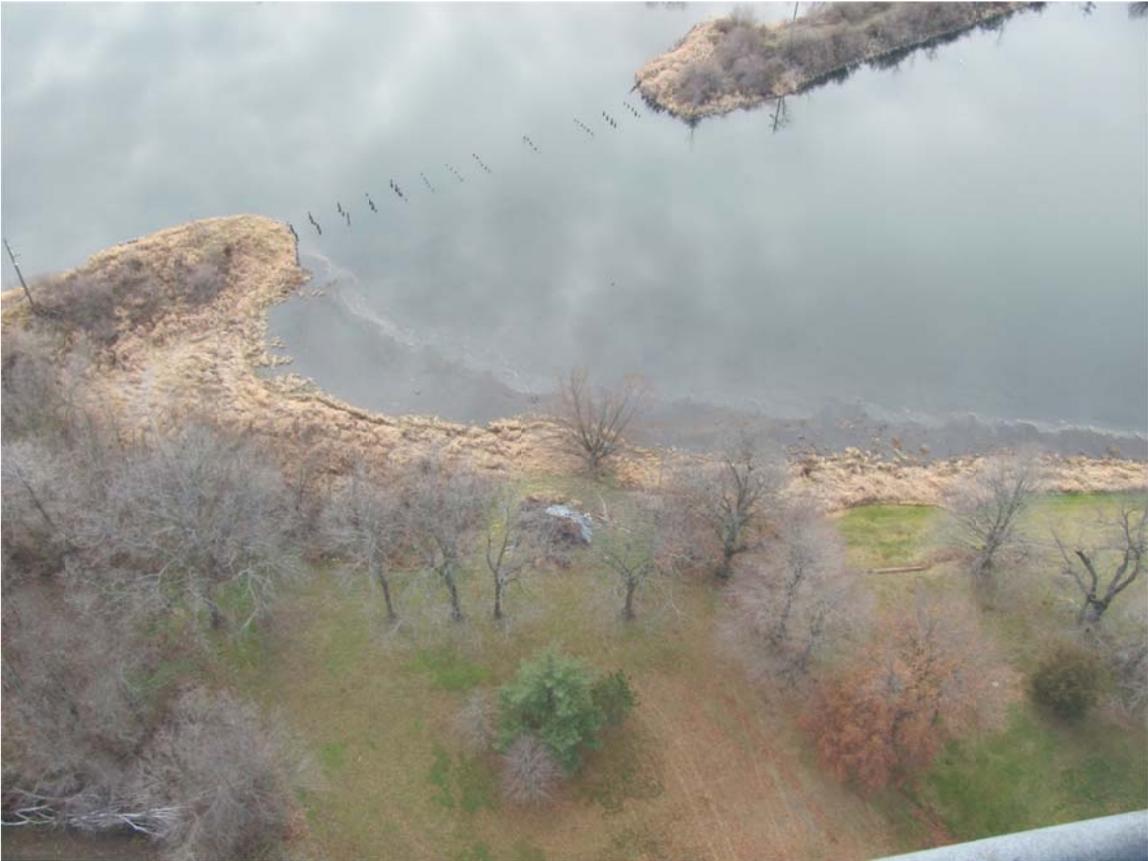
5. Ceresco Dam trestle RDB, no sheen observed.

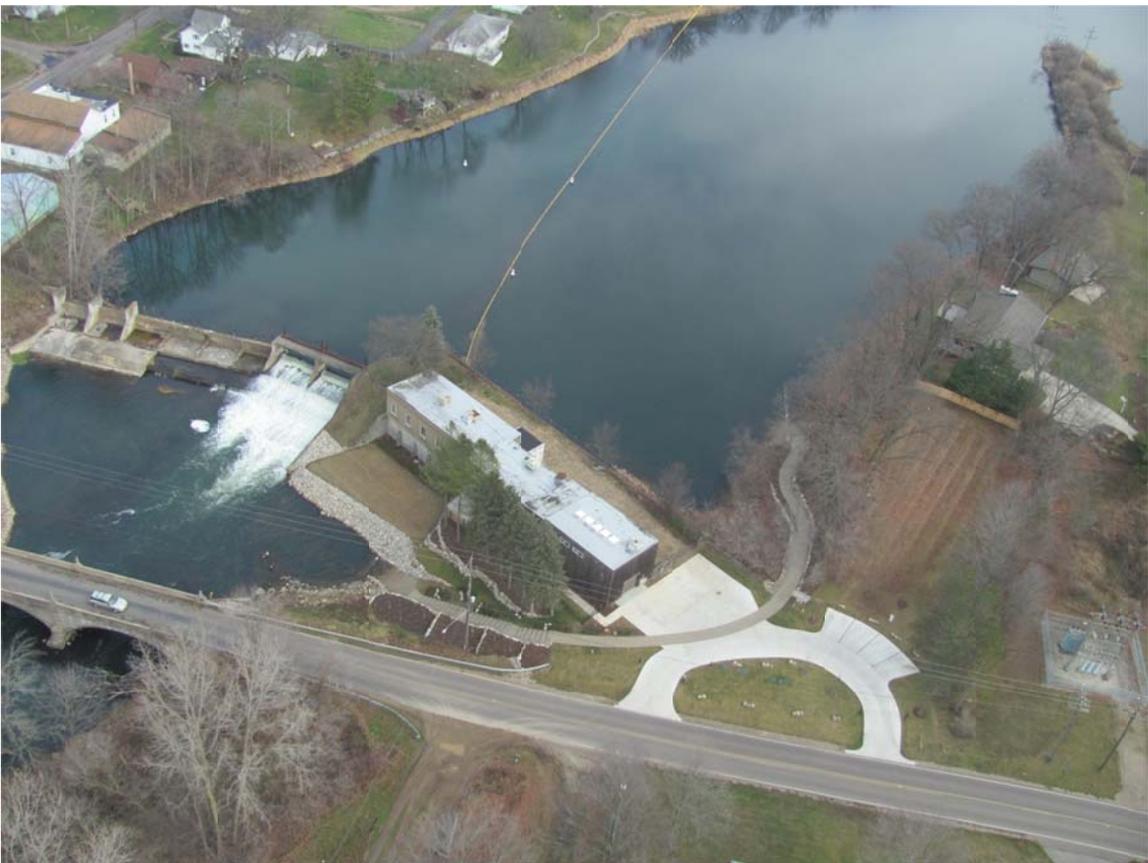
6. Ceresco Dam control point. No sheen observed from overflight. Sheen observed during ground inspection in afternoon.

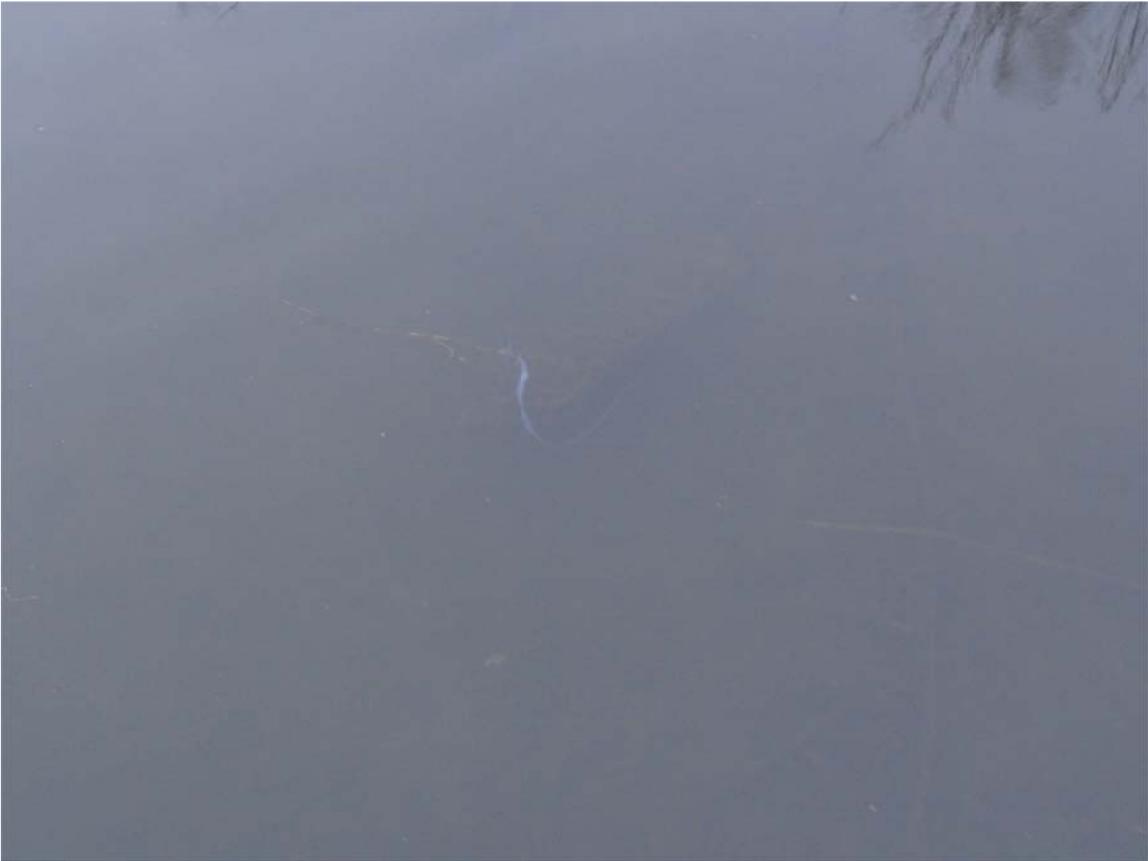
7. Sheen observed along Ceresco Dam control point.

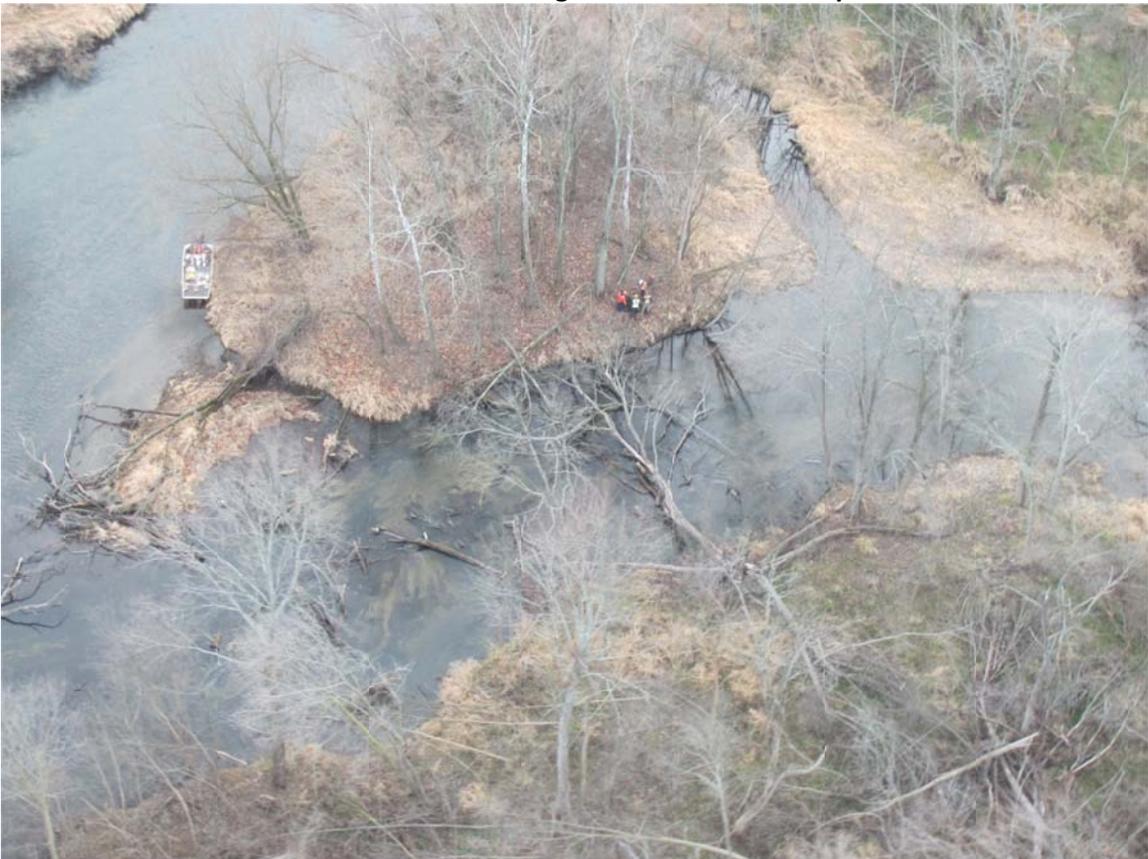
8. Observed RI crew surveying on island near MP 12.75.

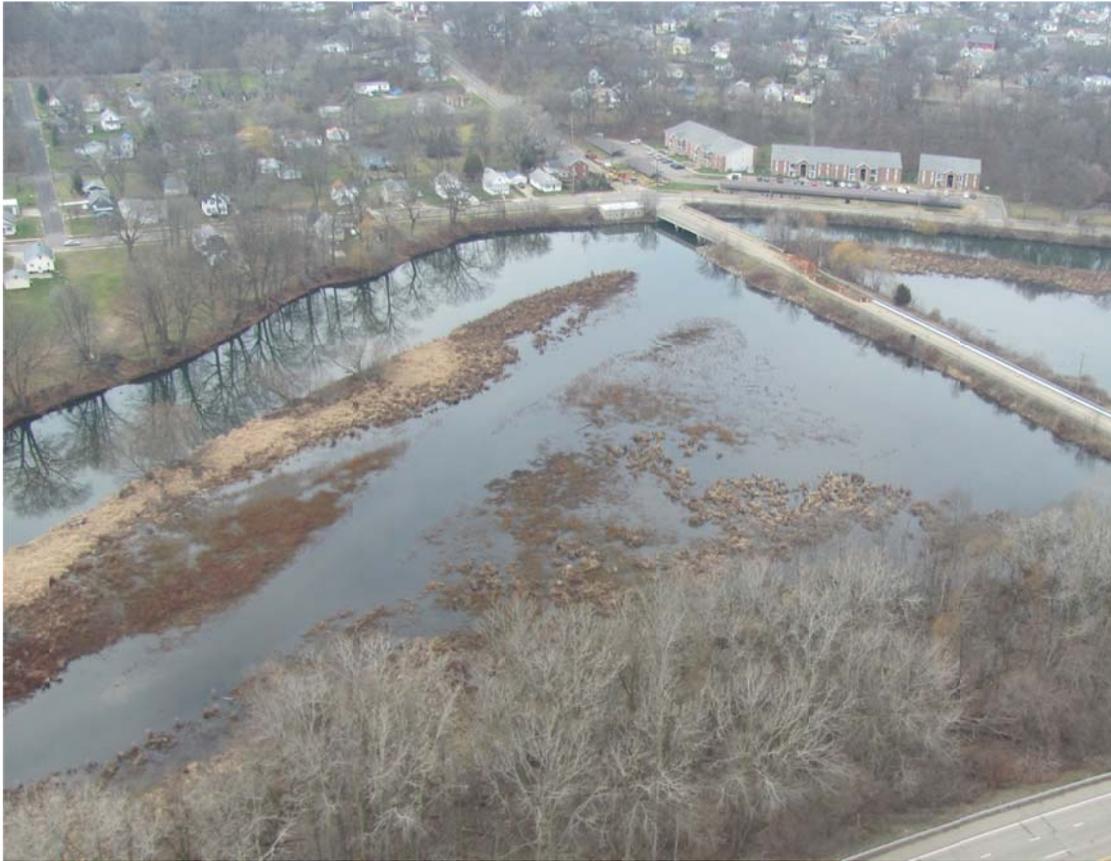
9. South Mill Pond, no sheen or ice observed.

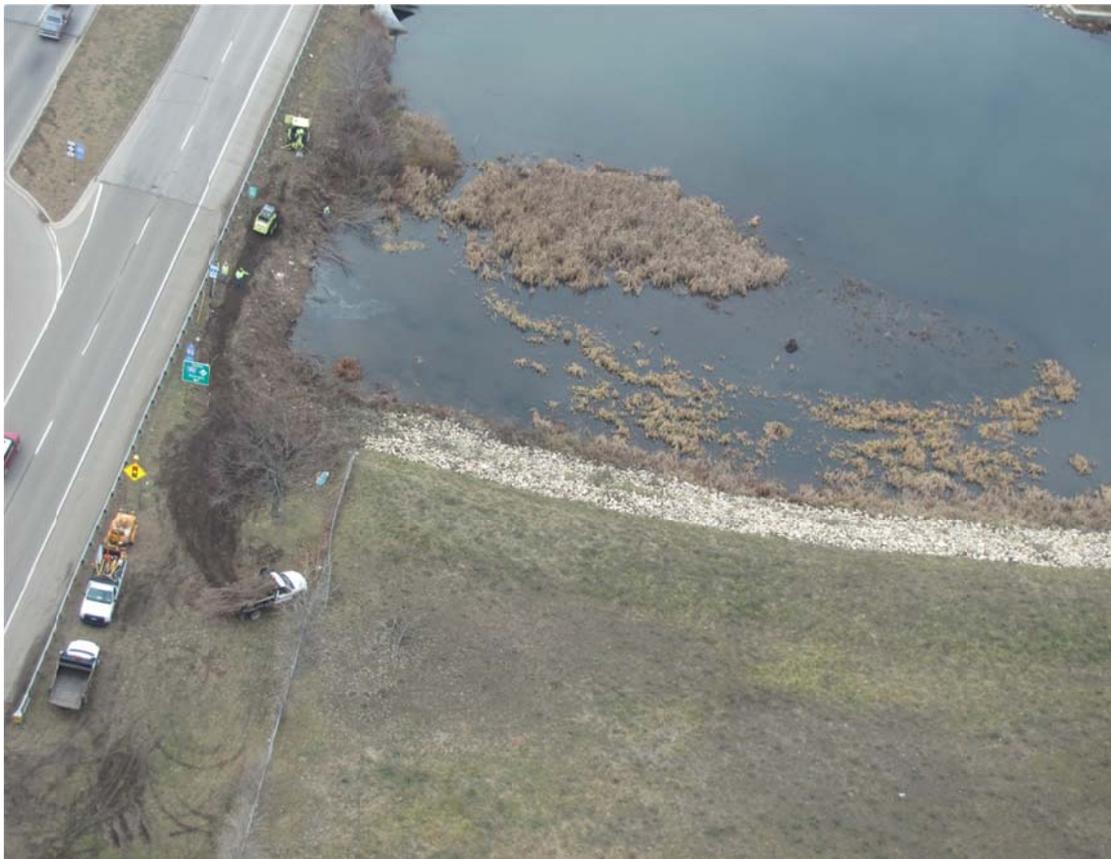
10. MP15.75 Battle Creek Spillway, sheen observed in vicinity of utility crews.  
No sheen observed during afternoon ground inspection.

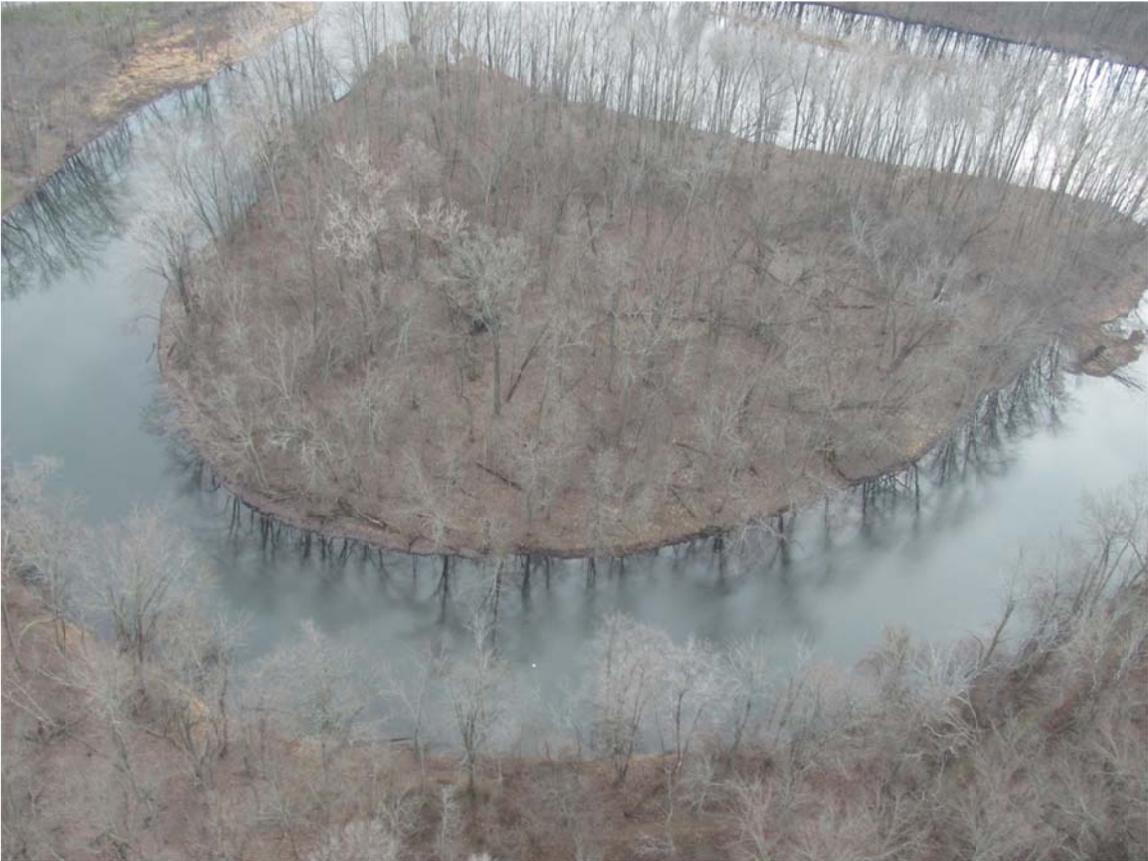
11. MP21.5 no ice or activity observed.

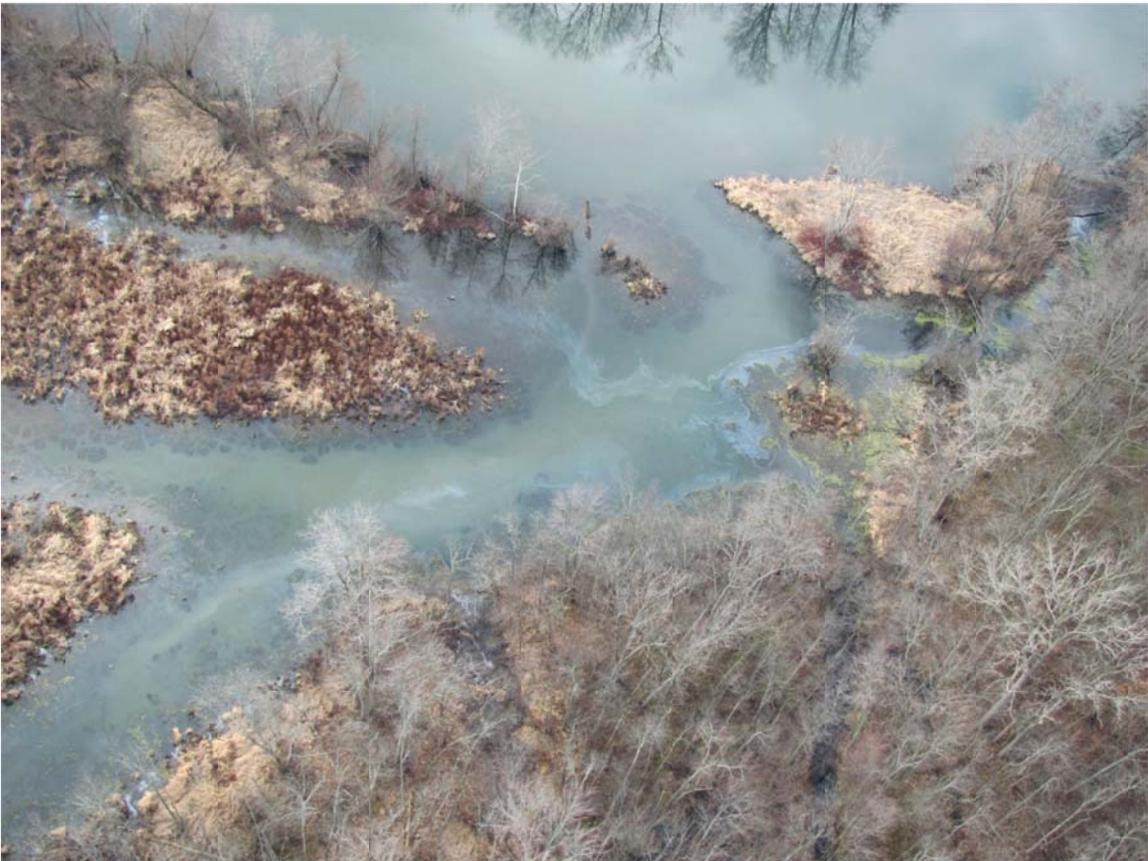
12. MP36.5 RDB, sheen observed in wetland area north of river. Sheen test from the area was inconclusive.

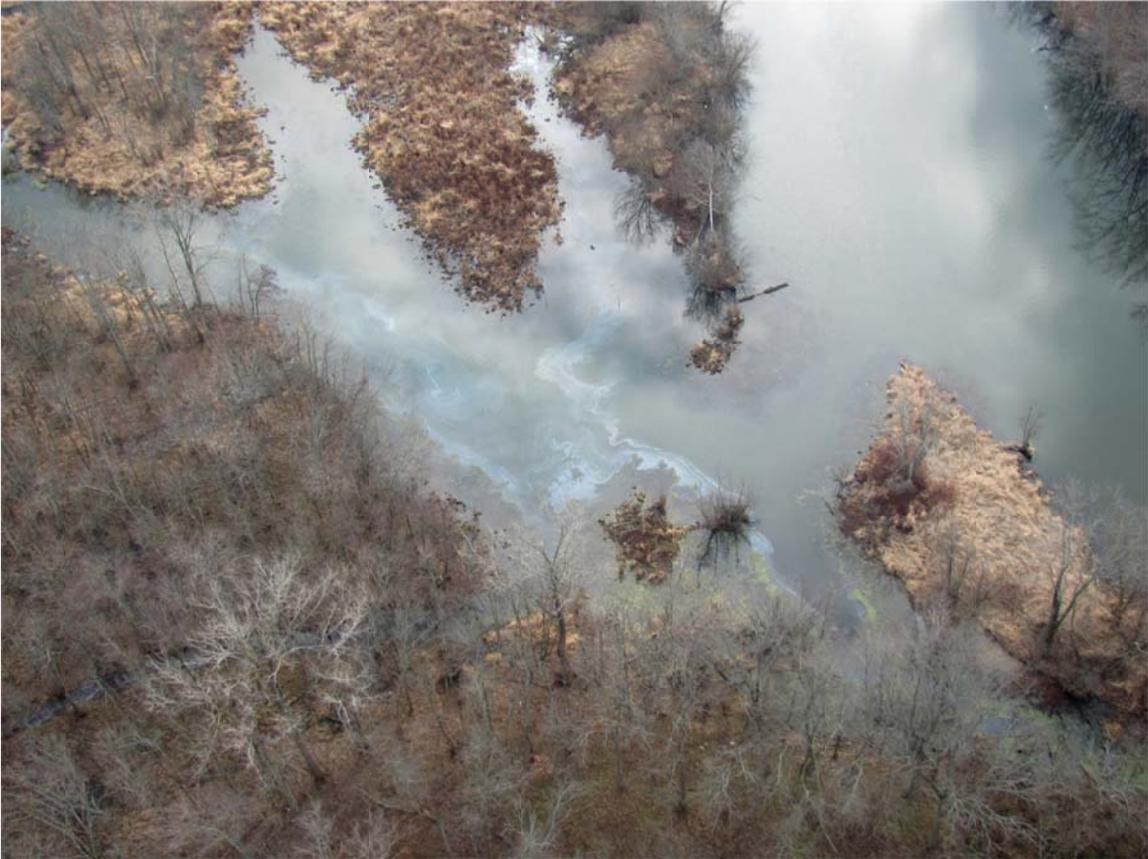
13. MP36.5 RDB, sheen observed in wetland area north of river. Sheen test from the area was inconclusive.

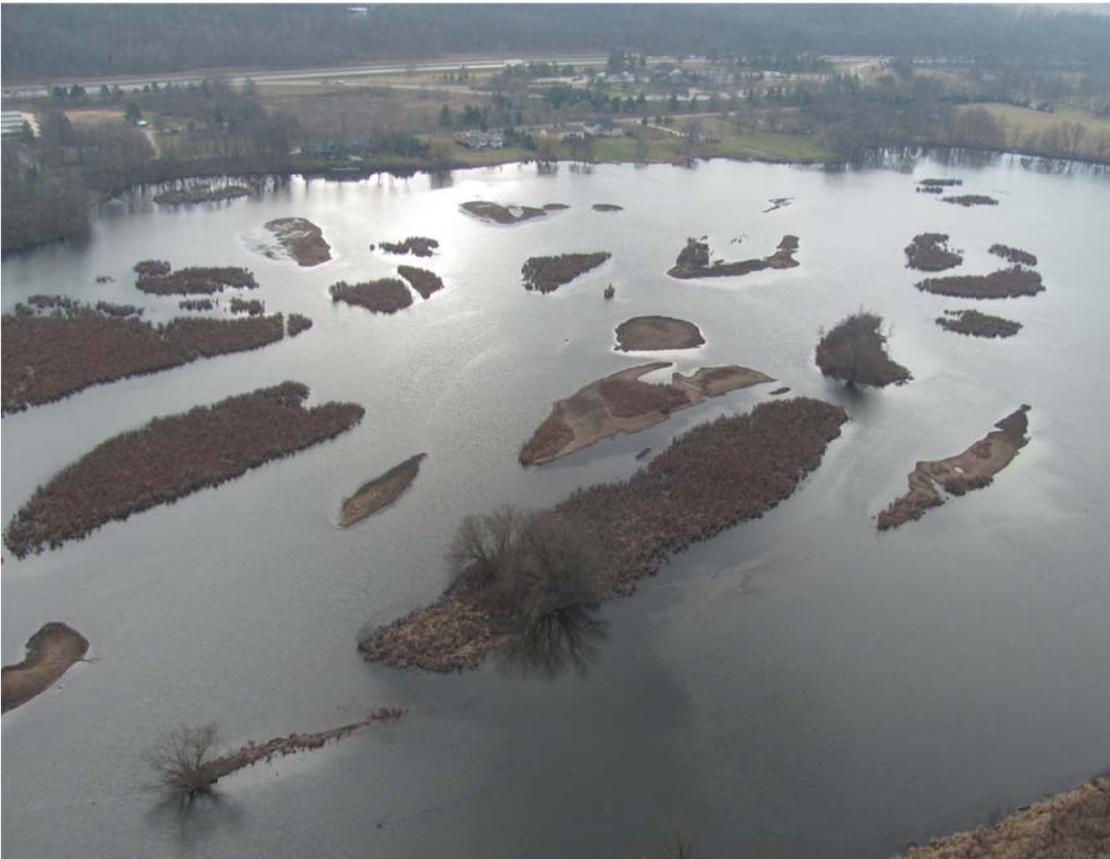
14. Morrow Lake Delta, no sheen or ice observed.

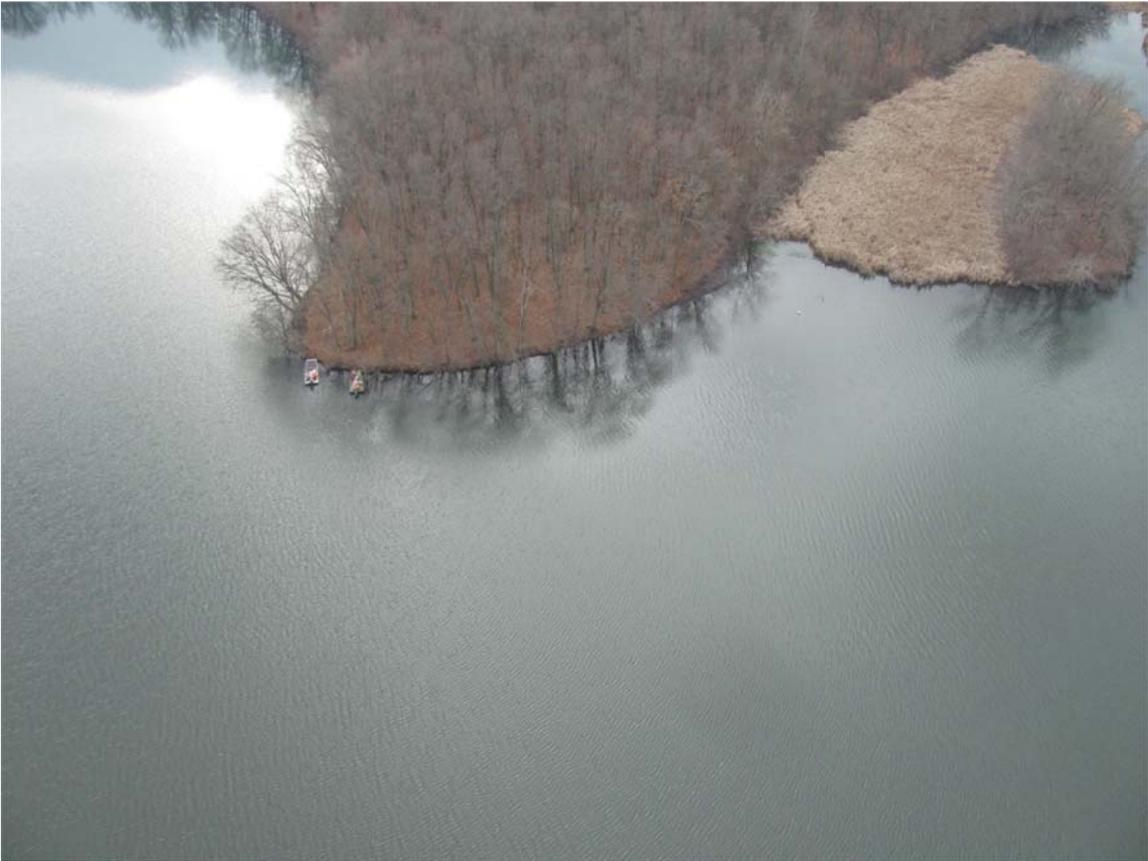
15. MP37.5 LDB, observed a bathymetry crew surveying at former E4.0 boom locations.

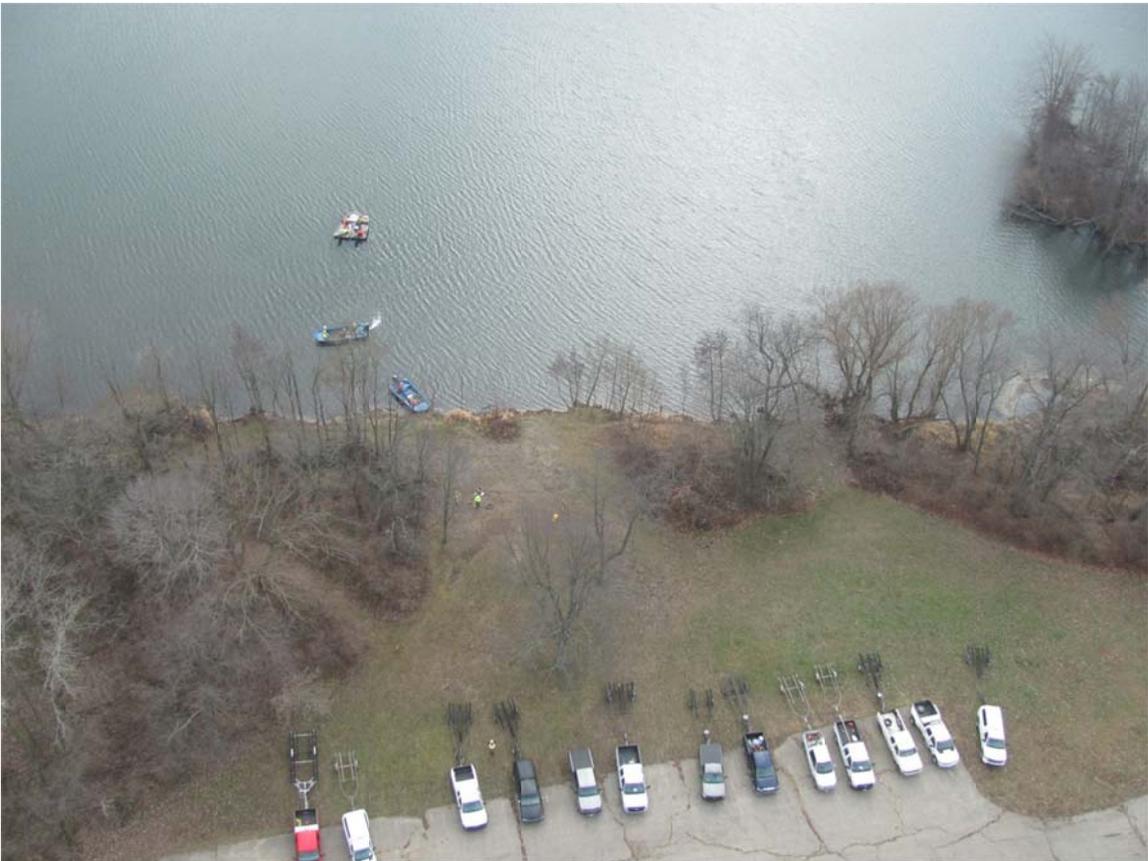
16. Observed bathymetry crews and survey equipment along RDB at former E4.0 boom location.

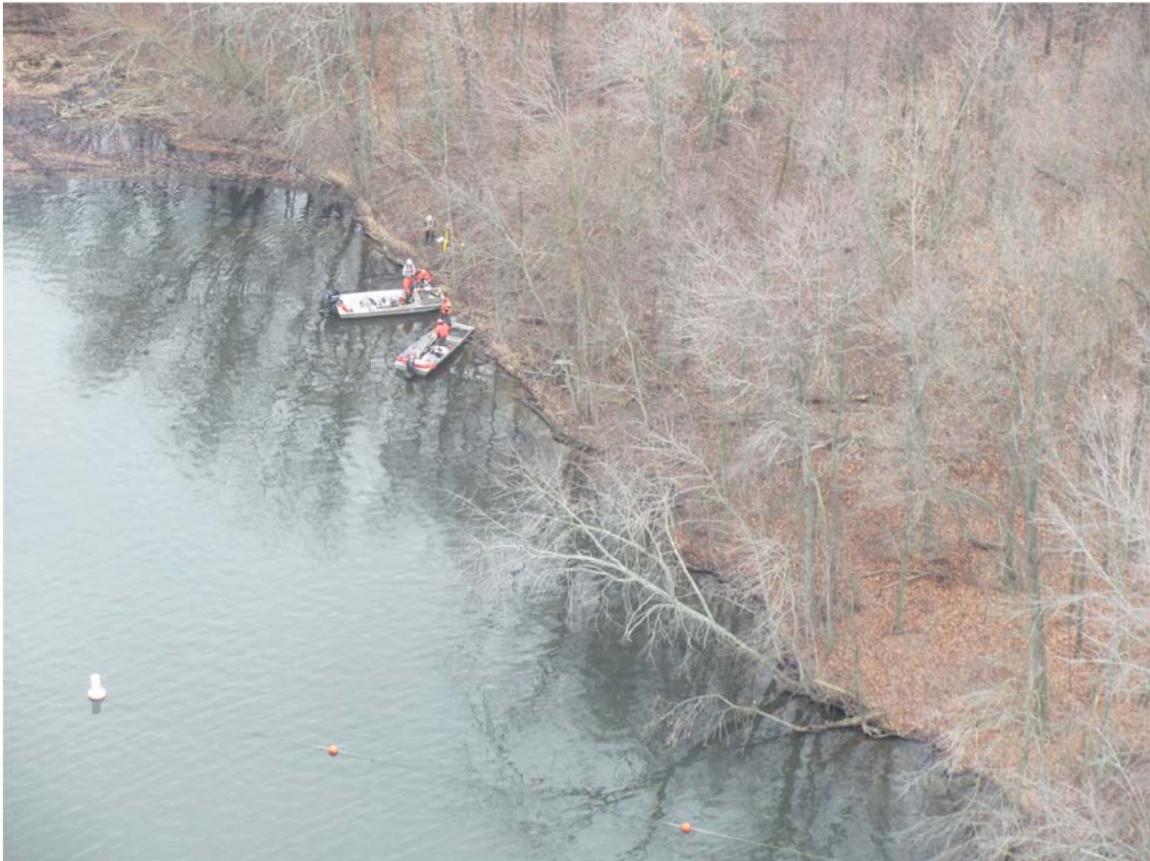
17. MP37.75, bathymetry crews observed along LDB.

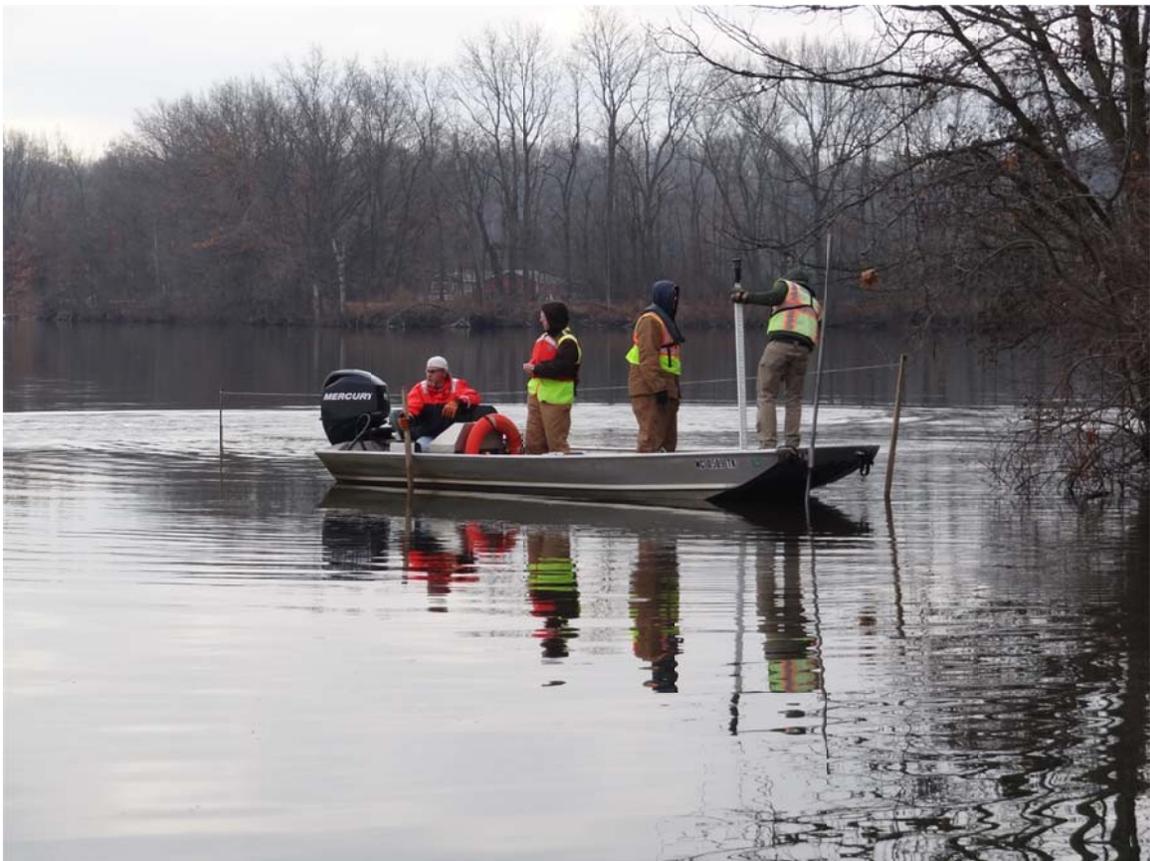
18. Bathymetry crew operating in morning near former location of C Boom west.
