# Situation Photo Log

Wednesday, December 20, 2012

Kalamazoo River / Enbridge Spill

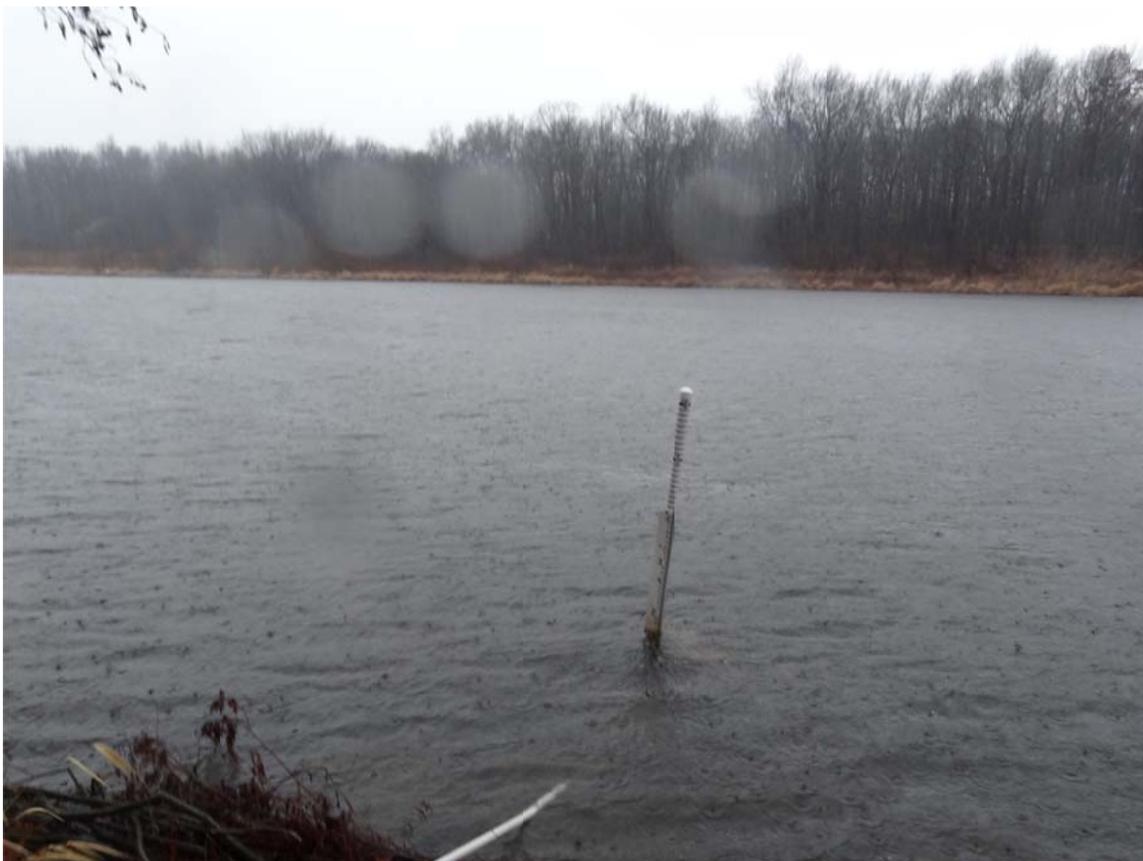
1. Water gauge at C0.4 boat launch. No sheen or ice observed in inclement weather conditions.

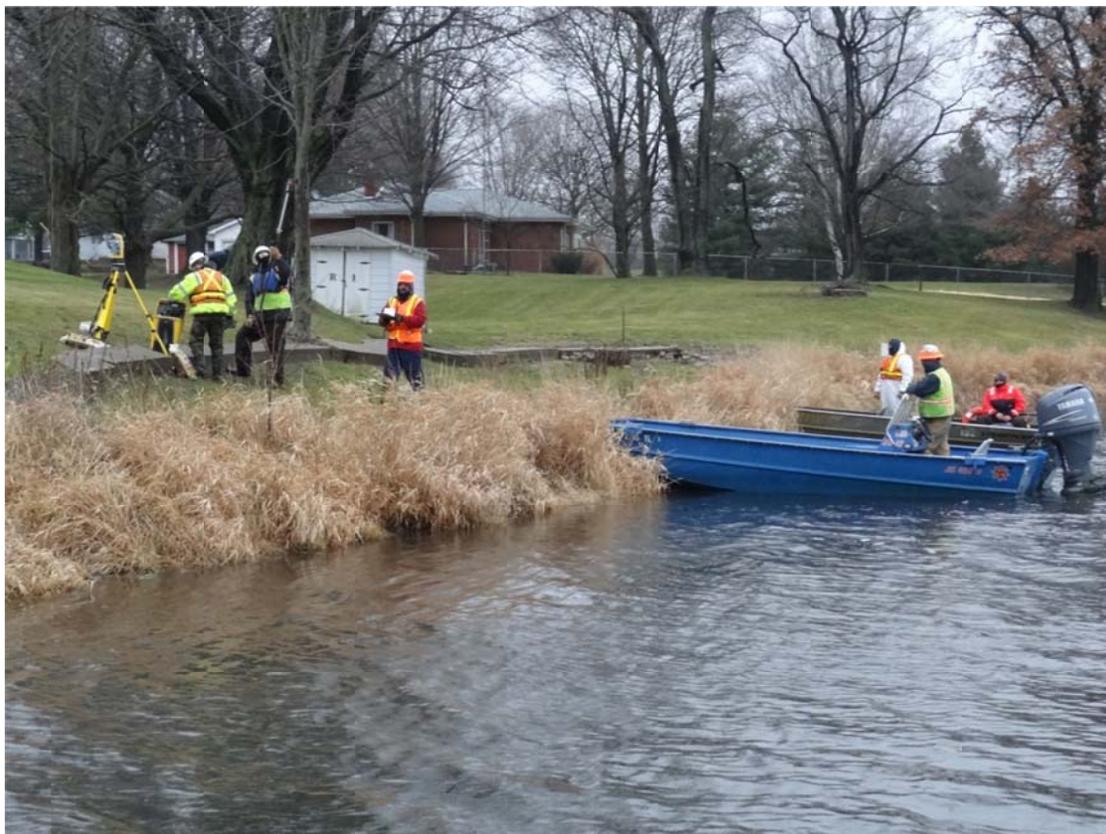
2. MP 5.63 RDB, bathymetry crews return to Ceresco Dam to re-survey some bathymetry points.

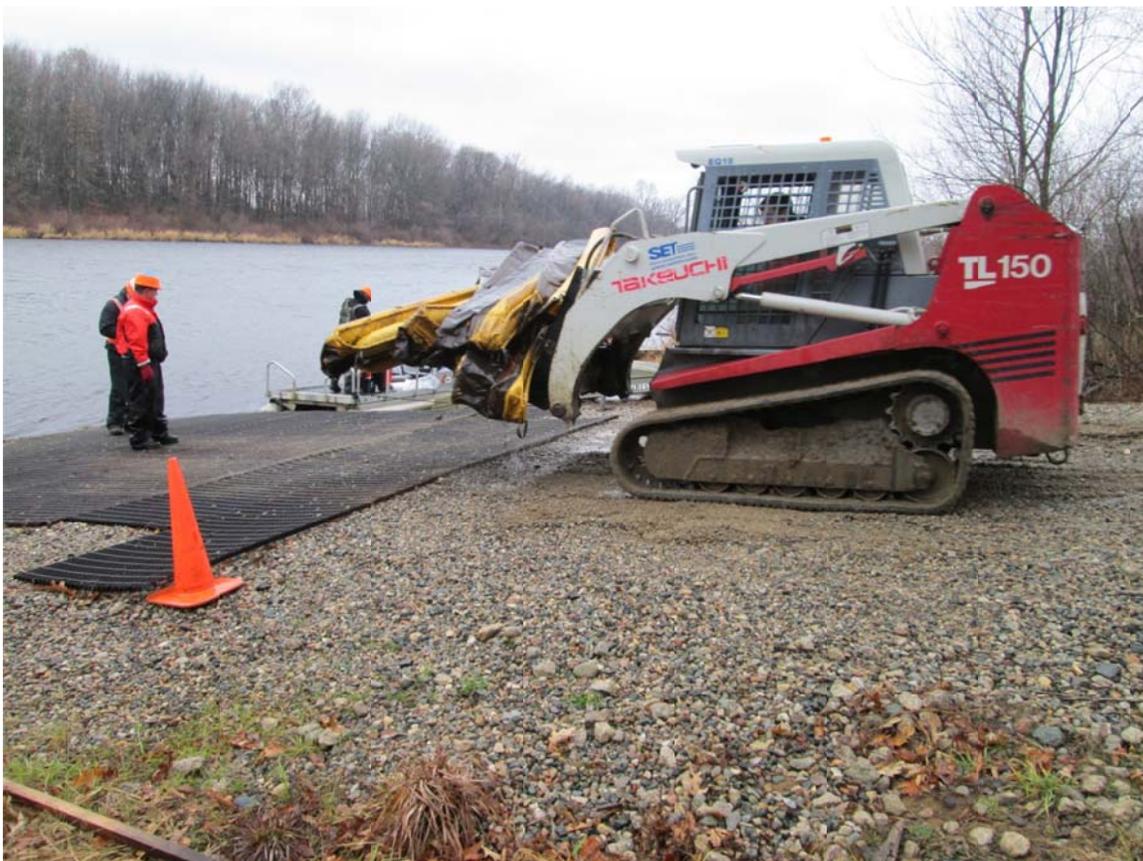
3. C0.4 boat launch. Containment crews observed removing control point boom from Ceresco Dam. Boom placed in roll-off box for disposal.

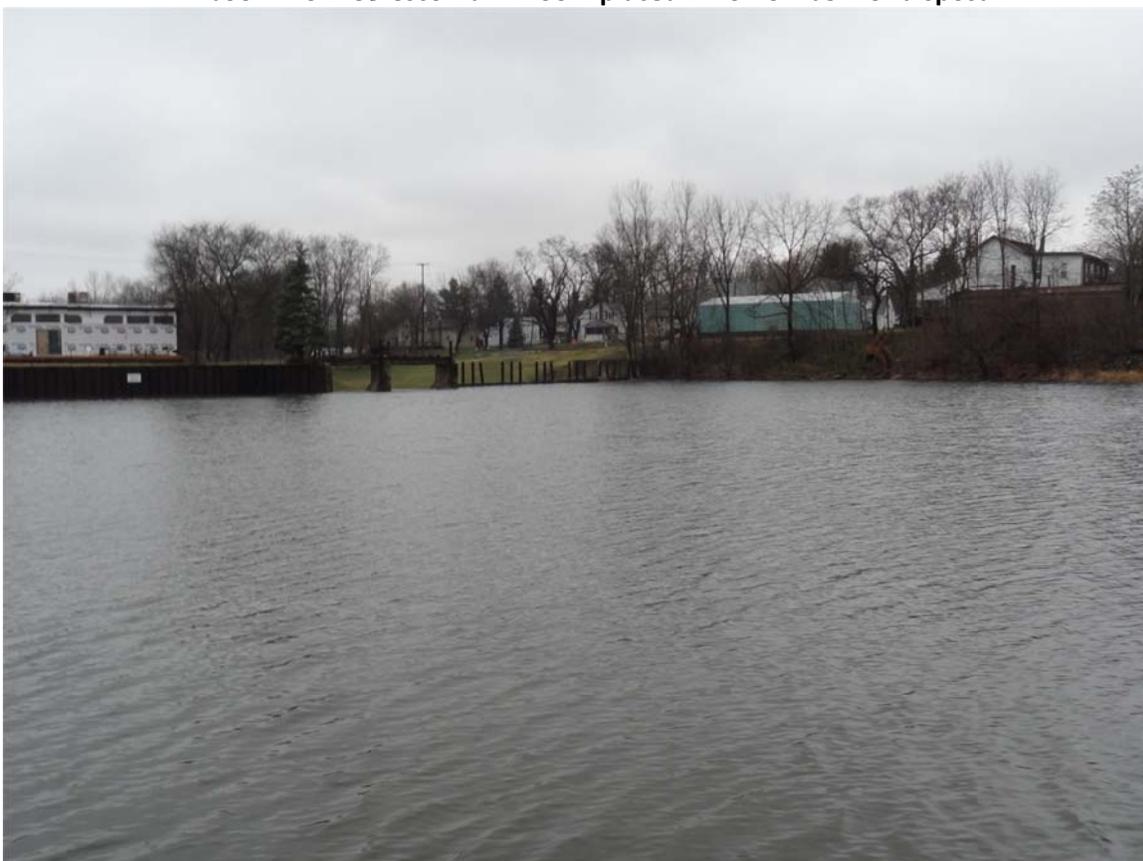
4. Ceresco Dam following removal of control point boom above dam.

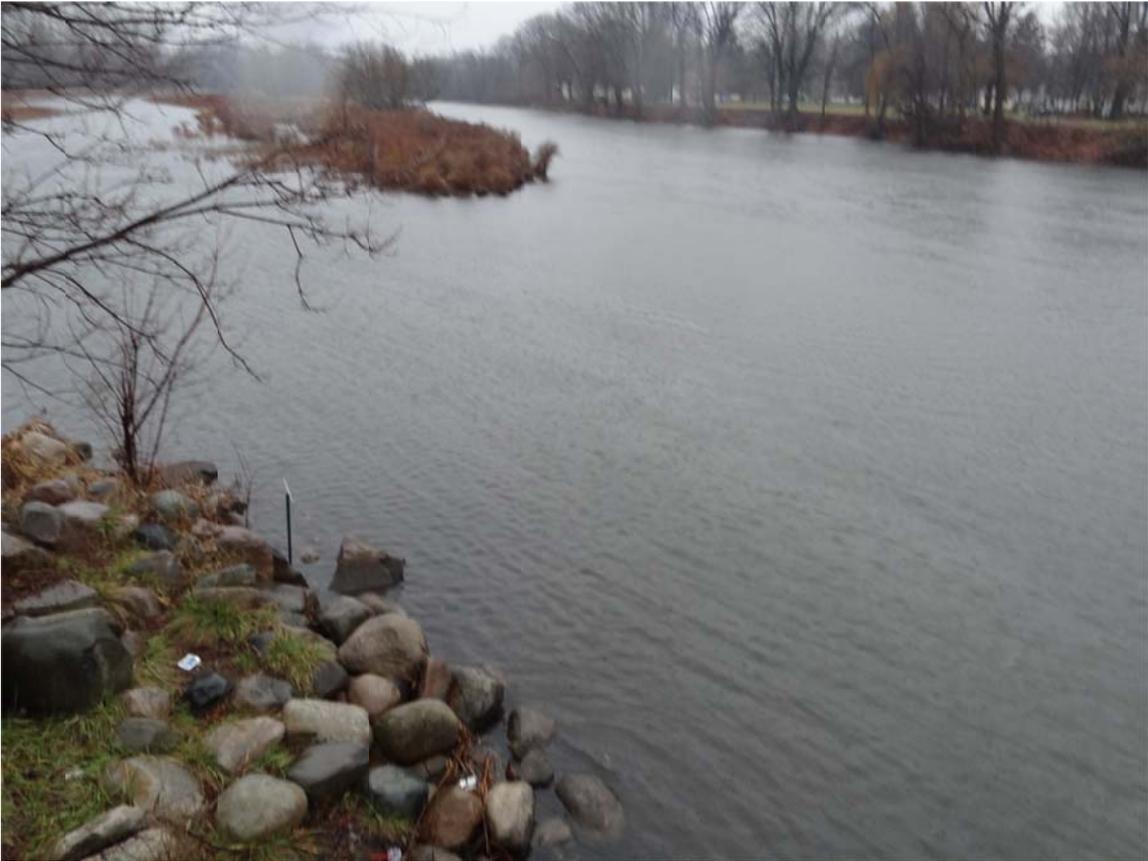
5. MP 15.50 South Mill Pond, no sheen or ice observed.

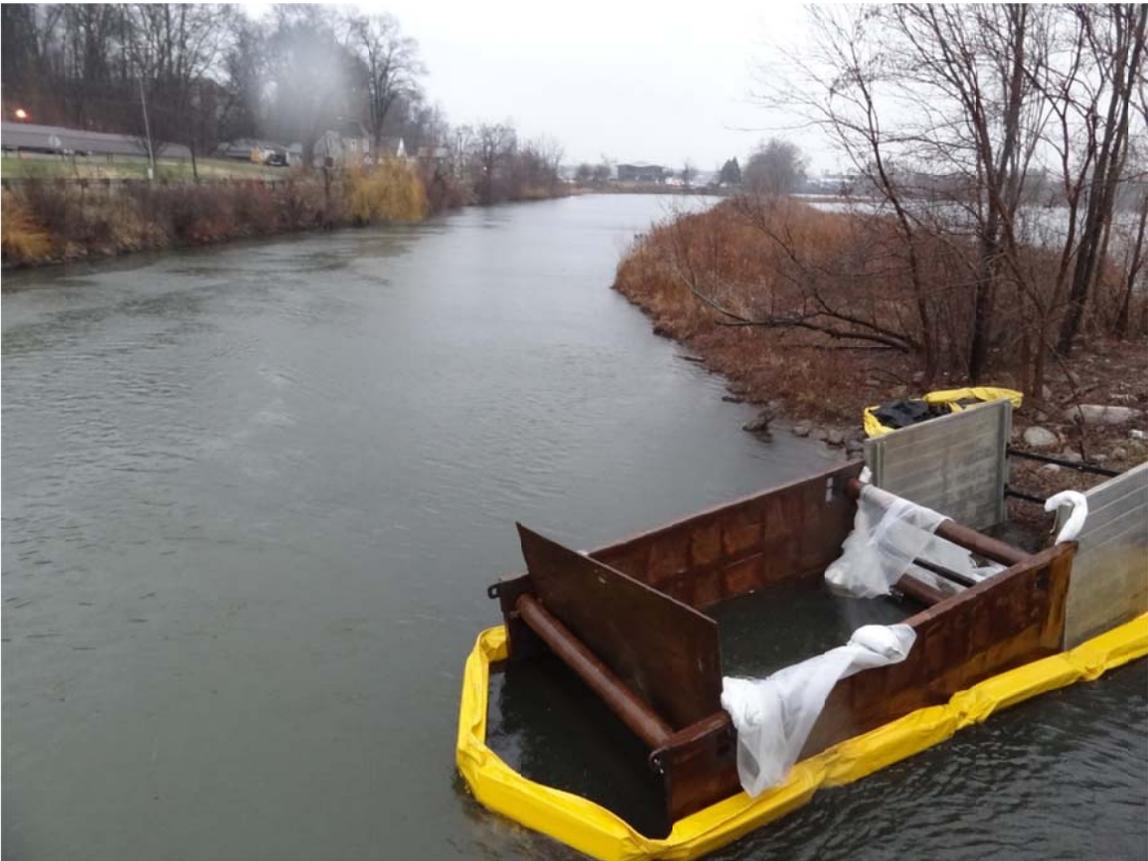
6. MP 15.5 North Mill Pond, no sheen or ice observed.

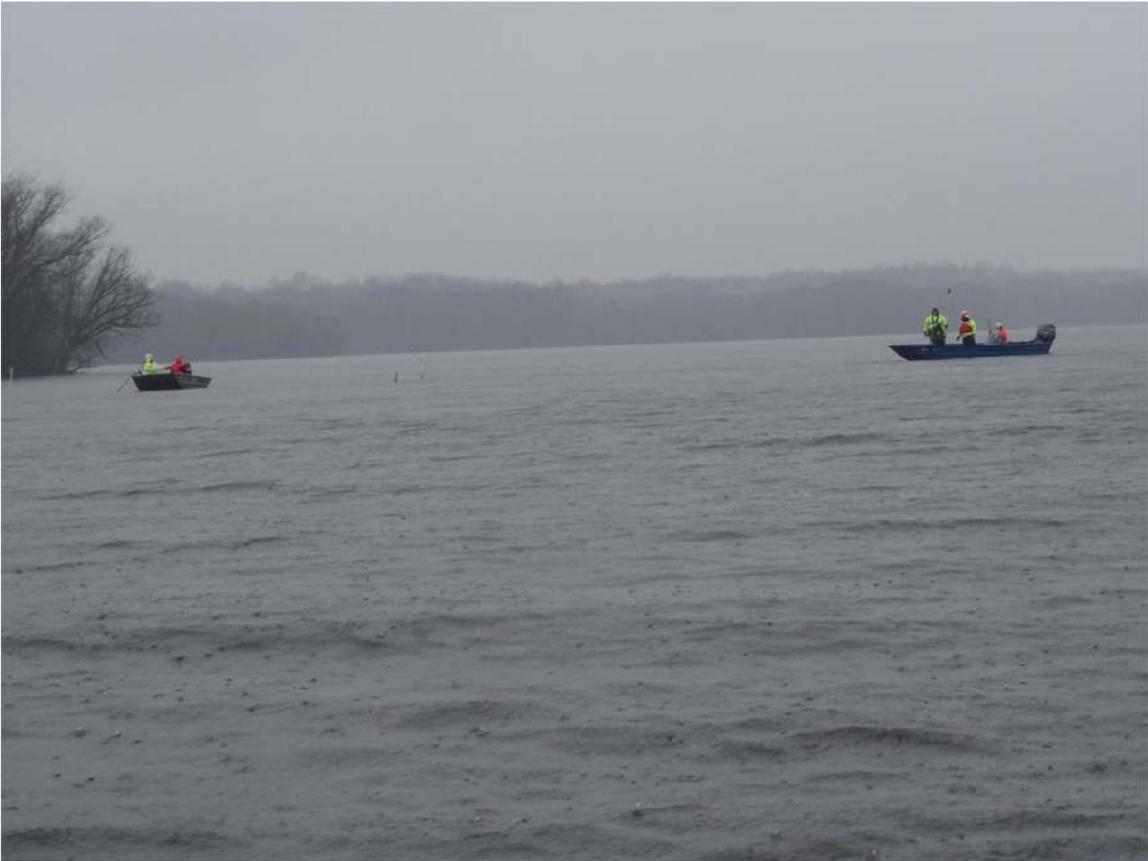
7. Bathymetry crews working in morning in Morrow Lake Delta. Work was shut down mid-day due to high winds and heavy rain.

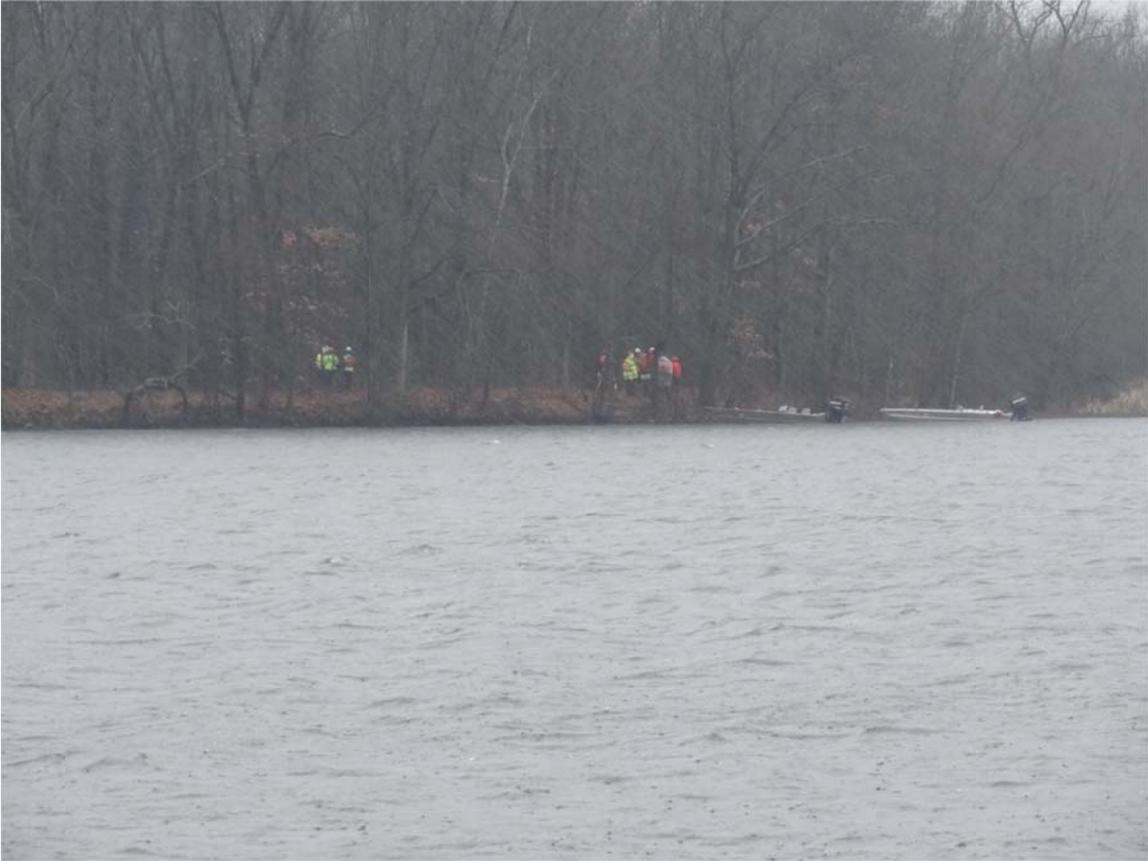
8. Bathymetry crews on shore in Morrow Lake Delta.
