Situation Photo Log

Saturday, December 22, 2012

Kalamazoo River / Enbridge Spill

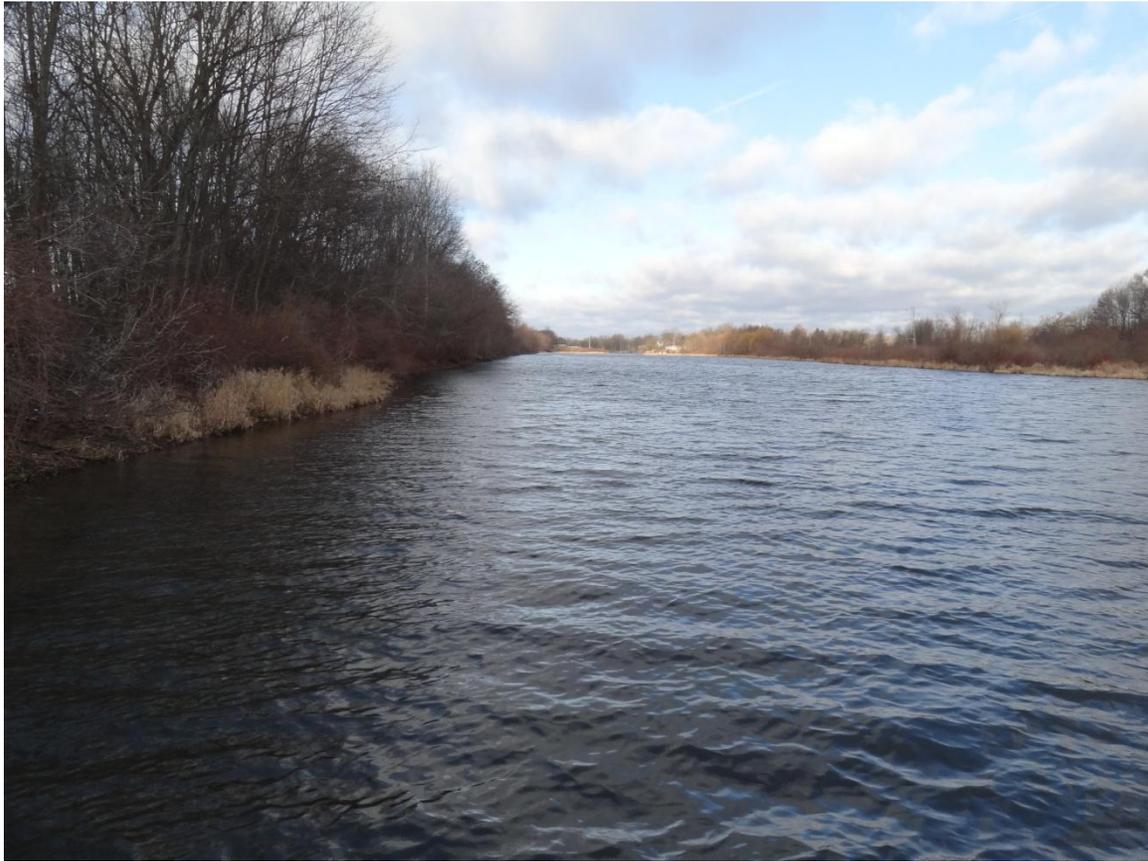
1. MP 5.25 LDB, no ice observed along river bank.

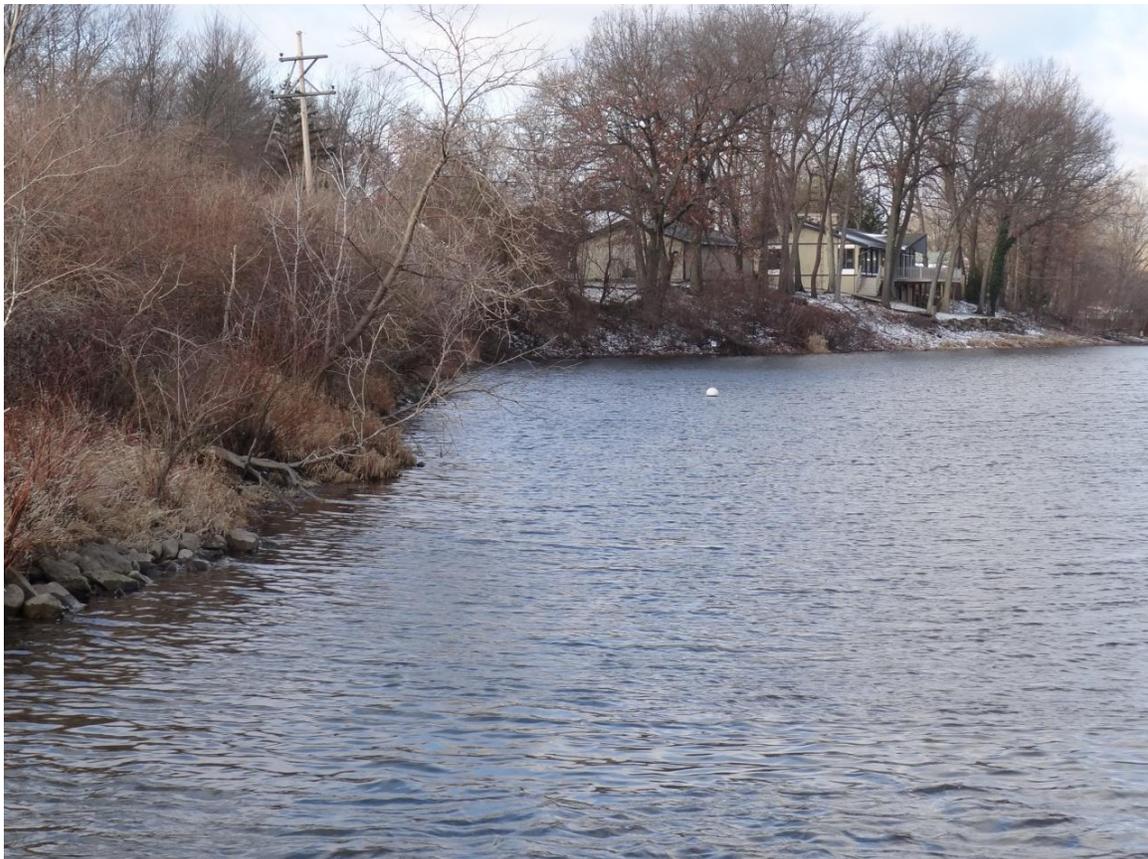
2. MP 5.63 LDB, no ice observed along river bank.

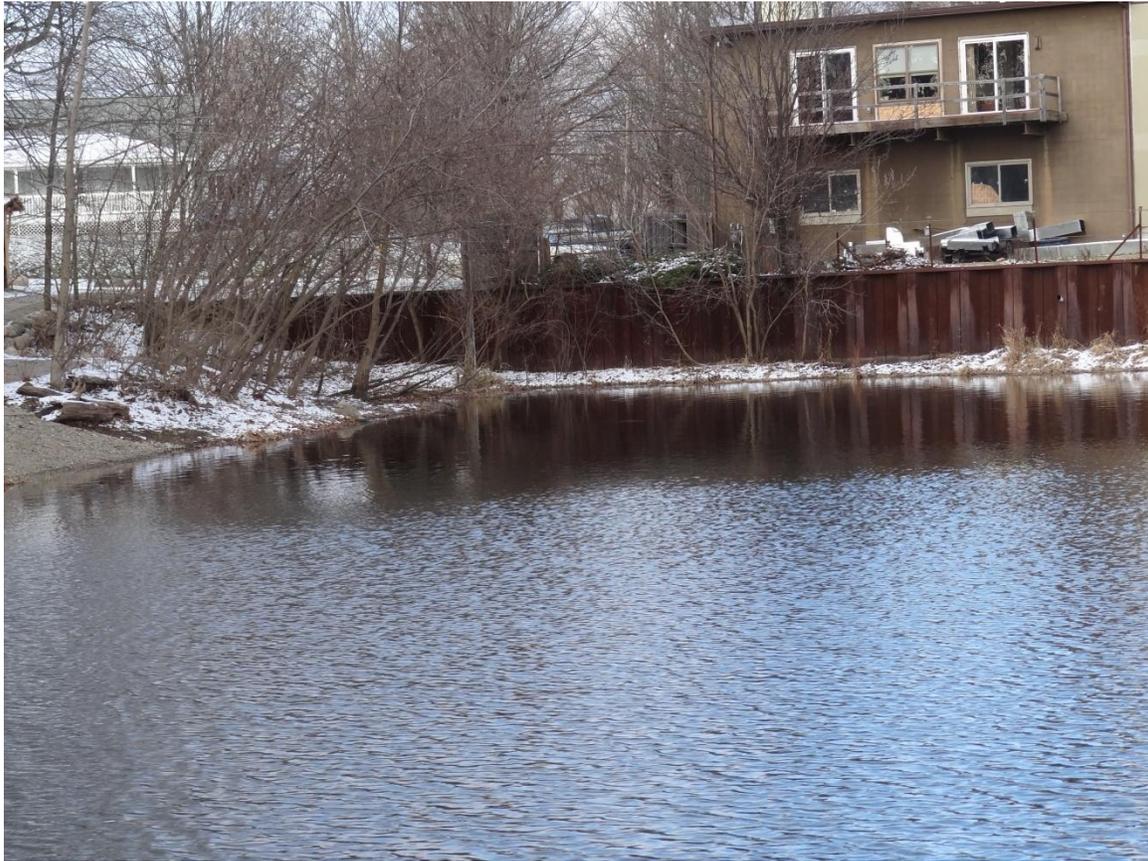
3. Ceresco Dam, no ice observed.

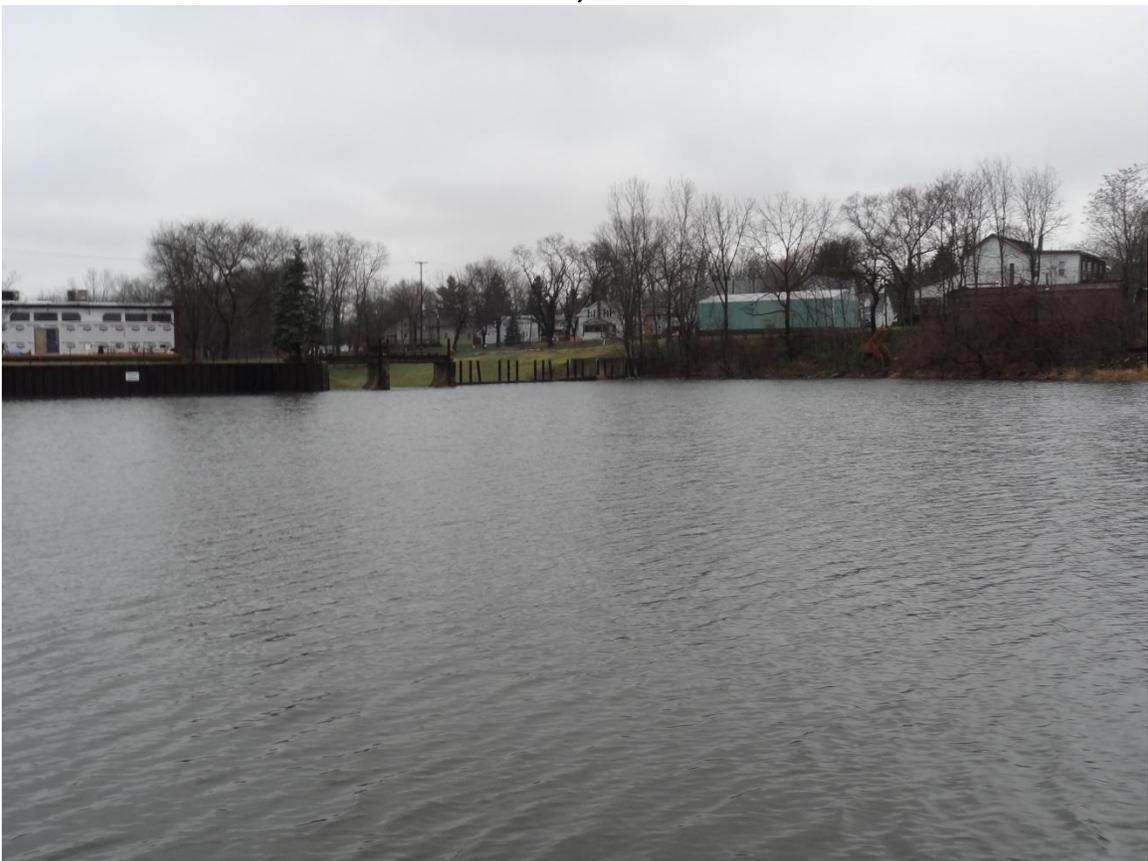
4. Ceresco Dam, no ice observed.

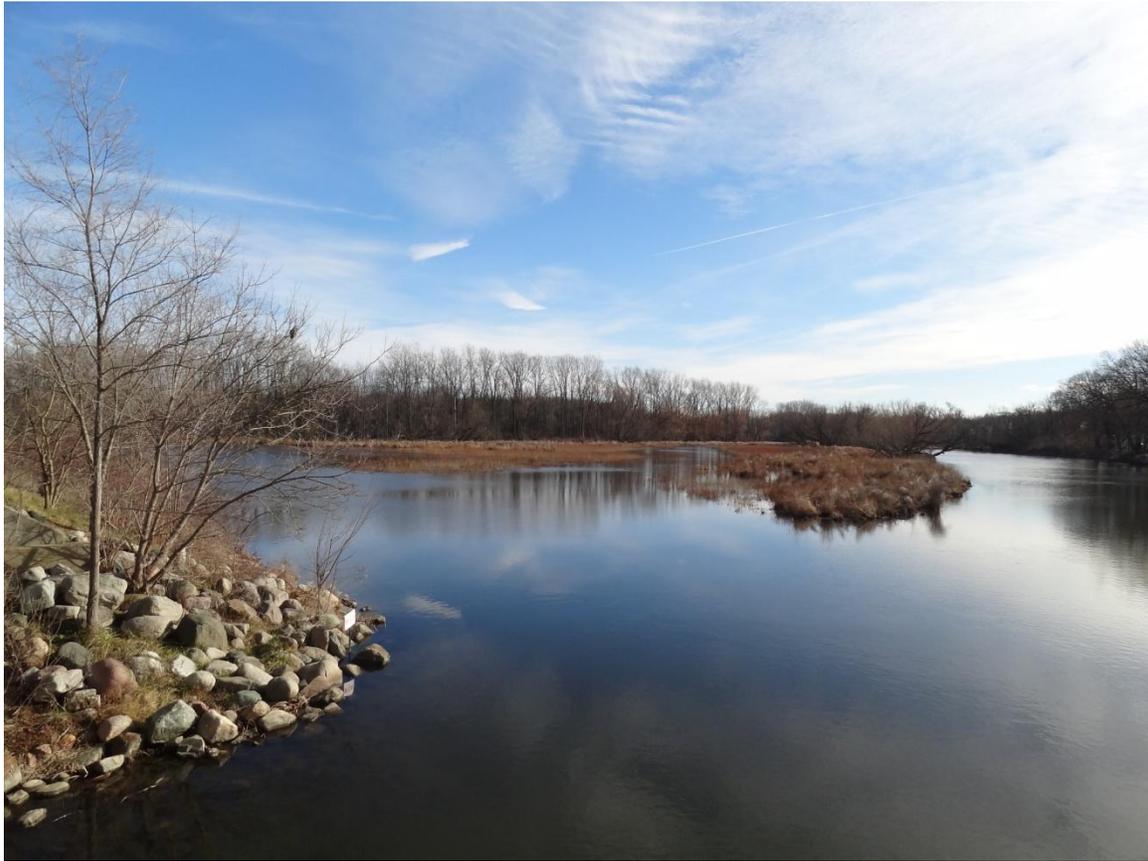
5. MP 15.50 South Mill Pond, no ice observed.

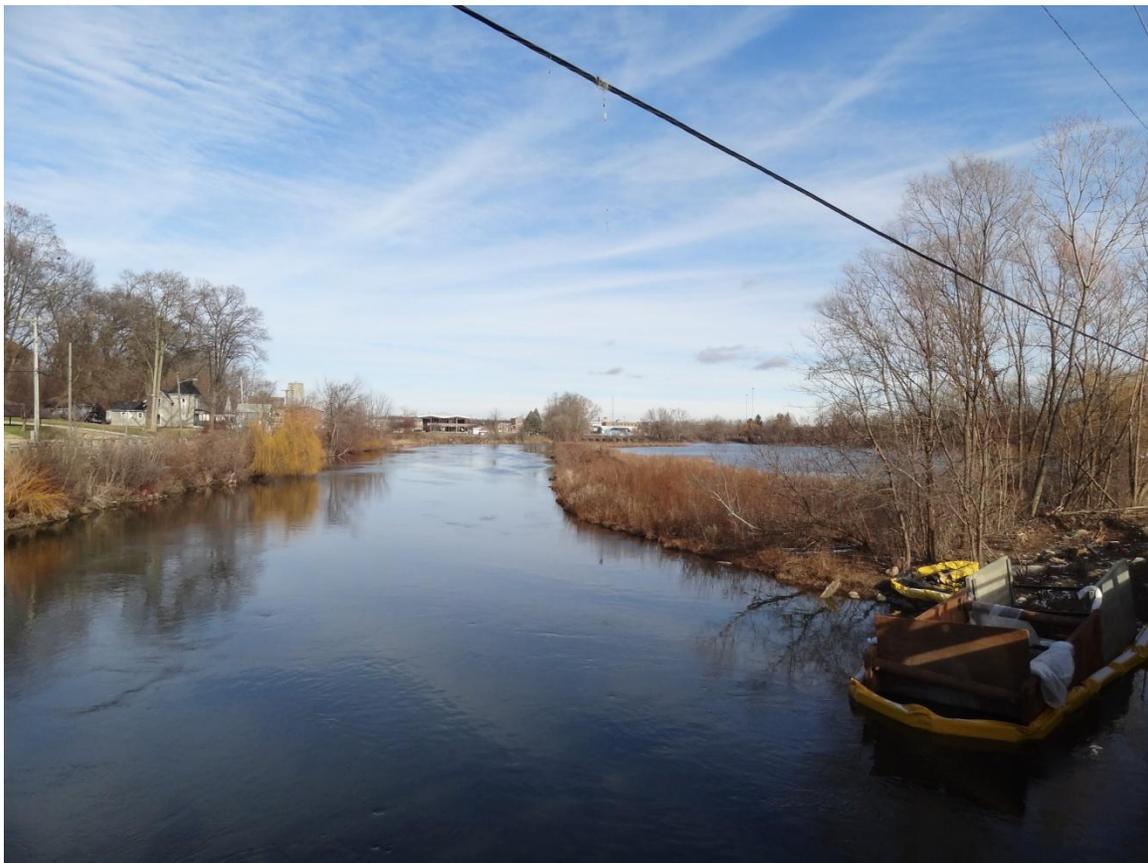
6. MP 15.5 North Mill Pond, no ice observed.

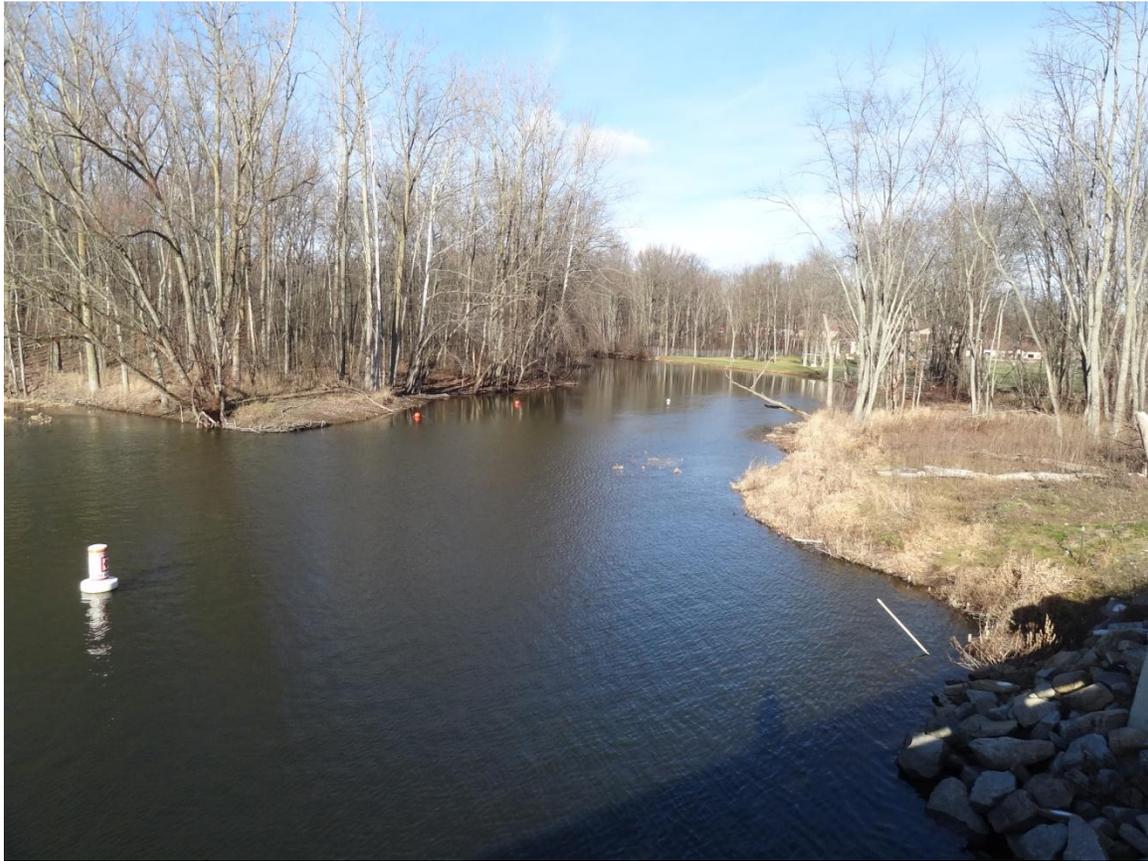
7. MP 21.5 RDB Sediment Trap, no ice observed forming in backchannel.

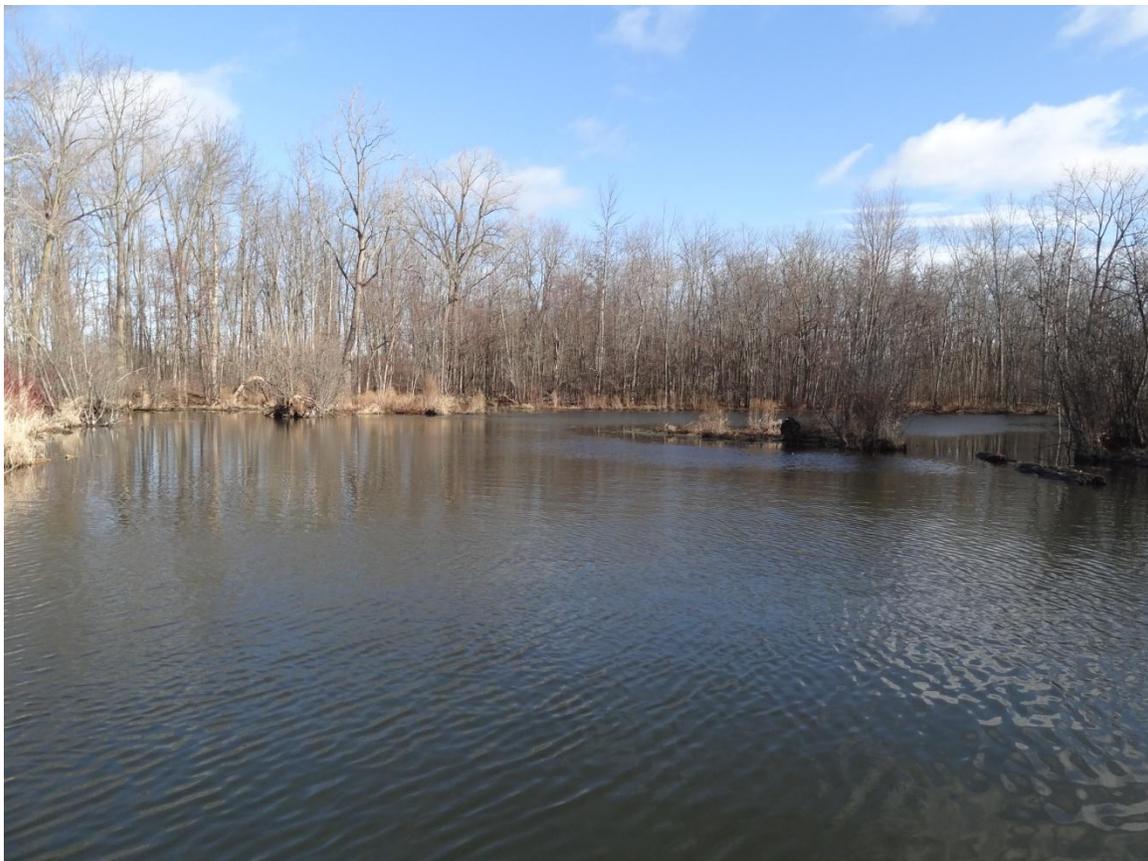
8. MP 36.5 RDB, no ice observed forming in backwater.

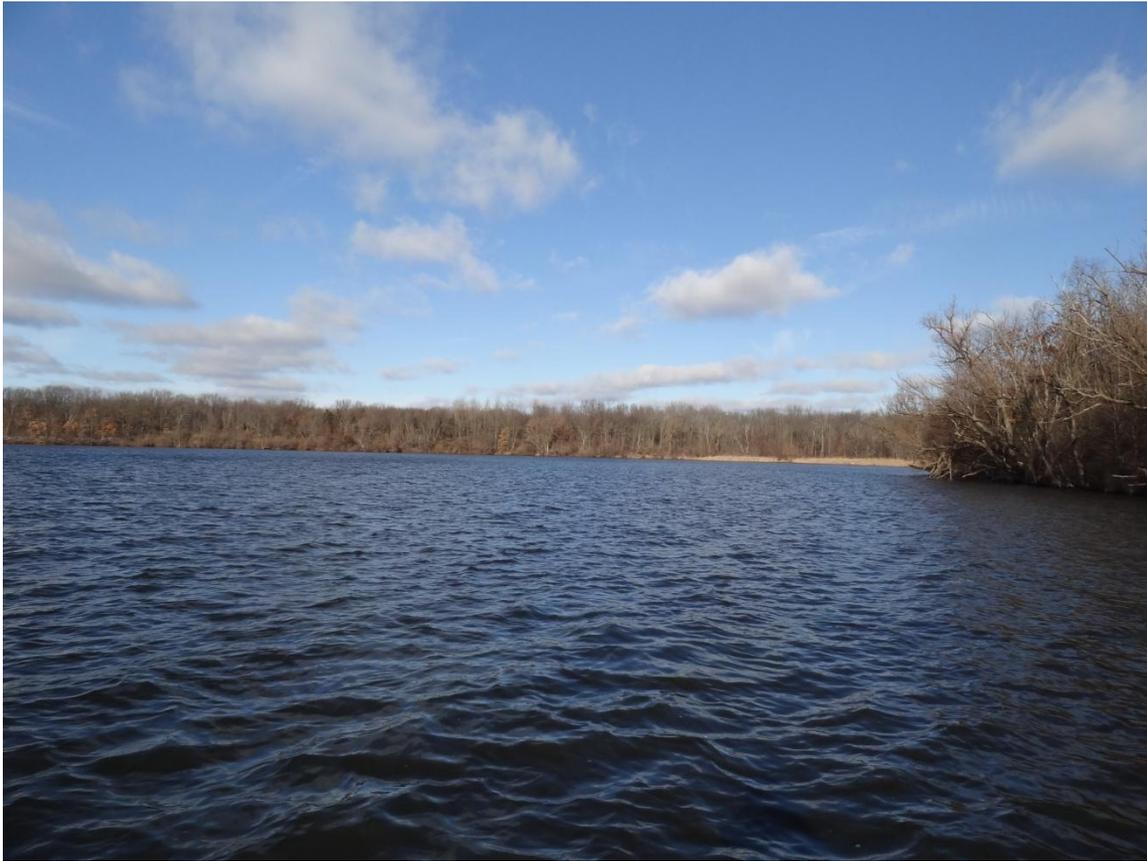
9. Morrow Lake North Cove, no ice observed.

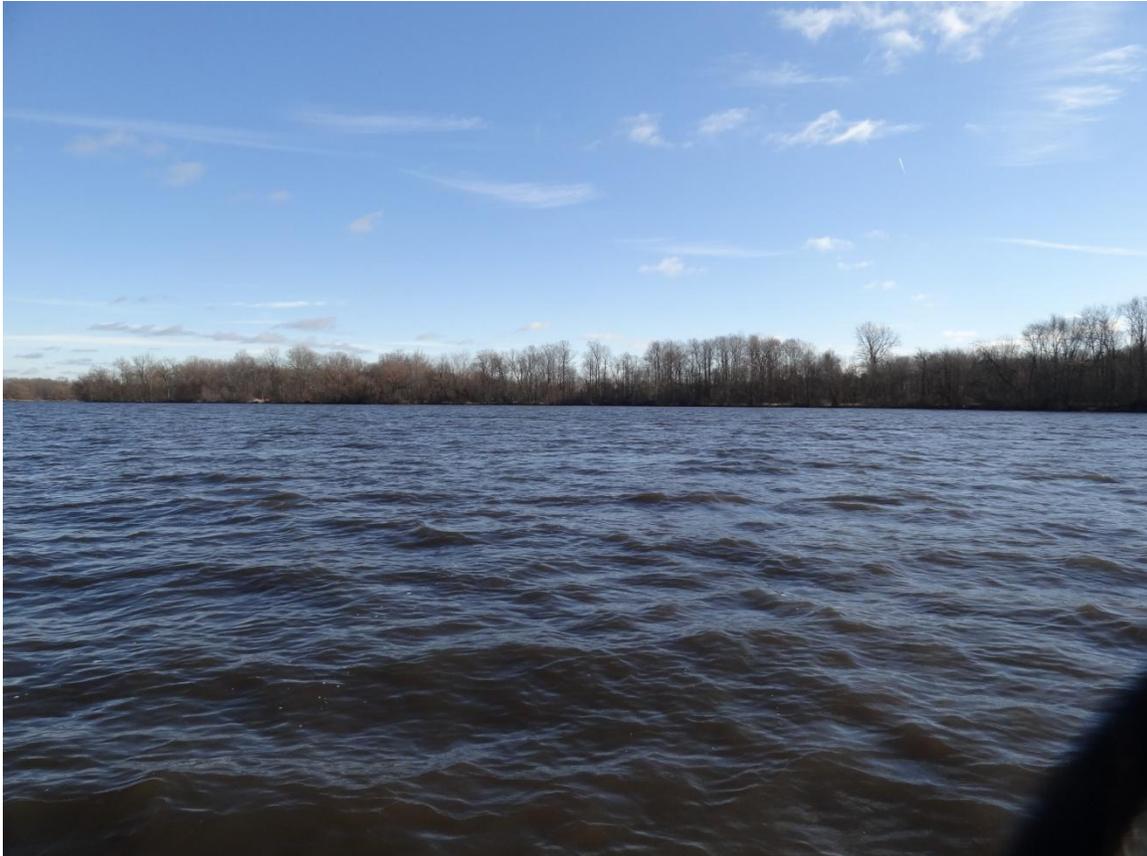
10. Morrow Lake South Cove, no ice observed.
