Situation Photo Log

Thursday, December 27, 2012

Kalamazoo River / Enbridge Spill

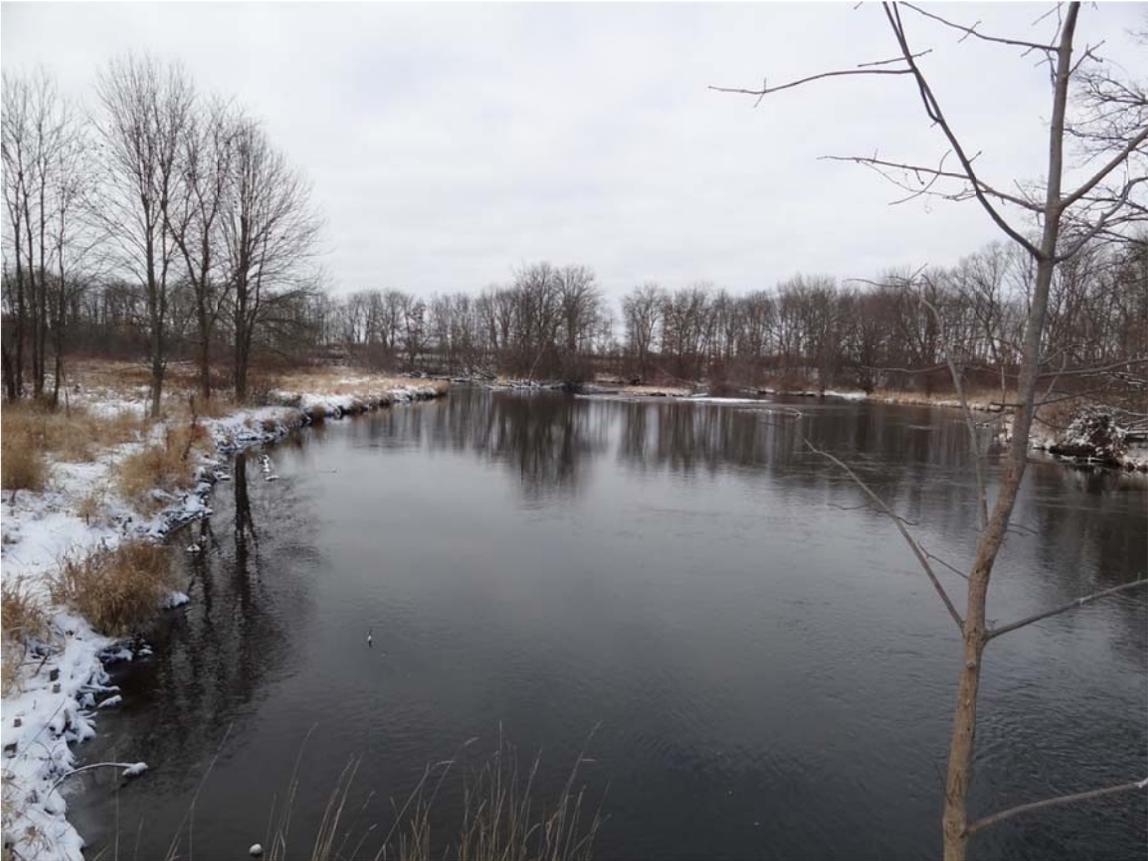
1. MP 2.25 LDB Saylor's Landing, no ice observed along river banks.

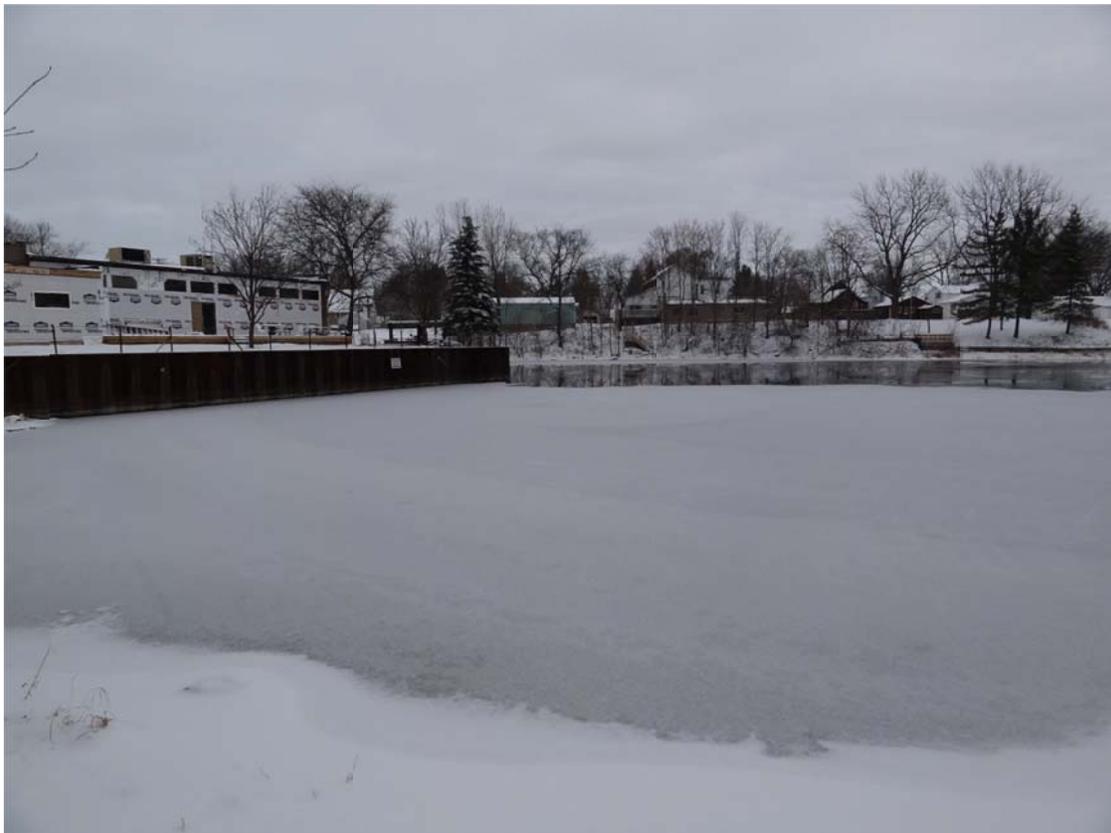
2. Ceresco Dam impoundment, ice and snow cover observed along both river banks. River channel remains open, with some ice and snow observed flowing downstream in channel.

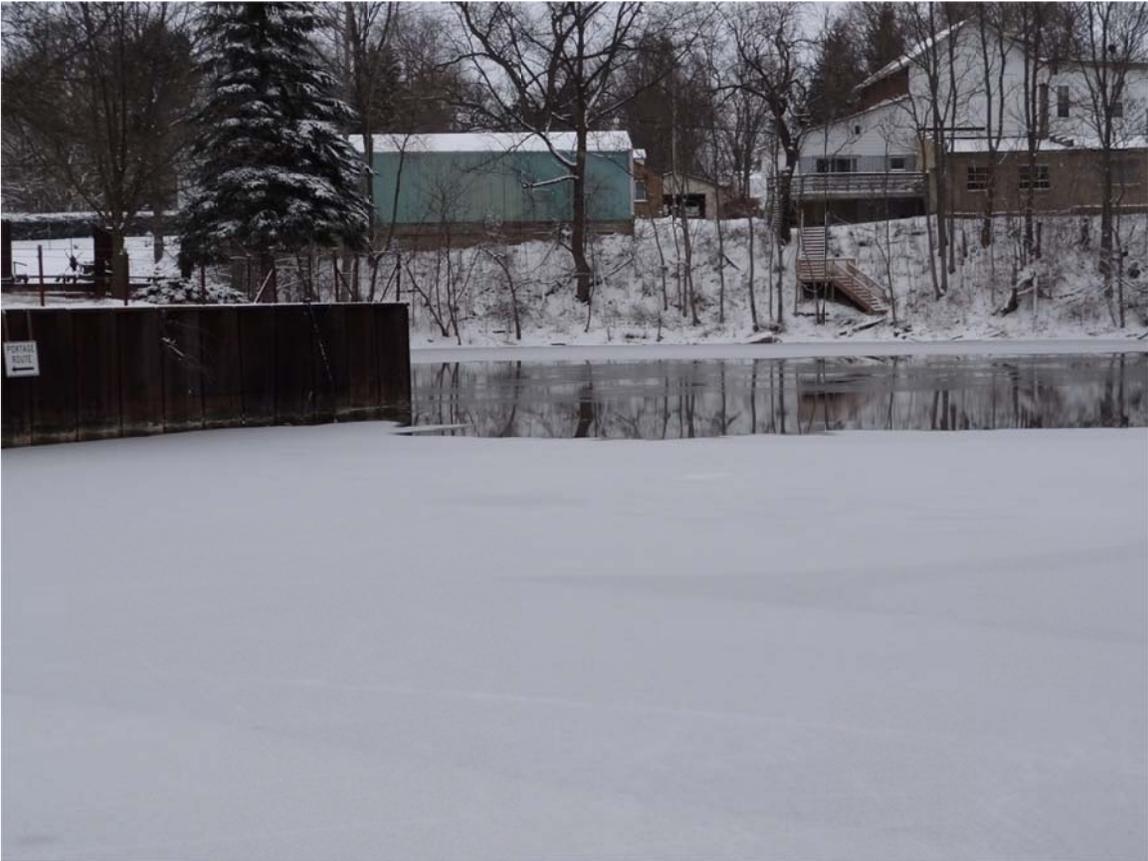
3. Ceresco Dam impoundment, some ice and snow observed flowing downstream in river channel.

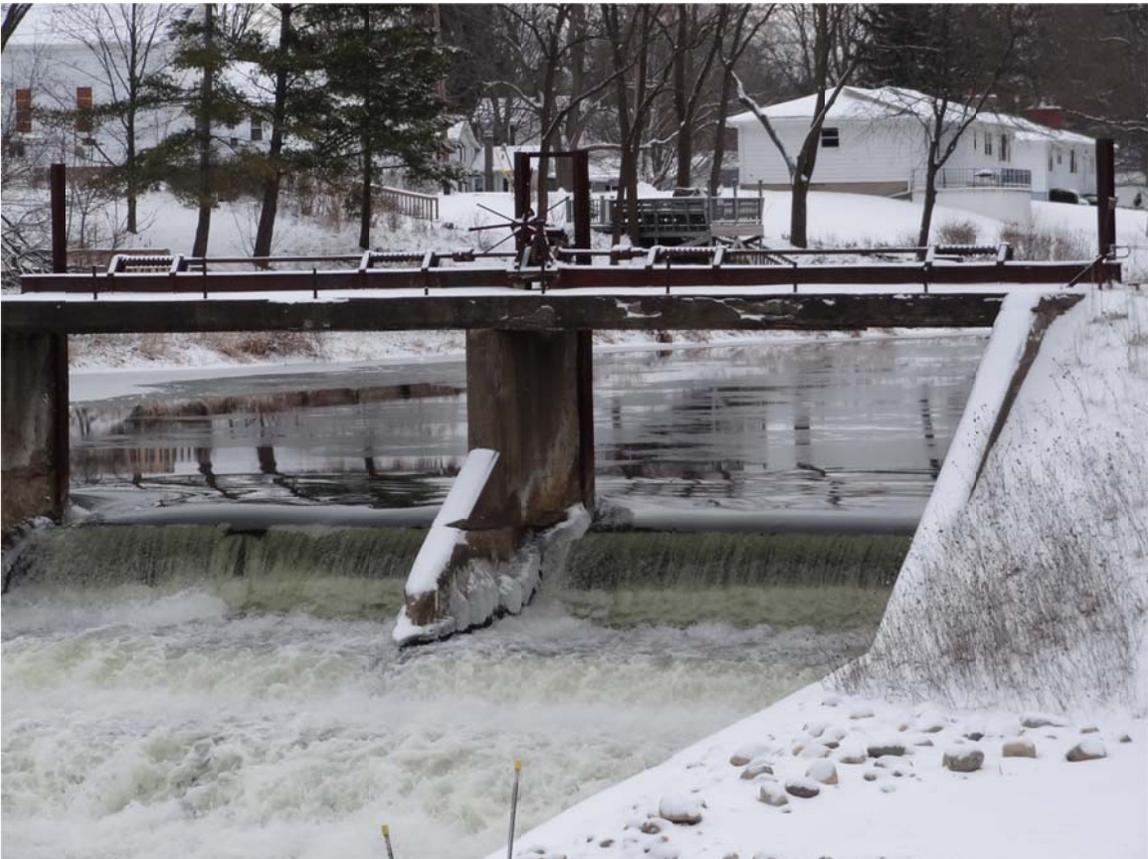
4. Ceresco Dam, some patches of ice and snow observed flowing over spillway.

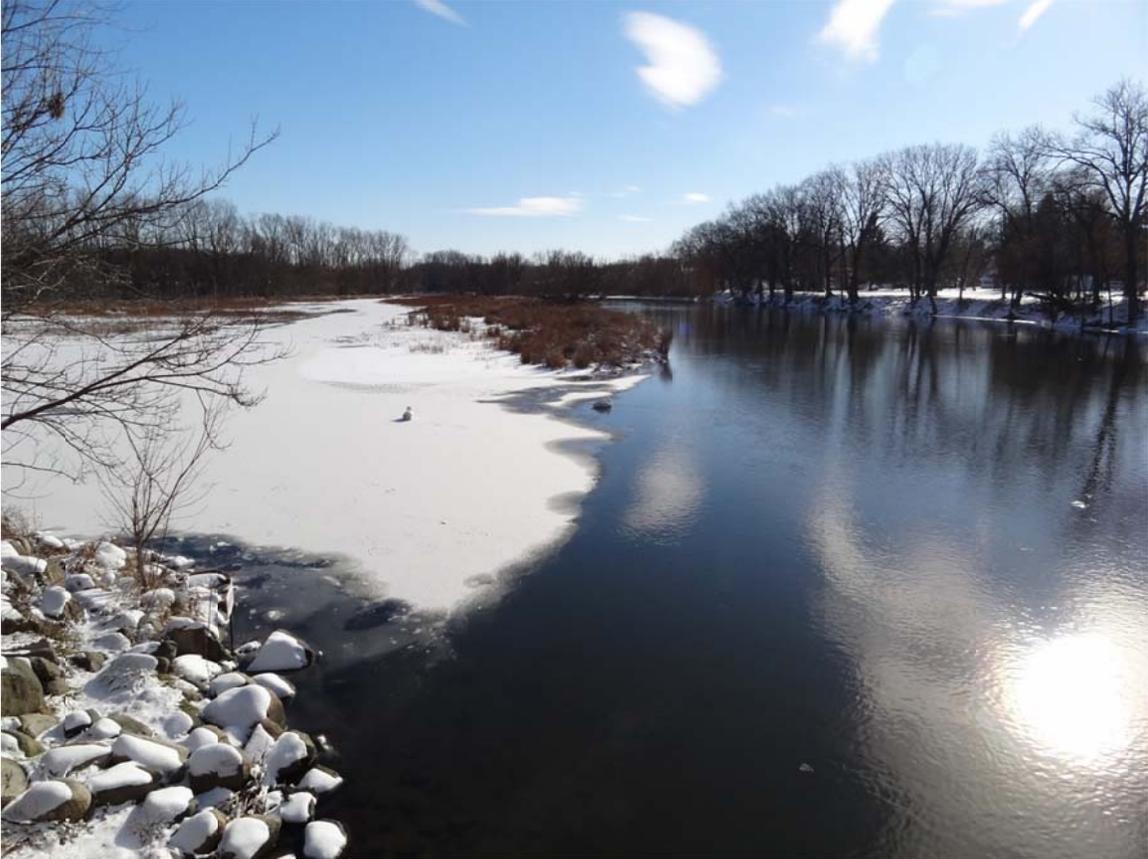
5. MP 15.50 South Mill Pond, eastern back water area is covered with ice and snow, river channel remains open. No sheen observed.

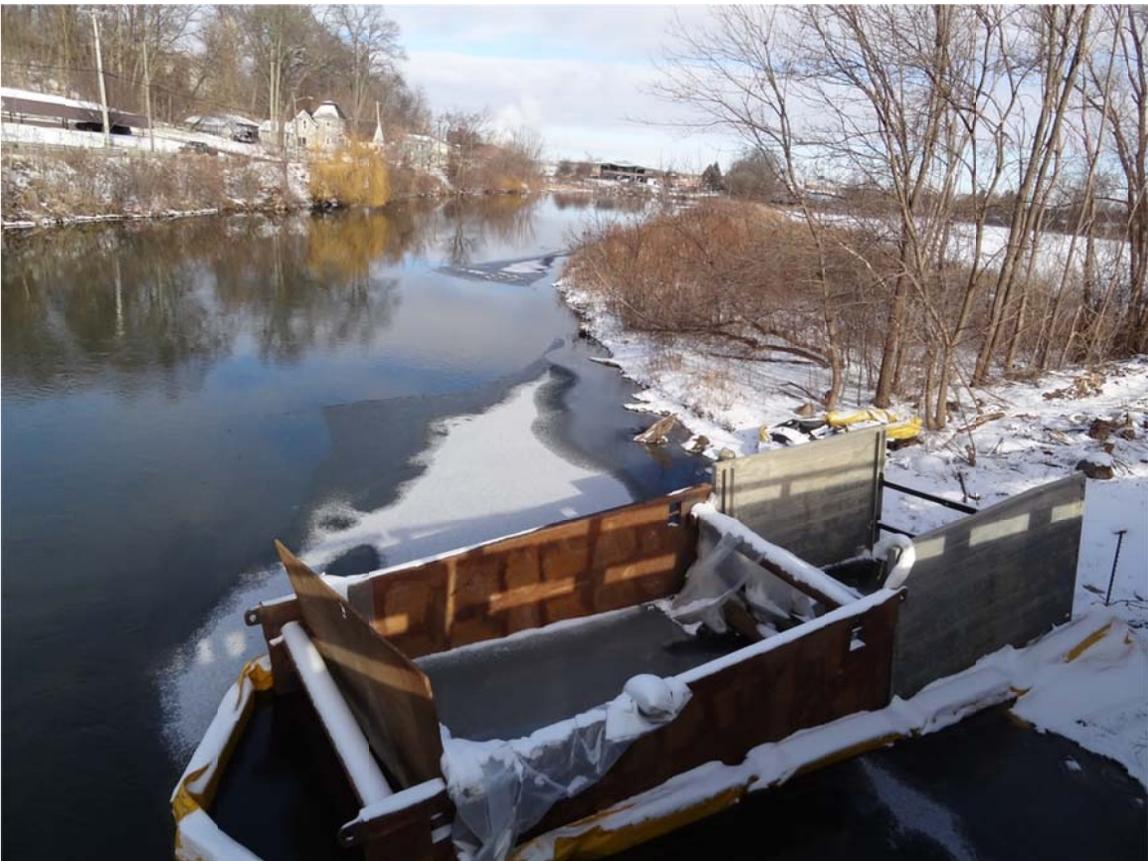
6. MP 15.5 North Mill Pond, river channel remains open.

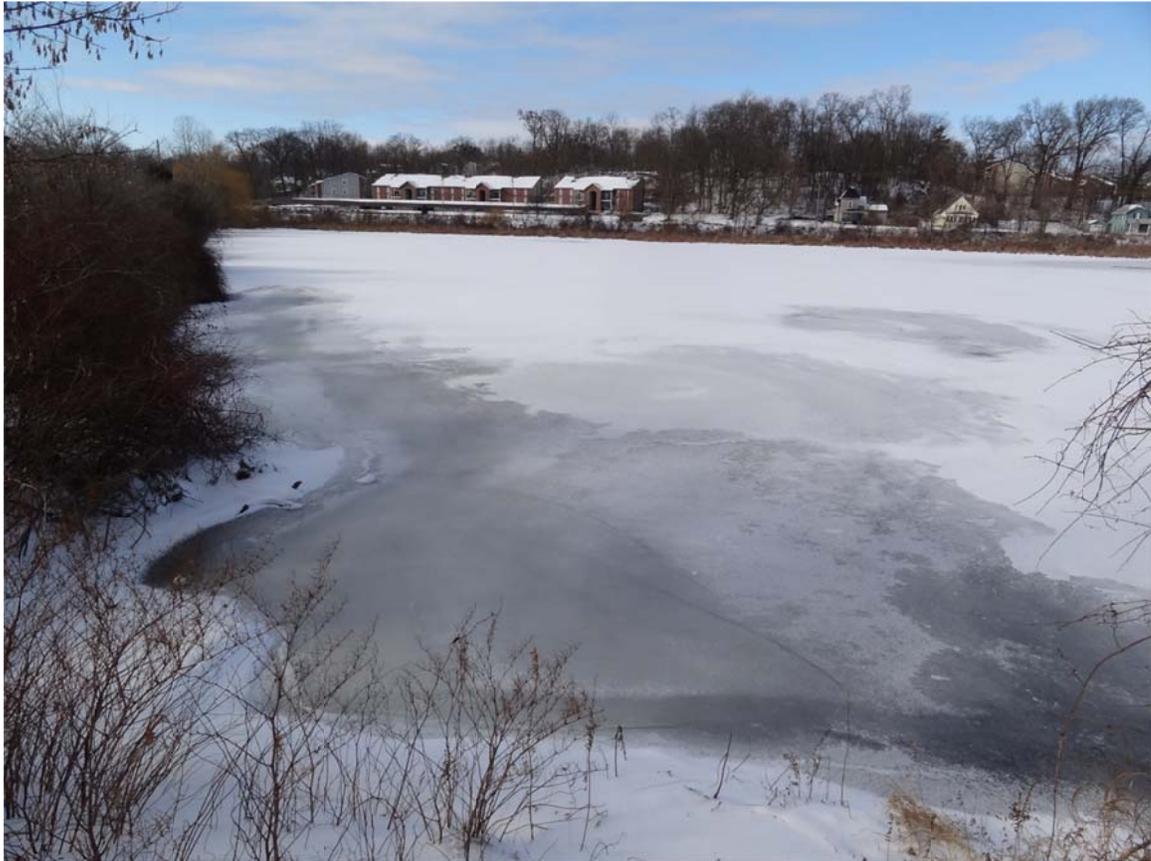
7. MP 15.50 eastern portion of North Mill Pond. Back water area covered with ice and snow. No sheen observed.

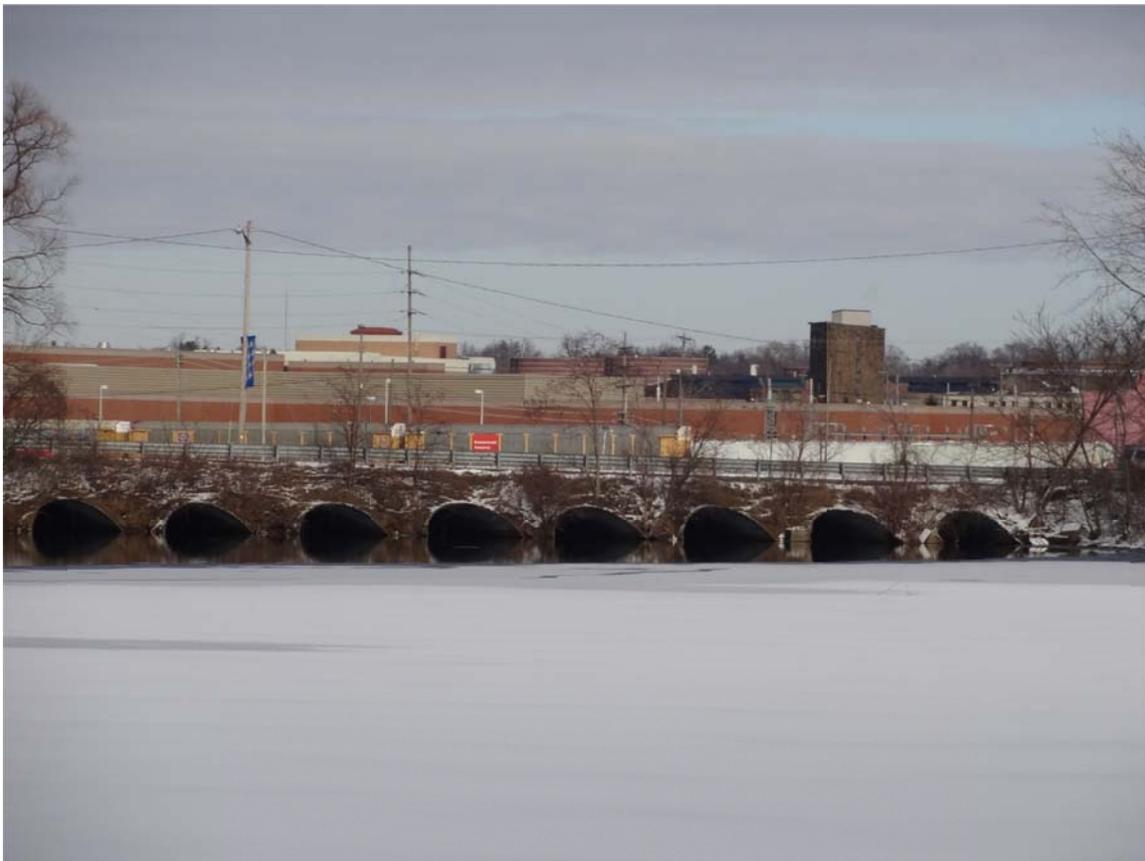
8. MP 15.75 North Mill Pond culverts, no ice build-up observed. River channel remains open.

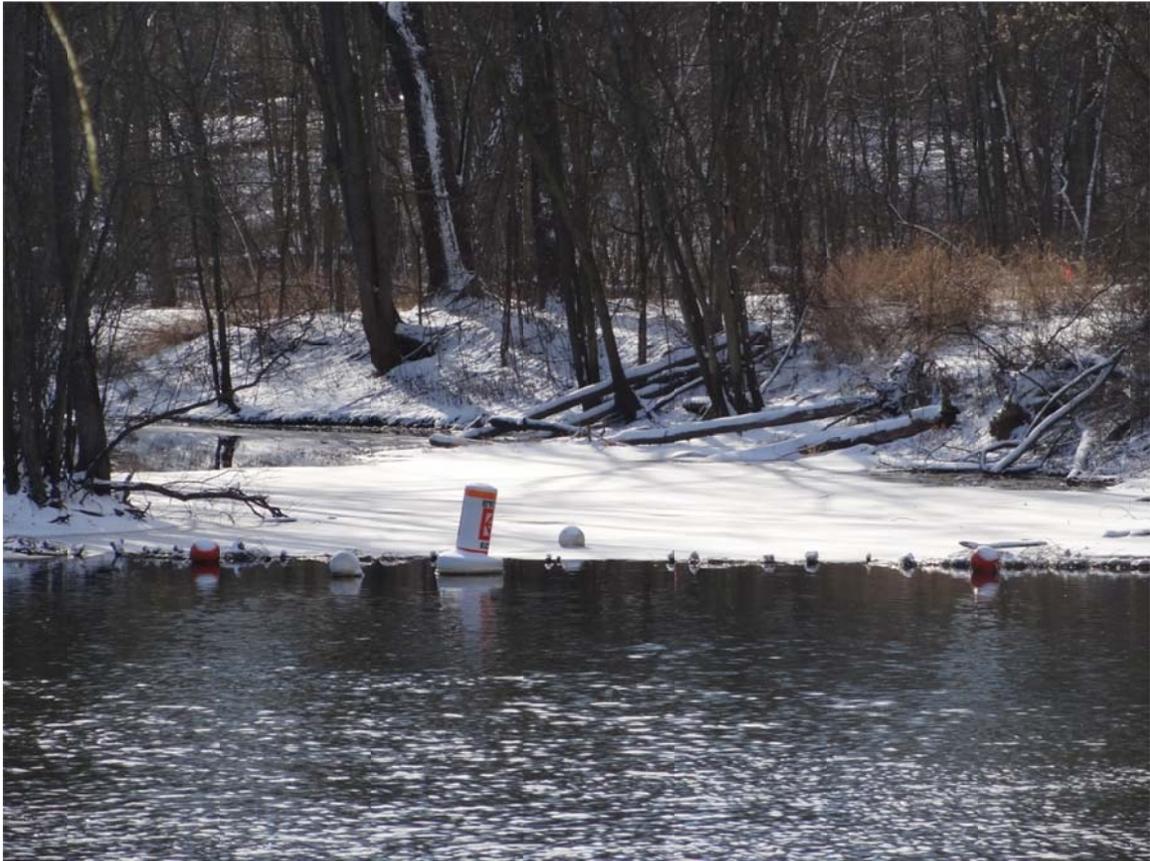
9. MP 19.25 LDB Sediment Trap, snow and ice cover observed in back channel.

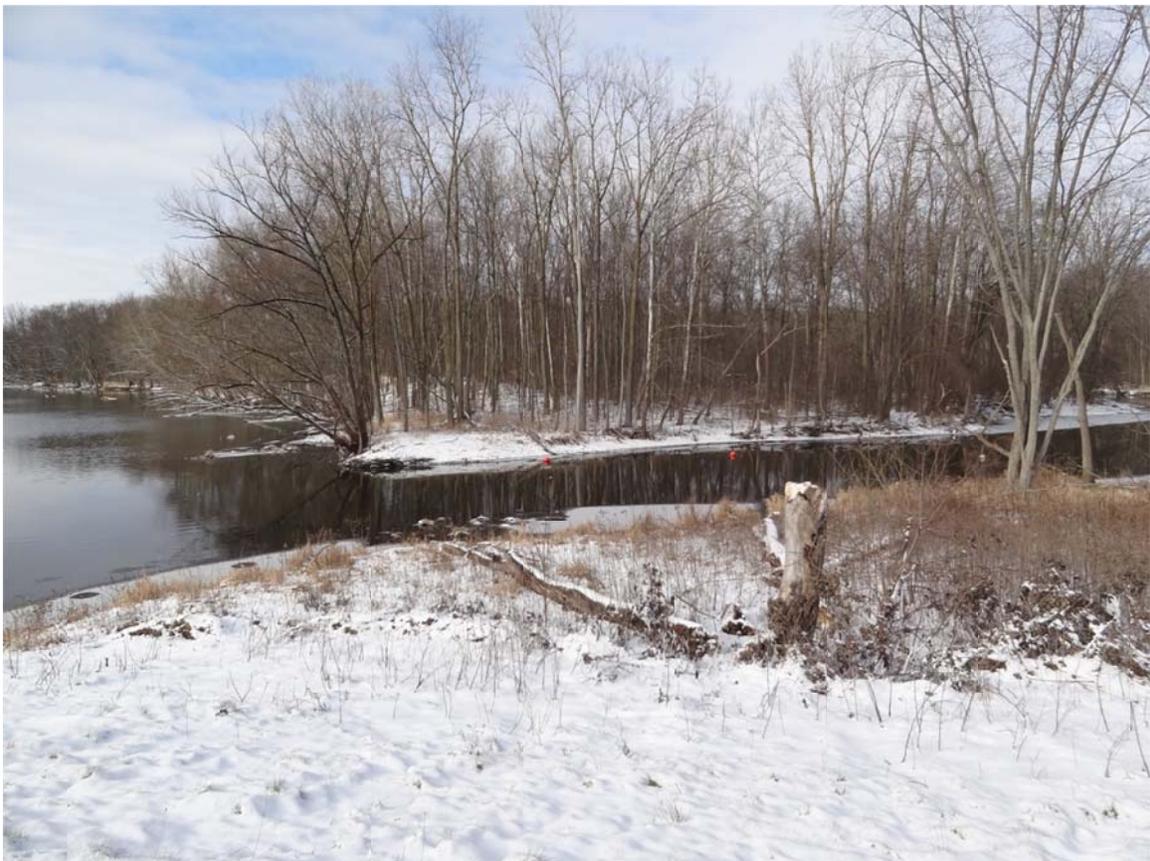
10. MP 21.5 RDB, no ice observed in back channel.

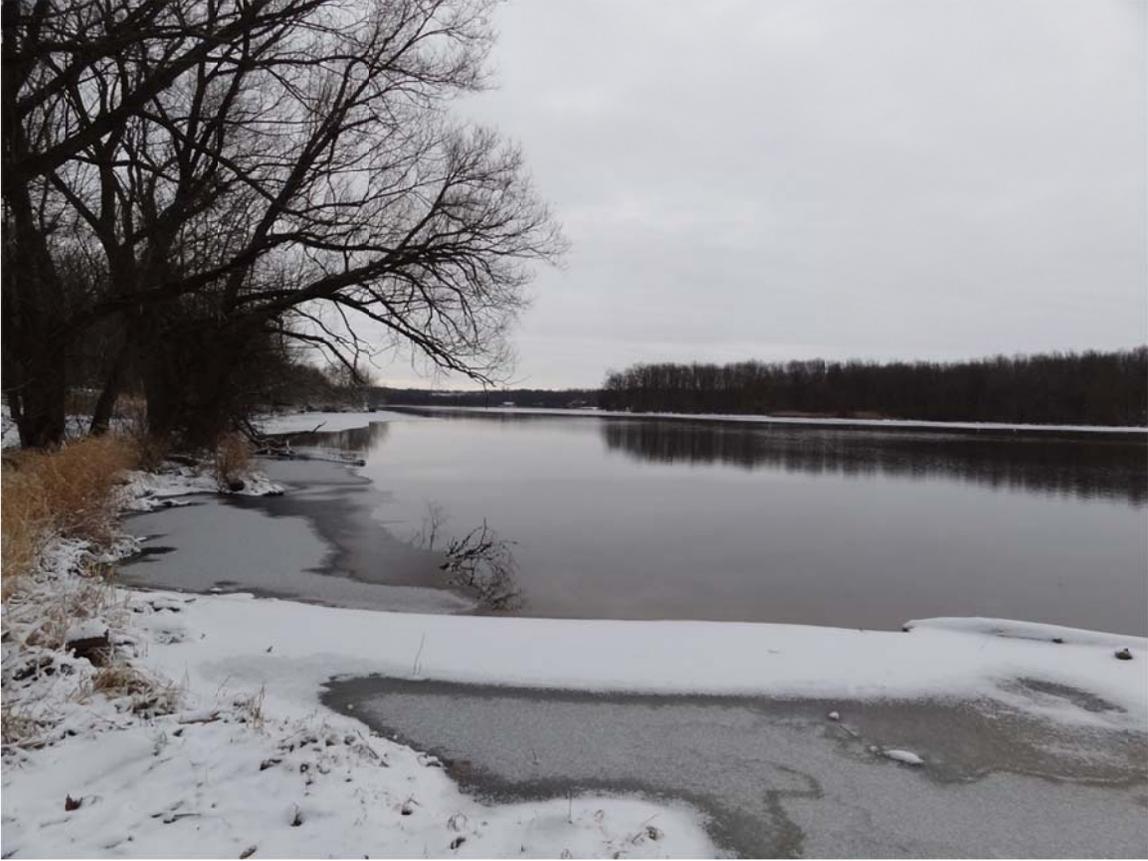
9. Former E4.0 boom location looking east into delta. No ice observed in river channel.

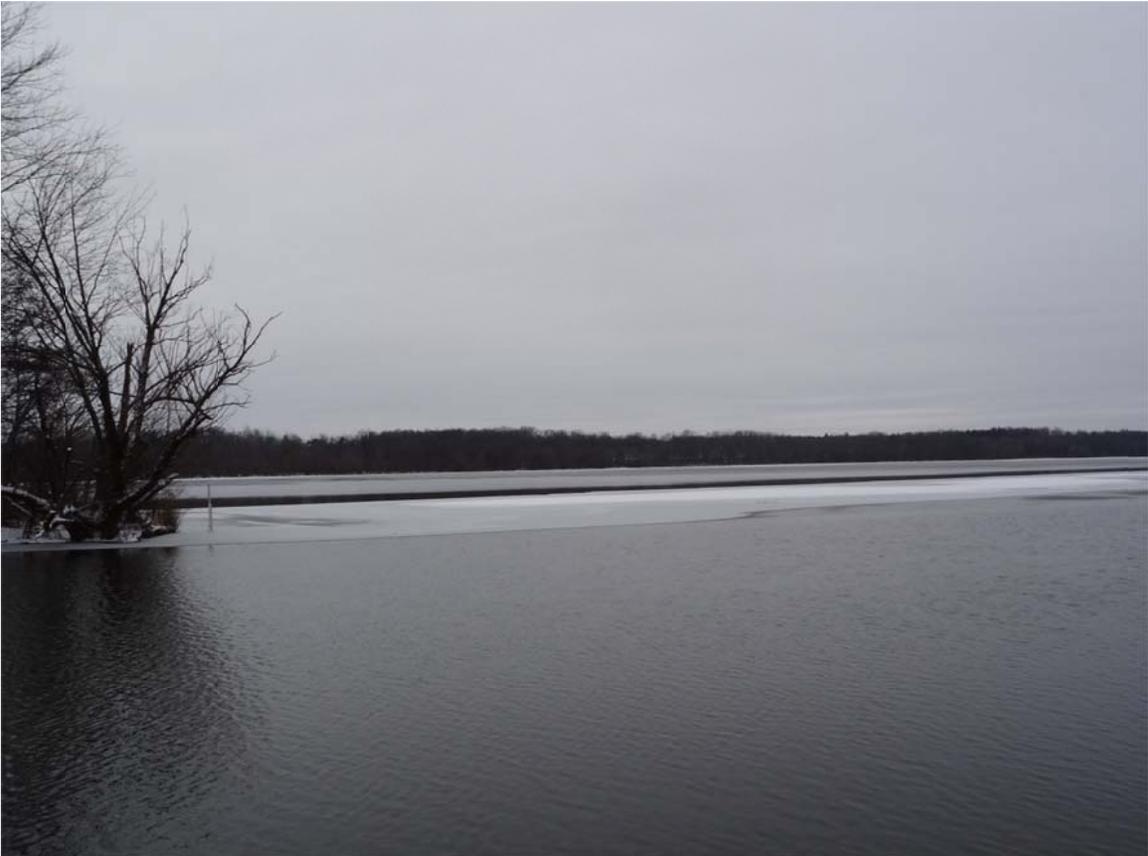
10. Island south of E4.0 boat launch. Snow and ice observed west of island and across south cove of Morrow Lake.

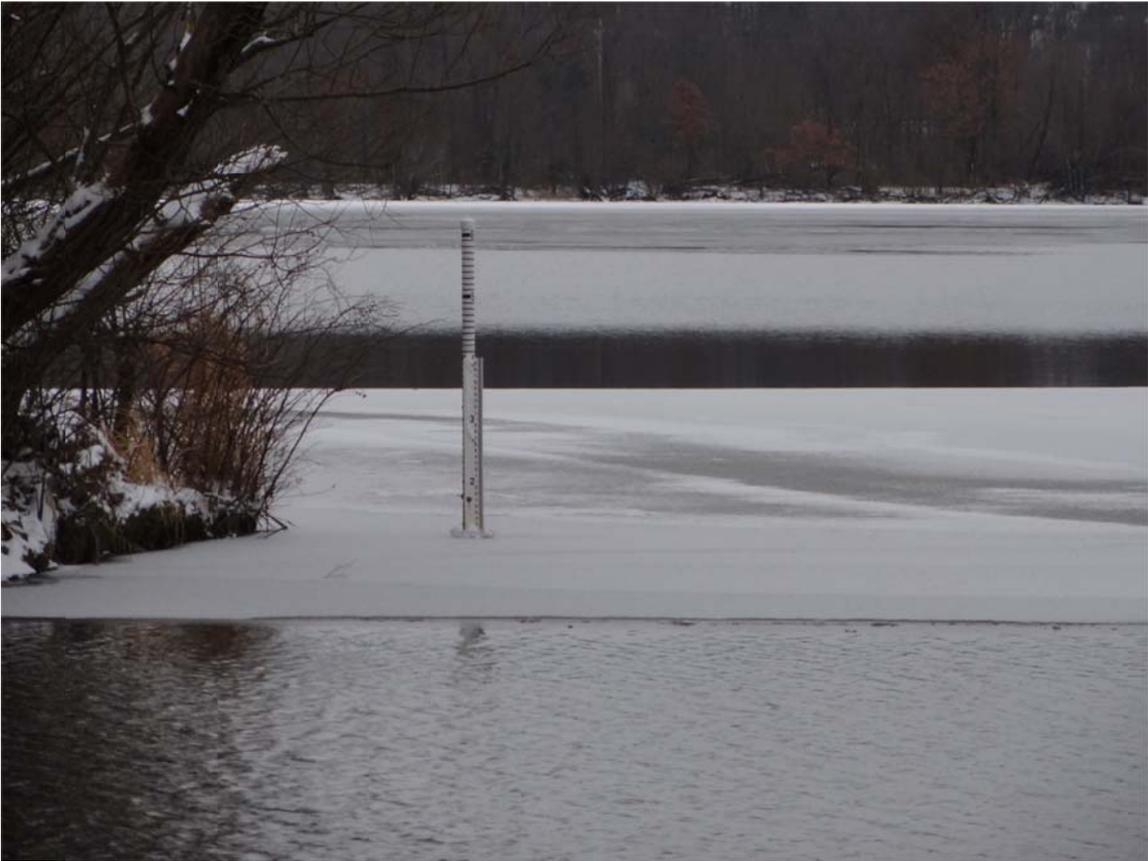
11. E4.0 boat launch river gauge in ice south of E4.0 boat launch.

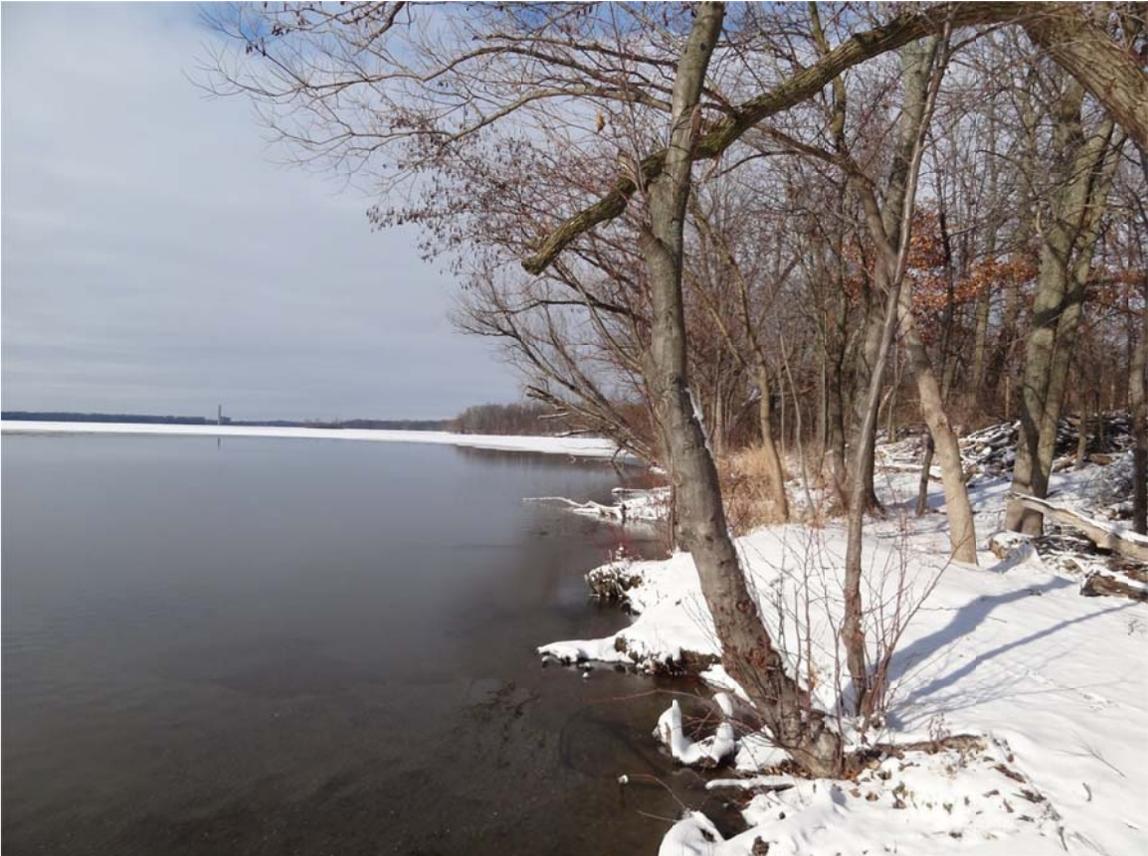
12. View of Morrow Lake looking west toward Morrow Lake Dam. West end of Morrow Lake and north cove appear to be covered in ice and snow.
