Situation Photo Log

Monday, December 31, 2012

Kalamazoo River / Enbridge Spill

Water / Sediment Temperatures

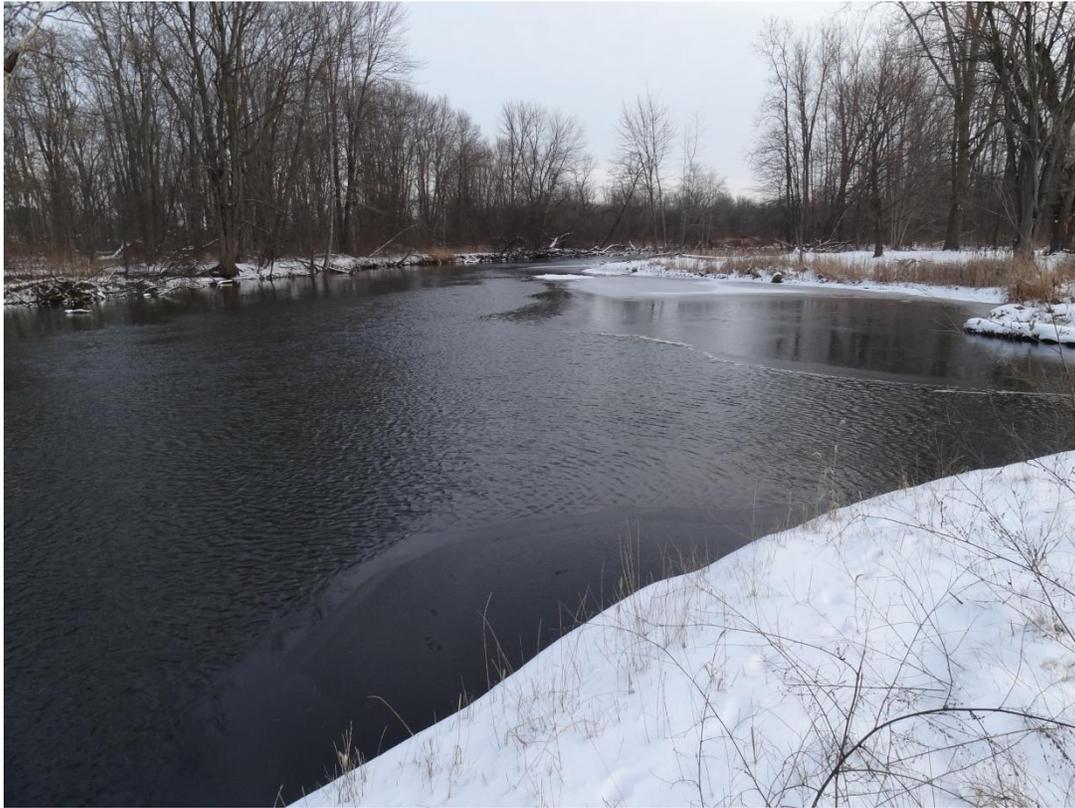
1. Confluence, minor bank ice observed.

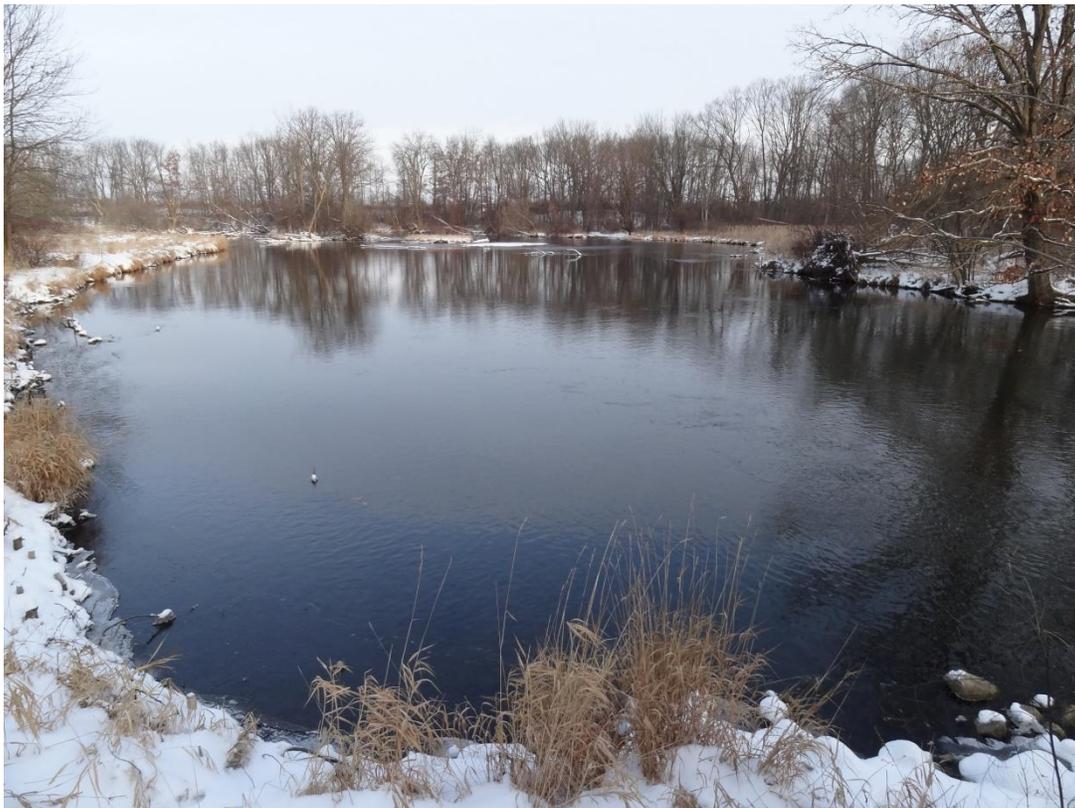
2. MP2.25 LDB no sheen, frazil ice or bank ice observed.

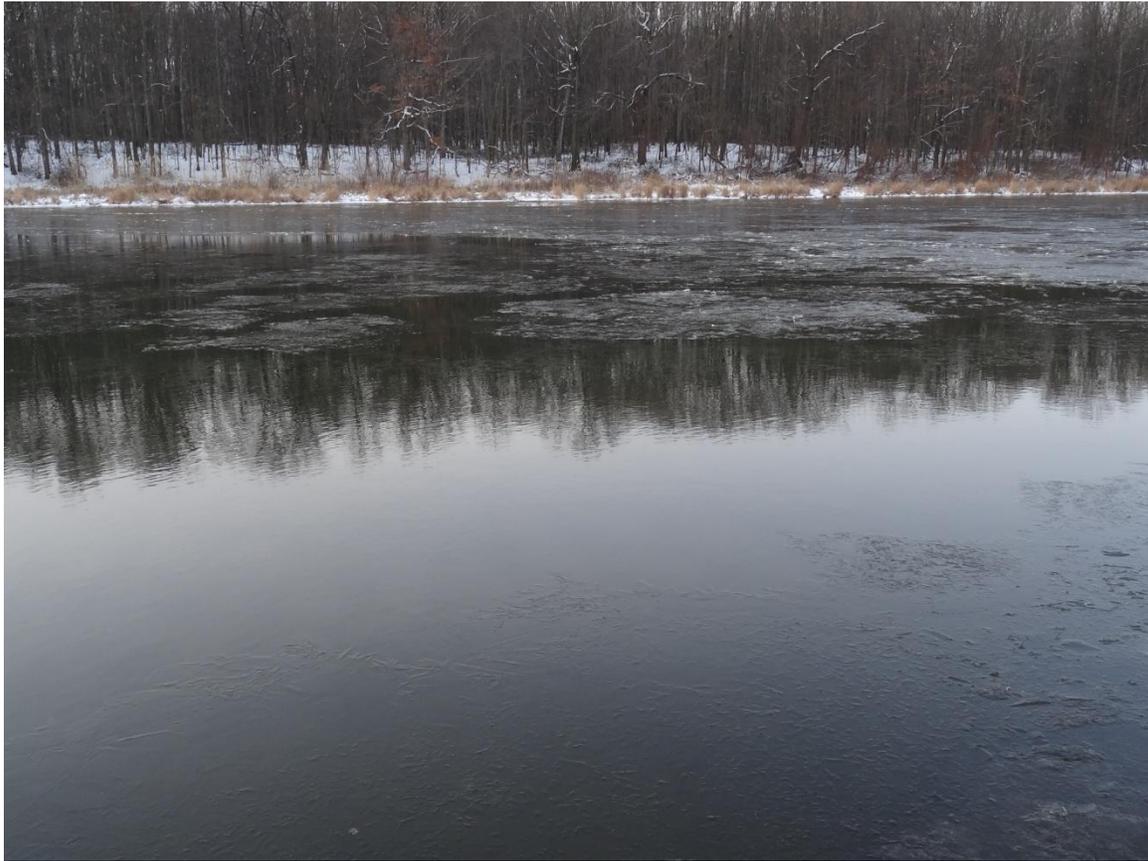
3. MP5.20 RDB, frazil ice observed flowing downstream and accumulating at C0.4 Boat Launch vicinity.

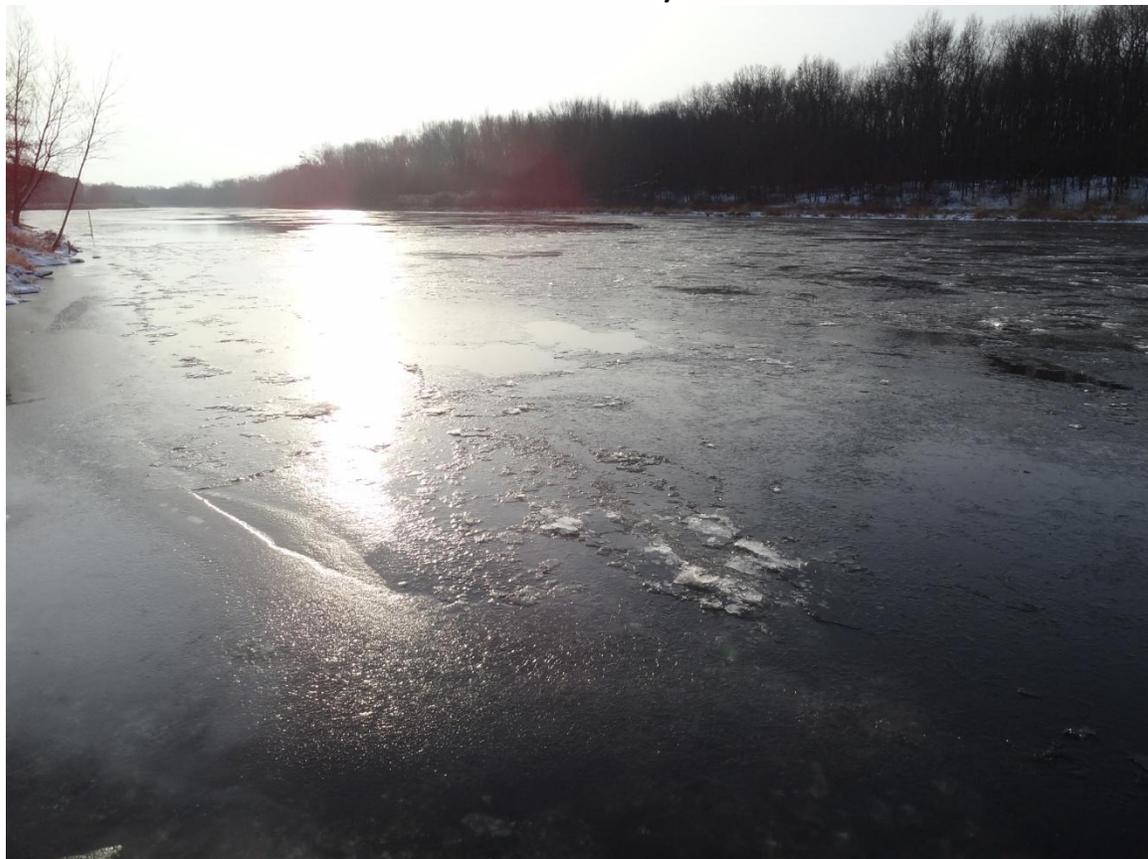
4. C0.4 Boat Launch, frazil ice observed accumulating on river at boat launch vicinity.

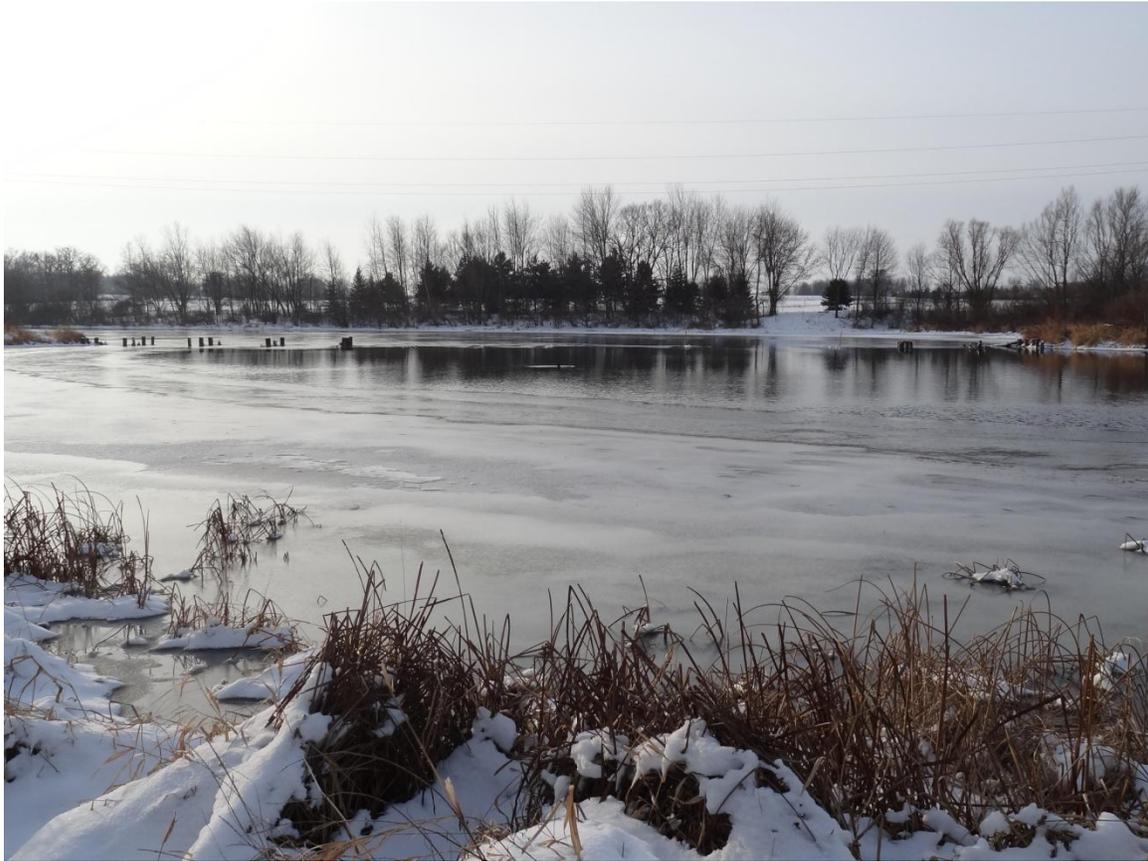
5. MP5.63 Ceresco Dam trestles, ice observed along both river banks. River channel remains open.

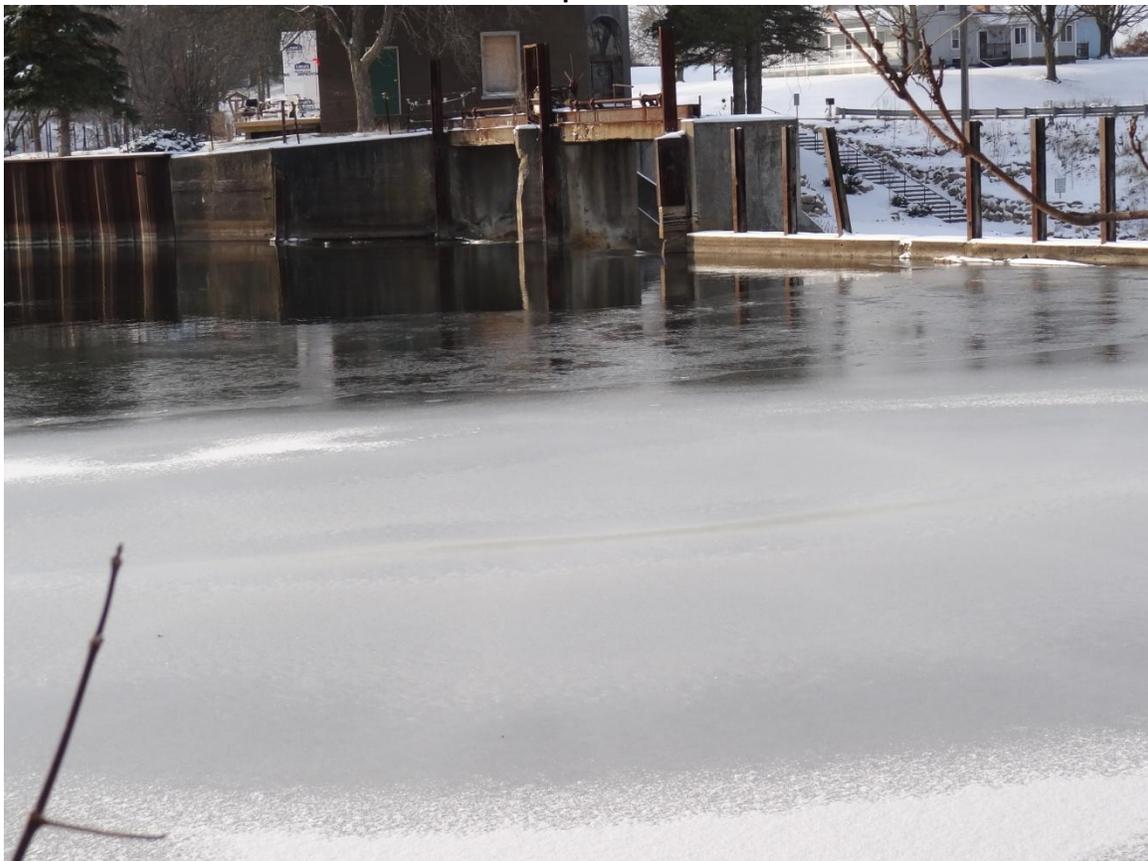
6. Ceresco Dam impoundment RDB, ice observed along river bank. River channel remains open.

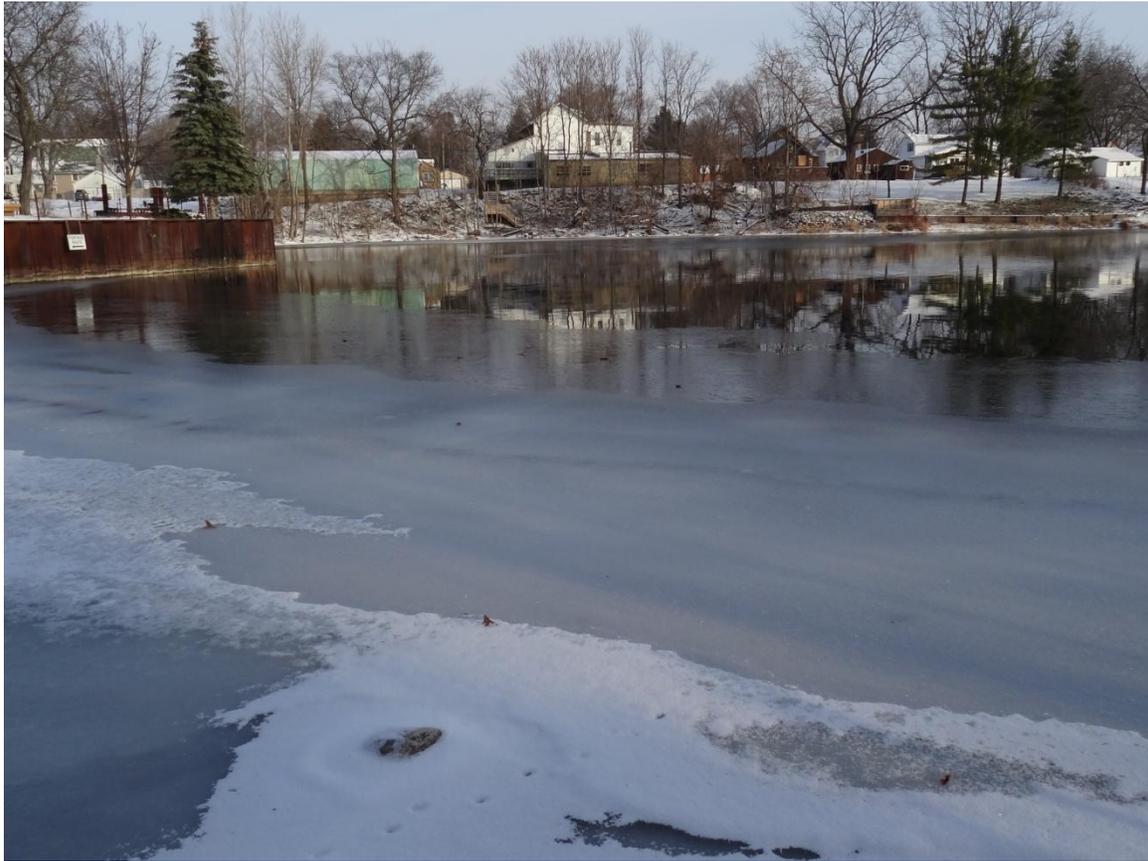
7. Ceresco Dam Impoundment LDB, ice observed along river bank.

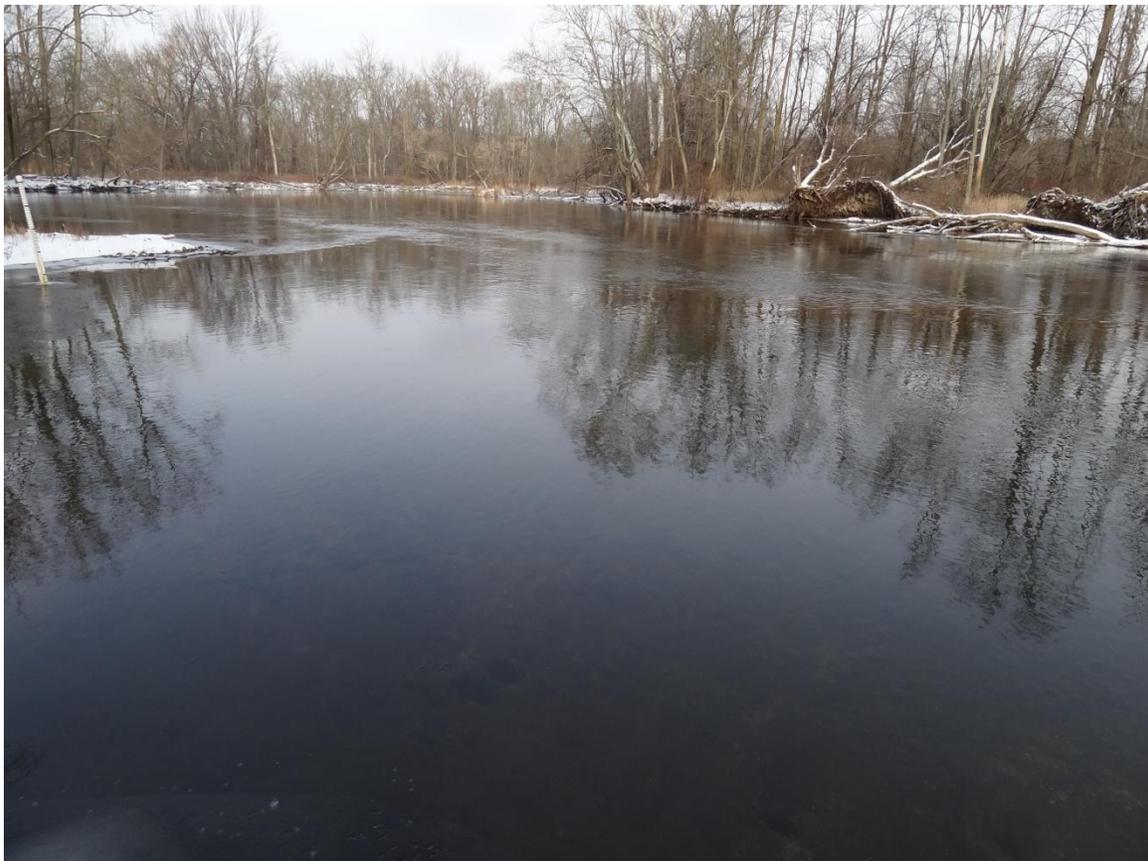
8. C3.2 Boat Launch. No sheen, frazil ice or significant bank ice observed.

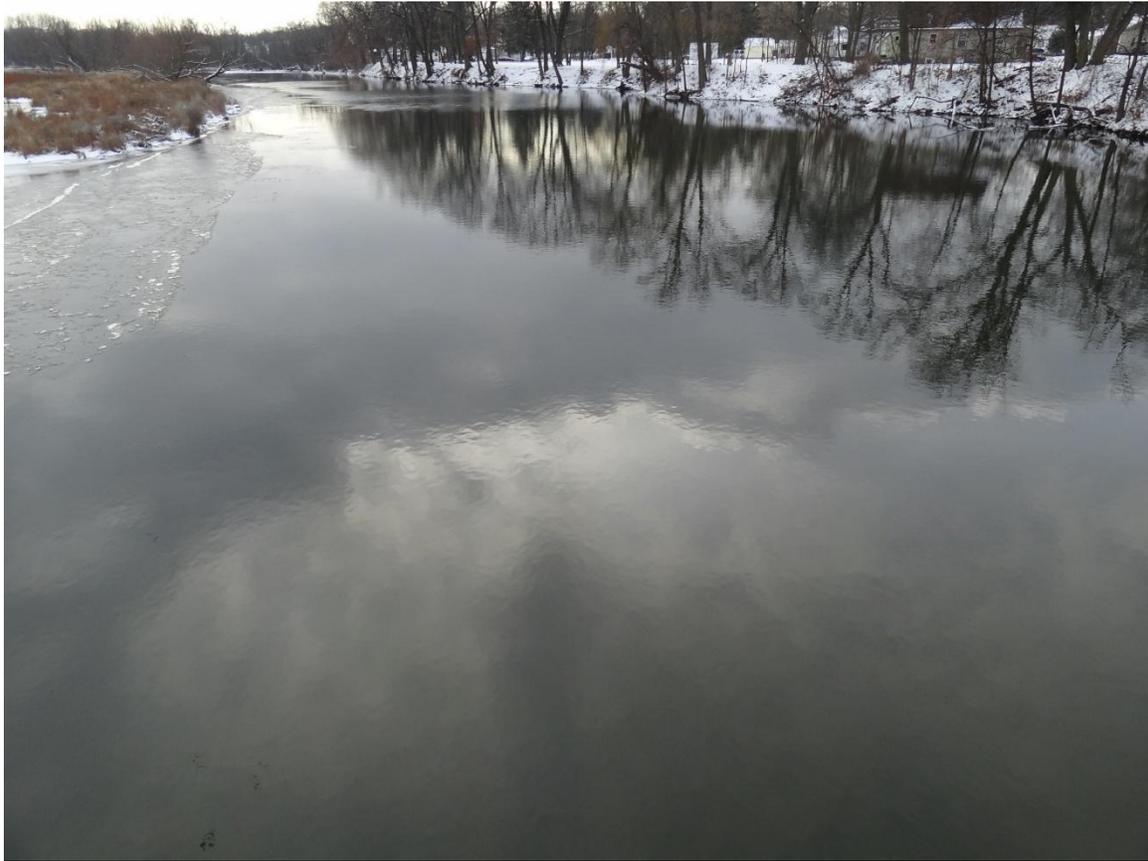
9. MP 15.25 river channel remains open. No sheen observed or frazil ice noted flowing downstream.

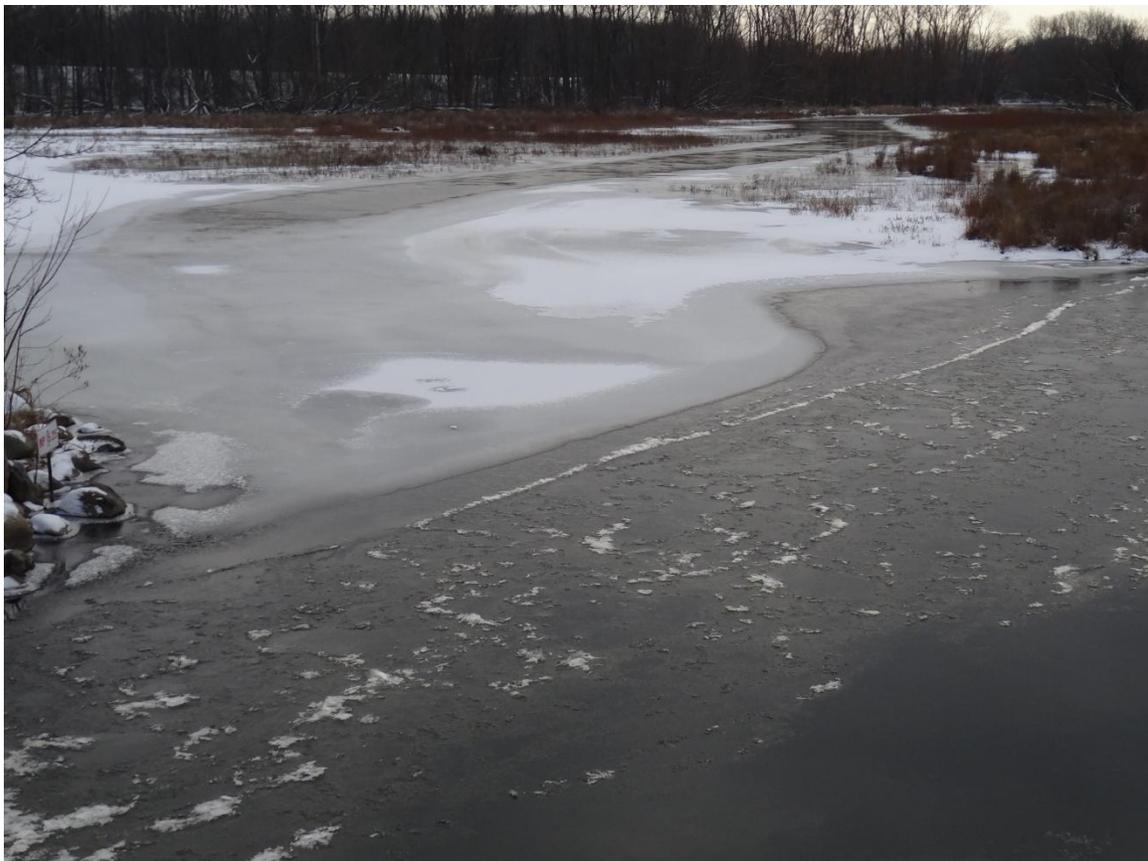
10. MP 15.25 South Mill Pond. Backwater area channel remains open.

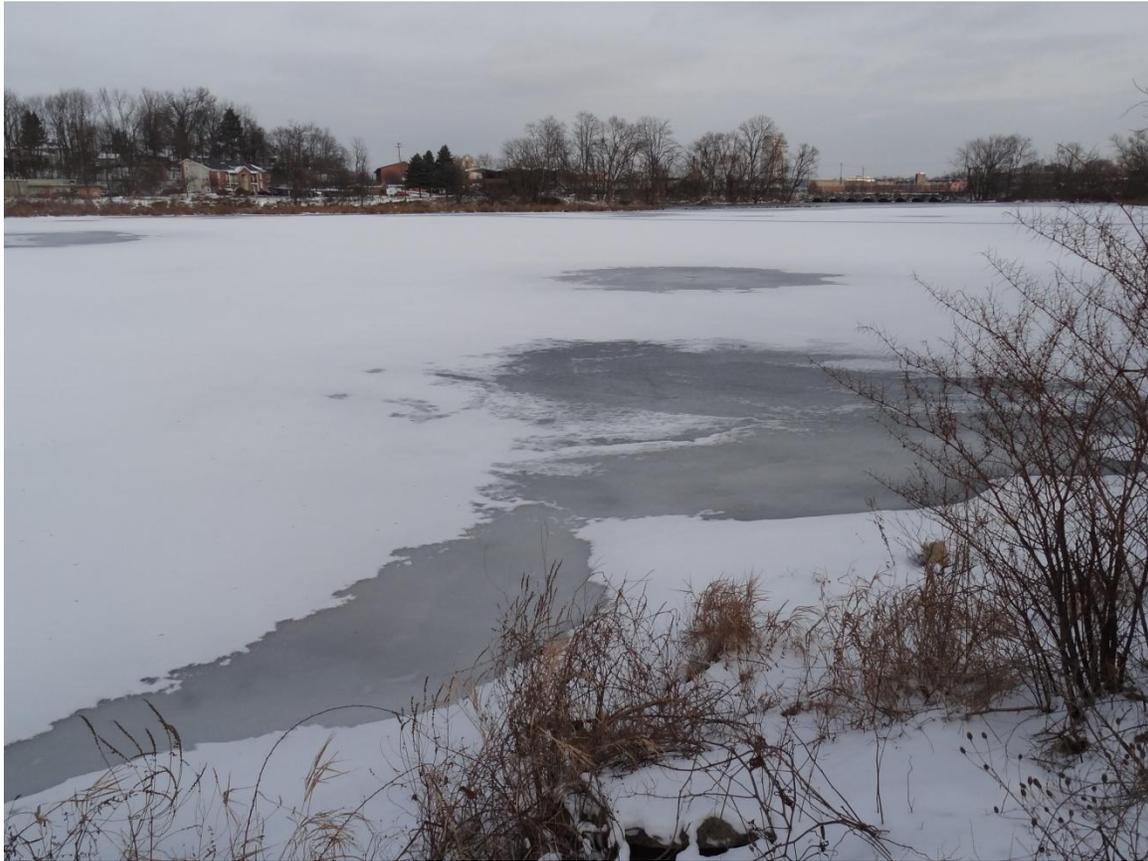
11. MP15.50 North Mill Pond. Backwater area covered in ice and snow.

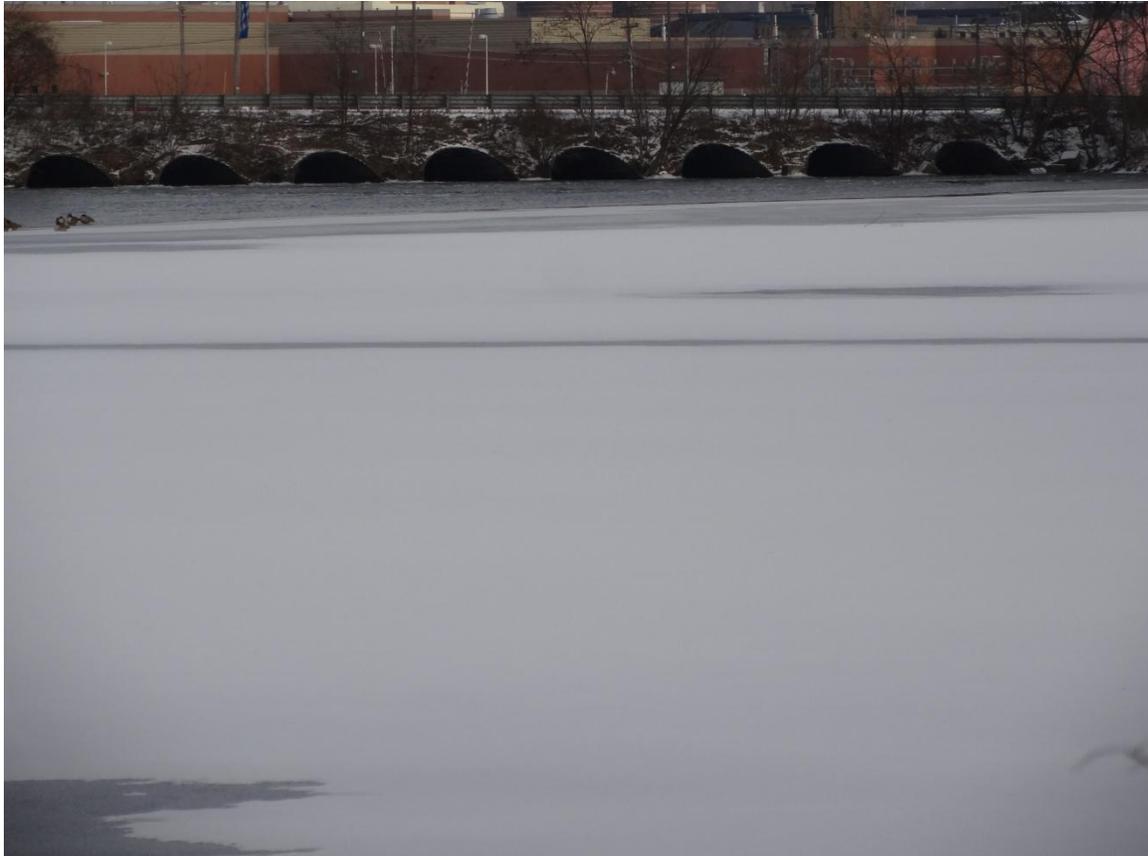
12. MP15.60 North Mill Pond, no ice observed in vicinity of culverts.

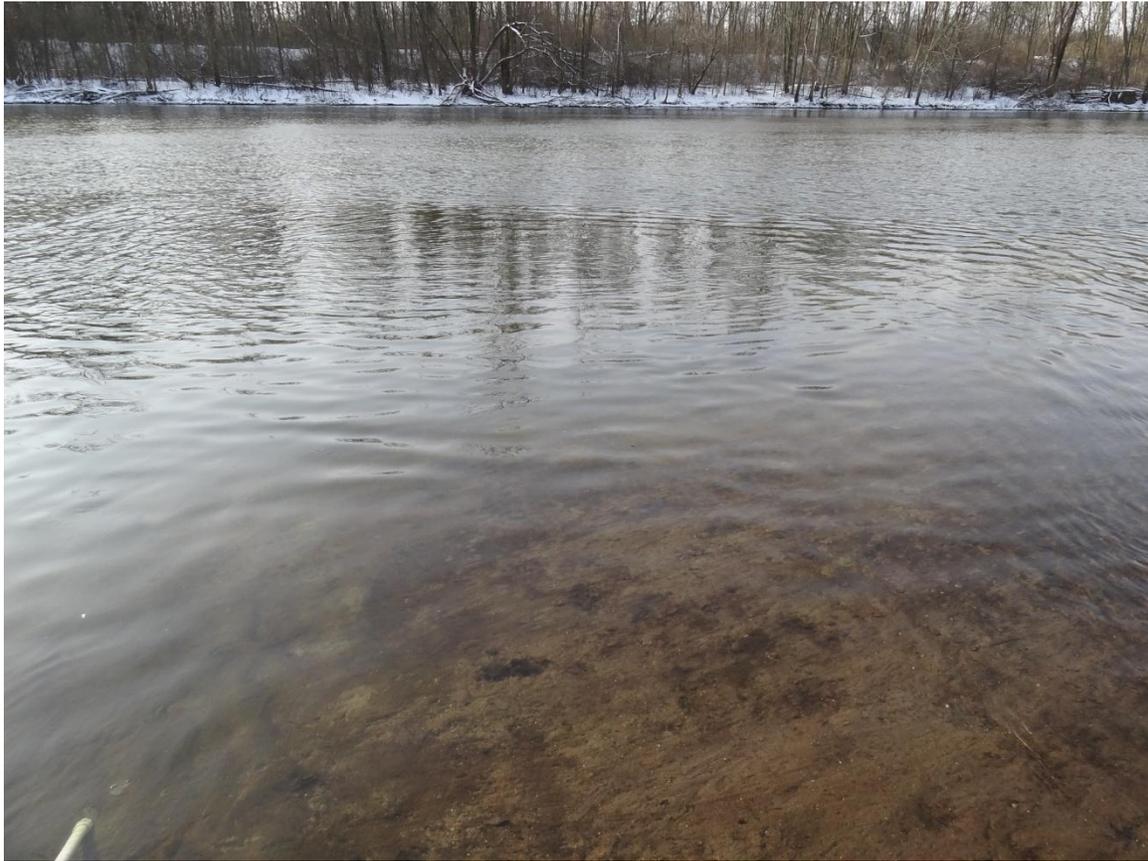
13. D2 Boat Launch. No sheen, frazil ice or bank ice observed.

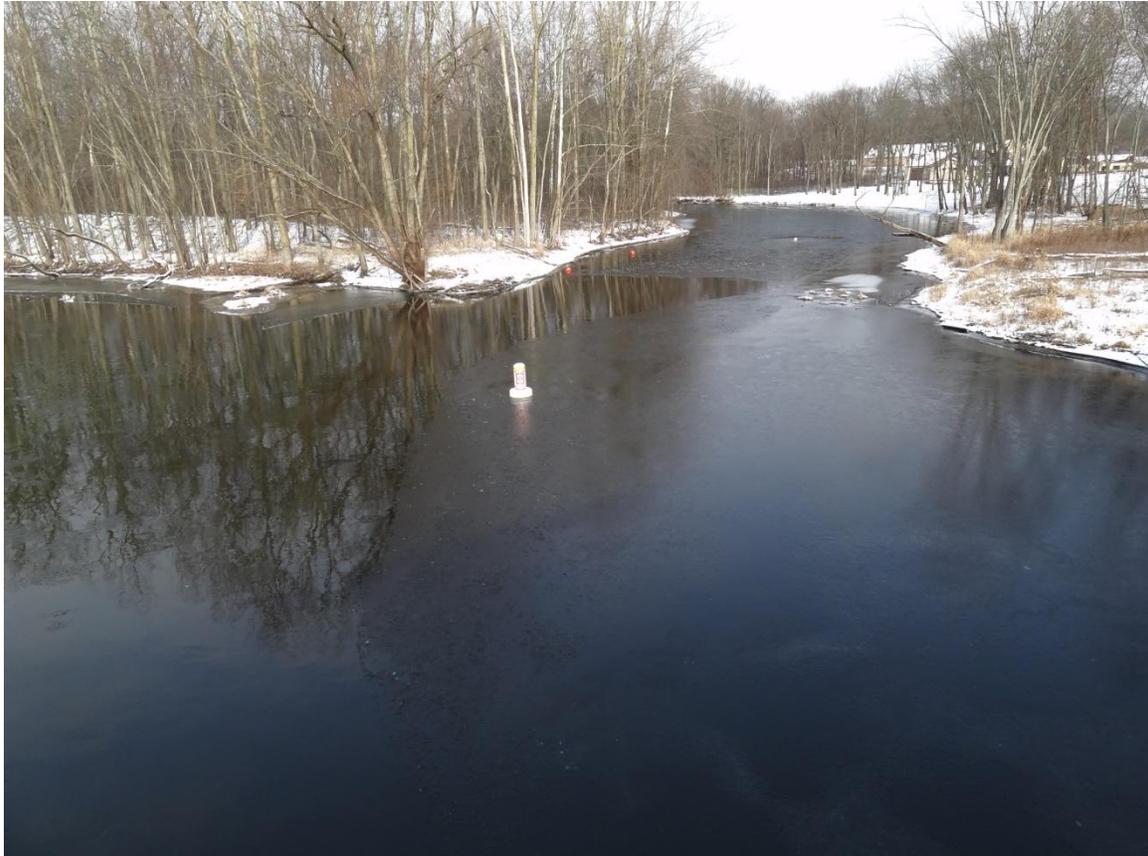
14. MP21.50 RDB, ice observed along river bank and back channel of oxbow.

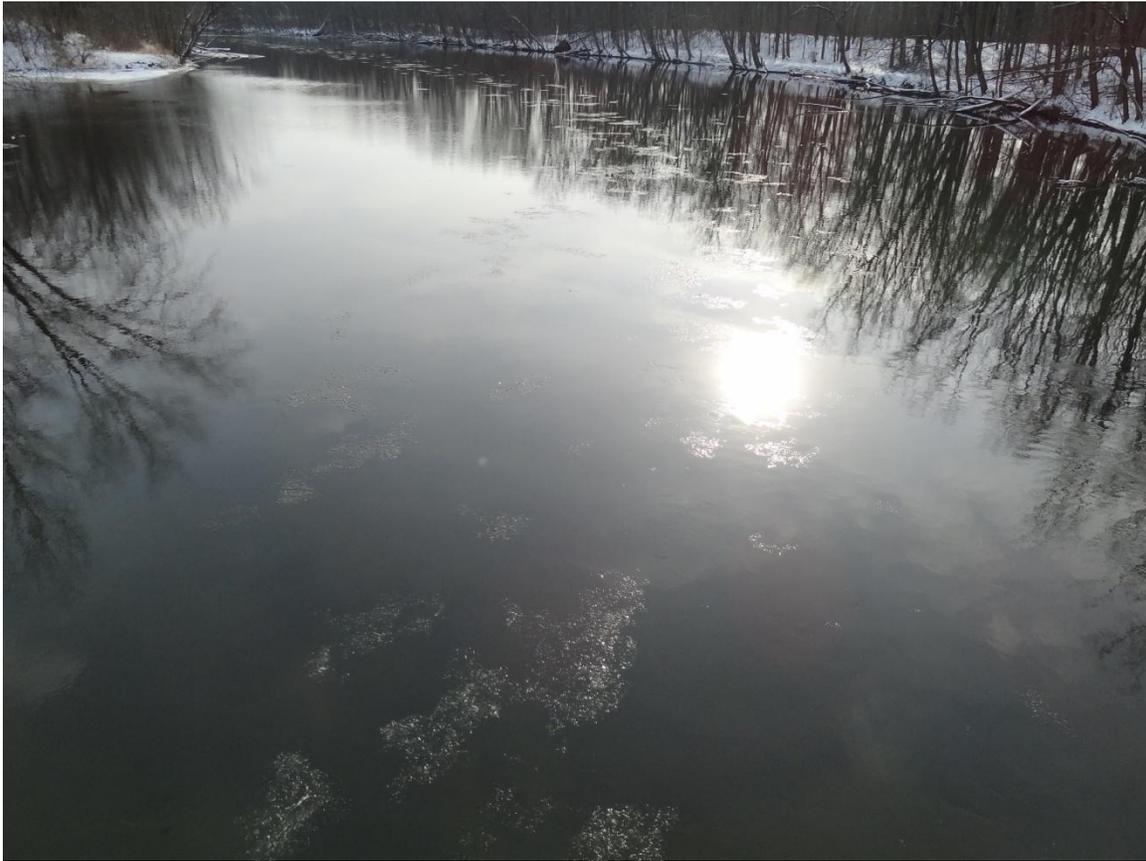
15. MP21.50, frazil ice observed flowing downstream in river channel.

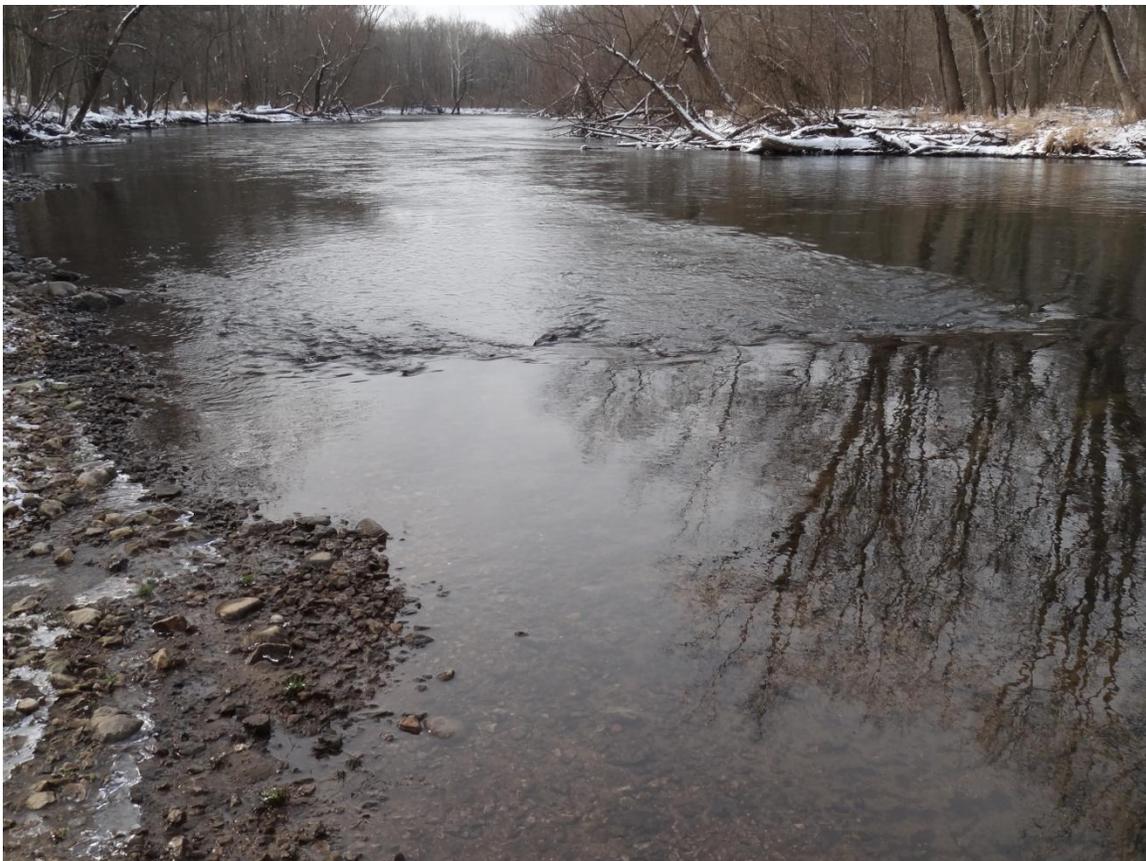
16. E2 Boat Launch. No sheen, frazil ice or bank ice observed.

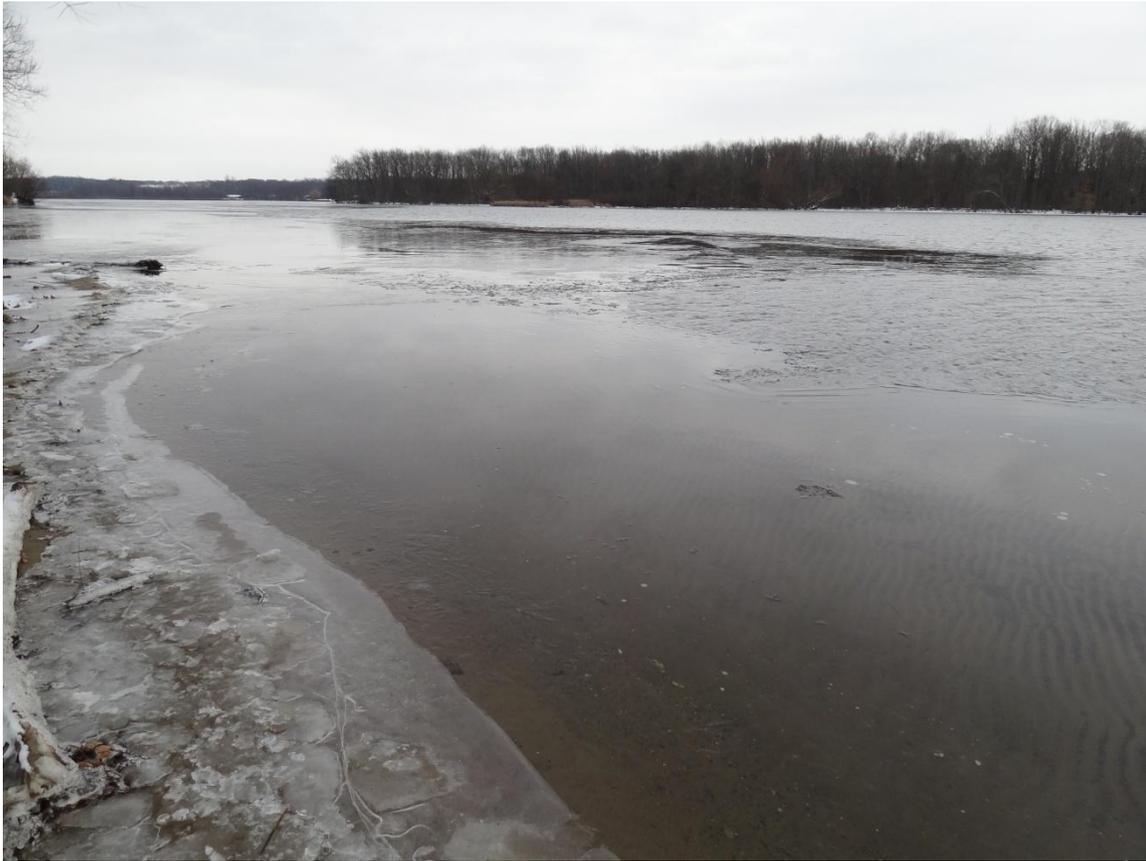
17. Former E4 boom location looking east into Delta. Ice observed along both banks.

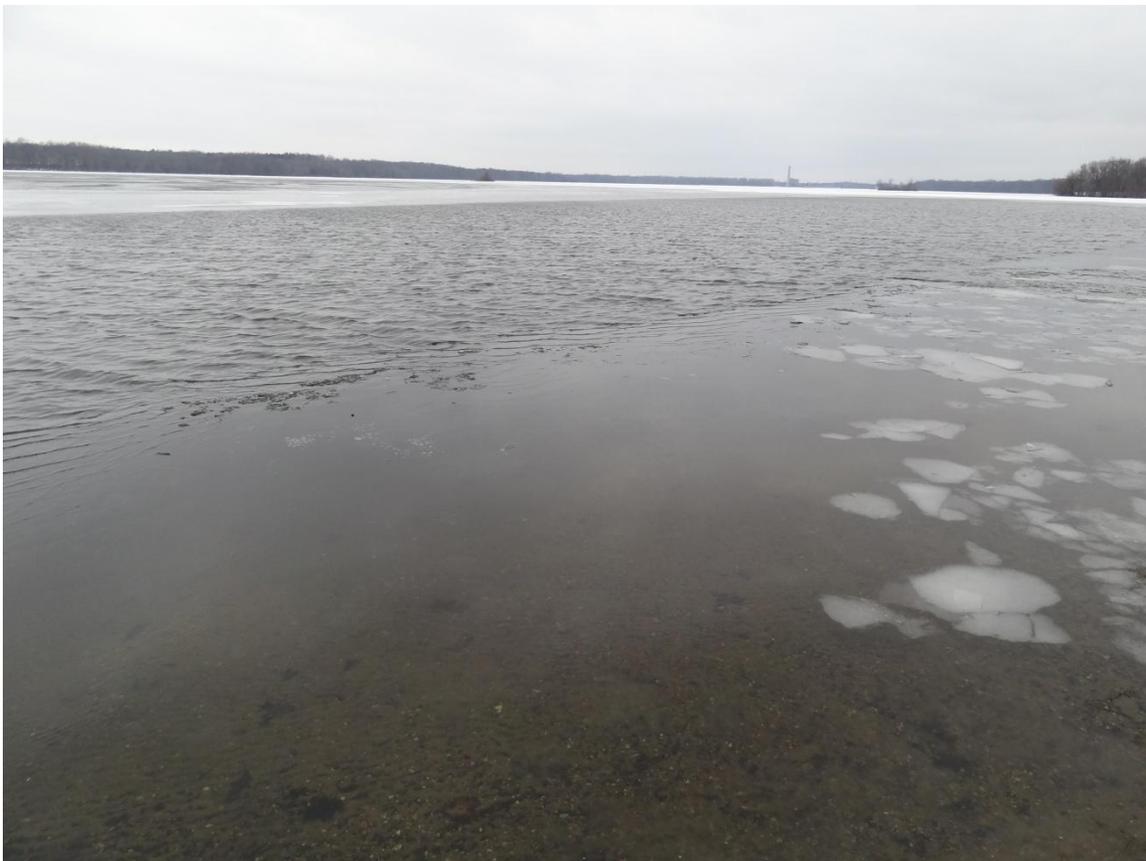
18. View of Morrow Lake from E4 Boat Launch looking southwest. Ice observed in southern and western portion of lake.

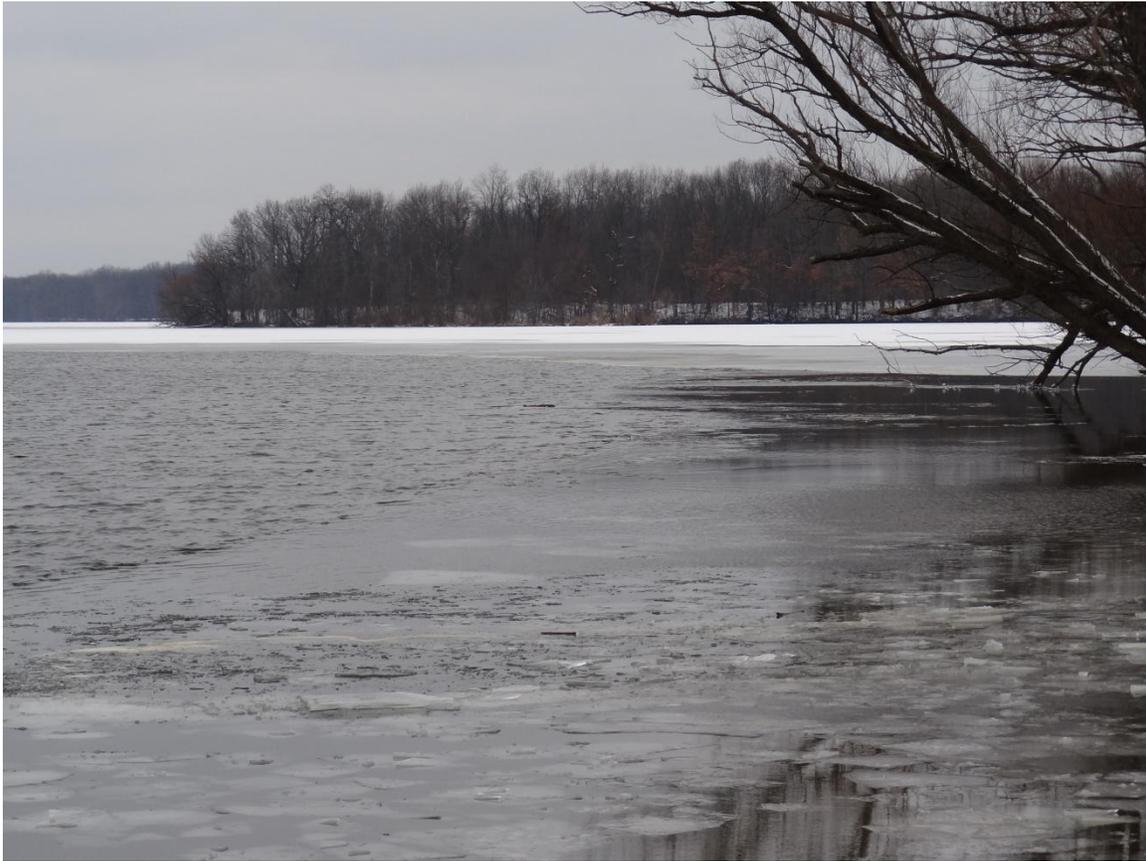
19. View of north shoreline and cove from E4 Boat Launch. North cove appears to be covered in ice.

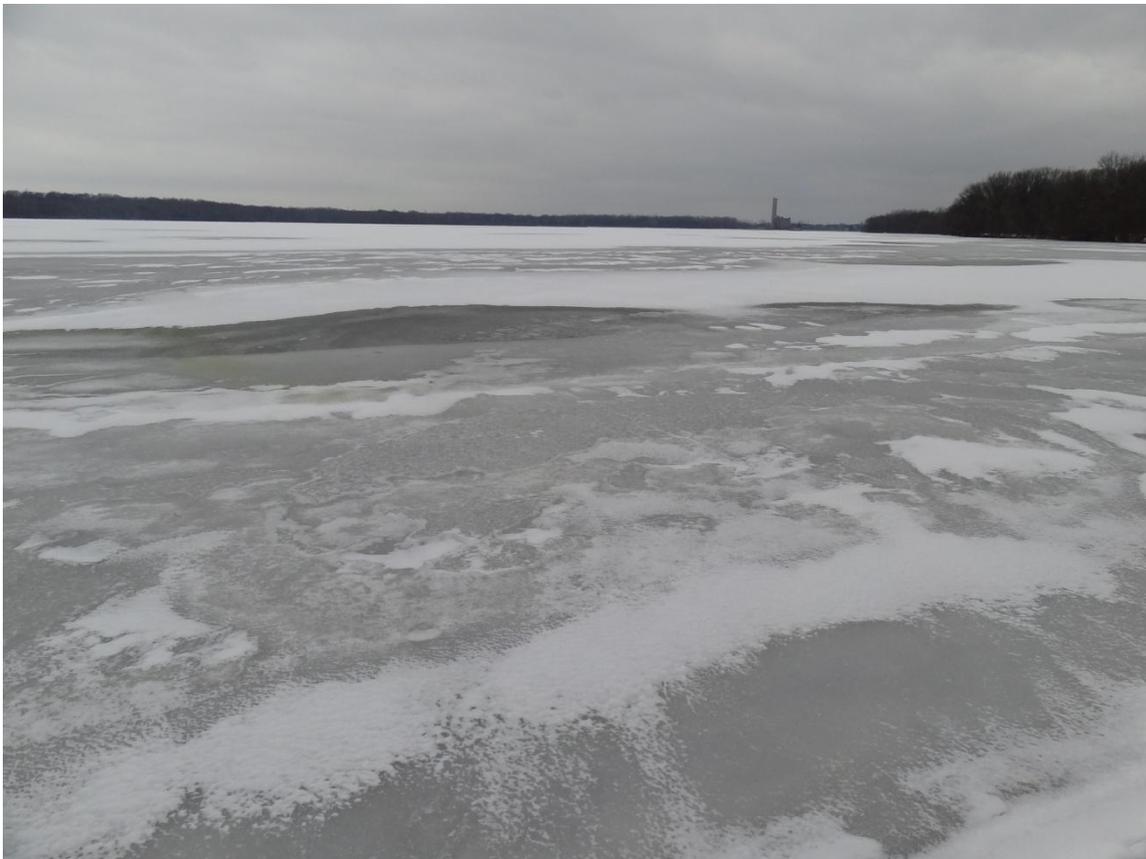
20. View of western end of Morrow Lake from E4.5 Boat Launch. West end of Morrow Lake covered in ice.
