Situation Photo Log

Friday, January 4, 2013

Kalamazoo River / Enbridge Spill

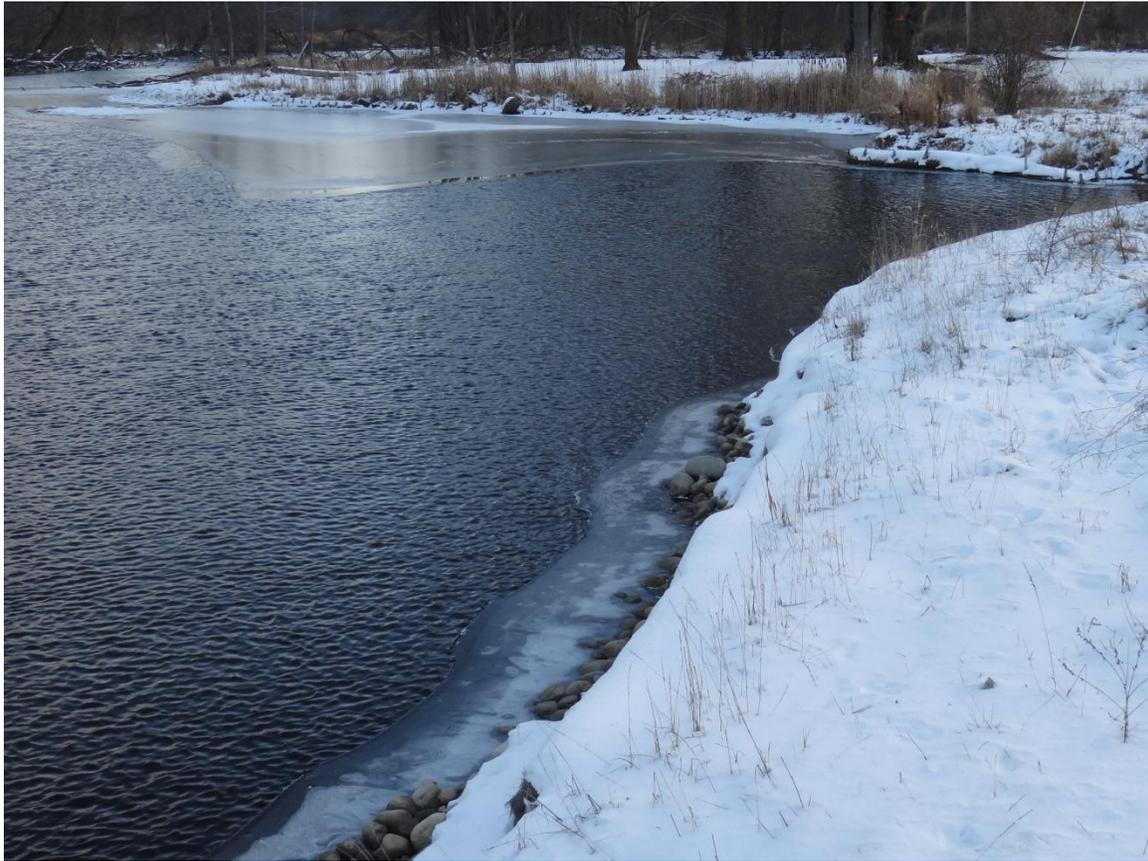
1. Confluence, bank ice observed has decreased from yesterday.

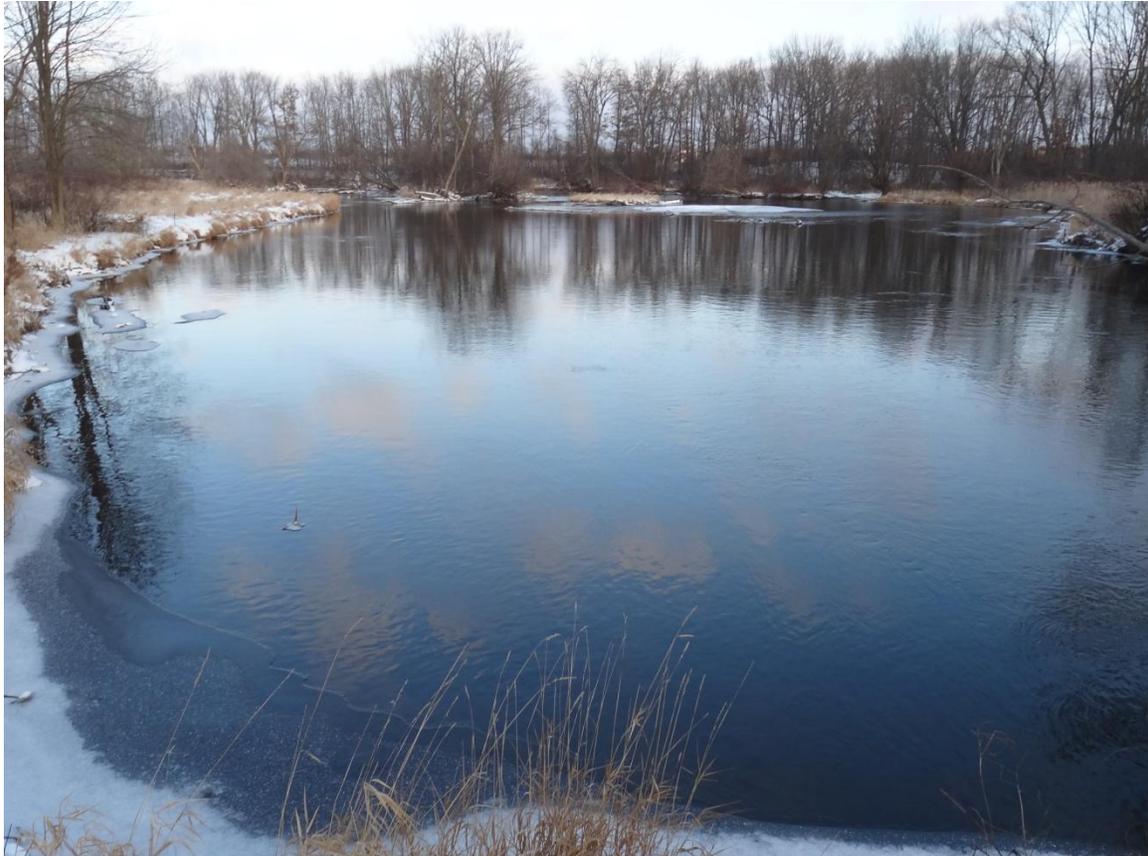
2. MP2.25 LDB, no sheen or significant bank ice observed.

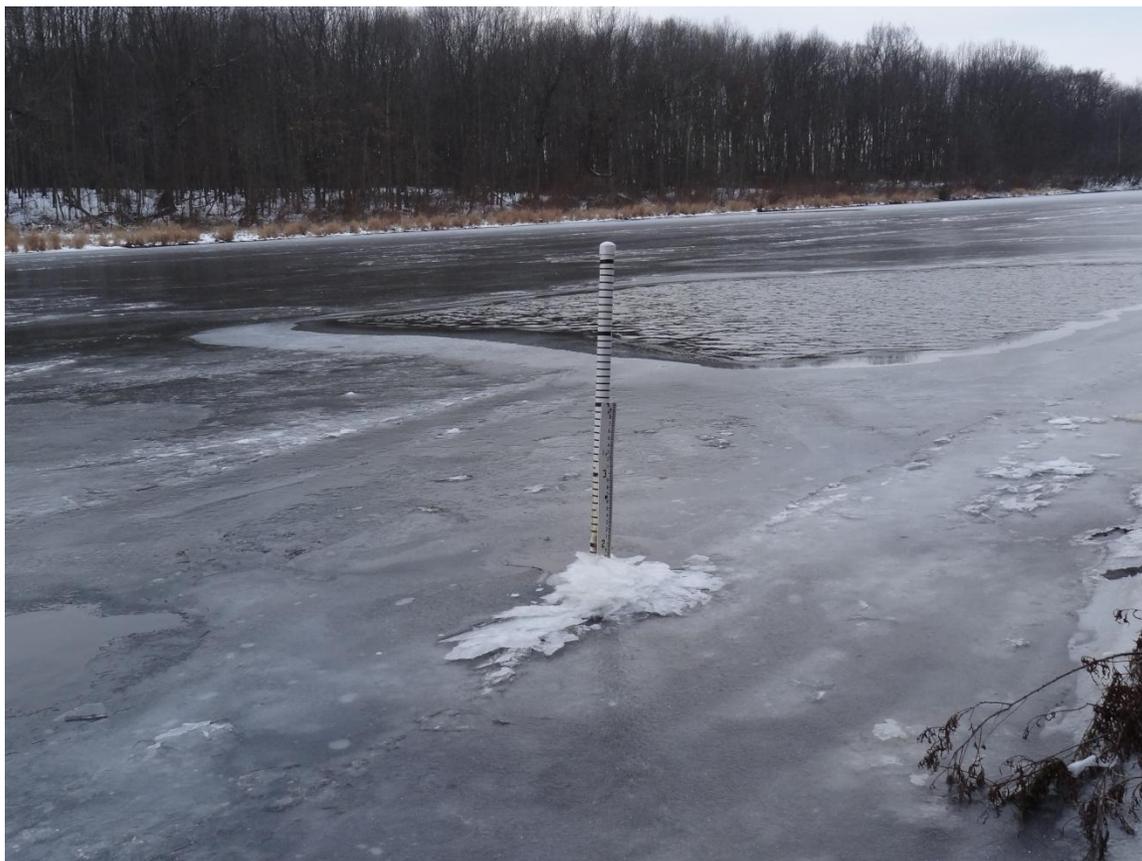
3. Water Gauge at C0.4 Boat Launch. River channel remains largely covered in ice.

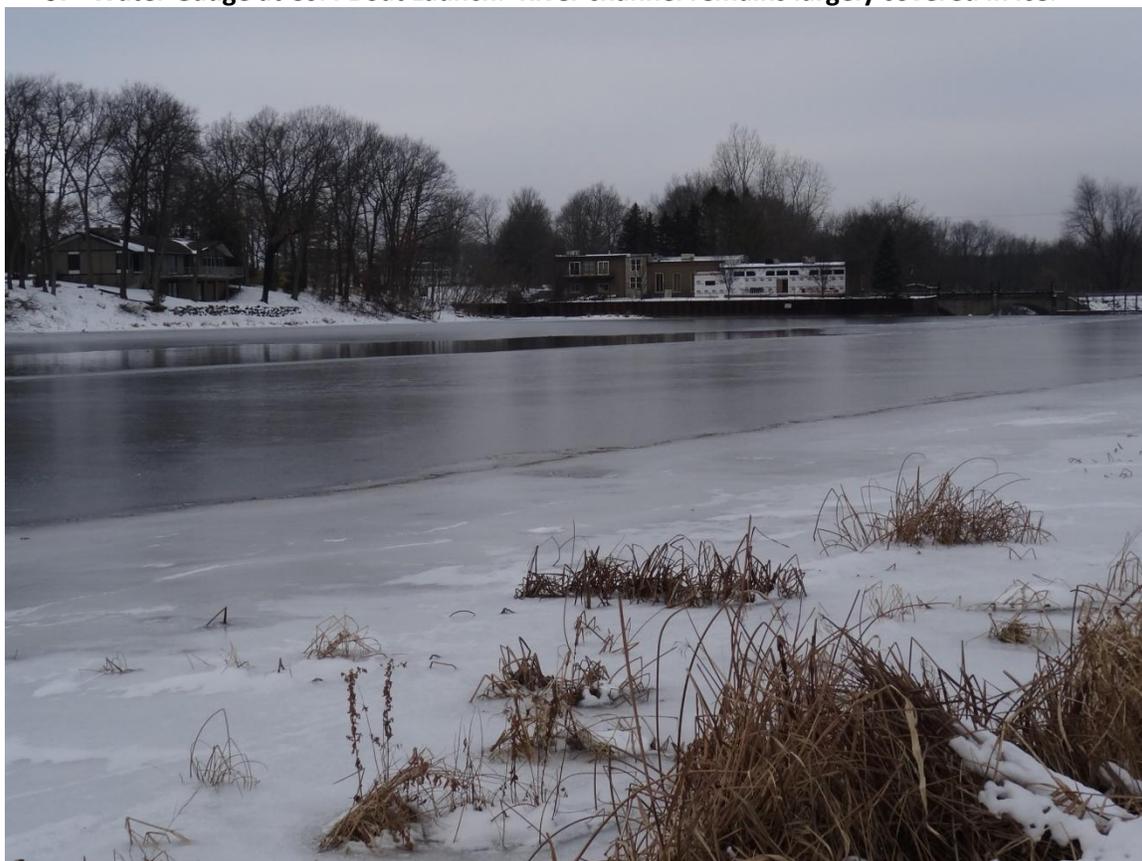
4. MP5.70 RDB, ice and snow observed along both river banks. River channel remains open.

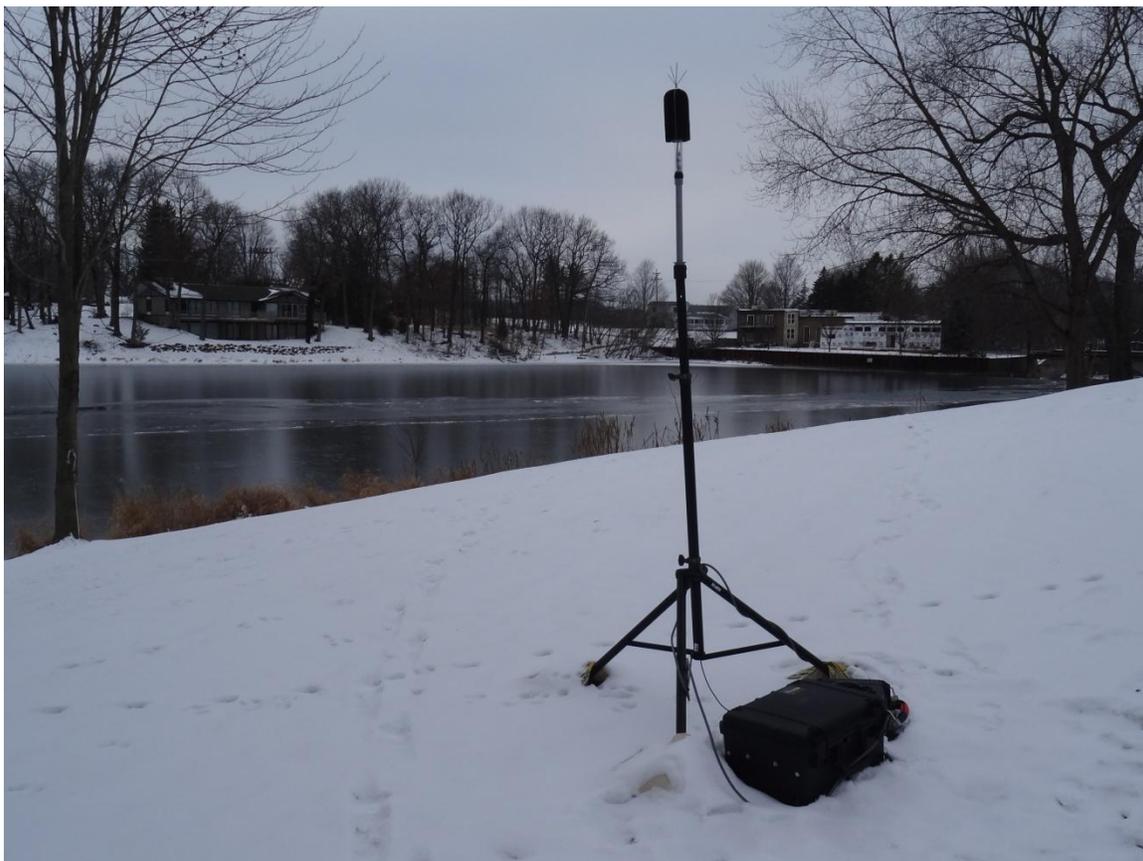
5. MP5.75 RDB, observed recently positioned noise monitoring meter.

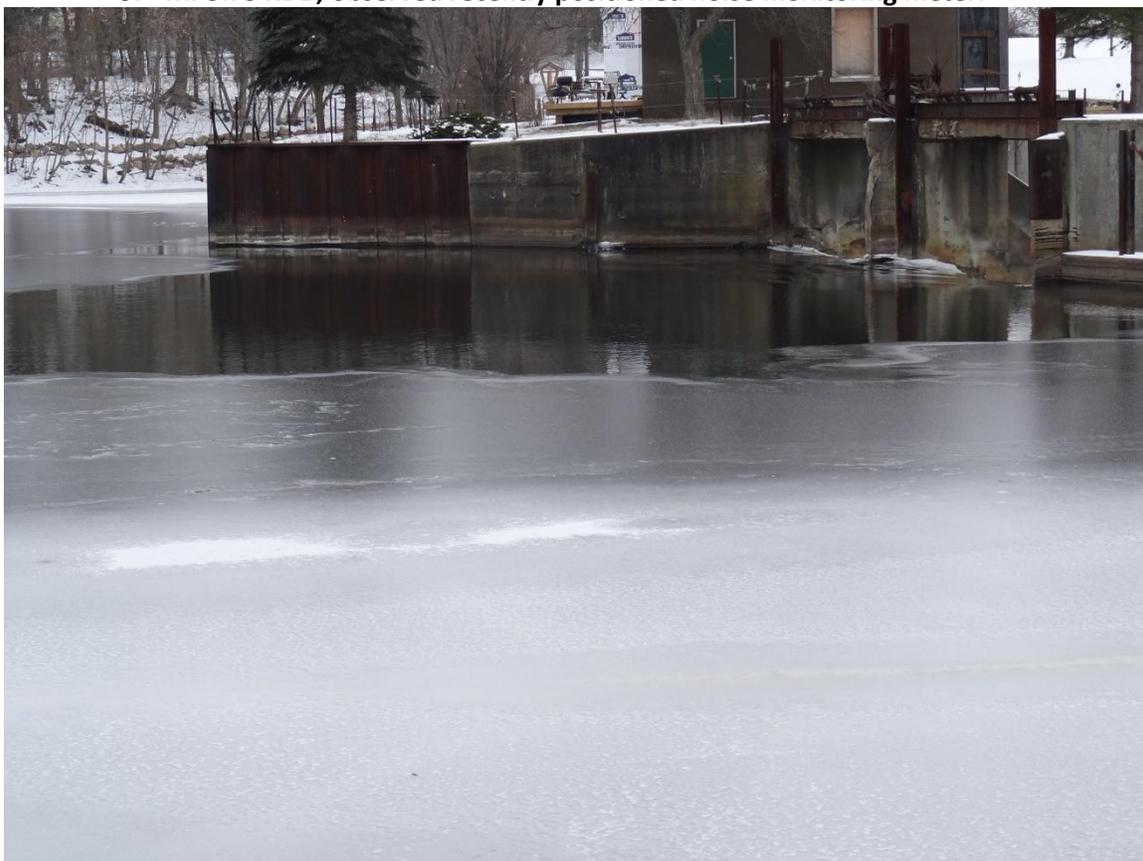
6. Ceresco Dam Impoundment, no ice observed flowing downstream in river channel.

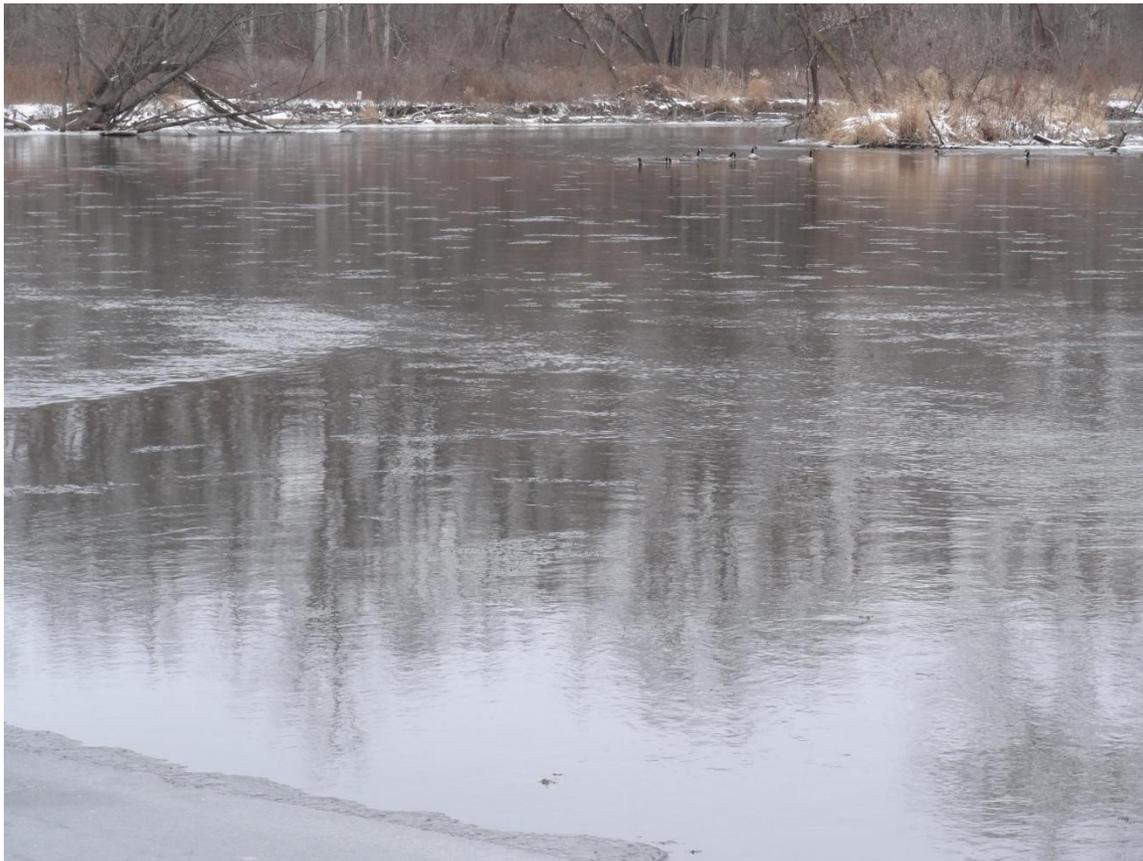
7. C3.2 Boat Launch, small patches of frazil ice observed flowing downstream in river channel.

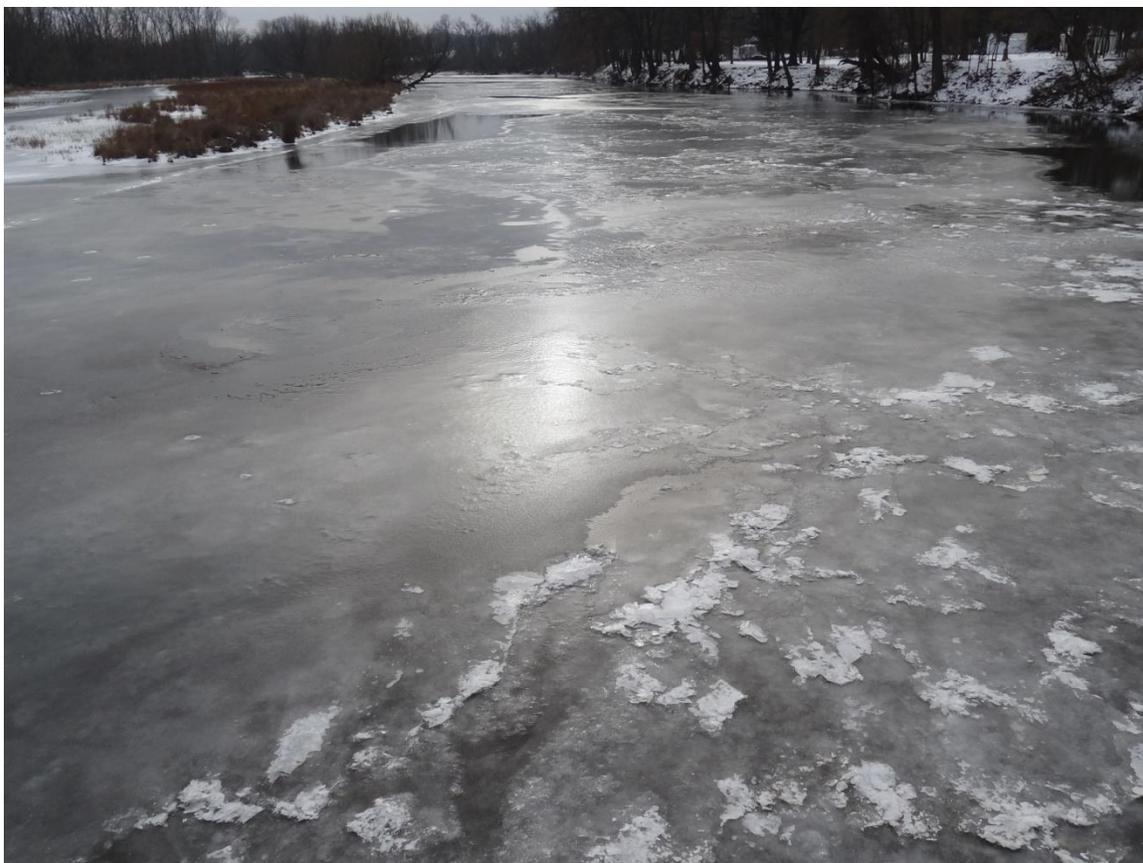
8. MP 15.25 South Mill Pond, river channel predominantly covered in ice.

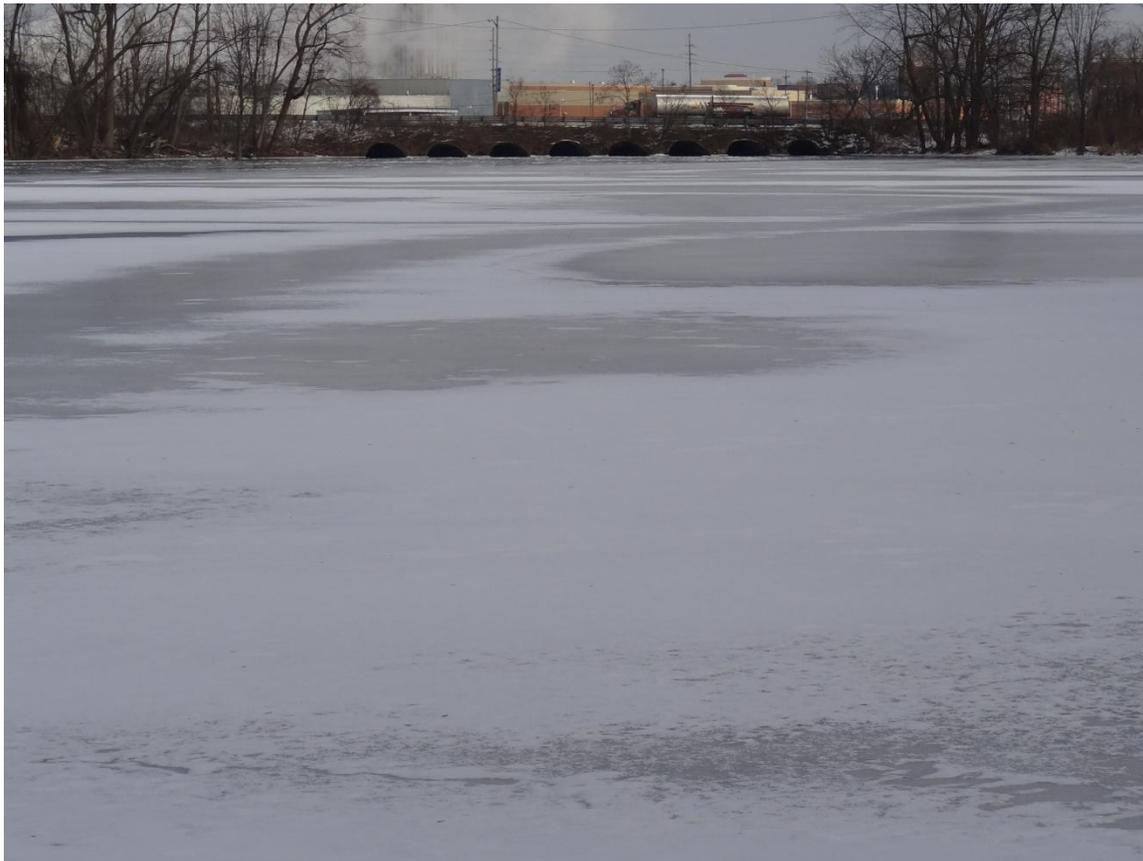
9. MP15.50 North Mill Pond and culverts remain covered in ice and snow.

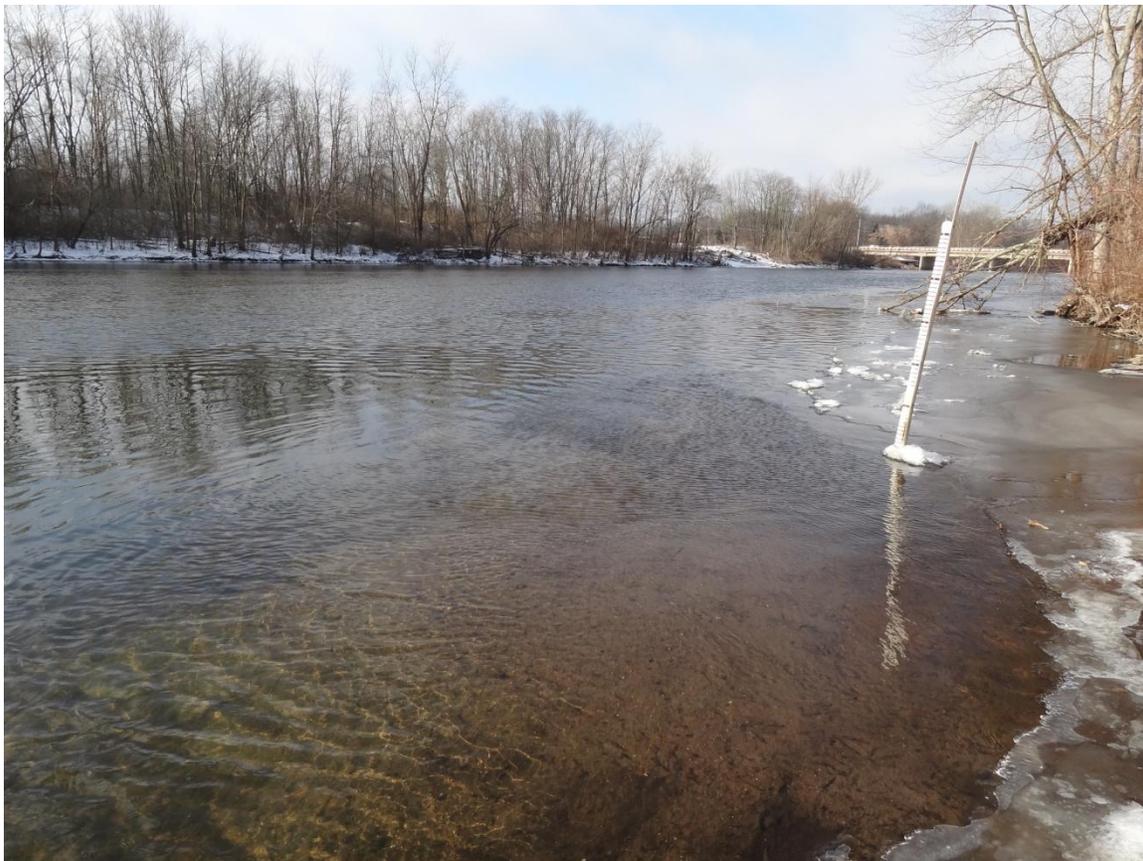
10. Water Gauge at D2 Boat Launch, minor bank ice observed.

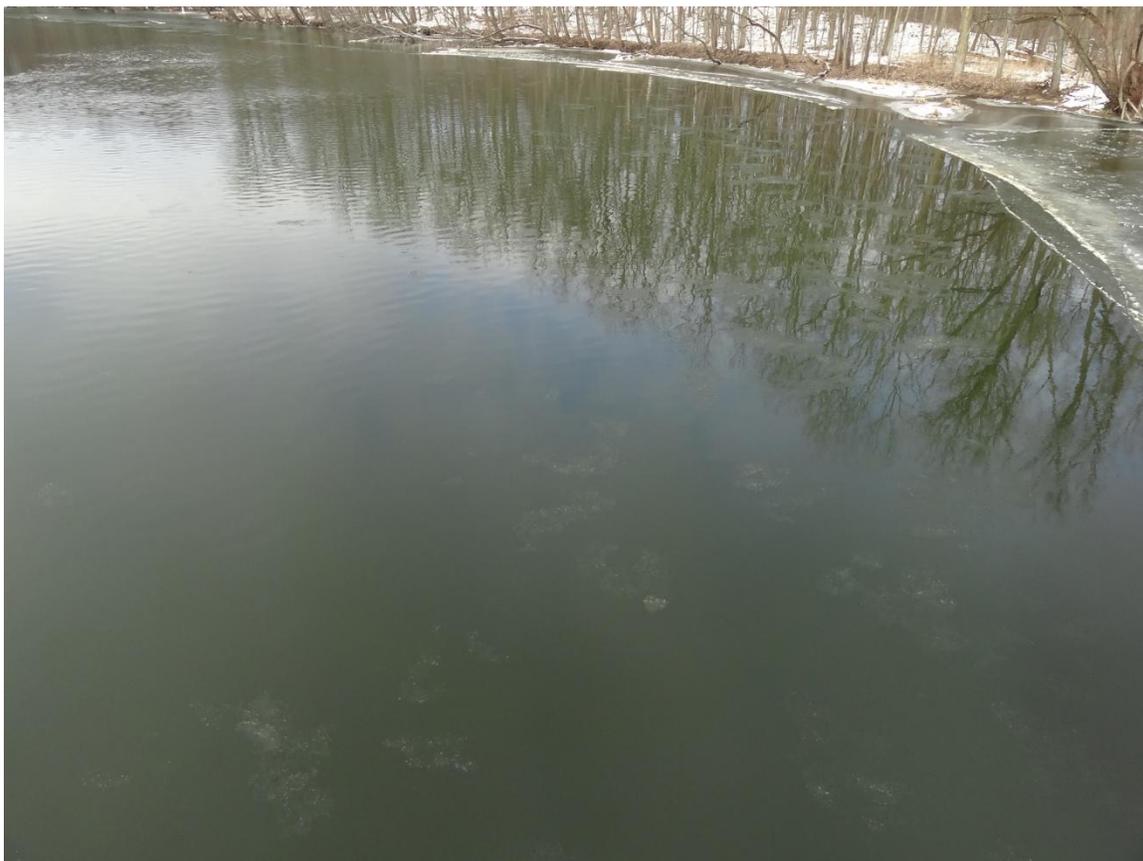
11. MP21.50 frazil ice observed flowing downstream in river channel has decreased from yesterday.

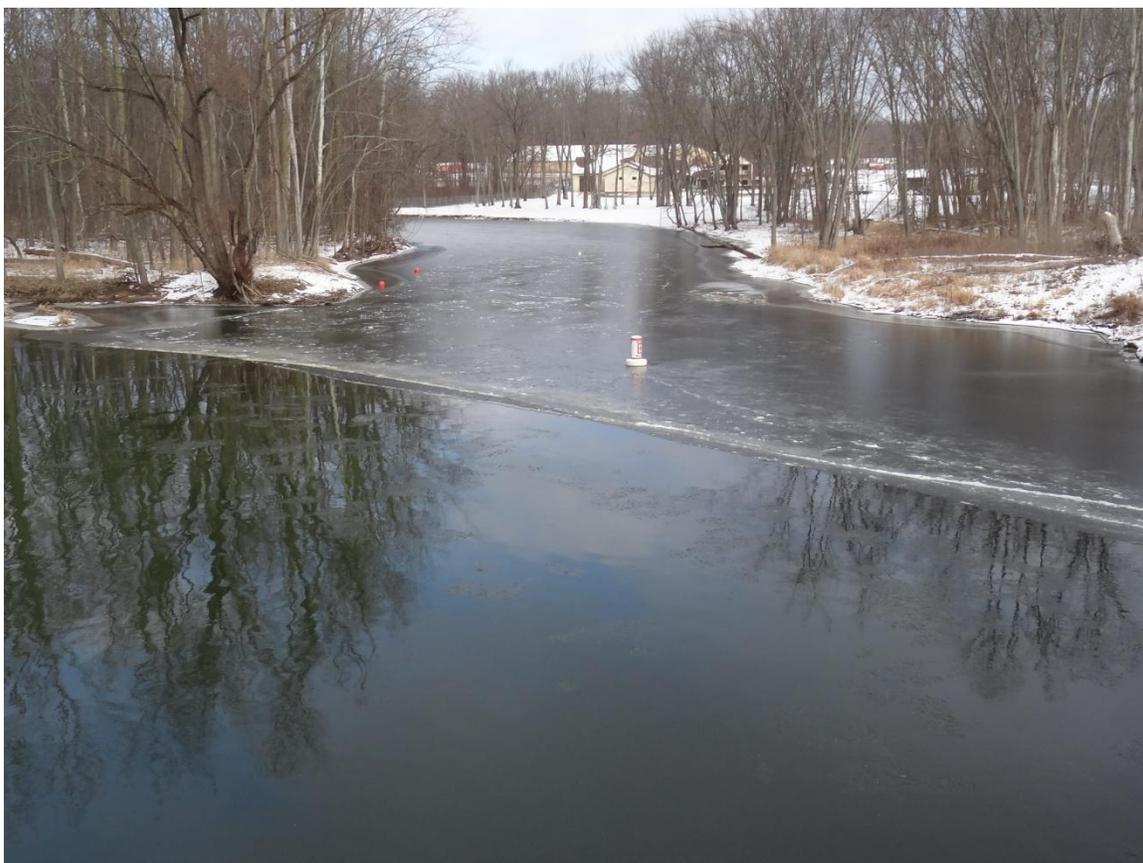
12. MP21.50 RDB, ice has receded from yesterday.

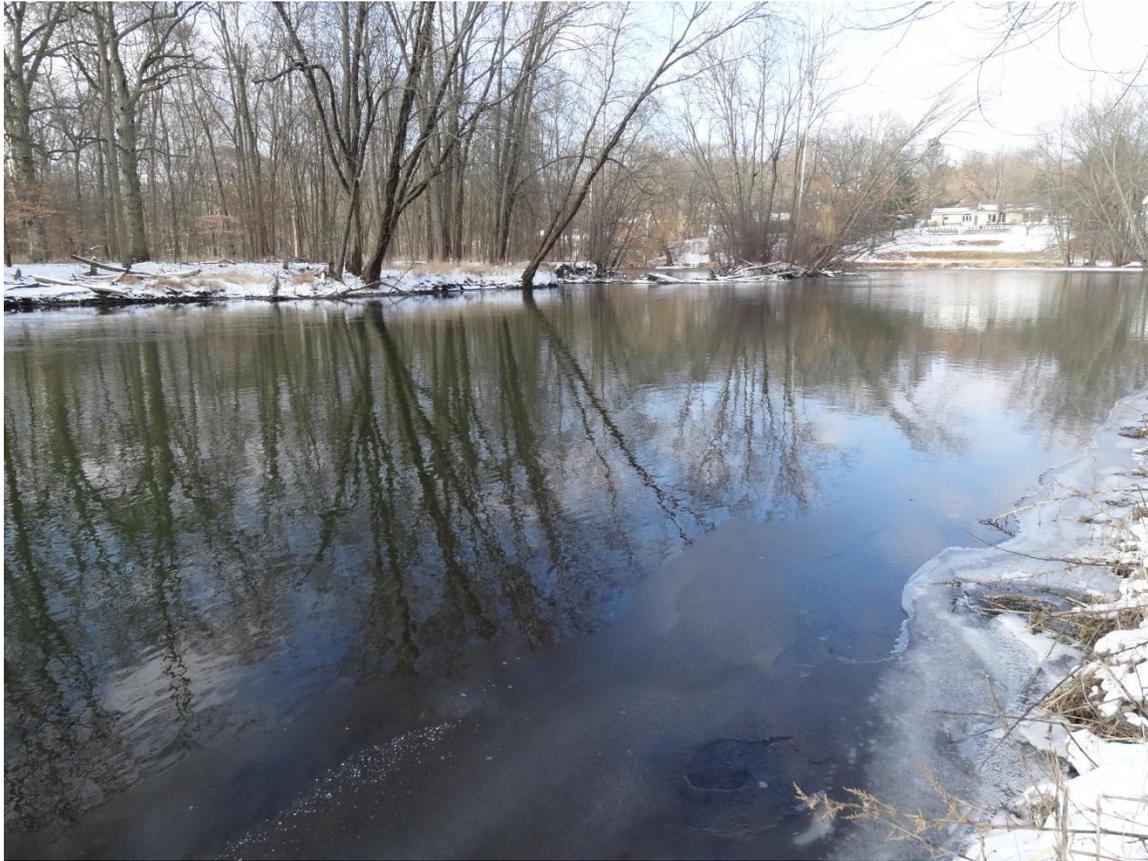
13. MP27.00 Shady Bend Campground, only minor bank ice observed.

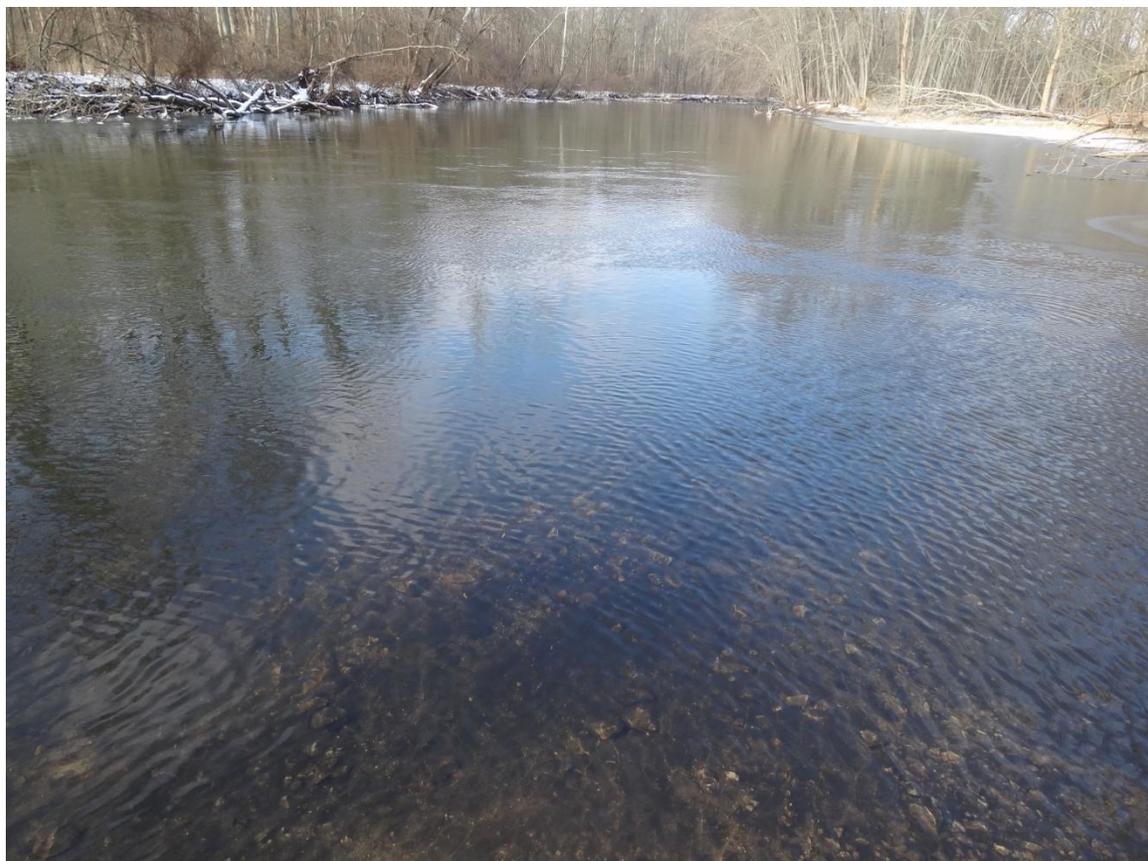
14. E2 Boat Launch, no sheen or significant bank ice observed.

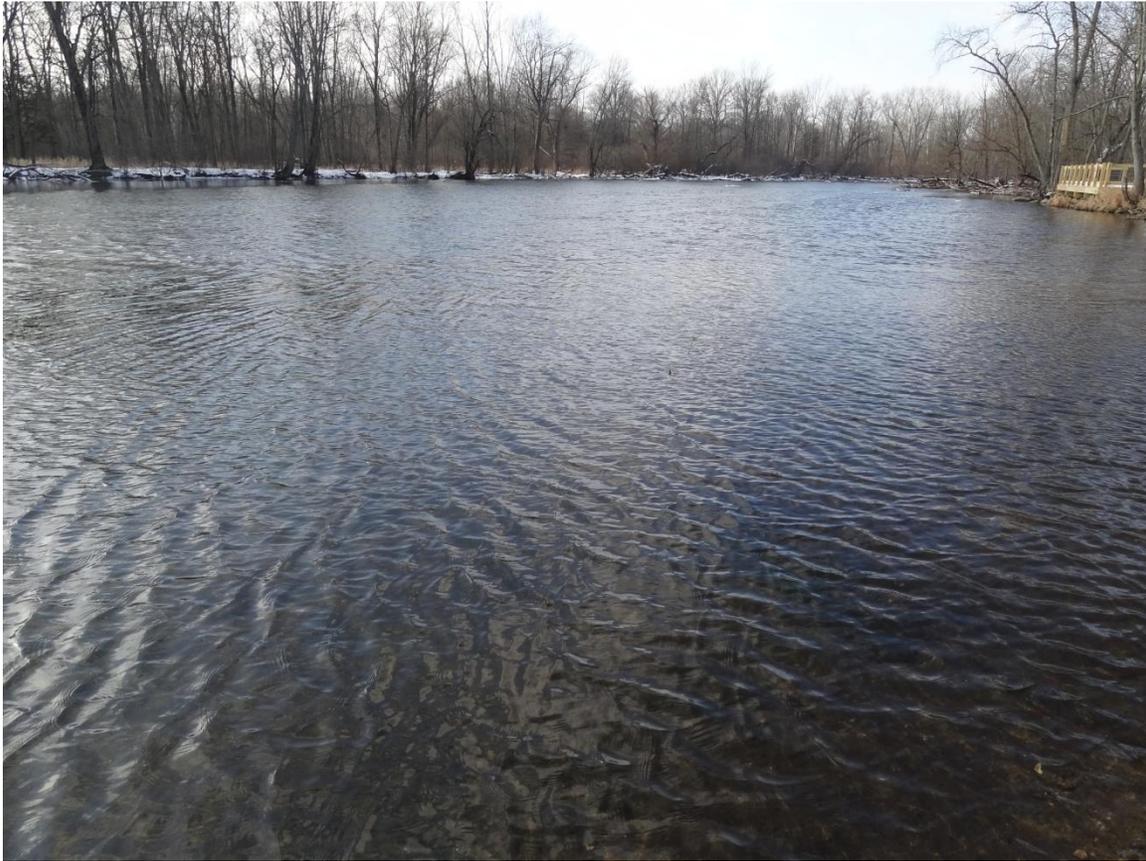
15. E3 Boat Launch, no sheen or bank ice observed.

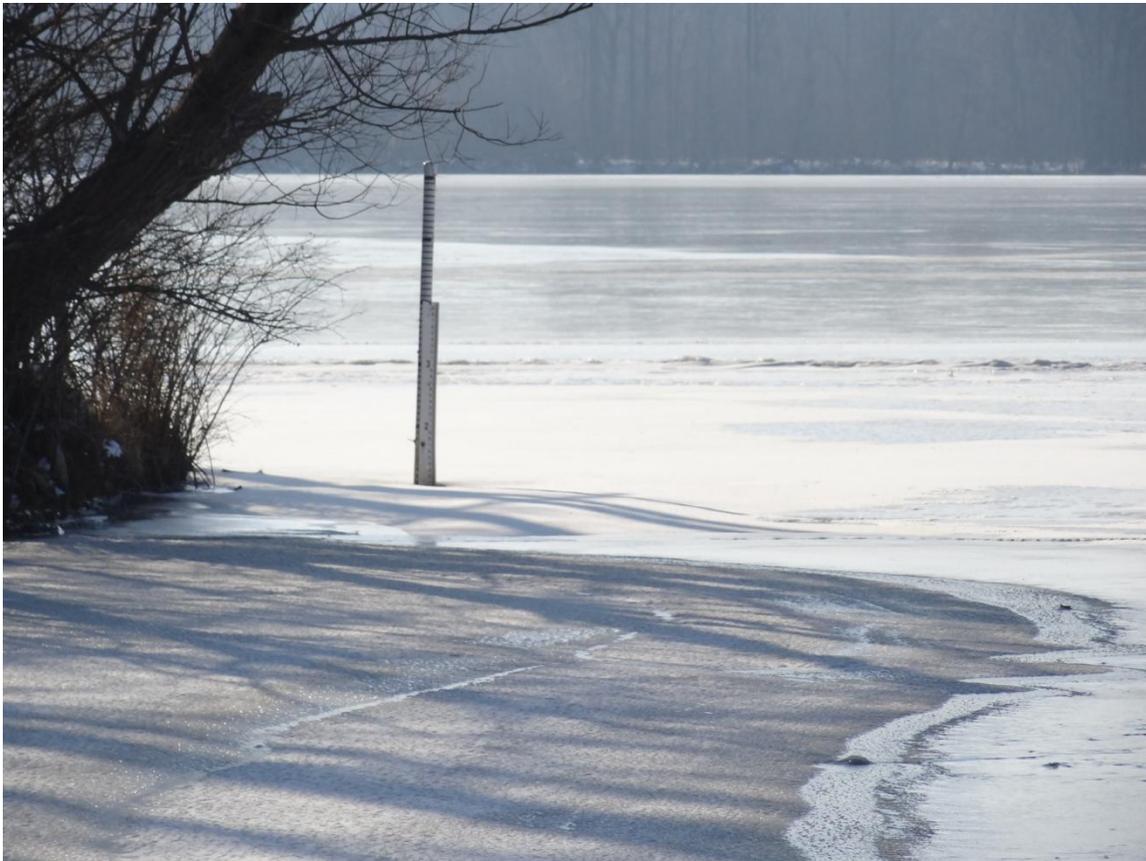
16. Water gauge south of E4 Boat Launch surrounded by ice and snow.

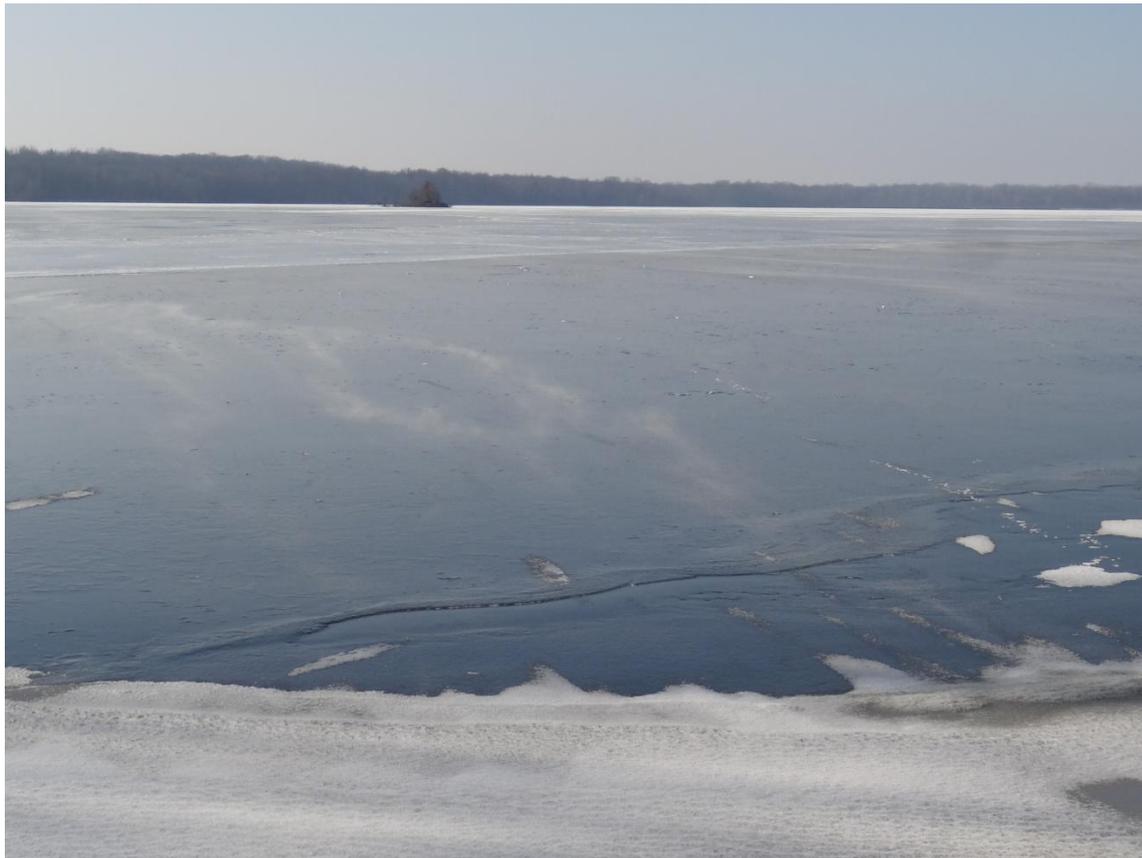
17. Morrow Lake looking southwest from E4 Boat Launch. Morrow Lake and south cove covered in ice and snow.

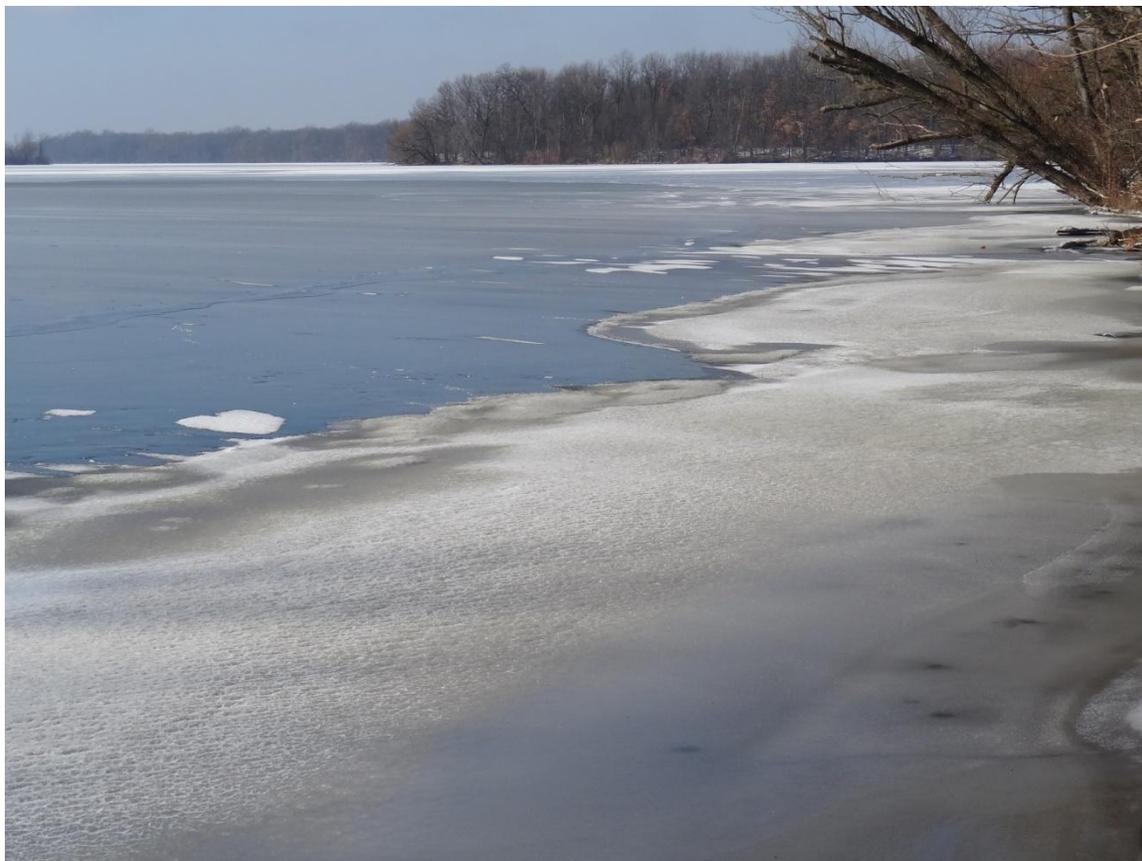
18. North shoreline and north cove of Morrow Lake covered in ice and snow.
