Situation Photo Log

Saturday, January 5, 2013

Kalamazoo River / Enbridge Spill

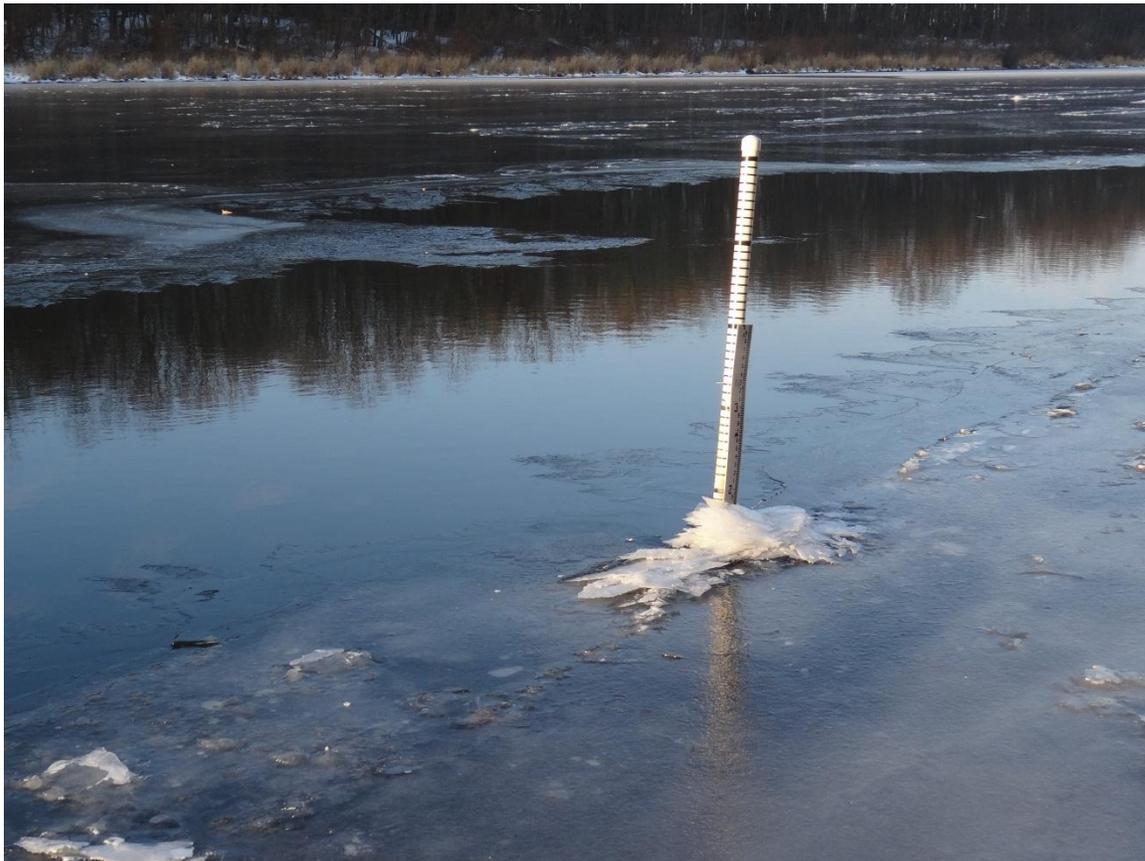
1. Water Gauge at C0.4 Boat launch. River channel covered by ice in vicinity of gauge has decreased from yesterday.

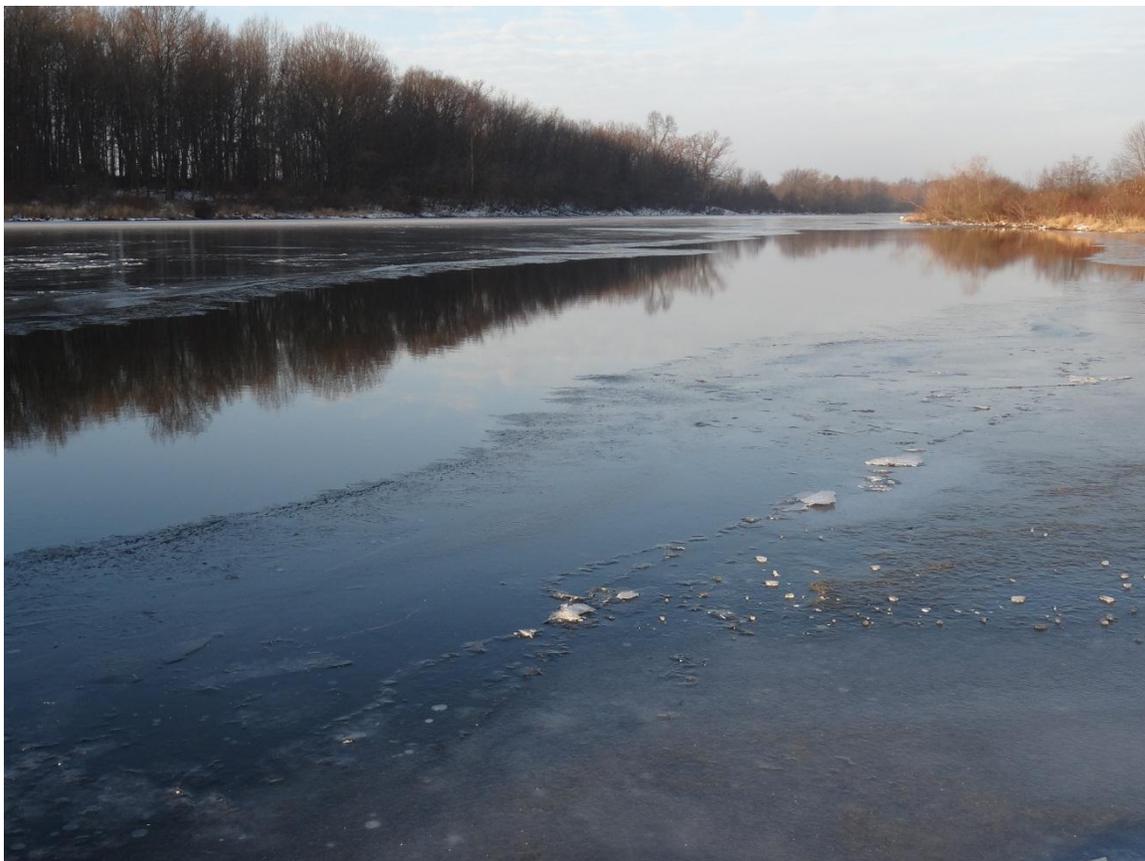
2. C0.4 Boat Launch, ice along river channel has decreased from previous days.

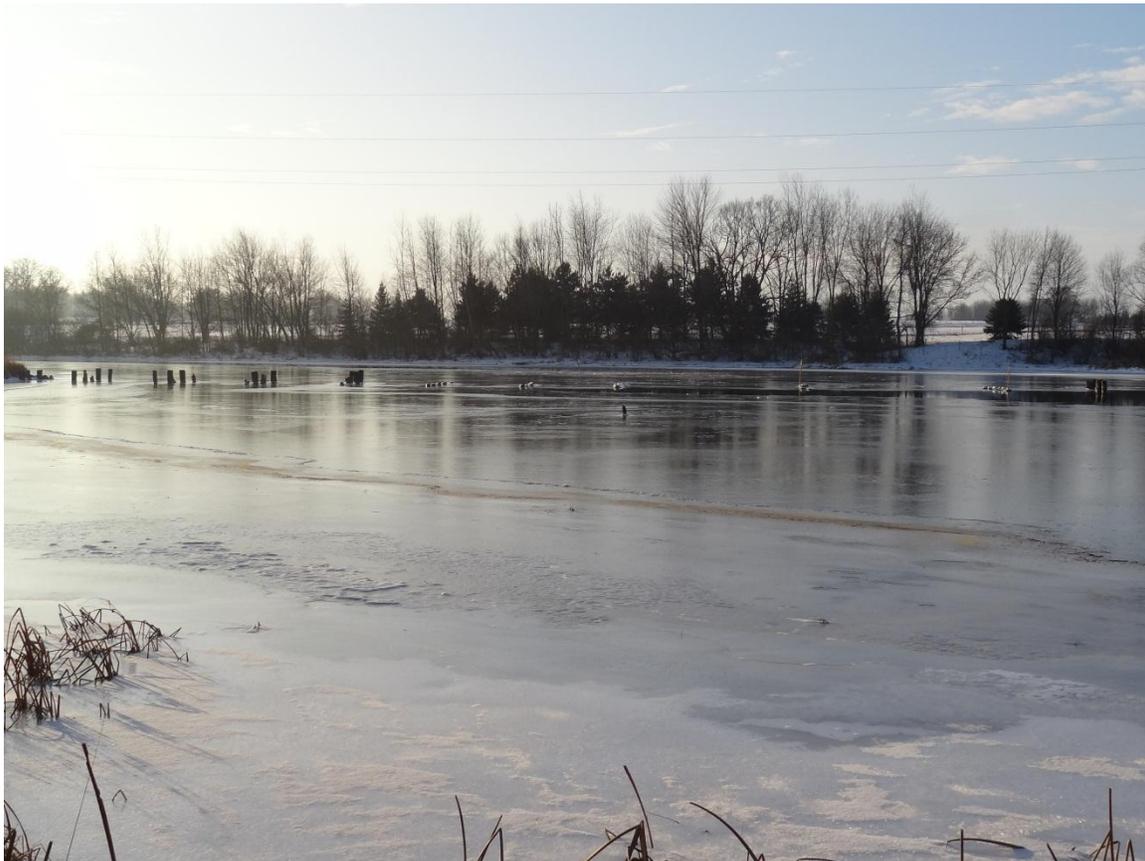
3. MP5.63 Ceresco Dam, ice in vicinity of trestle has decreased from yesterday.

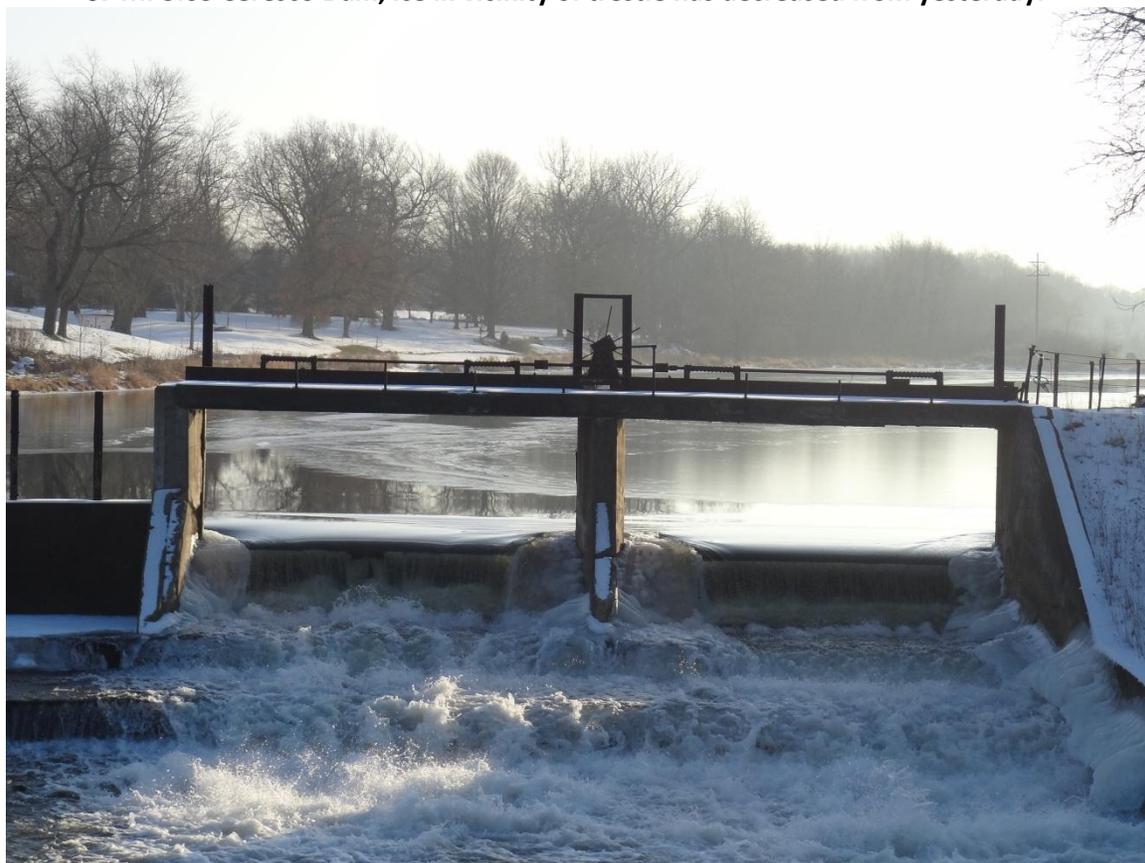
4. Ceresco Dam Impoundment. Ice in vicinity of dam has decreased from yesterday.

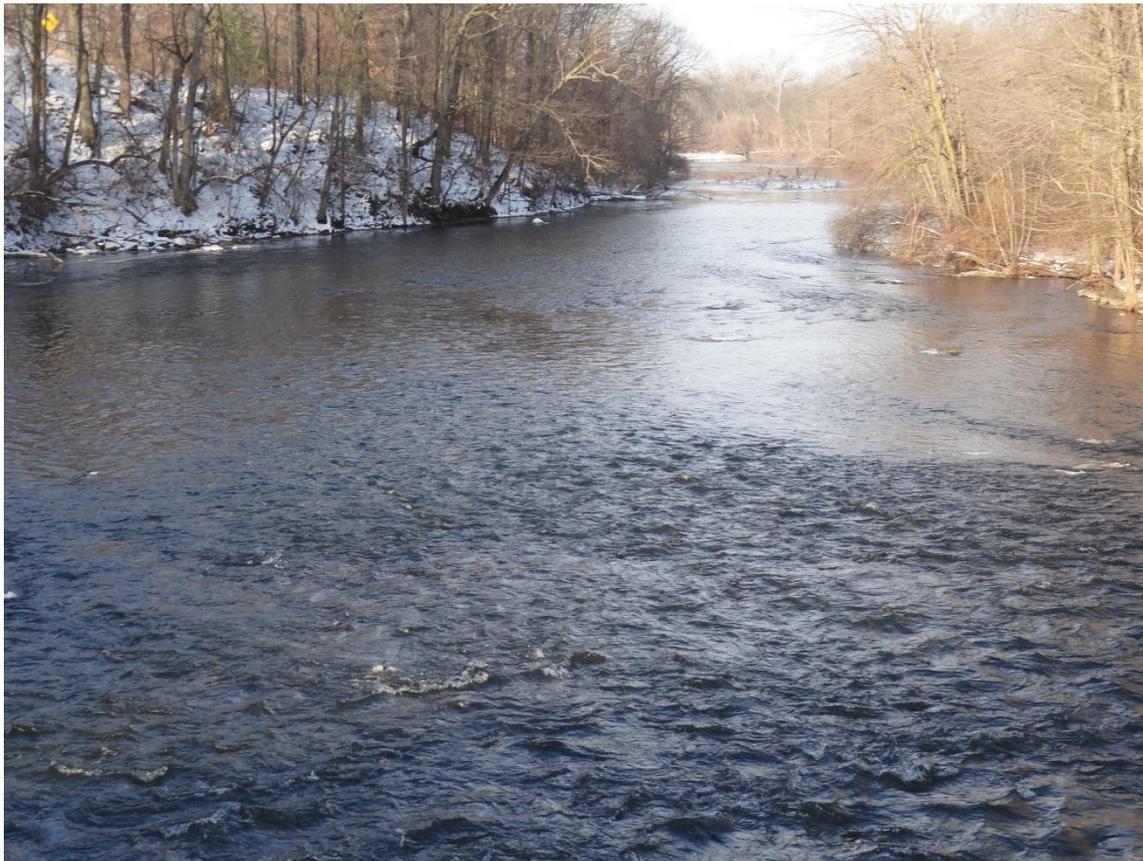
5. MP7.25, no sheen or bank ice observed

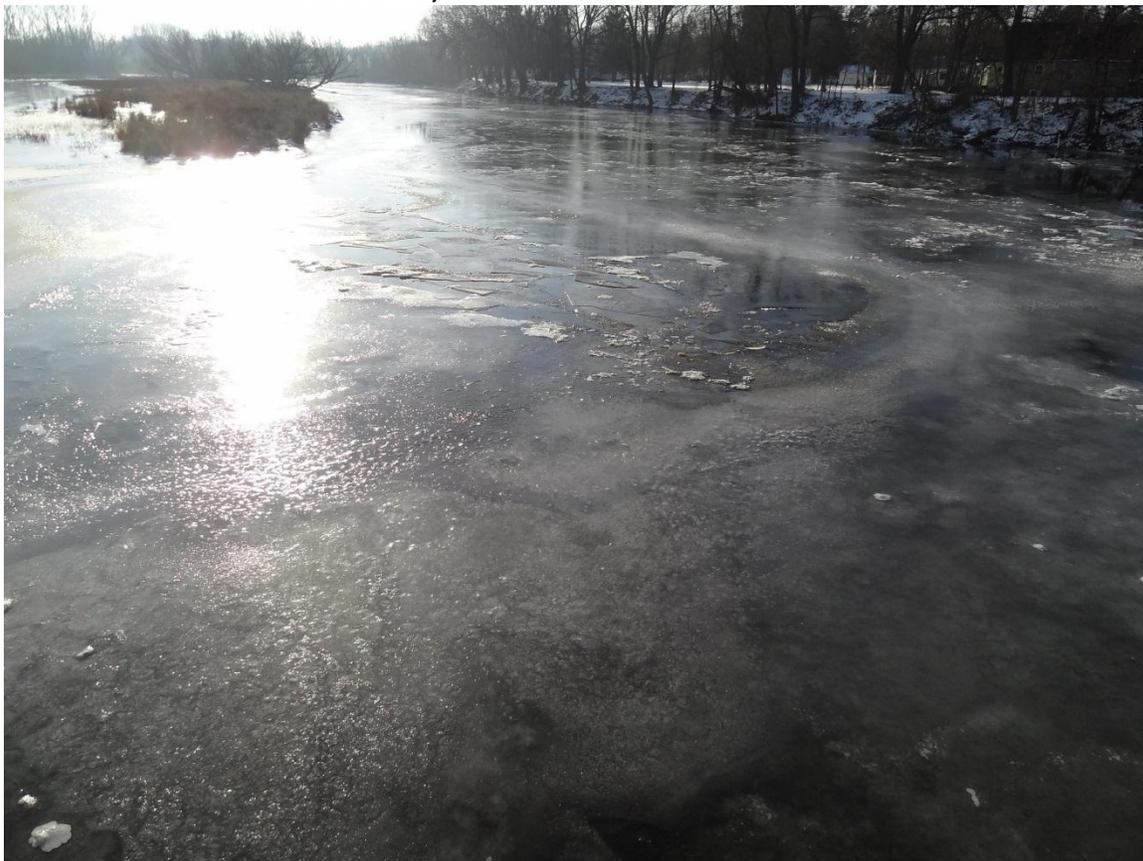
6. MP15.25 South Mill Pond. Ice along river channel has receded slightly from yesterday.

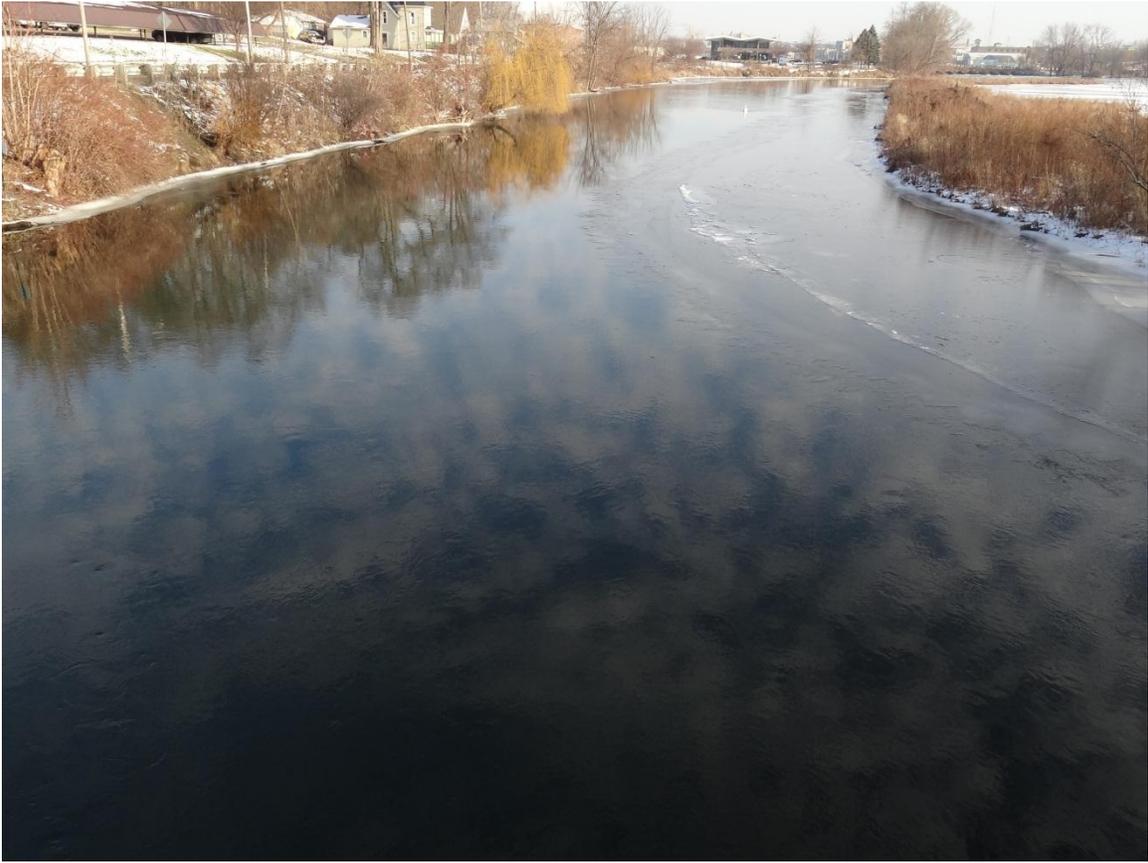
7. MP15.50 North Mill Pond, bank ice observed.

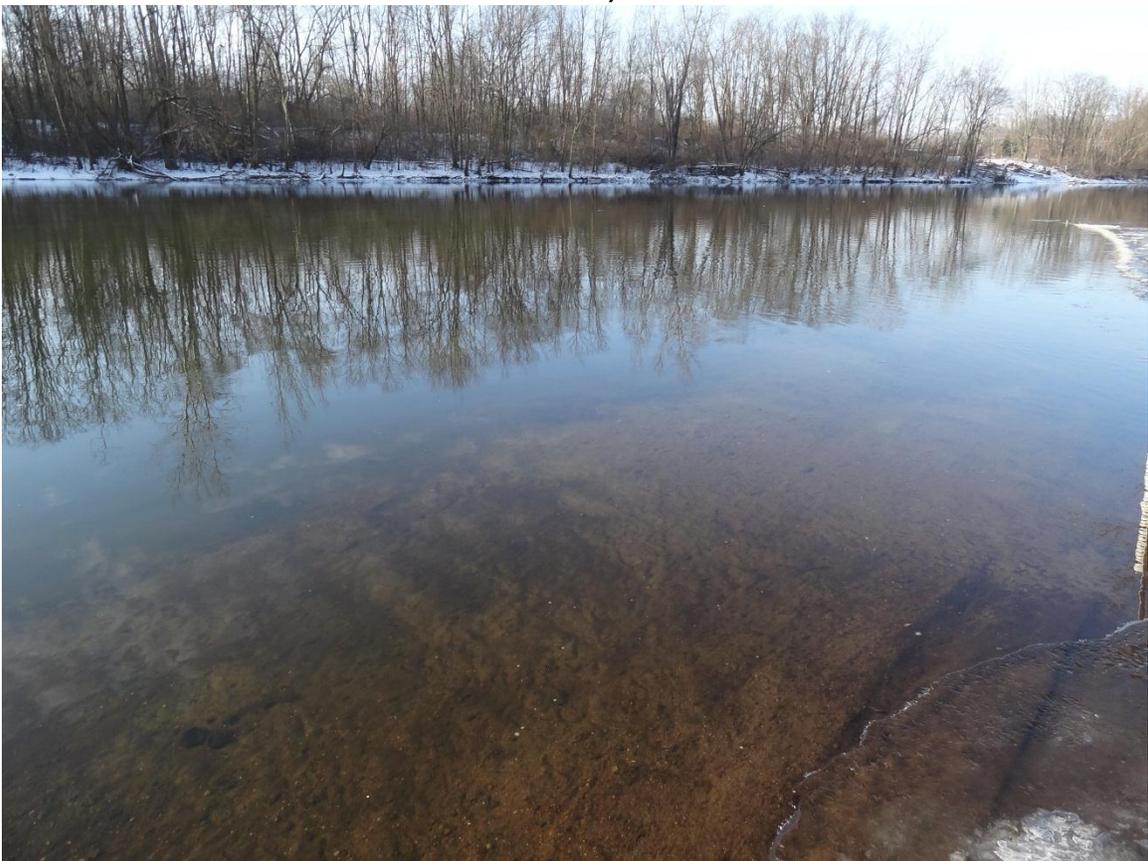
8. D2 Boat Launch, only minor bank ice observed.

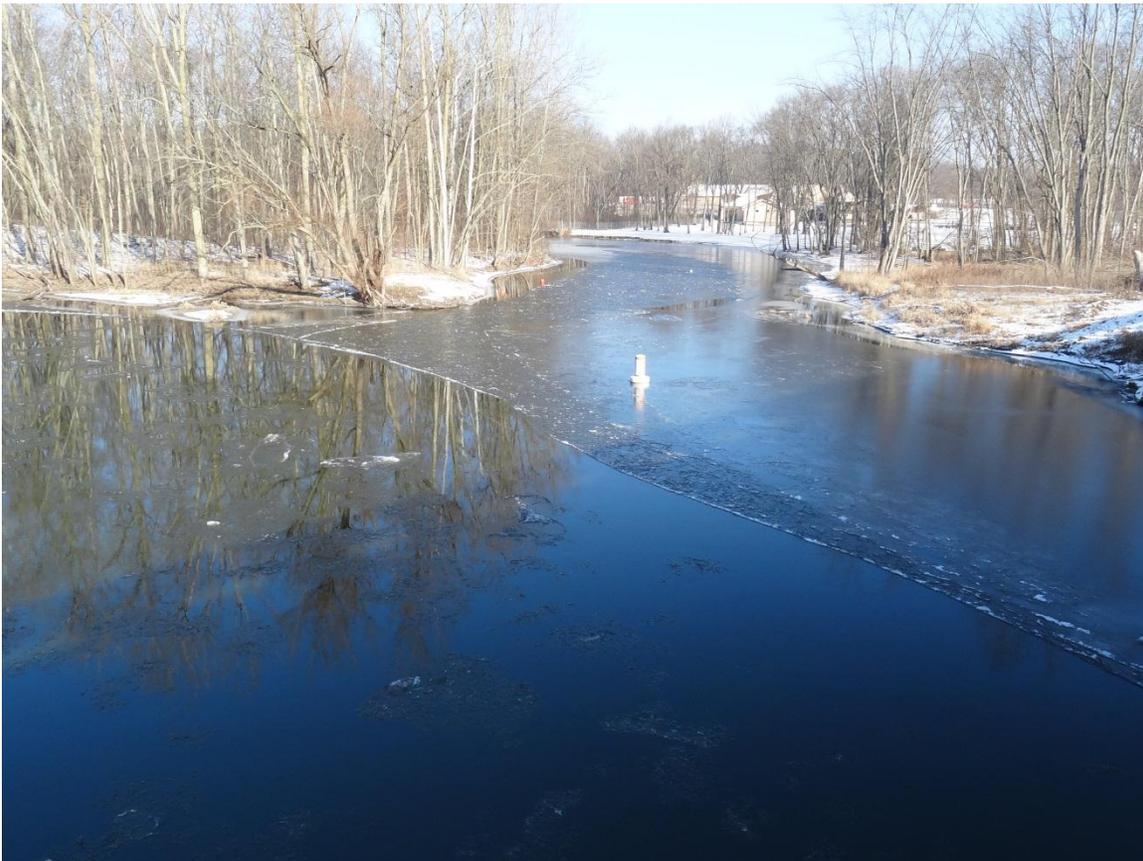
9. MP21.50 RDB, ice continues to recede from previous days.

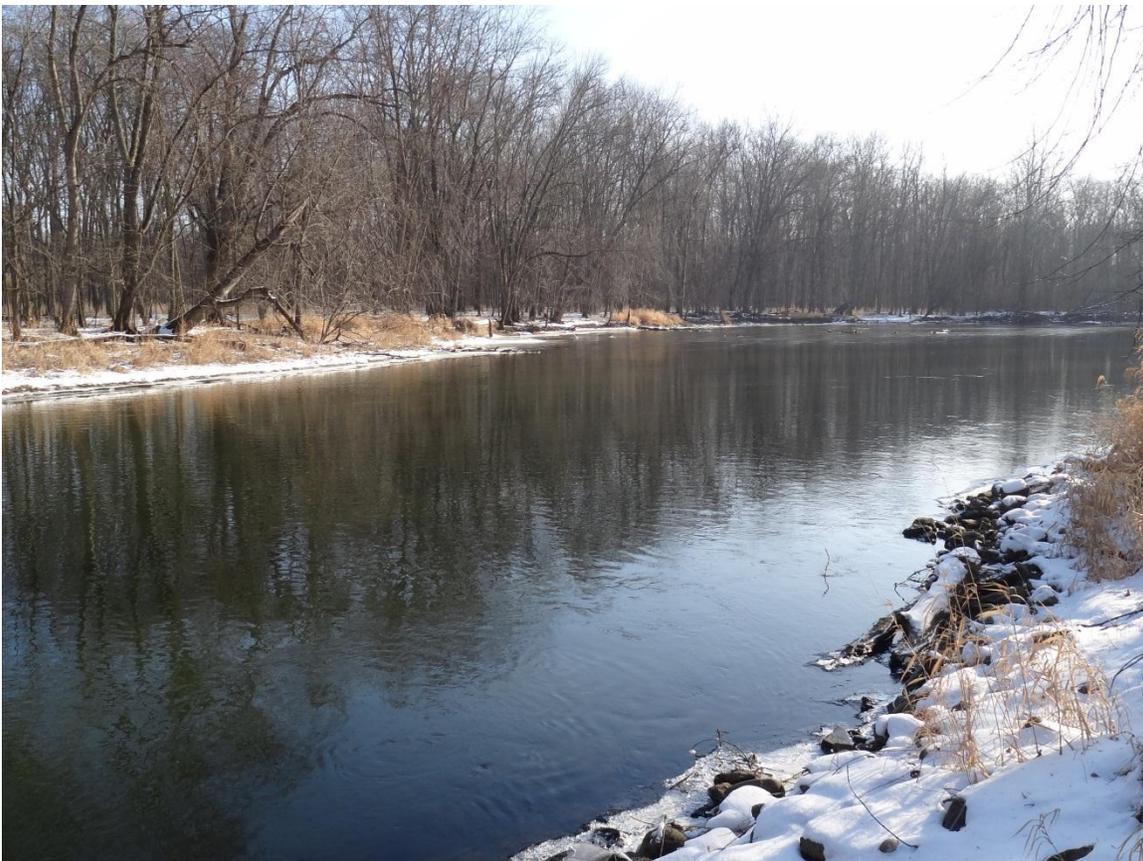
10. MP27.0 Shady Bend Campground, no sheen or significant bank ice observed.

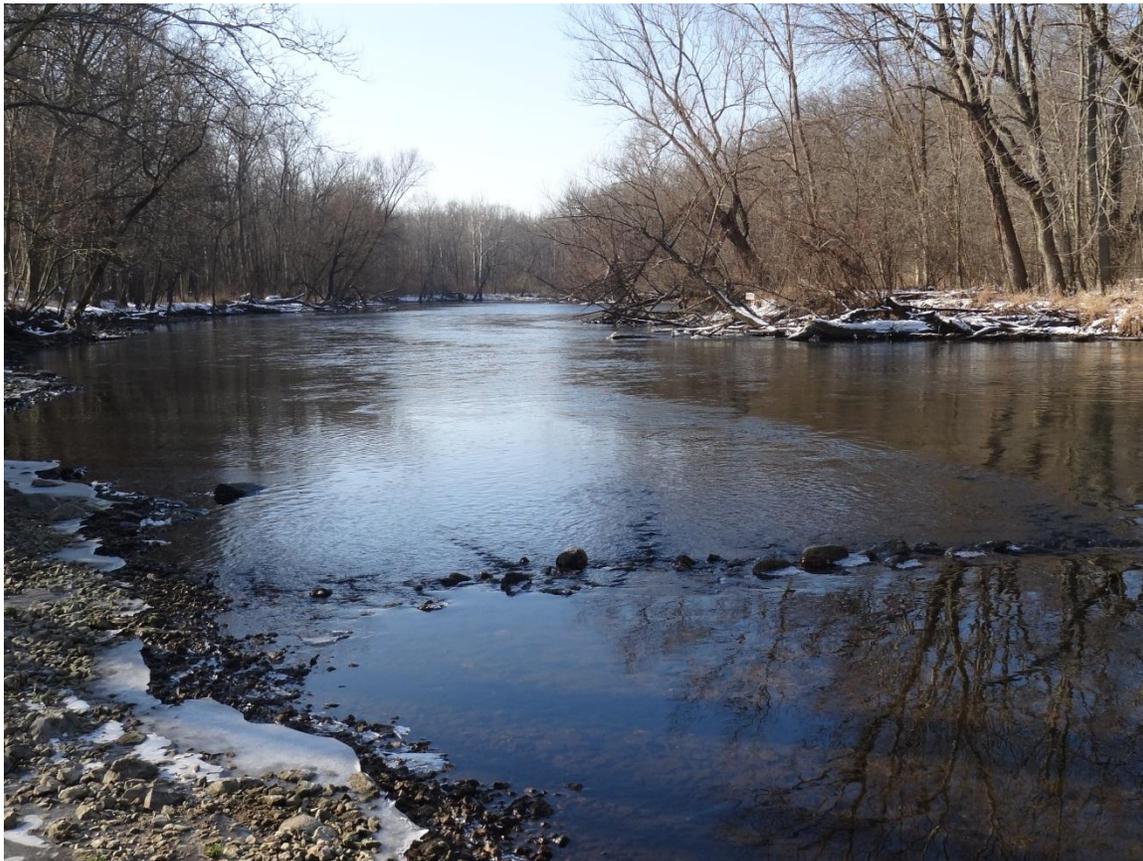
11. E2 Boat Launch, no sheen or bank ice observed.

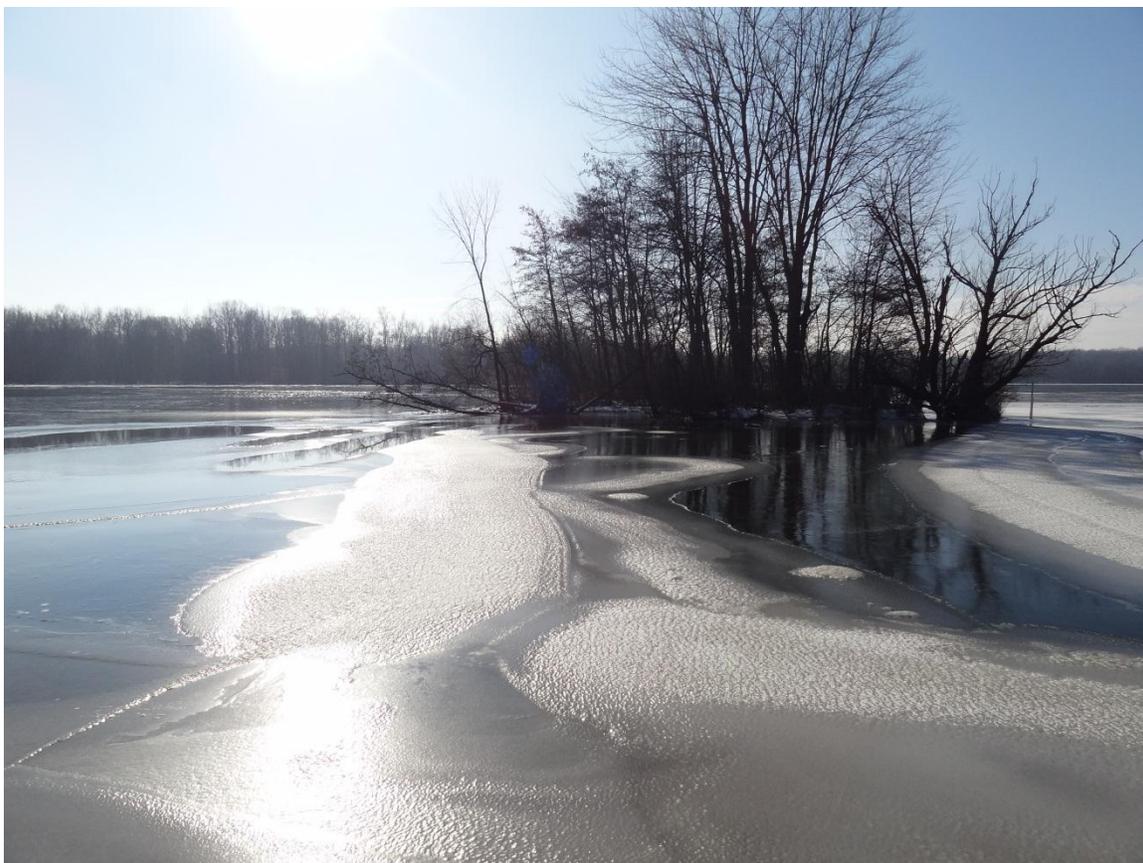
12. E4 Boat launch, ice has receded slightly south of the launch.

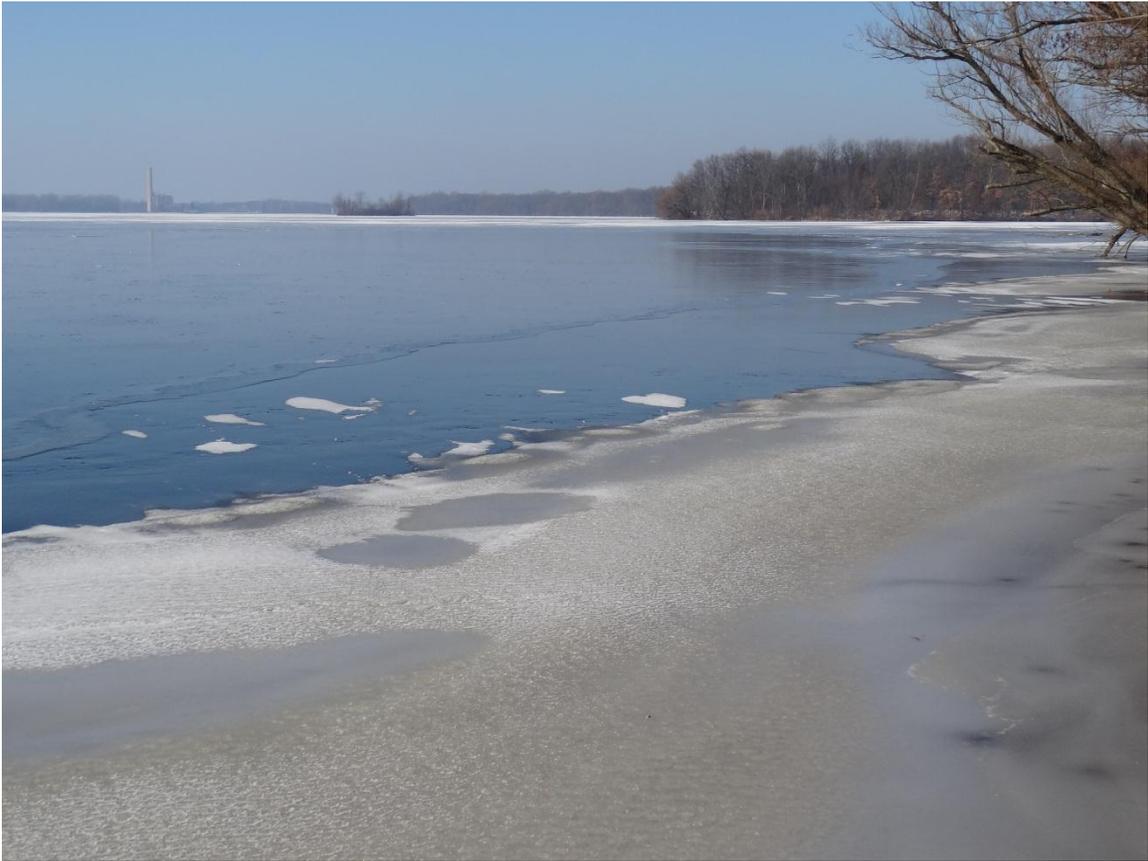
13. West end of Morrow Lake and north cove appear to remain covered in ice and snow.

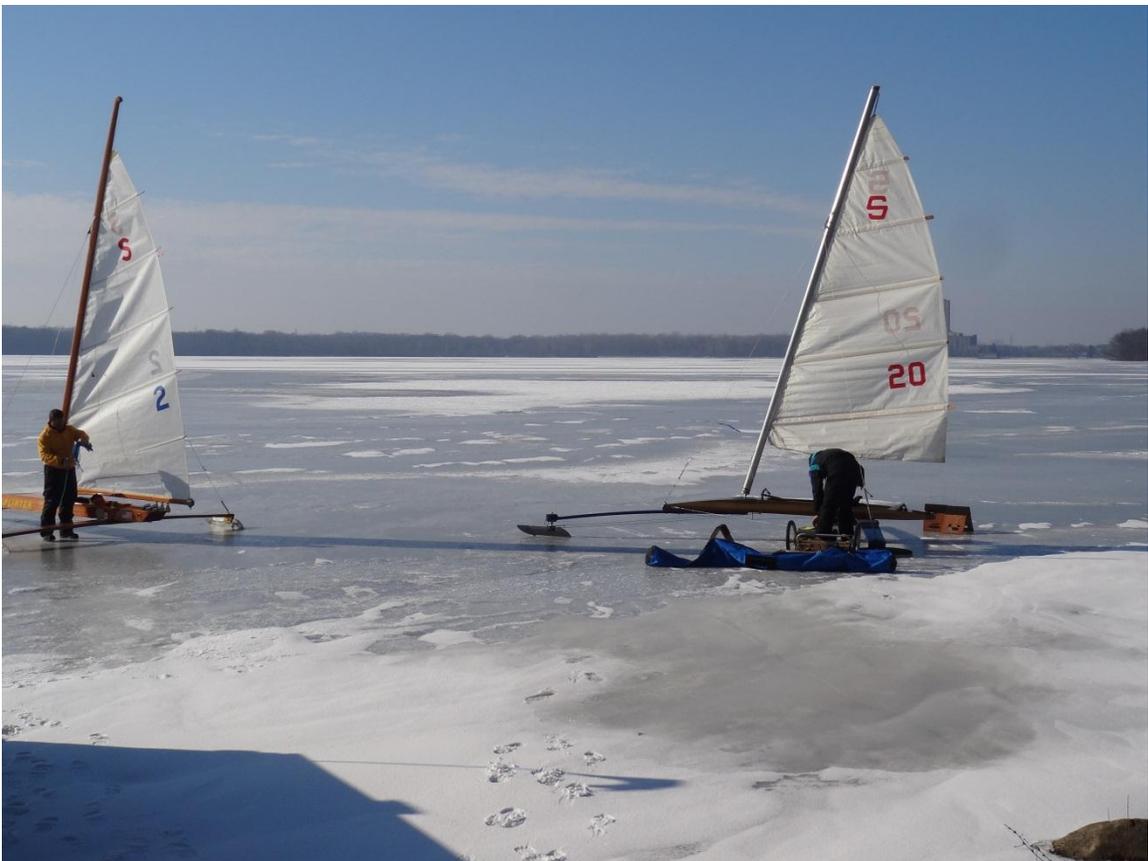
14. E4.5 Boat Launch. Ice boats observed on western portion of Morrow Lake.
