Situation Photo Log

Monday, January 7, 2013

Kalamazoo River / Enbridge Spill

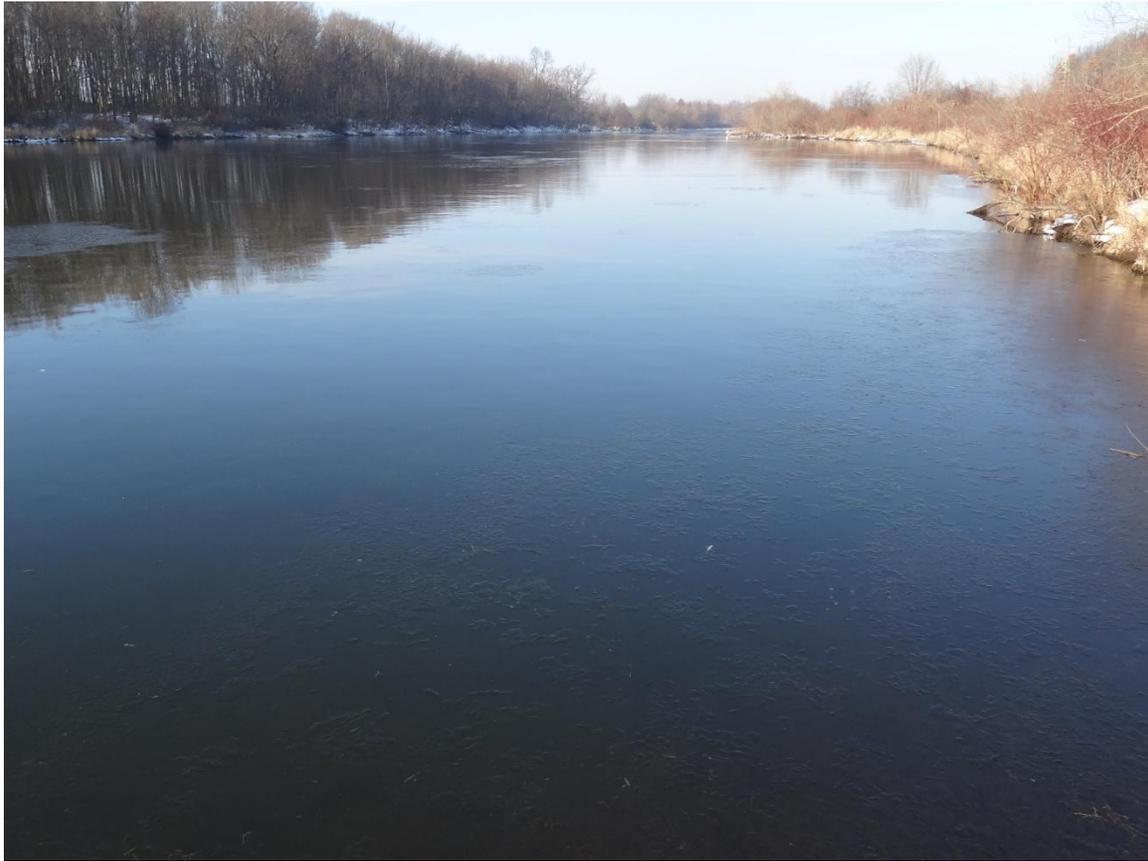
1. C0.4 Boat launch, ice observed along river channel has receded from previous days.

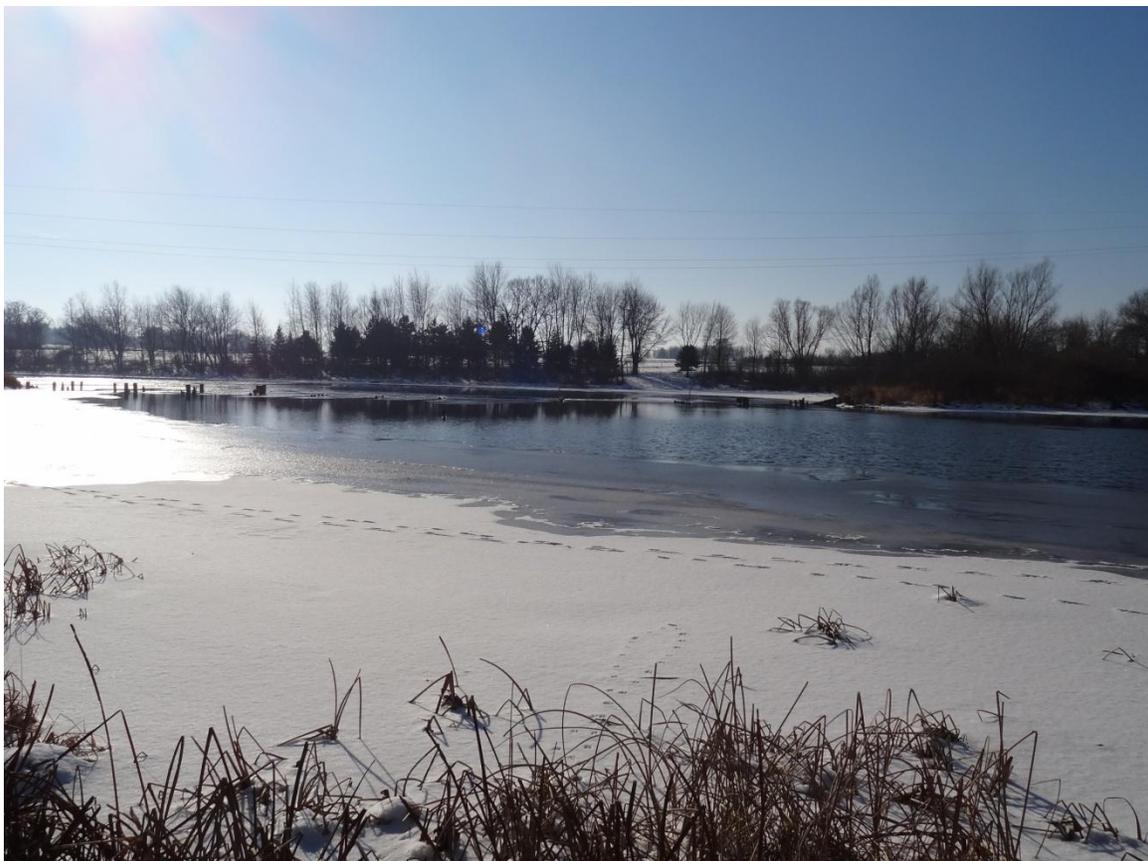
2. MP5.63 Ceresco Dam trestle, ice in vicinity of trestle has notably decreased.

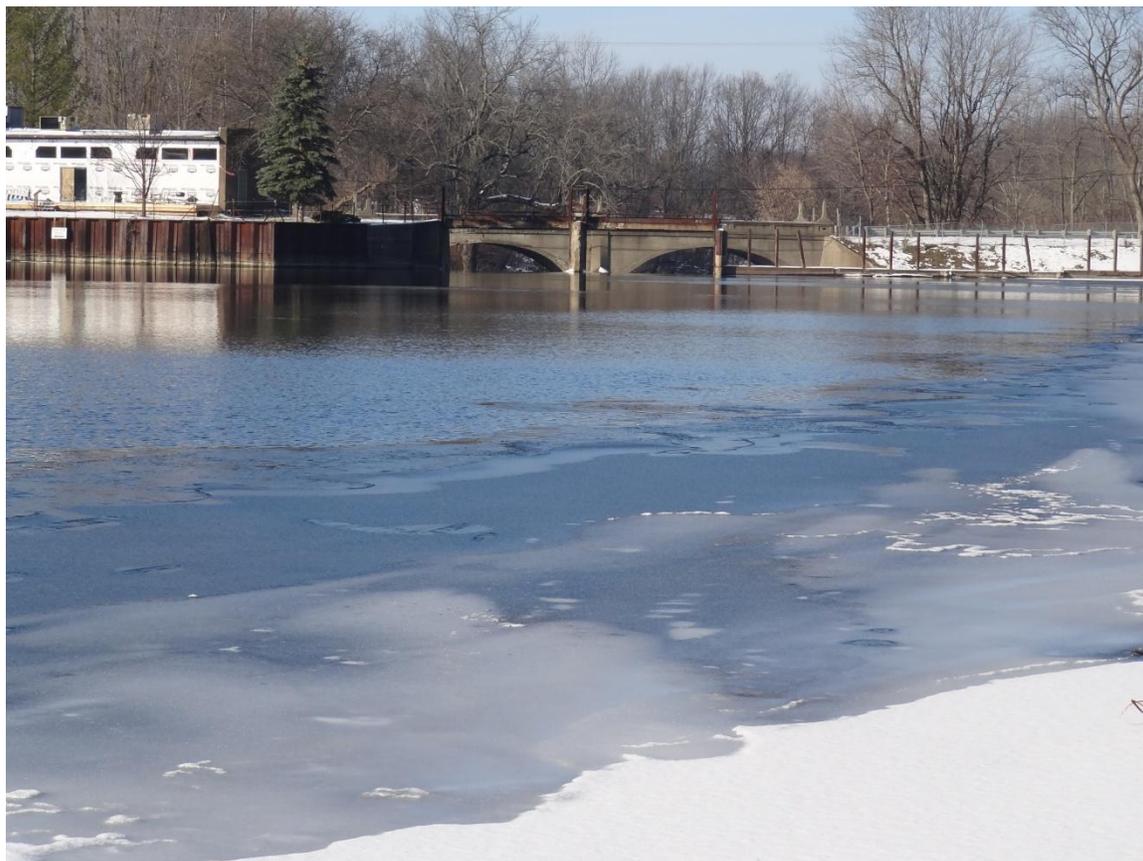
3. MP5.75 Ceresco Dam, only bank ice observed.

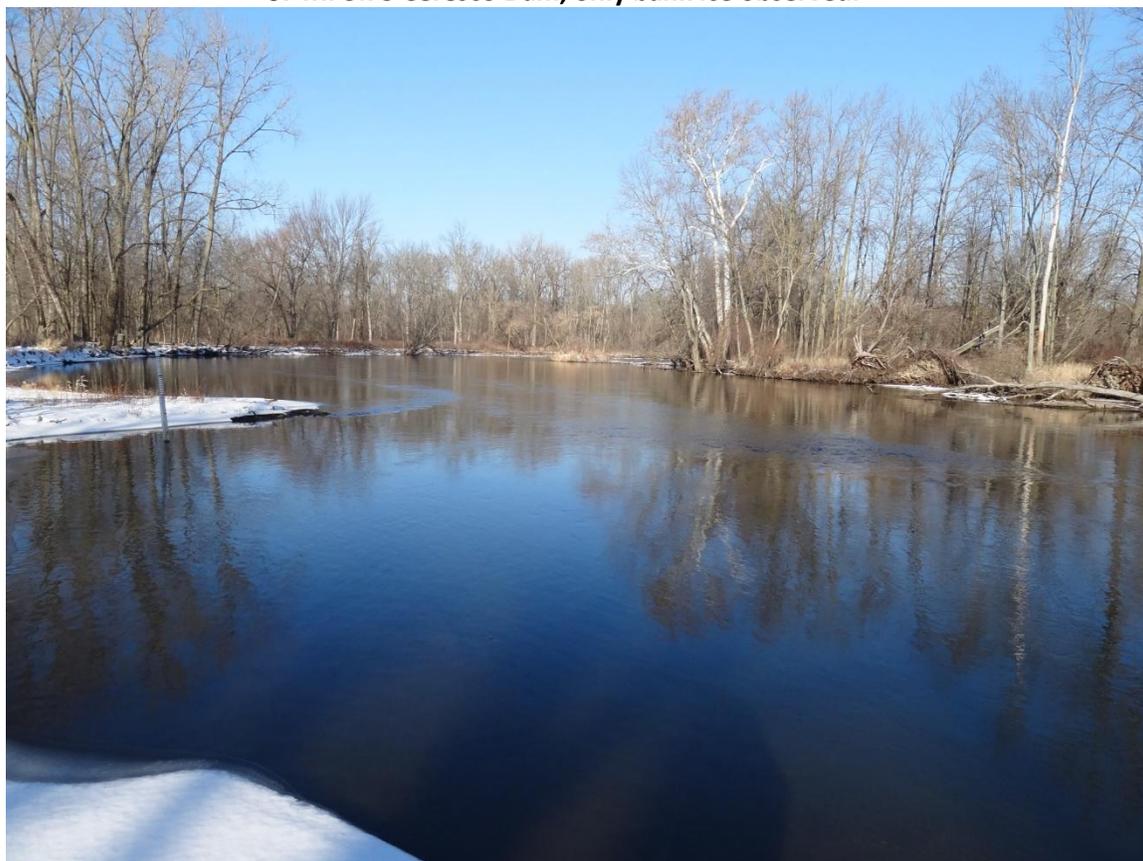
4. C3.2 Boat Launch, no sheen or significant bank ice observed.

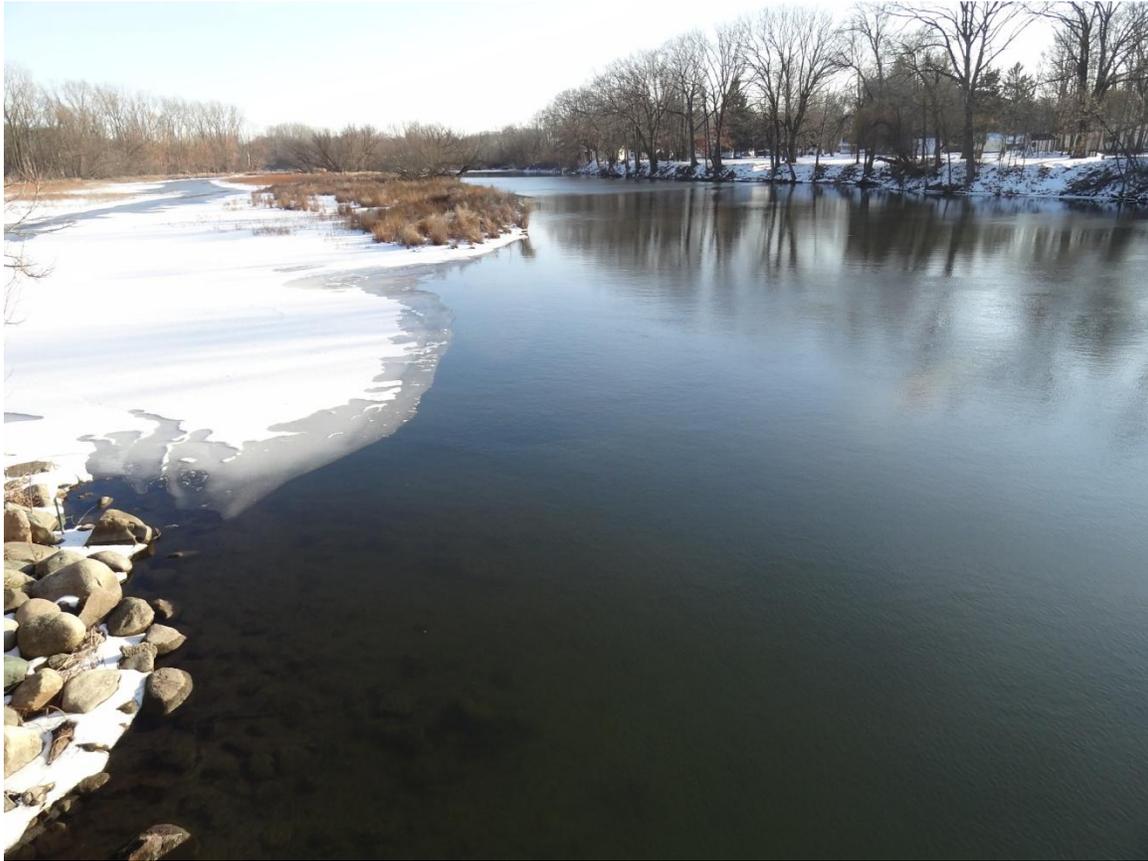
5. MP15.25 South Mill Pond, ice along river channel has receded.

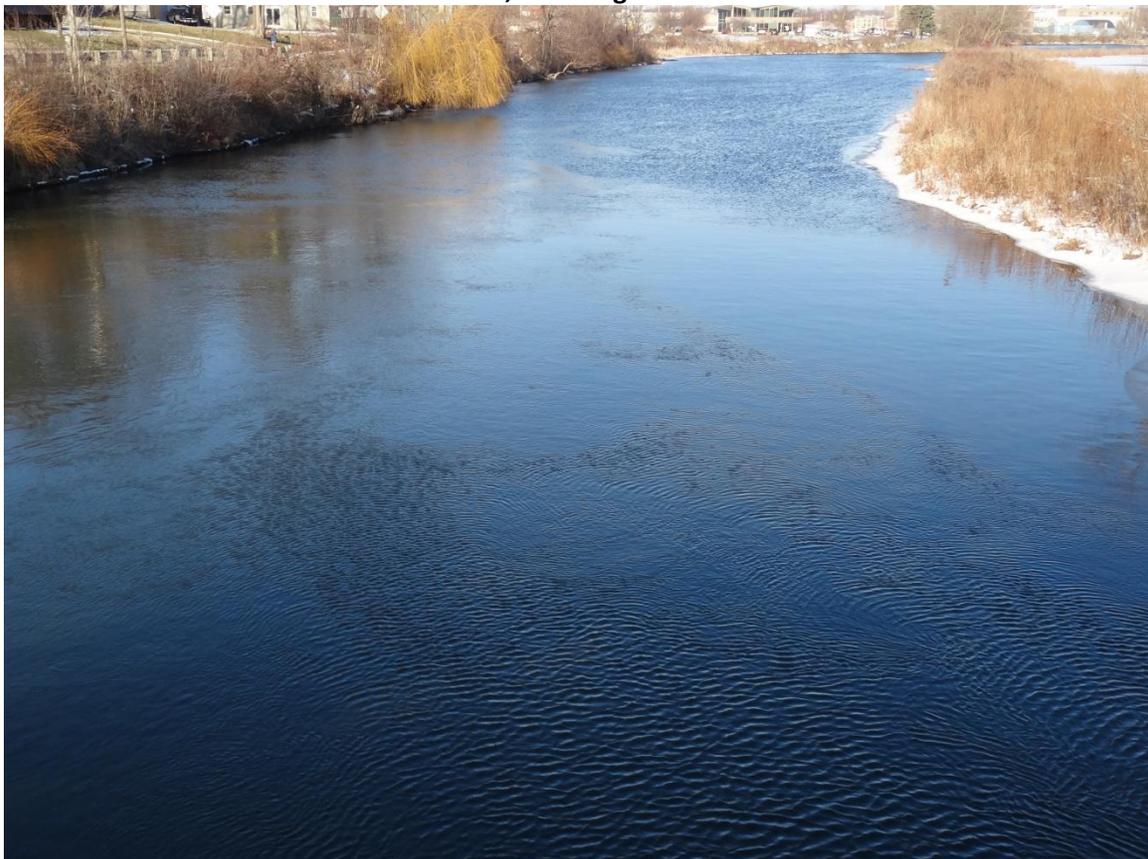
6. MP15.50 North Mill Pond, no sheen or notable bank ice observed.

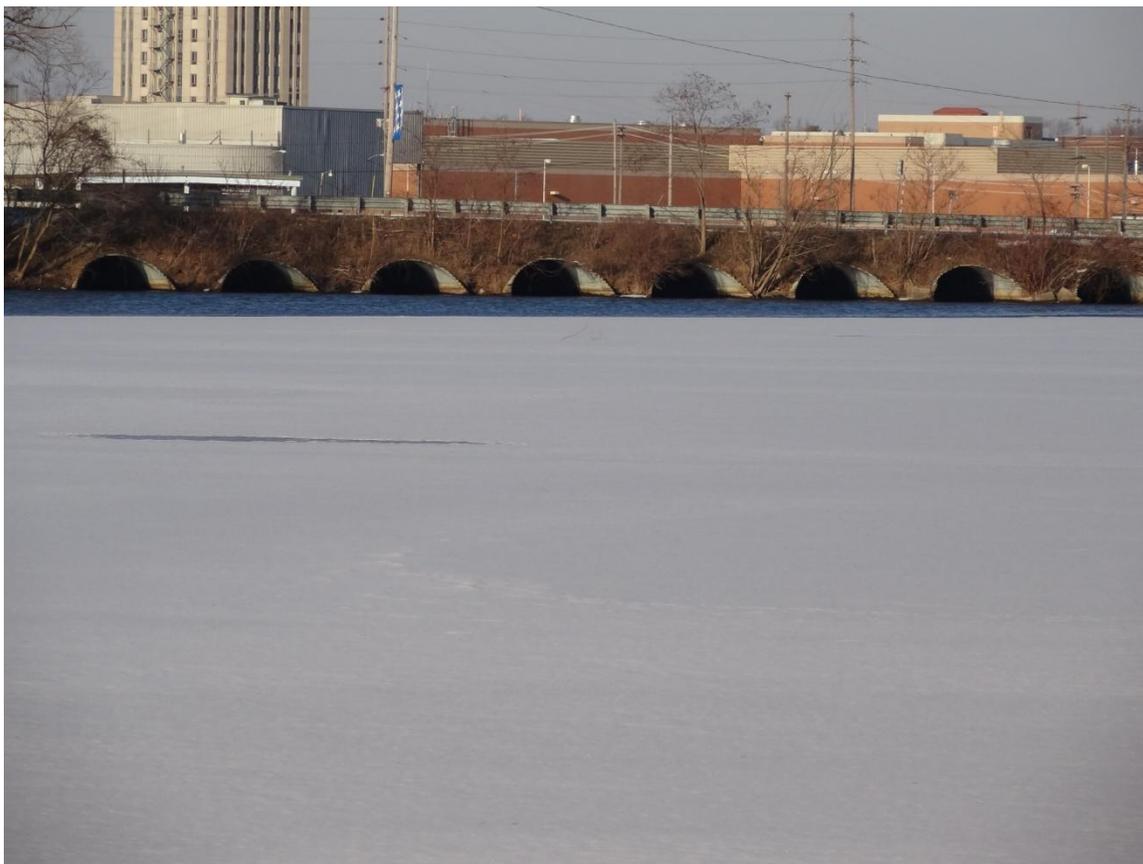
7. MP15.65 North Mill Pond culverts, ice in vicinity of culverts has receded.

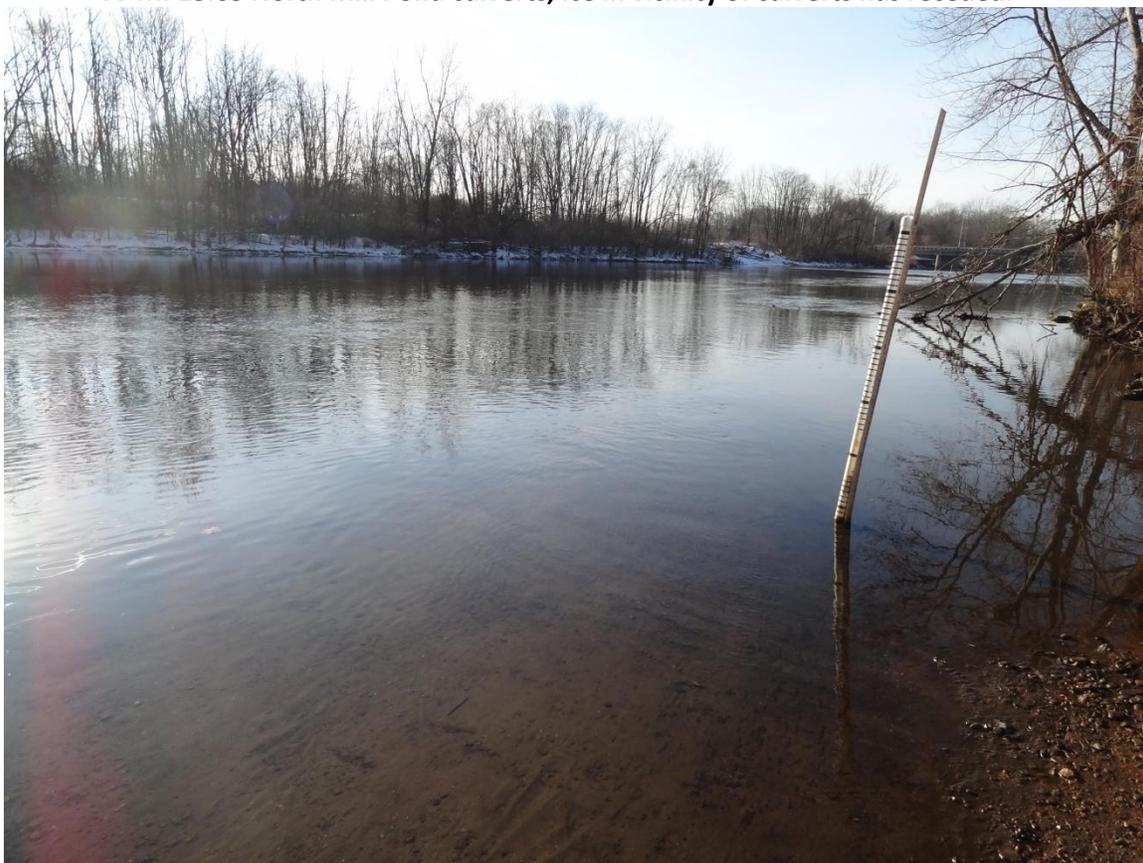
8. Water gauge at D2 Boat Launch, no sheen or bank ice observed.

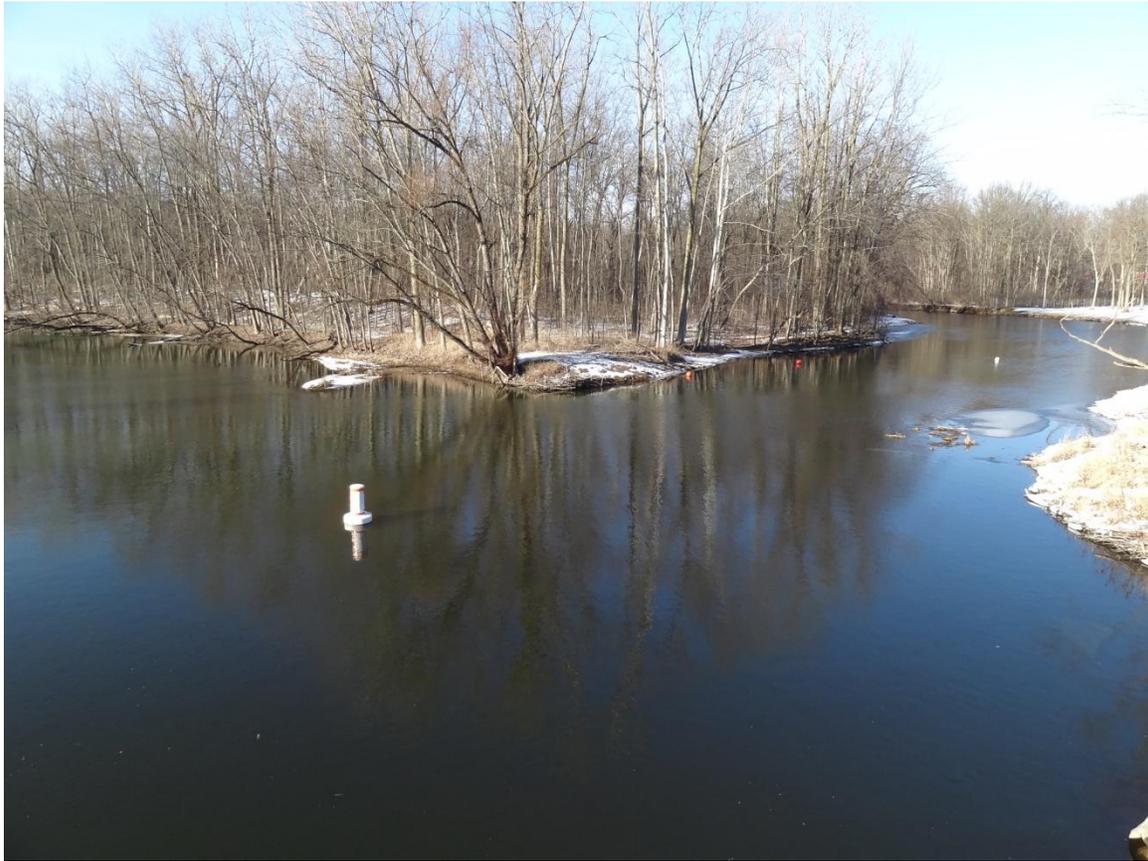
9. MP21.50 RDB, ice has significantly receded along river channel and oxbow.

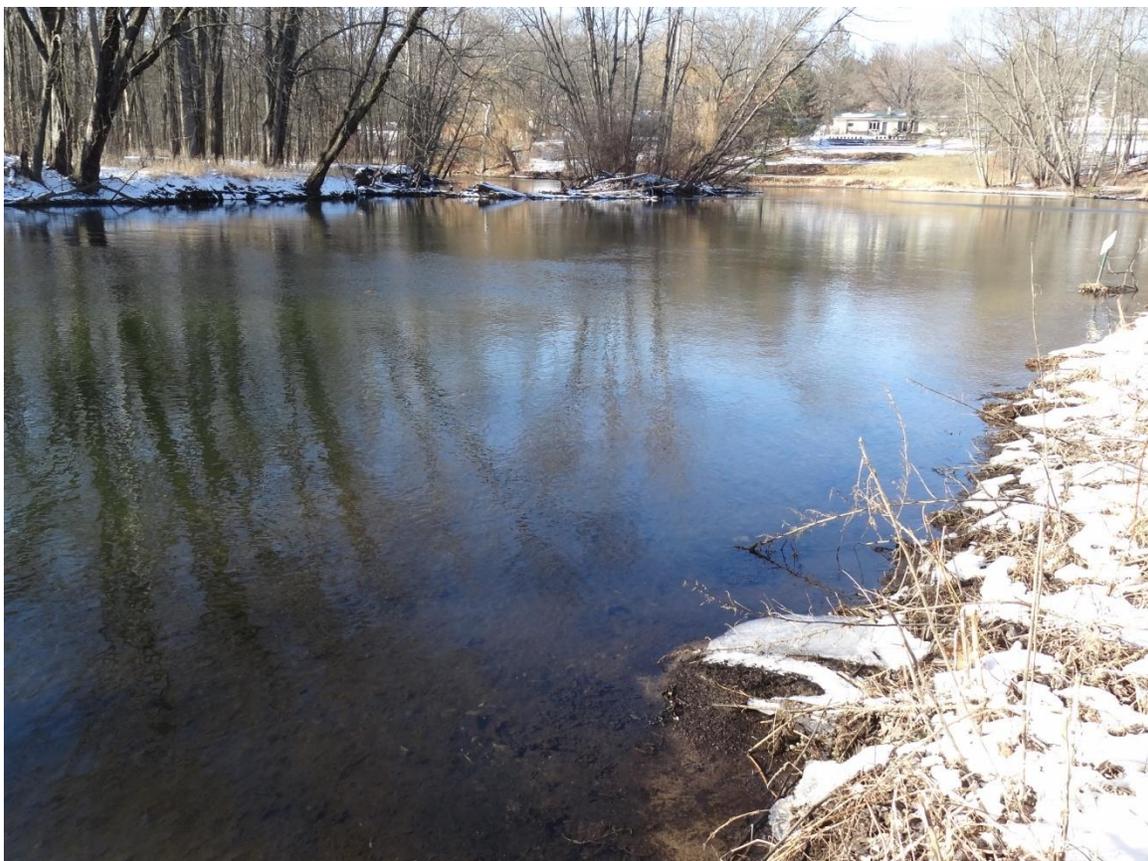
10. MP27.0 Shady Bend Campground, no sheen or bank ice observed.

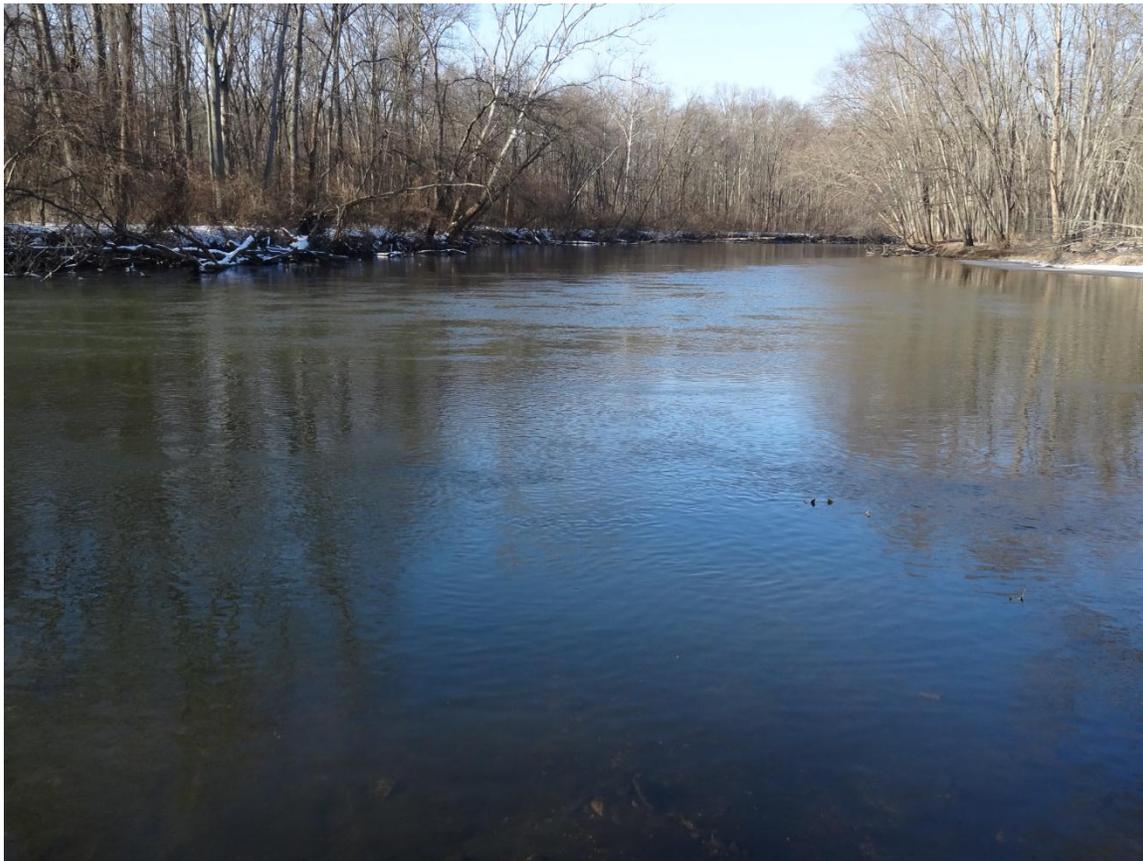
11. E2 Boat Launch, no sheen or bank ice observed.

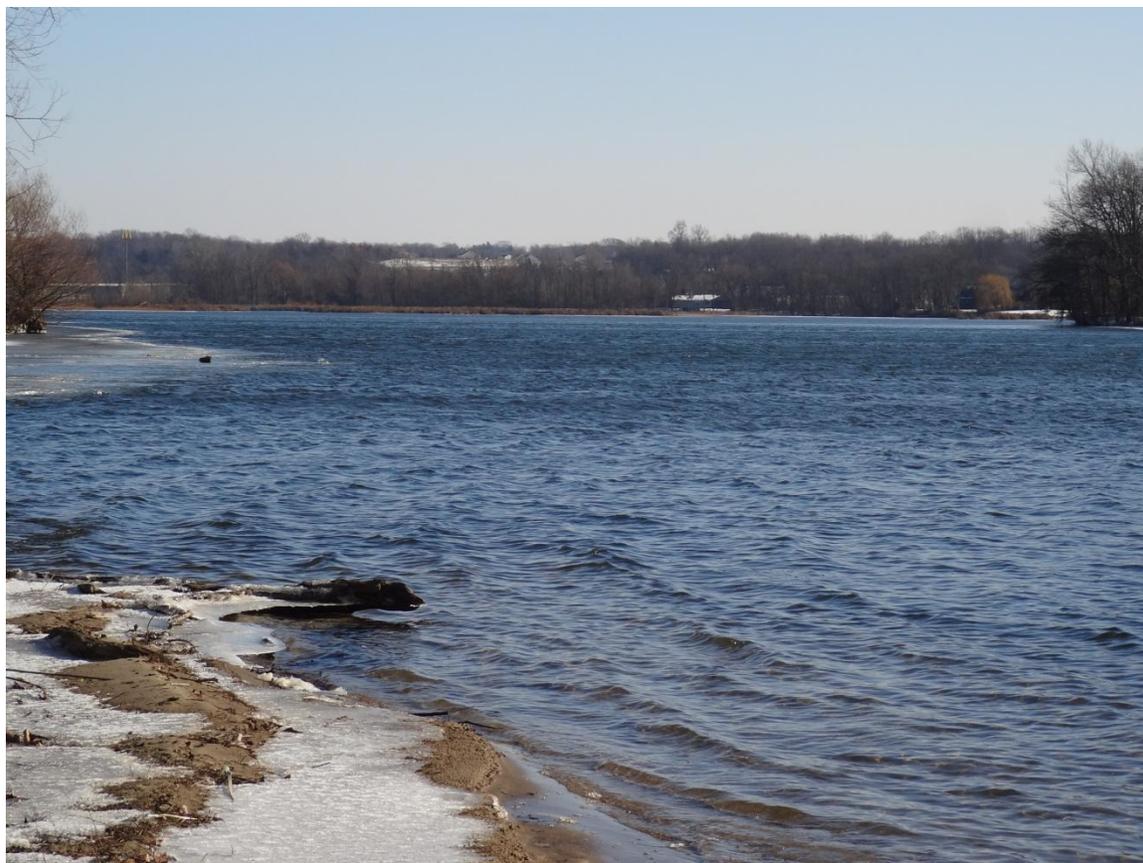
12. E4 Boat launch looking east into Delta, no significant ice observed.

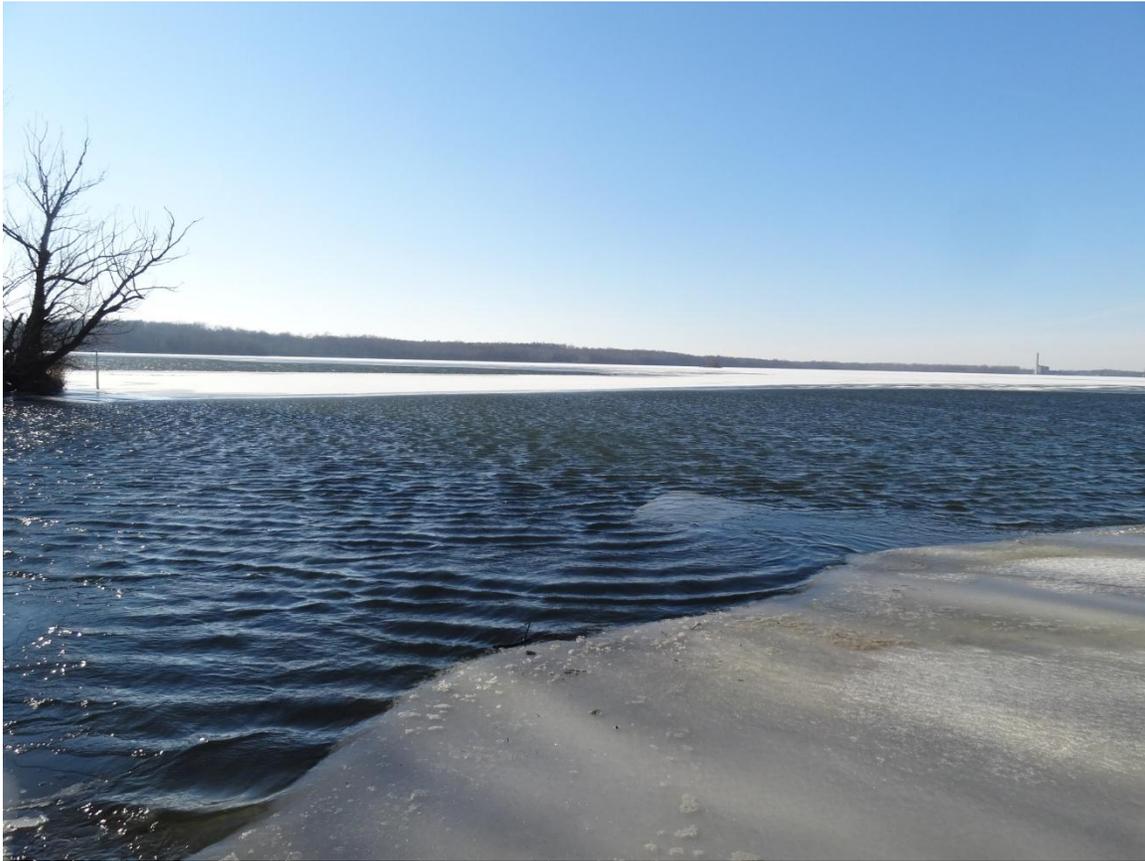
13. Looking south from E4 Boat Launch, ice has receded substantially from previous days.

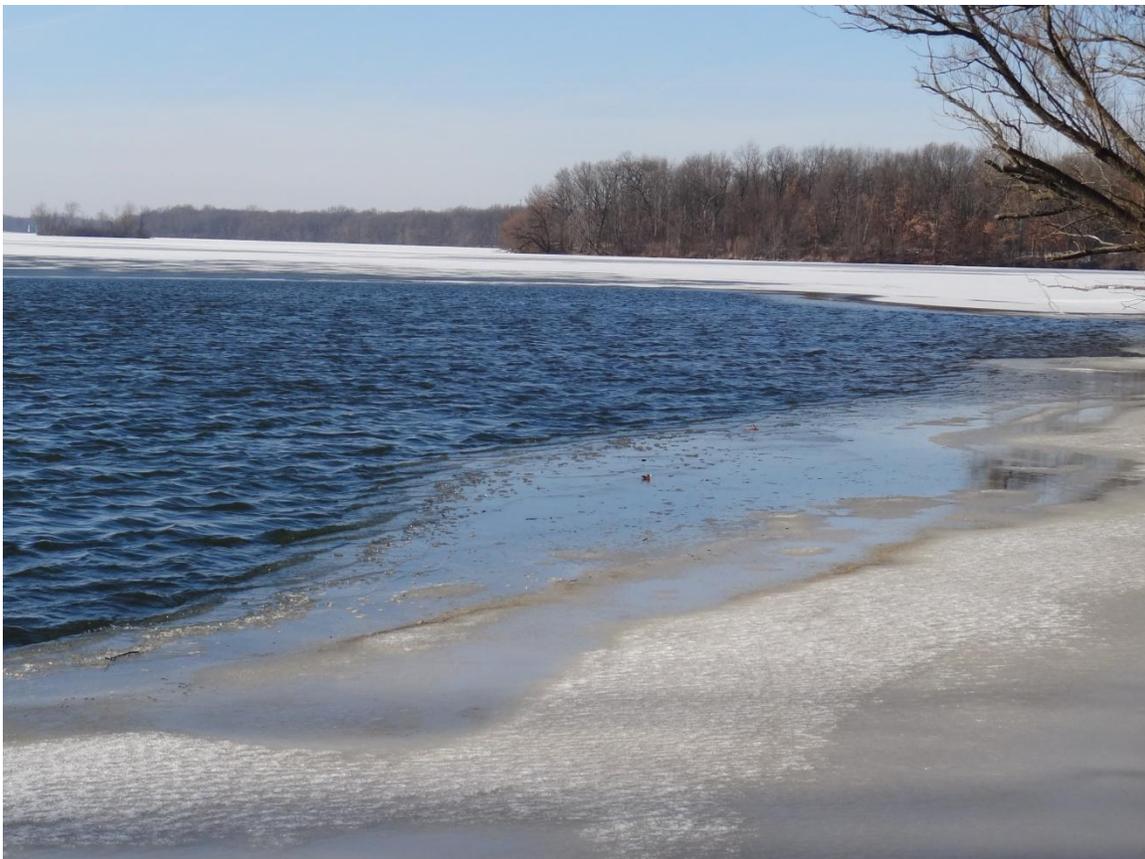
14. Ice along north shoreline and north cove of Morrow Lake has begun to notably recede.

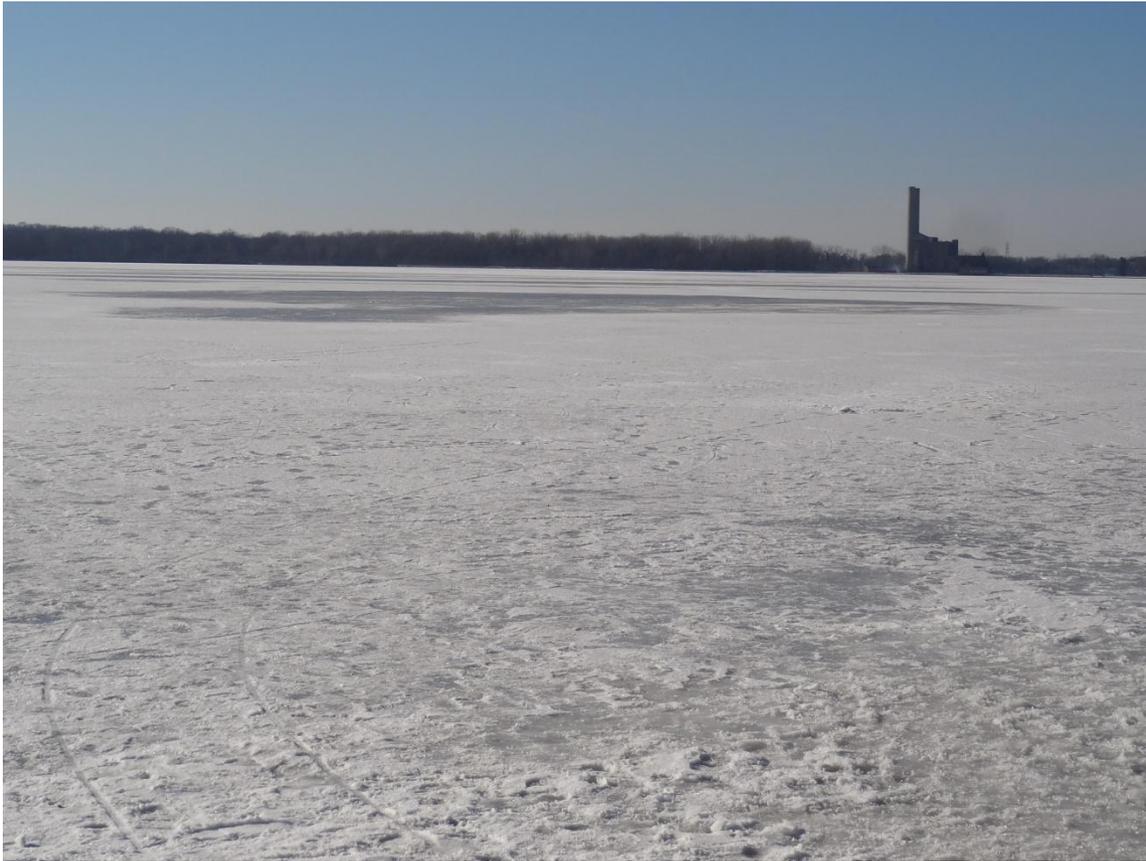
15. E4.5 Boat Launch, western portion of Morrow Lake remains covered in ice and snow.
