# Situation Photo Log

Tuesday, January 8, 2013

Kalamazoo River / Enbridge Spill

Prepared by:  
Karen Berez  
START-USEPA  
Situation Unit Leader

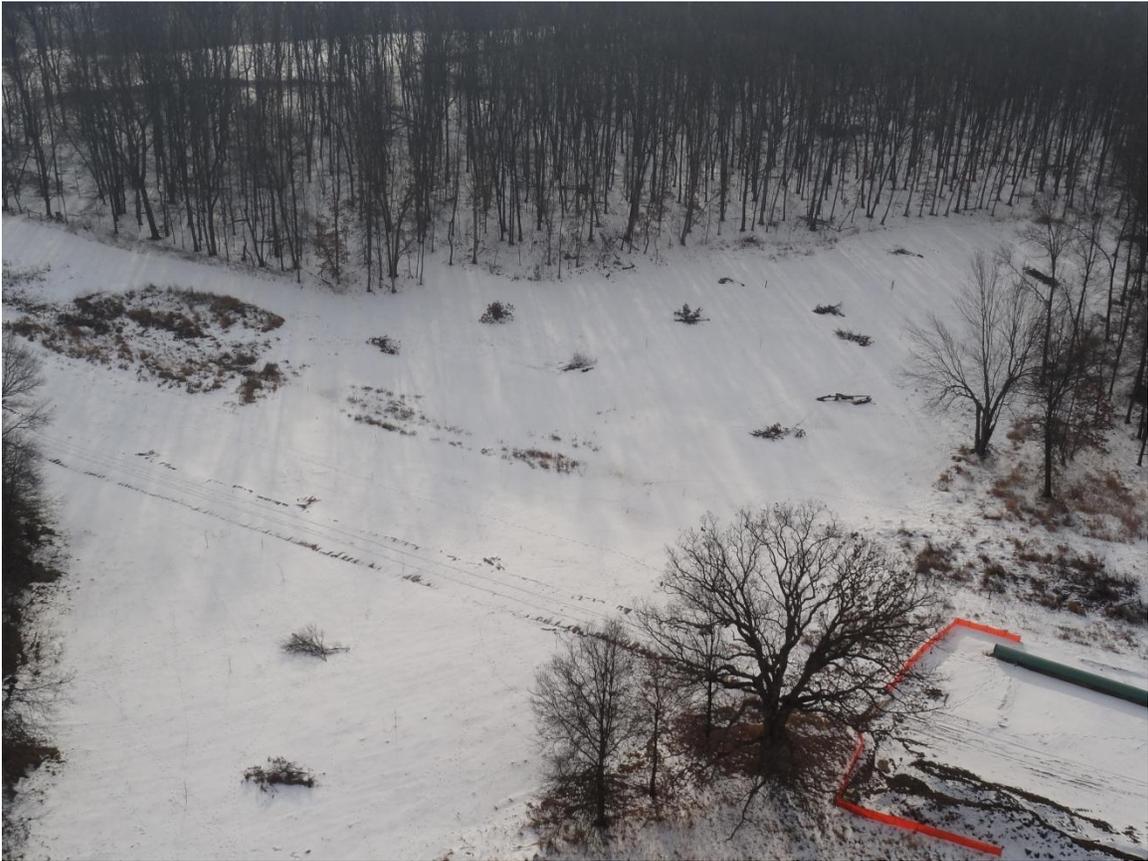
1. Source Area, no work observed.

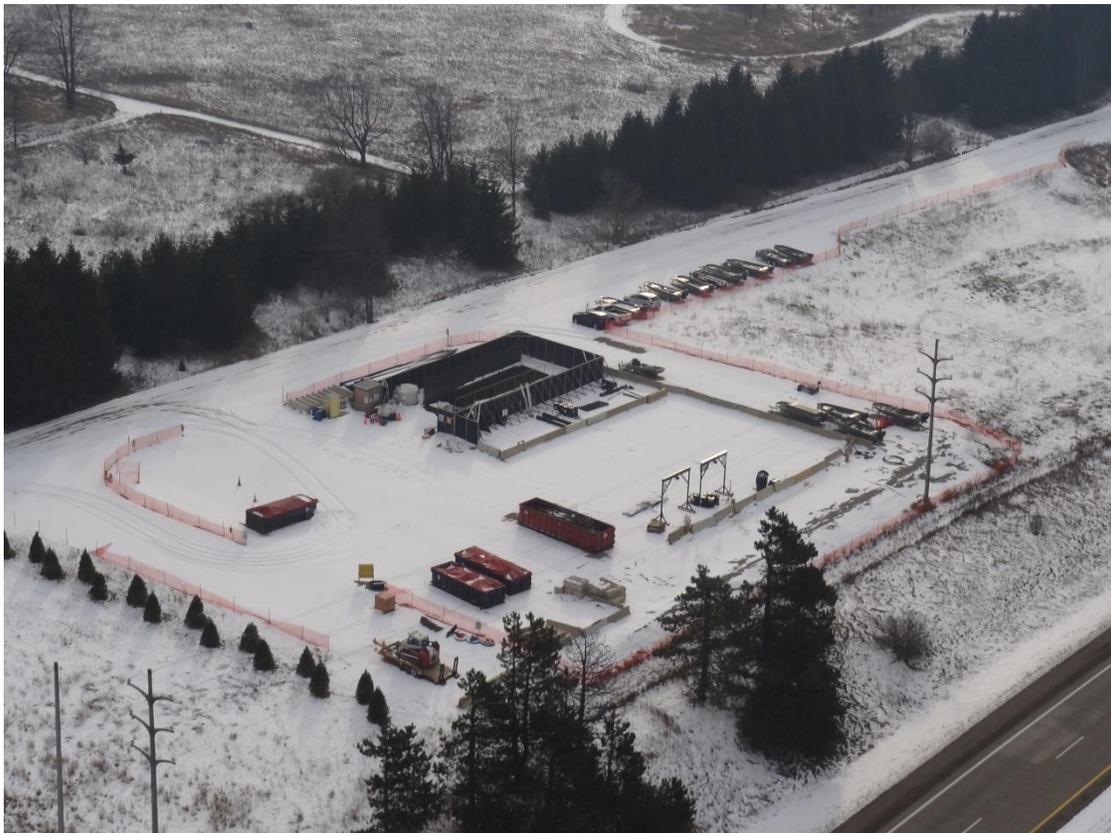
2. Frac Tank City, no decon operations observed.

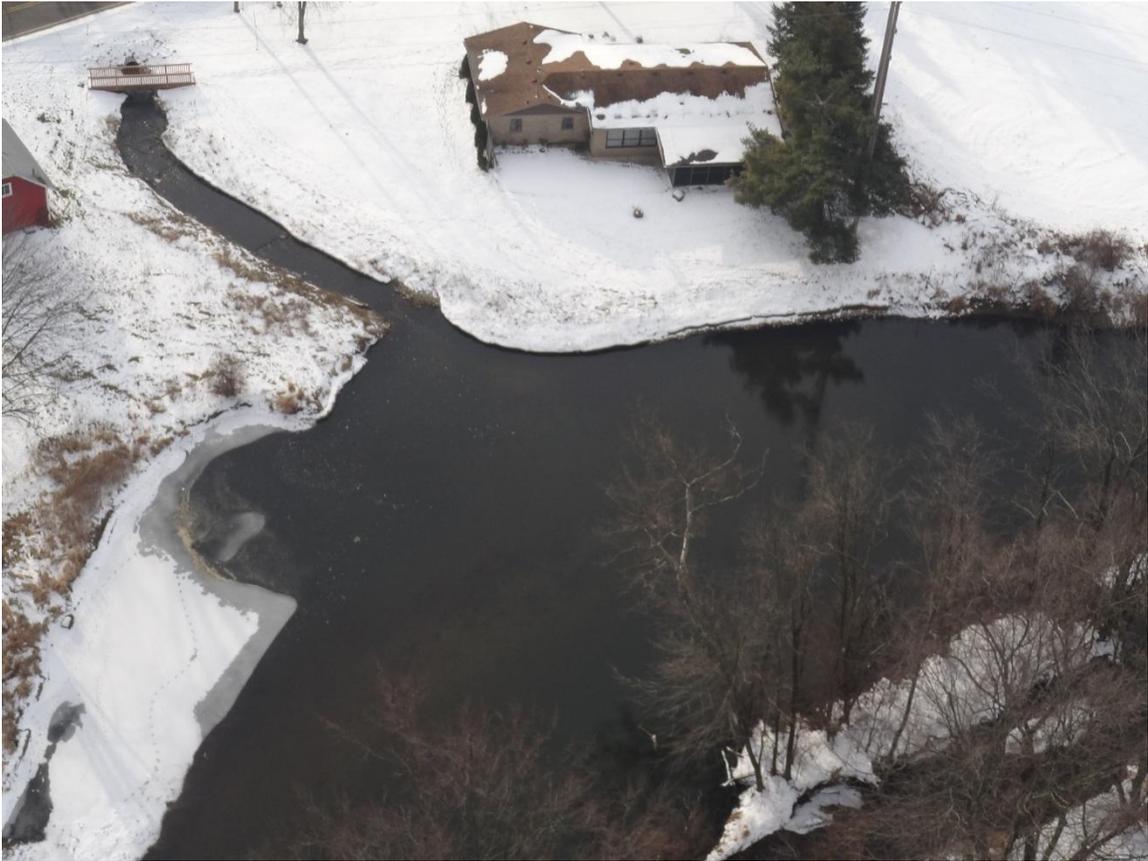
3. Confluence, bank ice observed north of the confluence.

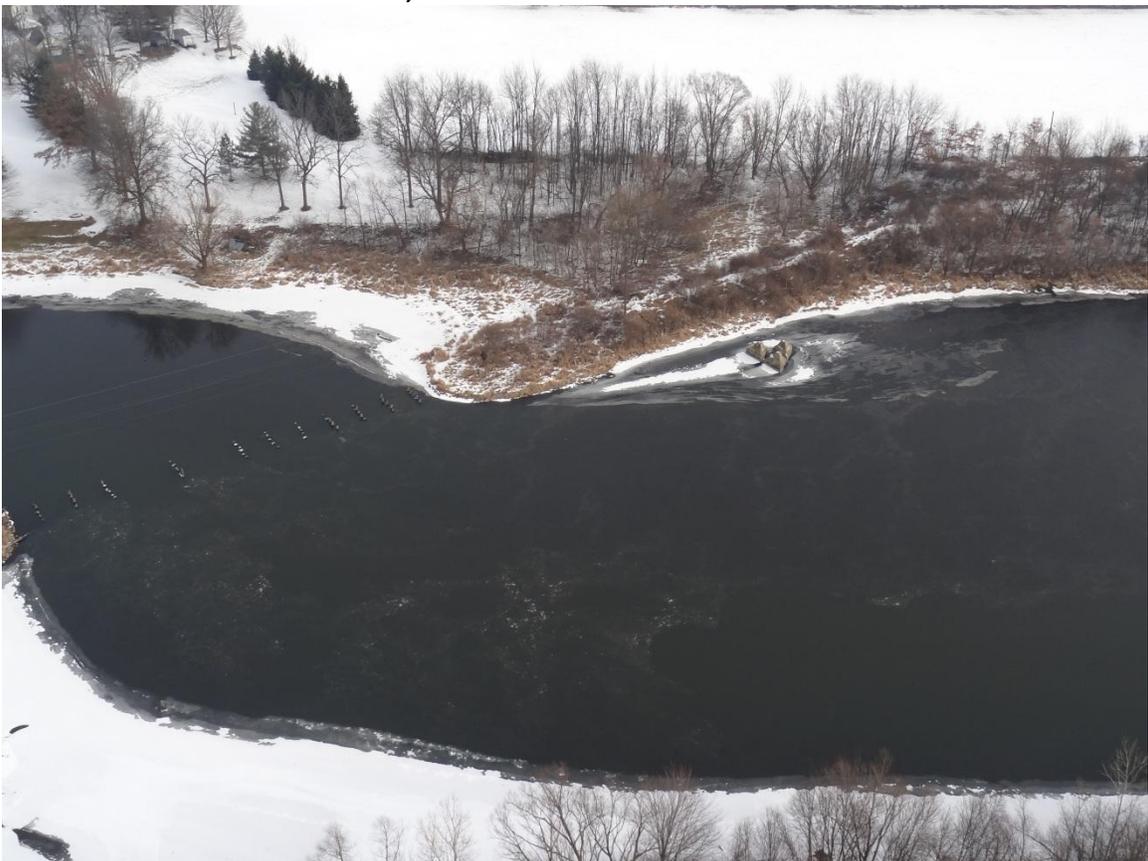
4. Ceresco Dam trestle, ice observed flowing in river channel above trestle.

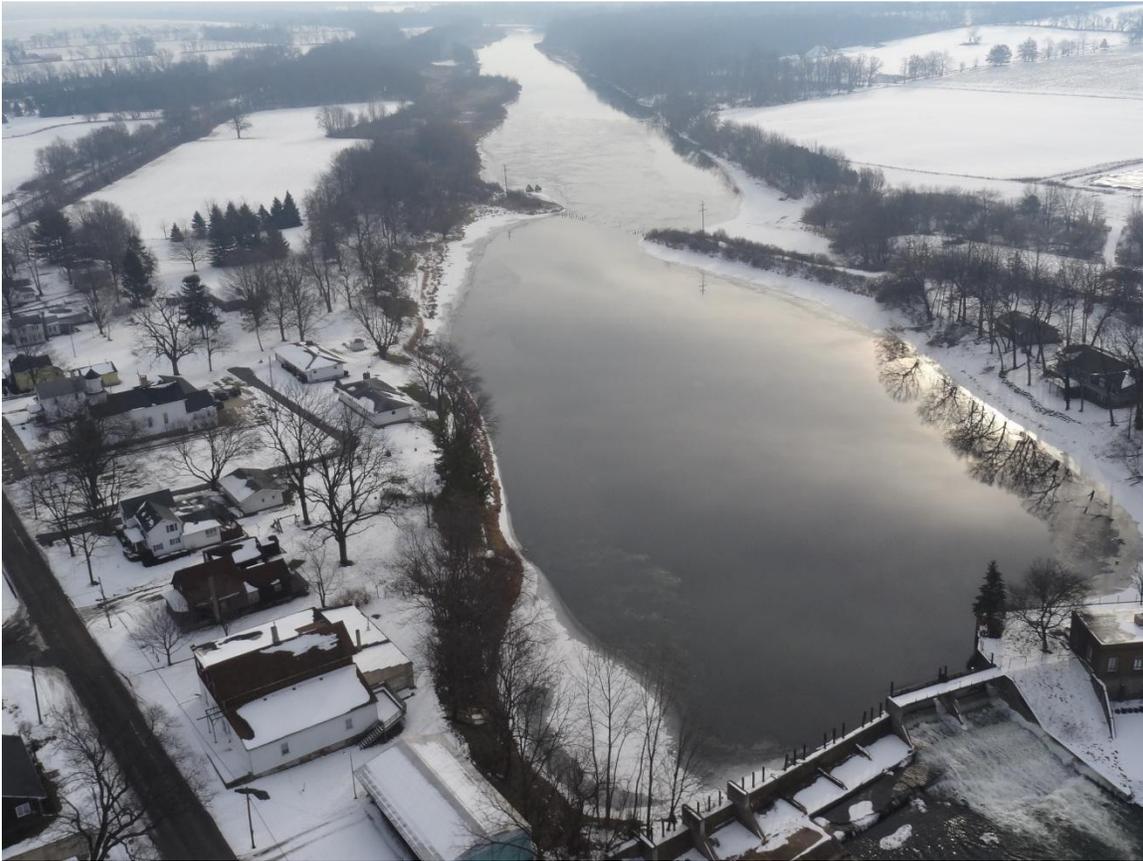
5. Ceresco Dam impoundment, river channel remains open with slight bank ice observed.

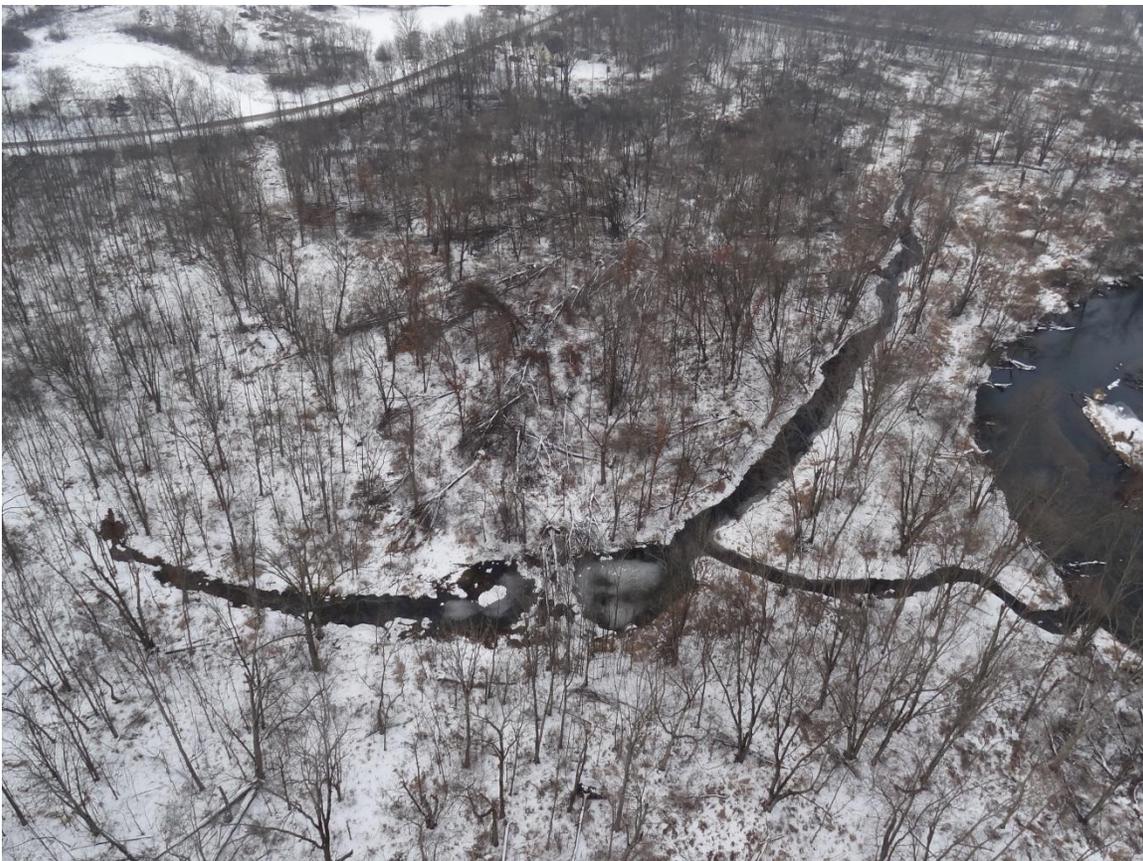
6. MP11.78 LDB, minor ice observed along bank channel.

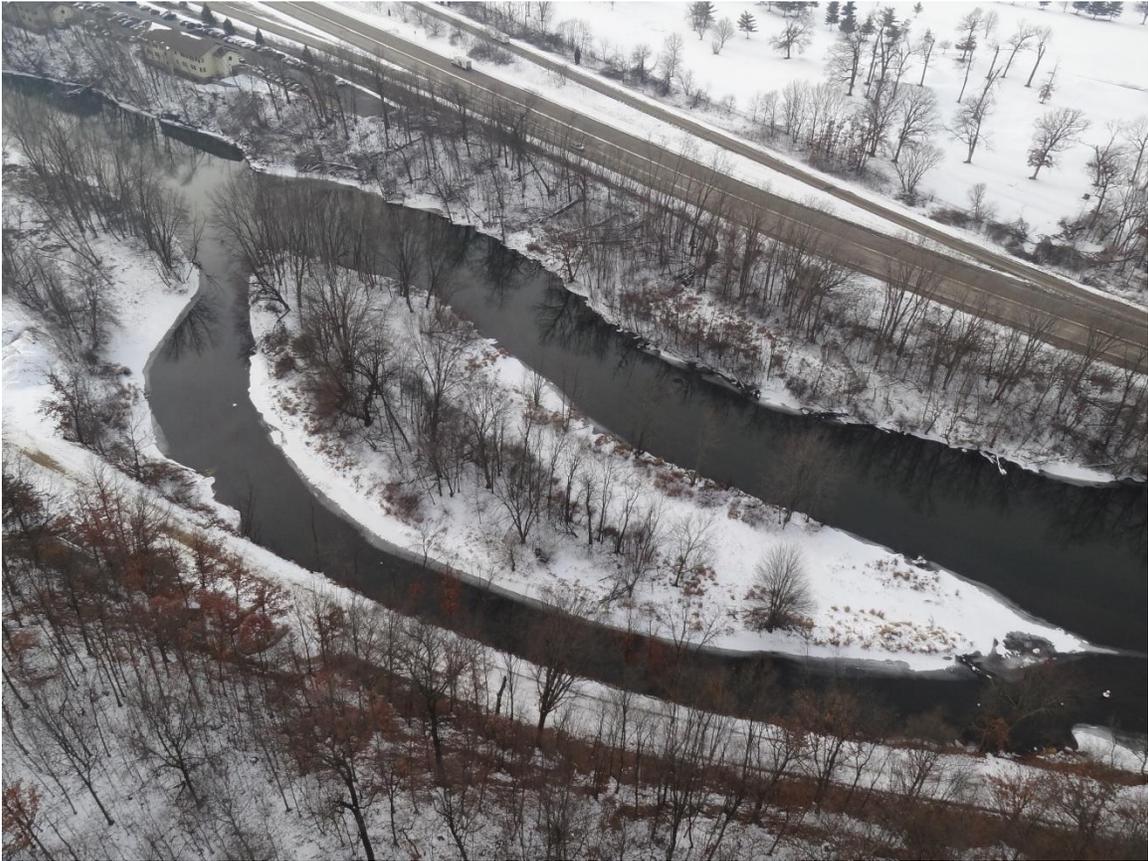
7. MP14.75 RDB, no sheen and minor bank ice observed

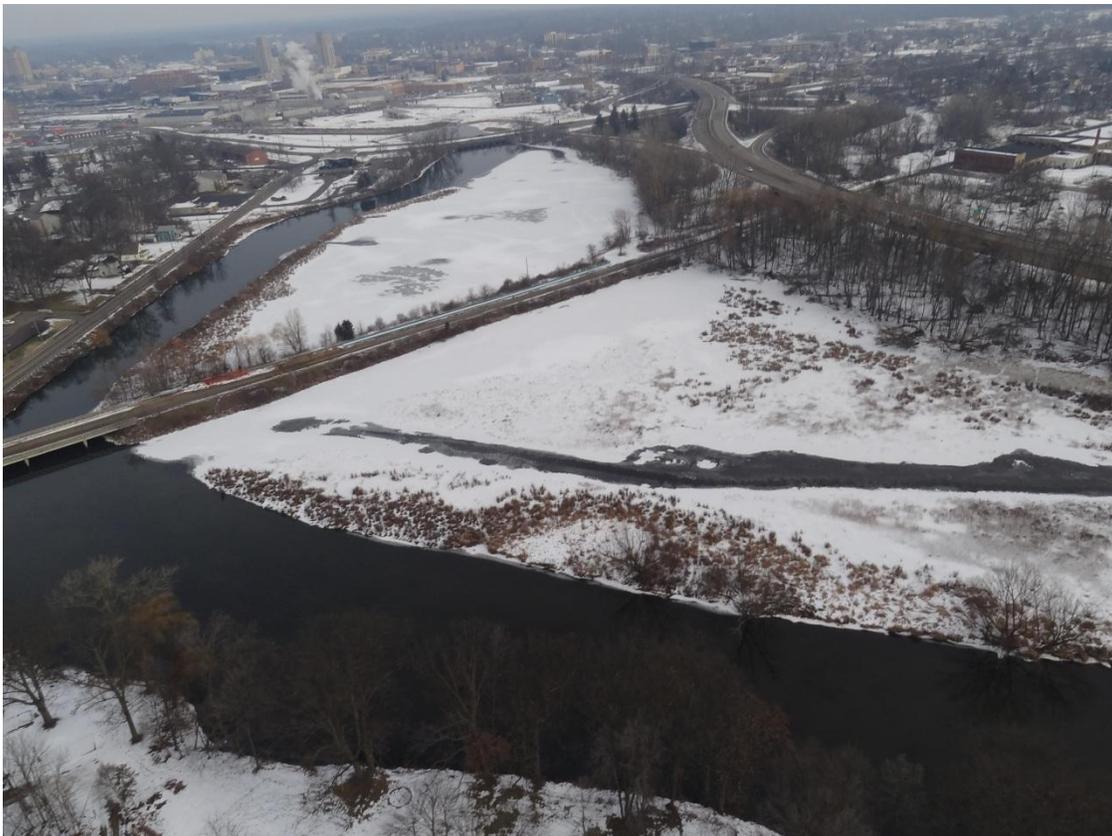
8. South Mill Pond and North Mill Pond, no sheen or bank ice observed along river channel.

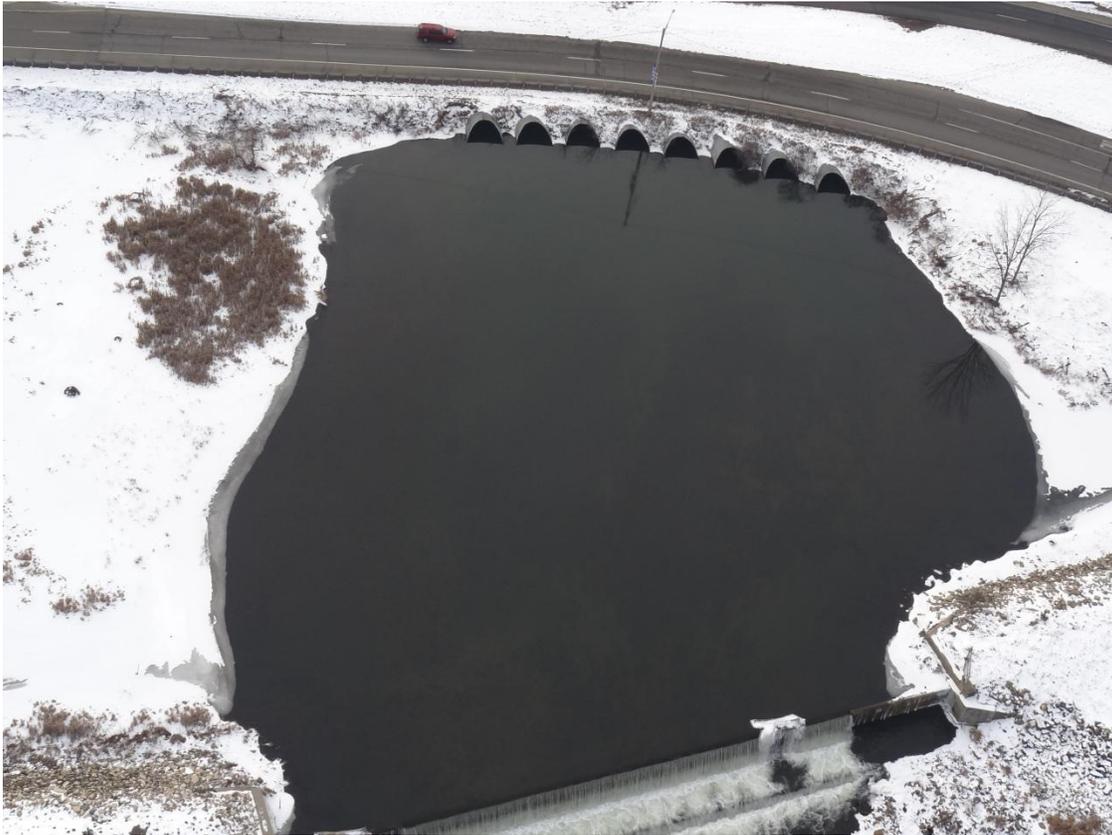
9. MP15.75 Battle Creek Spillway, no sheen observed during over flight.

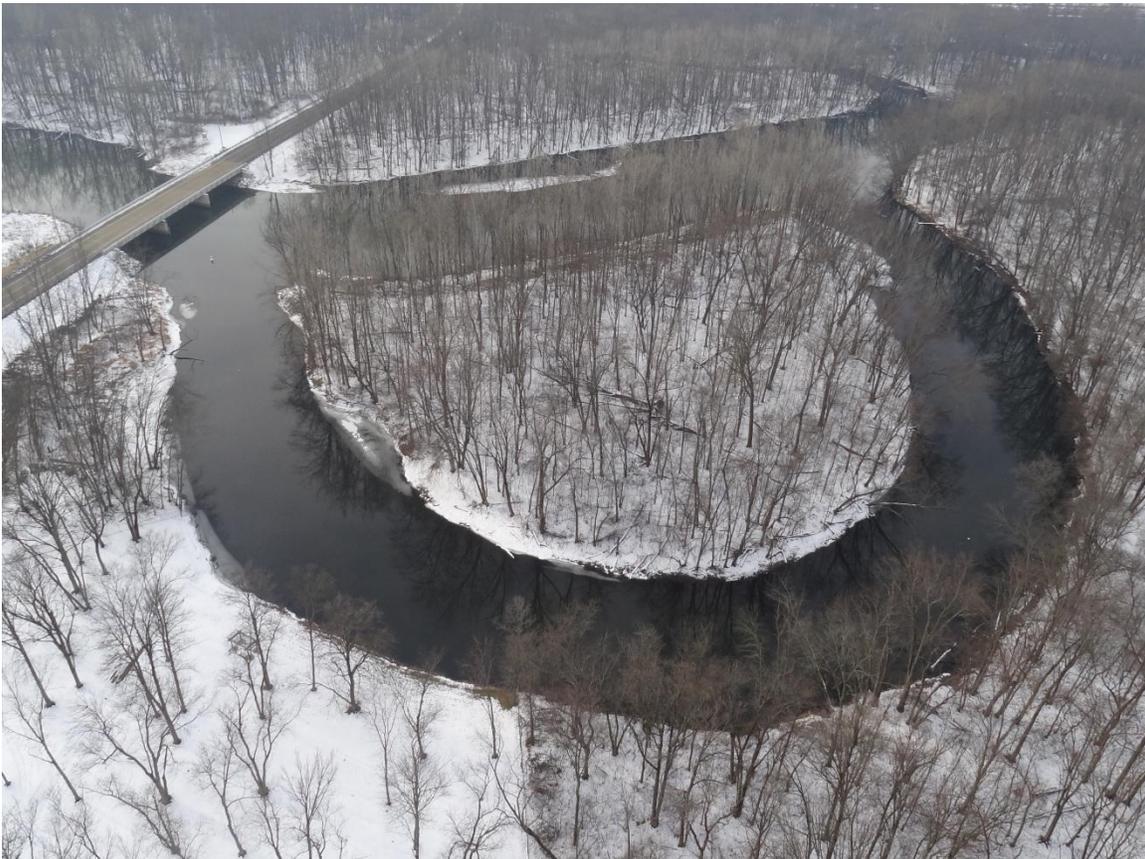
10. MP21.5 RDB, only minor bank ice observed.

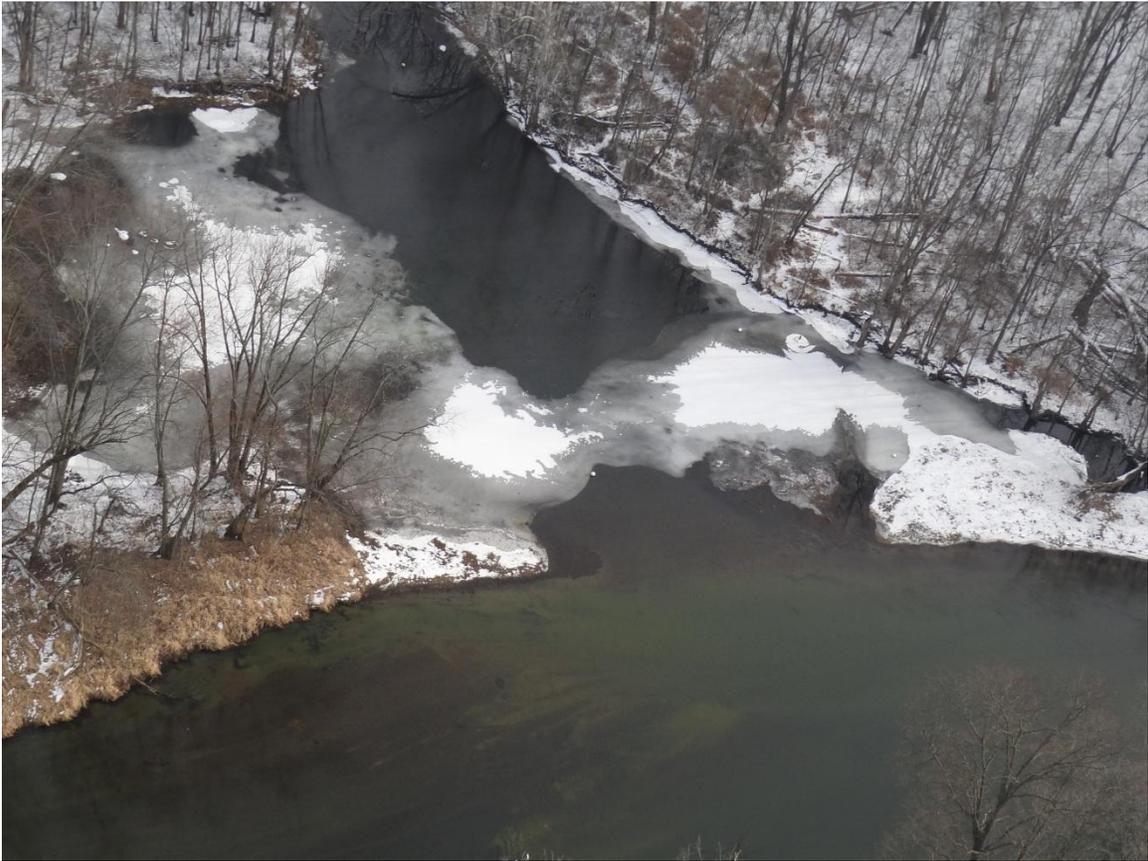
11. MP30.8 LDB, ice observed in back channel.

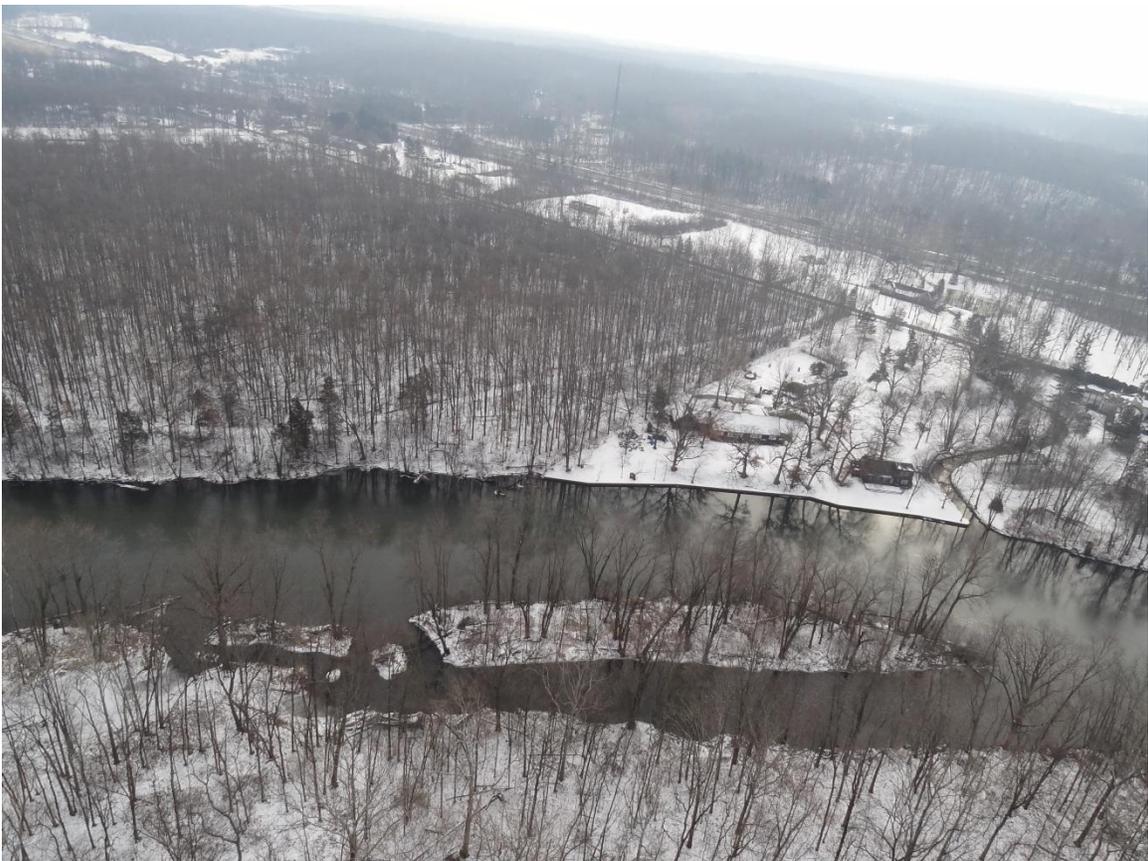
12. MP36.10 RDB, no sheen or bank ice observed along back channel.

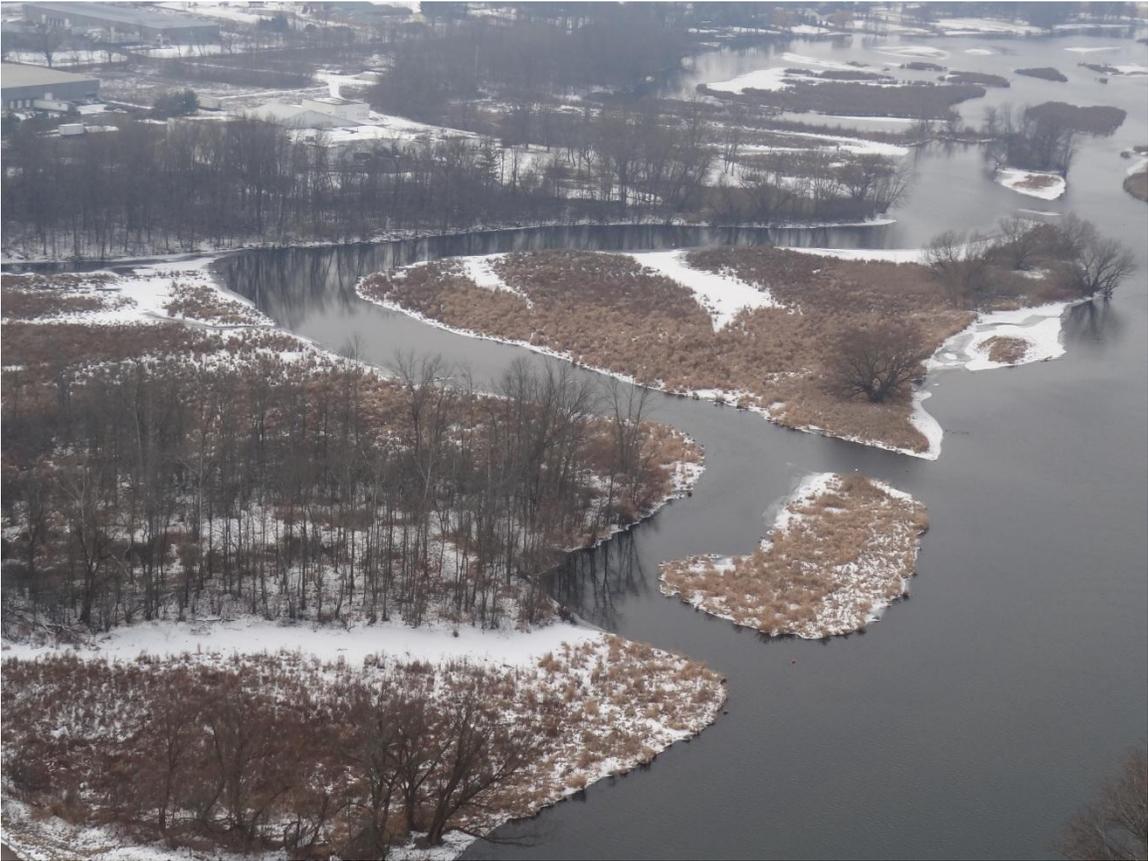
**13. Delta A, no sheen and minor bank ice observed.**

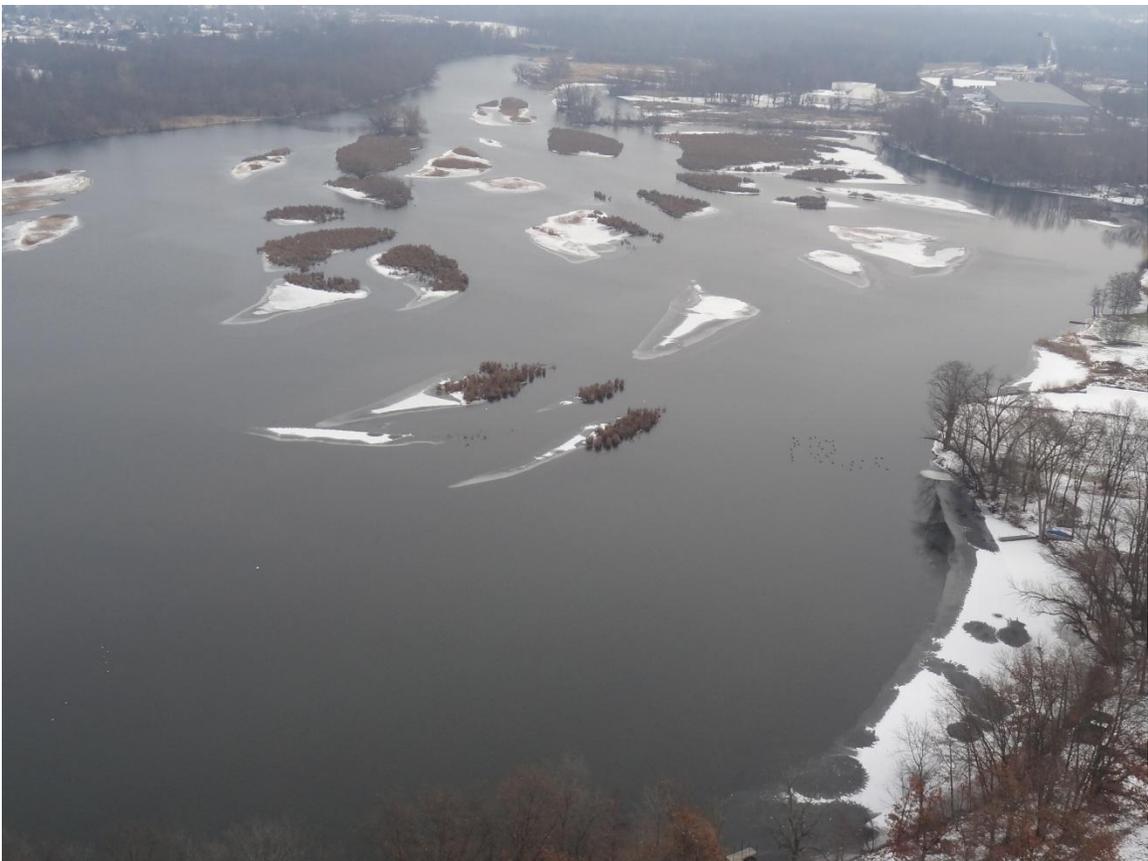
**14. Morrow Lake Delta, no sheen and minor ice observed.**

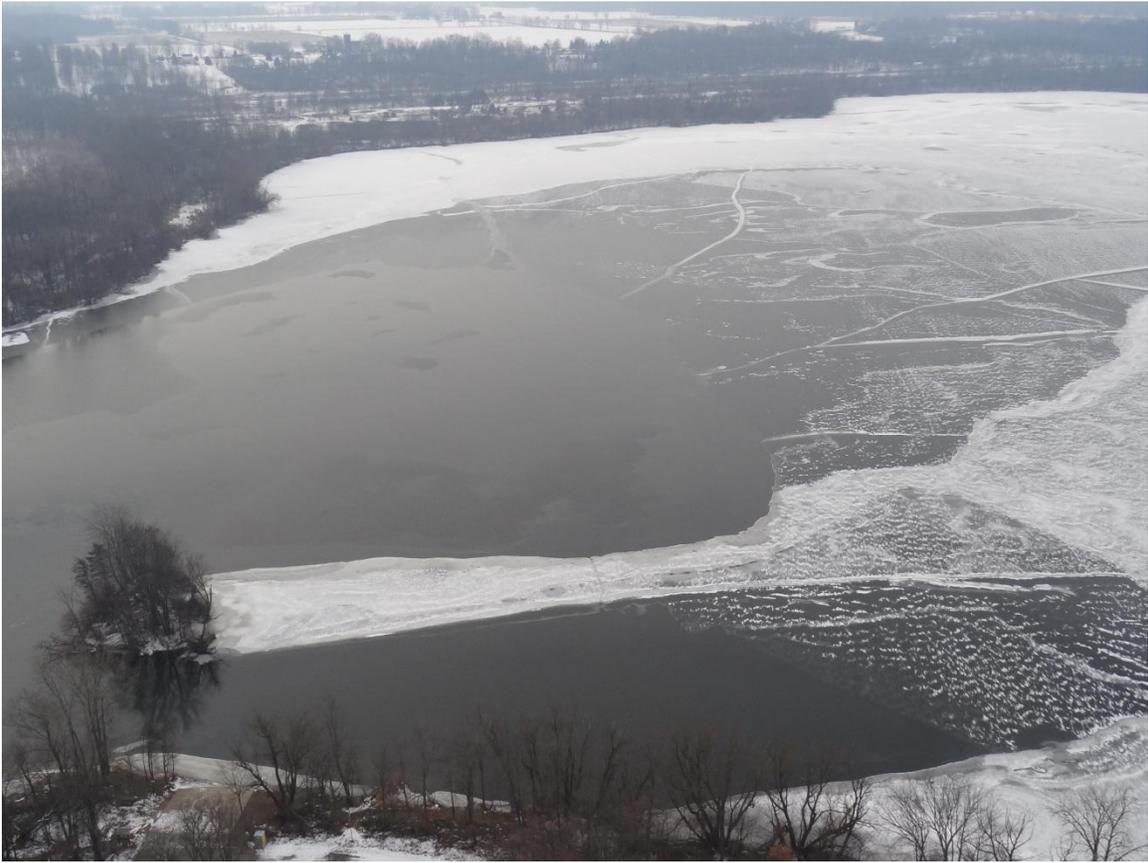
15. MP37.5 RDB, ice has begun to recede on eastern portion of Morrow Lake

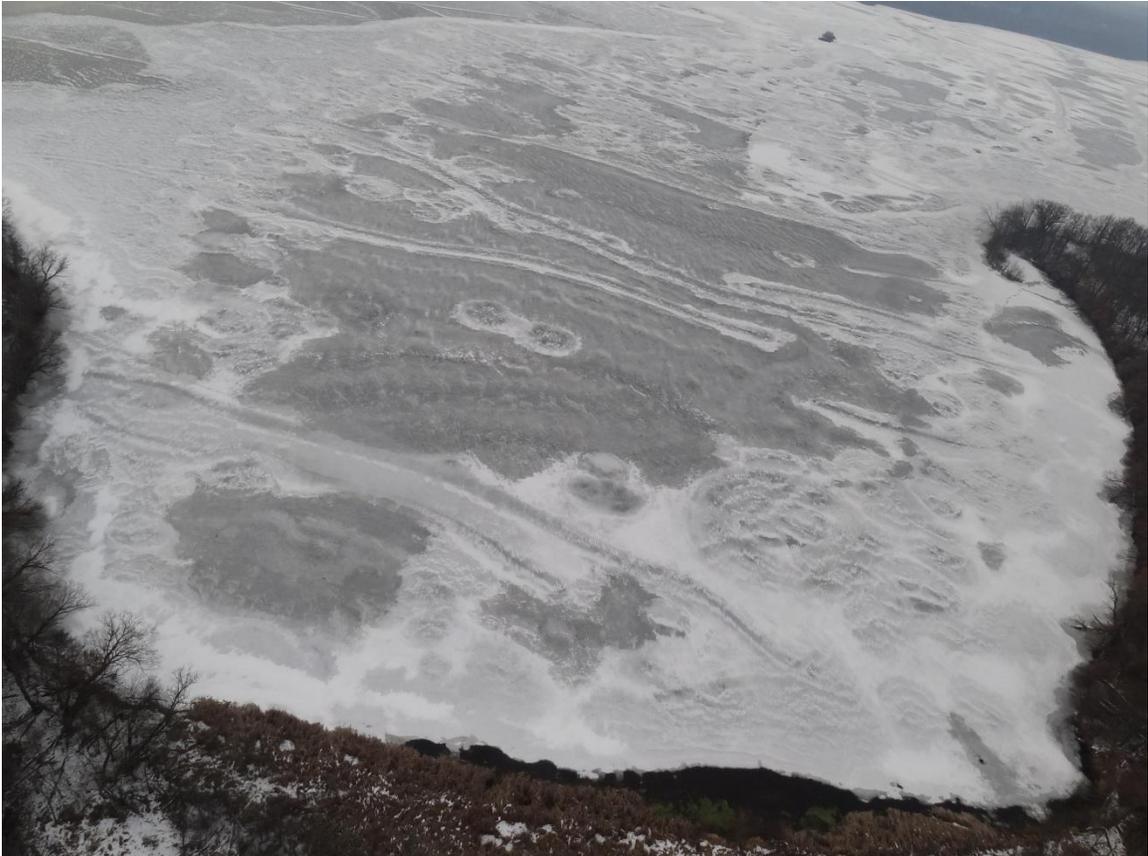
16. North cove on Morrow Lake remains covered in ice and snow.

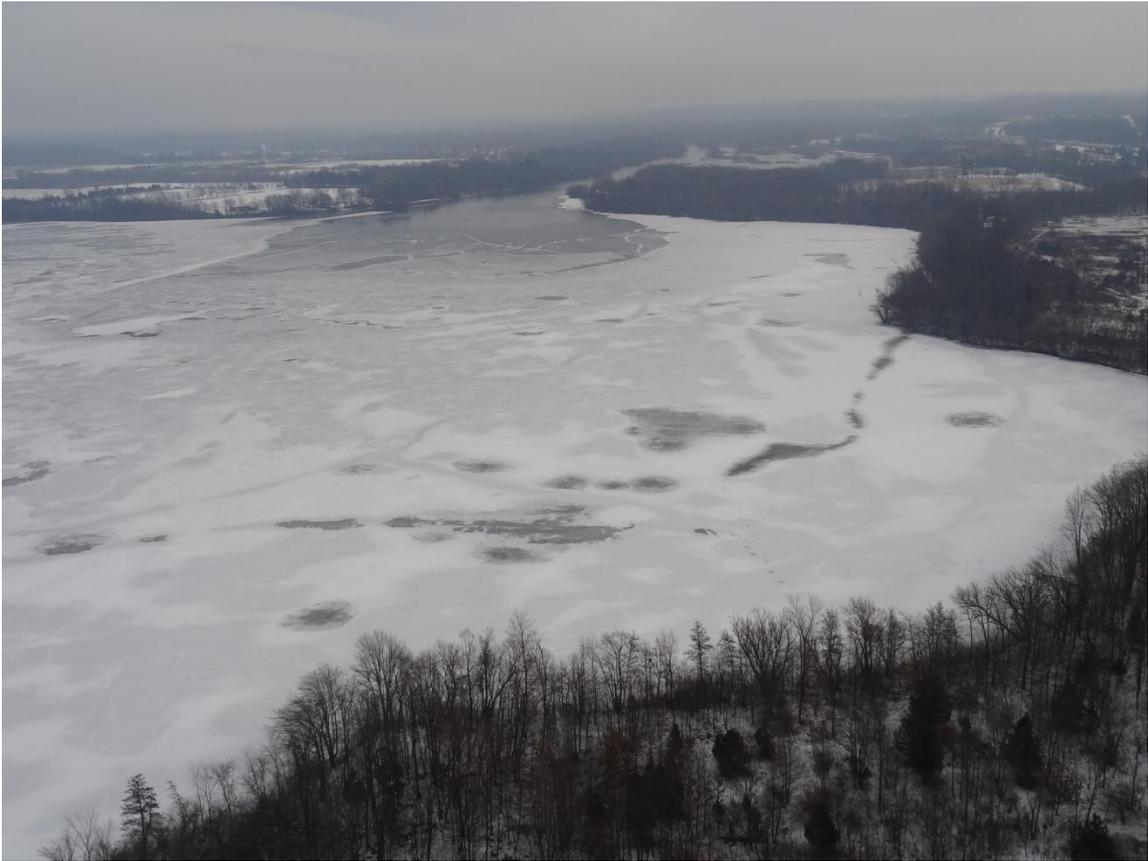
**17. South cove looking into Delta, remains covered in ice and snow.**

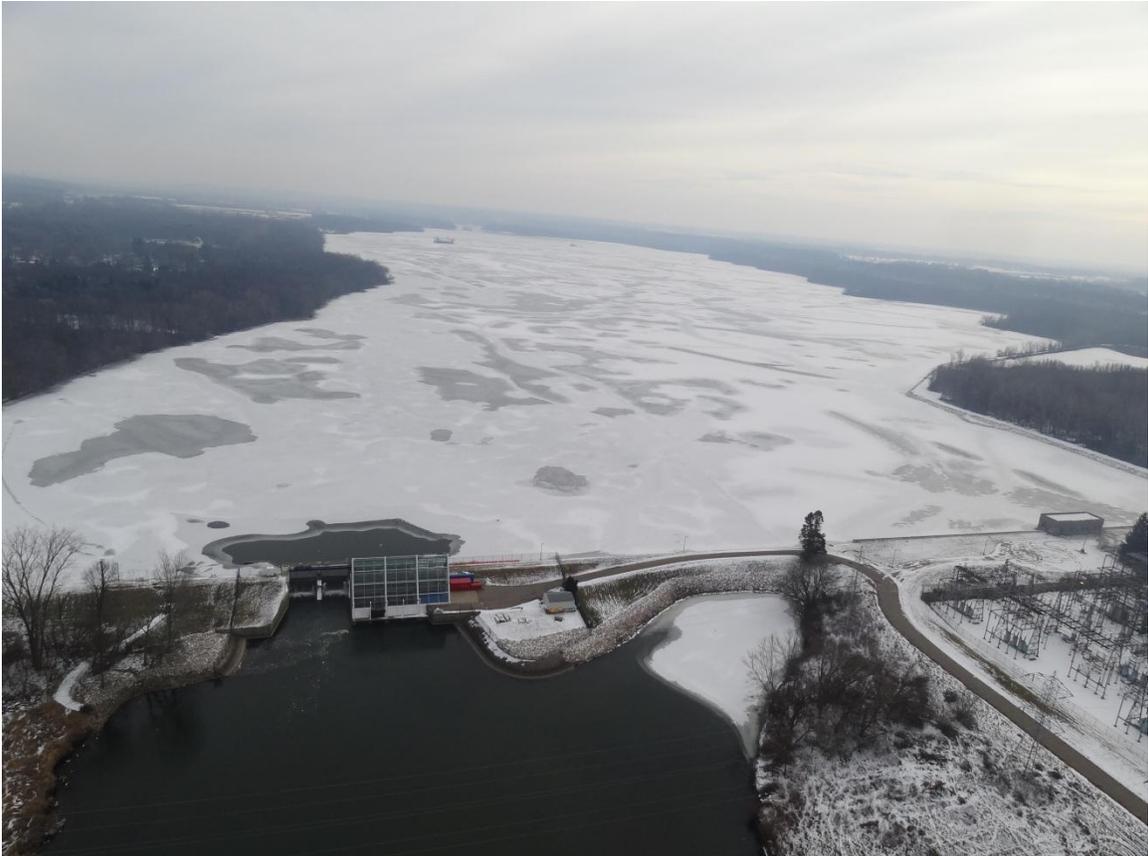
**18. Western Morrow Lake covered in ice and snow.**

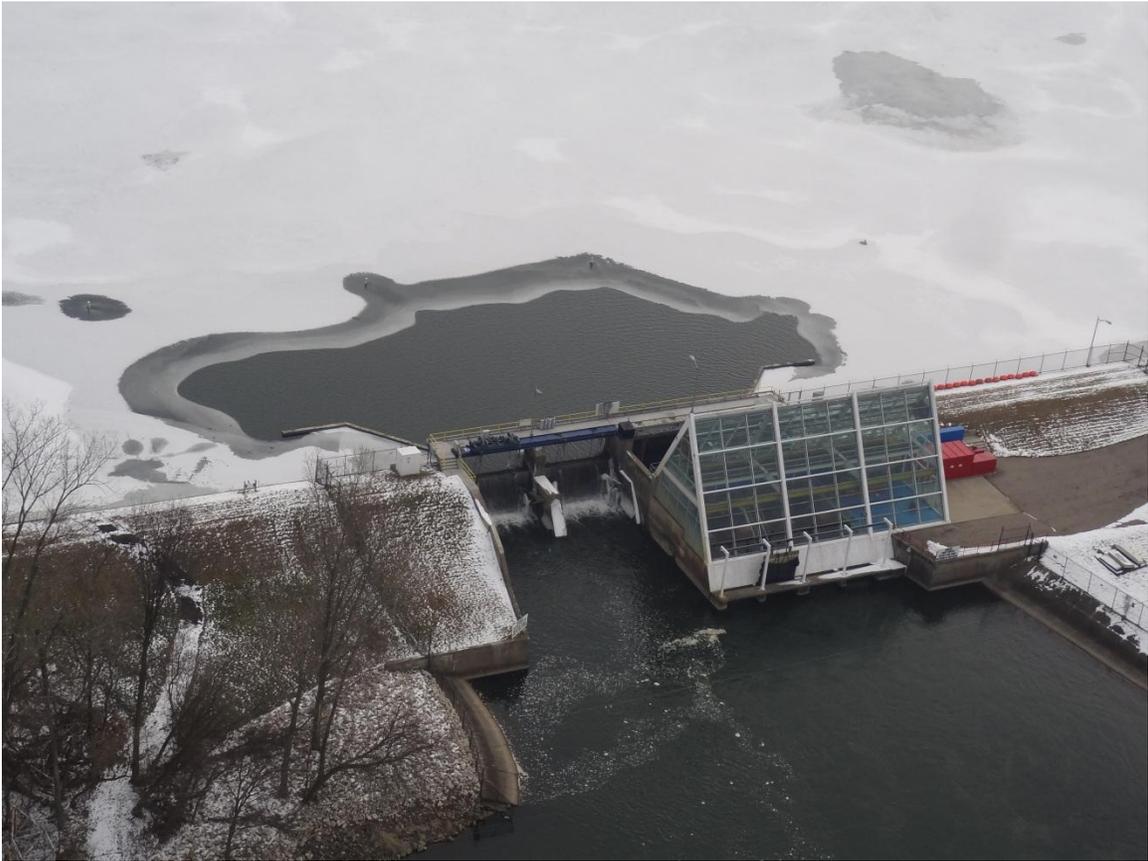
19. Morrow Lake Dam, flow observed over spillway of dam.
