# Situation Photo Log

Wednesday, January 9, 2013

Kalamazoo River / Enbridge Spill

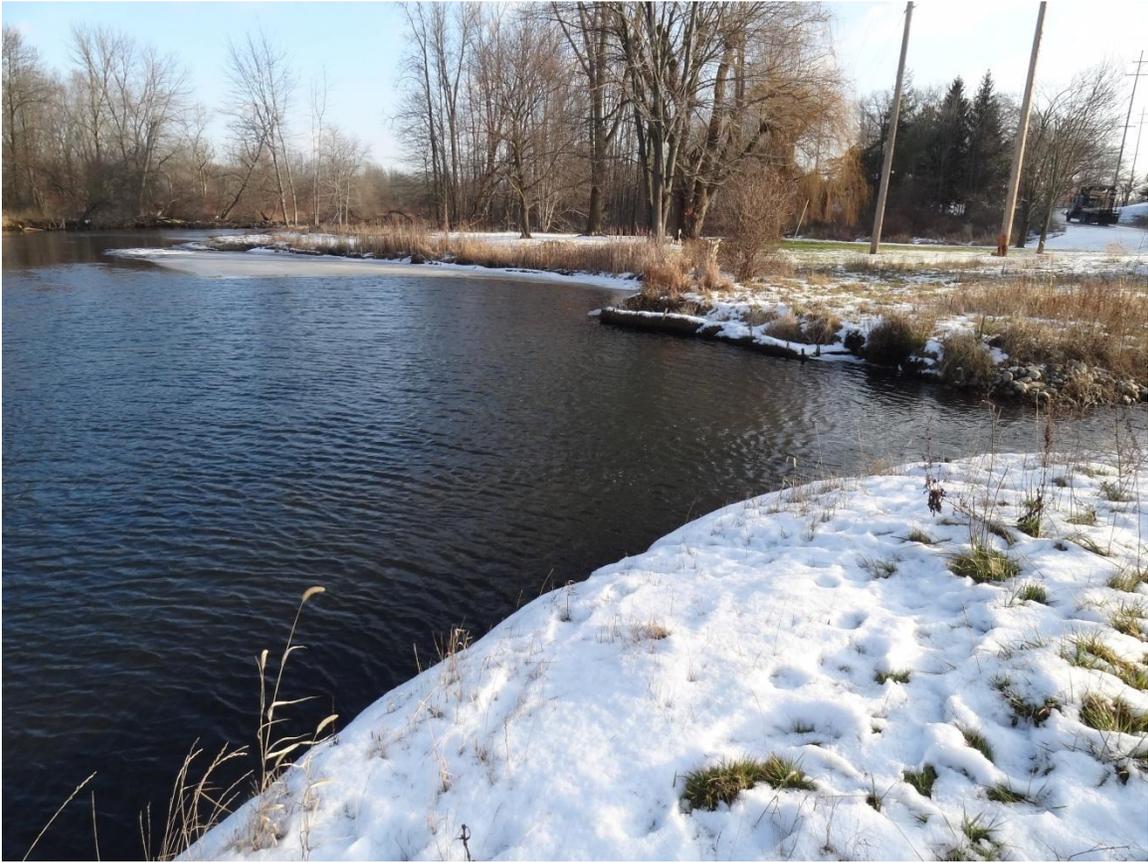
1. Confluence, minimal bank ice observed just north of the confluence.

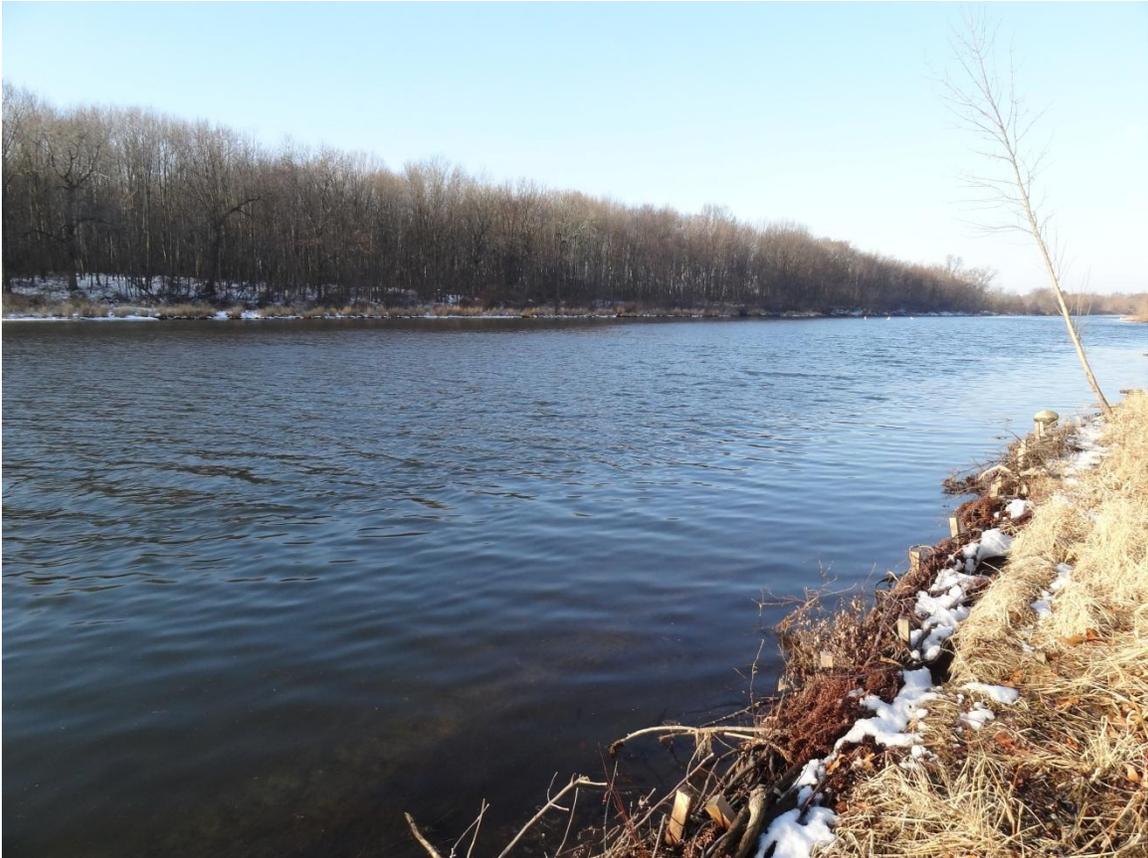
2. MP5.20 RDB, no bank ice observed.

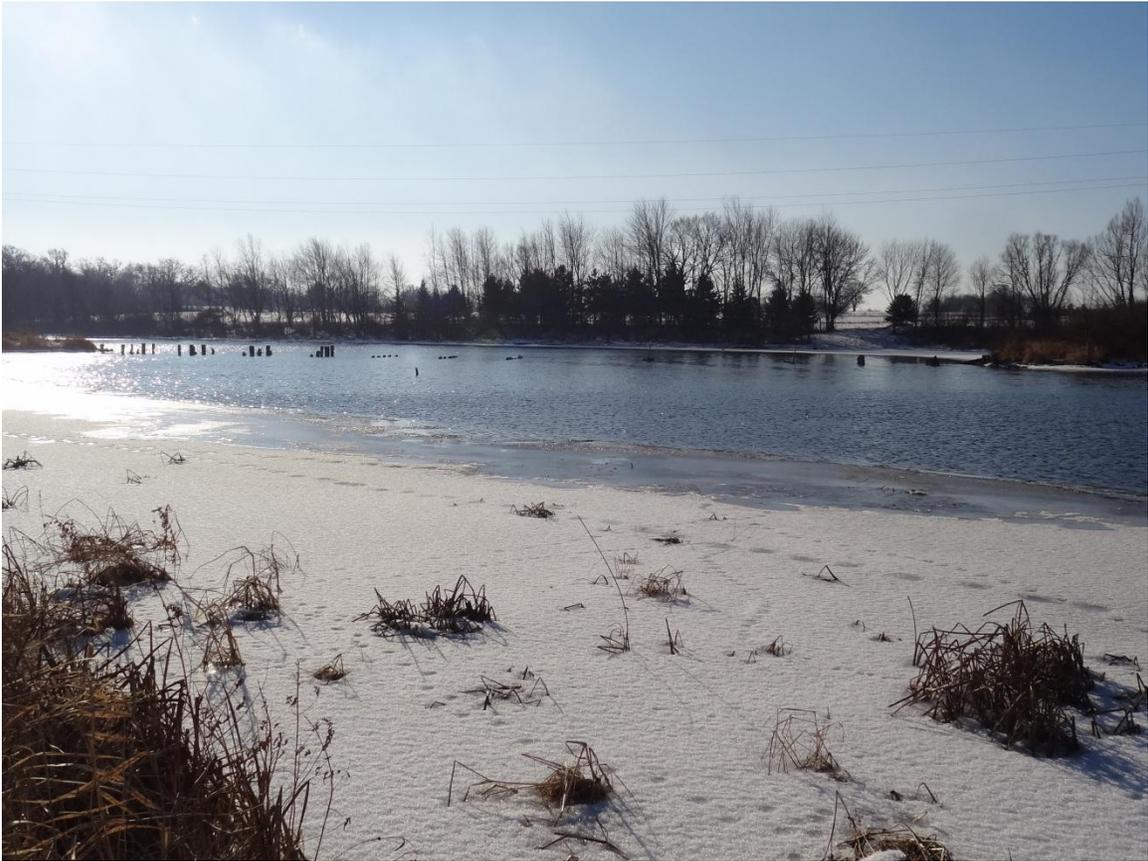
3. MP5.63 Ceresco Dam trestle, minor ice observed along RDB below trestle.

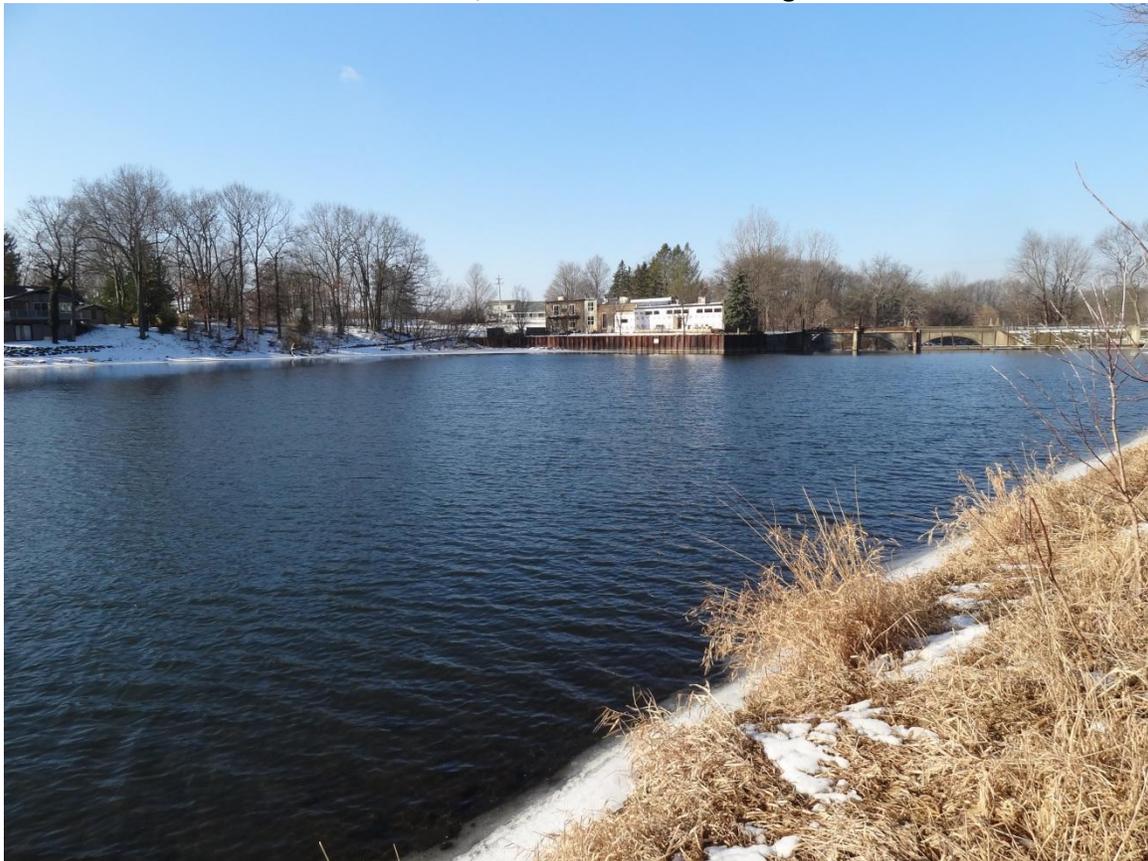
4. Ceresco Dam Impoundment, minimal bank ice observed.

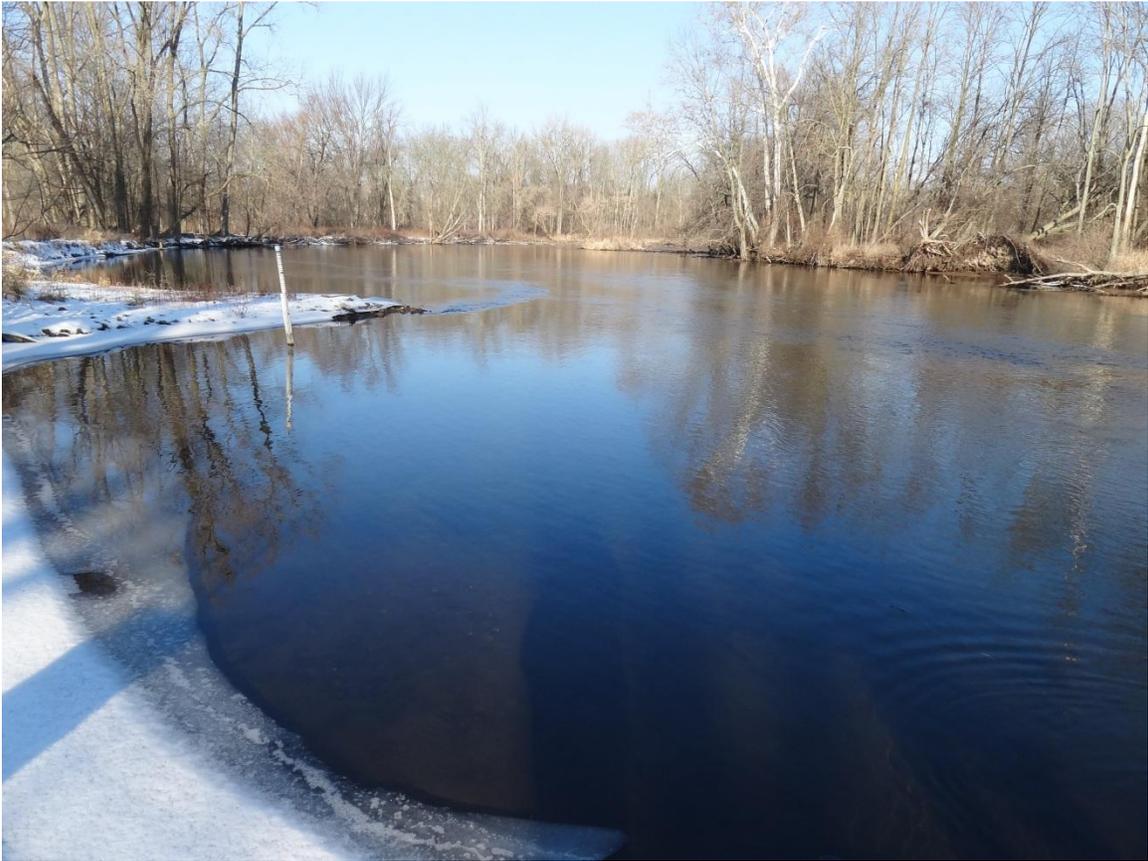
5. C3.2 Boat Launch, minor ice observed along LDB.

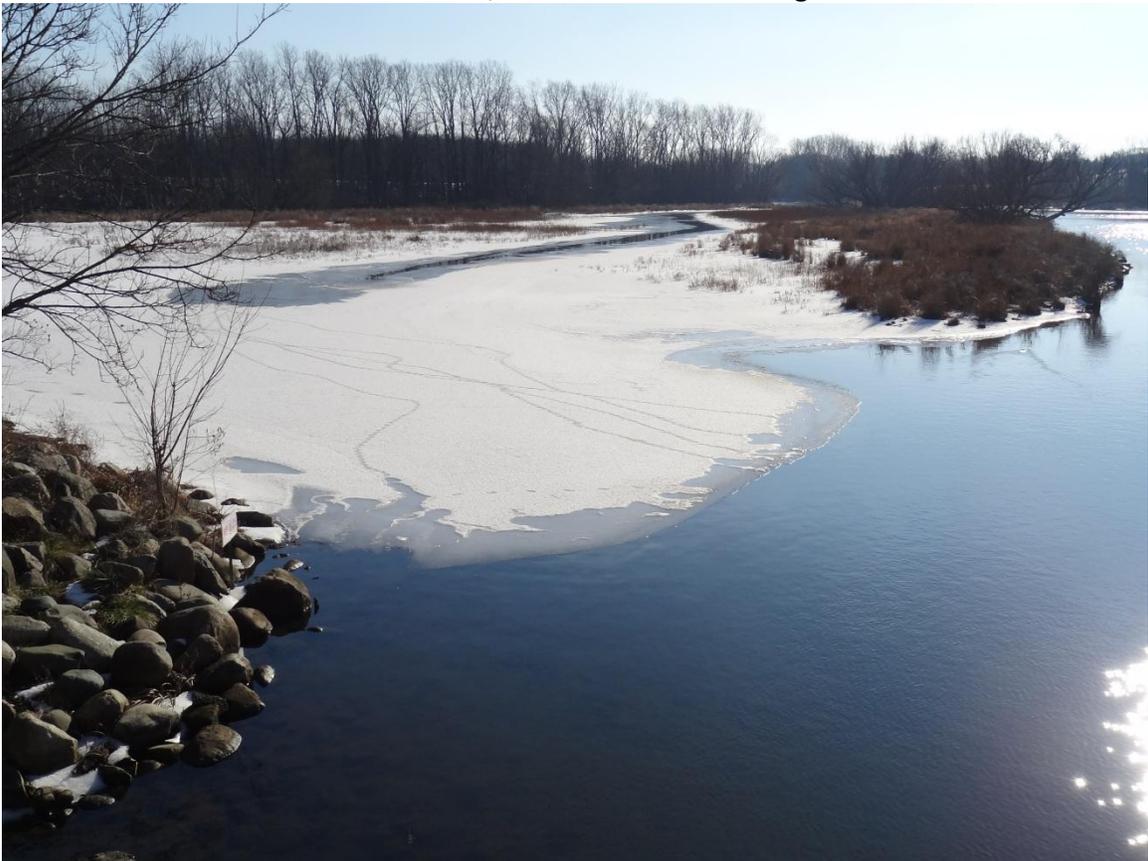
6. MP15.25 South Mill Pond, ice in back water area has begun to recede.

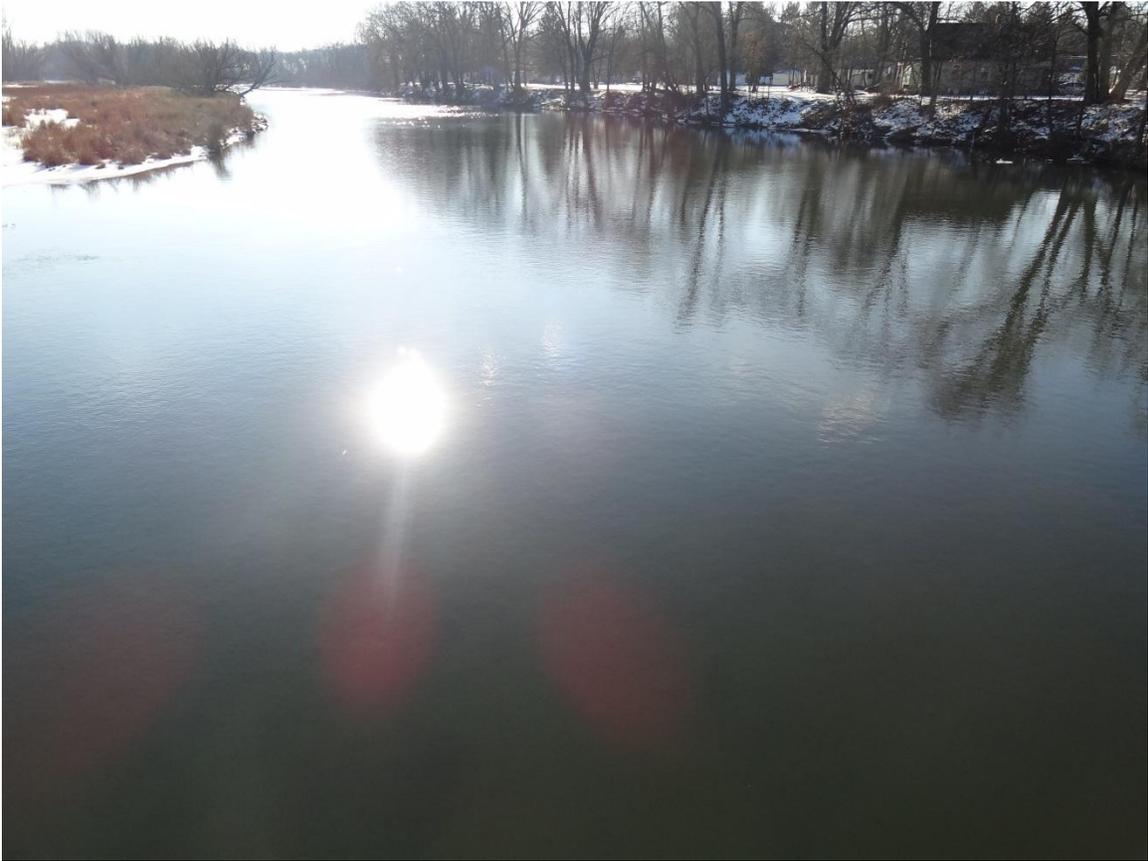
**7. MP15.25 South Mill Pond, no sheen or ice observed along river channel.**

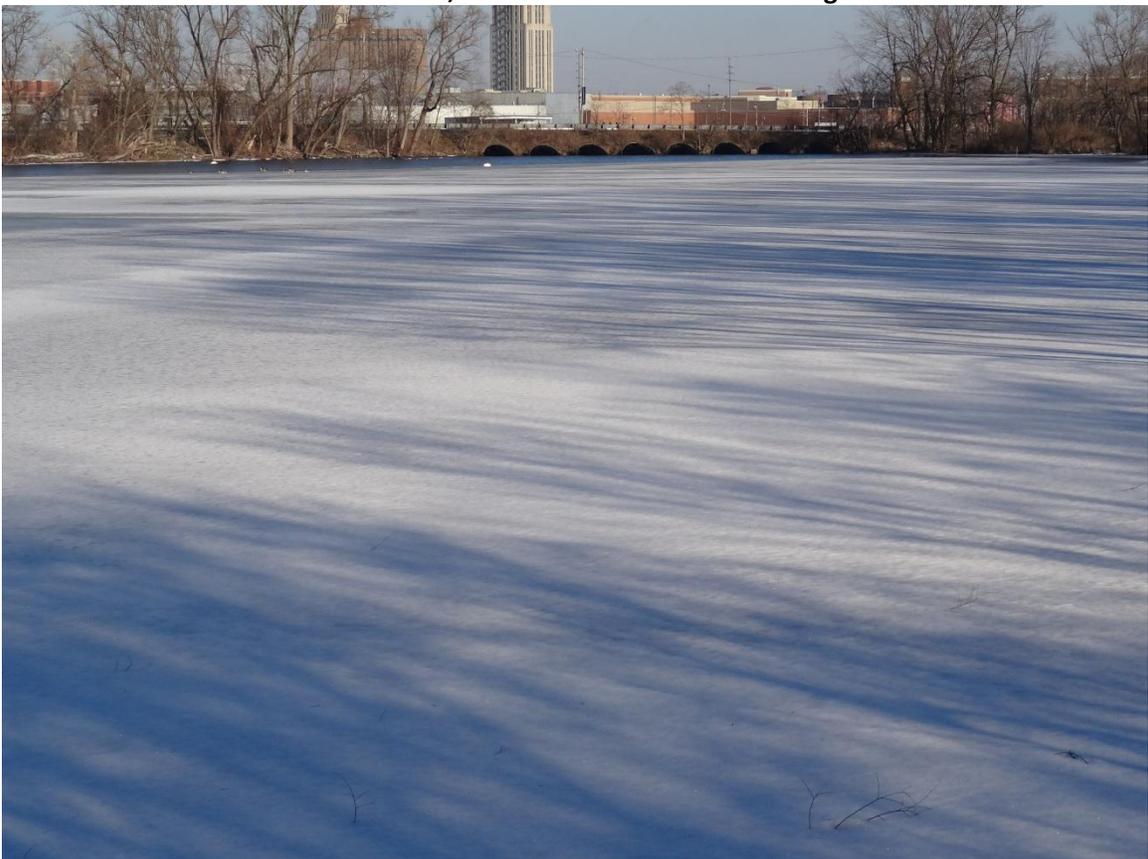
**8. MP15.50 North Mill Pond, no ice observed in vicinity of culverts. Back water area remains covered in ice.**

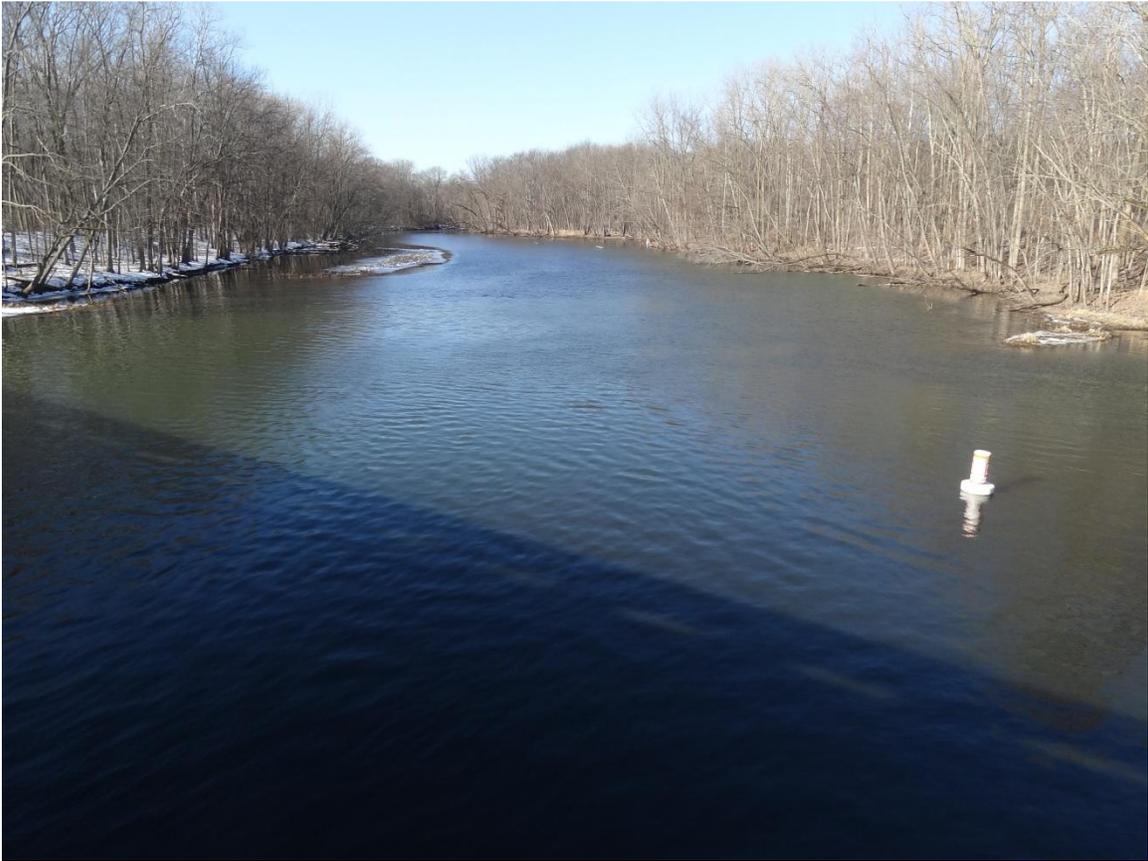
9. MP21.50, no sheen or bank ice observed along river channel.

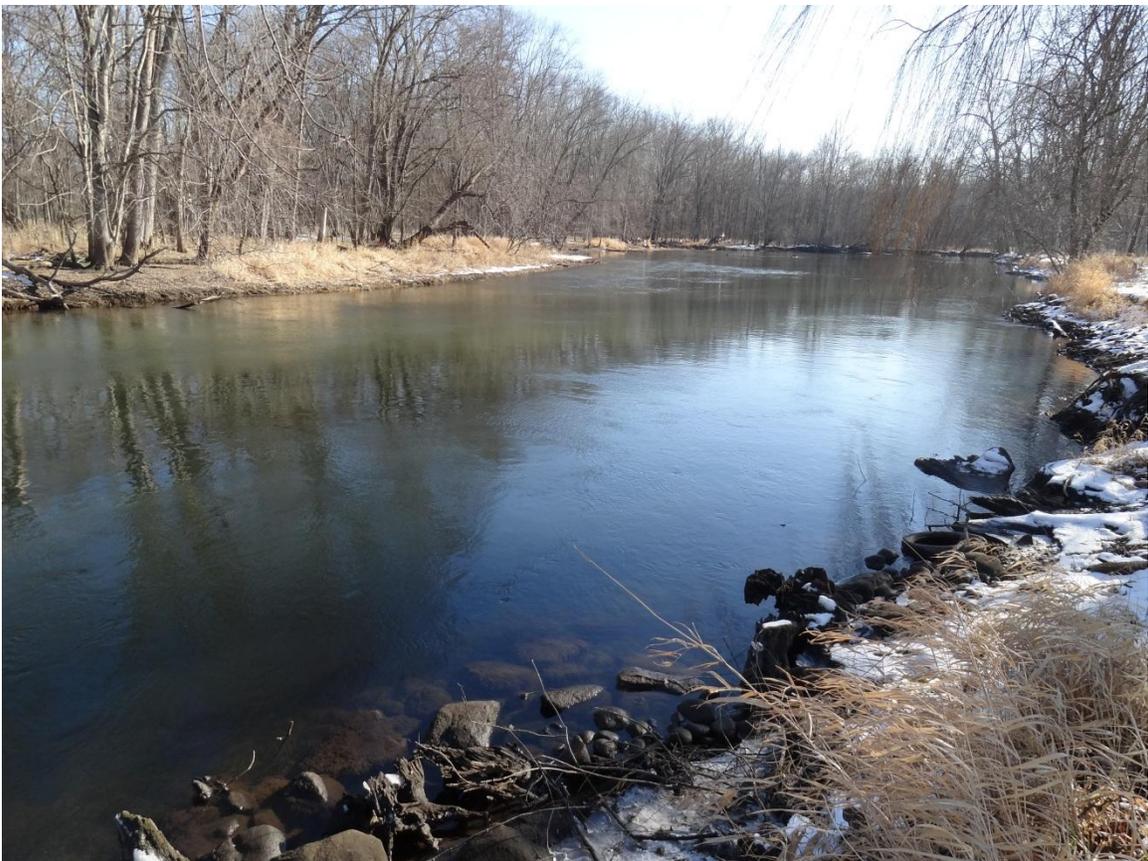
10. MP27.0 Shady Bend Campground, no bank ice observed.

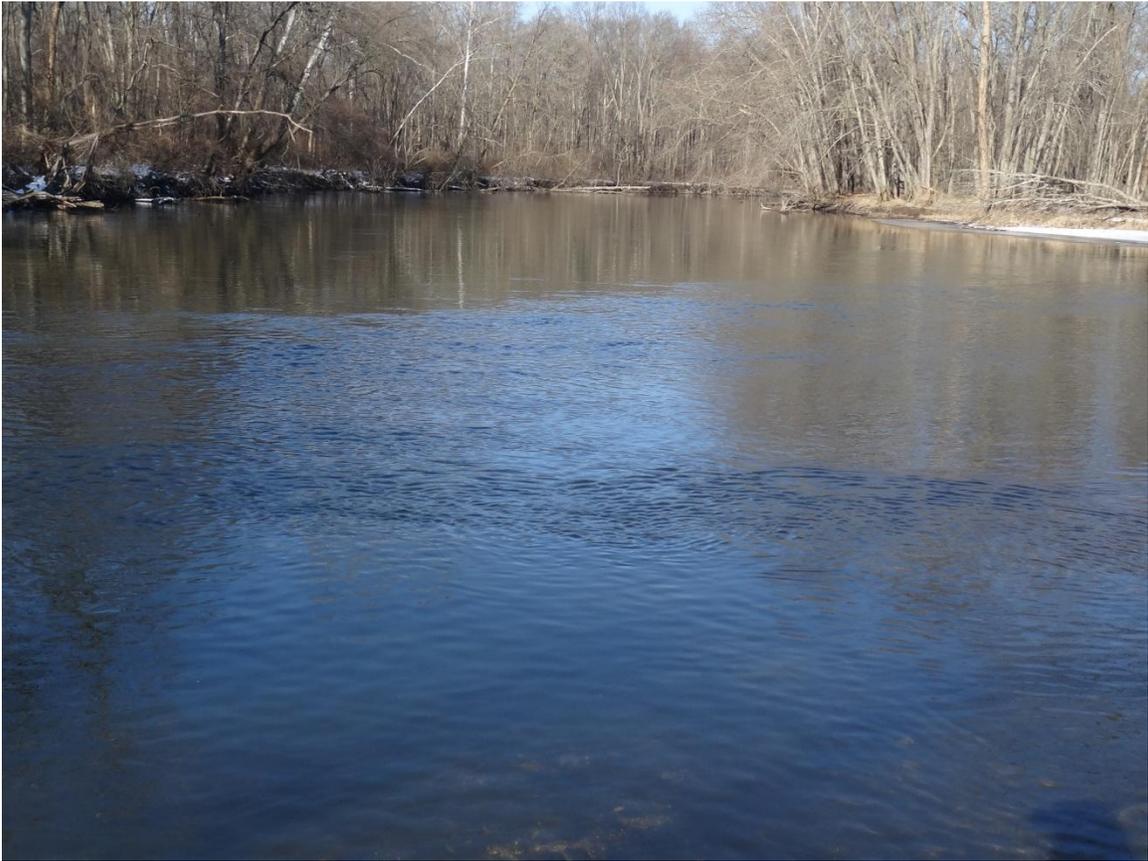
11. E2 Boat Launch, no bank ice observed.

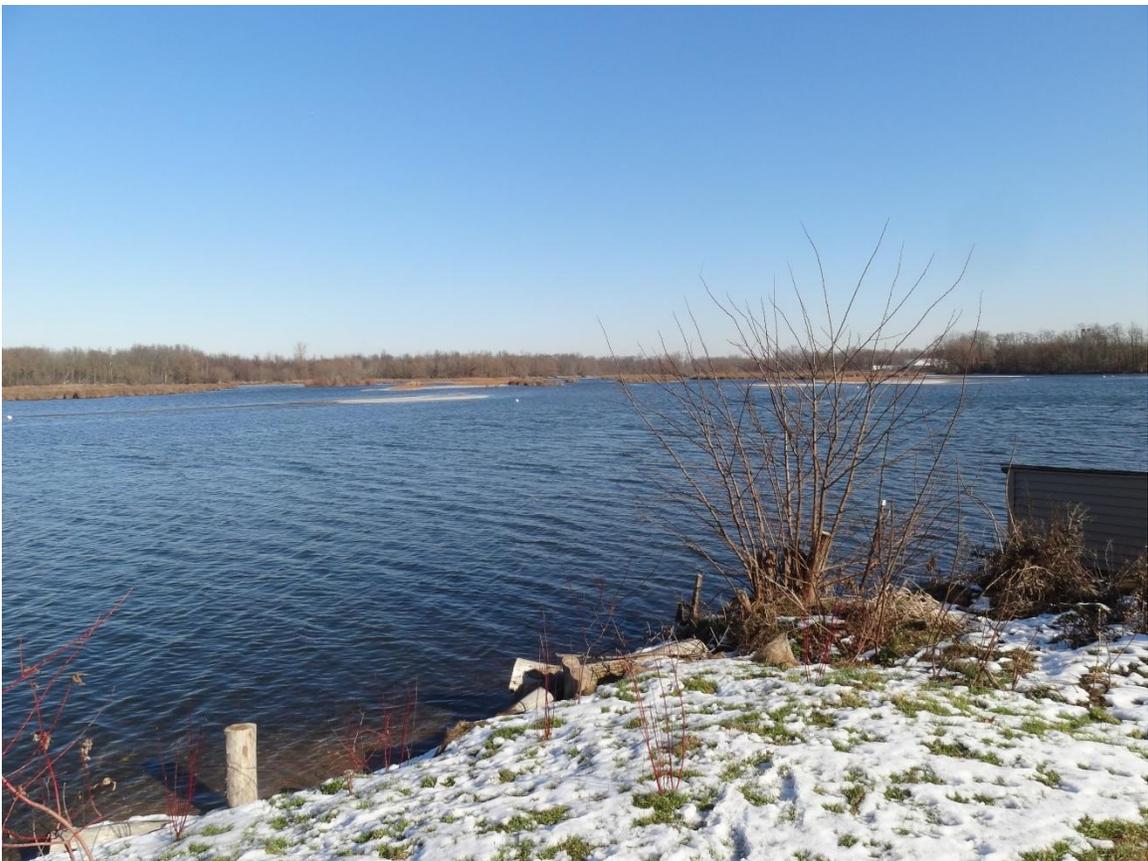
12. MP37.00 LDB looking northeast across Delta, minor ice observed around islands.

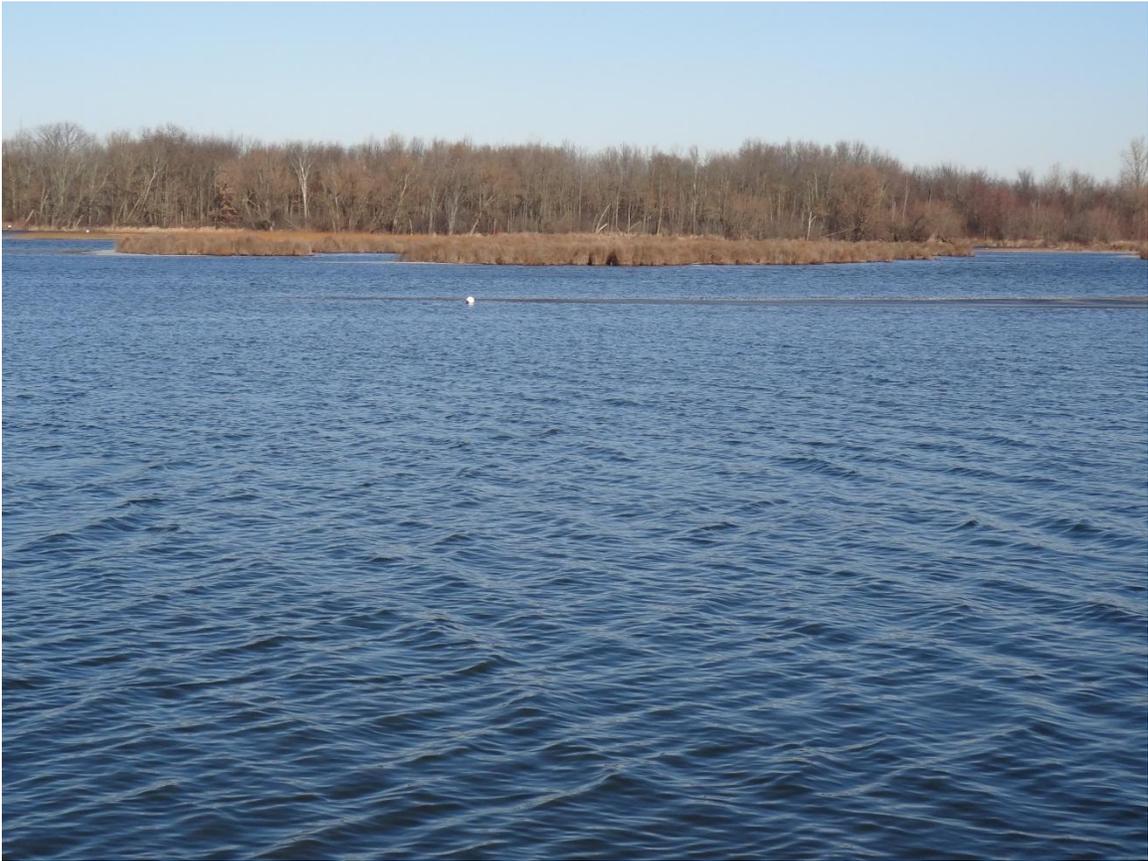
13. Looking north from MP37.00 LDB, minor ice observed around islands.

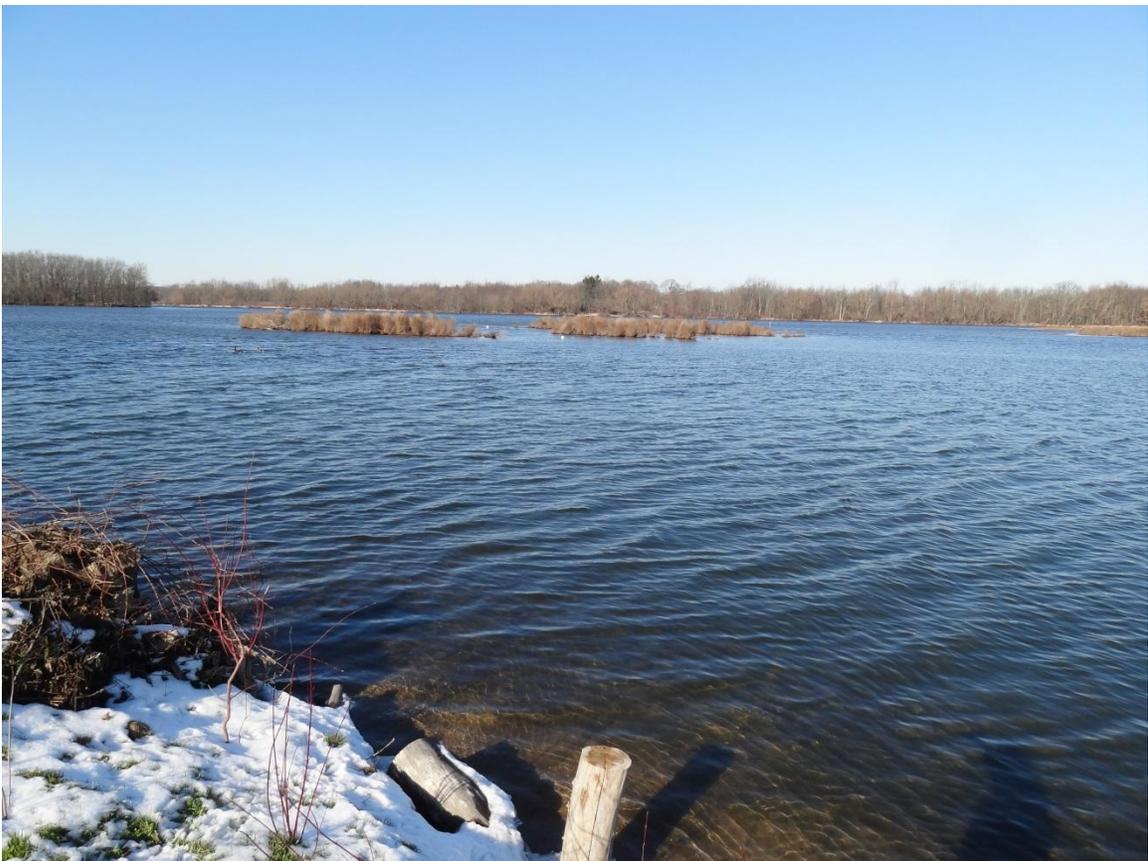
14. MP37.00 LDB looking northwest in Delta, no ice observed.

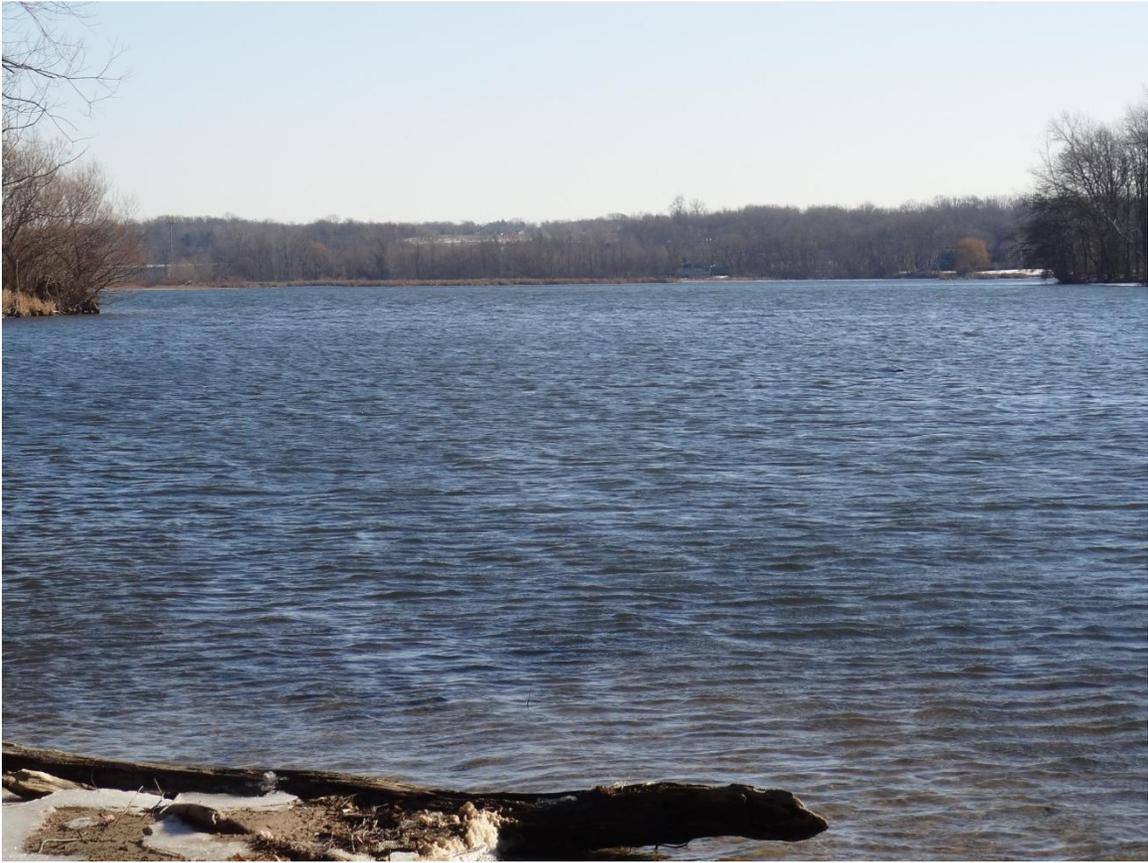
15. Former E4 boom location looking east into Delta, no ice observed.

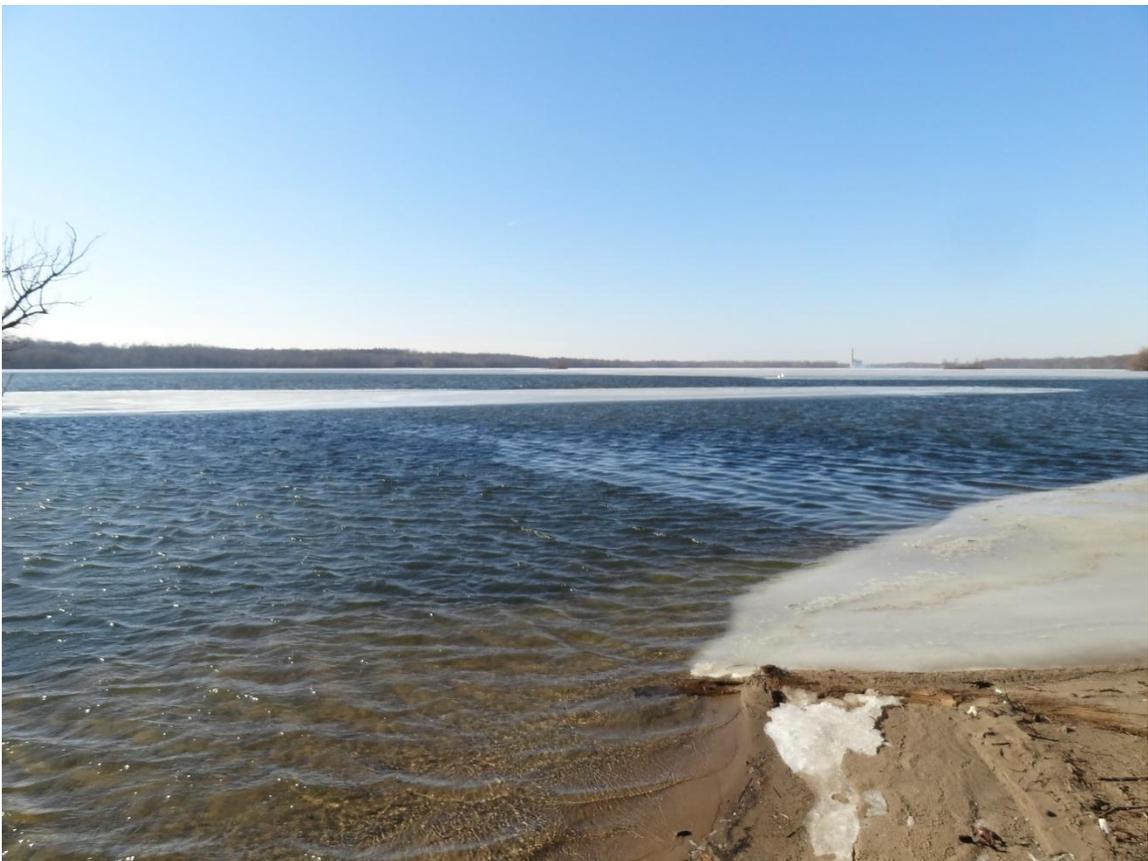
16. E4 Boat Launch, ice on eastern section of Morrow Lake continues to recede.

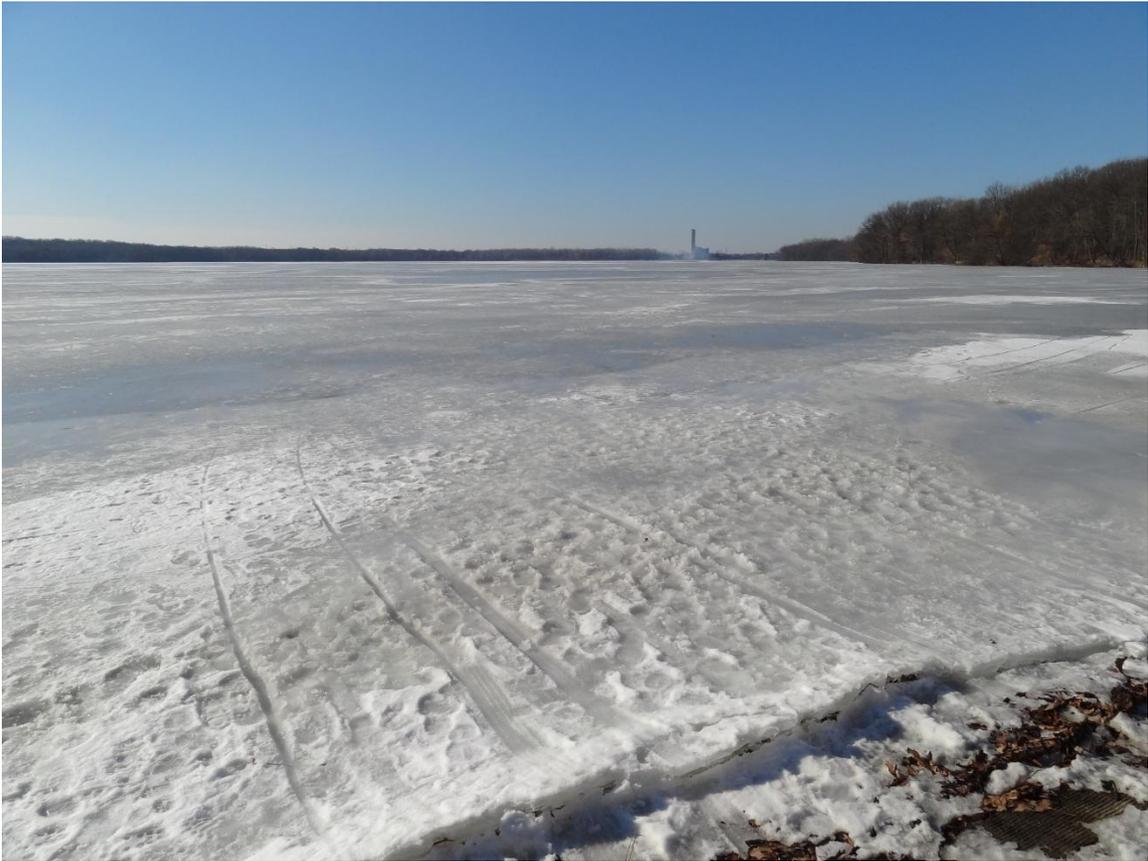
17. E4.5 Boat Launch, western end of Morrow Lake covered in ice and snow.

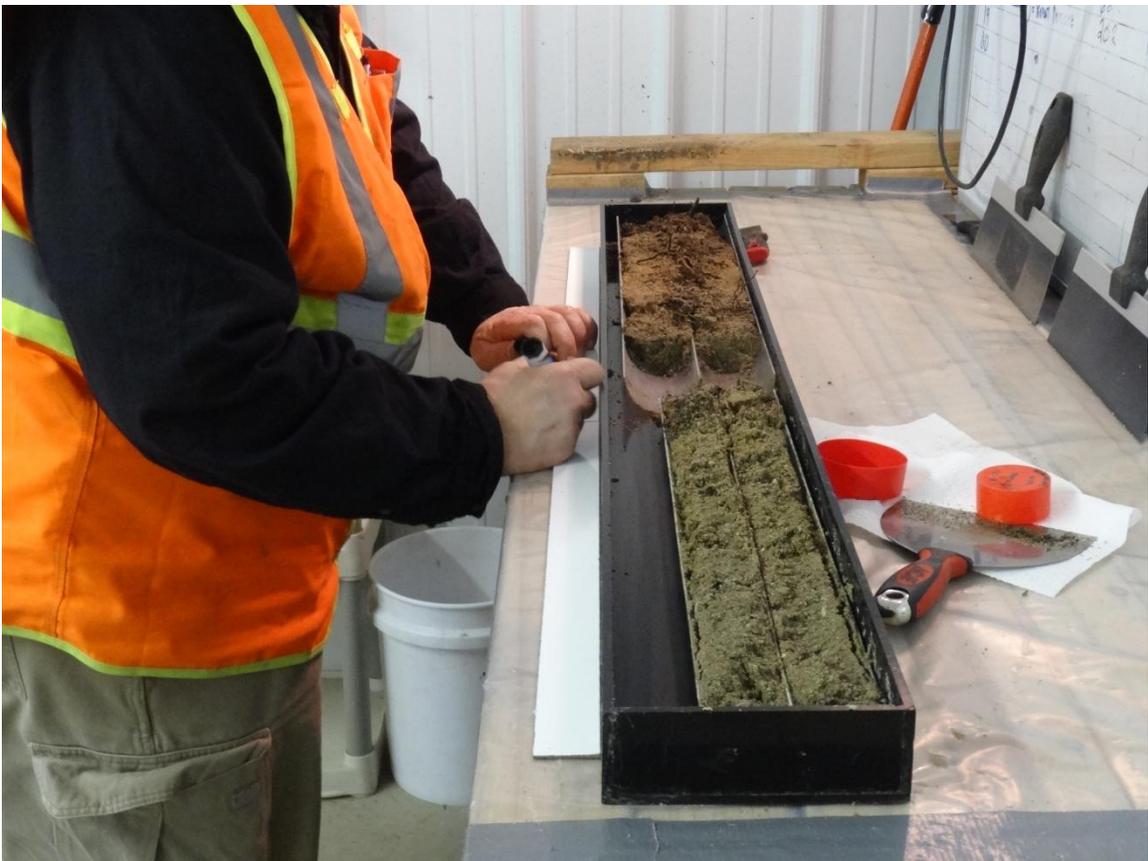
18. Observed core logging and sampling at the C3.2 building.
