Situation Photo Log

Thursday, January 10, 2013

Kalamazoo River / Enbridge Spill

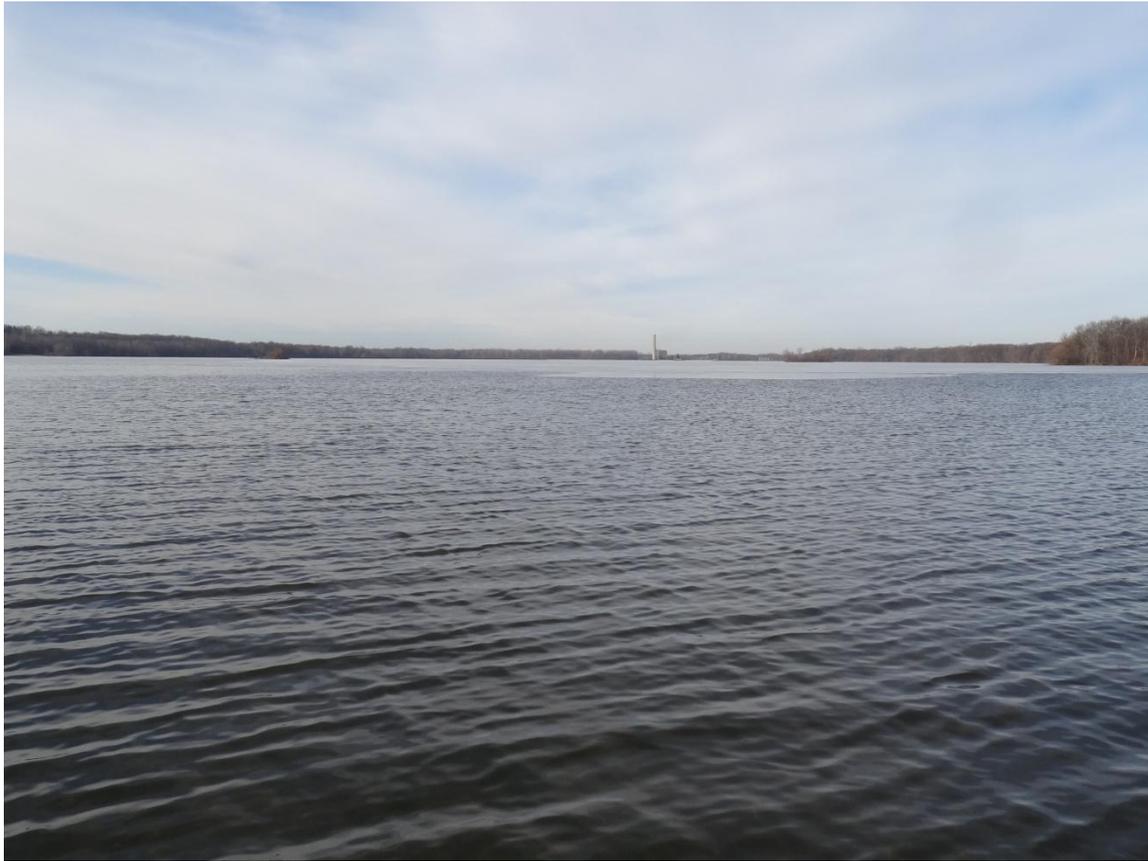
1. Ice continues to recede on the western portion of Morrow Lake.

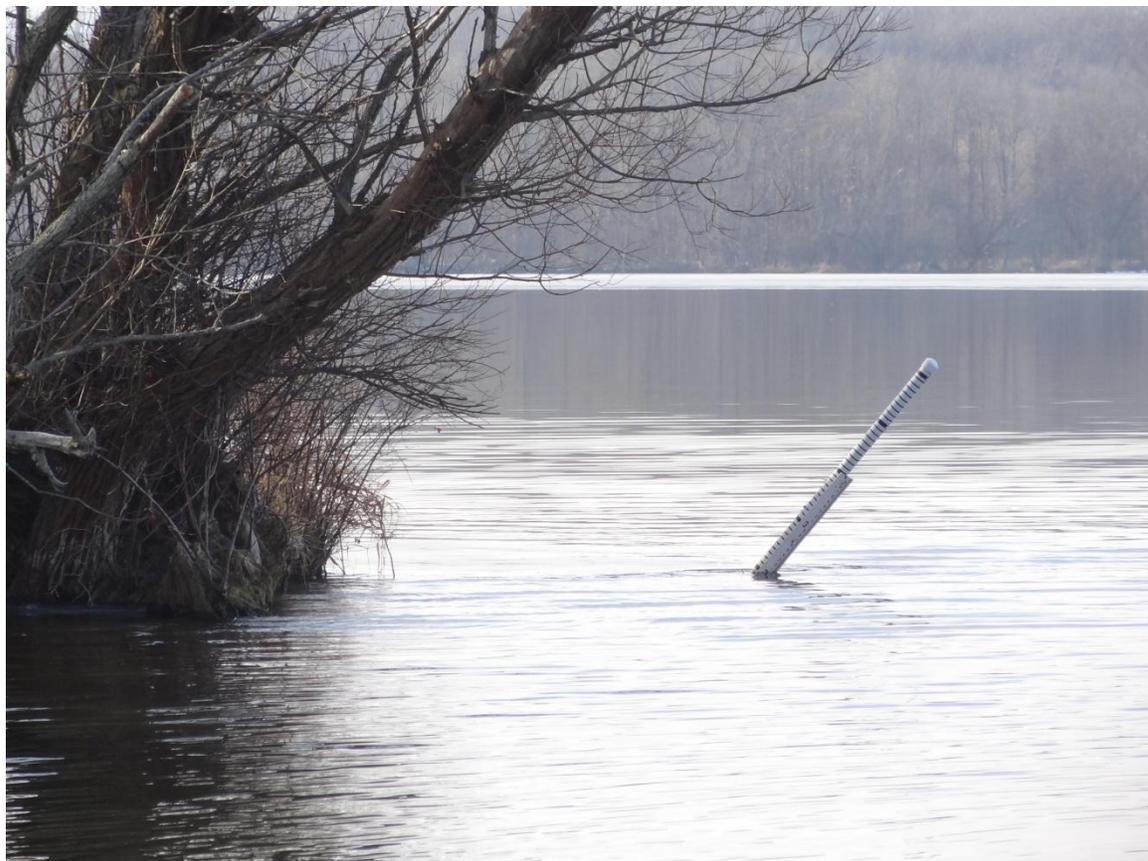
2. E4 Water Gauge evidently displaced from receding ice. Water gauge was adjusted by crew.

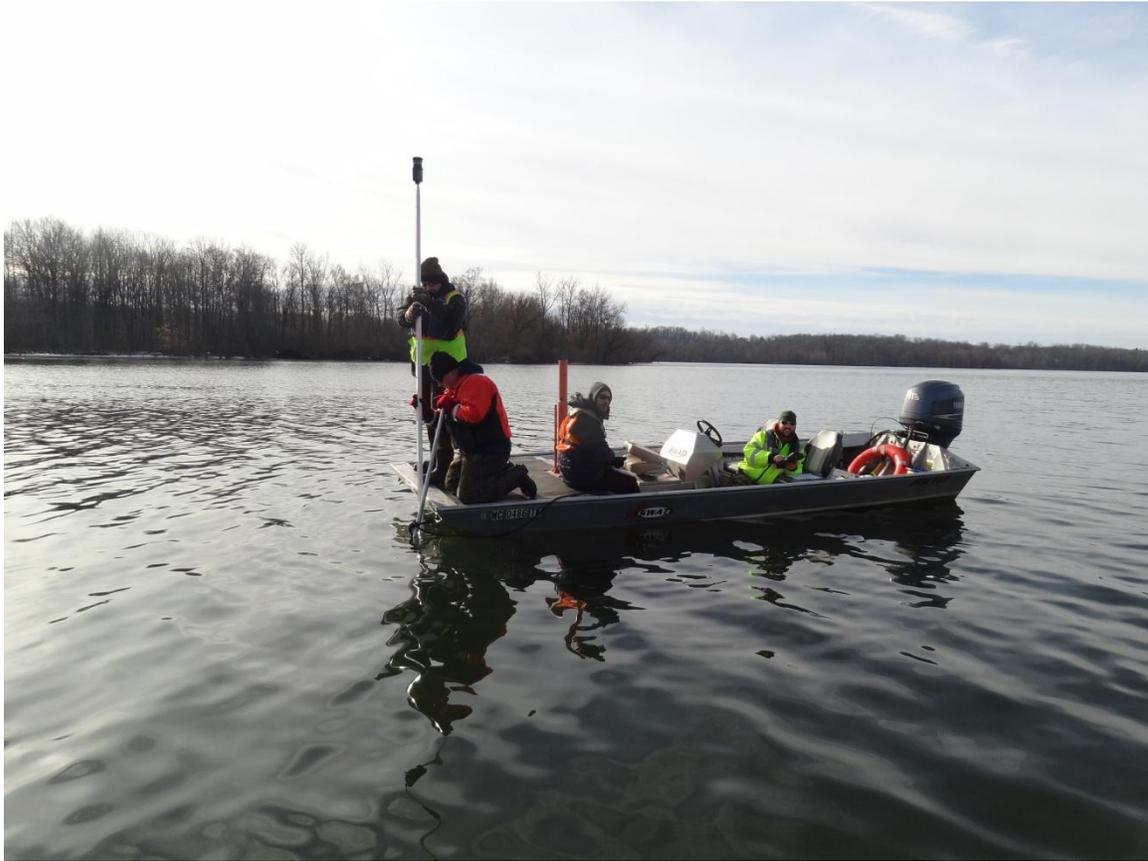
3. Former E4 boom location, observed a bathymetry team collecting measurements.

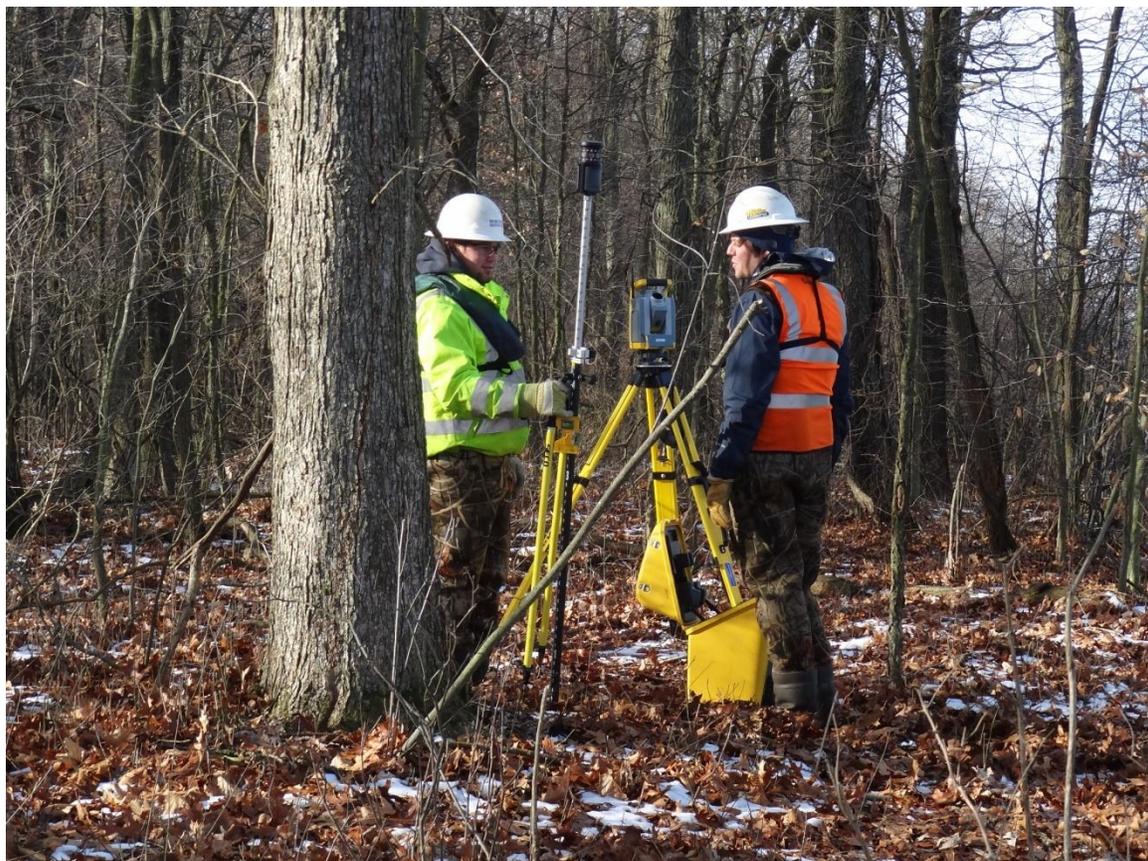
4. Morrow Lake Delta observed a bathymetry team calibrating equipment.

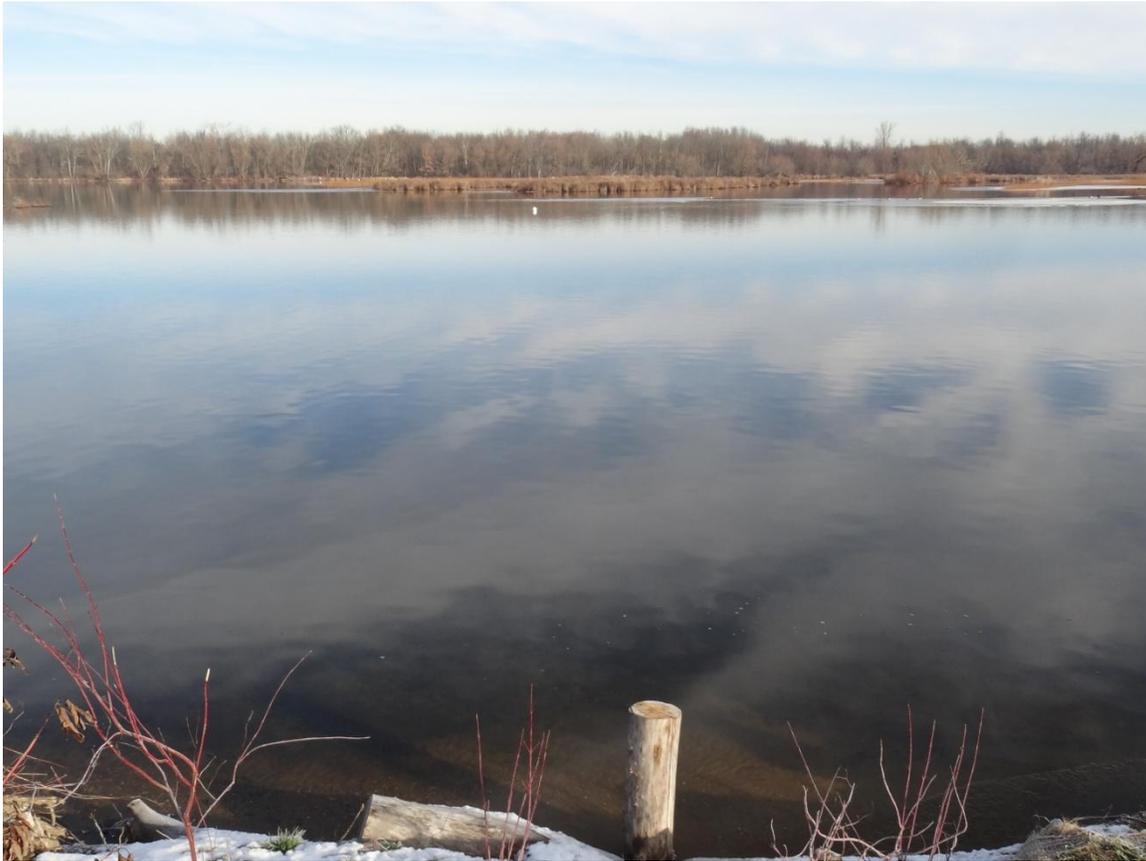
5. MP37.00 LDB looking north across Delta. Minor ice observed around islands.

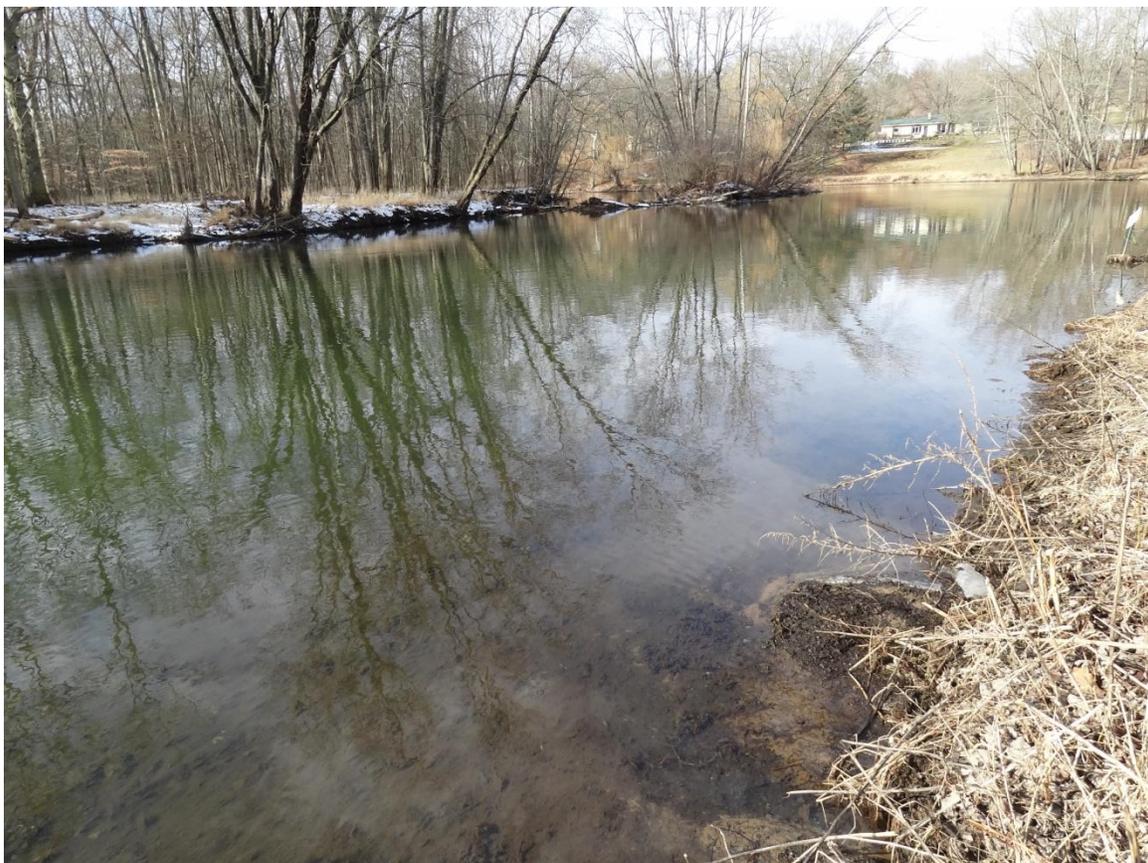
6. MP27.00 Shady Bend Campground, no sheen observed.

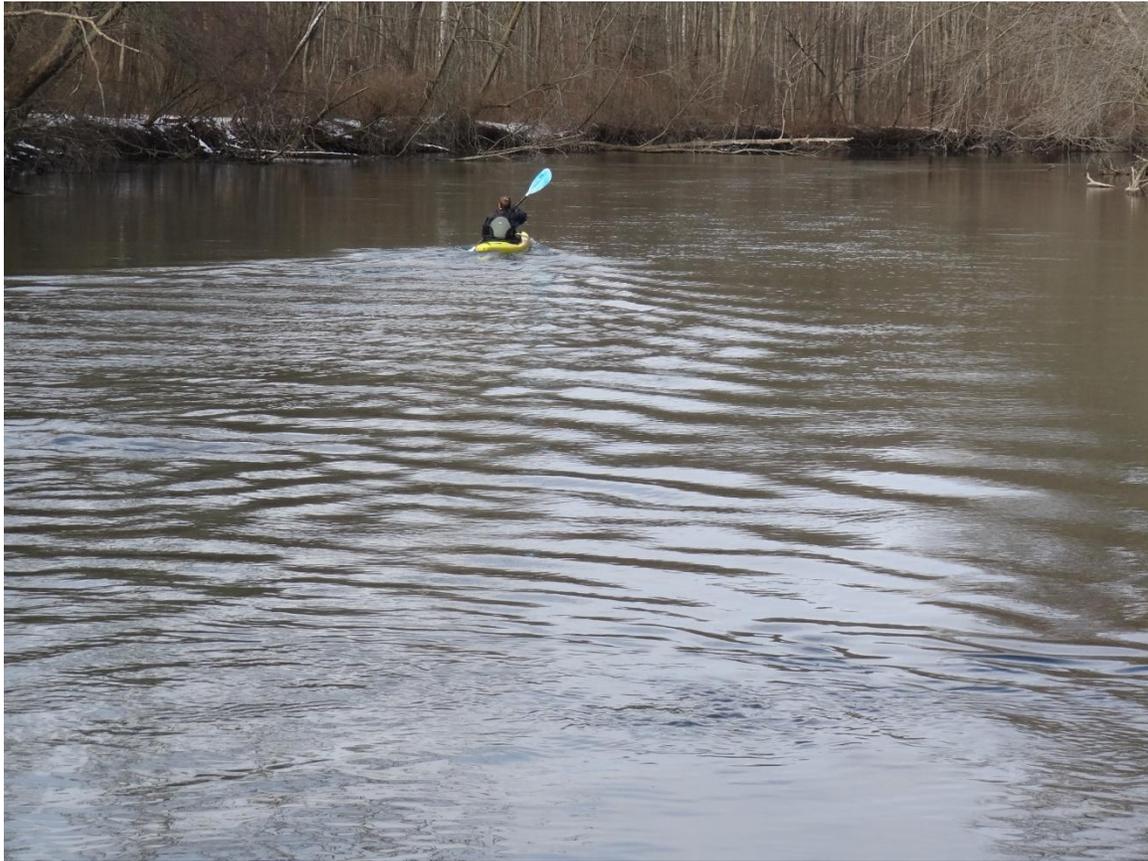
7. Observed a kayaker departing E2 Boat Launch.

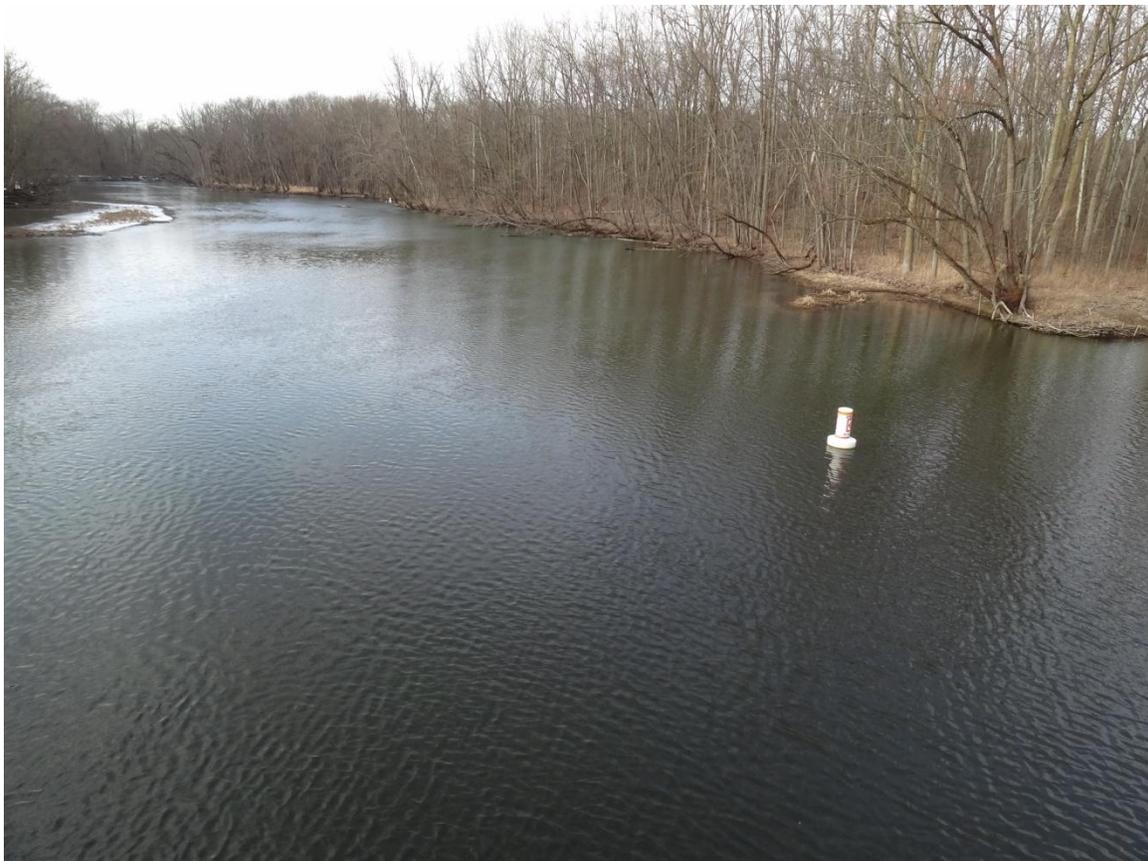
8. MP21.50, no sheen or bank ice observed.

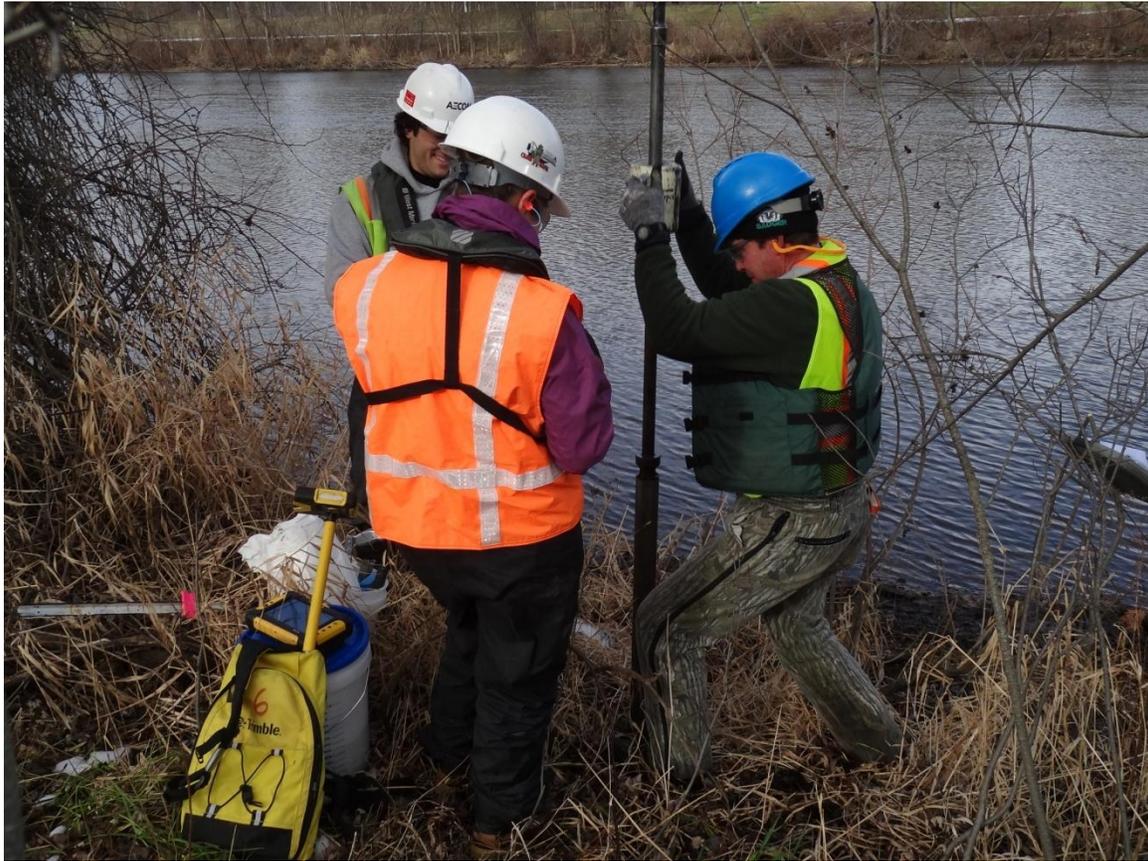
9. MP18.00 LDB, observed the RI team collecting soil samples.

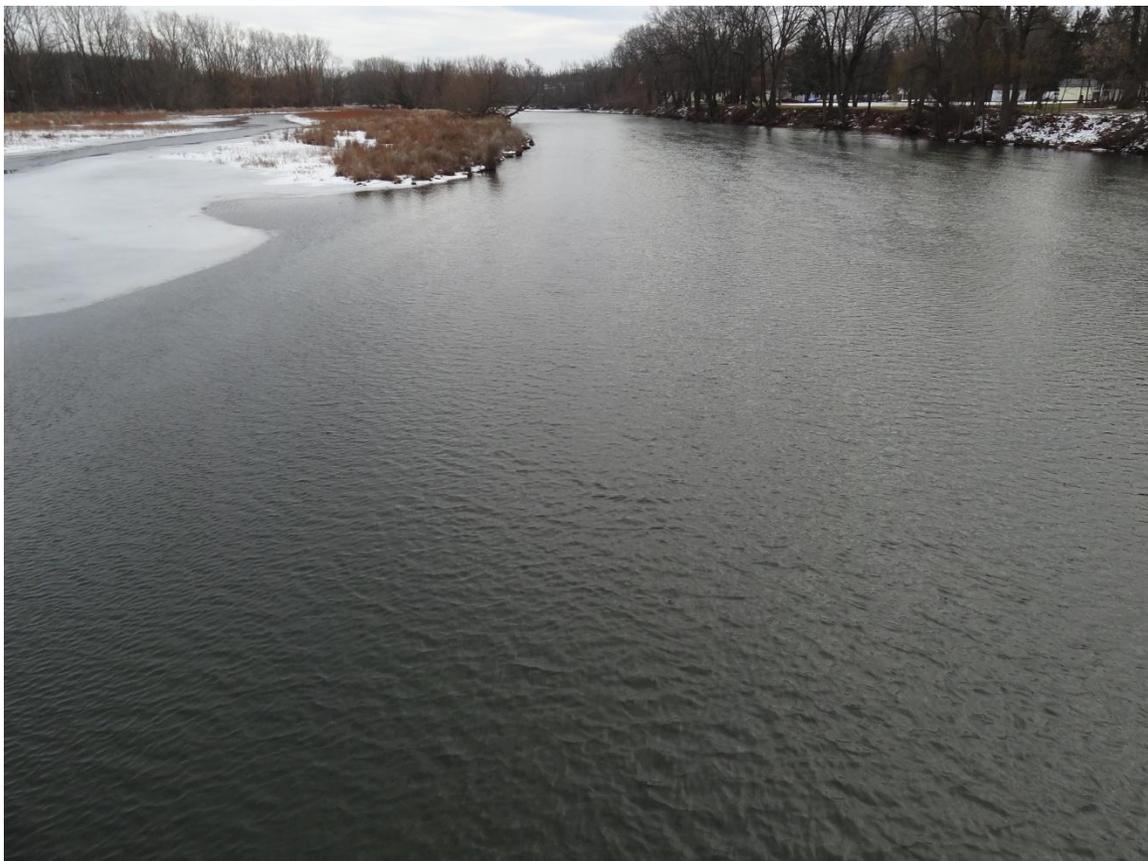
10. MP15.25 South Mill Pond, no sheen observed.

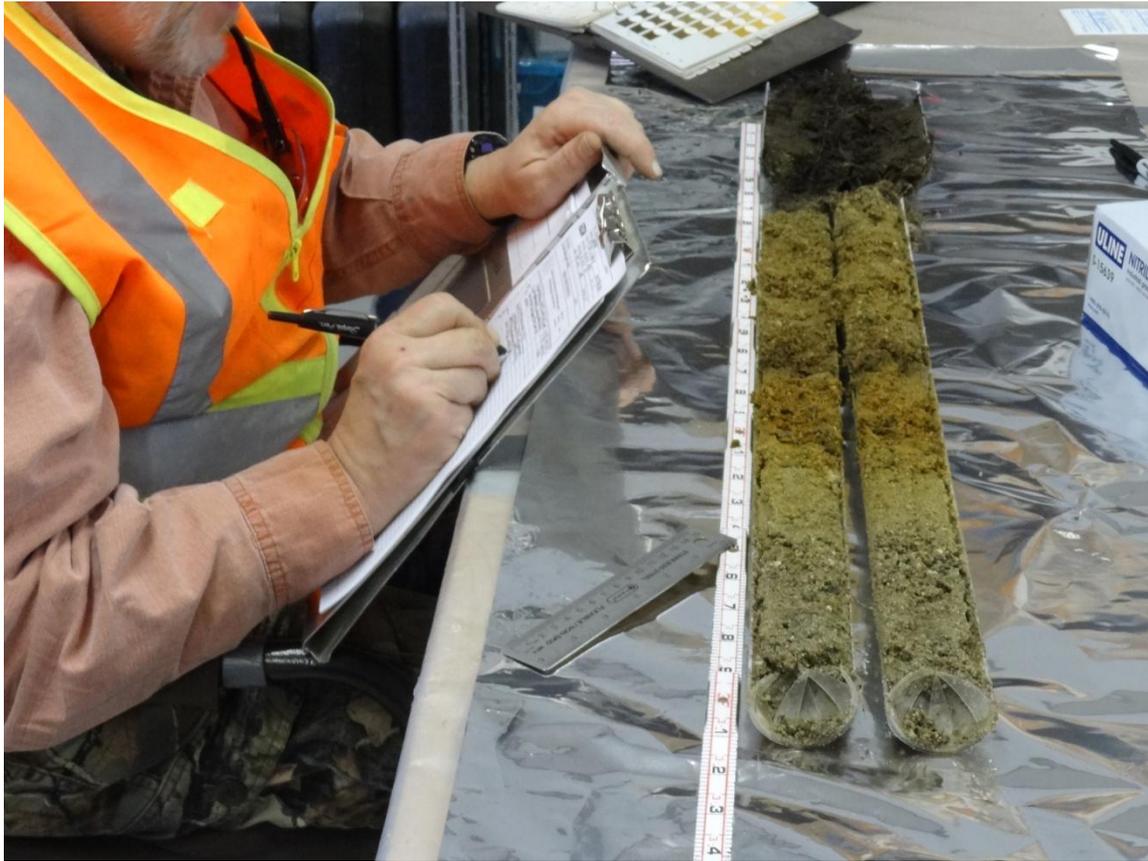
11. C3.2 building, observed core logging.

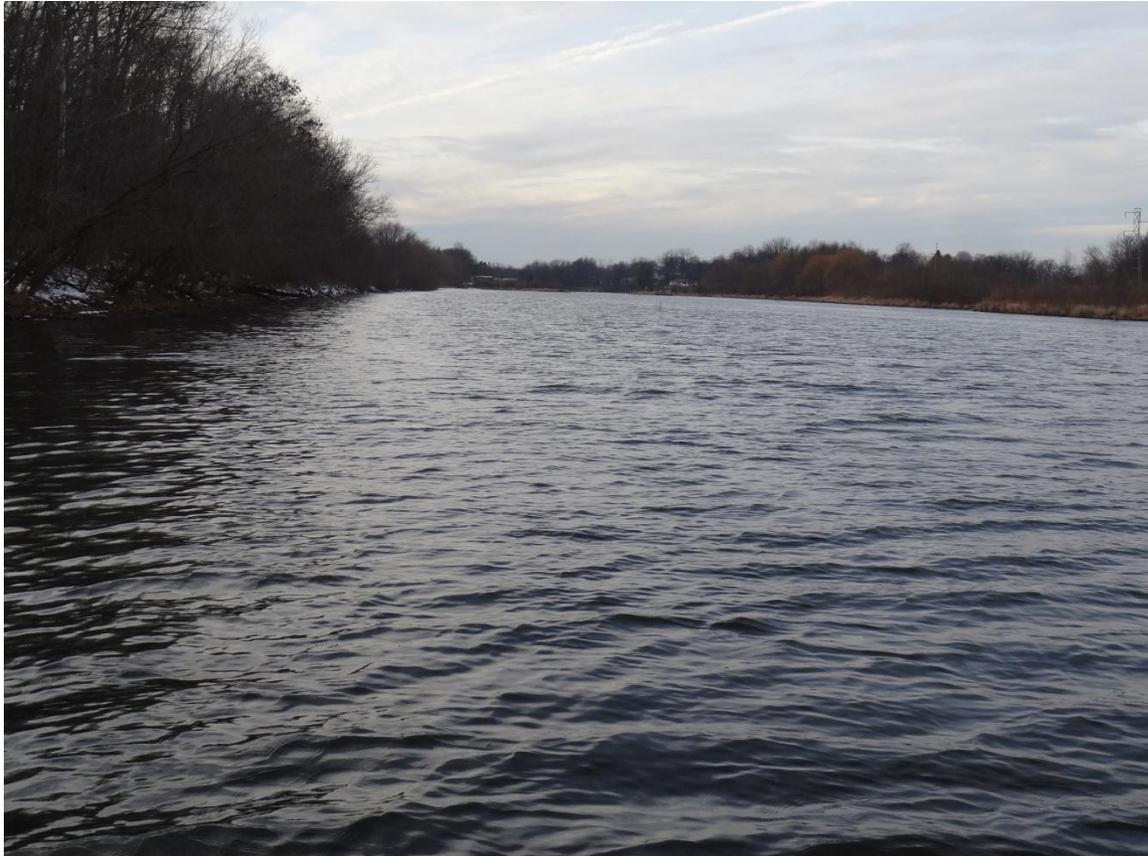
12. MP5.25 LDB, no sheen or bank ice observed.

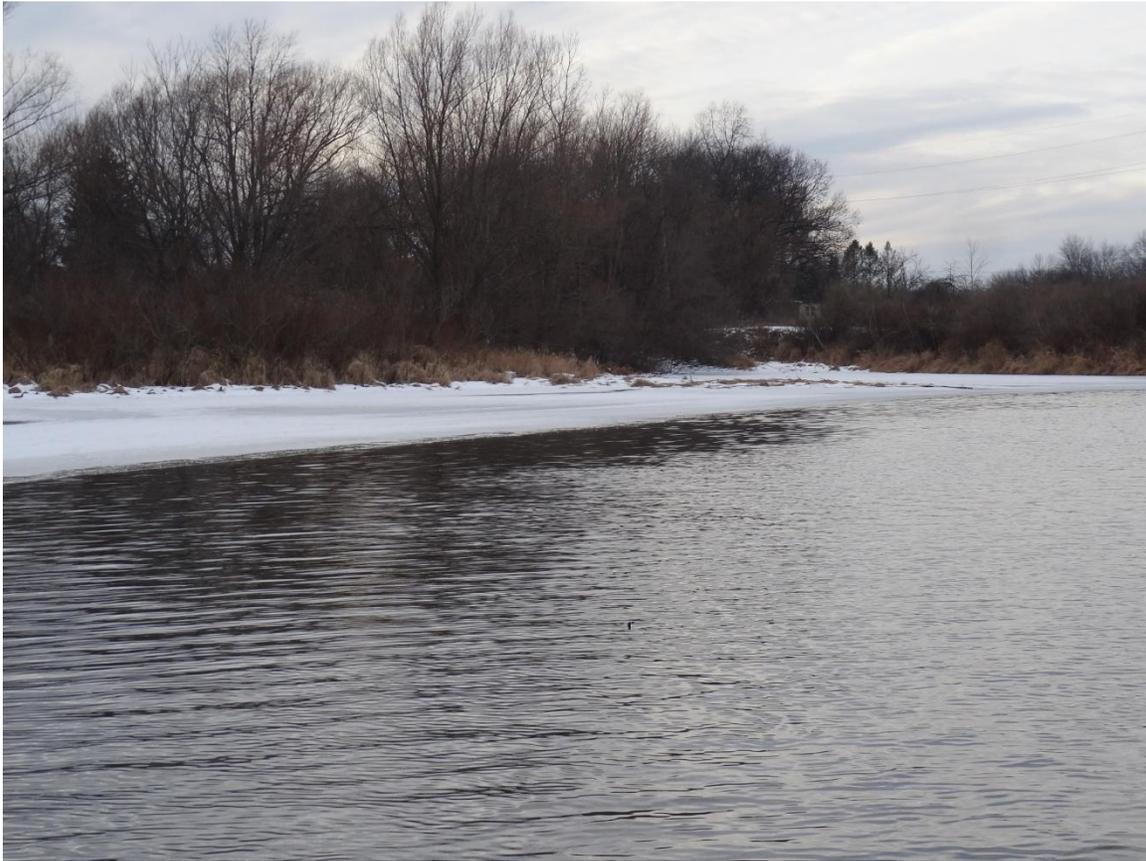
13. MP5.55 LDB, minor bank ice observed above Ceresco Dam trestle.

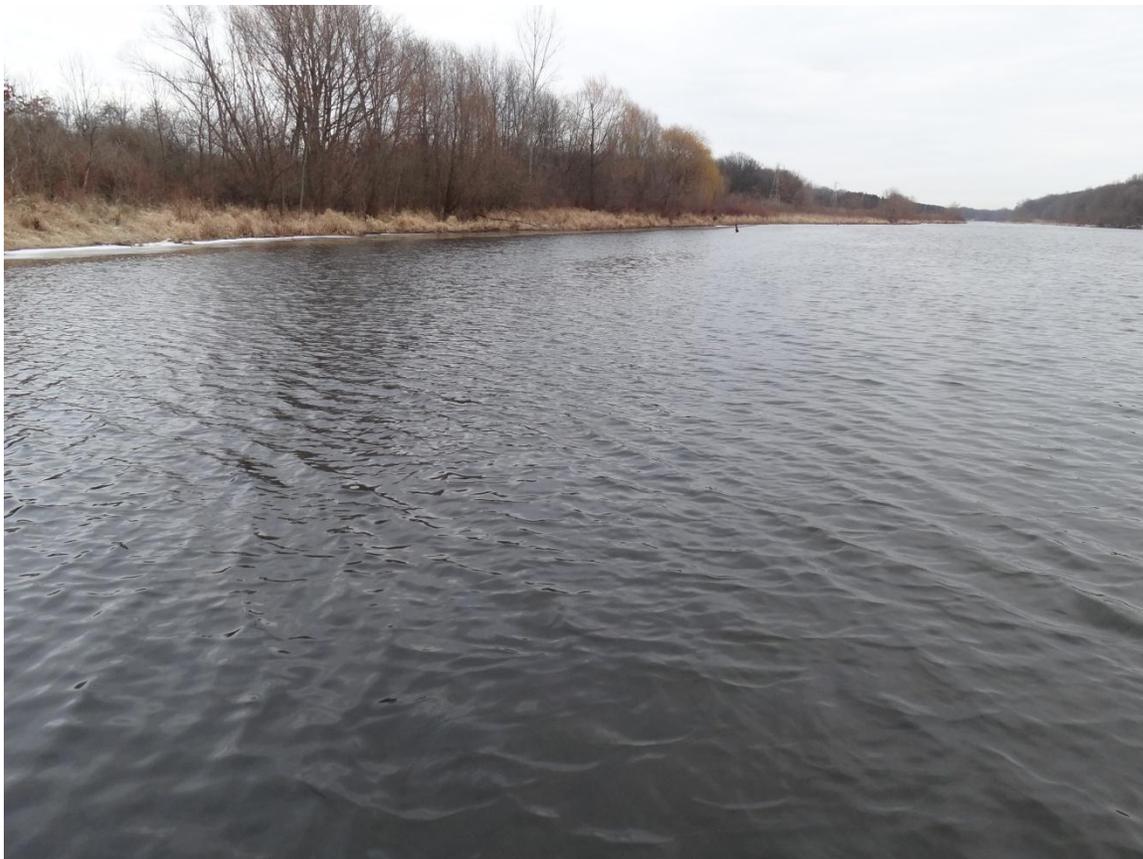
14. MP5.55 RDB, no sheen observed.

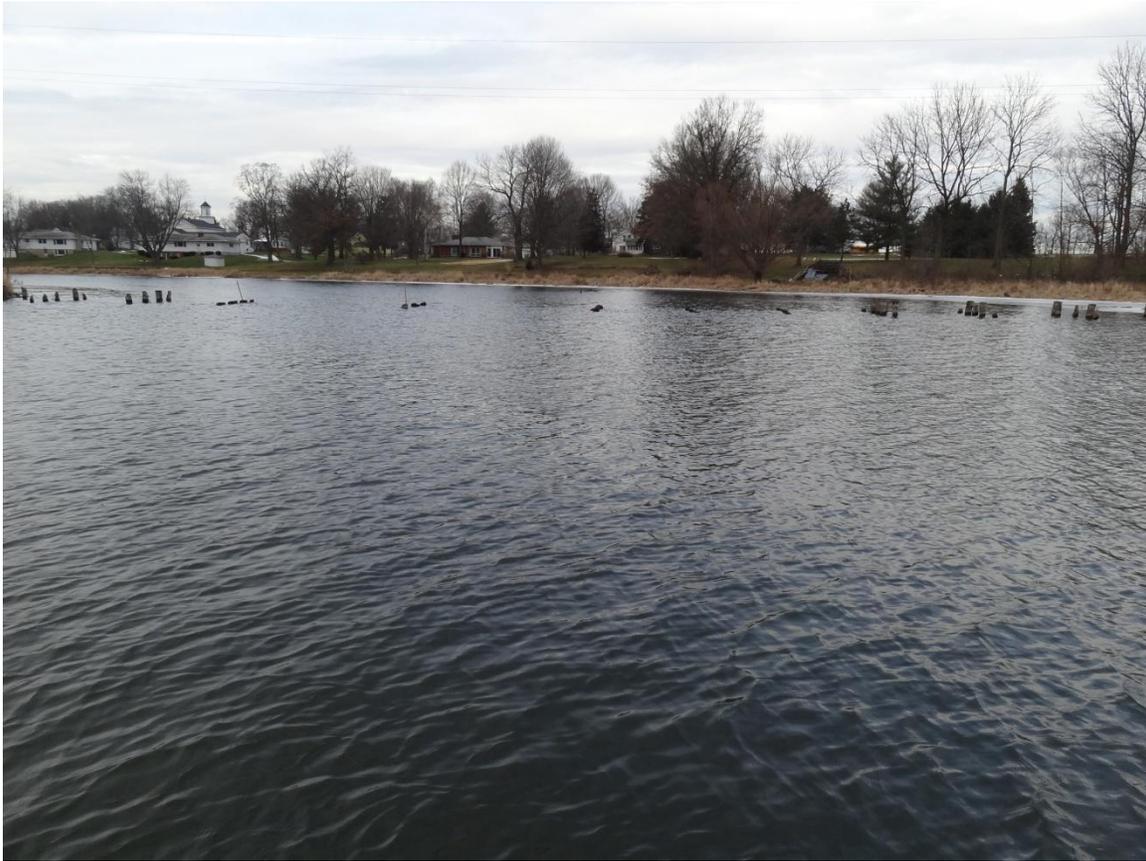
15. No ice or sheen observed in vicinity of Ceresco Dam Trestle.

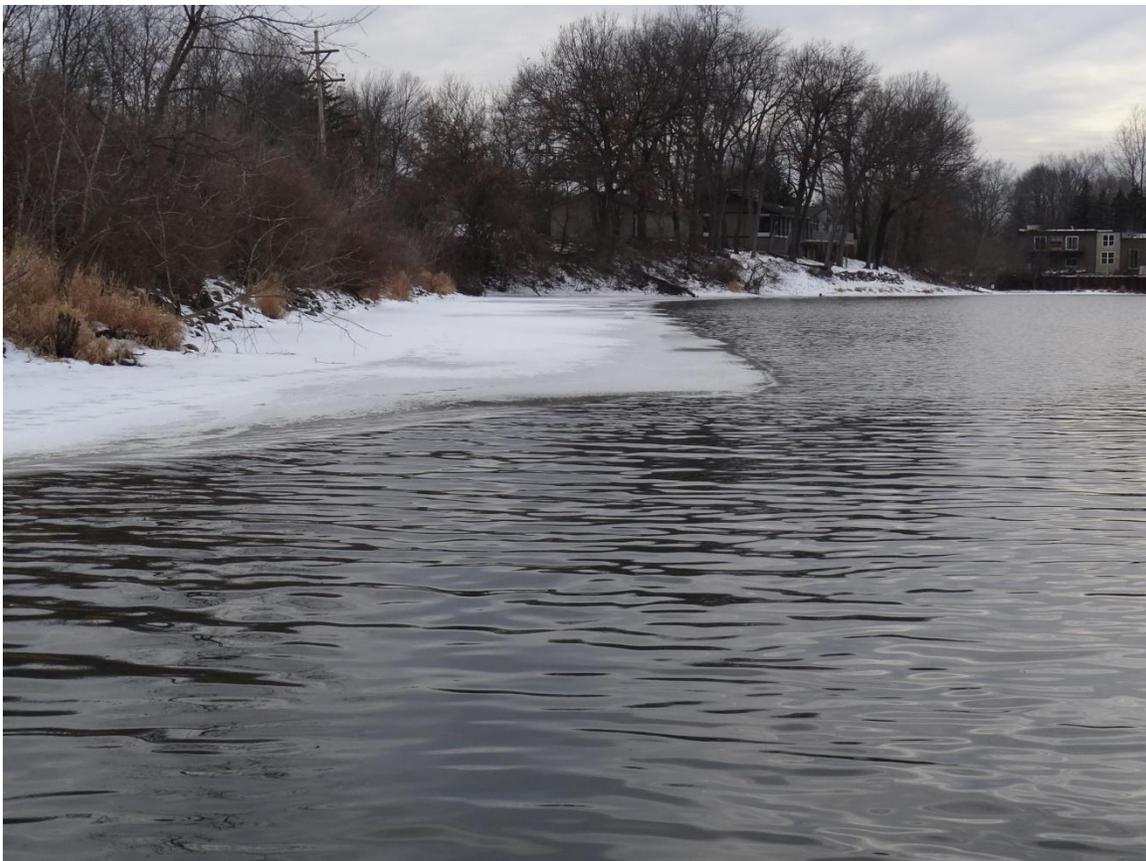
16. MP5.63 LDB, no sheen however minor bank ice observed.

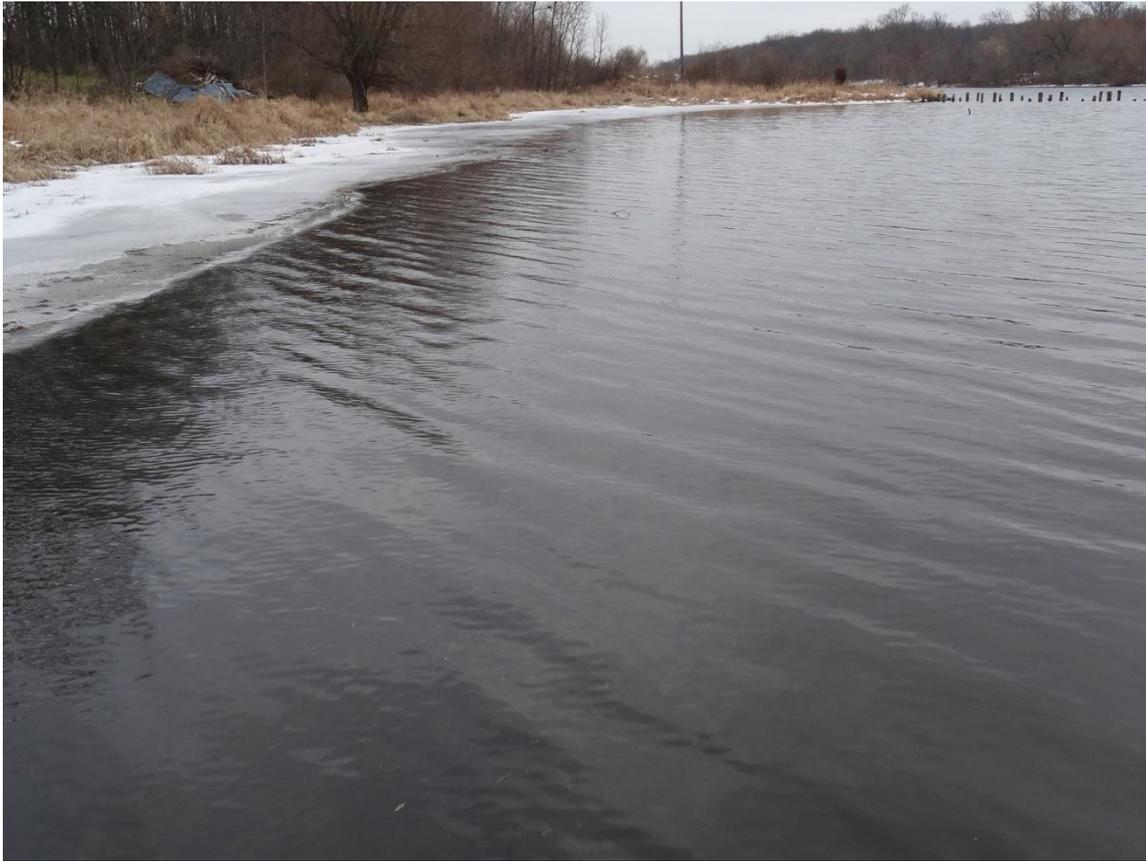
17. MP5.65 RDB, minor bank ice observed.

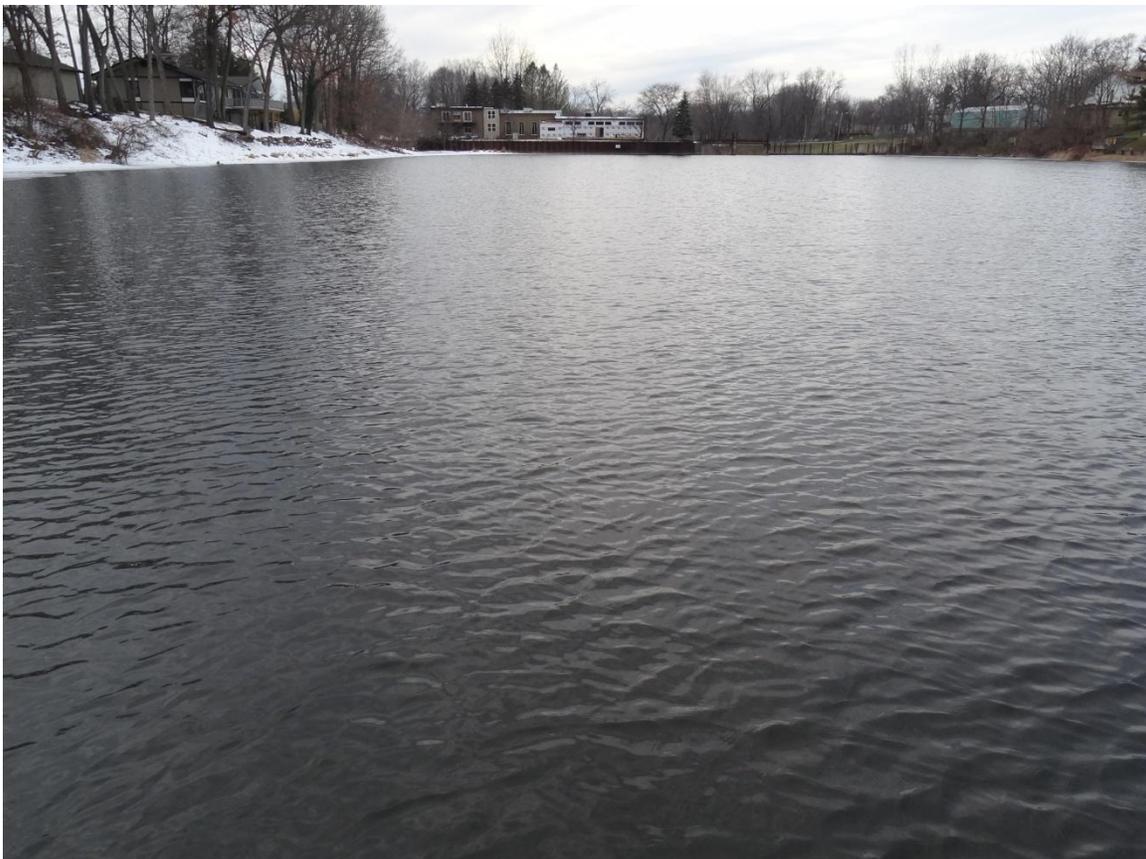
18. MP5.65 center channel, no sheen observed.
