Situation Photo Log

Saturday, January 12, 2013

Kalamazoo River / Enbridge Spill

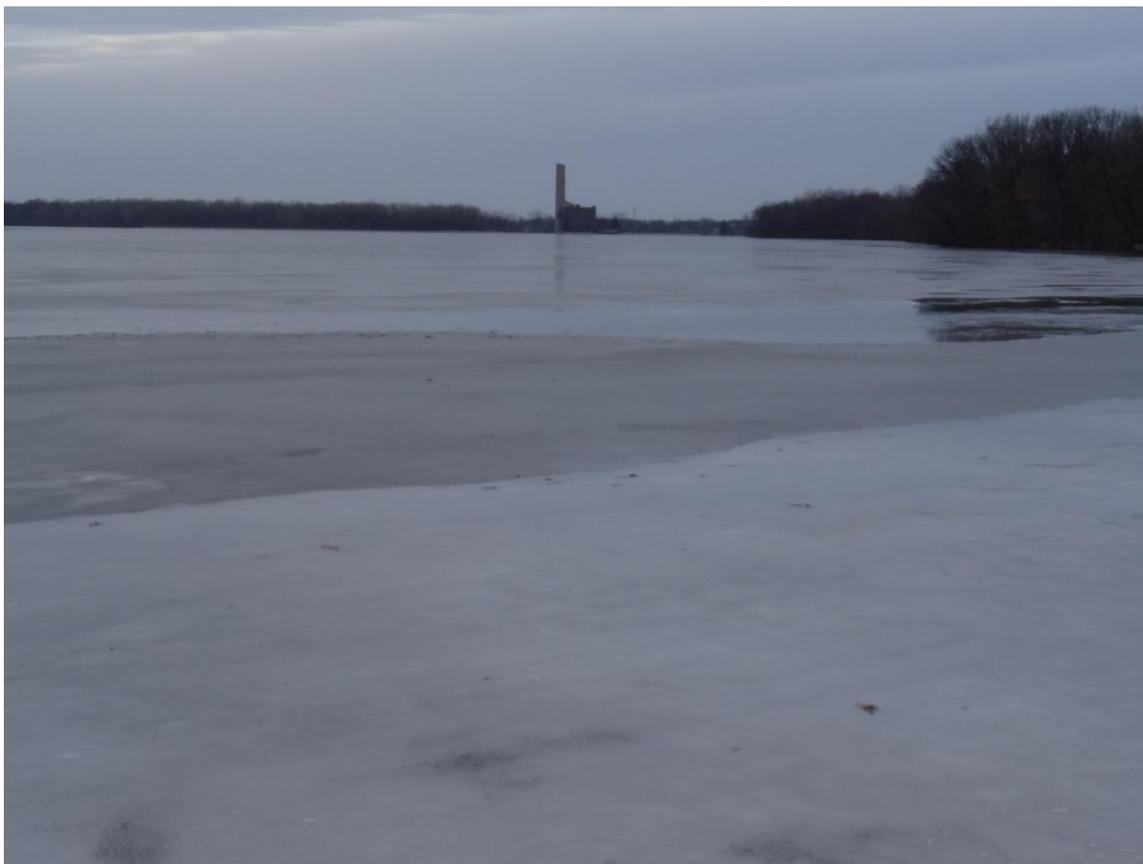
1. E4.5 boat launch, ice continues to recede along western portion of Morrow Lake.

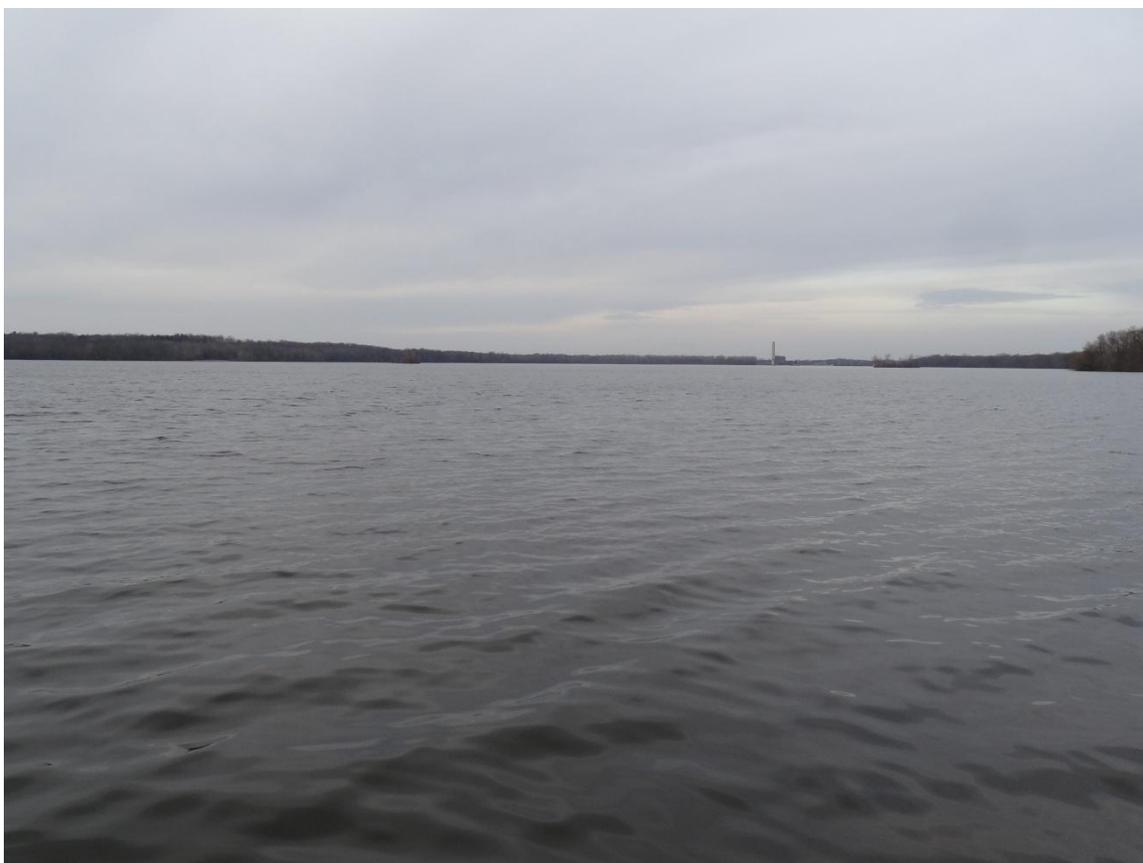
2. Ice in western portion of Morrow Lake barely visible from E4 boat launch.

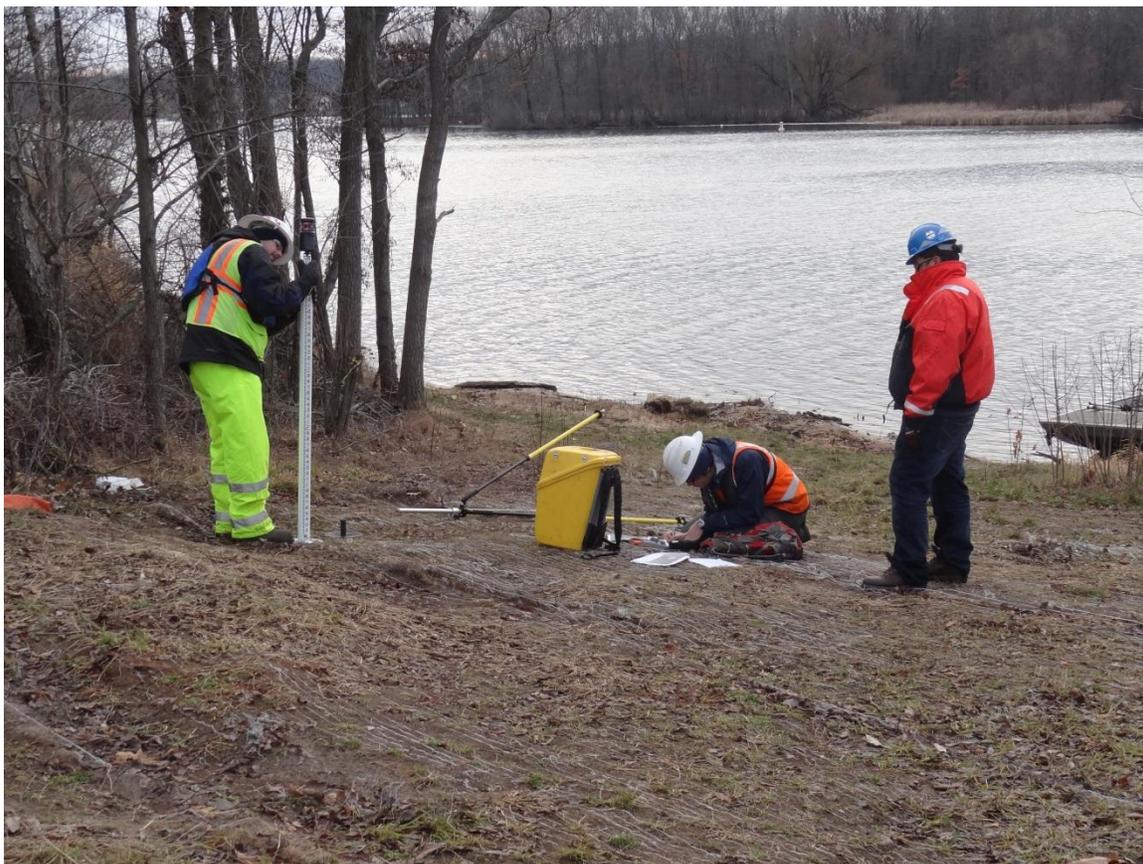
3. Observed bathymetry team and survey equipment along RDB at former E4 boom location.

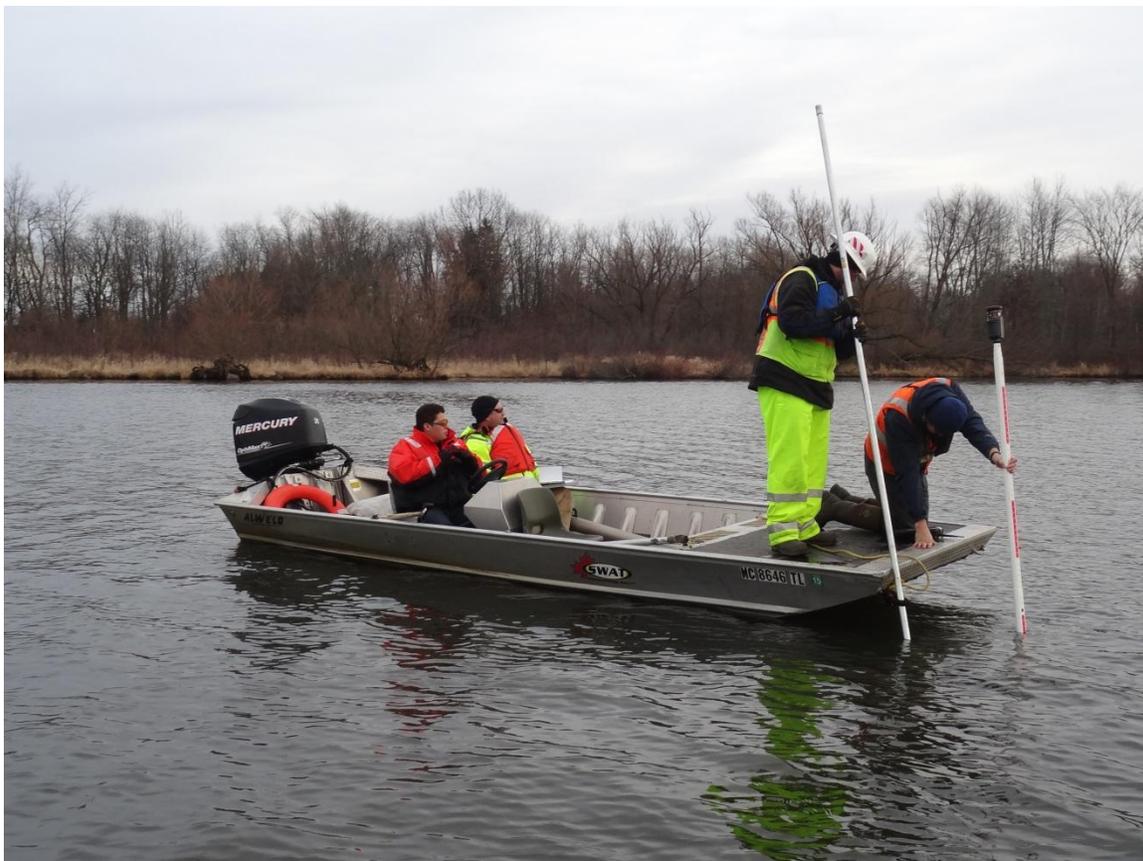
4. Observed bathymetry team in west end of Morrow Lake Delta.

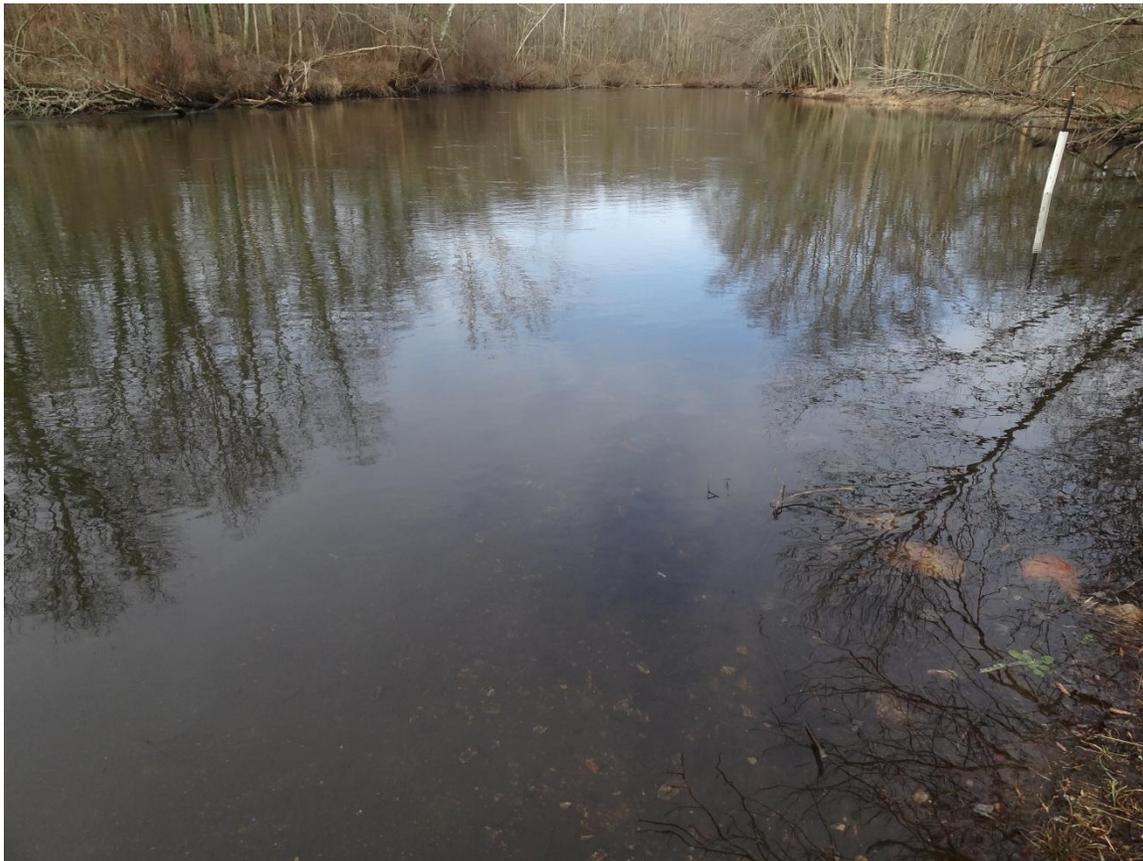
5. E2 boat launch, no sheen observed.

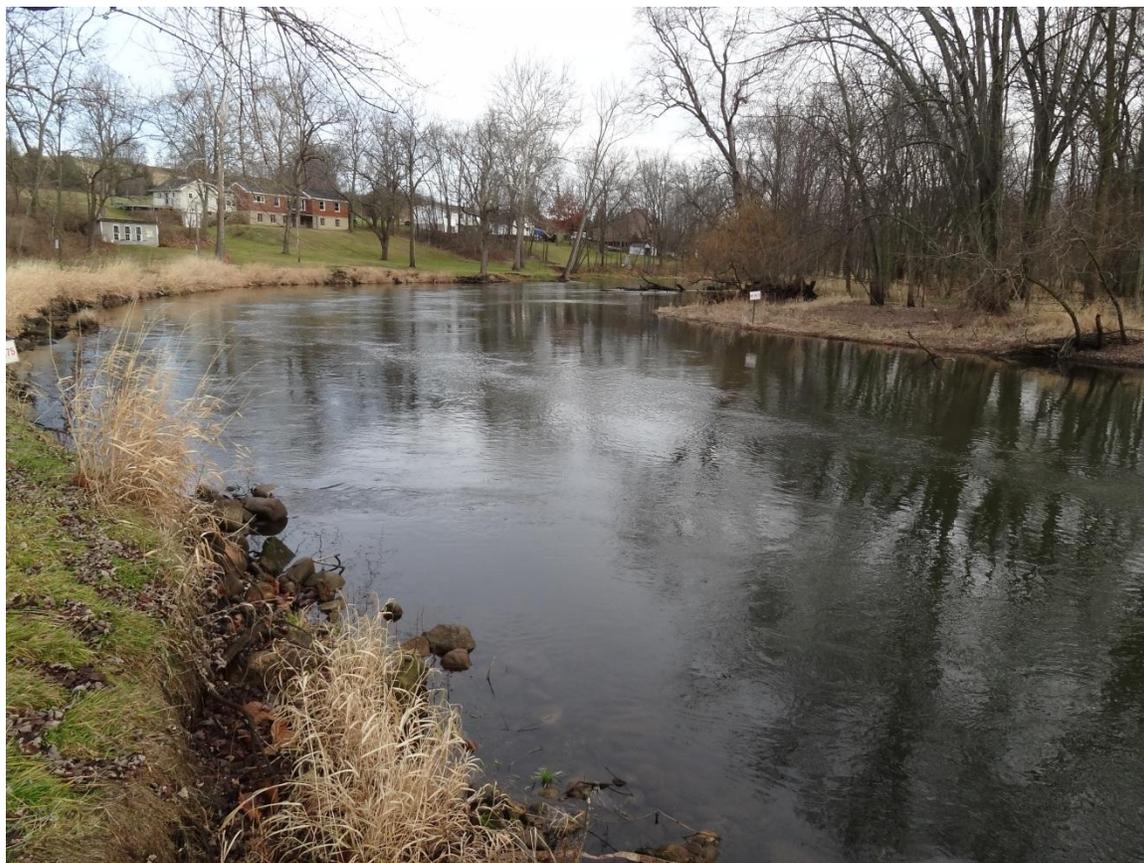
6. MP27.00 Shady Bend Campground, river level remains higher than previous days.

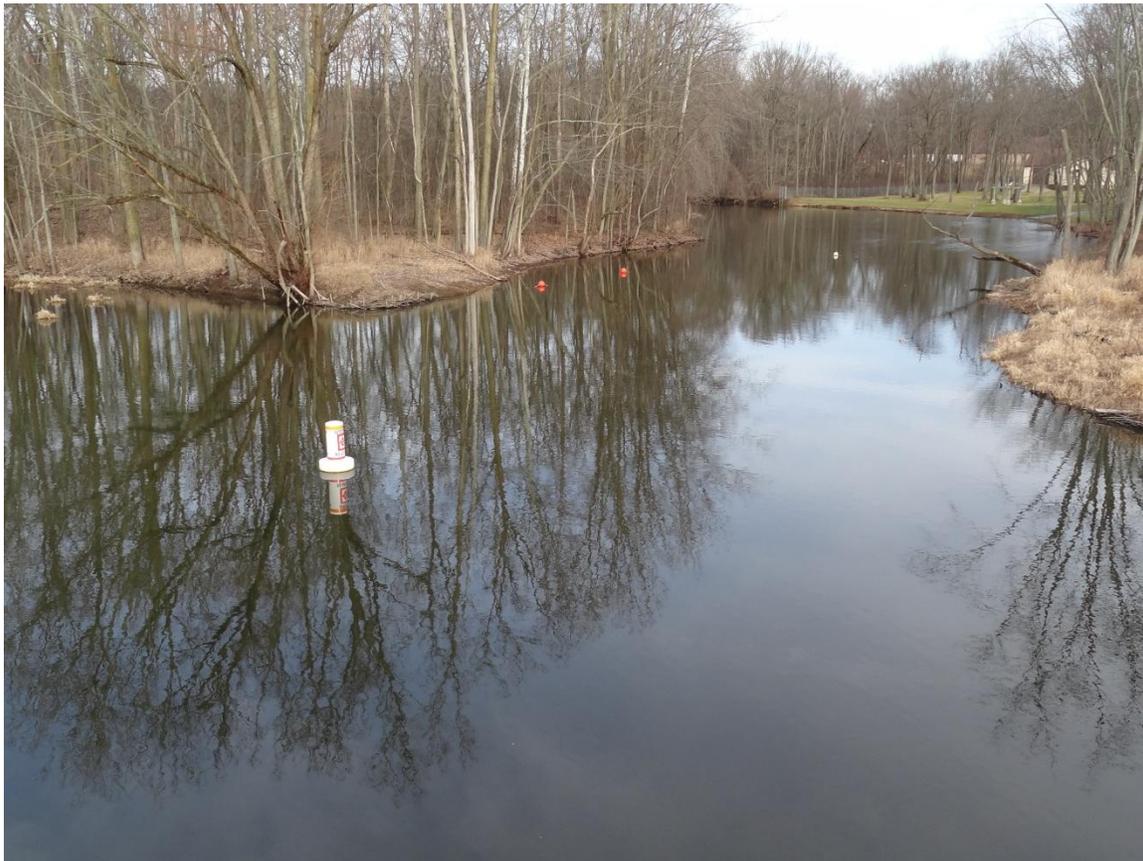
7. MP21.50 RDB, no sheen observed.

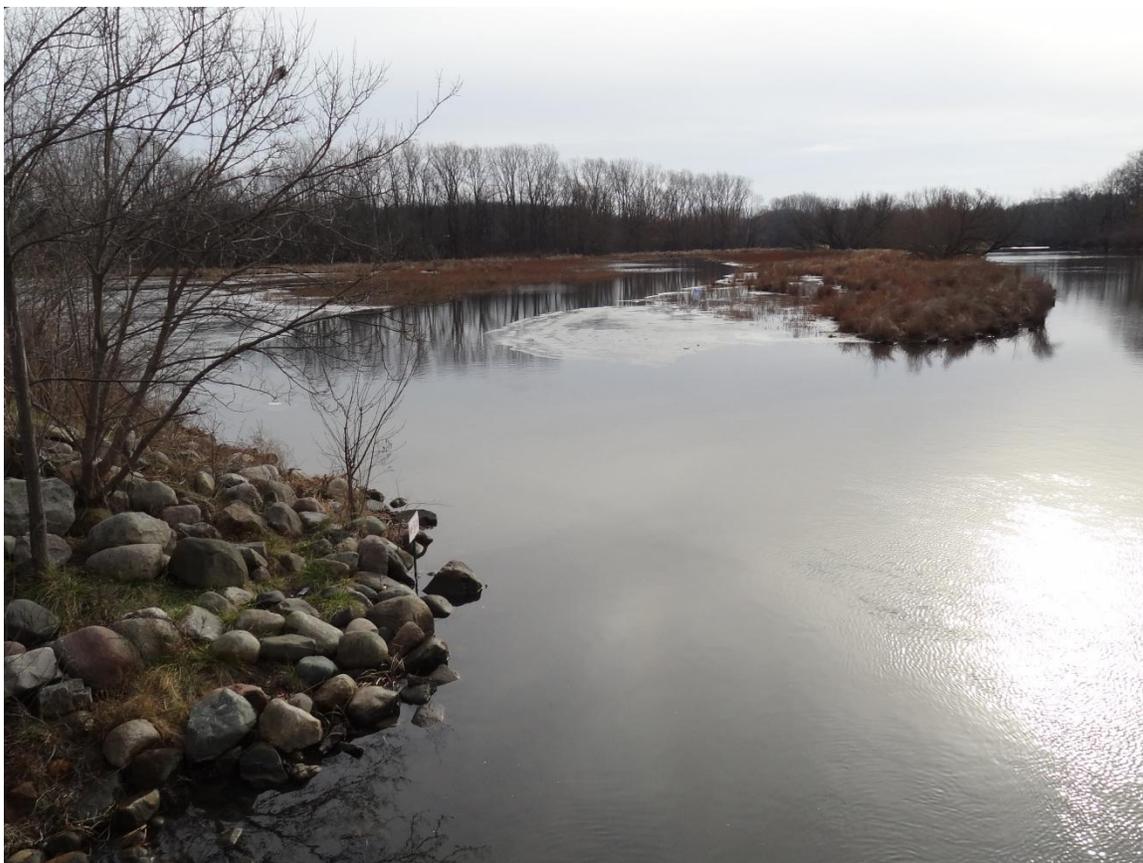
8. MP15.25 South Mill Pond, ice in back water area continues to recede. No sheen observed.

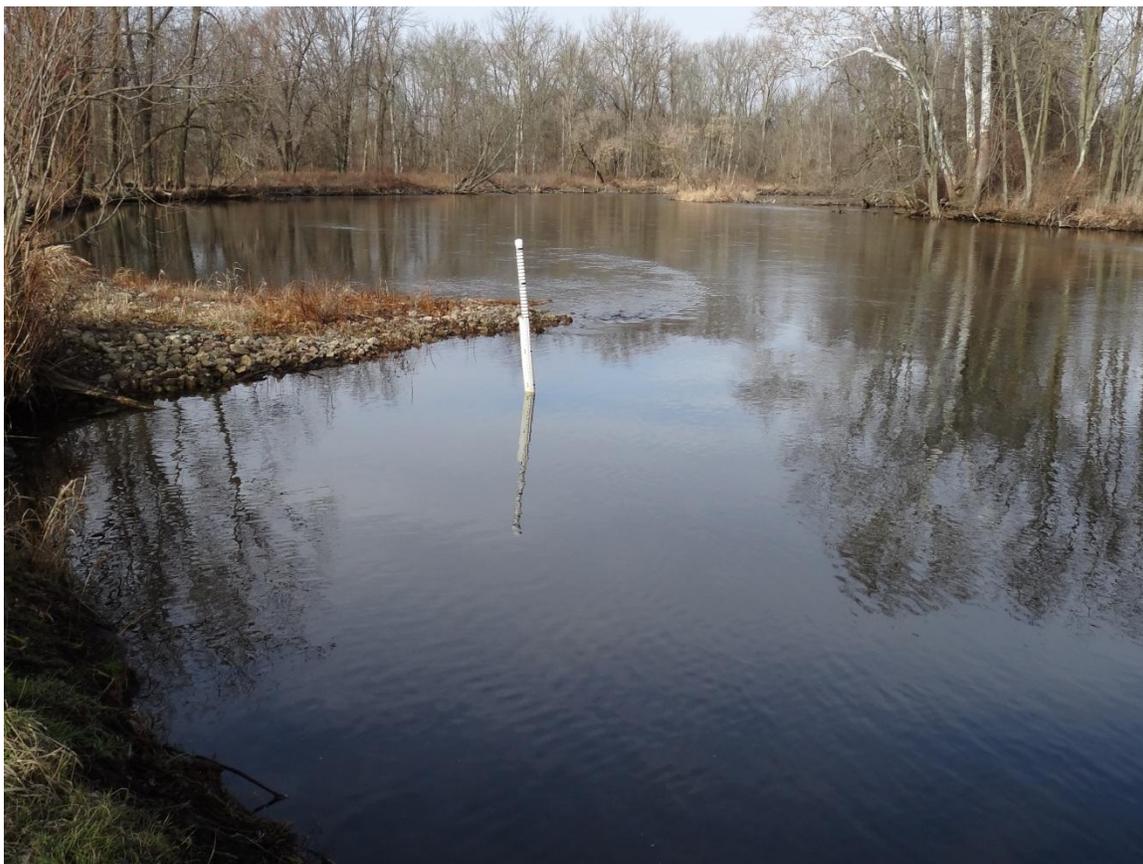
9. C3.2 boat launch, no sheen or bank ice observed.

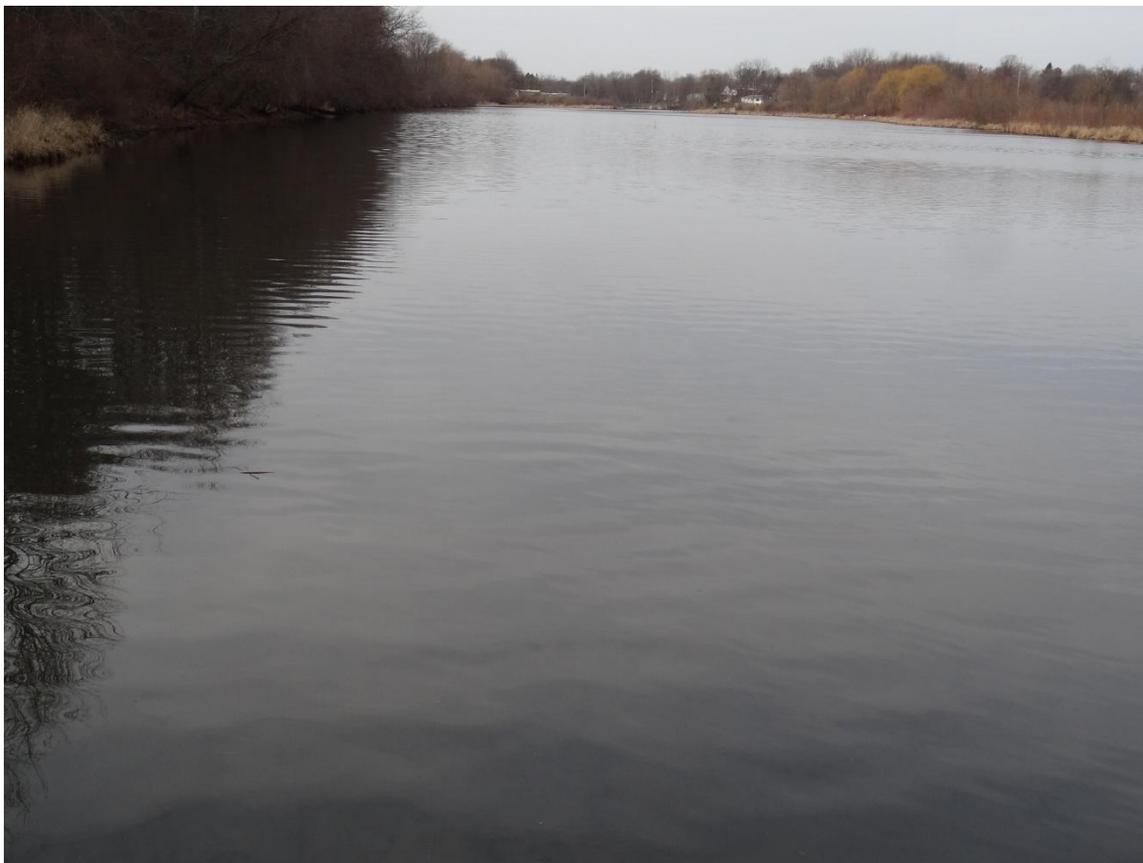
10. MP5.25 LDB, area where sheen and tar globule was observed.

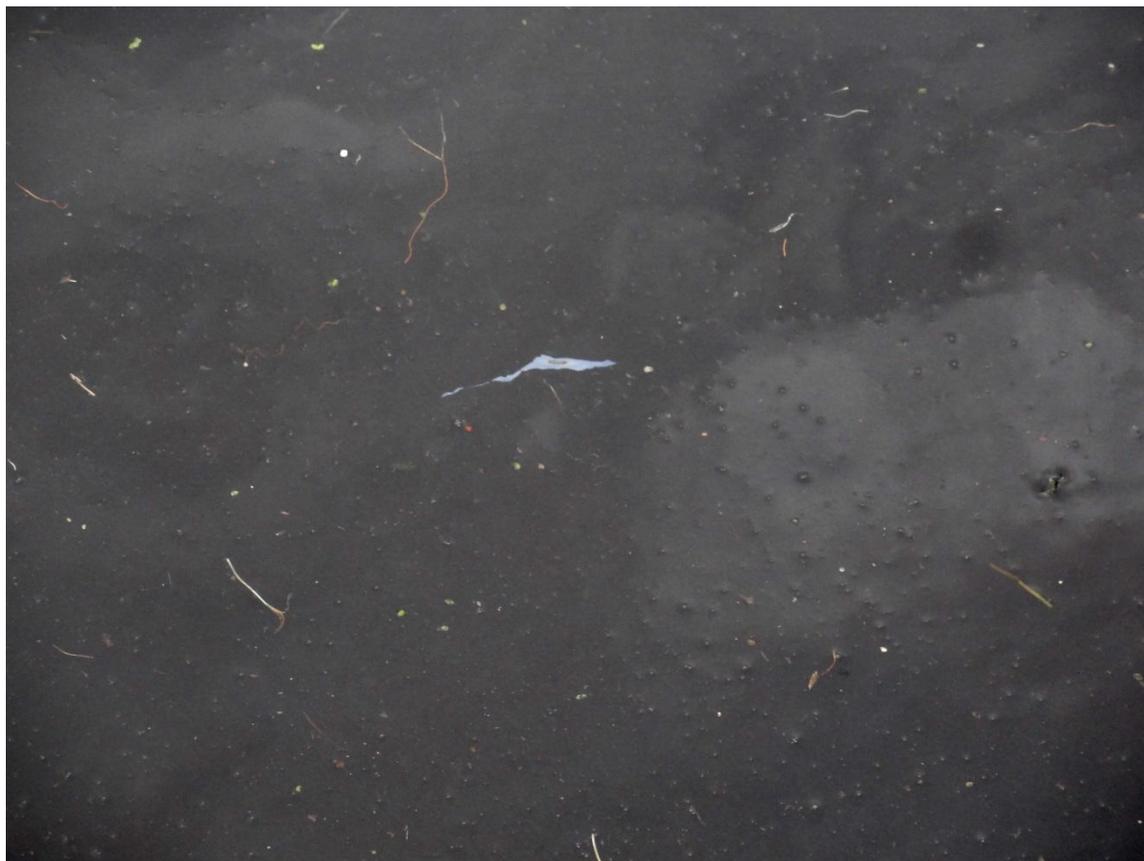
11. MP5.25 LDB, sheen and tar globule observed.

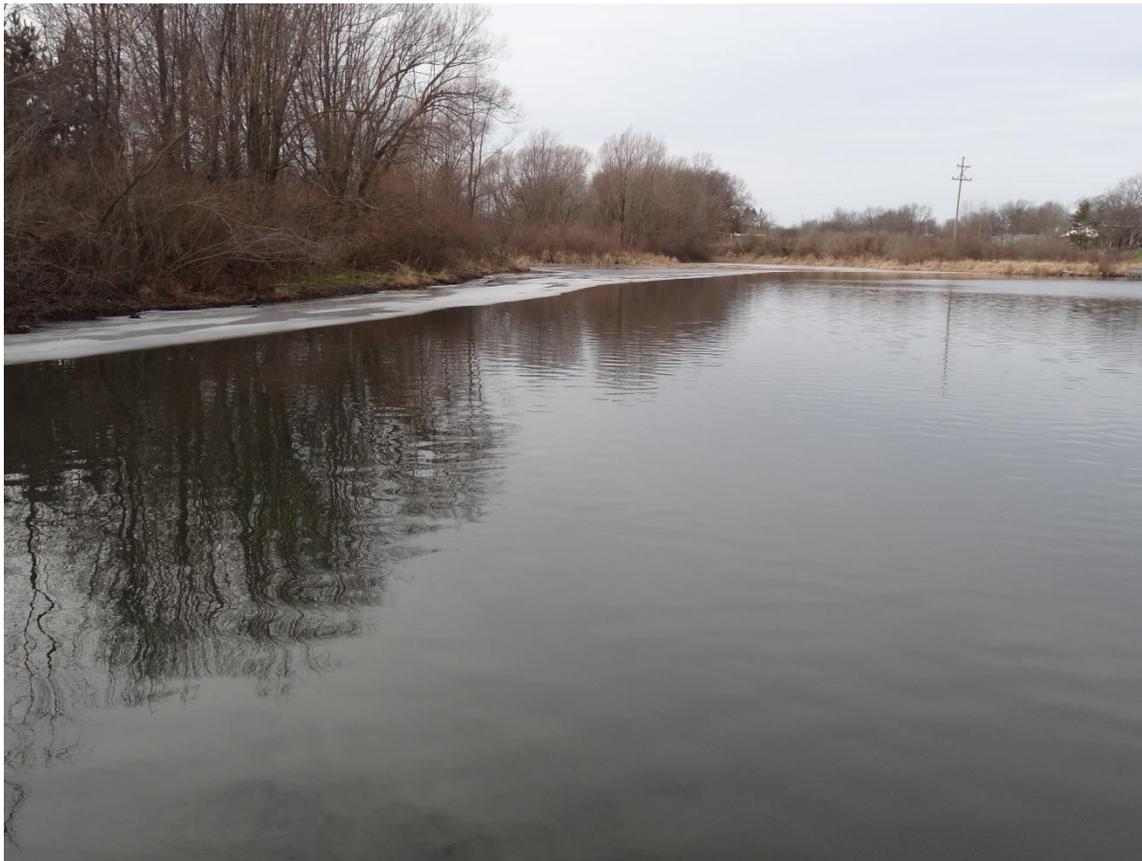
13. MP5.55 LDB, minor bank ice observed.

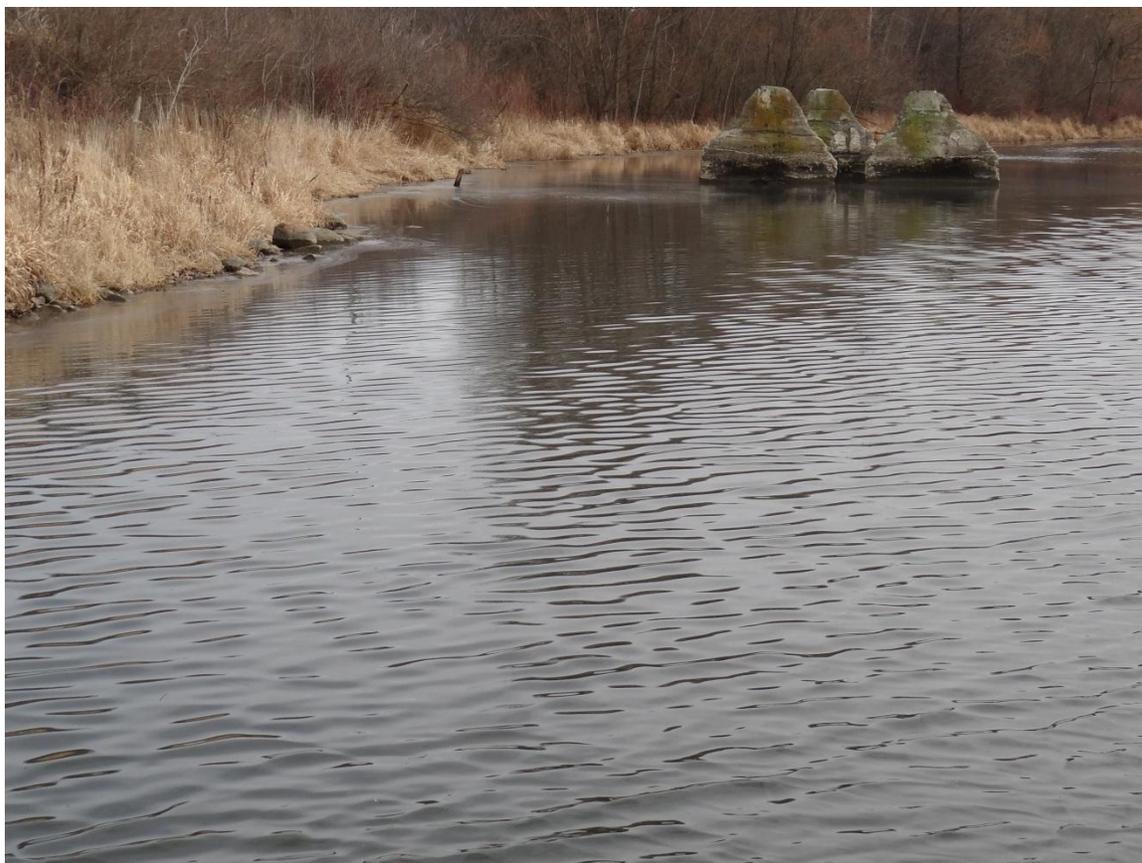
14. MP5.60 RDB, area where sheen and tar globules were observed.

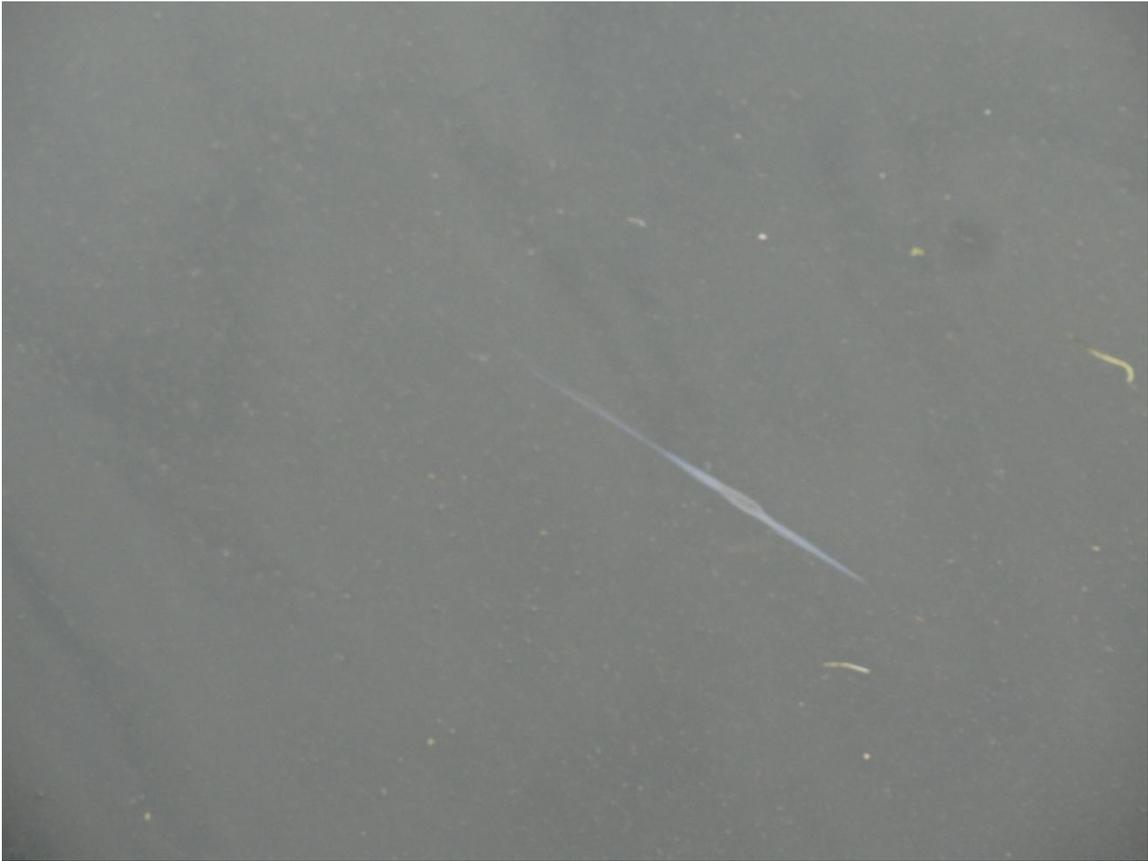
15. MP5.60 RDB, sheen and tar globule observed.

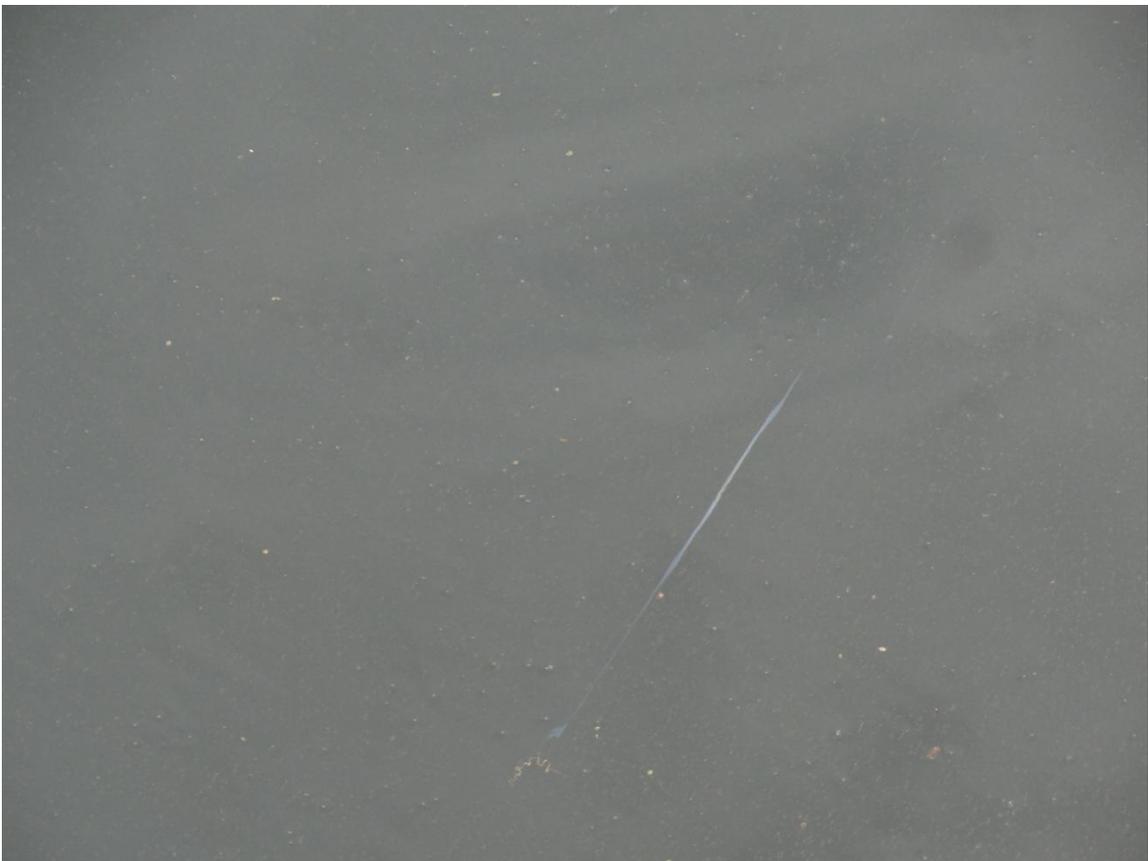
16. MP5.60 RDB, sheen observed.

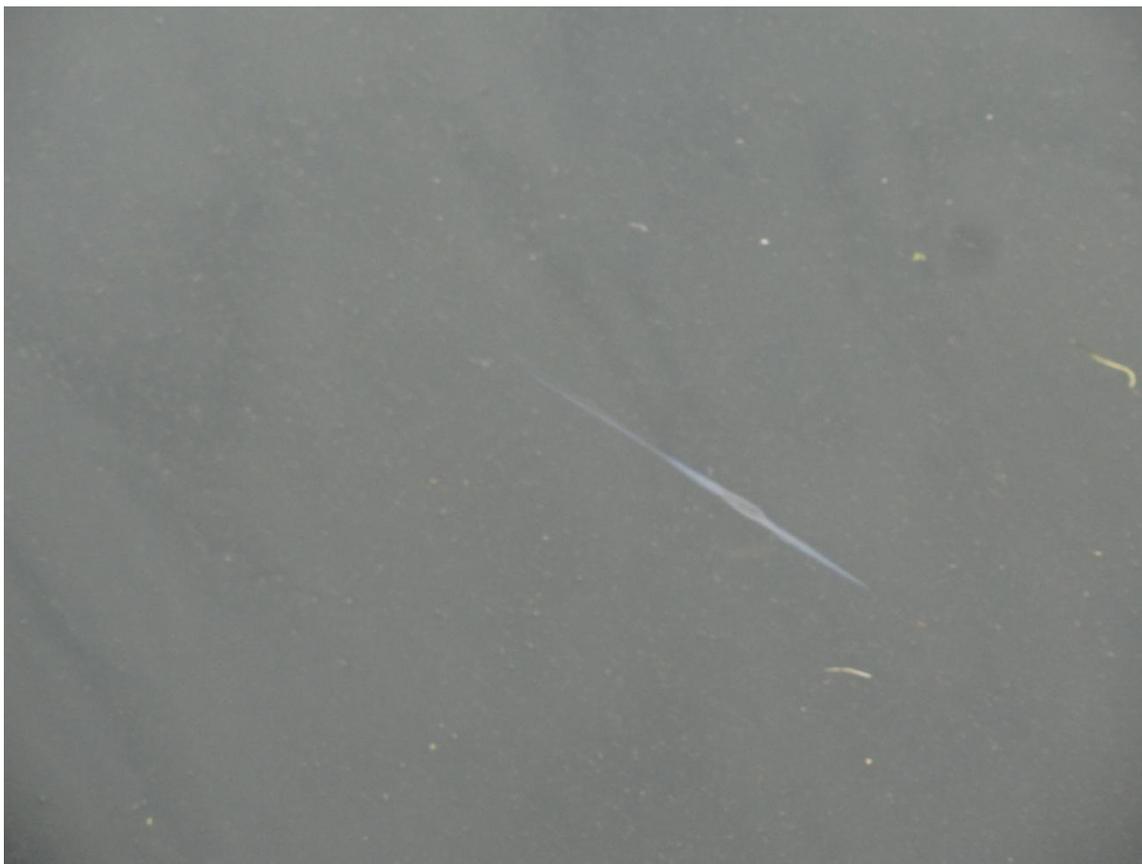
17. MP5.60 RDB, sheen and tar globule observed.

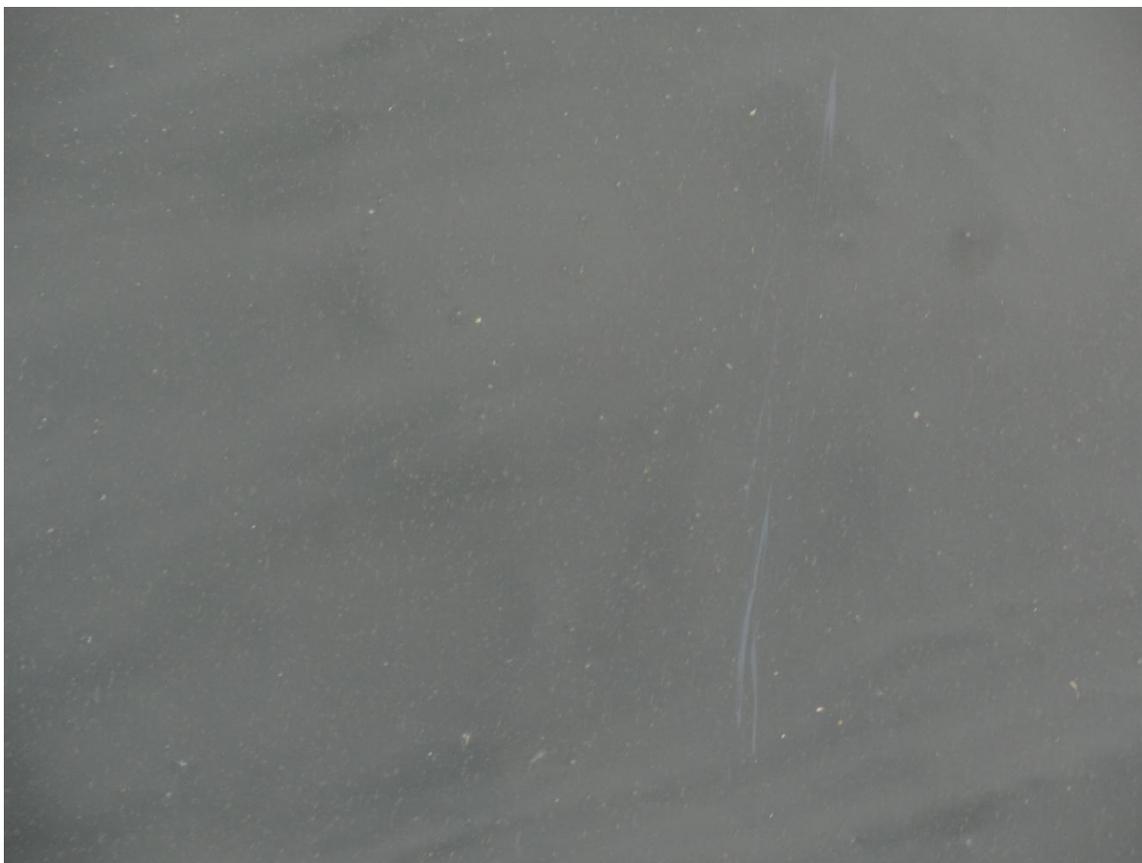
18. MP5.60 RDB, sheen observed.

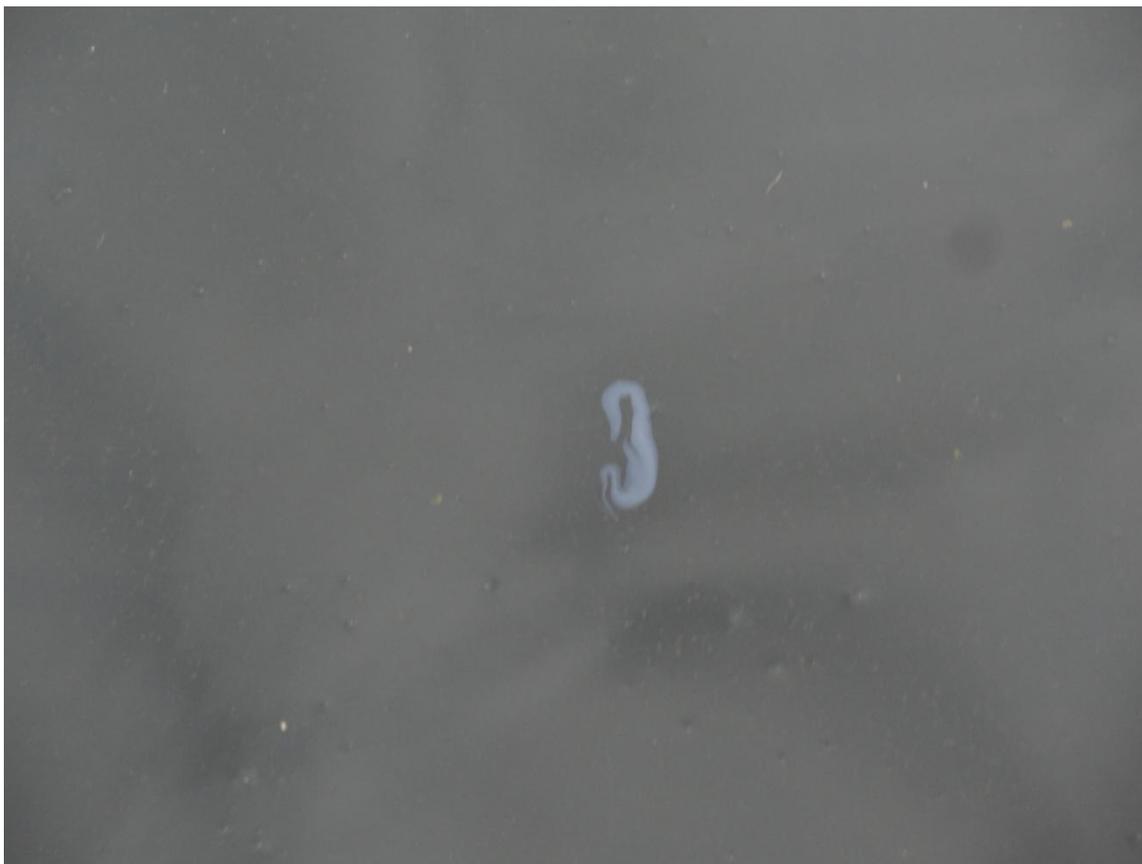
19. MP5.60 RDB, sheen observed.

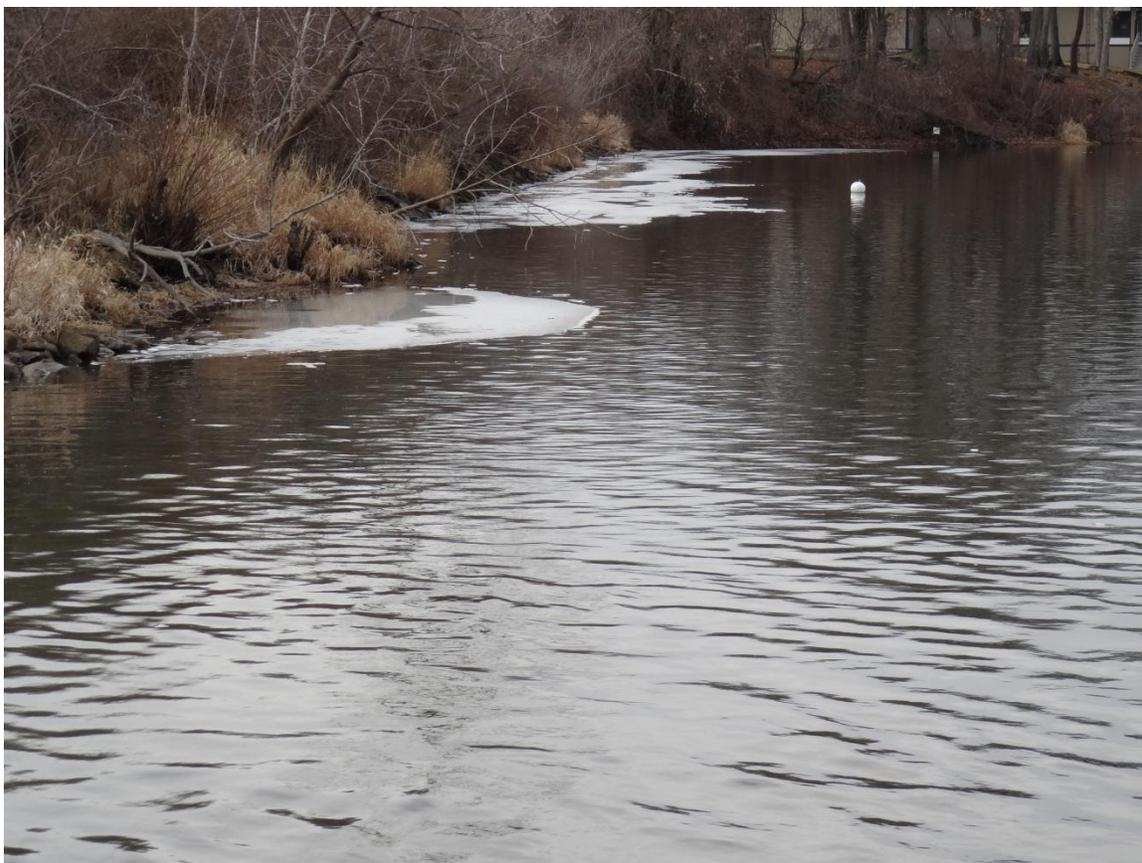
20. MP5.63 LDB, minor bank ice observed.

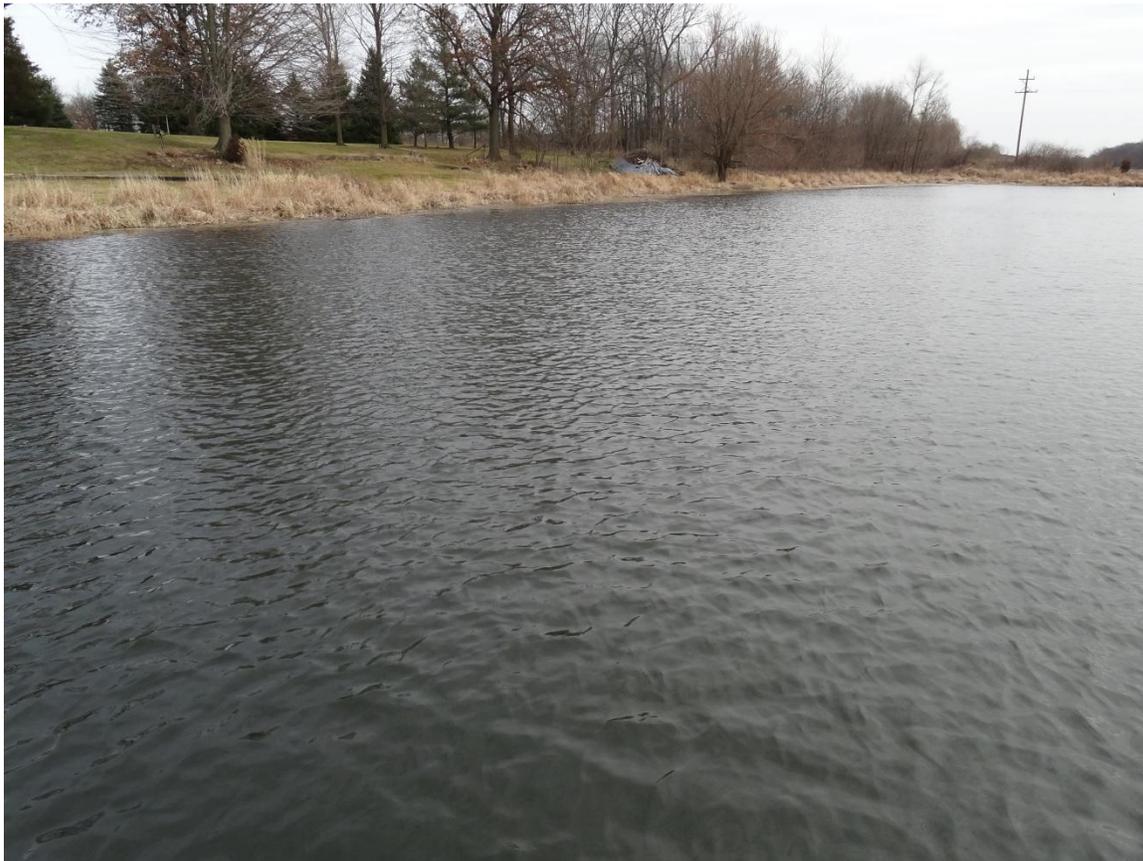
21. MP5.65 RDB, no sheen or bank ice observed.

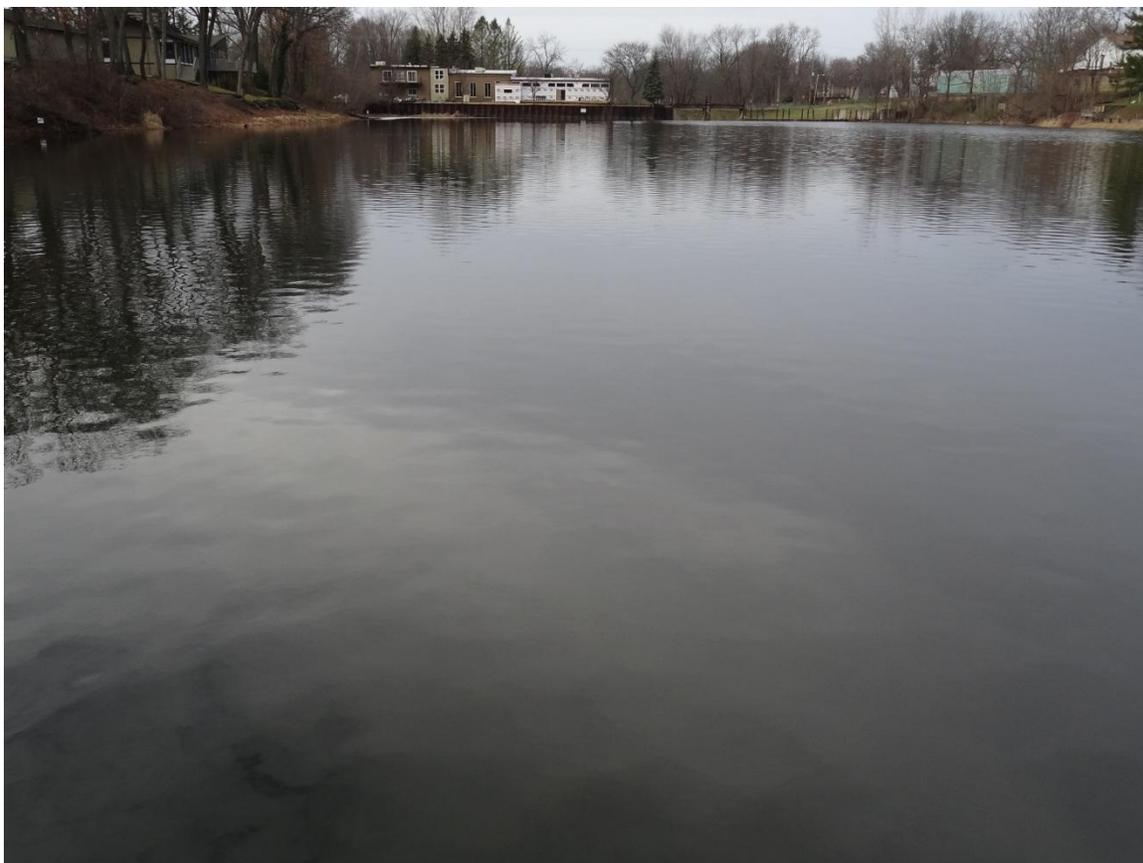
22. Ceresco Dam Impoundment no sheen observed.
