# Situation Photo Log

Monday, January 14, 2013

Kalamazoo River / Enbridge Spill

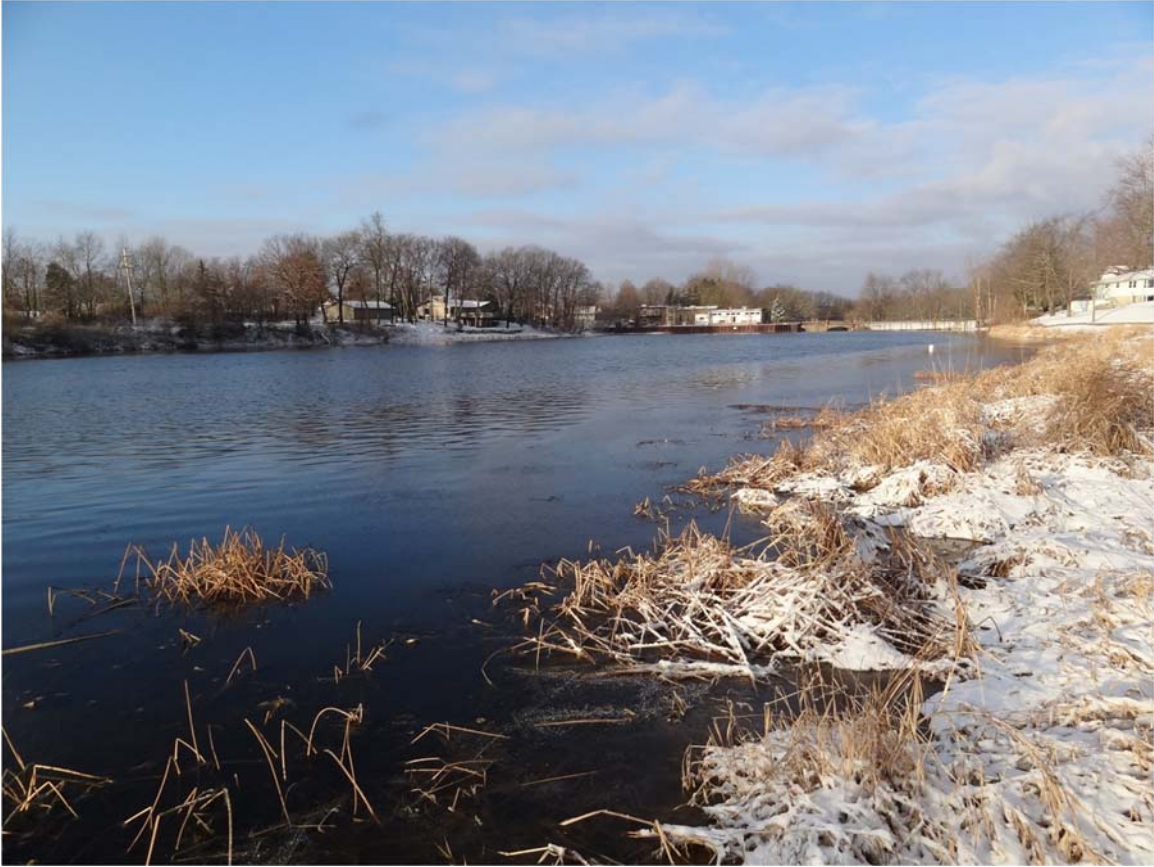
1. MP5.73 RDB slushy ice observed forming along the RDB.

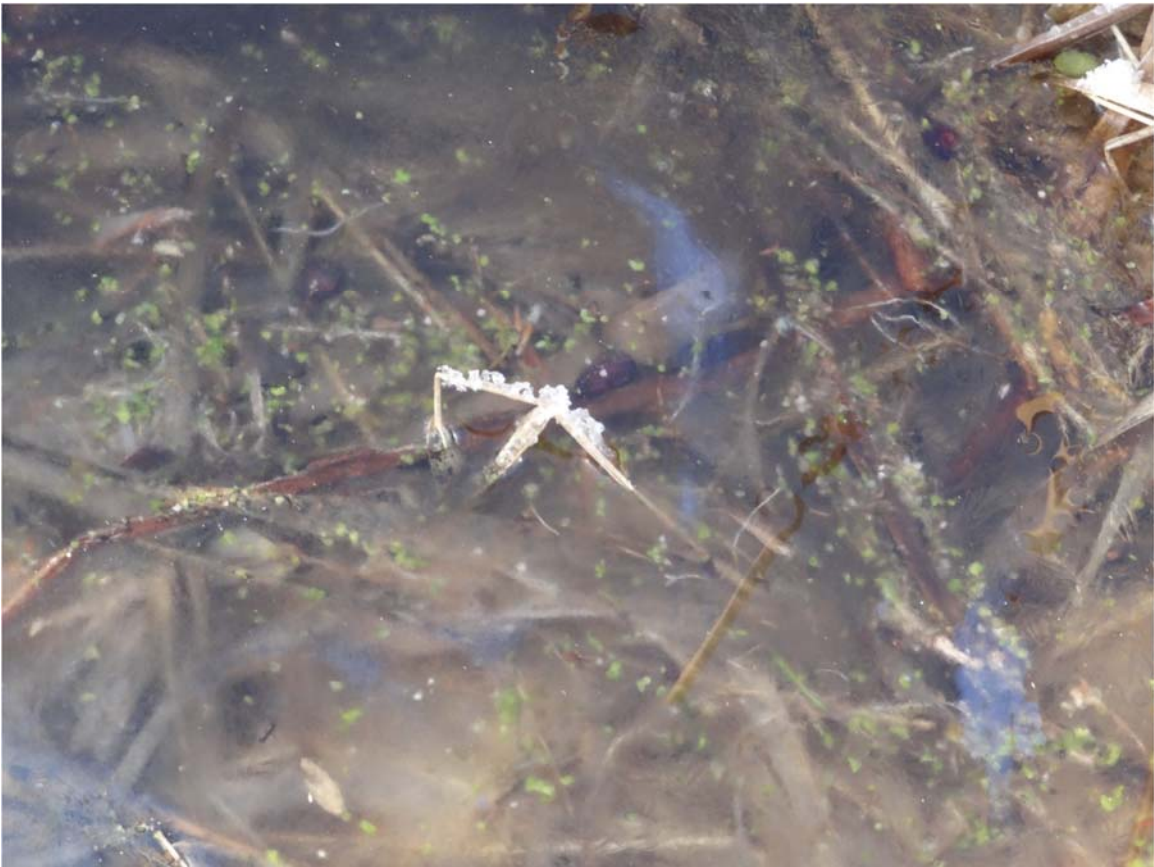
2. MP5.70 RDB sheen and tar globs observed within the vegetation and ice.

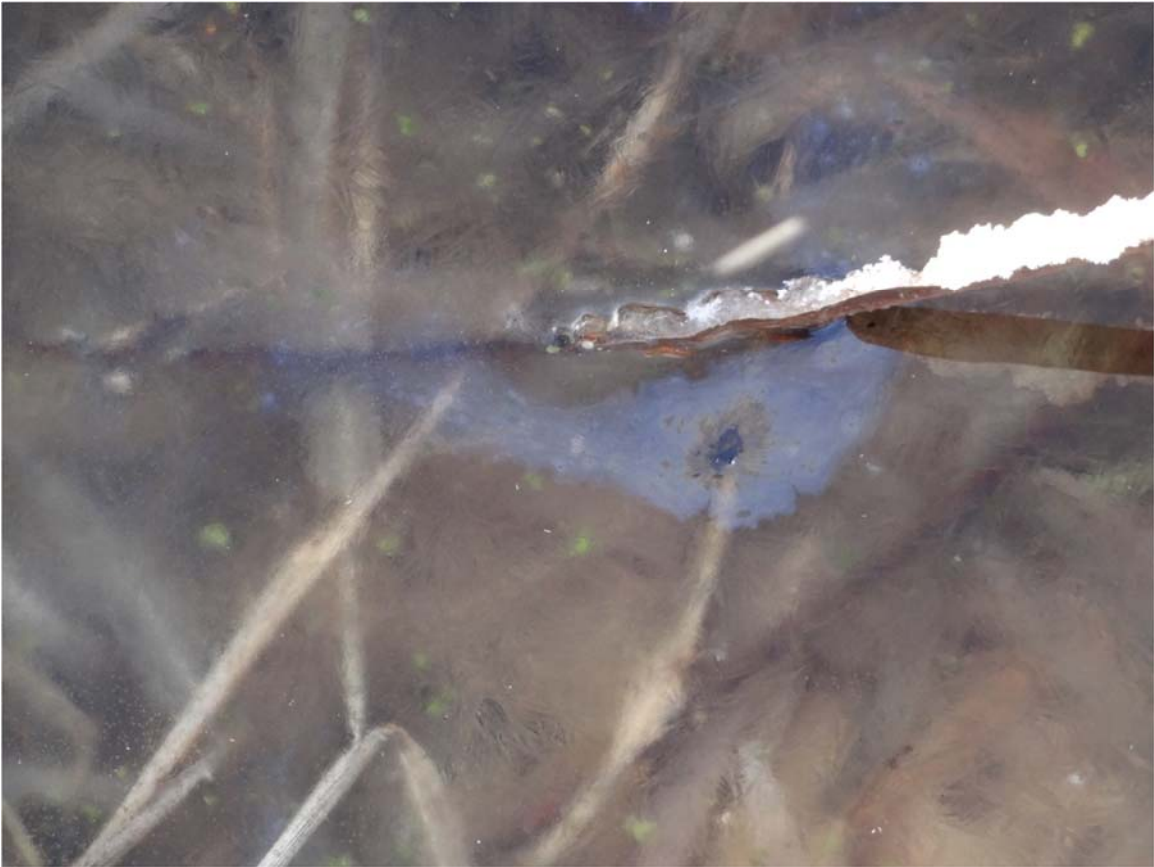
3. MP5.70 RDB sheen and tar globs observed within the vegetation and ice.

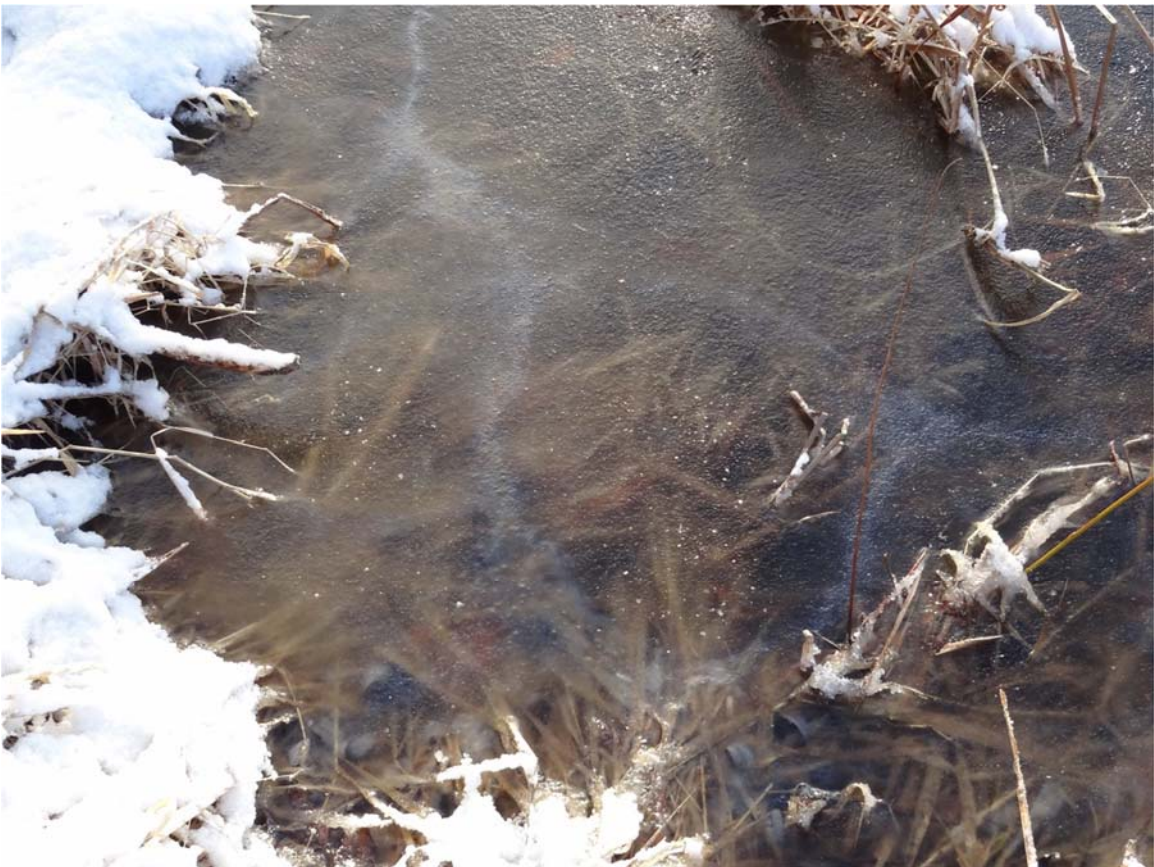
4. MP5.70 RDB sheen and tar globs observed within the vegetation and ice.

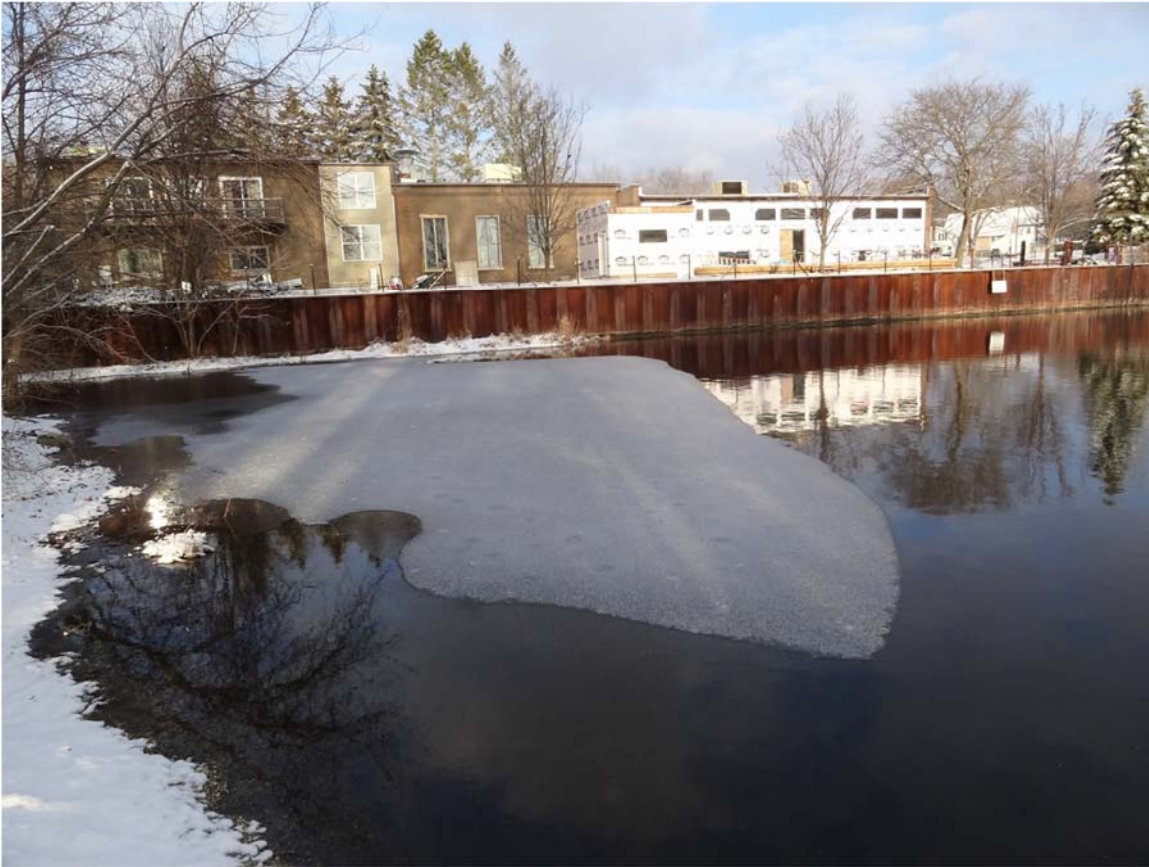
5. LDB above Ceresco Dam observed ice forming.

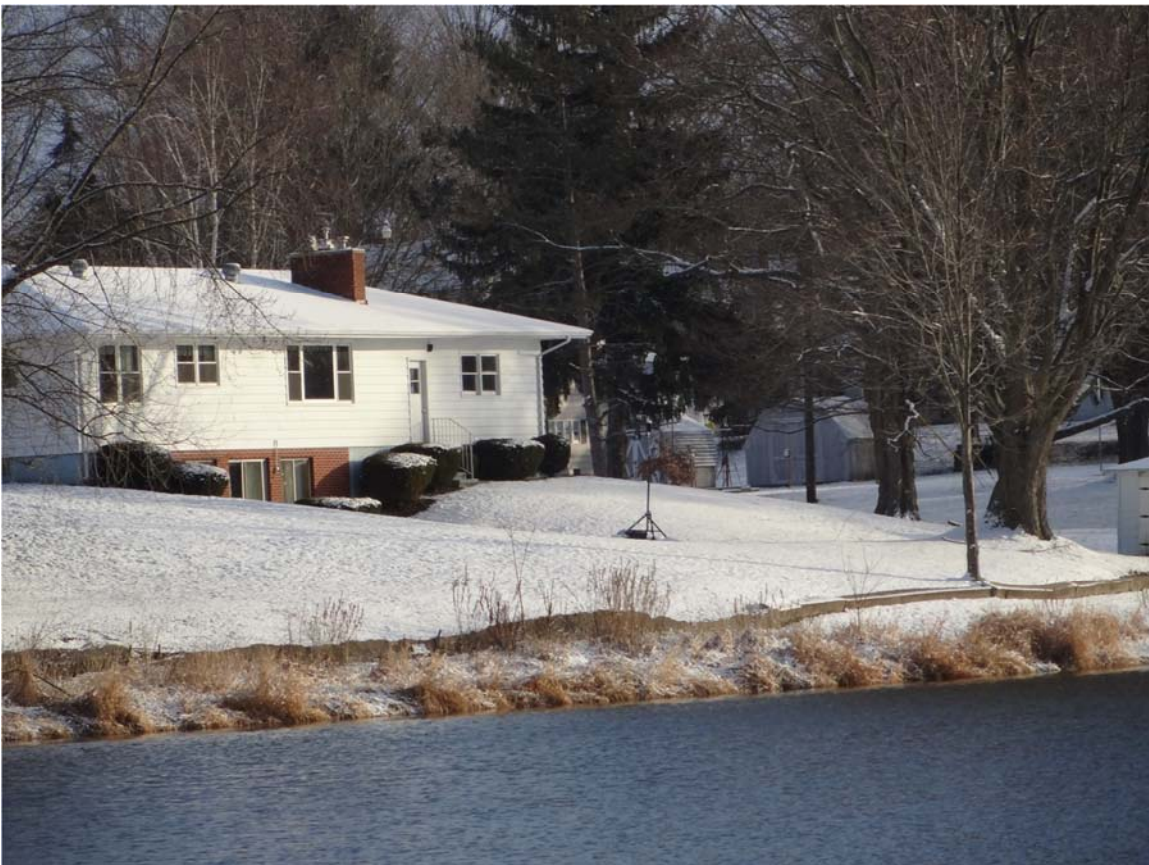
6. MP5.80 RDB above Ceresco Dam observed a noise monitoring station.

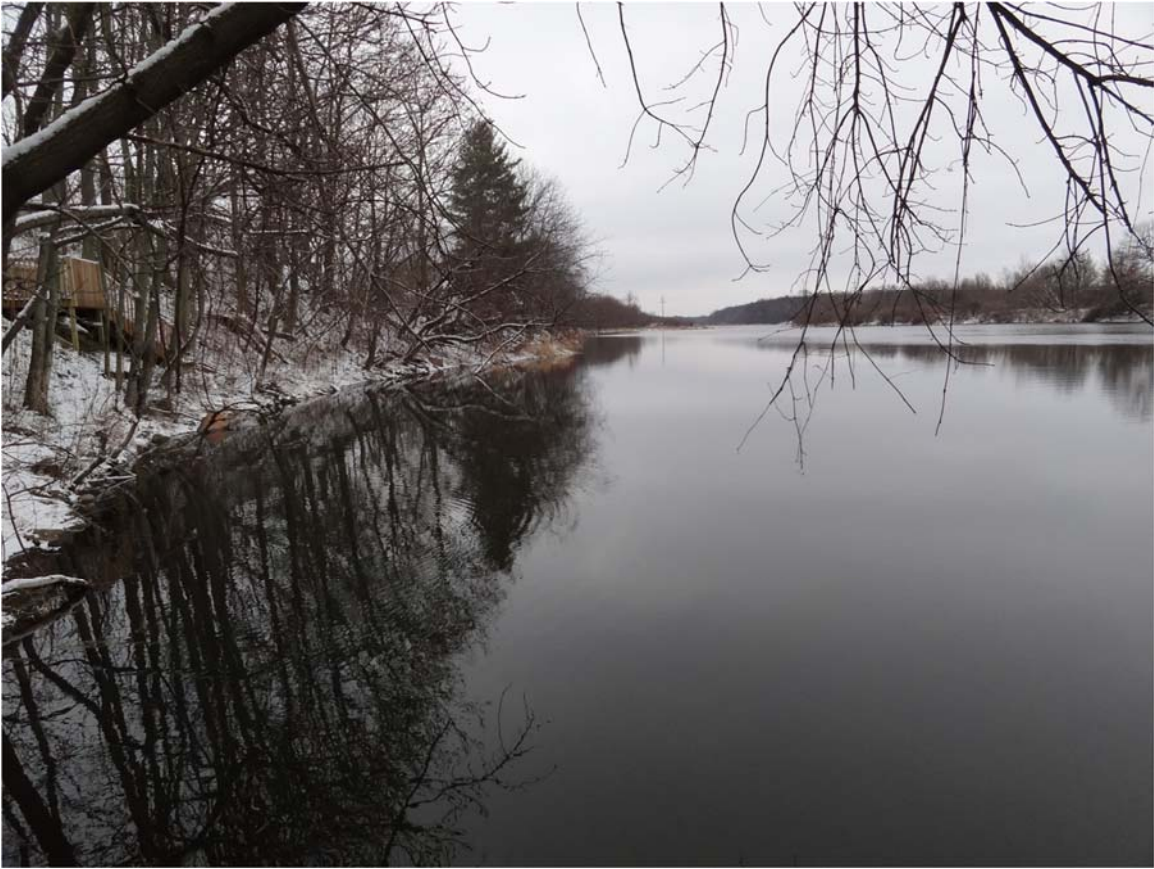
7. RDB above Ceresco Dam no ice or sheen observed.

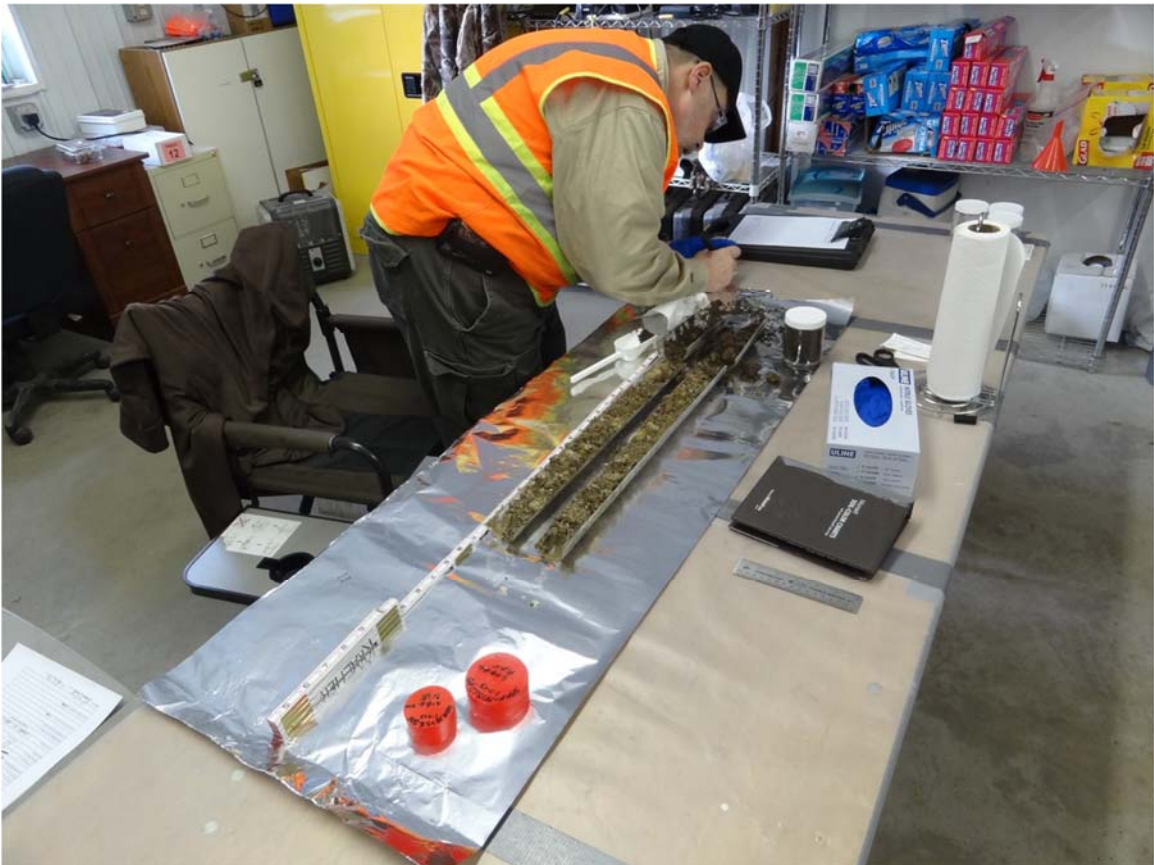
8. Observed core logging in the C3.2 pole barn.

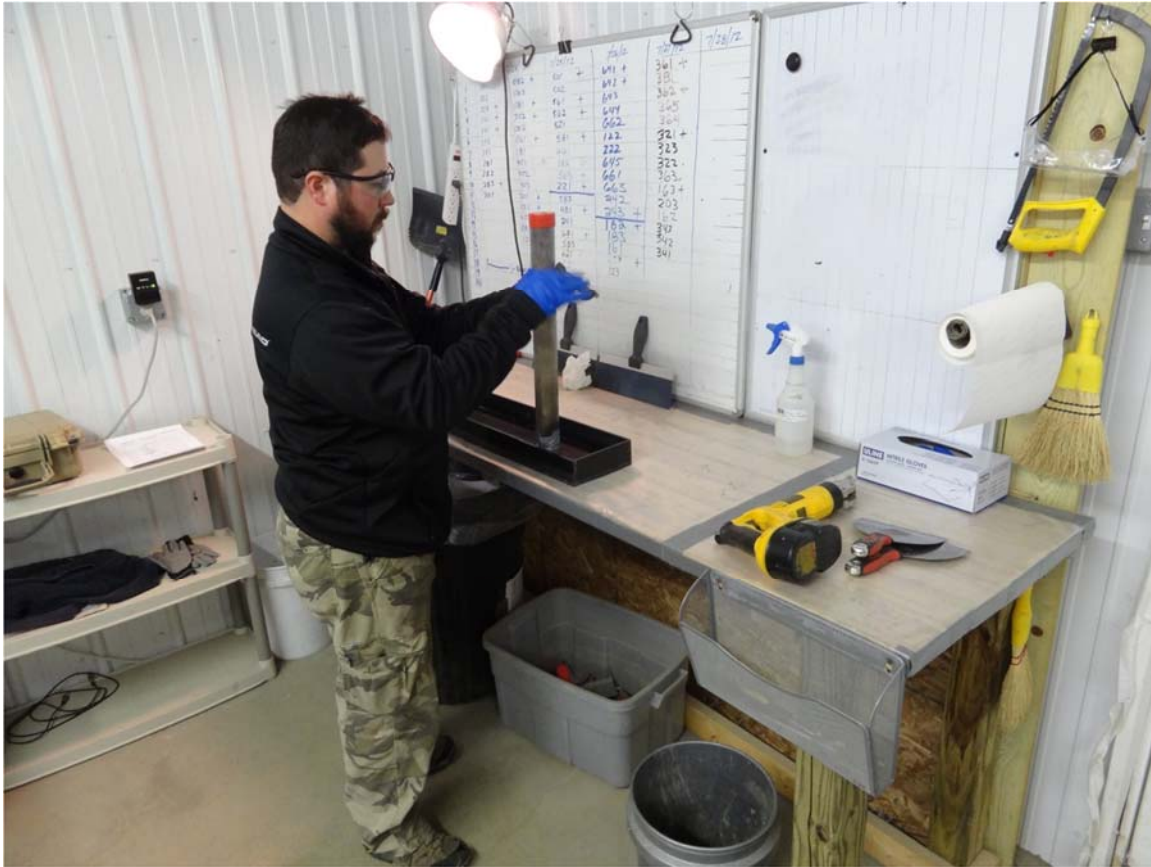
9. Observed core logging in the C3.2 pole barn.

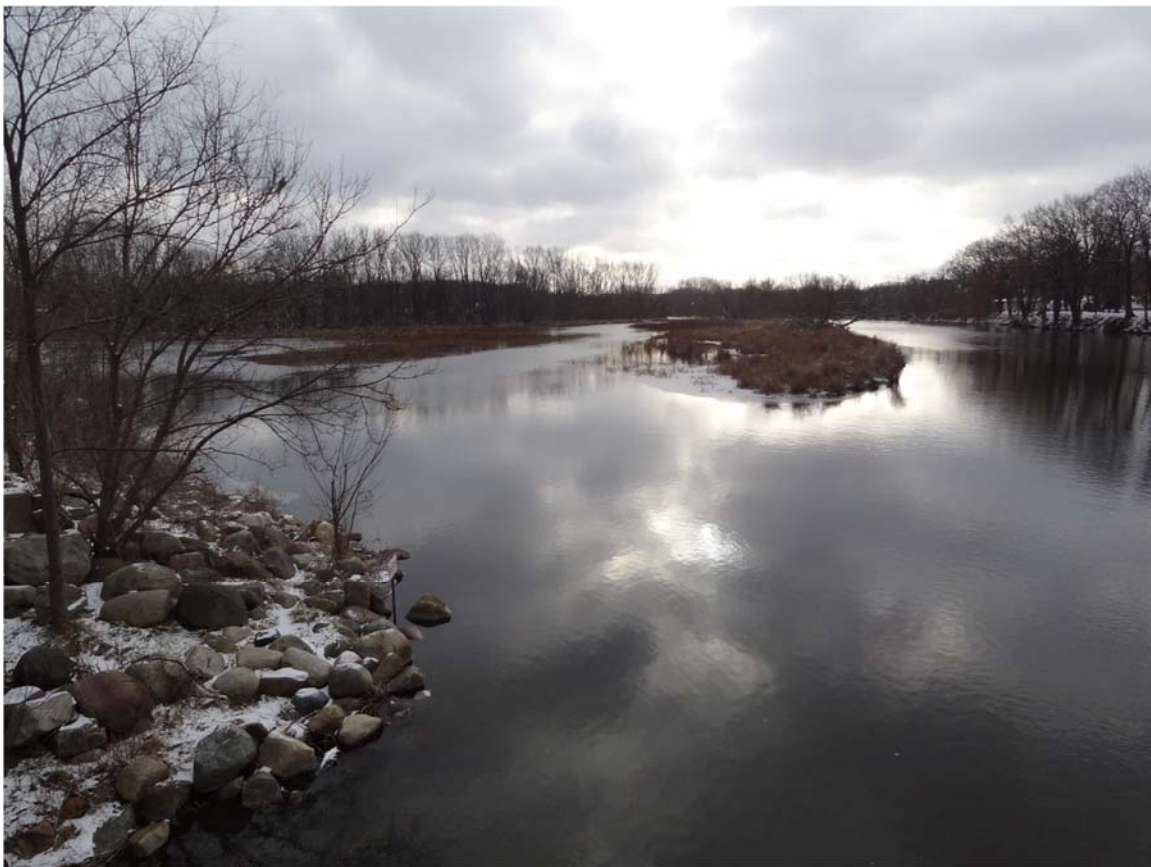
10. MP15.25 South Mill Ponds no sheen observed.

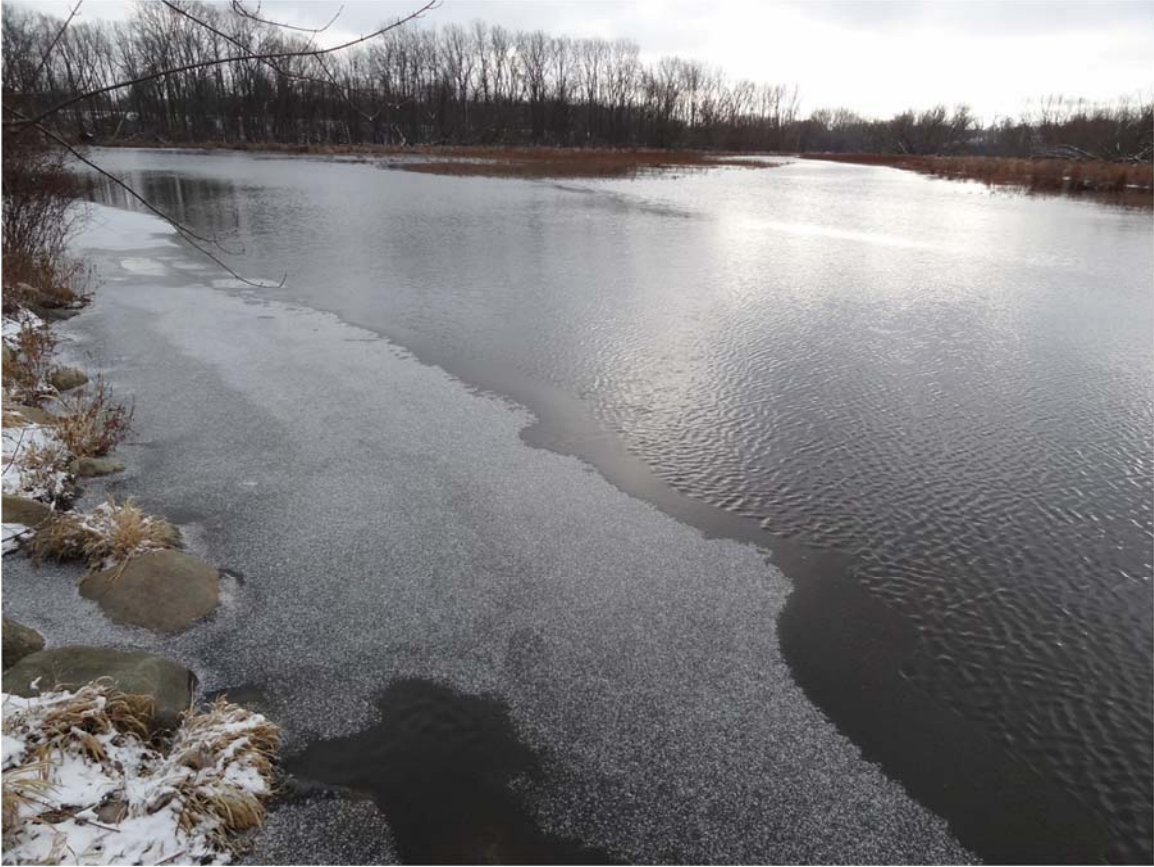
11. MP15.25 South Mill Ponds observed ice forming along the bank.

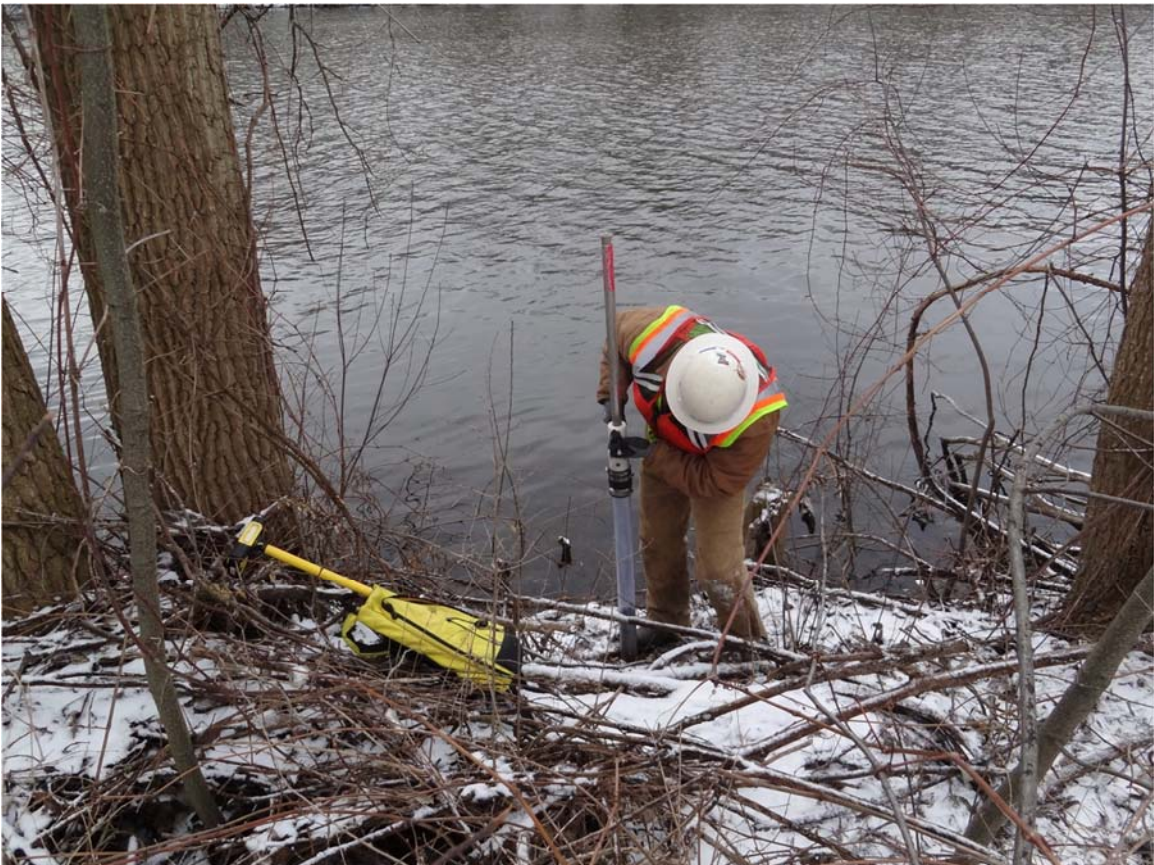
12. MP19.0 RDB observed an RI crew.

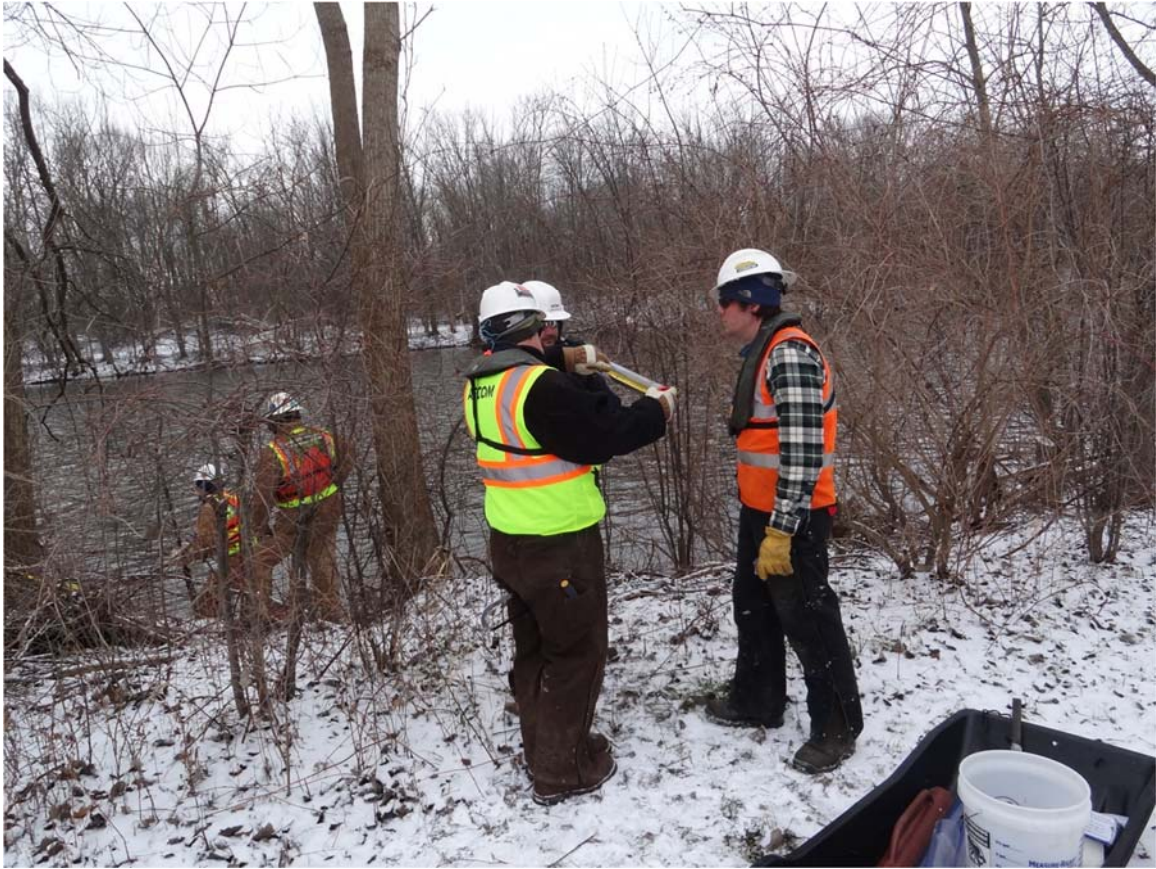
13. MP19.0 RDB observed an RI crew.

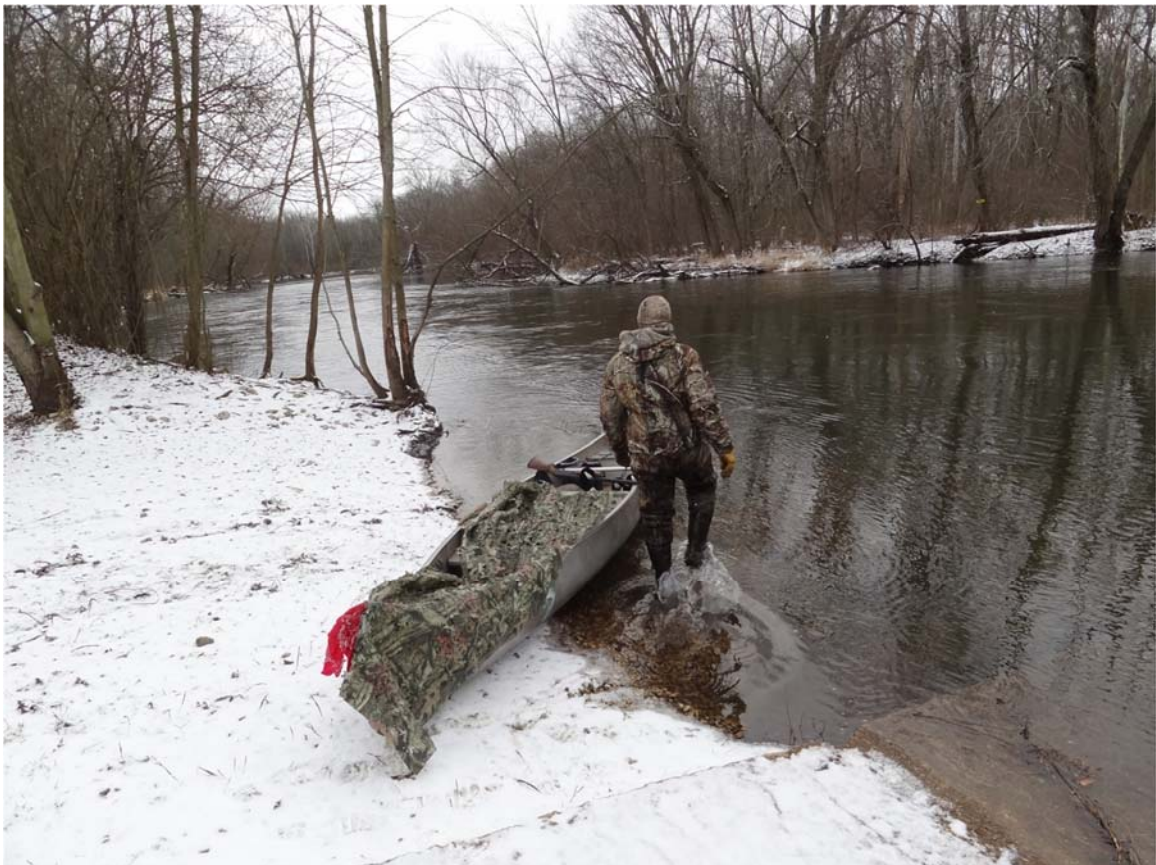
14. E2 Boat Launch observed a goose hunter.

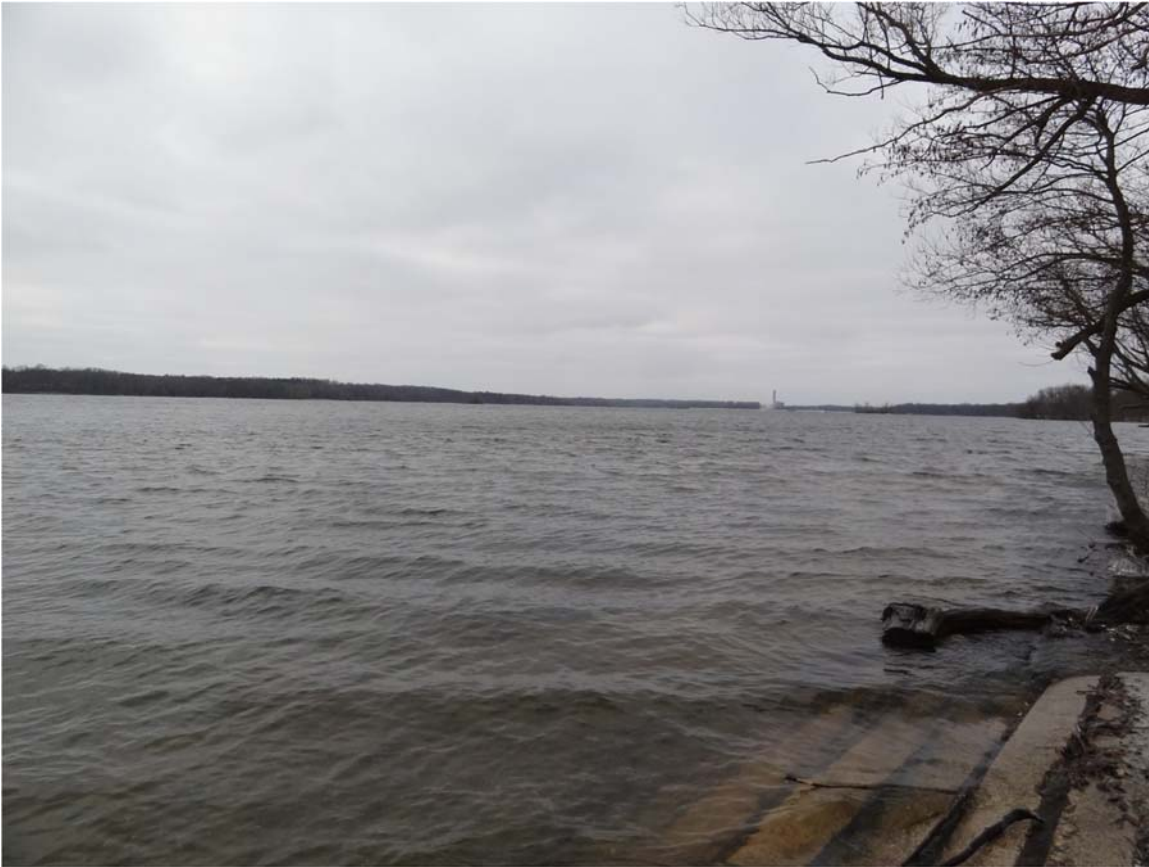
**15. Morrow Lake no ice or sheen observed.**

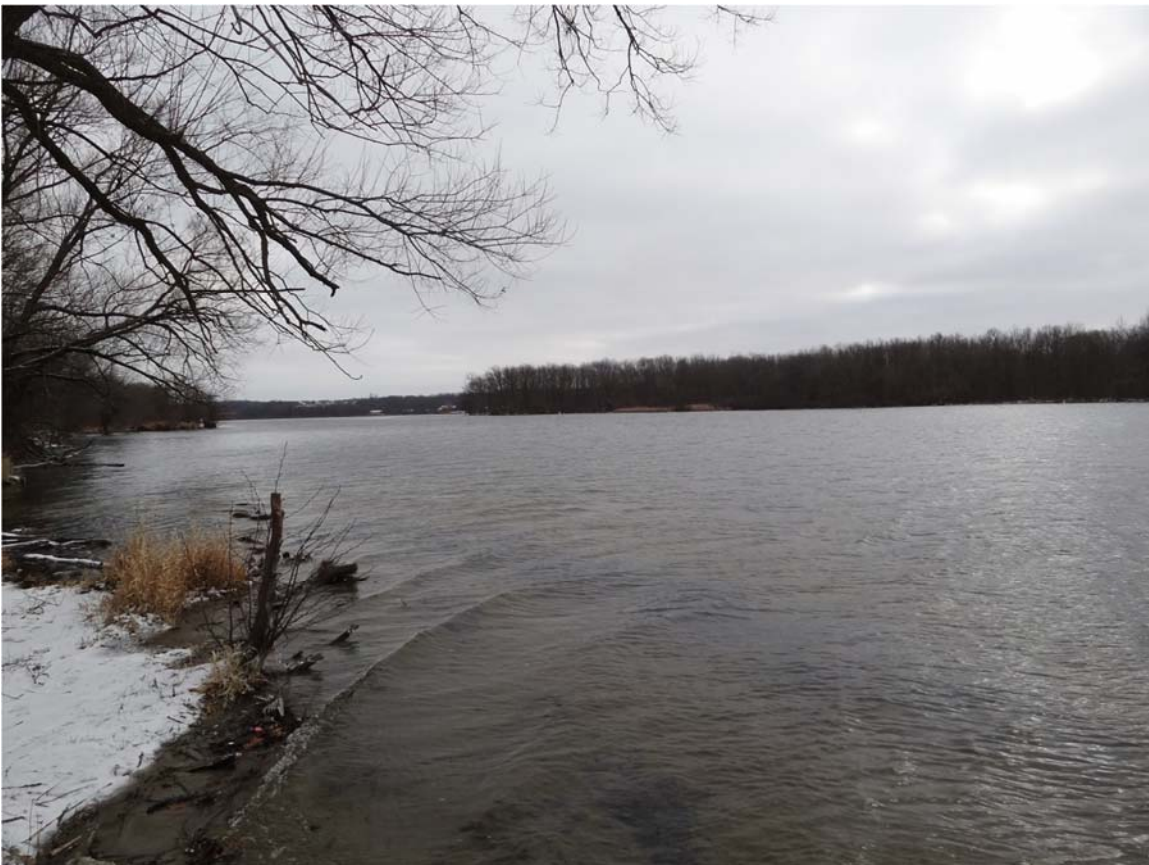
**16. Morrow Lake Delta no ice or sheen observed.**
