# Situation Photo Log

Friday, January 18, 2013

Kalamazoo River / Enbridge Spill

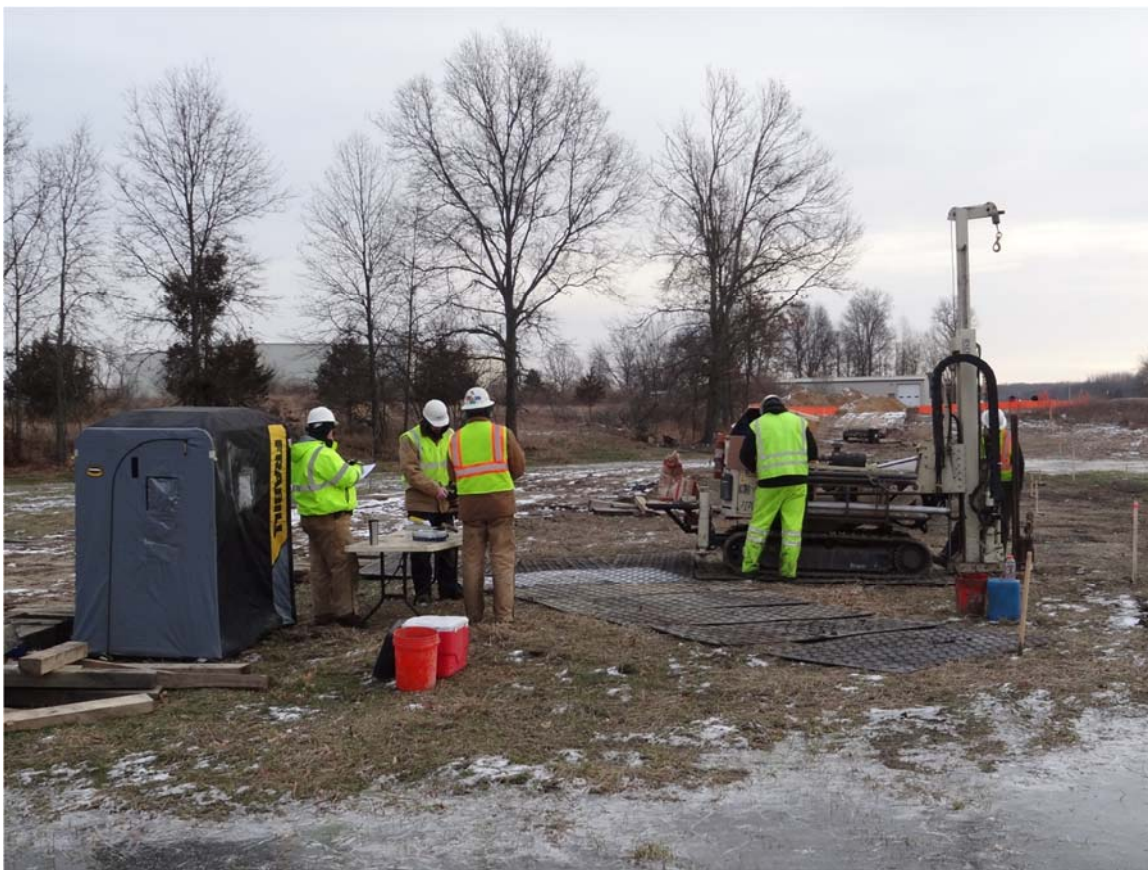
1. Source area observed a crew collecting soil cores.

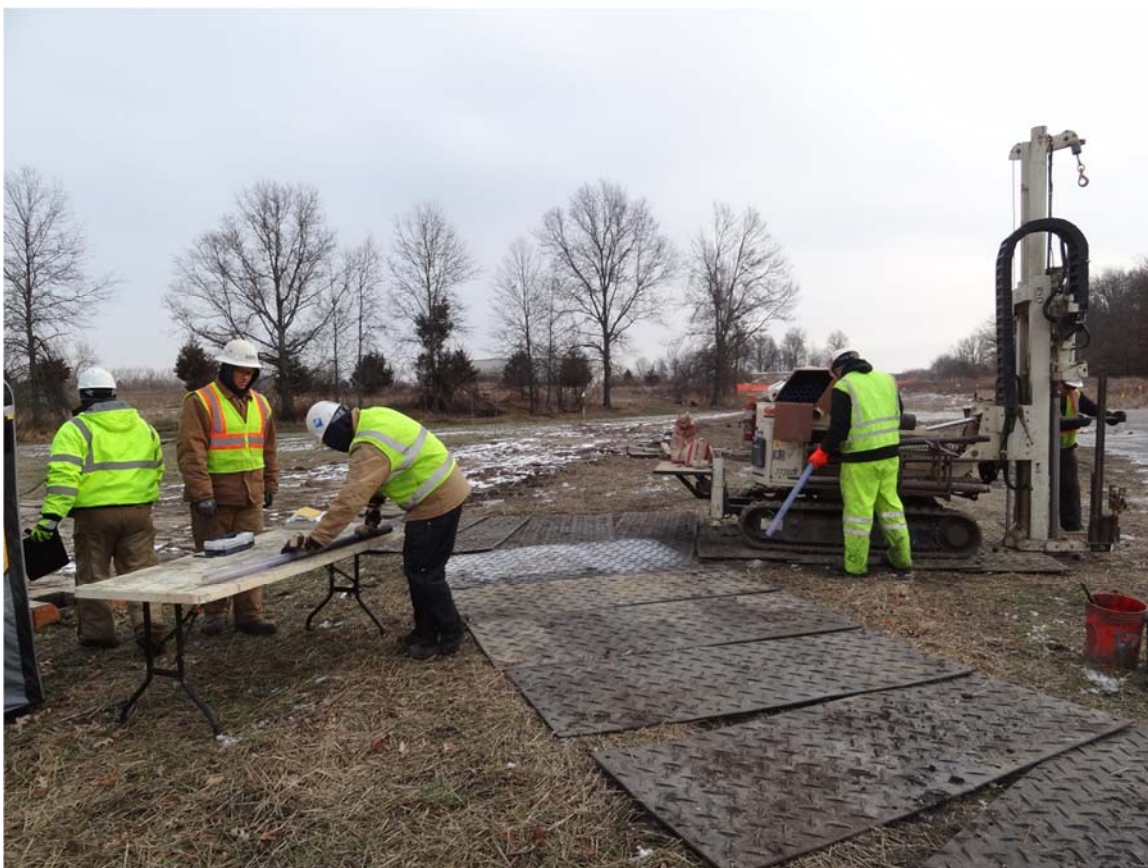
2. Source area observed a crew collecting soil cores.

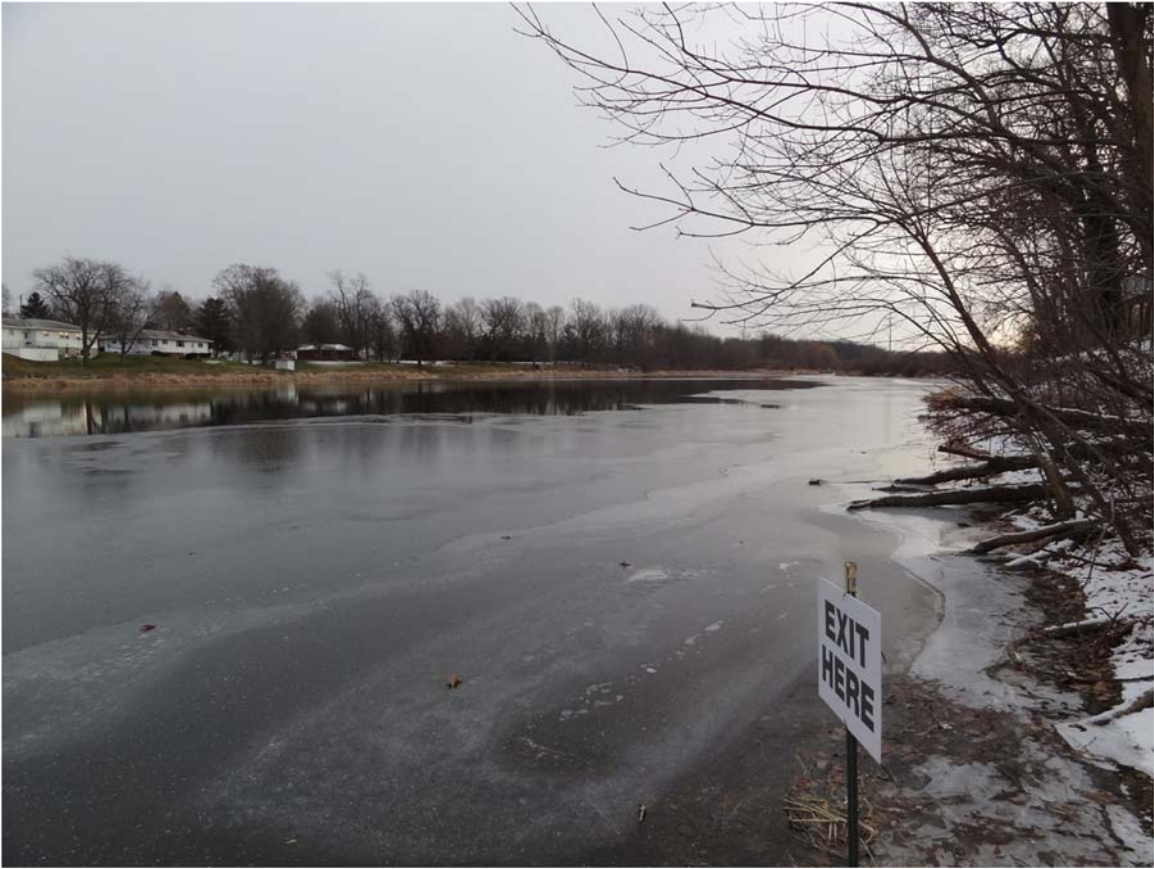
3. Ceresco Dam impoundment observed bank ice reforming.

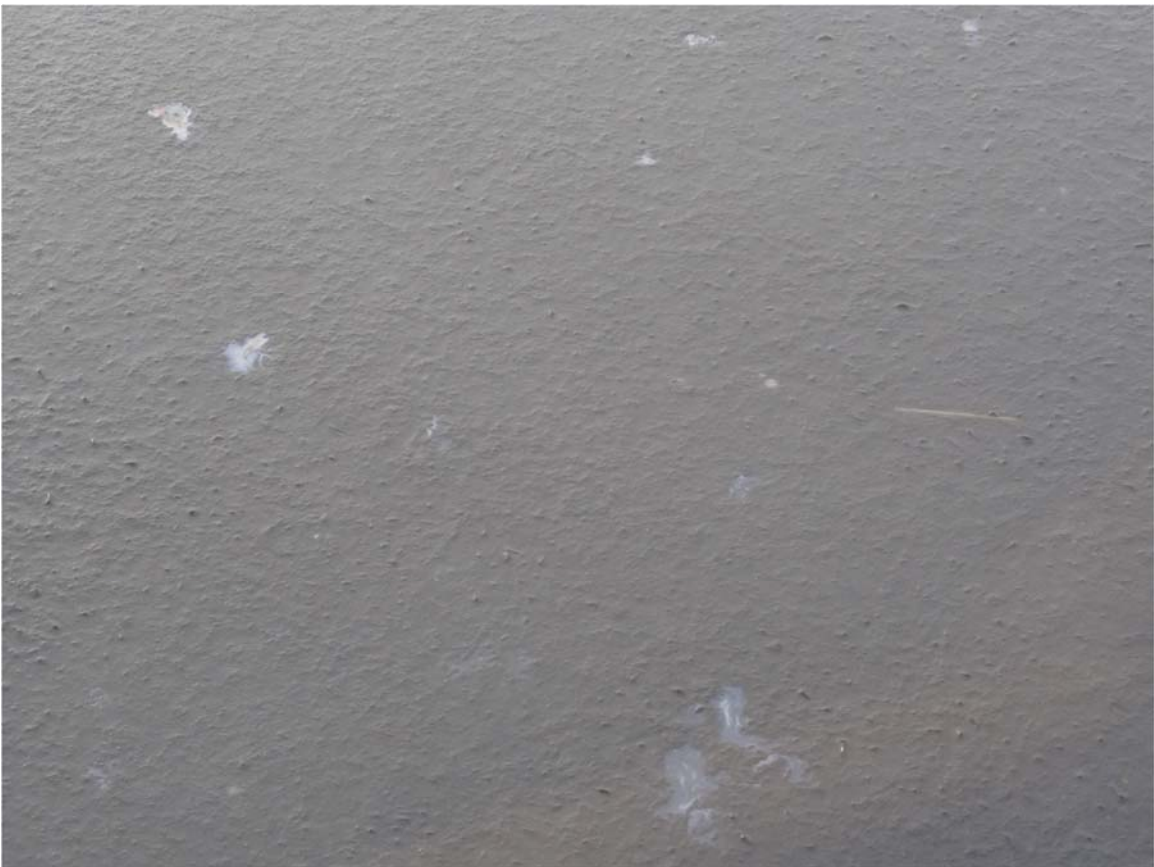
4. MP5.8 RDB observed tar globs and sheen frozen in the ice.

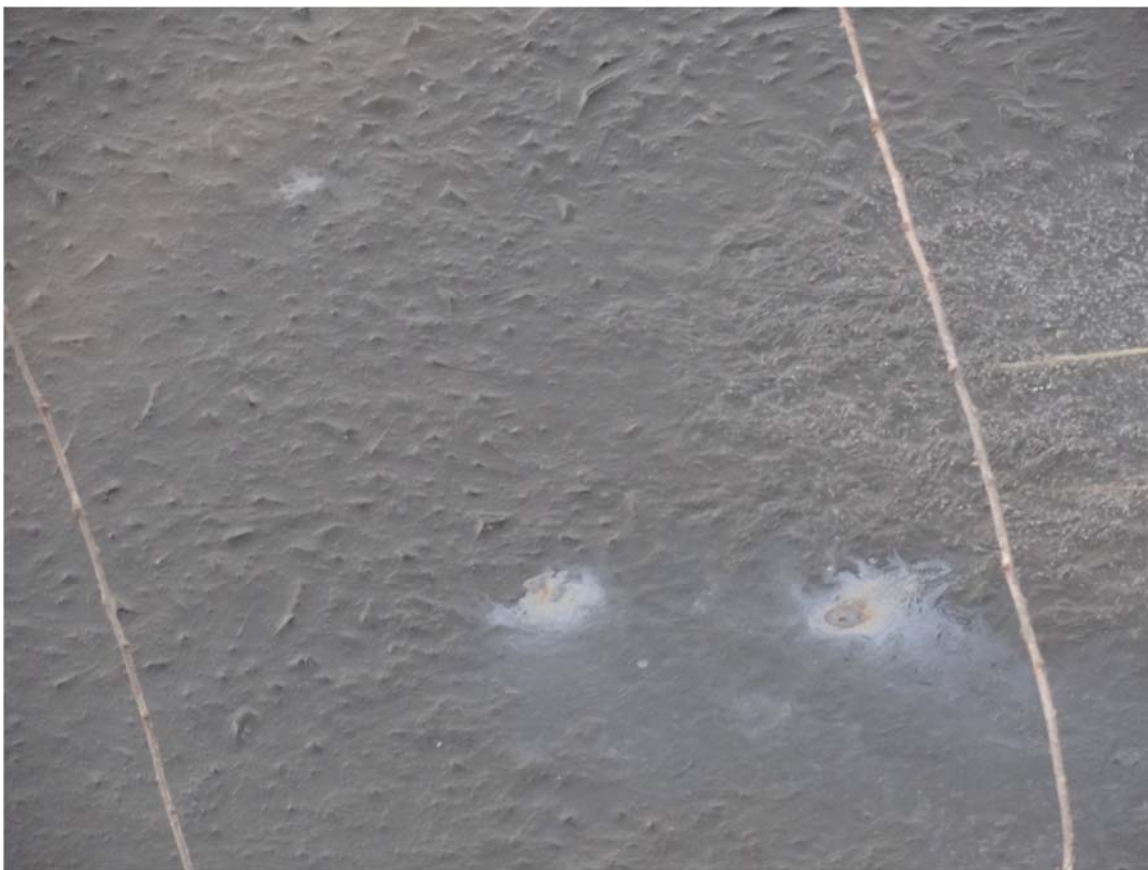
5. MP5.8 RDB observed tar globs and sheen frozen in the ice.

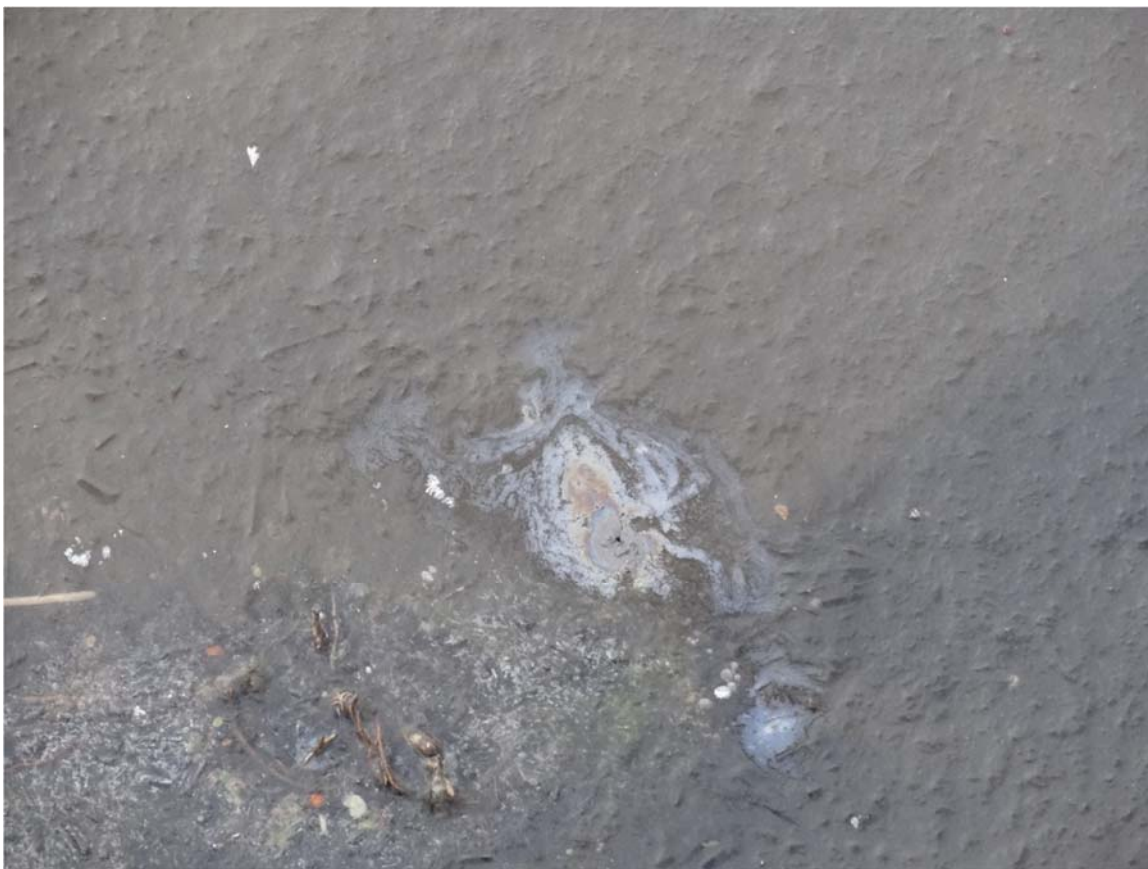
6. MP5.8 RDB observed tar globs and sheen frozen in the ice.

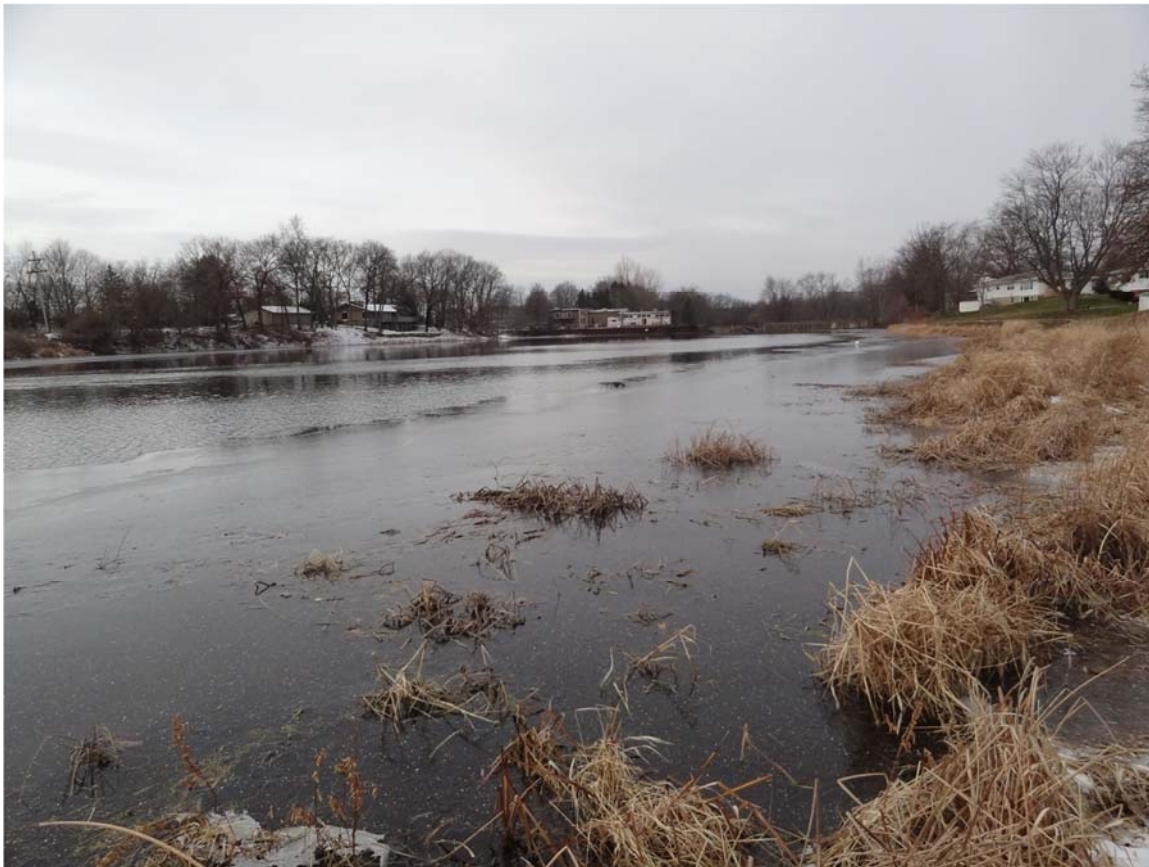
7. MP5.75 RDB observed bank ice reforming.

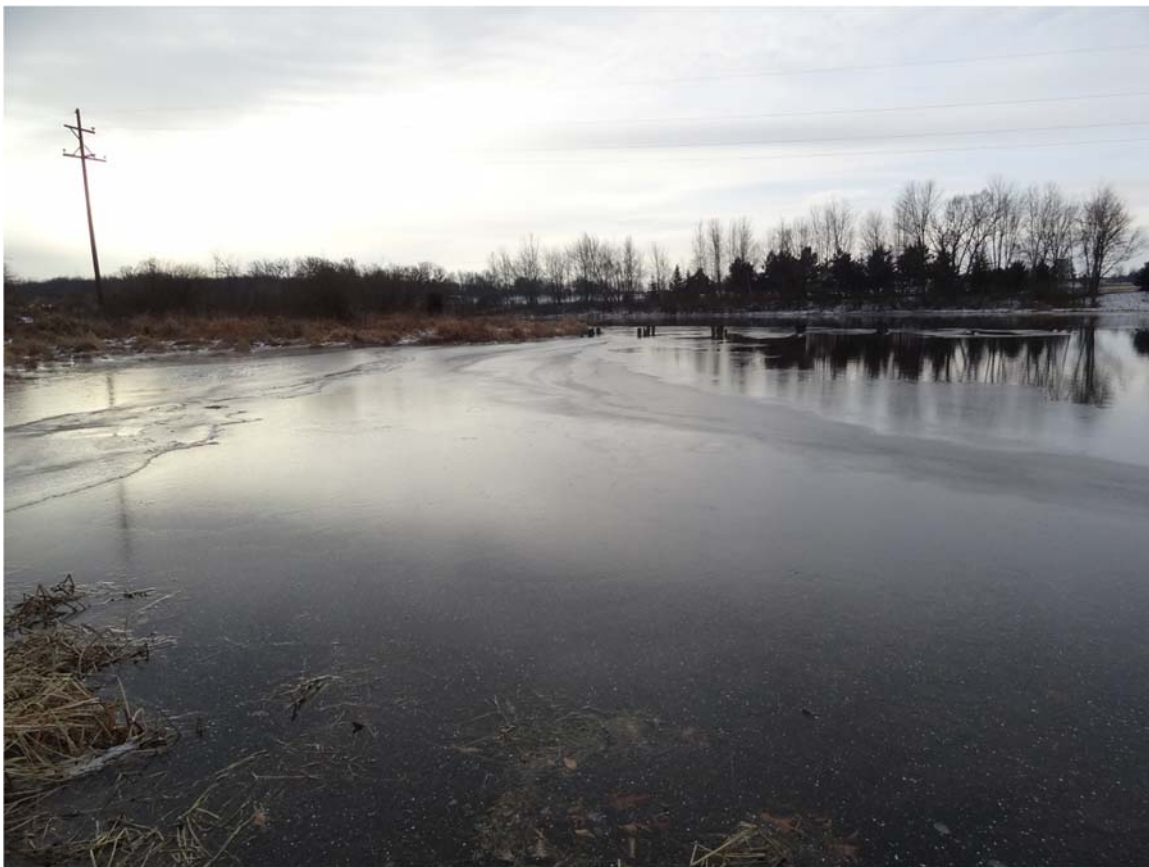
8. MP5.63 RDB observed bank ice reforming.

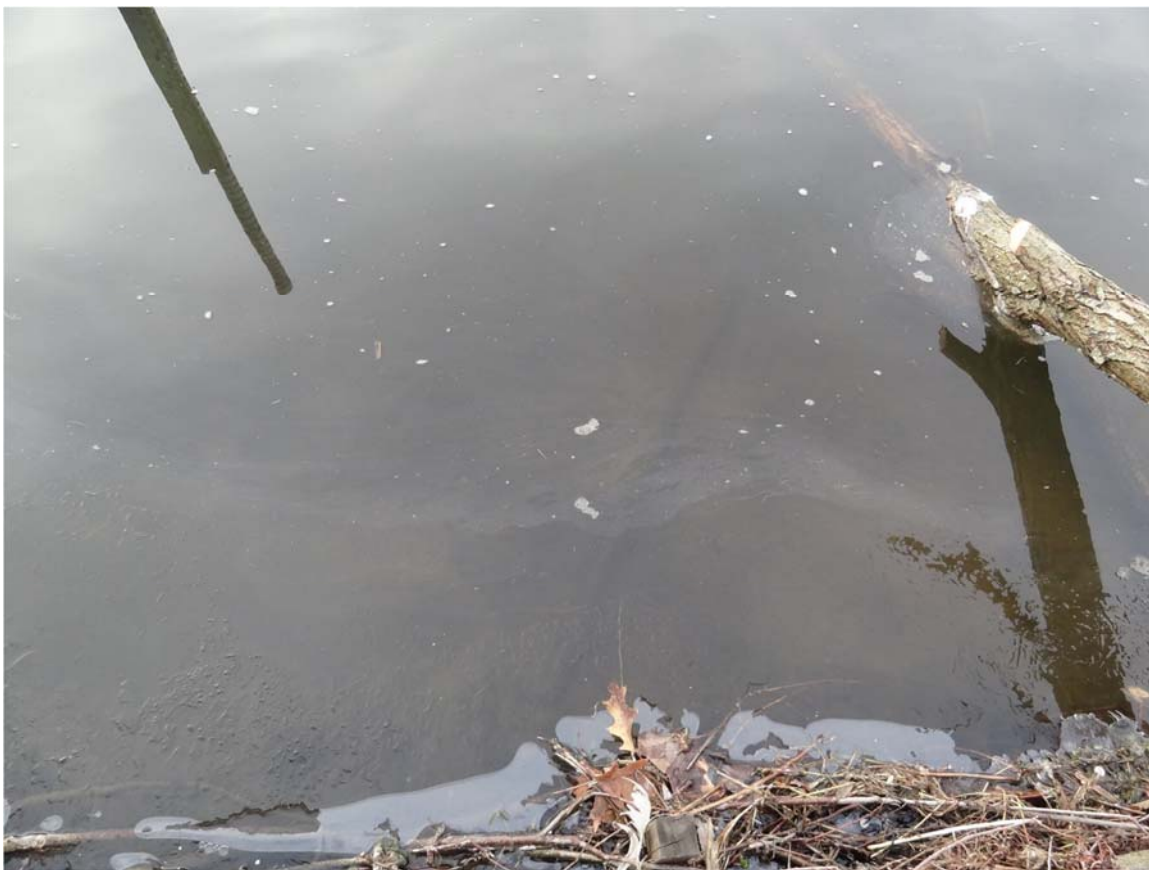
9. C0.4 Boat launch staff gauge observed sheen along the ice.

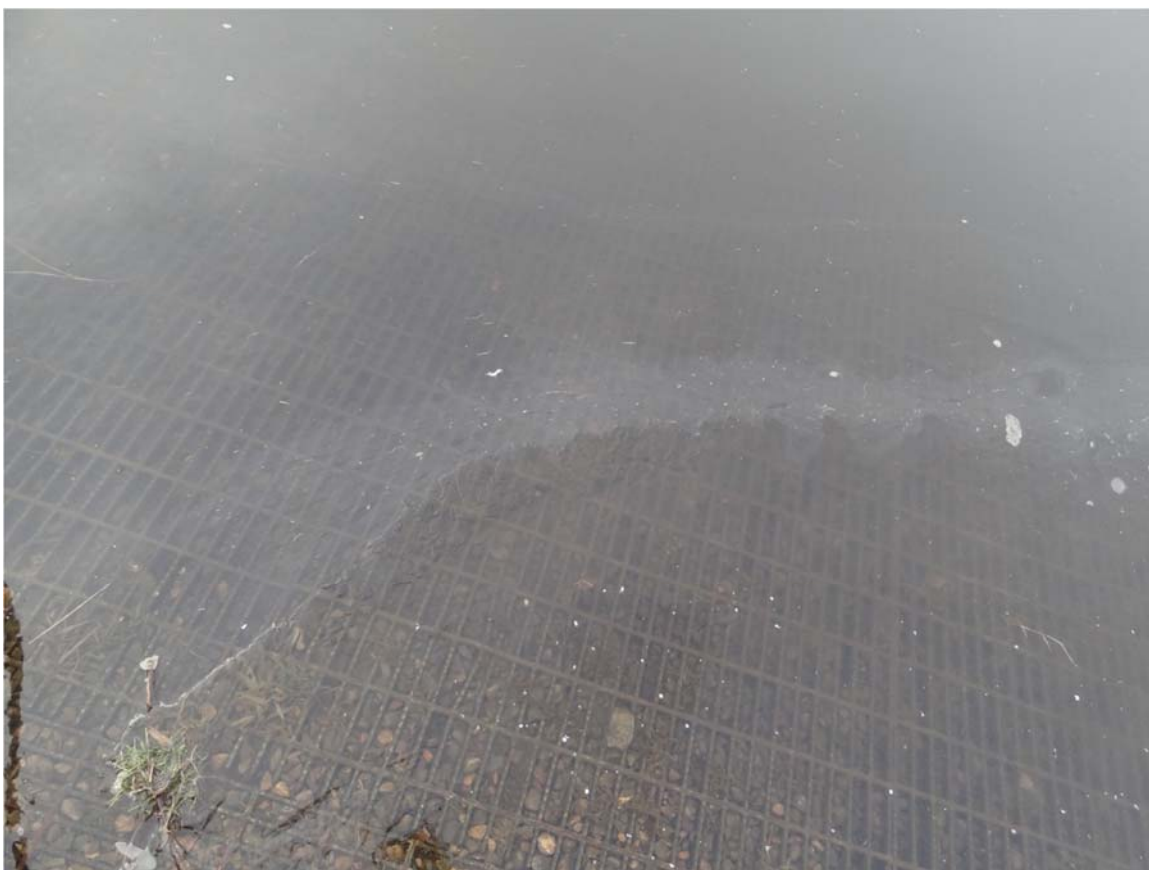
10. C0.4 Boat launch observed sheen along the ice.

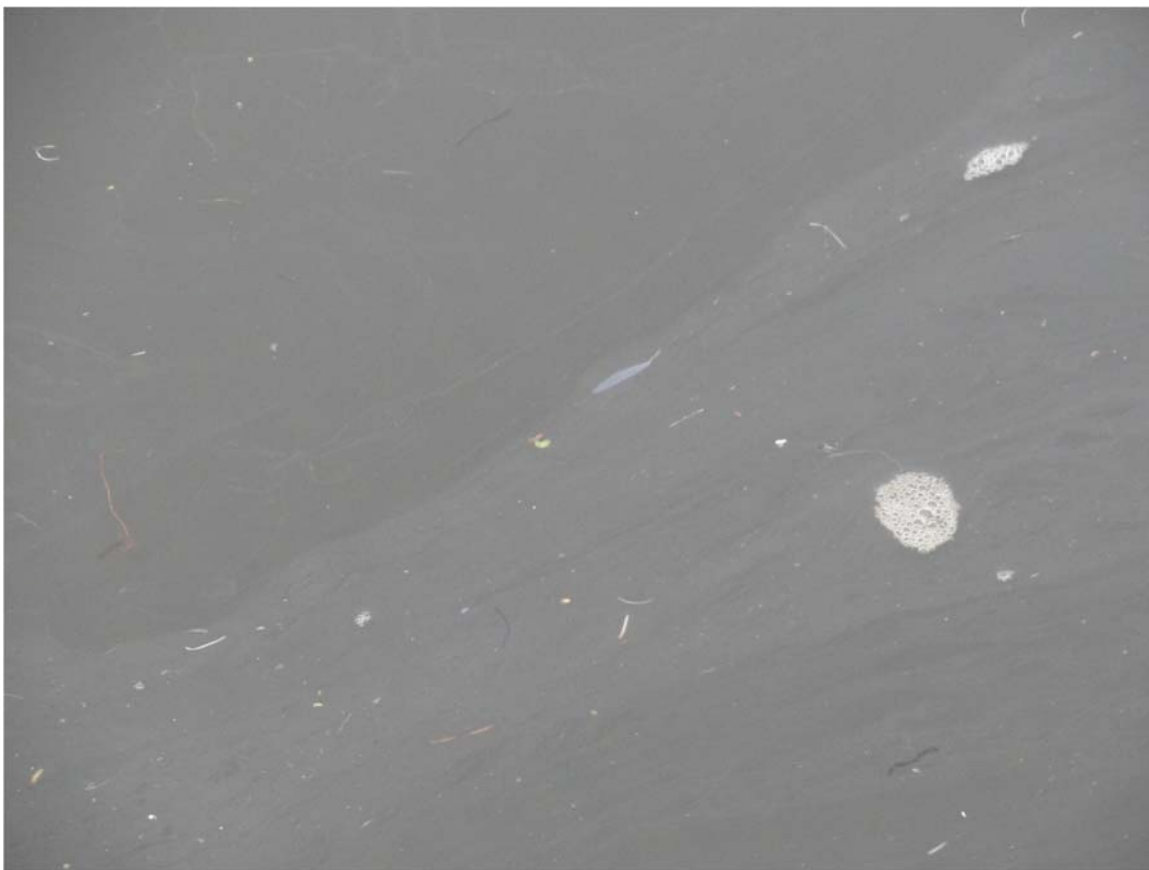
11. C0.4 Boat launch observed sheen along the ice.

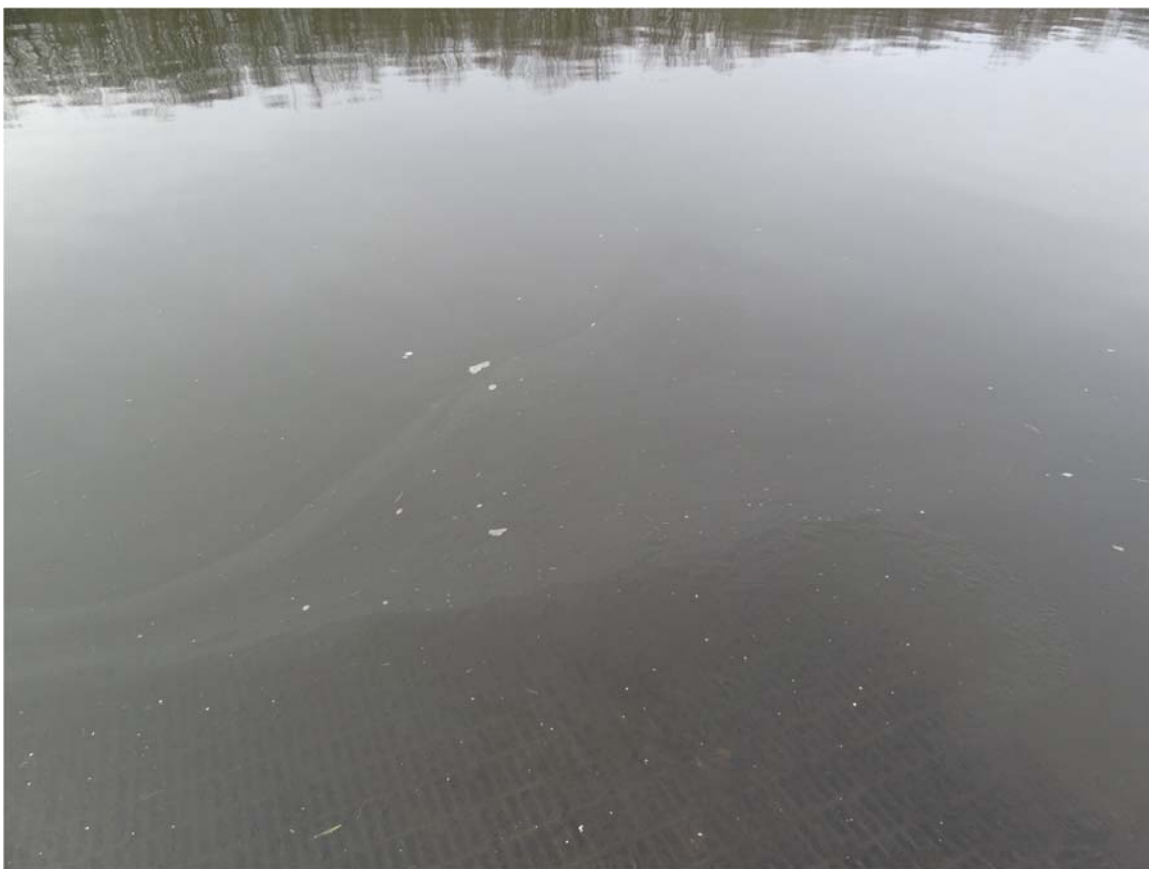
12. C0.4 Boat launch observed sheen along the ice.

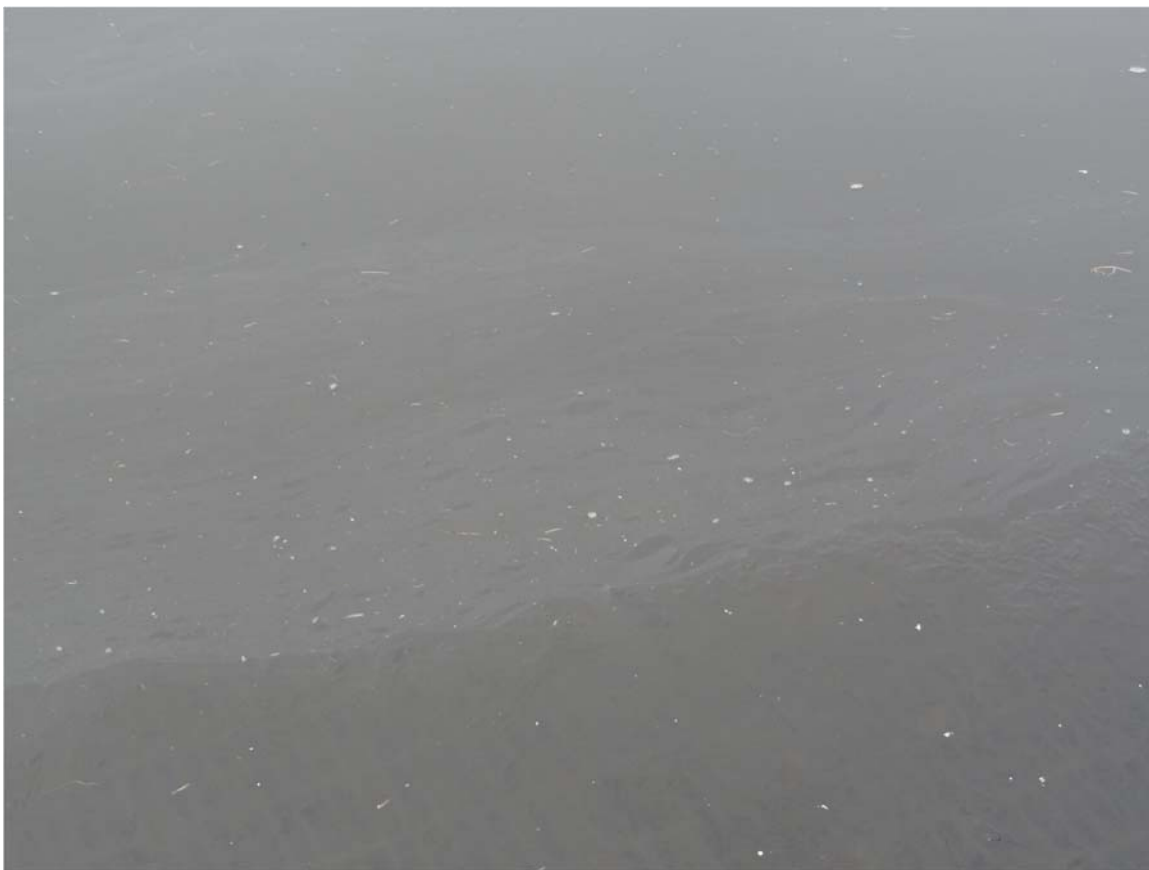
13. C0.4 Boat launch observed sheen along the ice.

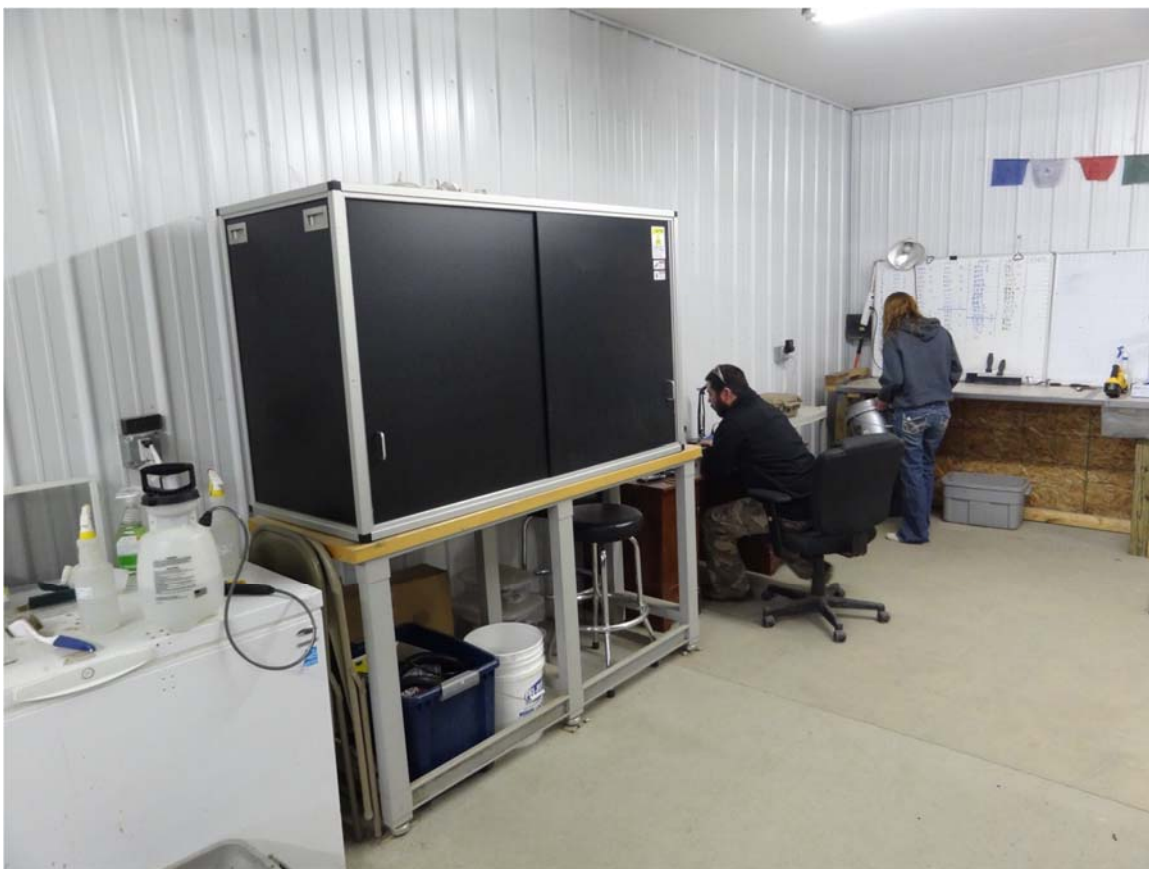
14. C3.2 pole barn observed core logging.

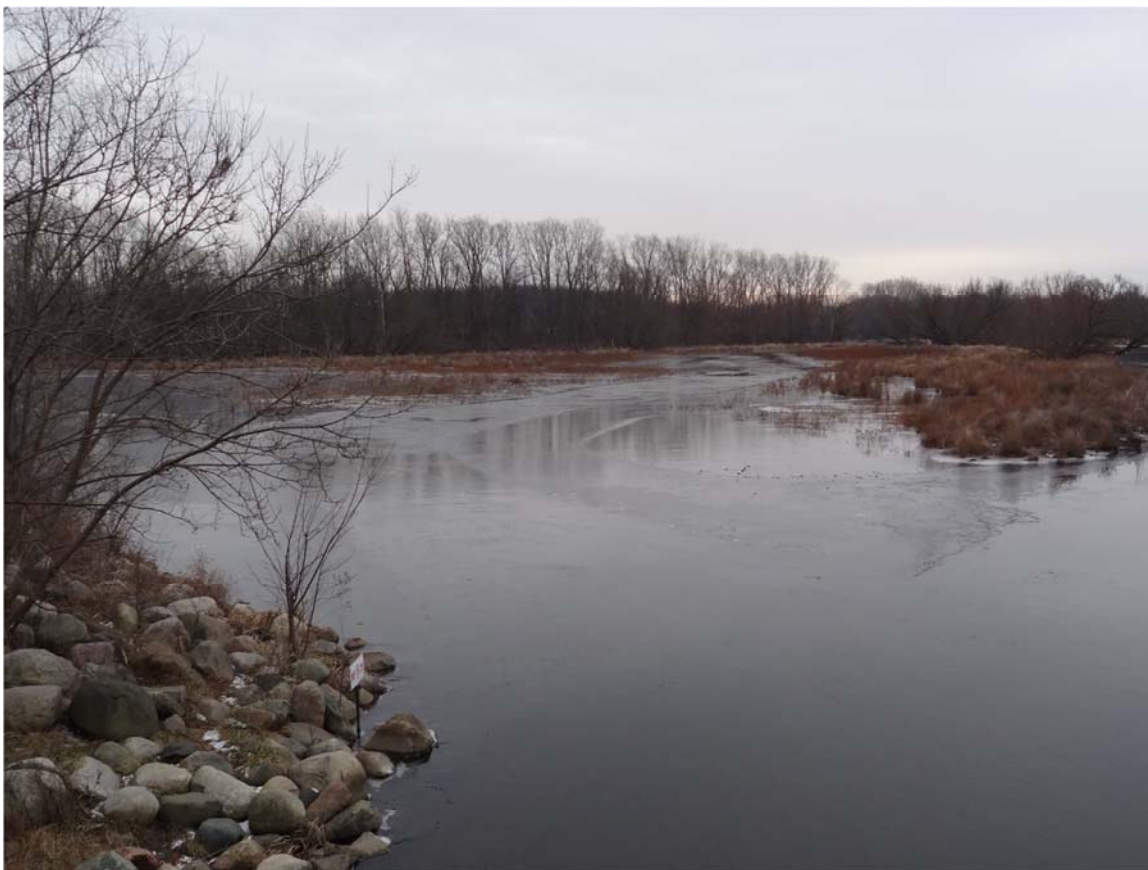
15. MP15.25 South Mill Pond observed ice reforming.

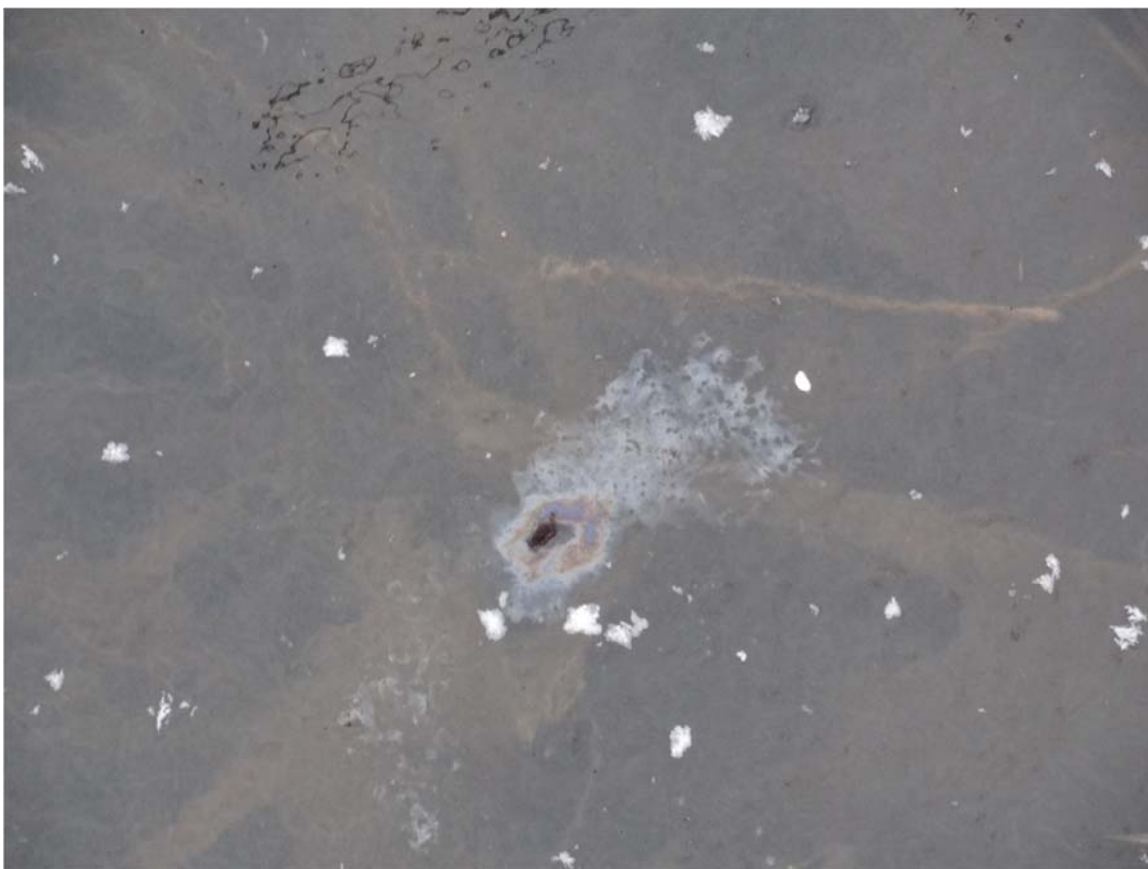
16. MP15.25 South Mill Pond observed a tar glob and sheen frozen in the ice.

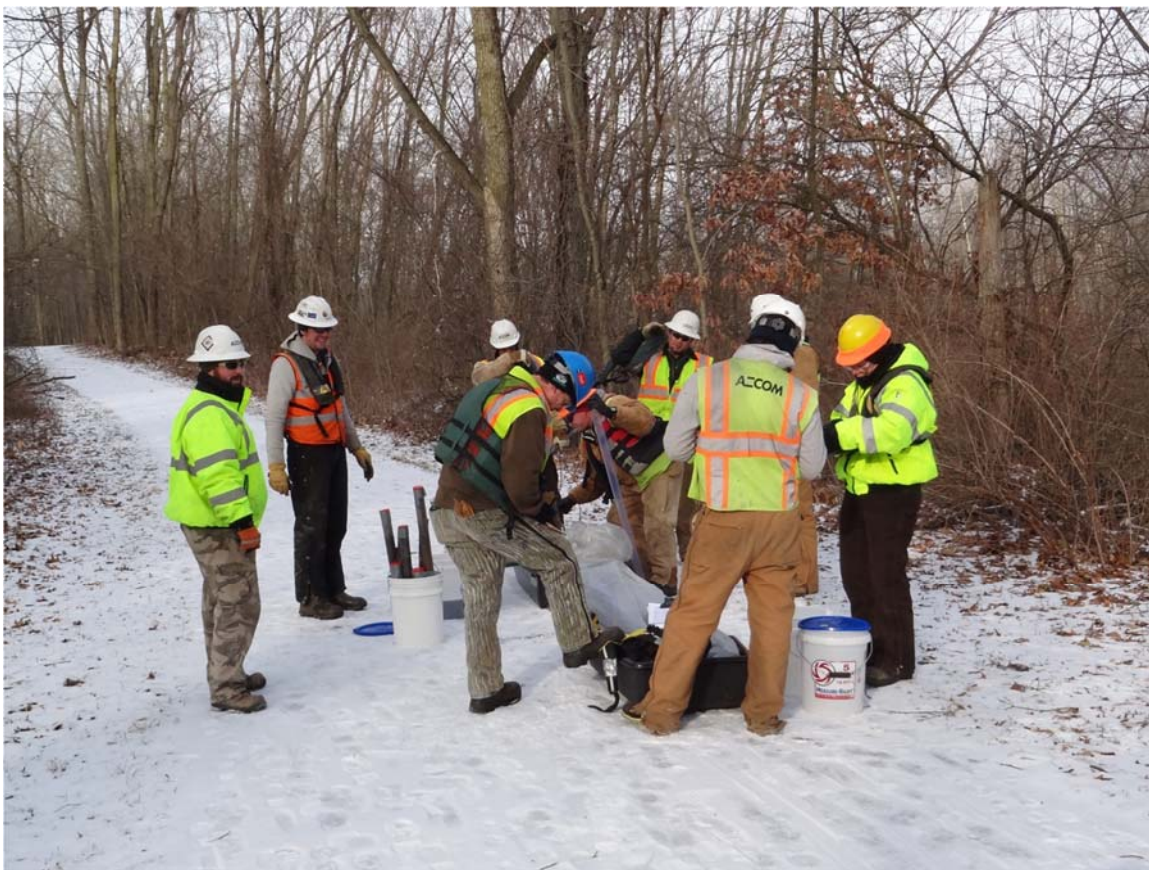
17. MP19.5 LDB observed the RI crew.

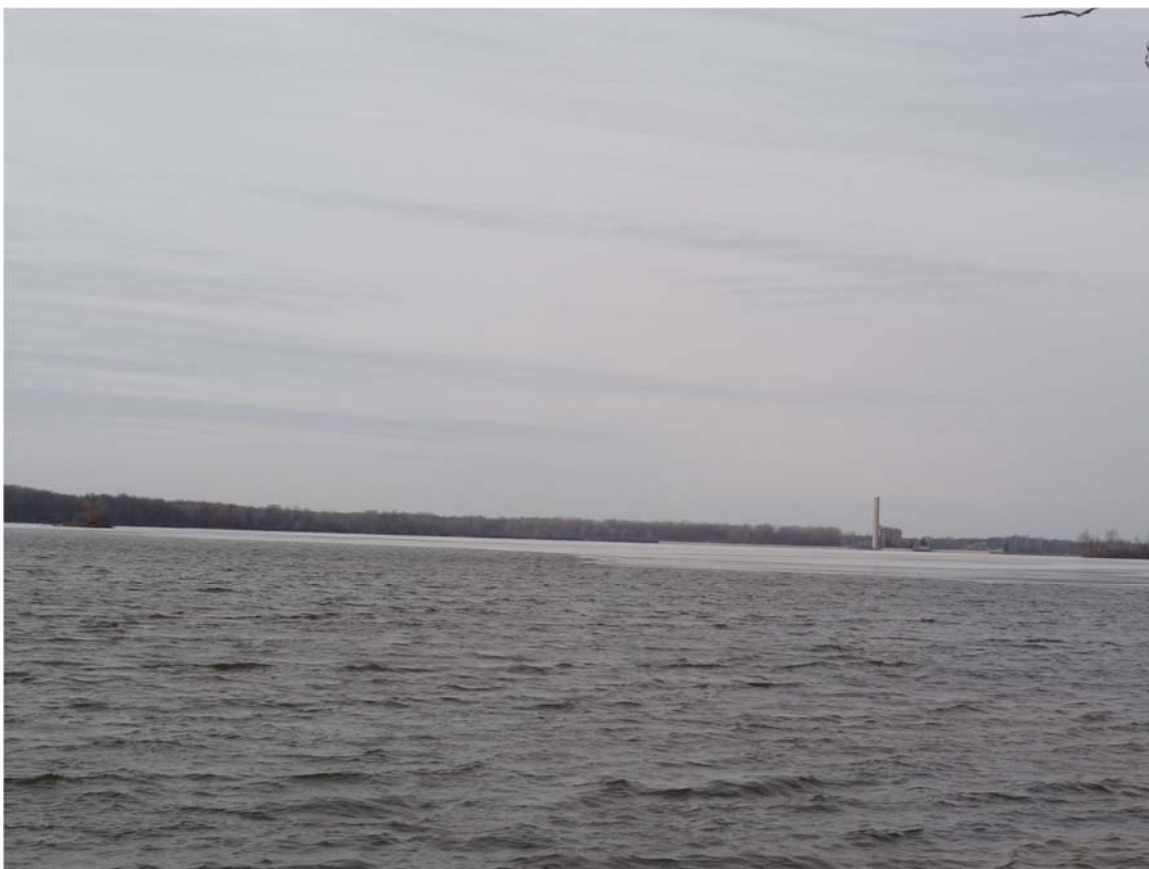
18. E4 Boat Launch Morrow Lake observed ice reforming.

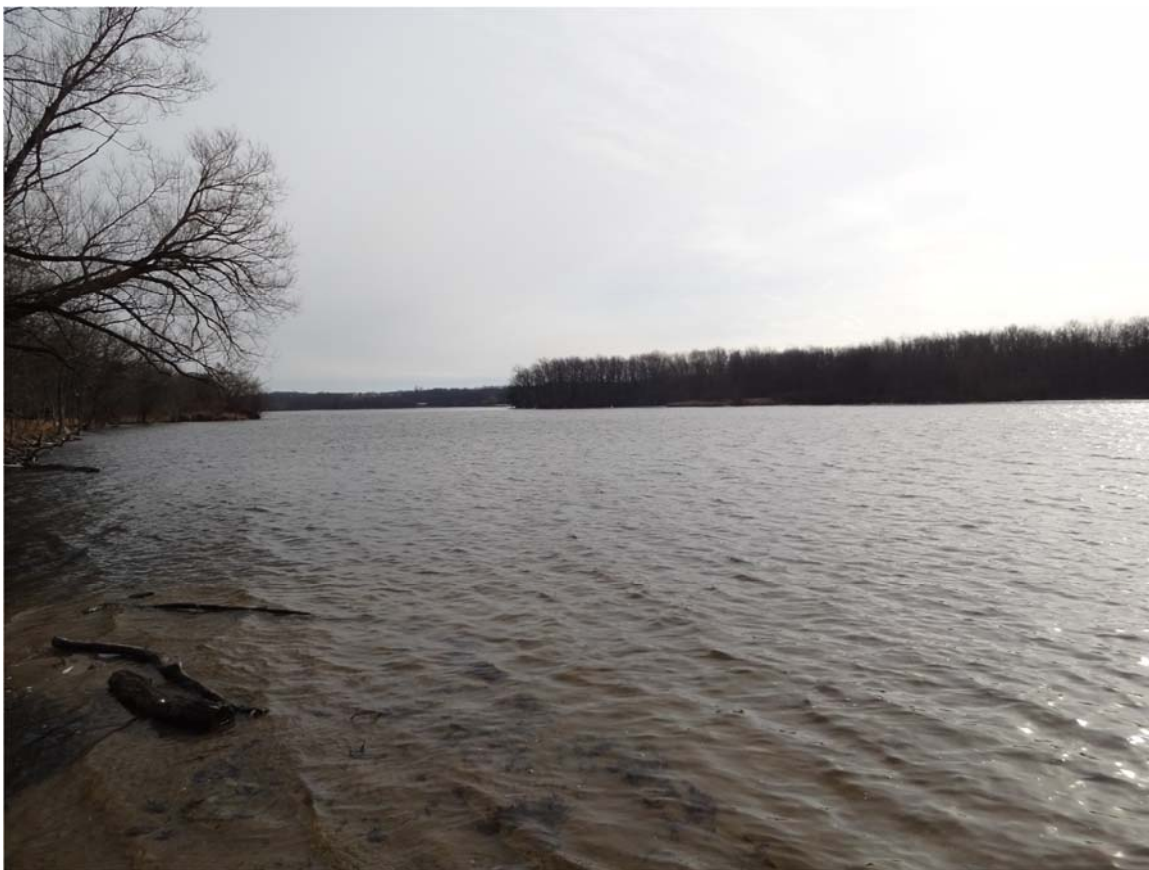
**19. Morrow Lake Delta/Morrow Lake Neck no ice observed.**

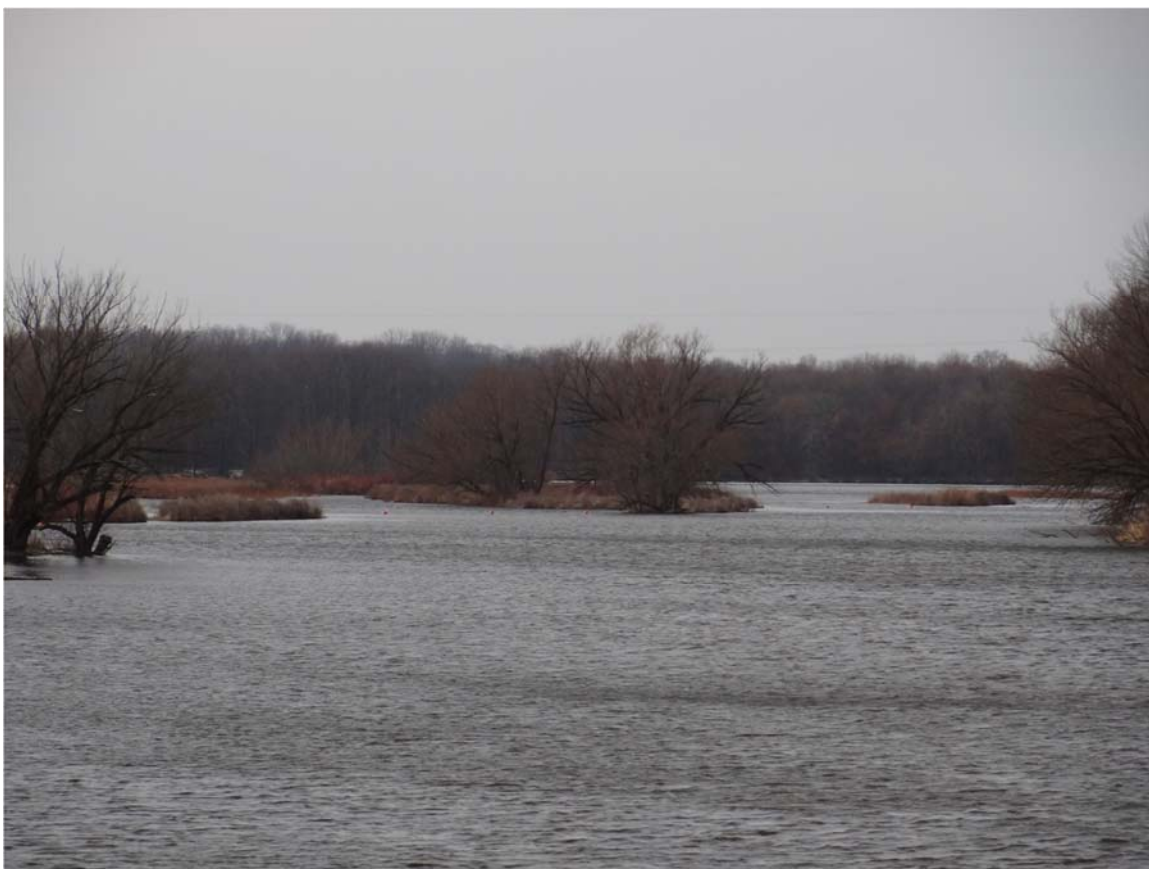
**20. Morrow Lake Delta no ice observed from the 35<sup>th</sup> Street Bridge.**

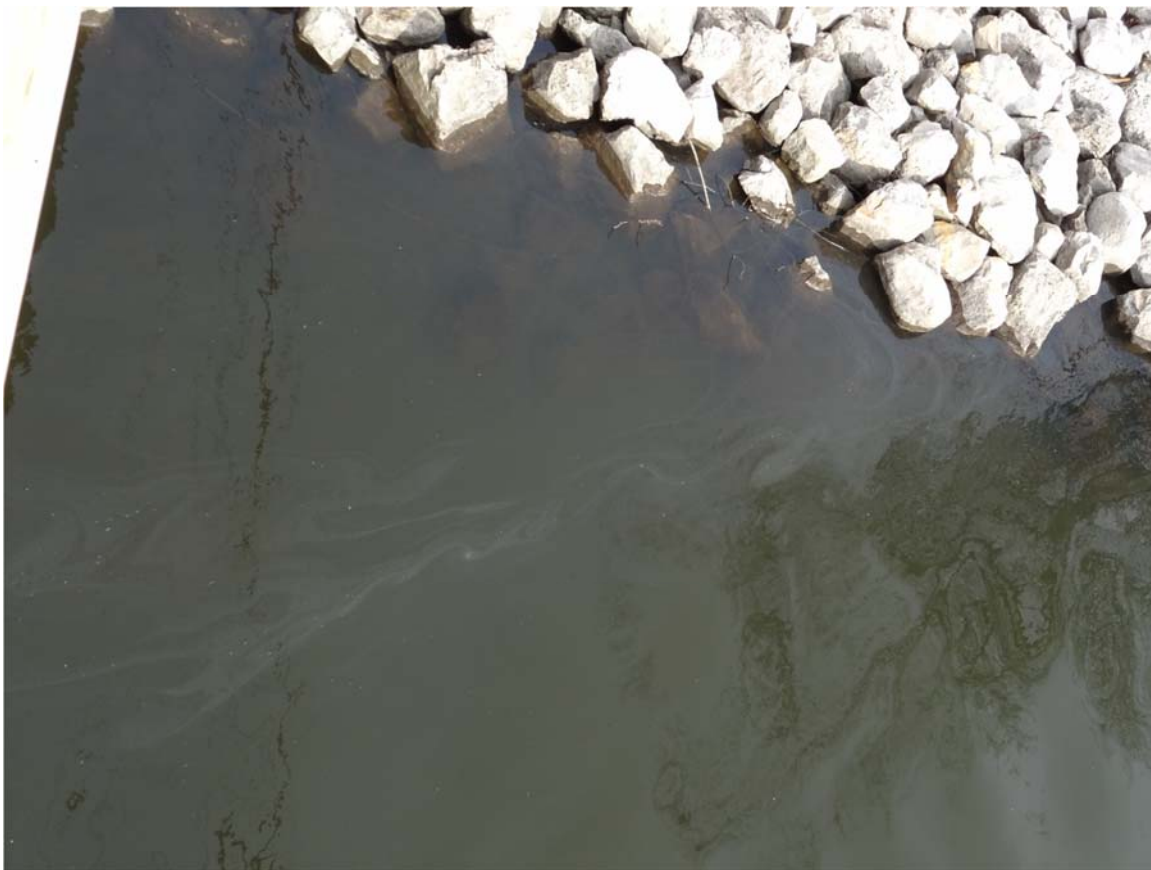
21. MP36.5 RDB Upstream side of the 35<sup>th</sup> Street Bridge observed sheen.

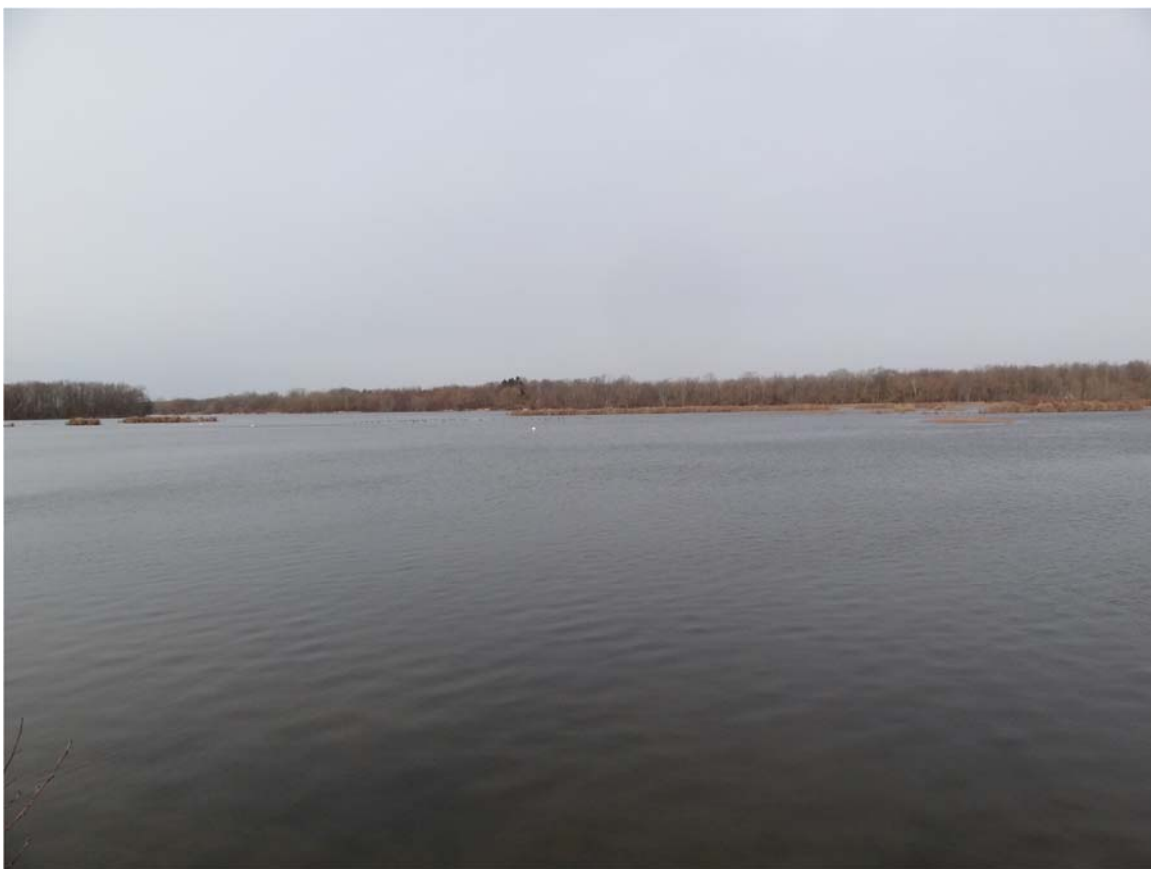
22. Morrow Lake Delta observed bank ice forming around the islands.

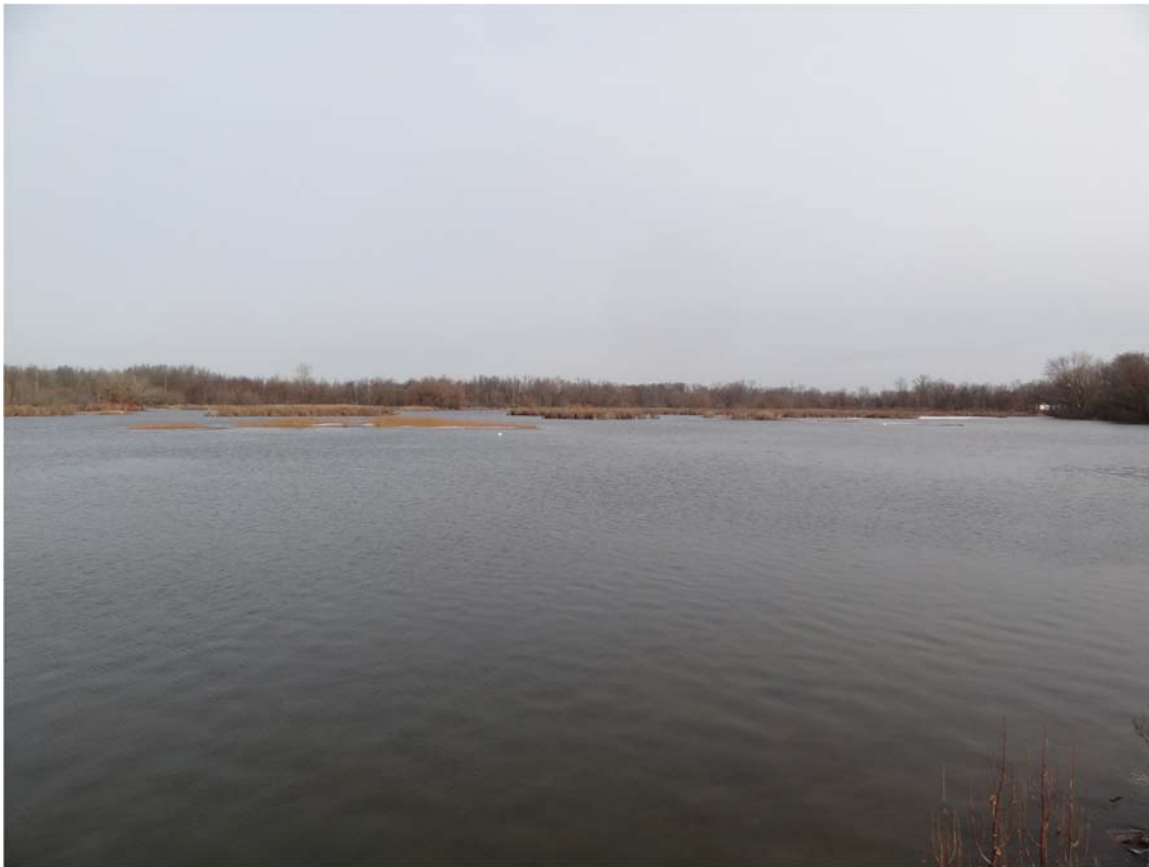
**23. Morrow Lake Delta observed bank ice forming around the islands.**
