# Situation Photo Log

Friday, January 18, 2013

Kalamazoo River / Enbridge Spill

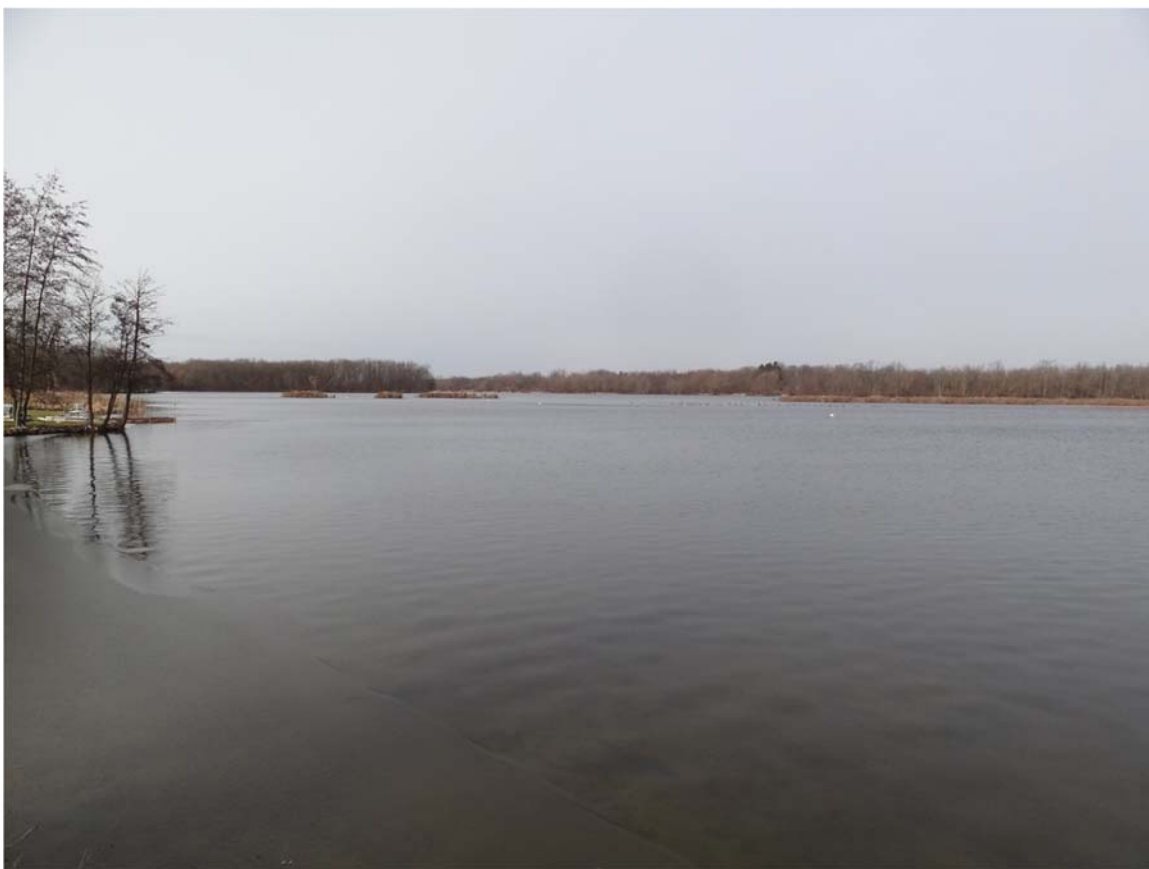
**24. Morrow Lake Delta observed bank ice forming around the islands and bank.**
