# Situation Photo Log

Monday, January 21, 2013

Kalamazoo River / Enbridge Spill

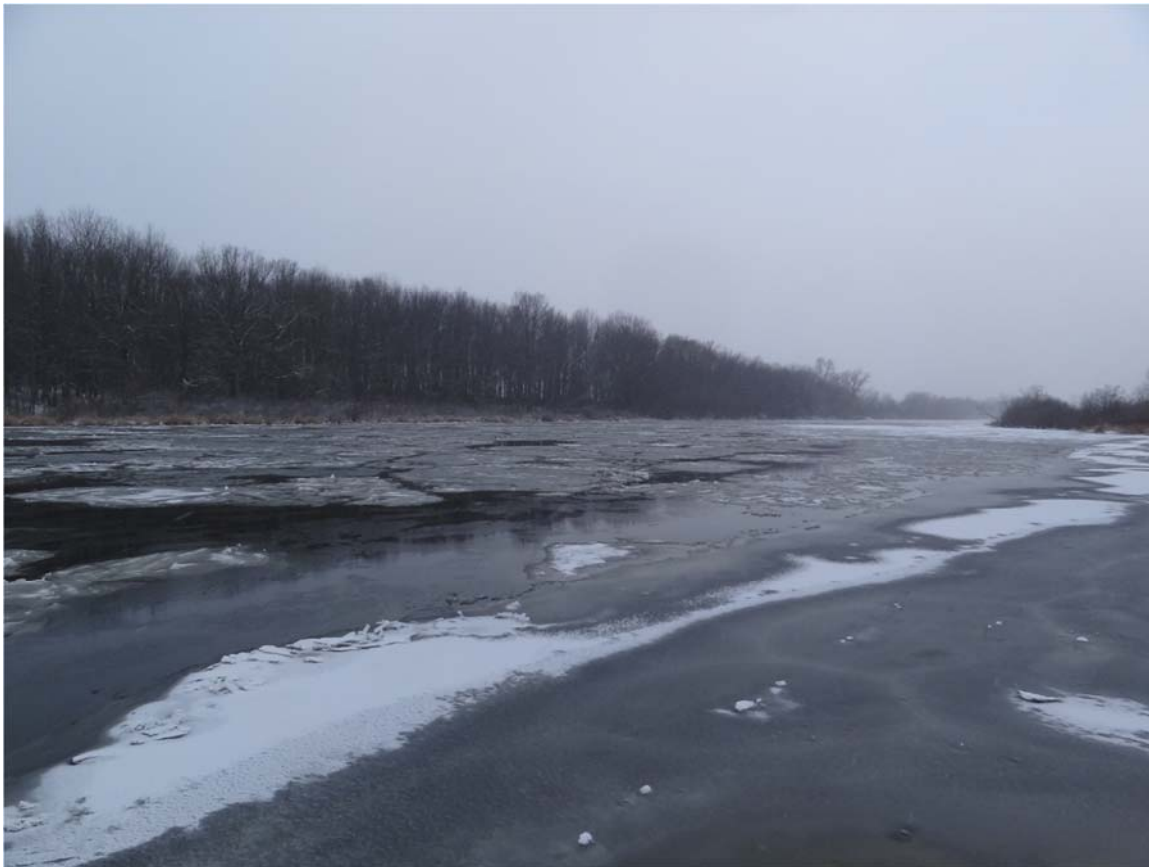
1. C0.4 Boat launch observed bank ice forming and sheet ice flowing in the river.

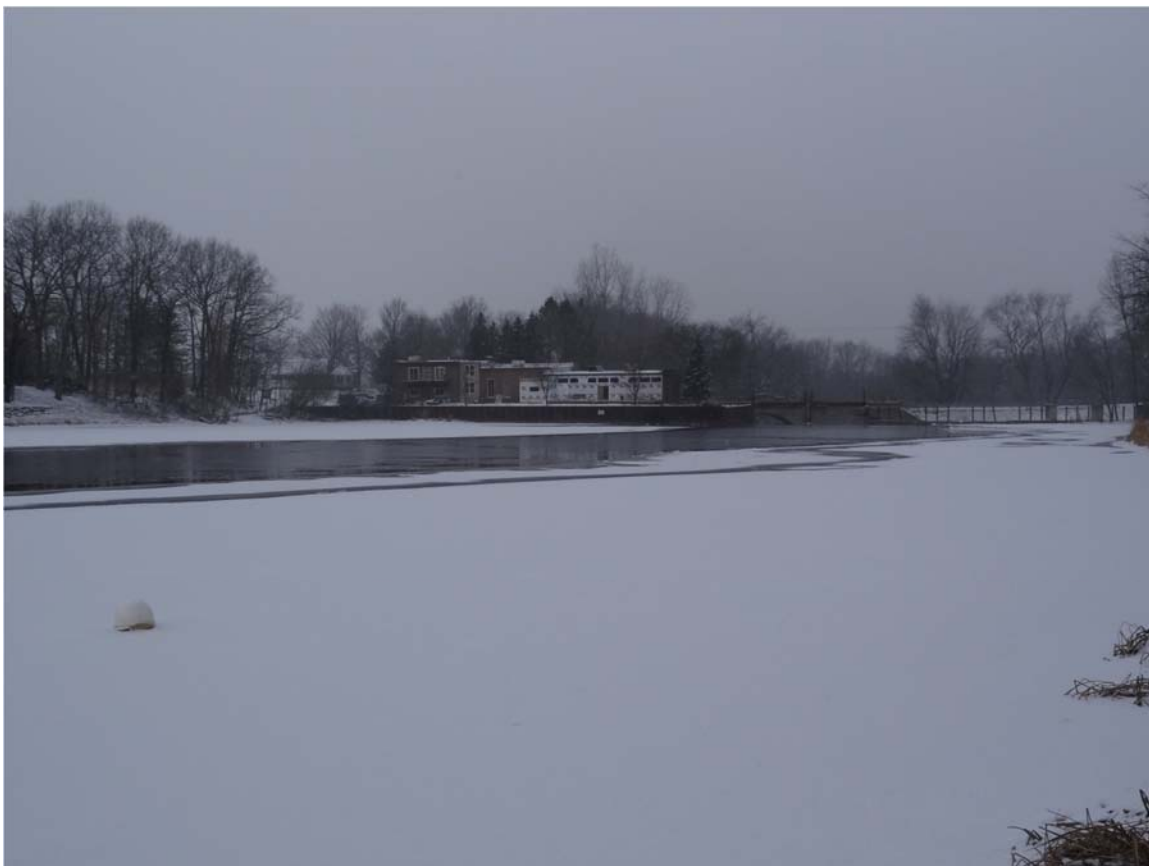
2. MP5.75 Ceresco Dam impoundment observed ice forming.

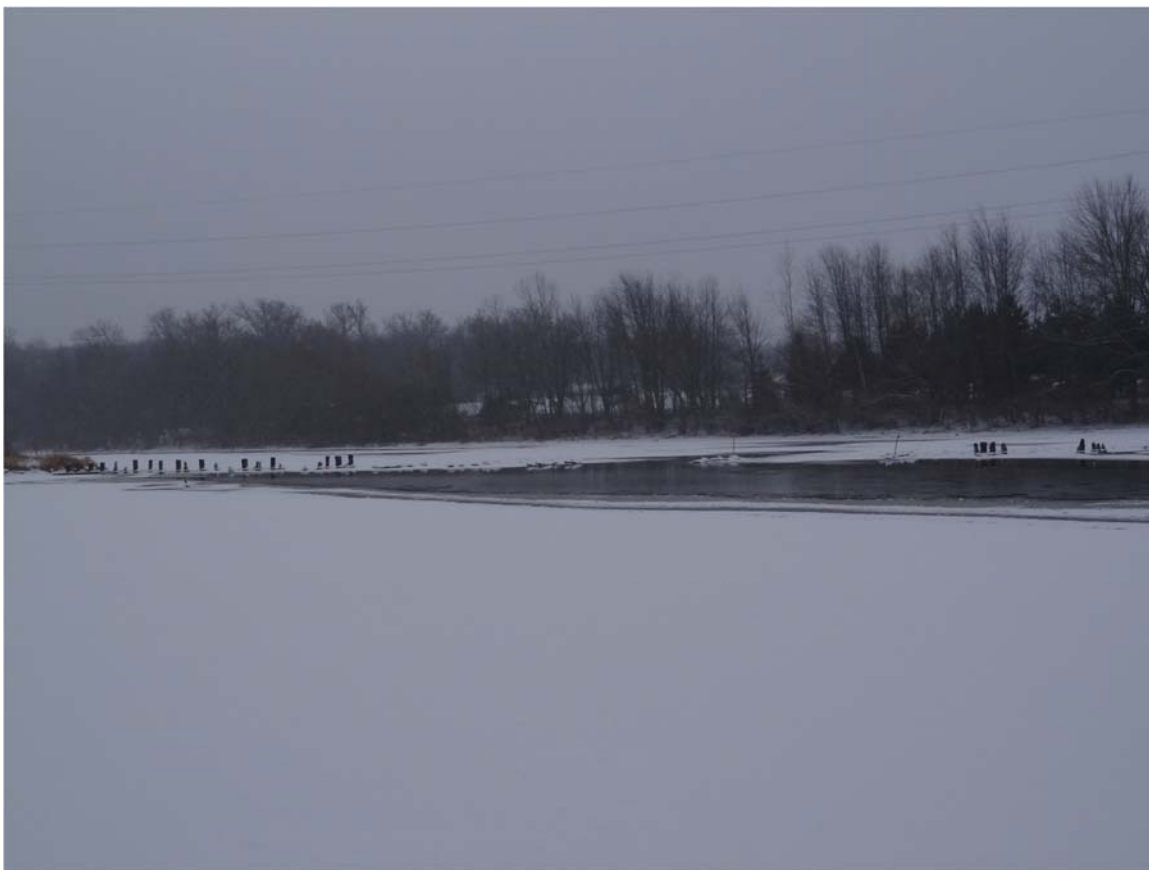
3. MP5.63 Railroad Trestles observed ice forming, center channel remains open with sheet ice flowing in the river.

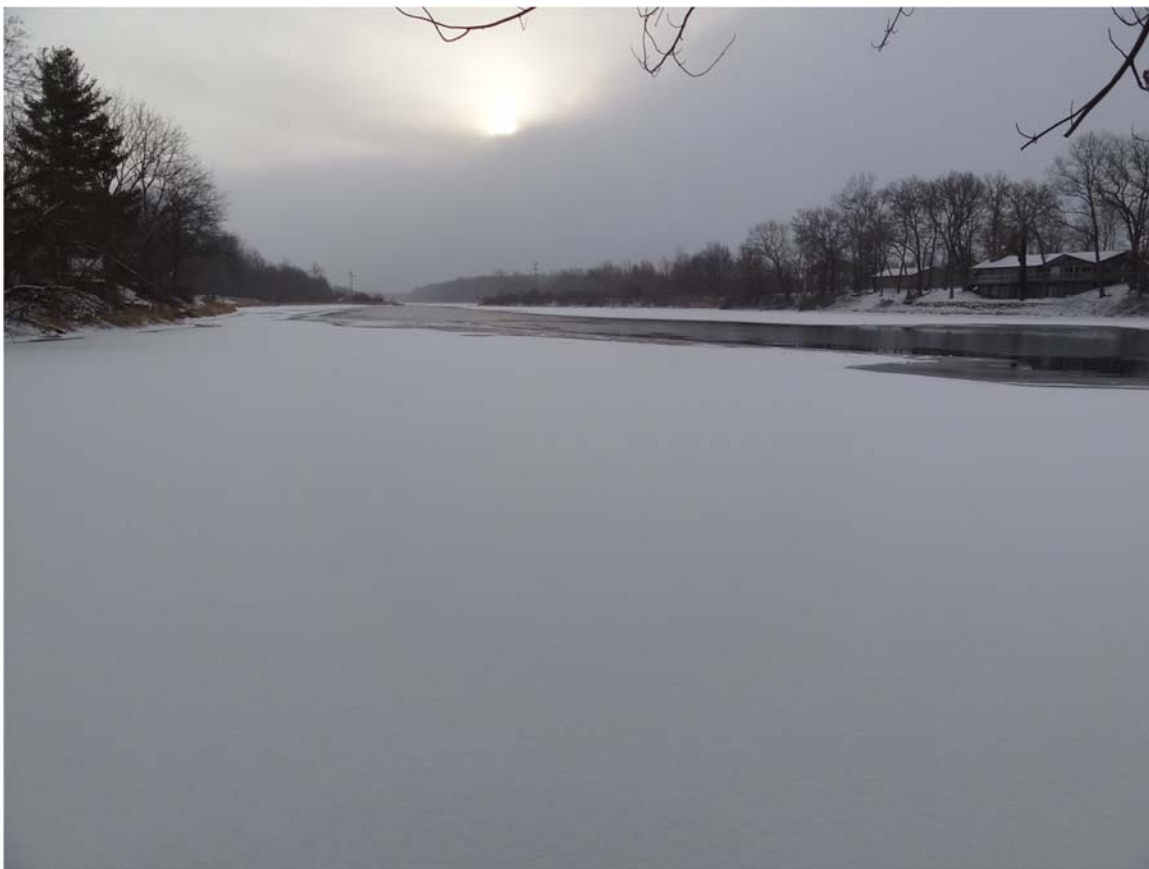
4. MP5.85 observed ice forming, center channel remains open with sheet ice flowing in the river.

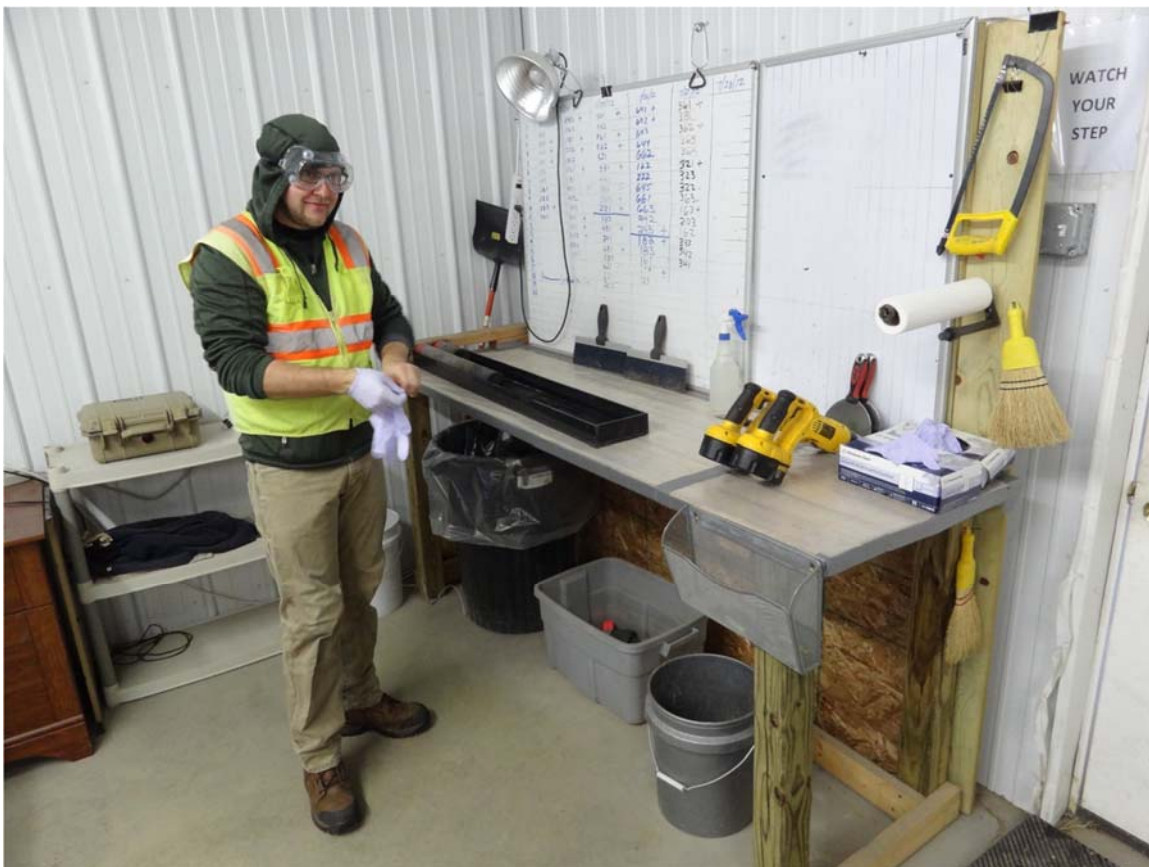
5. C3.2 Pole Barn observed core logging operations.

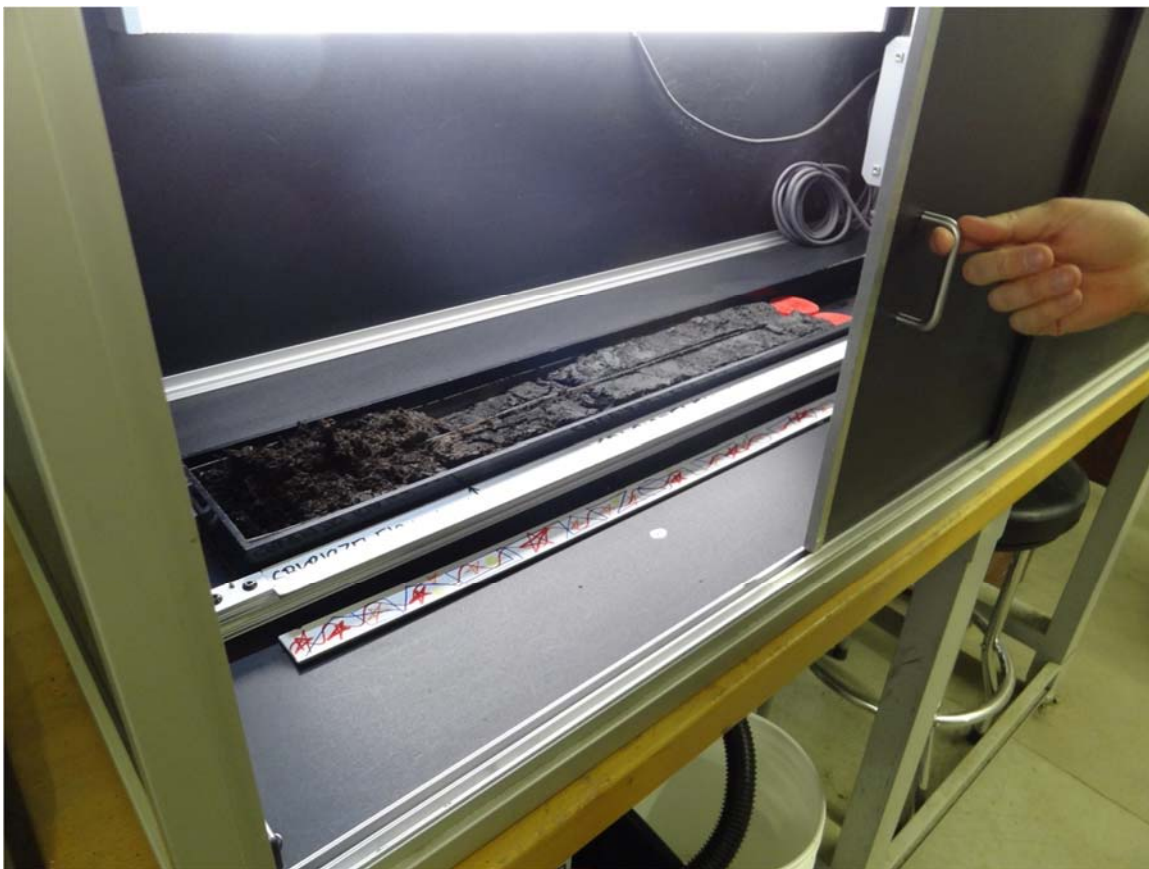
6. C3.2 Pole Barn observed core logging operations.

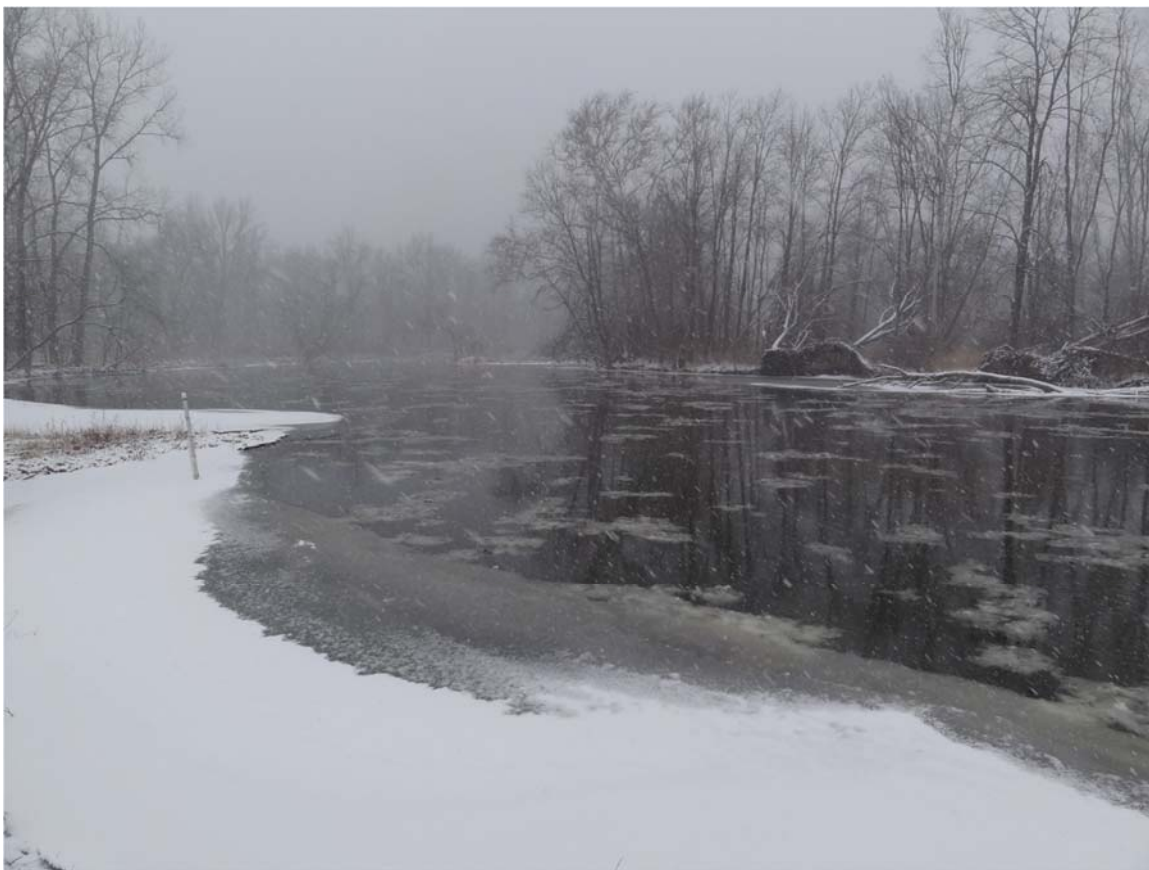
**7. C3.2 Boat launch observed bank ice forming and sheet ice flowing in the river.**

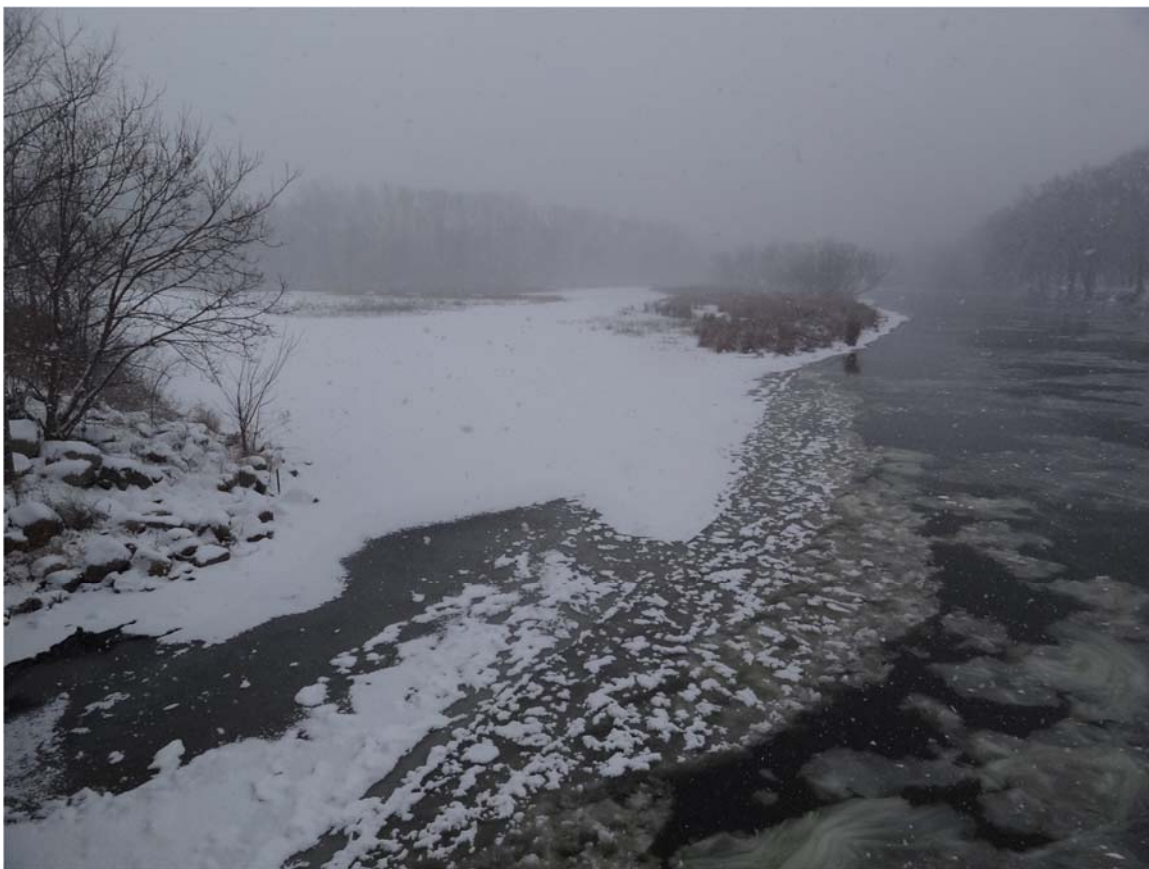
**8. MP15.25 South Mill Pond observed the South Mill Pond frozen over and sheet ice flowing in the river.**

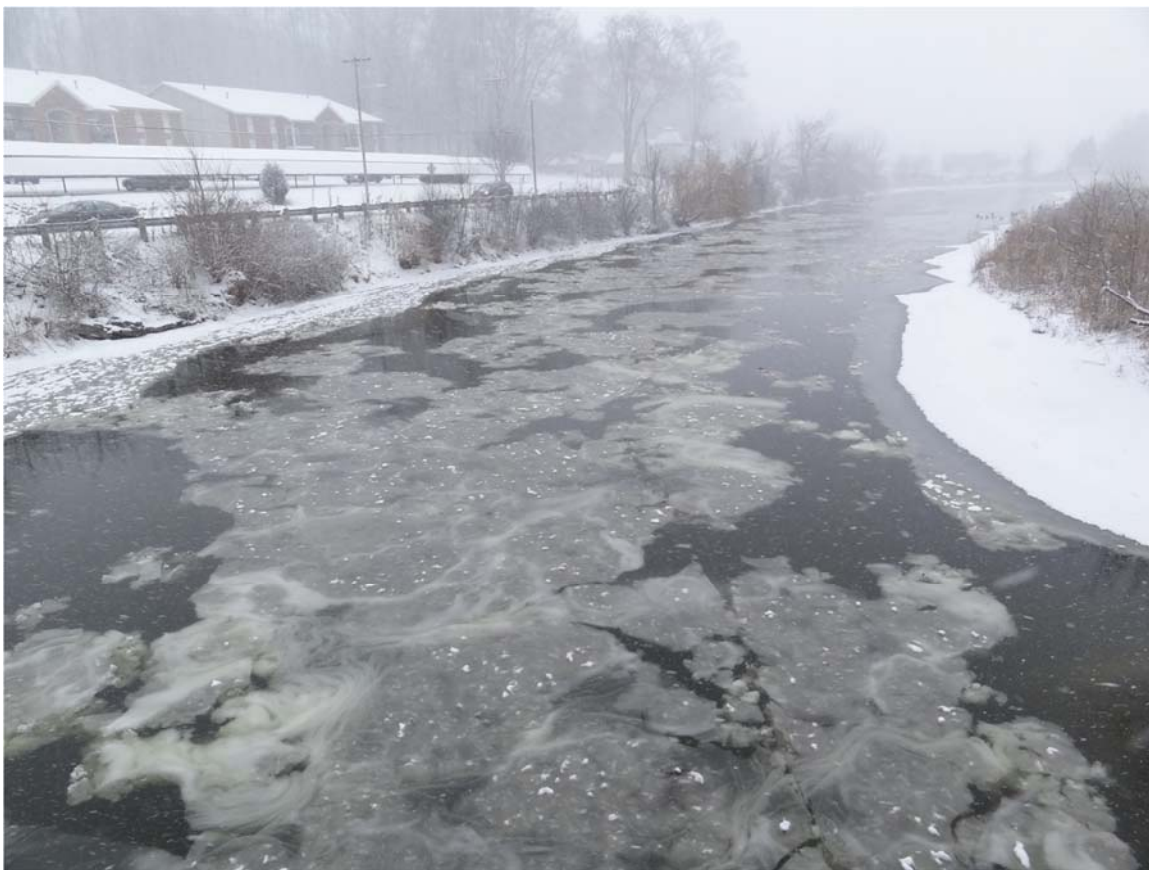
9. MP15.25 bank ice forming and sheet ice flowing in the river

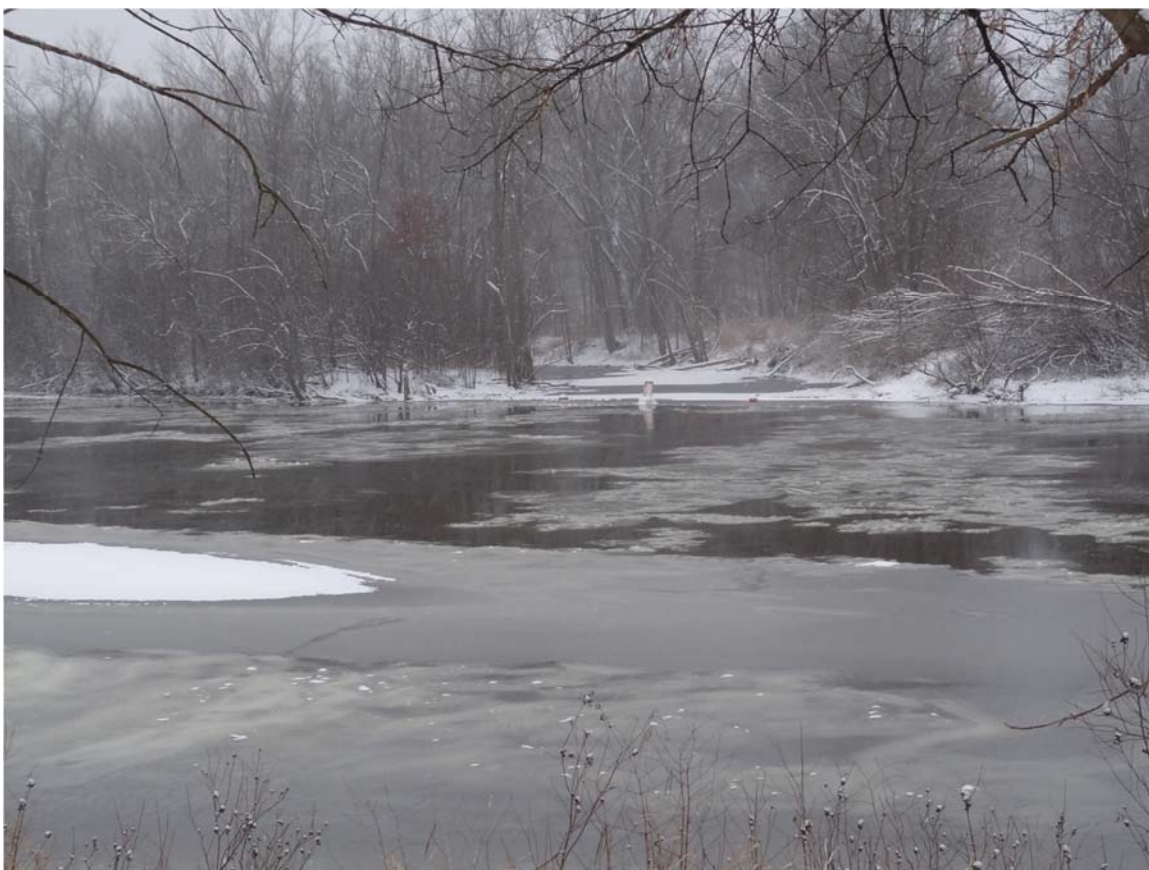
10. MP19.25 observed bank ice forming and sheet ice flowing in the river.

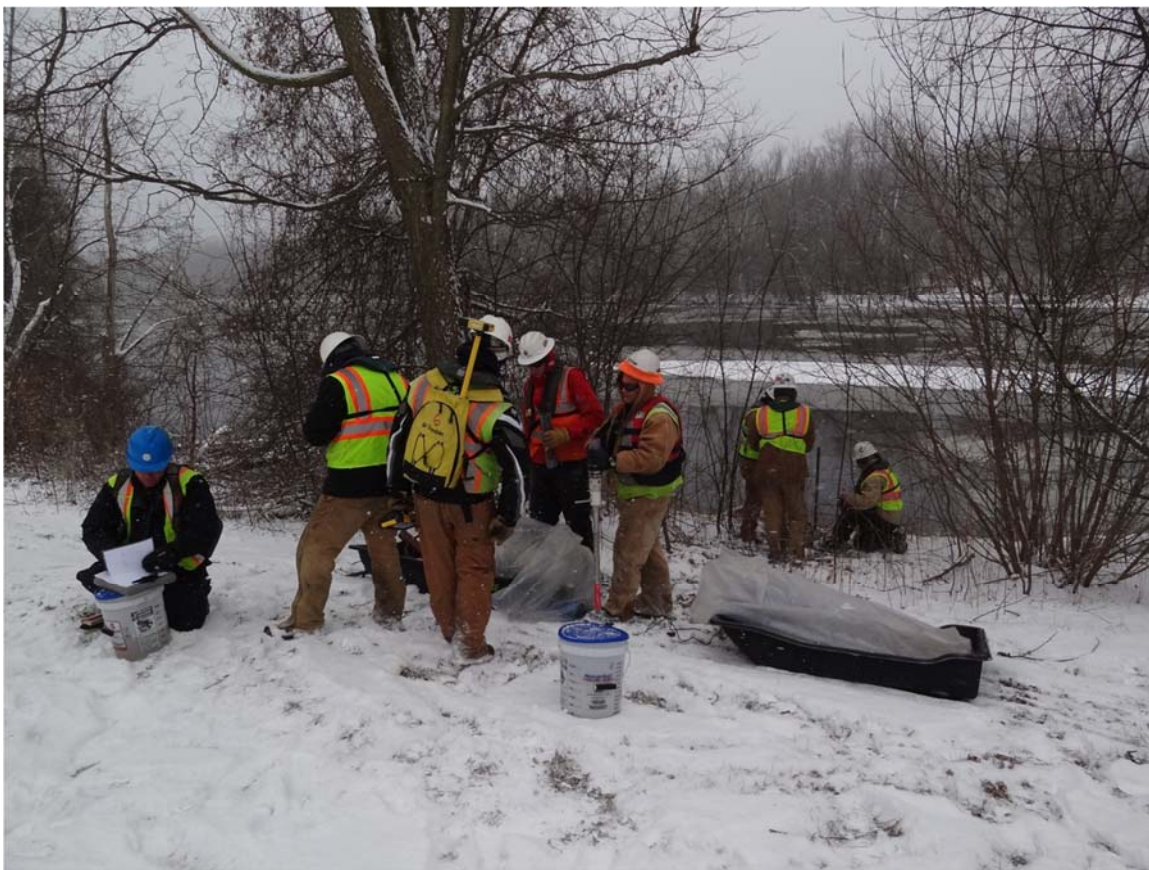
11. MP19.25 RDB observed the RI crew.

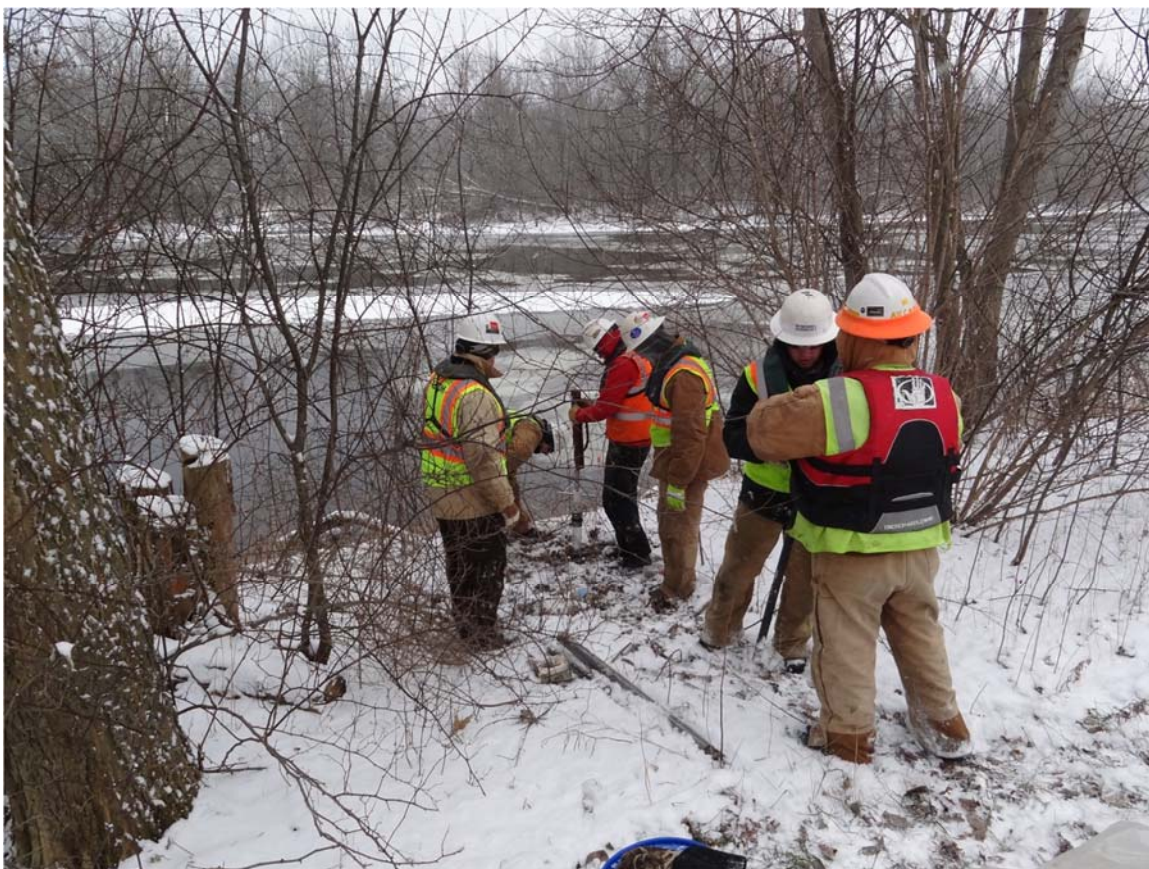
12. MP19.25 RDB observed the RI crew.

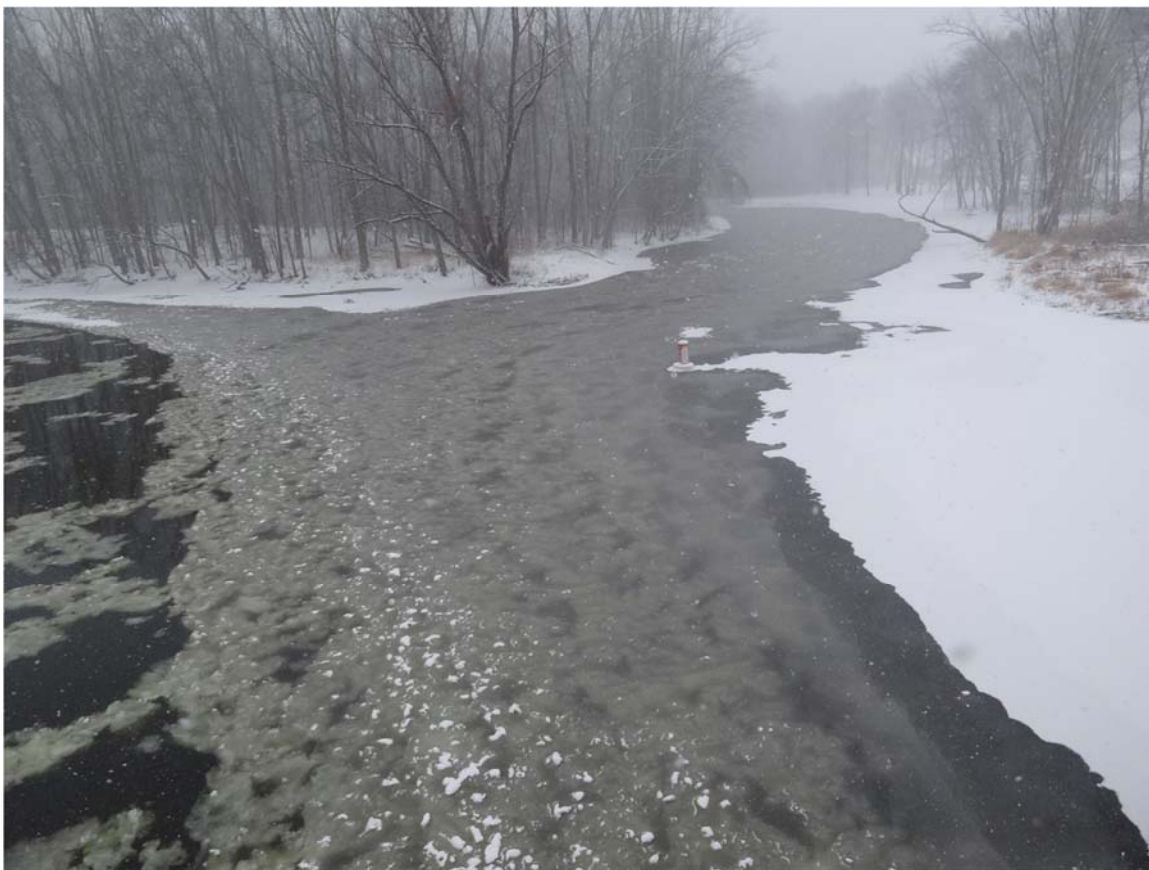
**13. MP21.5 observed the oxbow frozen over and sheet ice flowing in the river.**

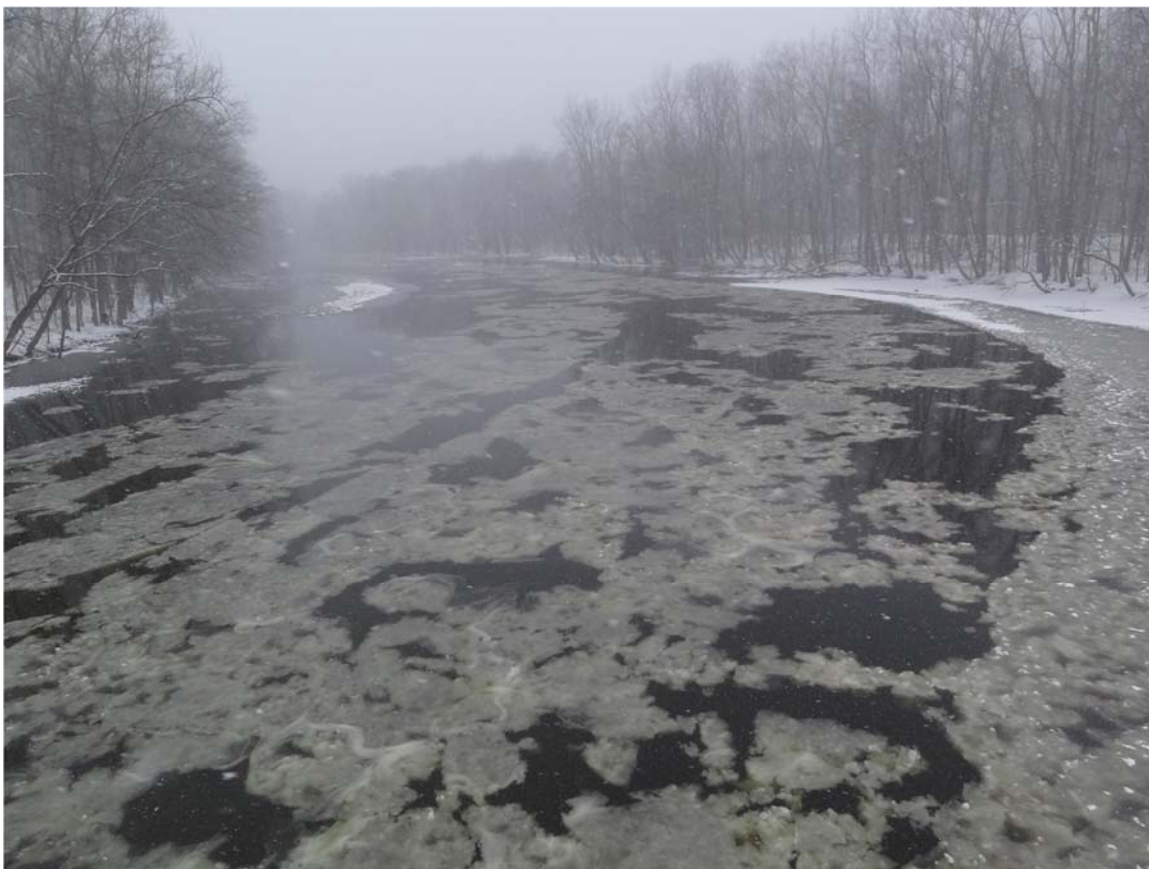
**14. MP21.5 observed sheet ice flowing in the river.**

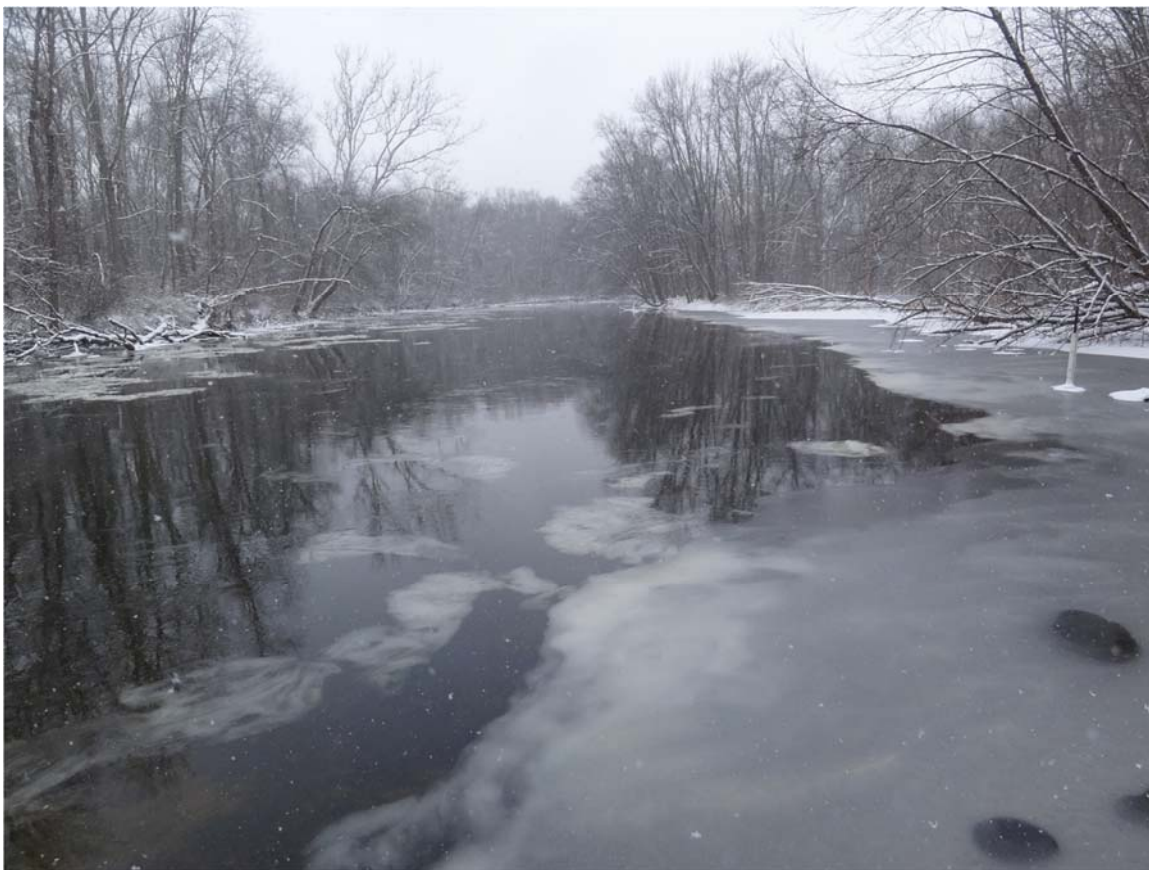
**15. E2 Boat launch observed bank ice forming and sheet ice flowing in the river.**

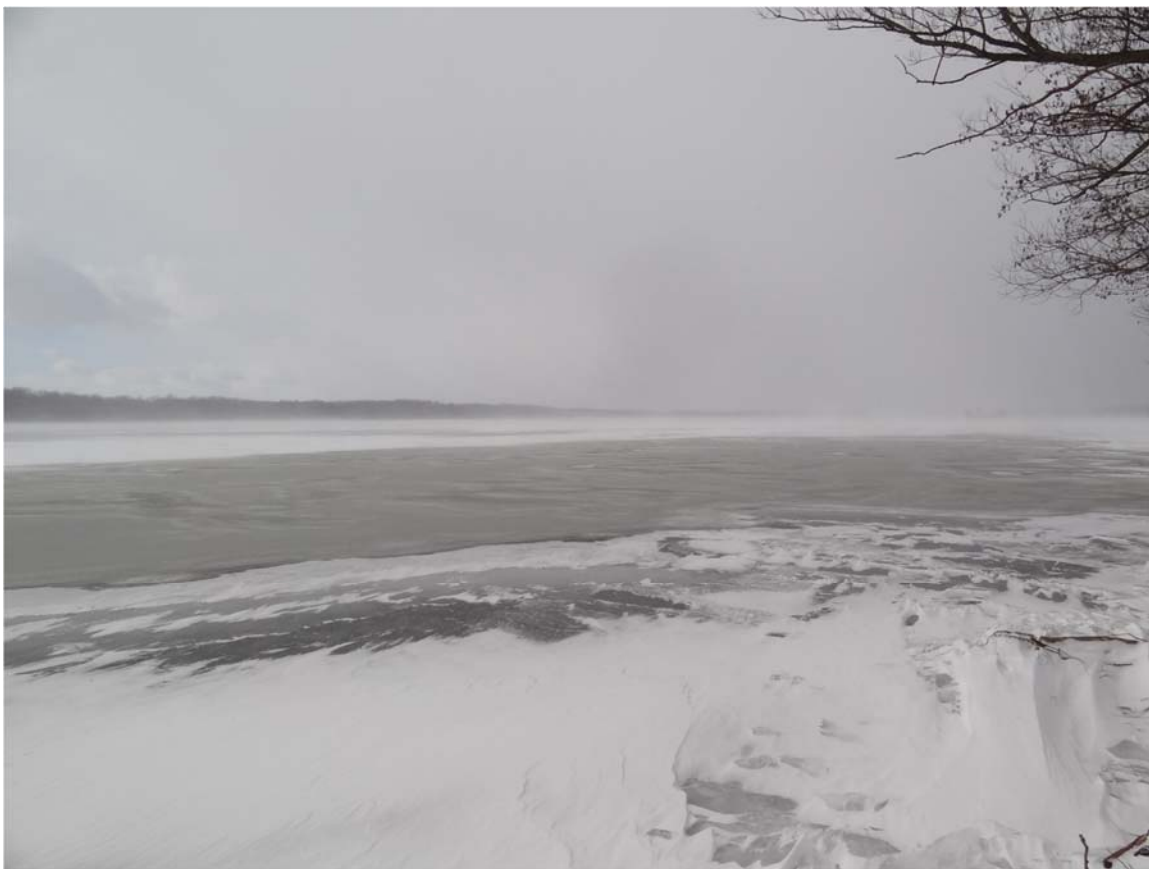
**16. Morrow Lake observed the lake completely frozen over.**

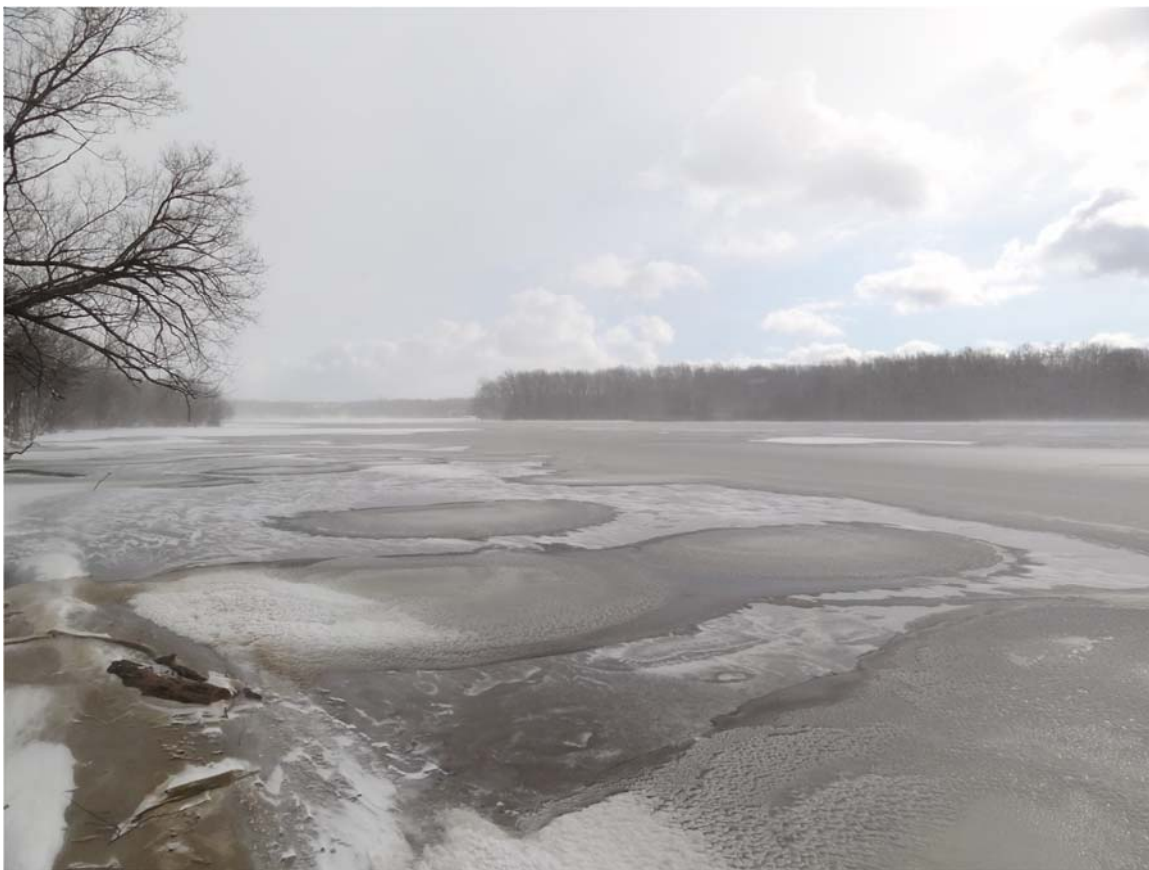
**17. Morrow Lake Delta/Morrow Lake Neck observed frozen over.**

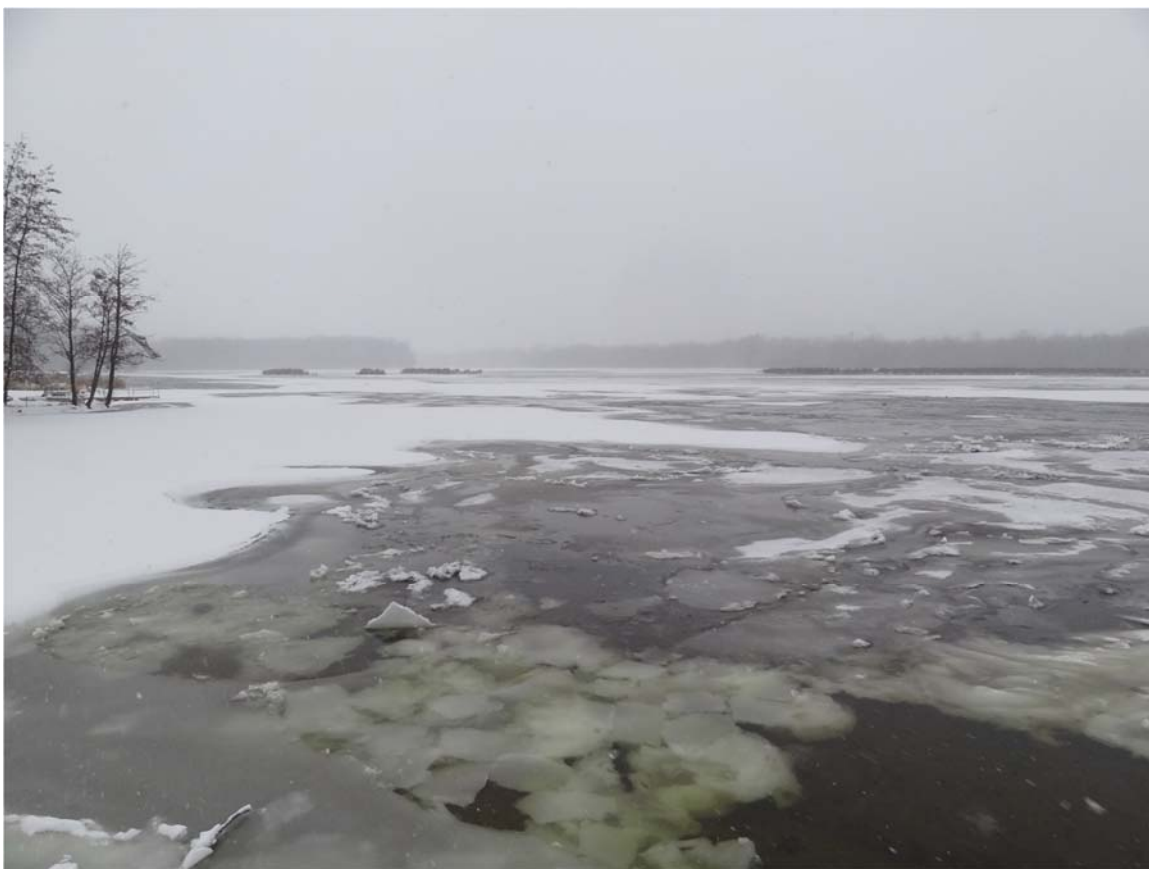
**18. Morrow Lake Delta observed the delta nearly frozen over.**
