Situation Photo Log

Tuesday, January 22, 2013

Kalamazoo River / Enbridge Spill

Prepared by:
Matthew Haak
START-USEPA
Situation Unit Leader

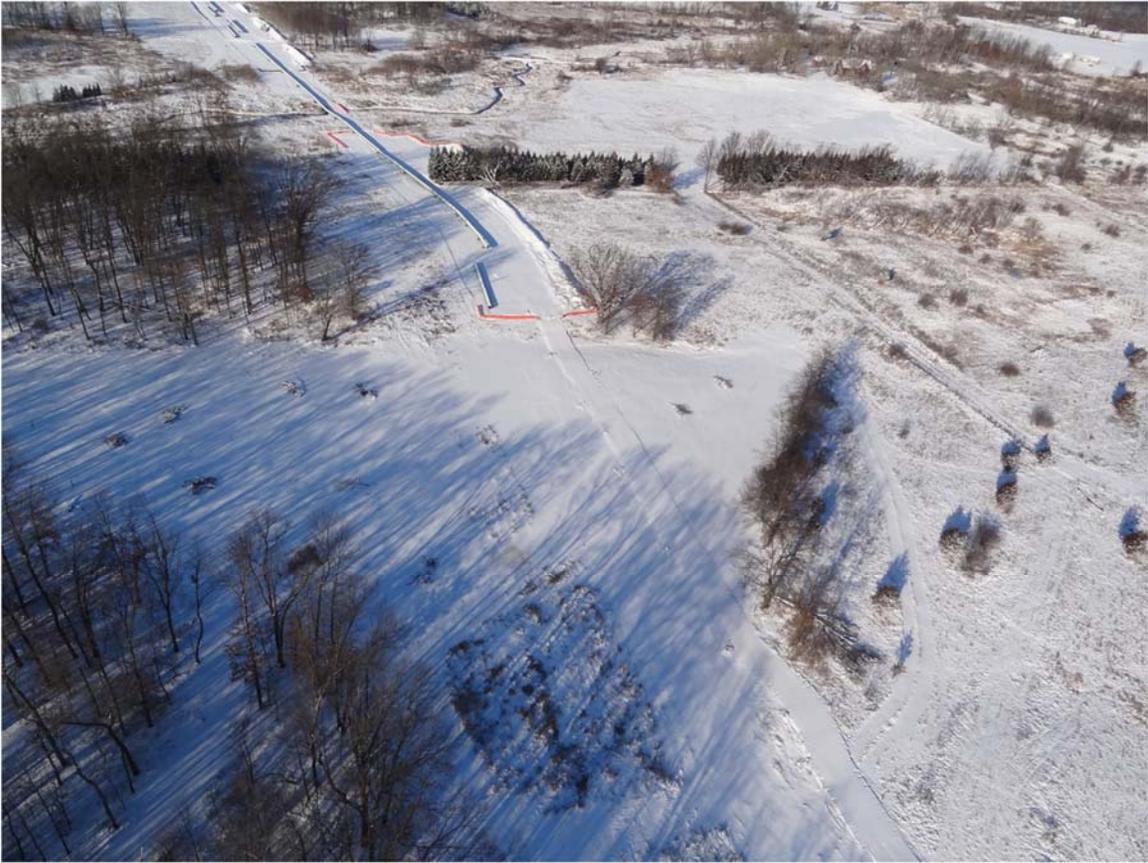
1. Source Area, observed frozen over.

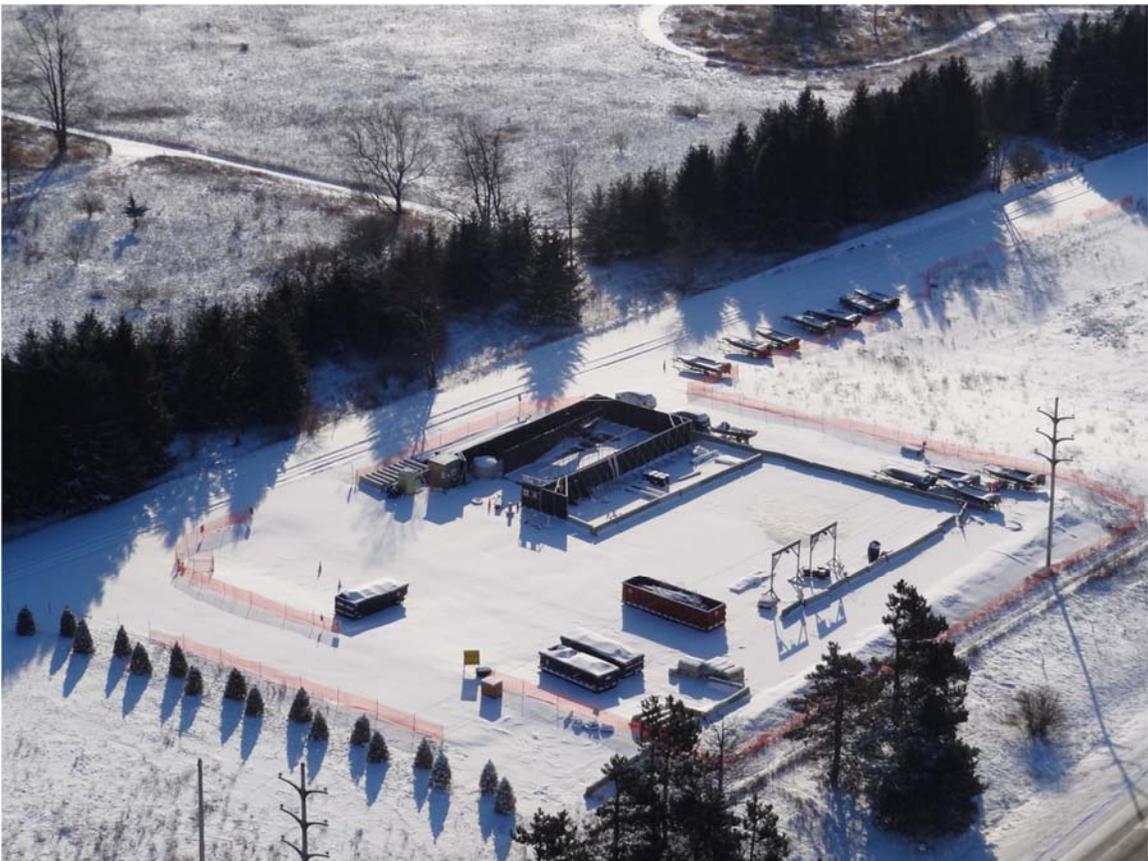
2. Frac Tank City, no decon operations observed.

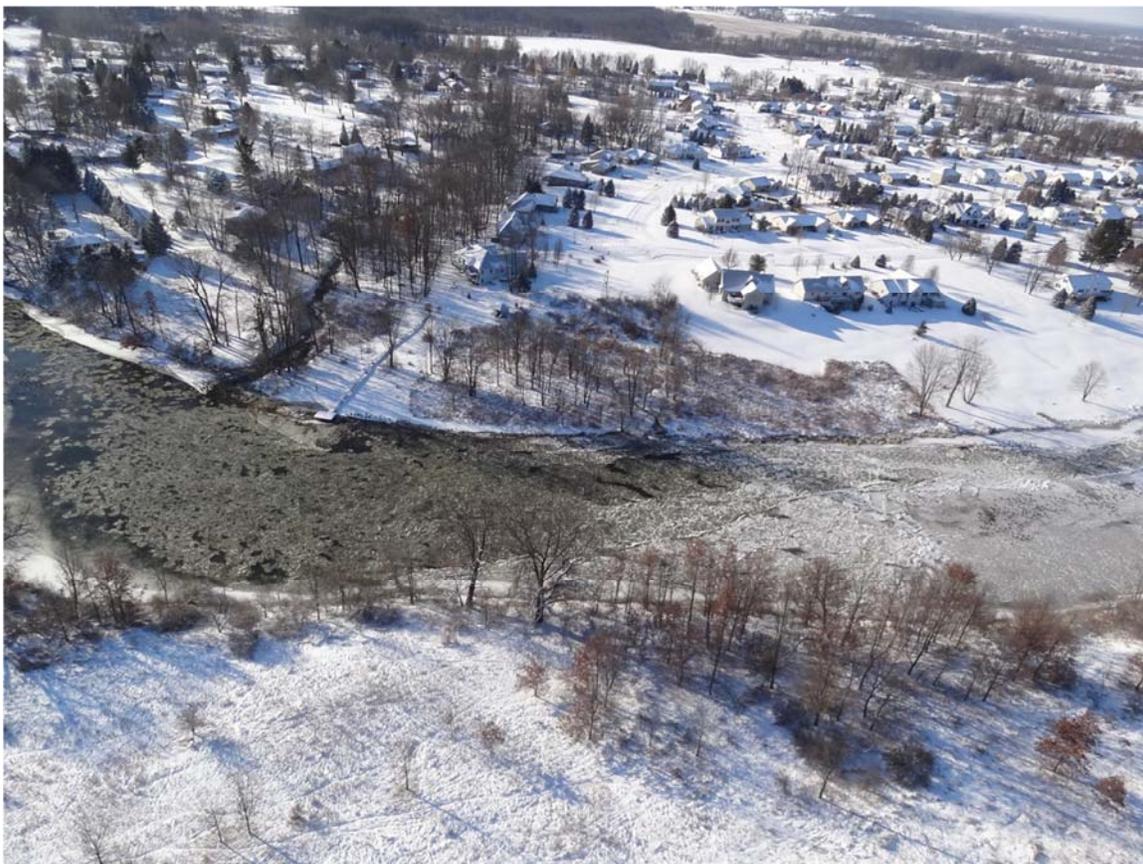
3. MP2.75 Observed the start of the river beginning to freeze over.

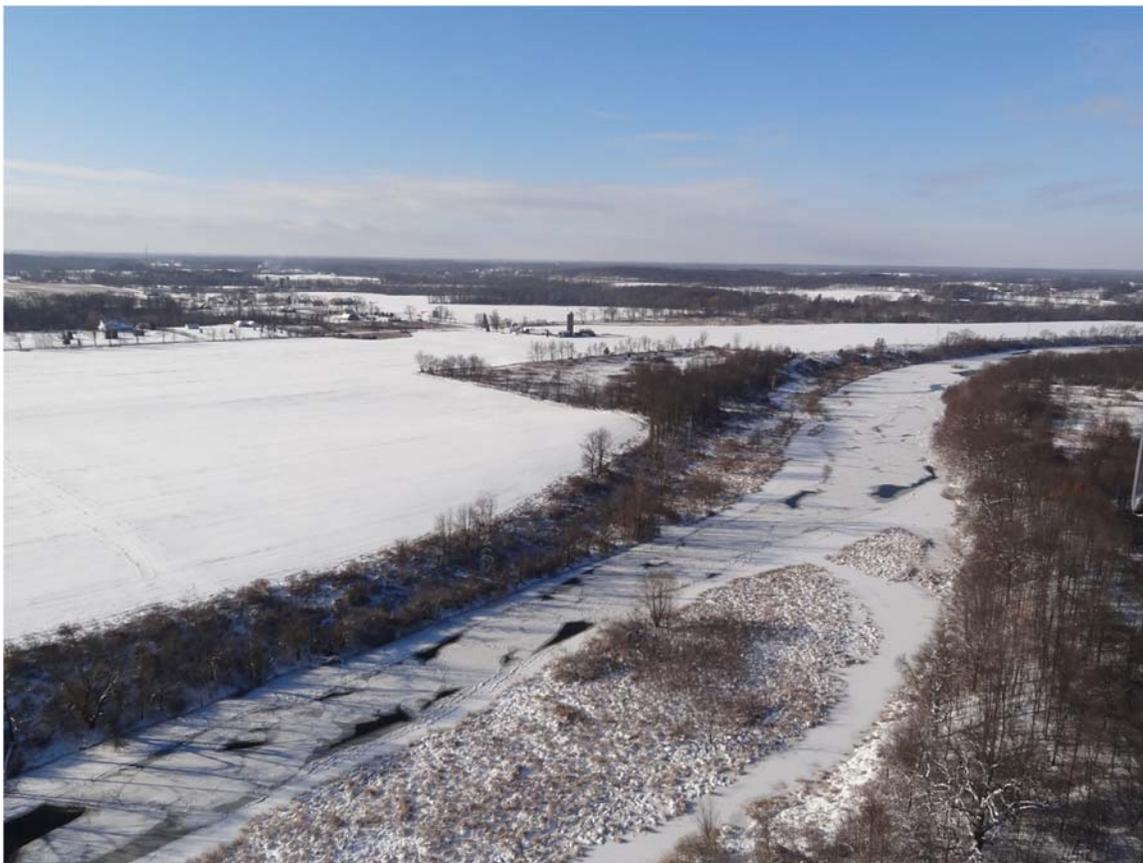
4. MP3.25 Observed the river close to completely frozen over.

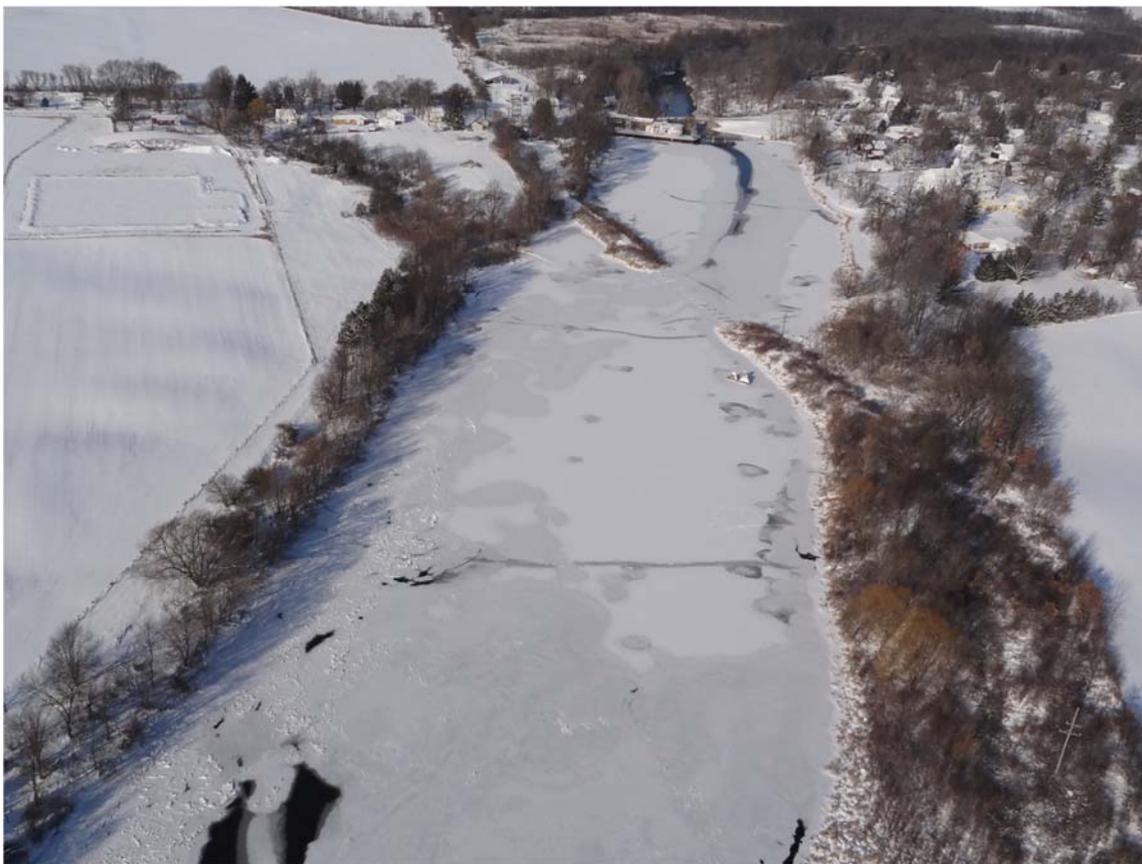
5. Ceresco Dam impoundment, observed the impoundment close to completely frozen over.

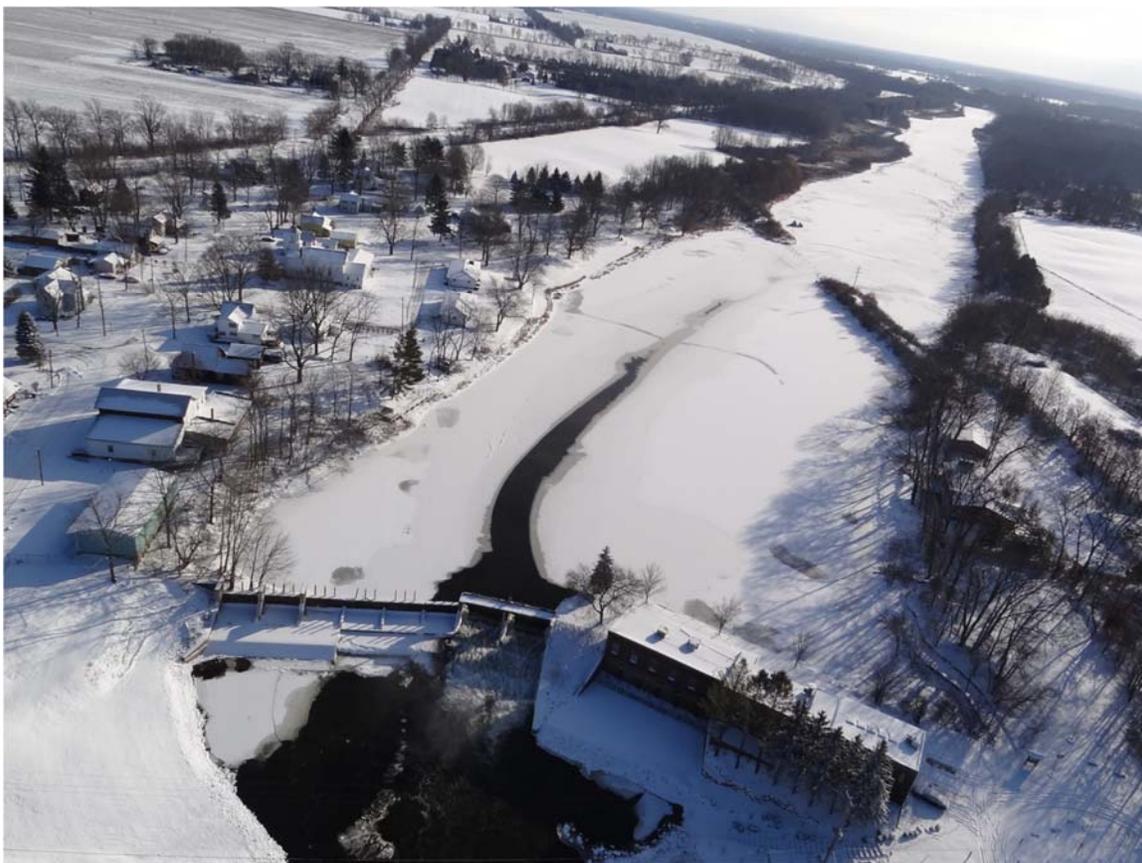
6. Ceresco Dam impoundment, observed the impoundment close to completely frozen over.

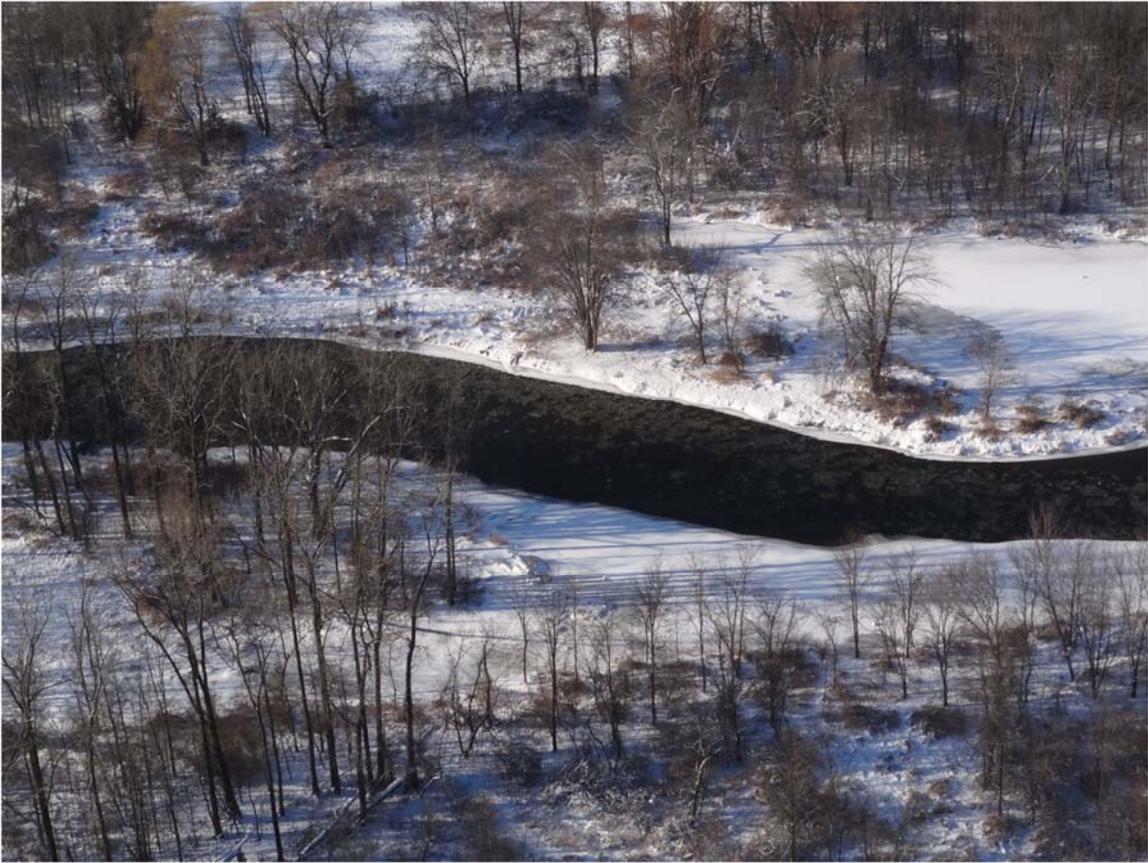
7. MP10.4 Sediment Trap ice conditions.

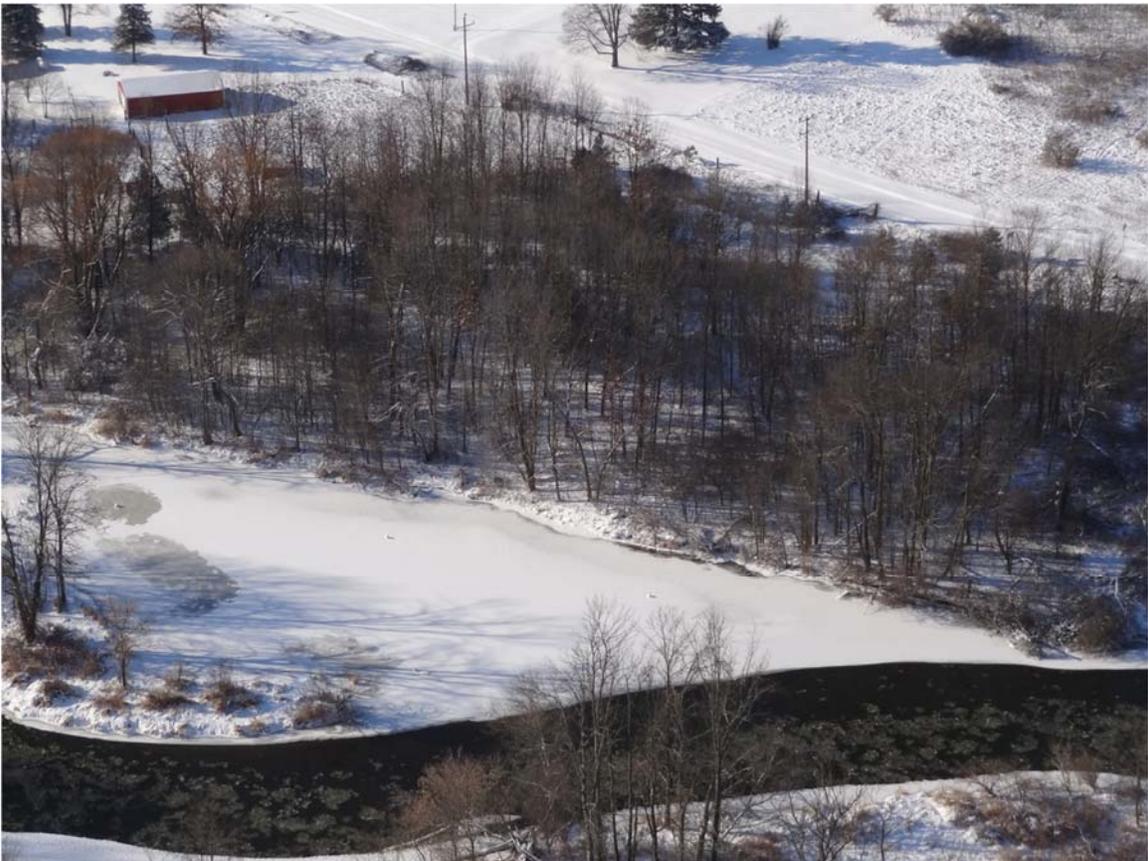
8. MP10.5 Sediment Trap ice conditions.

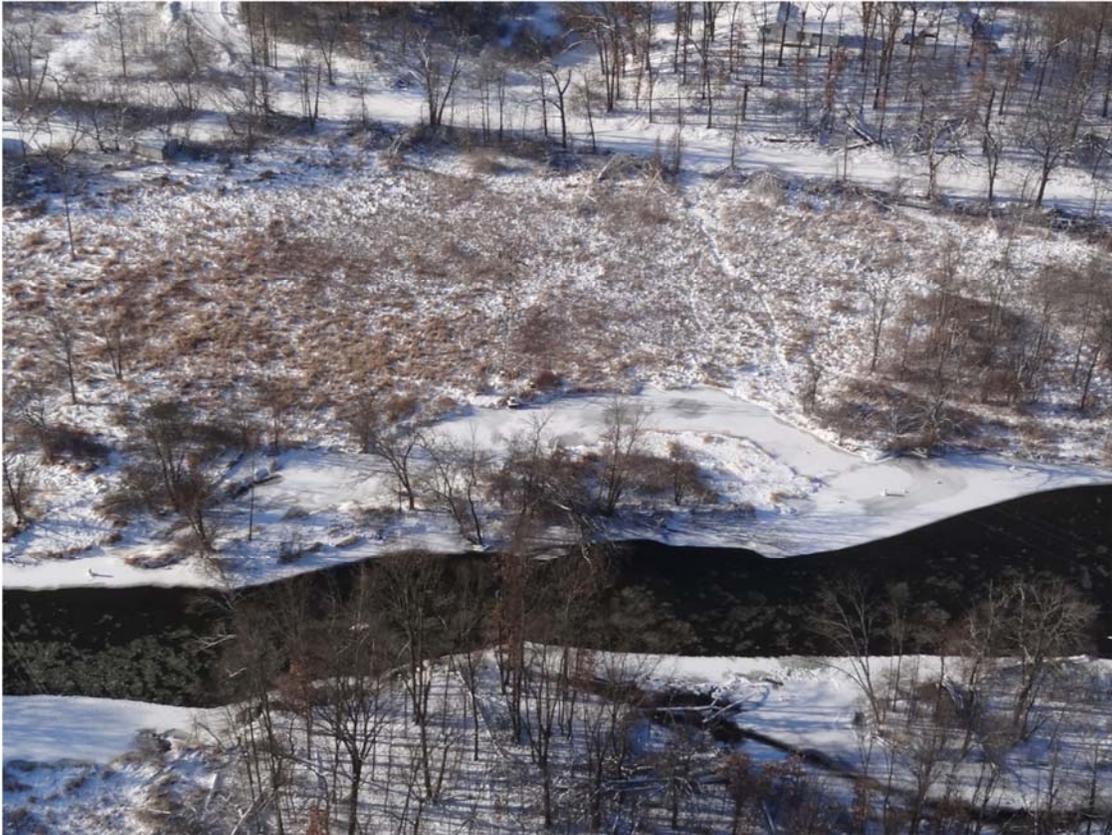
9. MP10.75 Sediment Trap ice conditions.

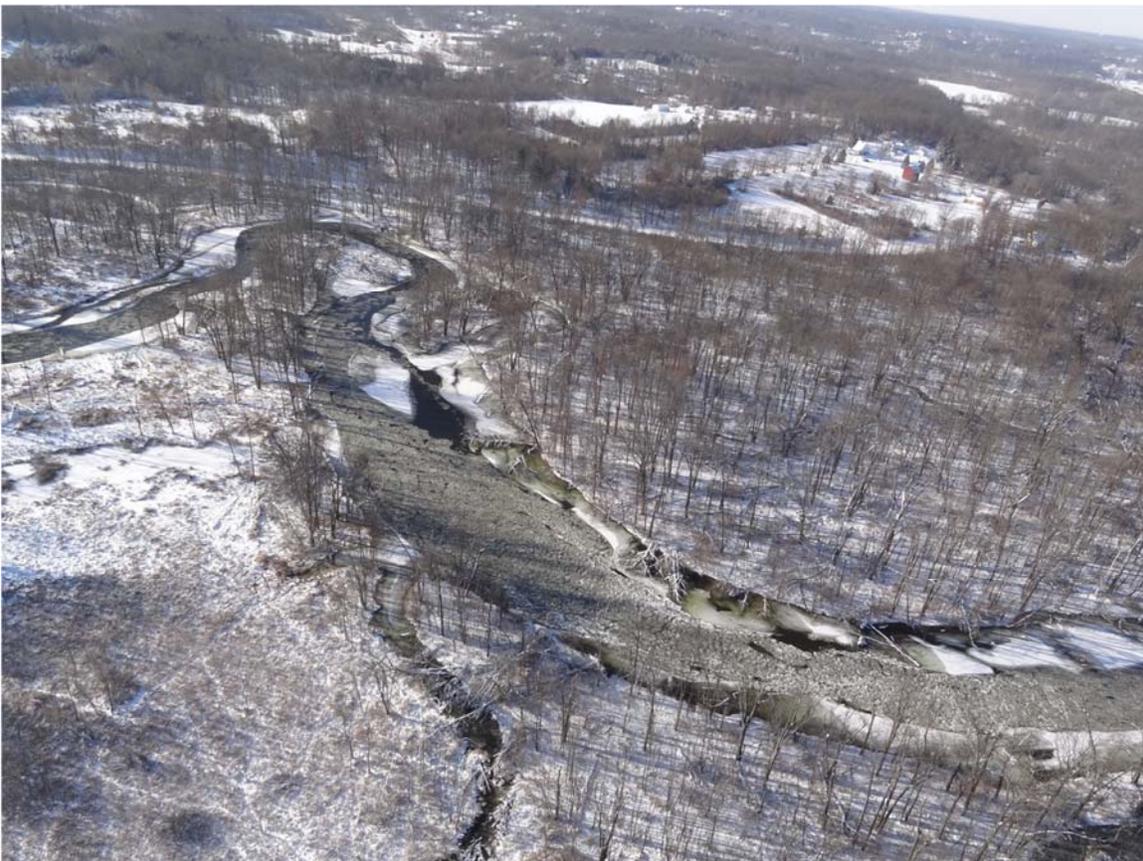
10. MP11.5 Observed the river close to completely frozen over.

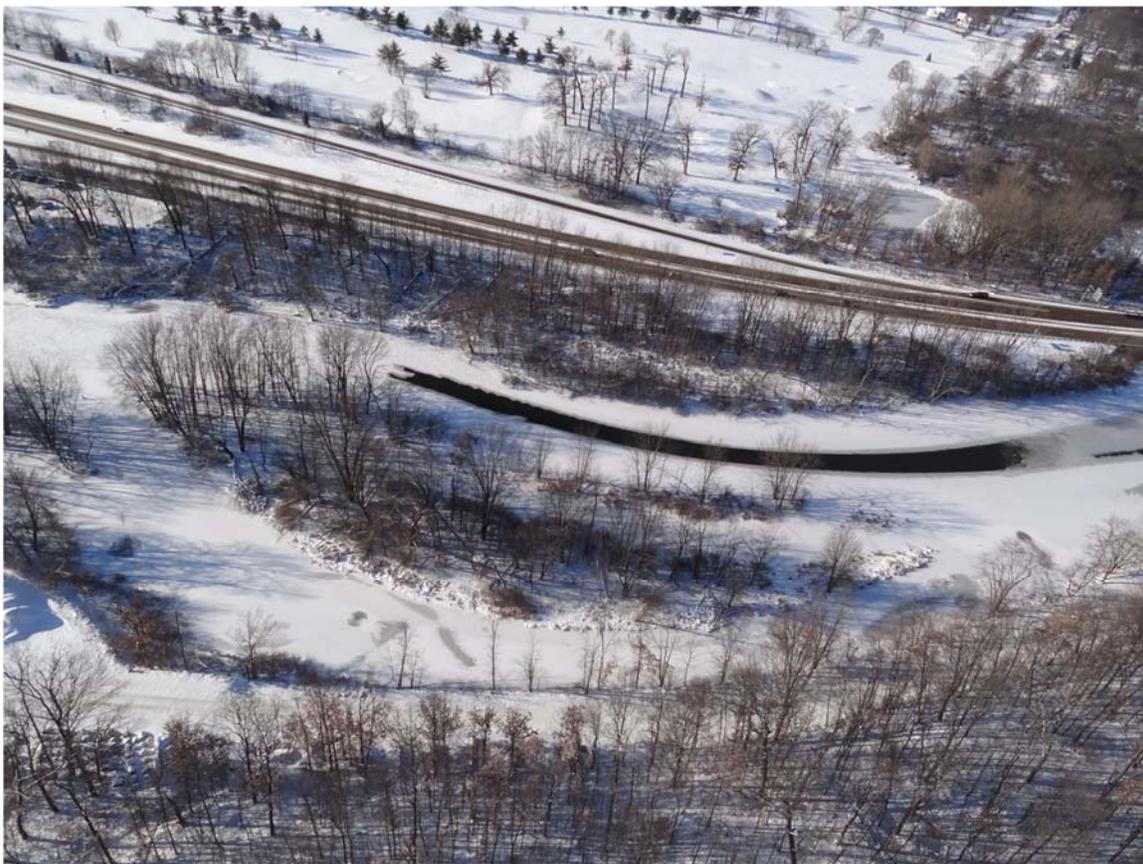
11. MP14.75 Sediment Trap ice conditions.

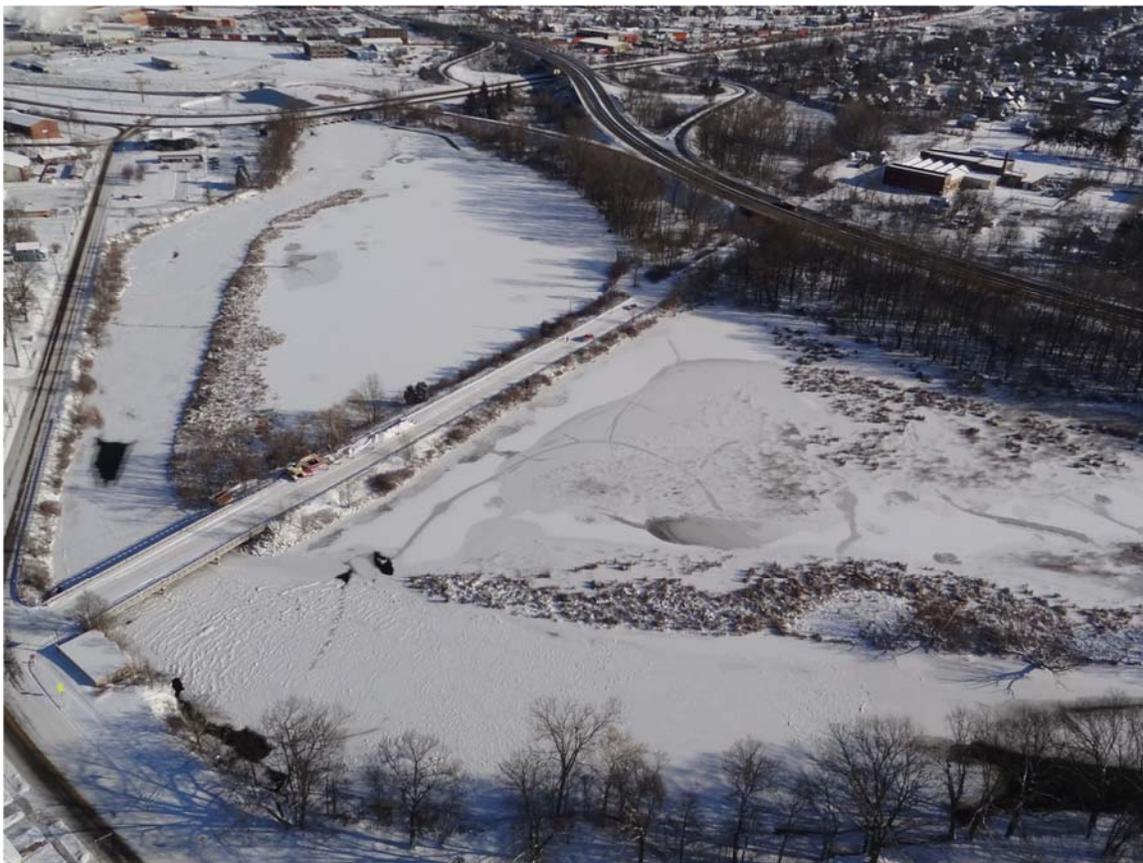
12. Observed the Mill Ponds ice conditions.

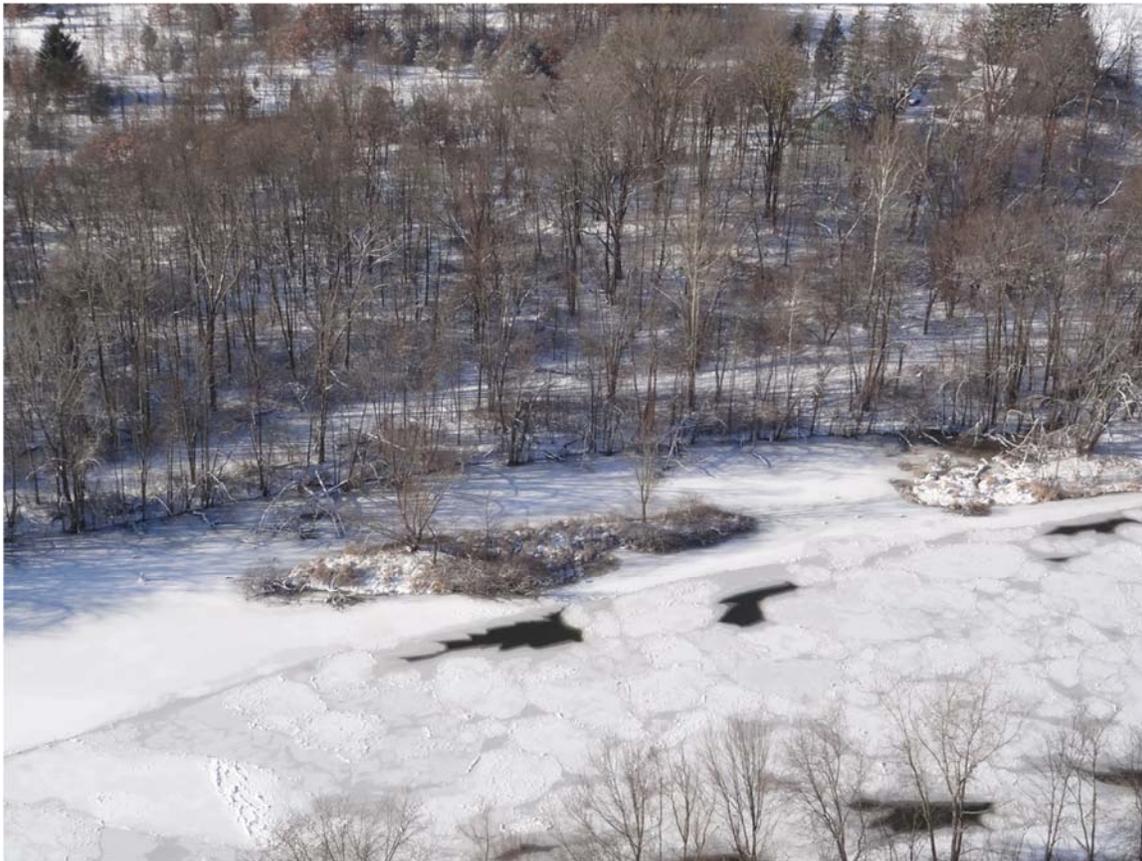
13. MP19.25 Sediment Trap ice conditions.

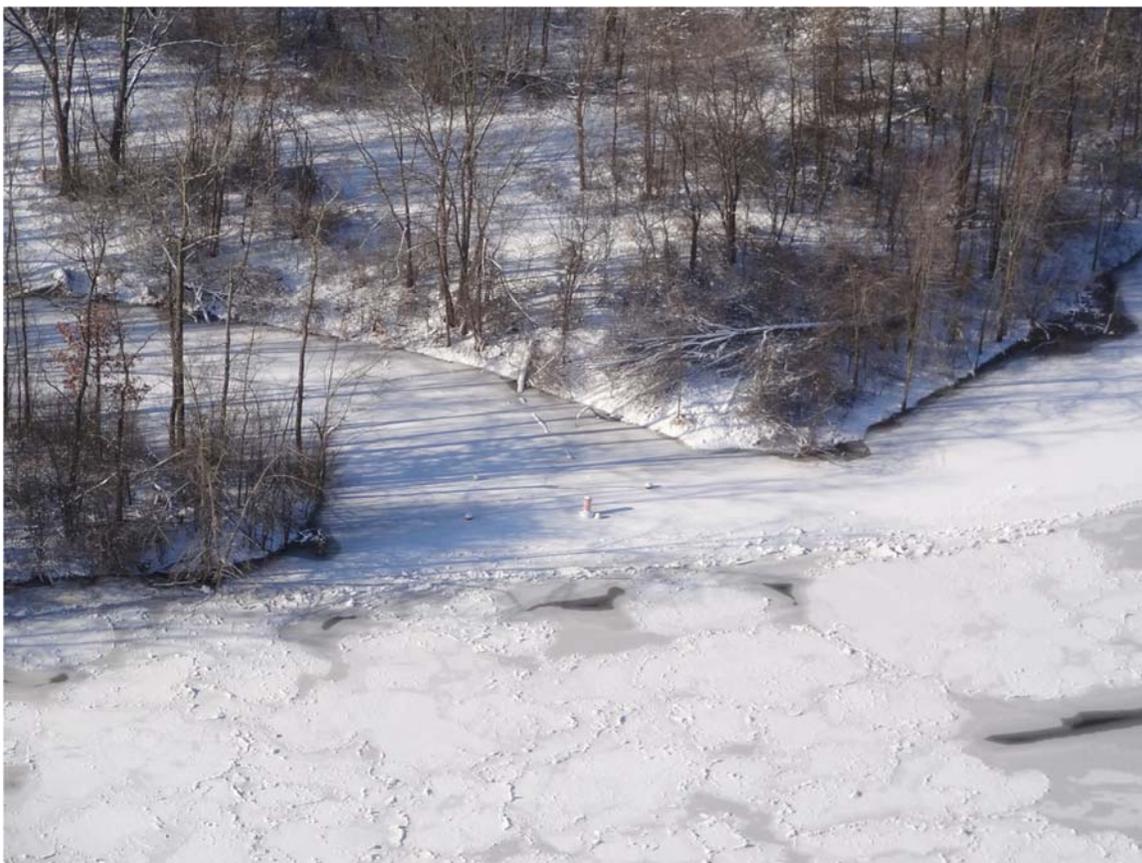
14. MP19.25 Sediment Trap ice conditions.

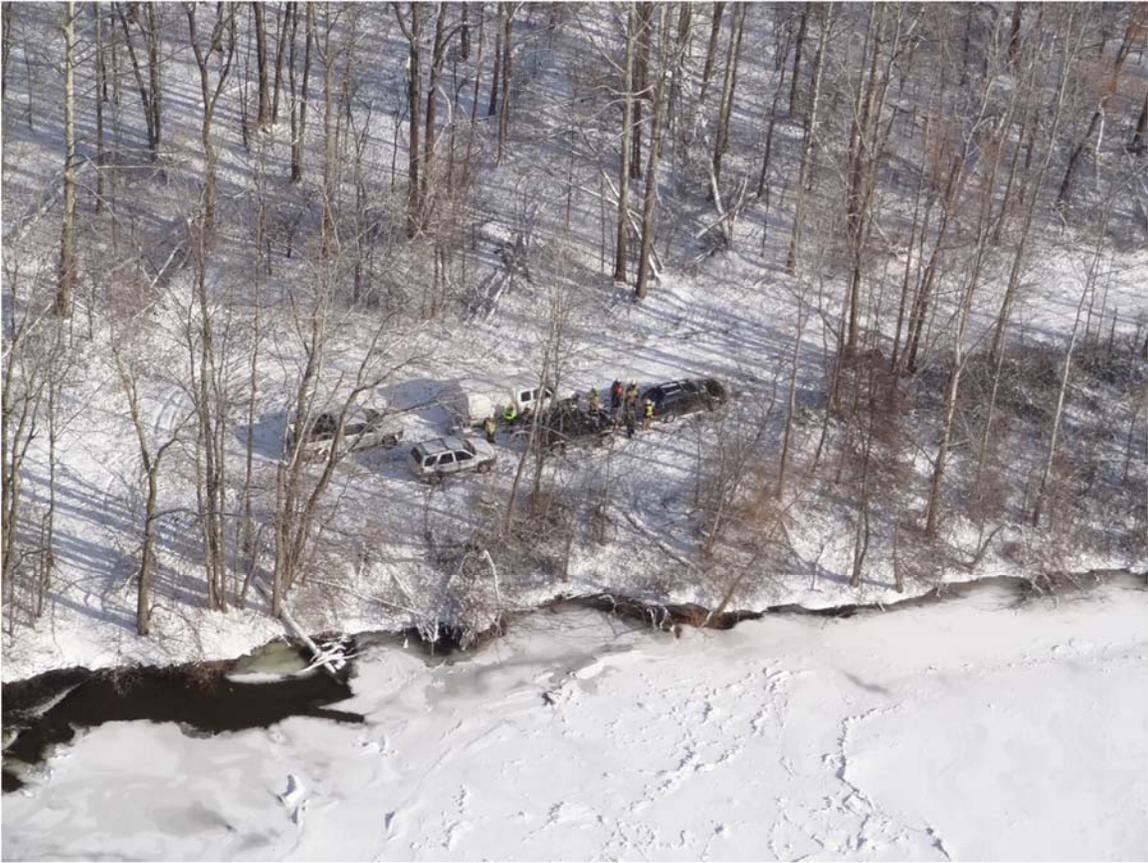
15. MP20.75 RDB observed the RI Crew.

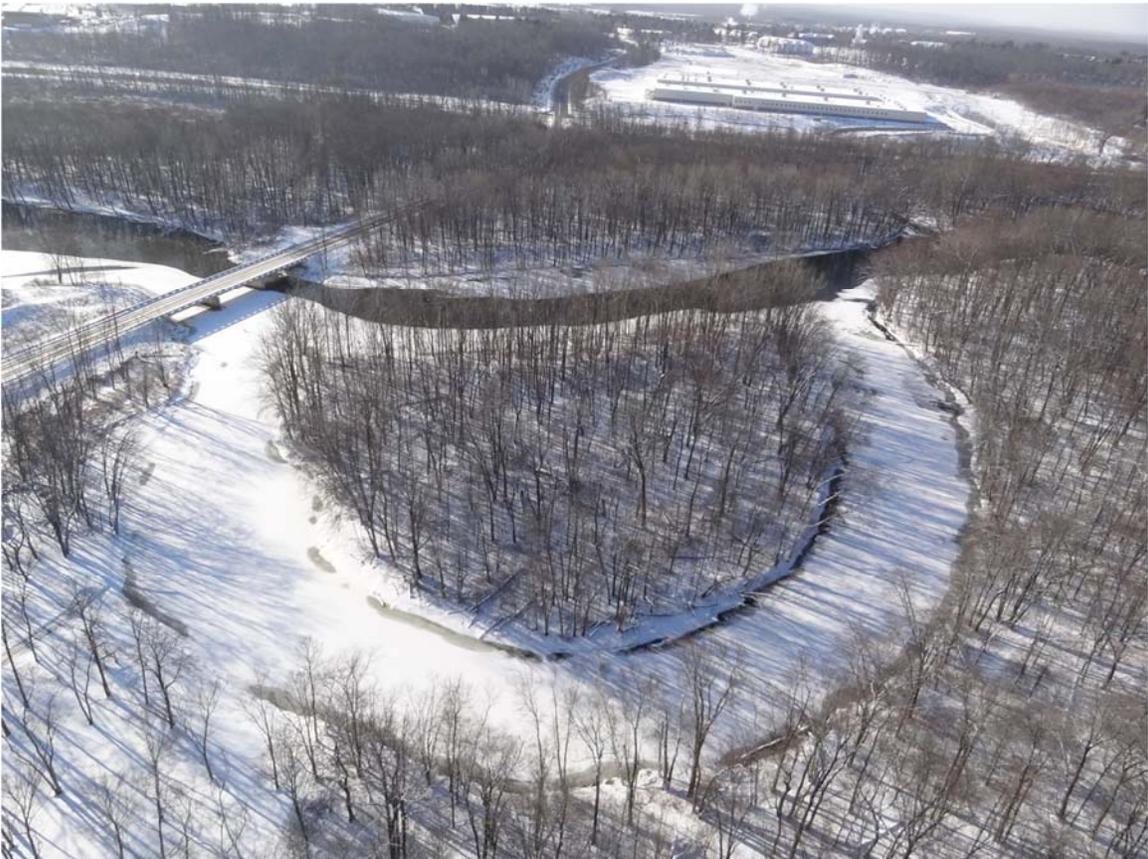
16. MP21.5 Sediment Trap ice conditions.

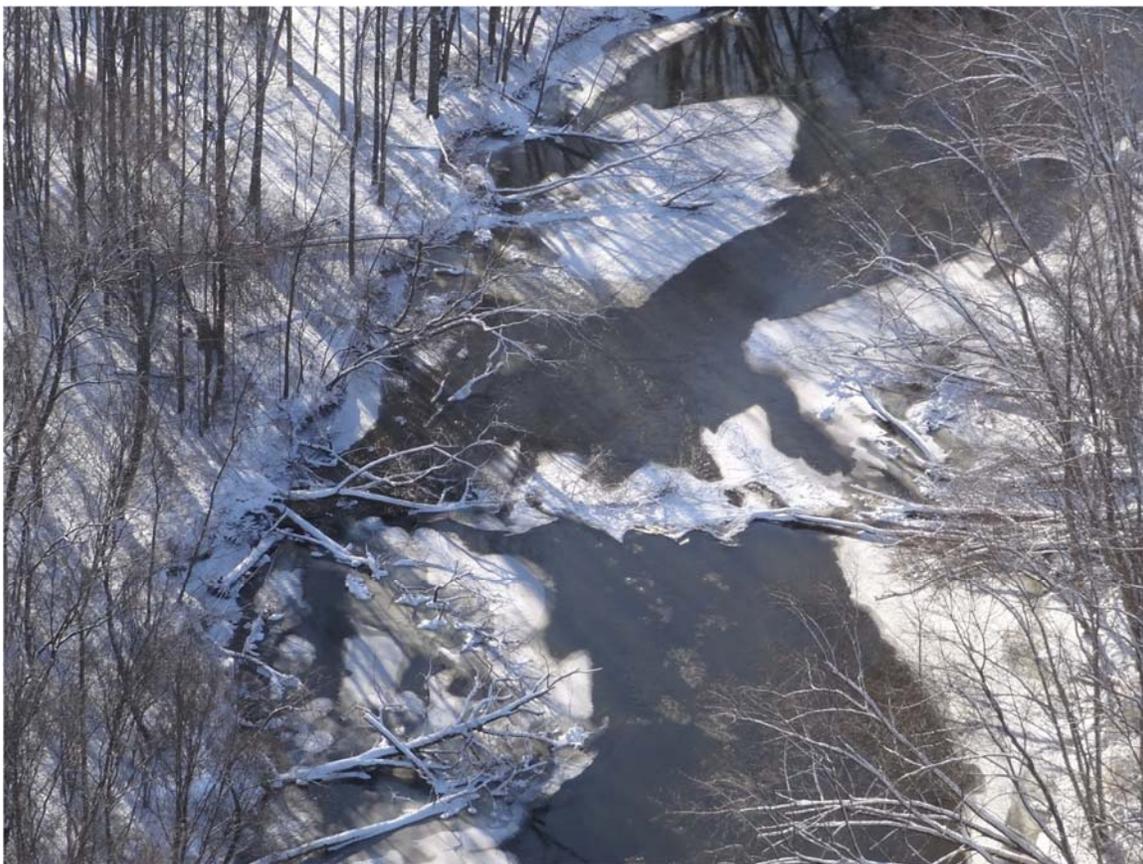
17. MP23.5 Observed two trees across the river.

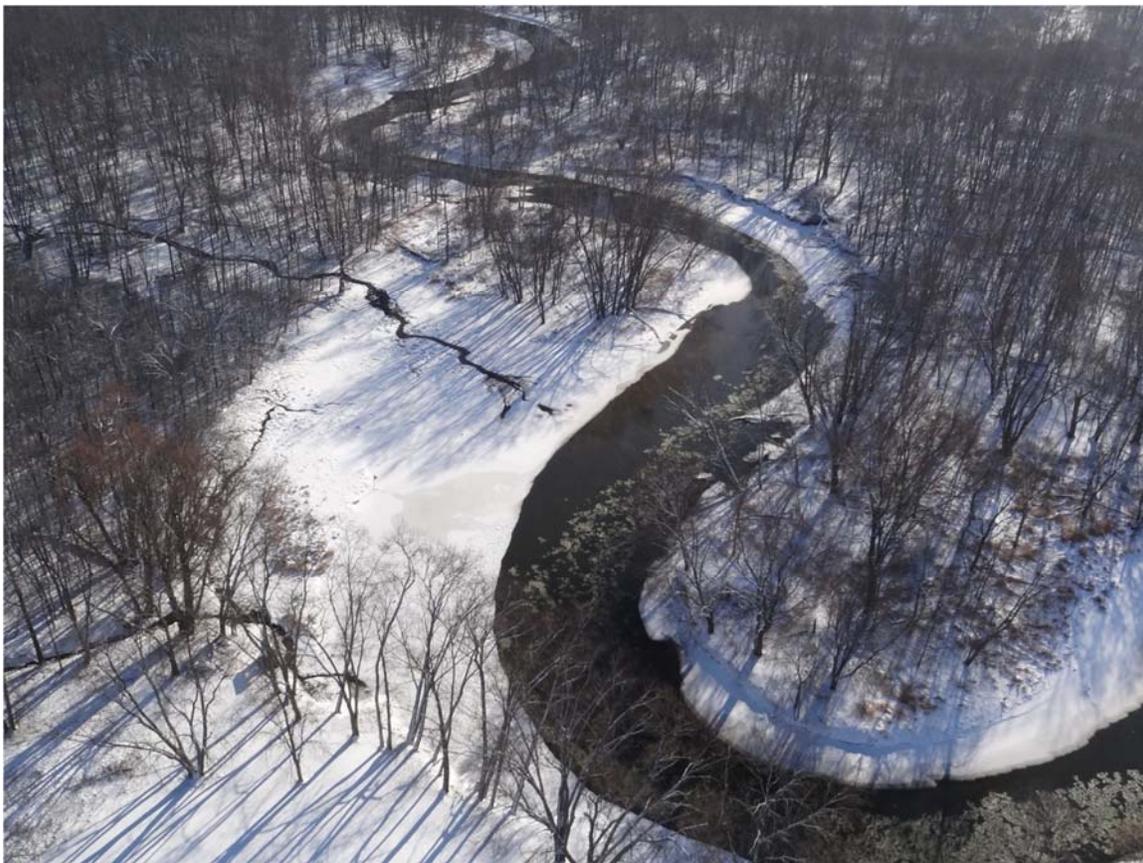
18. MP26.0 Sediment Trap ice conditions.

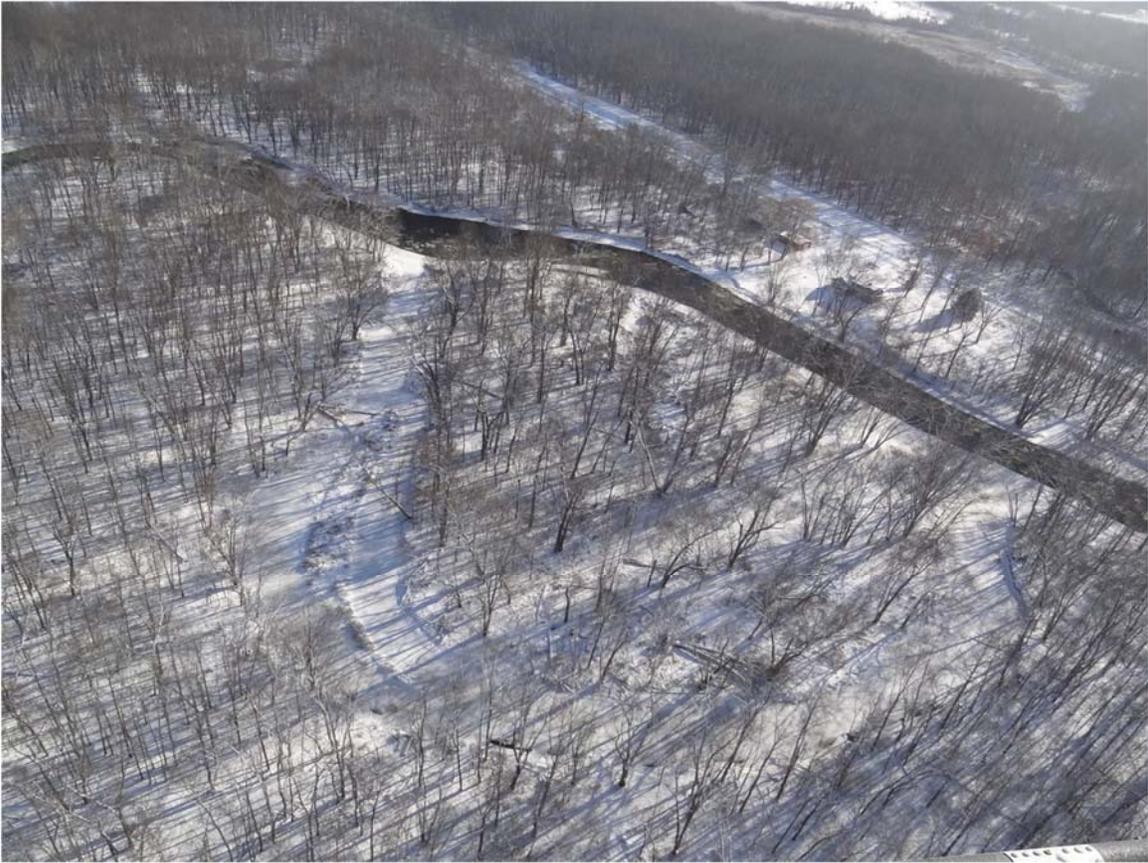
19. MP28.25 Sediment Trap ice conditions.

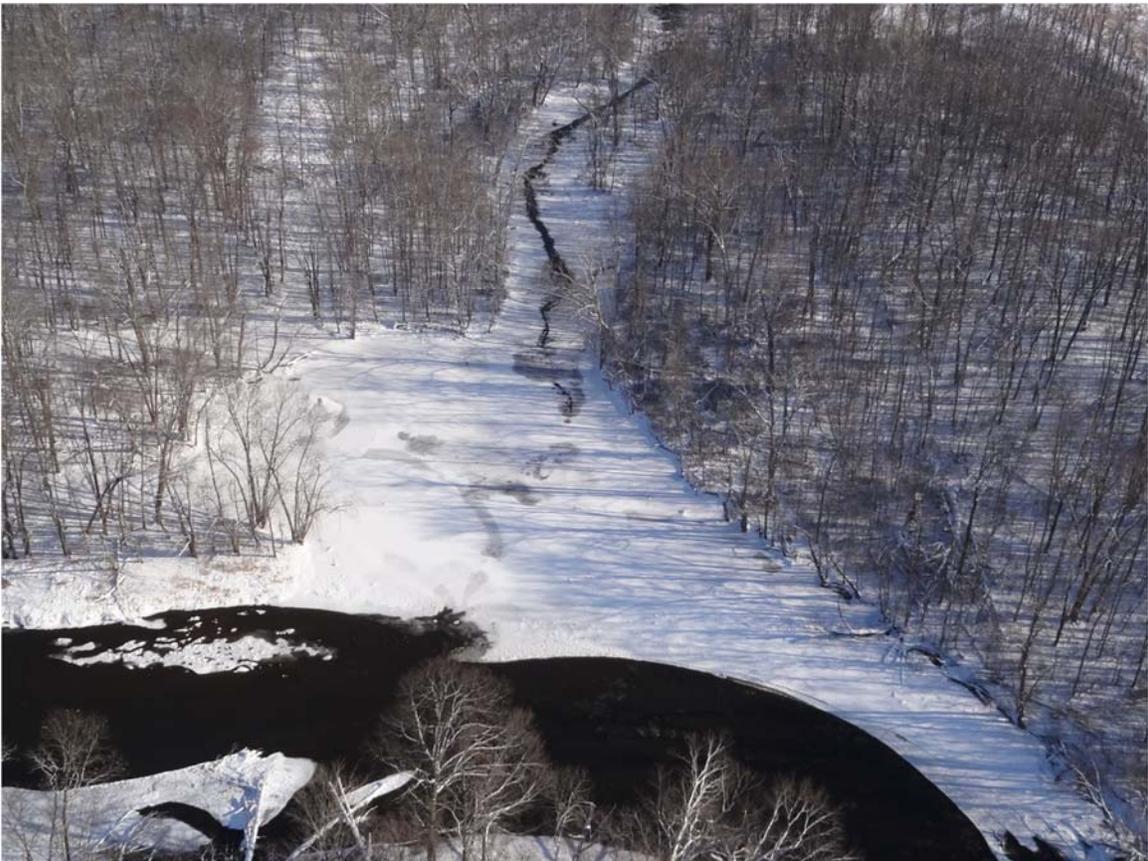
20. MP30.8 Sediment Trap ice conditions.

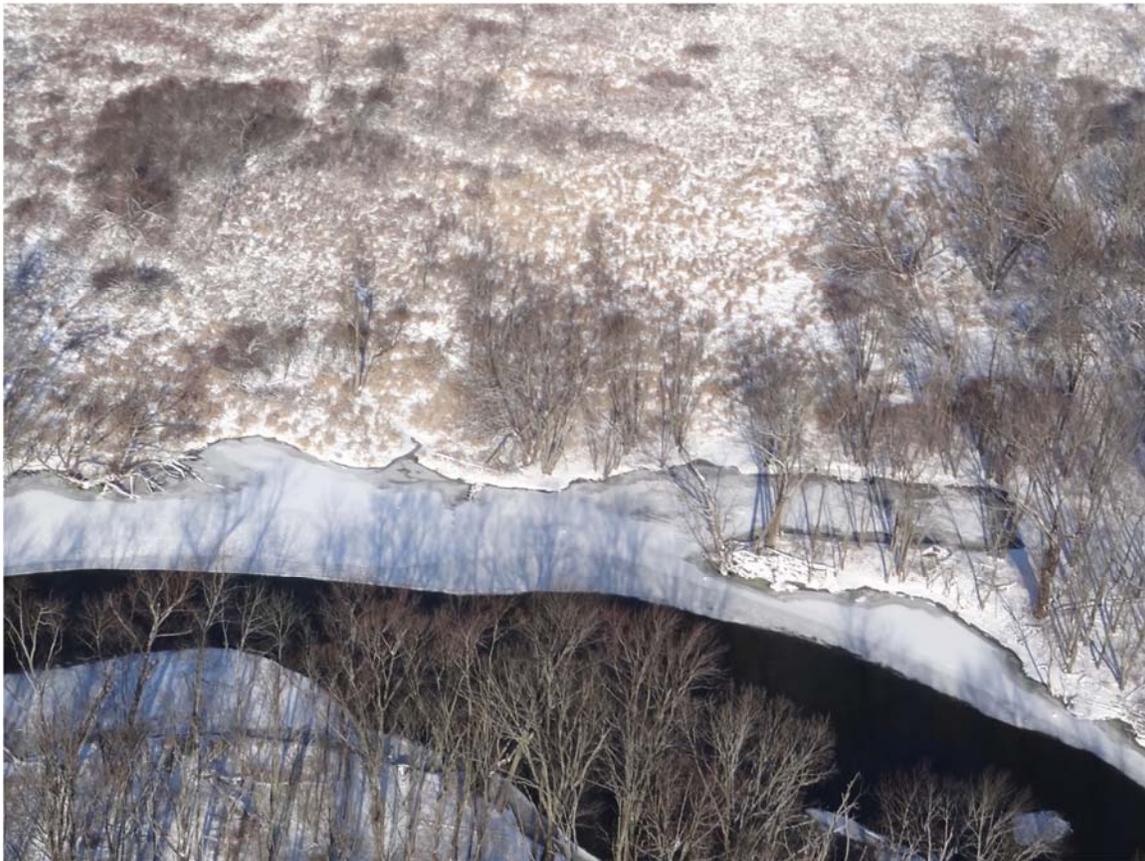
21. MP33.0A Sediment Trap ice conditions.

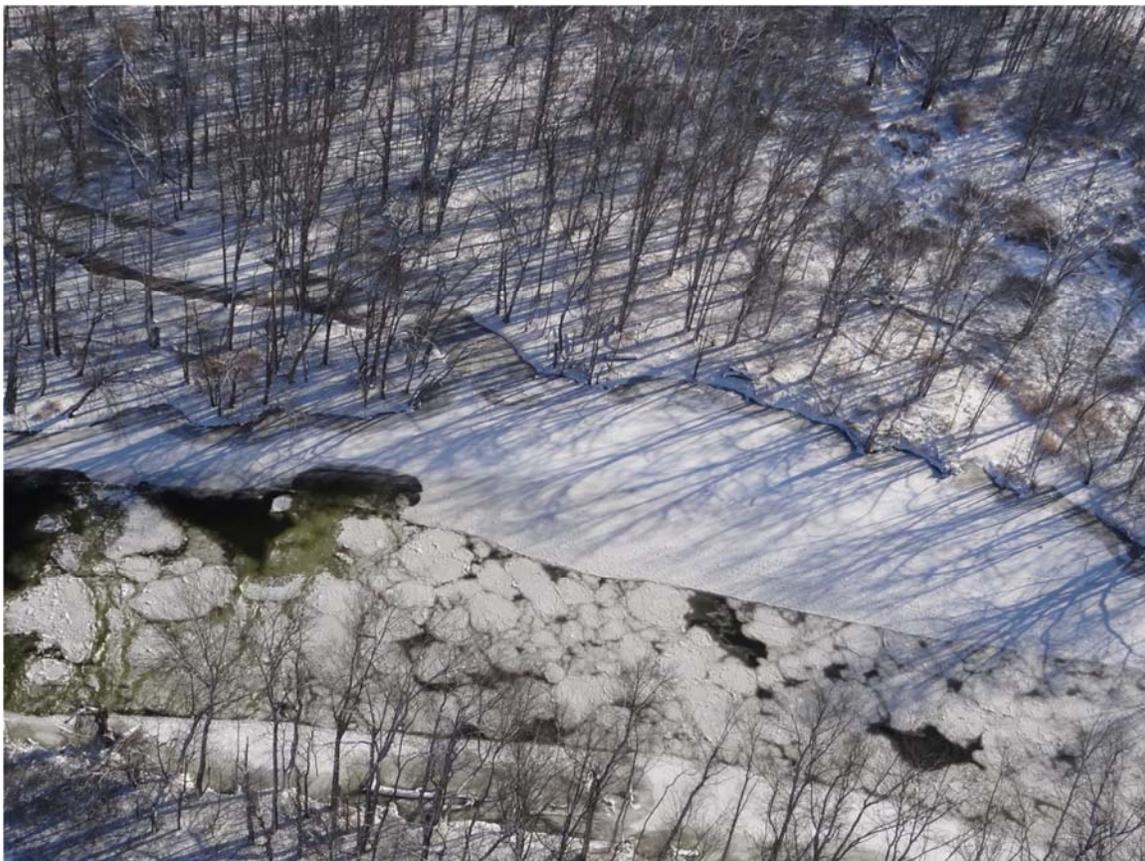
22. MP33.0B Sediment Trap ice conditions.

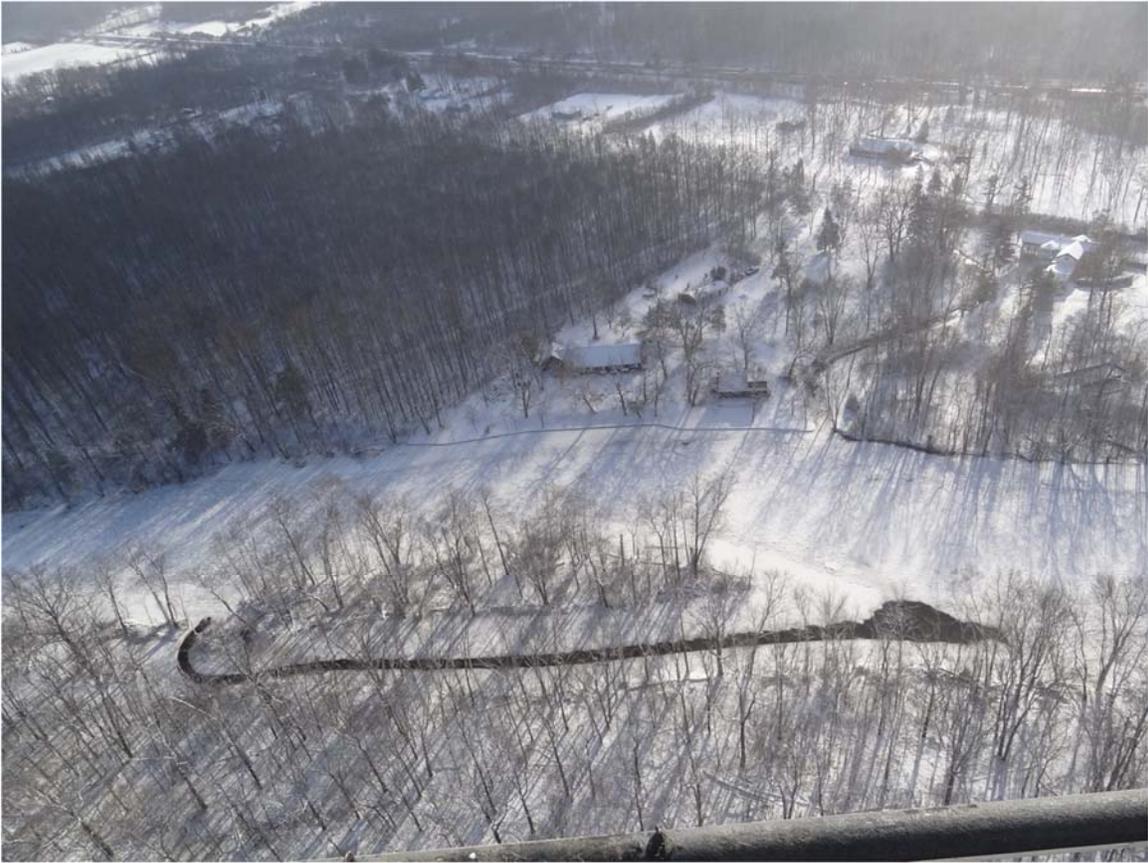
23. MP36.10 Sediment Trap ice conditions.
