Situation Photo Log

Tuesday, January 22, 2013

Kalamazoo River / Enbridge Spill

Prepared by:
Matthew Haak
START-USEPA
Situation Unit Leader

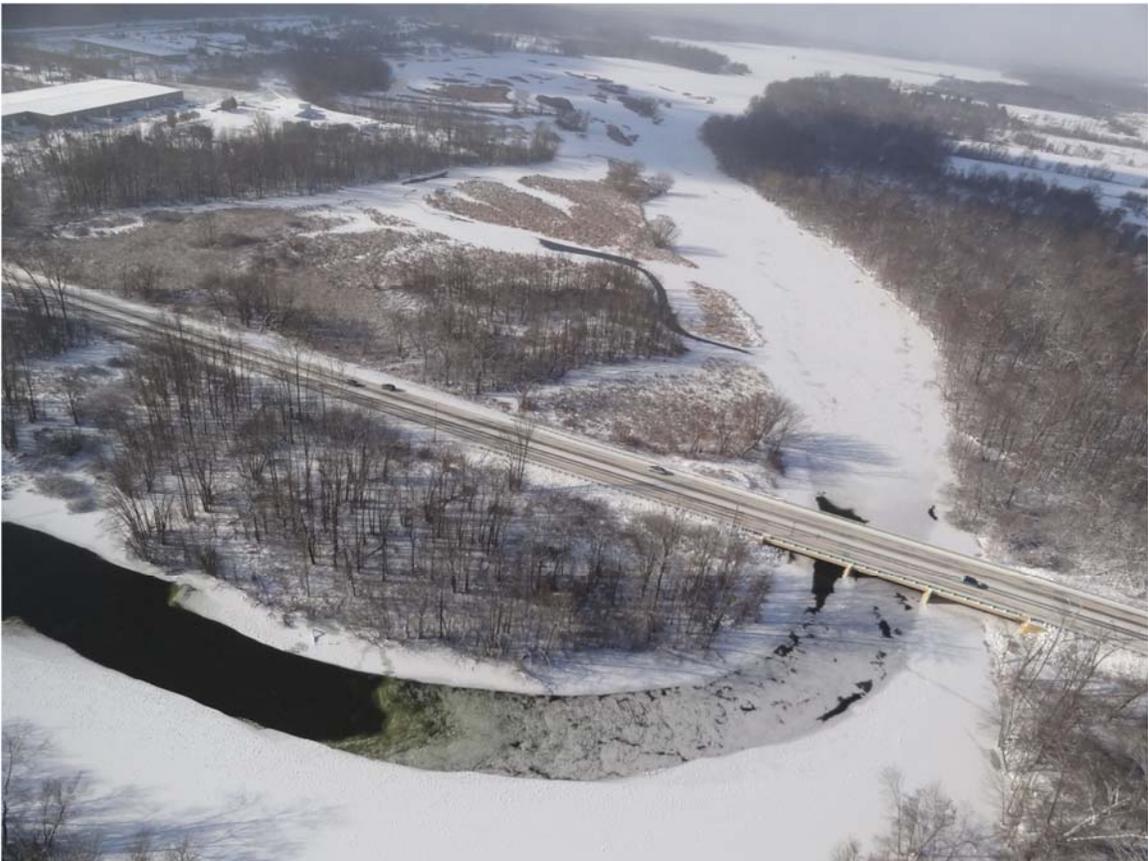
24. MP36.5 Entering into the Morrow Lake Delta ice conditions.

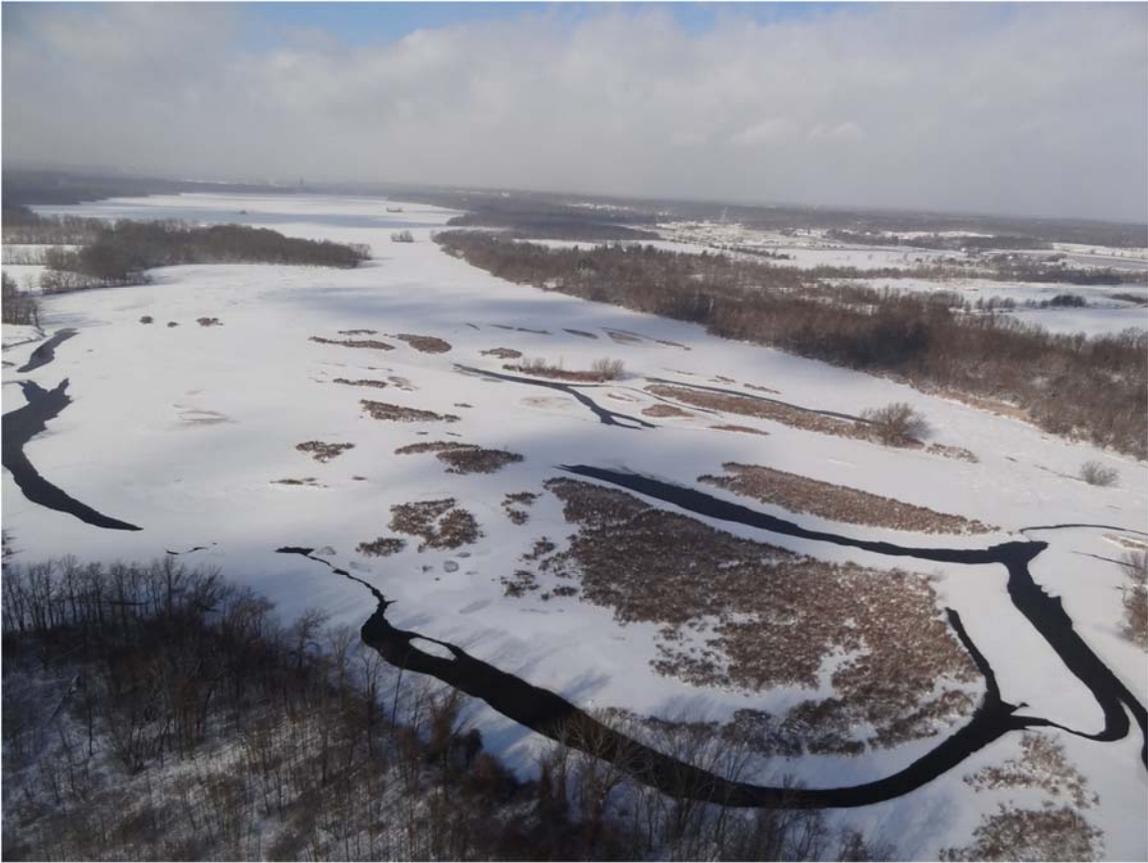
25. Morrow Lake Delta ice conditions.

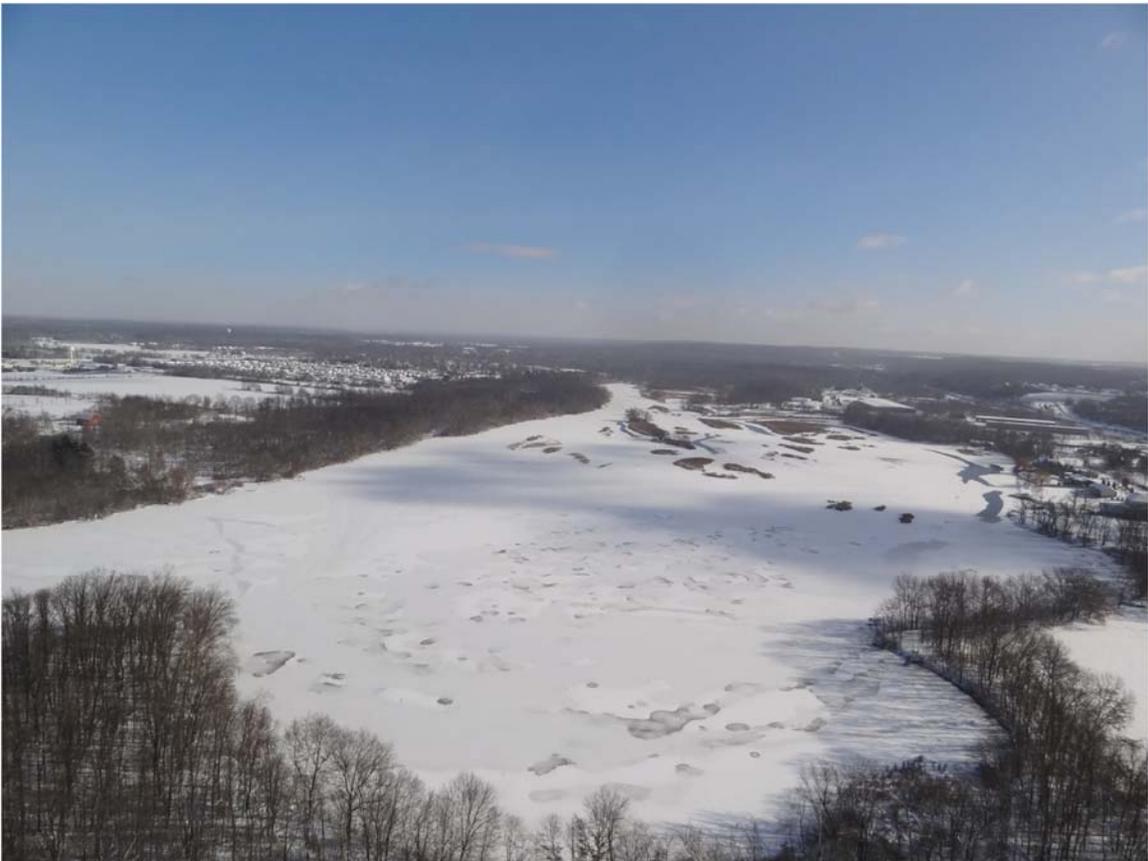
26. Morrow Lake Delta ice conditions.

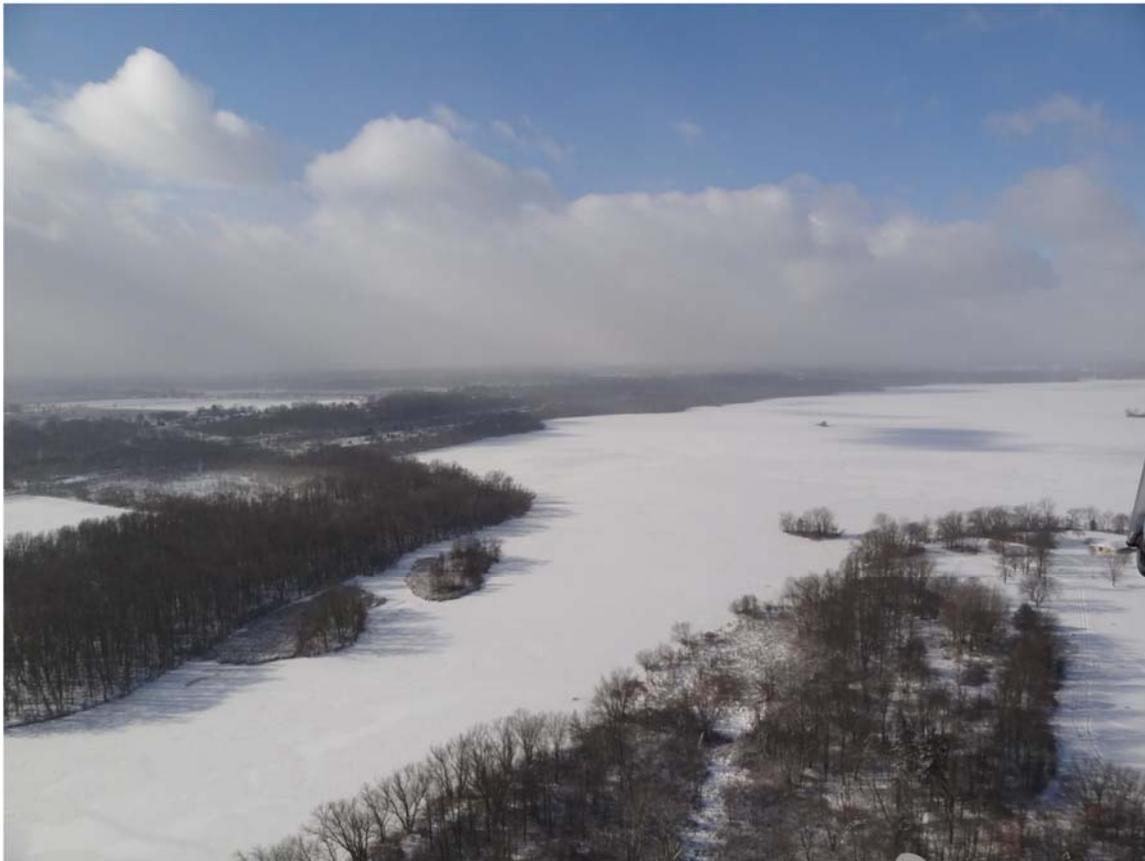
27. Morrow Lake Neck and Morrow Lake Ice conditions.

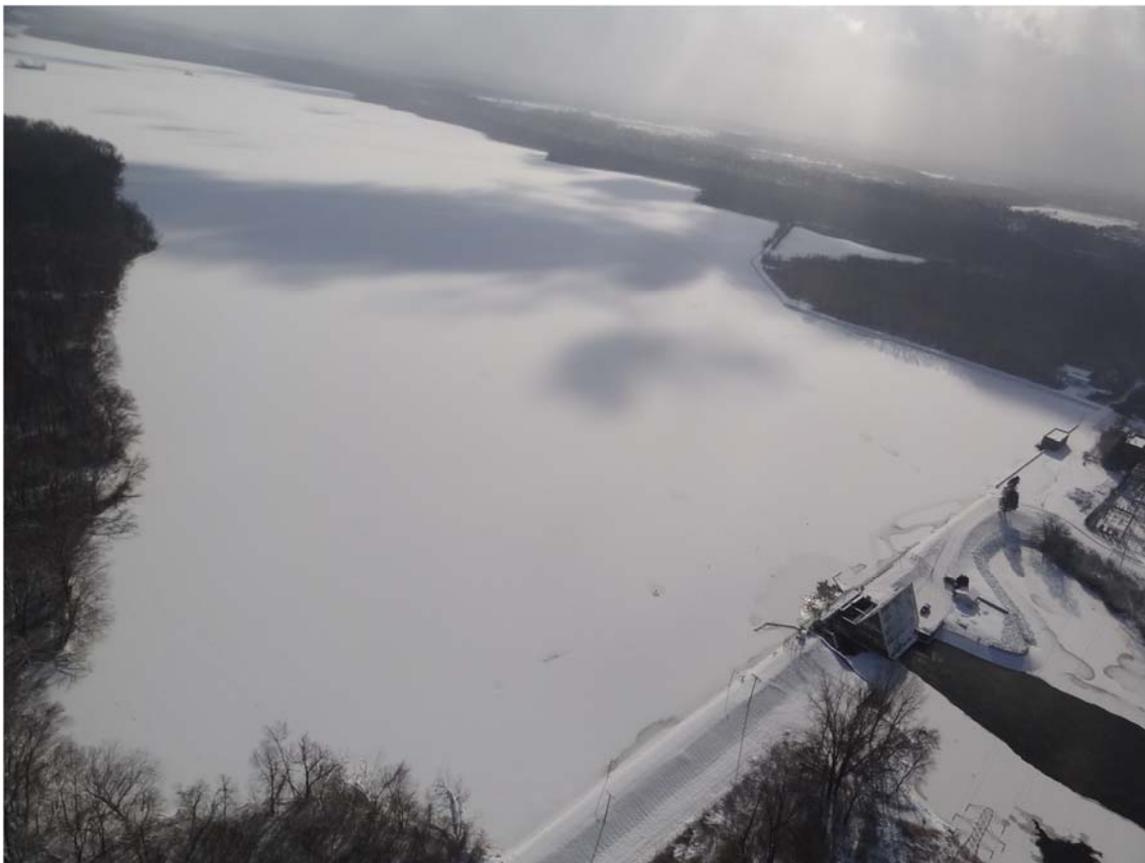
28. Morrow Lake ice conditions.

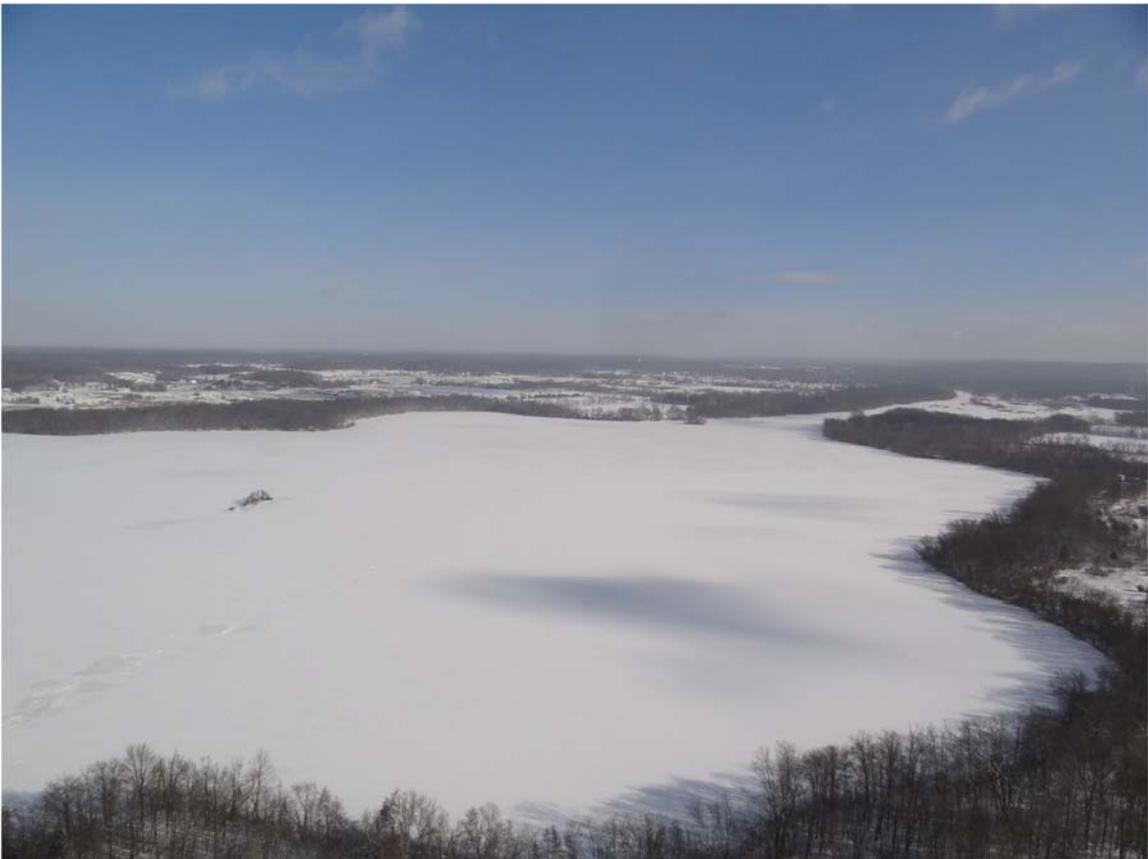
30. Morrow Lake ice conditions.
