# Situation Photo Log

Wednesday, January 23, 2013

Kalamazoo River / Enbridge Spill

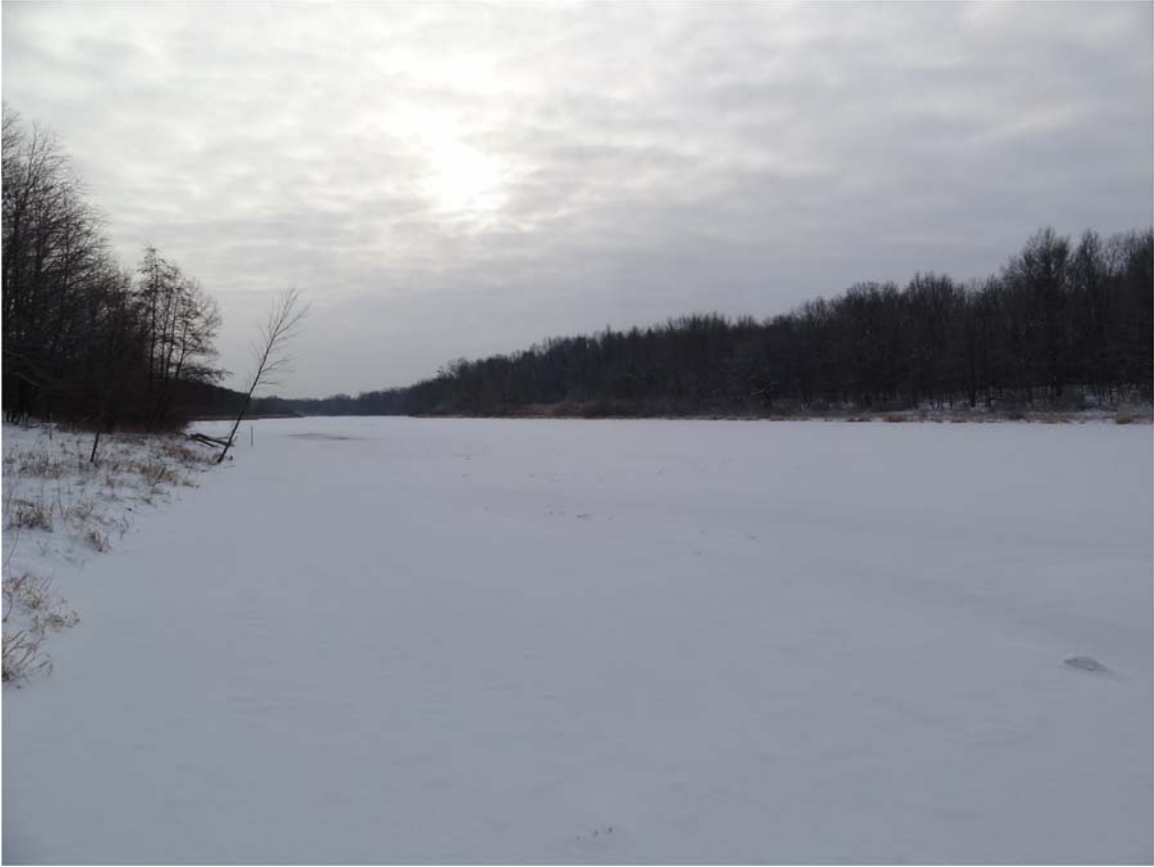
1. C0.4 Boat launch observed the river completely frozen over.

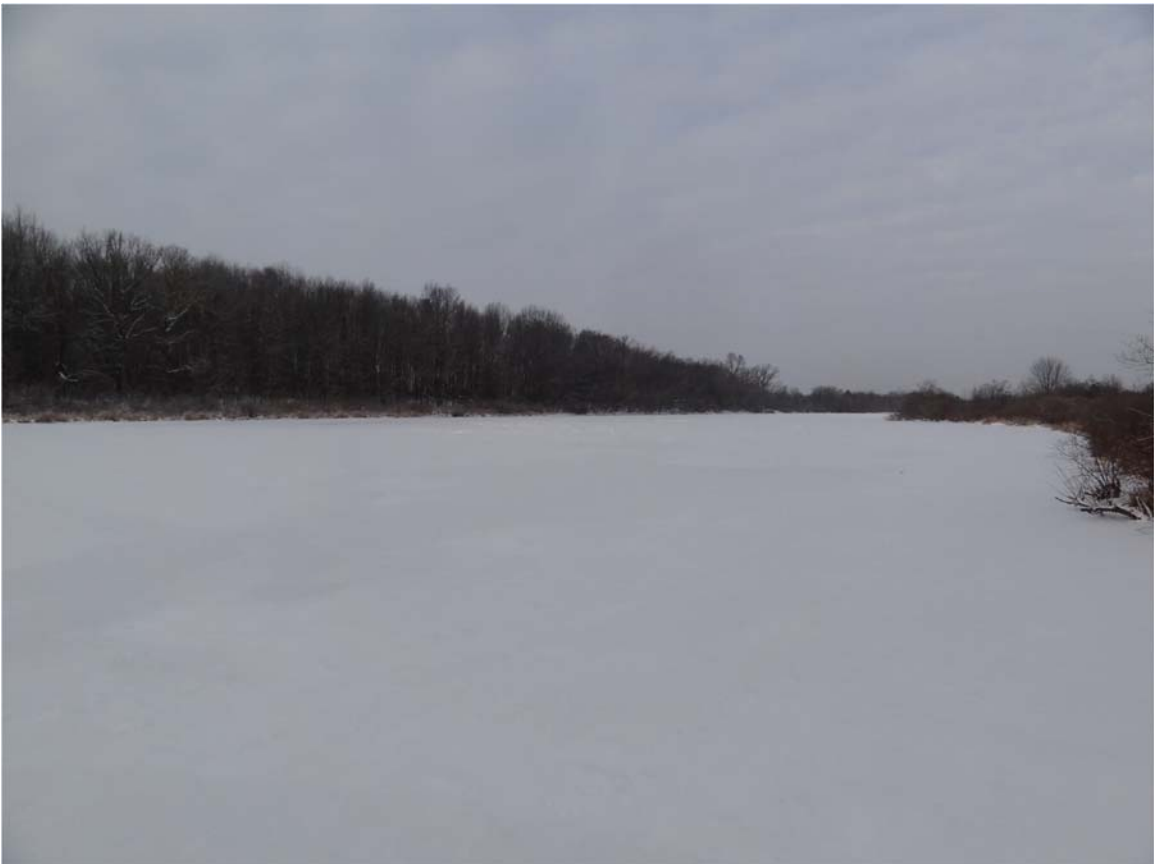
2. C0.4 Boat launch observed the river completely frozen over.

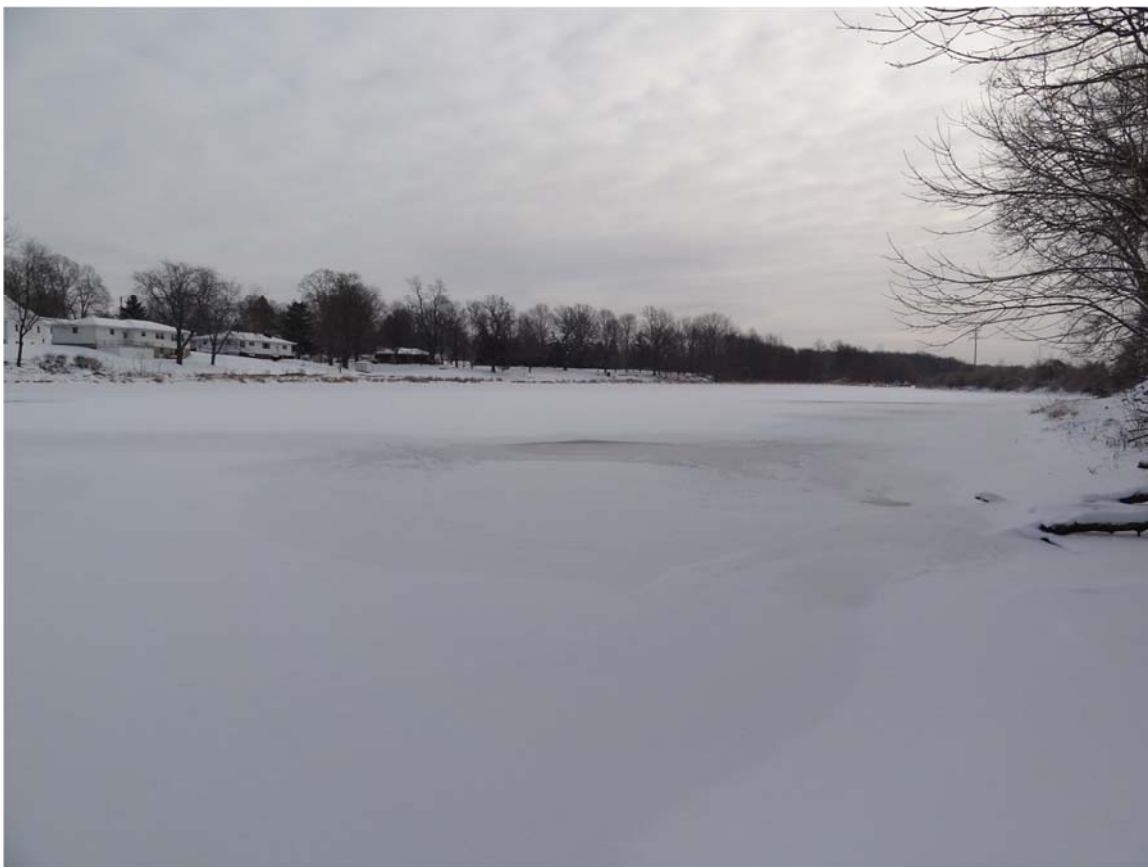
3. Ceresco Dam impoundment observed the impoundment completely frozen over.

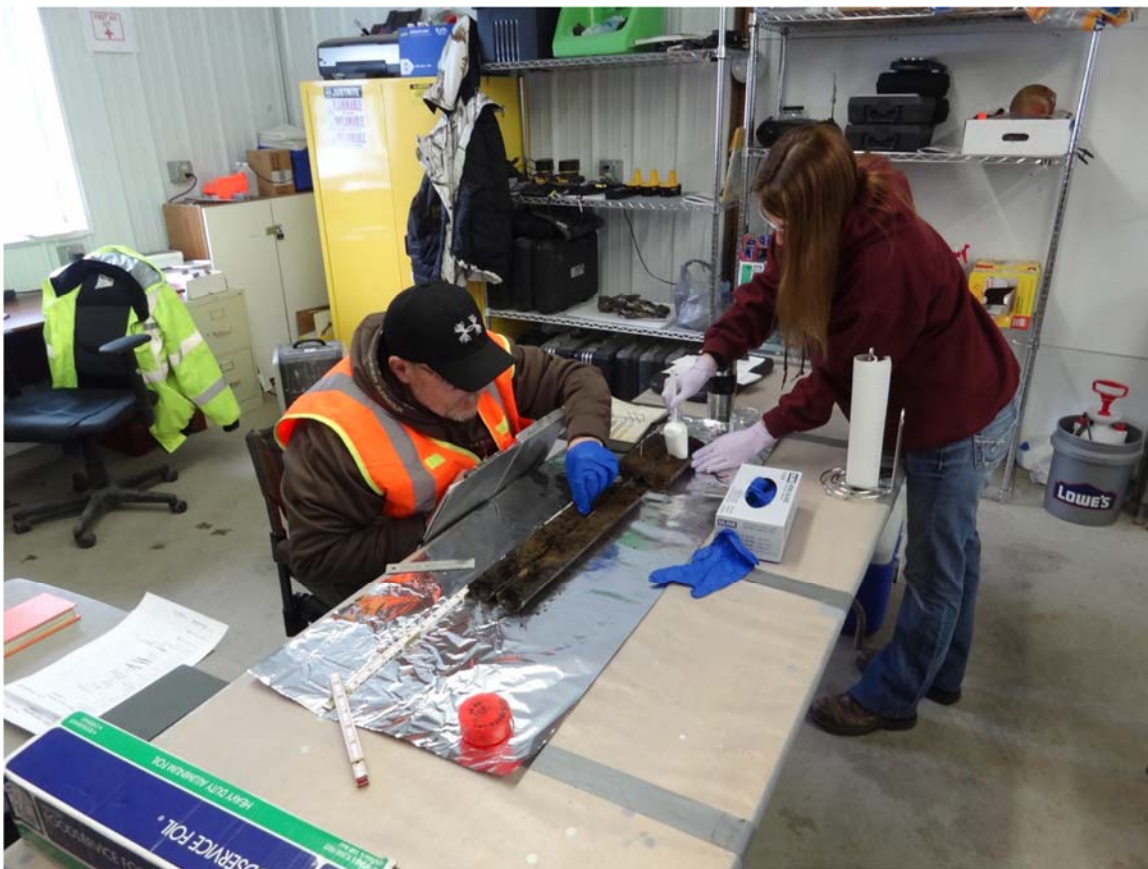
4. C3.2 Pole Barn observed core logging operations.

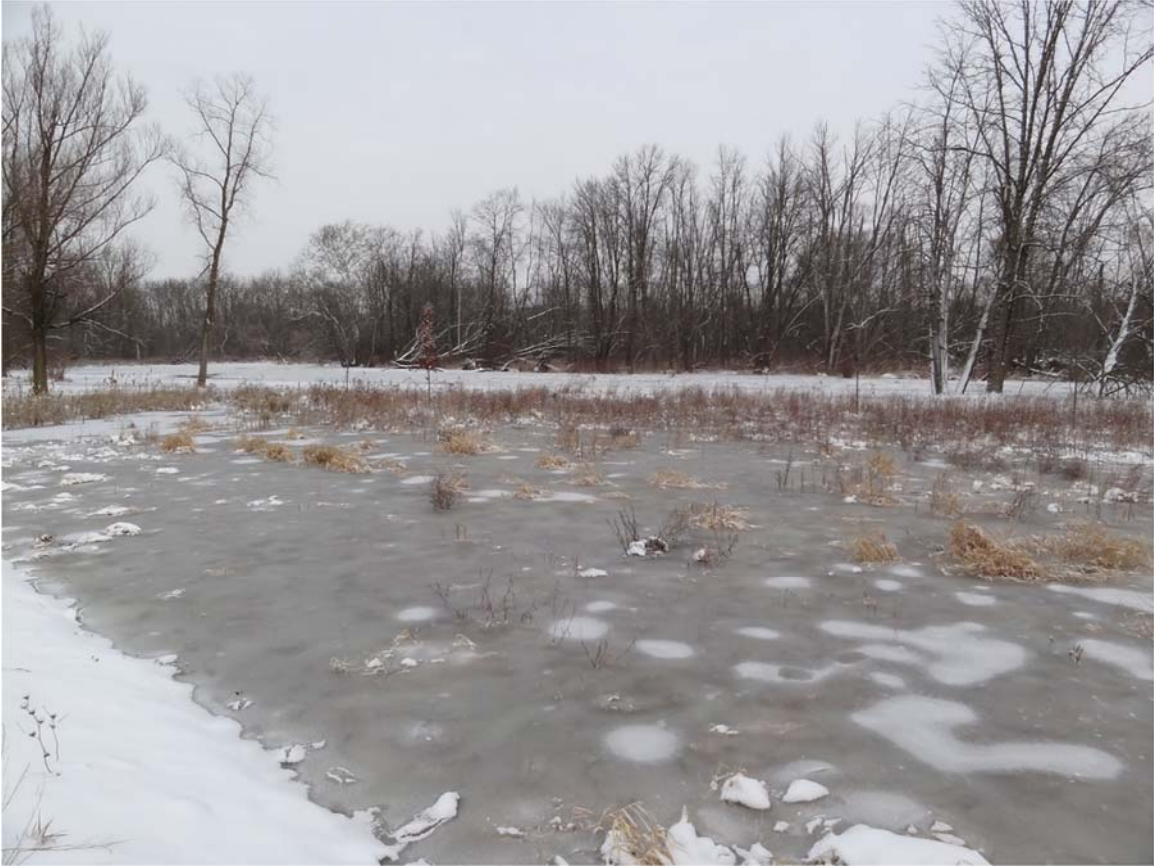
**5. C3.2 Boat launch observed the river backing up and flooding into the overbank.**

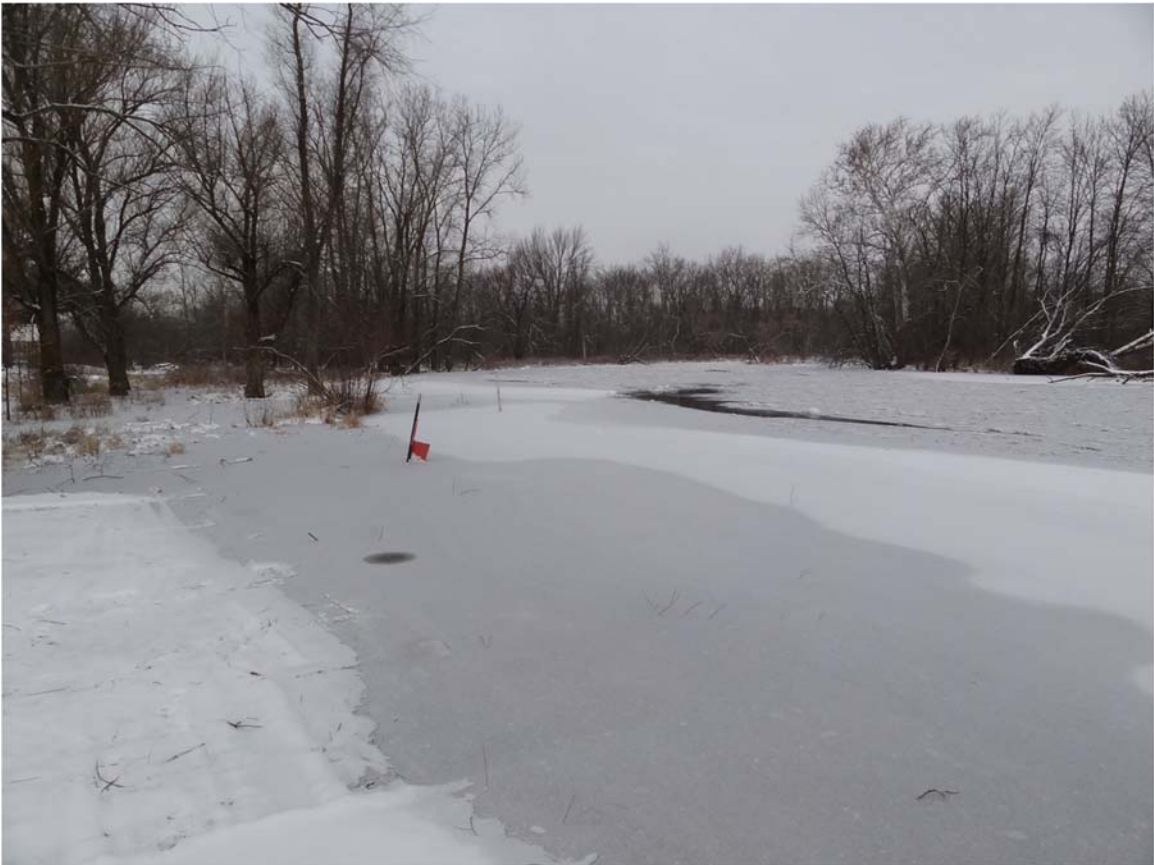
**6. C3.2 Boat launch observed the river backing up and flooding into the overbank.**

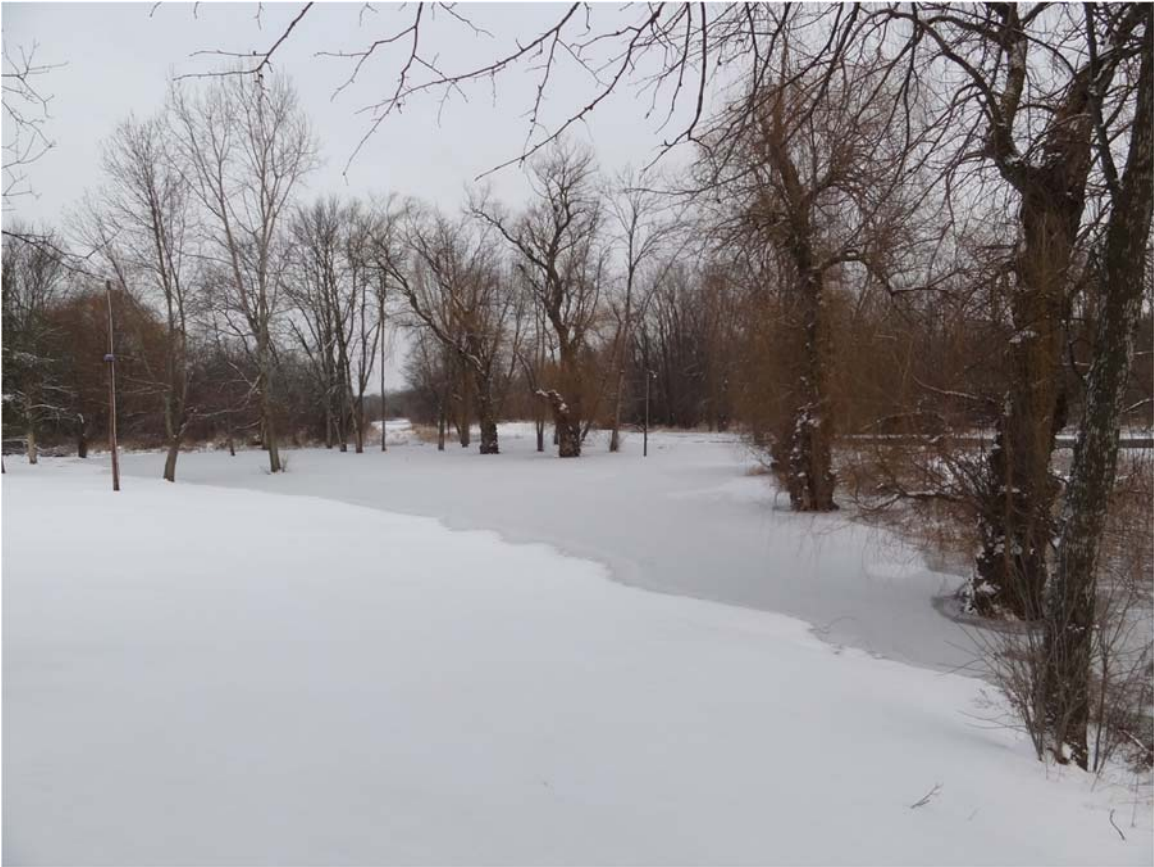
**7. MP10.35 LDB observed the river backing up and flooding into the overbank.**

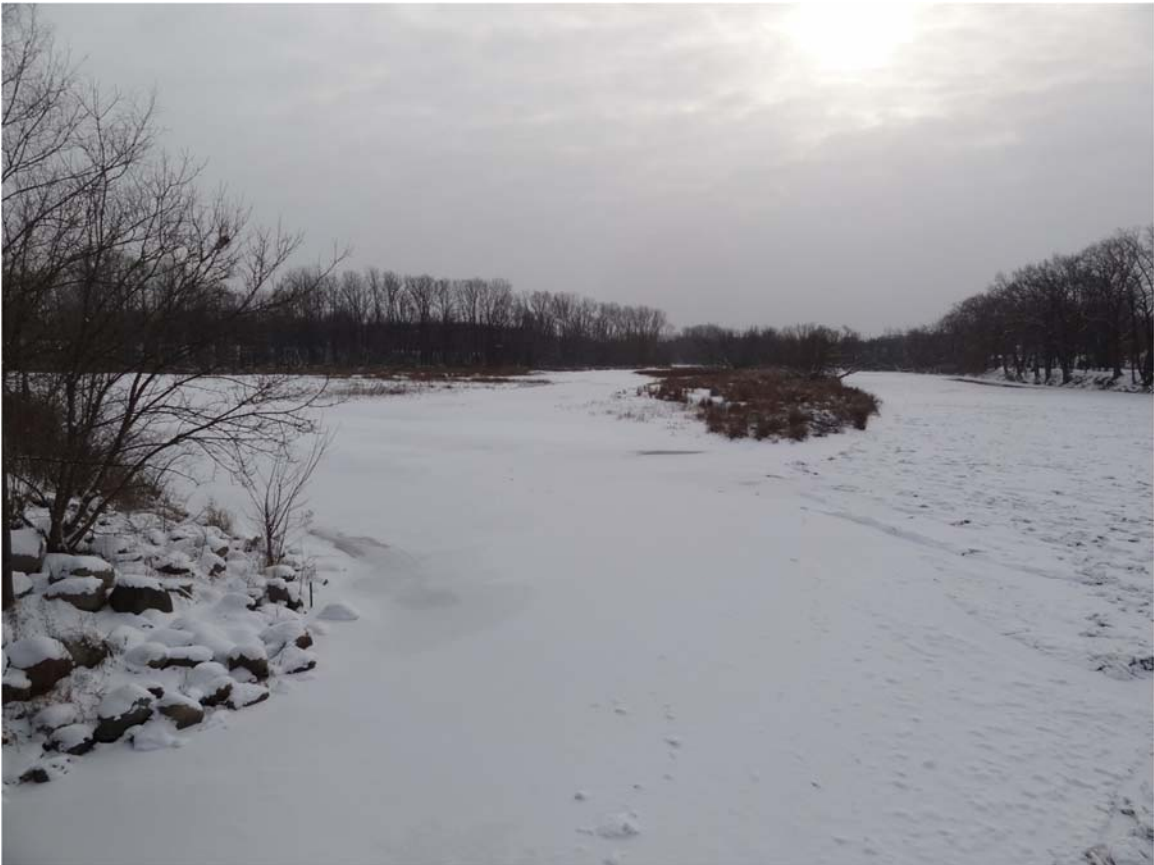
**8. MP15.25 South Mill Pond observed the South Mill Pond frozen over.**

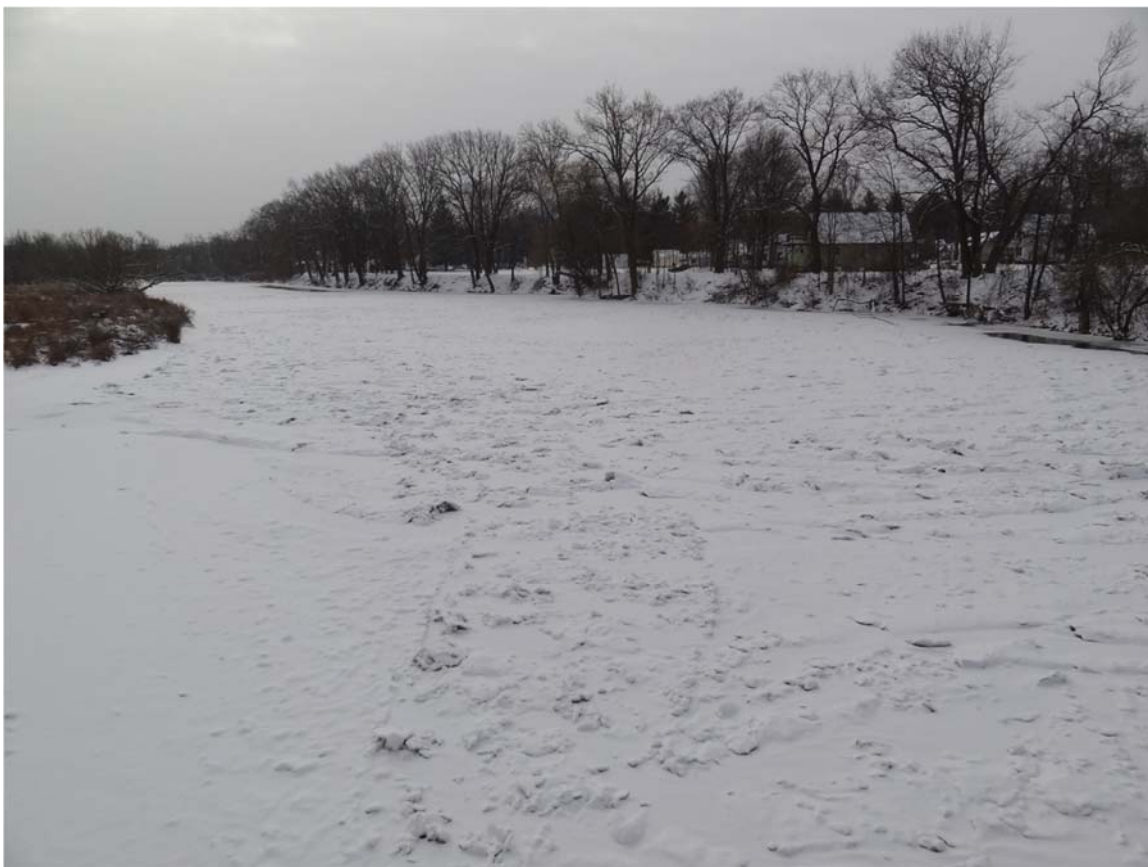
9. MP15.25 observed the river completely frozen over.

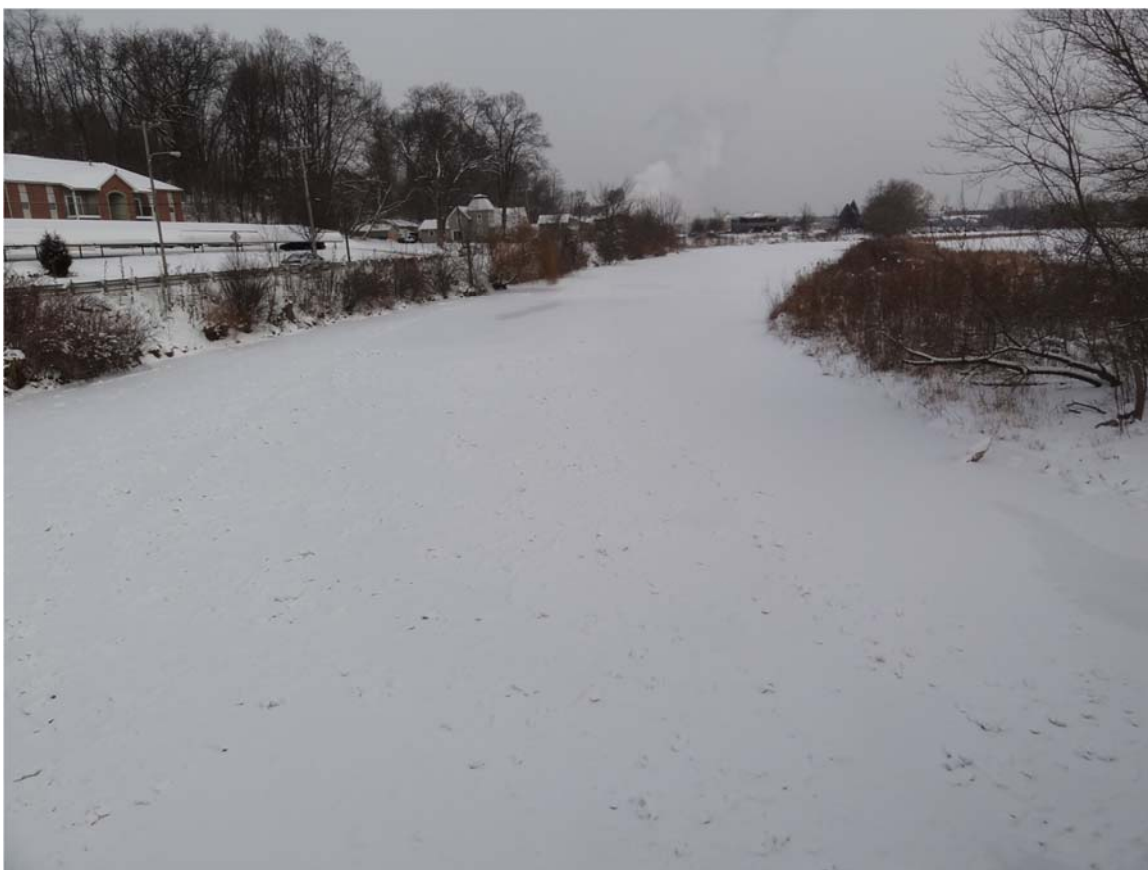
10. MP15.5 observed the river completely frozen over.

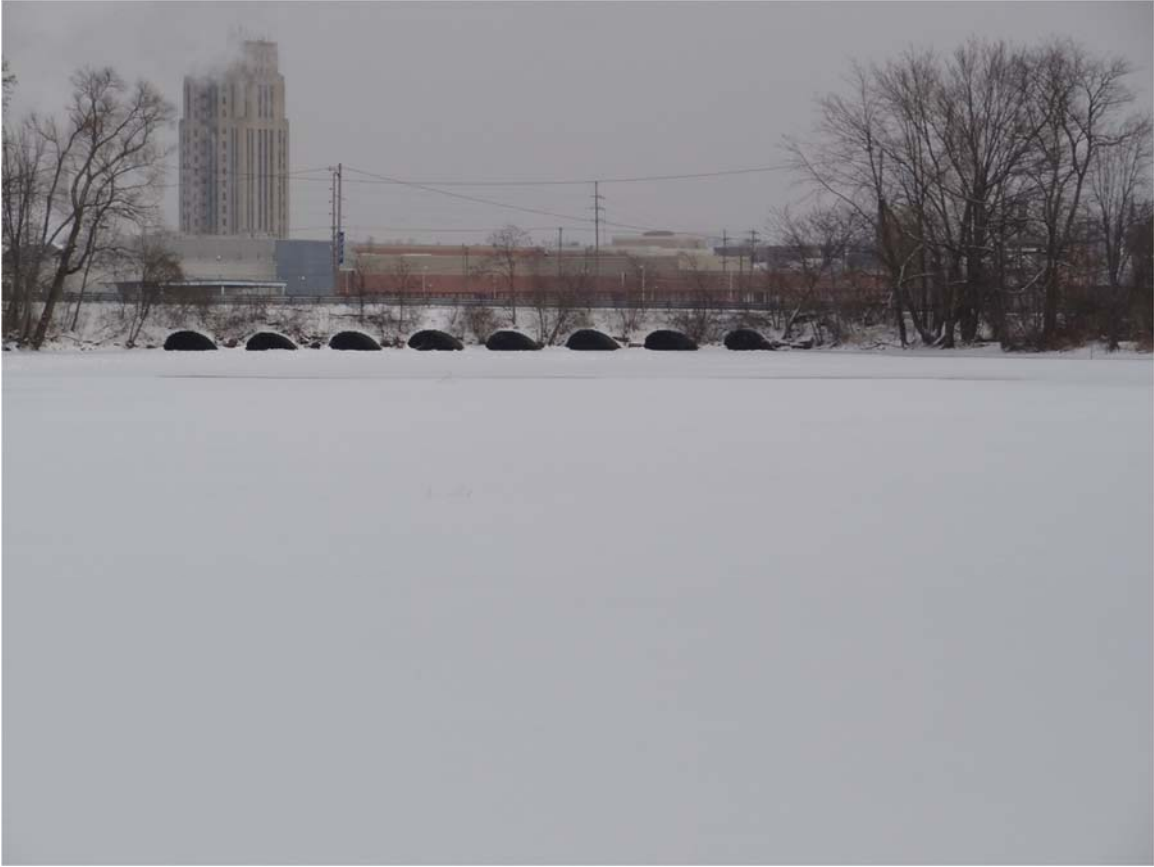
11. MP15.75 North Mill Pond culverts, observed the river completely frozen over.

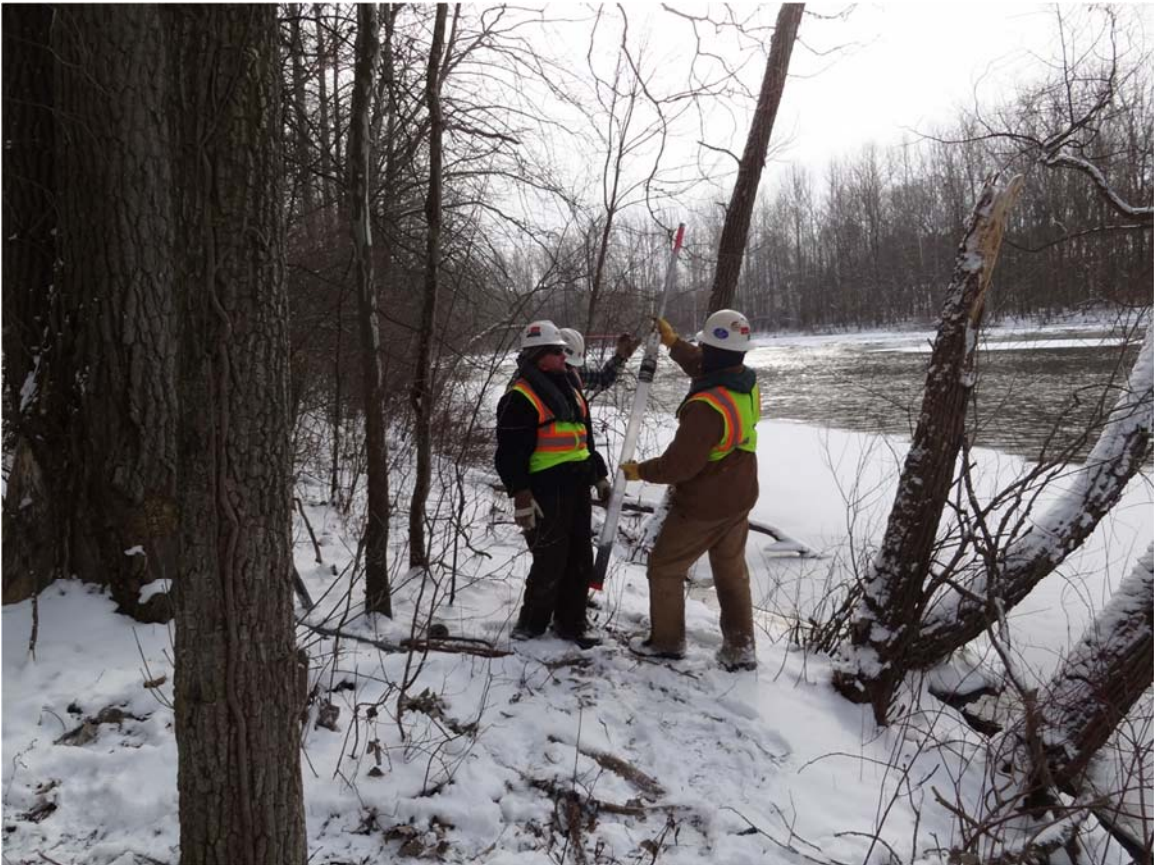
12. MP20.75 RDB observed the RI crew.

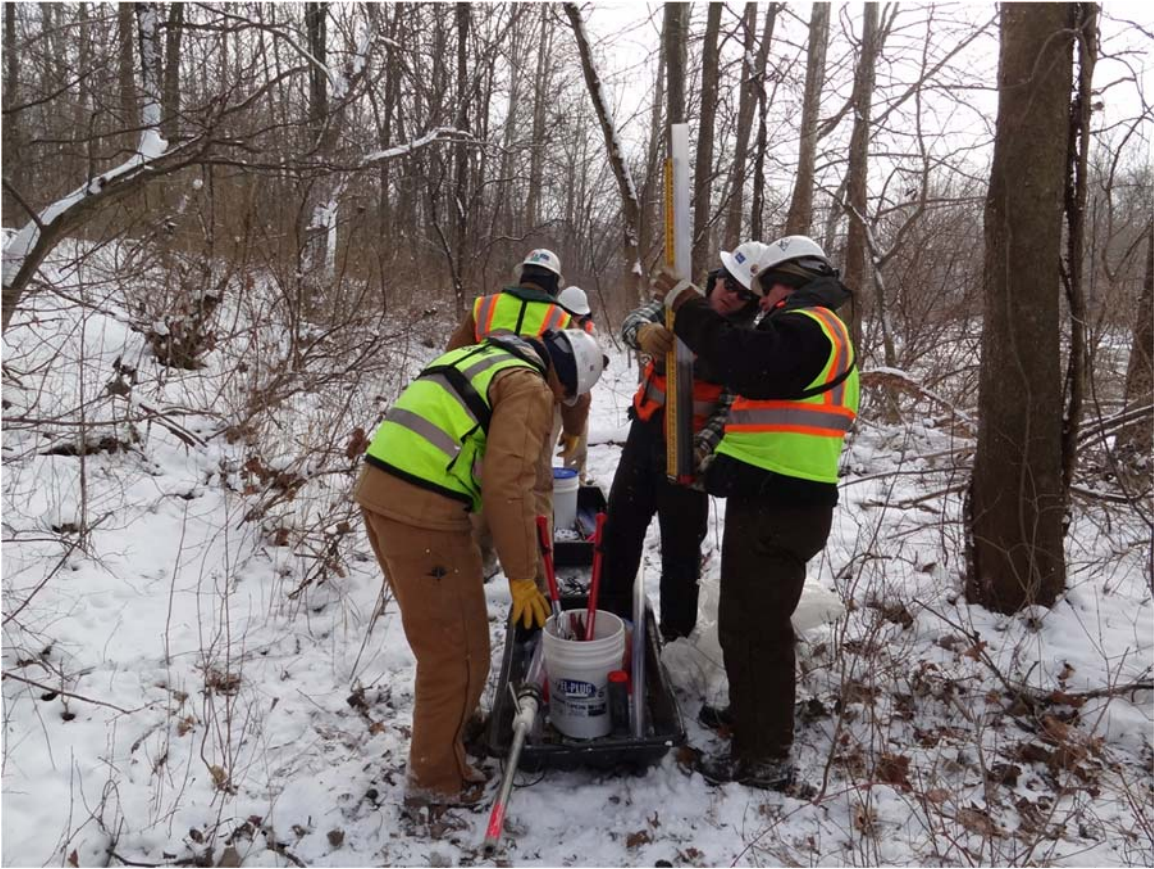
13. MP20.75 RDB observed the RI crew.

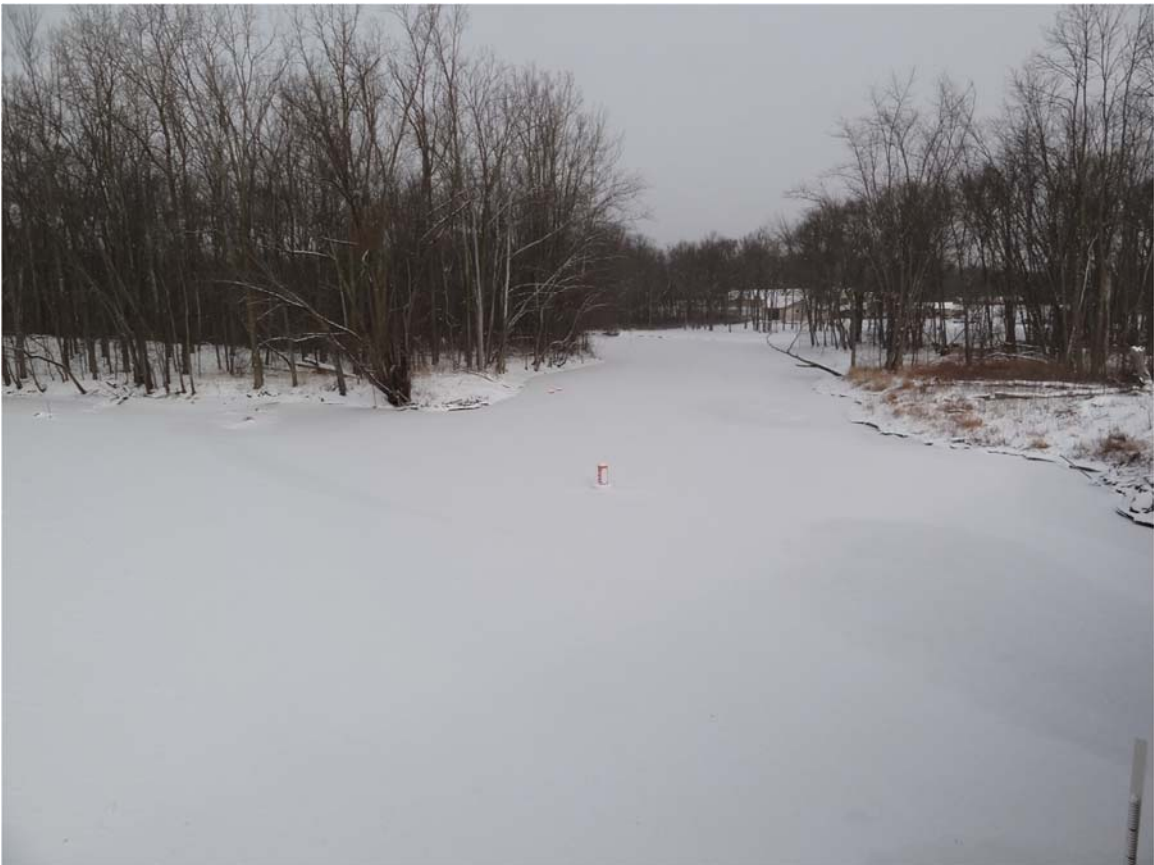
14. MP21.5 observed the oxbow and the majority of the river frozen over.

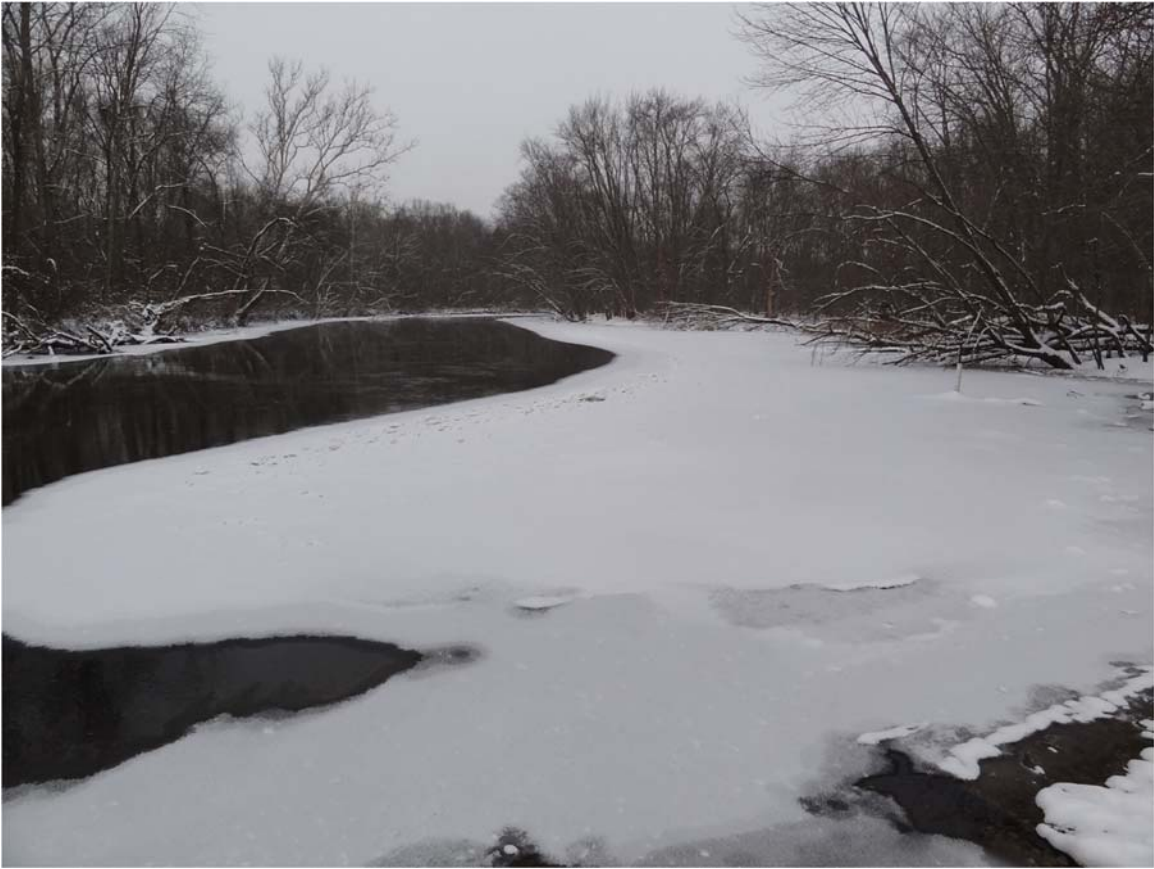
**15. E2 Boat launch observed bank ice forming and sheet ice flowing in the river.**

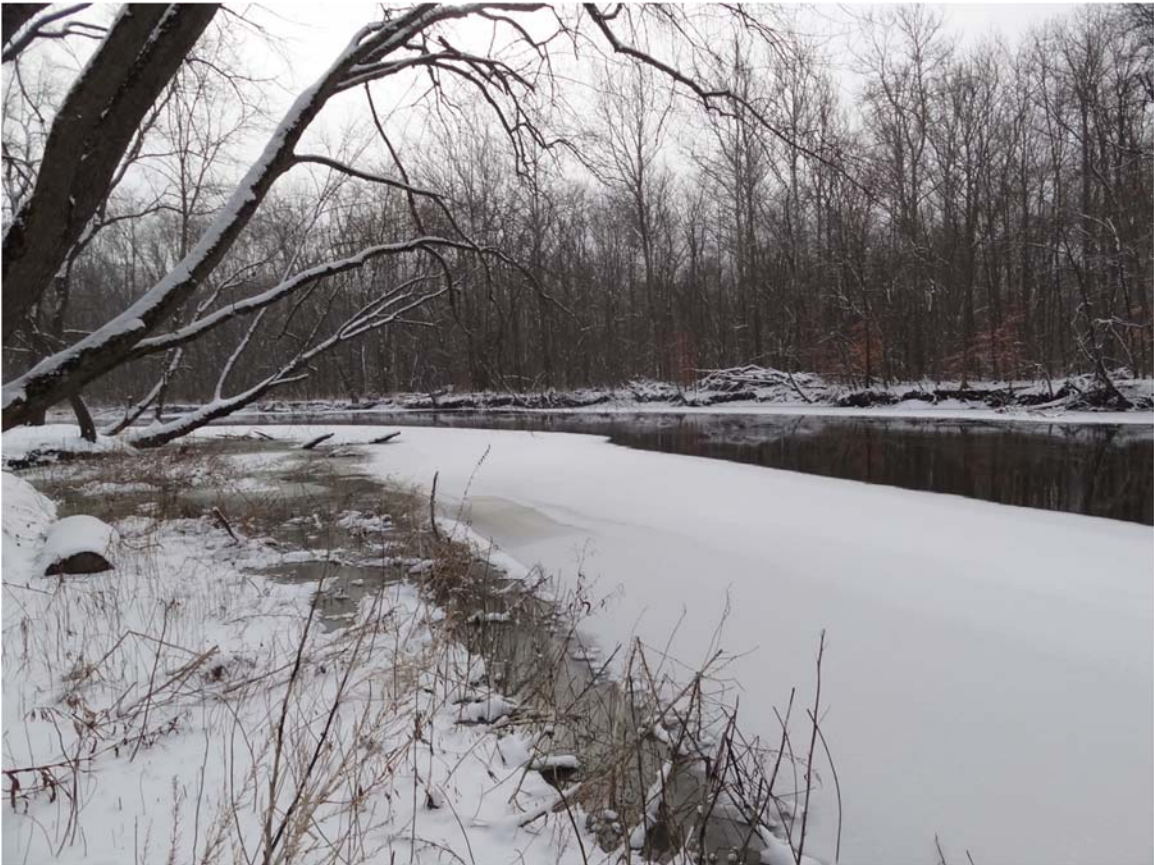
**16. MP27.0 E0.5 Boat launch observed bank ice forming and sheet ice flowing in the river. Observed the river level slightly elevated.**

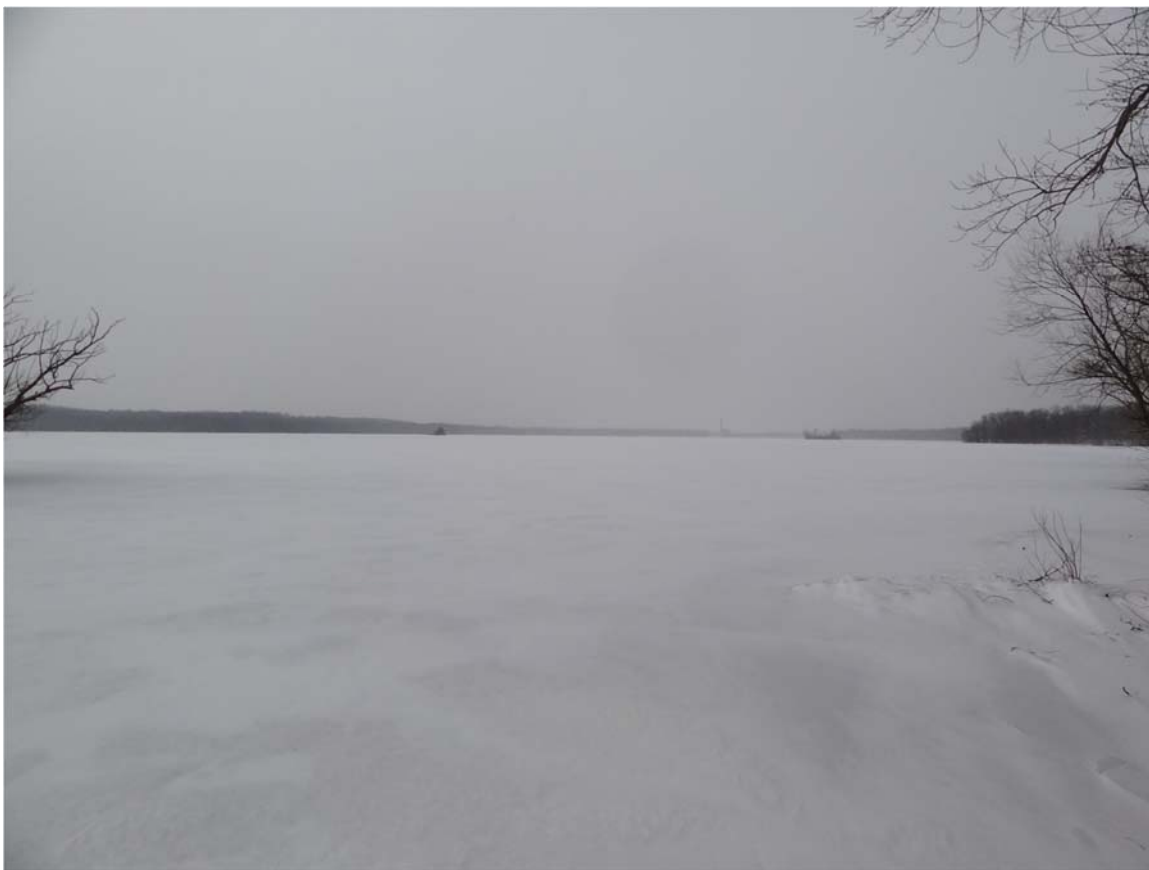
**17. Morrow Lake observed frozen over.**

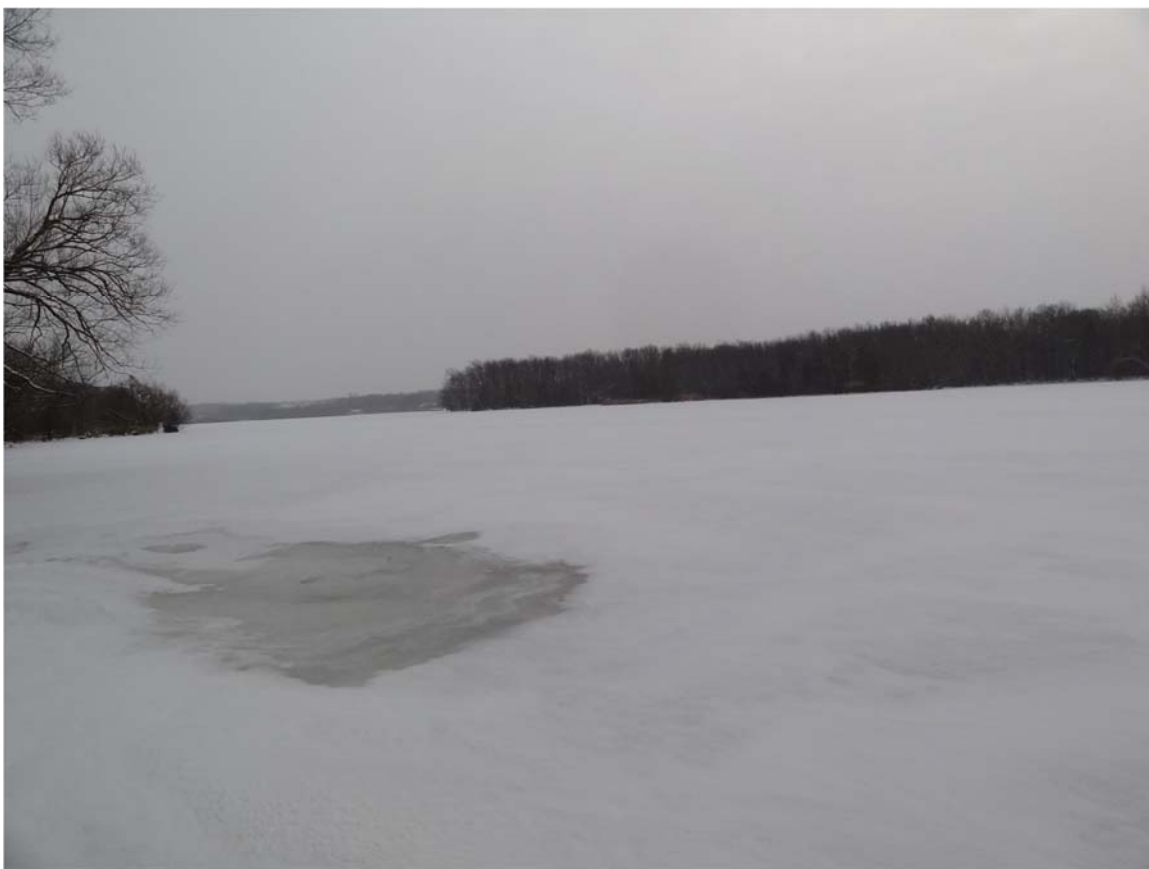
**18. Morrow Lake Delta/Morrow Lake Neck observed frozen over.**

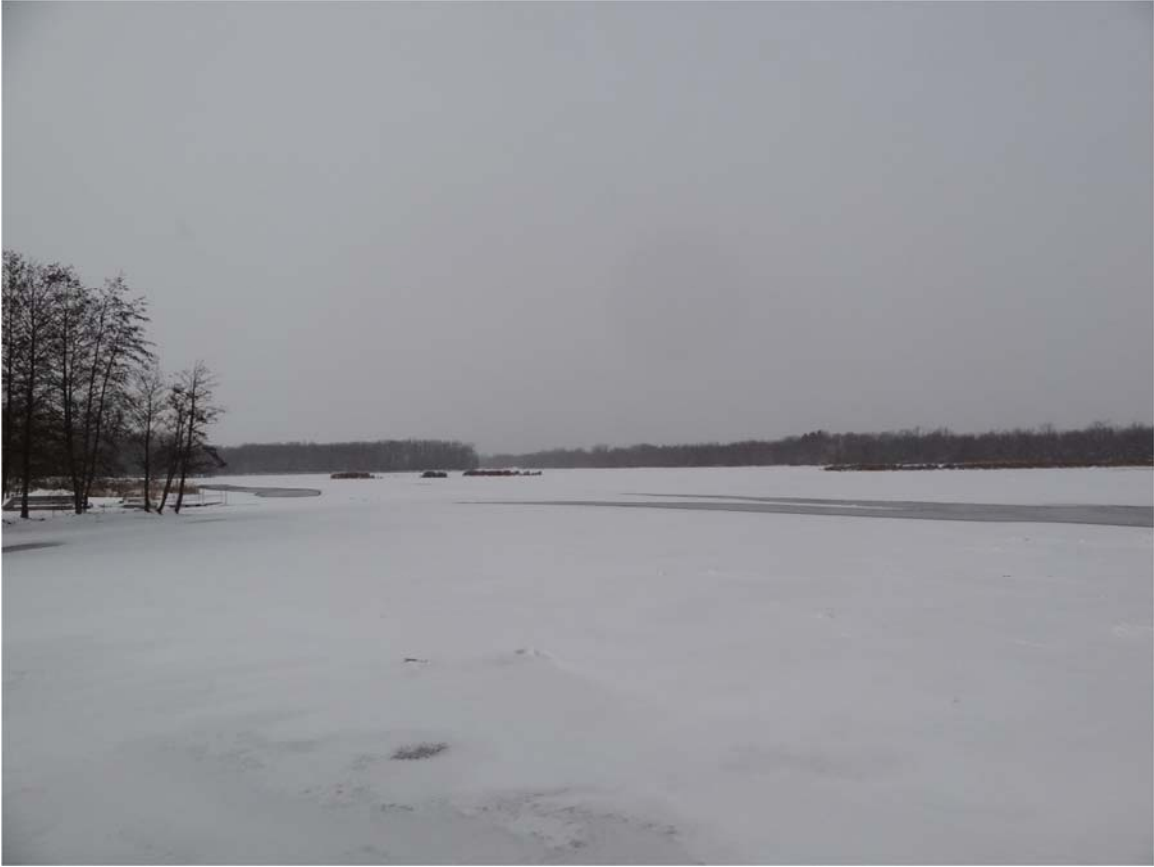
**19. Morrow Lake Delta observed frozen over.**

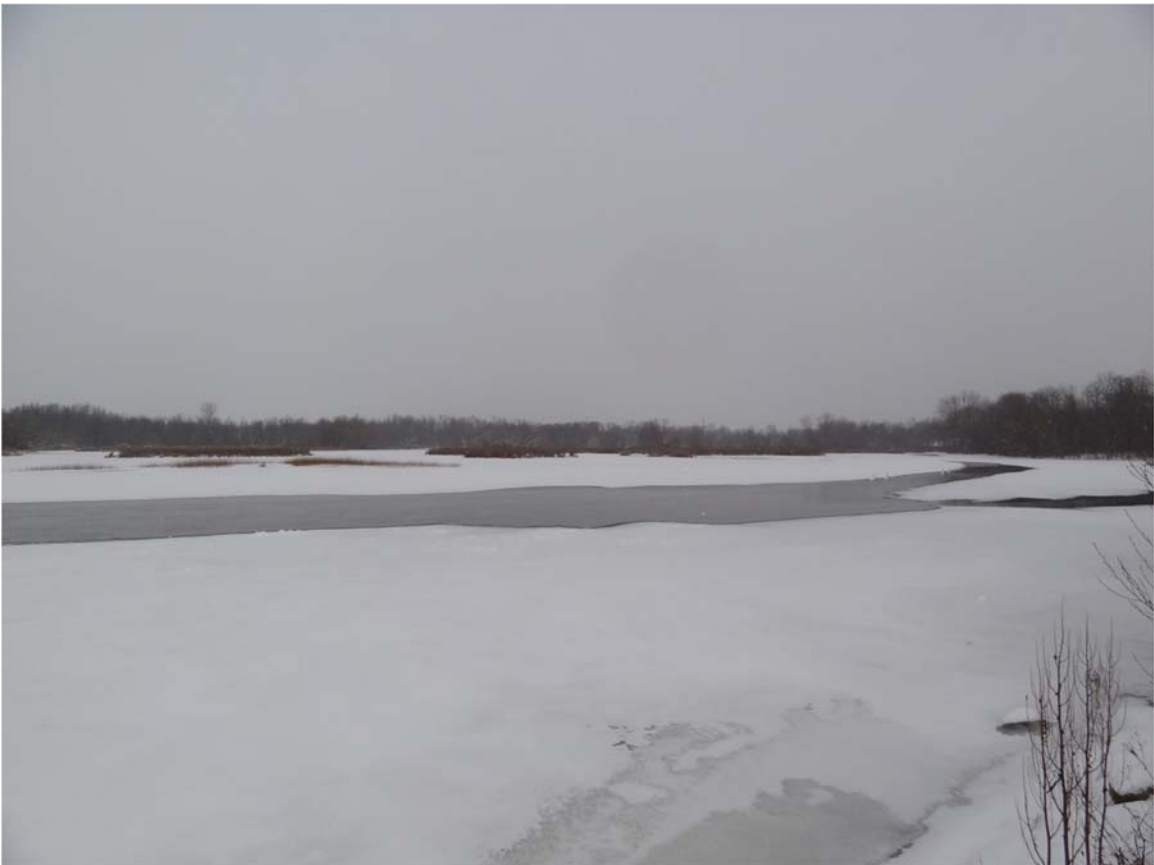
**20. Morrow Lake Delta observed frozen over.**
