# Situation Photo Log

Friday, January 25, 2013

Kalamazoo River / Enbridge Spill

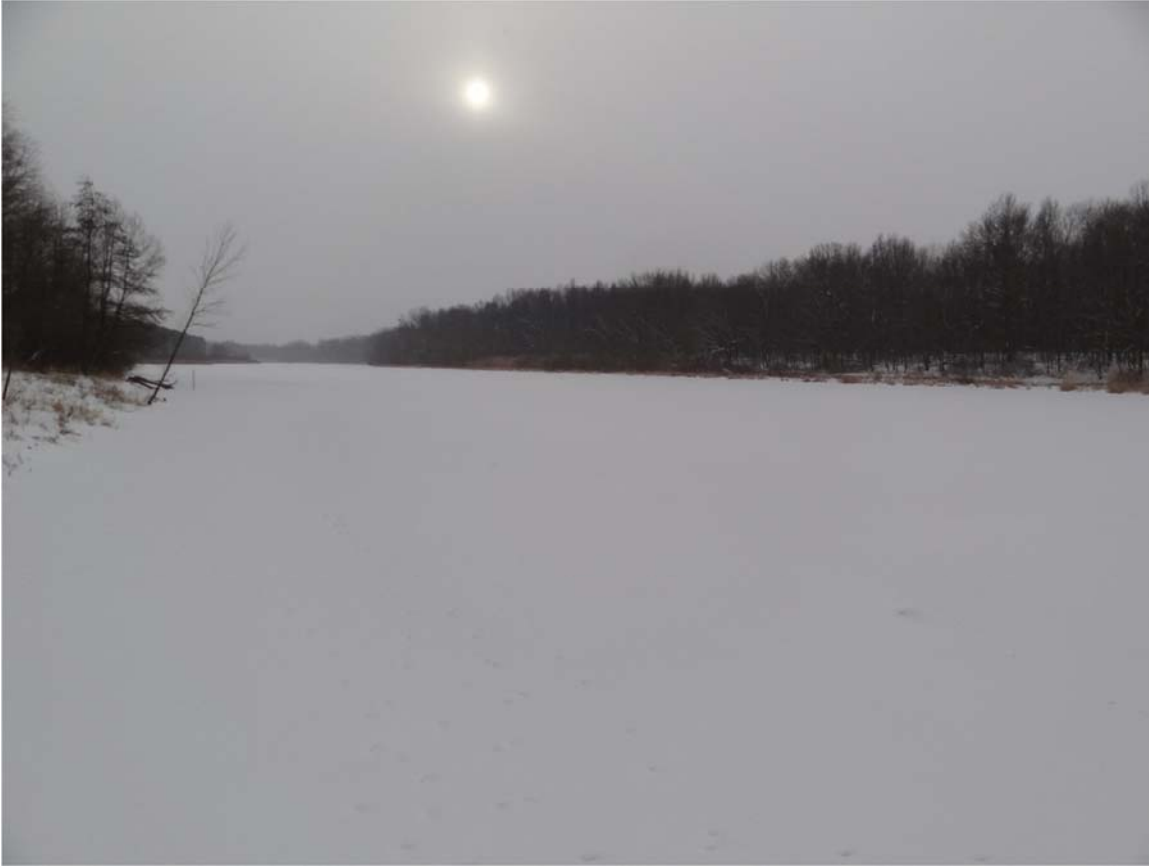
1. C0.4 Boat launch observed upstream river icing conditions.

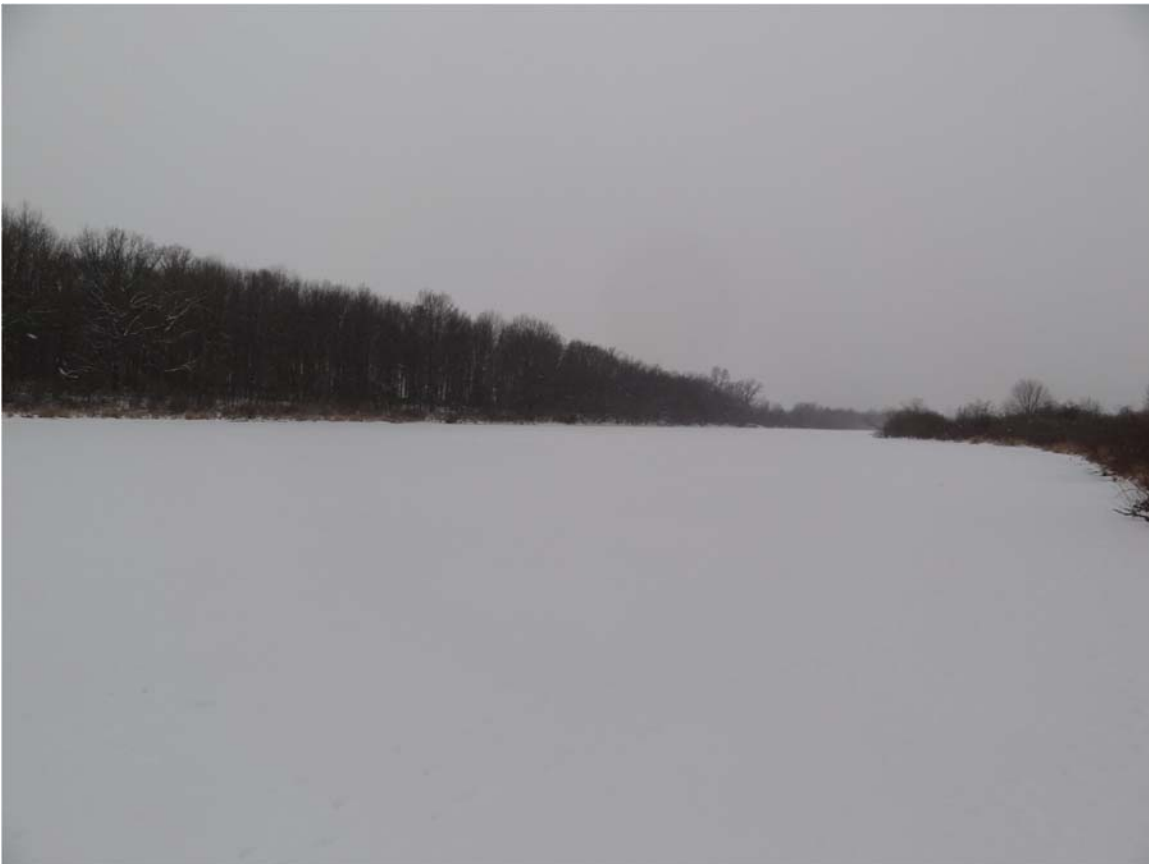
2. C0.4 Boat launch observed downstream river icing conditions.

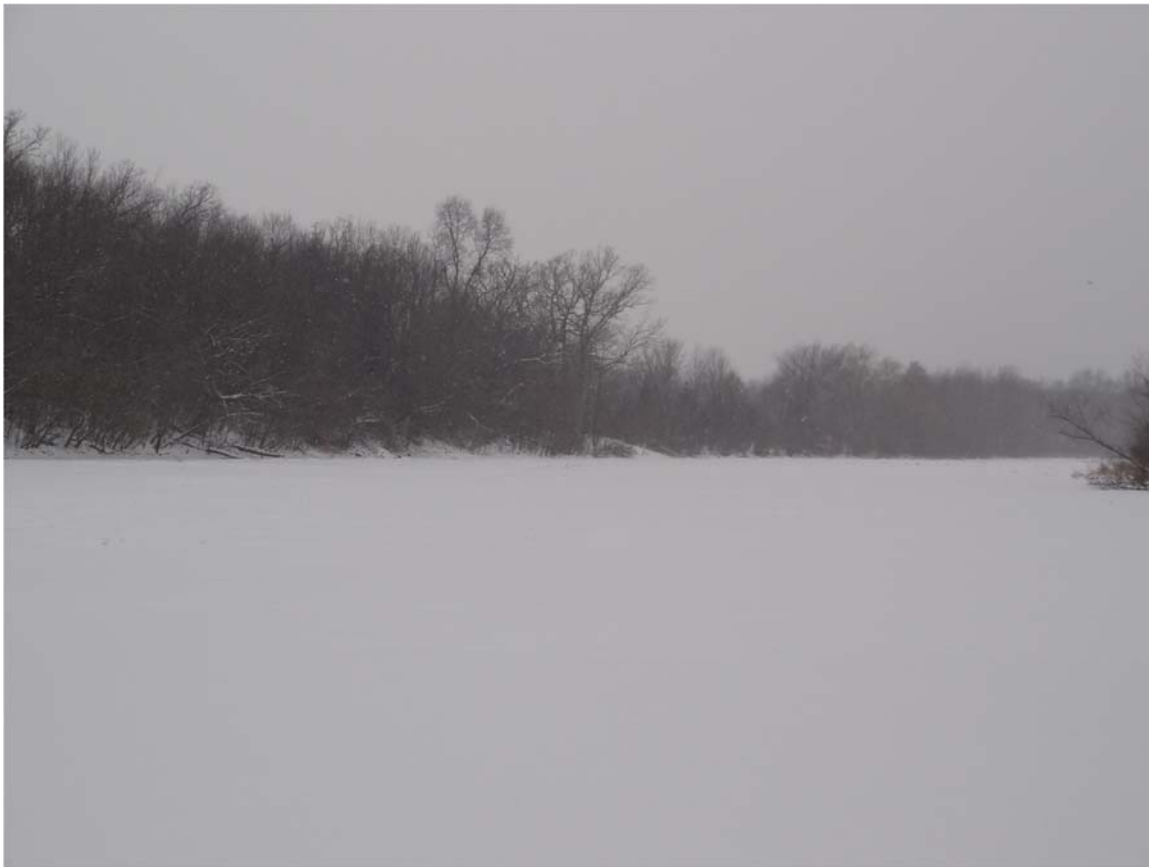
3. MP5.25 C0.4 observed river icing conditions.

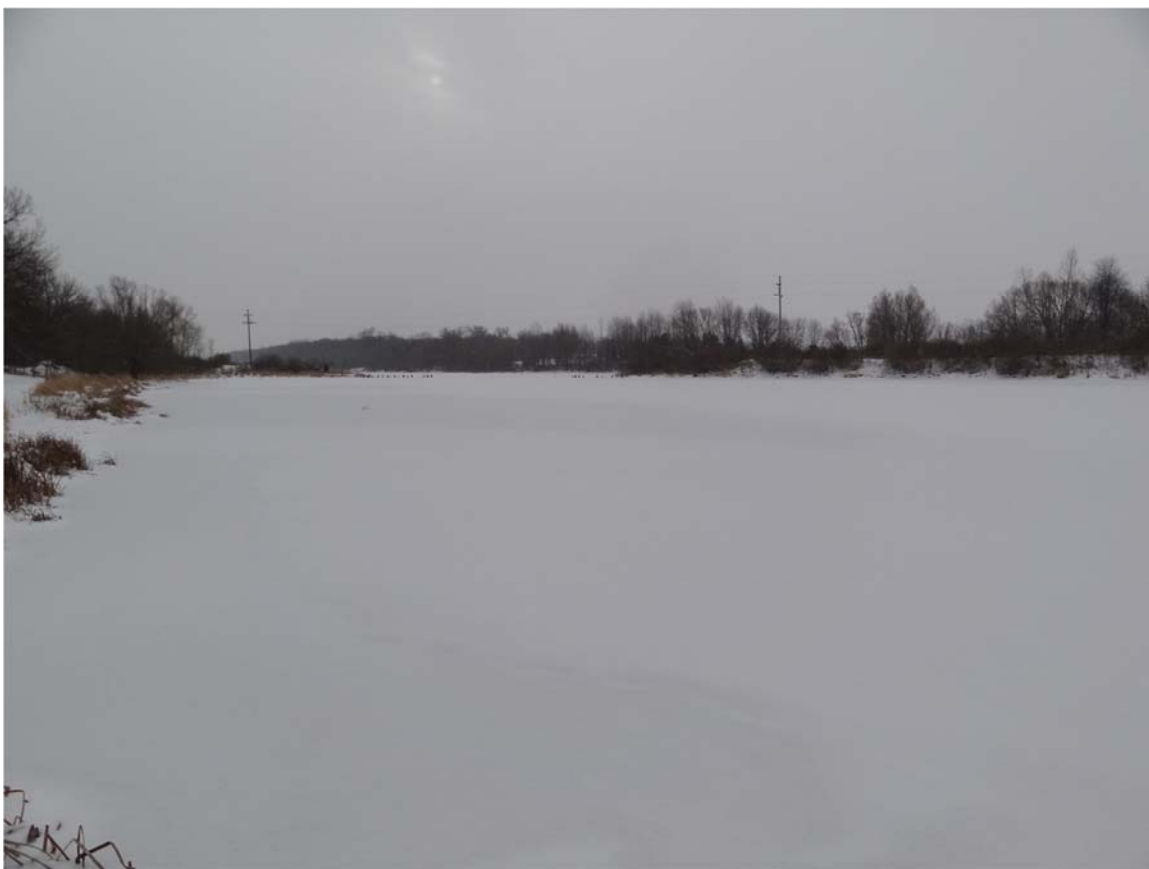
4. Ceresco Dam impoundment observed river icing conditions.

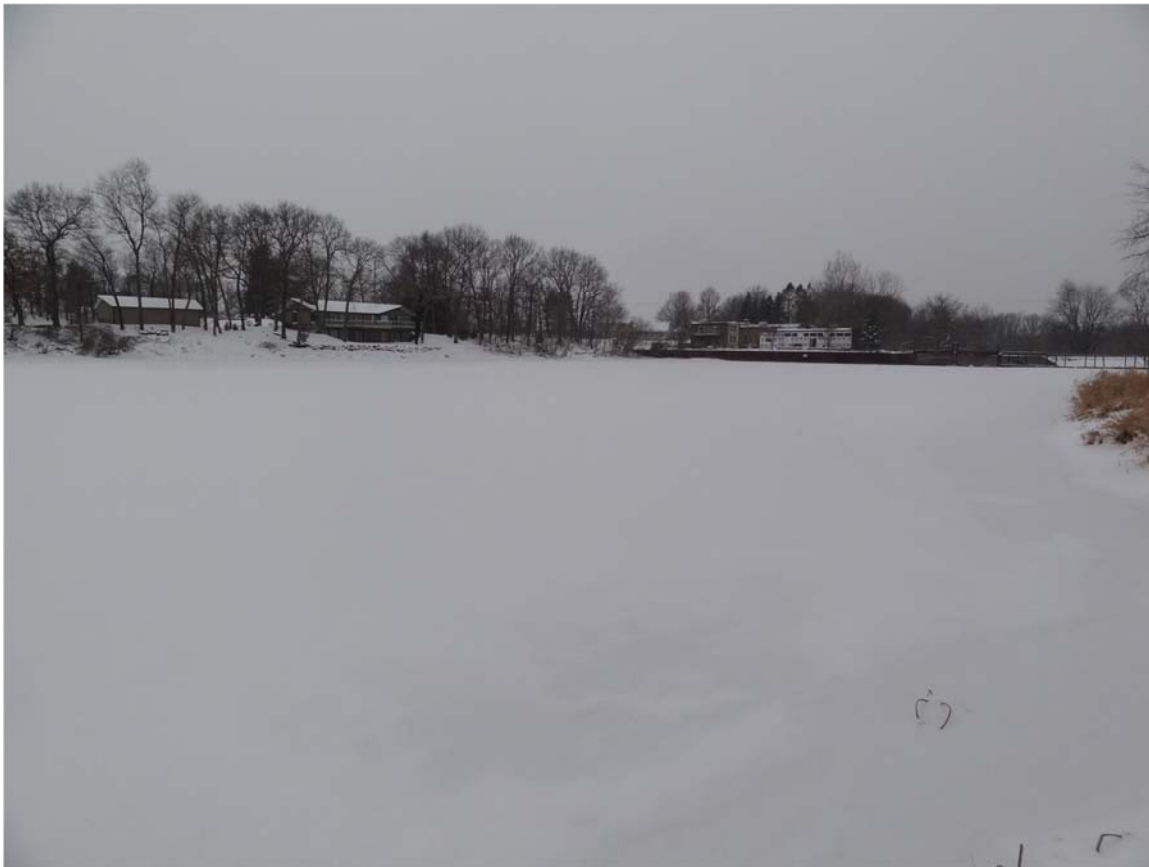
5. Ceresco Dam impoundment observed river icing conditions.

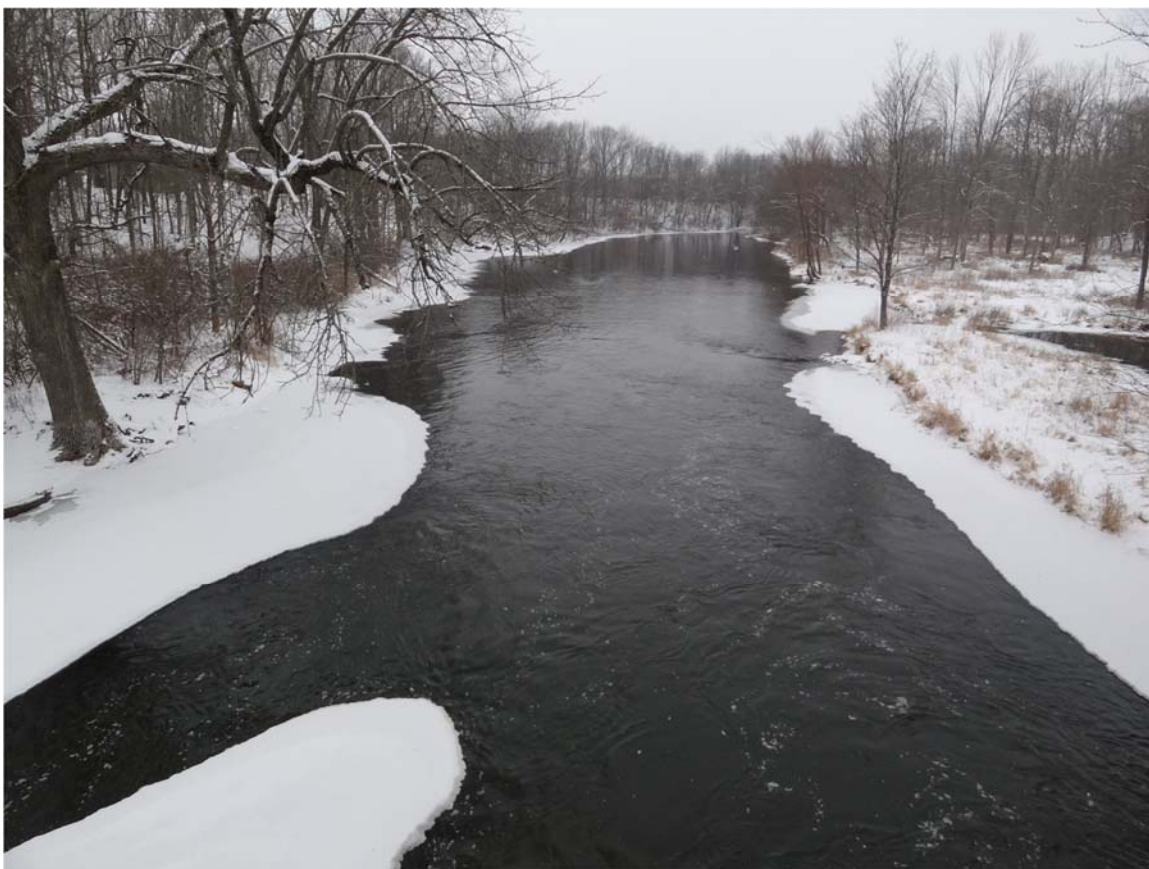
6. MP5.9 Downstream from Ceresco Dam observed river conditions.

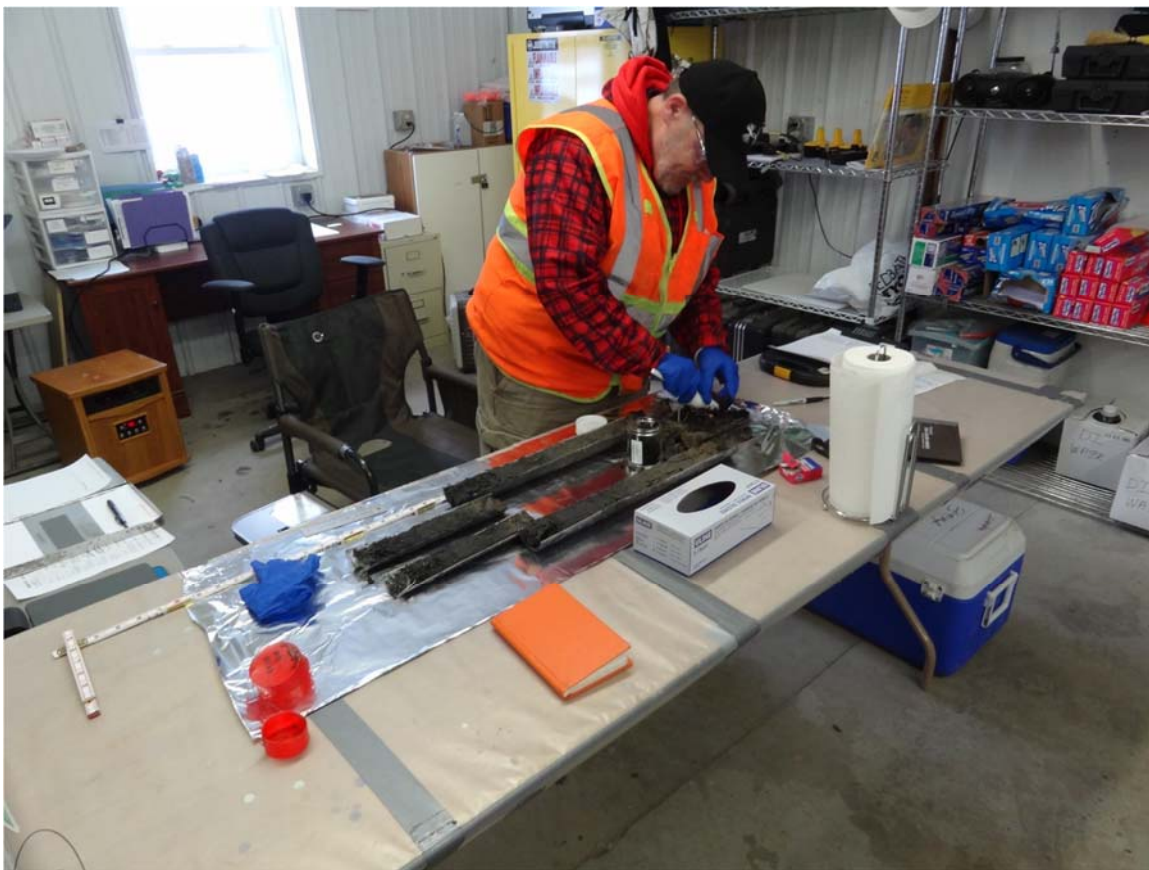
7. C3.2 Pole Barn observed core logging operations.

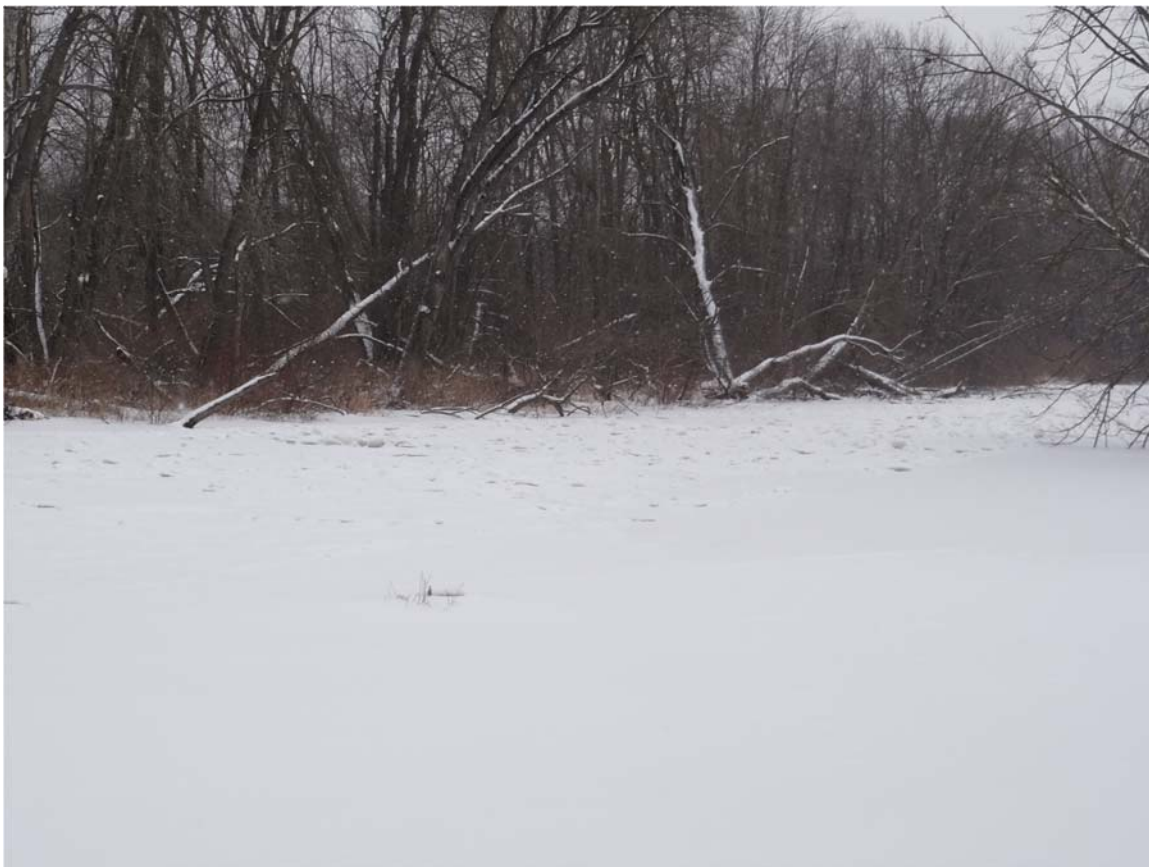
8. C3.2 Boat launch observed river icing conditions.

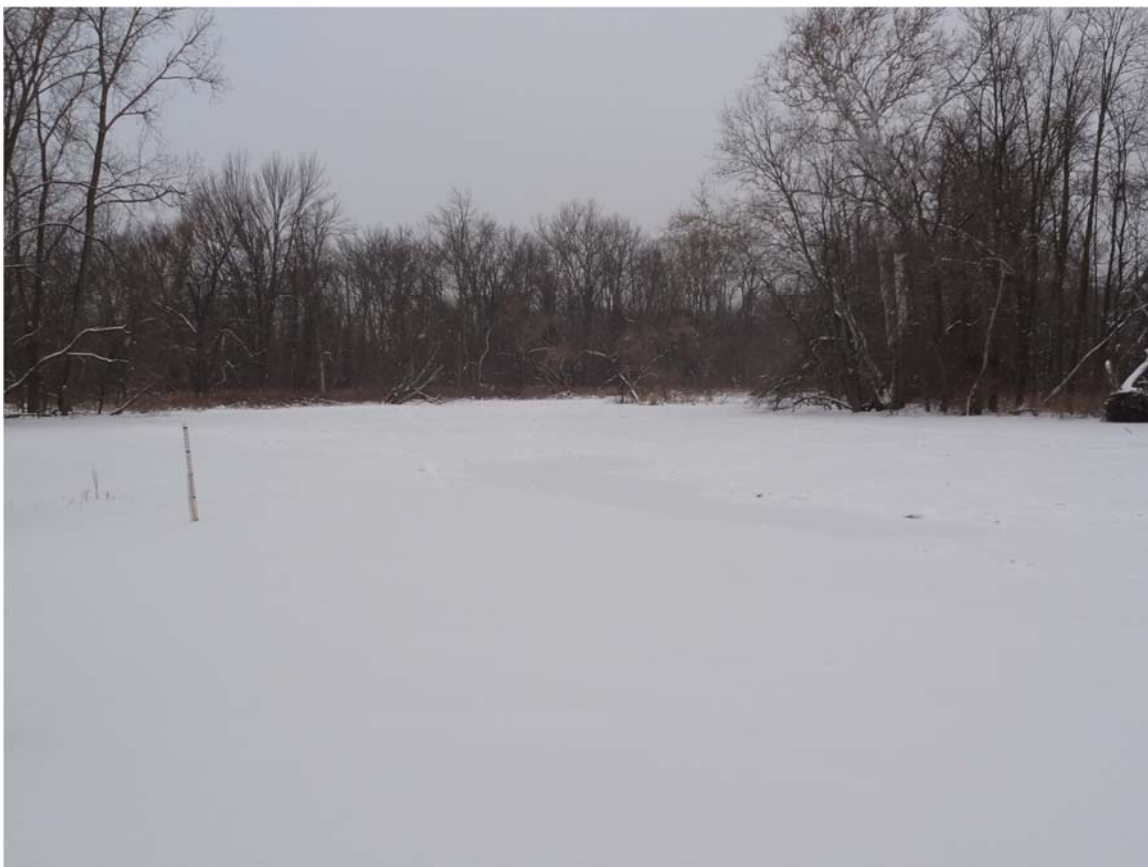
**9. C3.2 Boat launch observed river icing conditions.**

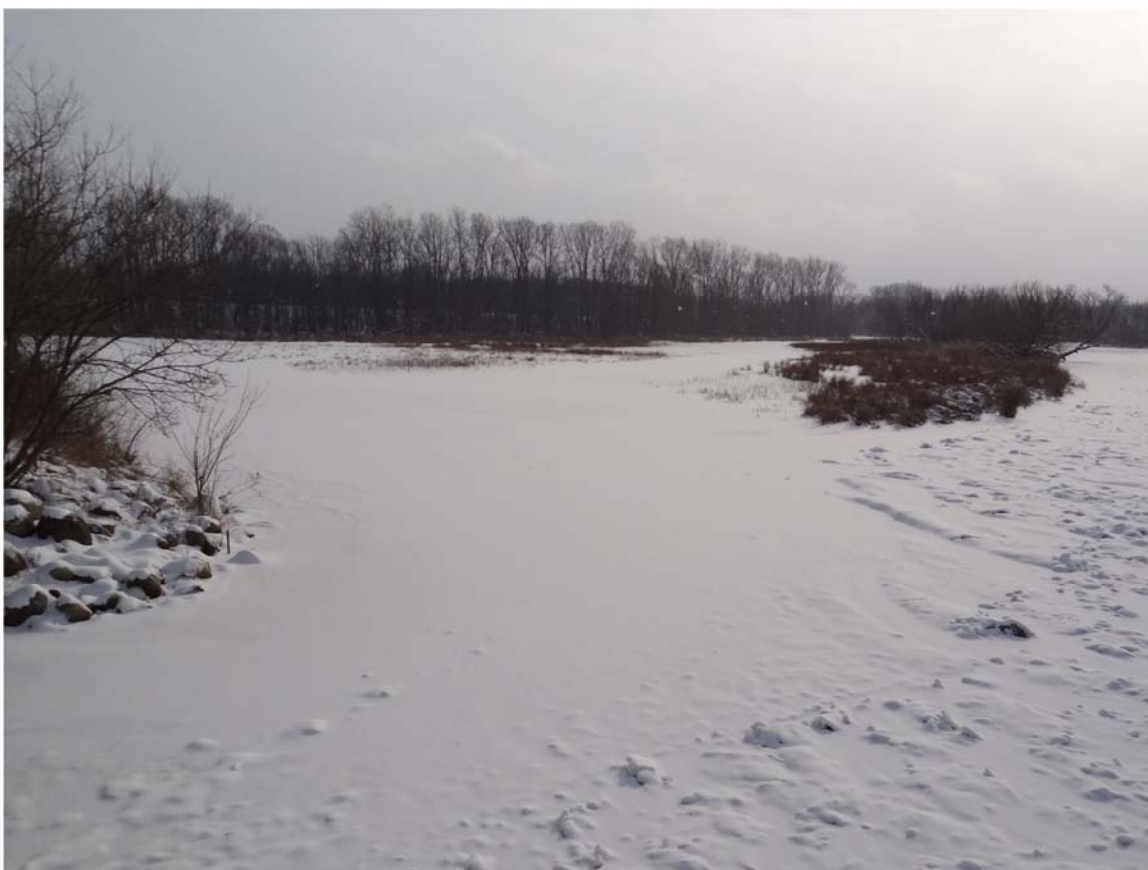
**10. MP15.25 South Mill Pond observed river icing conditions.**

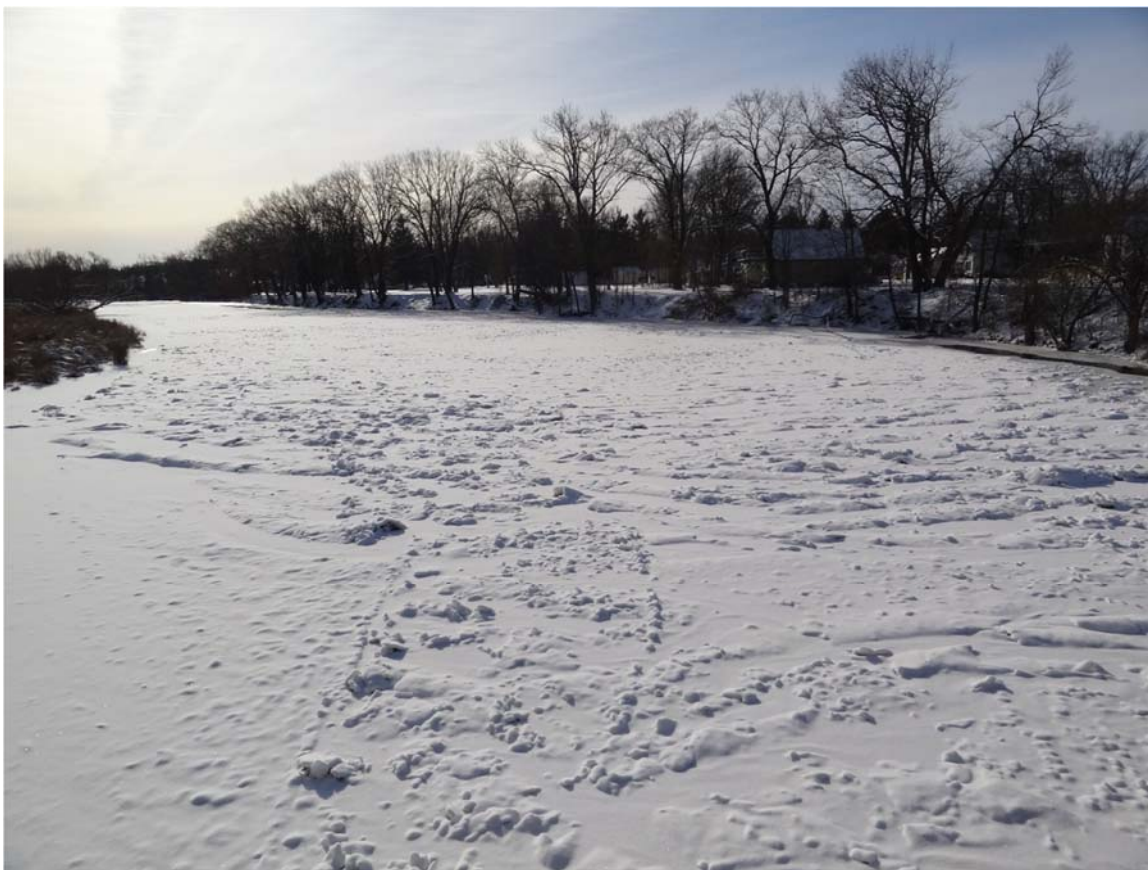
**11. MP15.25 South Mill Pond observed river icing conditions.**

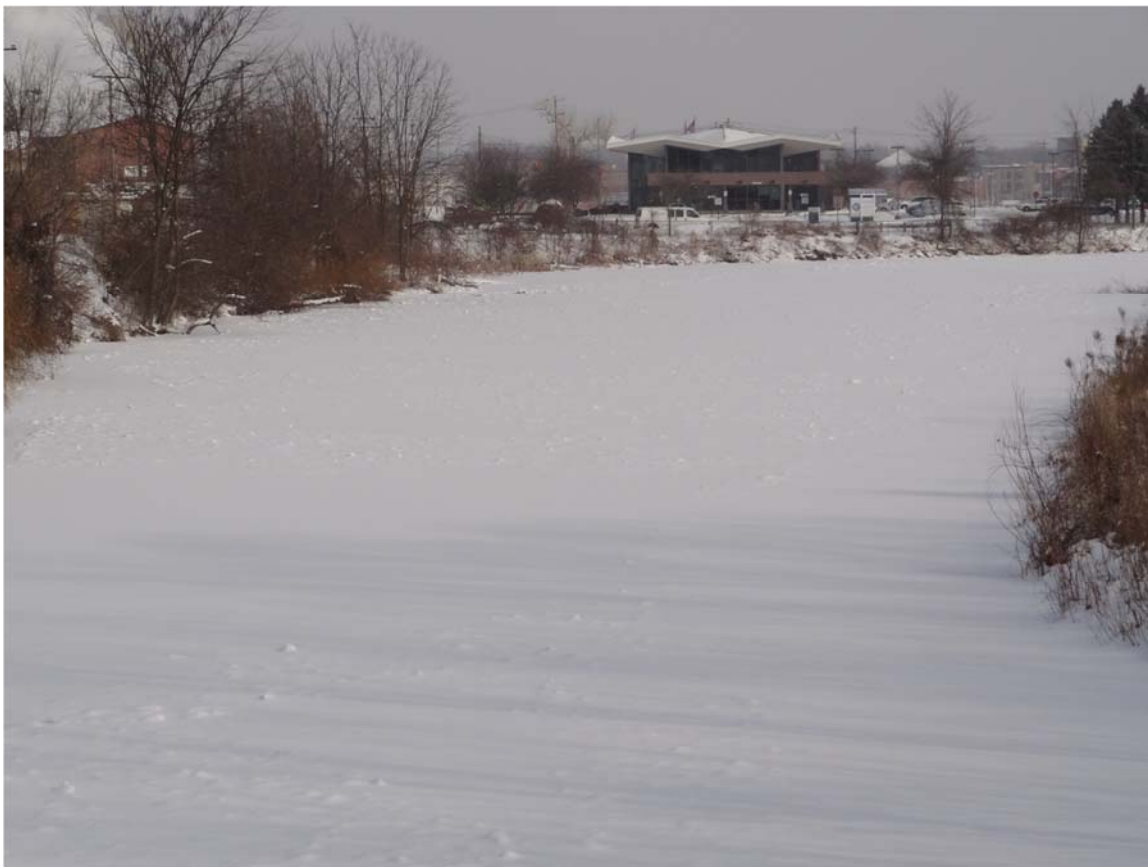
**12. MP15.5 North Mill Pond observed river icing conditions.**

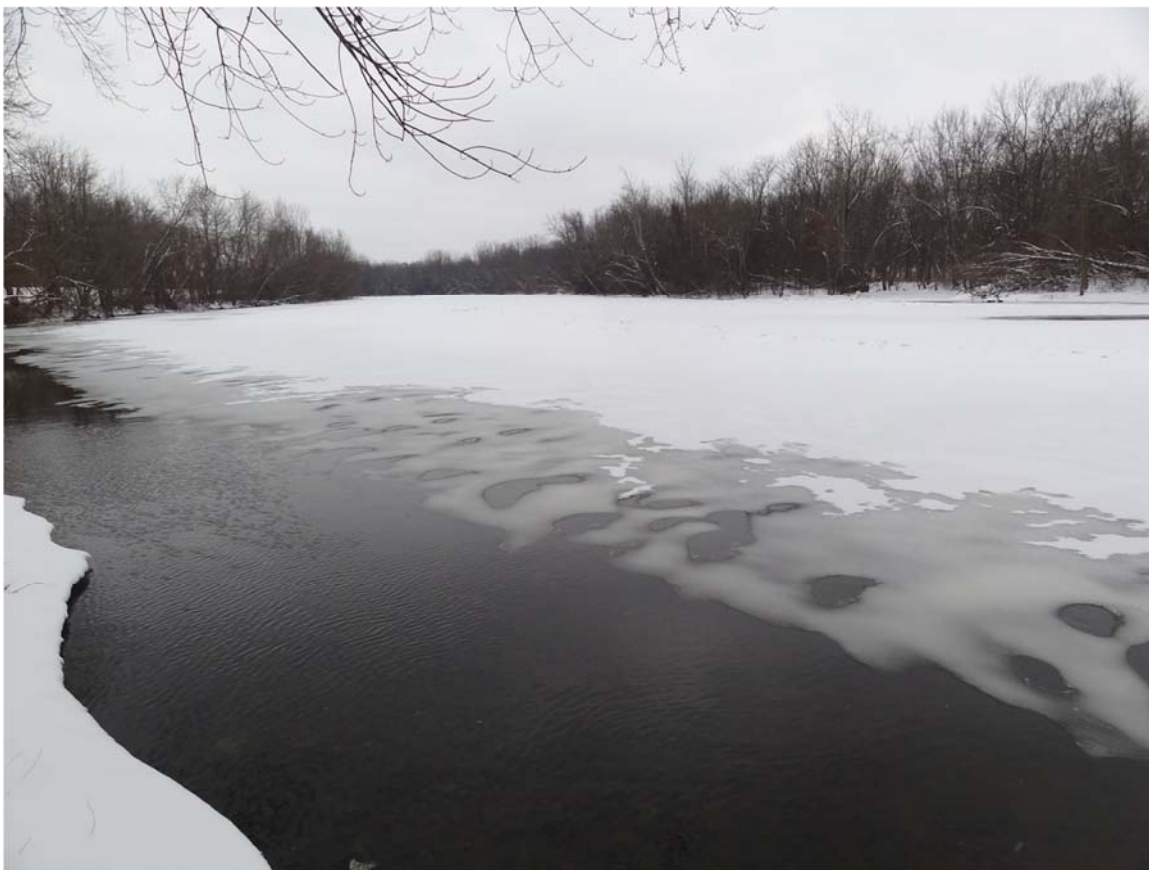
**13. MP19.25 observed river icing conditions.**

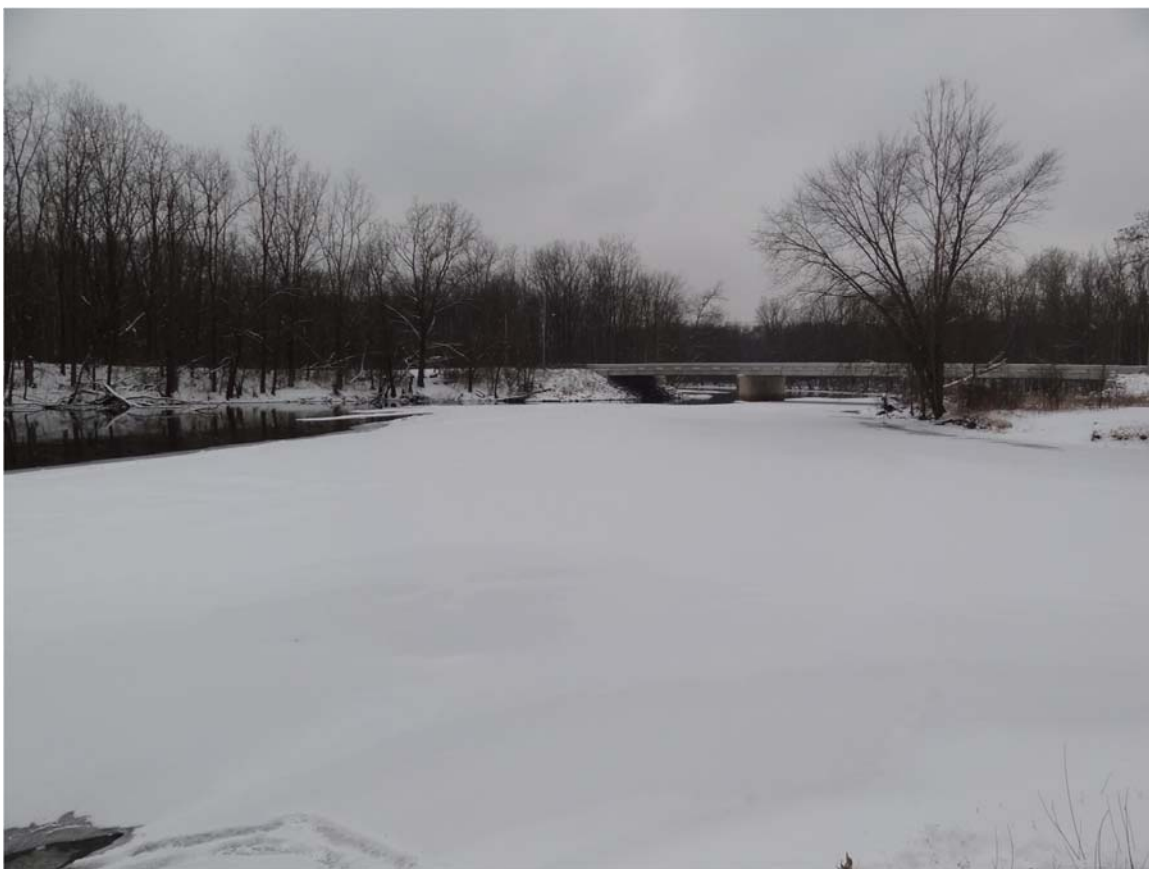
**14. MP21.5 observed river icing conditions.**

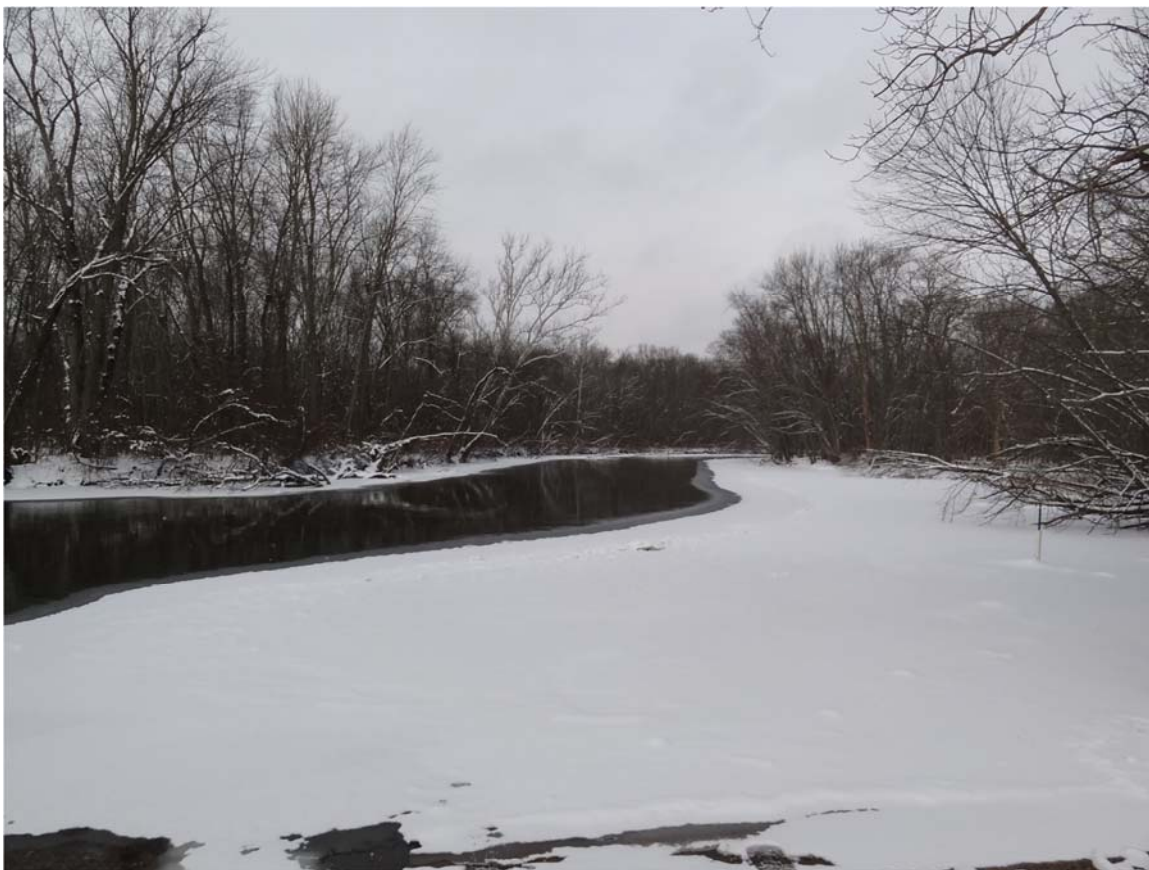
**15. E2 Boat launch observed river icing conditions.**

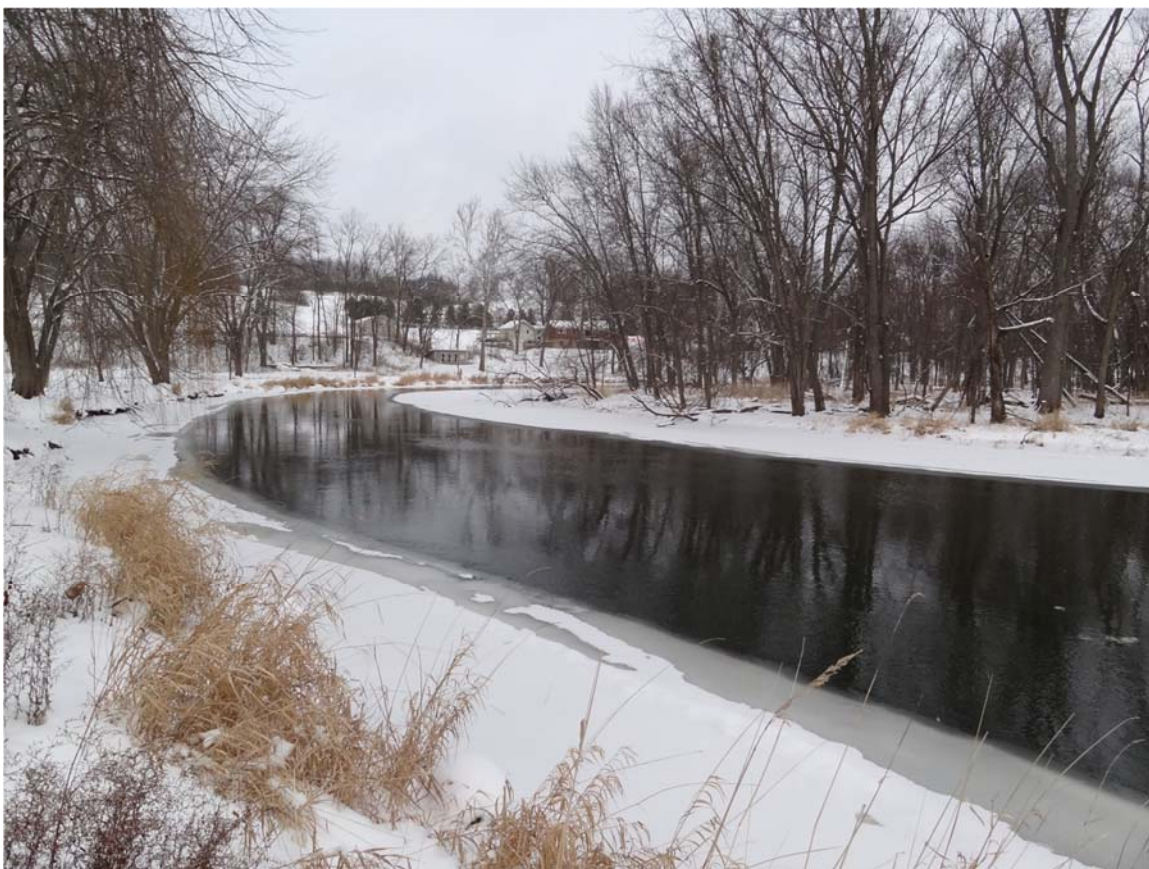
**16. MP27.0 E0.5 Boat launch observed river icing conditions.**

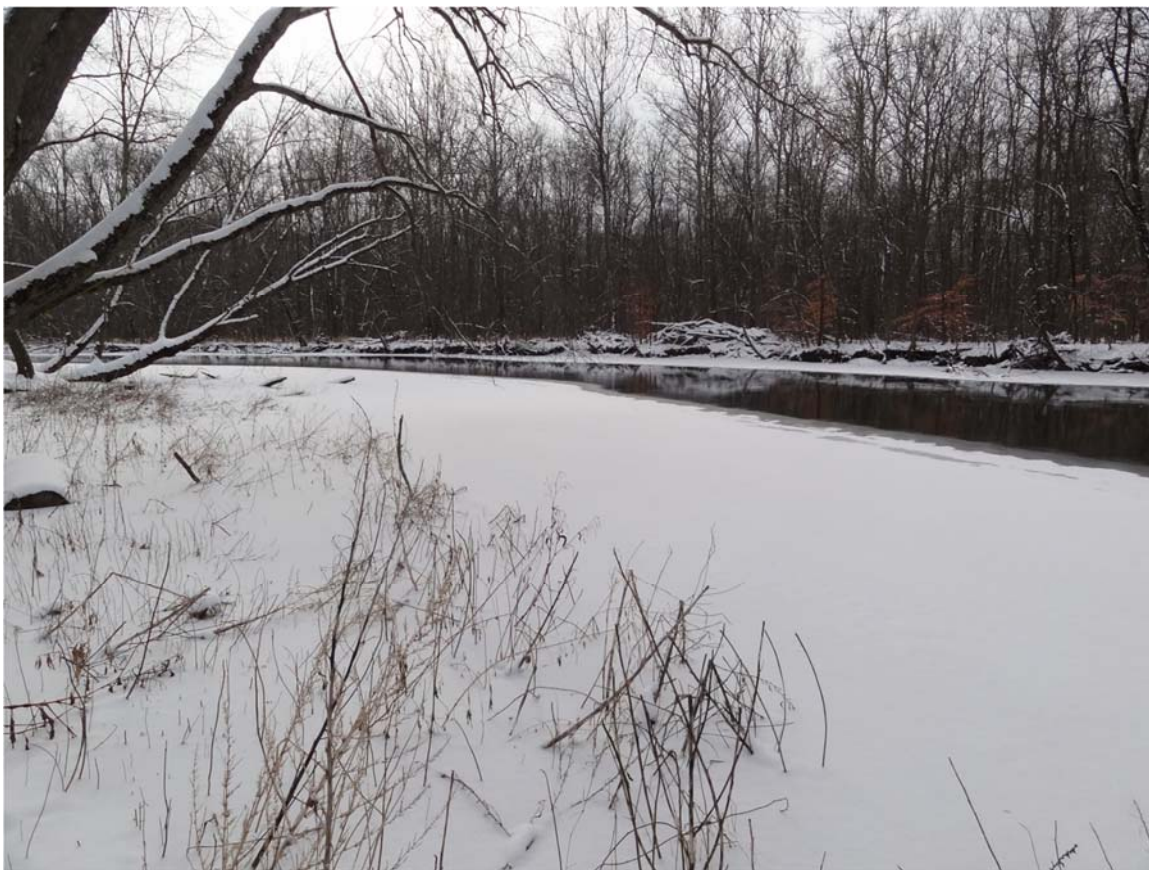
**17. MP27.0 E0.5 Boat launch observed river icing conditions.**

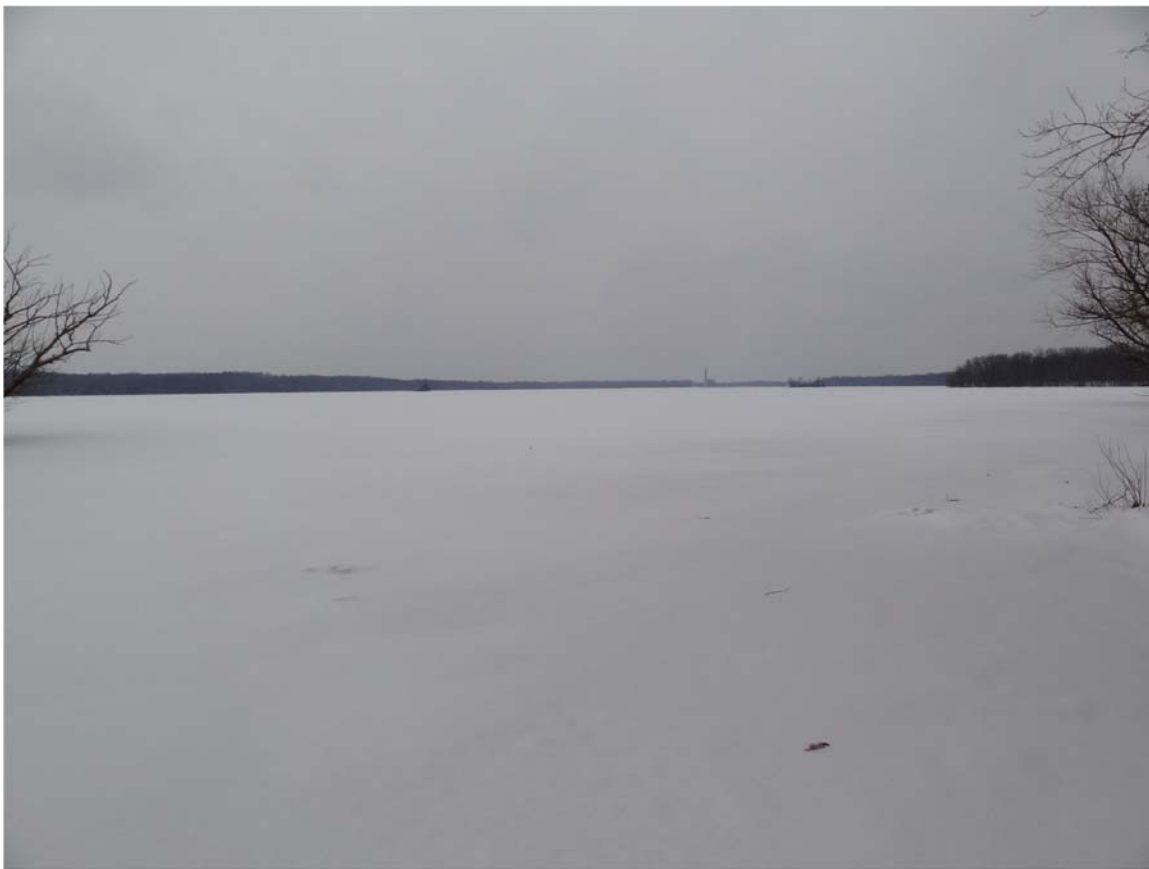
**18. Morrow Lake observed icing conditions.**

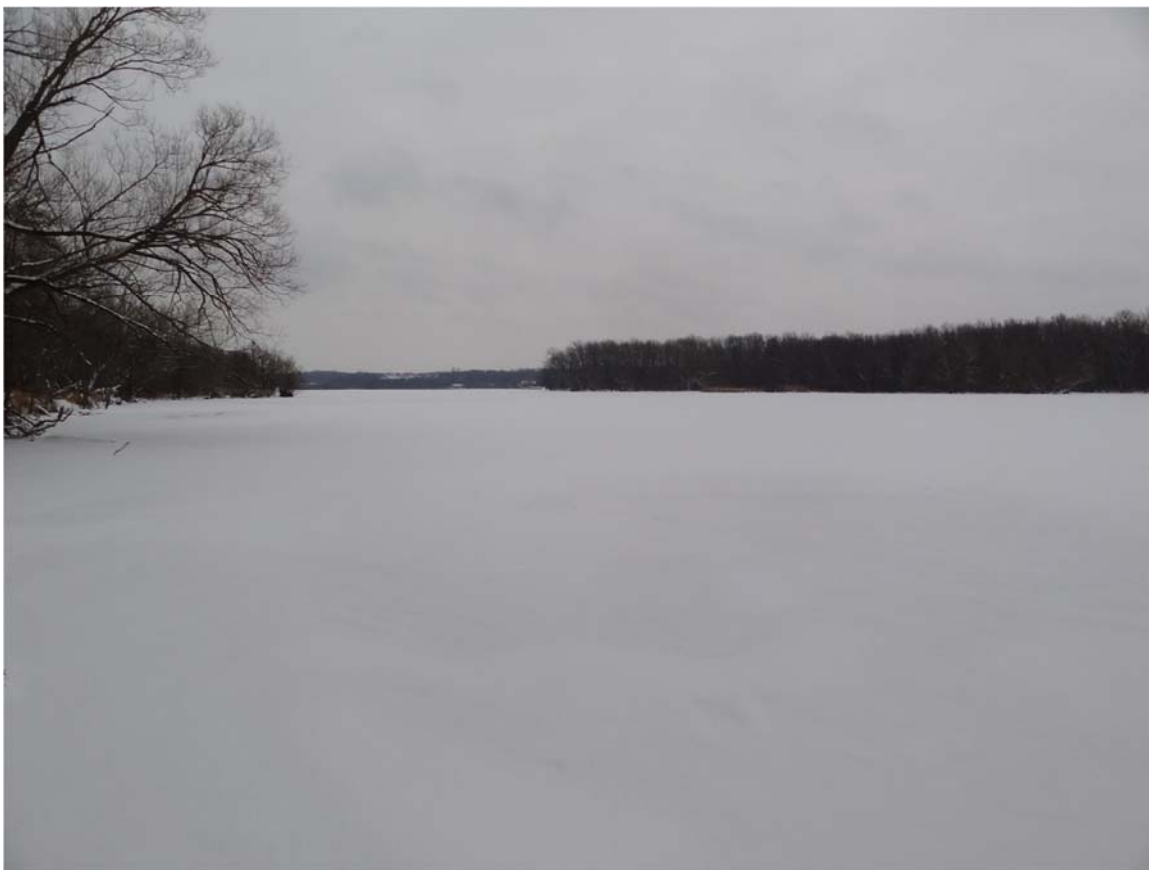
**19. Morrow Lake Neck/Morrow Lake Delta observed icing conditions.**

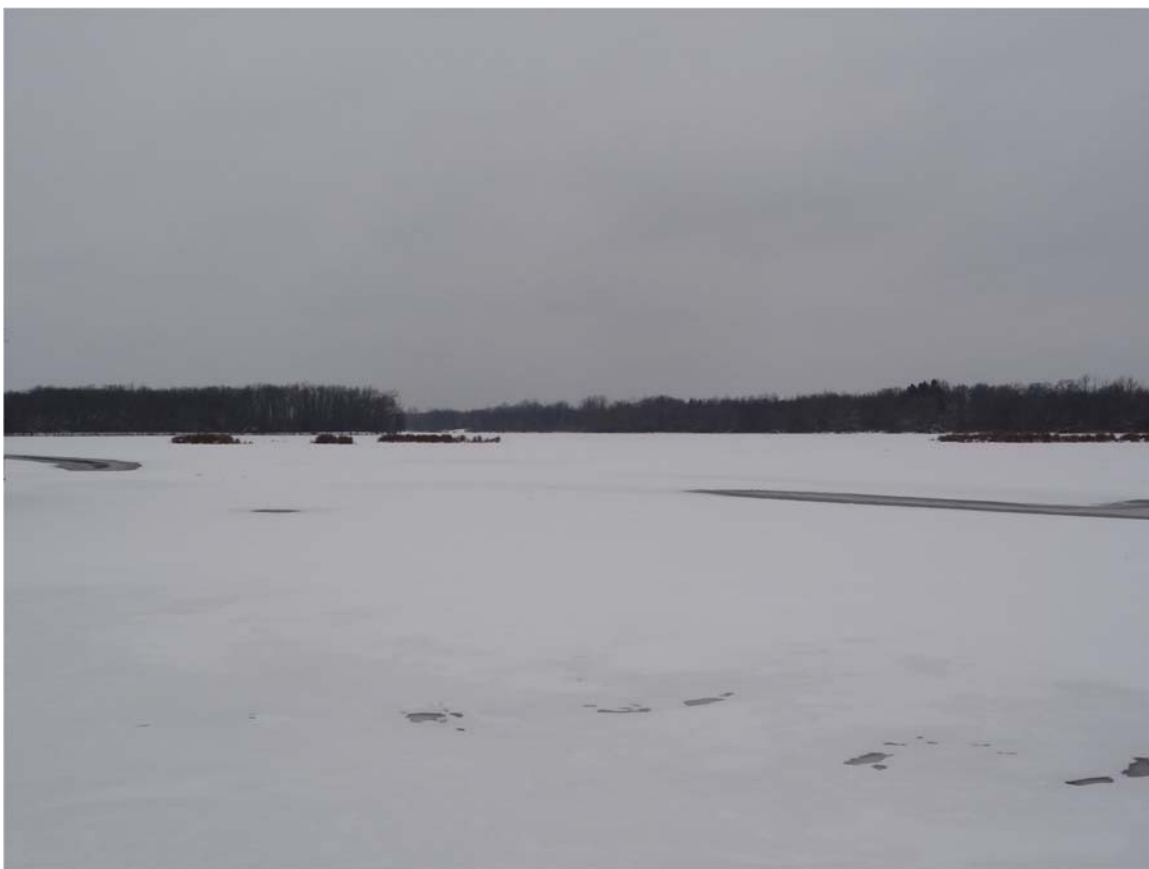
**20. Morrow Lake Delta observed icing conditions.**

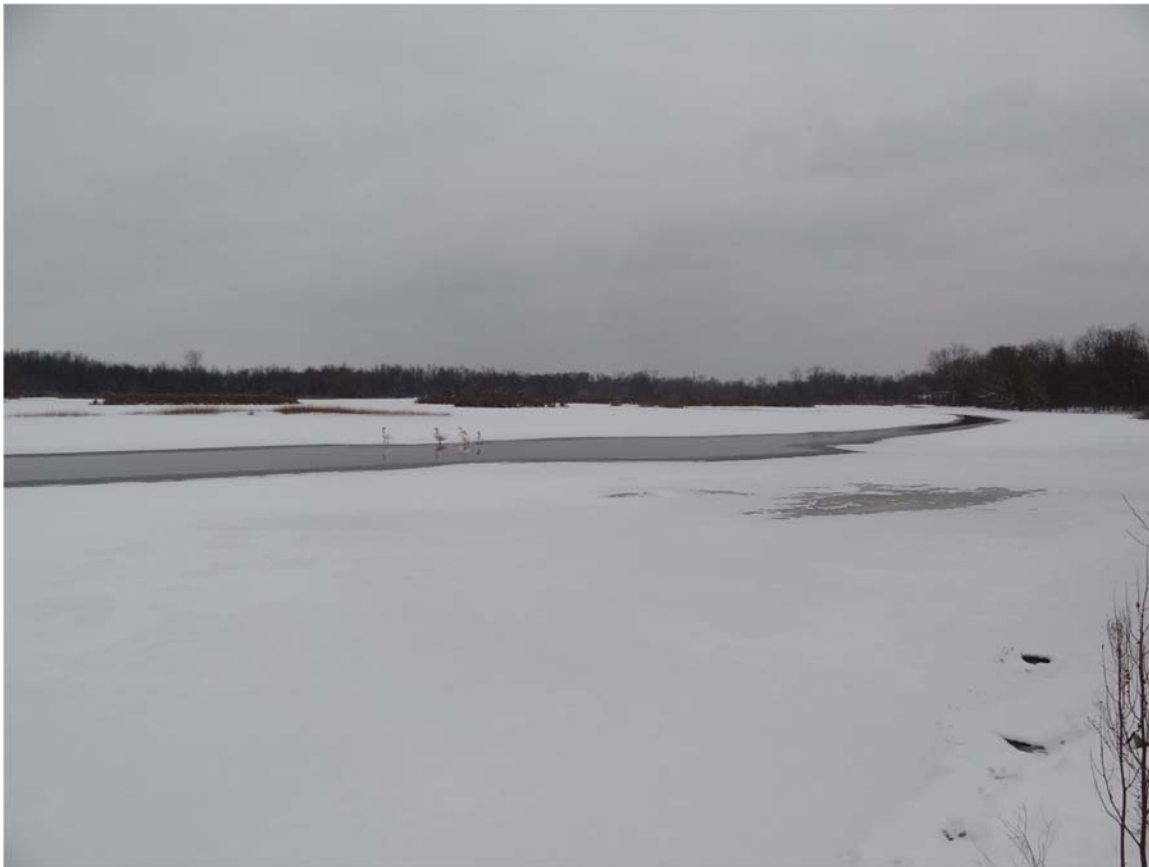
**21. Morrow Lake Delta observed icing conditions.**

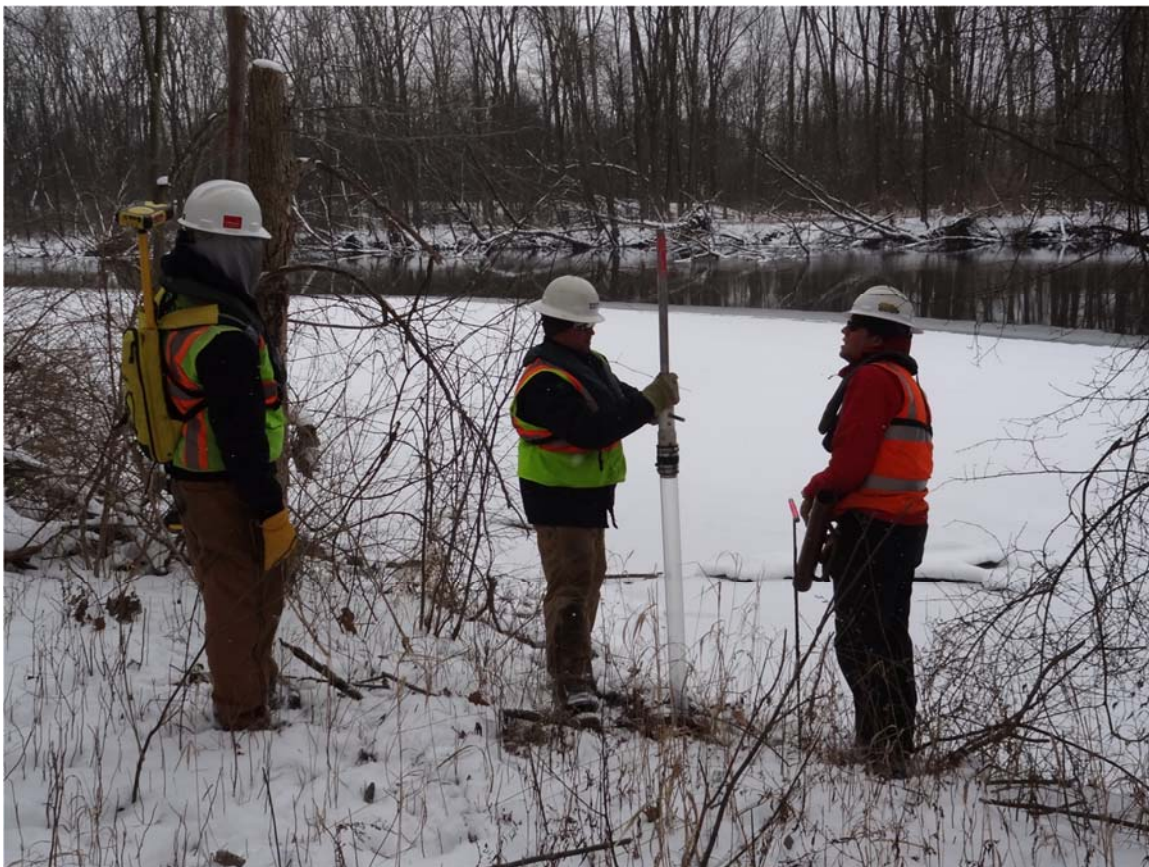
**22. MP21.25 RDB overbank oxbow observed the RI crew.**
