# Situation Photo Log

Saturday, January 26, 2013

Kalamazoo River / Enbridge Spill

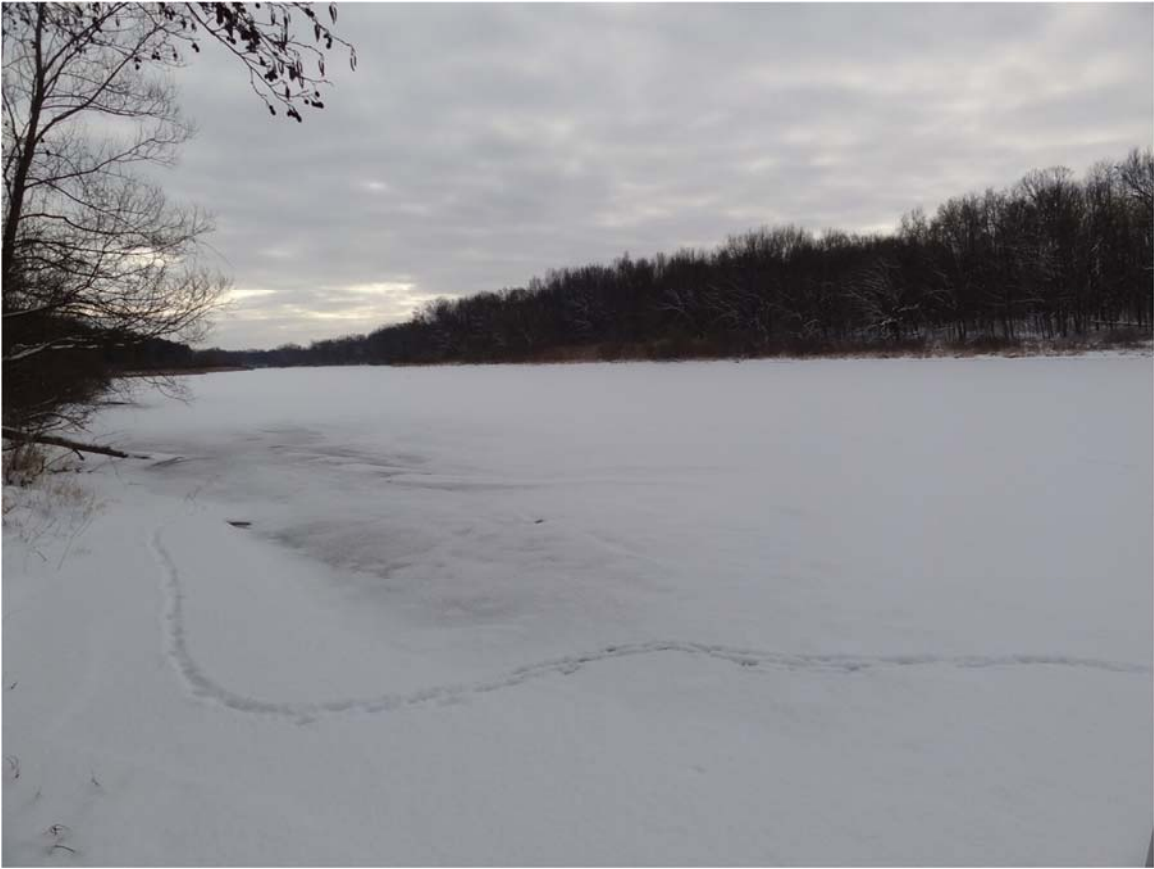
1. C0.4 Boat launch observed upstream river icing conditions.

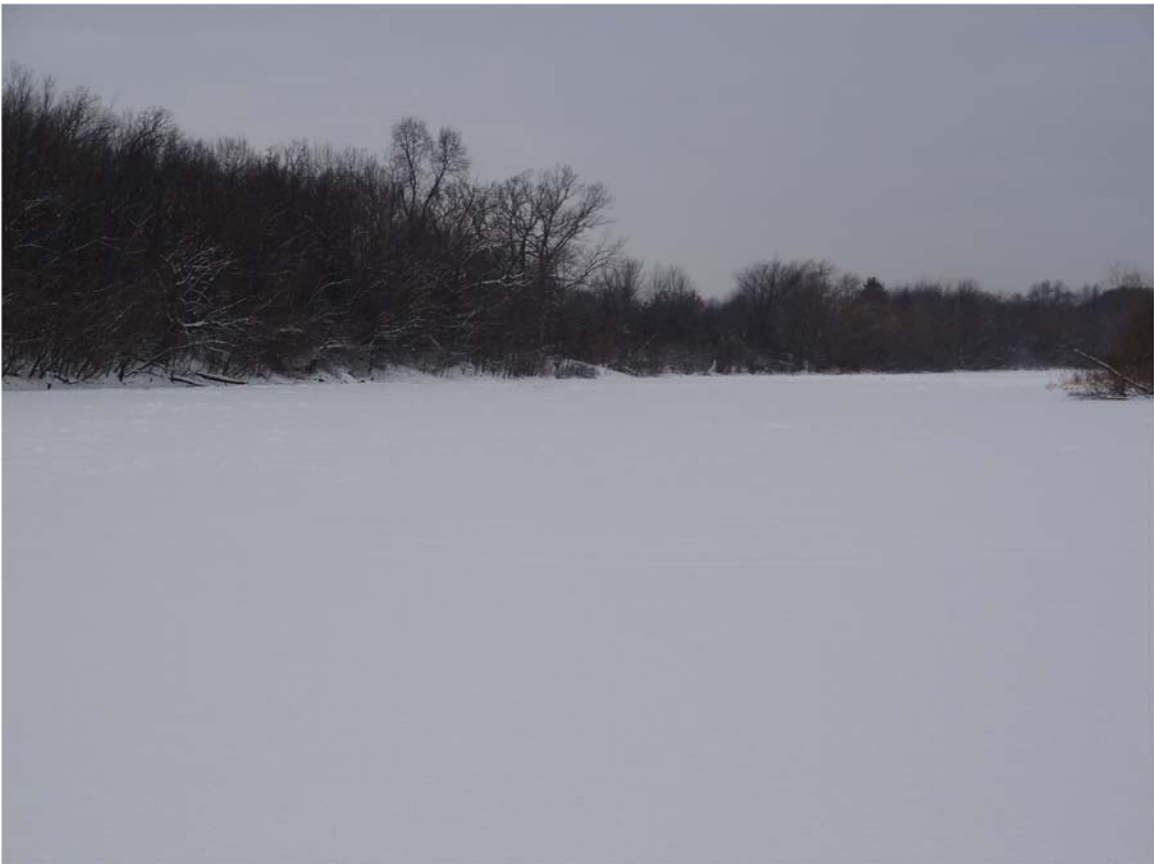
2. C0.4 Boat launch observed downstream river icing conditions.

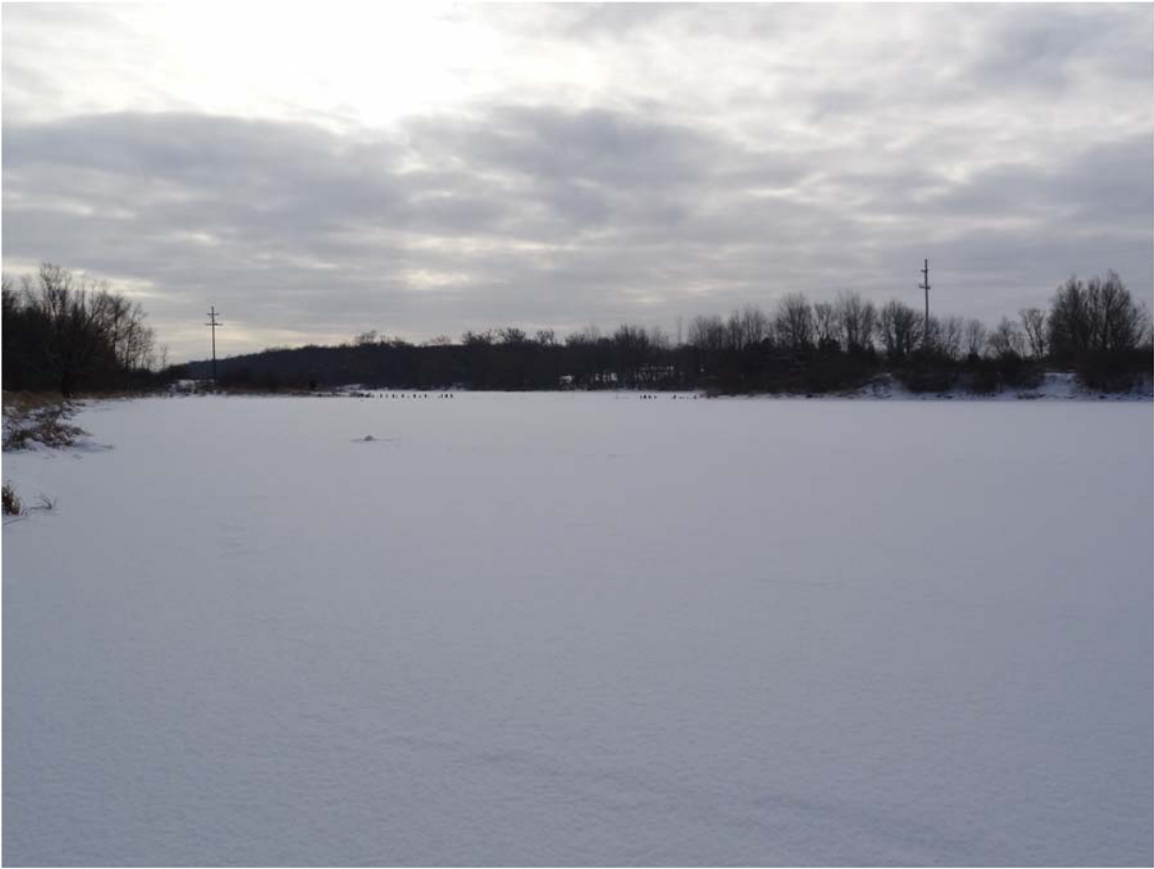
3. Ceresco Dam impoundment observed river icing conditions.

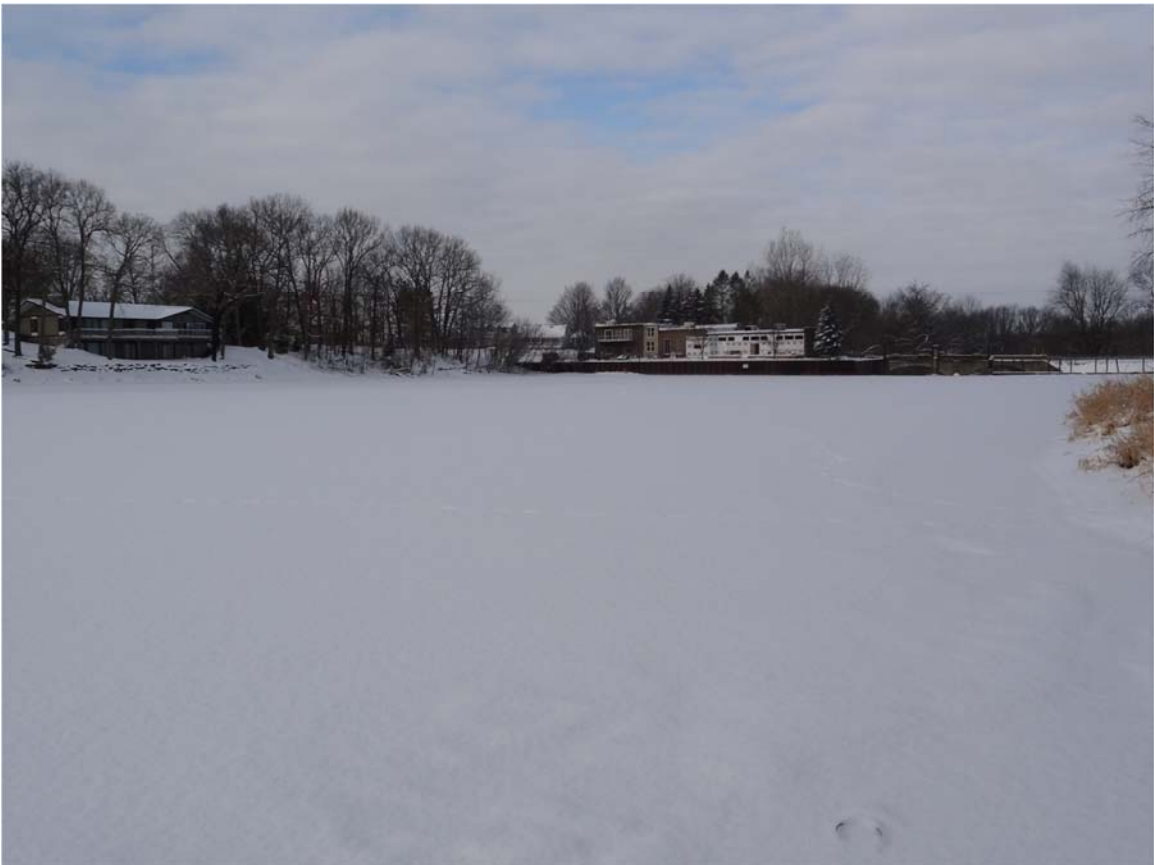
4. Ceresco Dam impoundment observed river icing conditions.

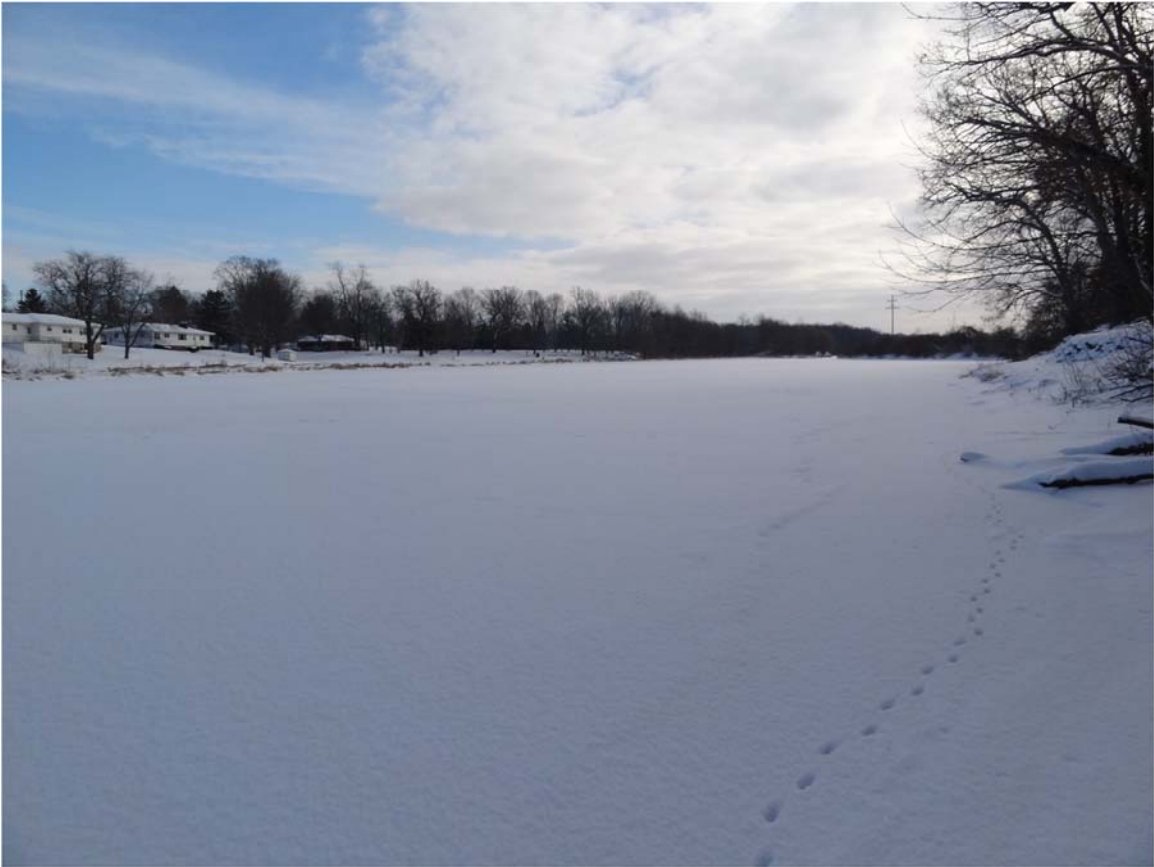
5. Ceresco Dam impoundment observed river icing conditions.

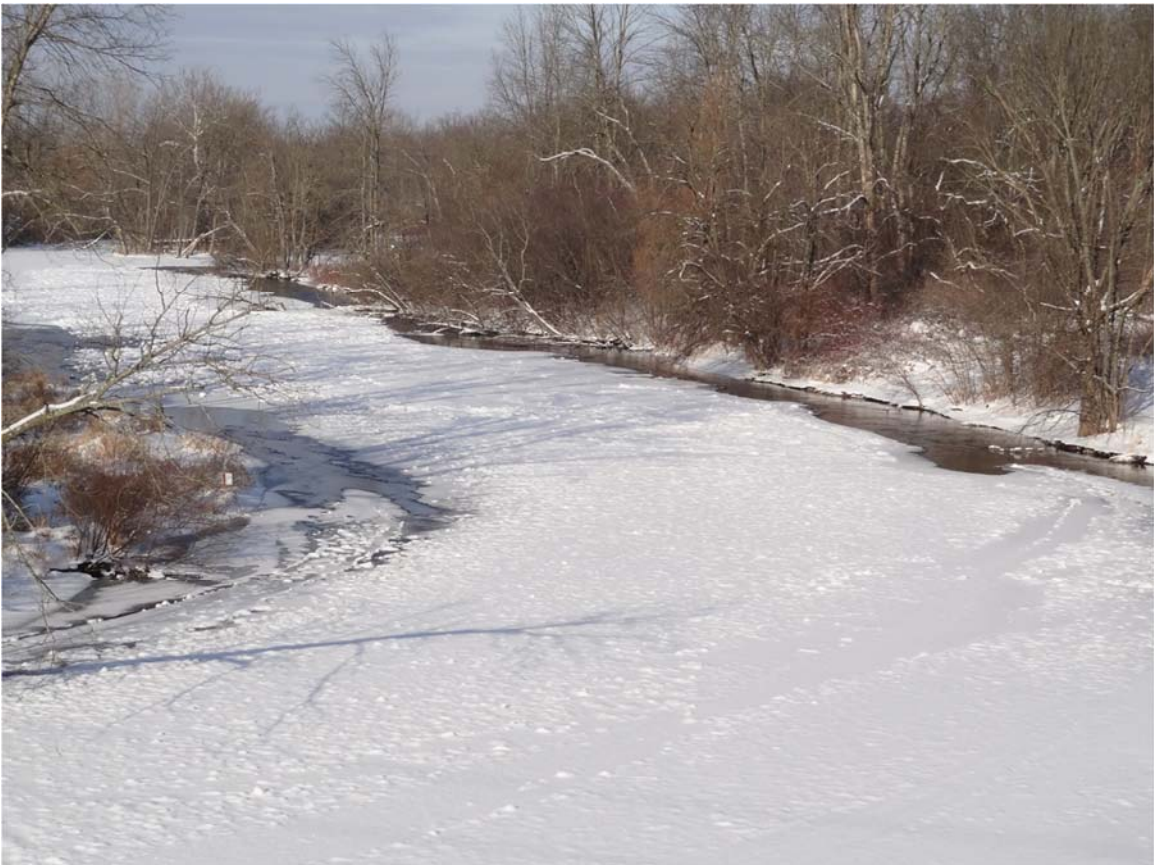
6. MP9.75 Downstream from Waddles Bridge observed river conditions.

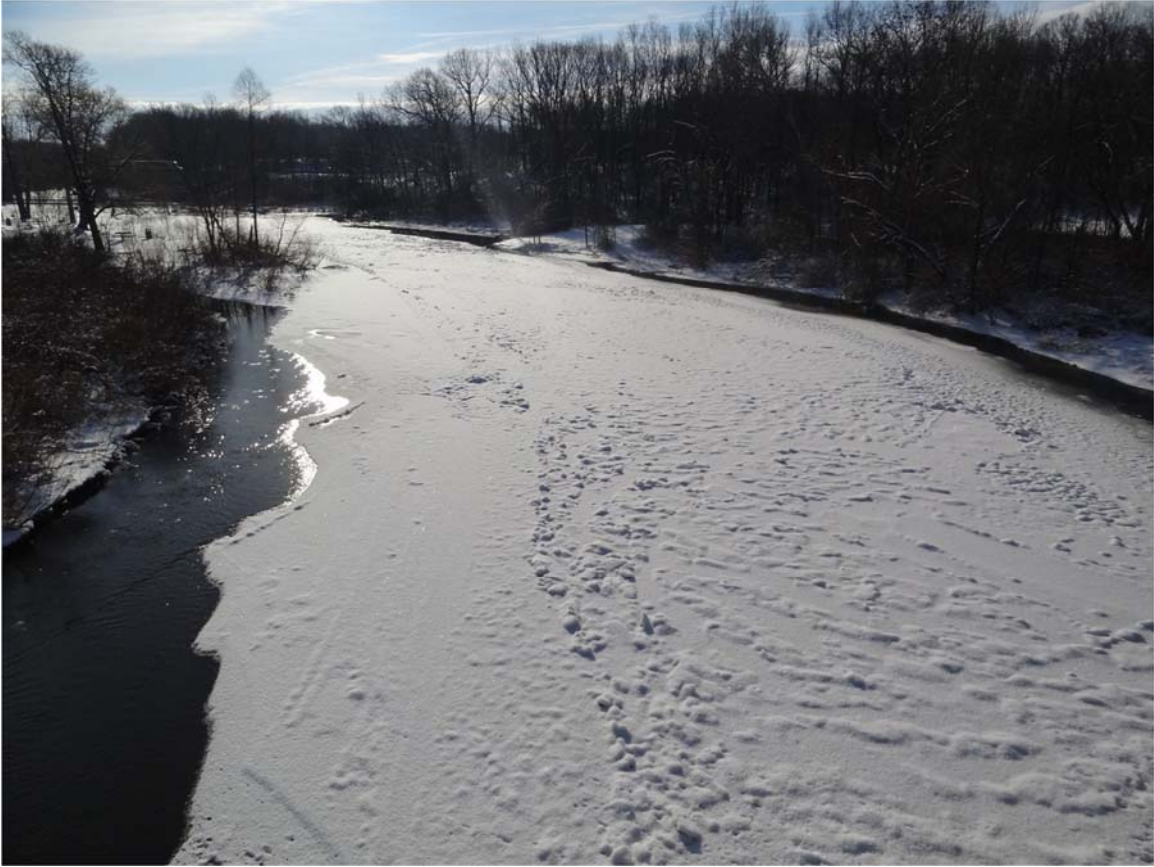
7. MP9.75 Upstream from Waddles Bridge observed river conditions.

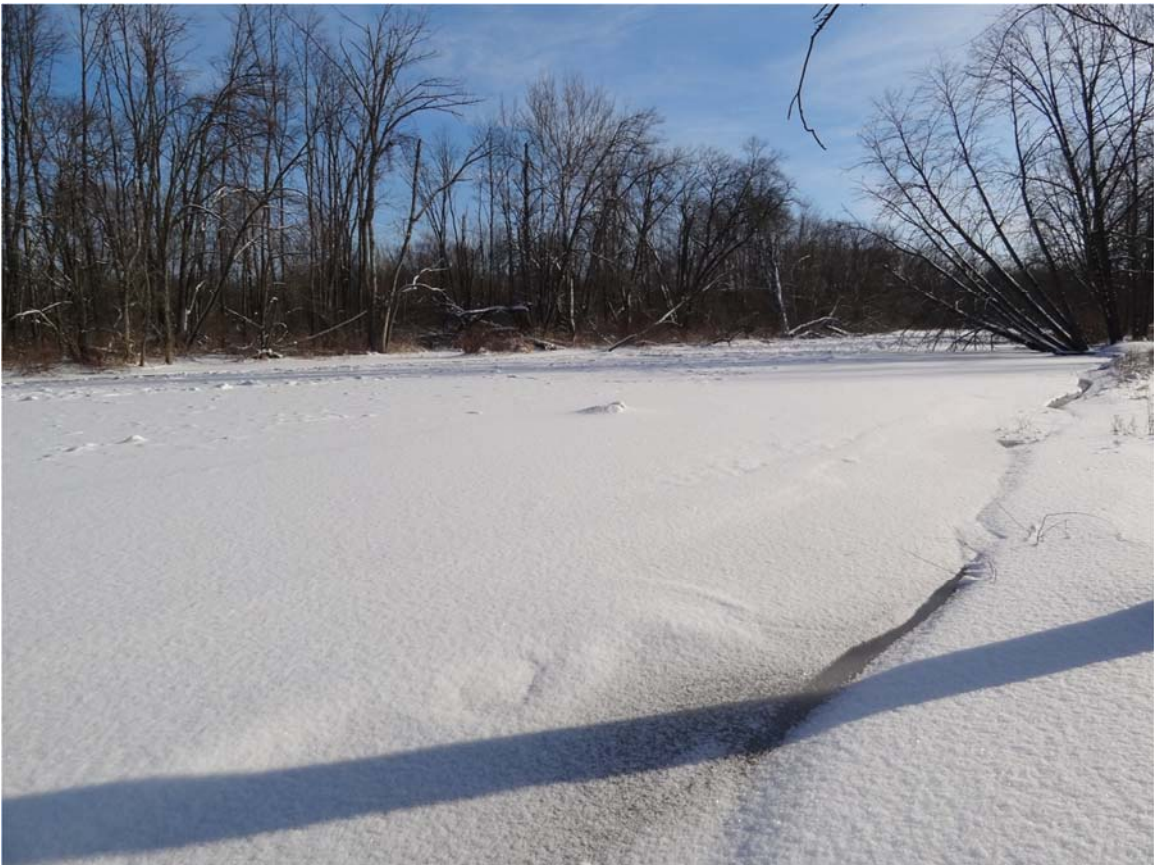
8. C3.2 Boat launch observed river icing conditions. River levels appeared to be dropping.

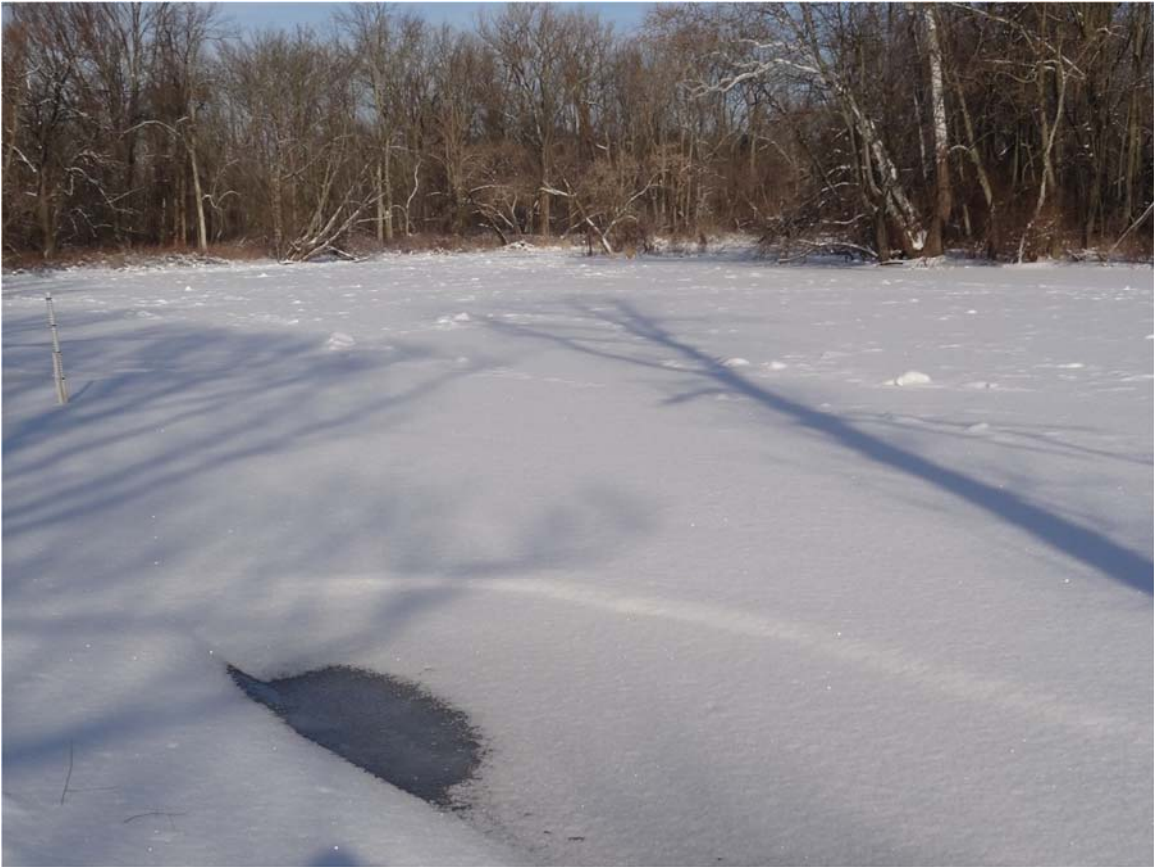
9. C3.2 Boat launch observed river icing conditions. River levels appeared to be dropping

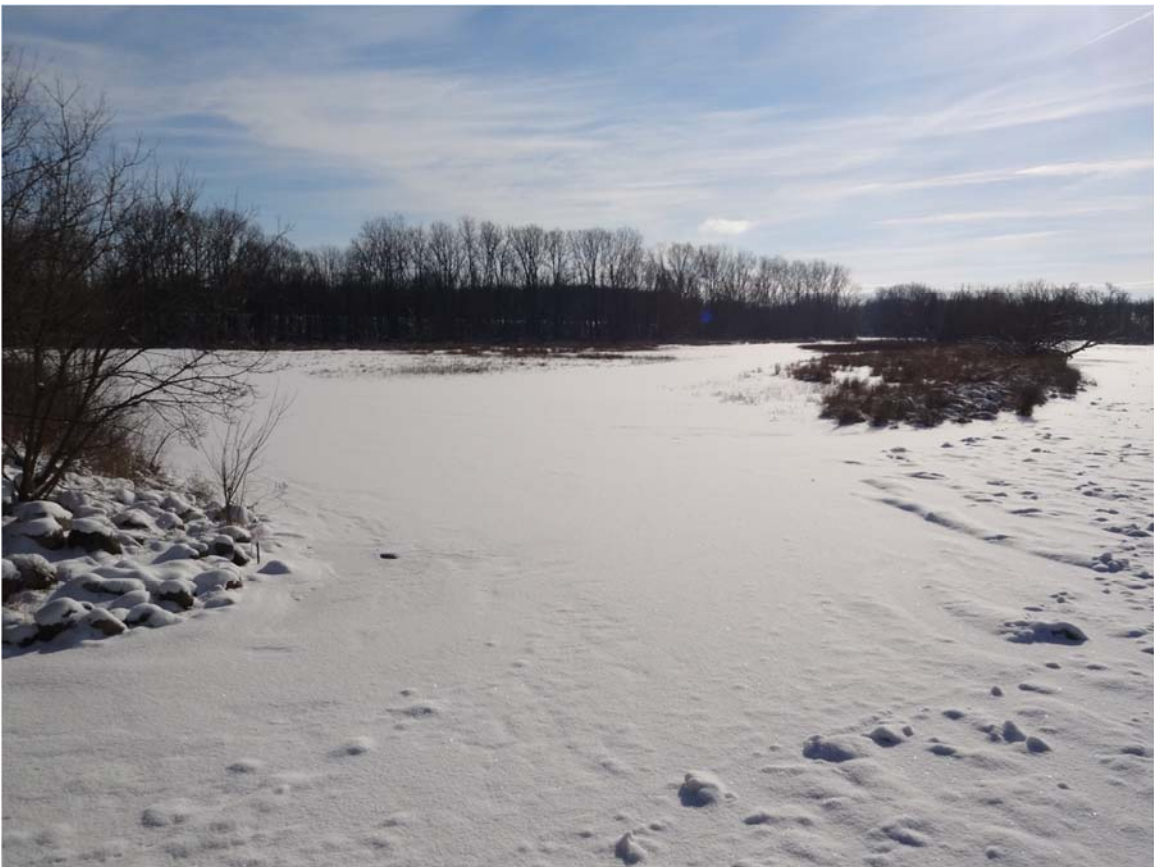
10. MP15.25 South Mill Pond observed river icing conditions.

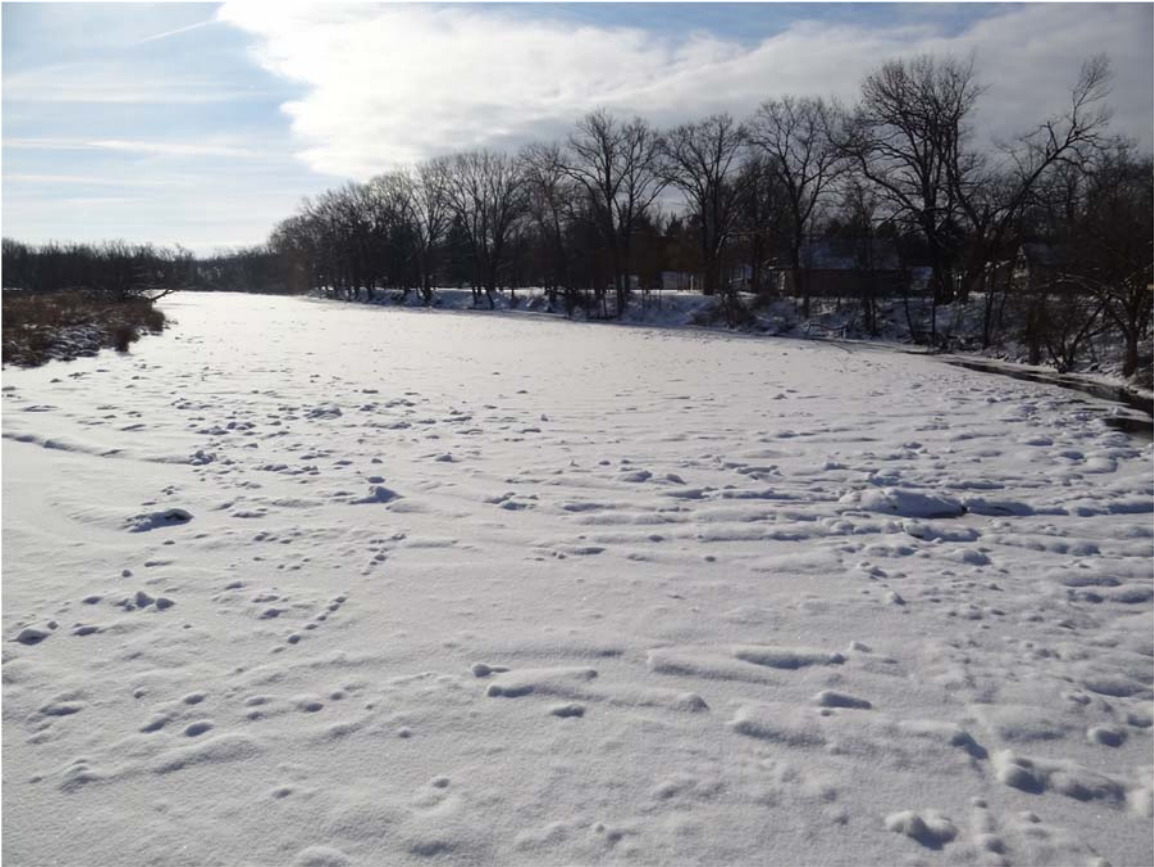
**11. MP15.25 South Mill Pond observed river icing conditions.**

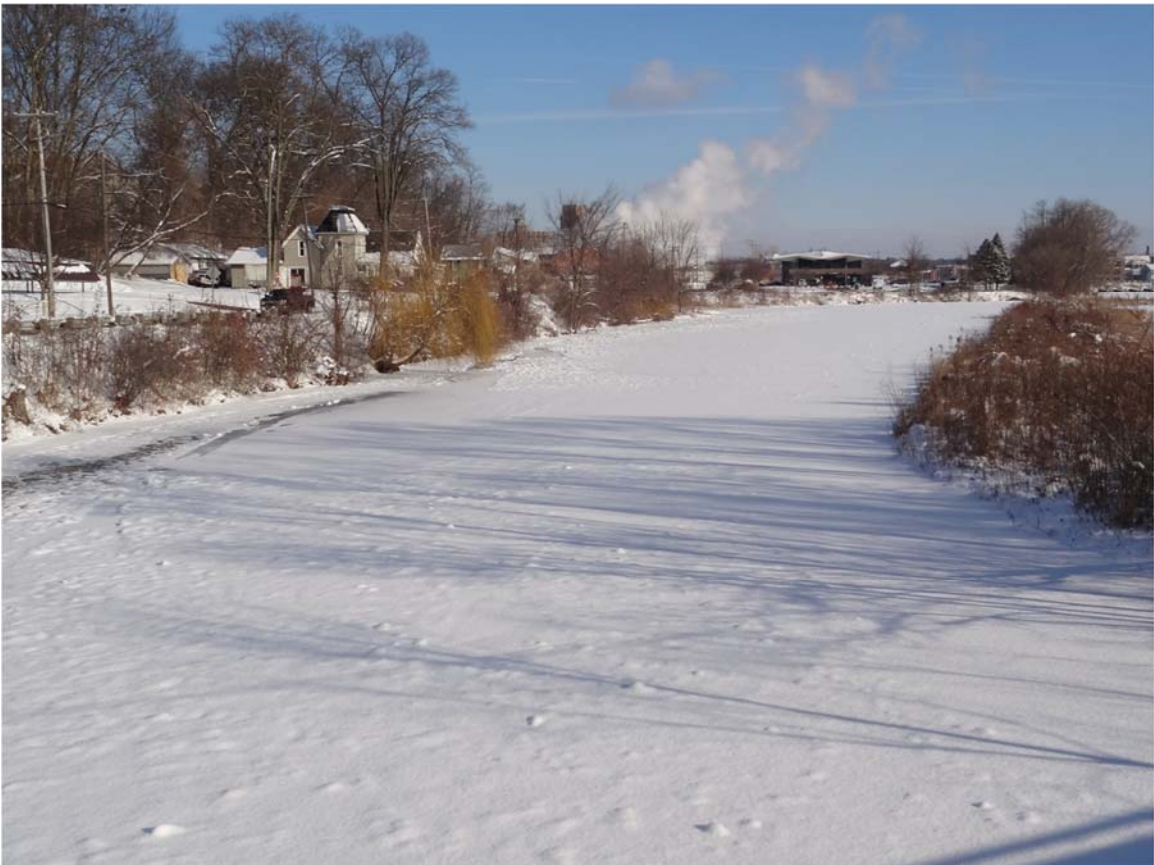
**12. MP15.5 North Mill Pond observed river icing conditions.**

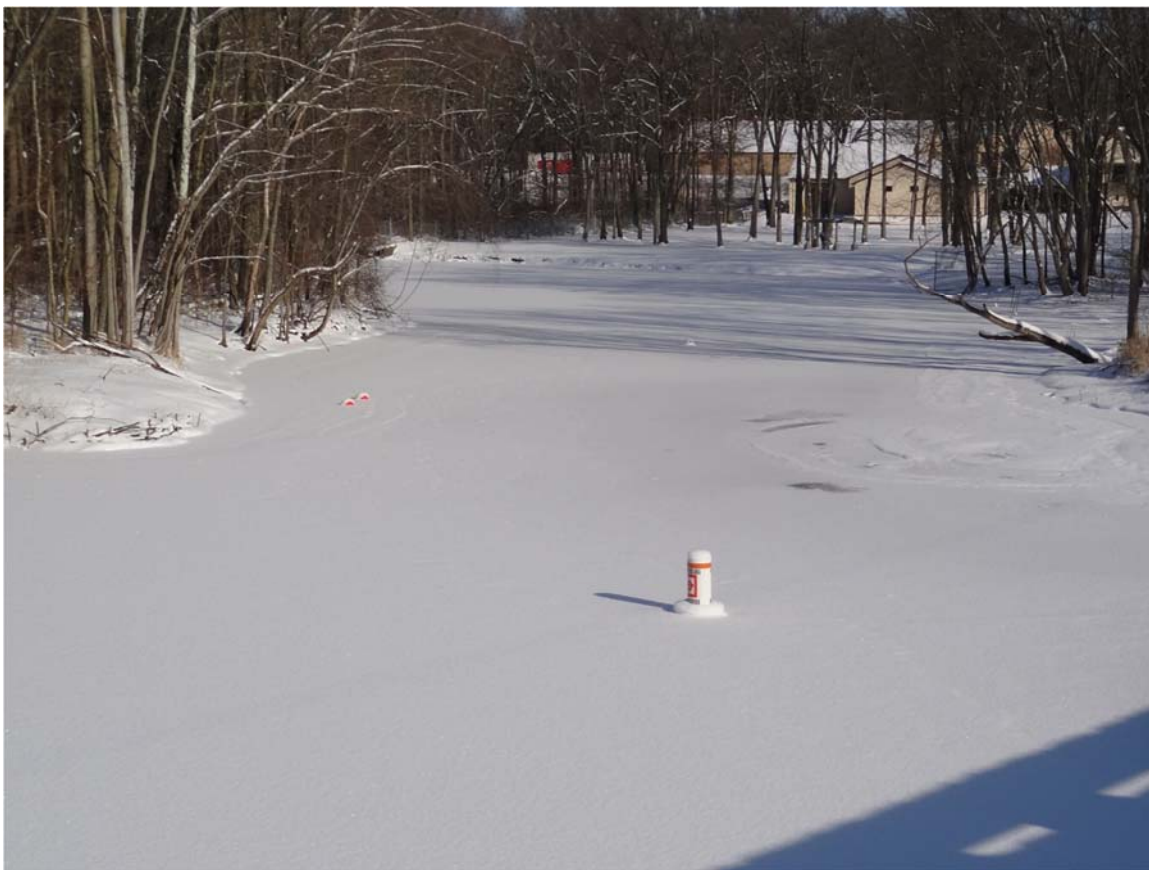
13. MP21.5 Oxbow observed river icing conditions.

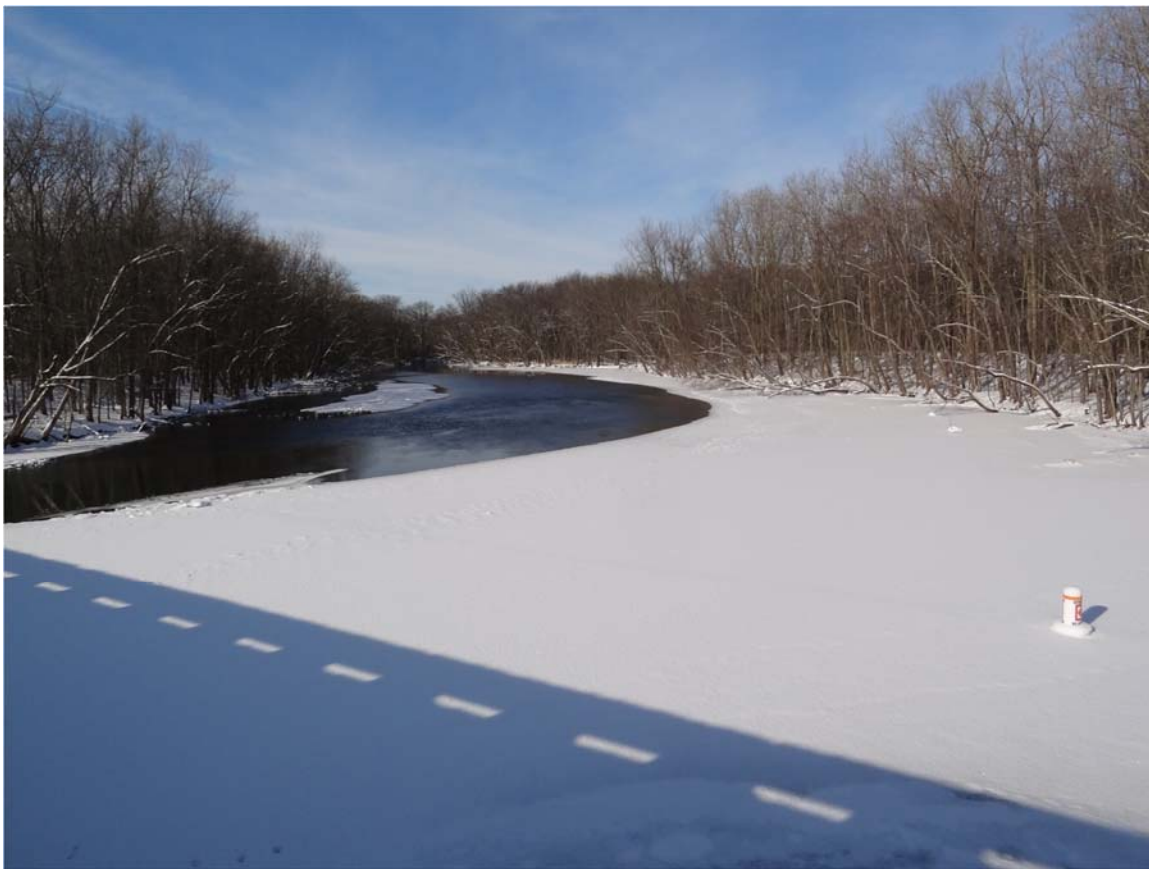
14. MP21.5 observed river icing conditions.

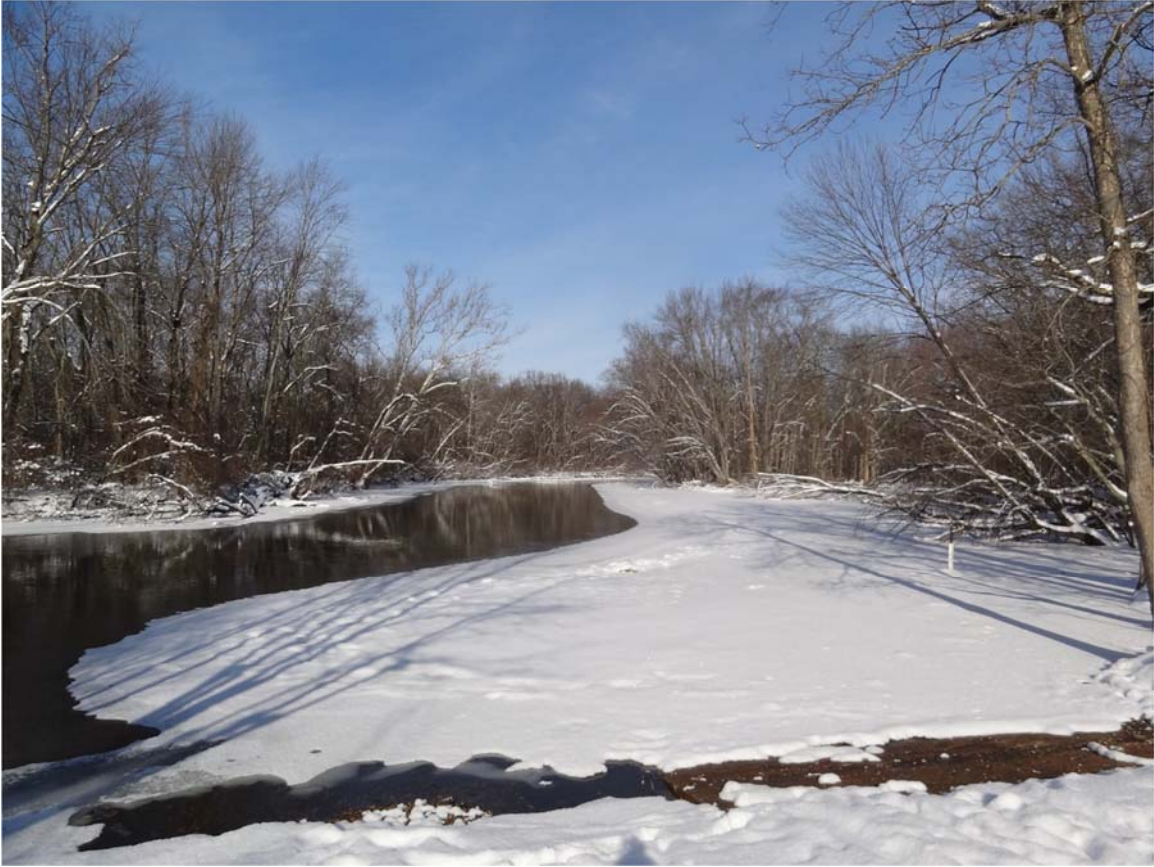
**15. E2 Boat launch observed river icing conditions. River levels appeared to be dropping.**

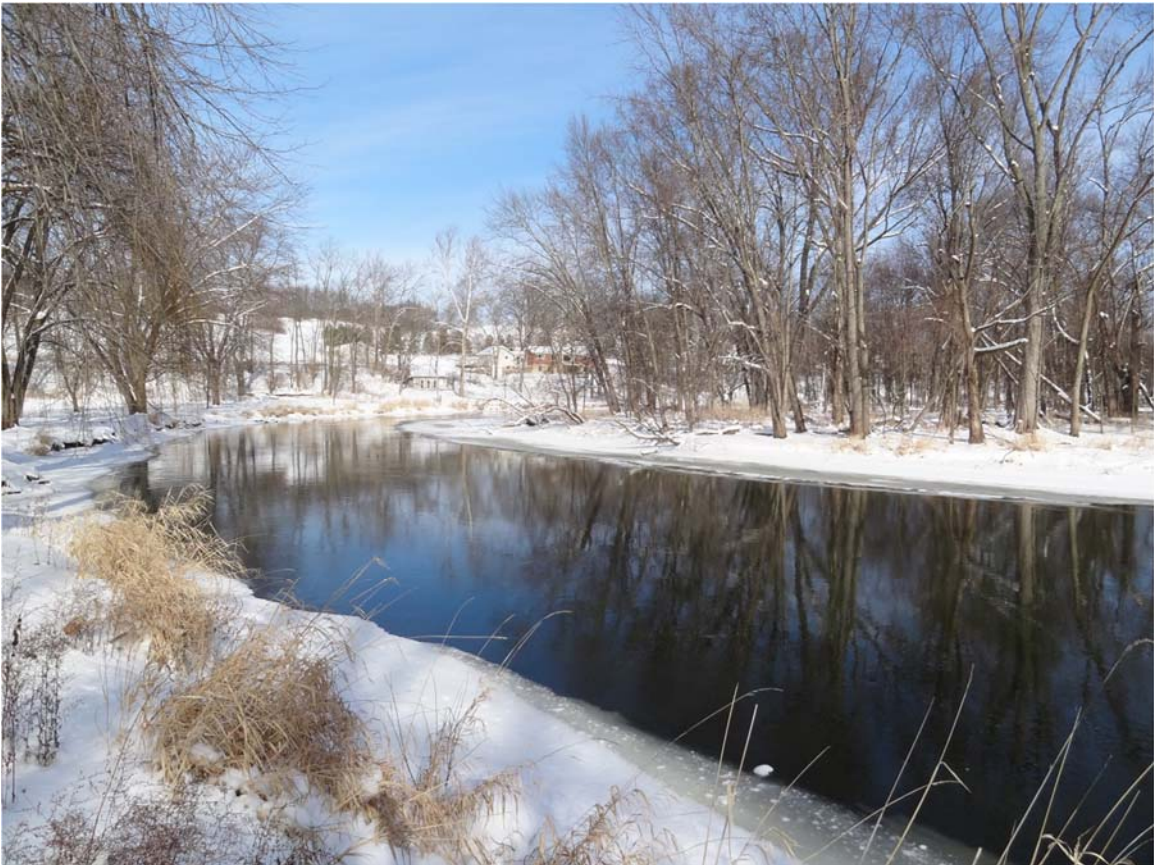
**16. MP27.0 E0.5 Boat launch observed river icing conditions.**

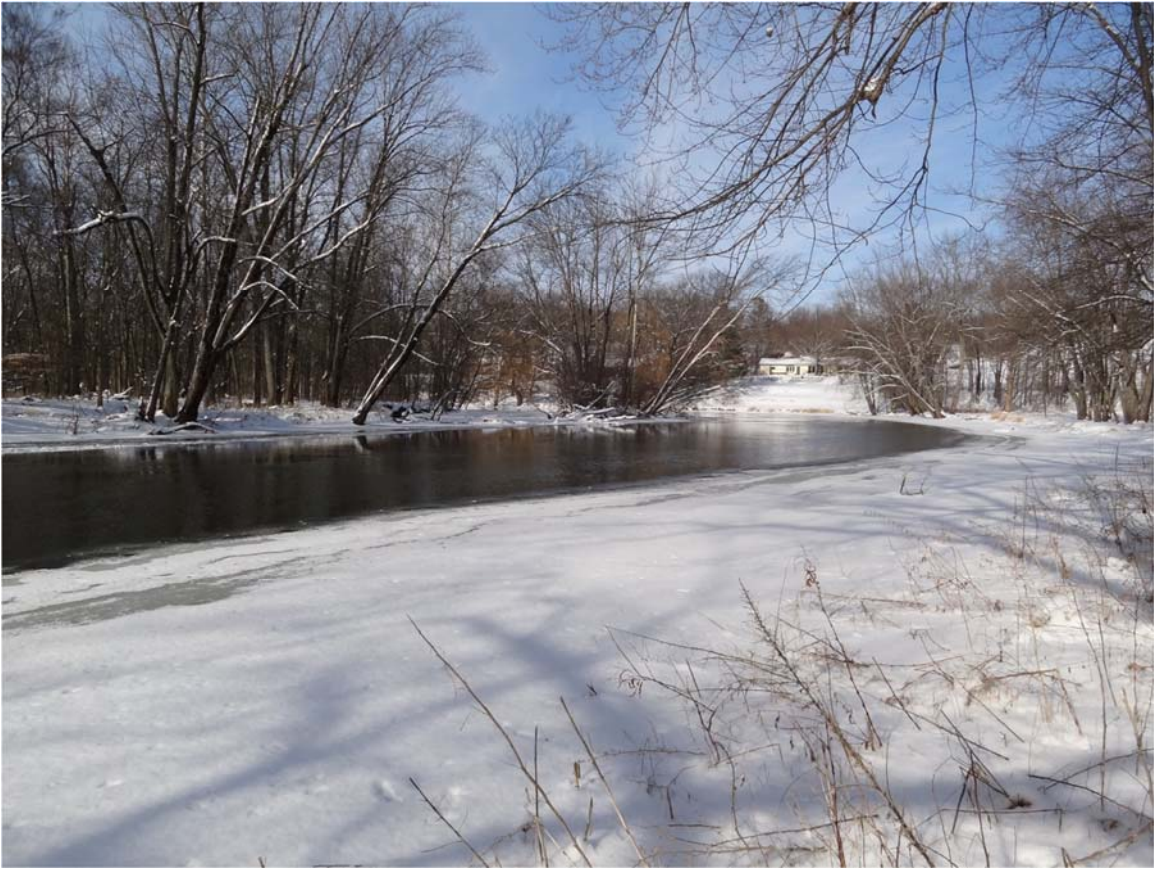
17. MP27.0 E0.5 Boat launch observed river icing conditions.

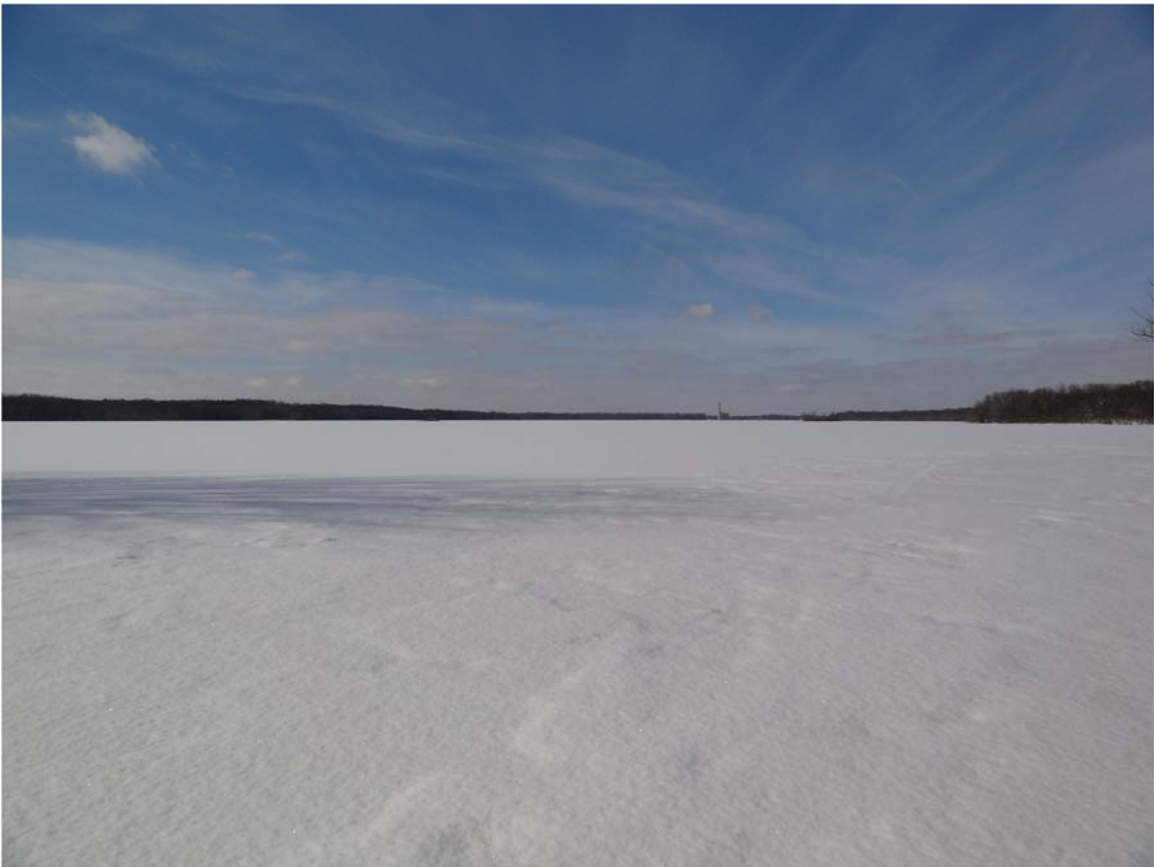
18. Morrow Lake observed icing conditions.

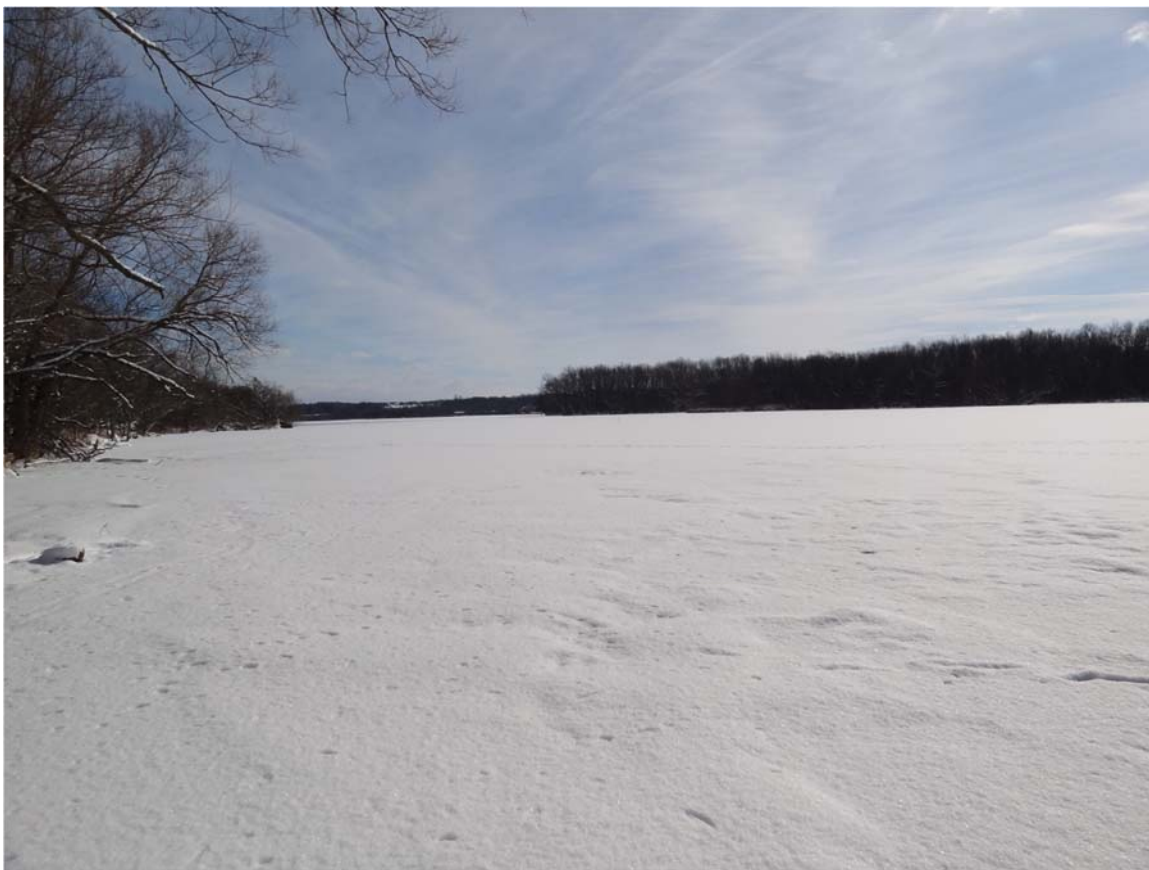
**19. Morrow Lake Neck/Morrow Lake Delta observed icing conditions.**

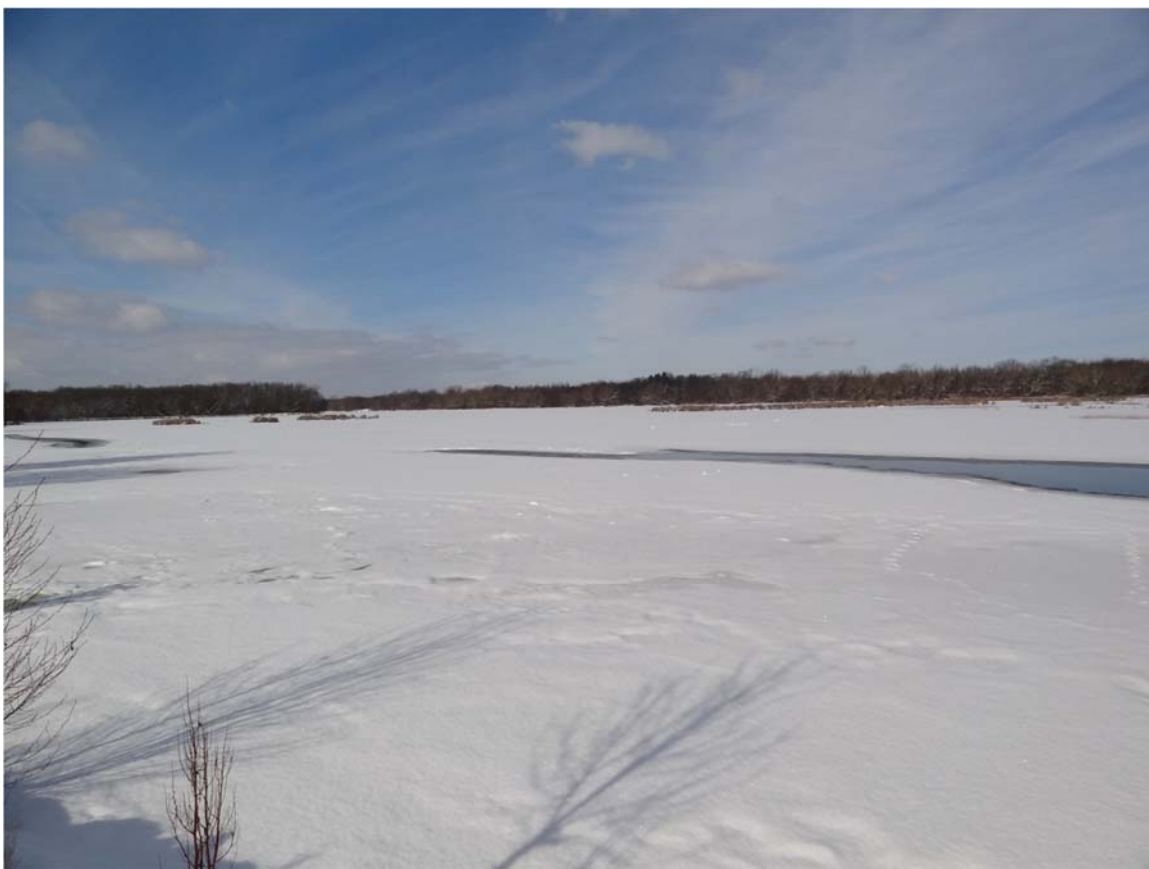
**20. Morrow Lake Delta observed icing conditions.**

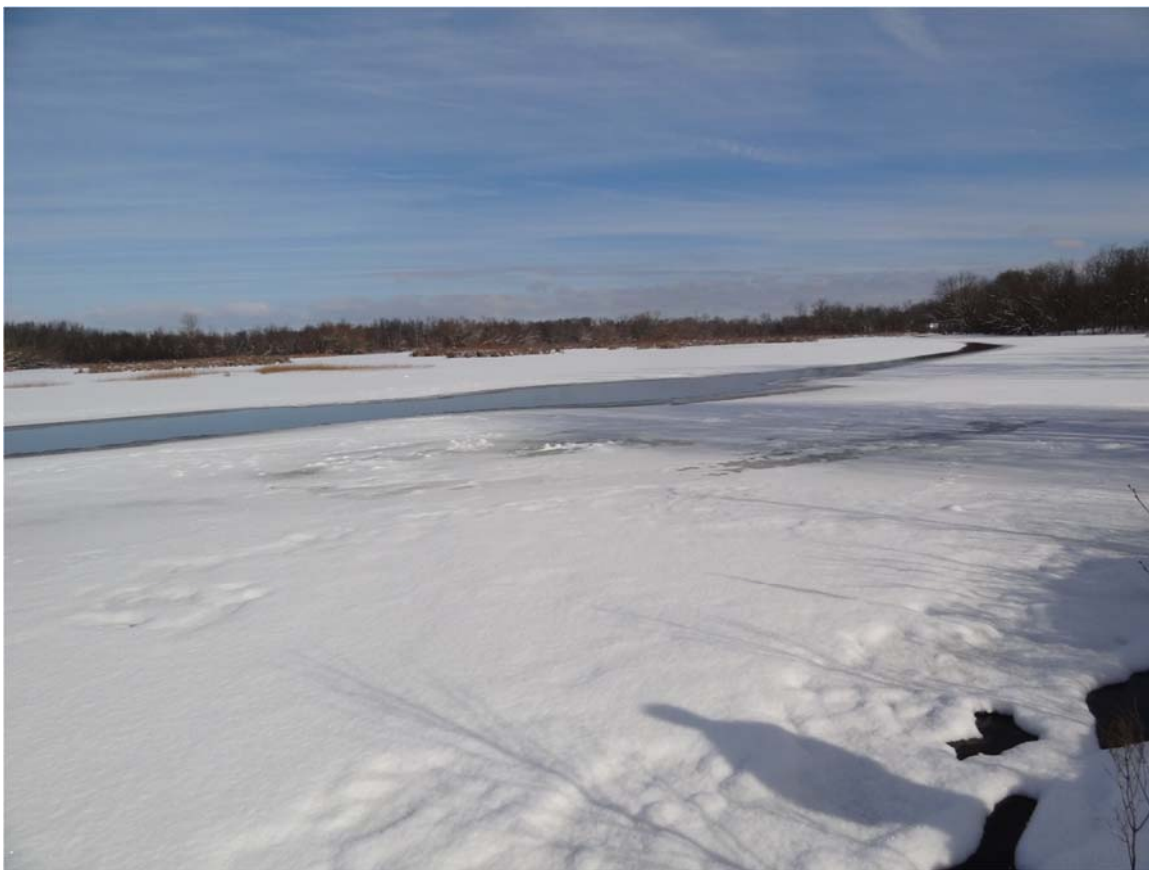
21. Morrow Lake Delta observed icing conditions.

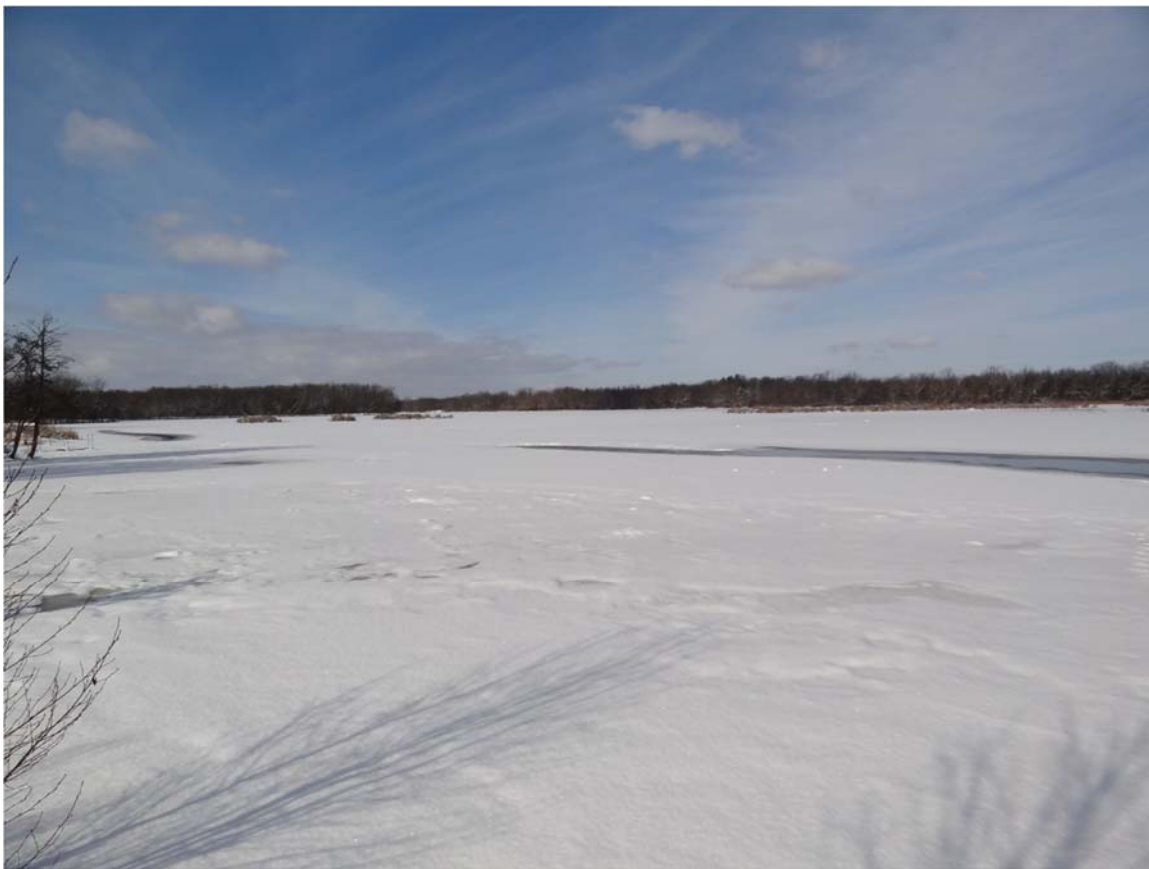
22. Morrow Lake Delta observed icing conditions.
