# Situation Photo Log

Monday, January 28, 2013

Kalamazoo River / Enbridge Spill

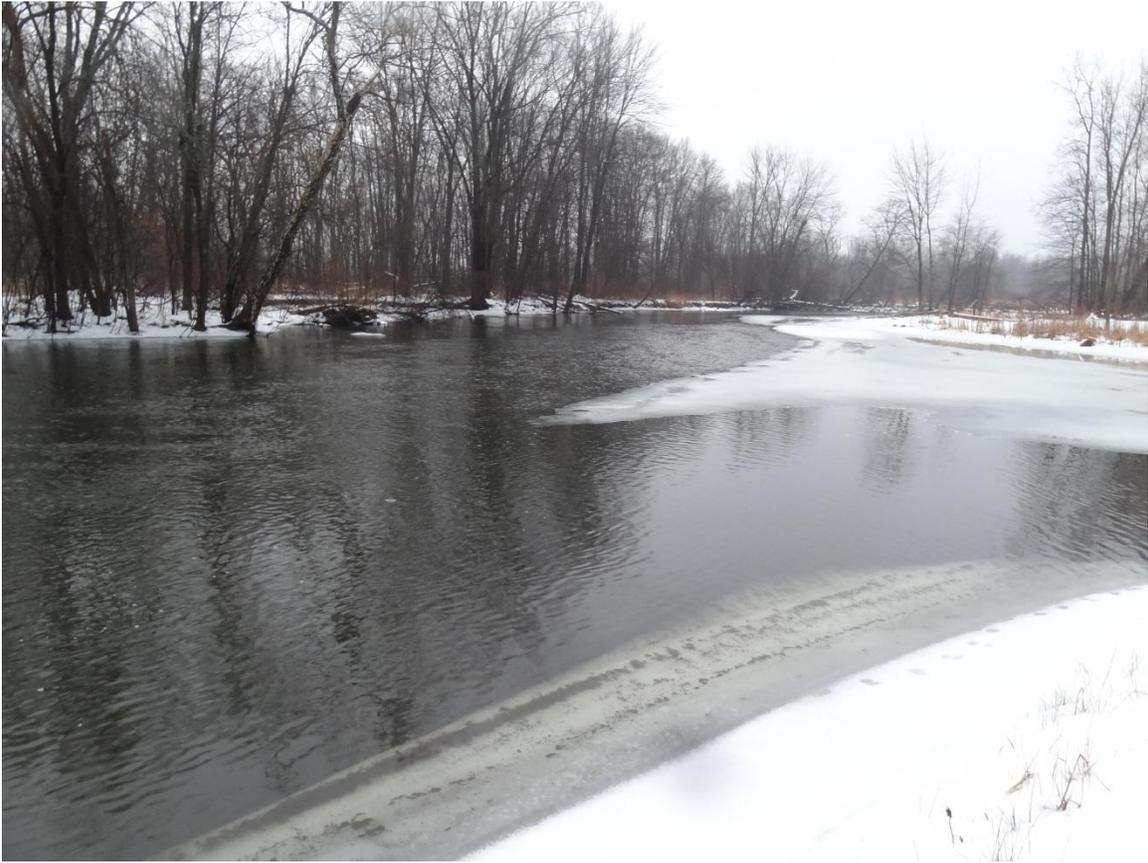
1. MP2.00 the confluence observed upstream river ice conditions.

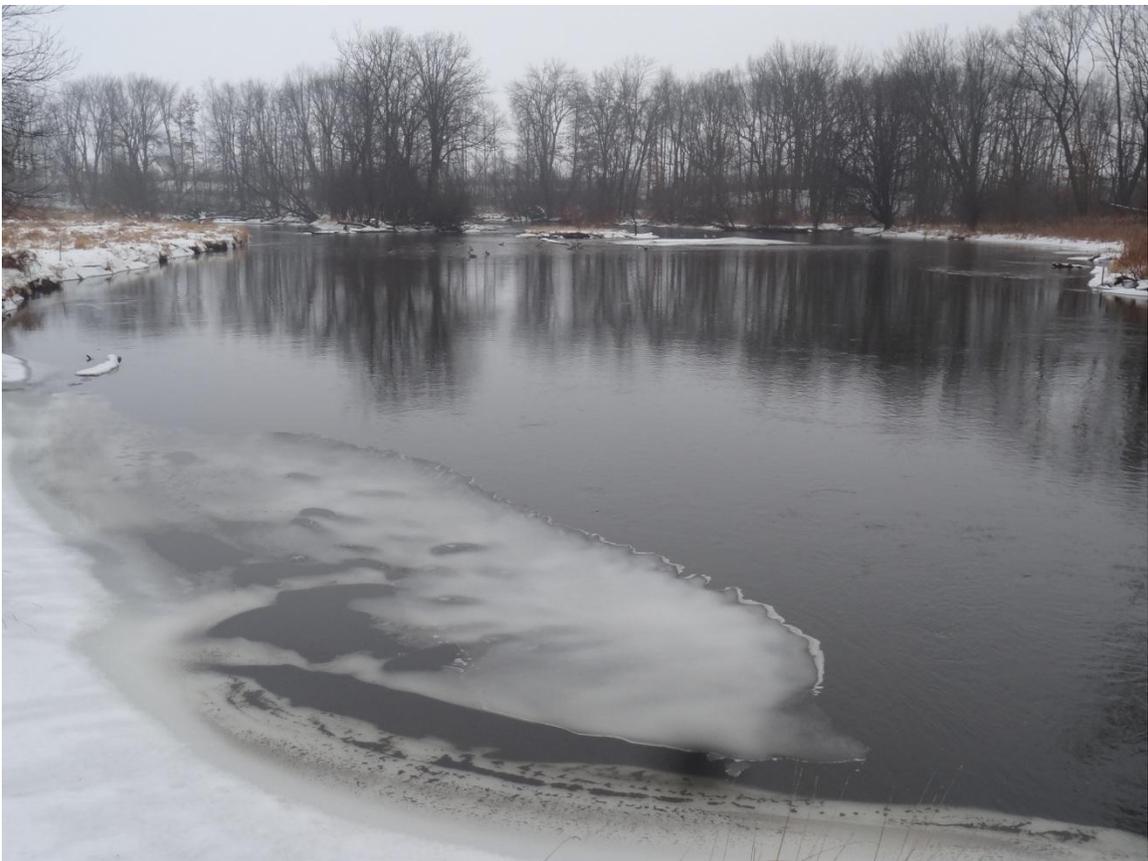
2. Saylor's Landing Boat Launch observed downstream river ice conditions.

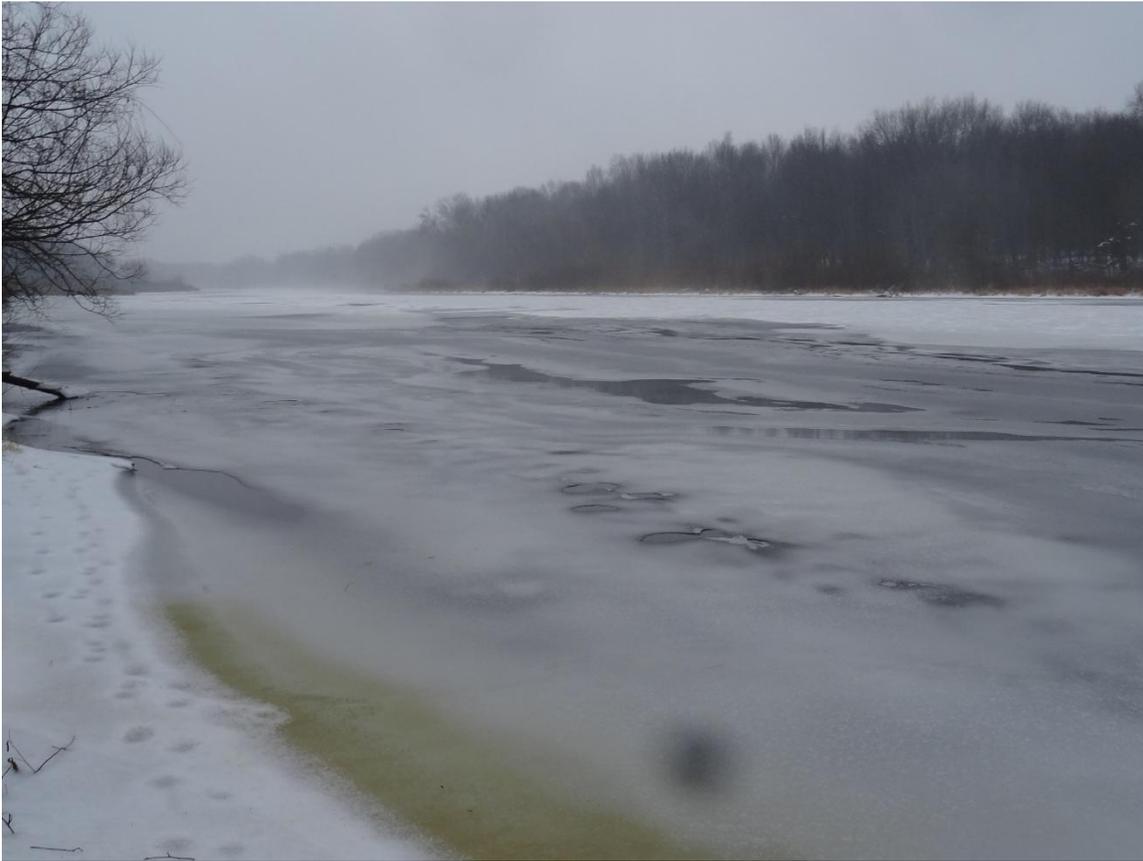
3. C0.4 Boat Launch observed upstream river ice conditions.

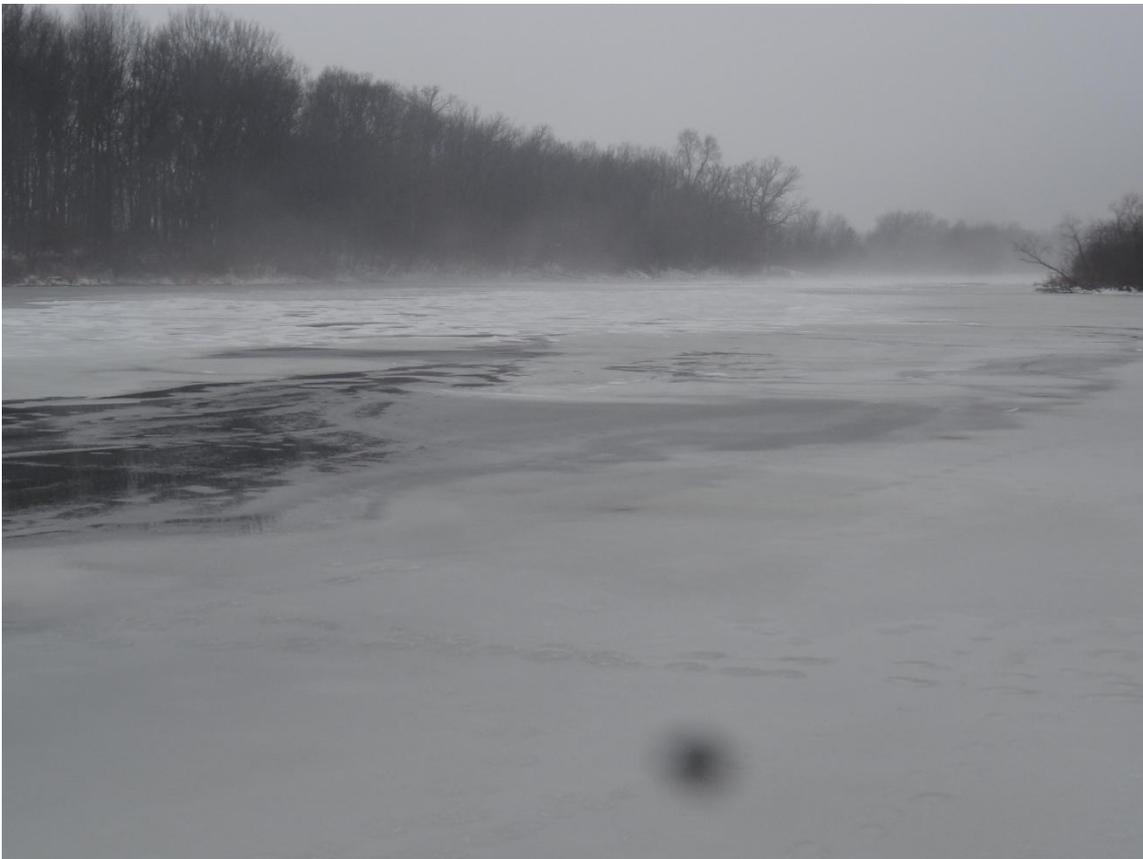
4. C0.4 Boat Launch observed downstream river ice conditions.

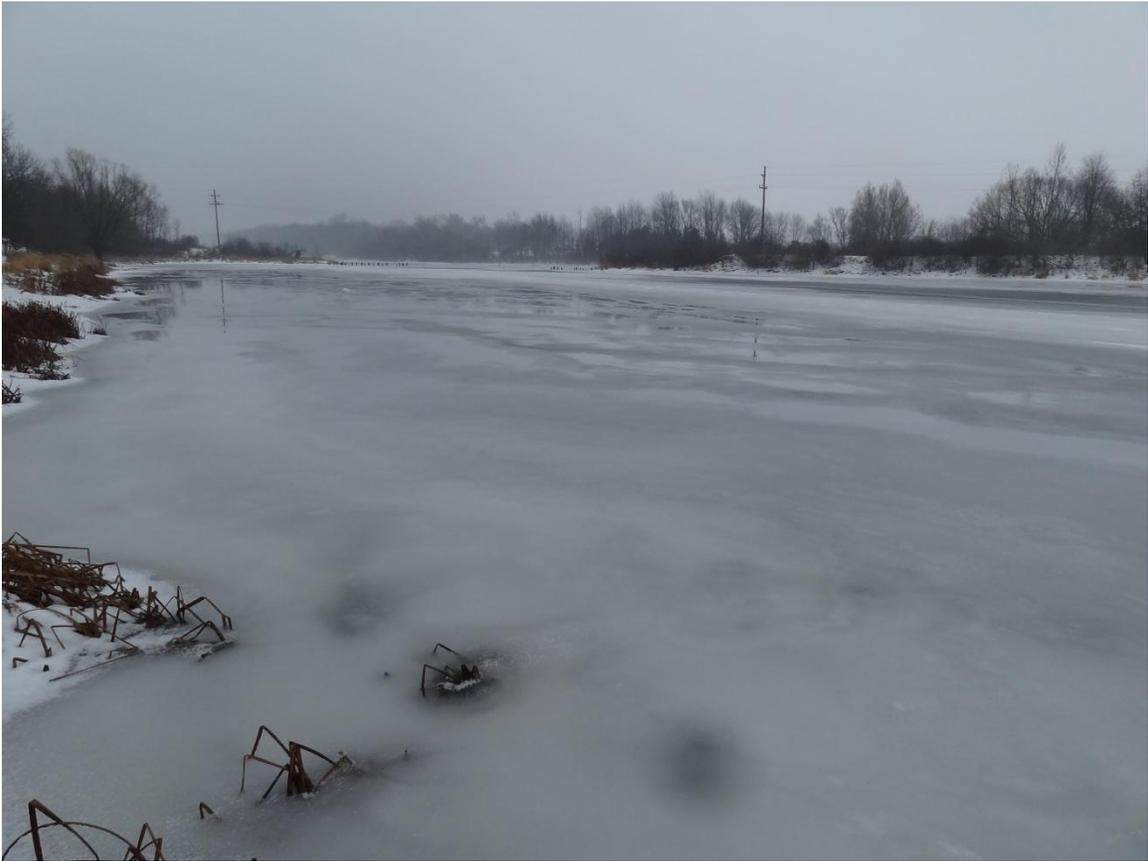
5. Ceresco Dam impoundment observed river ice conditions.

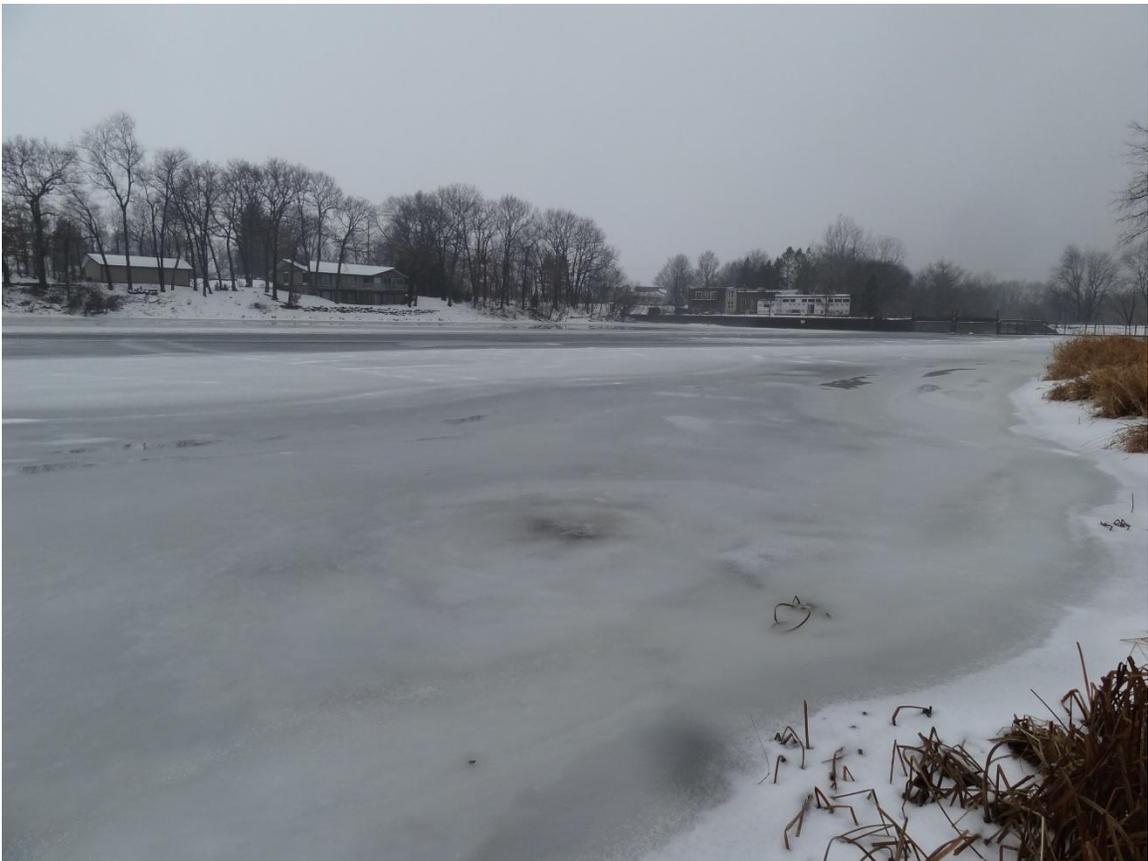
6. Ceresco Dam impoundment observed river ice conditions.

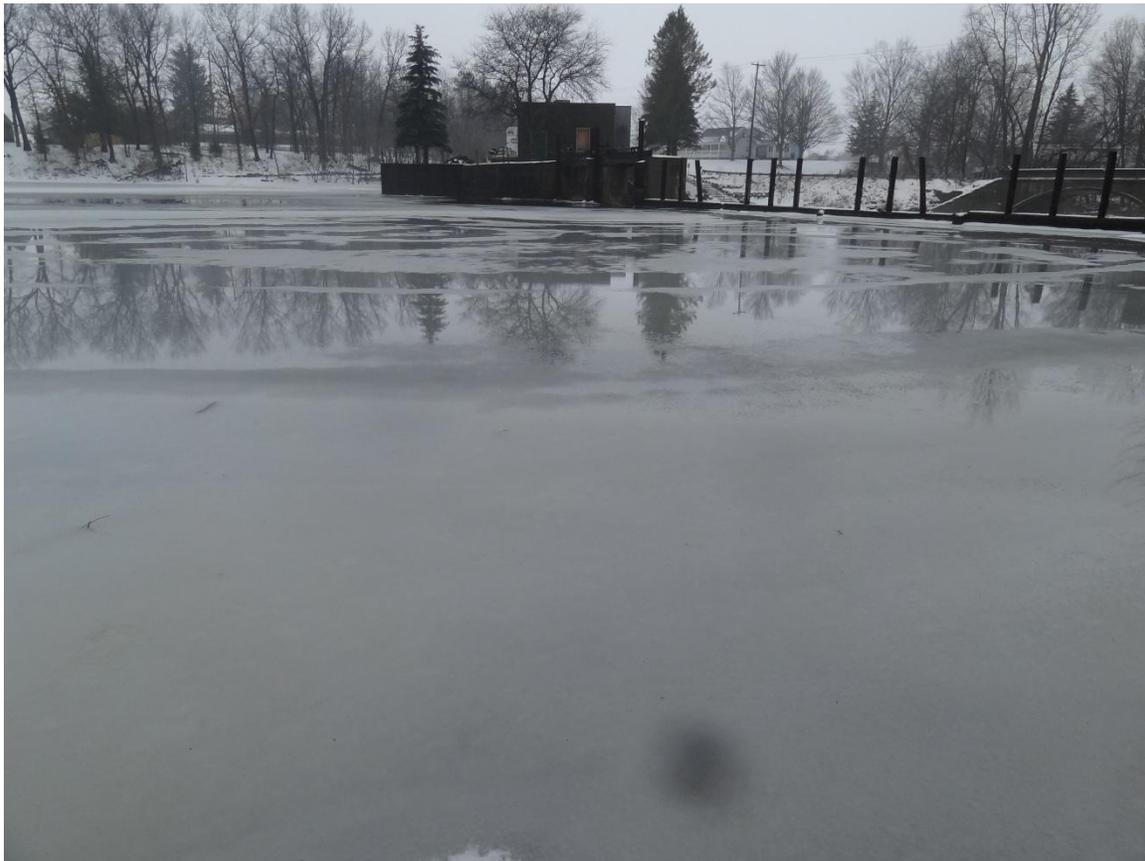
7. Ceresco Dam impoundment observed river ice conditions.

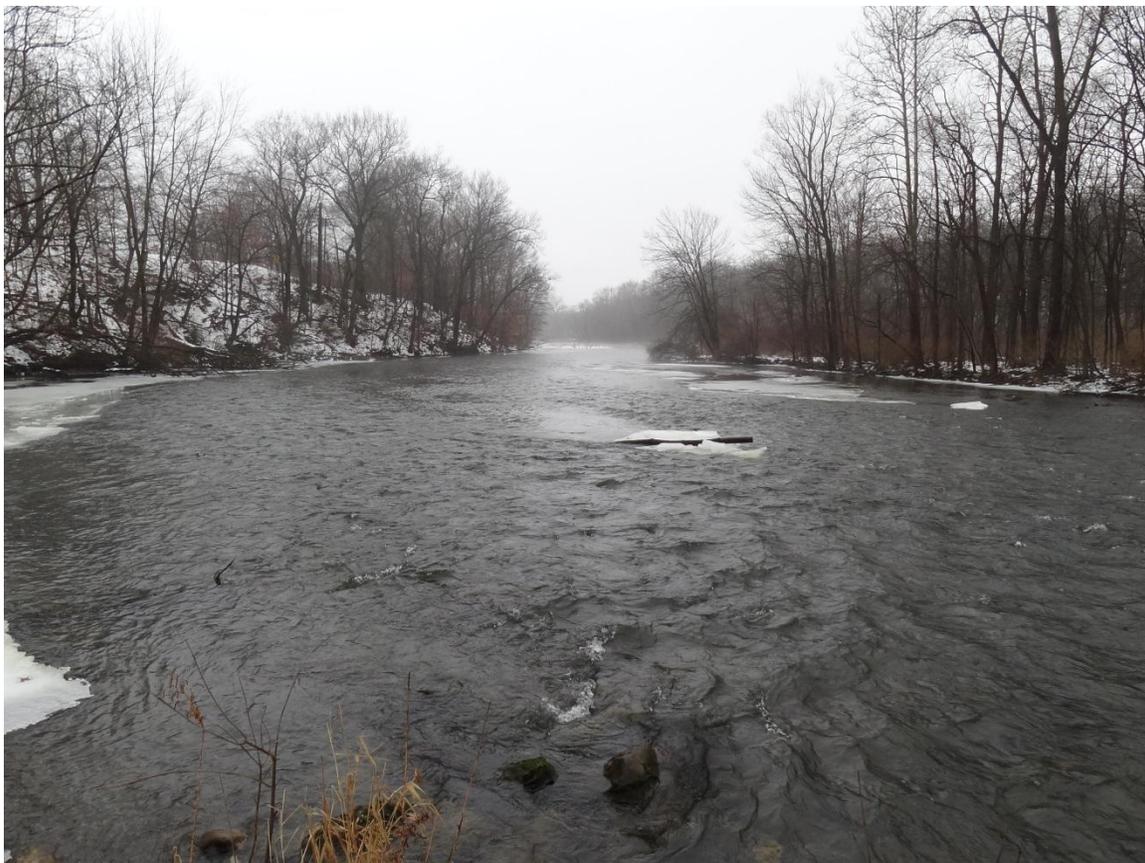
8. MP7.25 observed downstream river ice conditions.

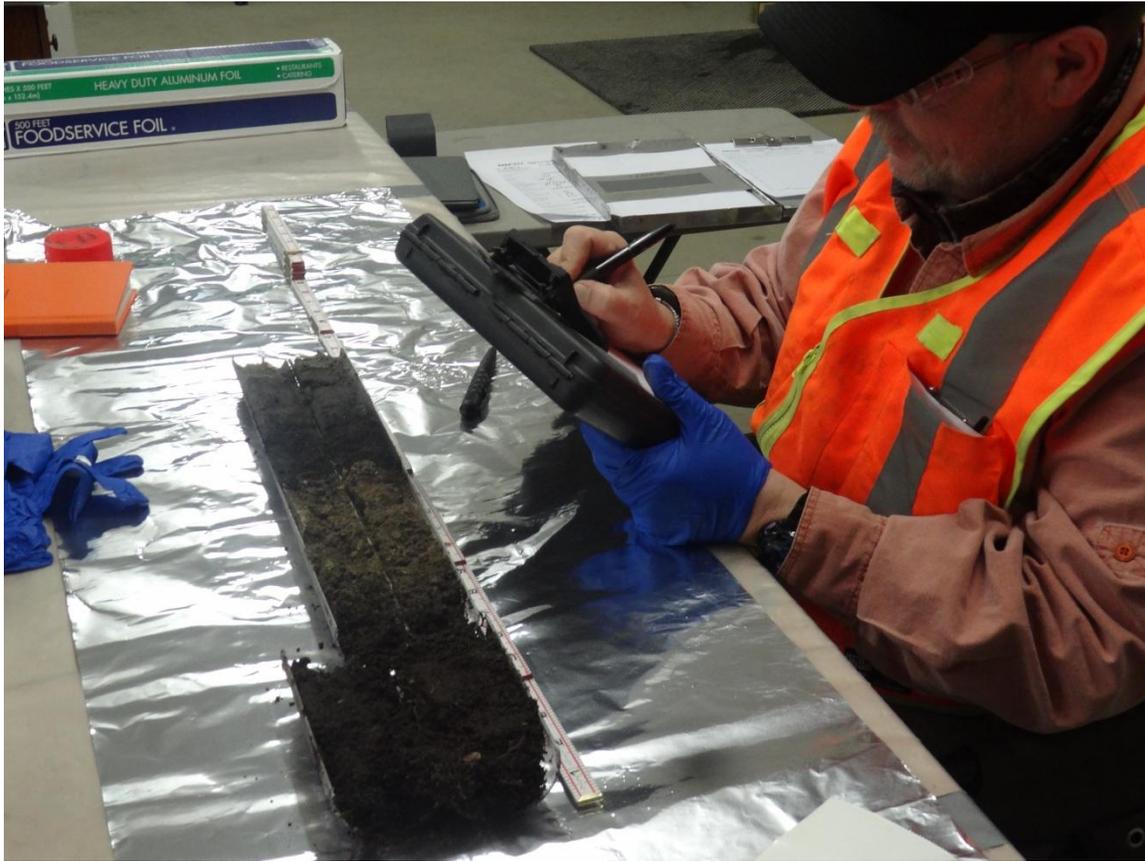
9. C3.2 Pole Barn observed core logging operations.

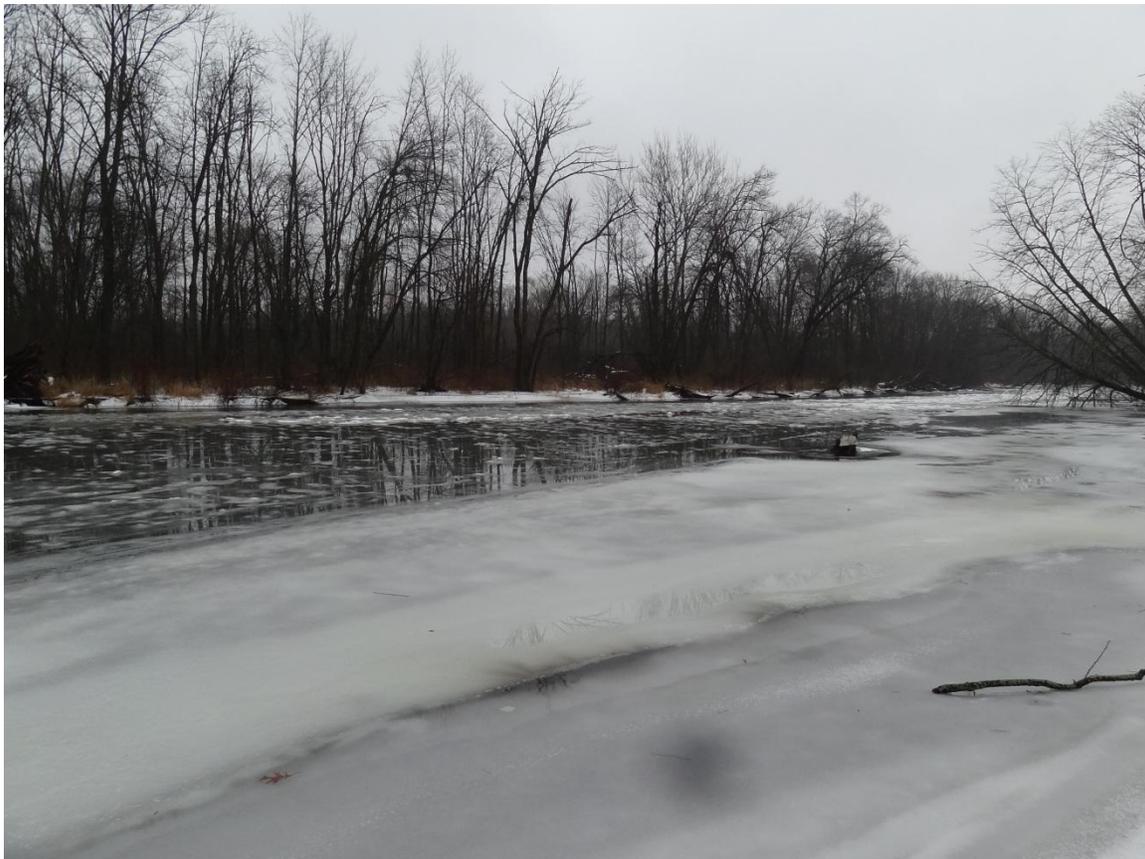
10. C3.2 Boat Launch observed upstream river ice conditions. River level appeared to have dropped.

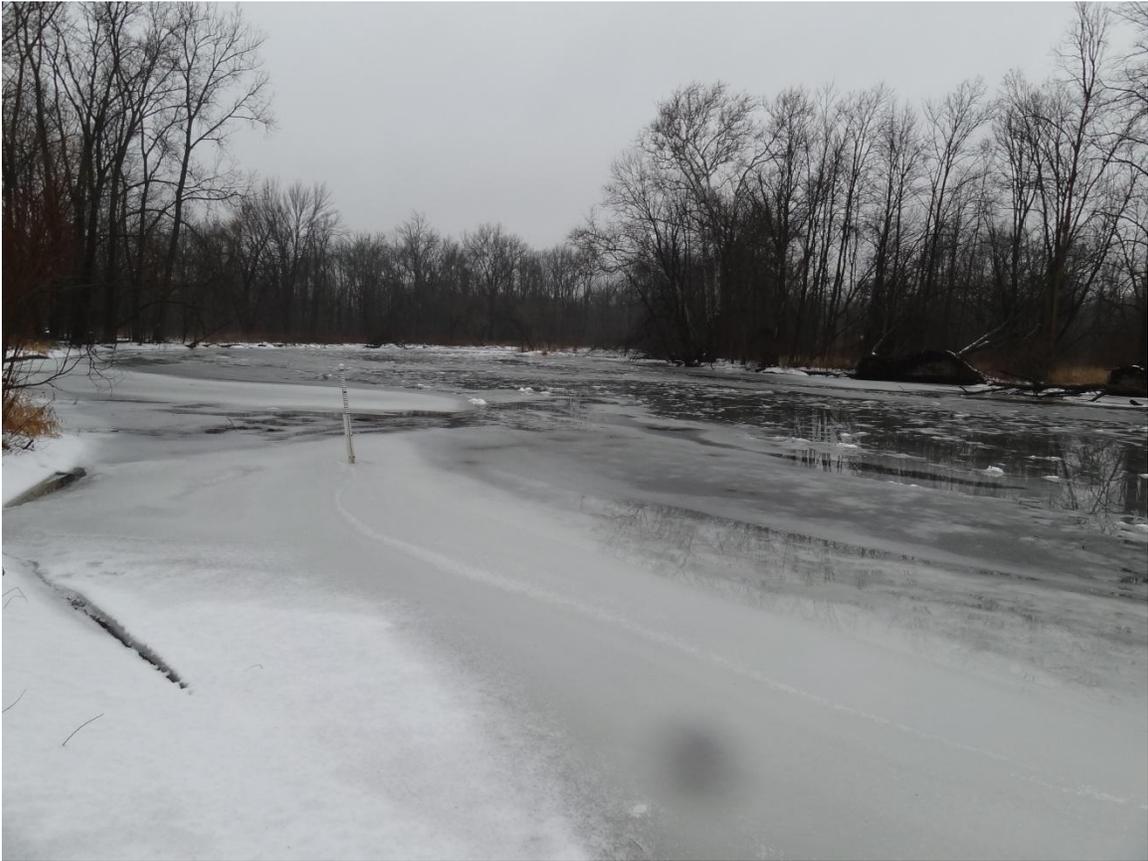
**11. C3.2 Boat Launch observed downstream river ice conditions. River level appeared to have dropped.**

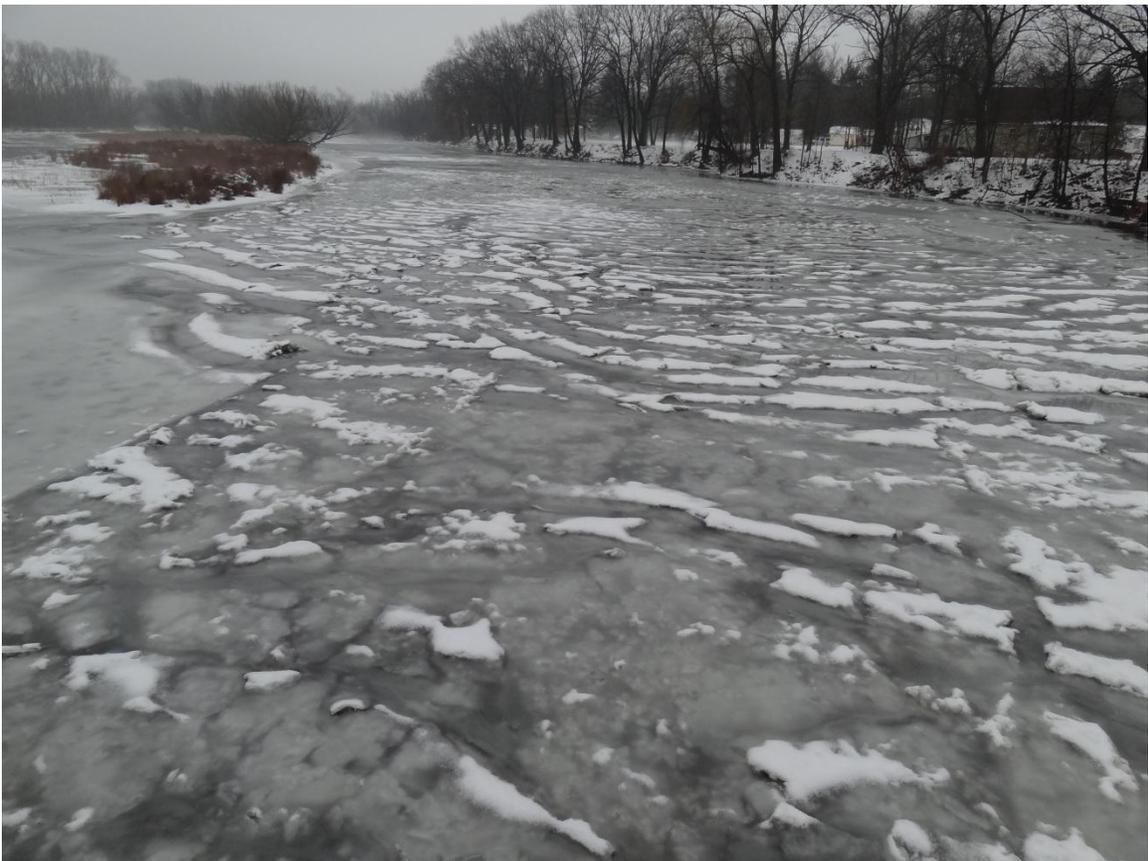
**12. MP15.25 South Mill Pond observed river ice conditions.**

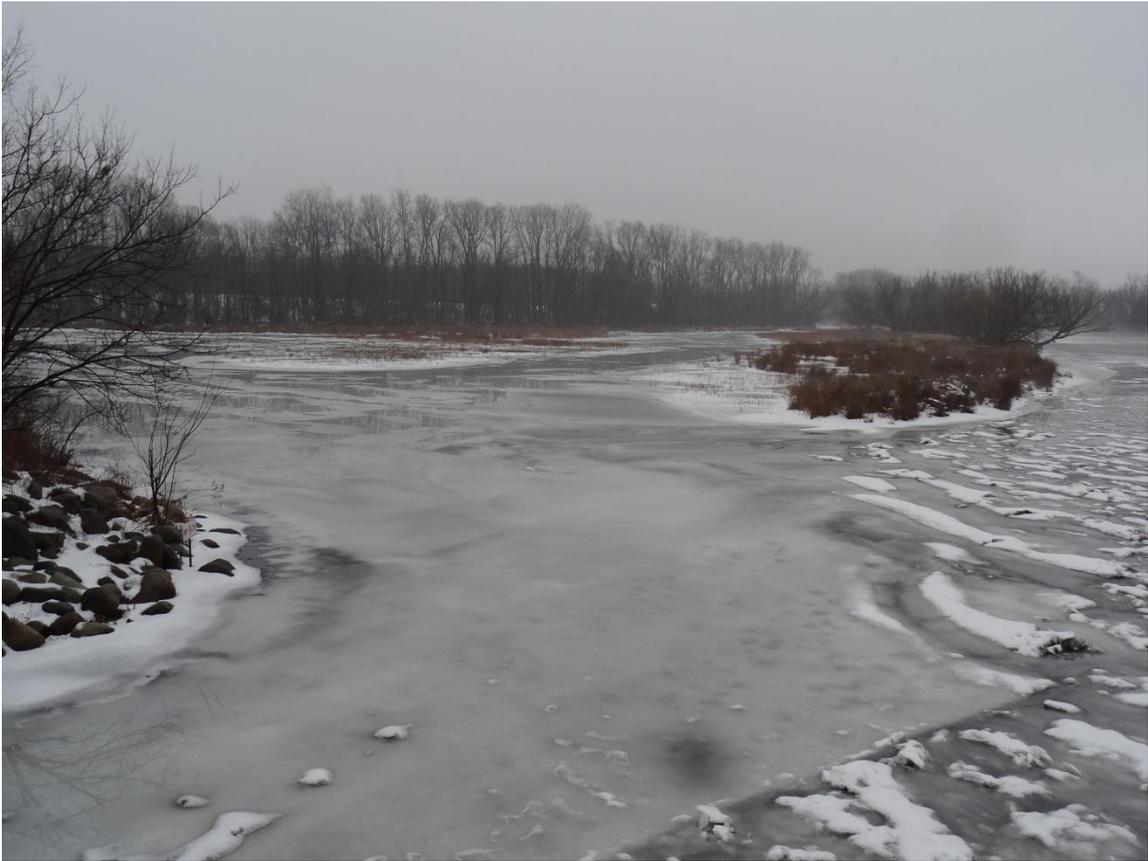
13. MP15.25 South Mill Pond observed back water ice conditions.

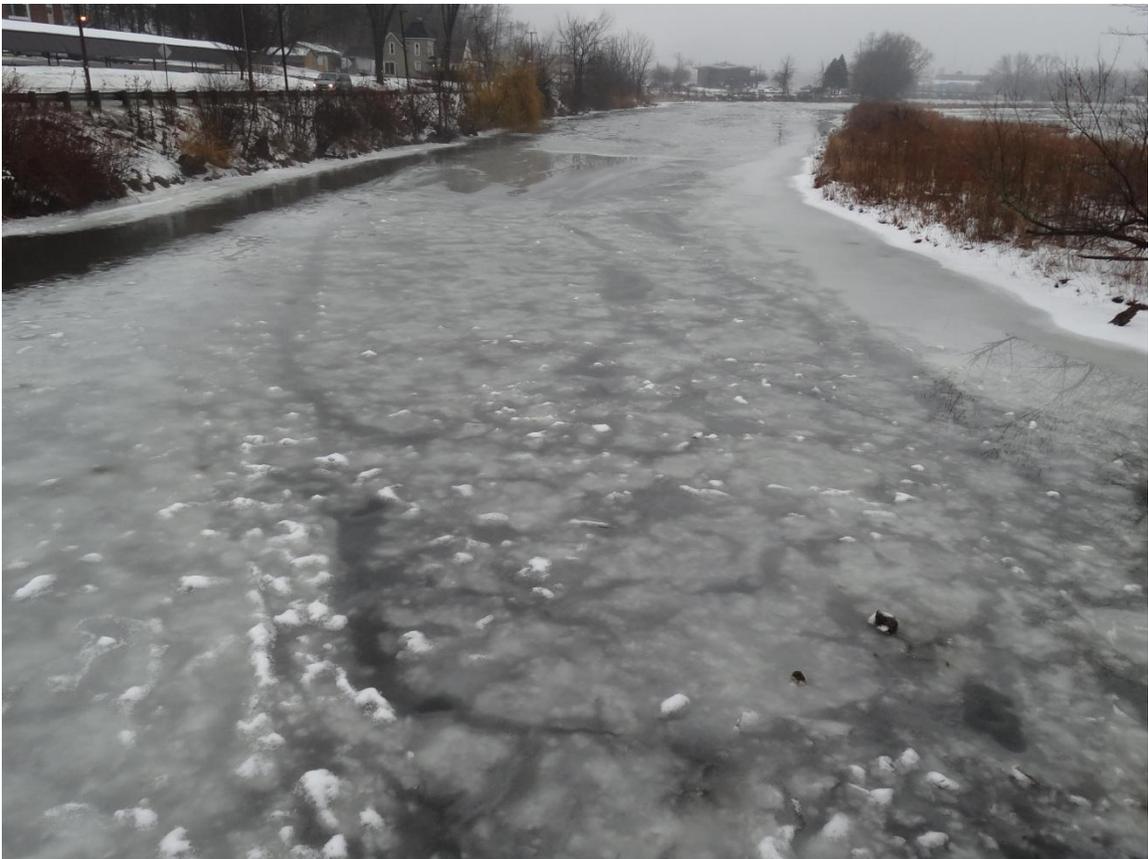
14. MP15.50 North Mill Pond observed river ice conditions.

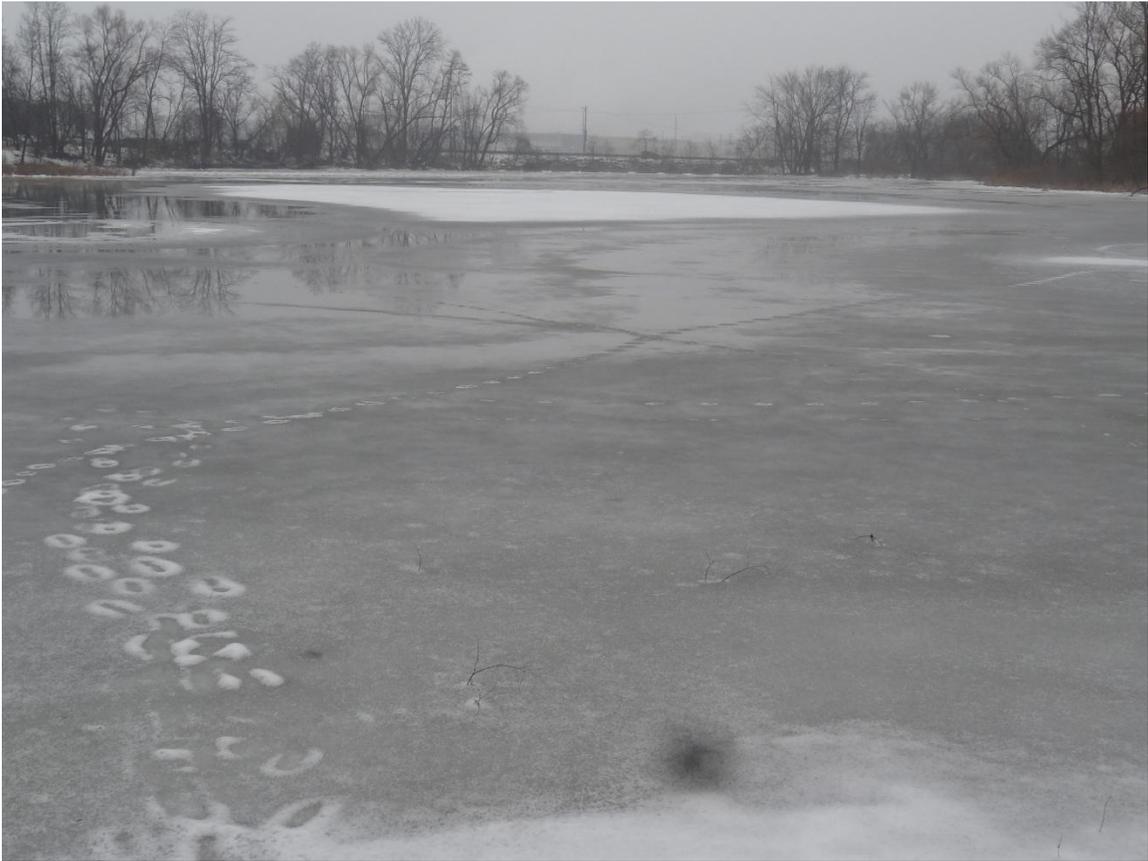
**15. MP15.50 North Mill Pond observed back water ice conditions.**

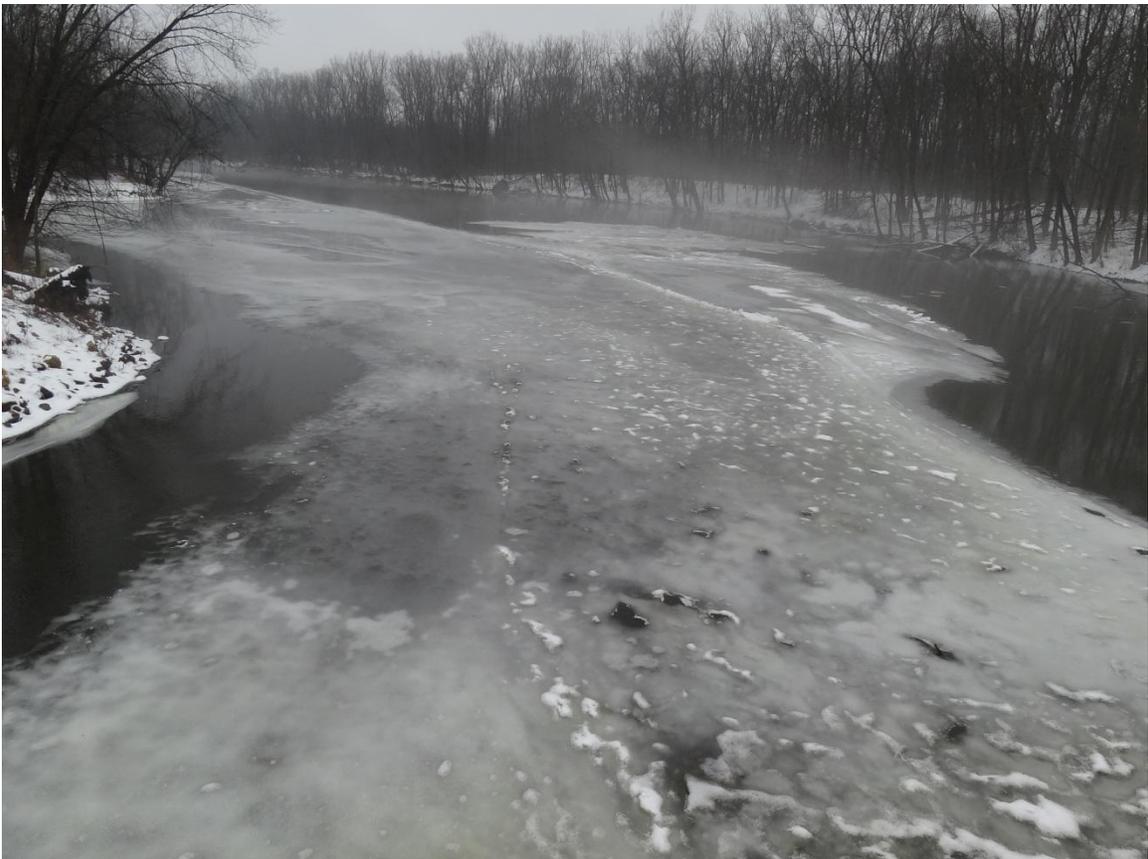
**16. MP21.50 observed upstream river ice conditions.**

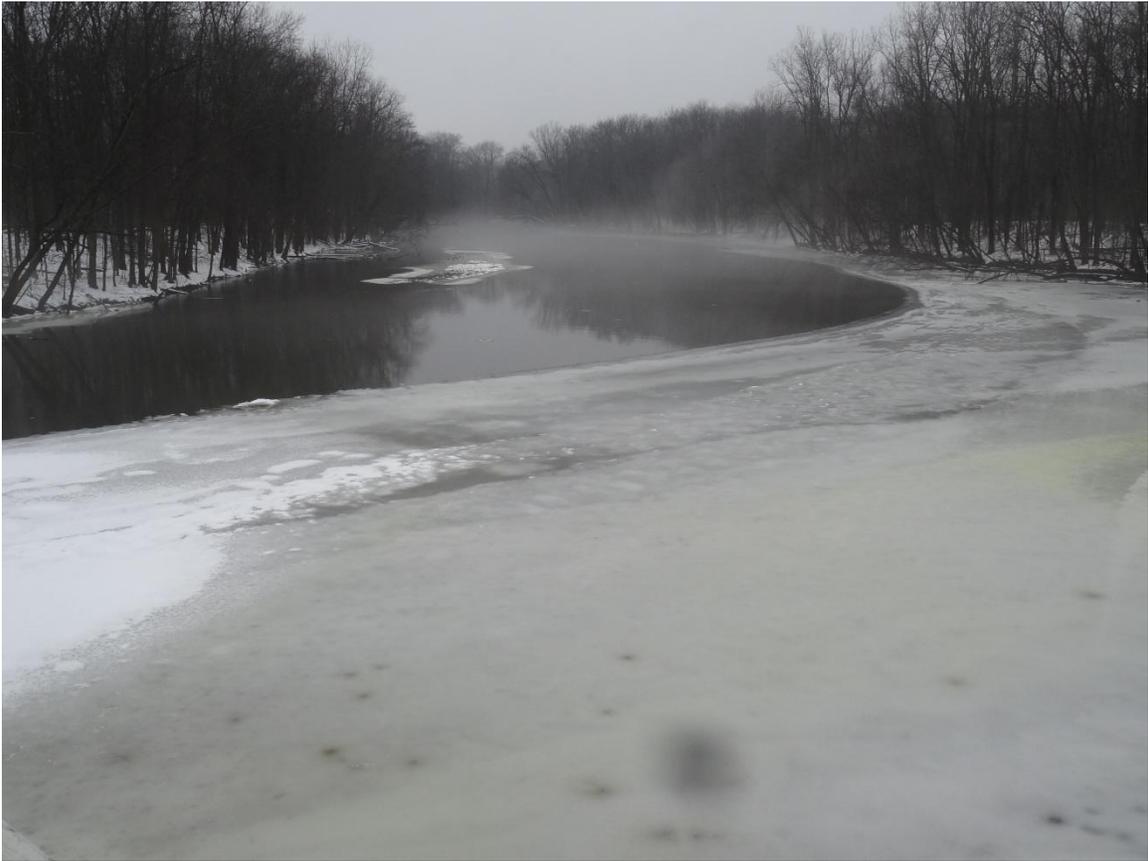
17. MP21.50 observed downstream river ice conditions.

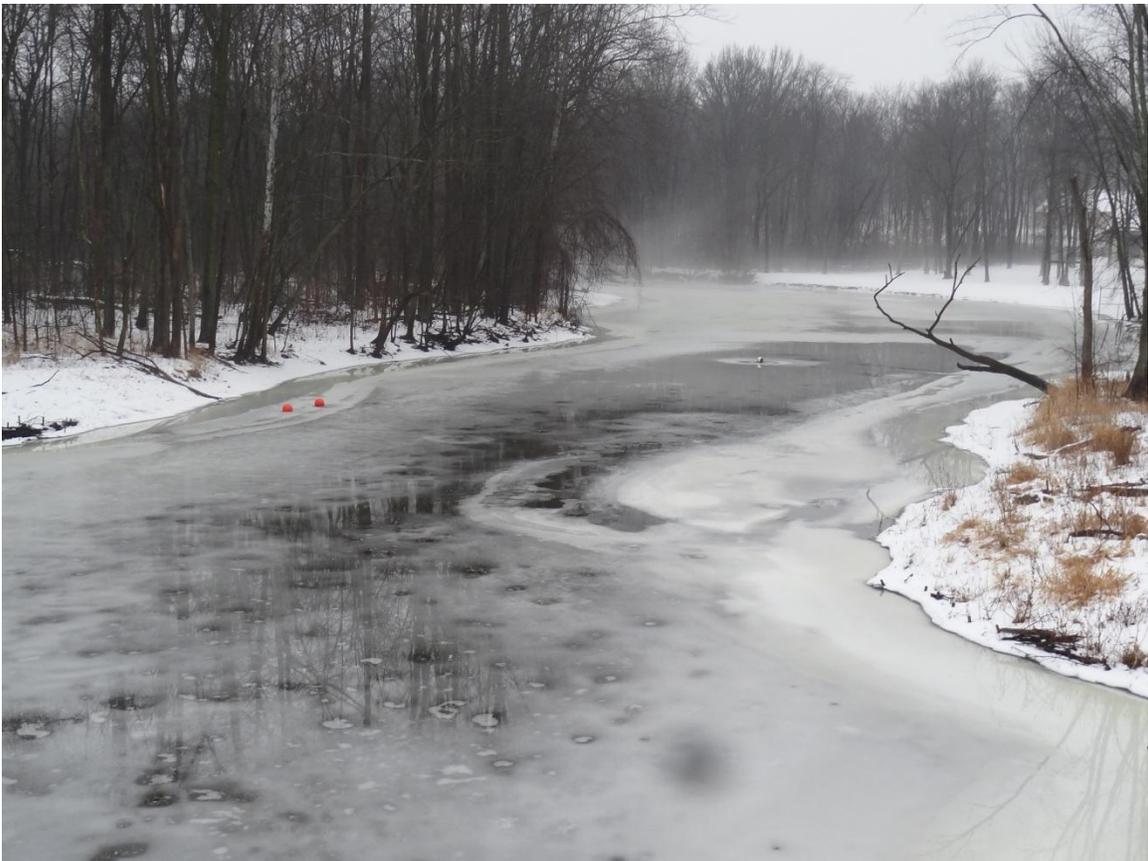
18. MP21.50 Oxbow observed river ice conditions.

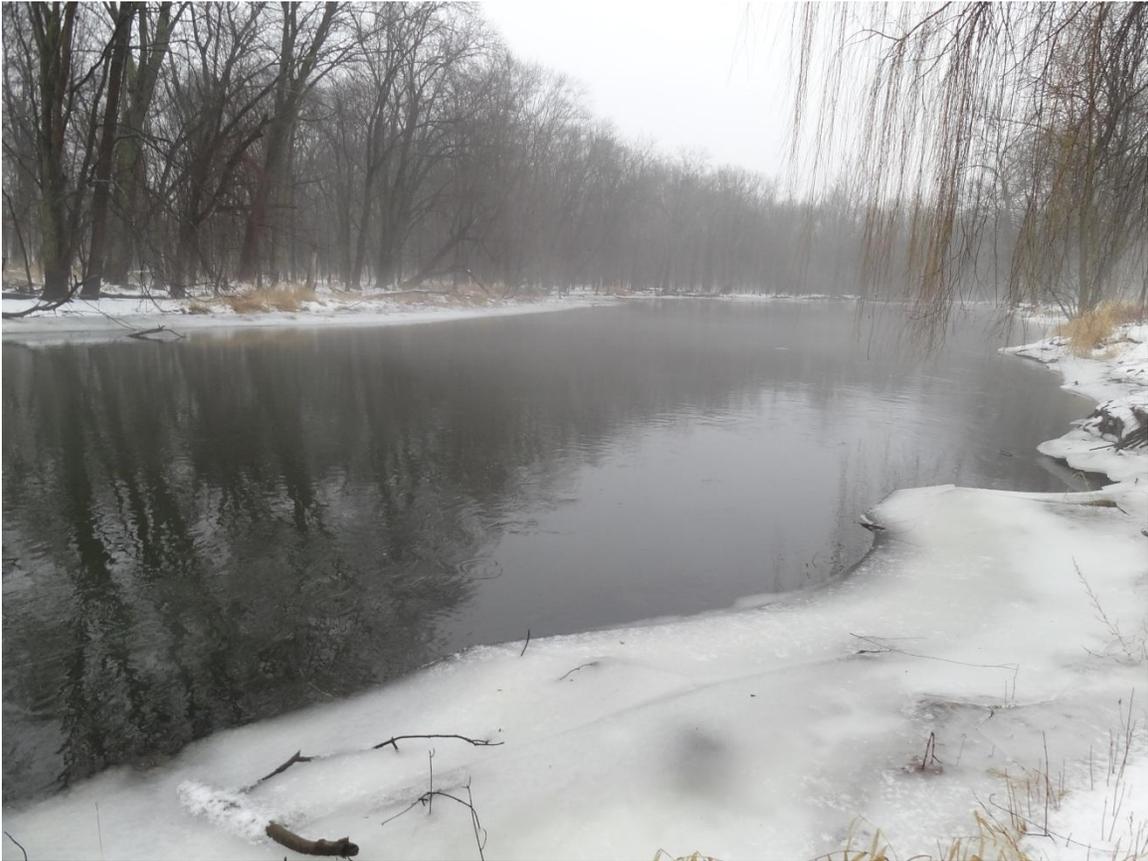
19. MP27.50 Shady Bend Campground observed river ice conditions.

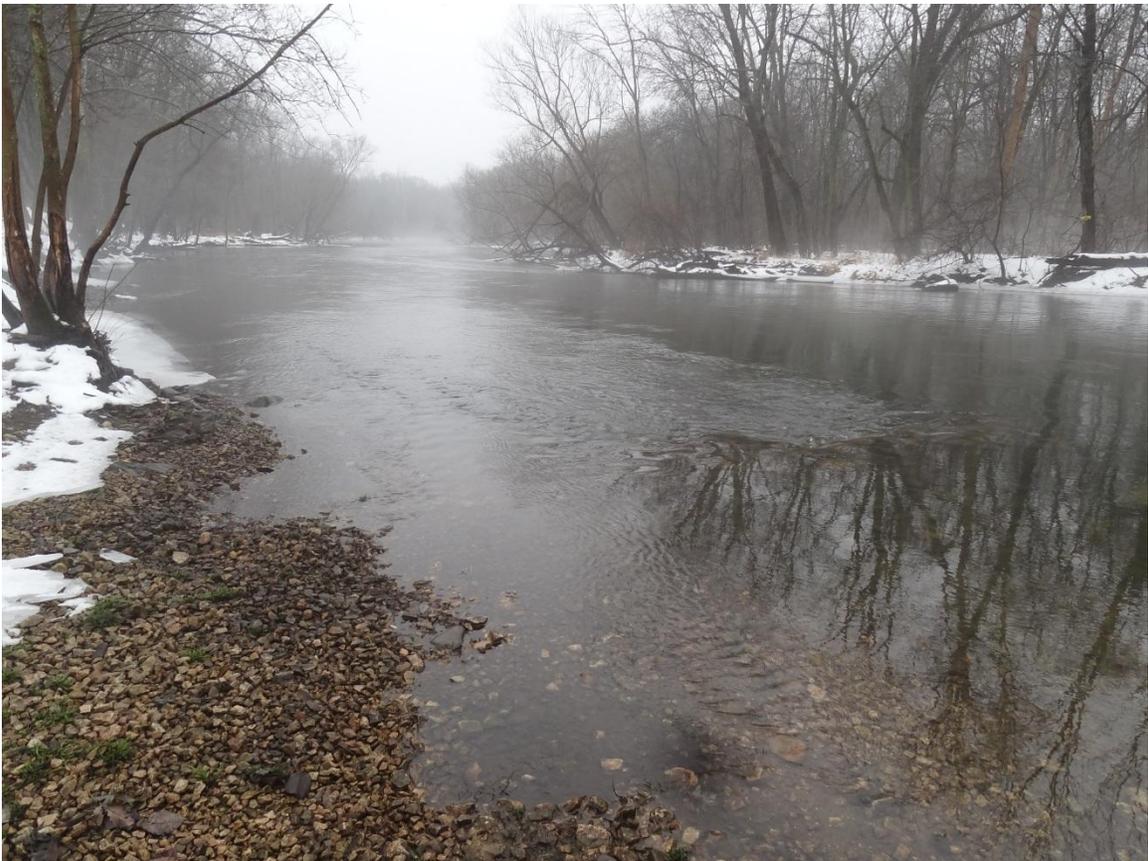
20. E2 Boat Launch observed river ice conditions. River level appeared to have dropped.

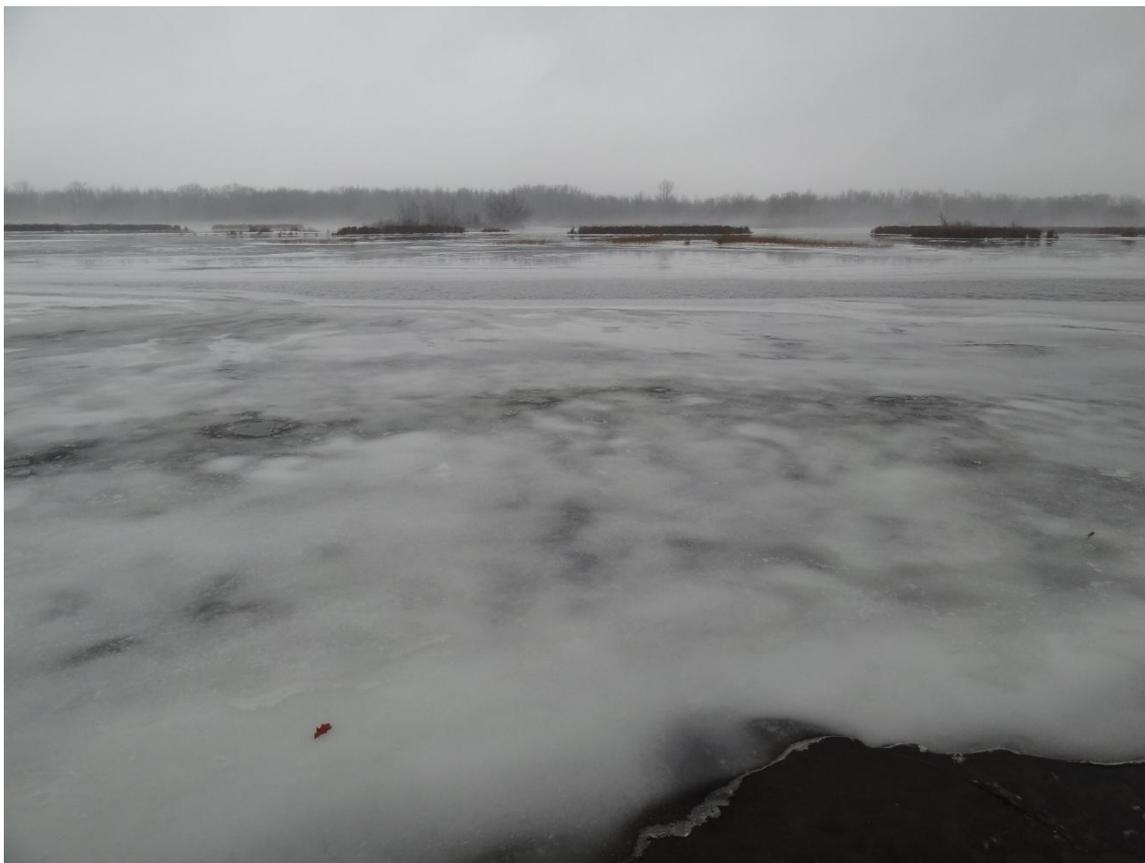
21. Morrow Lake Delta observed ice conditions.

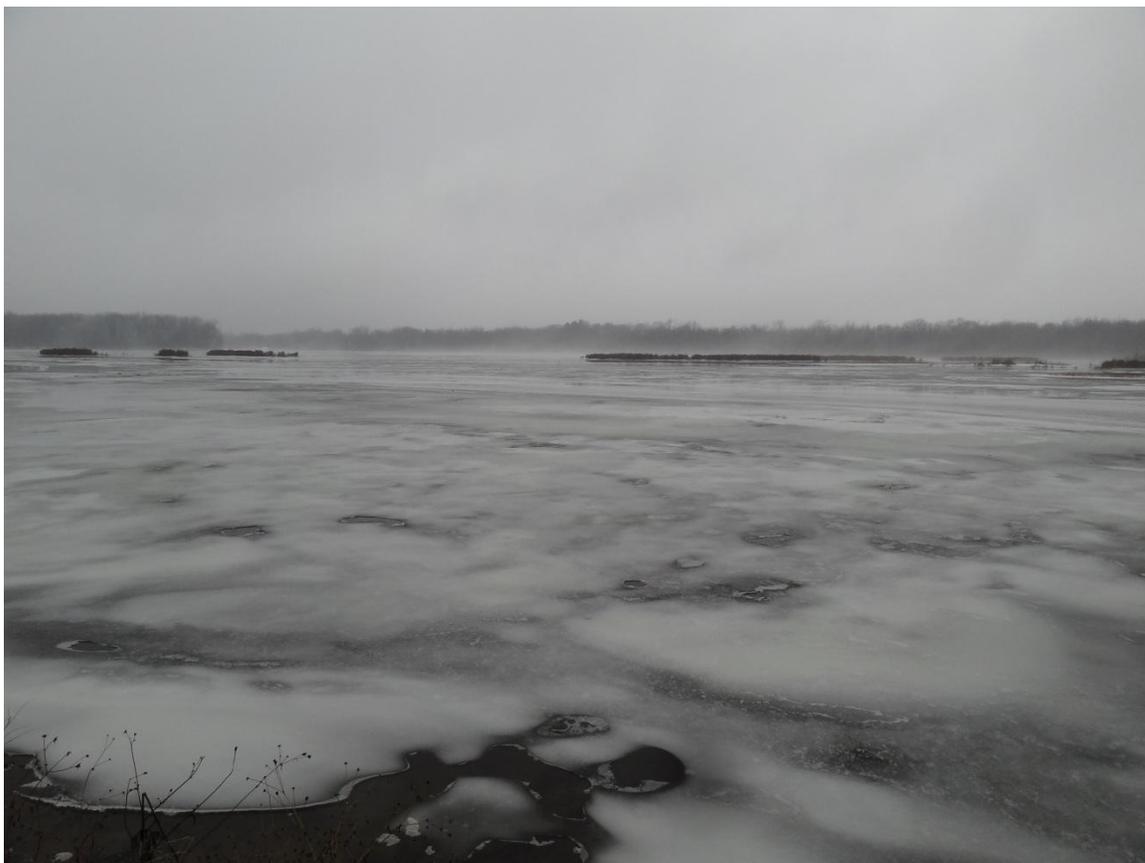
22. Morrow Lake Delta observed ice conditions.

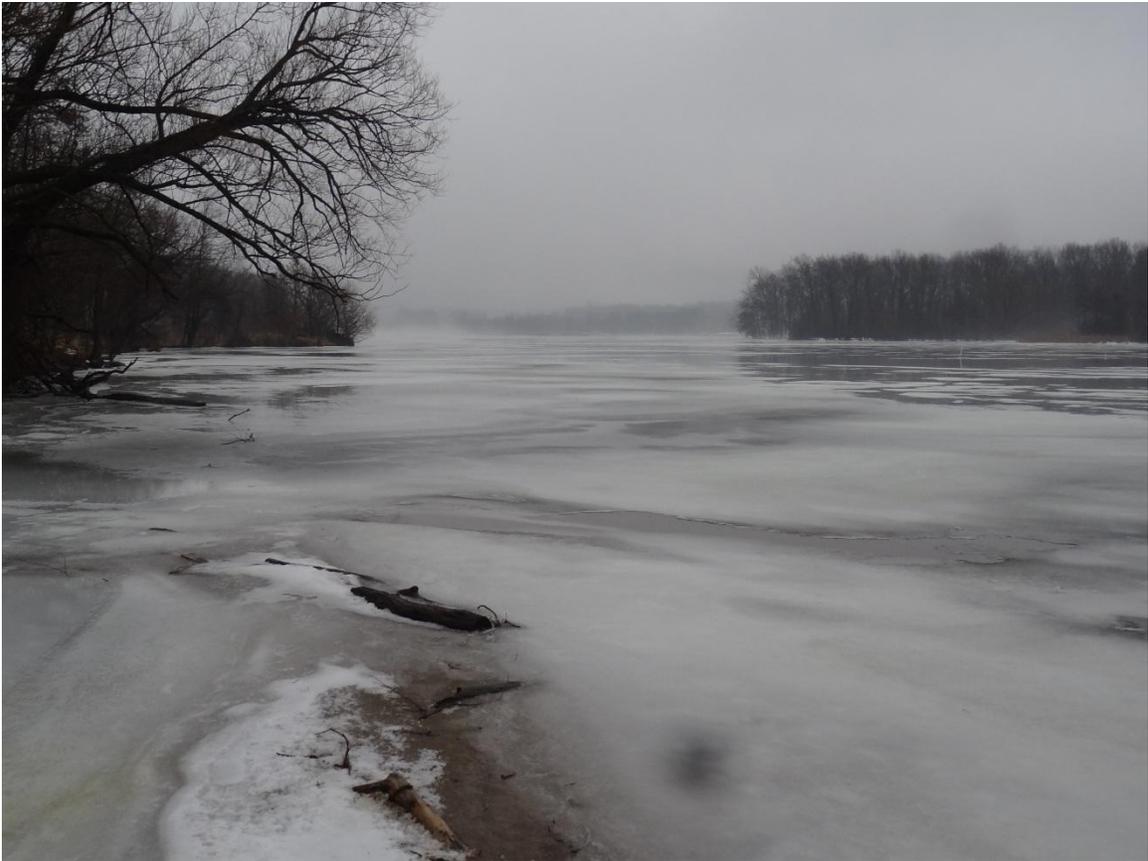
23. Morrow Lake Neck/Morrow Lake Delta observed ice conditions.
