# Situation Photo Log

Monday, January 28, 2013

Kalamazoo River / Enbridge Spill

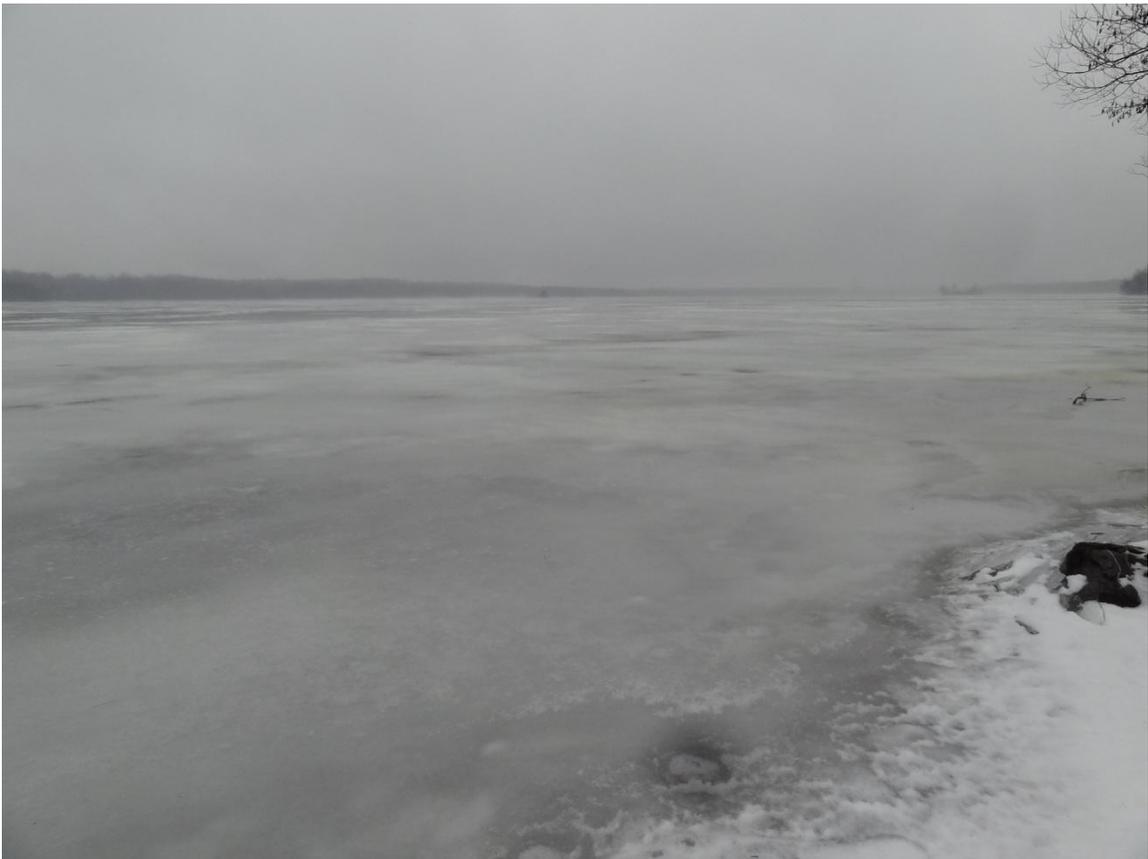
24. Morrow Lake observed ice conditions.

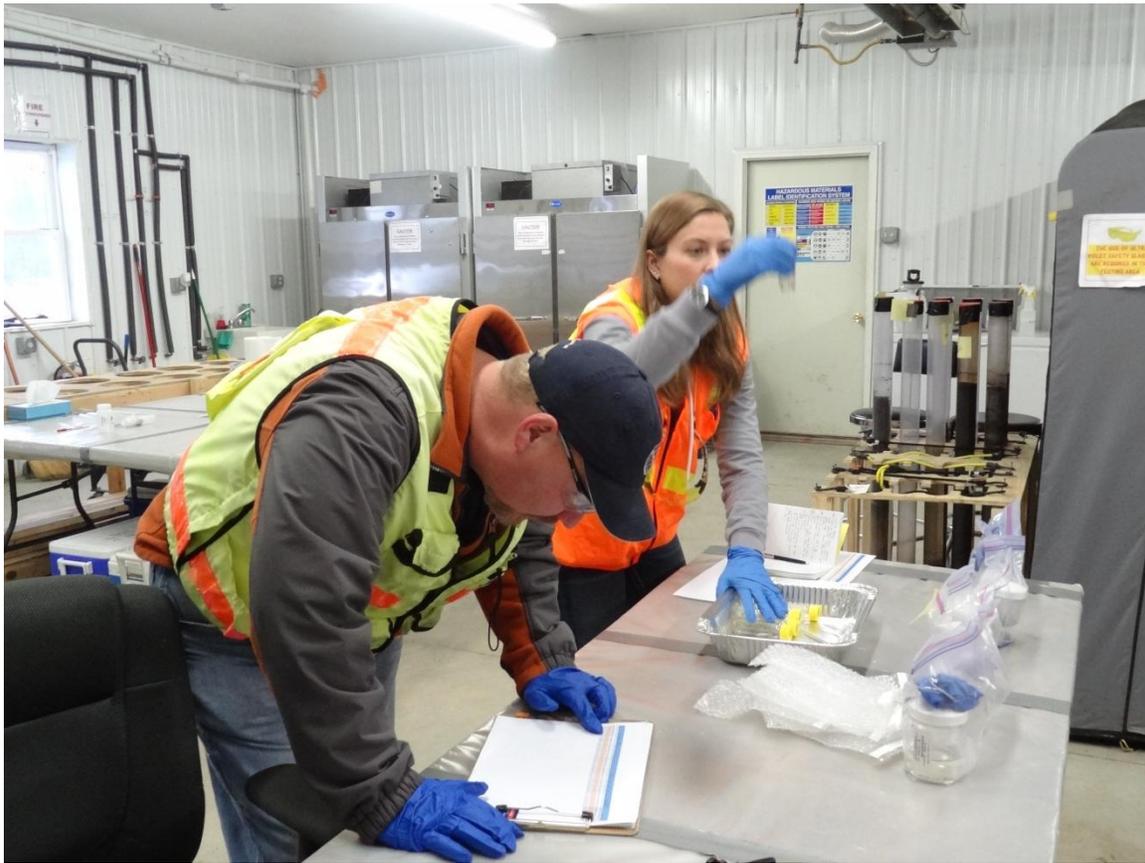
25. C3.2 Pole Barn observed ultraviolet assessment on hexane sheen tests.

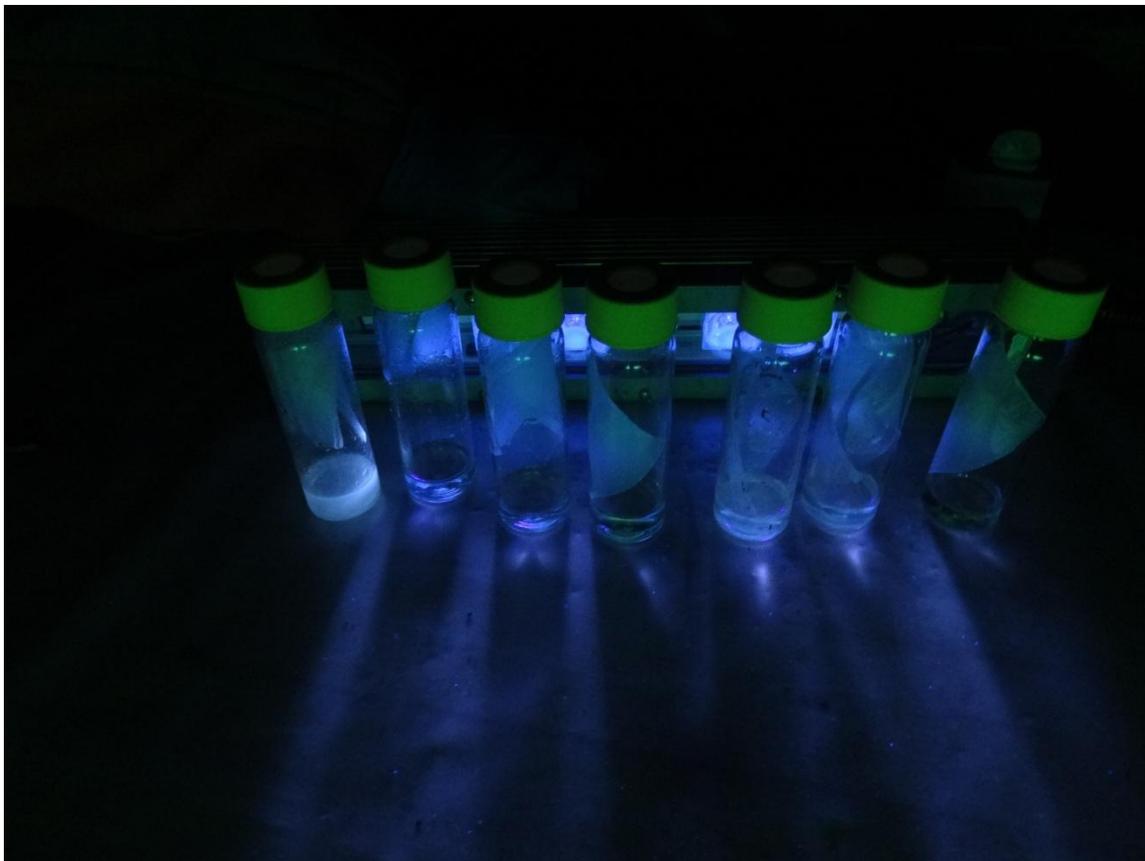
26. C3.2 Pole Barn ultraviolet assessment on hexane sheen tests.
