Situation Photo Log

Tuesday, January 29, 2013

Kalamazoo River / Enbridge Spill

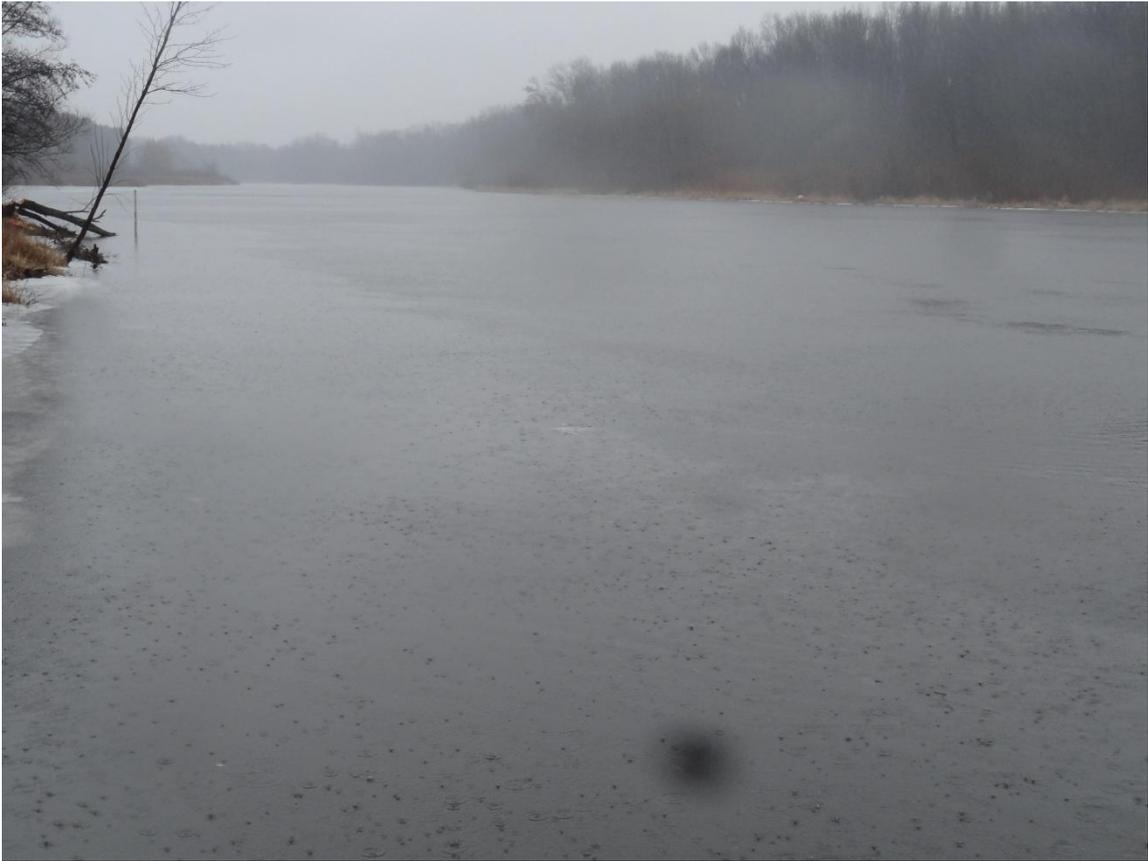
1. C0.4 Boat Launch upstream, ice has receded from river channel.

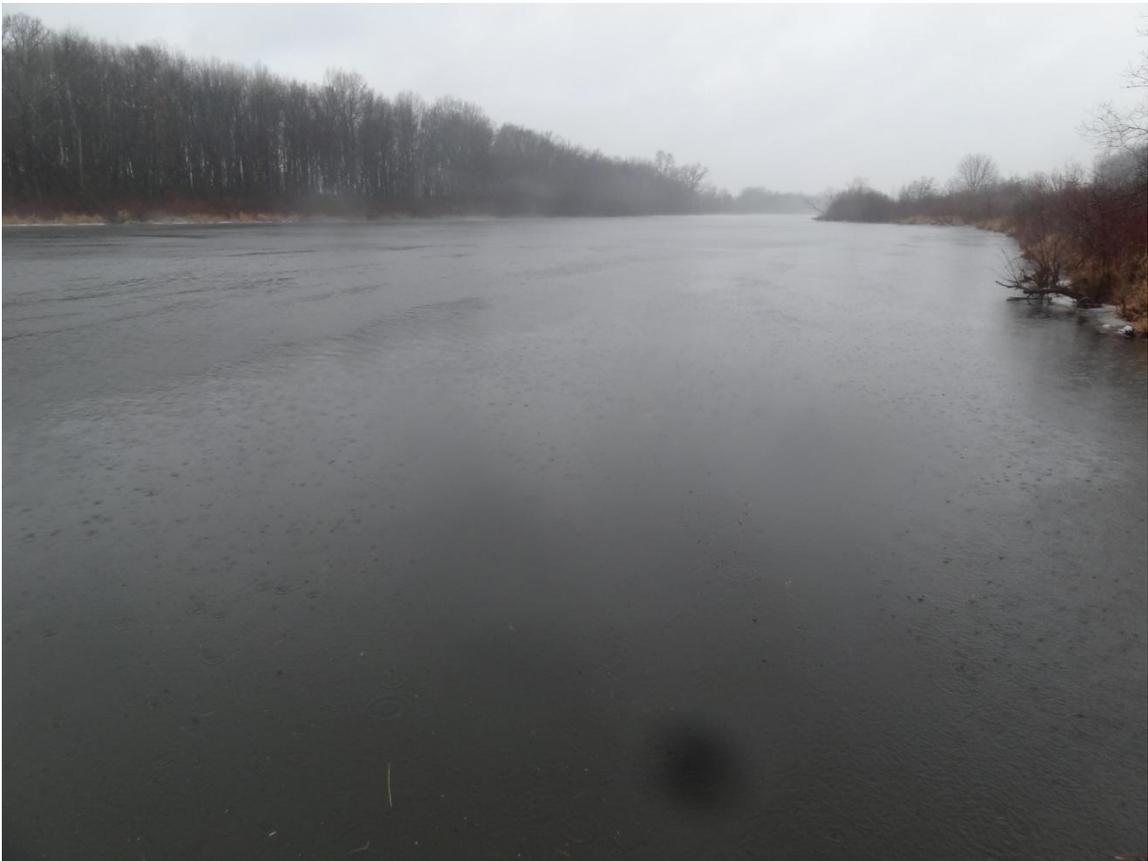
2. C0.4 Boat Launch downstream, ice has receded from river channel.

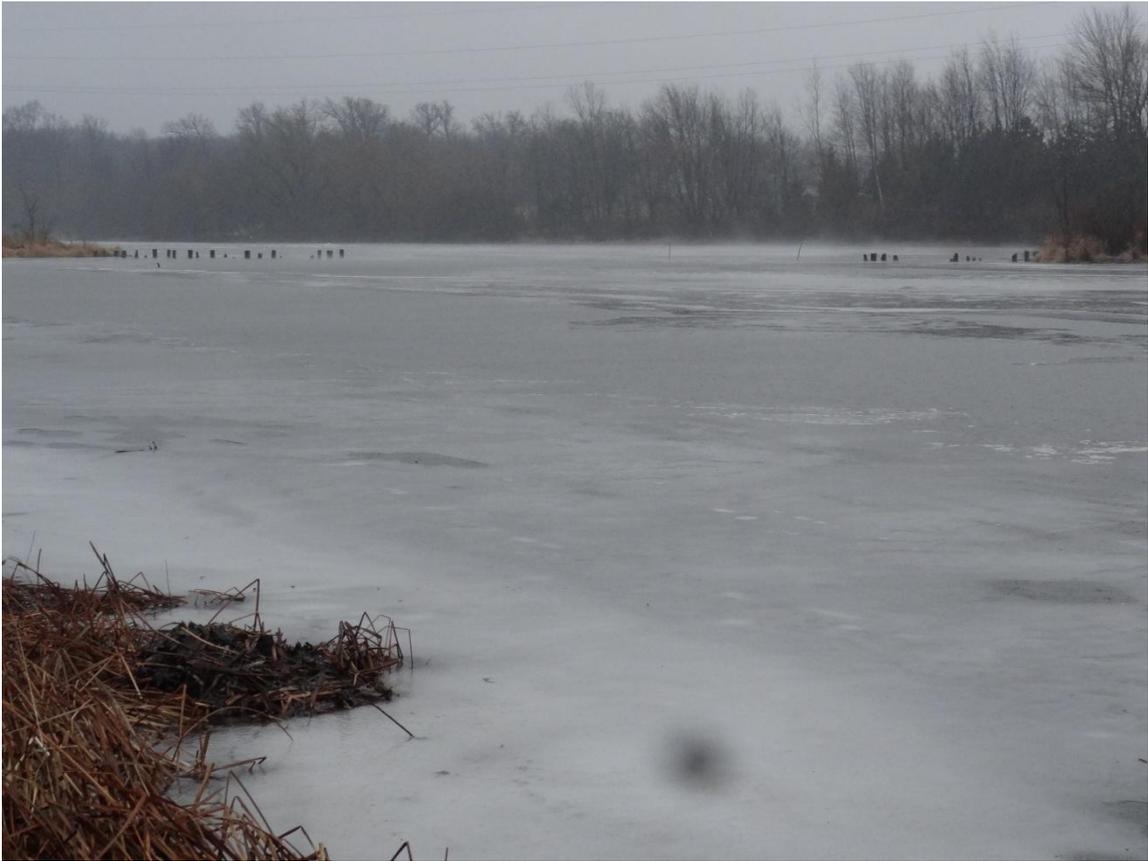
3. Ceresco Dam impoundment observed river ice conditions.

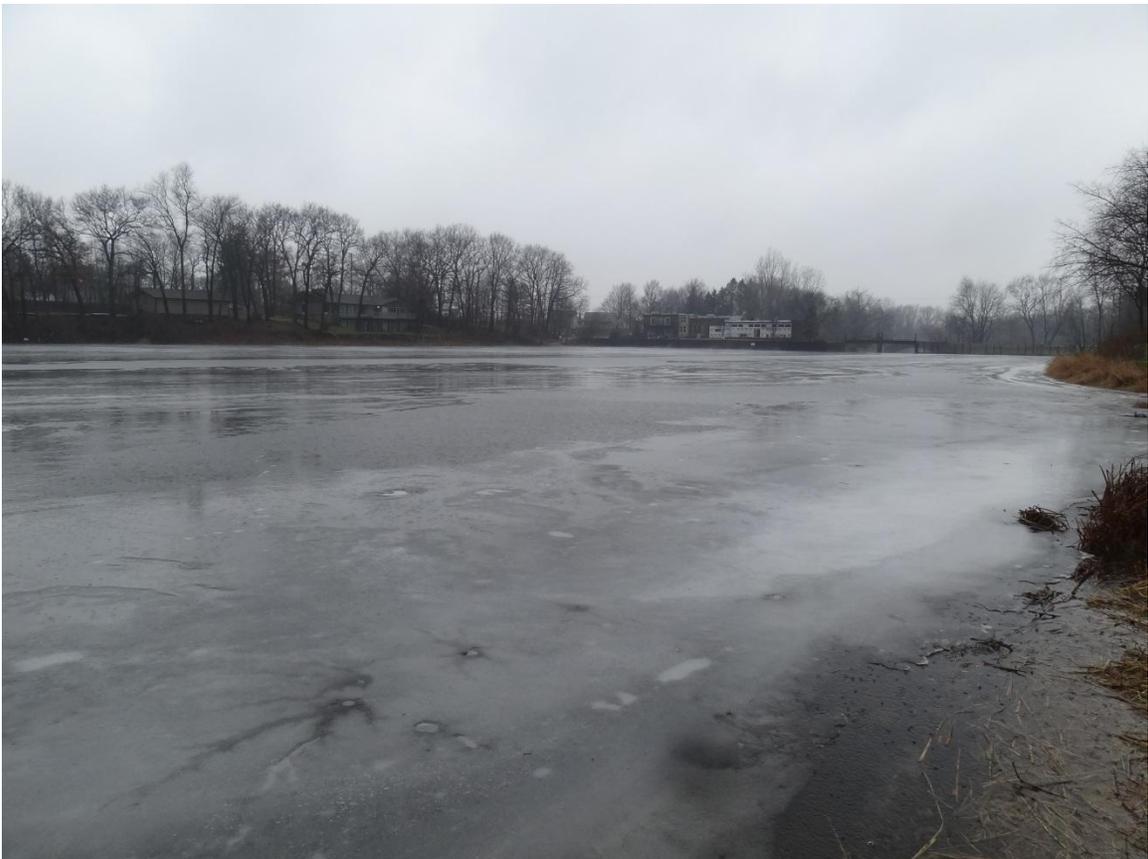
4. Ceresco Dam impoundment observed river ice conditions.

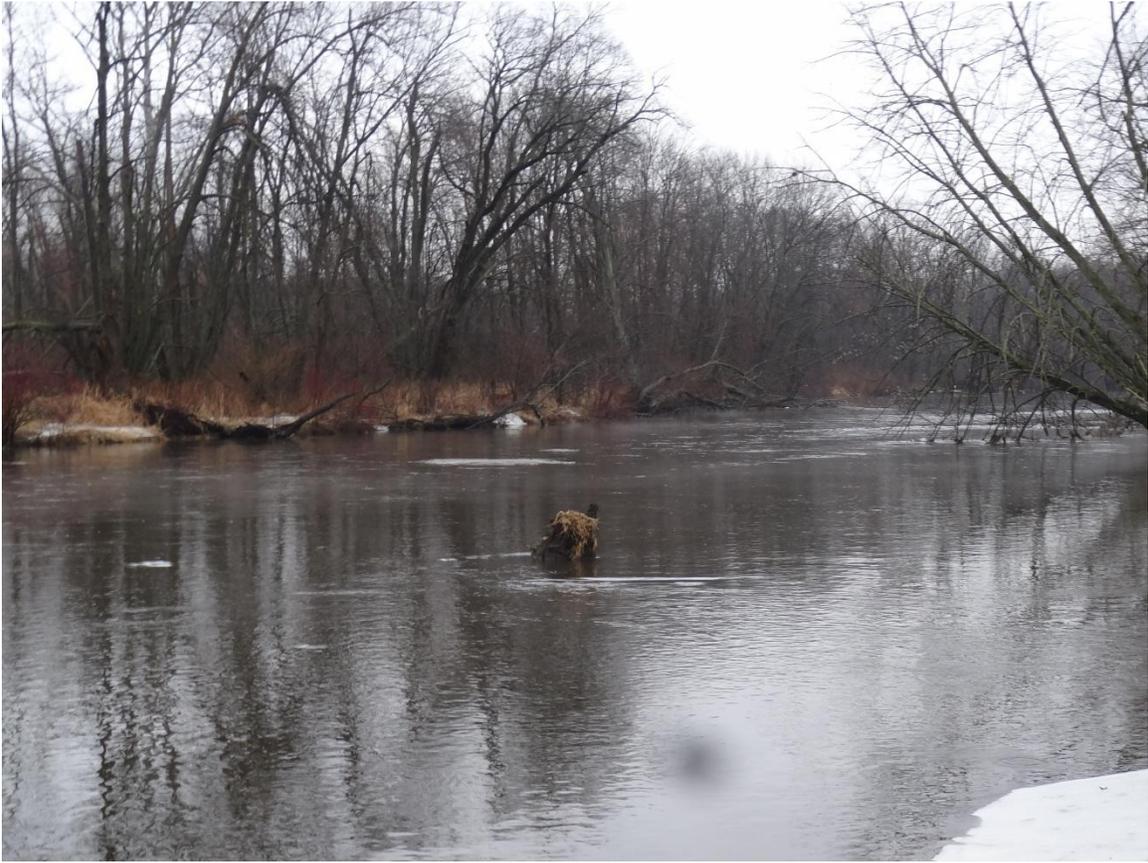
5. C3.2 Boat Launch ice has receded from river channel.

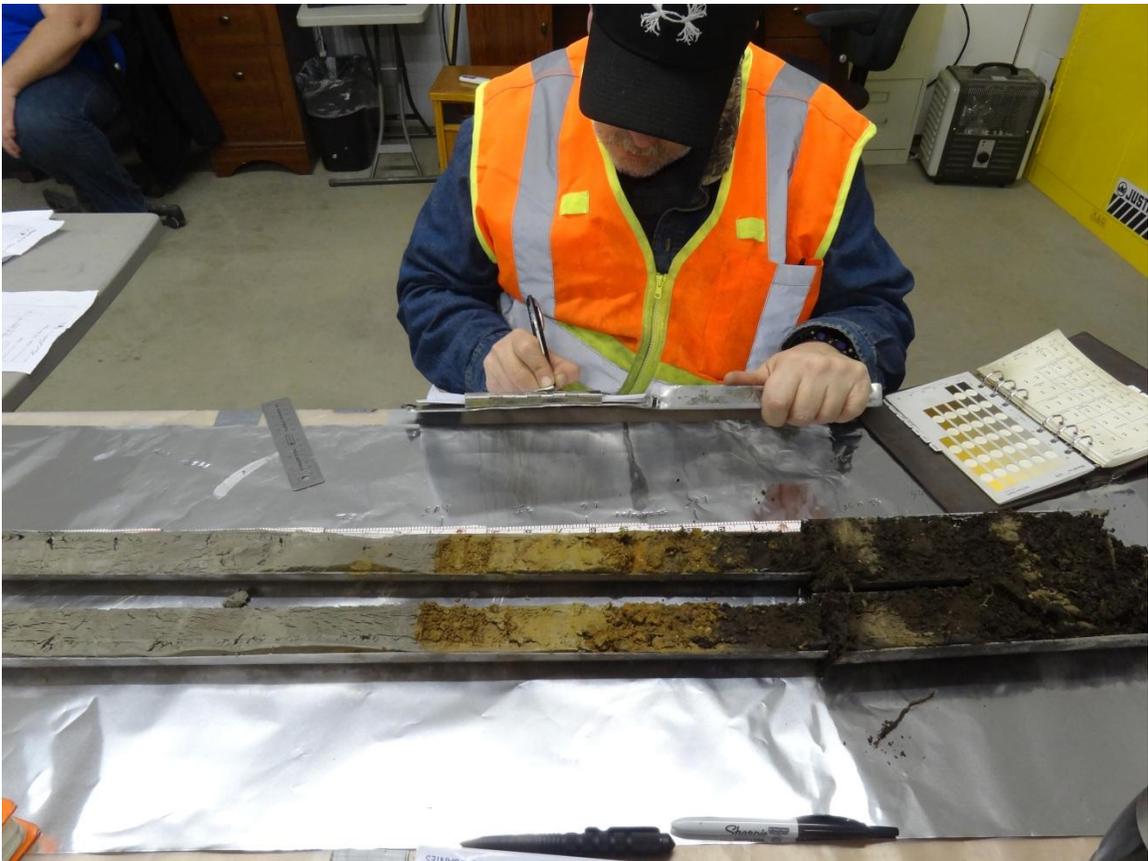
6. C3.2 Pole Barn observed core logging procedures.

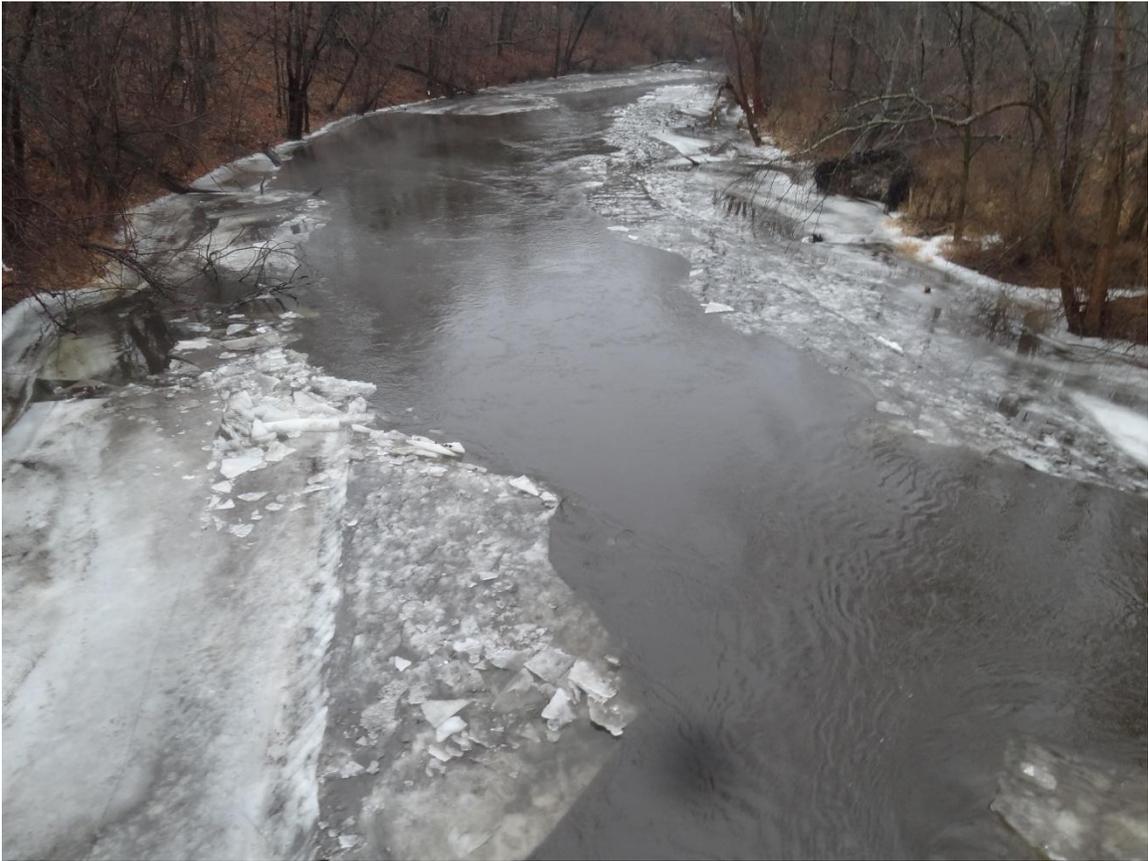
7. MP11.75 observed river ice conditions.

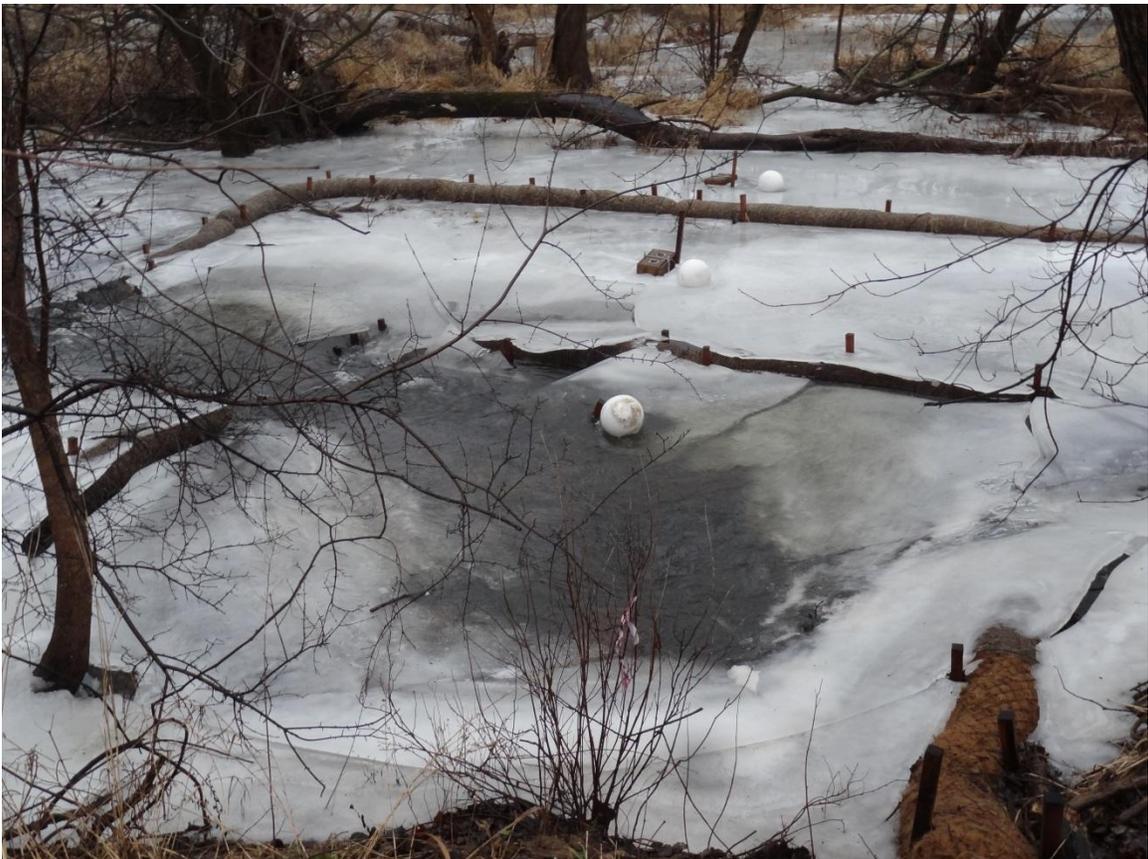
8. MP11.78 Sediment Trap observed ice conditions.

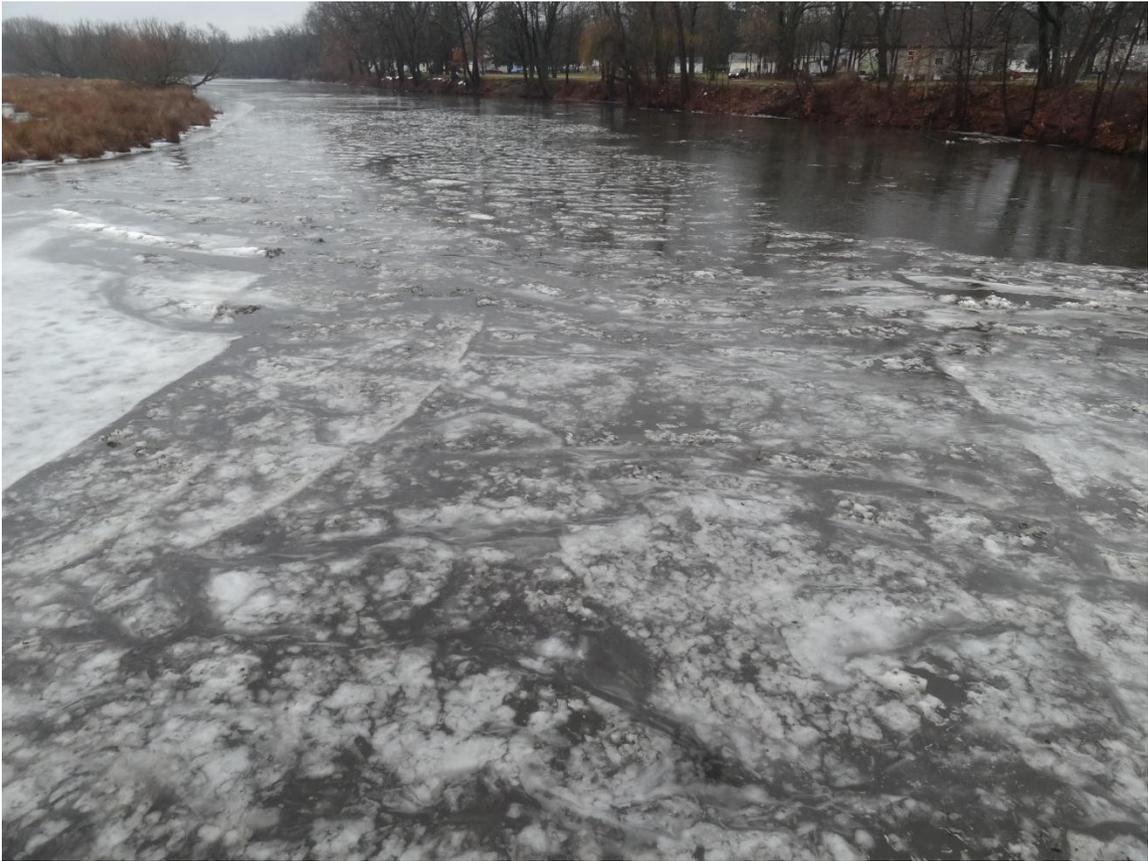
9. MP15.25 South Mill Pond observed river ice conditions.

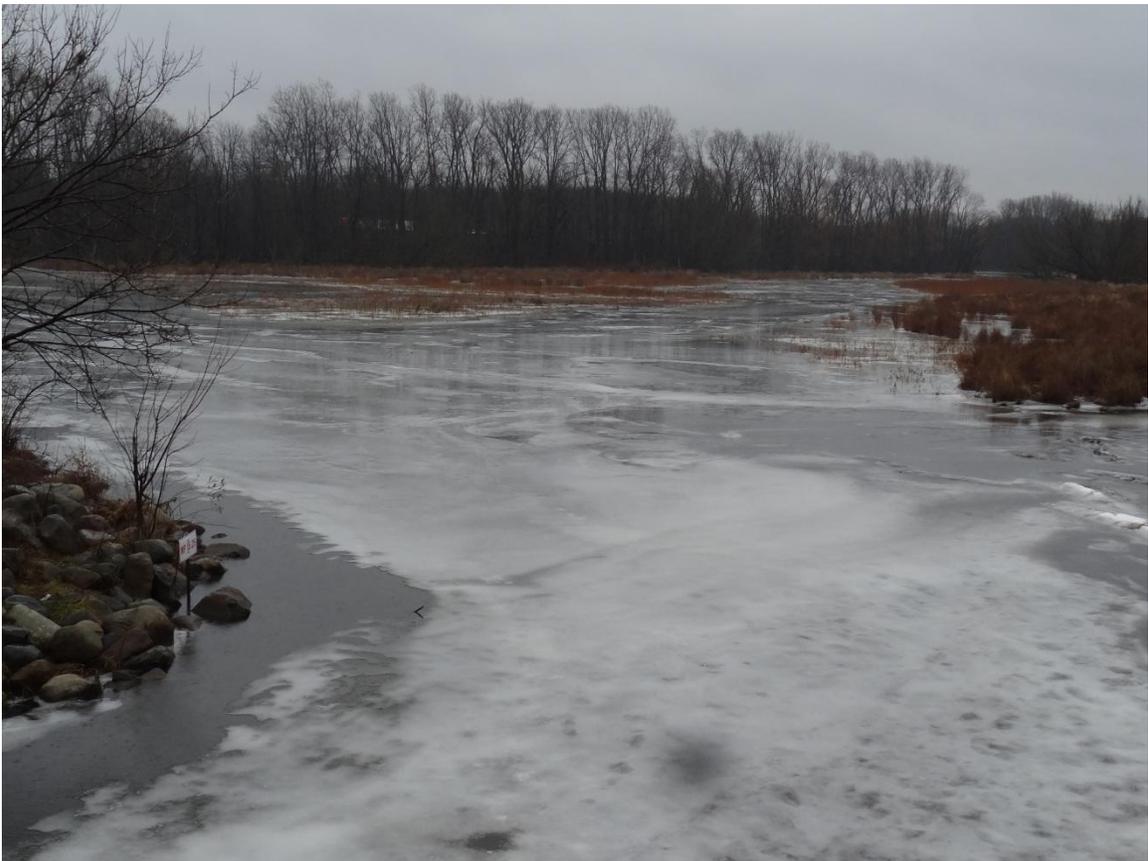
10. MP15.25 South Mill Pond observed back water ice conditions.

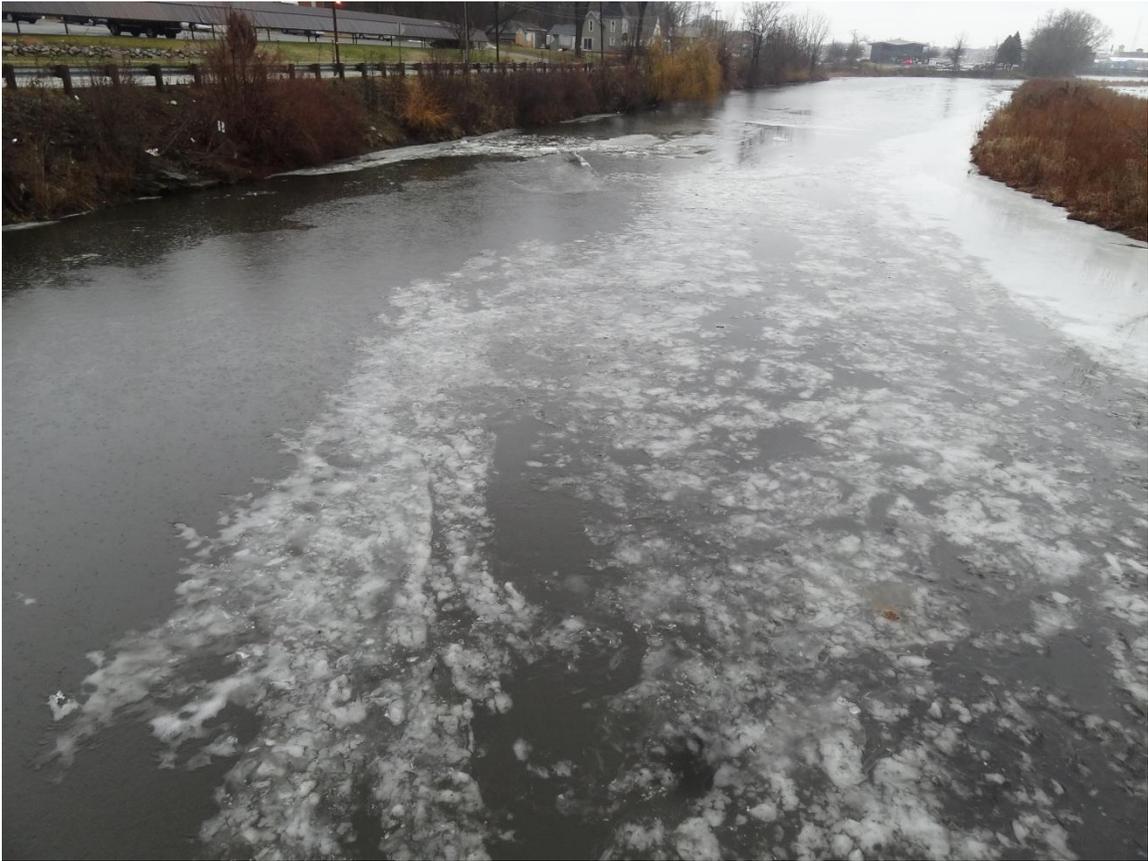
11. MP15.50 North Mill Pond observed river ice conditions.

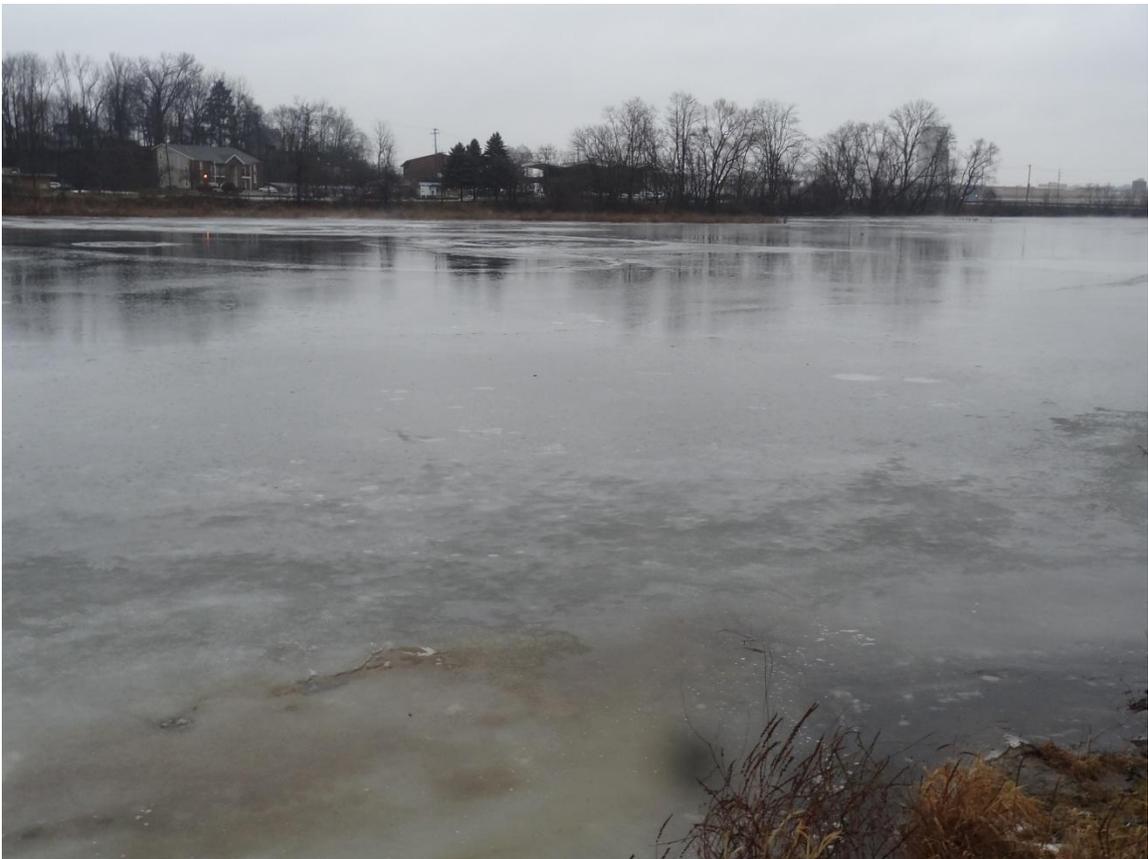
12. MP15.50 North Mill Pond observed back water ice conditions.

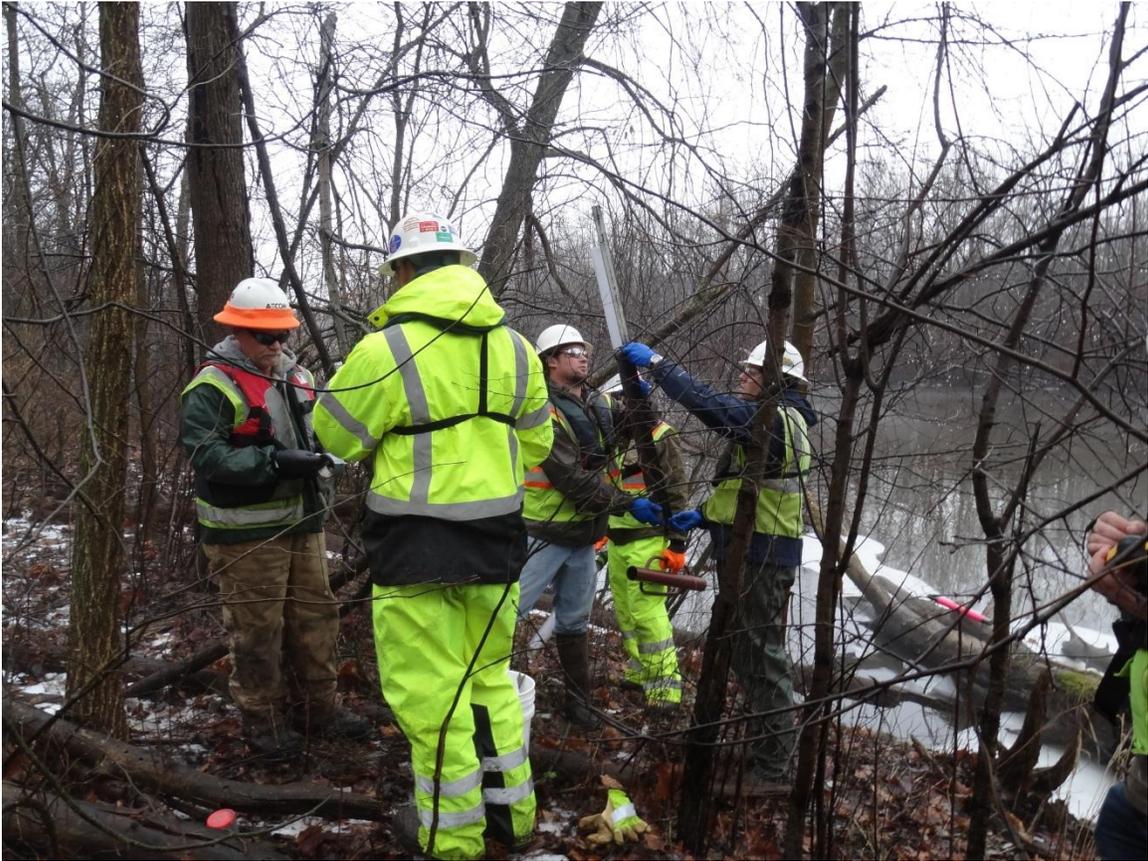
13. MP20.50 LDB observed the RI team.

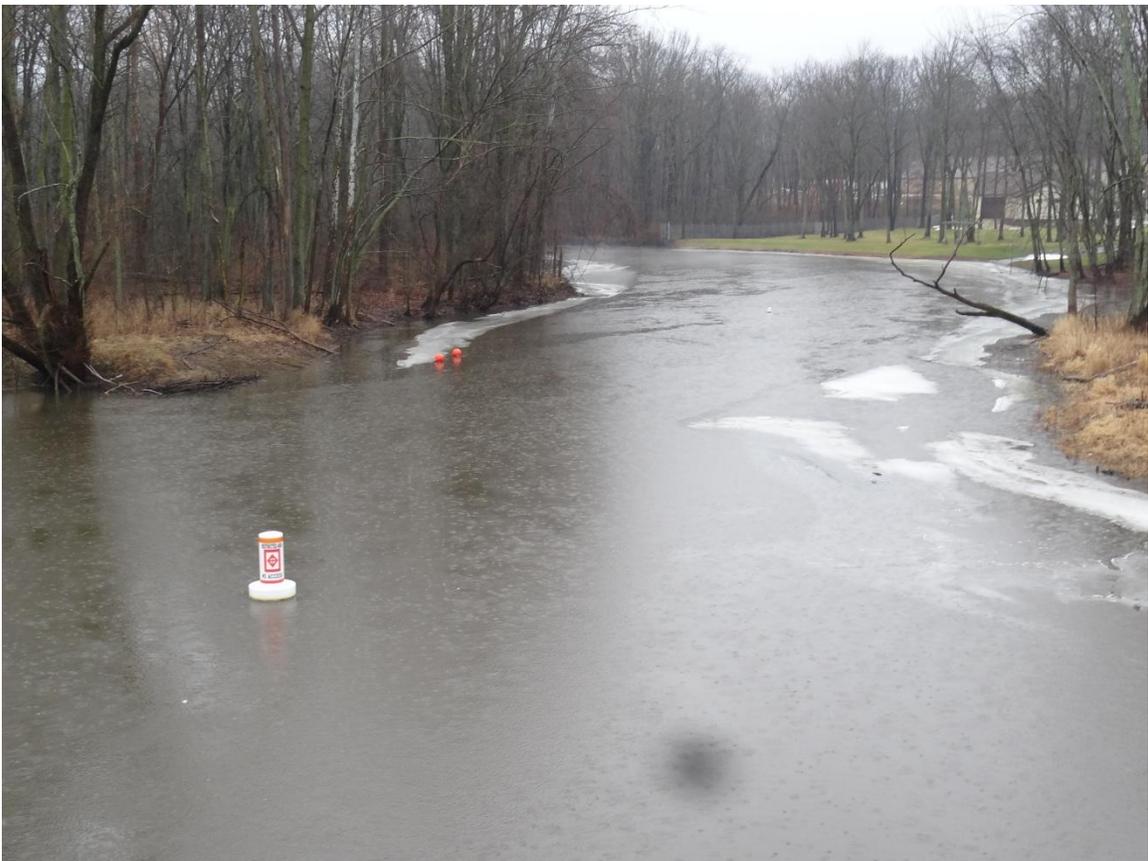
14. MP21.50 Oxbow ice has receded from back channel.

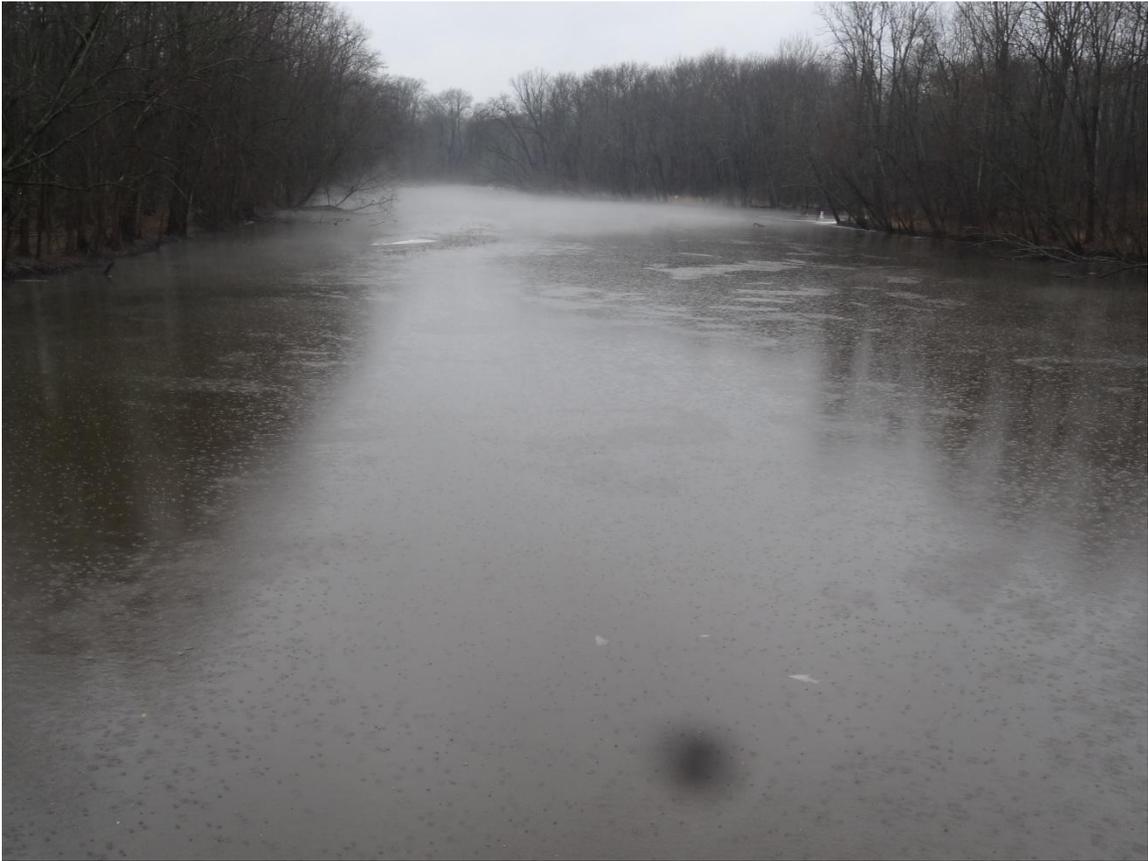
15. MP21.50 ice has receded from river channel.

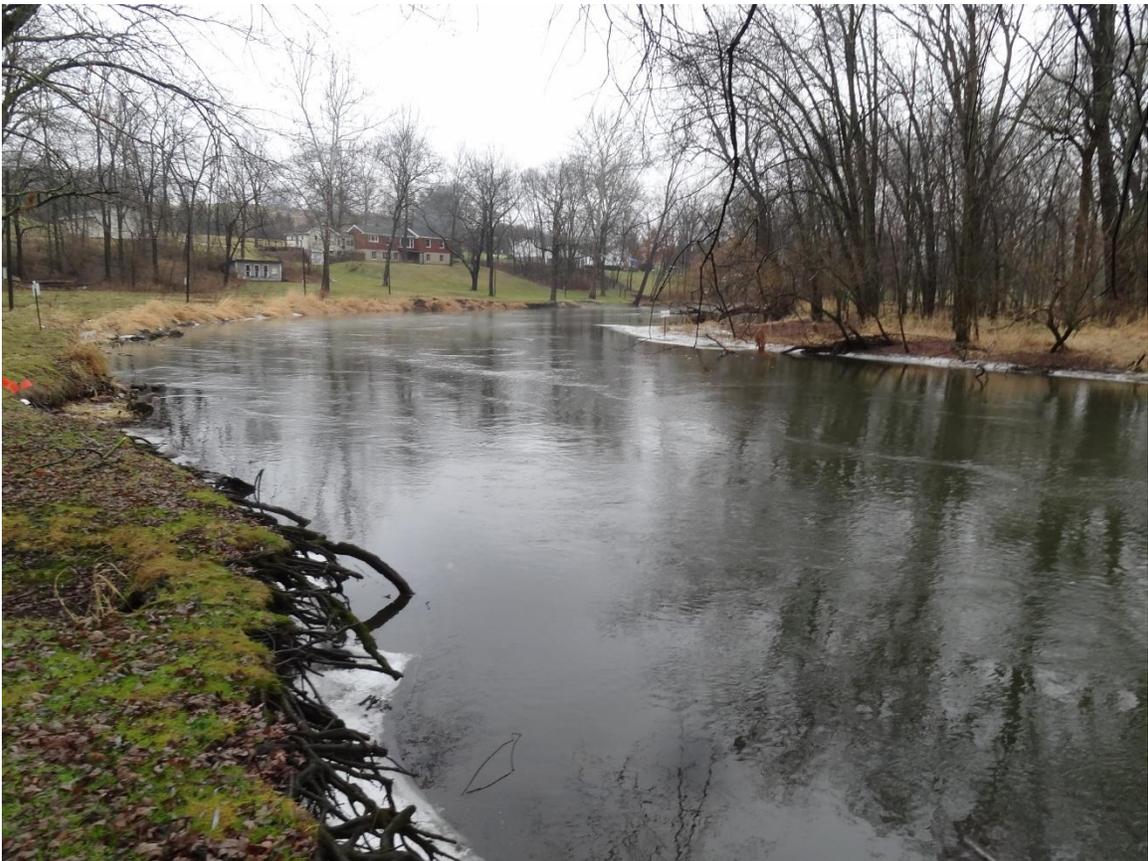
16. MP27.00 Shady Bend Campground ice has receded from upstream river channel.

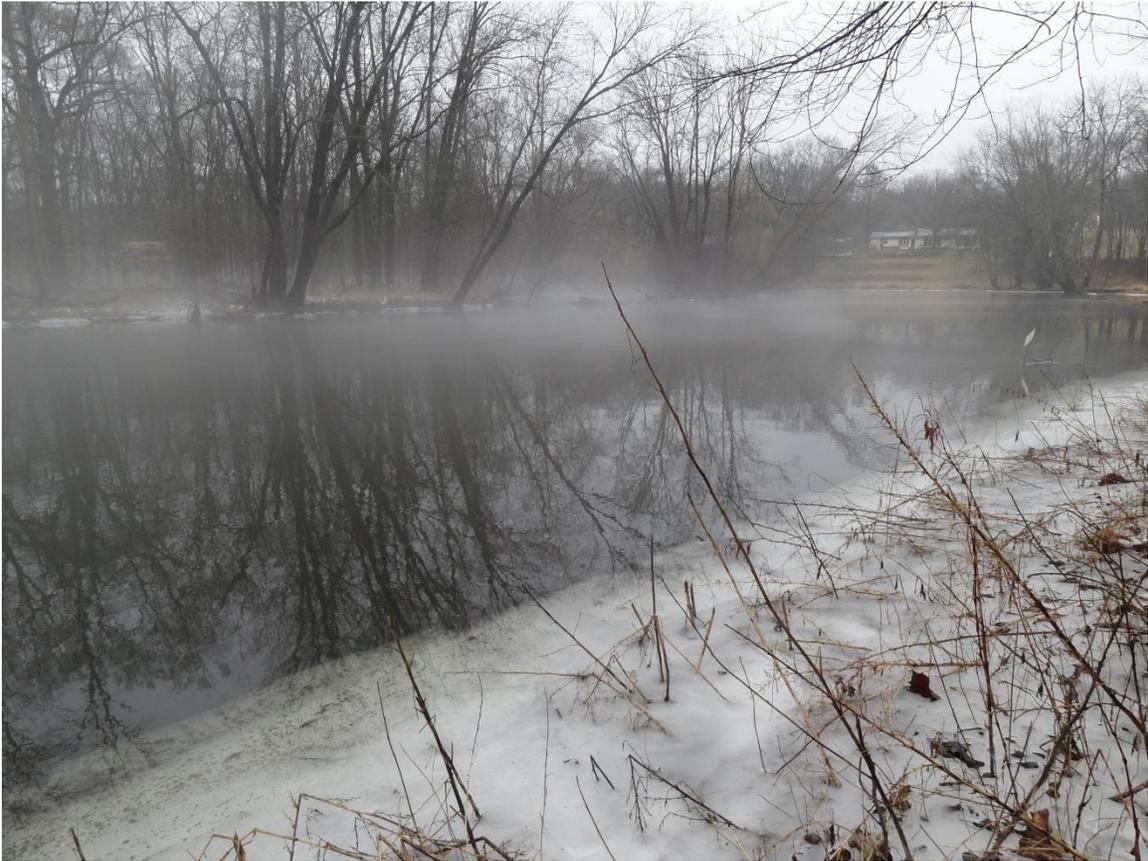
17. MP27.00 Shady Bend Campground observed downstream ice conditions.

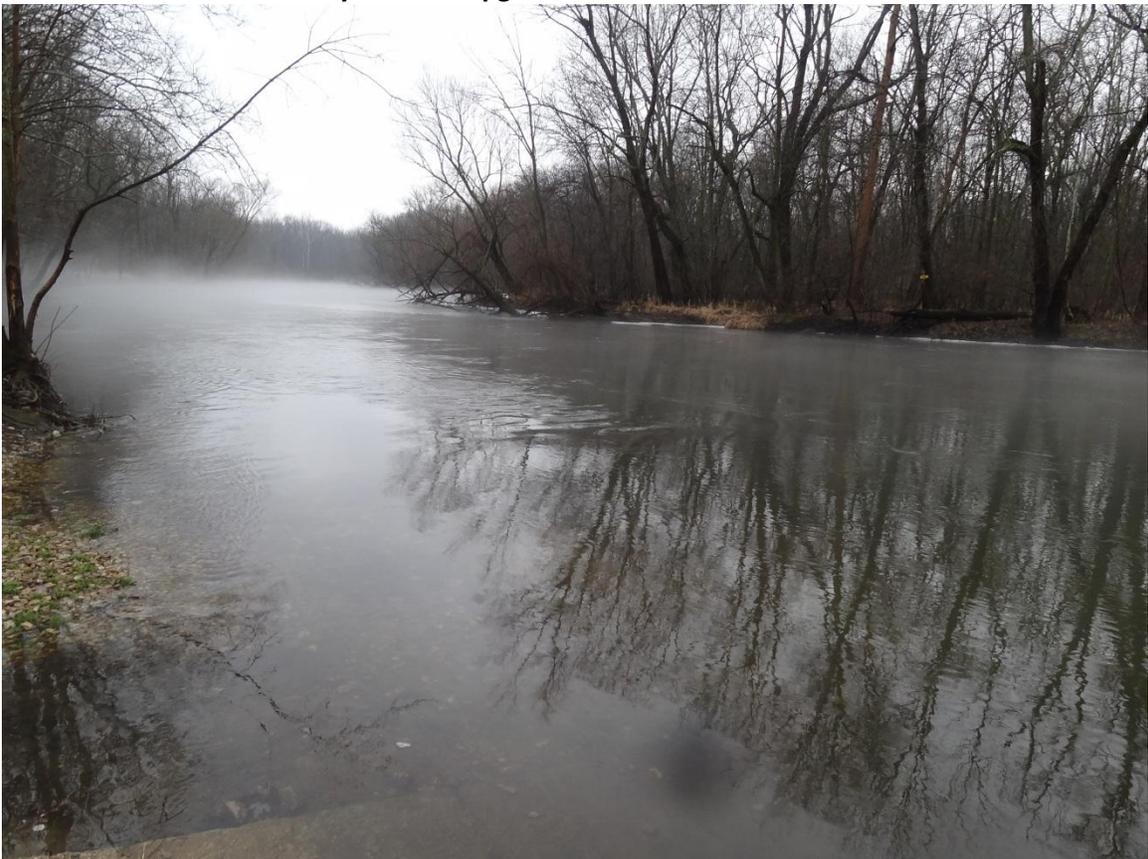
18. E2 Boat Launch ice has receded from river channel.

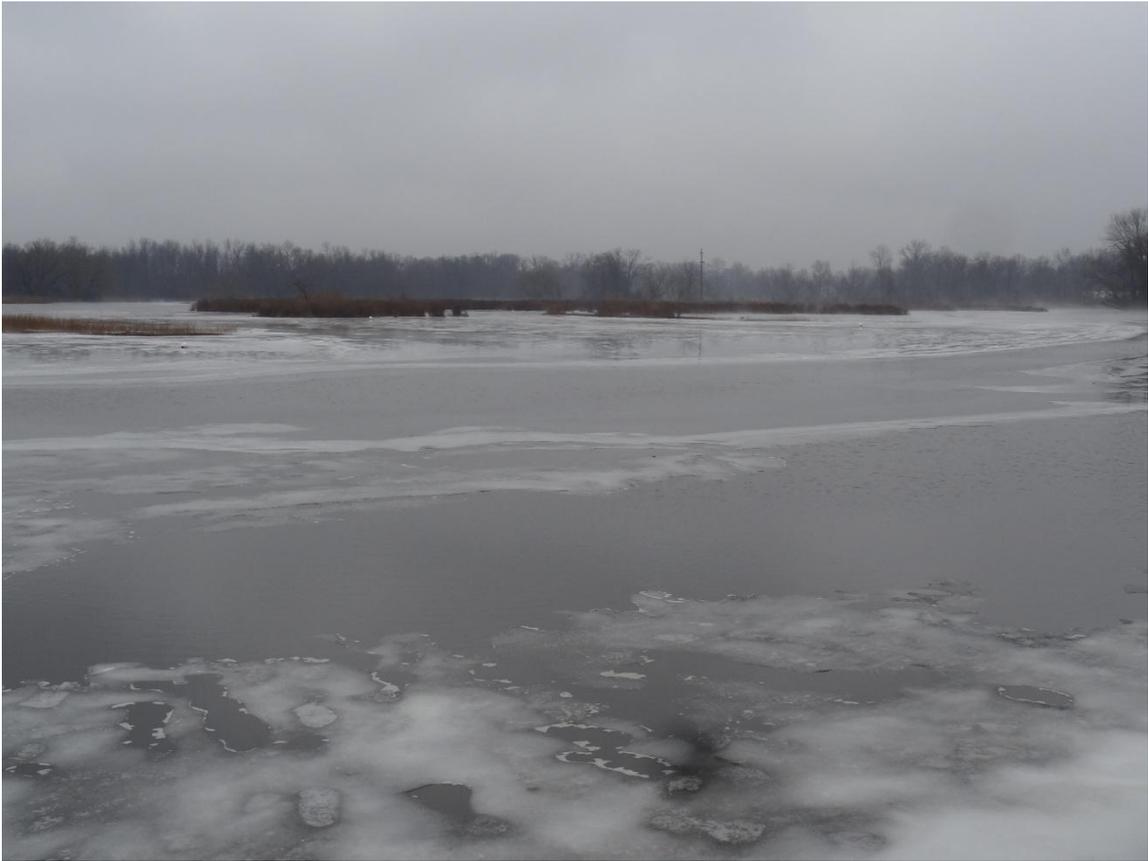
19. Morrow Lake Delta observed ice conditions.

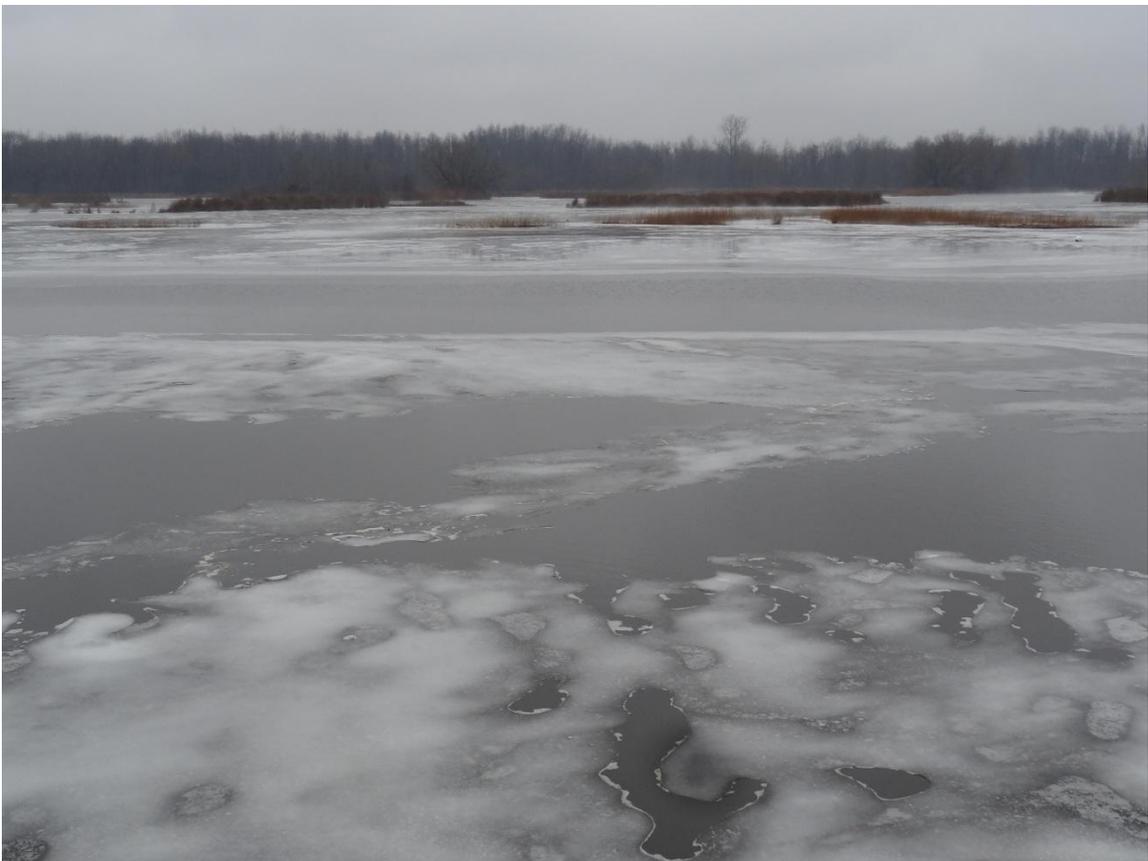
20. Morrow Lake Delta observed ice conditions.

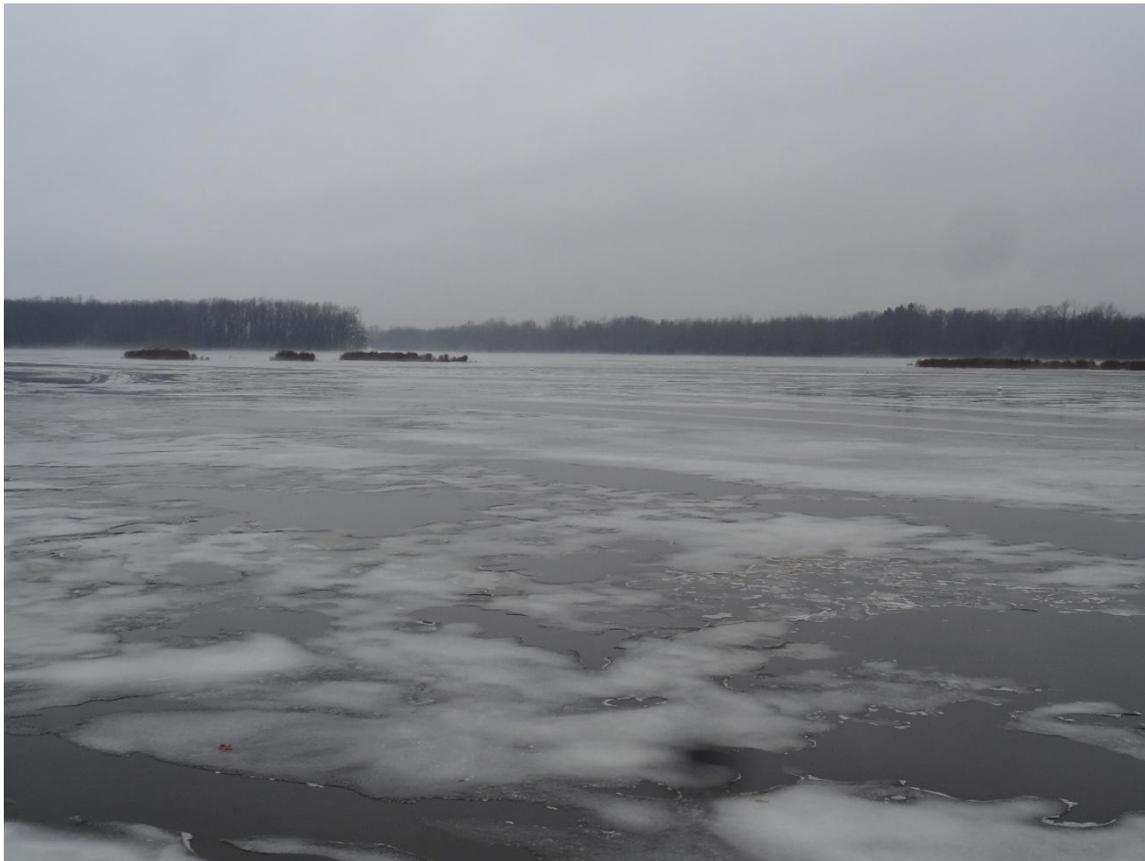
21. Morrow Lake Delta observed ice conditions.

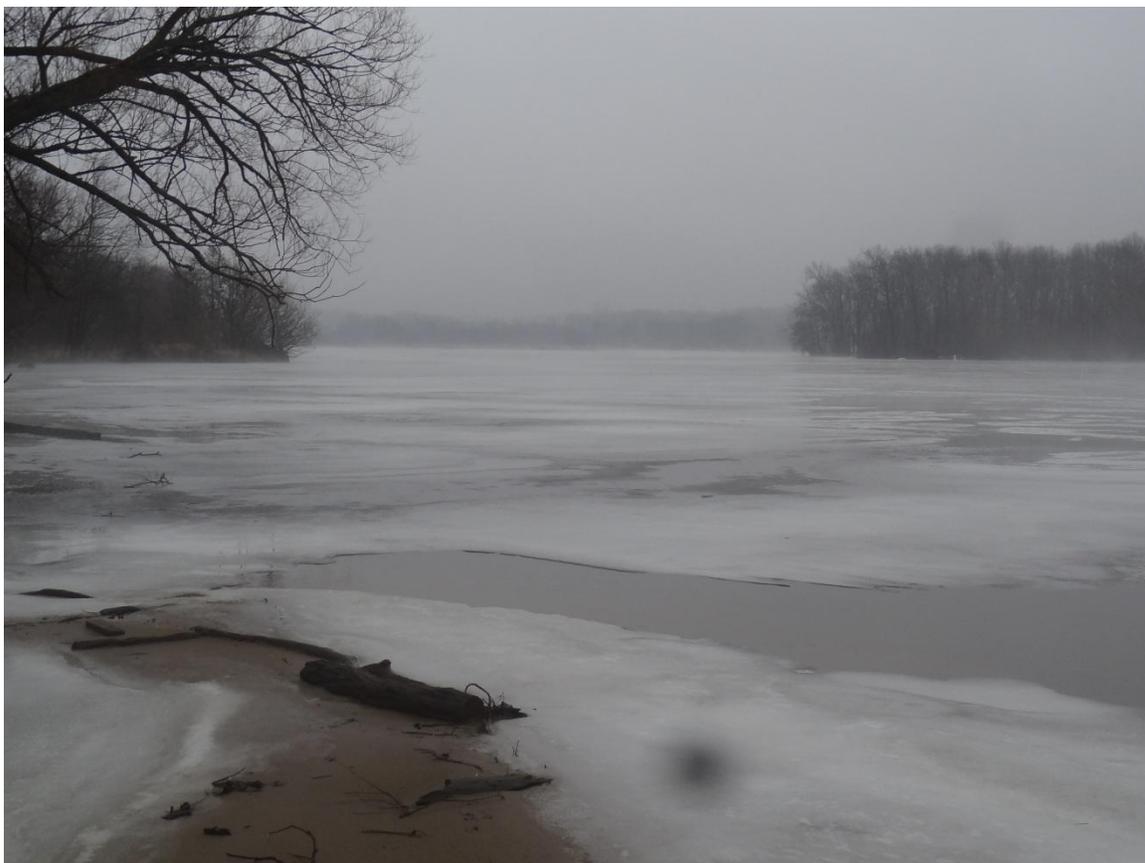
22. Morrow Lake Neck/Morrow Lake Delta observed ice conditions.

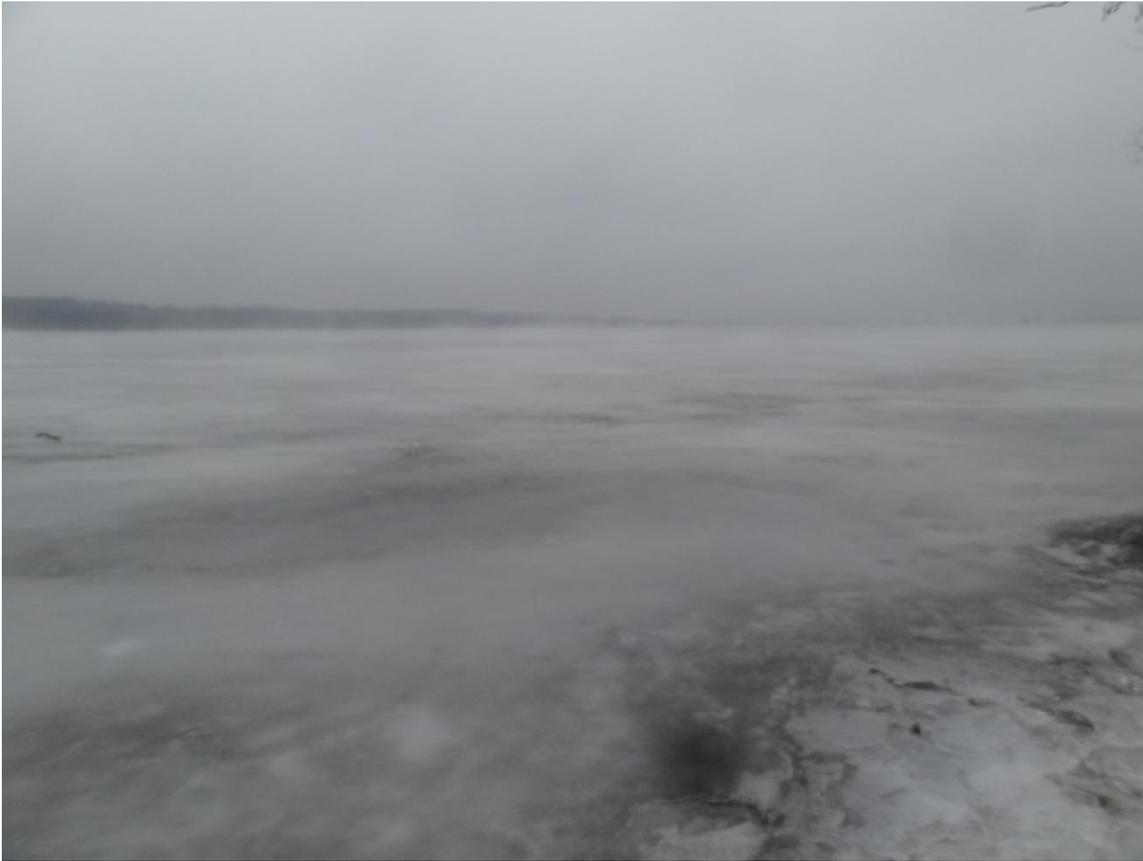
23. Morrow Lake observed ice conditions.
