# Situation Update

January 30, 2013

# Submerged Oil Science

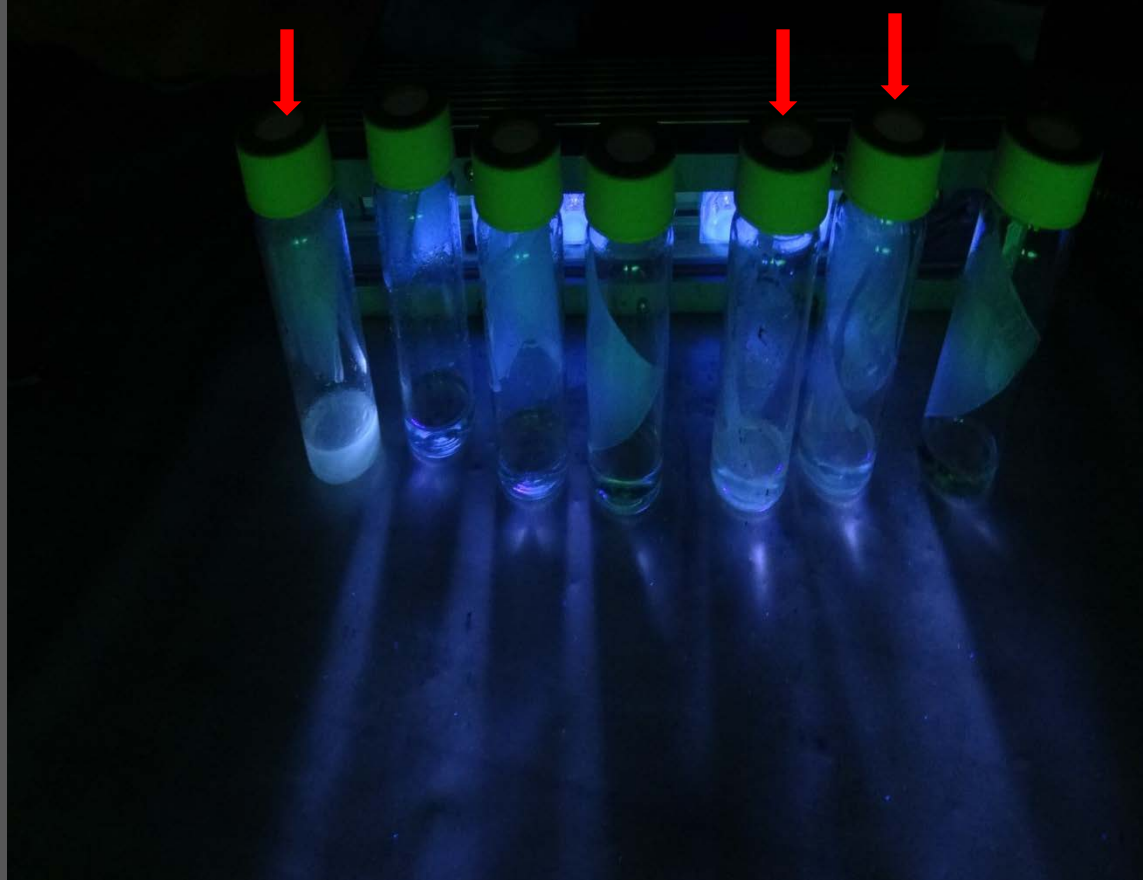
UV Assessment of hexane sheen tests  
01.28.2013

- 7 Tests Evaluated
- 3 Tests were positive for UV Florescence
- UV Florescence observed from tests at MP 6.60 RDB, MP 36.30 LDB, and MP 36.5 RDB

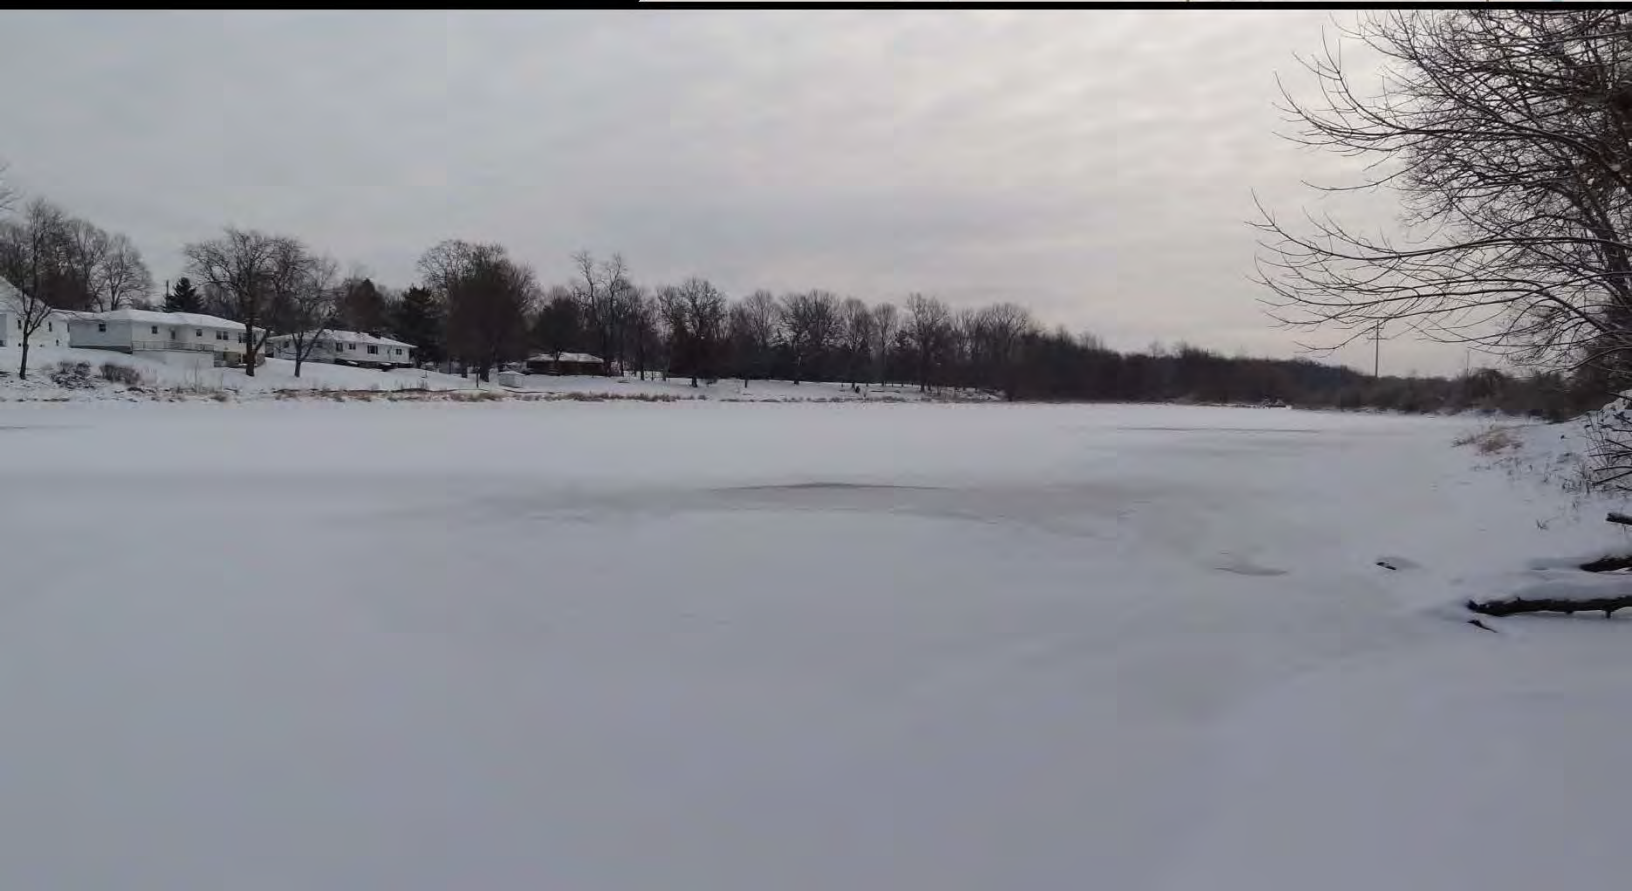
Ceresco Dam Impoundment

# River Icing Conditions

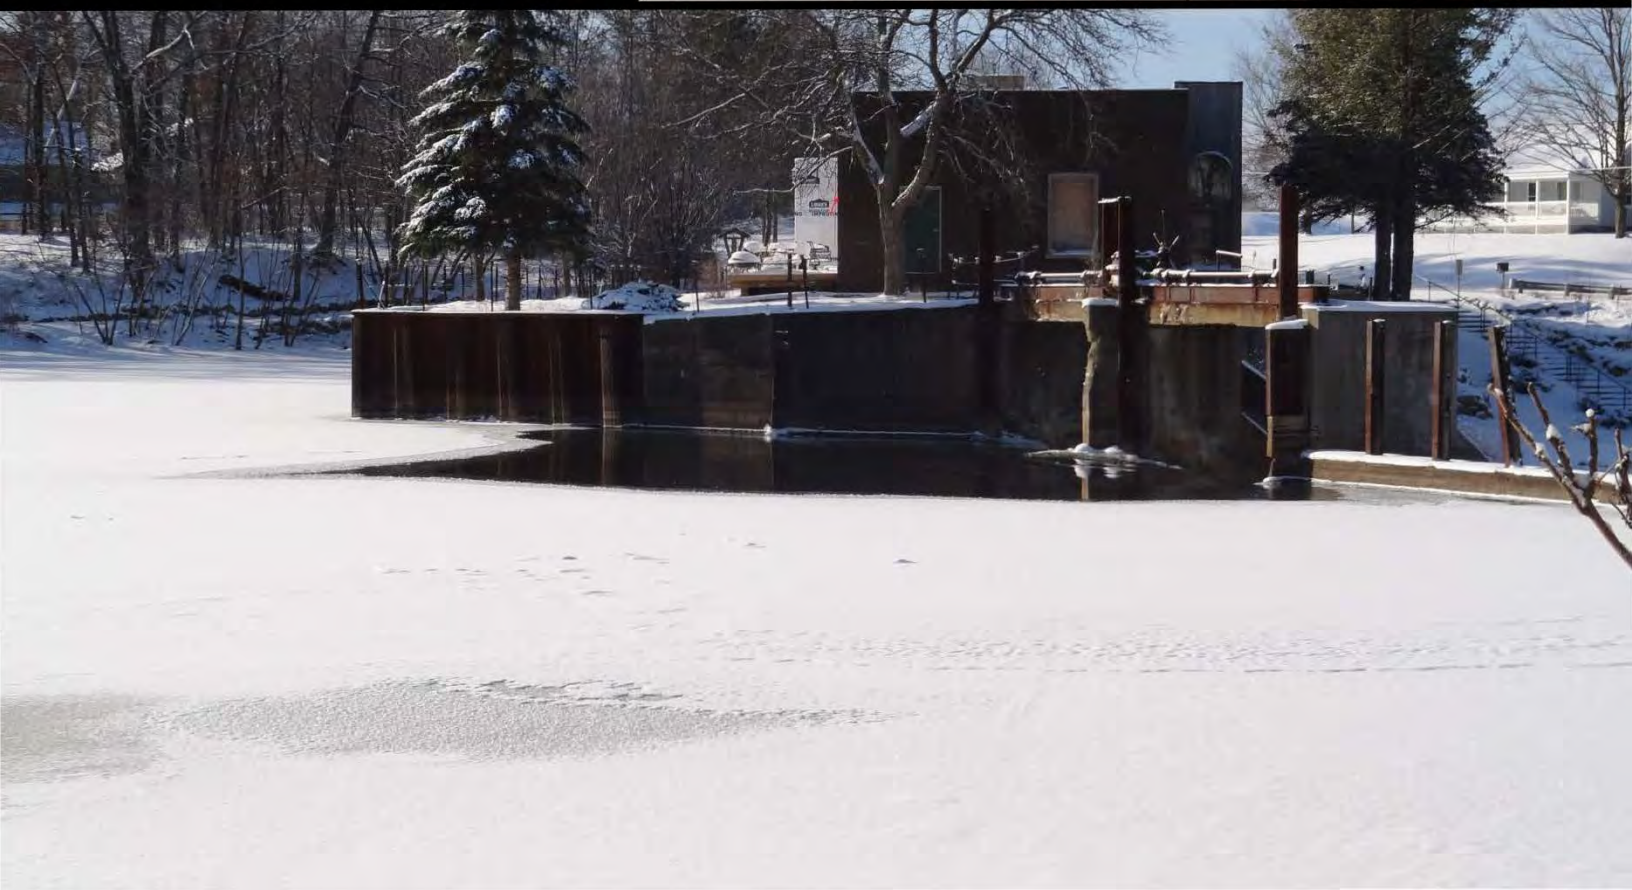
Ceresco Dam Impoundment

# River Icing Conditions

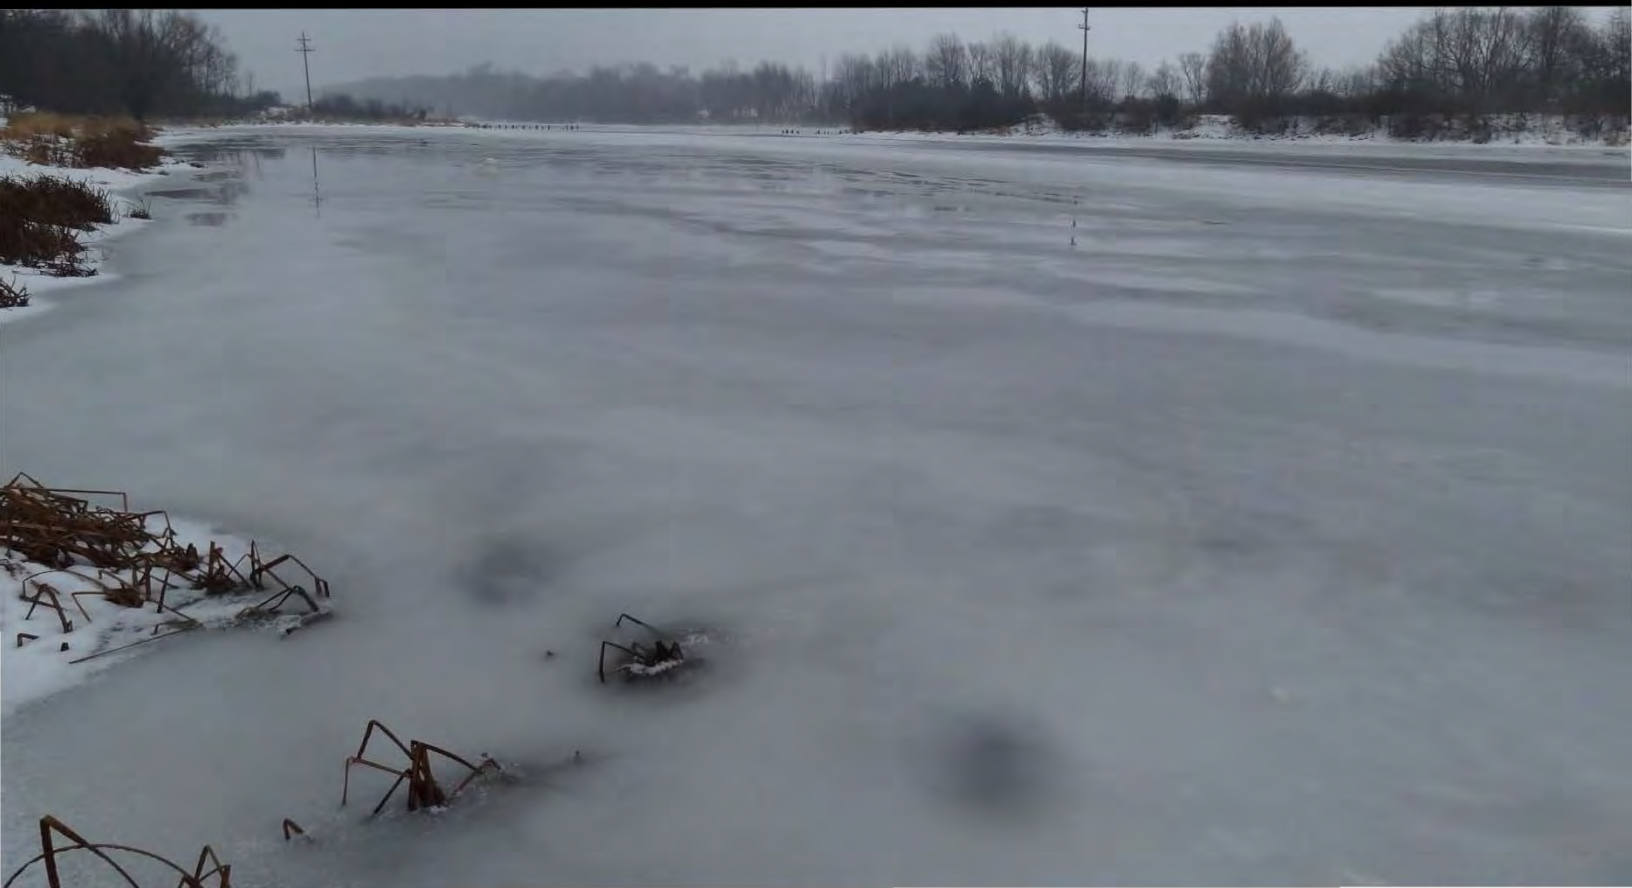
Ceresco Dam Impoundment

# River Icing Conditions

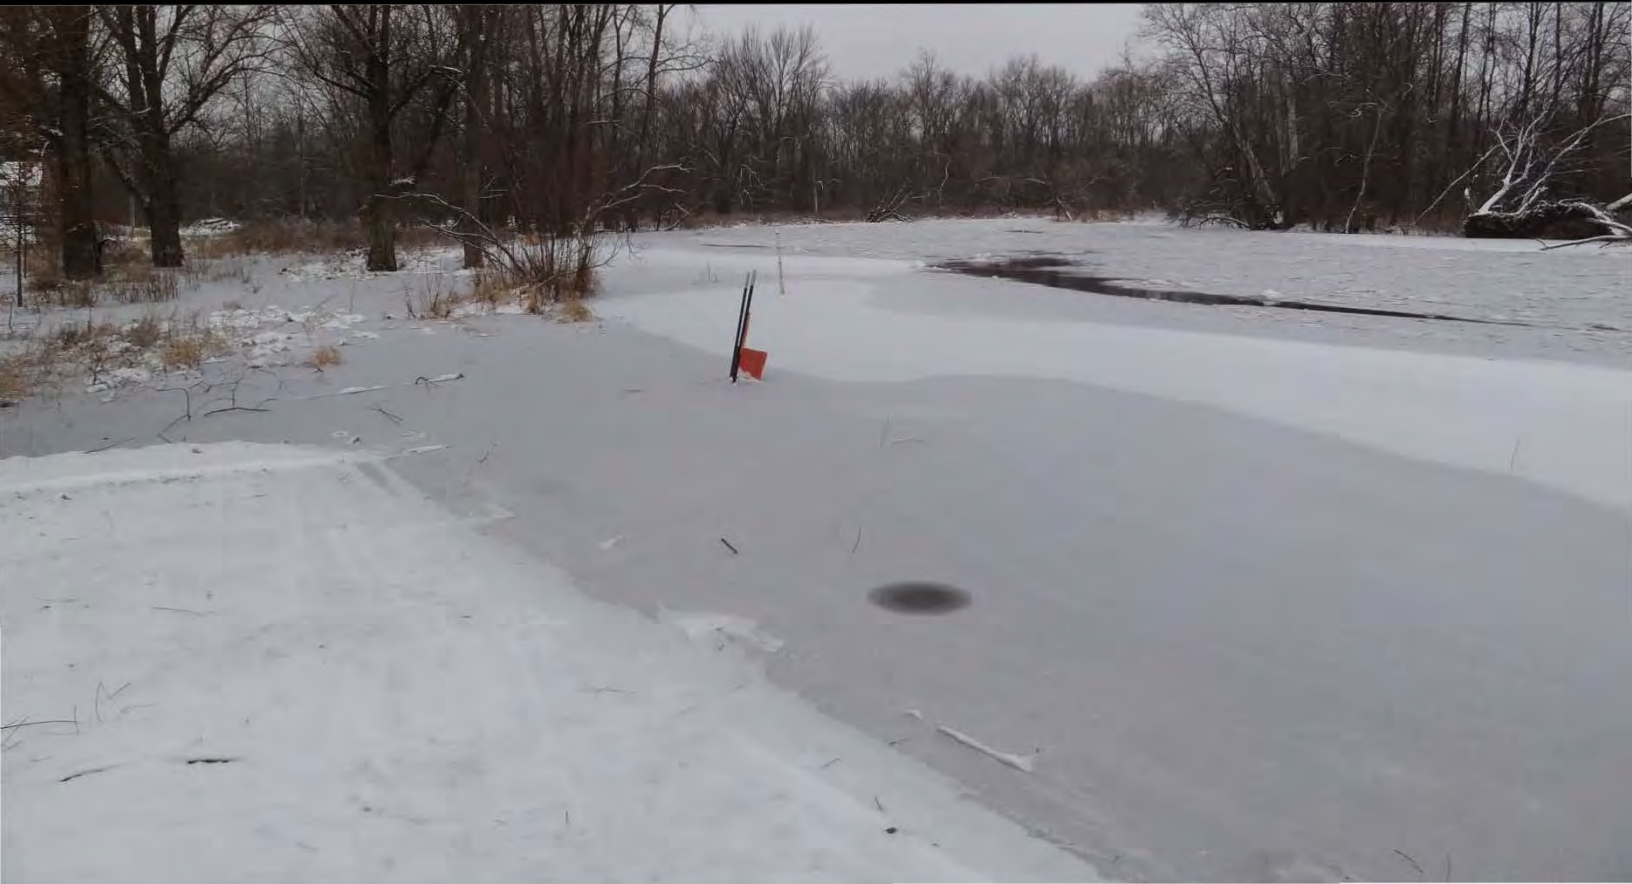
C3.2 Boat Launch  
01.23.2013

# River Icing Conditions

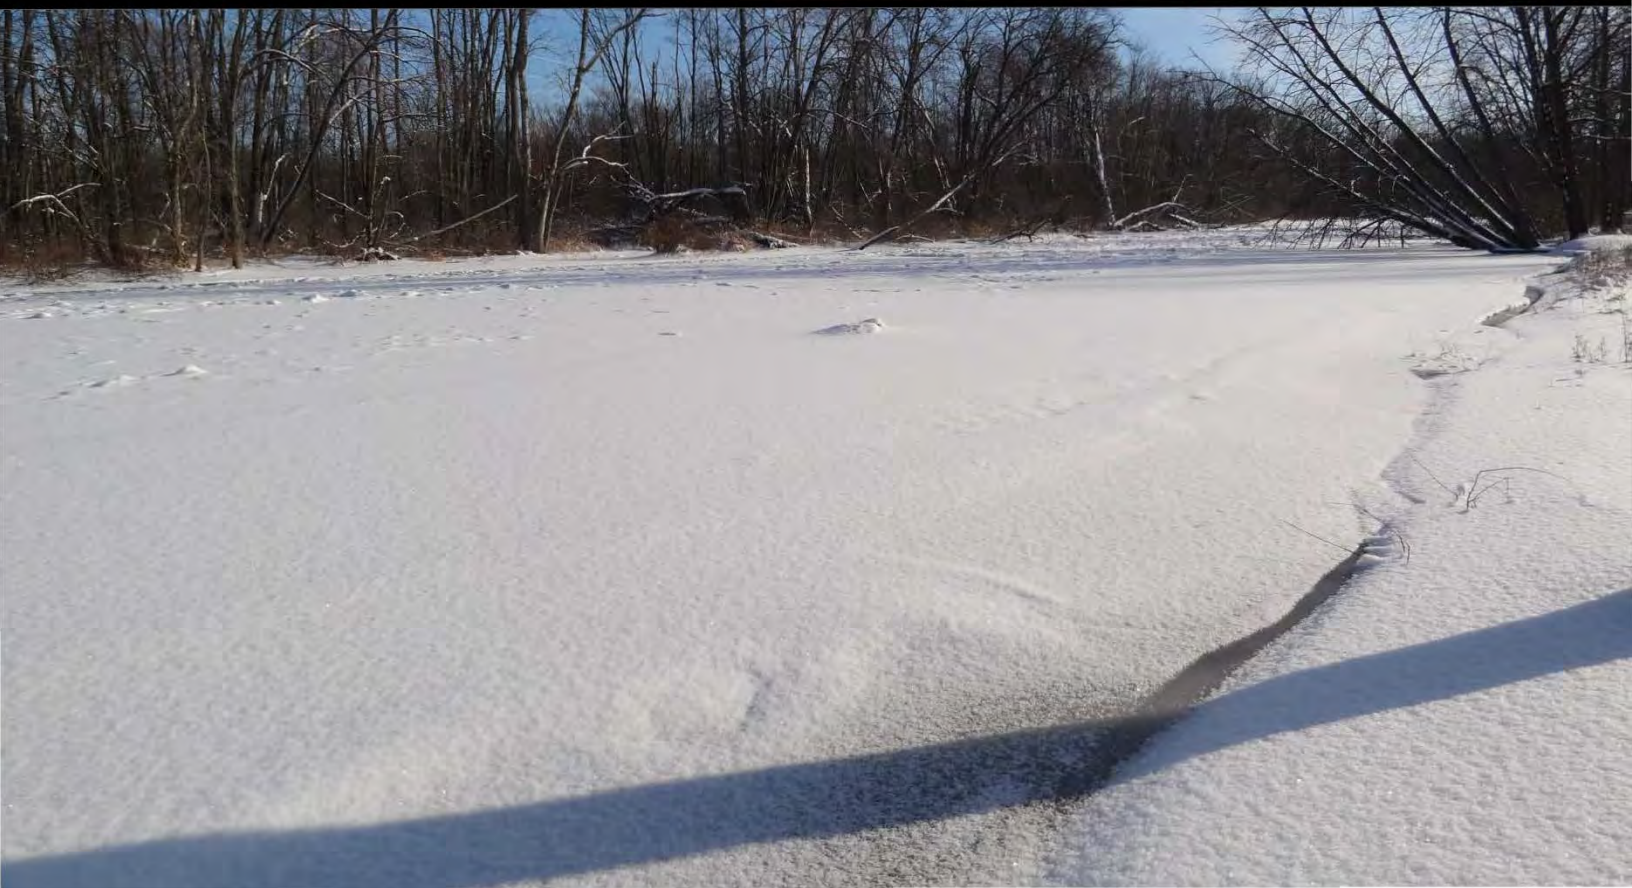
C3.2 Boat Launch

# River Icing Conditions

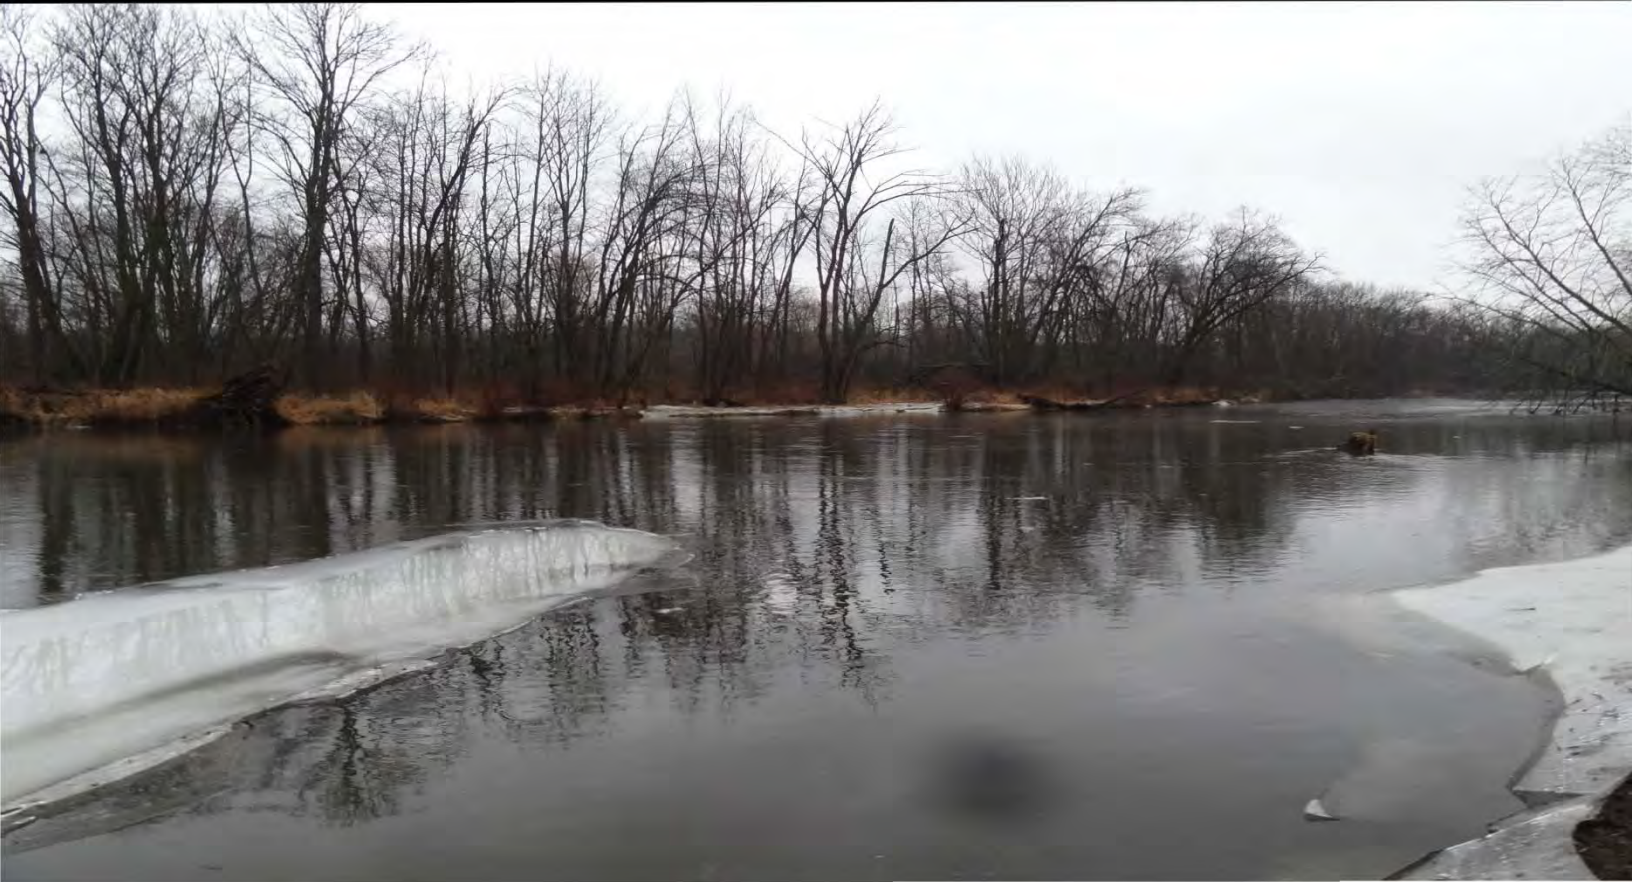
C3.2 Boat Launch

# River Icing Conditions

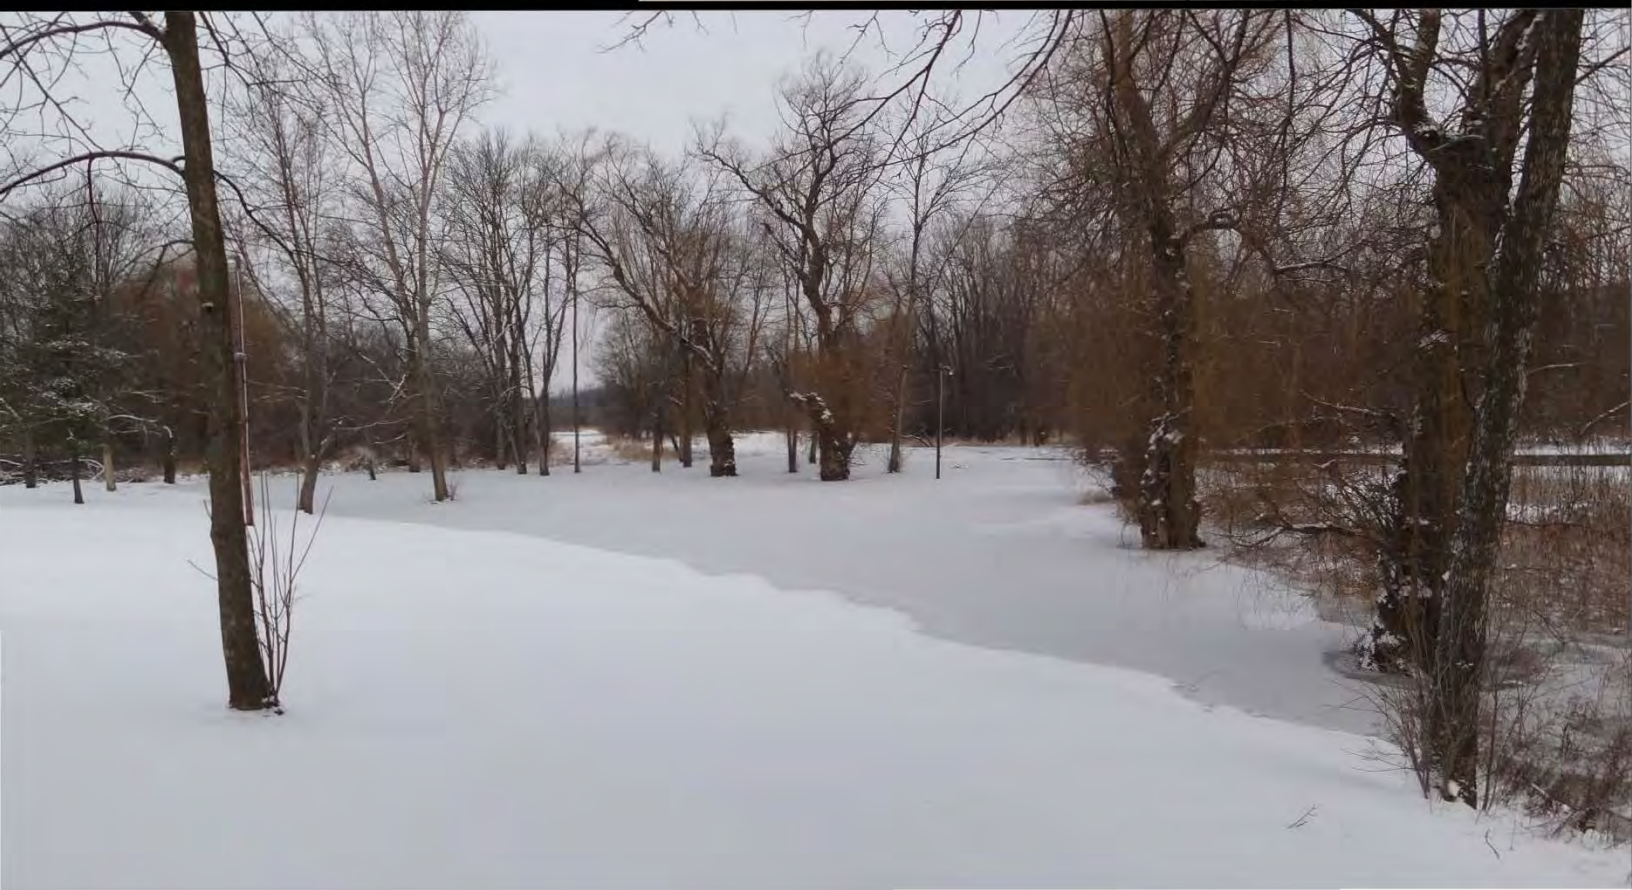
MP 10.35 LDB

# River Icing Conditions

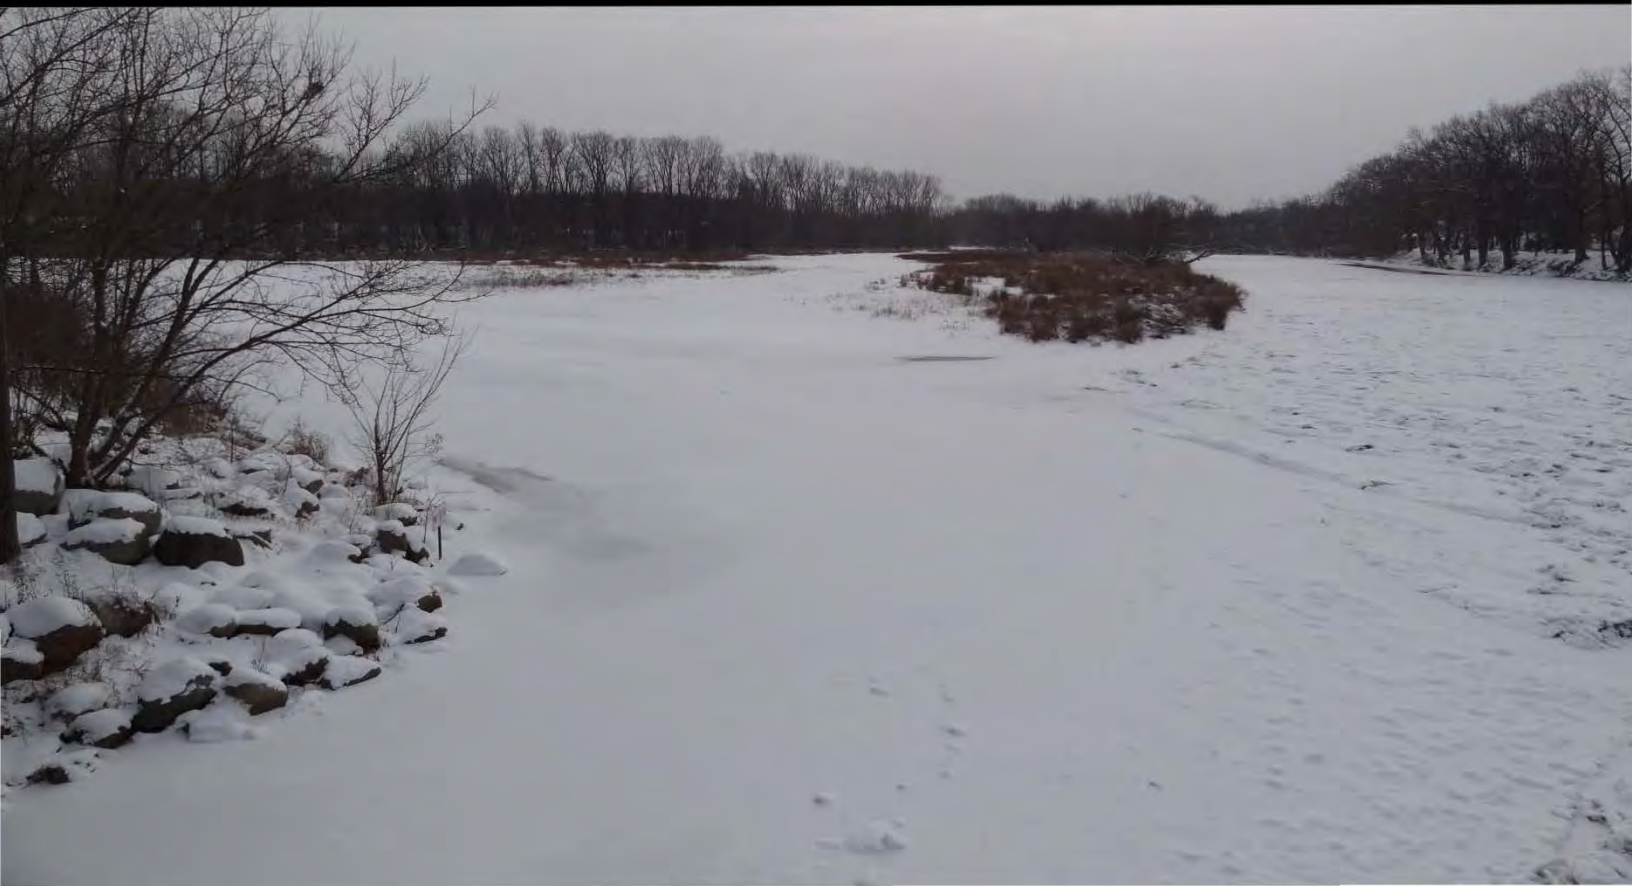
South Mill Pond – MP 15.25

# River Icing Conditions

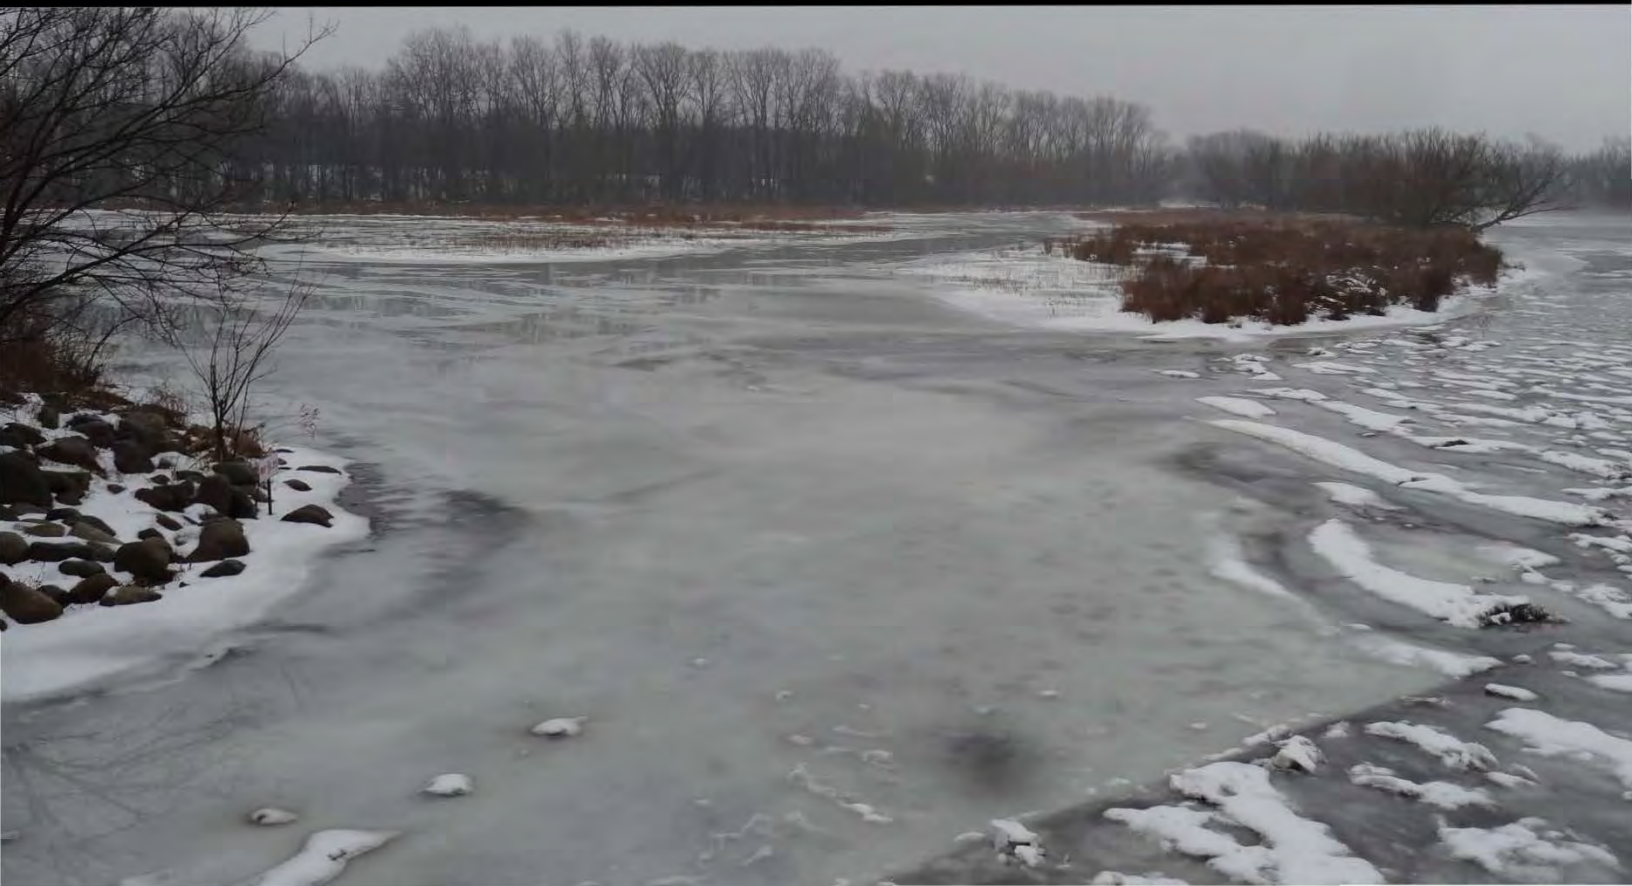
South Mill Pond – MP 15.25

# River Icing Conditions

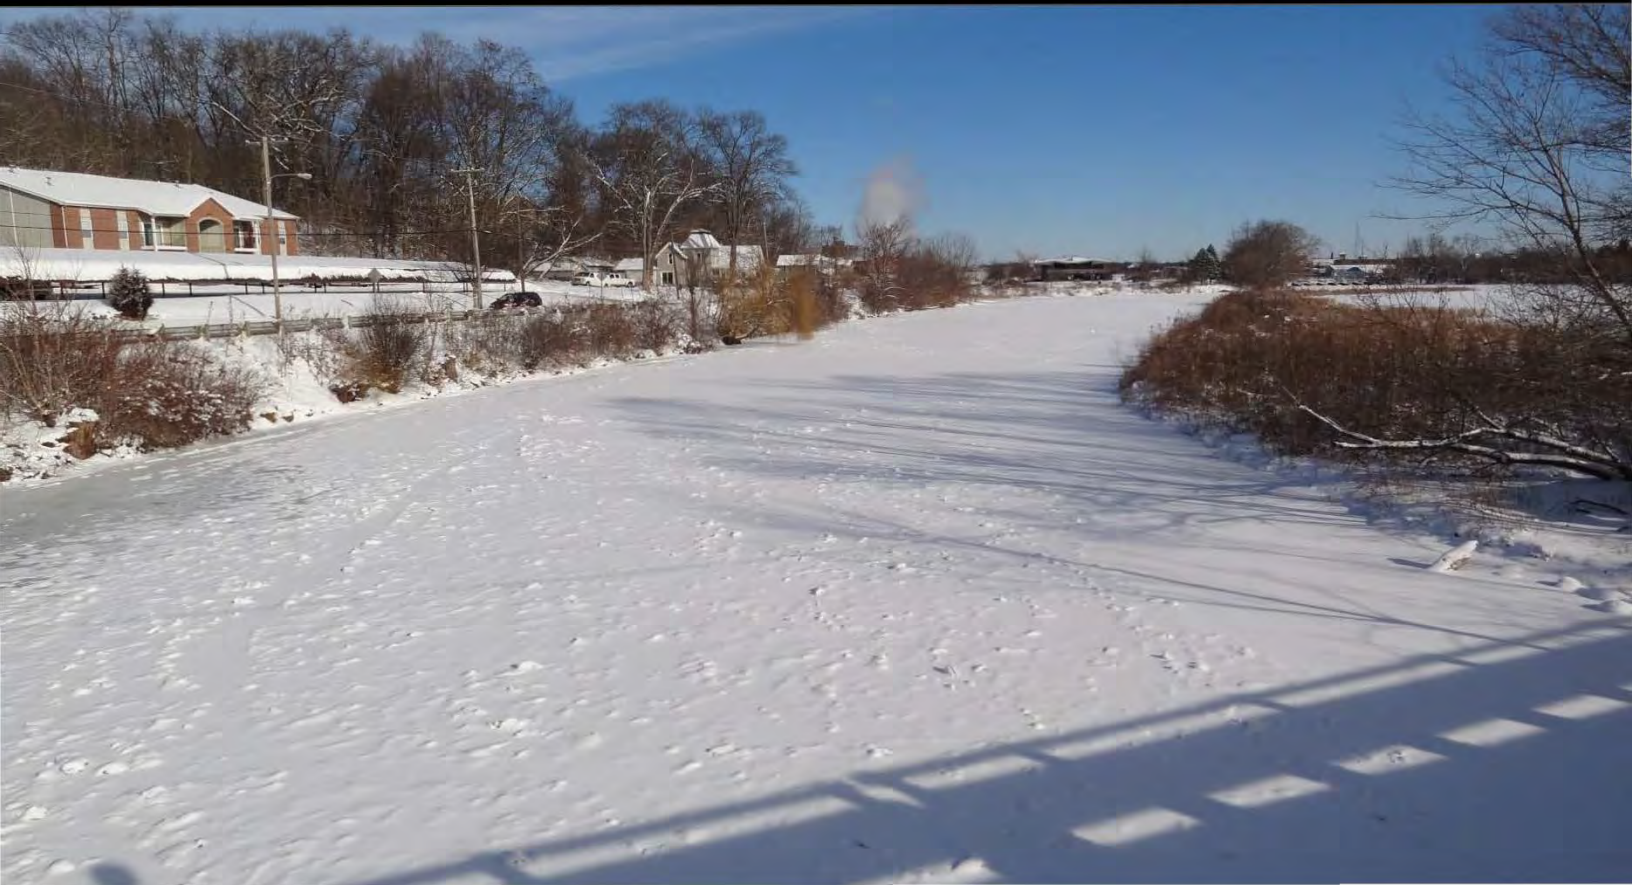
North Mill Pond – MP 15.5

# River Icing Conditions

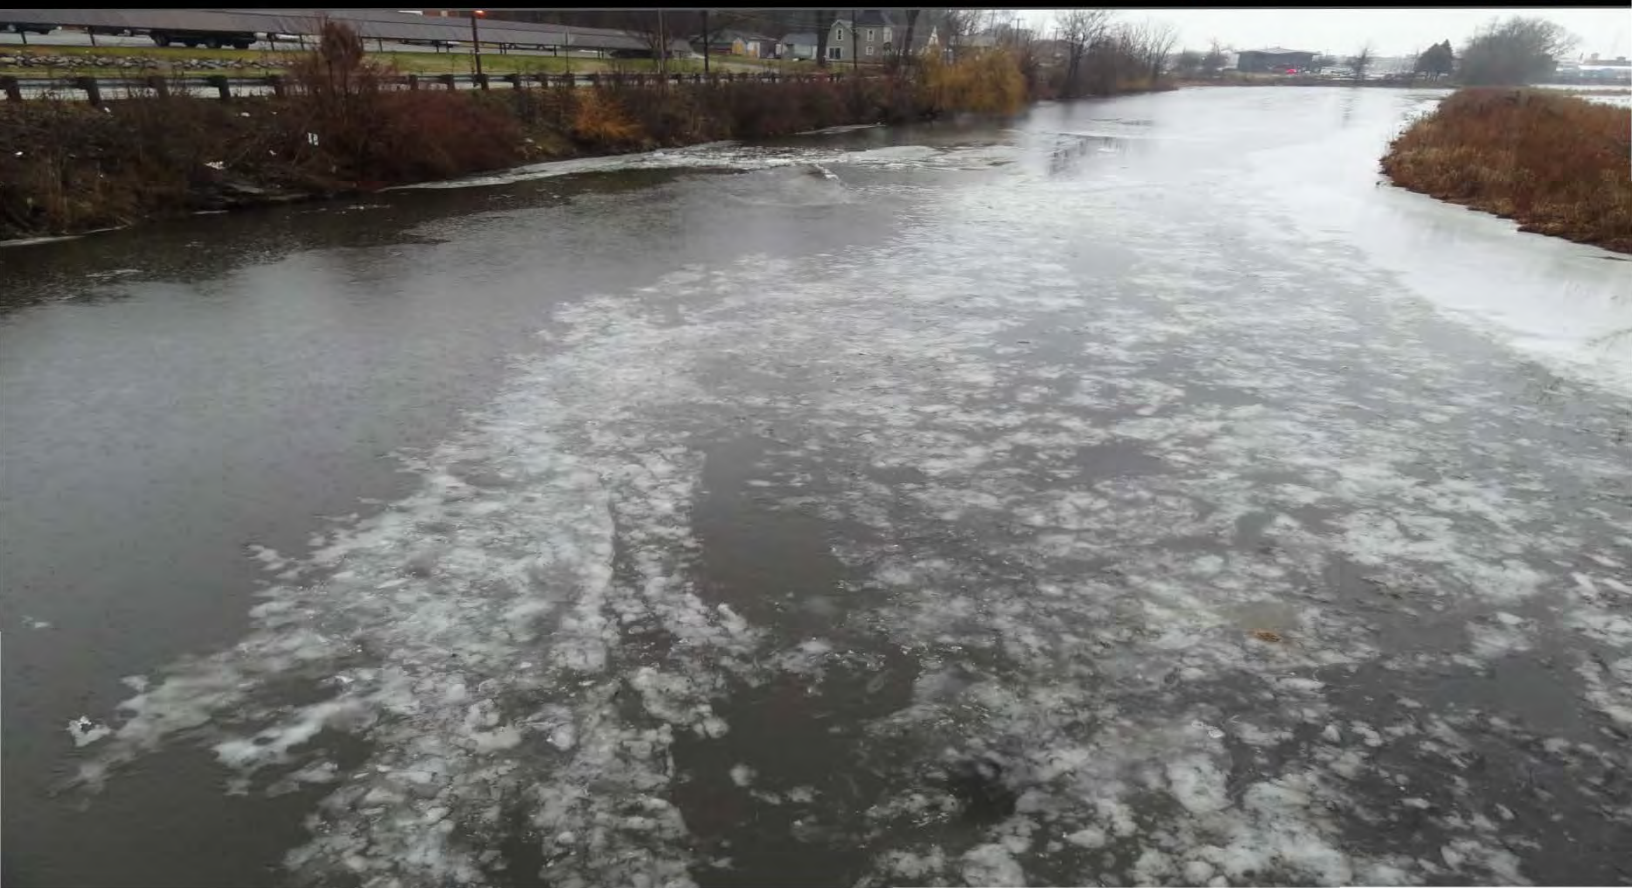
North Mill Pond – MP 15.5

# River Icing Conditions

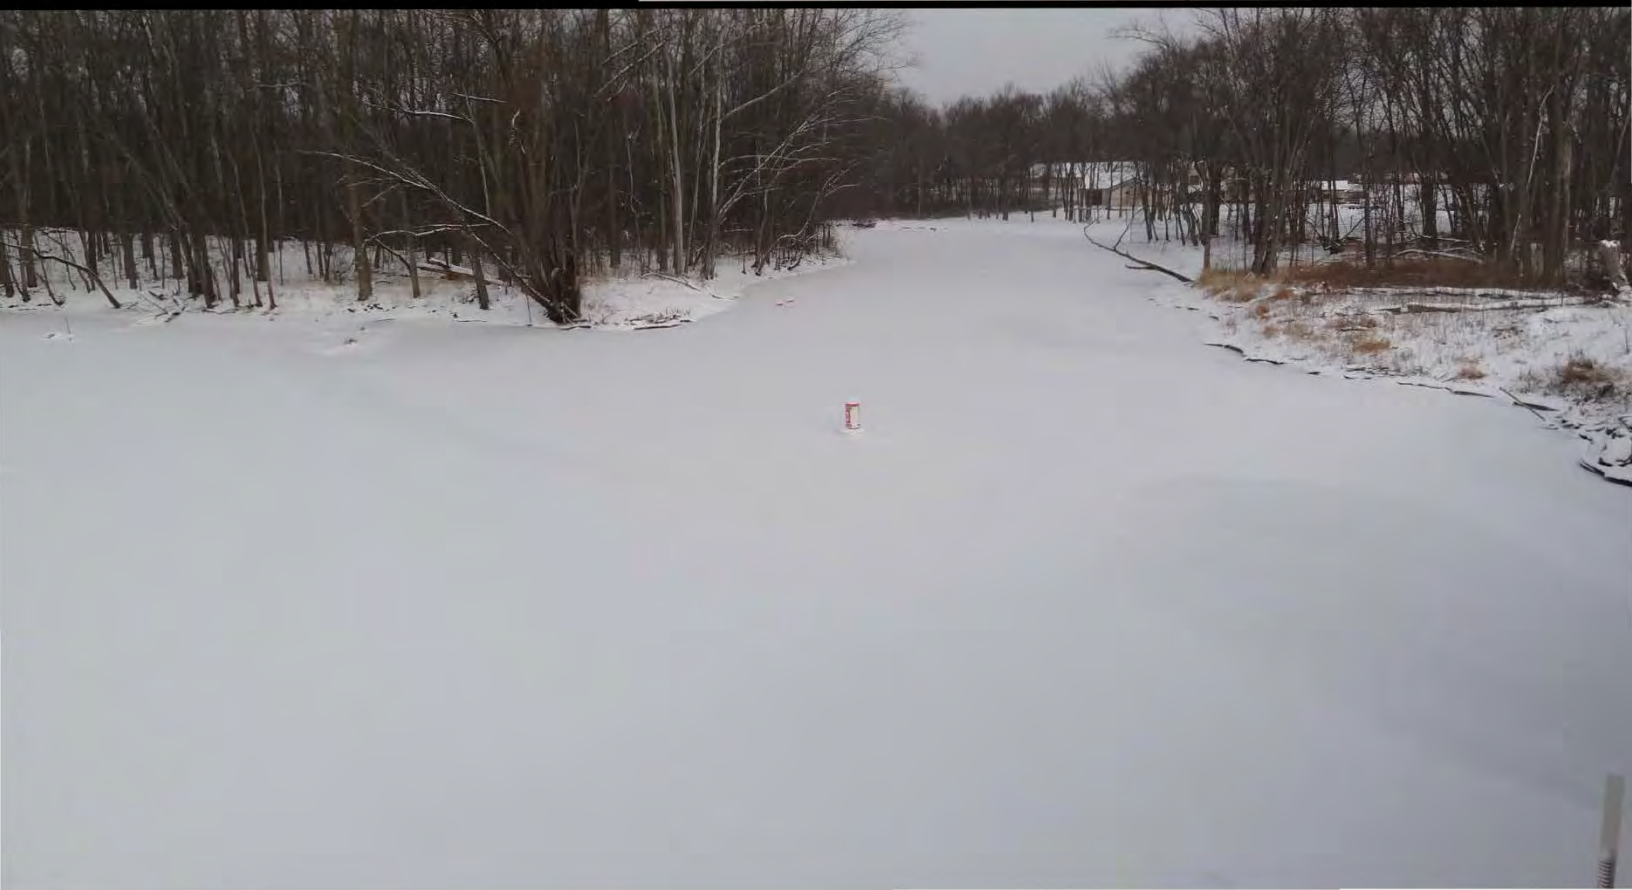
MP 21.5 Oxbow

# River Icing Conditions

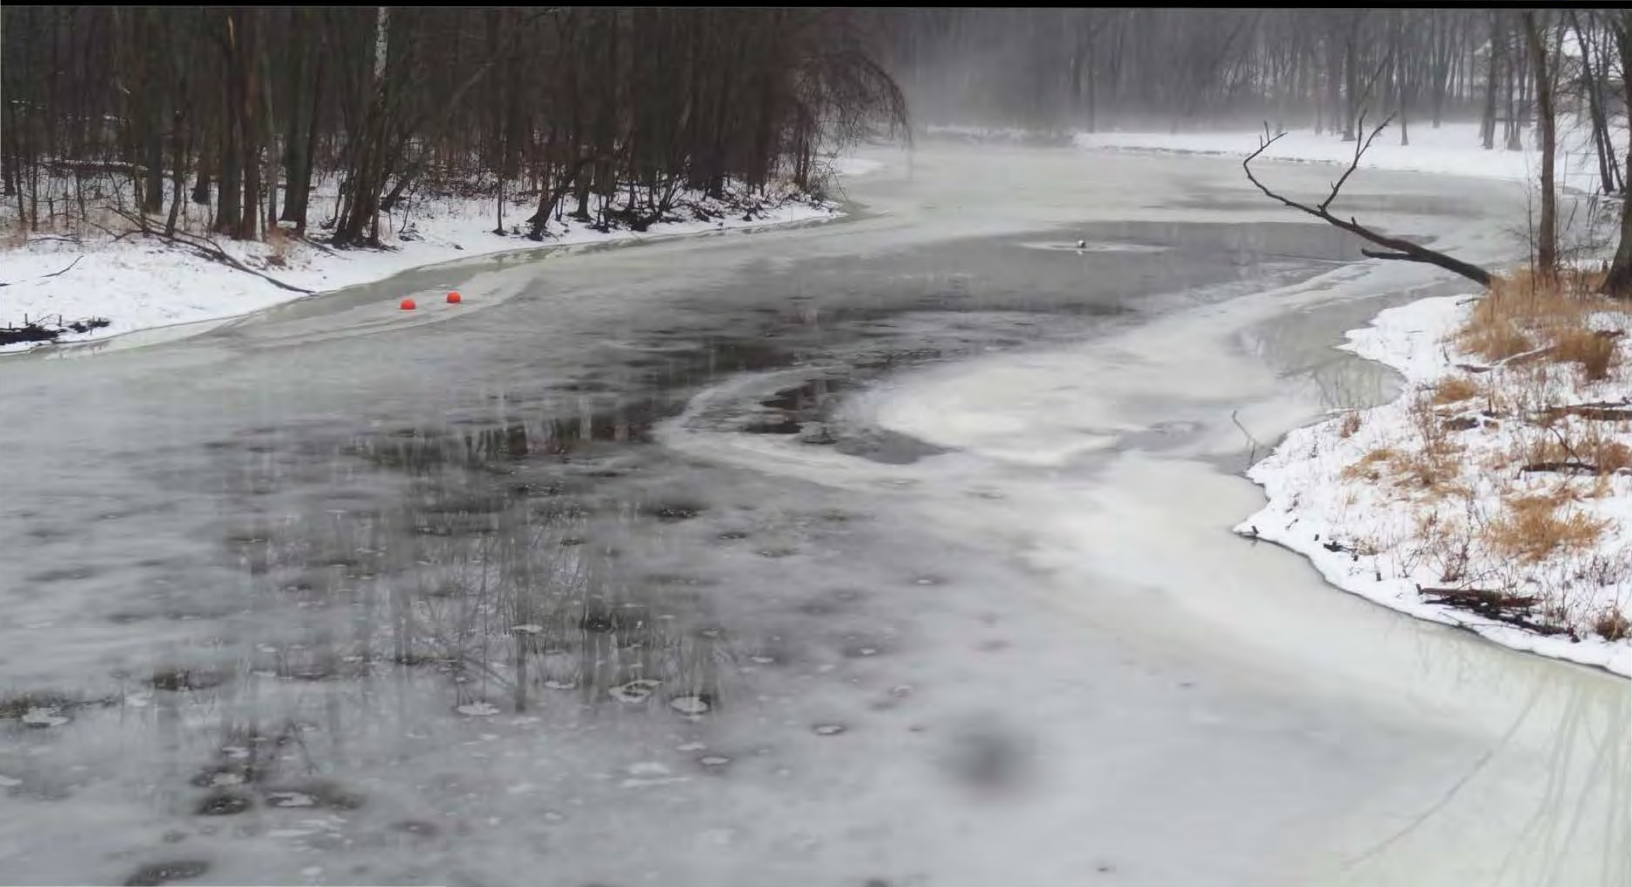
MP 21.5 Oxbow

# River Icing Conditions

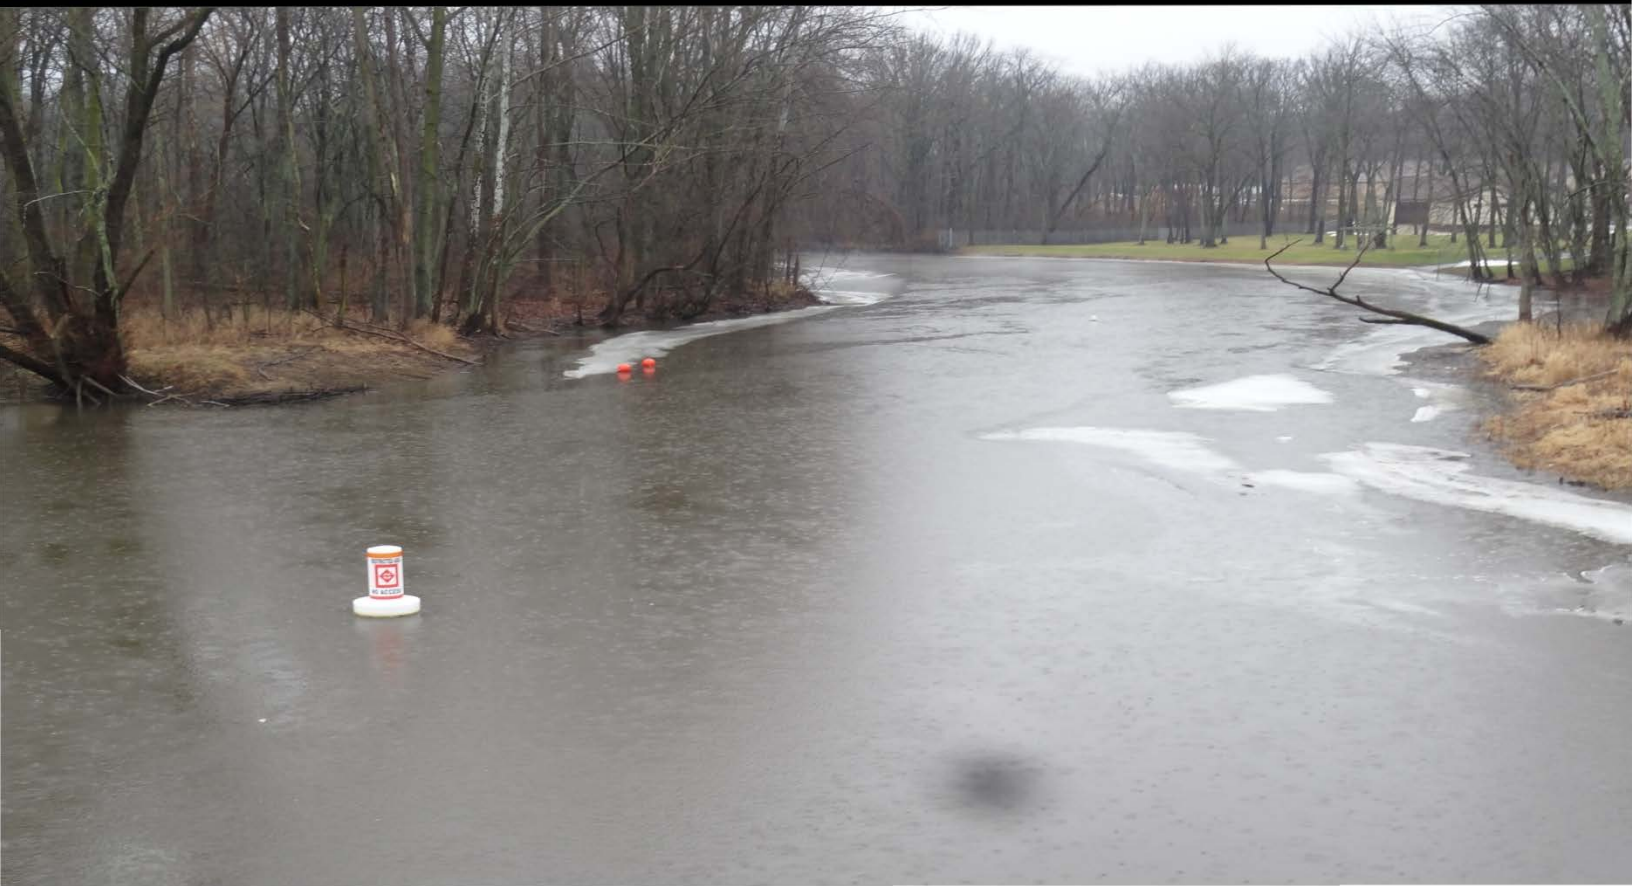
MP 21.5 Oxbow

# River Icing Conditions

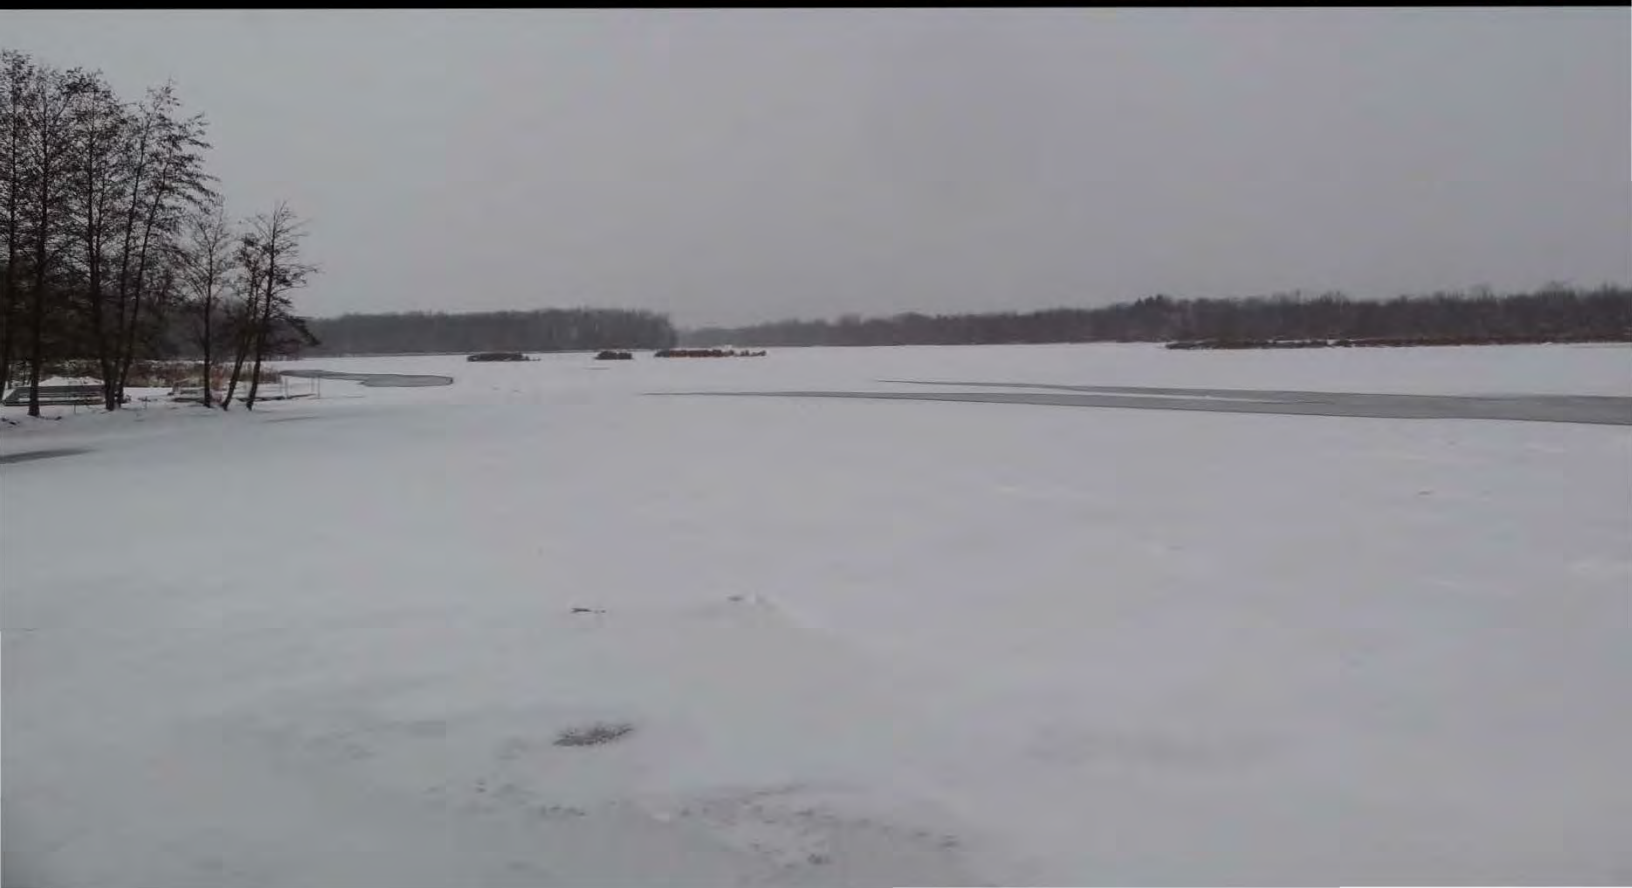
Morrow Lake Delta

# River Icing Conditions
