# Situation Update

January 30, 2013

# Submerged Oil Science

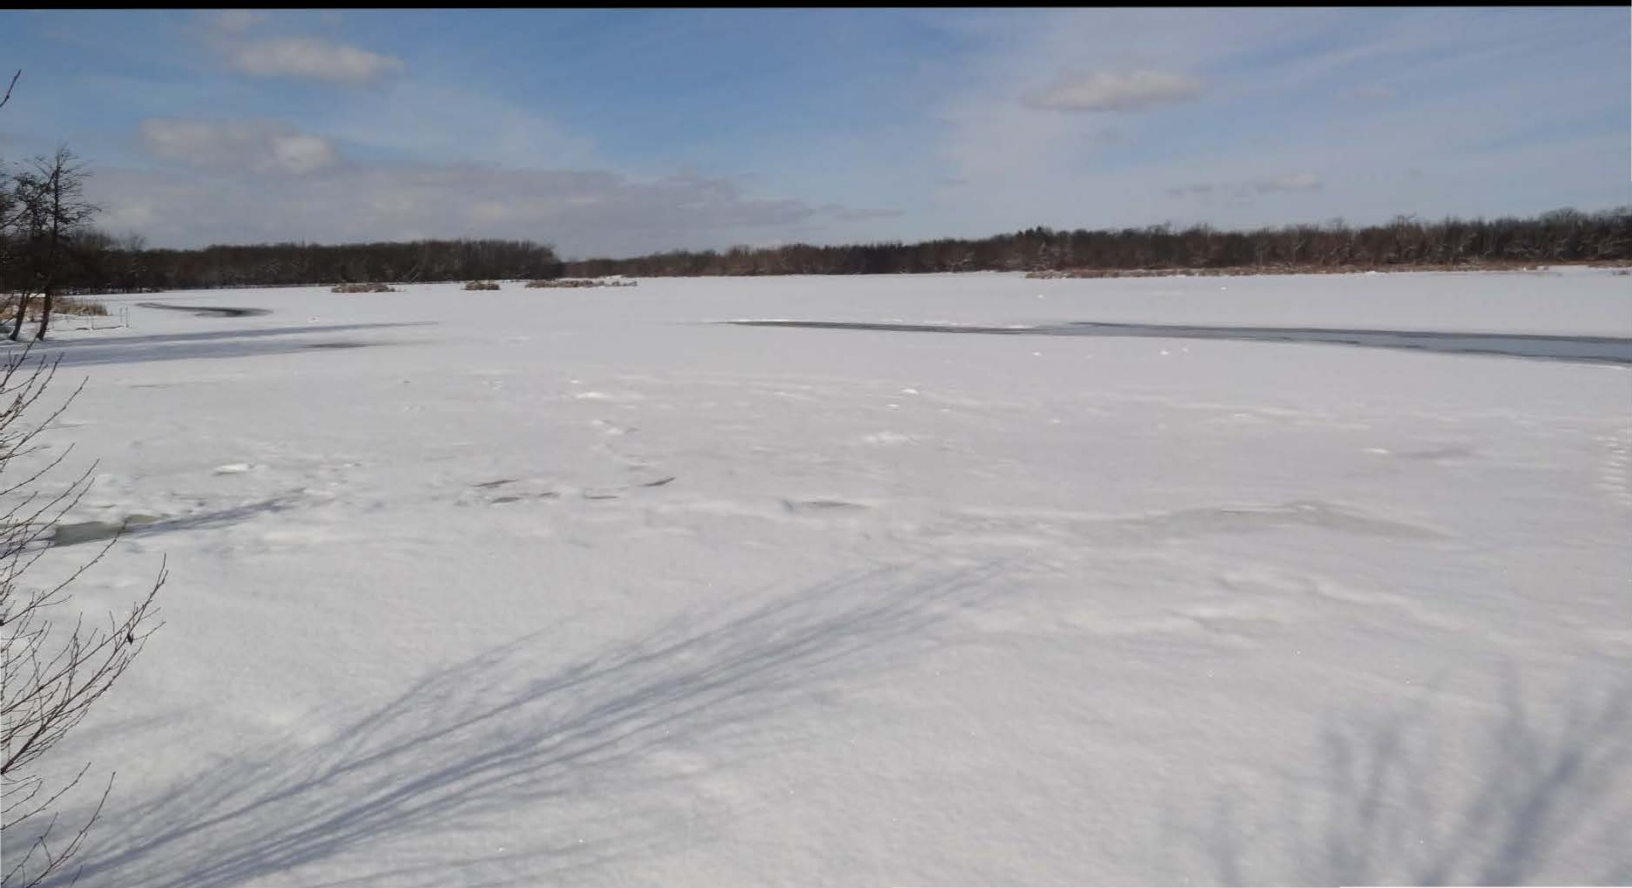
Morrow Lake Delta

# River Icing Conditions

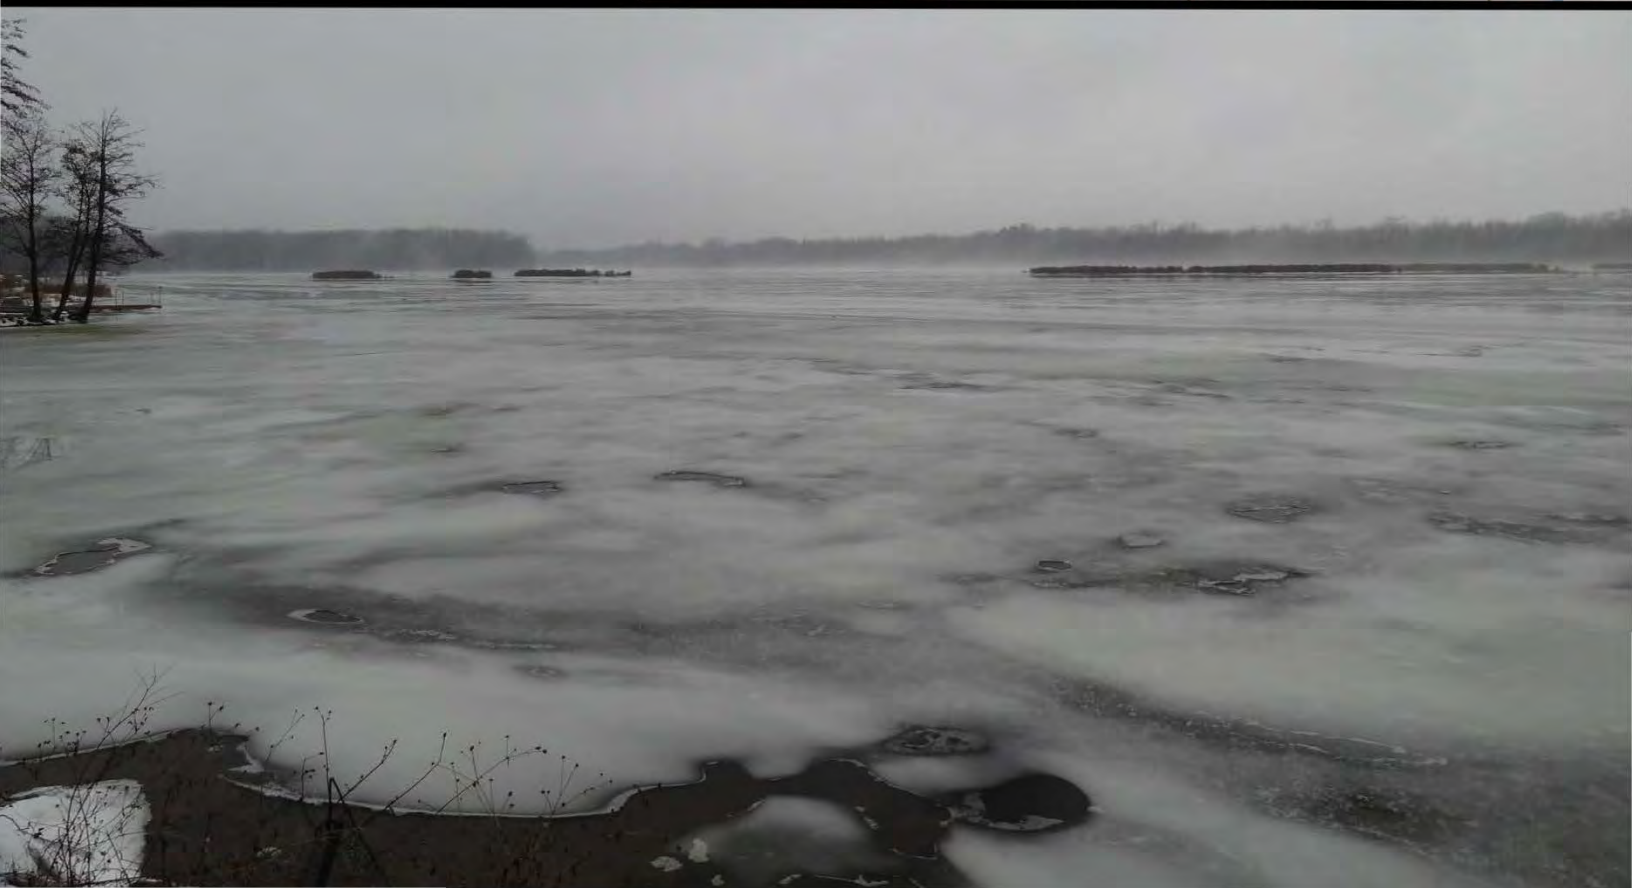
Morrow Lake Delta

# River Icing Conditions

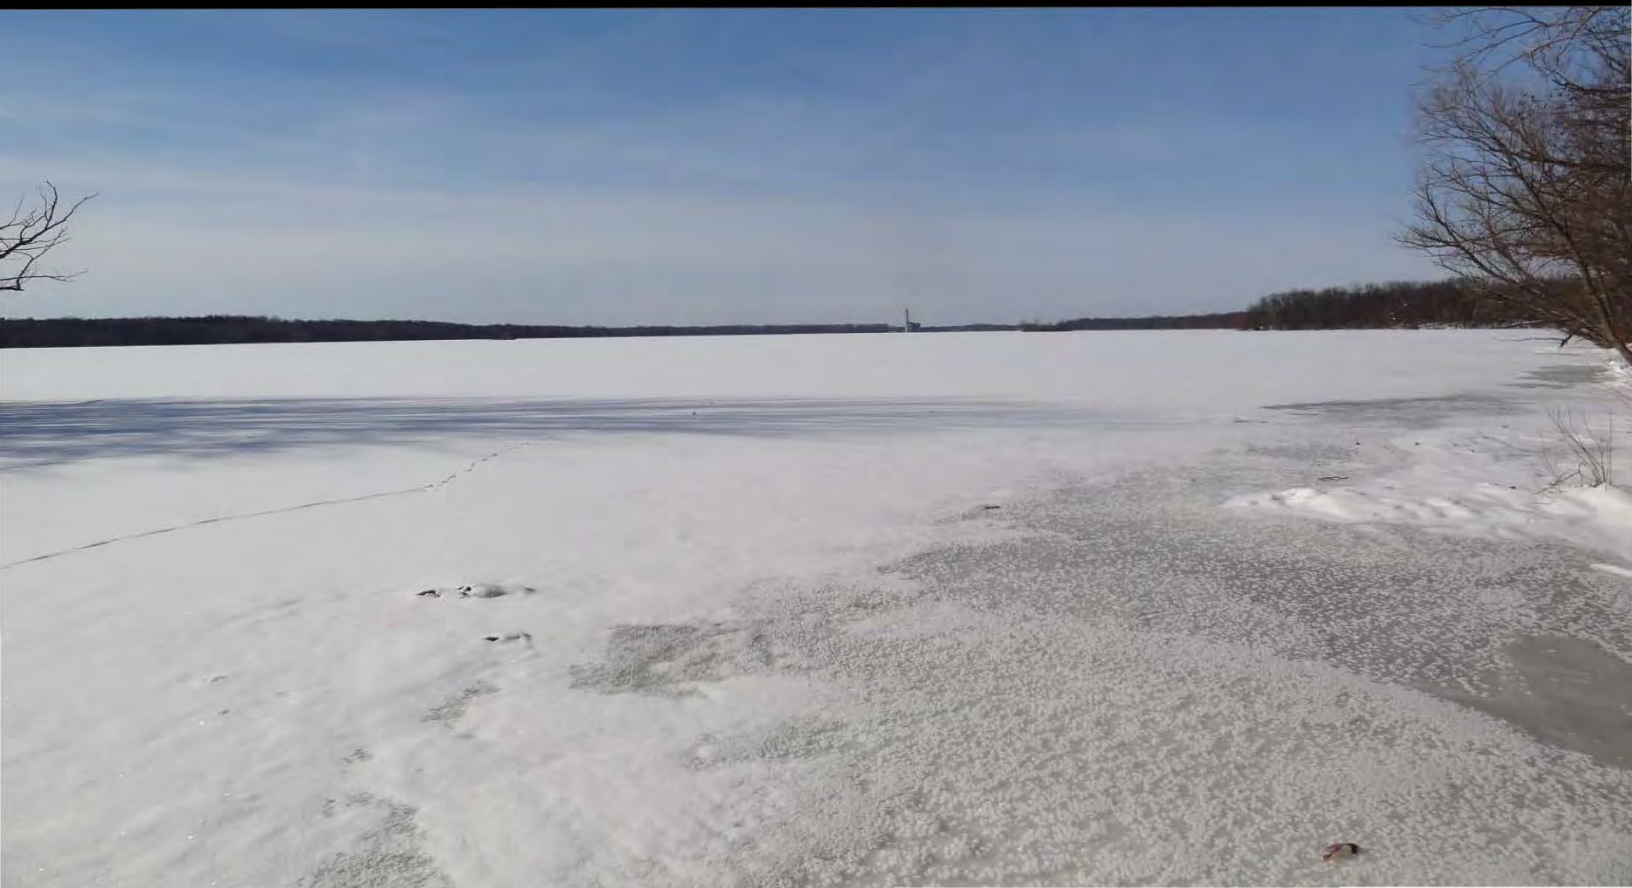
Morrow Lake

# River Icing Conditions

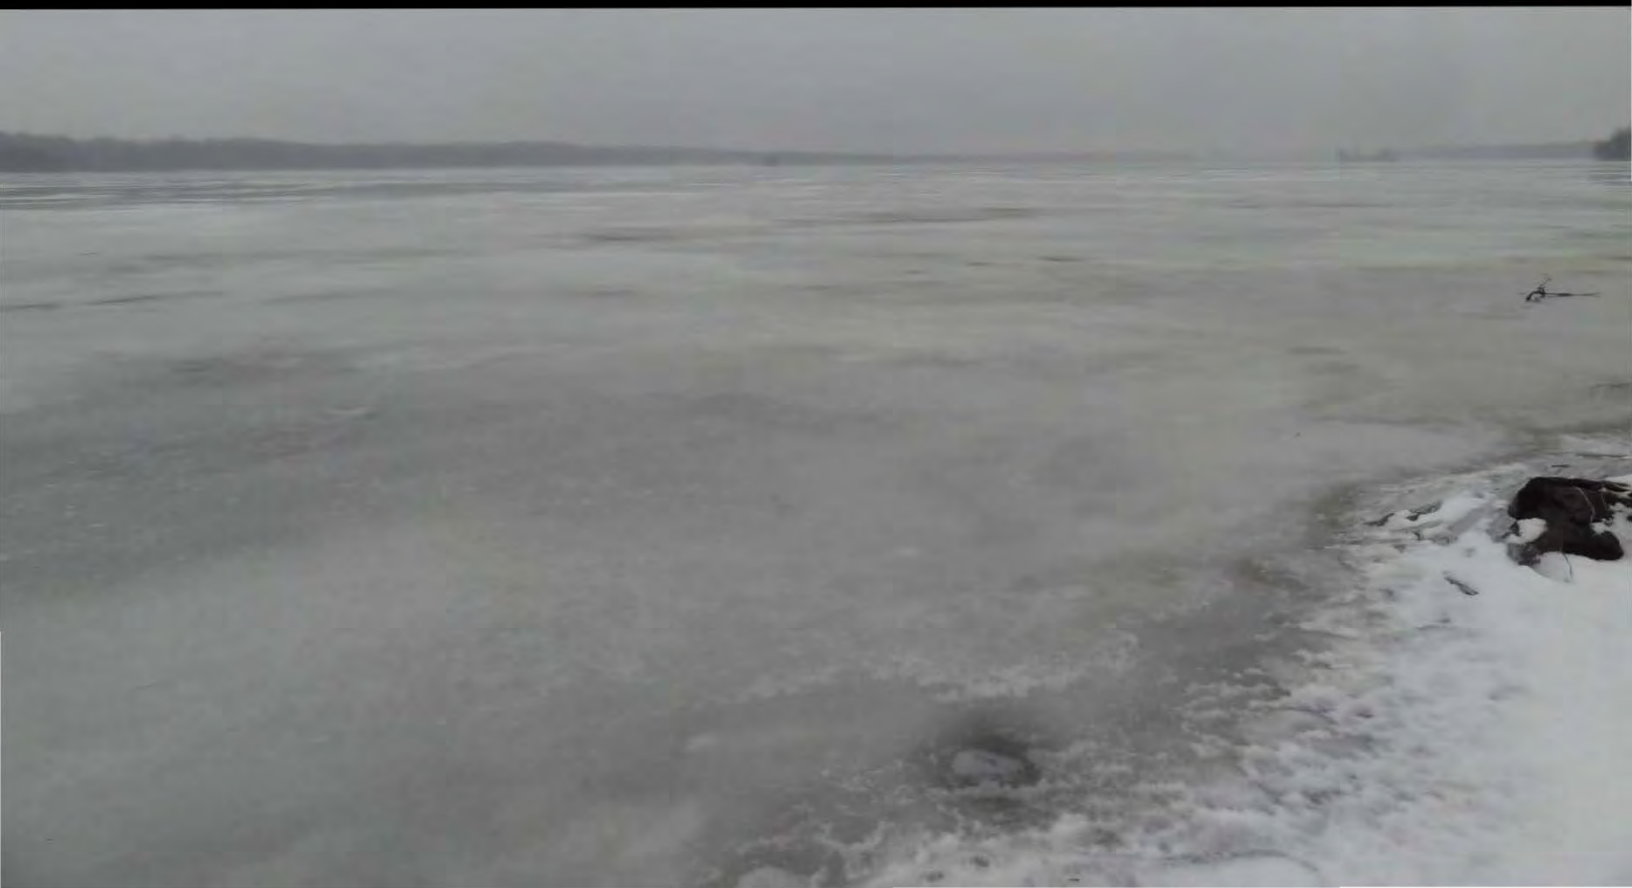
Morrow Lake

# River Icing Conditions
