Situation Photo Log

Thursday, January 31, 2013

Kalamazoo River / Enbridge Spill

Prepared by:
Karen Berez
START-USEPA
Situation Unit Leader

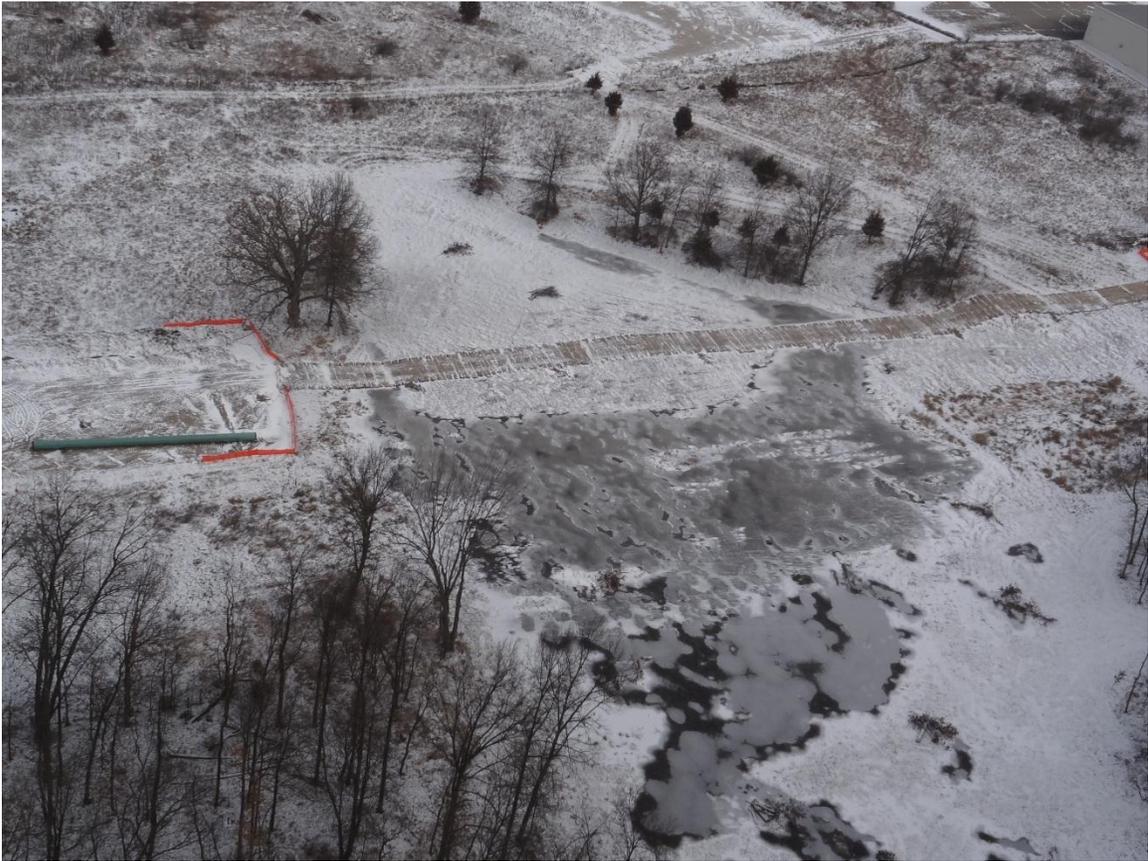
1. Source Area, observed frozen over.

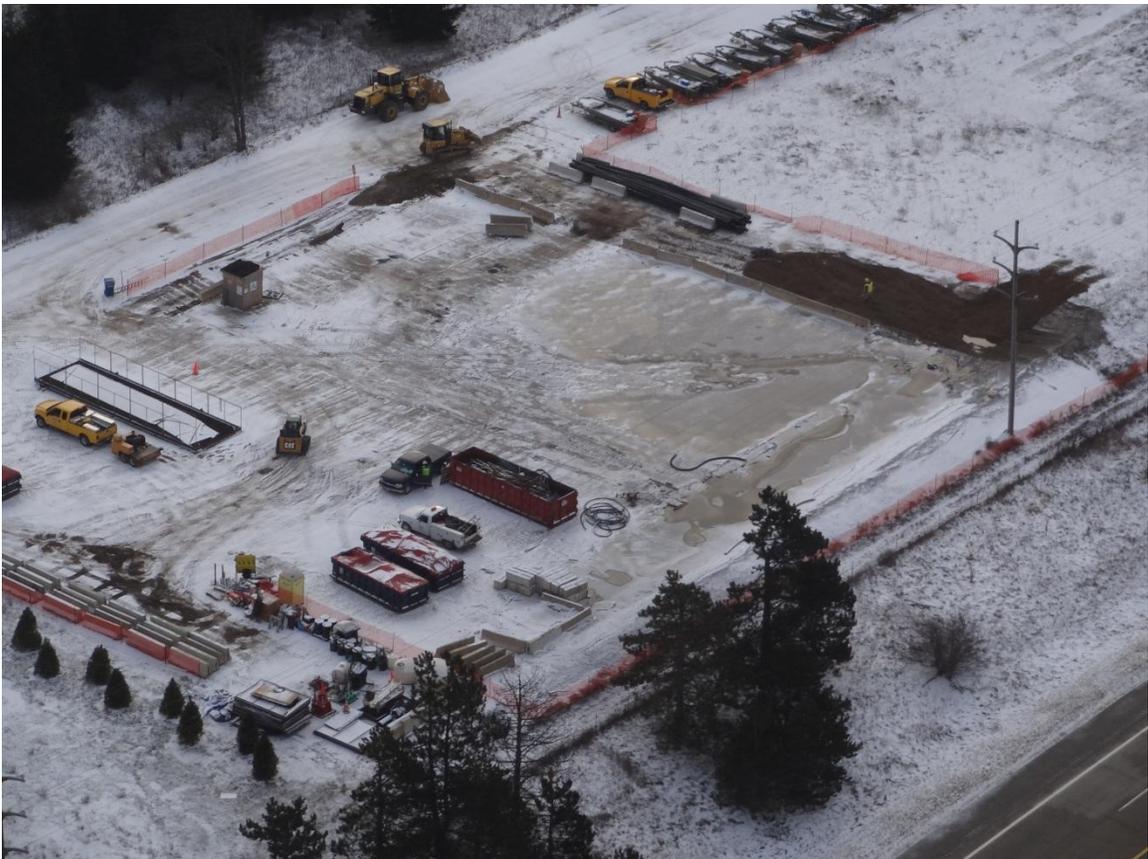
2. Frac Tank City observed Cells A/B cleared and grading/berm work.

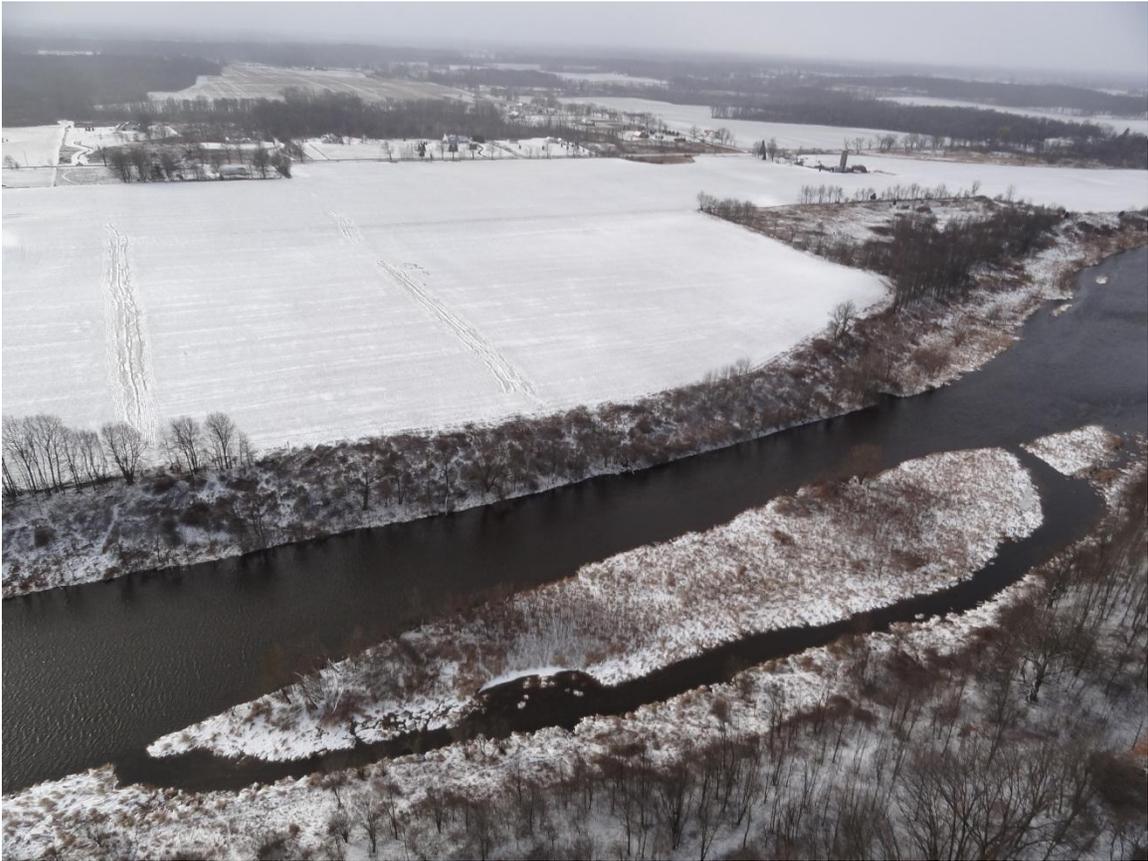
3. MP3.75 observed increased river level conditions.

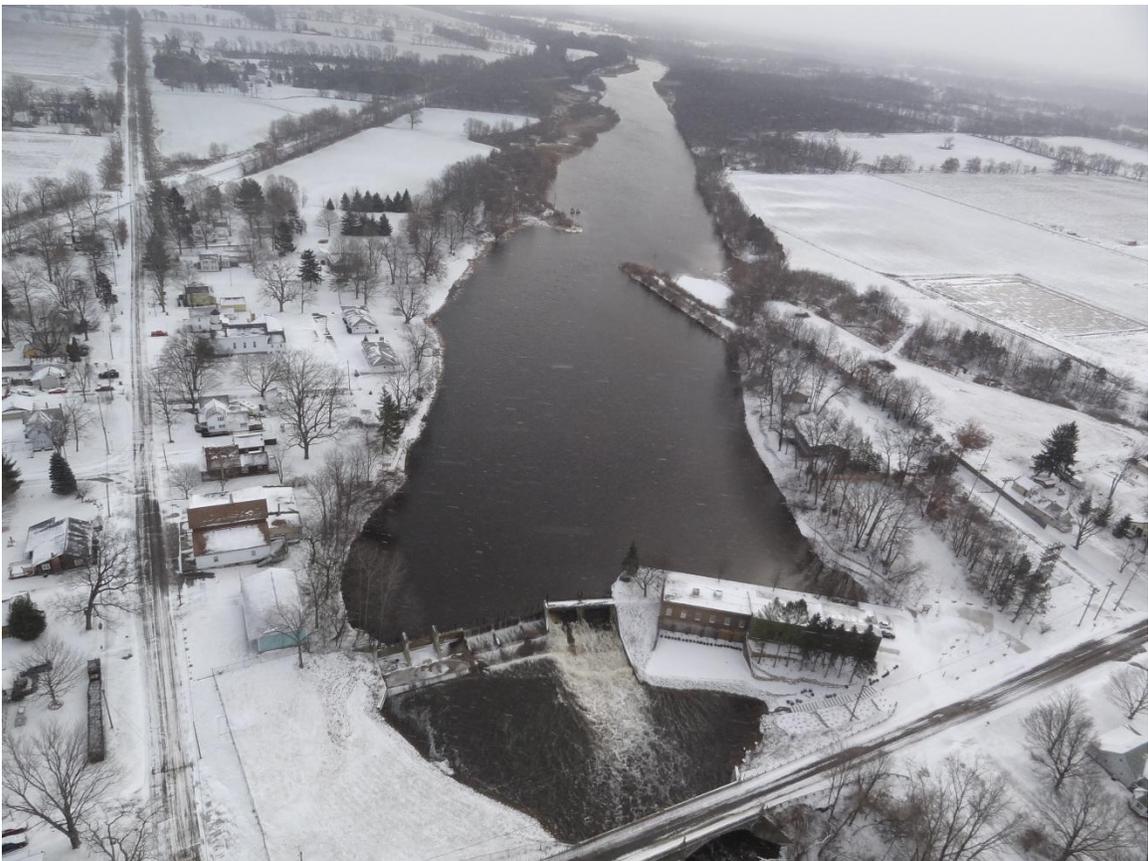
4. Ceresco Dam impoundment observed elevated river level.

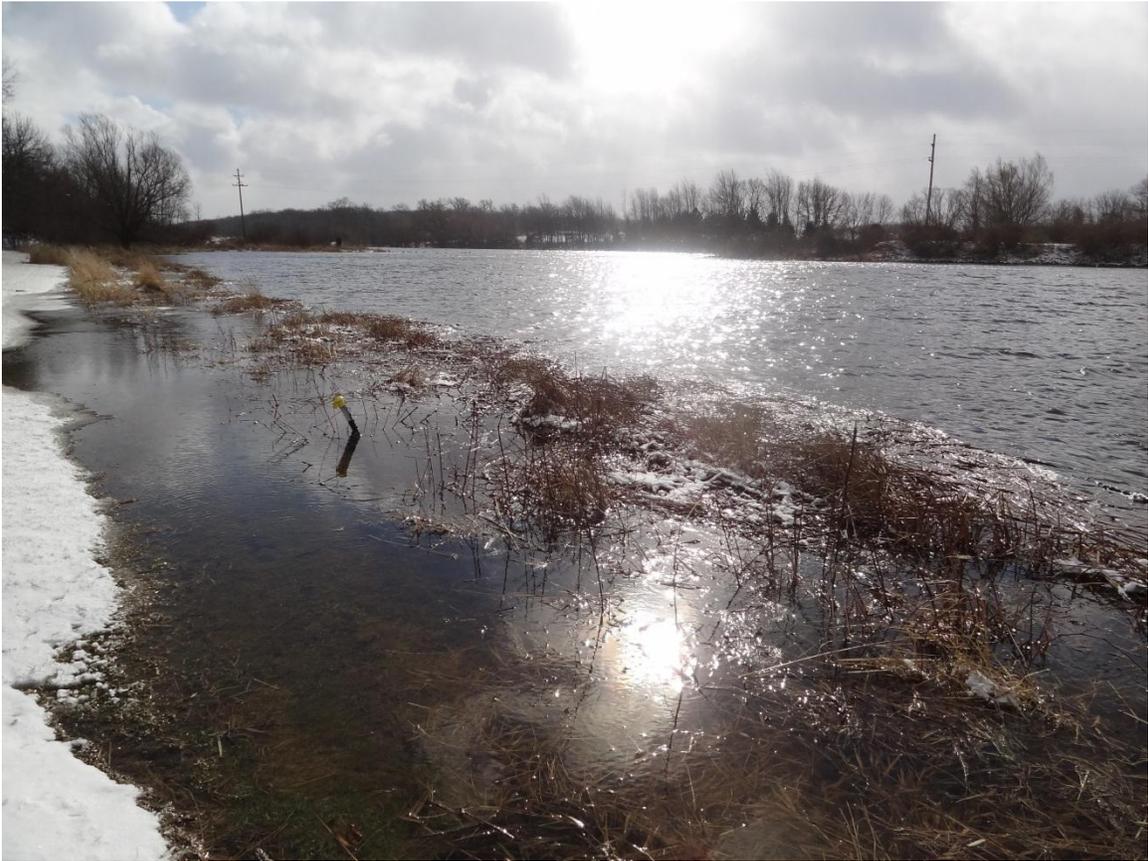
5. Ceresco Dam impoundment observed elevated river level along RDB.

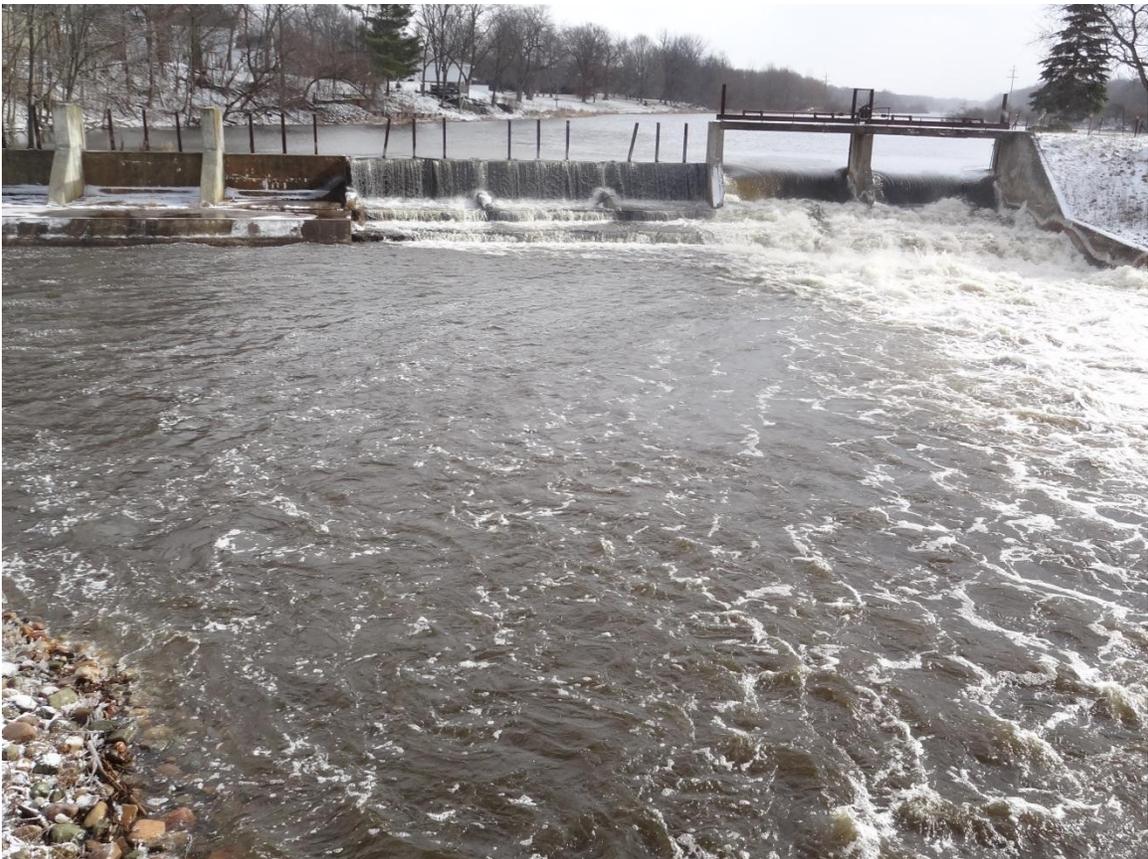
6. Ceresco Dam observed greater river flow over spillway.

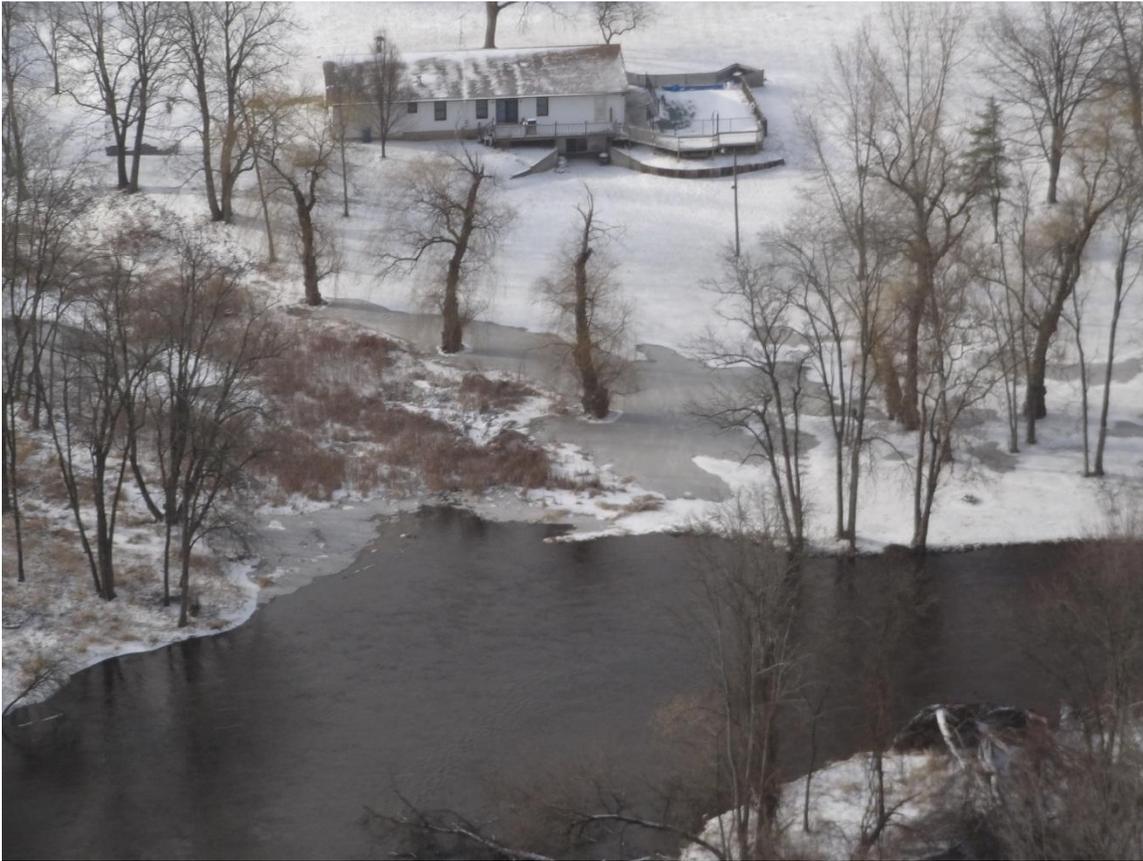
7. MP10.35 LDB observed increased river level conditions.

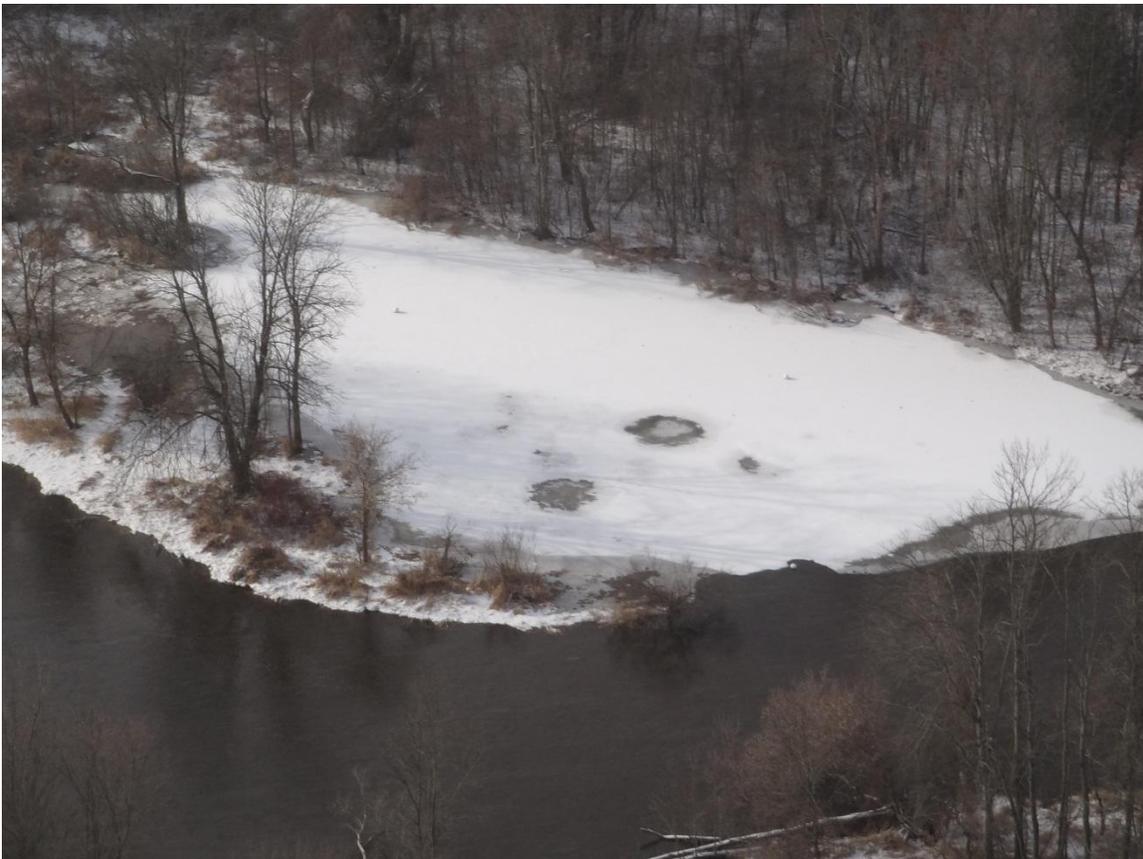
8. MP10.5 Sediment Trap ice conditions.

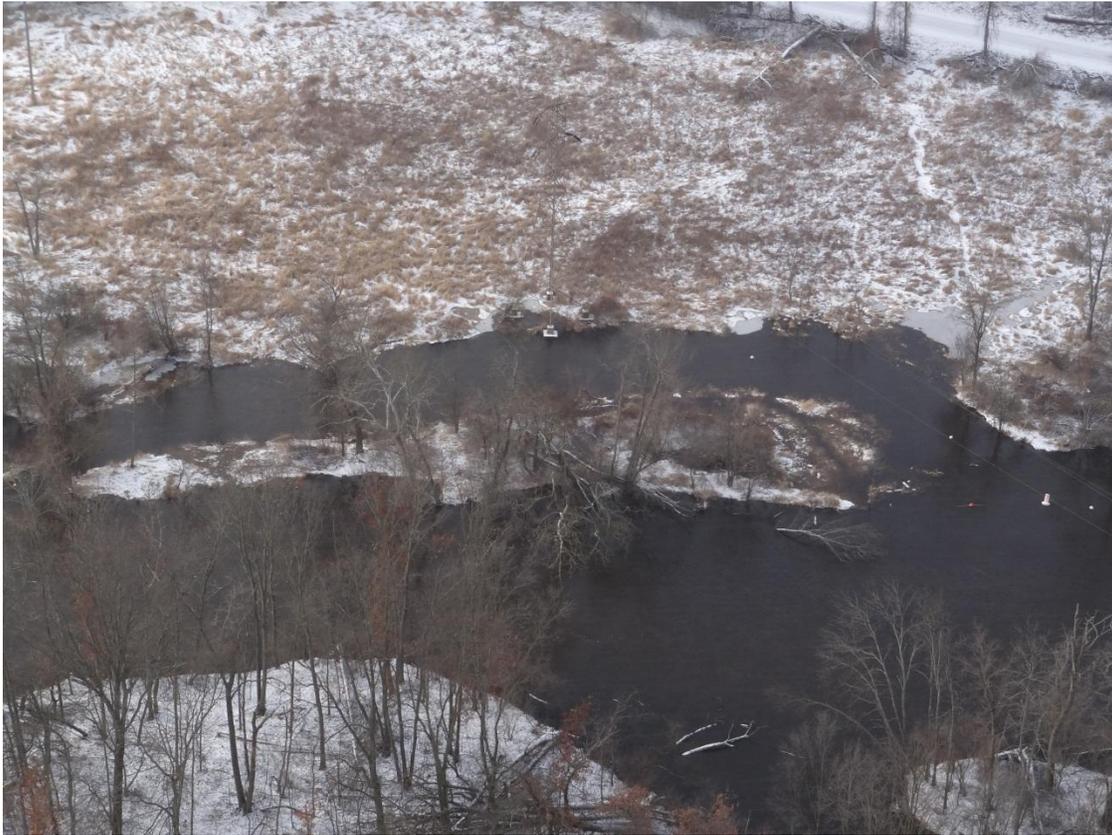
9. MP10.75 Sediment Trap observed increased river level conditions.

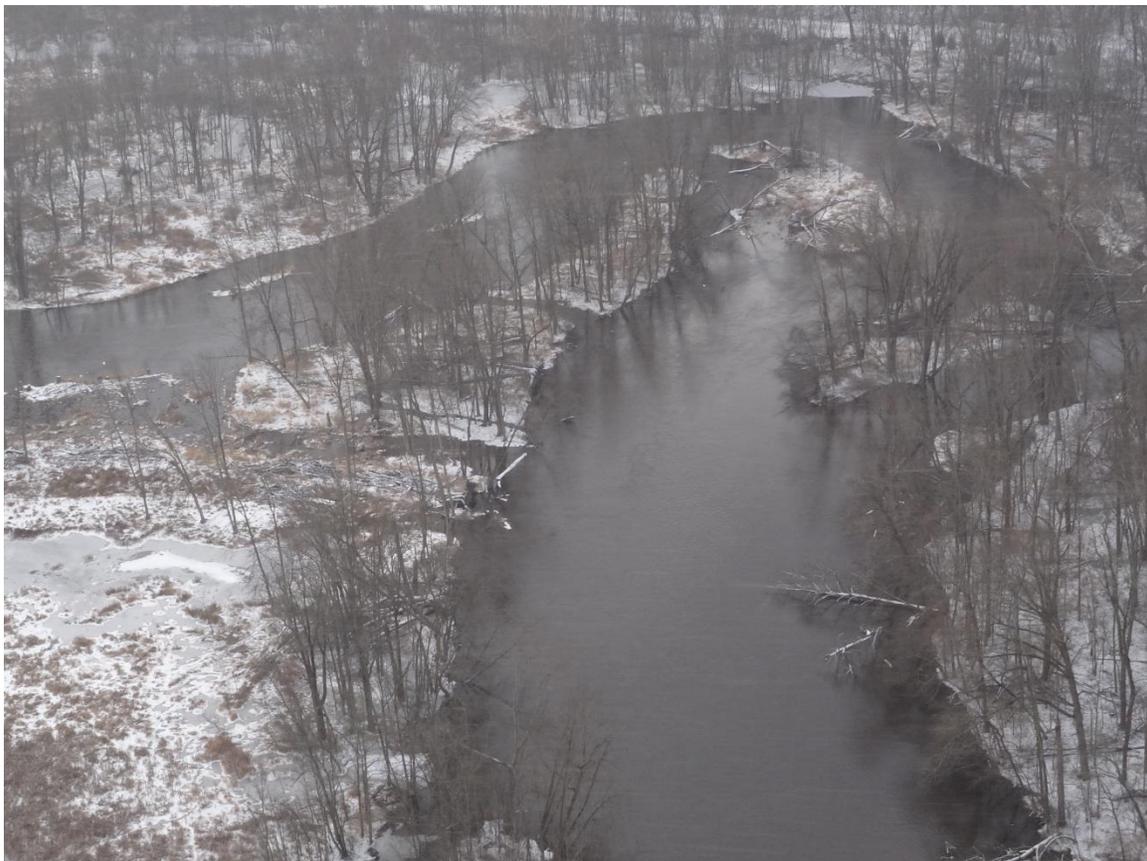
10. MP11.25 observed elevated river level conditions.

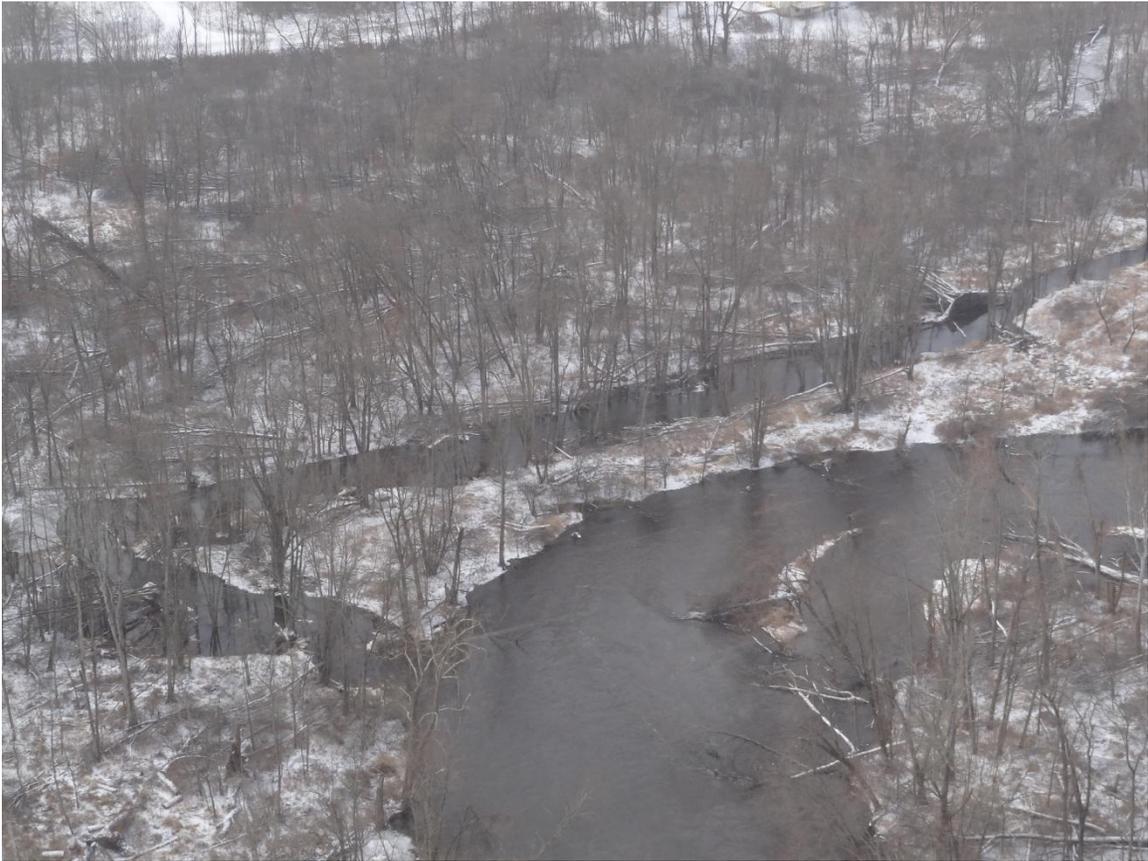
11. MP11.78 Sediment trap observed increased river level conditions.

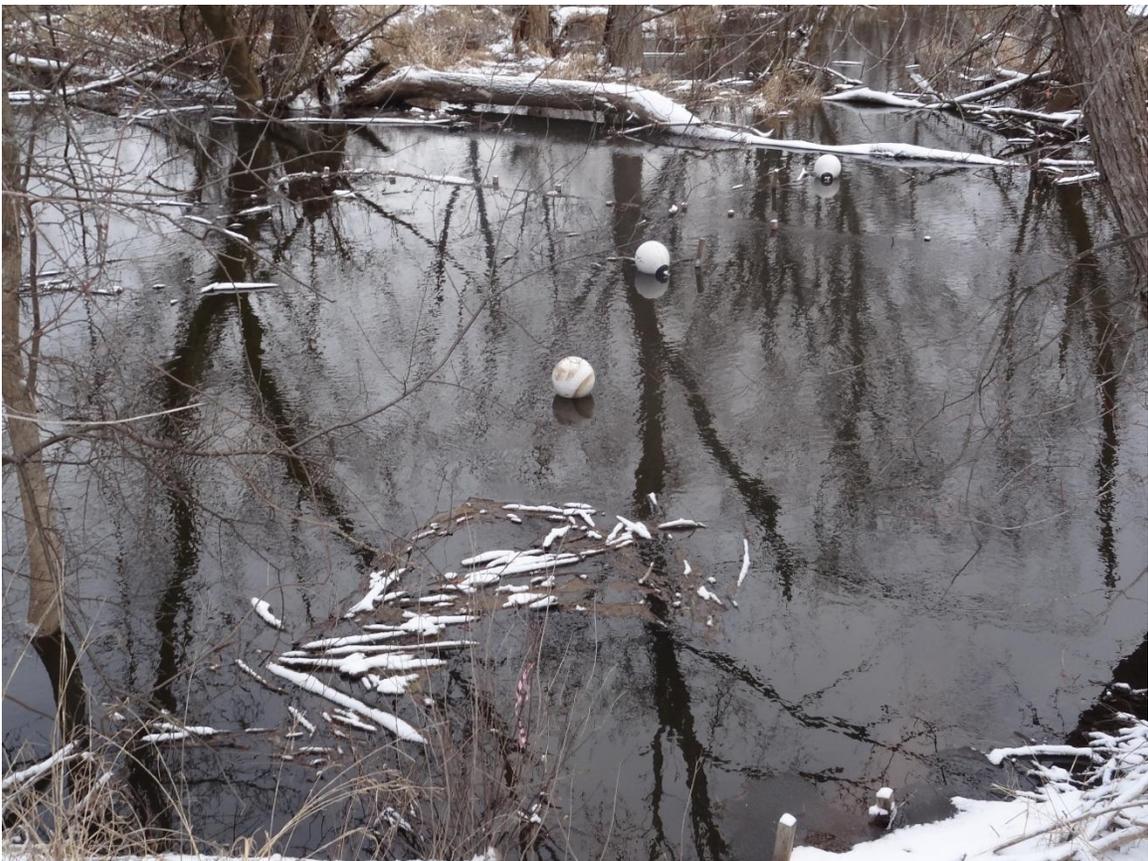
12. MP11.78 Sediment Trap observed increased river level conditions.

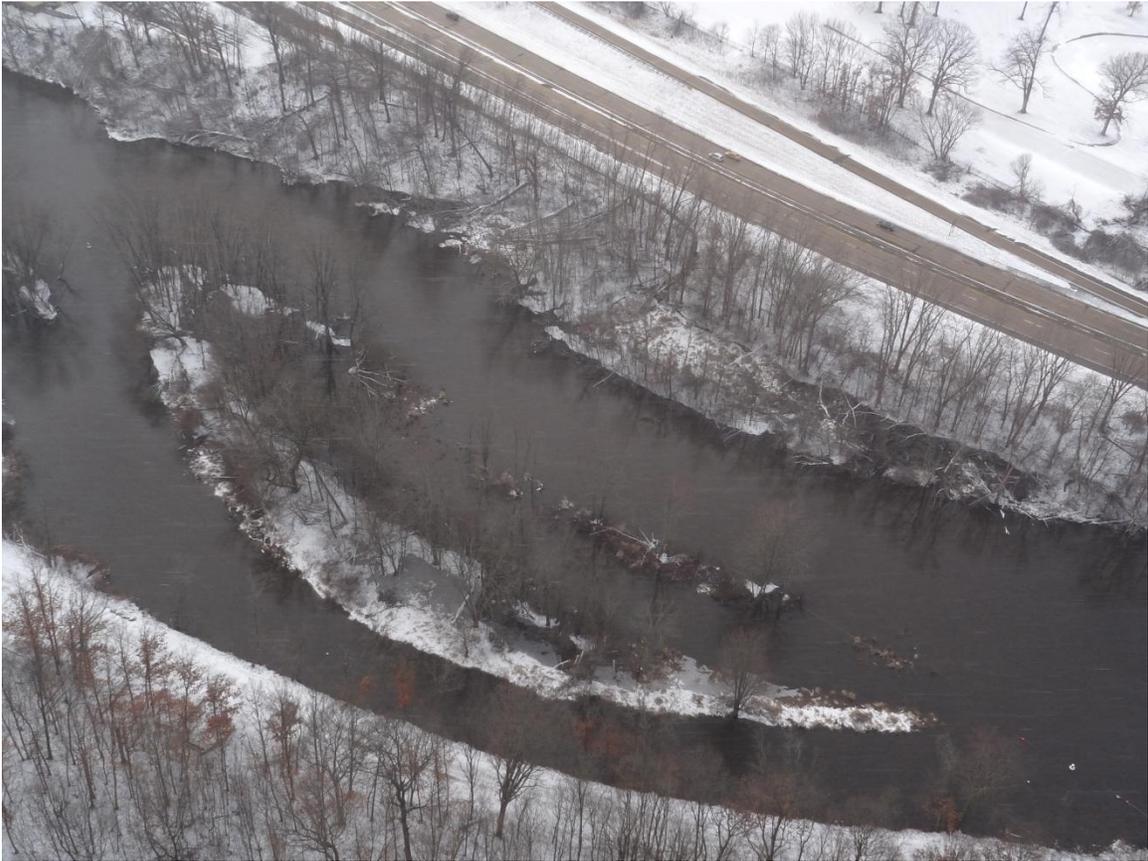
13. MP14.75 Sediment Trap observed increased river level conditions.

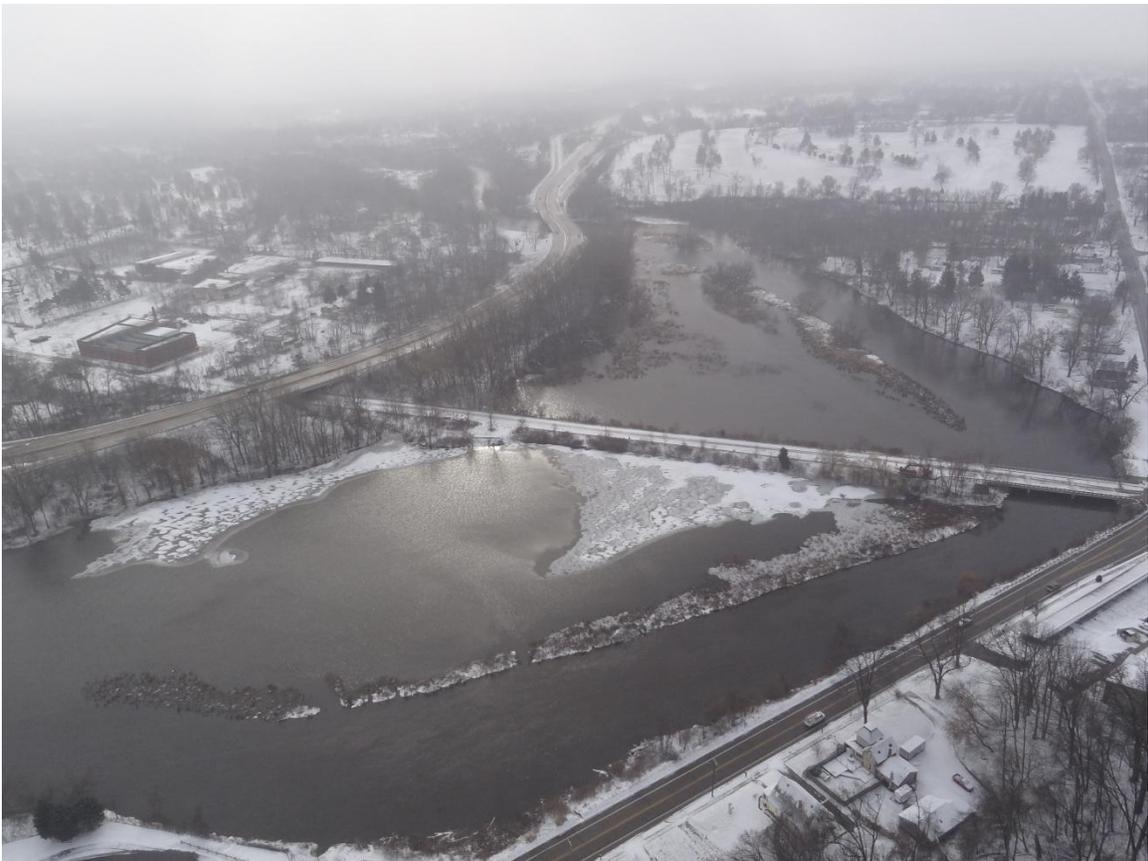
14. Observed elevated river level at the Mill Ponds.

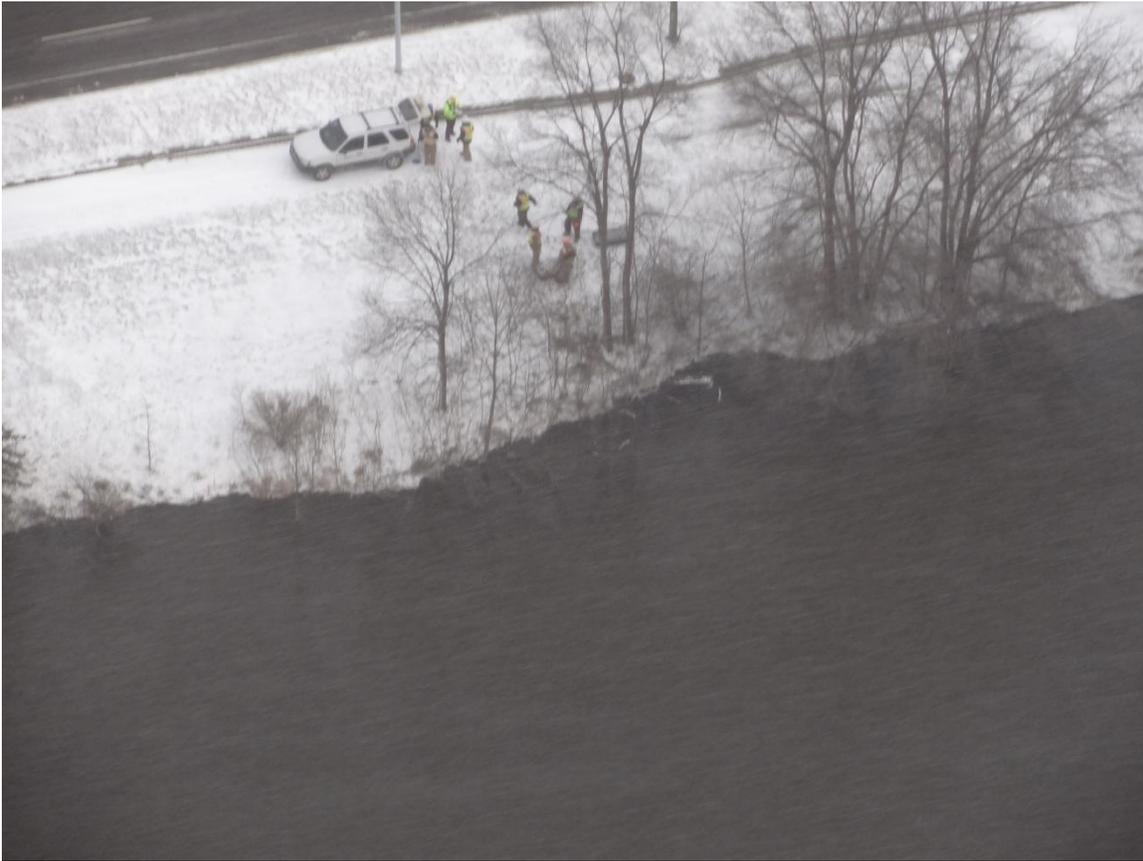
15. MP17.25 RDB observed the RI Crew.

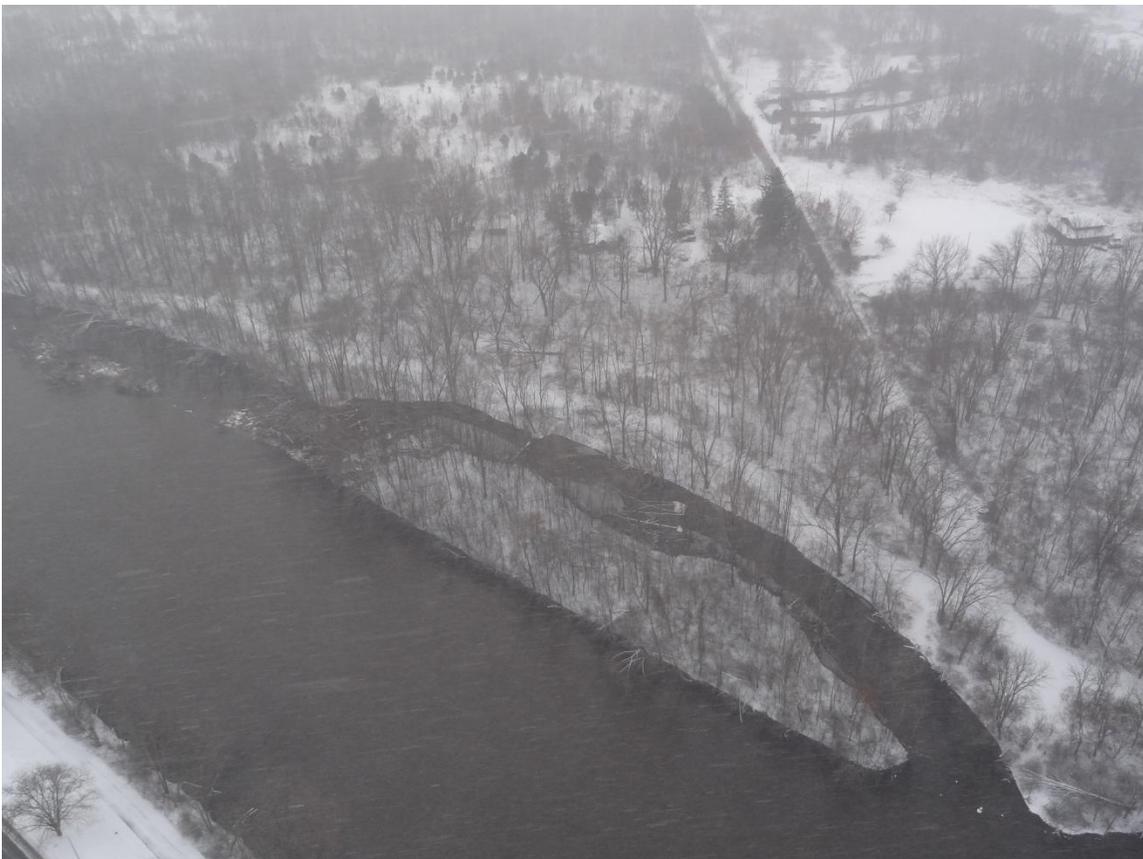
16. MP19.25 Sediment Trap observed increased river level conditions.

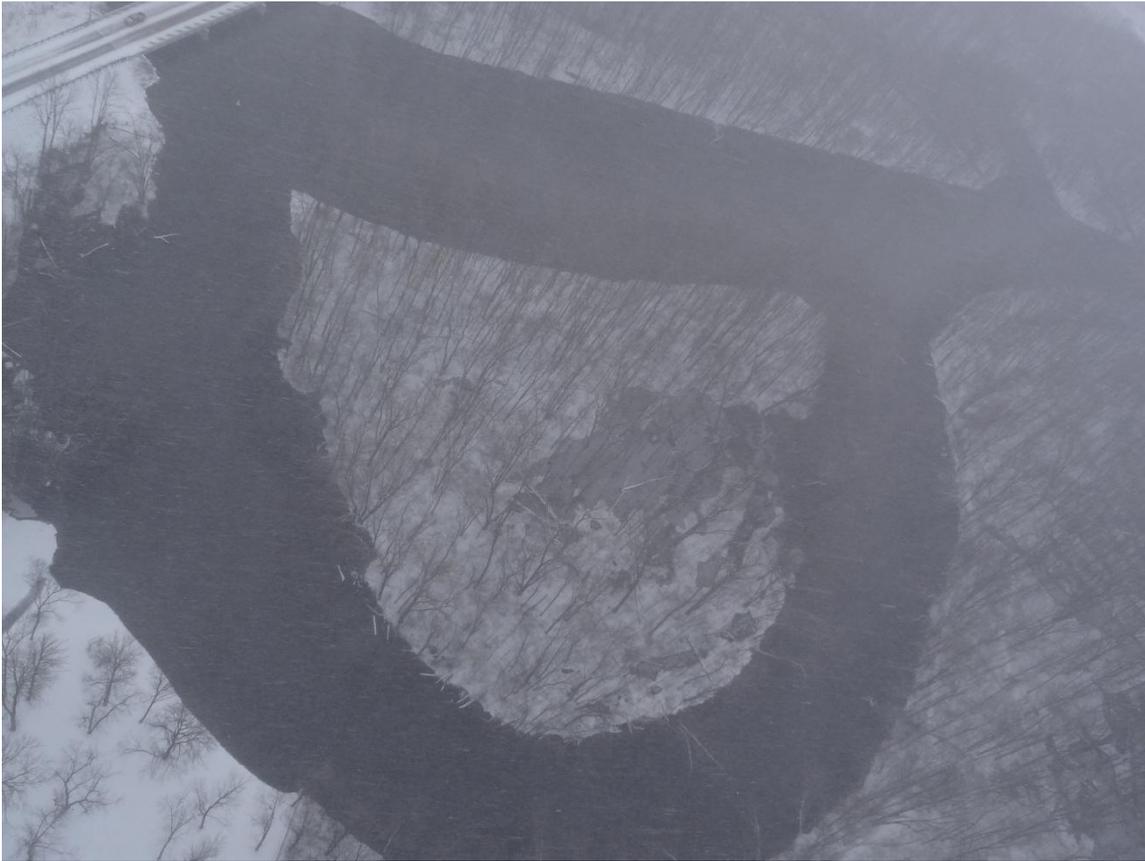
17. MP21.5 Sediment Trap observed increased river level conditions.

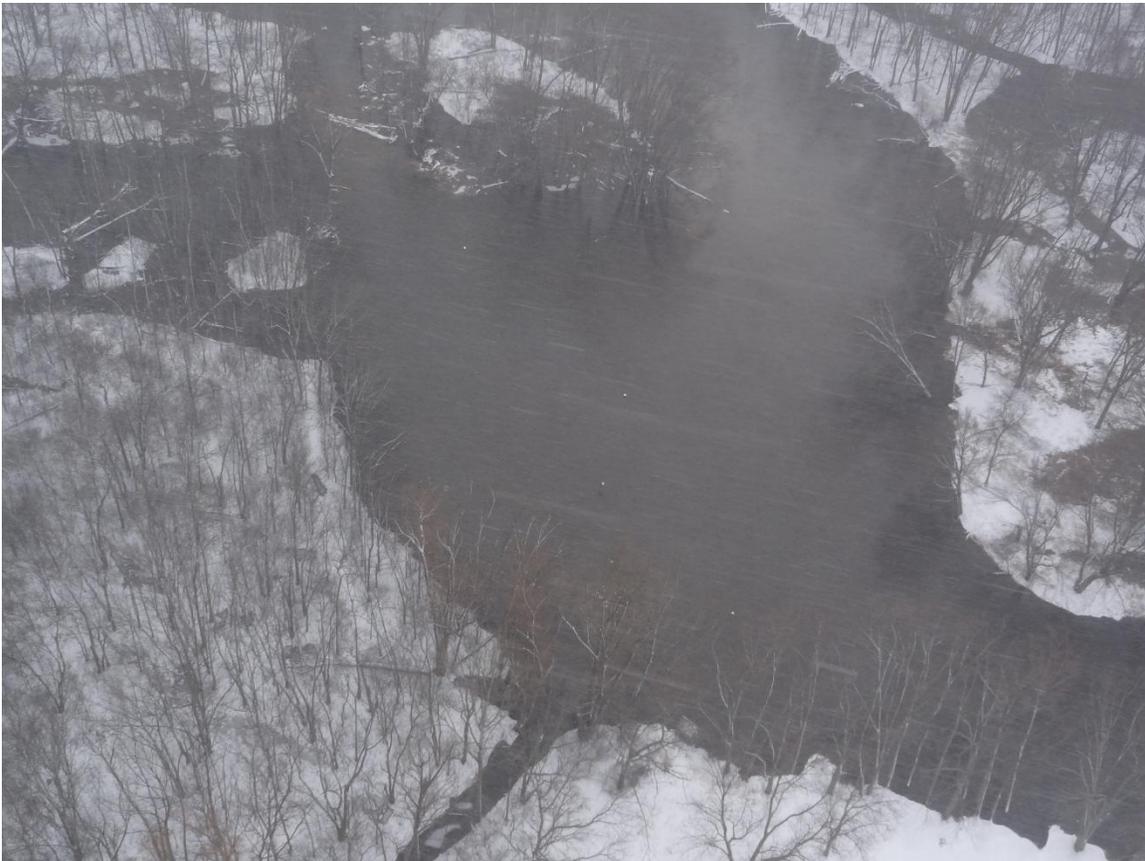
18. MP26.0 Sediment Trap observed increased river level conditions.

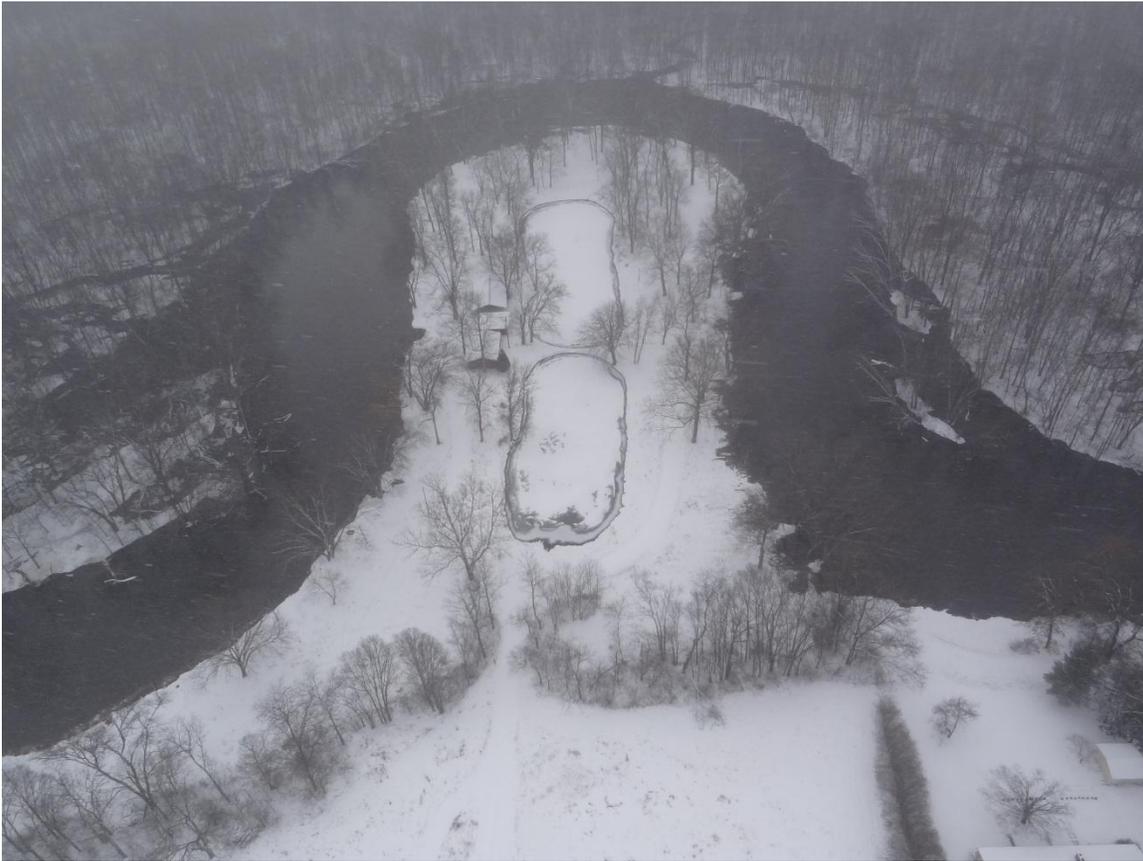
19. MP27.00 Shady Bend Campground observed increased river level conditions.

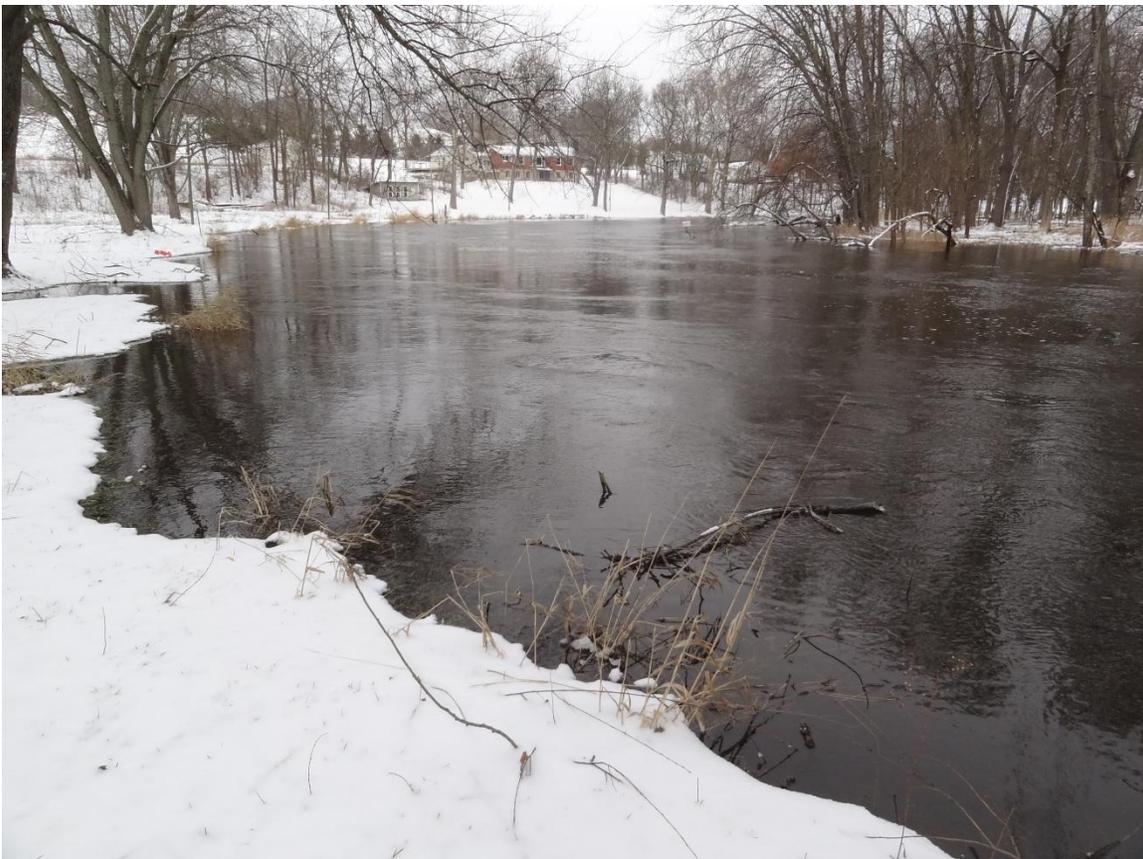
20. MP27.00 Shady Bend Campground observed elevated river level conditions.

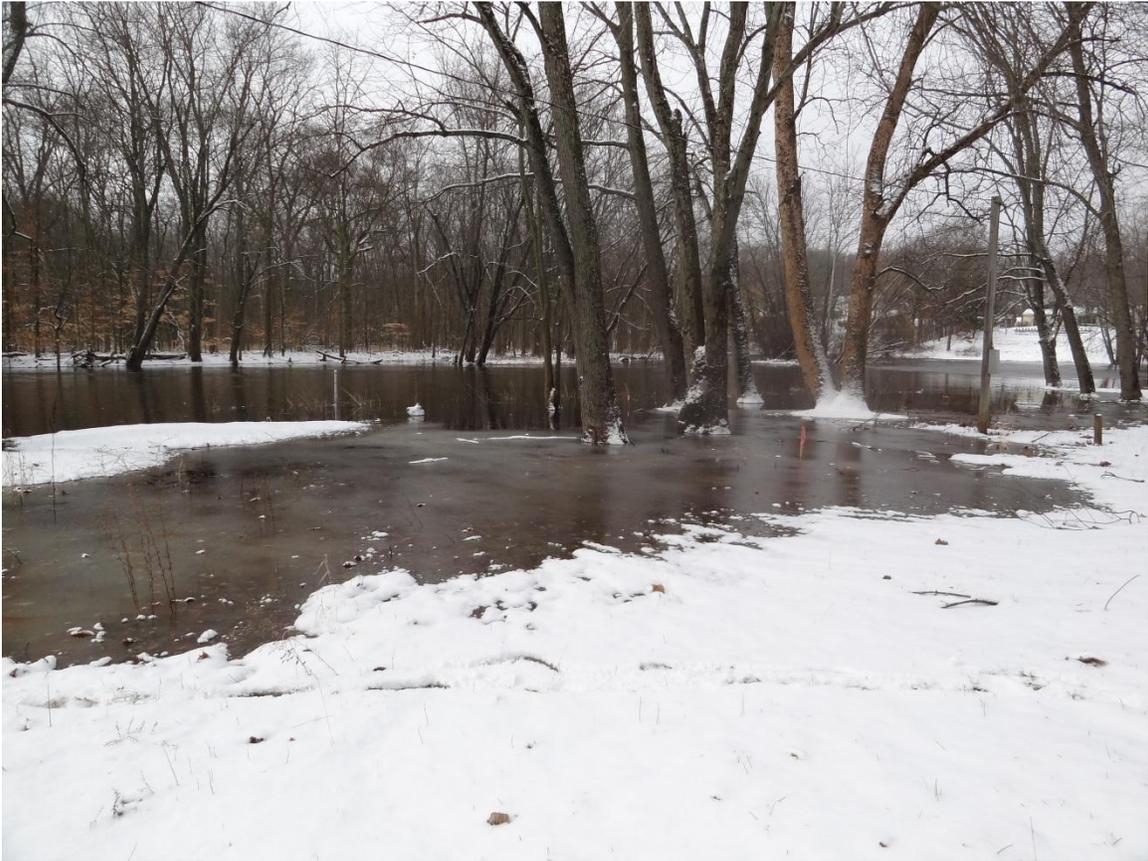
21. MP27.00 Shady Bend Campground observed elevated river level conditions.

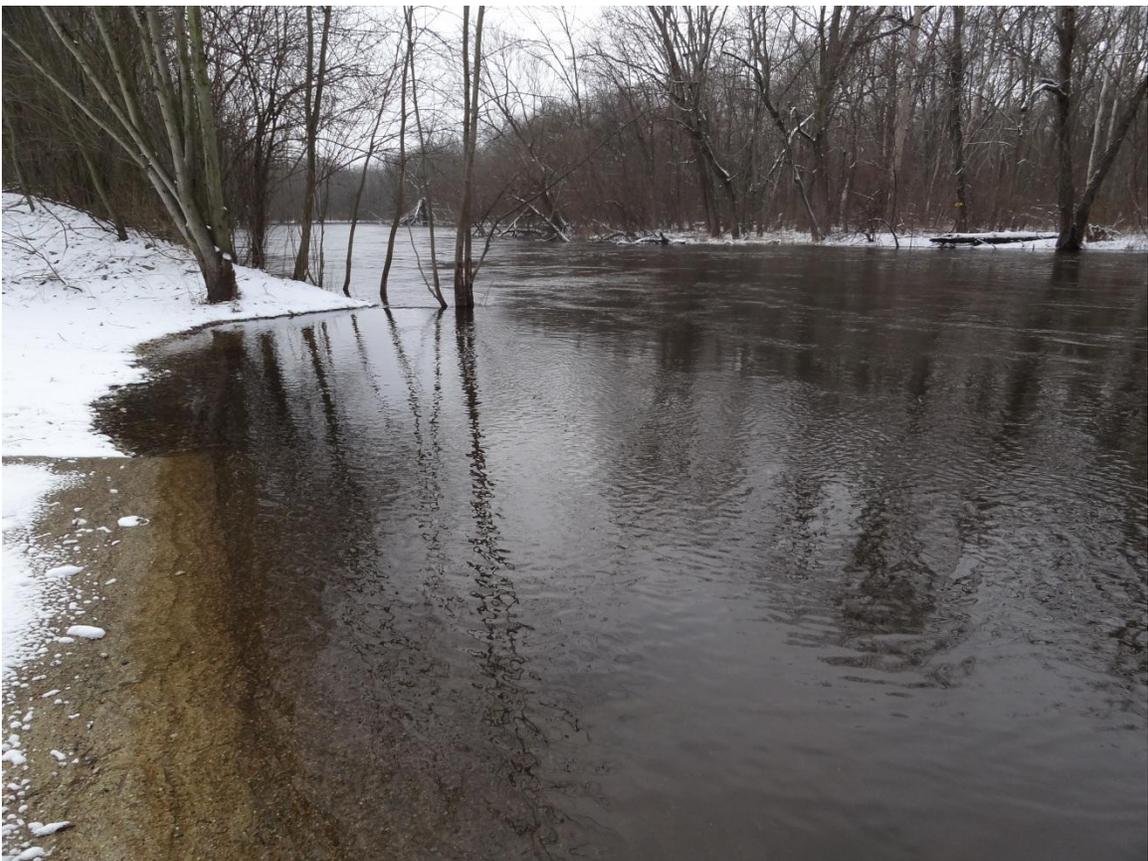
22. E2 Boat Launch observed elevated river level conditions.

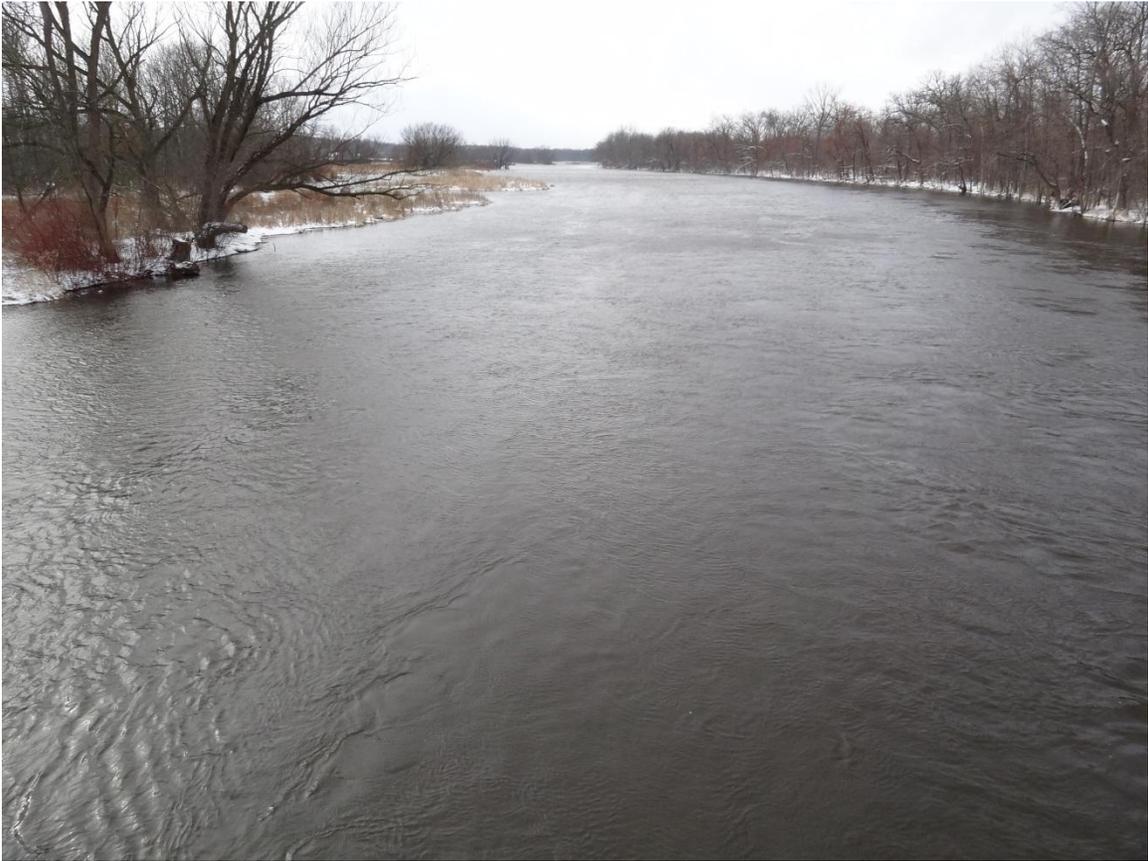
23. MP36.50 observed river conditions entering Morrow Lake Delta.
