Situation Photo Log

Thursday, January 31, 2013

Kalamazoo River / Enbridge Spill

Prepared by:
Karen Berez
START-USEPA
Situation Unit Leader

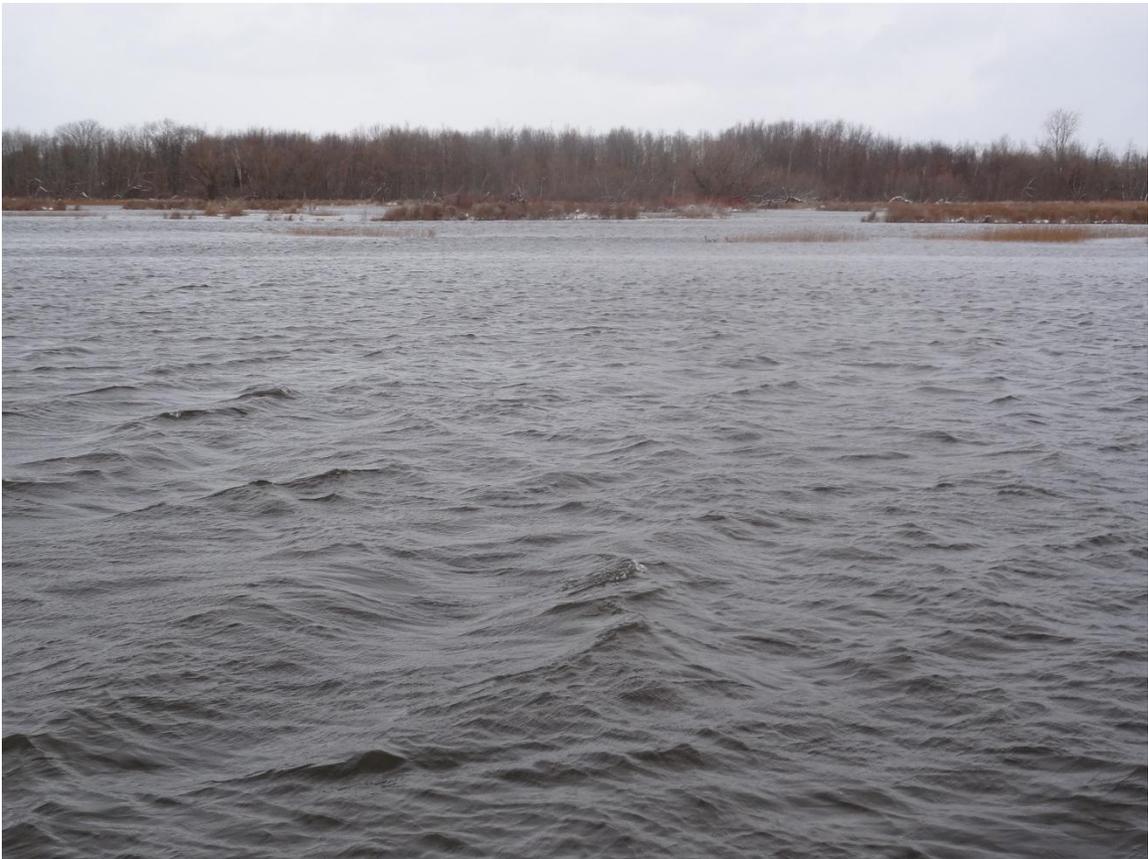
24. Morrow Lake Delta no ice observed.

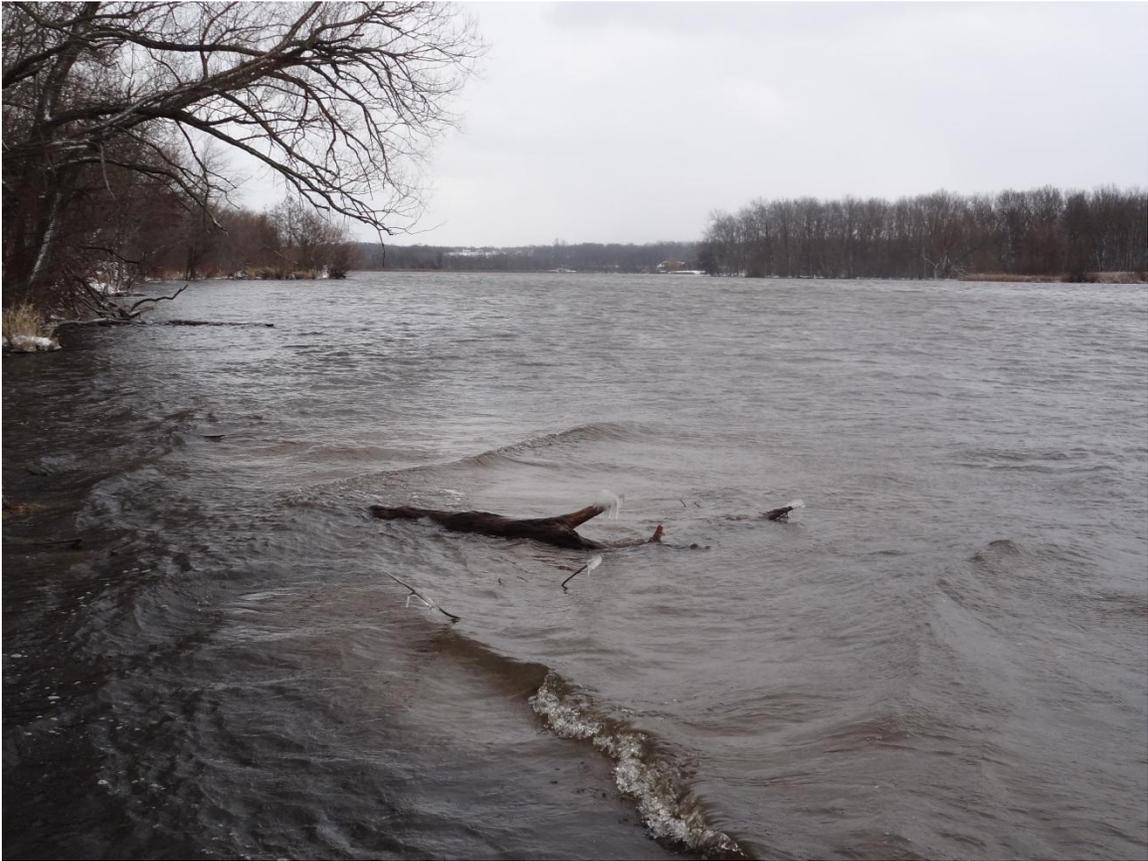
25. Morrow Lake Neck/Morrow Lake Delta observed slight increase in lake level.

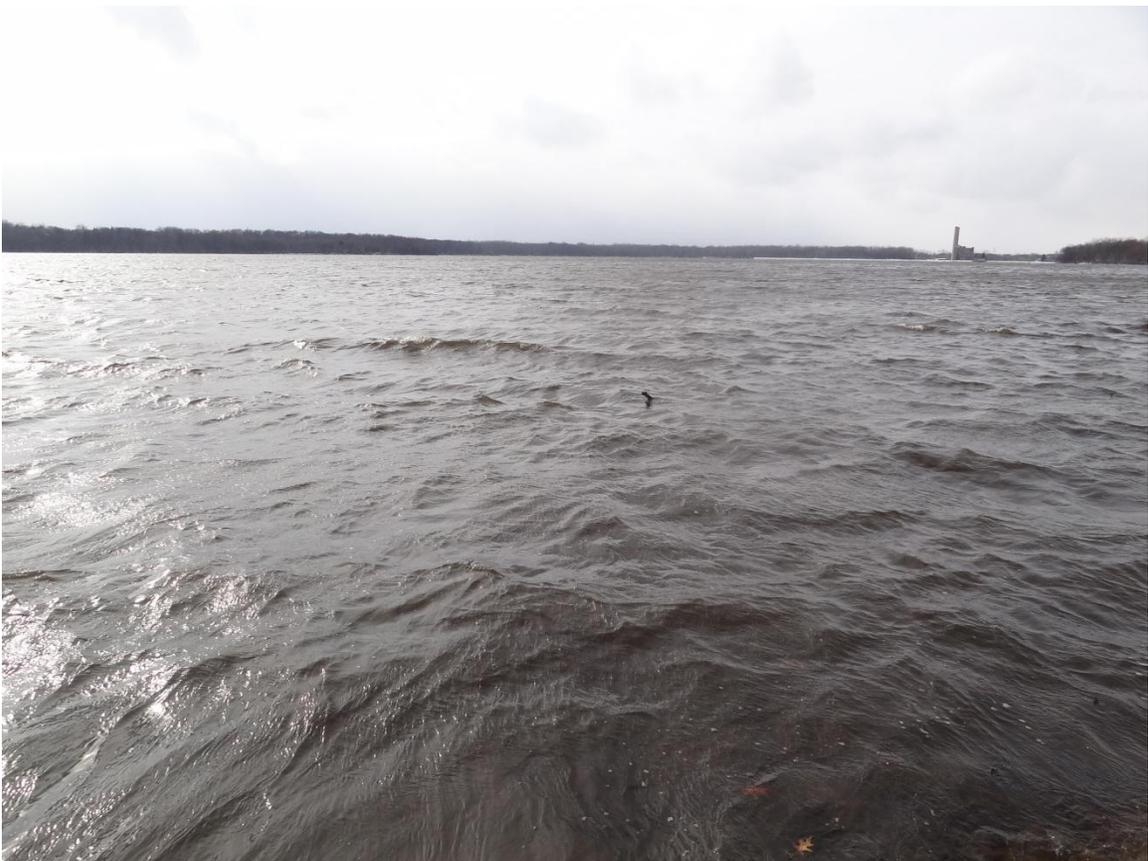
26. Morrow Lake observed slight increase in lake level.
