Situation Photo Log

Saturday, February 2, 2013

Kalamazoo River / Enbridge Spill

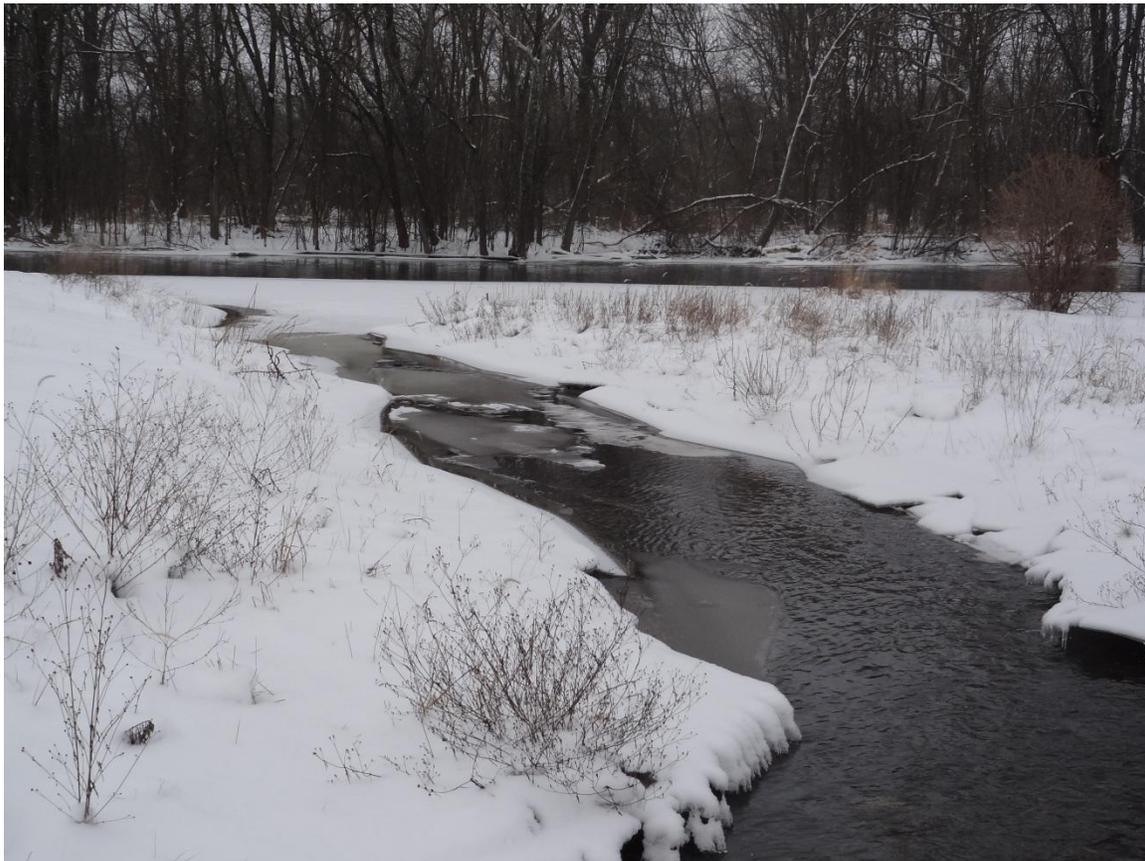
1. Talmadge Creek flowing to confluence observed icing conditions.

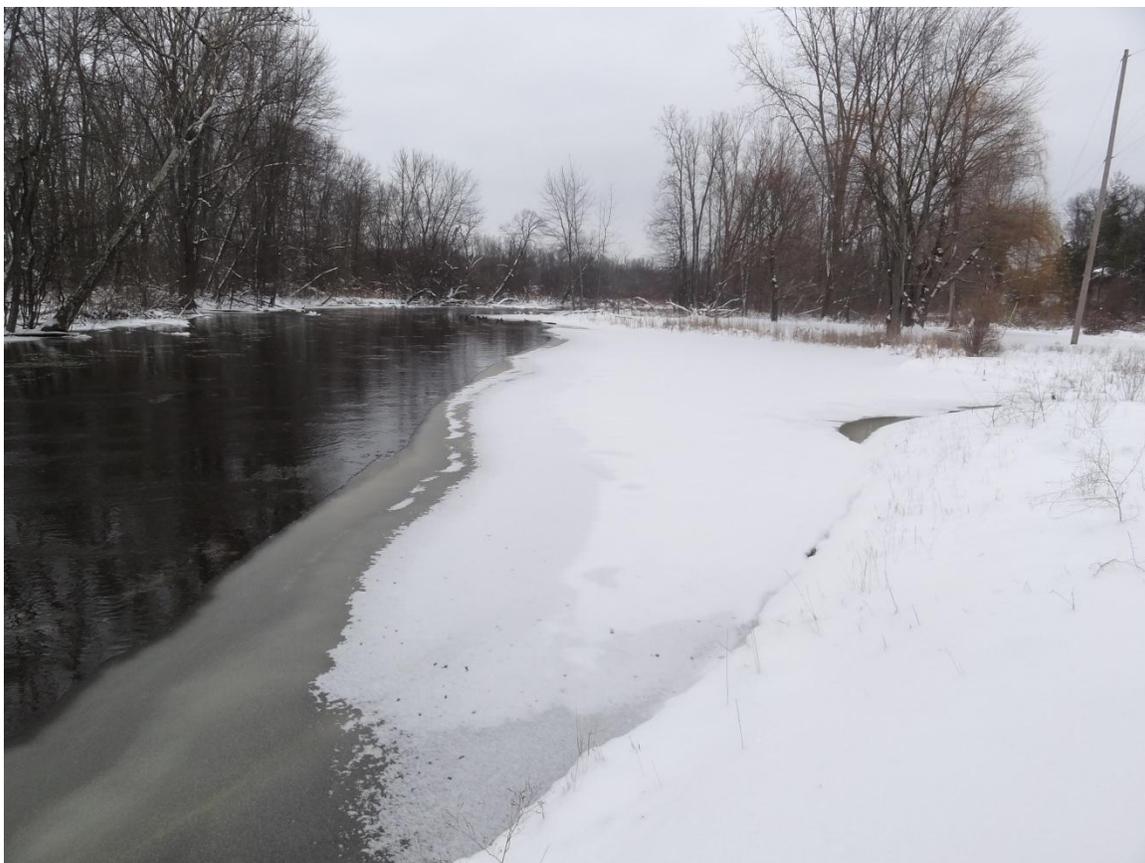
2. Confluence observed icing conditions.

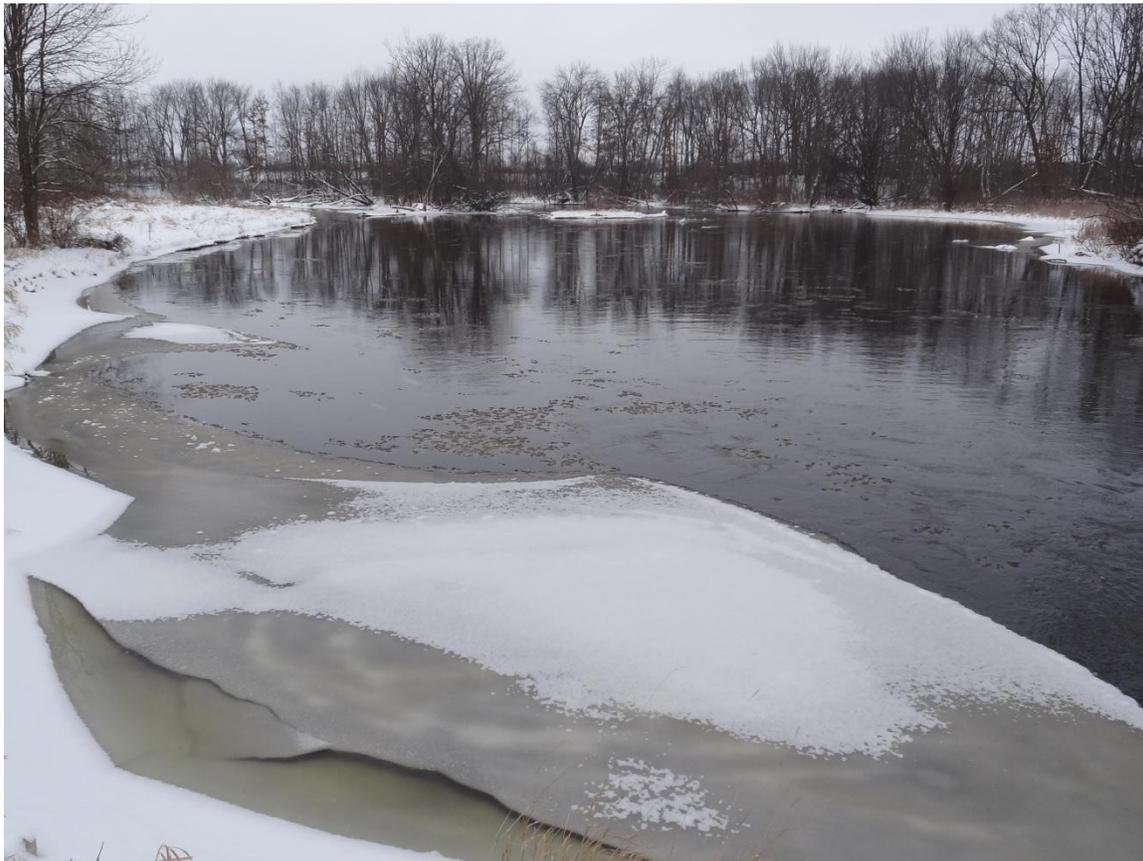
3. MP2.25 observed river icing conditions.

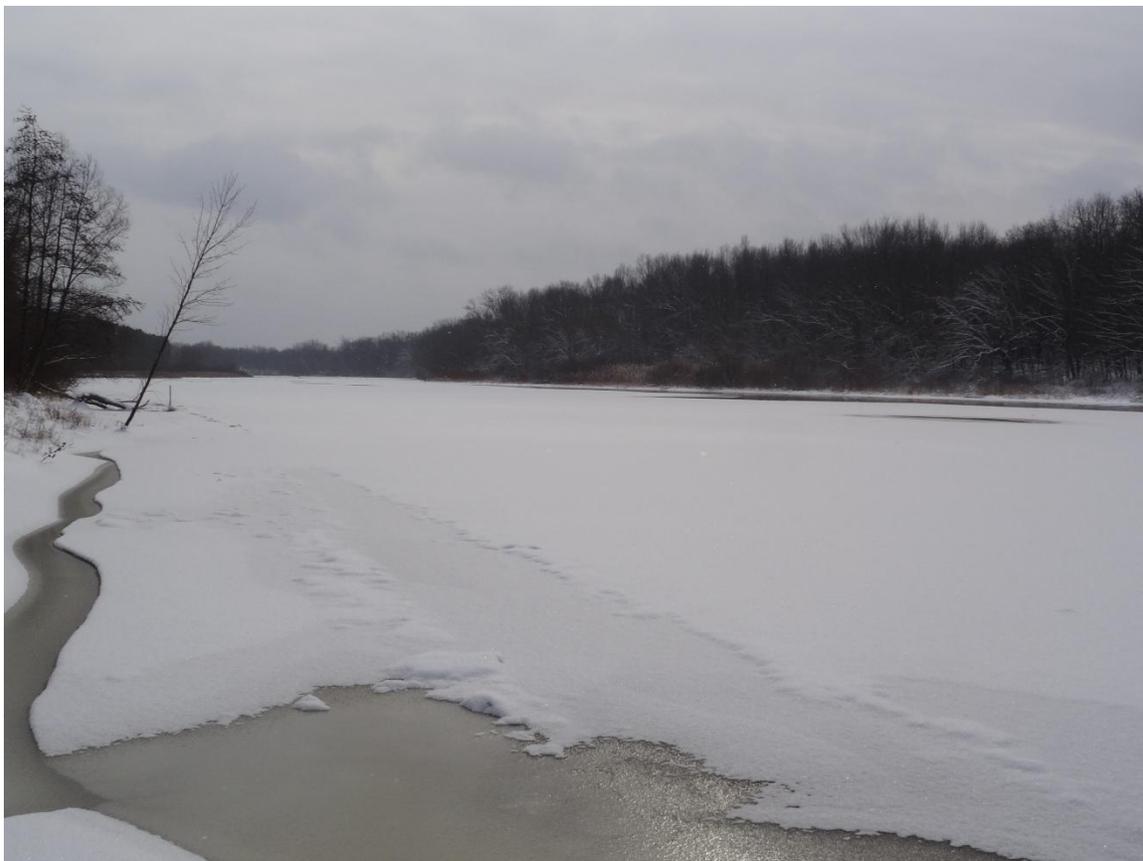
4. C0.4 Boat Launch observed river icing conditions.

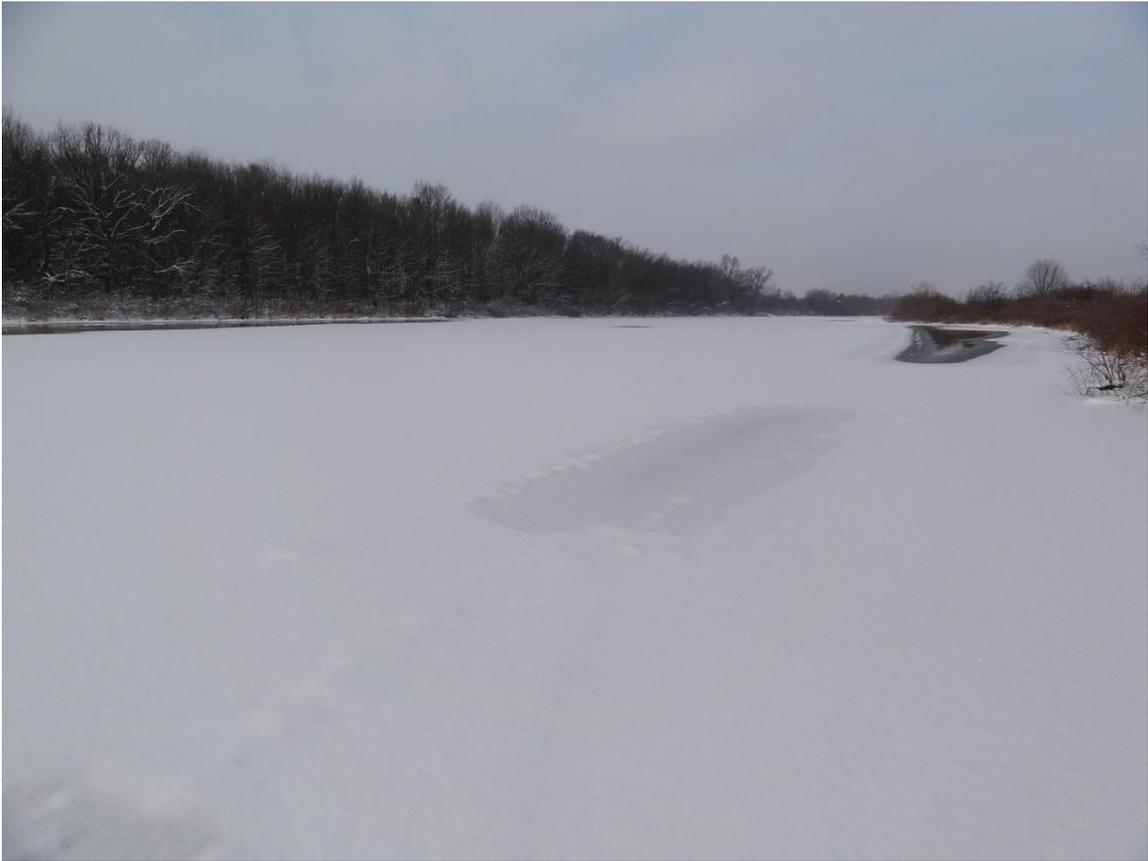
5. C0.4 Boat Launch observed river icing conditions.

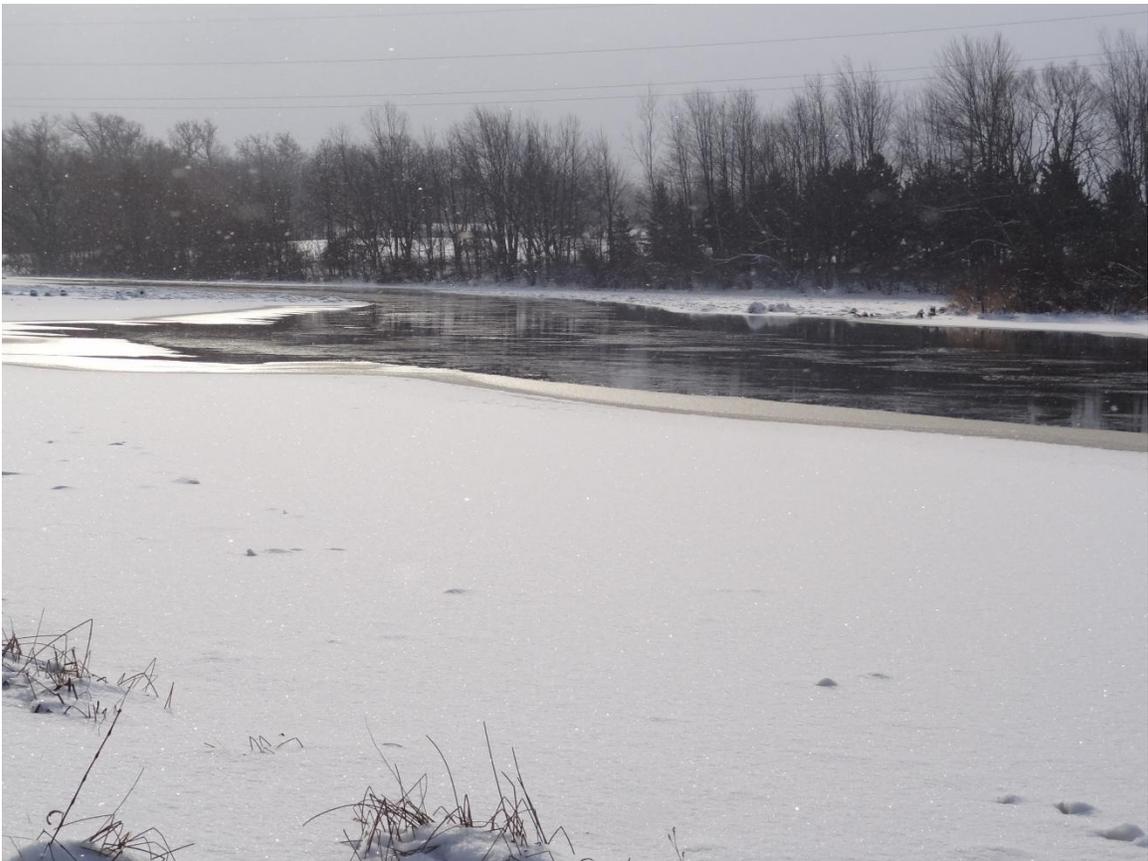
6. Ceresco Dam impoundment observed river icing conditions.

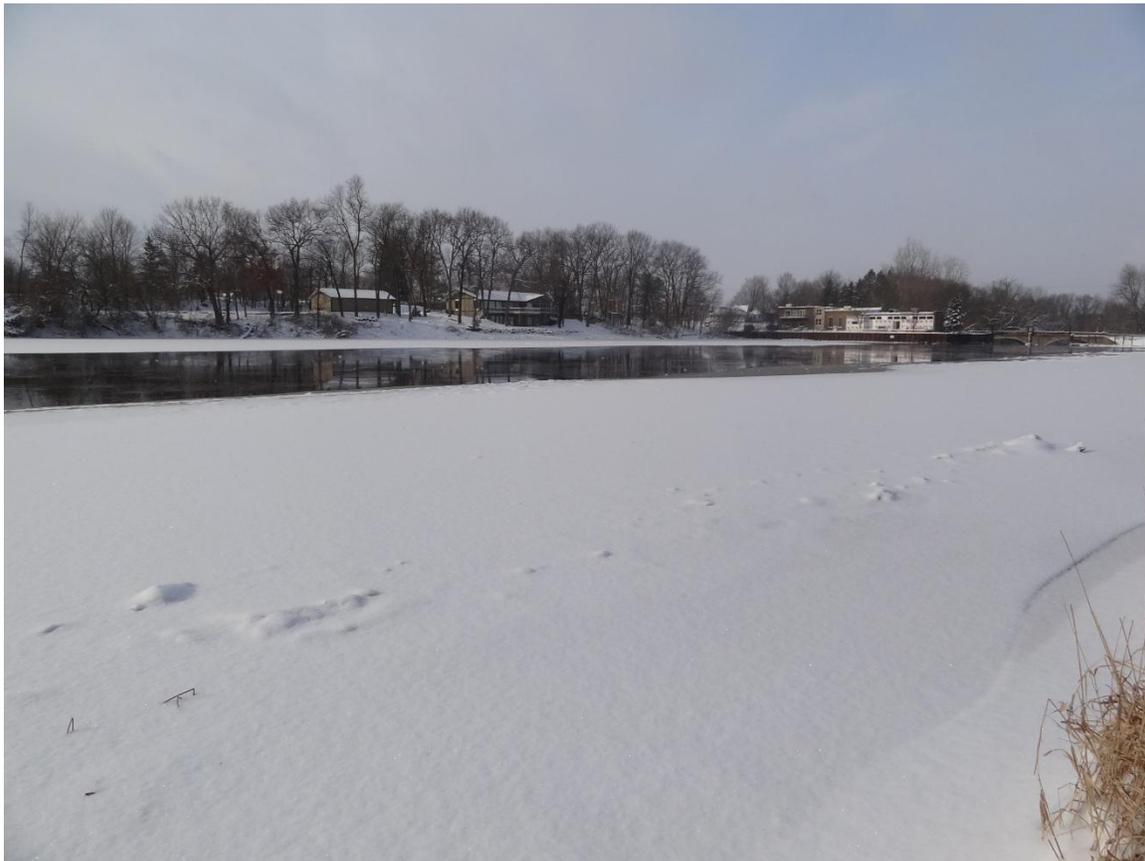
7. Ceresco Dam impoundment observed river icing conditions.

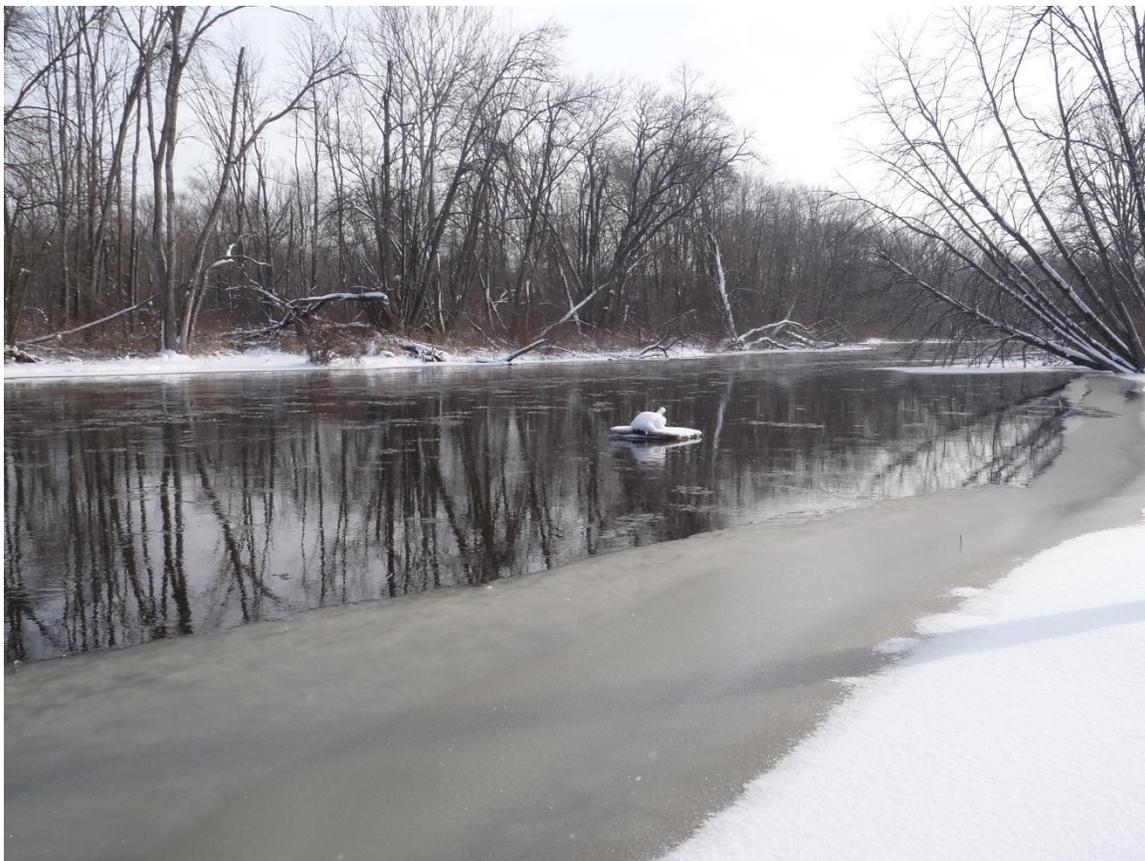
8. C3.2 Boat Launch observed river icing conditions.

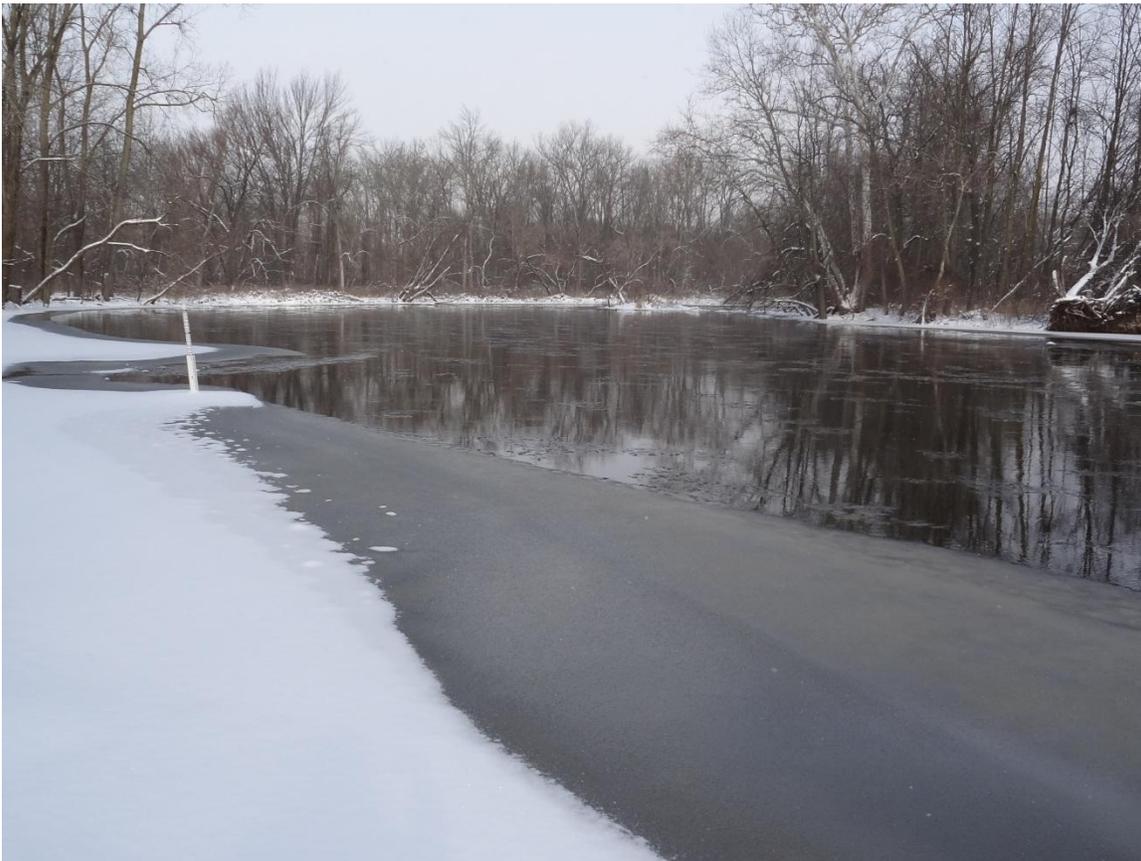
9. C3.2 Boat Launch observed river icing conditions.

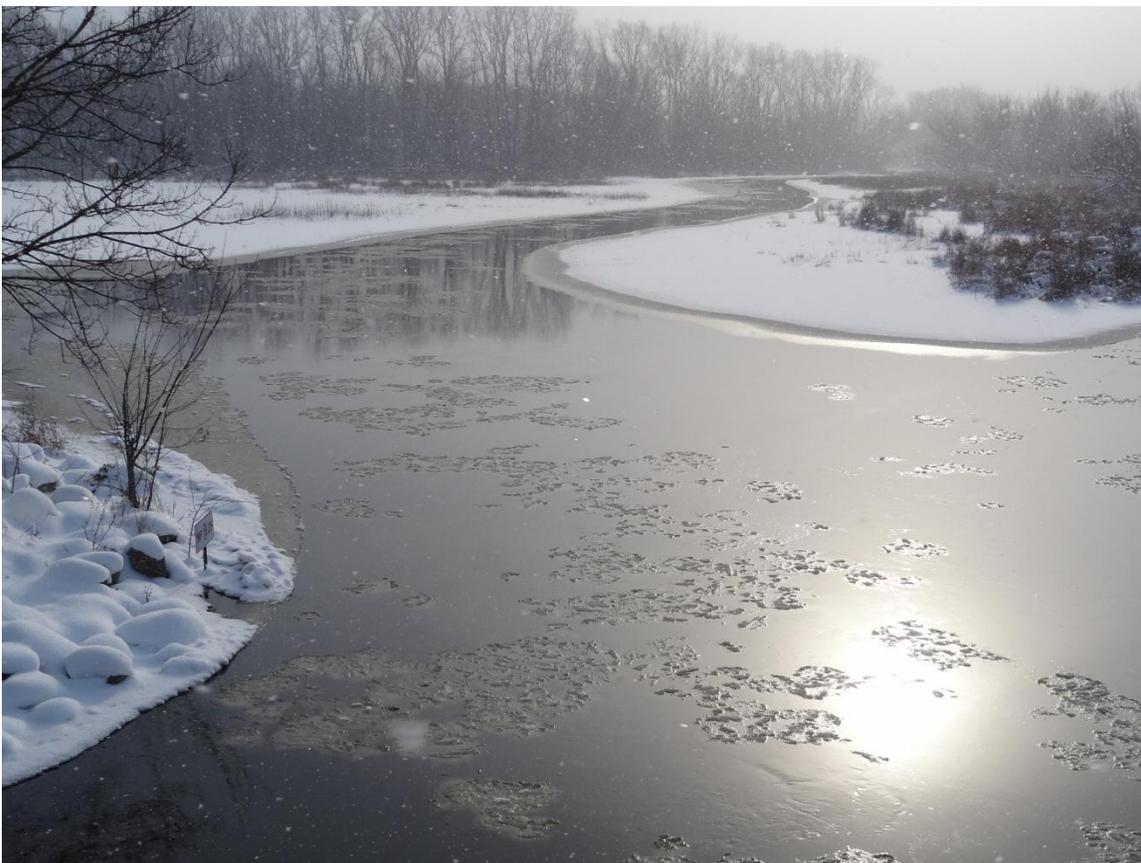
10. MP15.25 South Mill Pond observed back water icing conditions

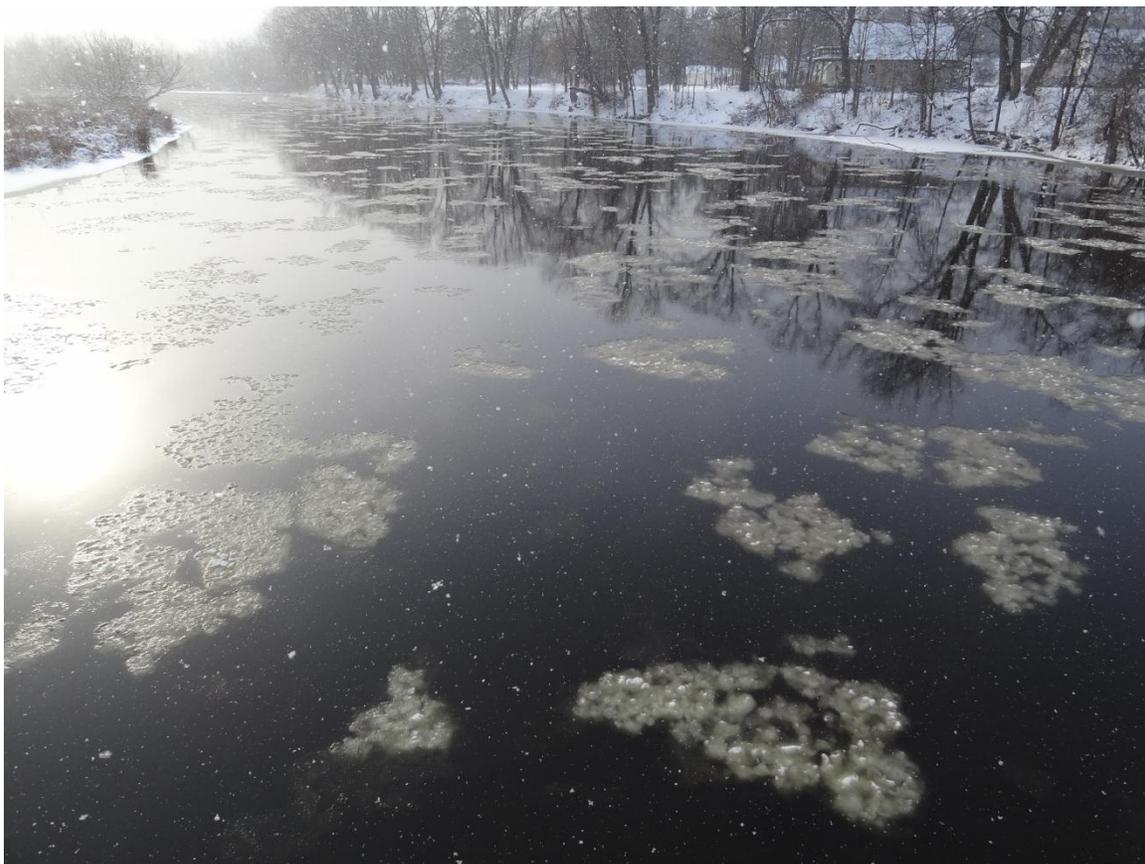
11. MP15.25 South Mill Pond observed river icing conditions.

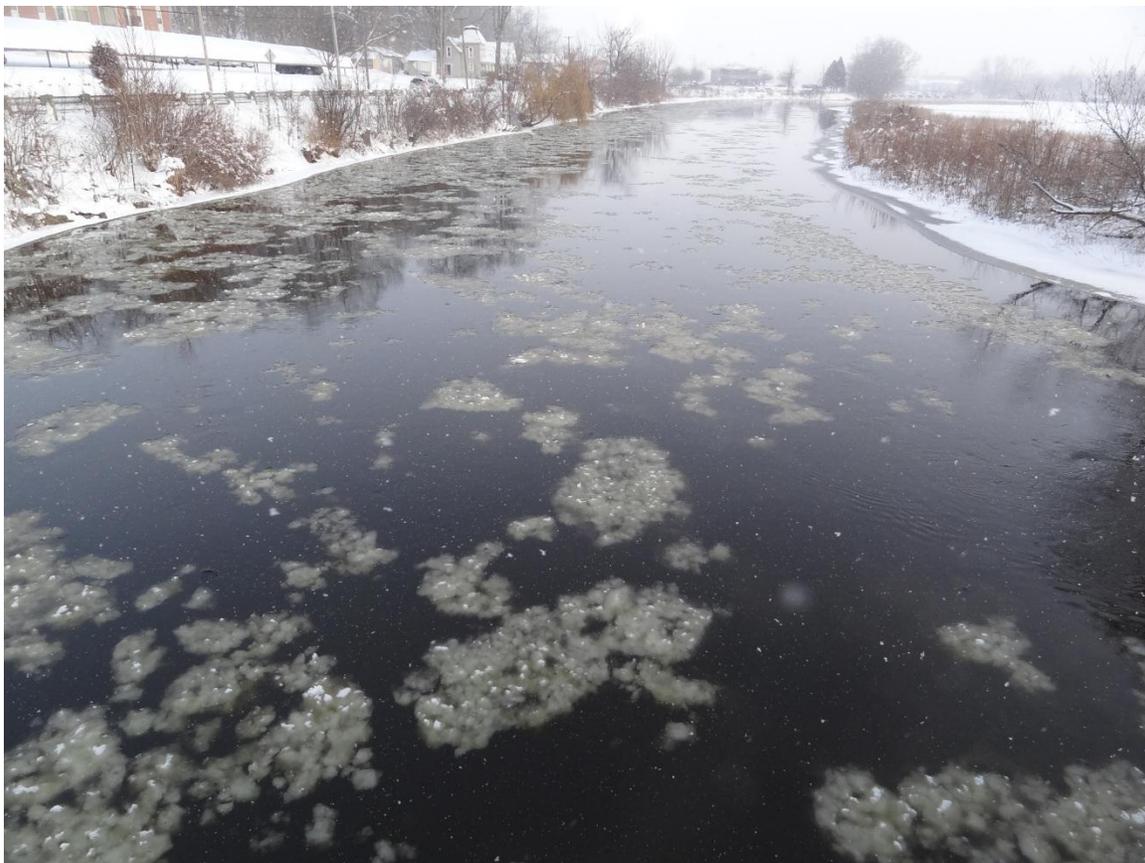
12. MP15.5 North Mill Pond observed river icing conditions.

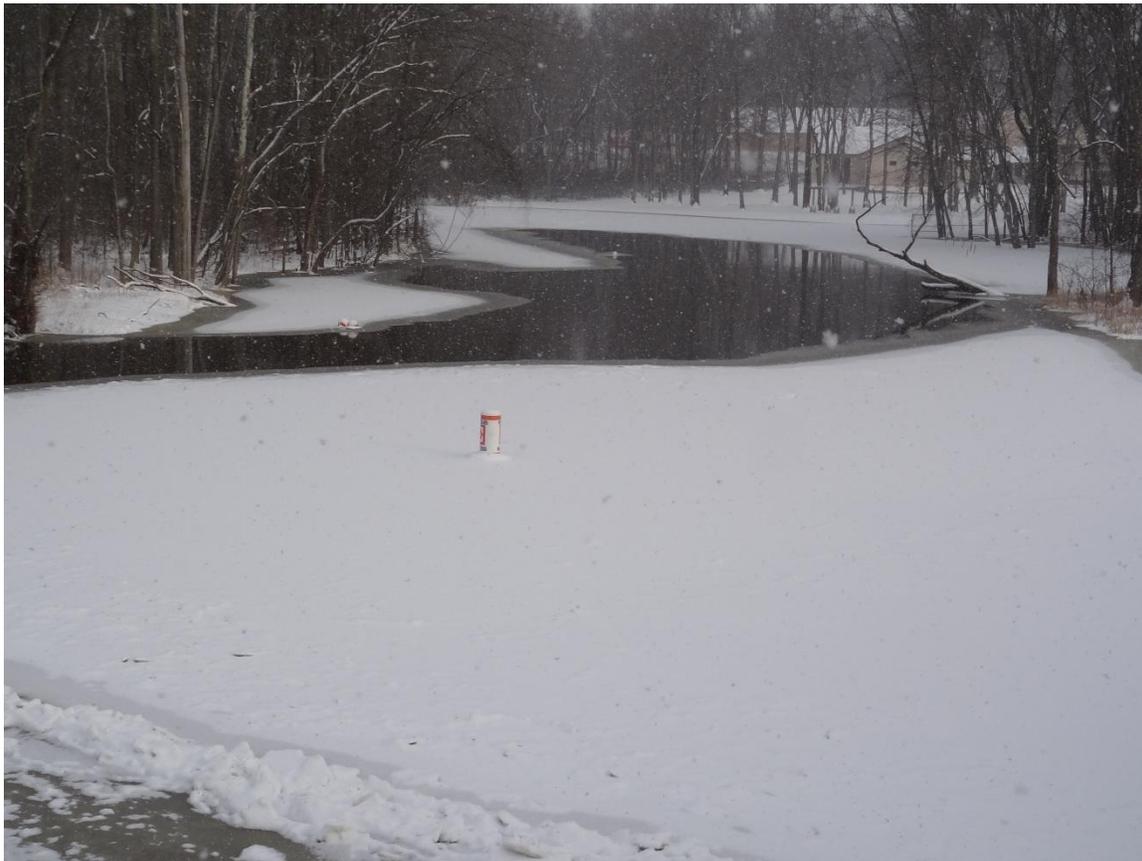
13. MP21.5 Oxbow observed icing conditions.

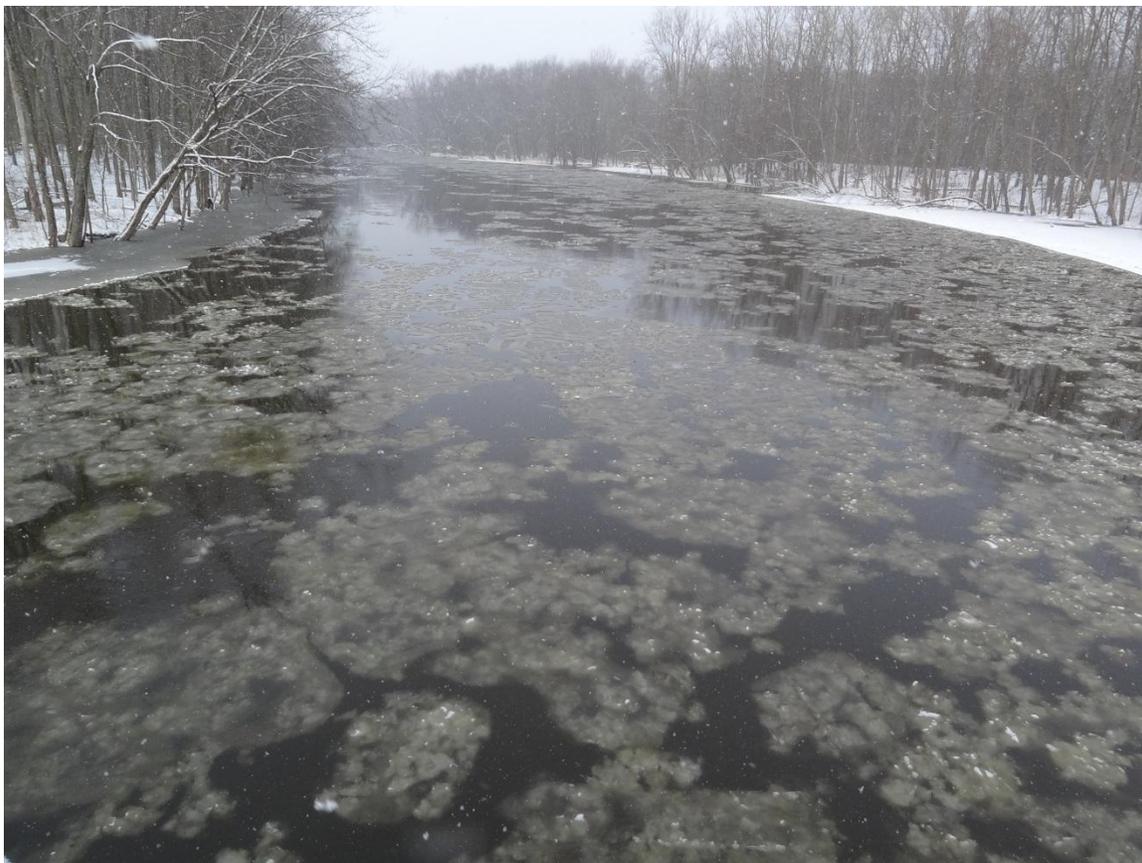
14. MP21.5 observed river icing conditions.

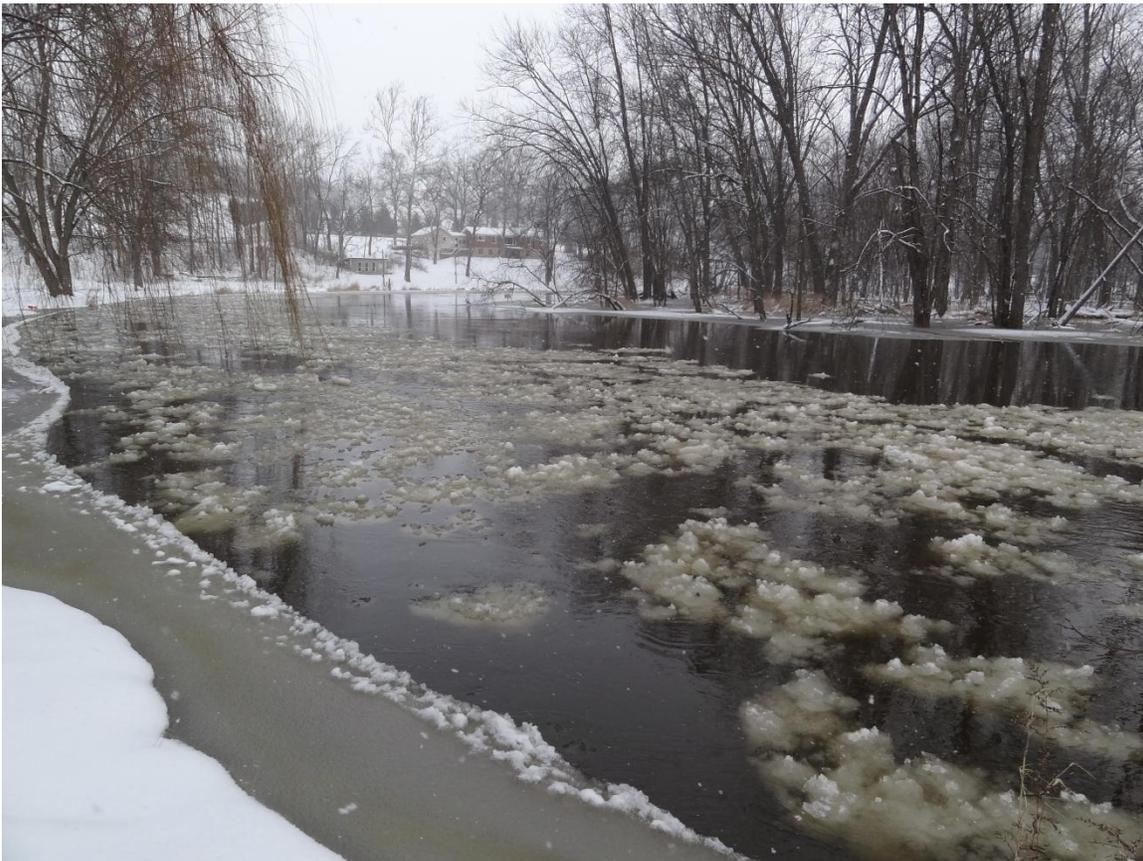
15. MP27.00 Shady Bend Campground observed river icing conditions.

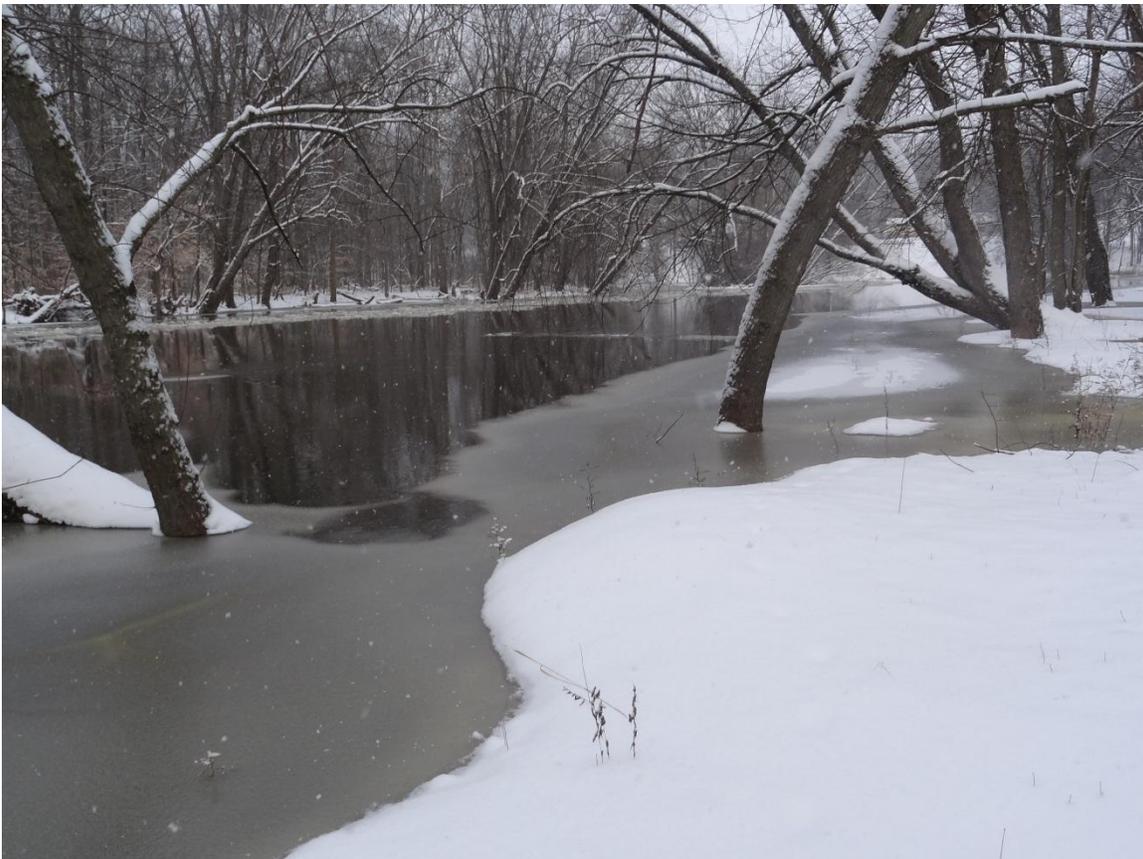
16. MP27.00 Shady Bend Campground observed river icing conditions.

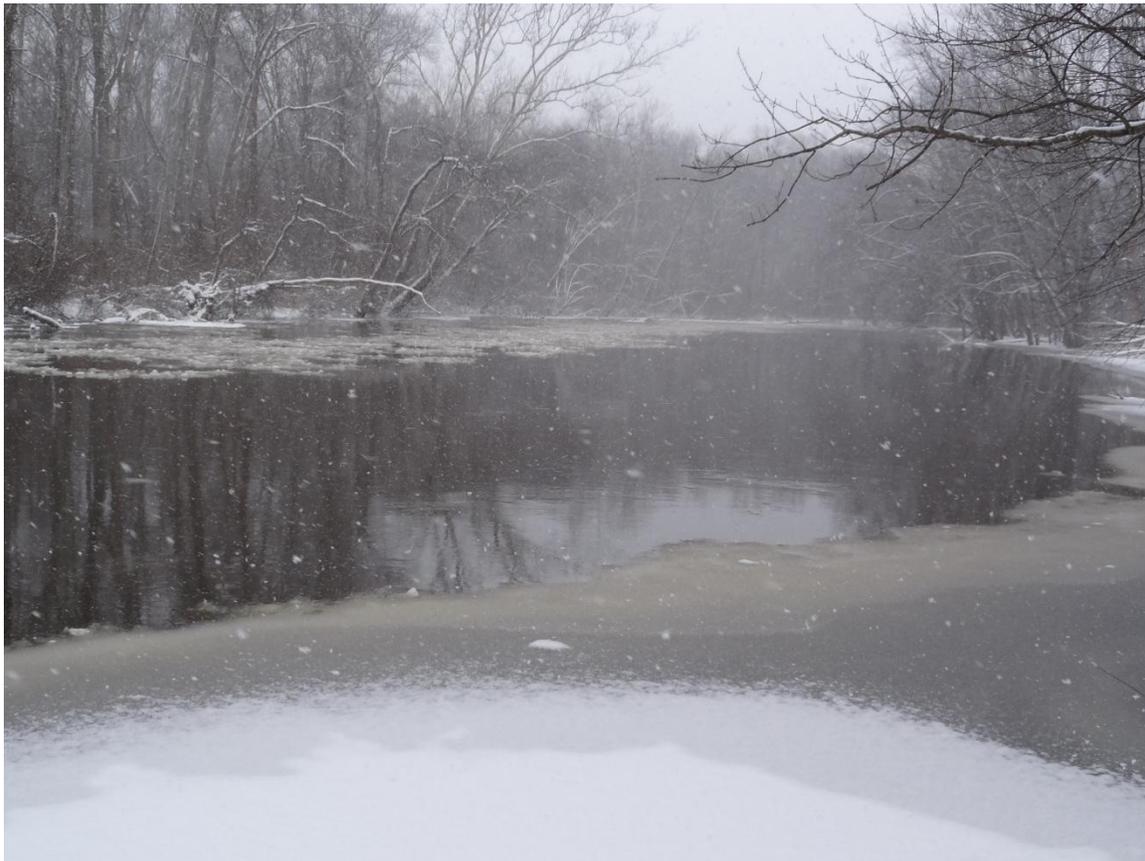
17. E2 Boat Launch observed river icing conditions.

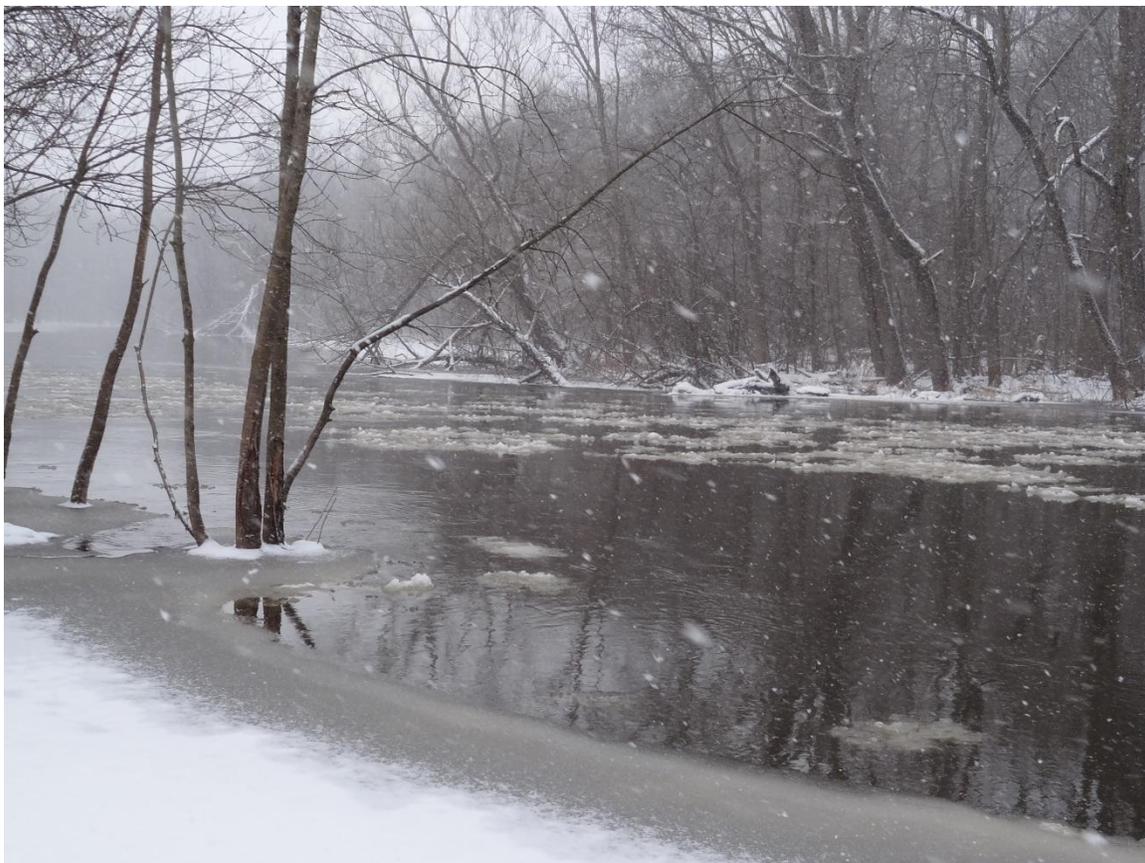
18. E2 Boat Launch observed river icing conditions.

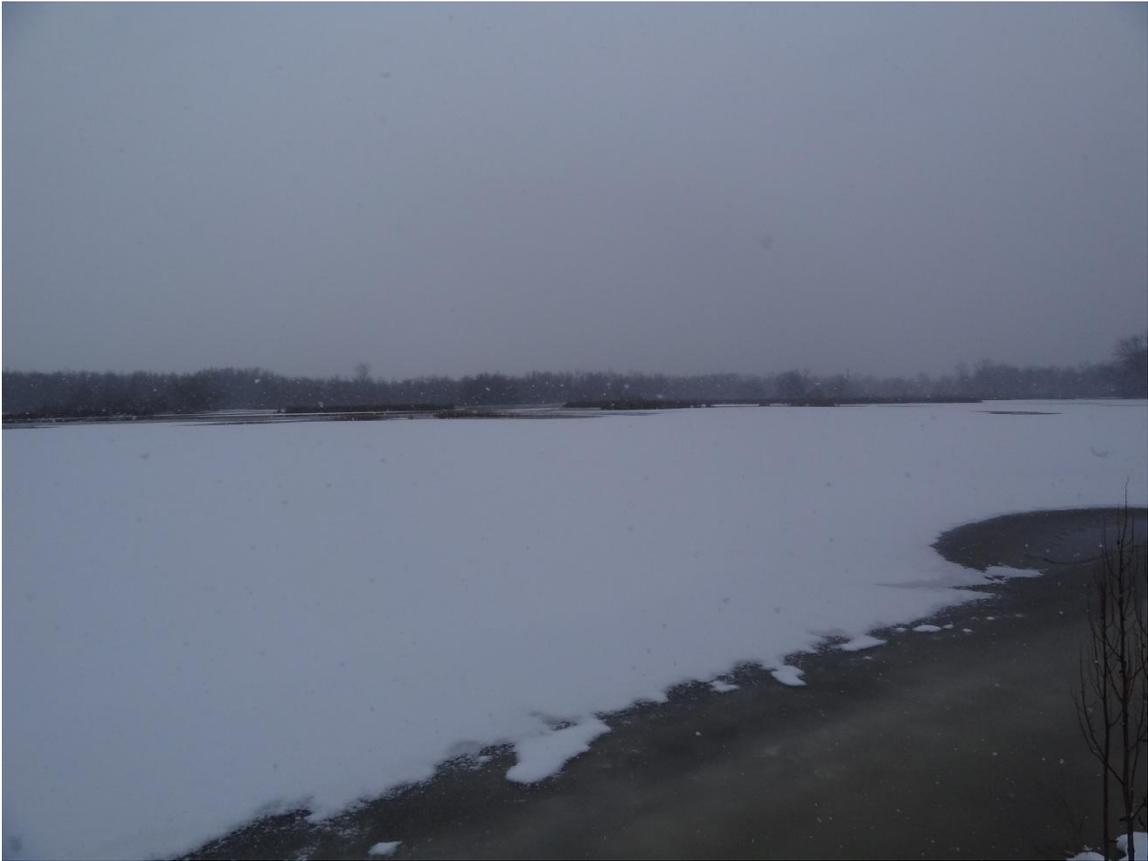
19. Morrow Lake Delta observed icing conditions.

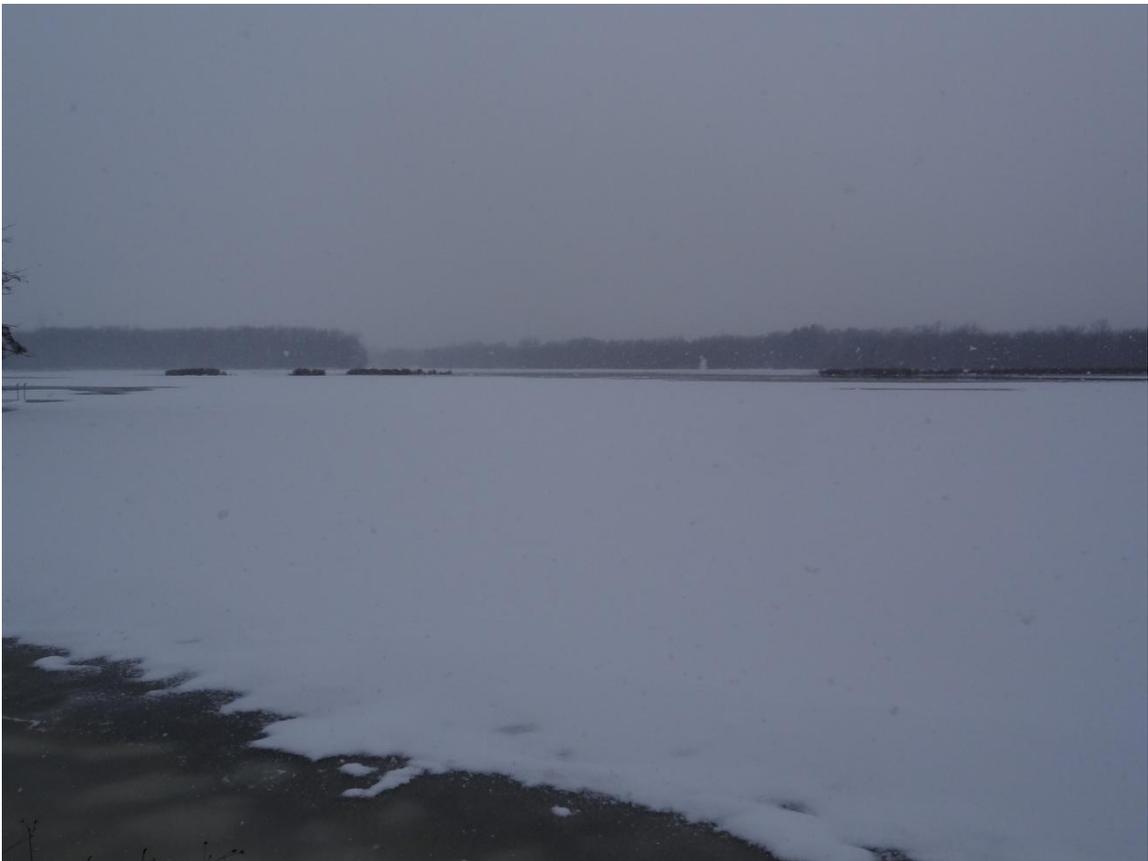
20. Morrow Lake Delta observed icing conditions.

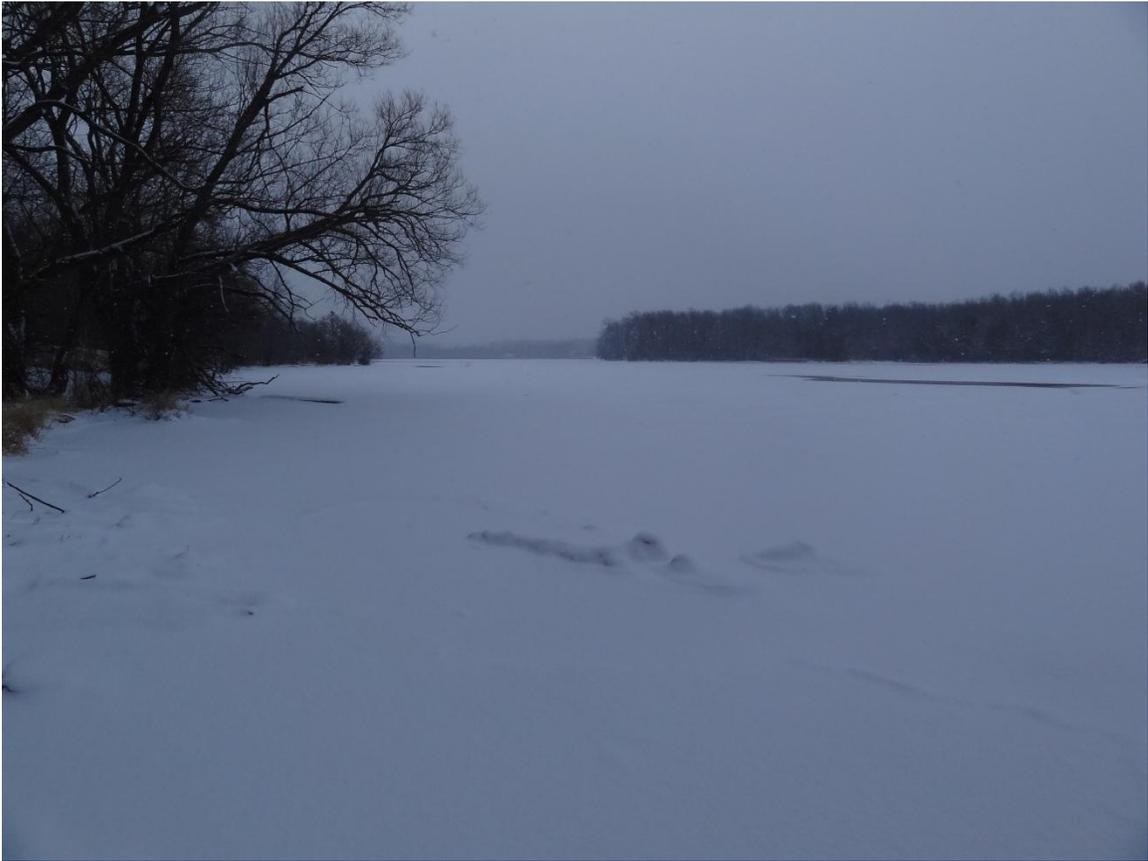
21. Morrow Lake Neck/Morrow Lake Delta observed icing conditions.

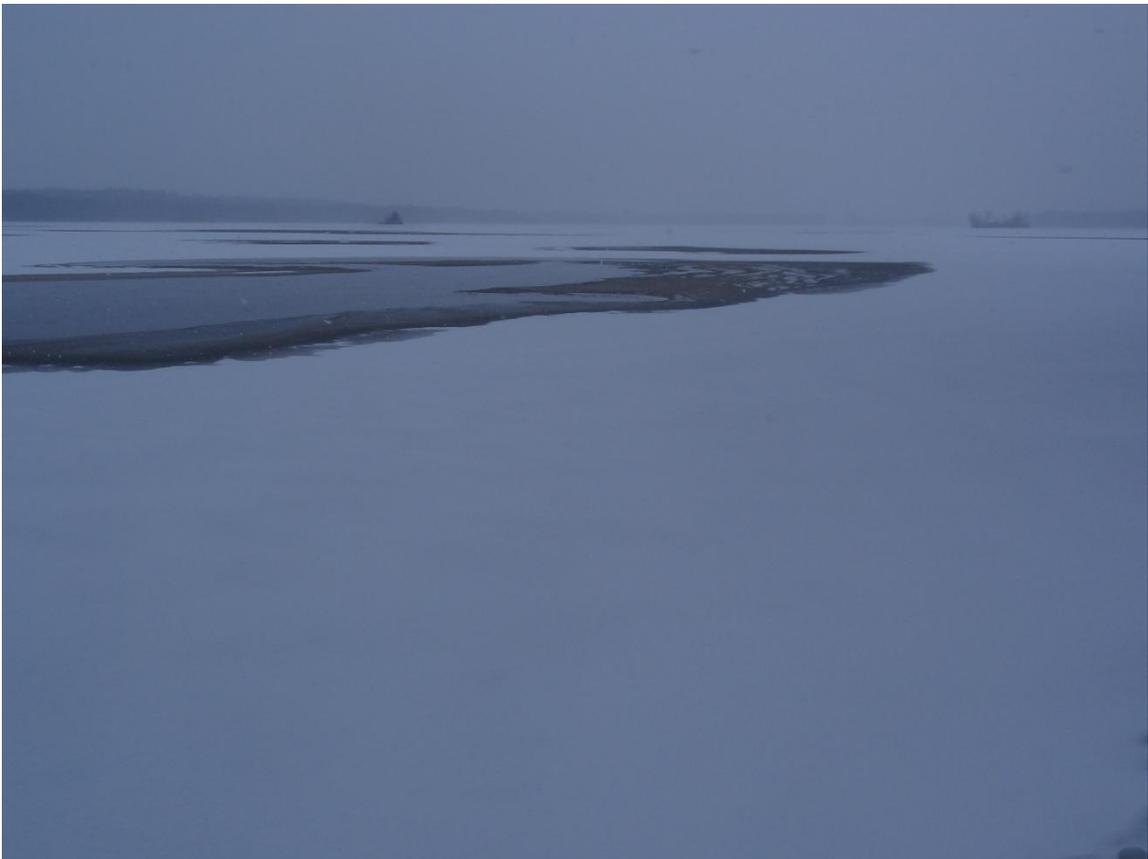
22. Morrow Lake observed icing conditions.
