Situation Photo Log

Wednesday, February 6, 2013

Kalamazoo River / Enbridge Spill

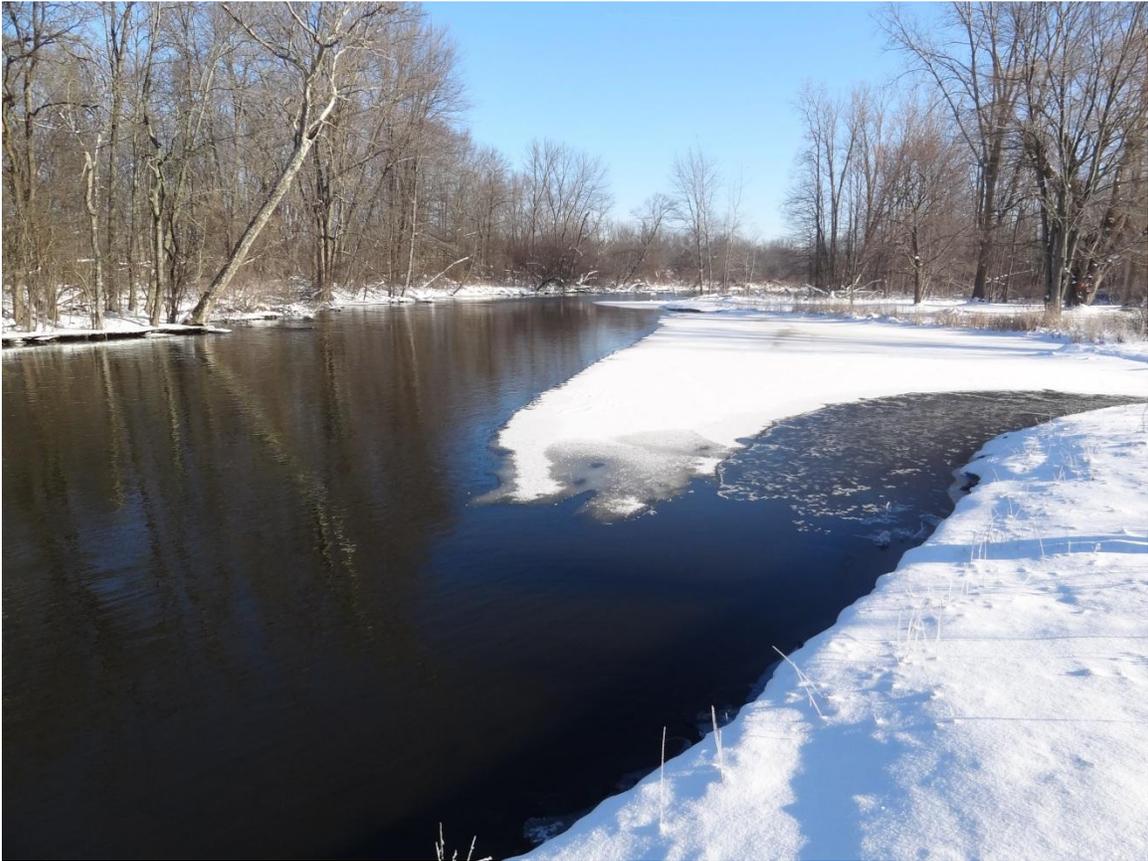
1. MP2.00 the Confluence observed icing conditions.

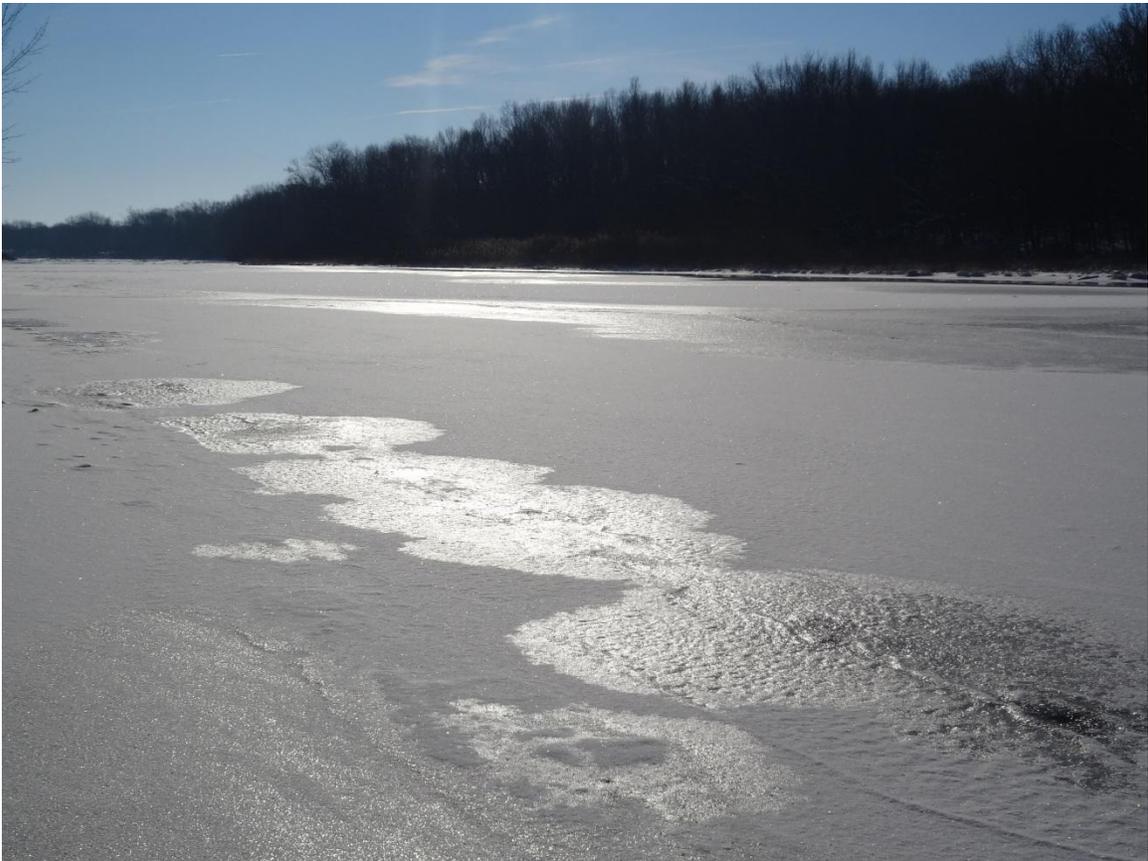
2. C0.4 Boat Launch observed river icing conditions.

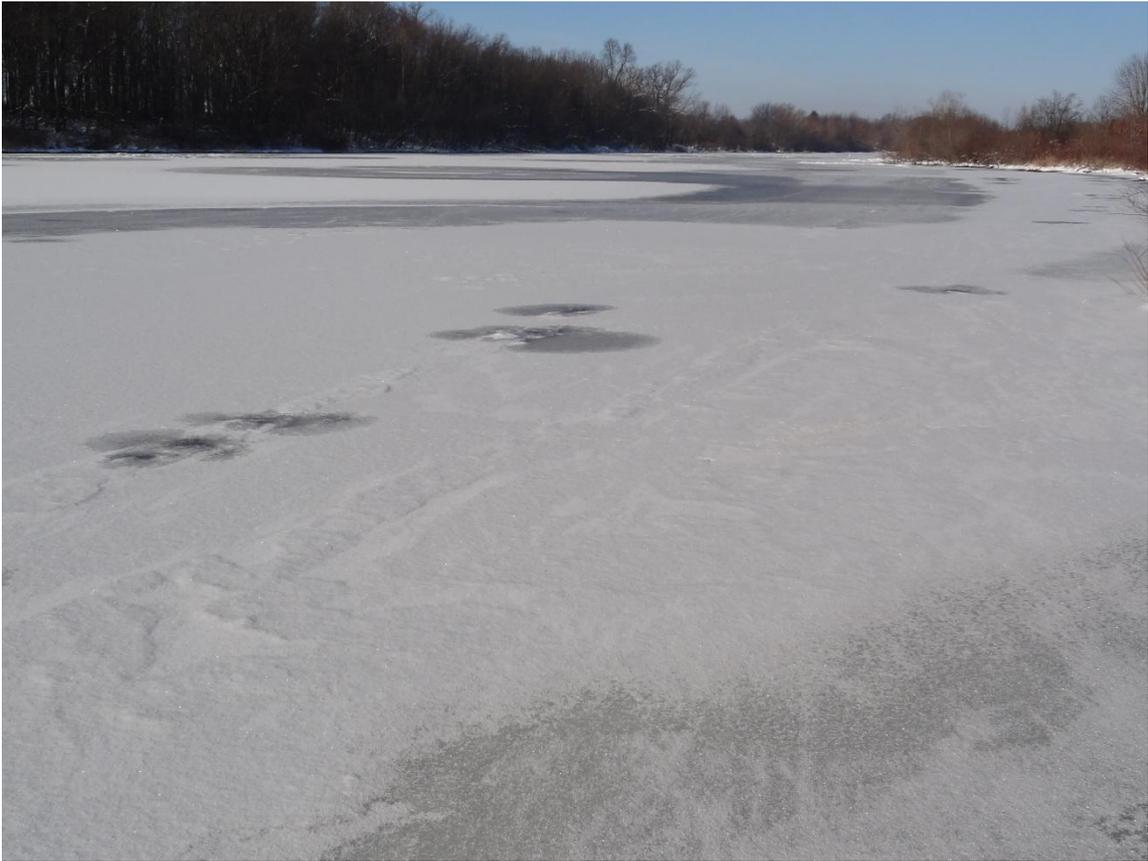
3. C0.4 Boat Launch observed river icing conditions.

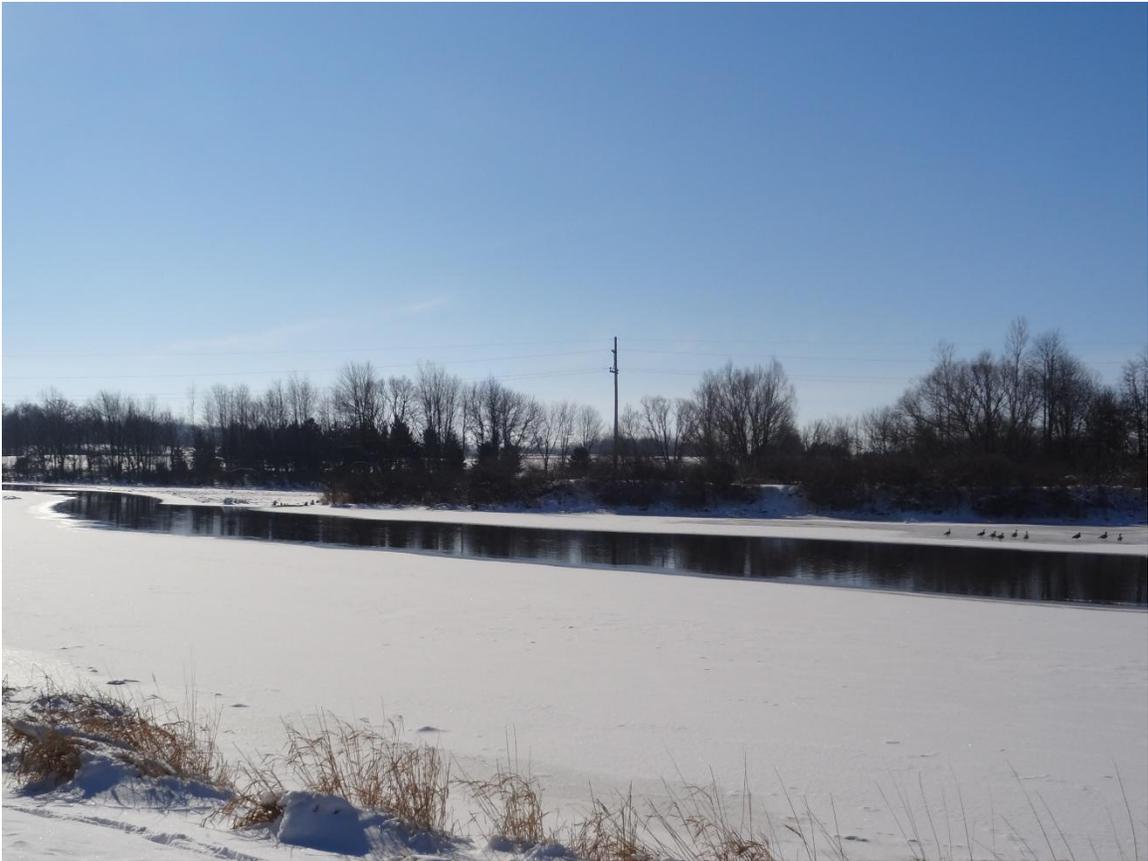
4. Ceresco Dam impoundment observed river icing conditions.

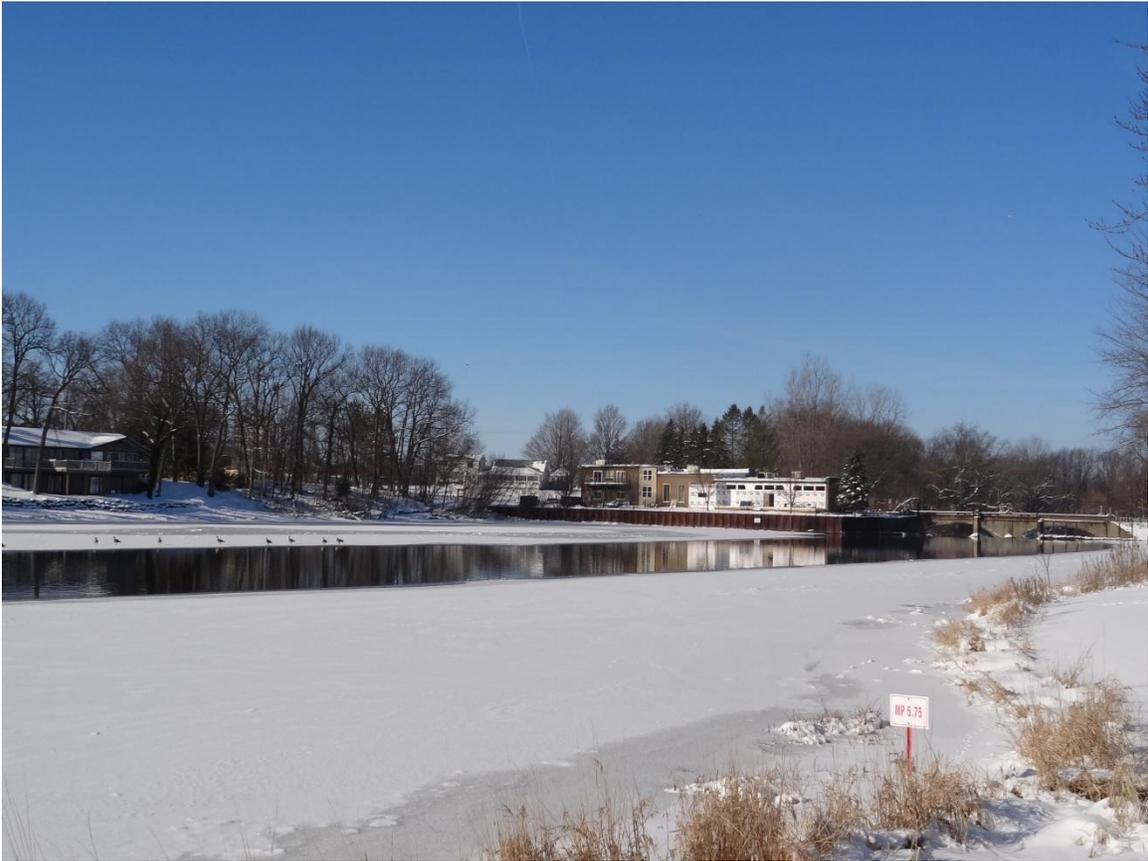
5. Ceresco Dam impoundment observed river icing conditions.

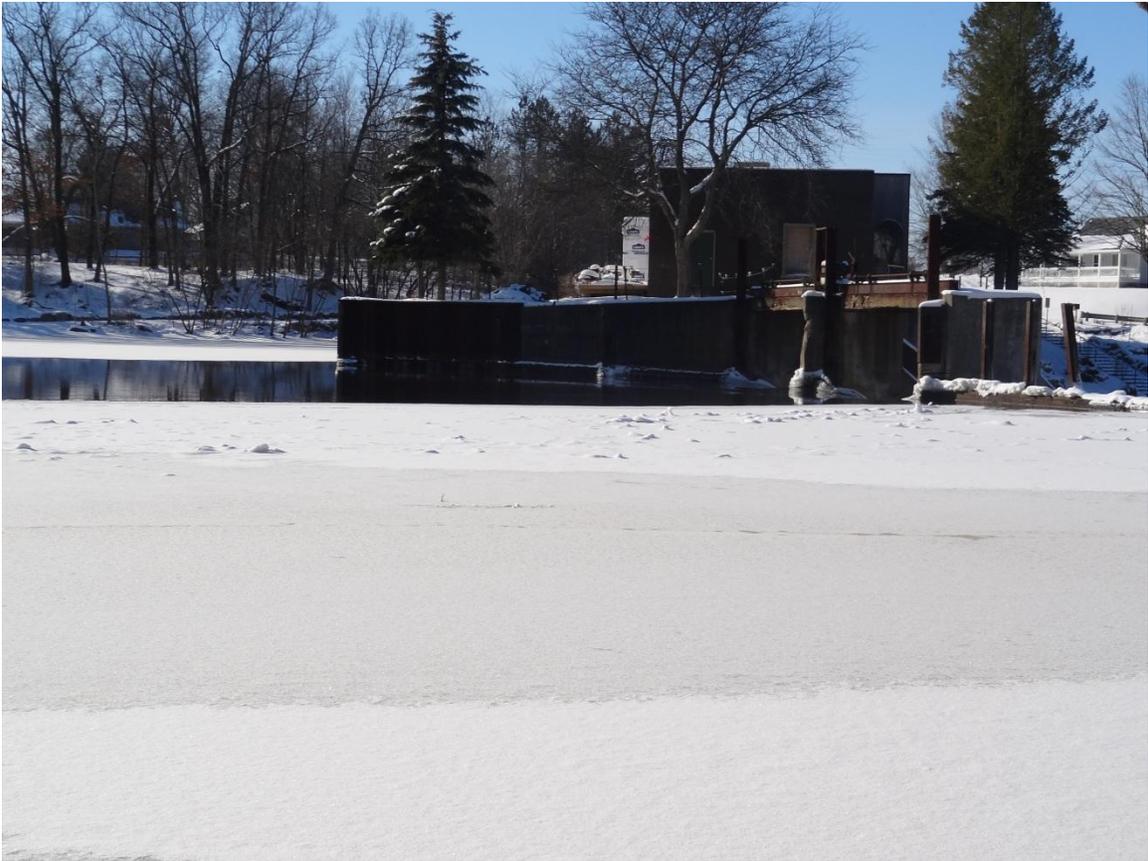
6. Ceresco Dam impoundment observed river icing conditions.

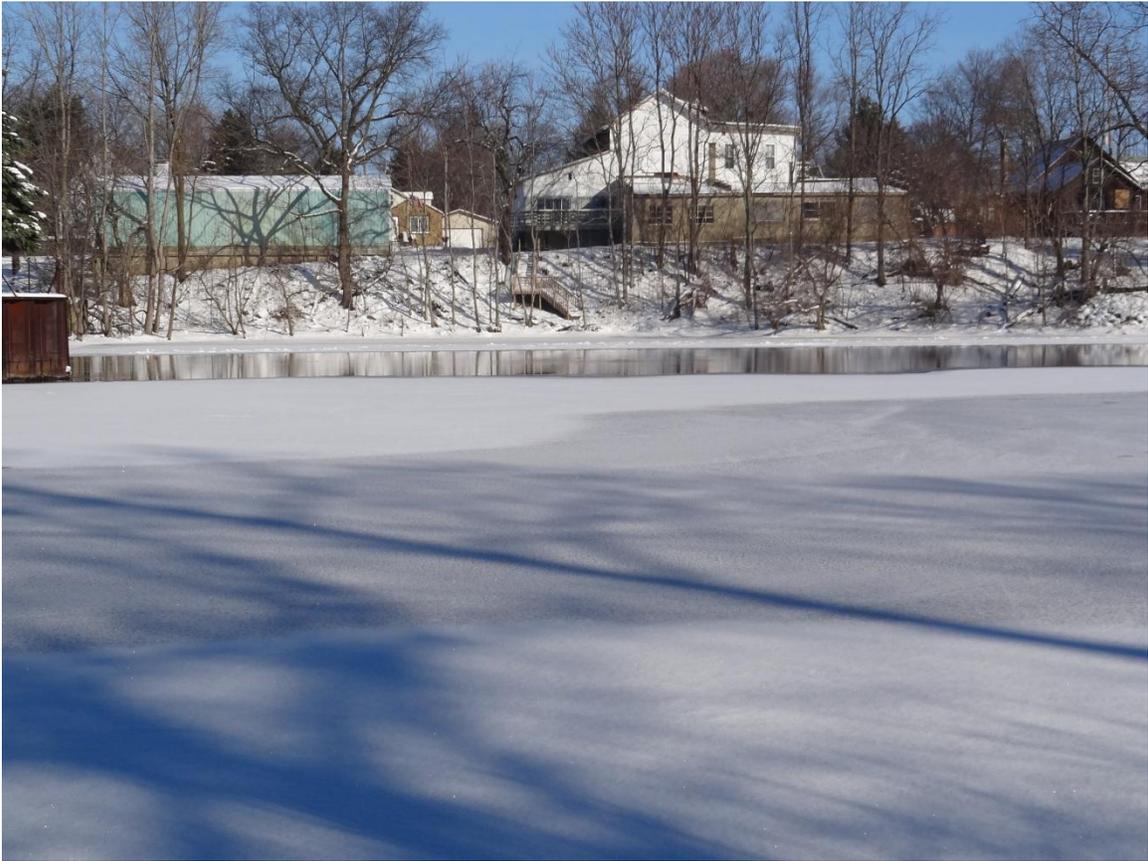
7. Ceresco Dam impoundment observed river icing conditions.

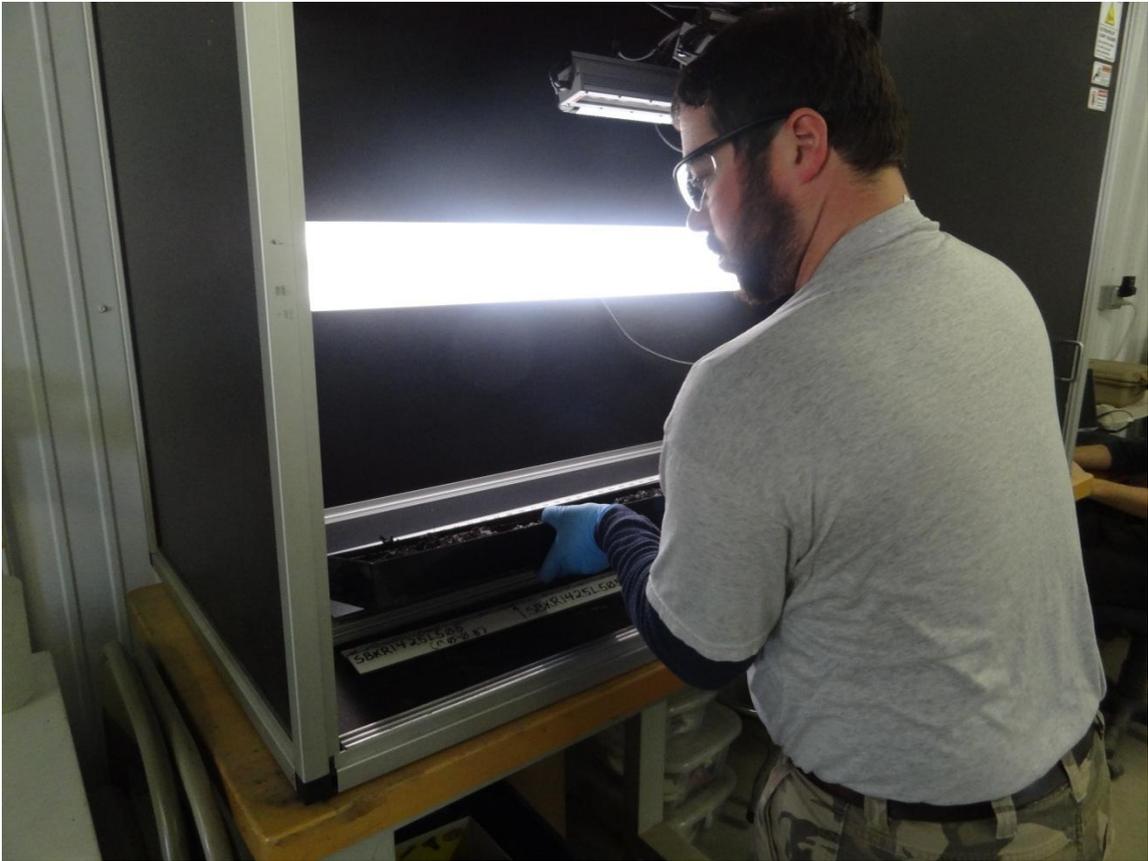
8. C3.2 Pole Barn observed core logging procedures.

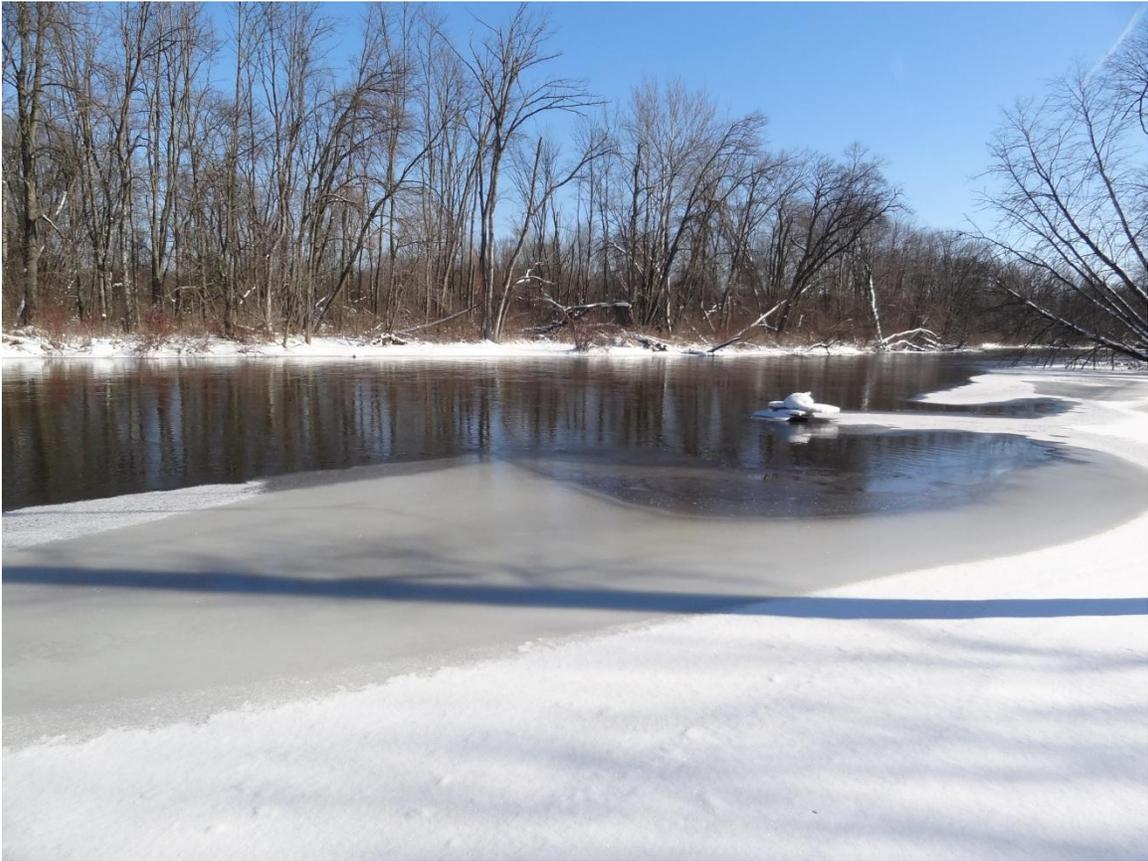
9. C3.2 Boat Launch observed river icing conditions.

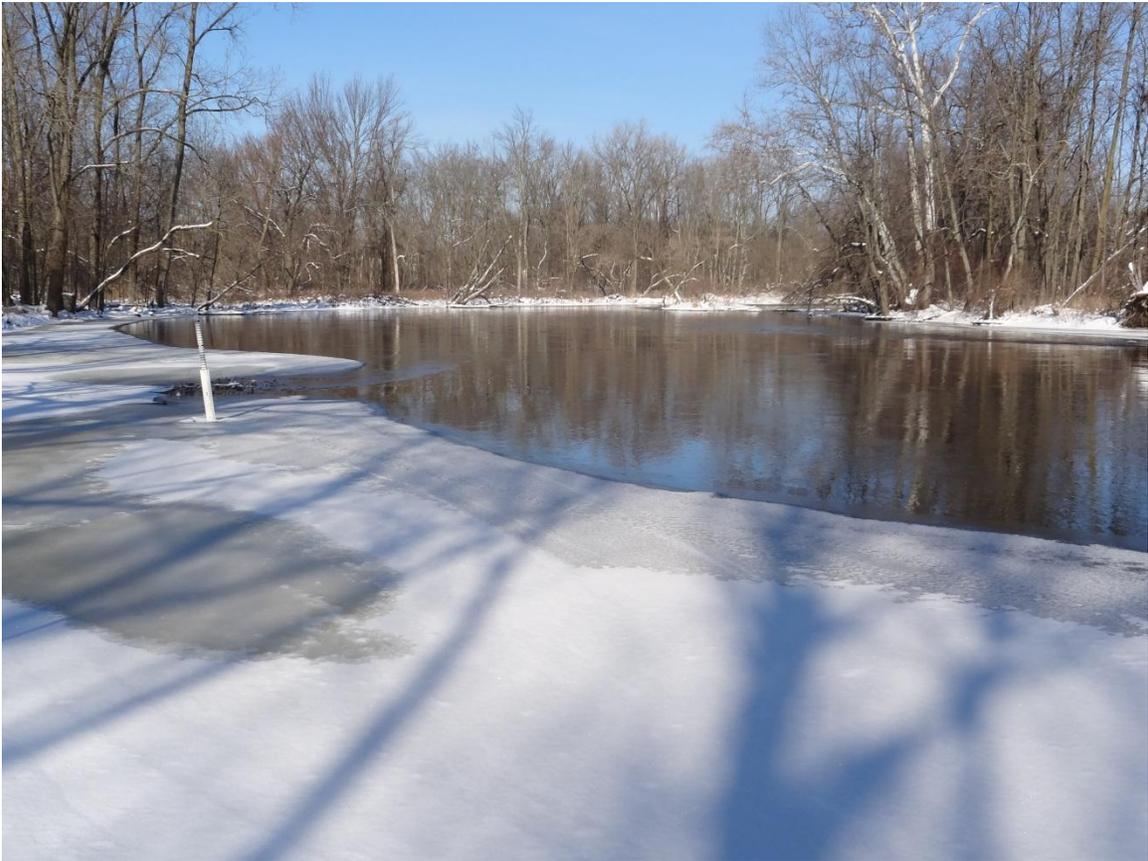
10. C3.2 Boat Launch observed river icing conditions.

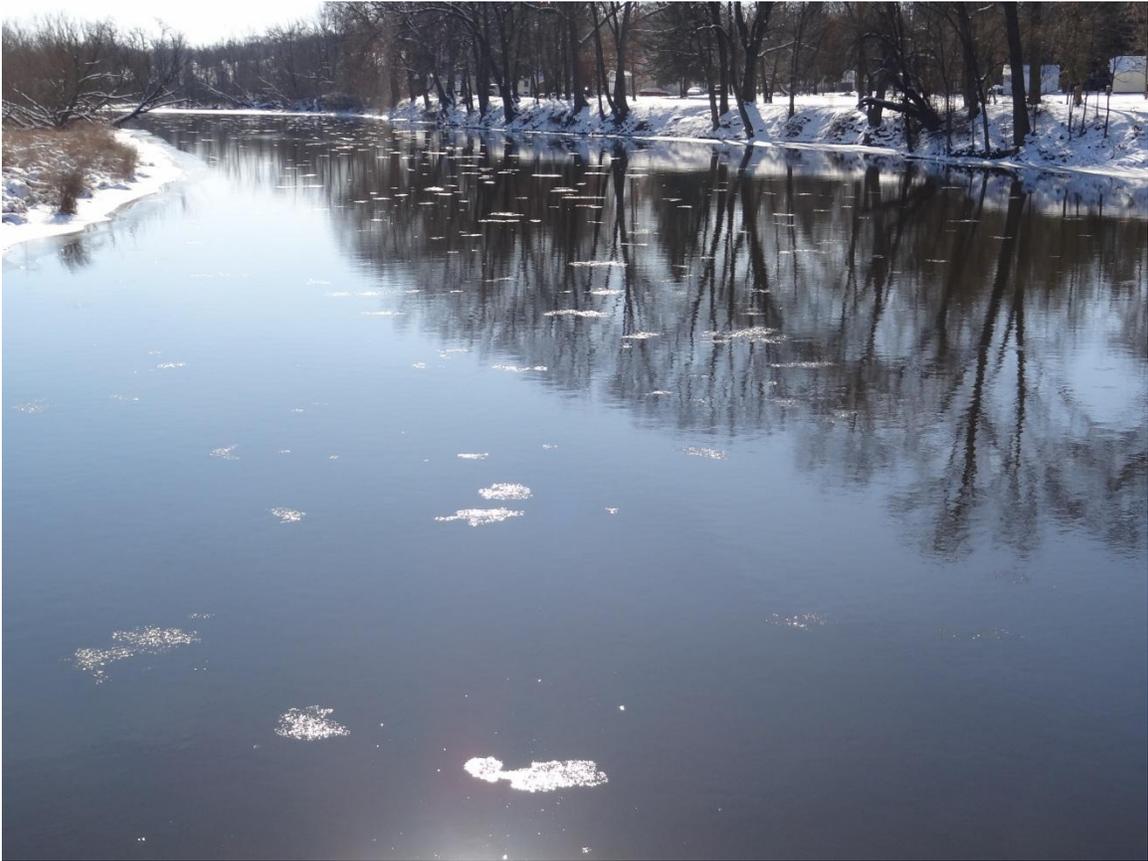
11. MP15.25 South Mill Pond observed river icing conditions.

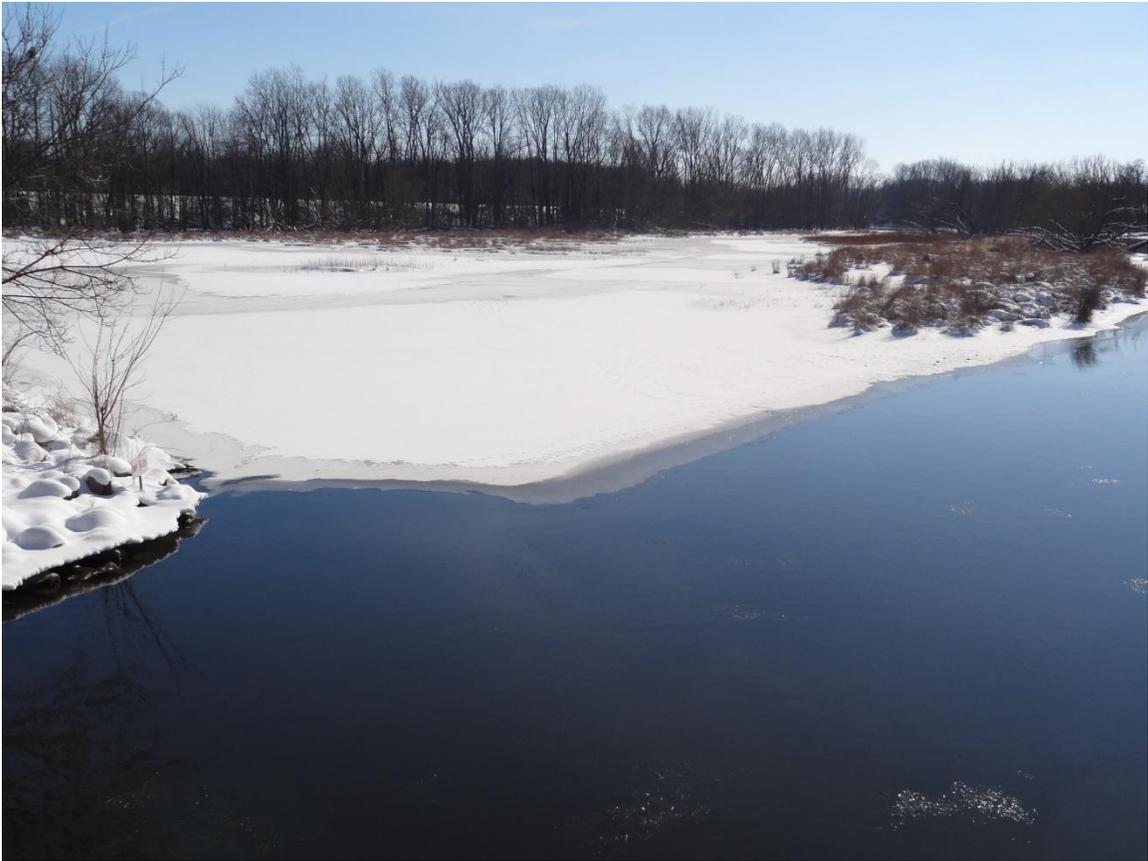
12. MP15.25 South Mill Pond observed back water icing conditions.

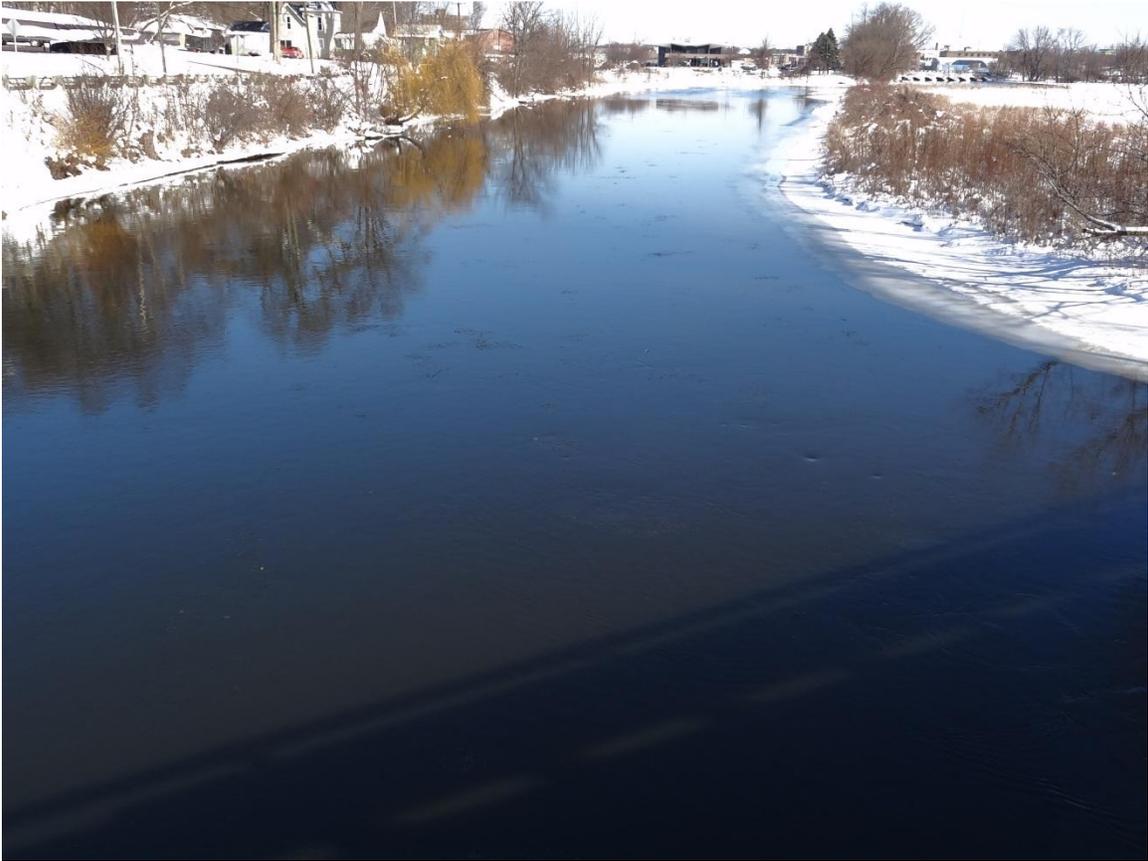
13. MP15.50 North Mill Pond observed river icing conditions.

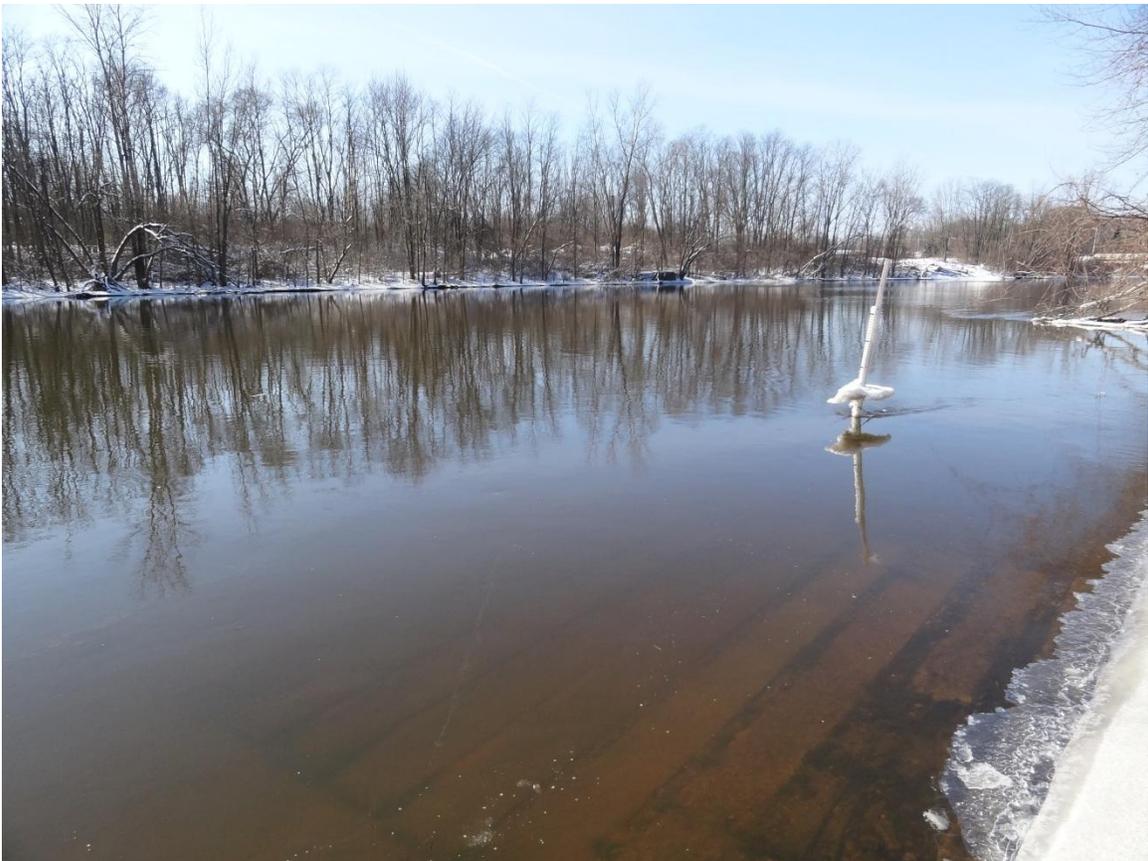
14. D2 Boat Launch observed river icing conditions.

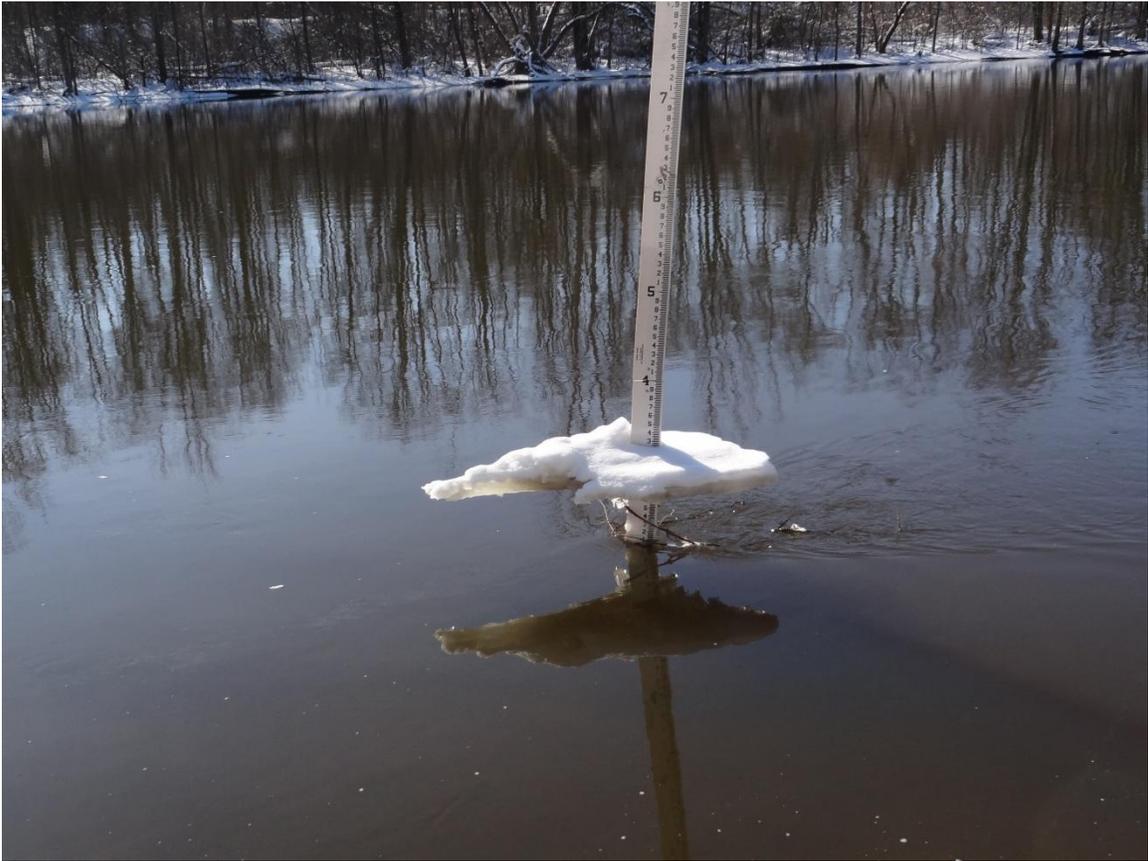
15. D2 water level gauge. Observed evident drop in river level.

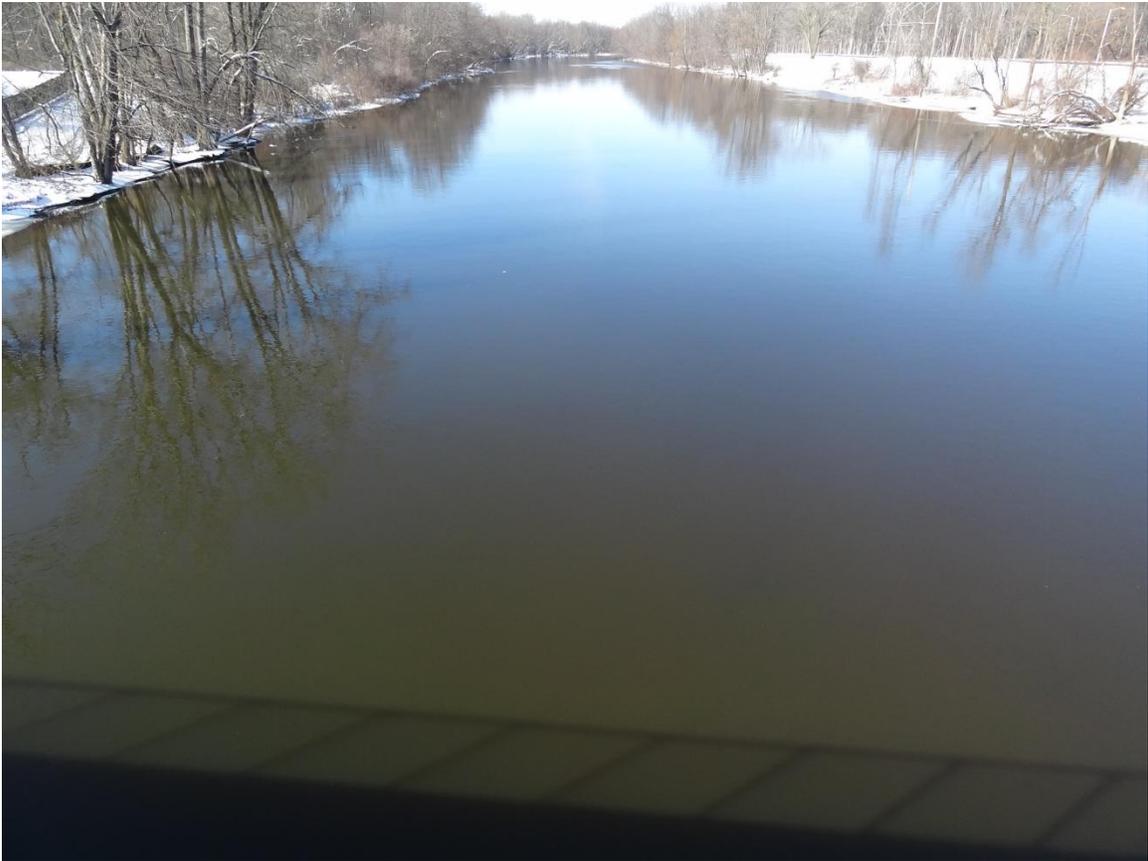
16. MP18.75 Bedford Road bridge observed turbidity in river.

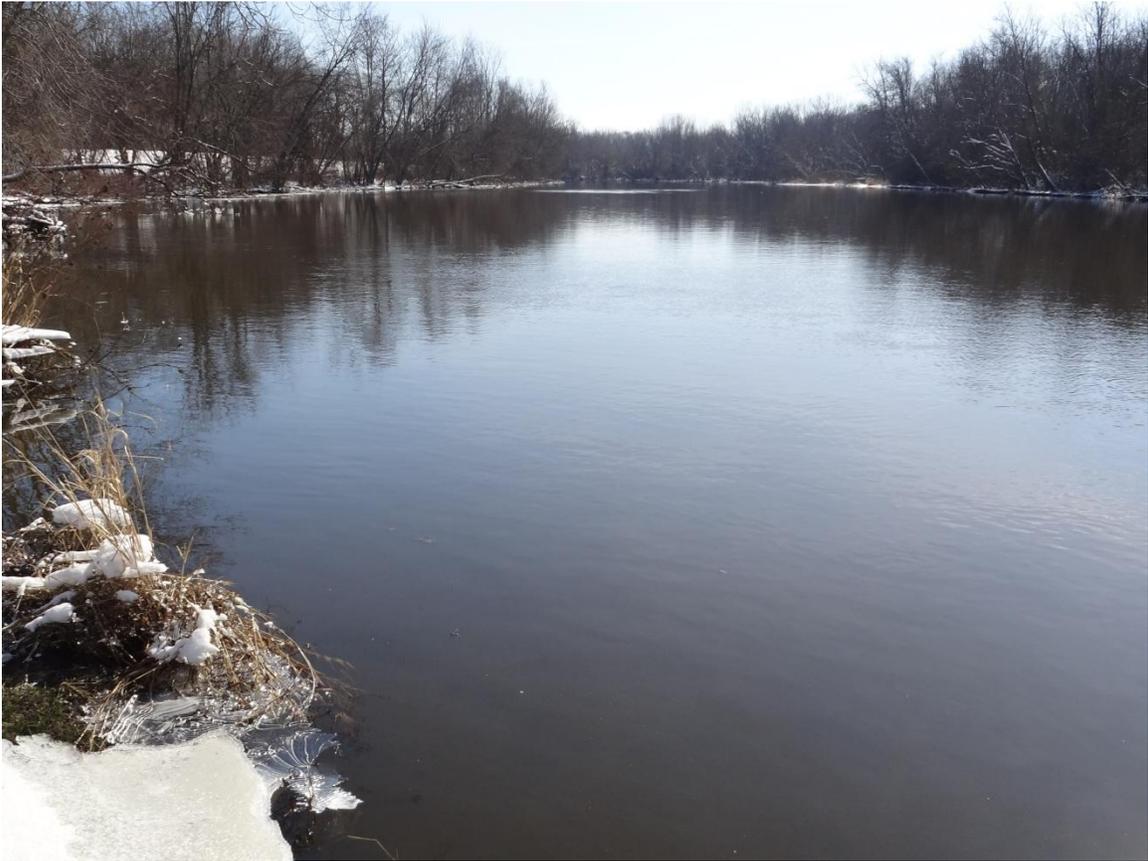
17. MP19.50 observed river icing conditions.

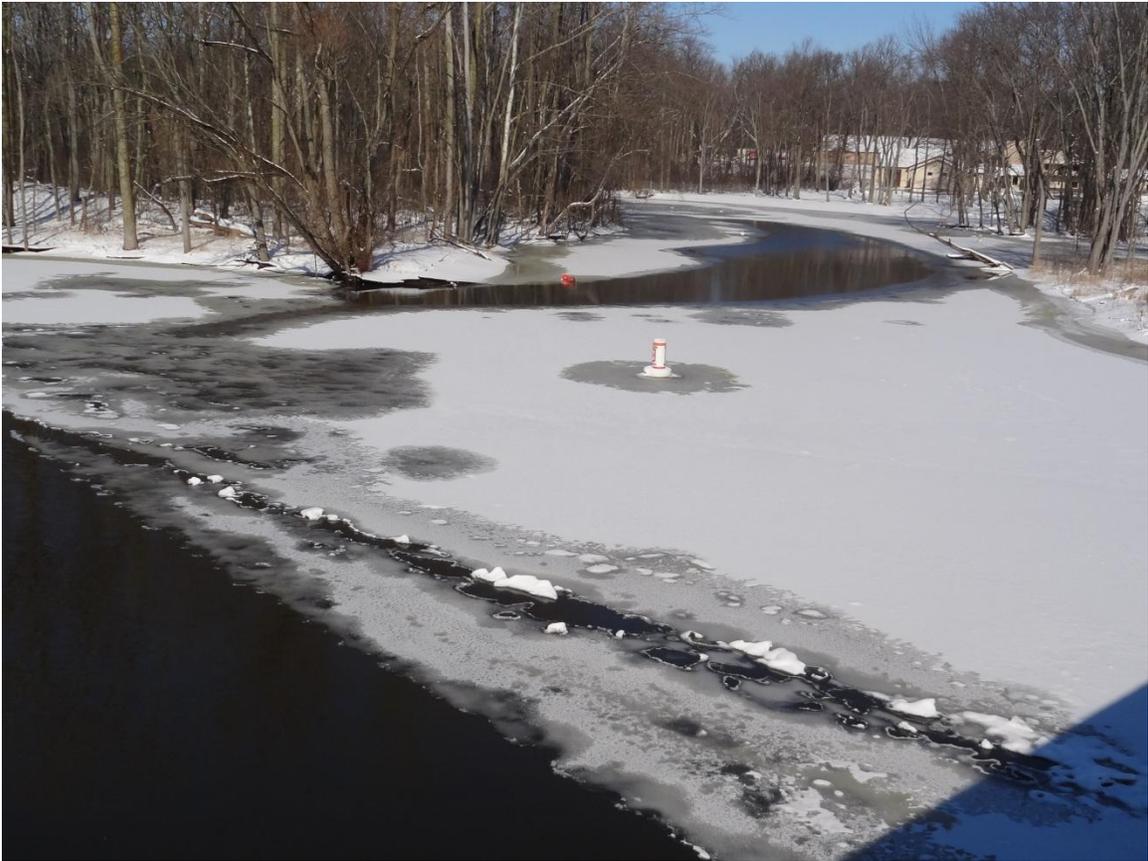
18. MP21.50 Oxbow observed icing conditions.

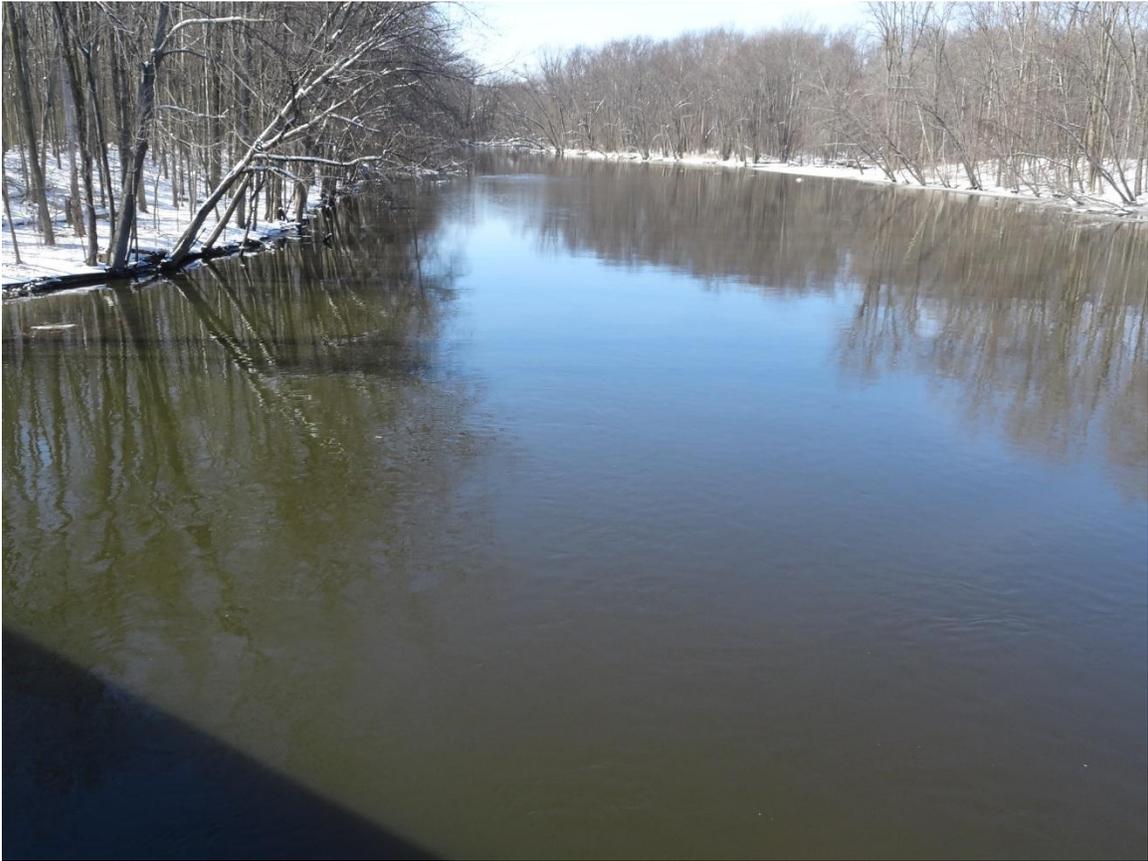
19. MP21.50 Custer Road bridge observed turbidity in river.

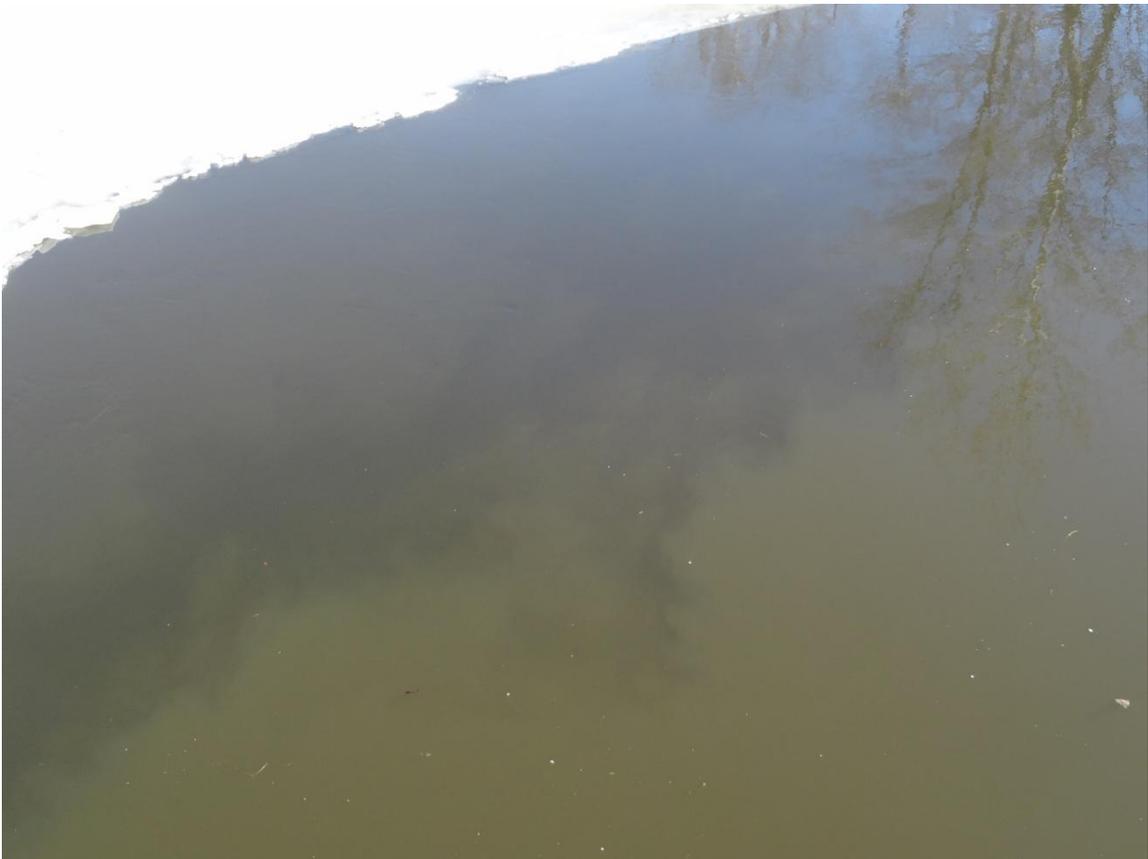
20. MP21.50 RDB turbidity observed in river.

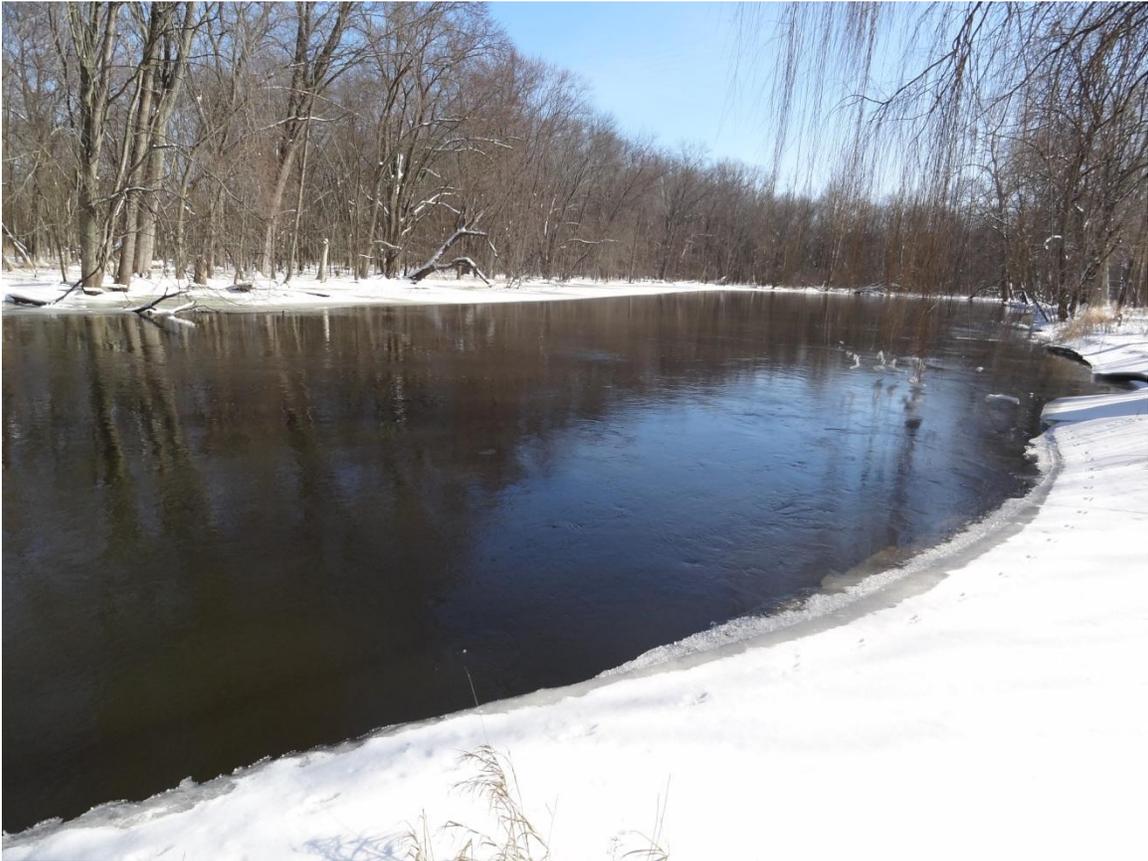
21. MP27.00 Shady Bend Campground observed river icing conditions.

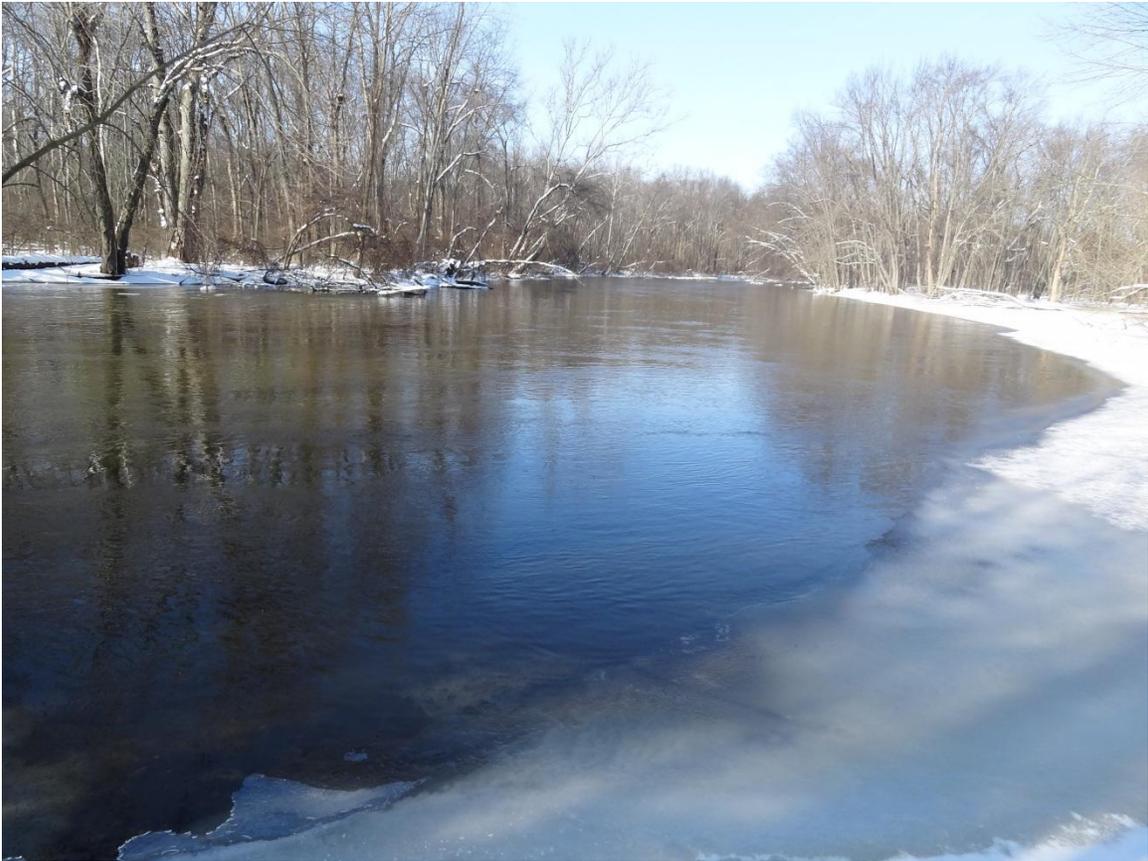
22. E2 Boat Launch observed river icing conditions.

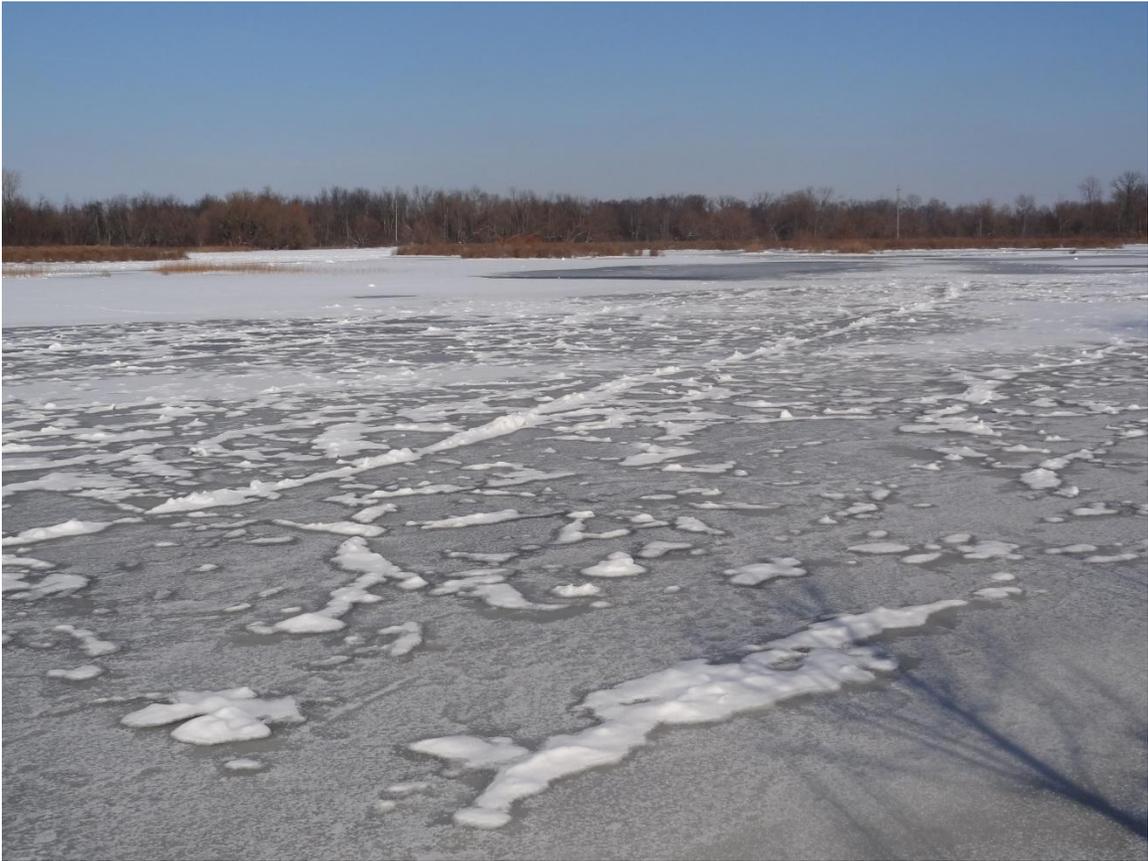
23. Morrow Lake Delta observed icing conditions.
