Situation Photo Log

Wednesday, February 6, 2013

Kalamazoo River / Enbridge Spill

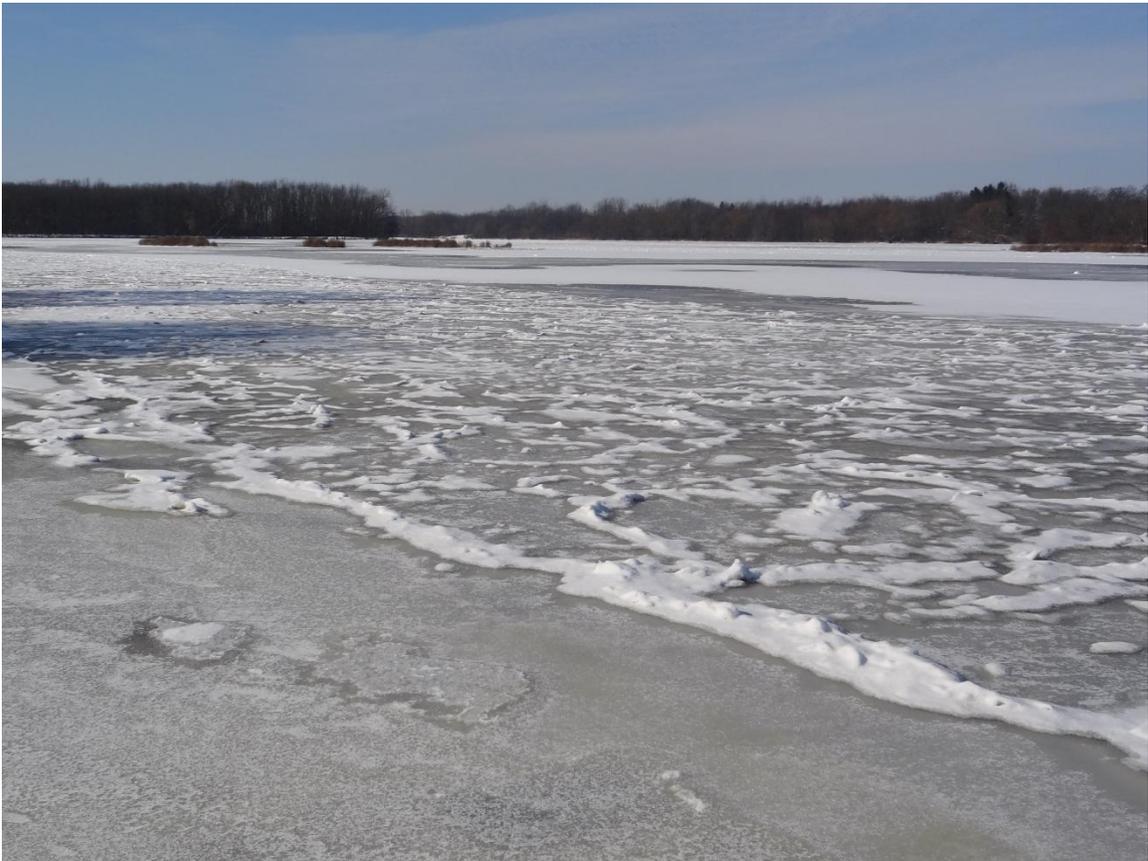
24. Morrow Lake Delta observed icing conditions.

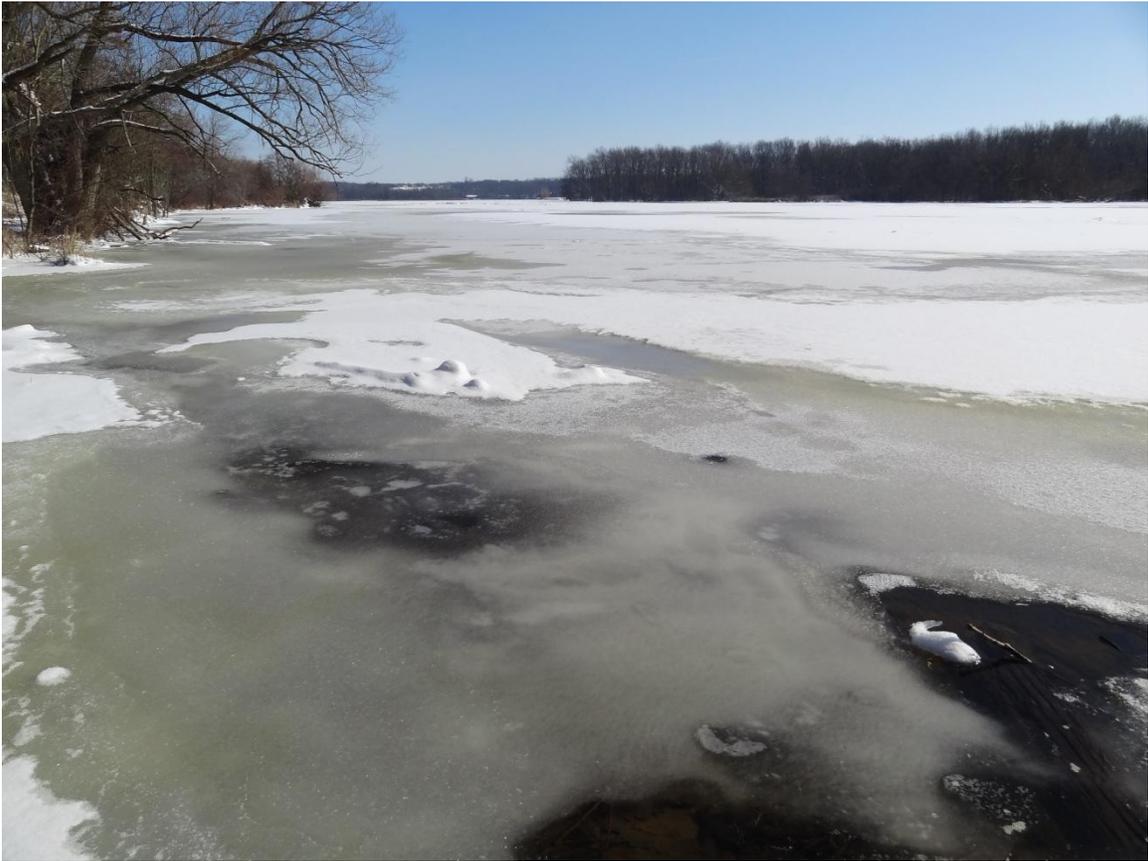
25. Morrow Lake Neck/Morrow Lake Delta observed icing conditions.

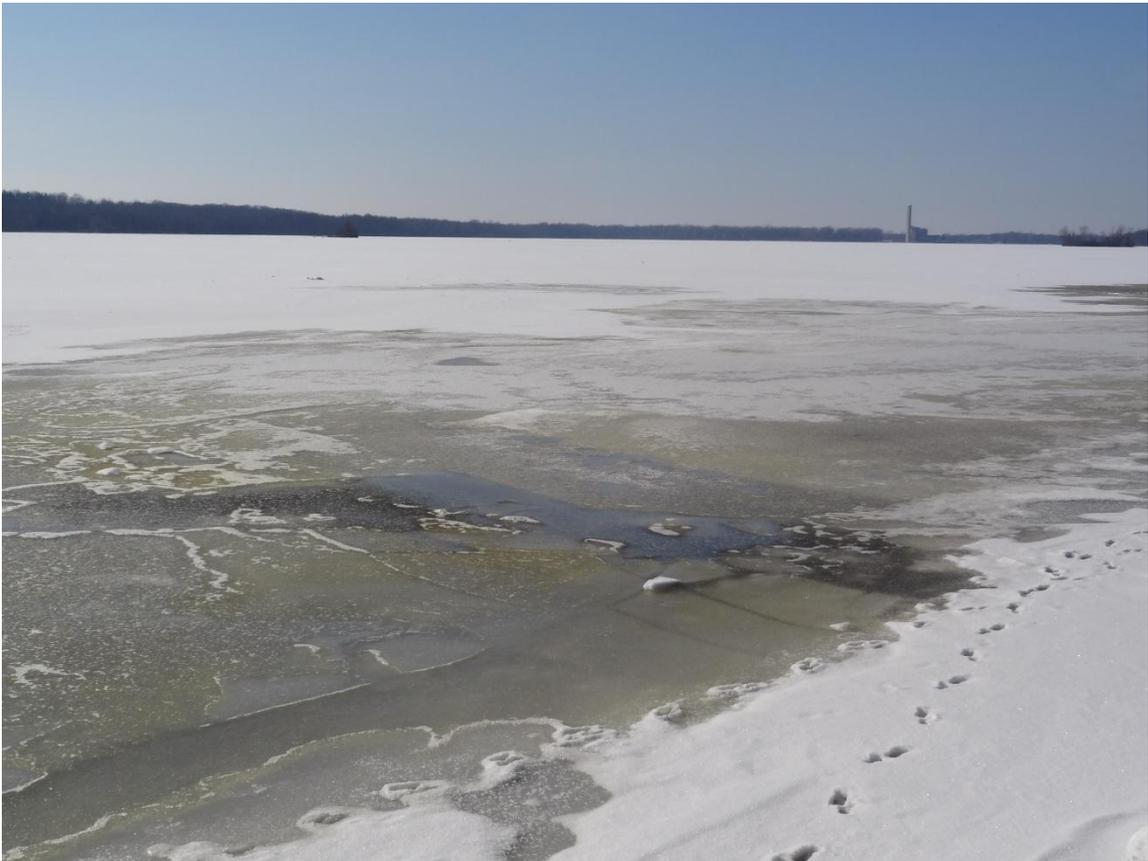
26. Morrow Lake observed icing conditions.
