# Situation Photo Log

Thursday, February 7, 2013

Kalamazoo River / Enbridge Spill

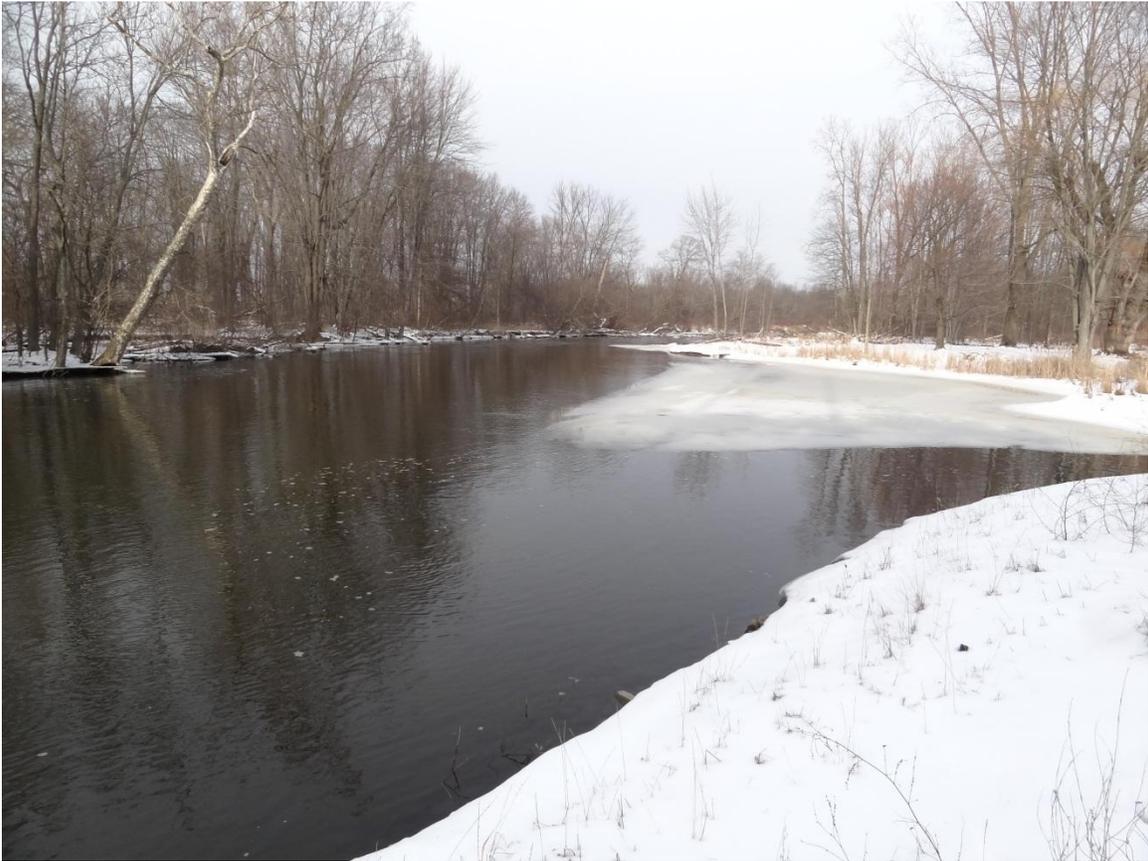
1. MP2.00 Confluence observed ice conditions.

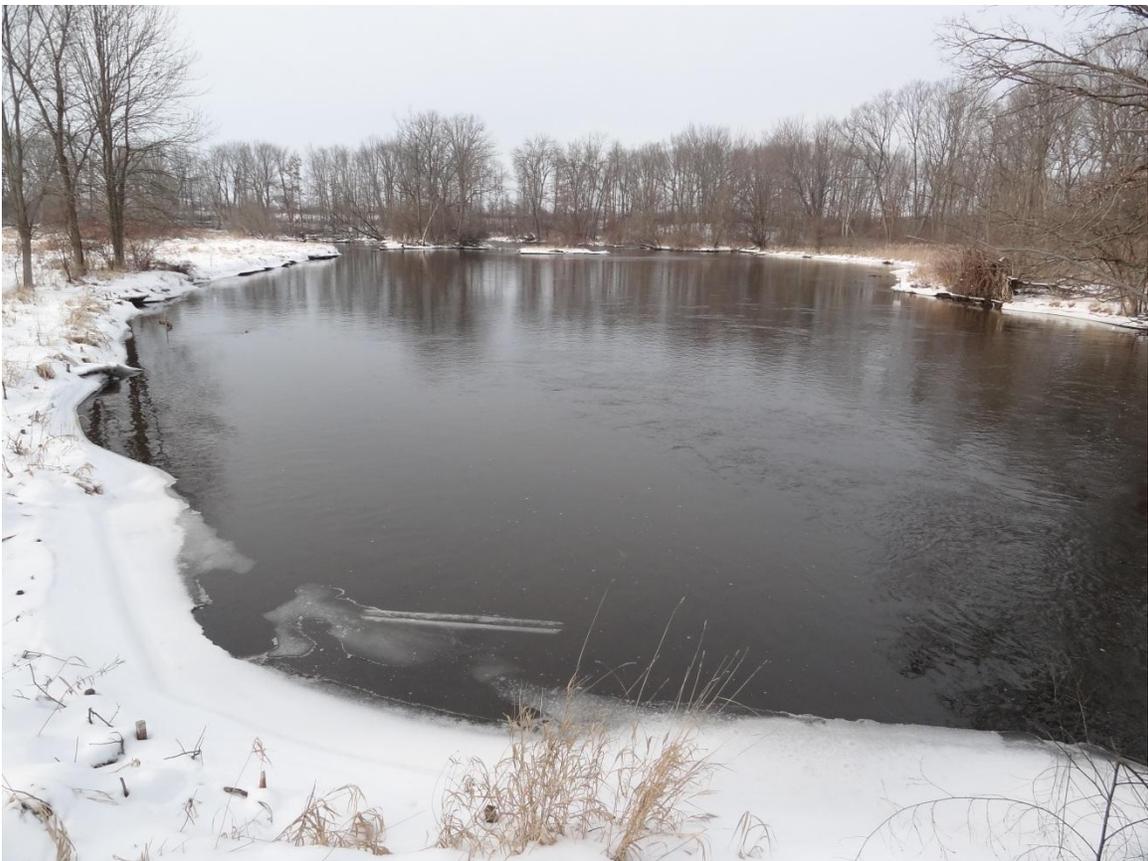
2. MP2.25 Saylor's Landing observed river ice conditions.

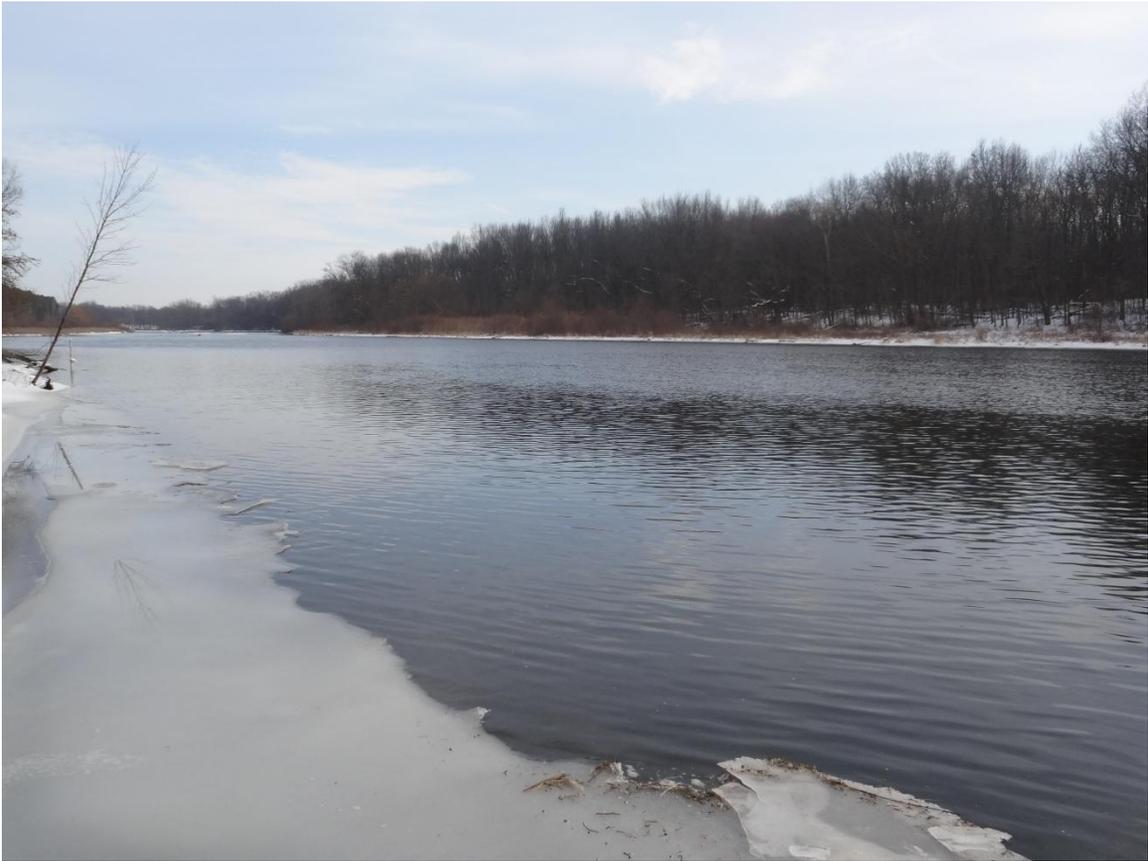
3. C0.4 Boat Launch observed river ice conditions.

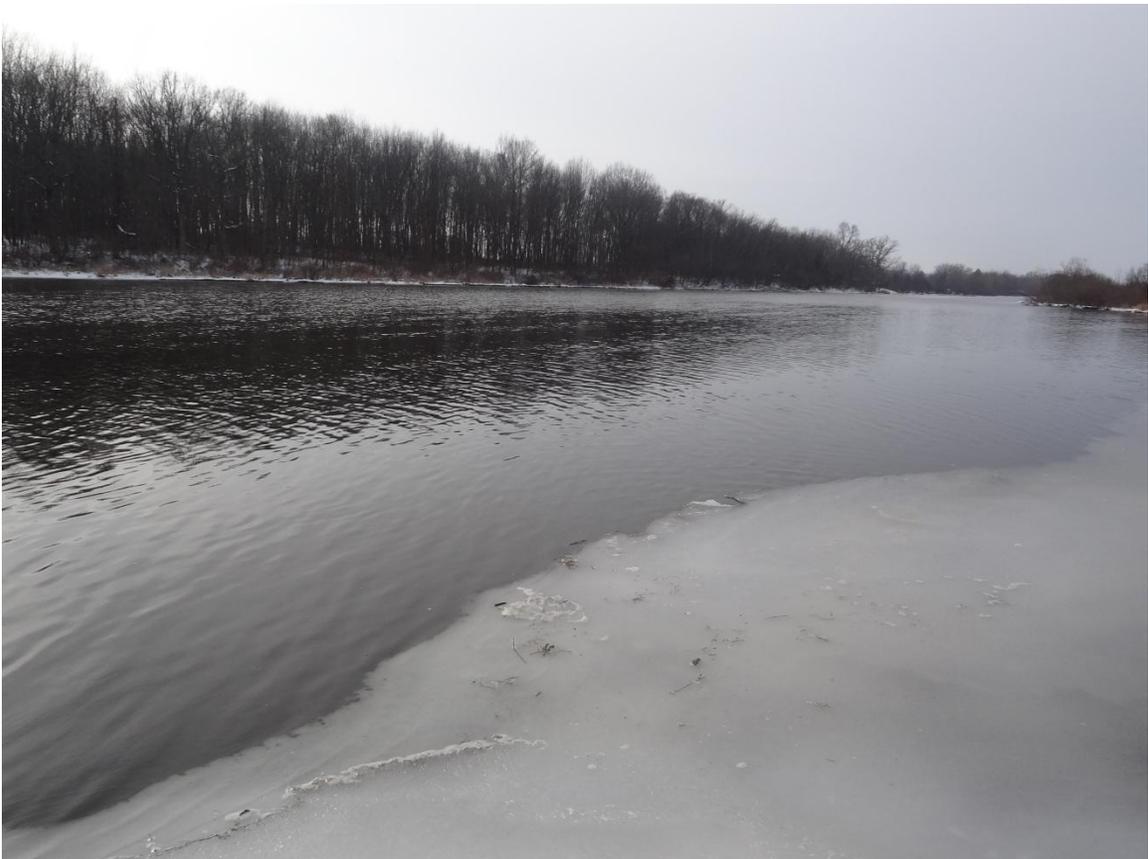
4. C0.4 Boat Launch observed river ice conditions.

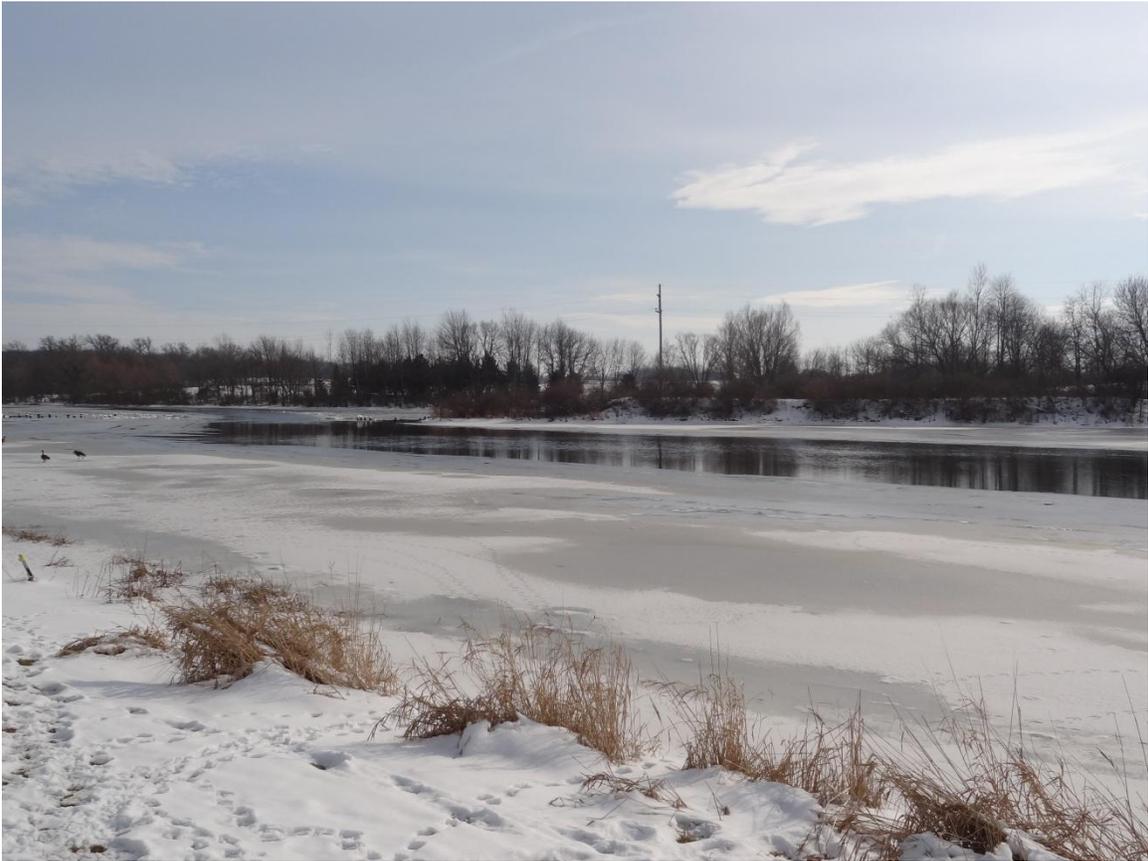
5. Ceresco Dam impoundment observed river ice conditions.

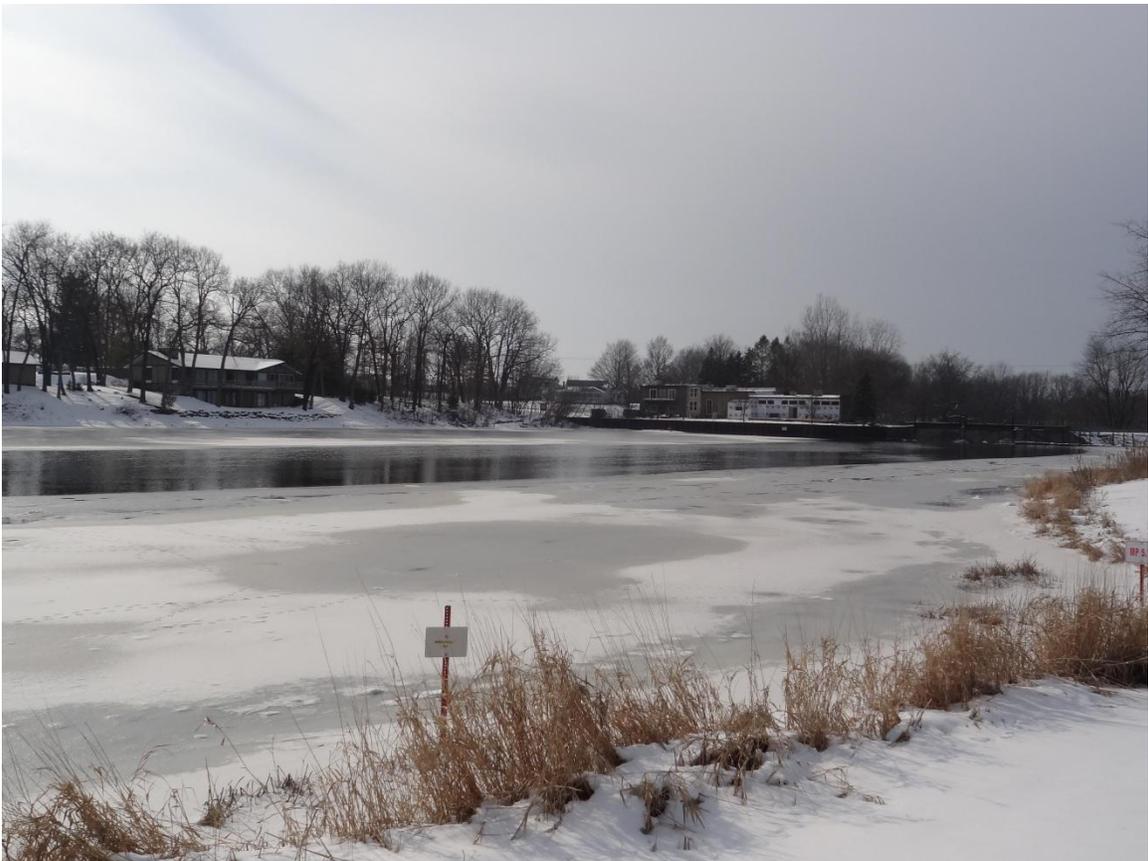
6. Ceresco Dam impoundment observed river ice conditions.

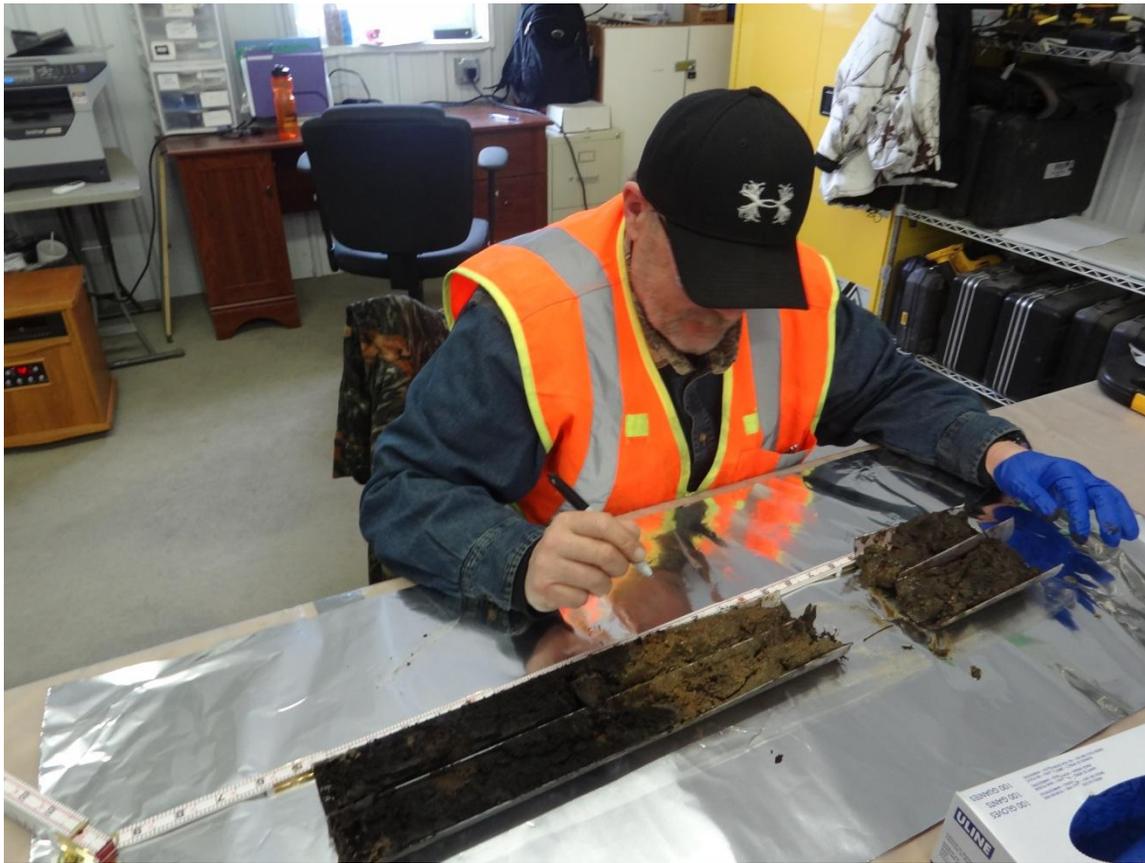
7. C3.2 Pole Barn observed core logging procedures.

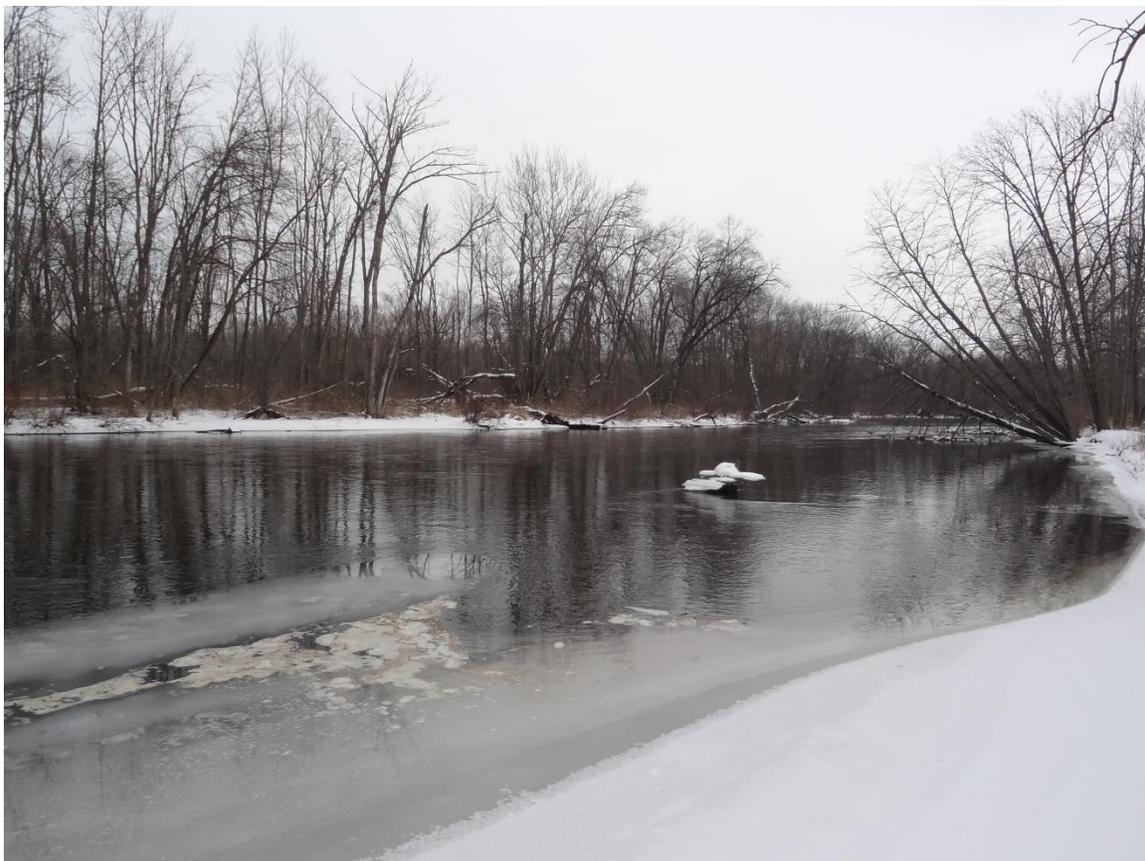
8. C3.2 Boat Launch observed river ice conditions.

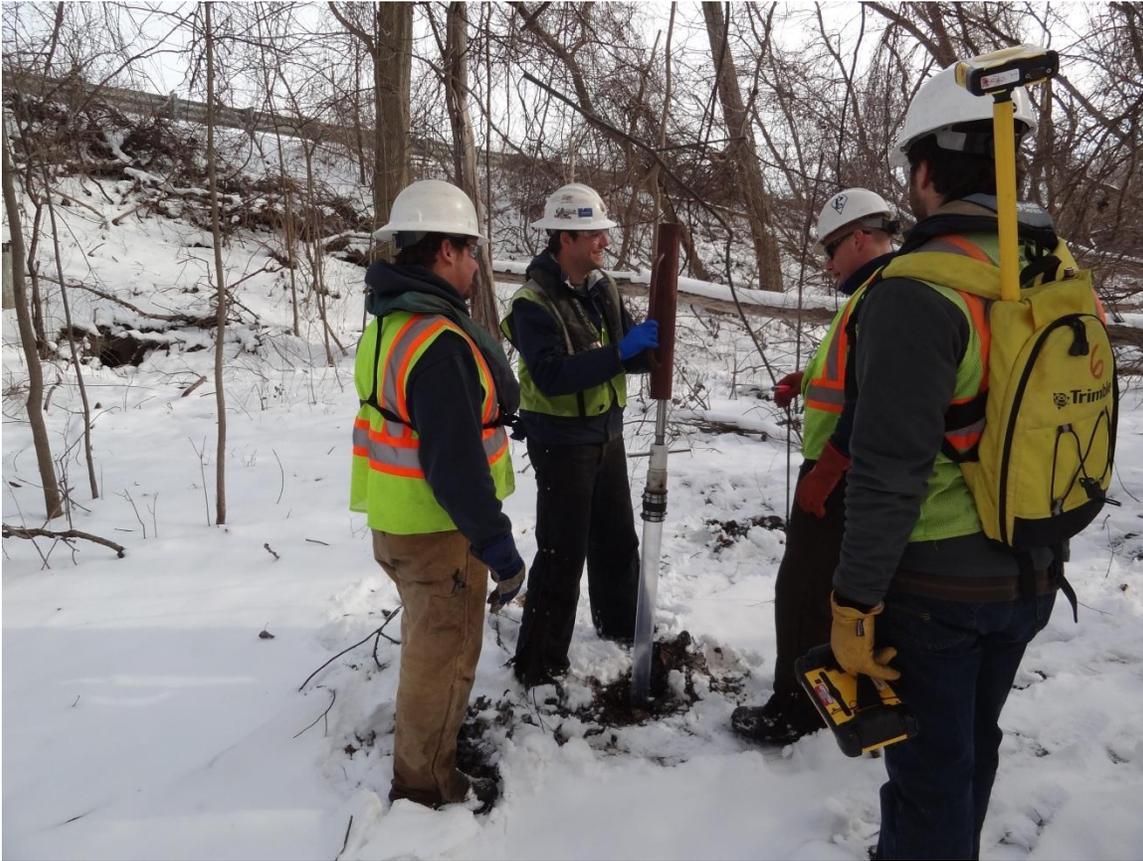
9. MP15.00 RDB observed RI team

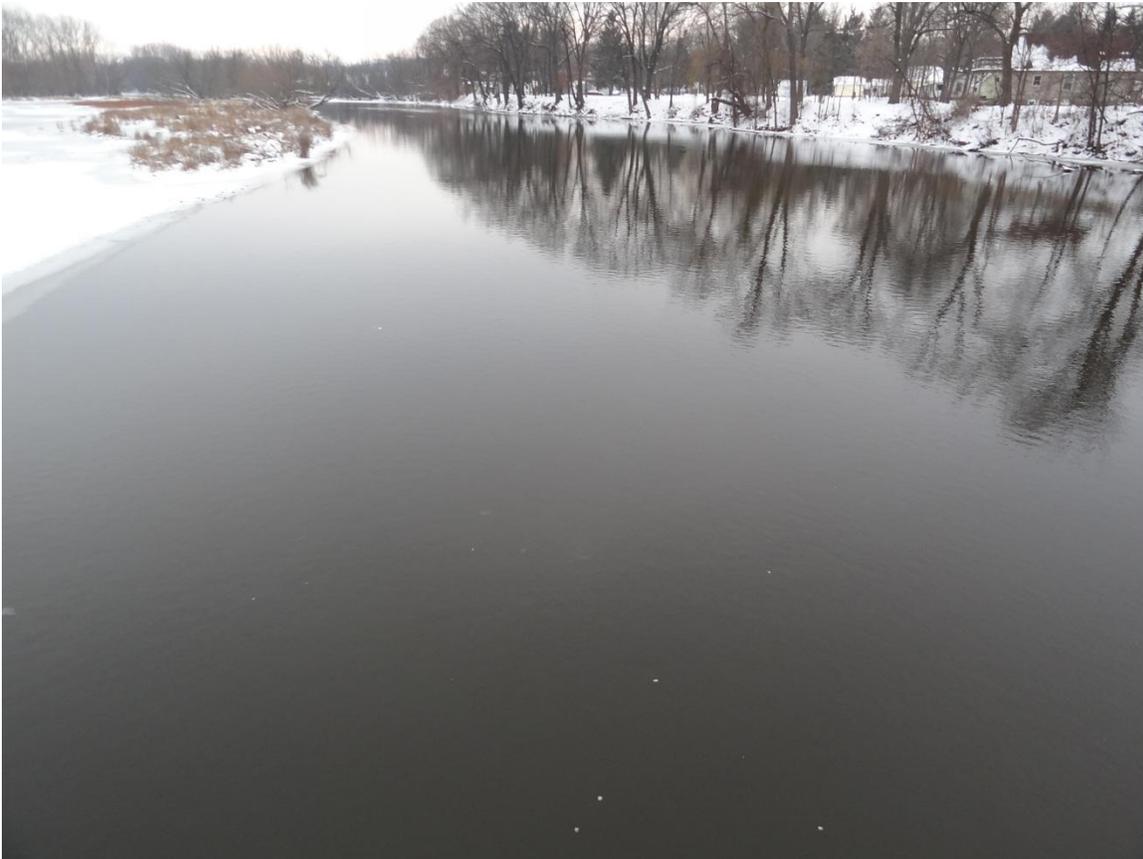
10. MP15.25 South Mill Pond observed river ice conditions.

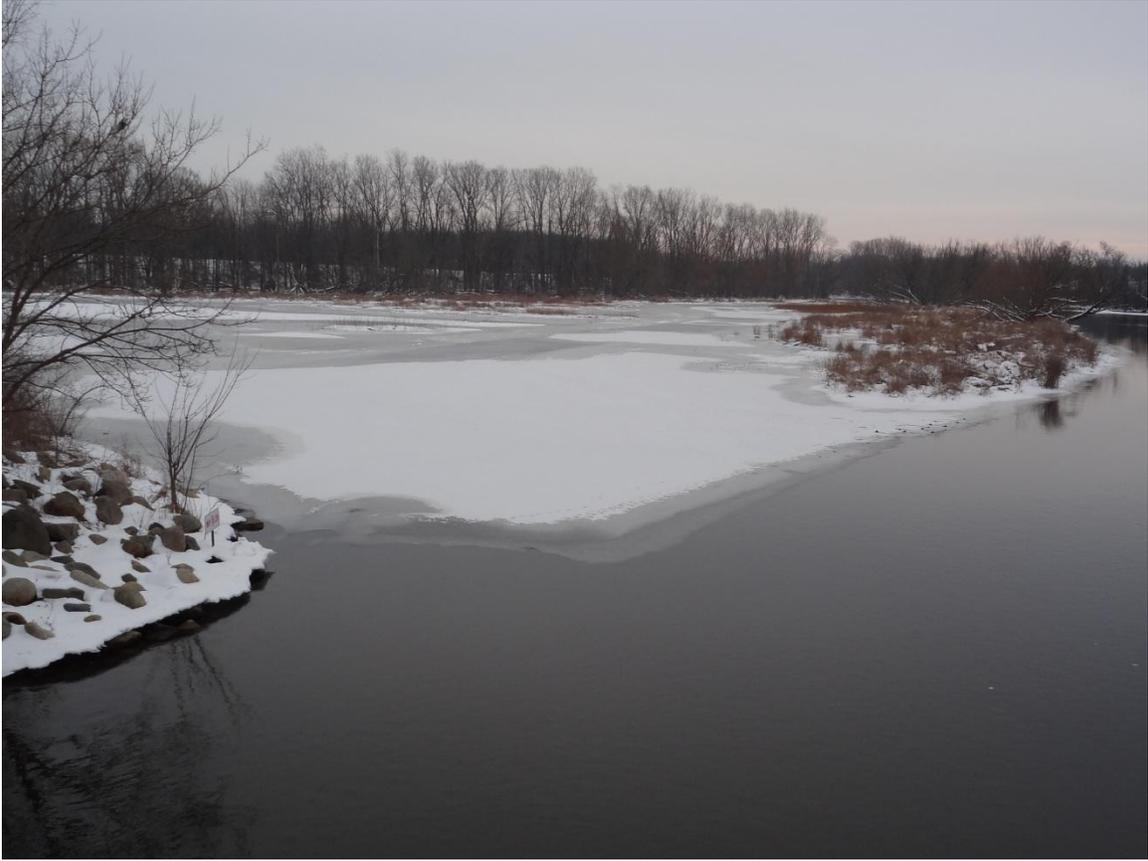
11. MP15.25 South Mill Pond observed back water ice conditions.

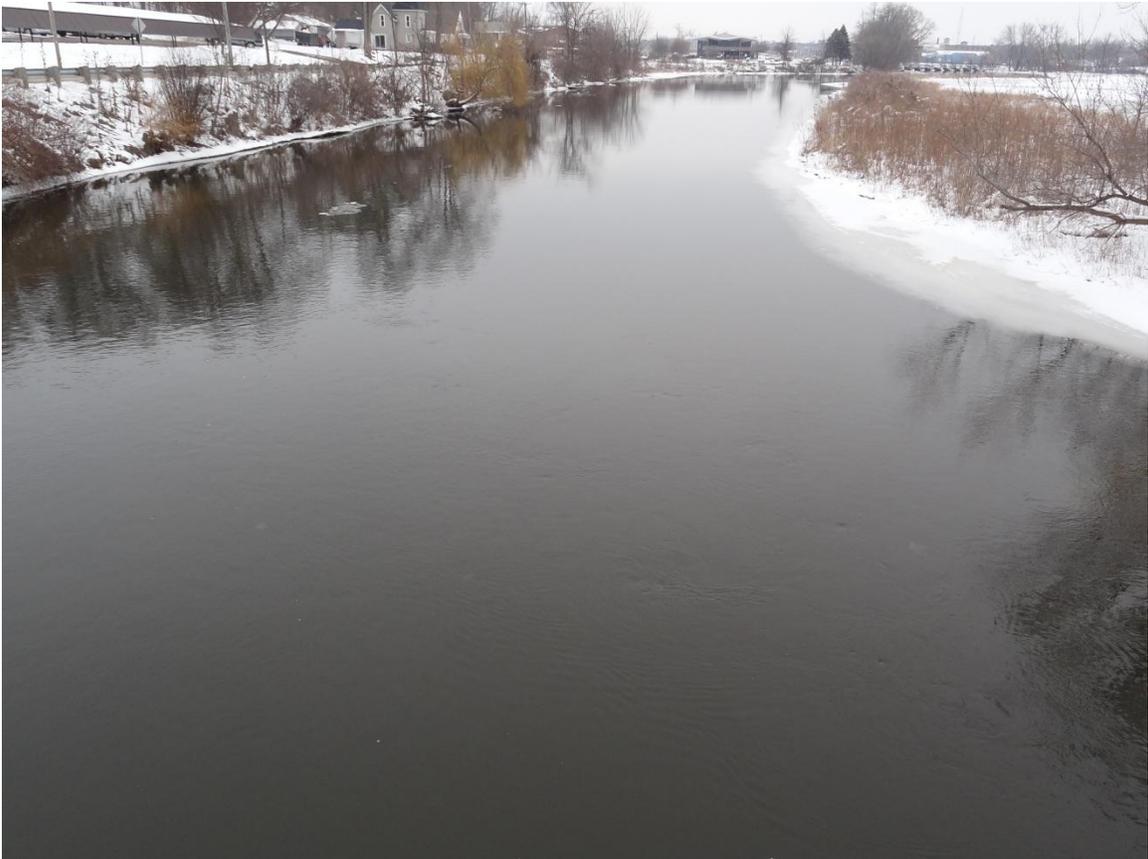
12. MP15.50 North Mill Pond observed river ice conditions.

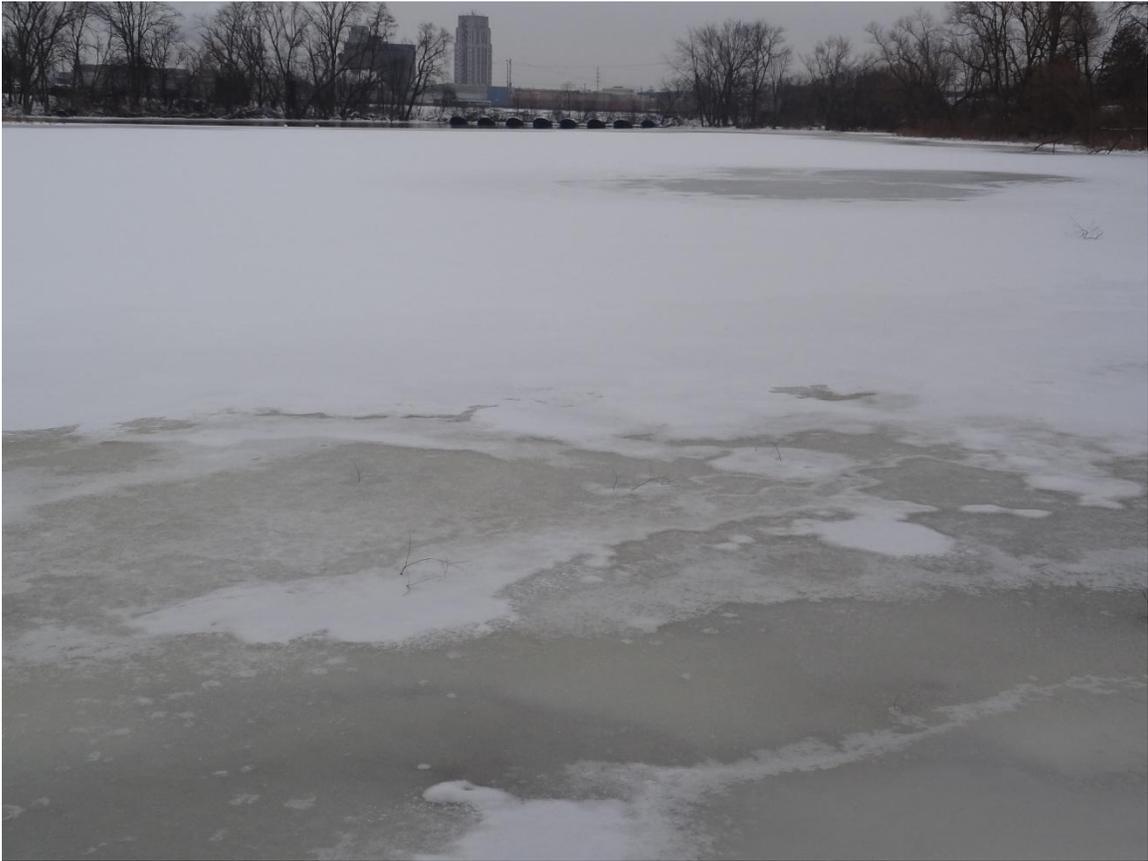
13. MP15.50 North Mill Pond observed back water ice conditions.

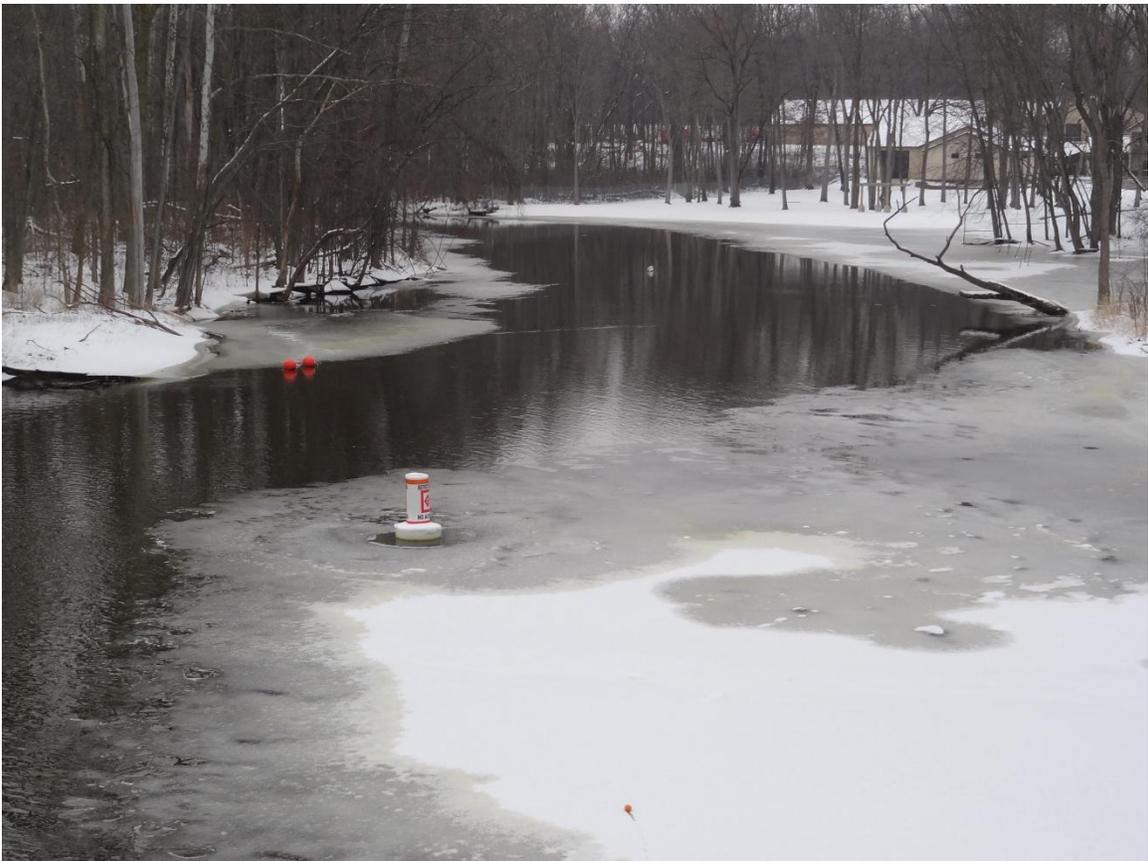
14. MP21.50 Oxbow observed ice conditions.

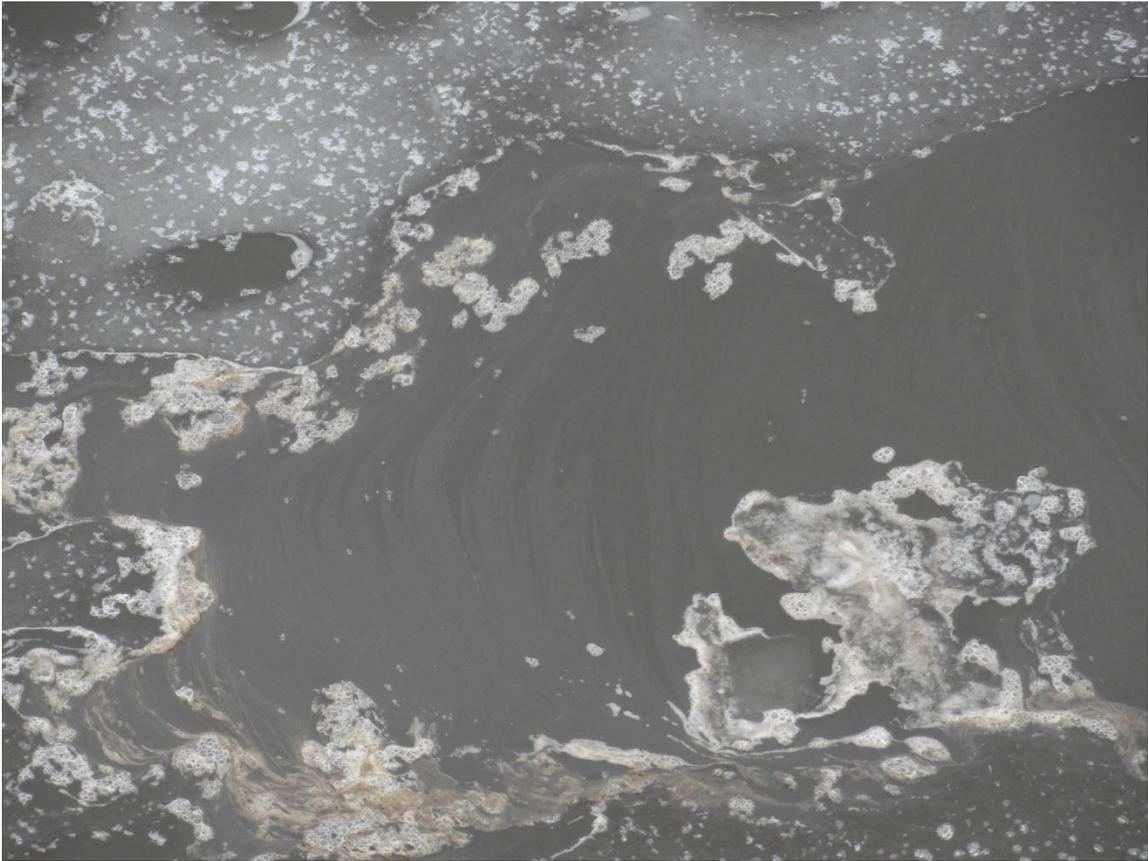
15. MP21.50 RDB sheen observed.

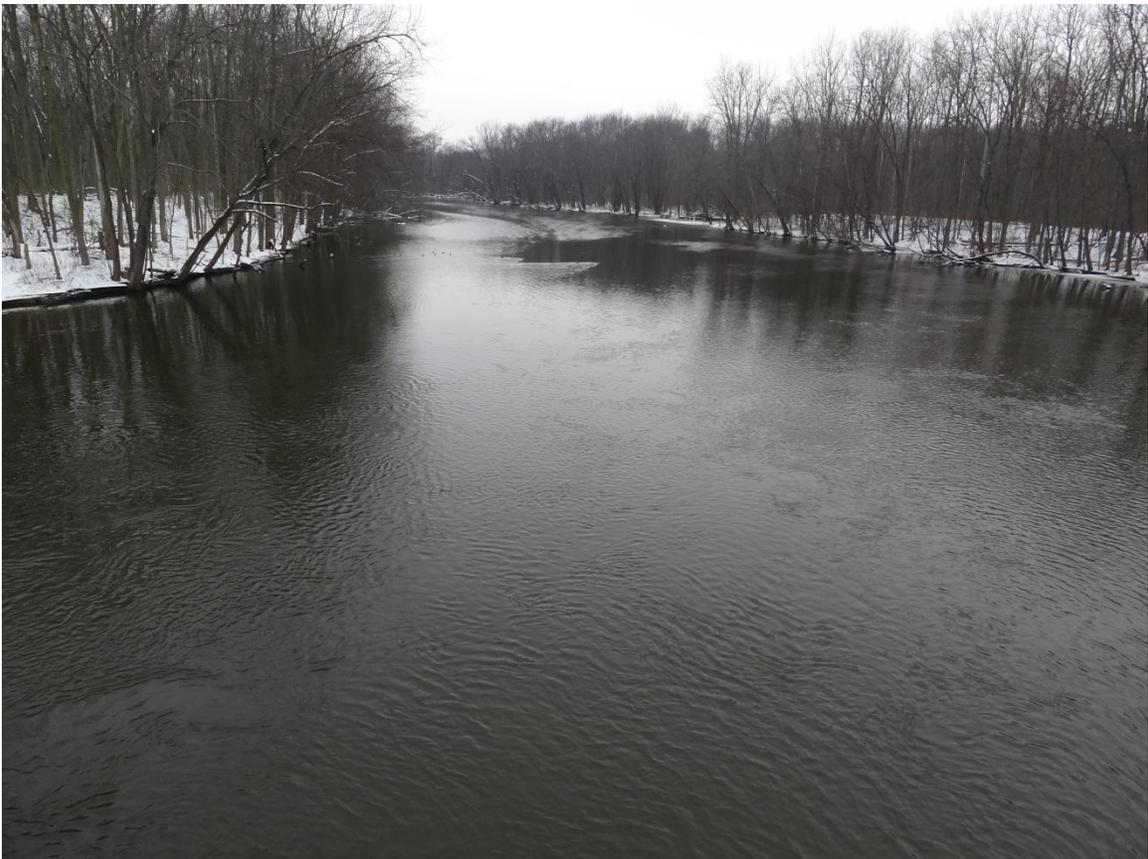
16. MP21.50 observed river ice conditions.

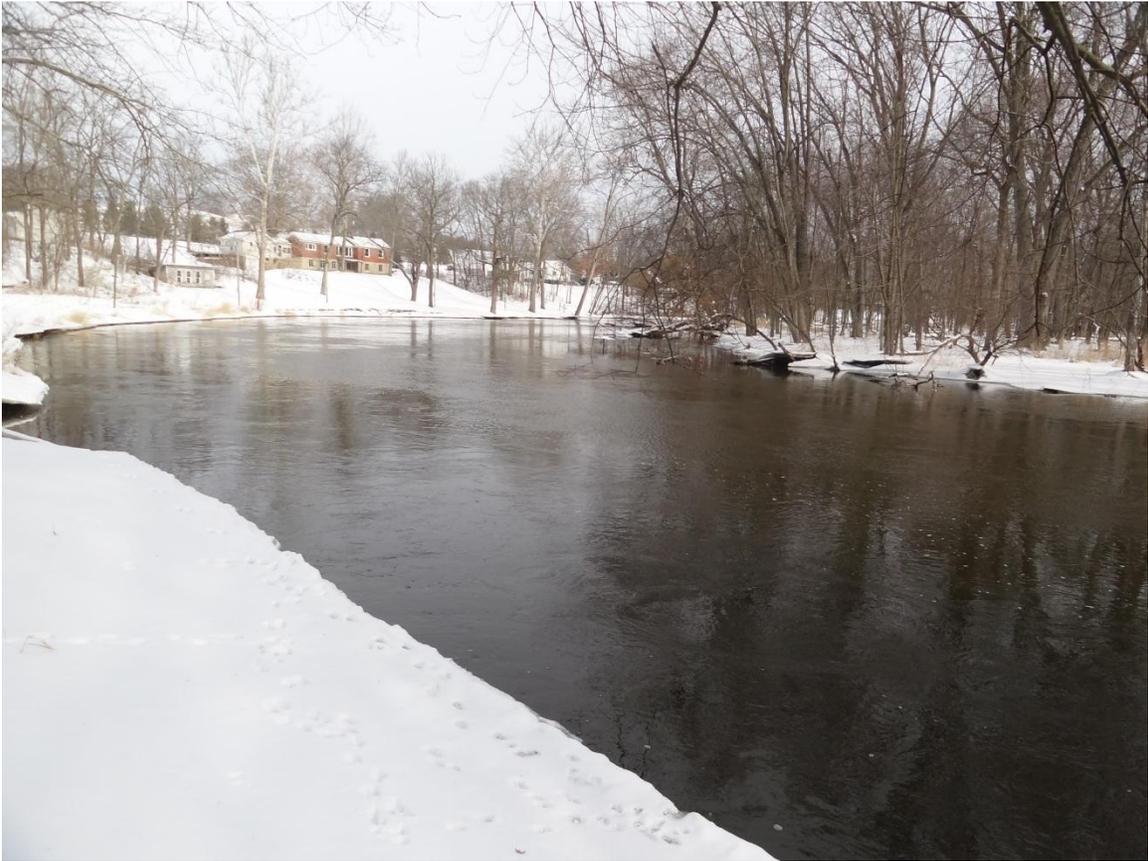
**17. MP27.00 Shady Bend Campground observed upstream river ice conditions.**

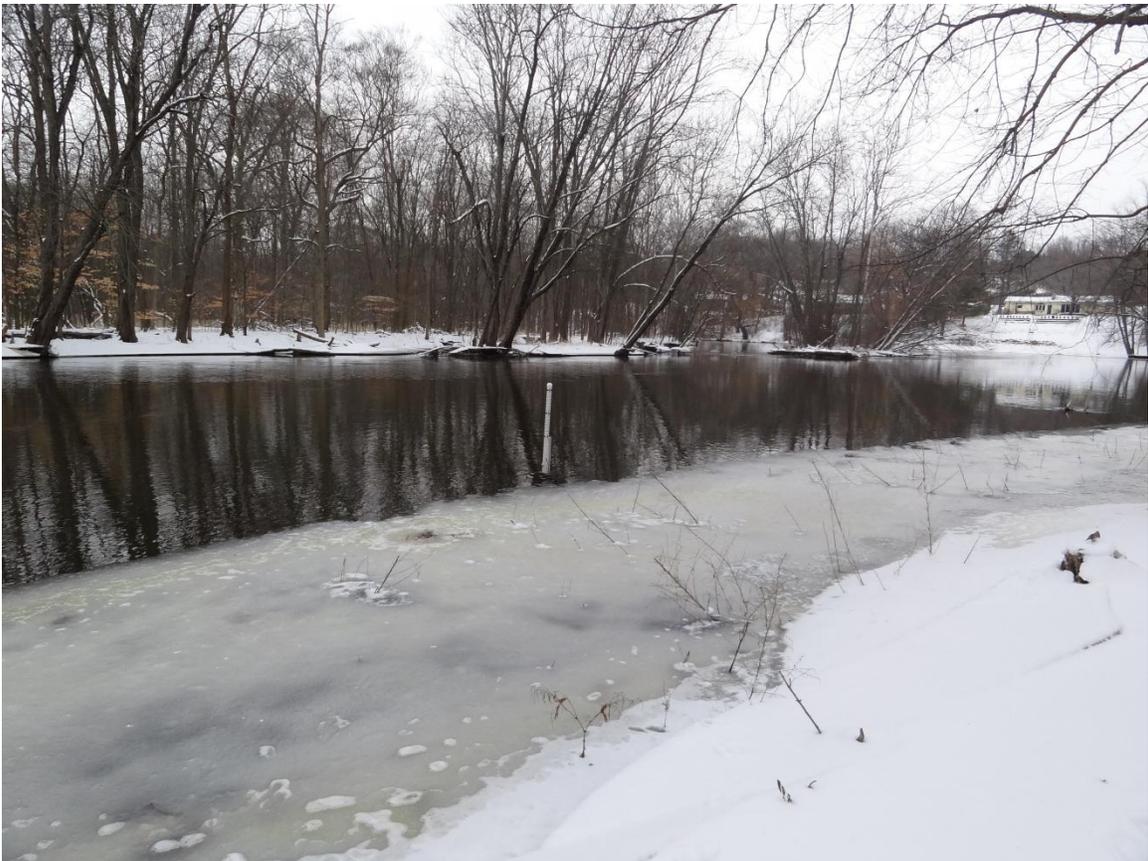
**18. MP27.00 Shady Bend Campground observed downstream river ice conditions.**

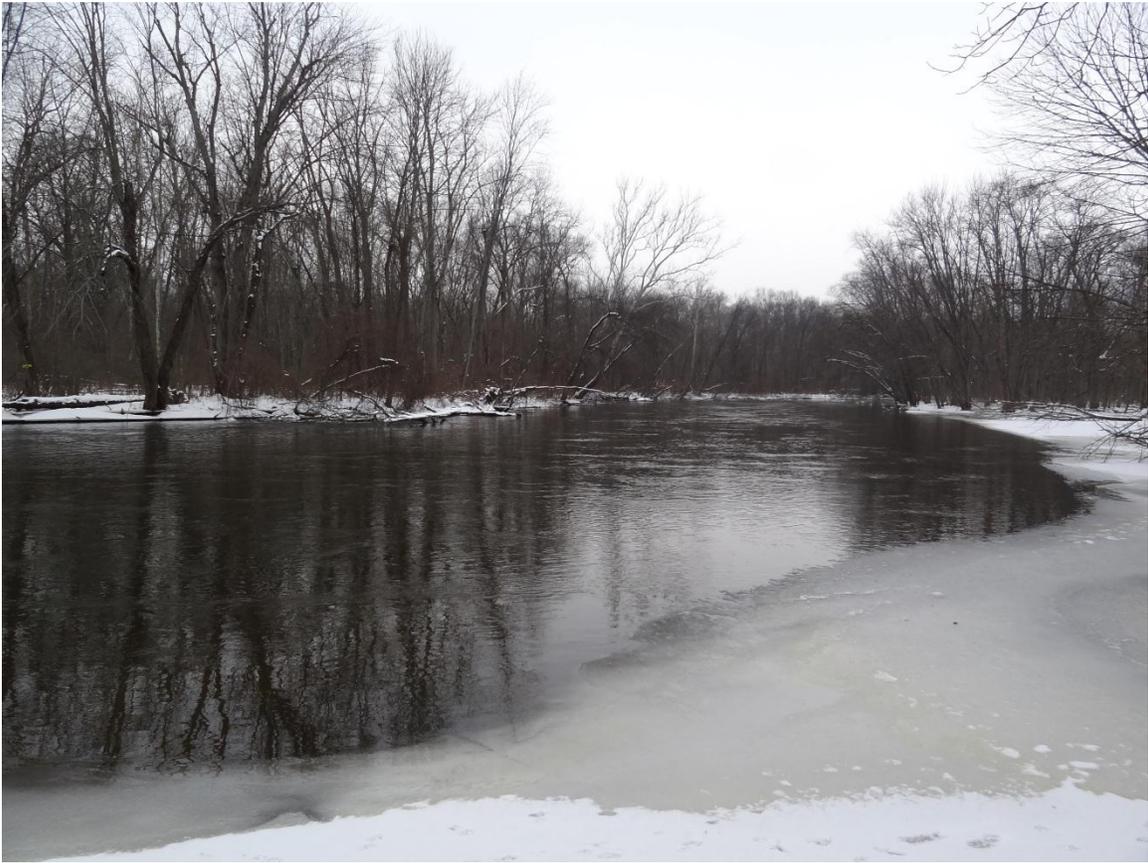
19. E2 Boat Launch observed upstream river ice conditions.

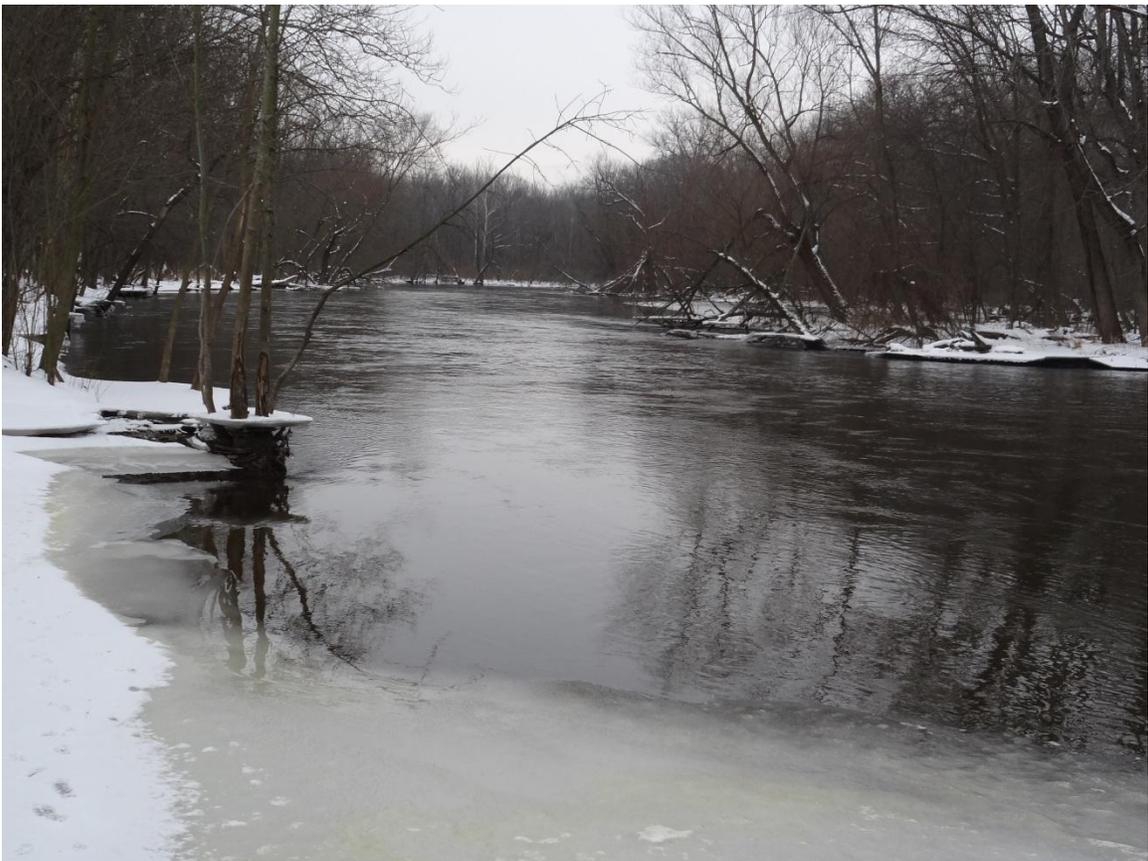
20. E2 Boat Launch observed downstream river ice conditions.

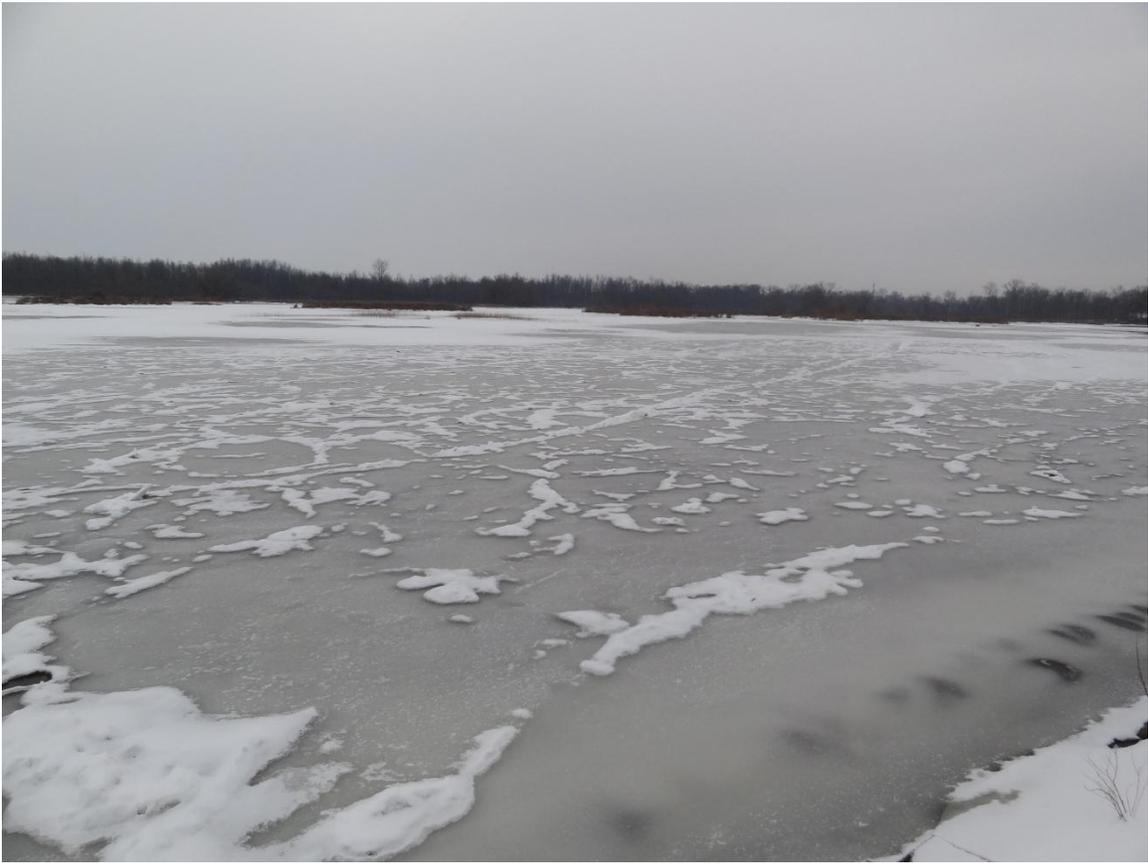
21. Morrow Lake Delta observed ice conditions.

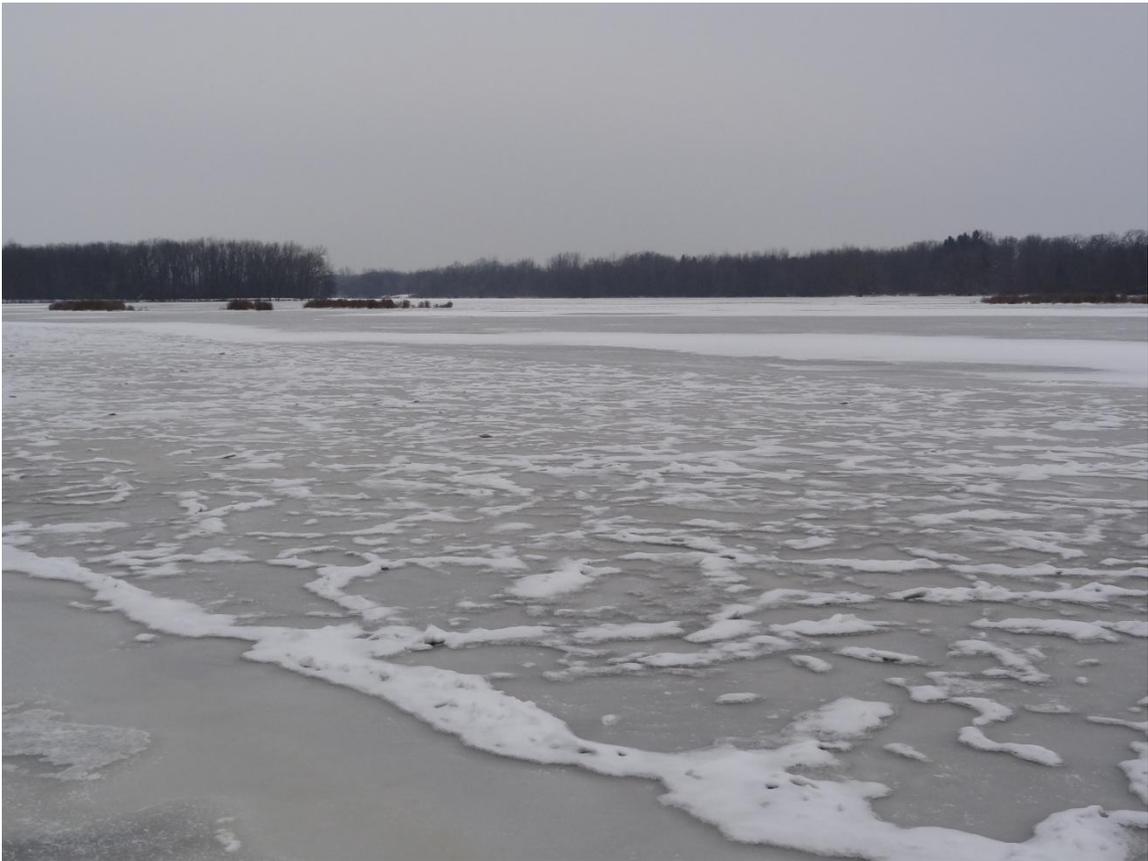
22. Morrow Lake Delta observed ice conditions.

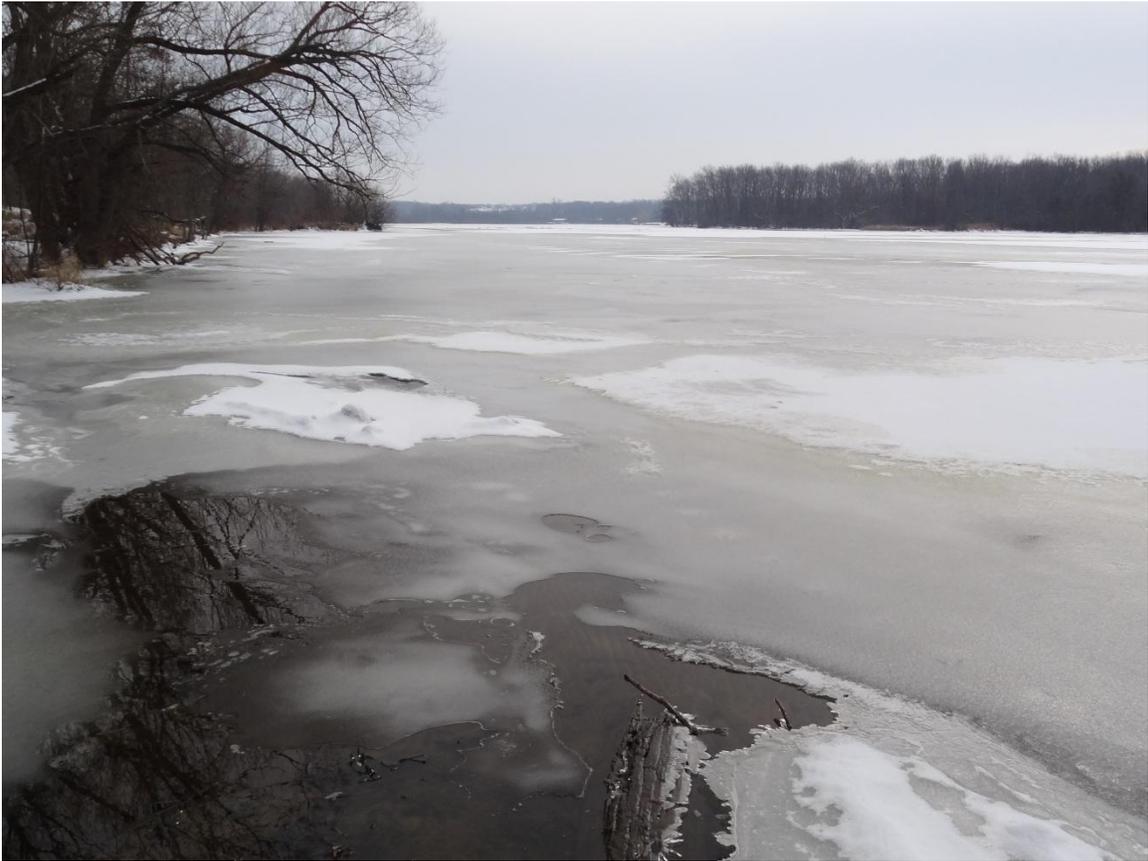
**23. Morrow Lake Neck/Morrow Lake Delta observed ice conditions.**
