# Situation Photo Log

Thursday, February 7, 2013

Kalamazoo River / Enbridge Spill

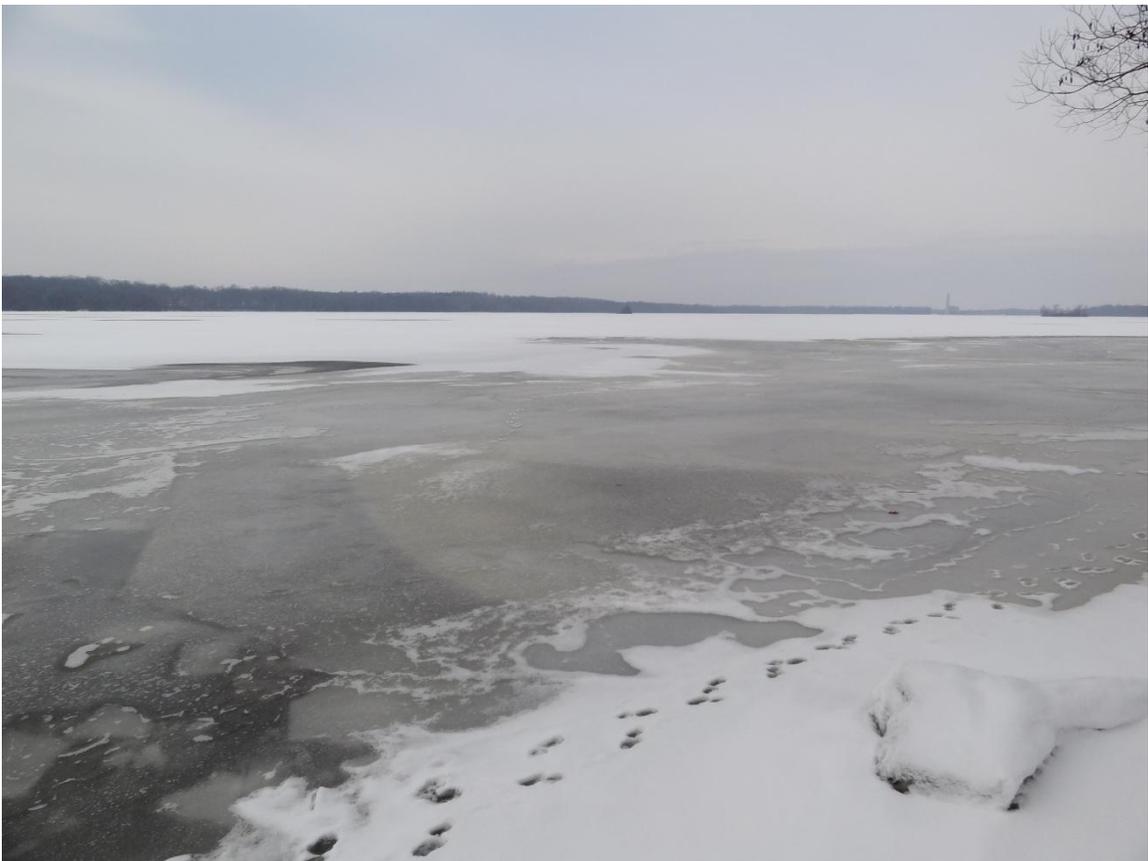
**24. Morrow Lake observed ice conditions.**
