Situation Photo Log

Saturday, February 9, 2013

Kalamazoo River / Enbridge Spill

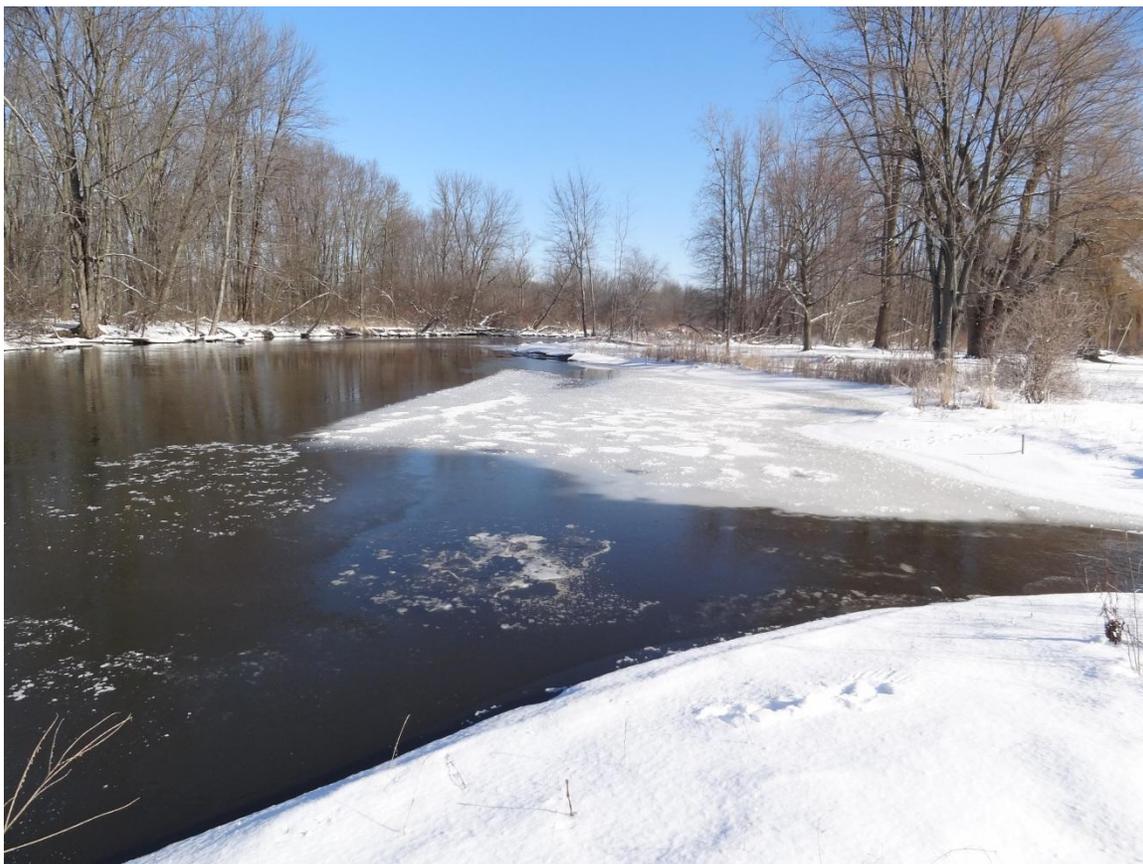
1. Confluence observed icing conditions.

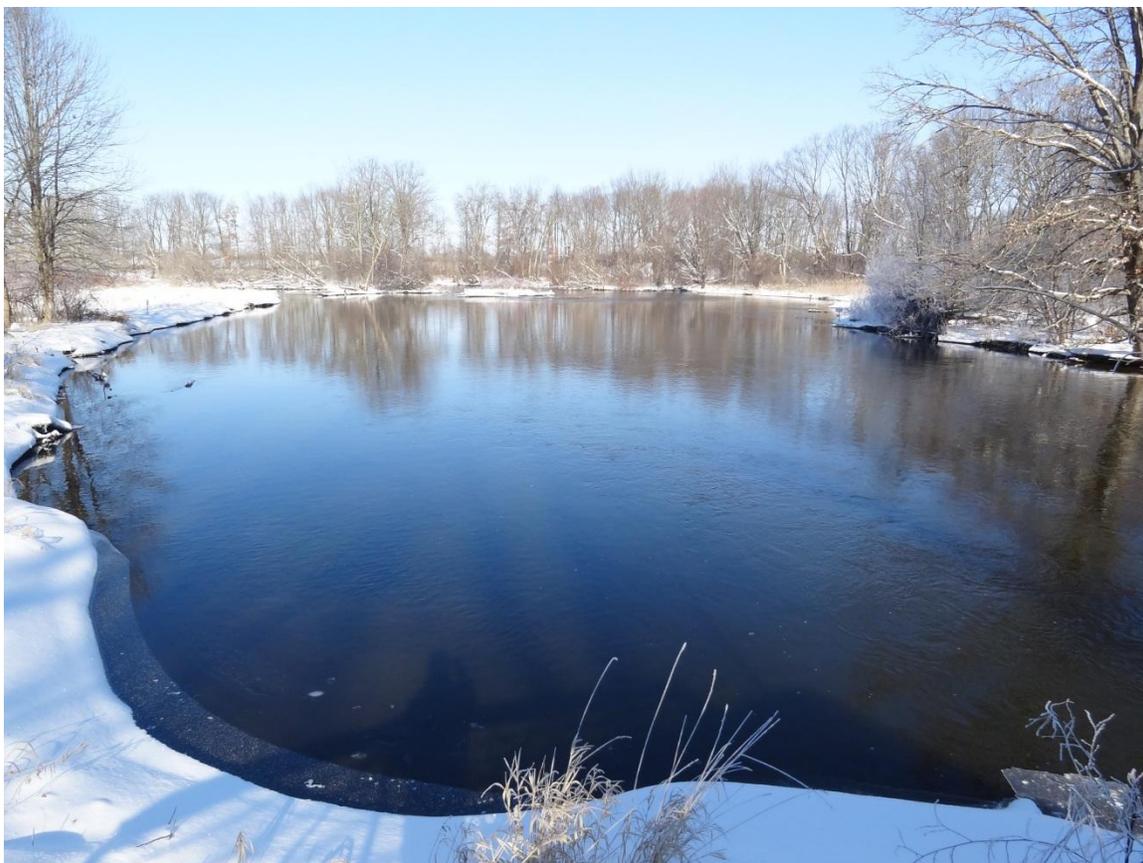
2. MP2.25 Saylor's Landing observed river icing conditions.

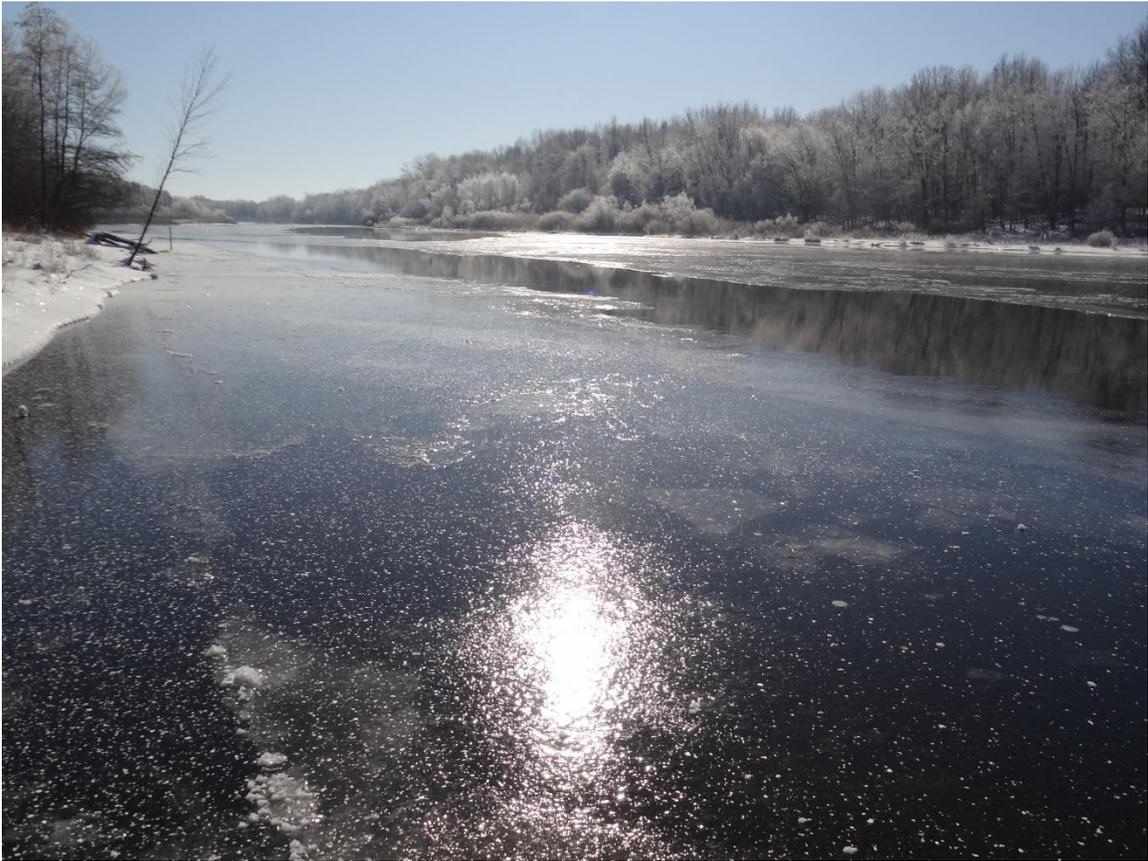
3. C0.4 Boat Launch observed river icing conditions.

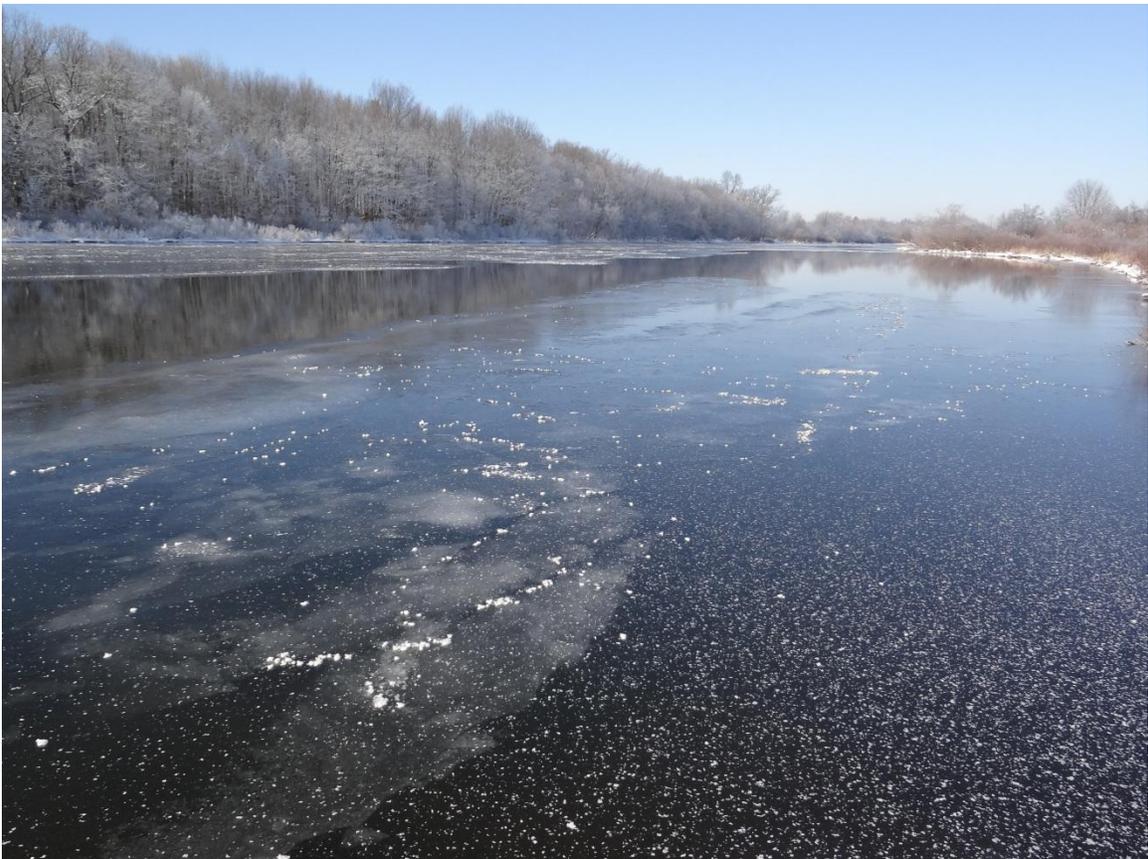
4. C0.4 Boat Launch observed river icing conditions.

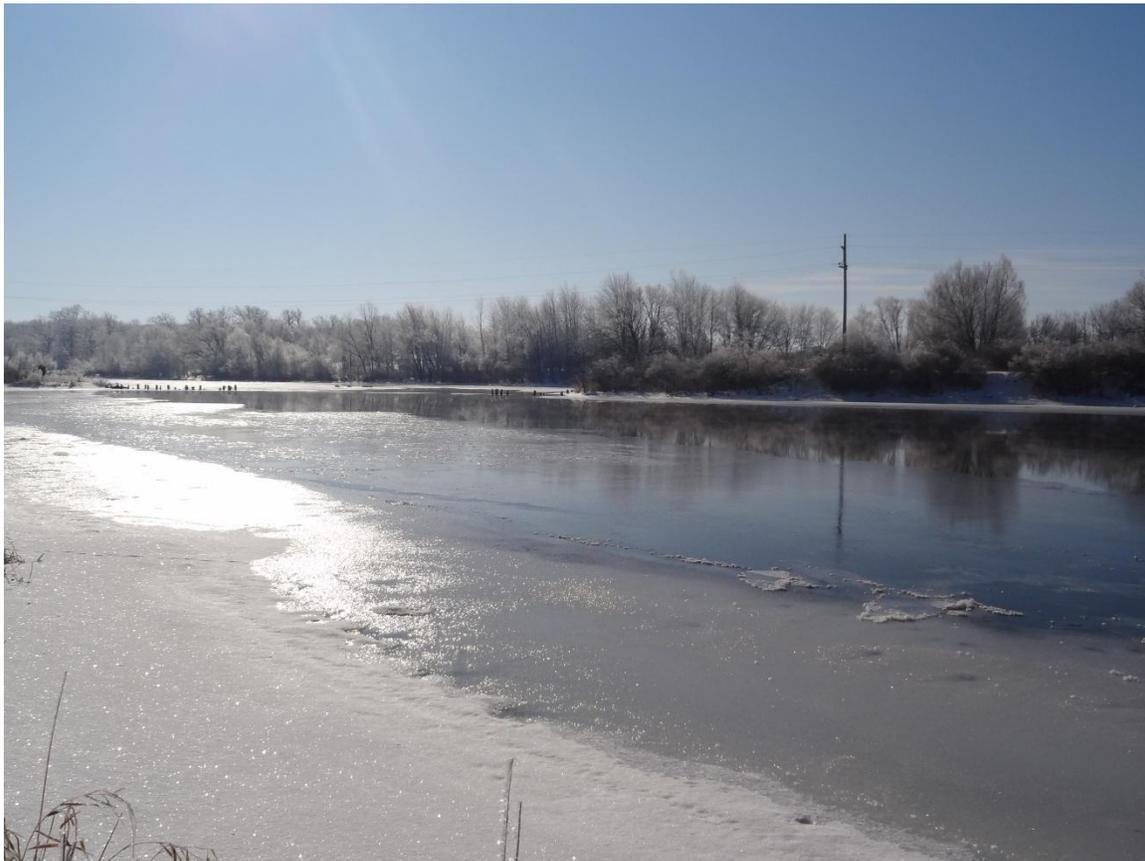
5. Ceresco Dam impoundment observed river icing conditions.

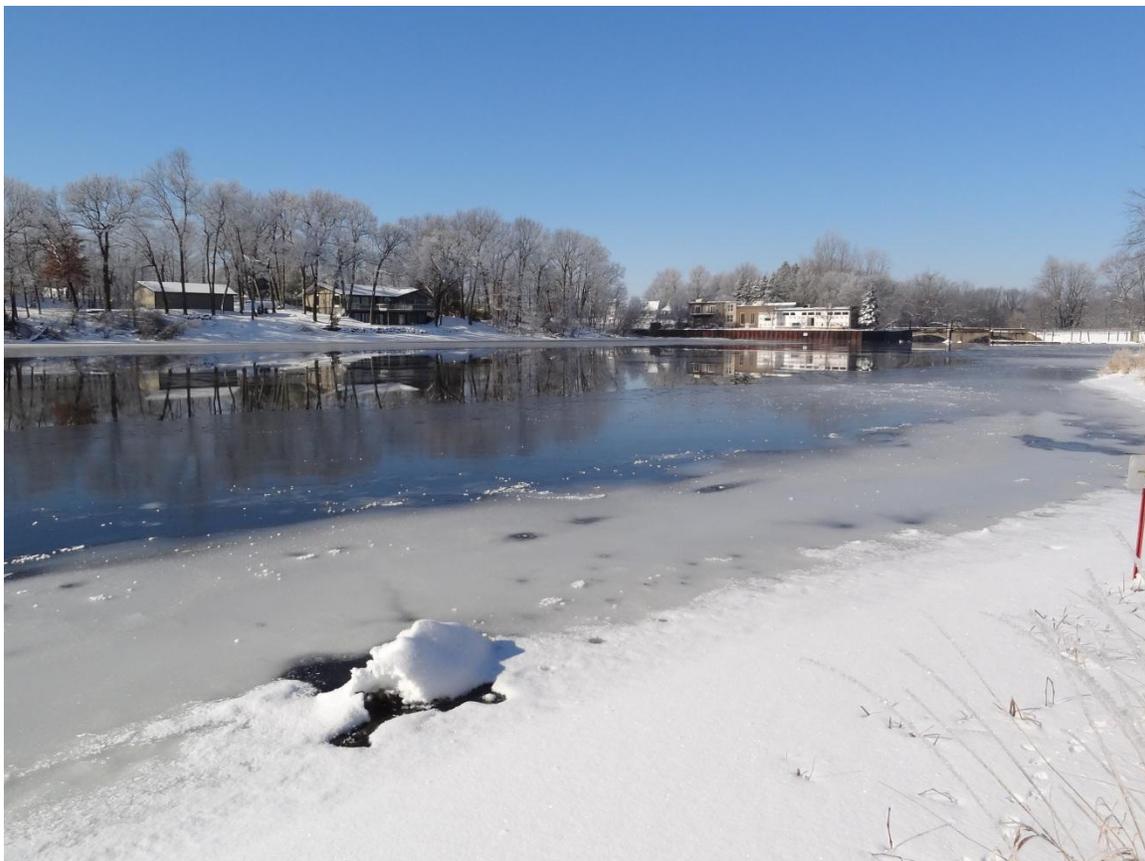
6. Ceresco Dam impoundment observed river icing conditions.

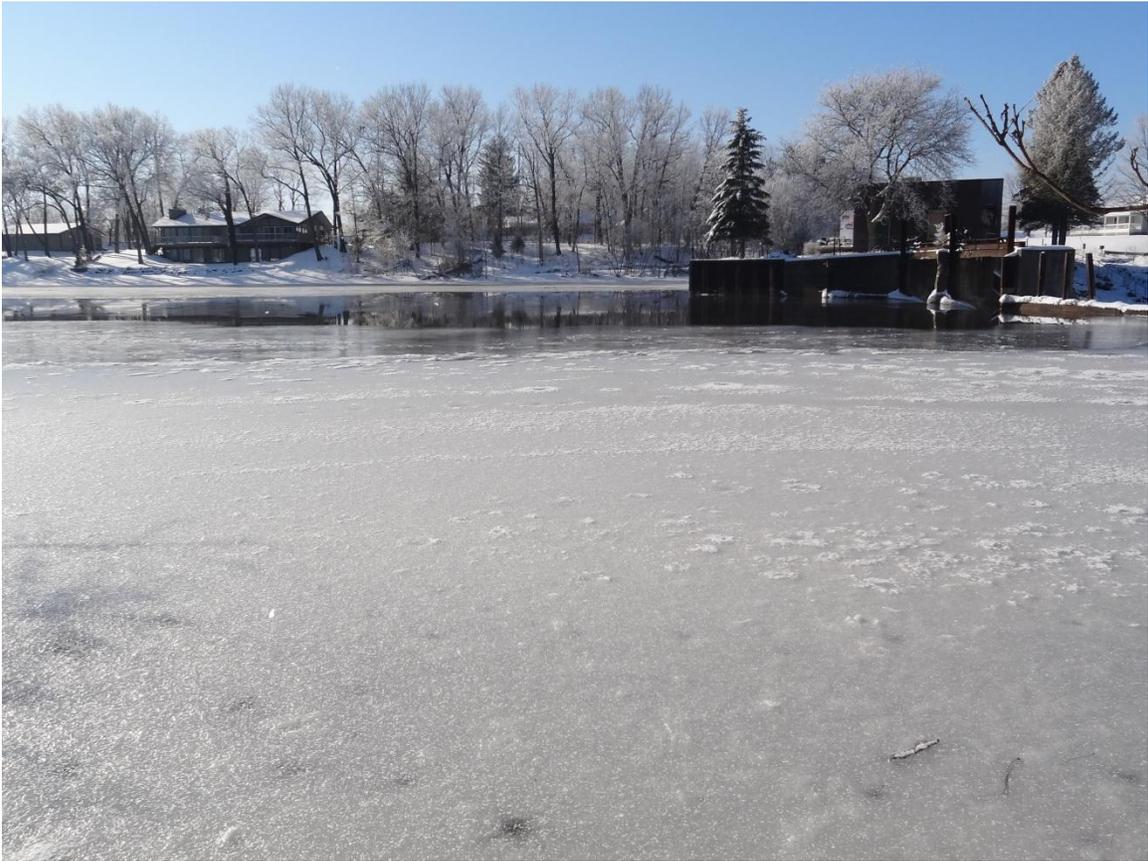
7. Ceresco Dam impoundment observed river icing conditions.

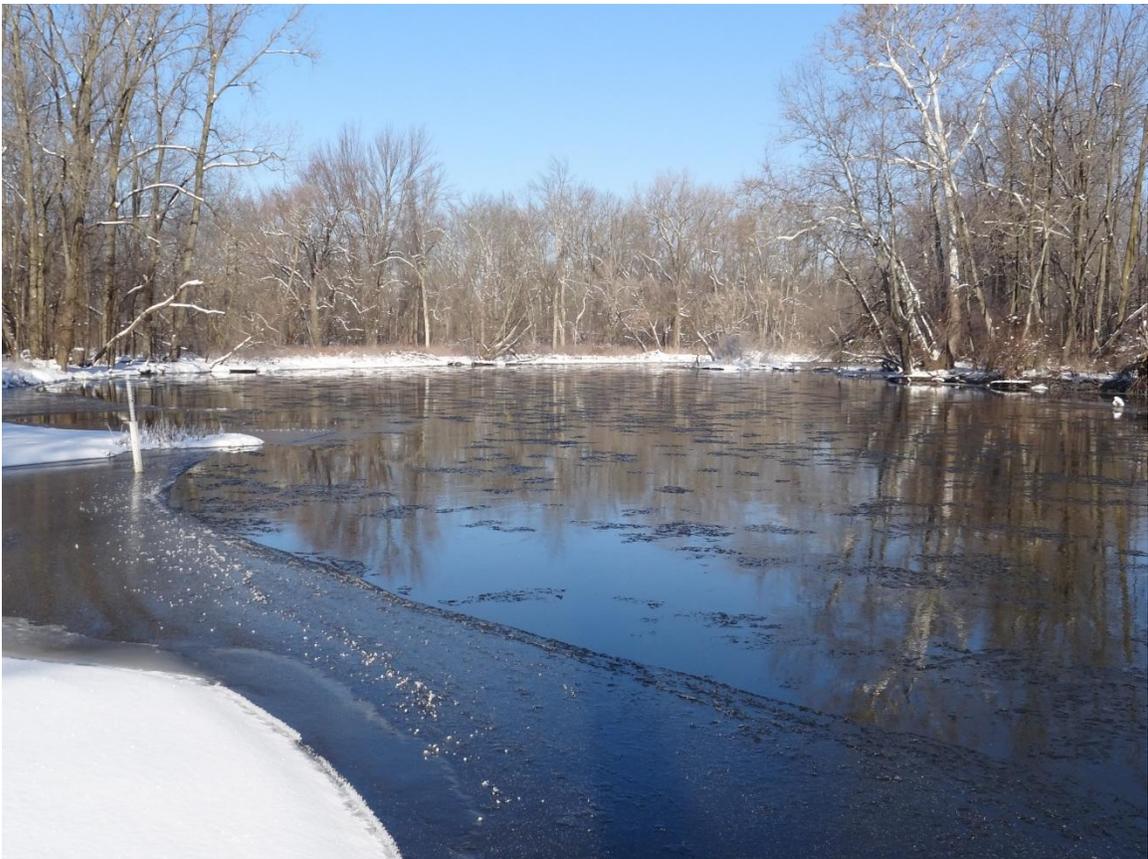
8. C3.2 Boat Launch observed river icing conditions.

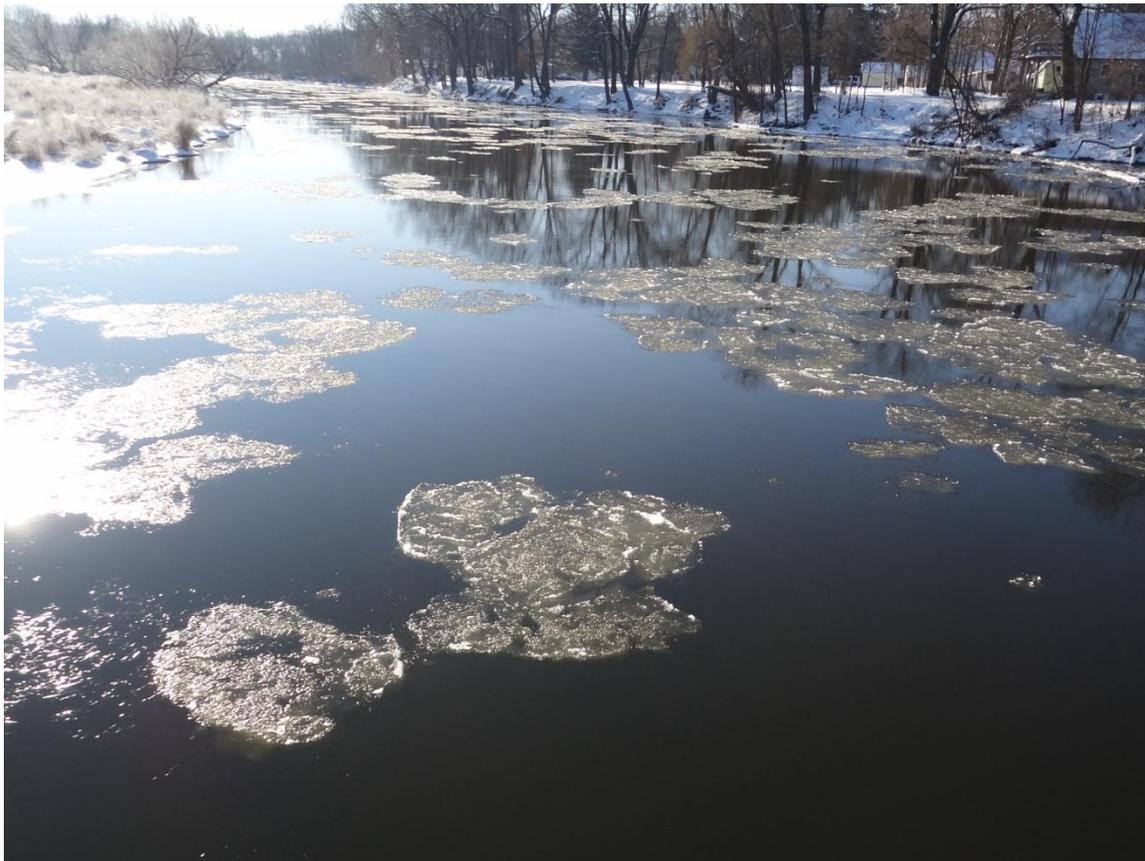
9. MP15.25 South Mill Pond observed river icing conditions.

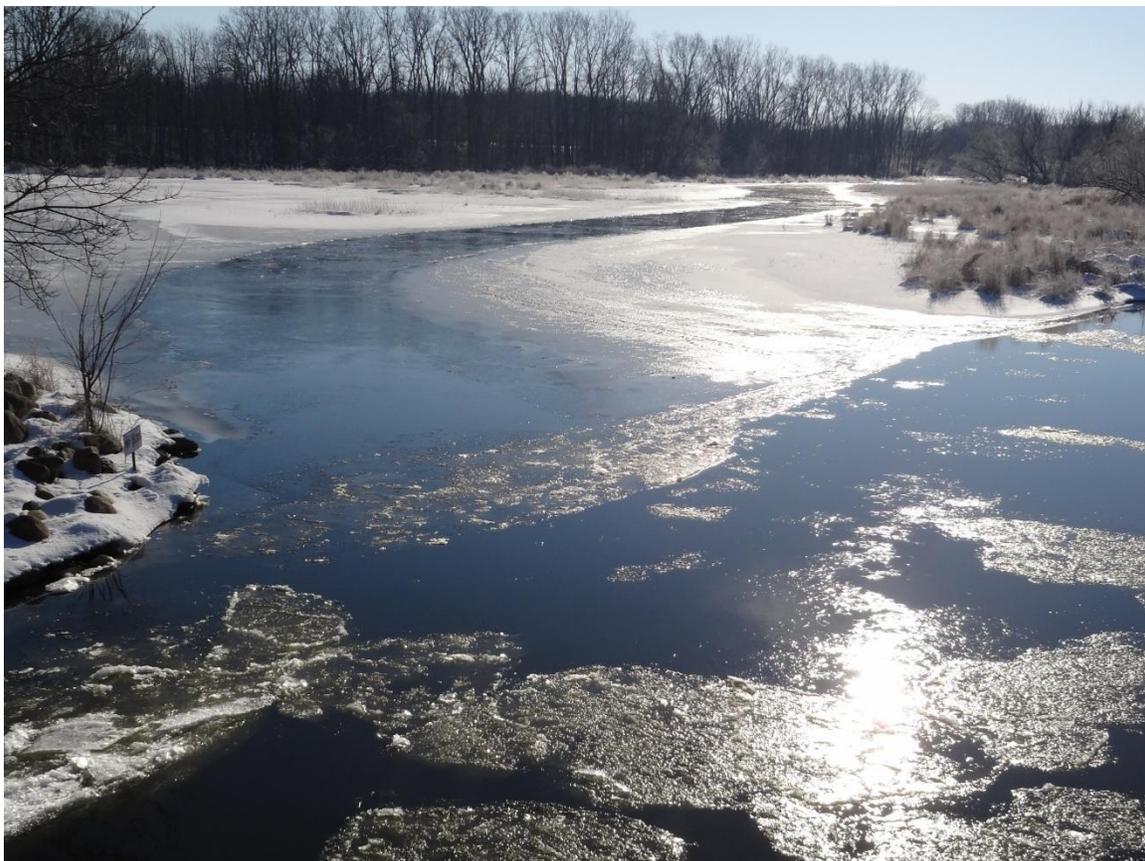
10. MP15.25 South Mill Pond observed back water icing conditions

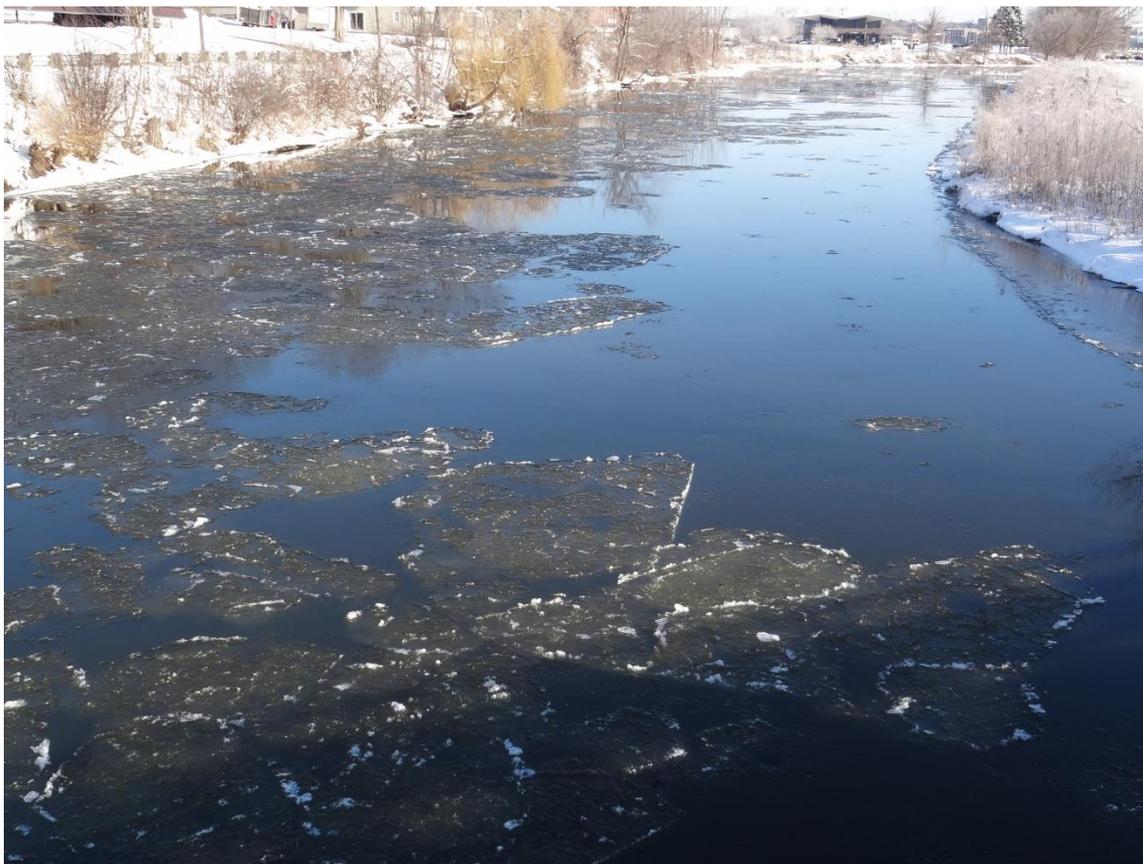
11. MP15.50 North Mill Pond observed river icing conditions.

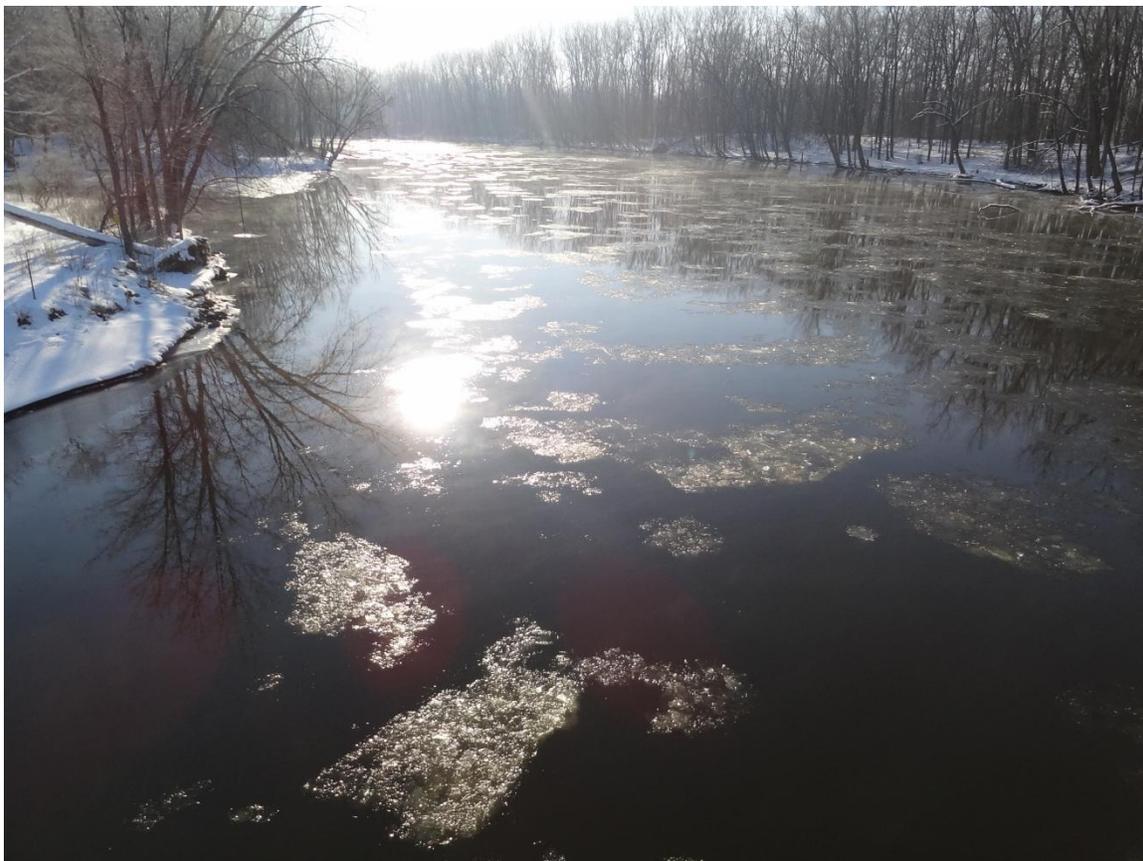
12. MP21.50 Custer Road bridge observed river icing conditions.

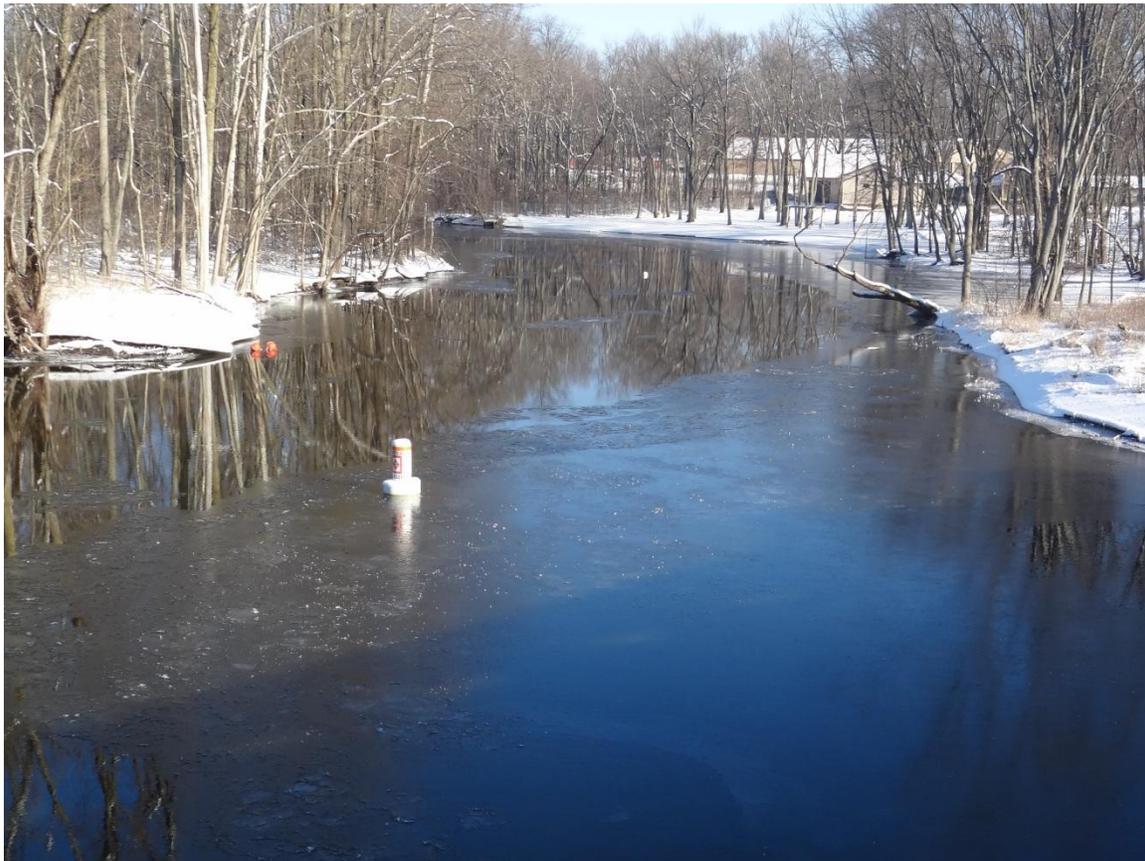
13. MP21.50 Oxbow observed icing conditions.

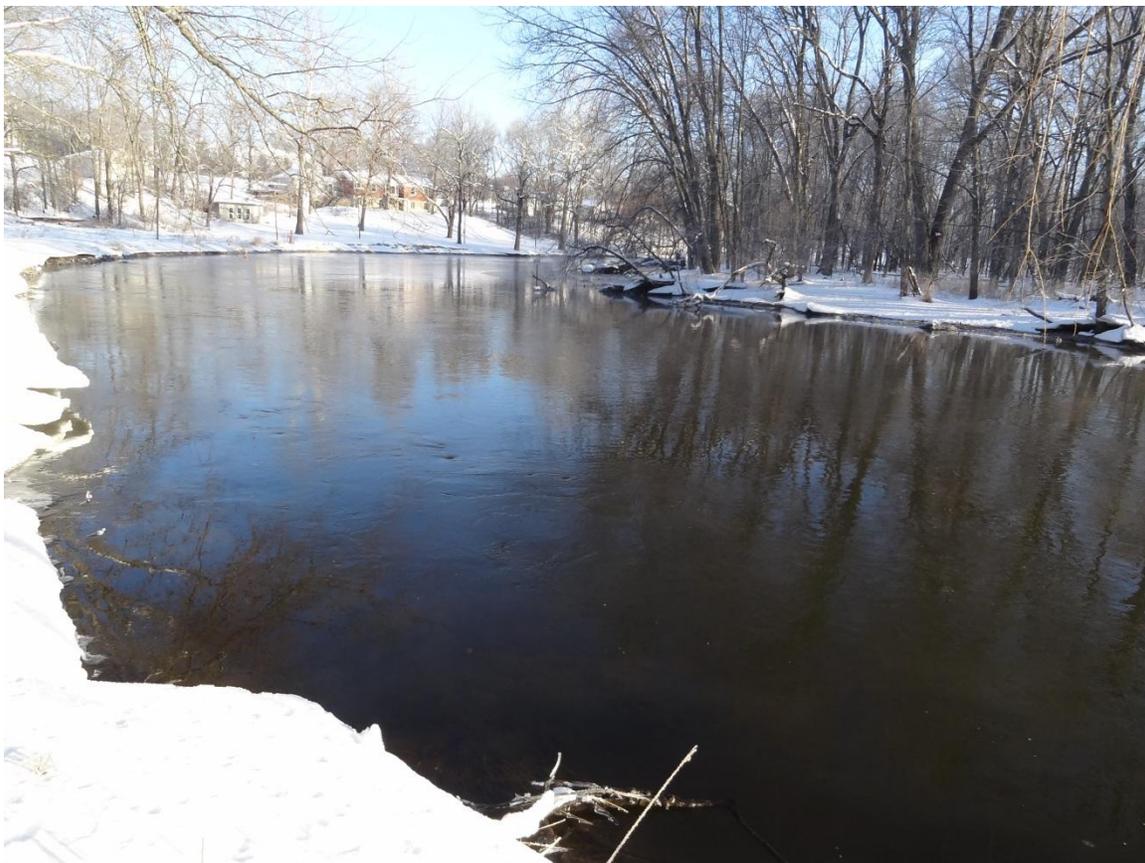
14. MP27.00 Shady Bend Campground observed river icing conditions.

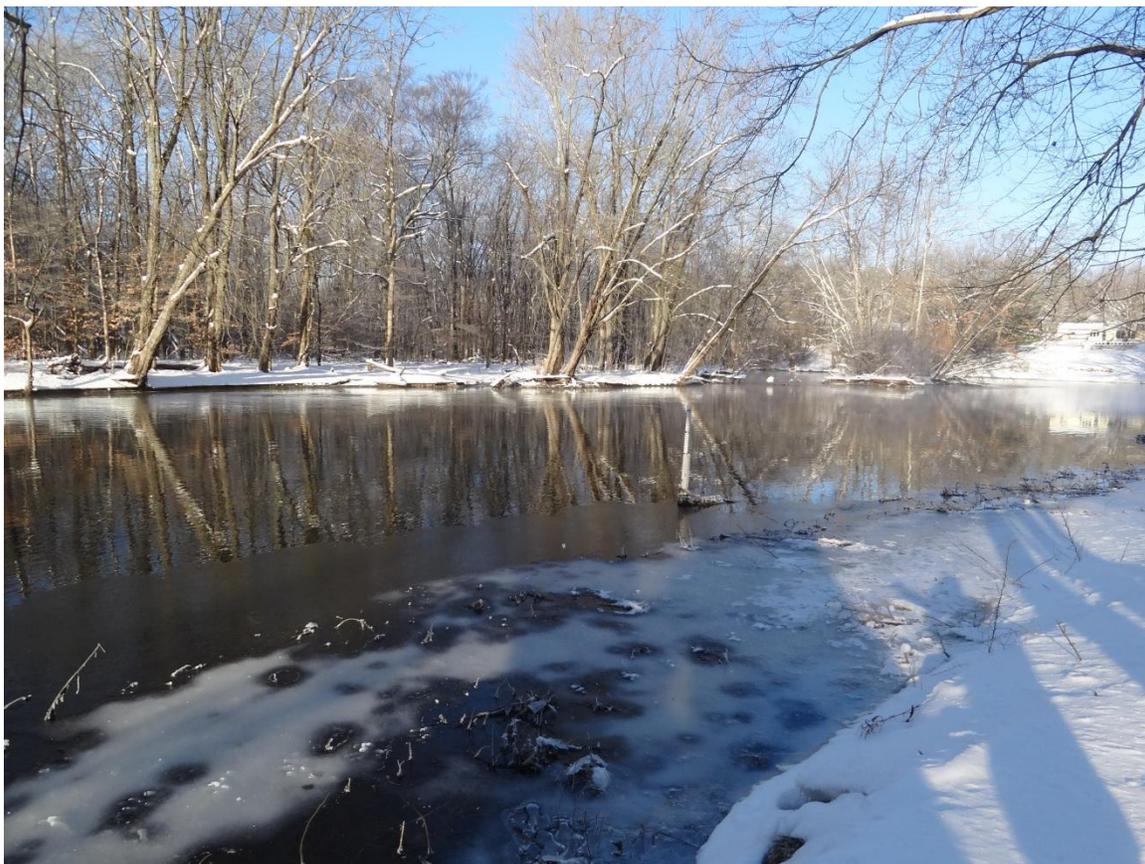
15. MP27.00 Shady Bend Campground observed river icing conditions.

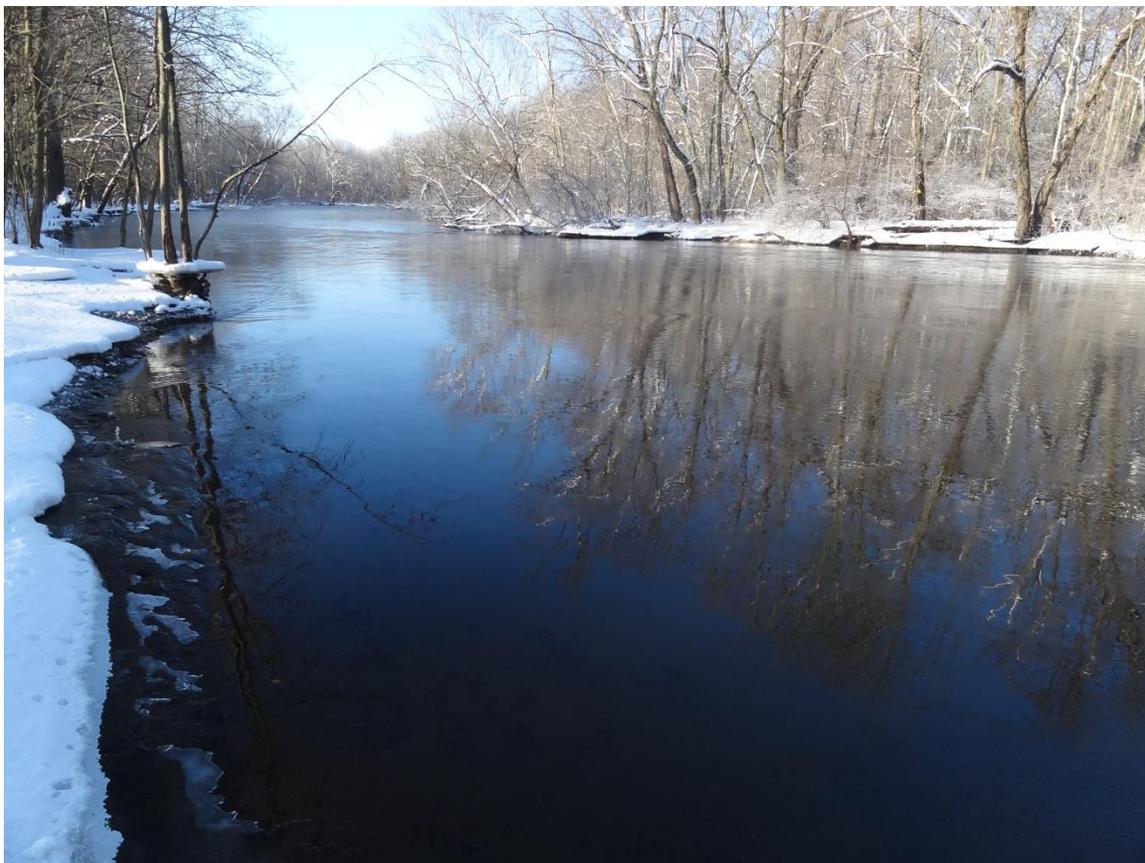
16. E2 Boat Launch observed river icing conditions.

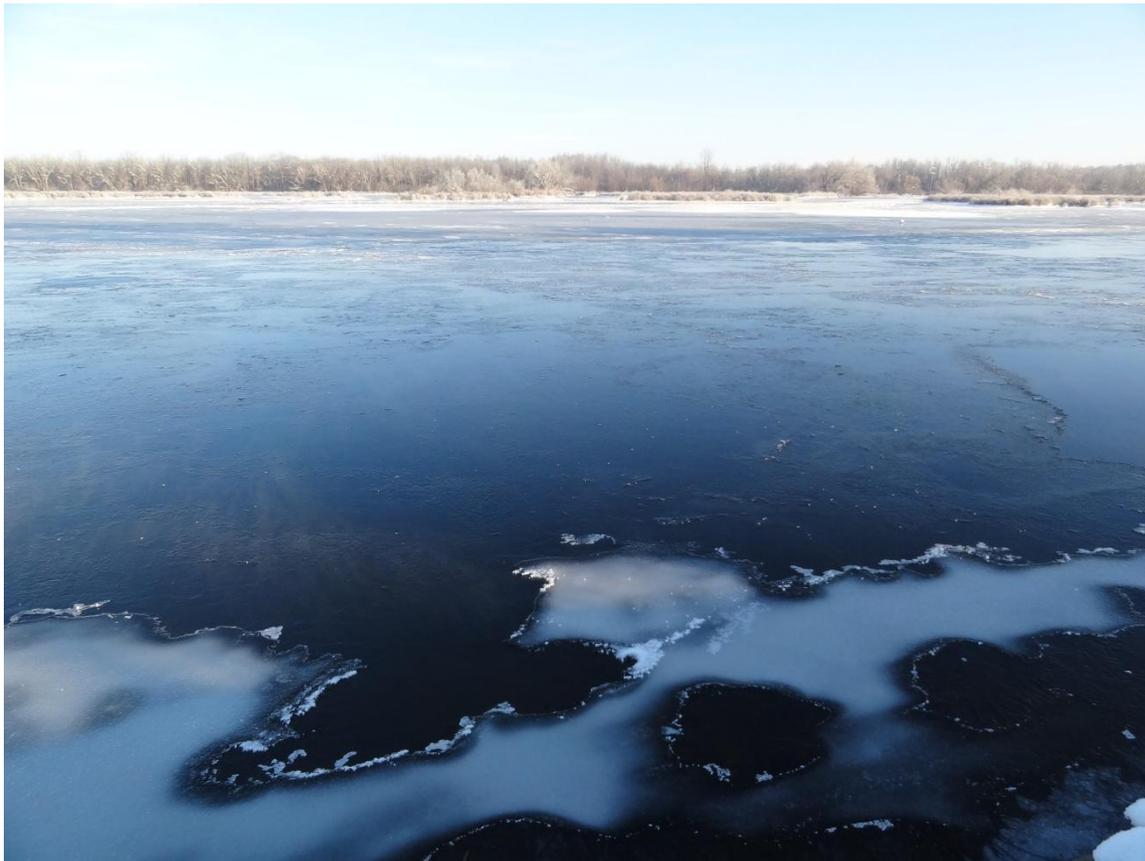
17. Morrow Lake Delta observed icing conditions.

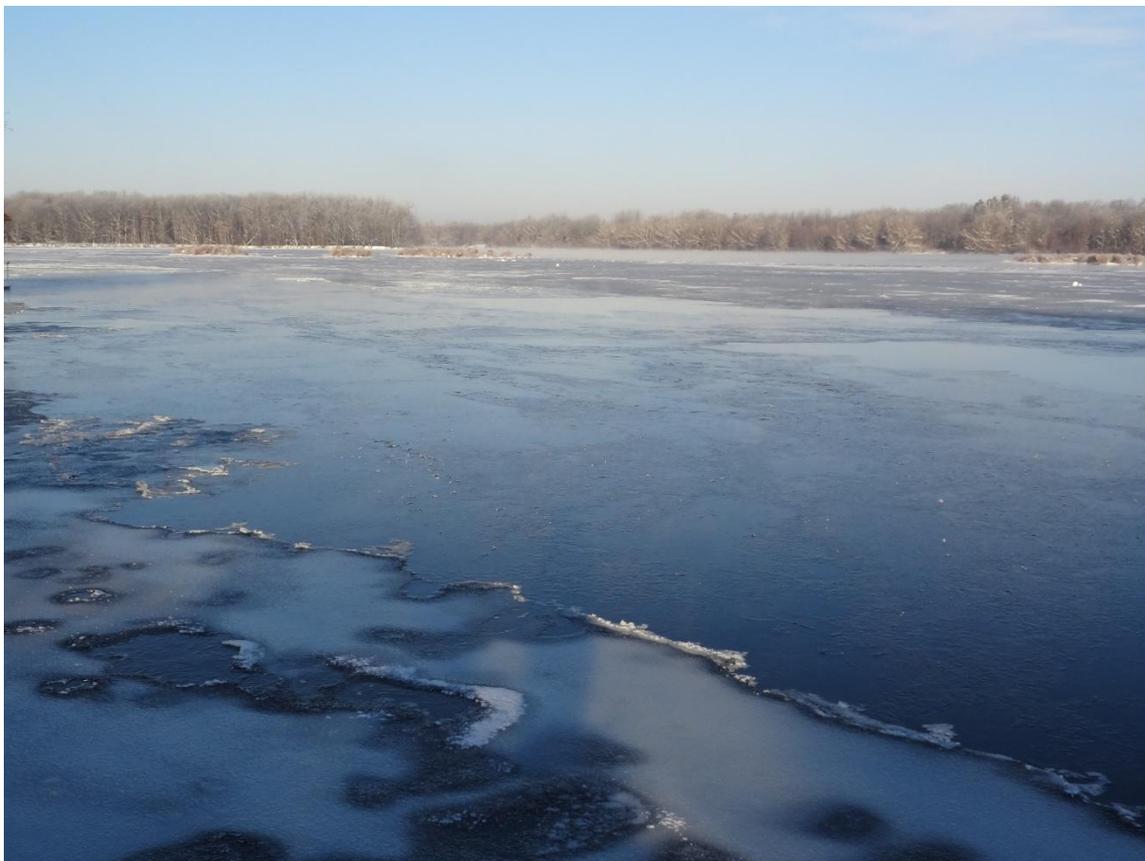
18. Morrow Lake Delta observed icing conditions.

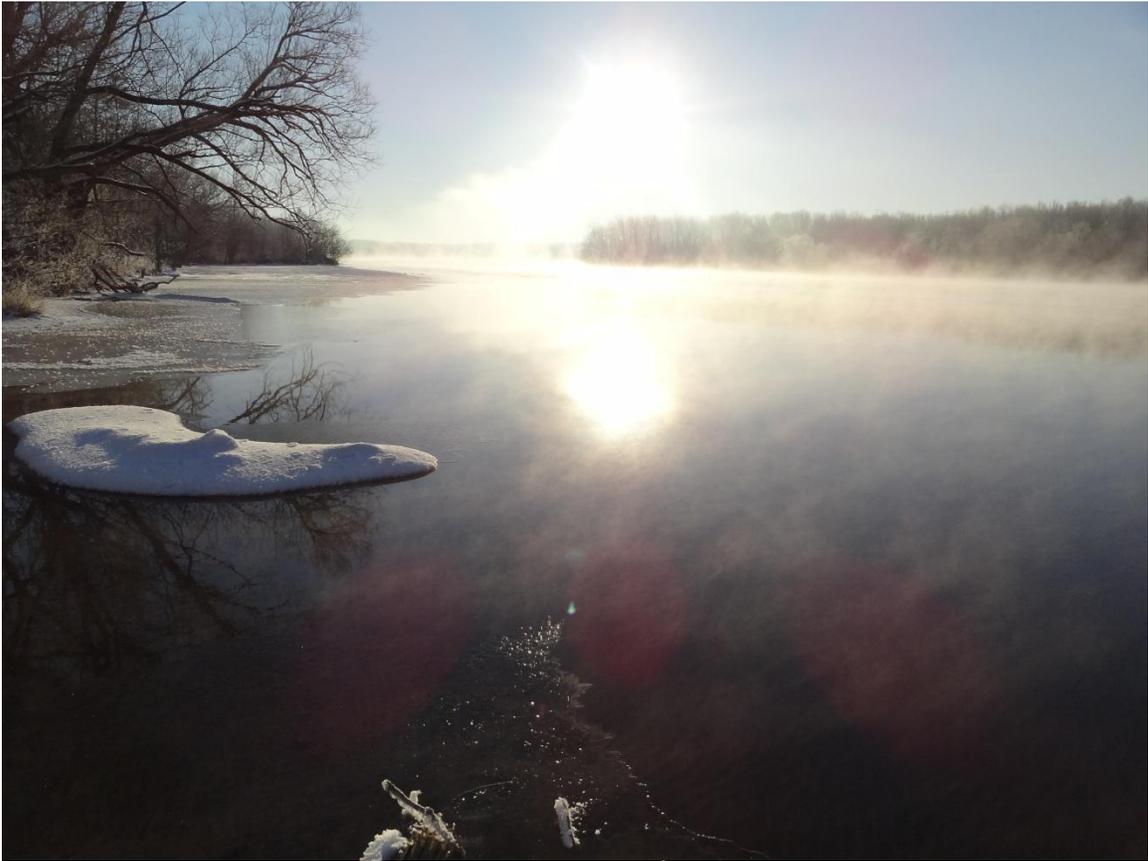
19. Morrow Lake Neck/Morrow Lake Delta observed icing conditions.

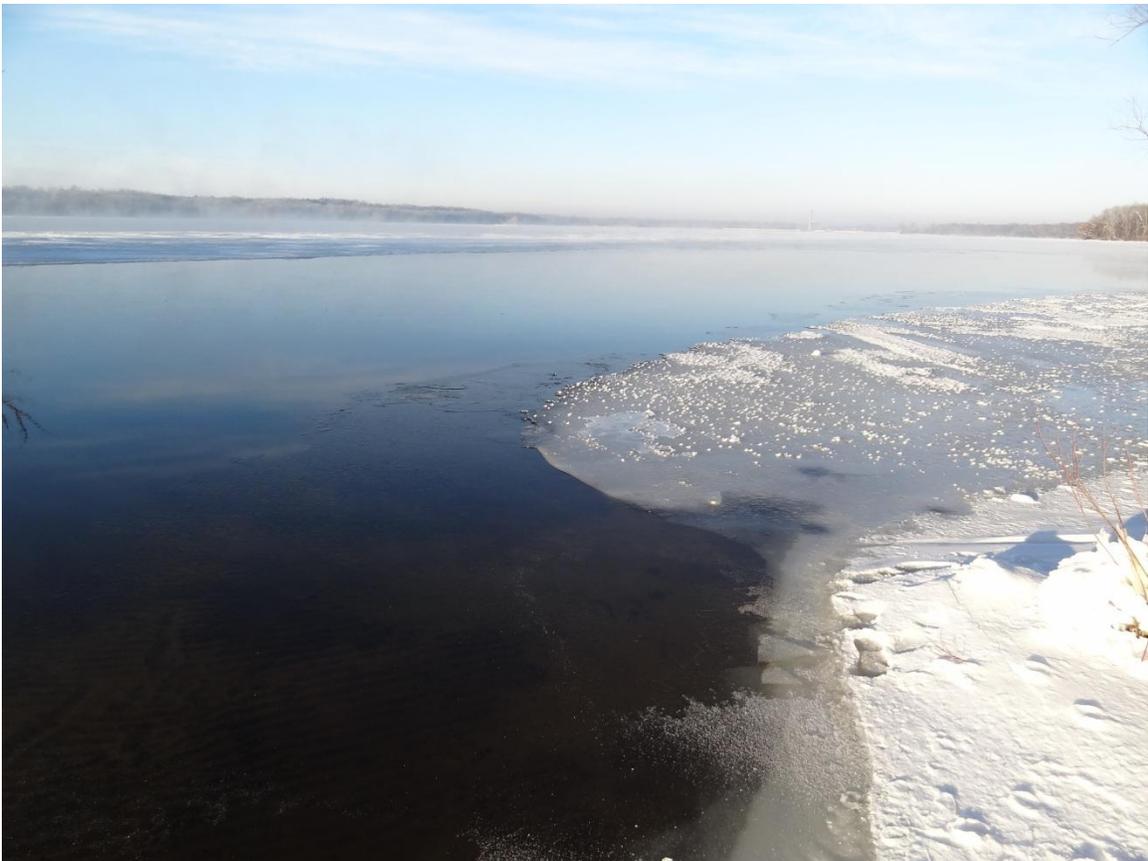
20. Morrow Lake observed icing conditions.
