# Situation Photo Log

Monday, February 11, 2013

Kalamazoo River / Enbridge Spill

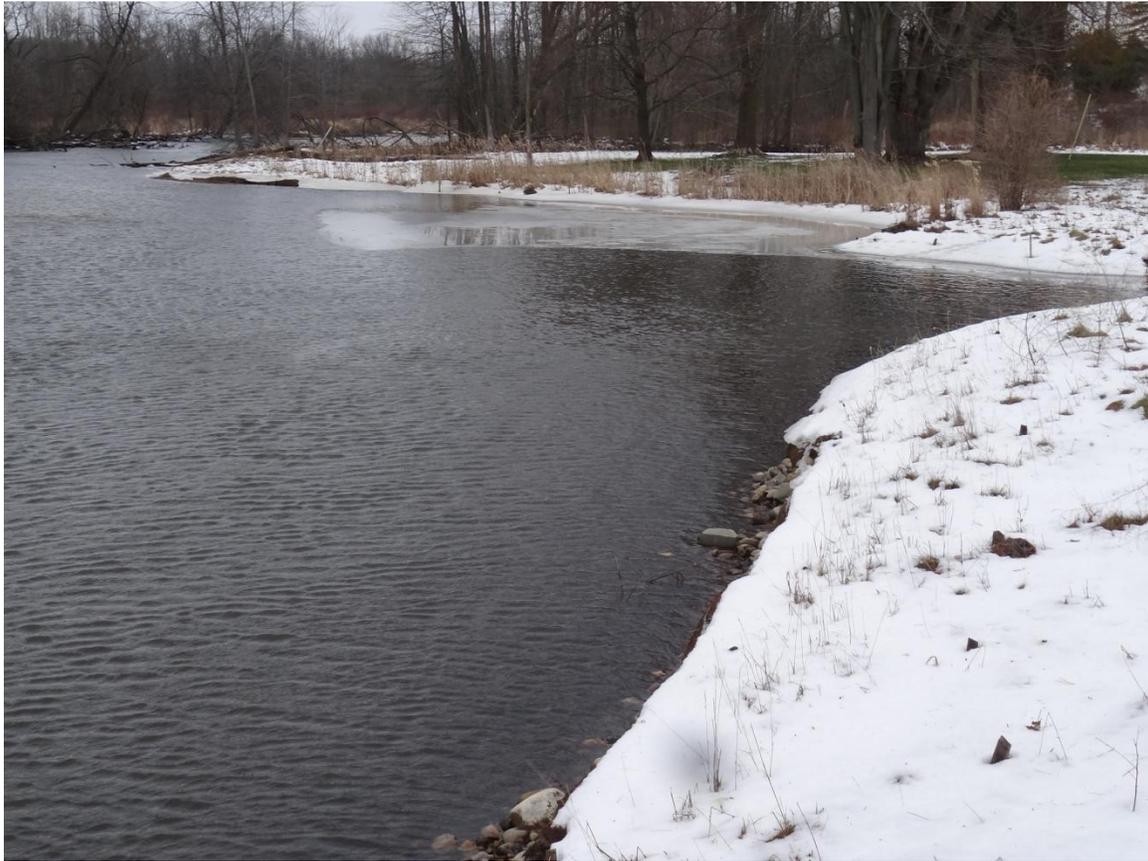
**1. Confluence observed ice conditions.**

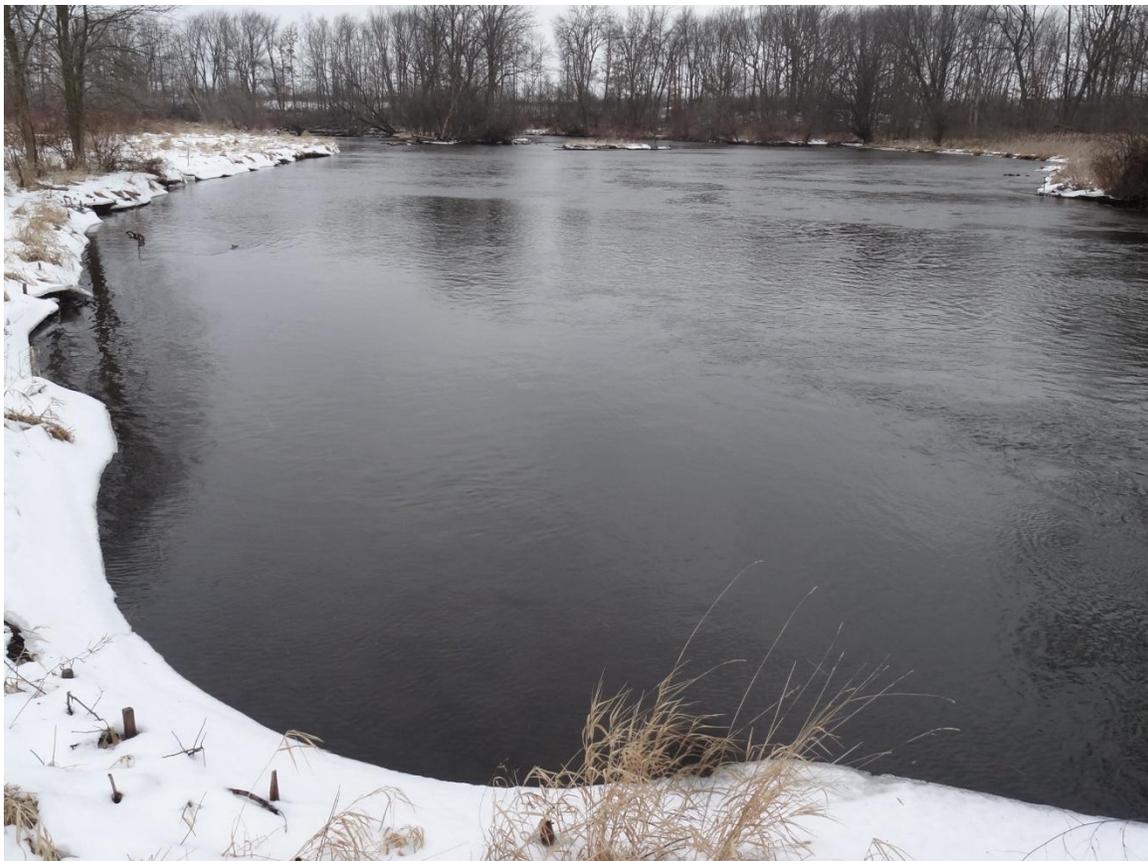
**2. MP2.25 Saylor's Landing no sheen observed.**

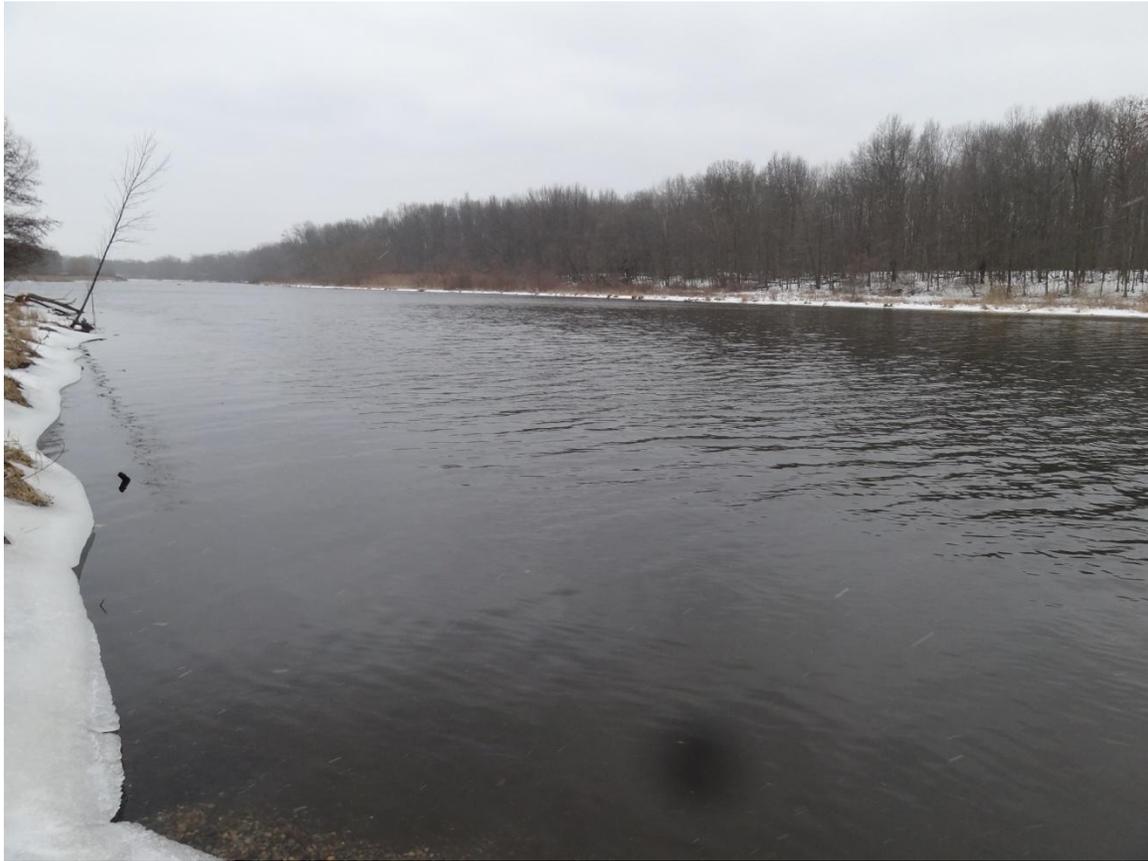
3. C0.4 Boat Launch ice has receded from upstream river channel.

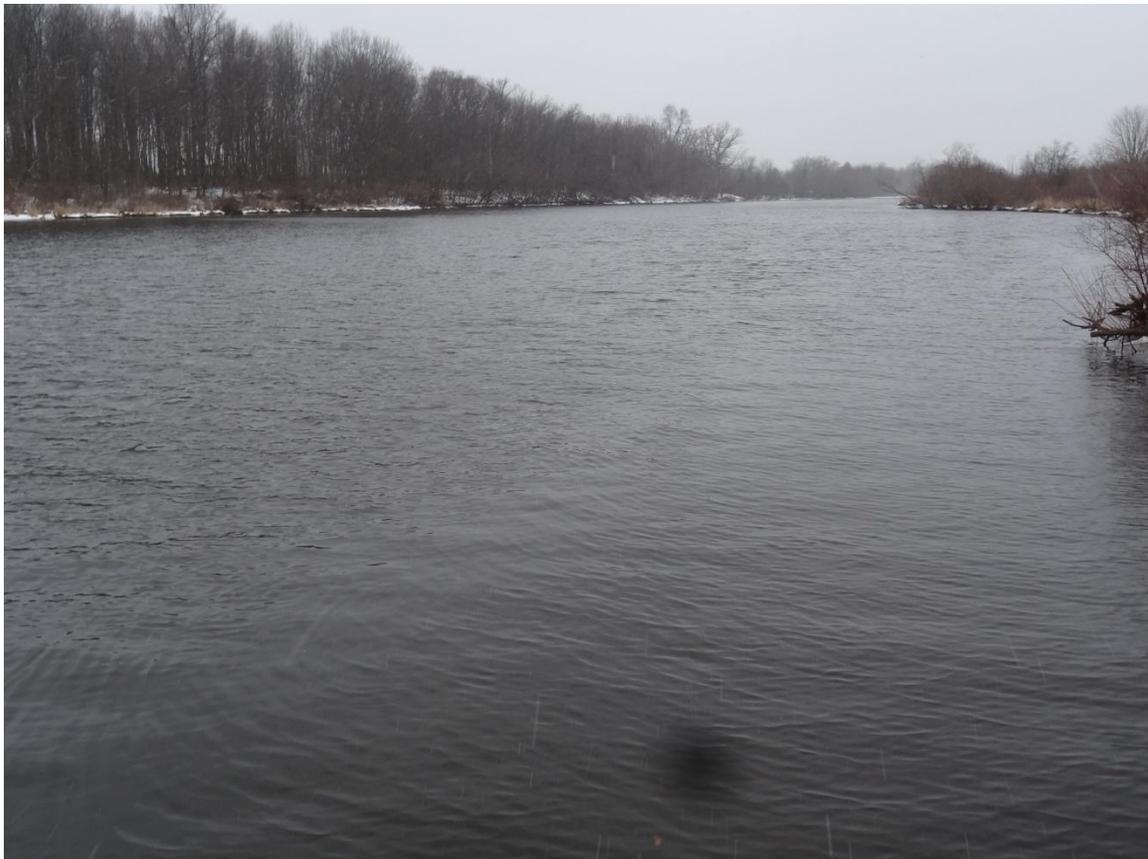
4. C0.4 Boat Launch ice has receded from downstream river channel.

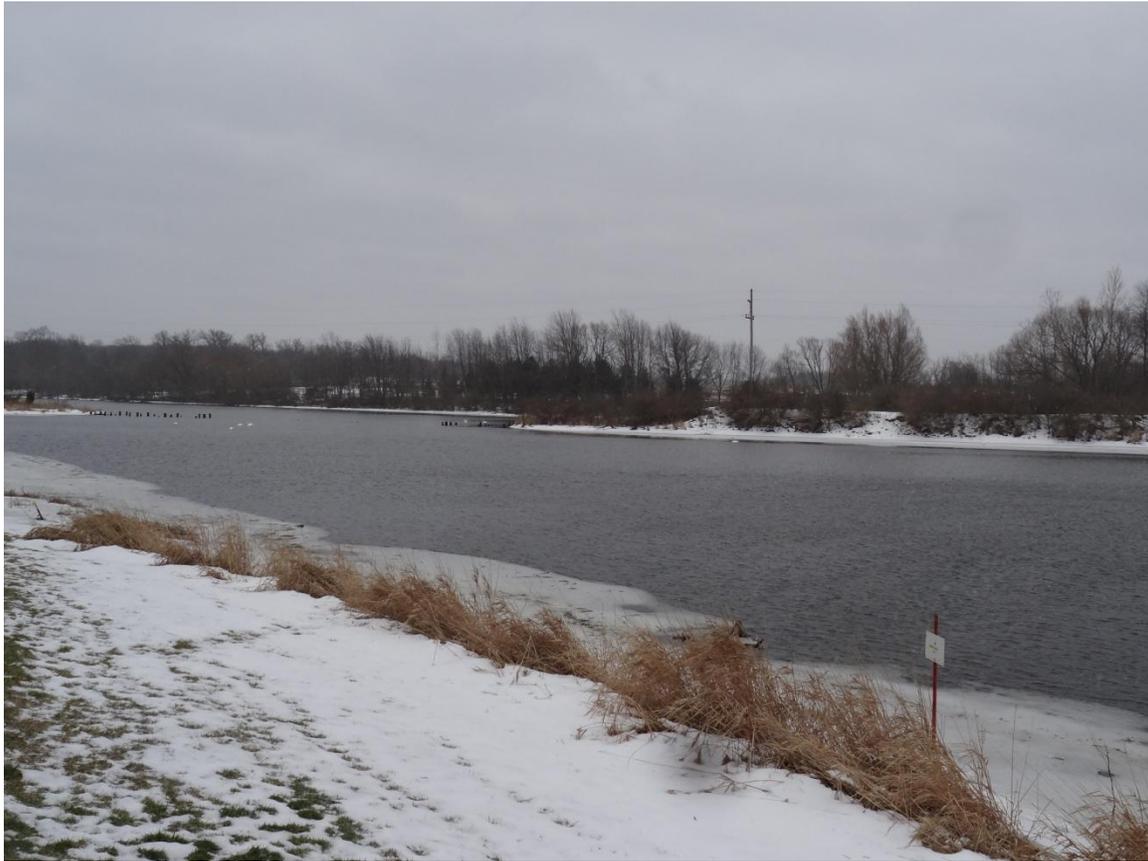
5. Ceresco Dam impoundment ice has receded from river channel.

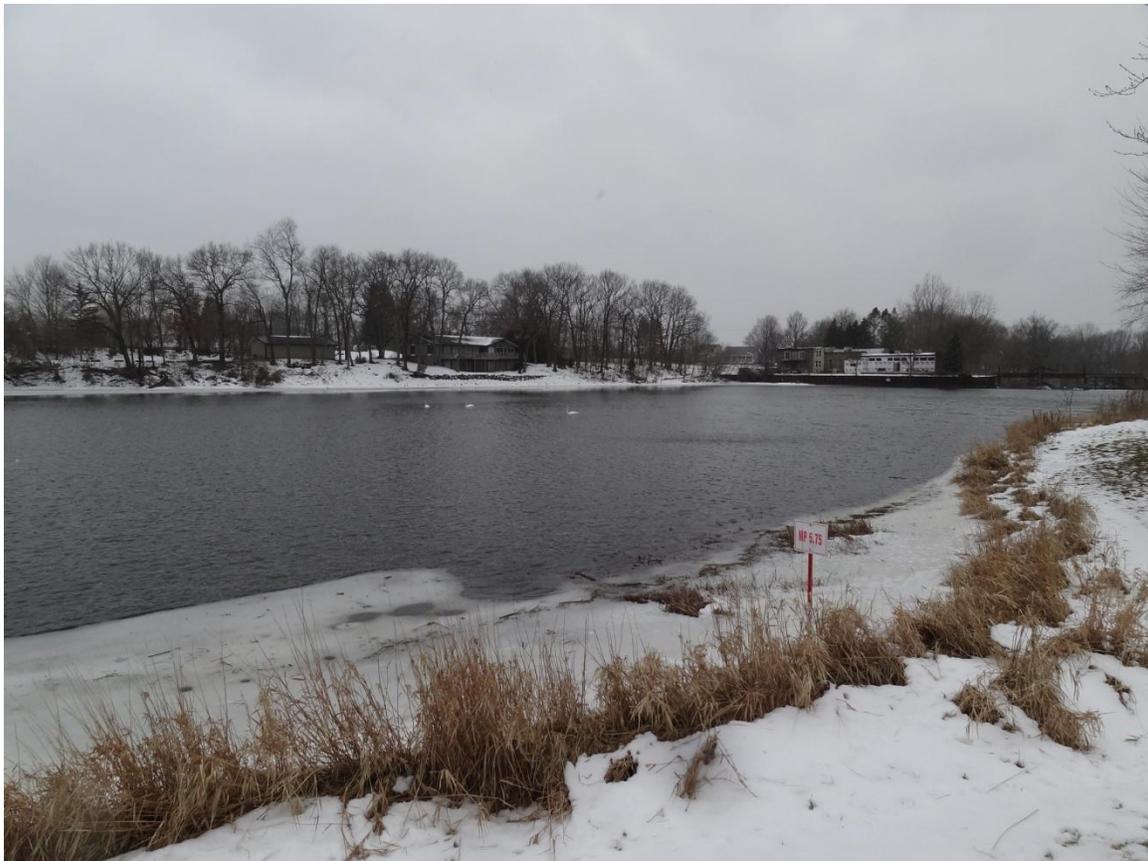
6. Ceresco Dam impoundment ice has receded from river channel.

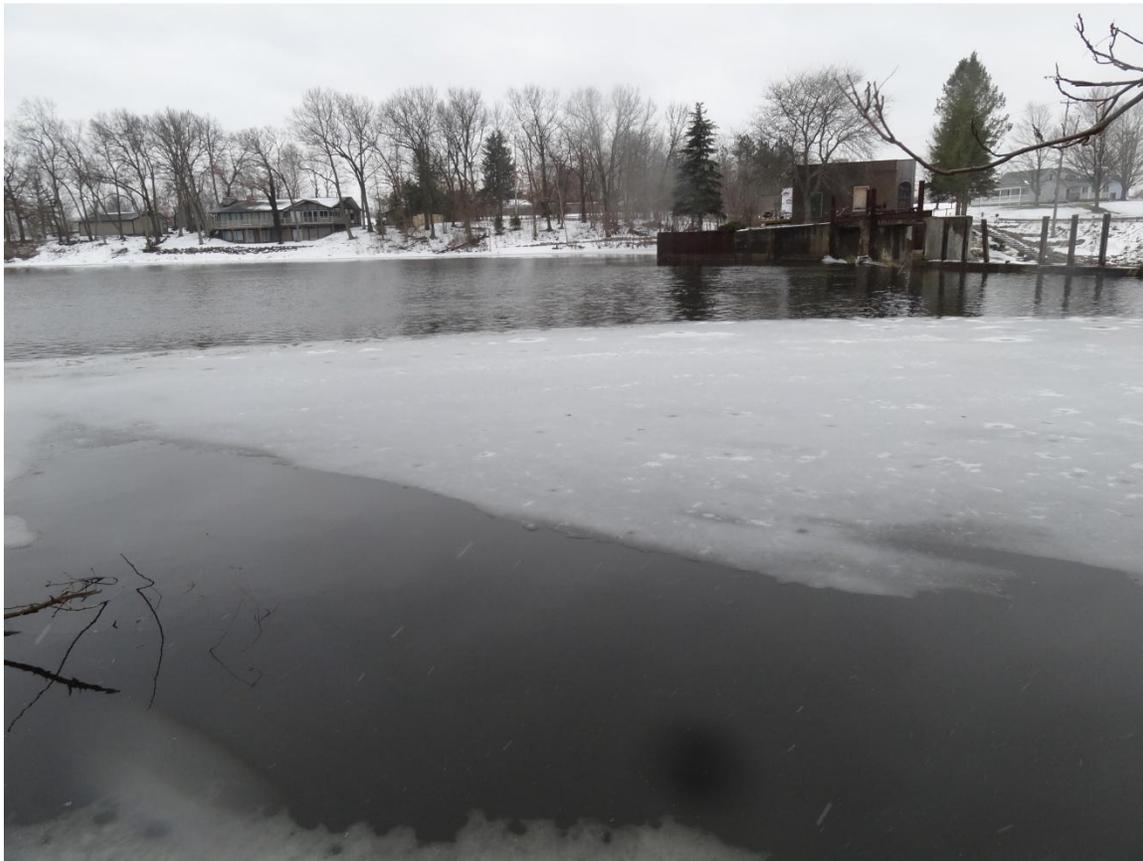
7. Ceresco Dam impoundment ice has receded from river channel.

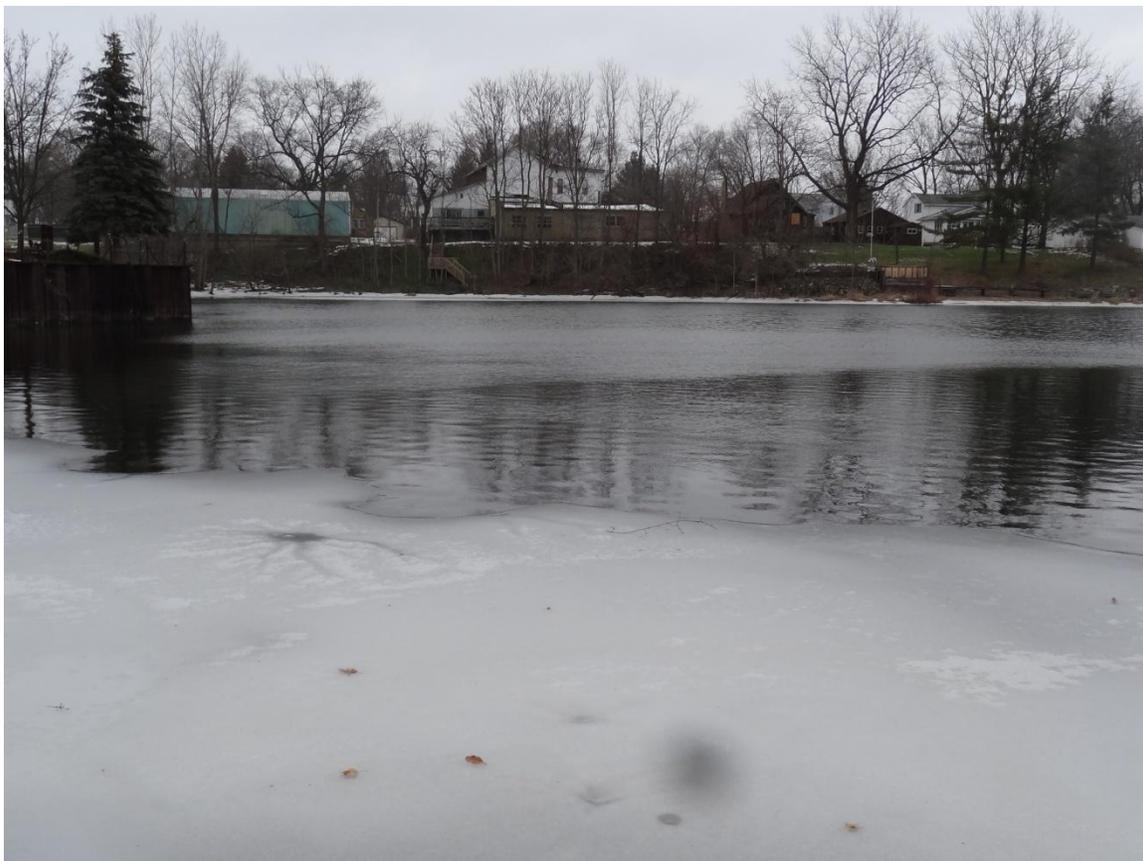
8. Ceresco Dam impoundment ice has receded from river channel.

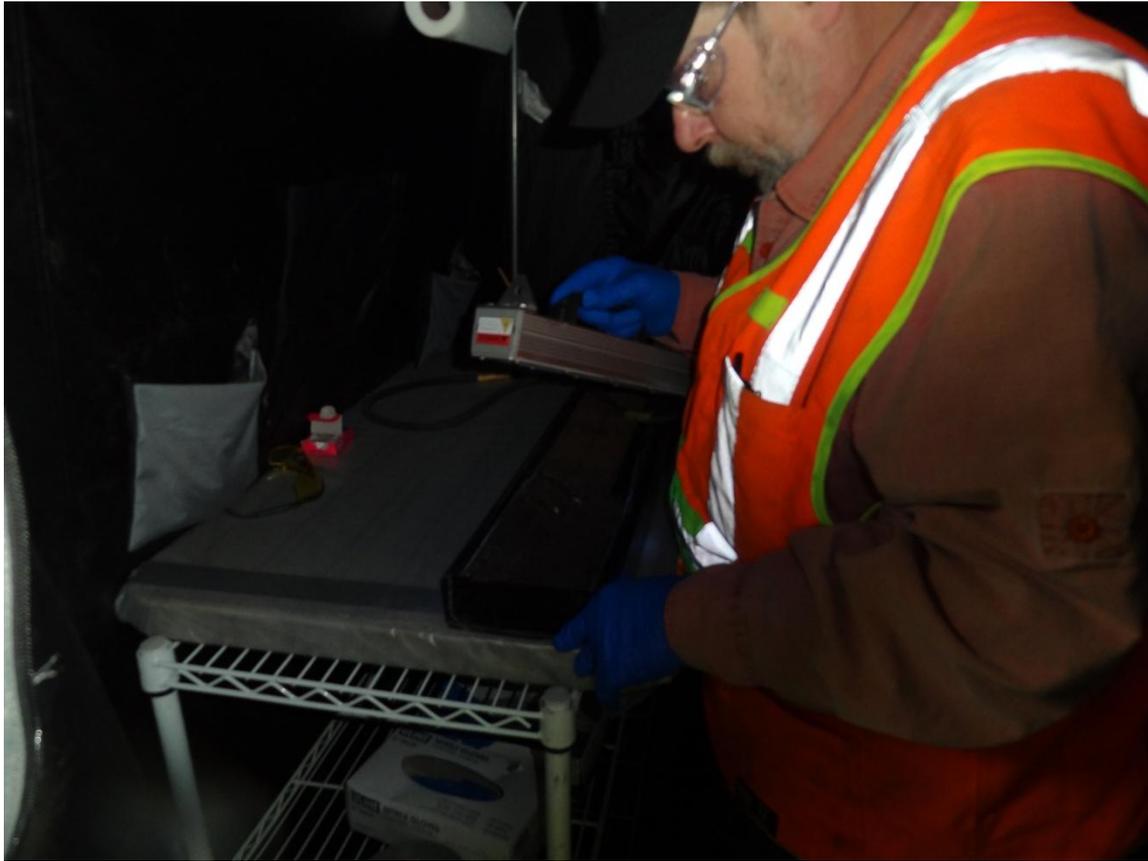
9. C3.2 Pole Barn observed core logging procedures.

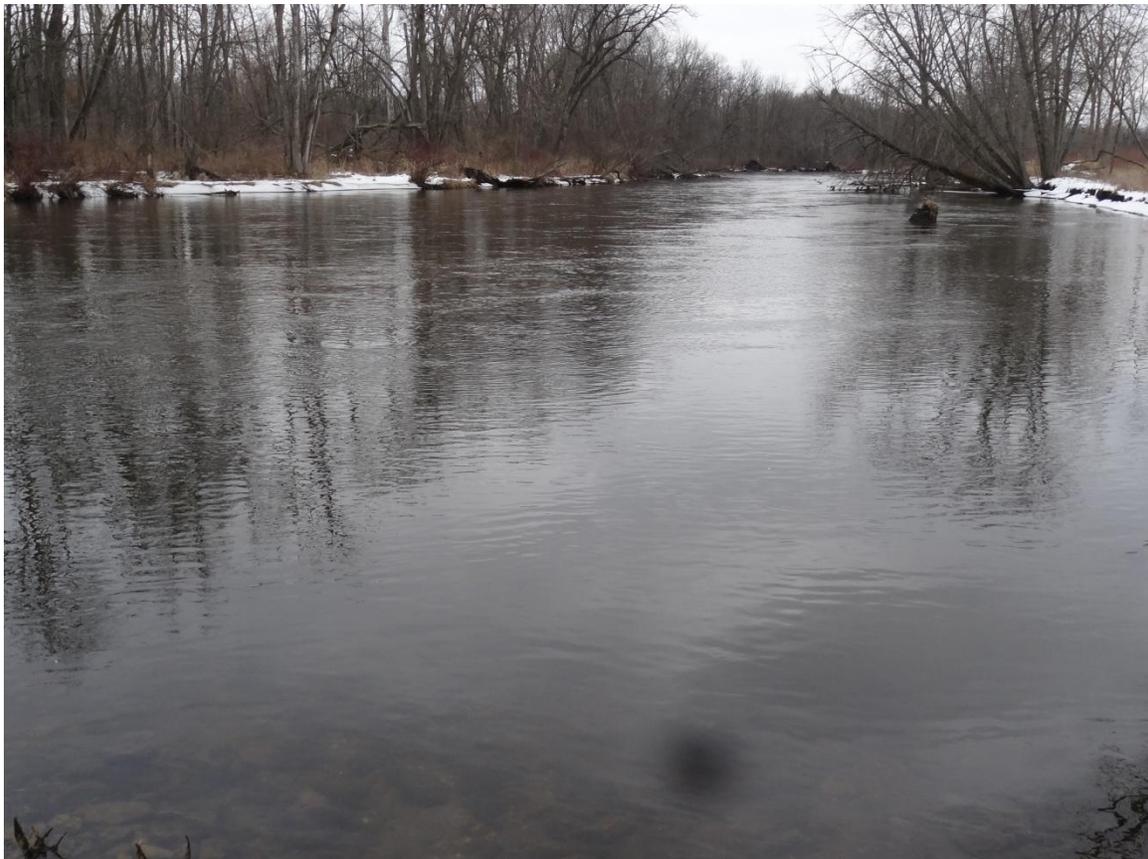
10. C3.2 Boat Launch no shien observed.

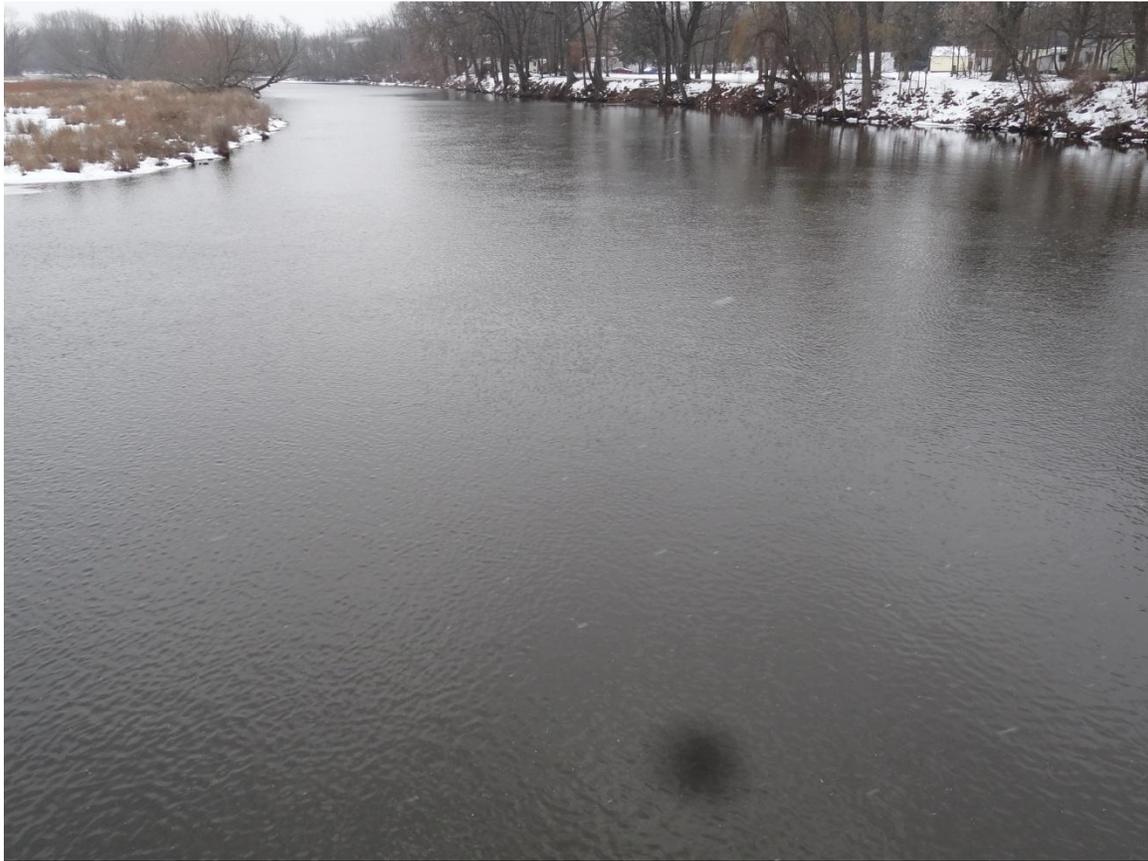
11. MP15.25 South Mill Pond no sheen observed.

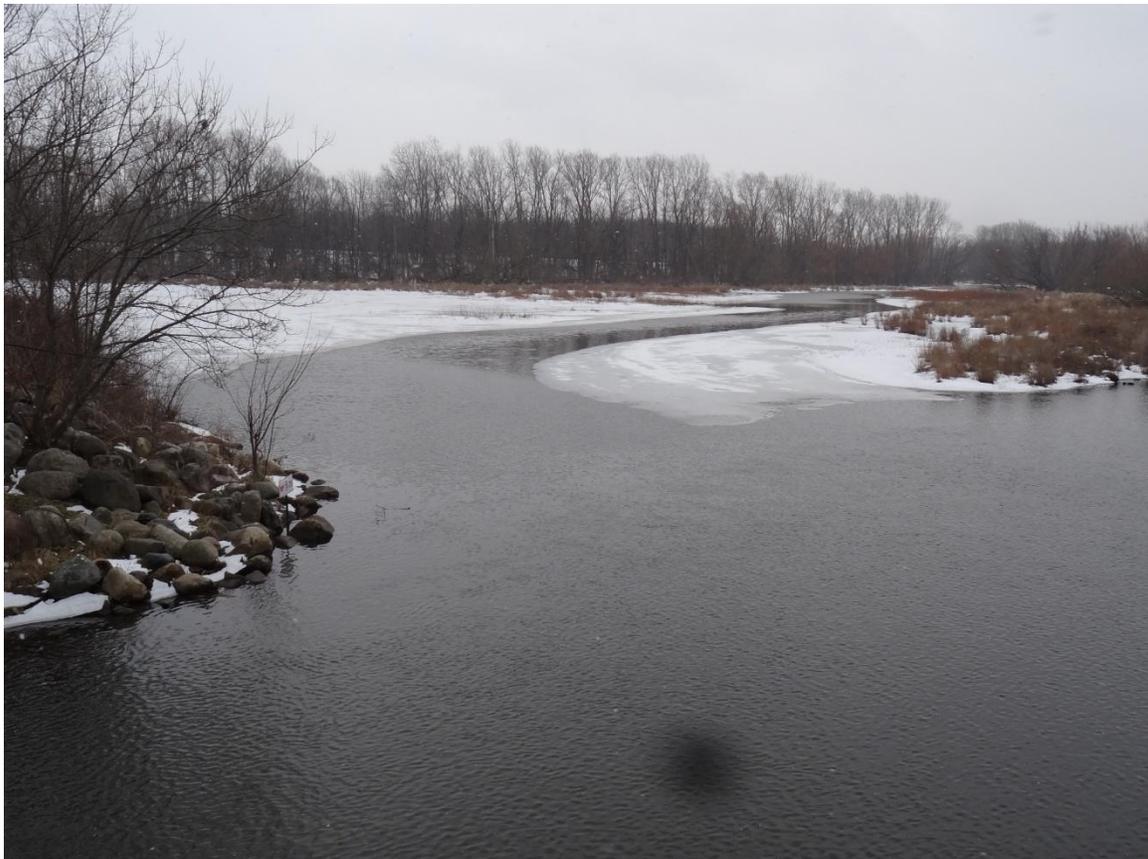
12. MP15.25 South Mill Pond observed back water ice conditions.

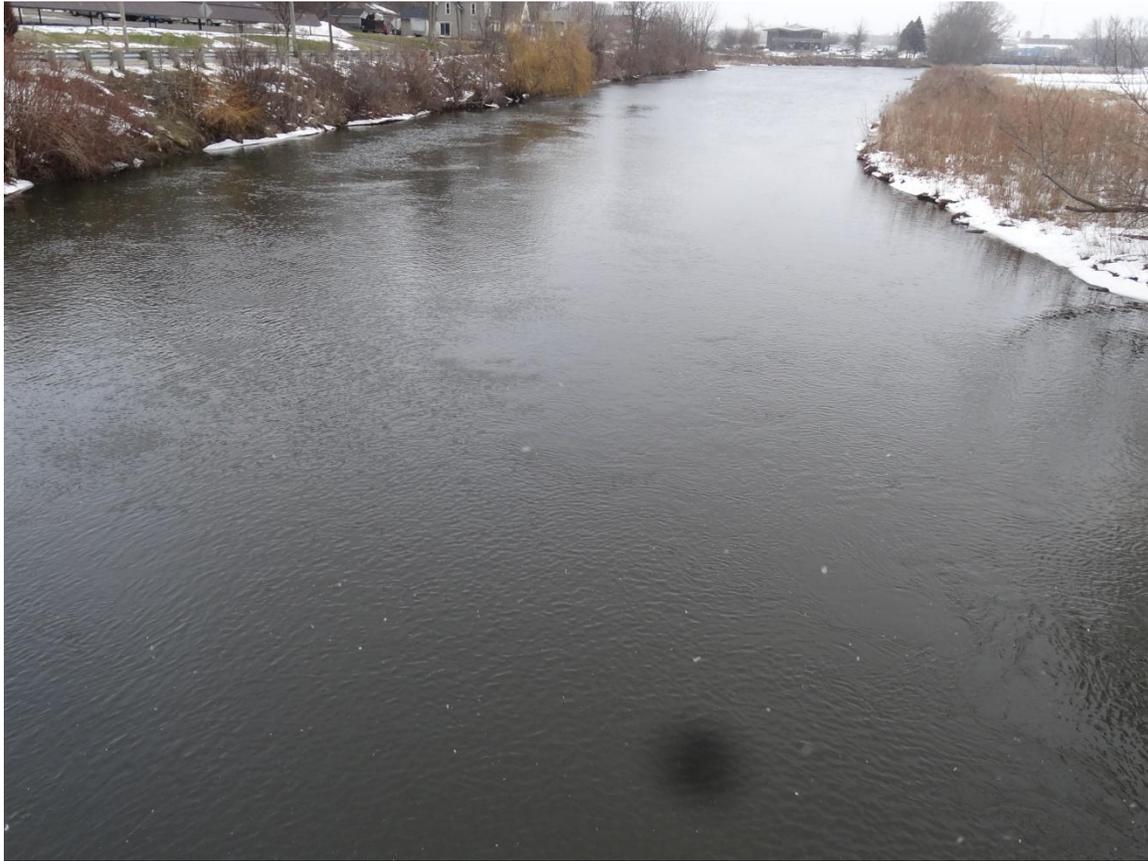
13. MP15.50 North Mill Pond no sheen observed.

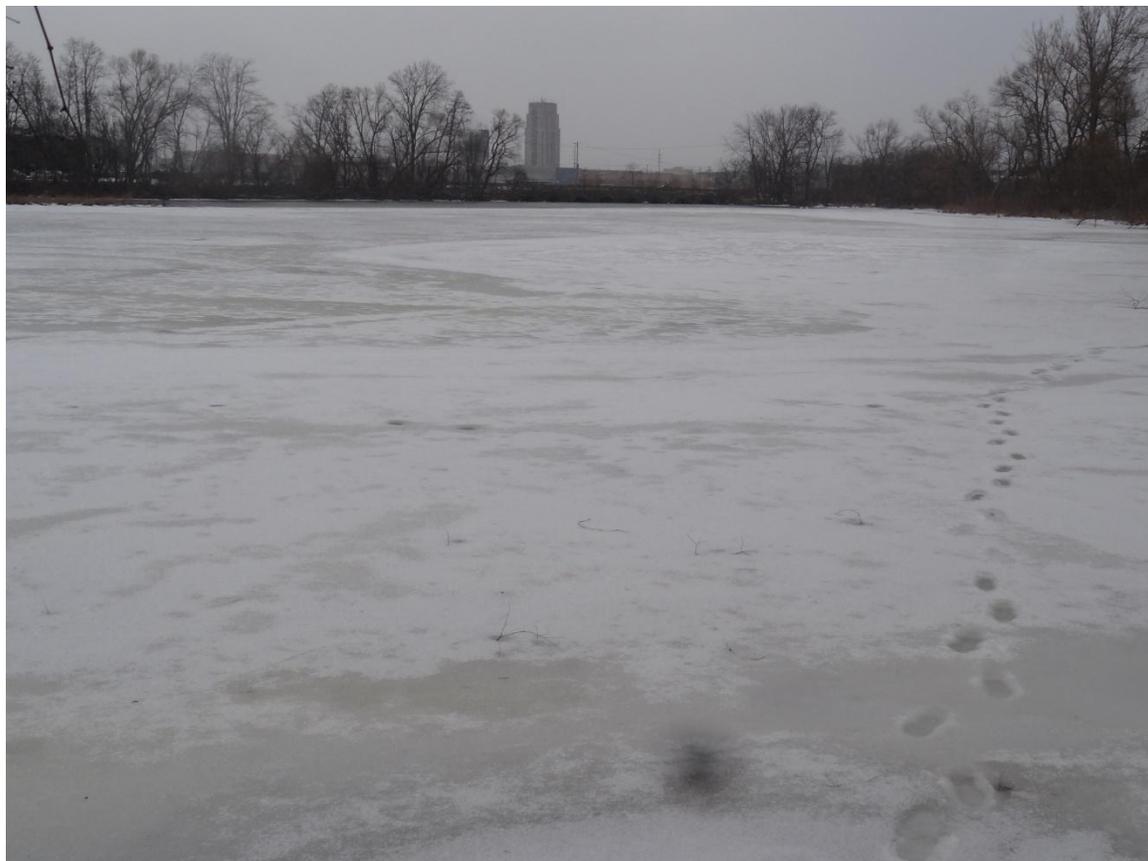
14. MP15.50 North Mill Pond observed back water ice conditions.

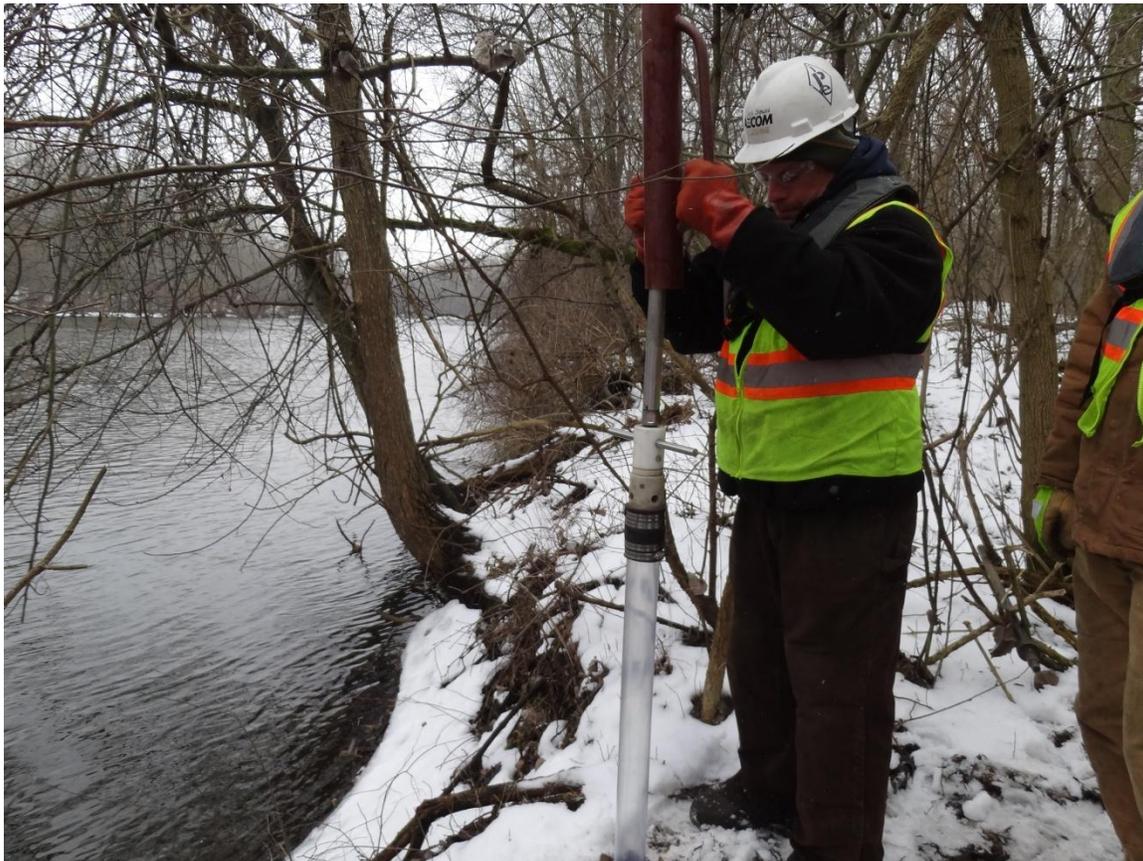
15. MP20.75 LDB observed RI team.

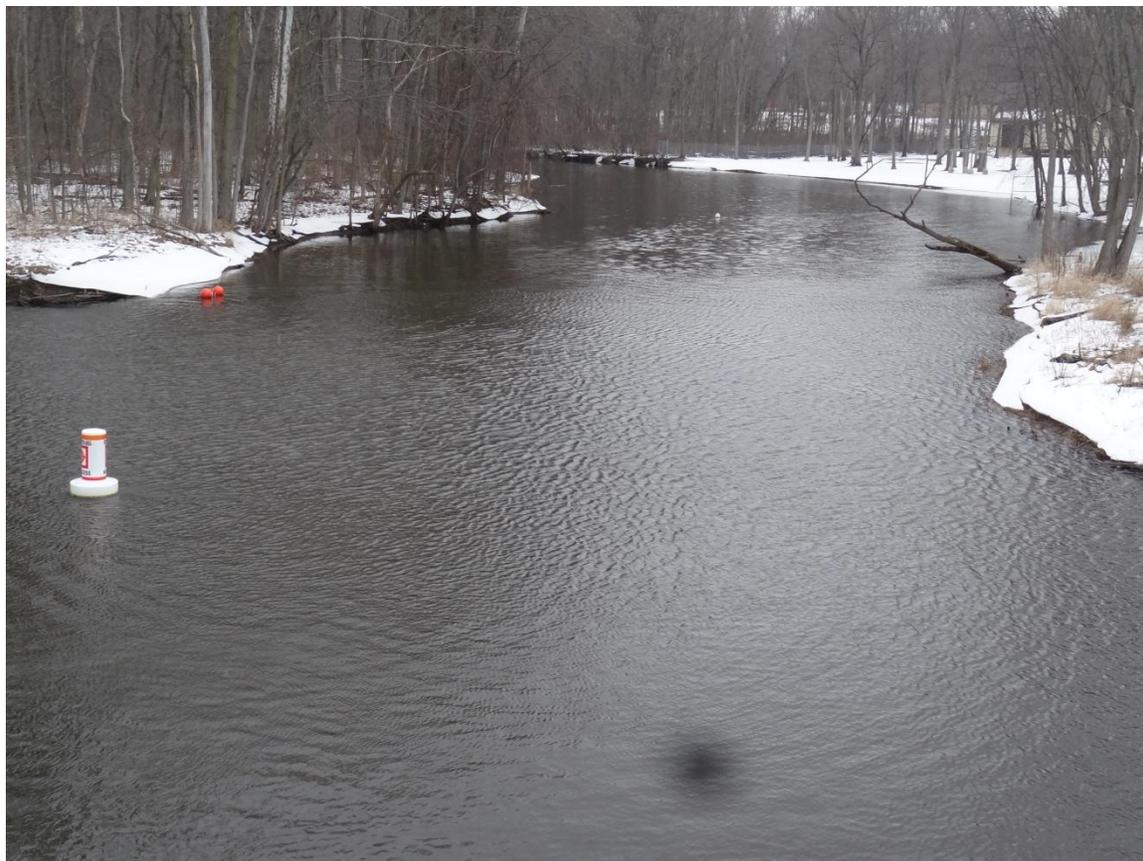
16. MP21.50 Oxbow ice has receded from back channel.

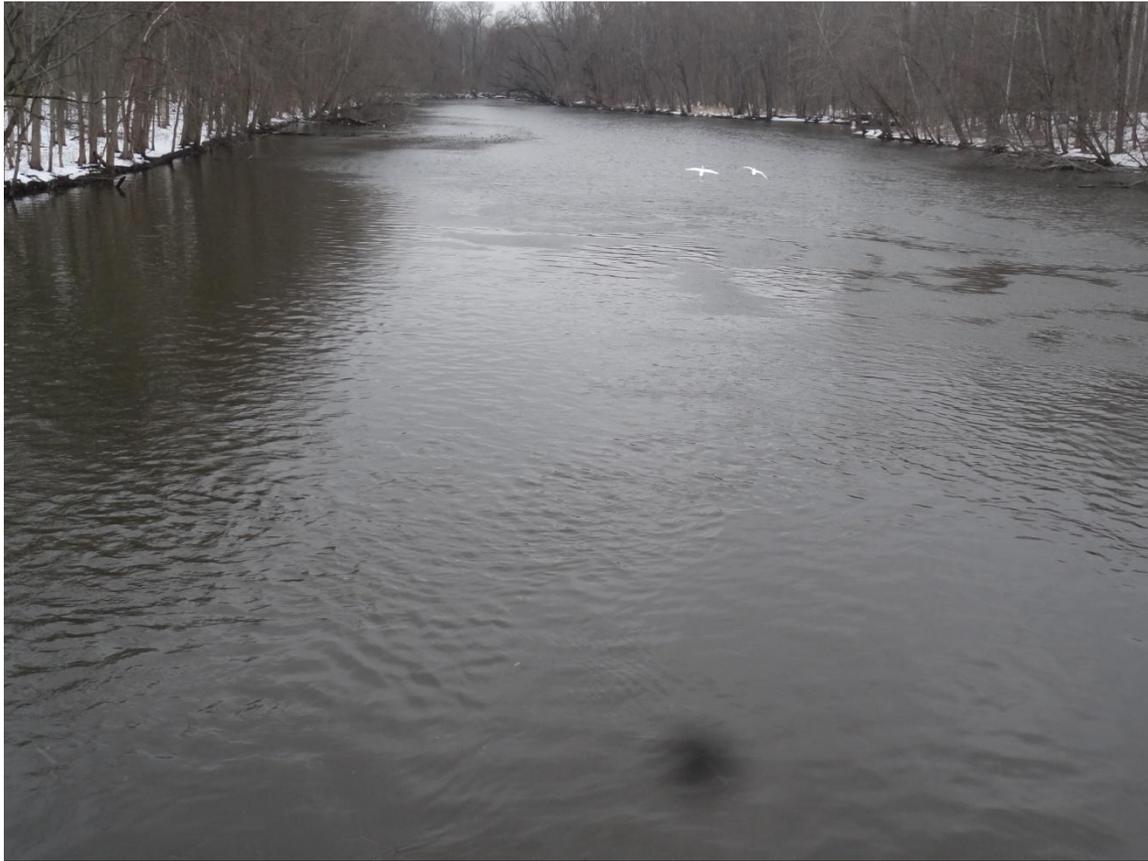
17. MP21.50 Custer Road bridge no sheen observed.

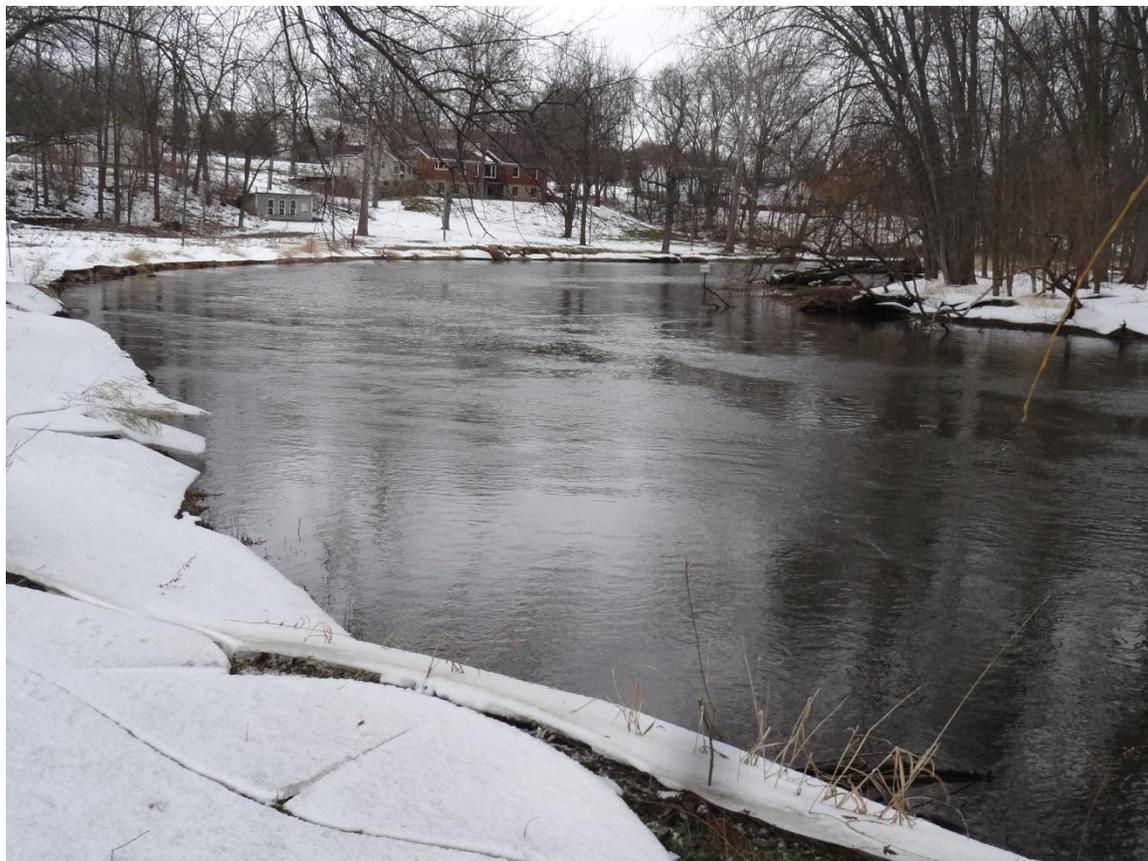
18. MP27.00 Shady Bend Campground ice has receded from upstream river channel.

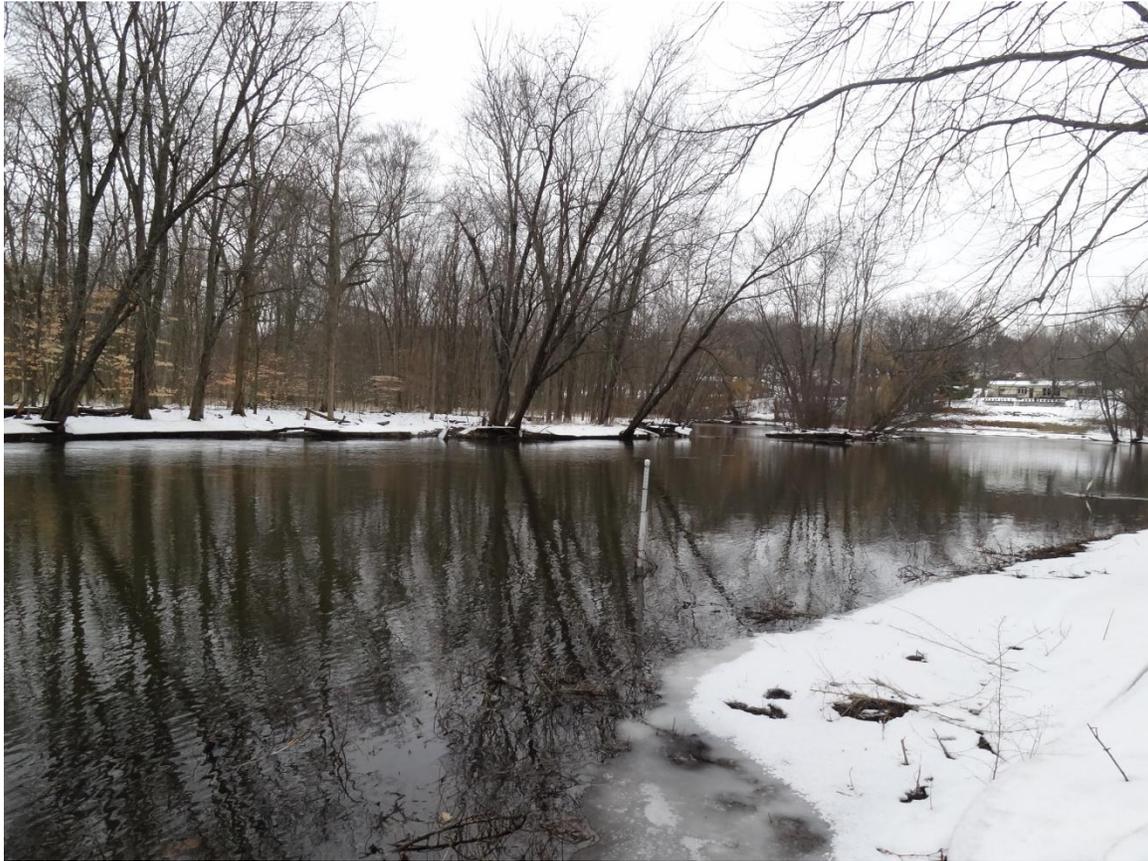
19. MP27.00 Shady Bend Campground ice has receded from downstream river channel.

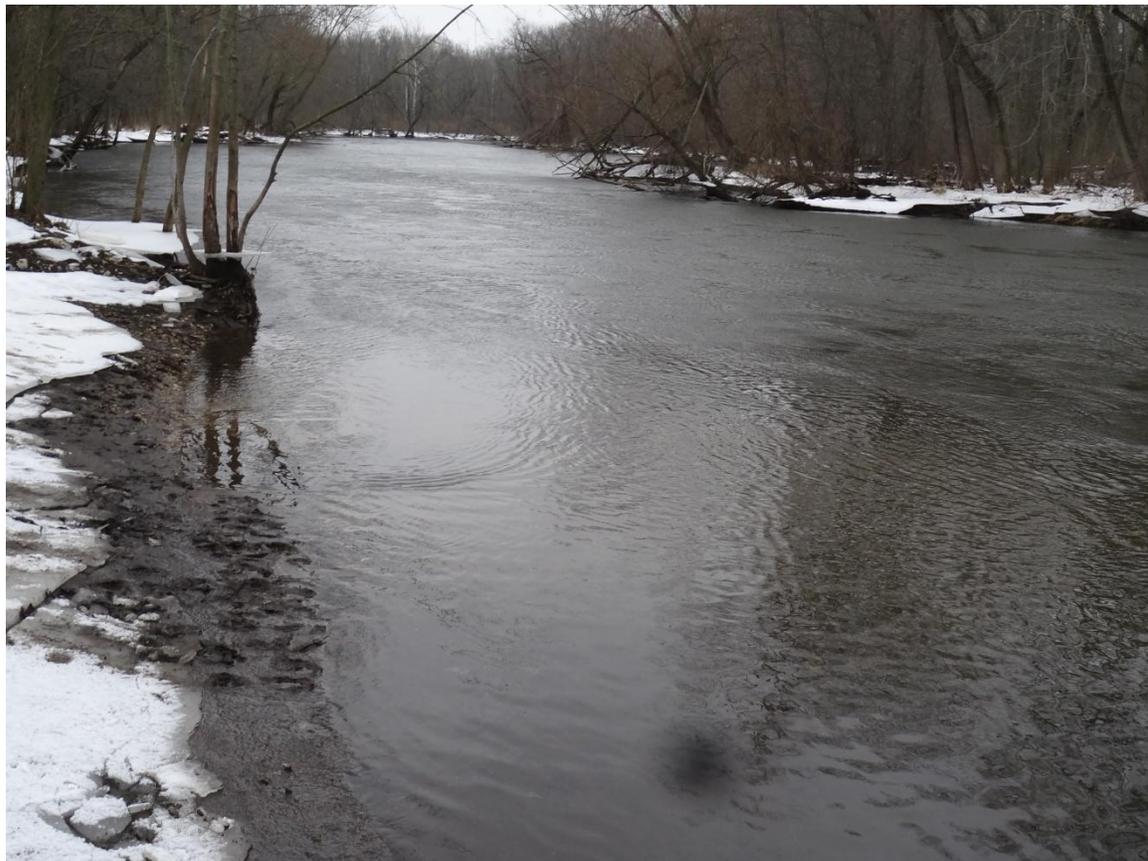
20. E2 Boat Launch no sheen observed.

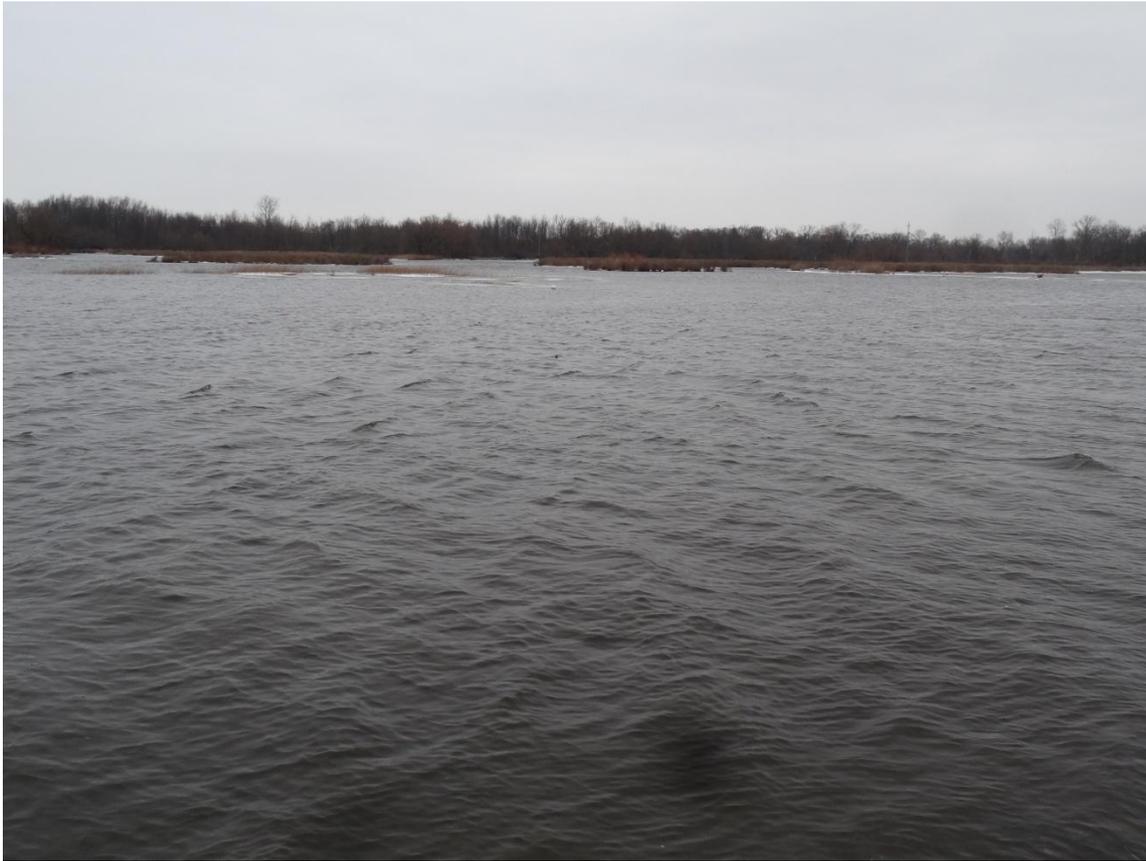
21. Morrow Lake Delta ice has receded.

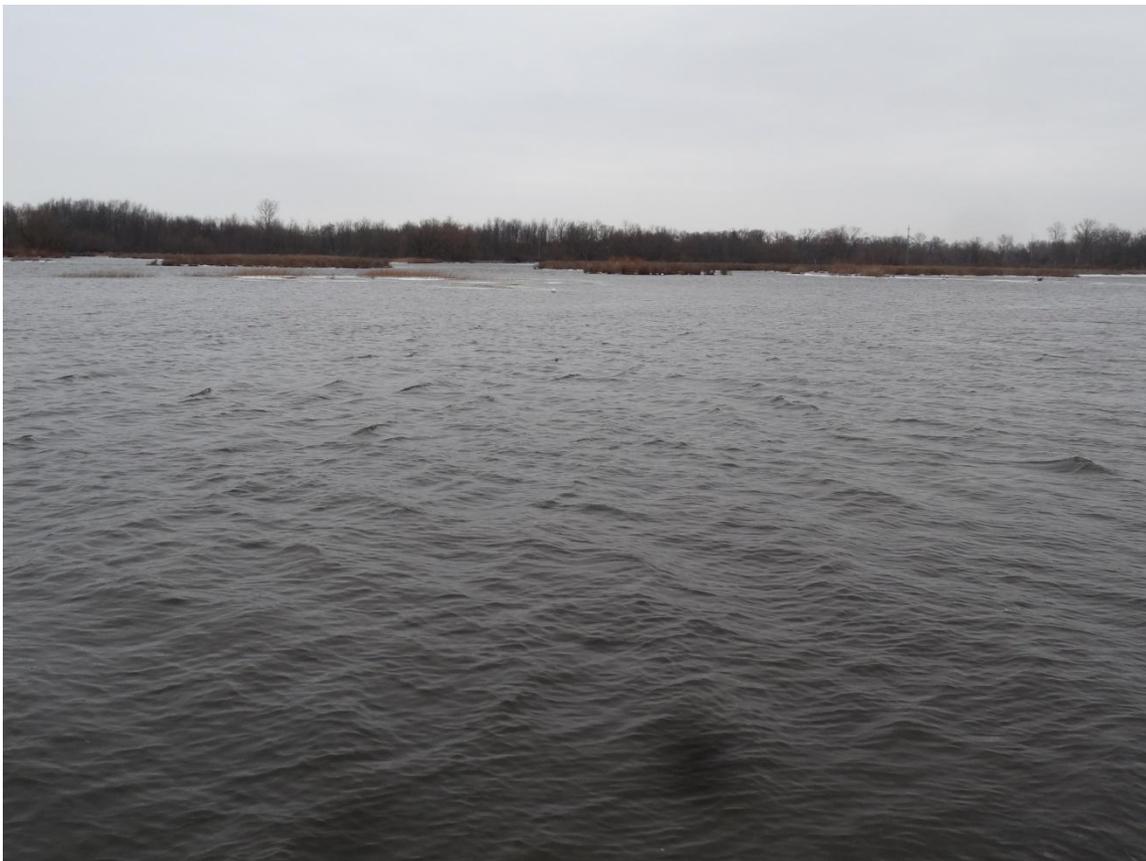
22. Morrow Lake Delta ice has receded.

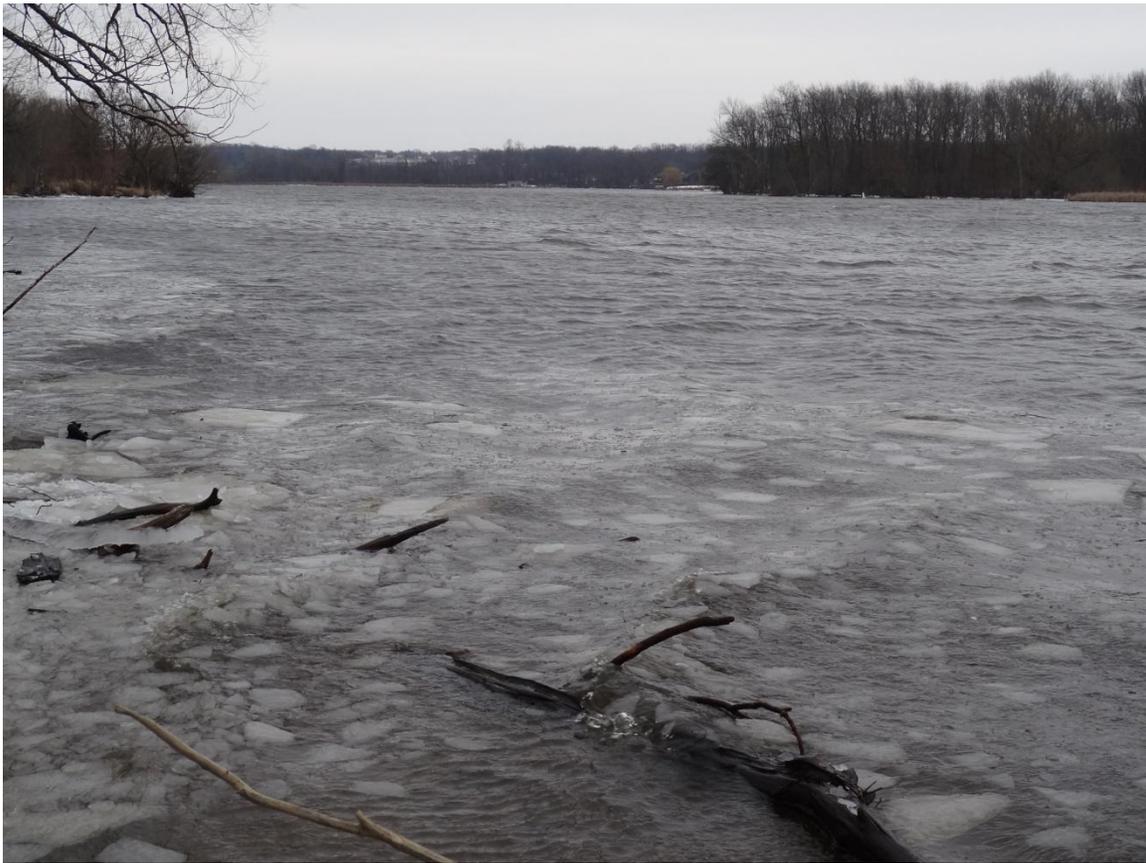
23. Morrow Lake Neck/Morrow Lake Delta observed ice conditions.
