# Situation Photo Log

Monday, February 11, 2013

Kalamazoo River / Enbridge Spill

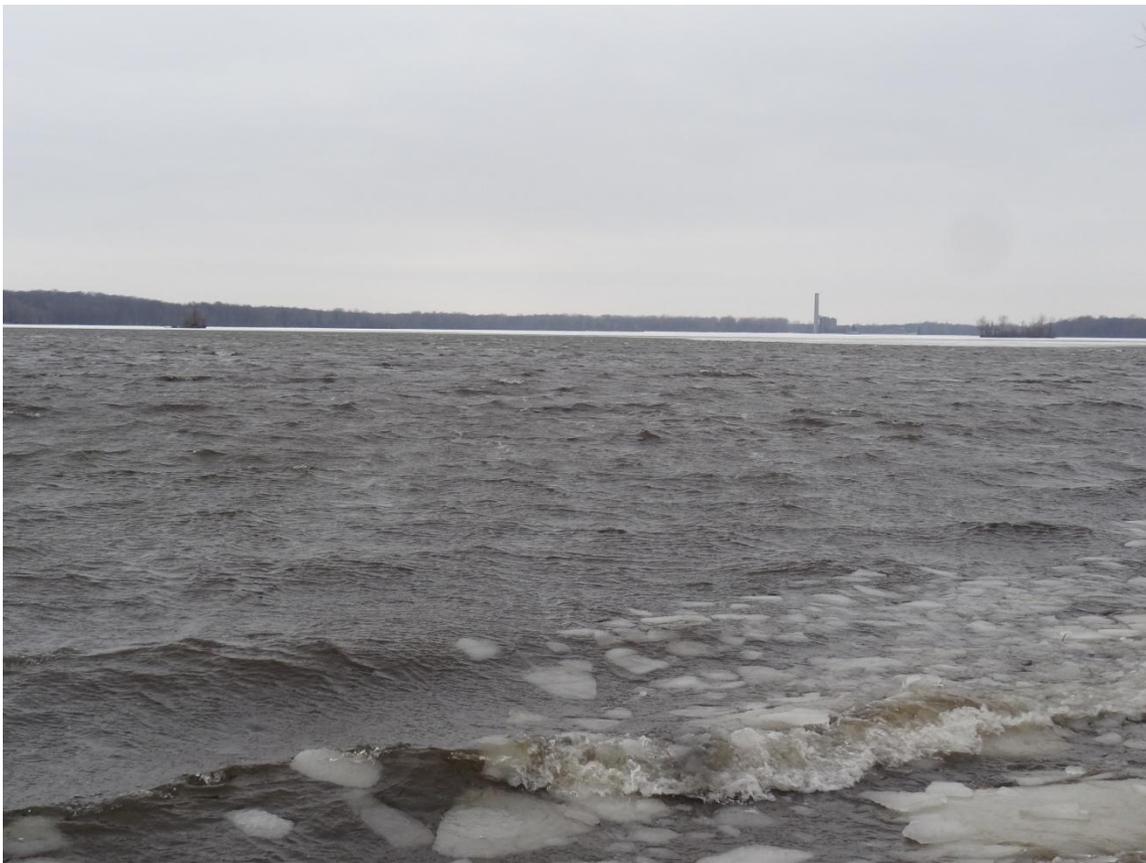
24. Morrow Lake observed ice conditions.
