# Situation Photo Log

Tuesday, February 12, 2013

Kalamazoo River / Enbridge Spill

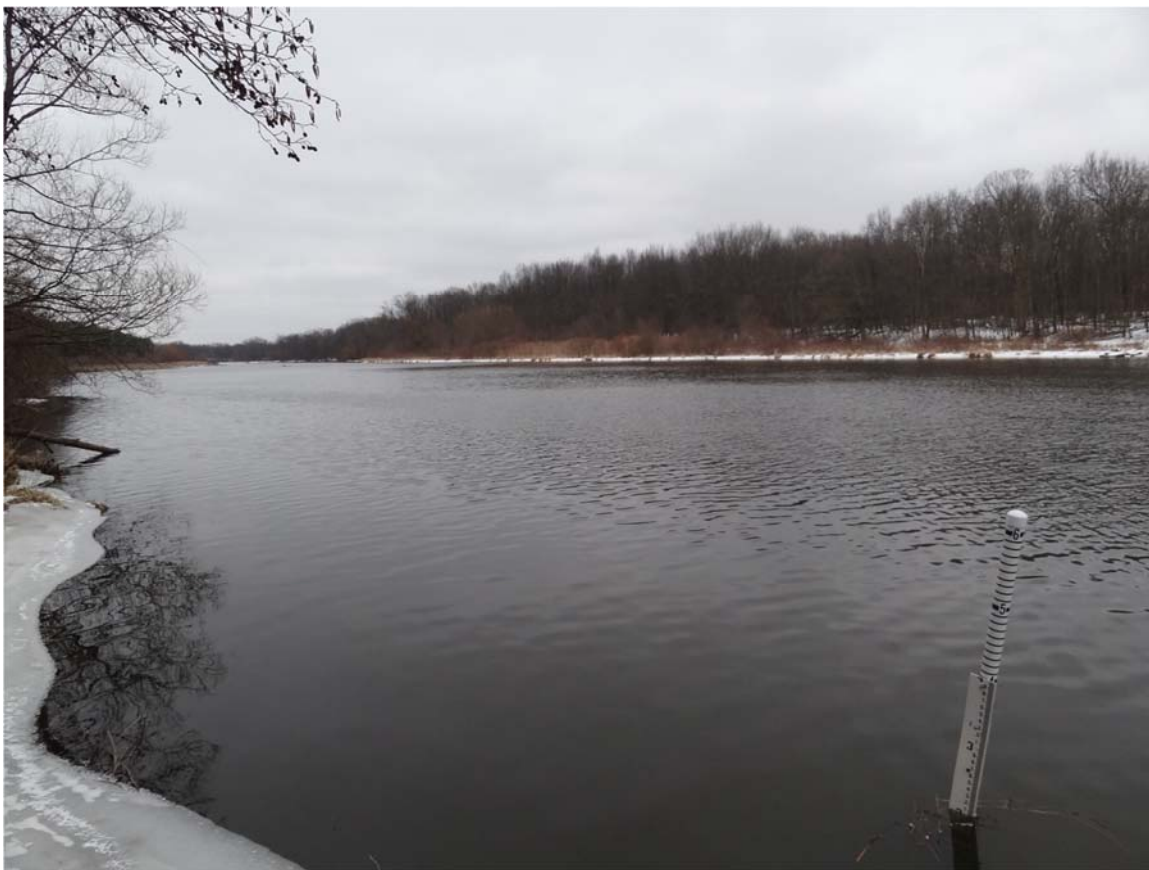
1. C0.4 Boat launch river icing conditions.

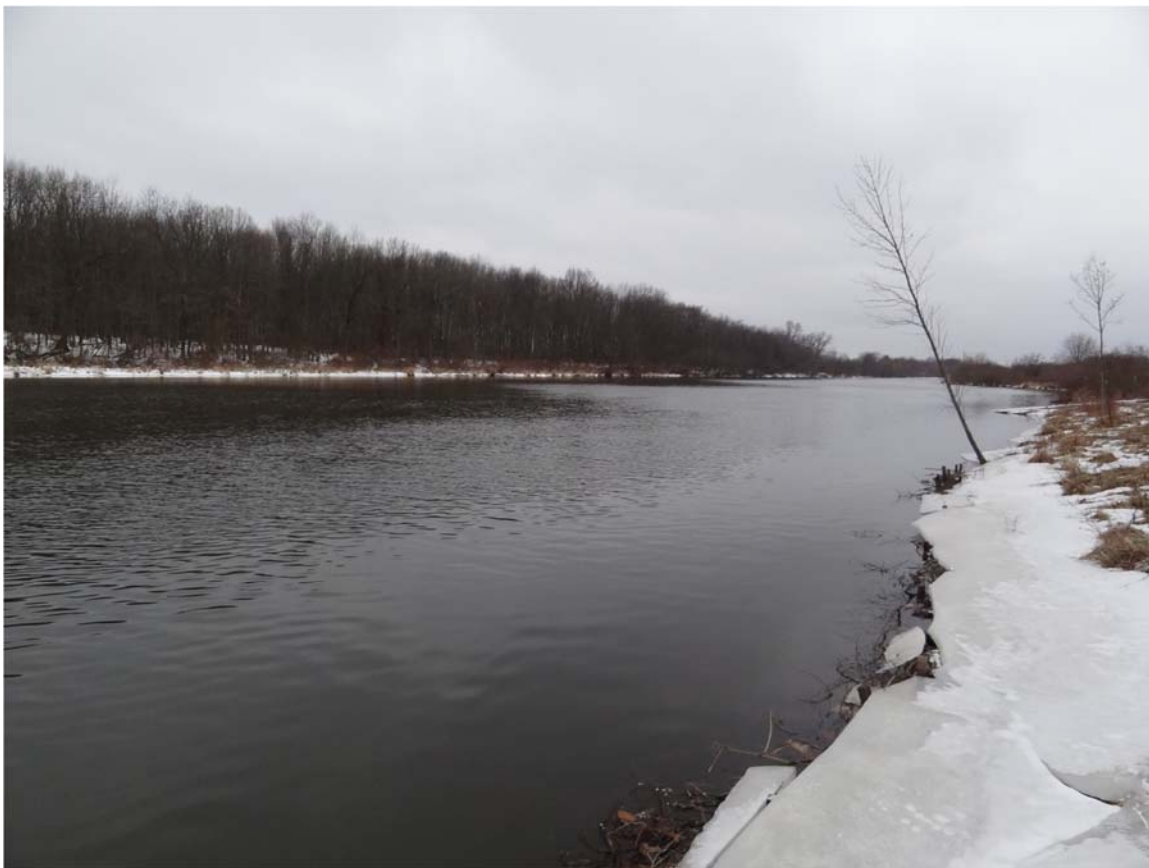
2. C0.4 Boat launch river icing conditions.

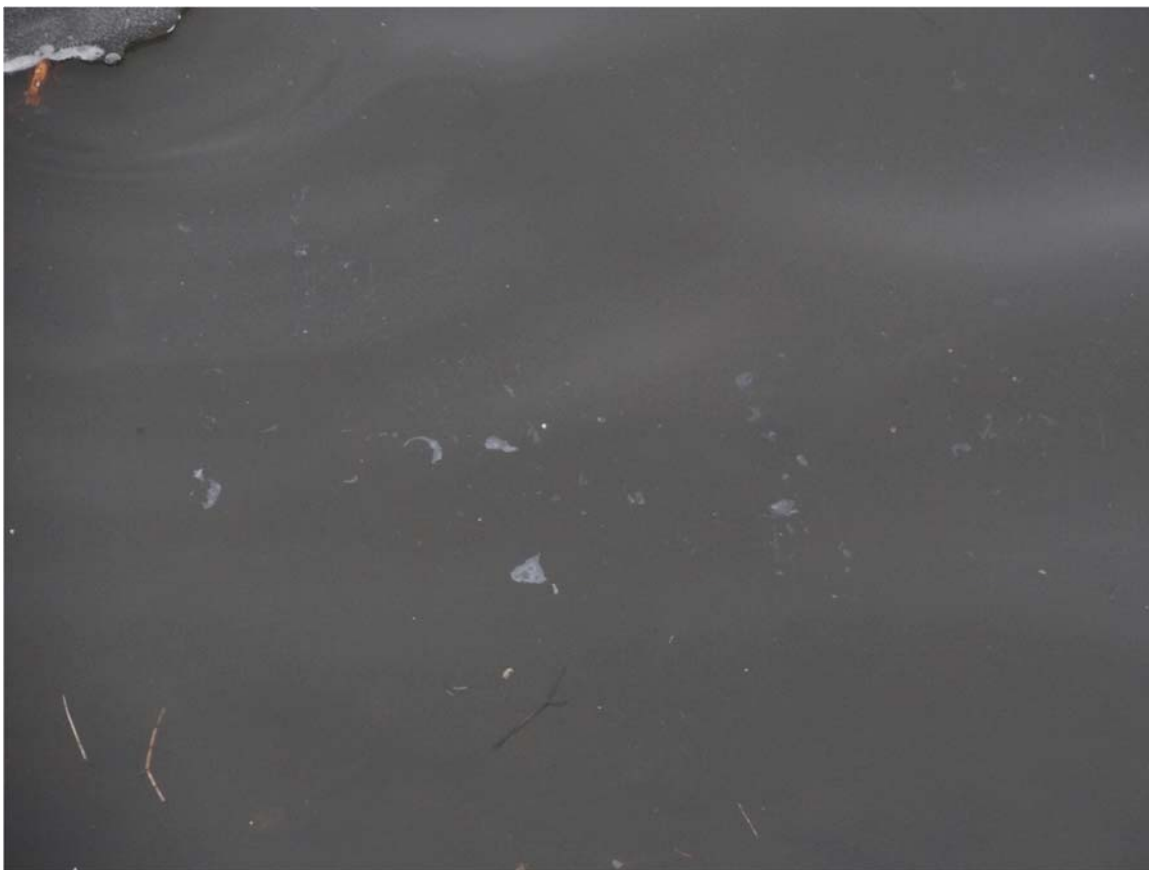
3. MP5.75 RDB observed sheen and tar globs.

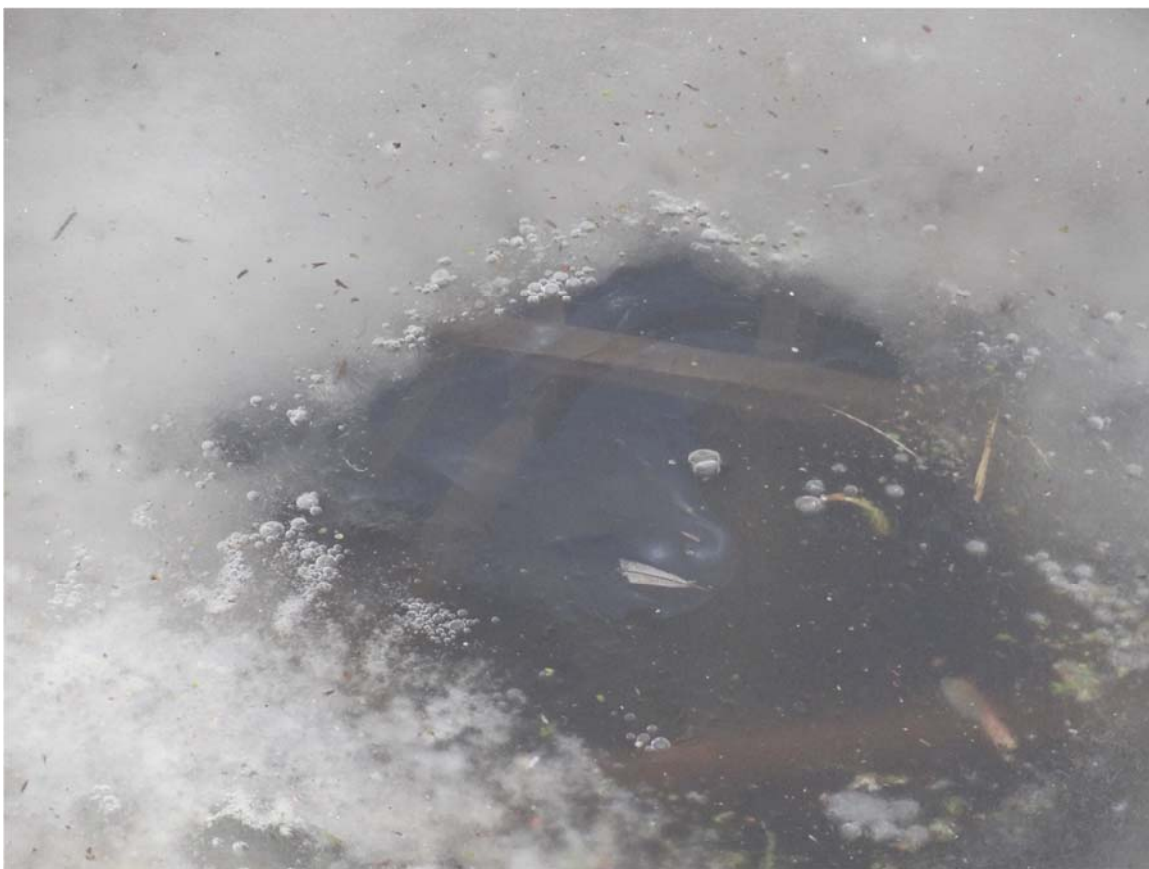
4. MP5.70 RDB observed sheen and tar globs.

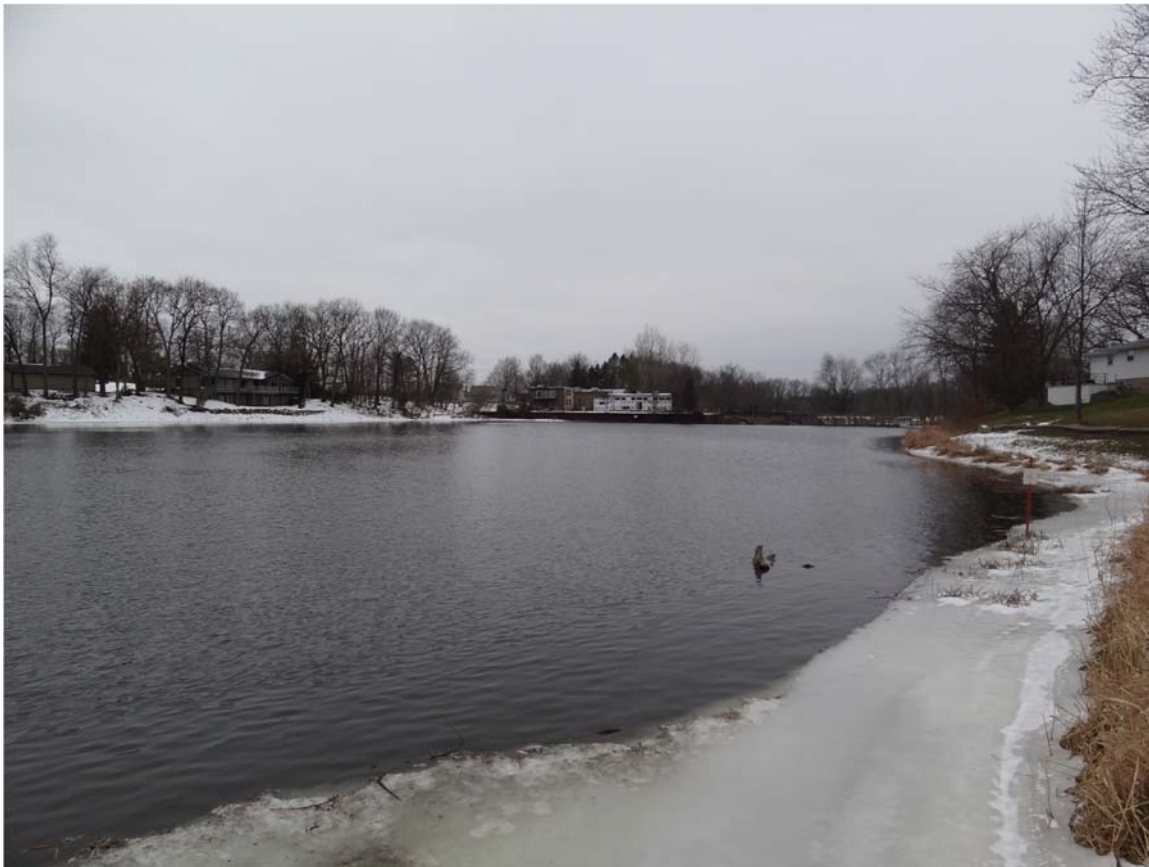
5. Ceresco Dam Impoundment River icing conditions.

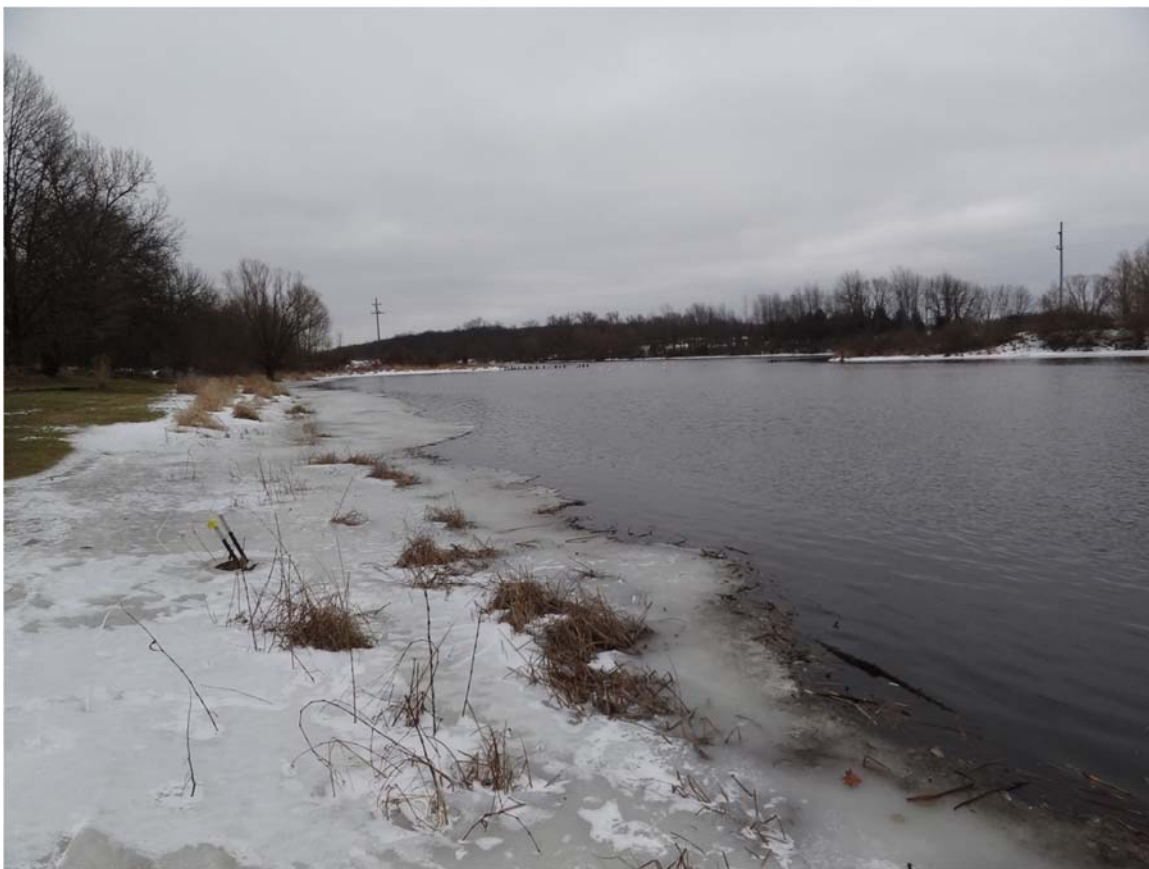
6. Ceresco Dam Impoundment River icing conditions.

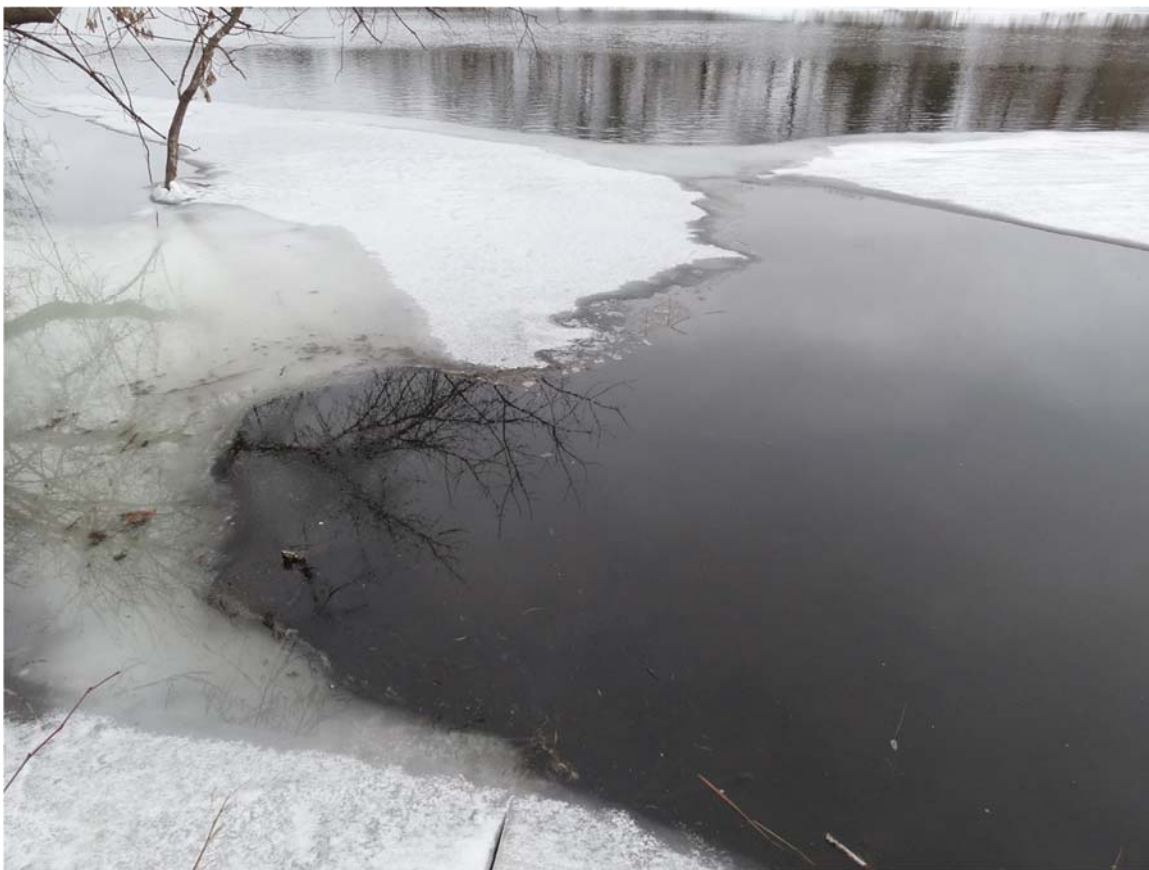
7. MP5.89 RDB above Ceresco Dam observed sheen.

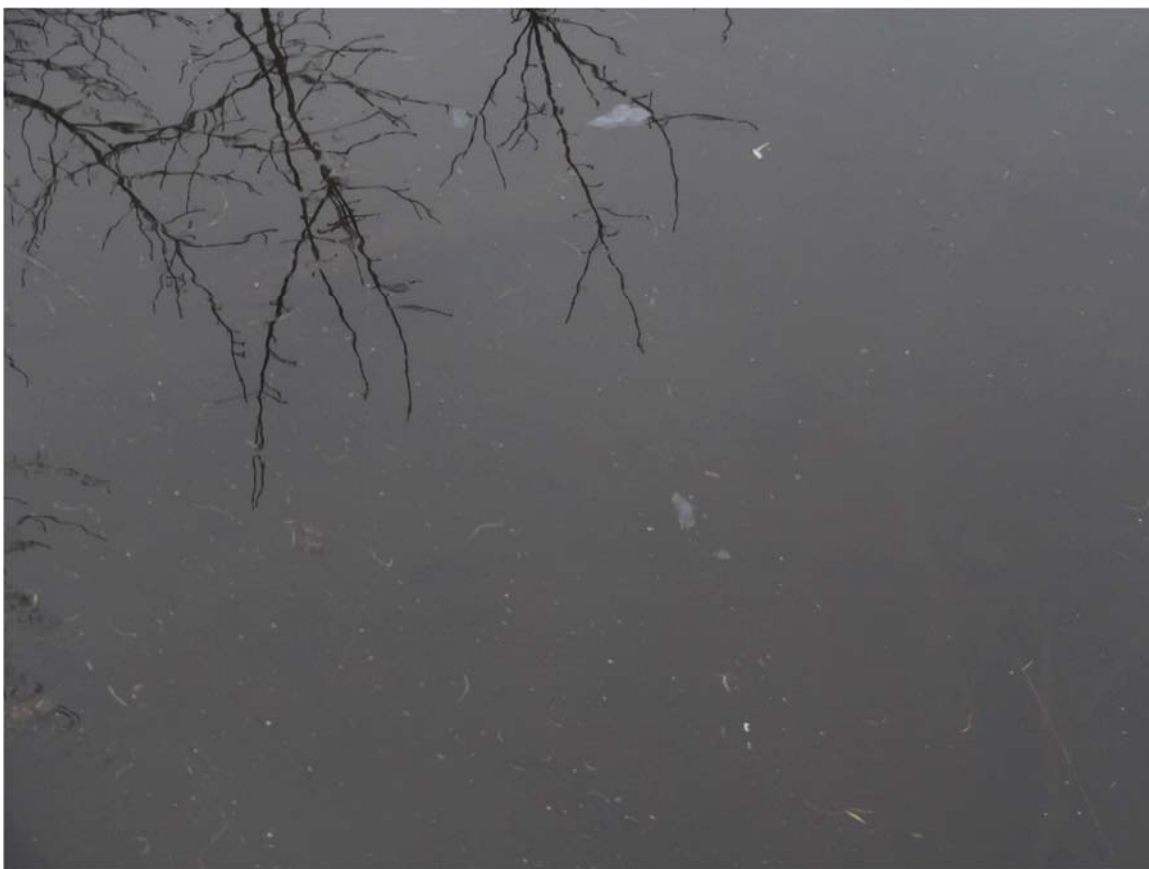
8. MP5.89 RDB above Ceresco Dam observed sheen.

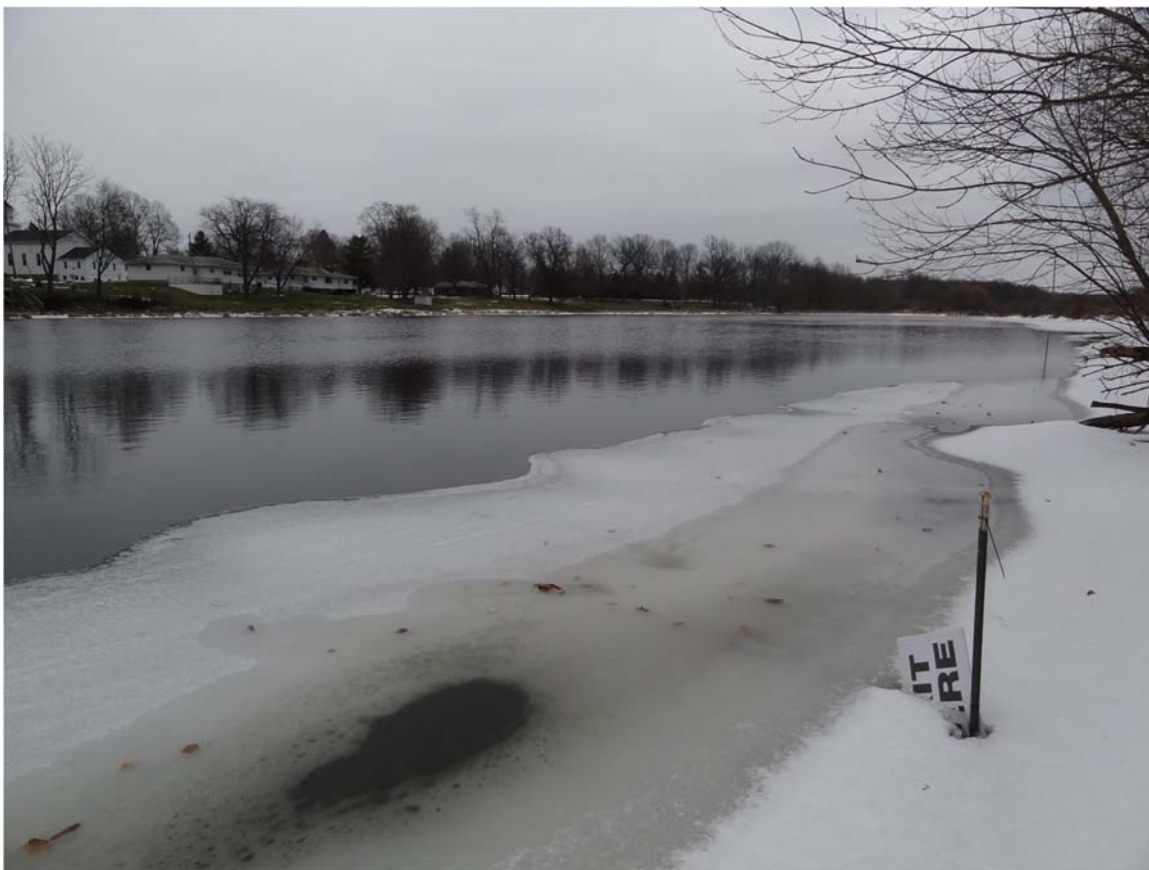
9. Ceresco Dam Impoundment River icing conditions.

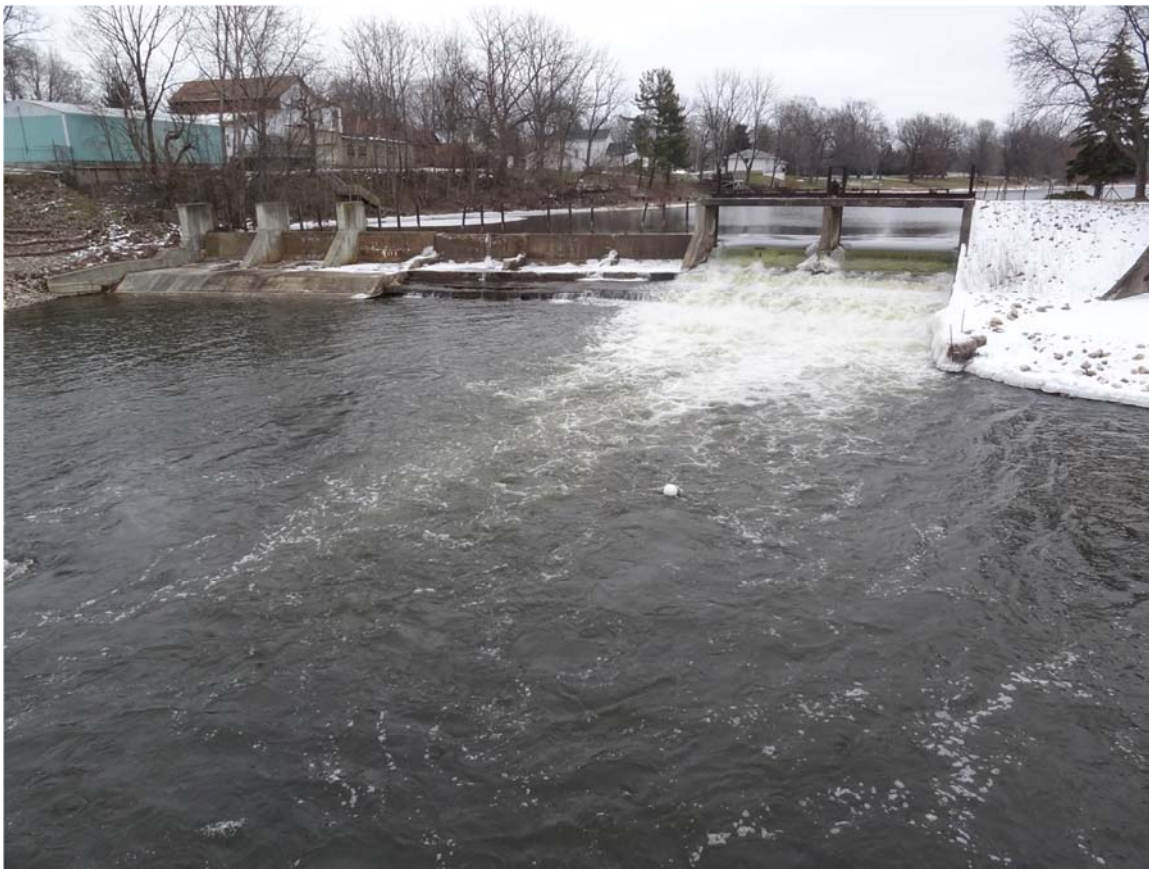
10. Ceresco Dam CSD buoy moved from the RDB above the dam observed below the dam.

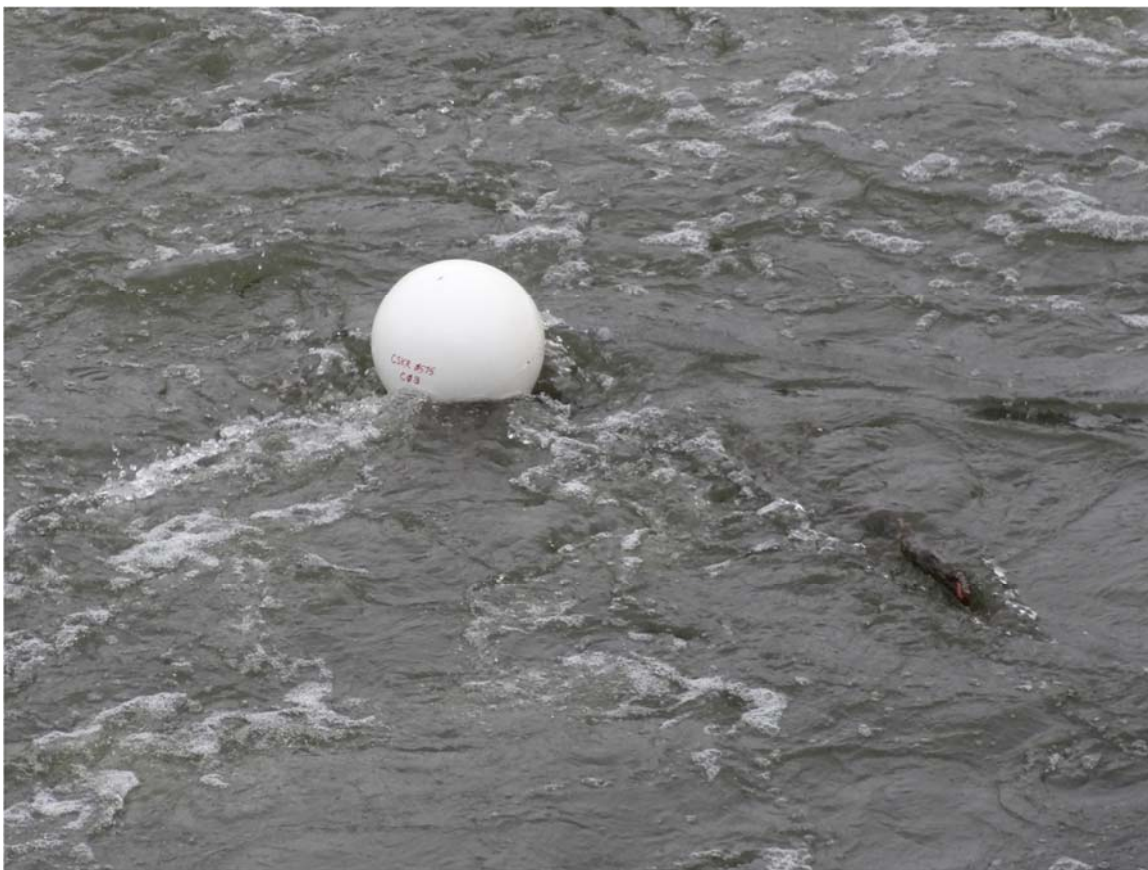
11. Ceresco Dam CSD buoy moved from the RDB above the dam observed below the dam.

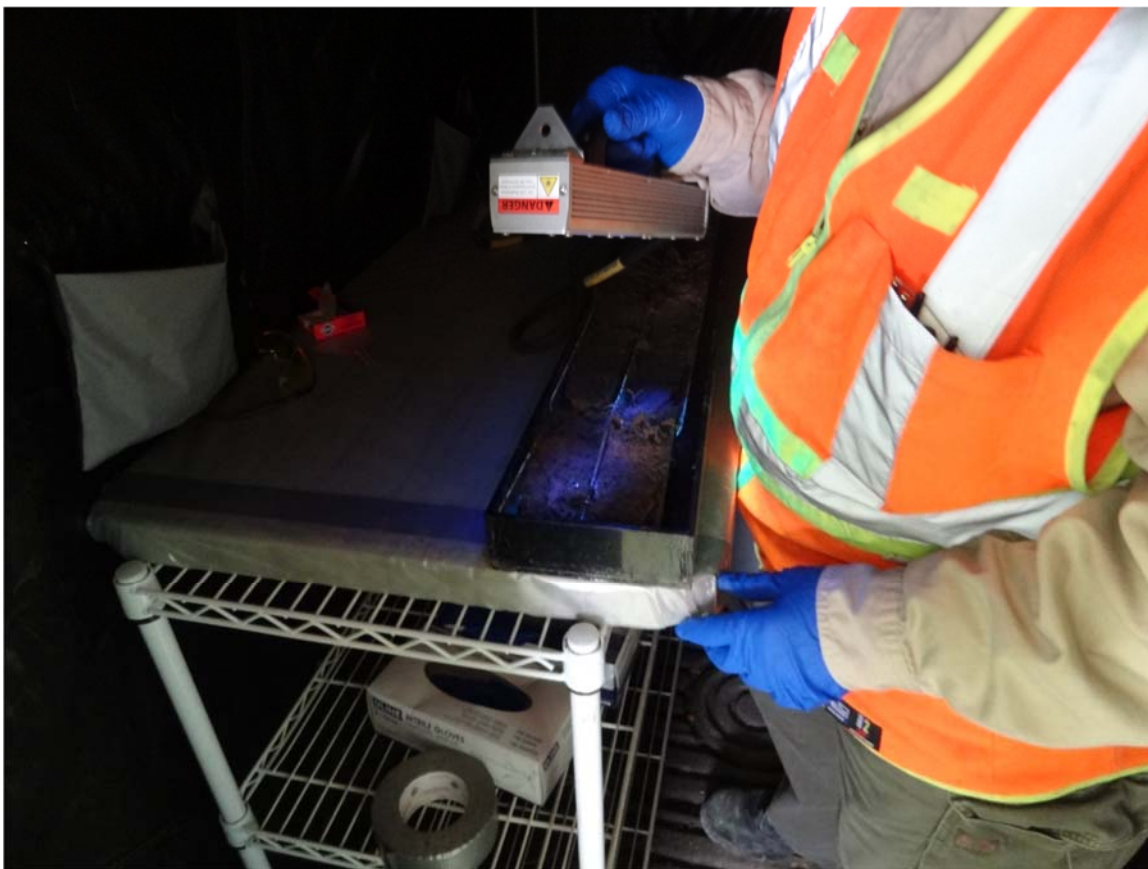
12. C3.2 Pole Barn observed core logging operations.

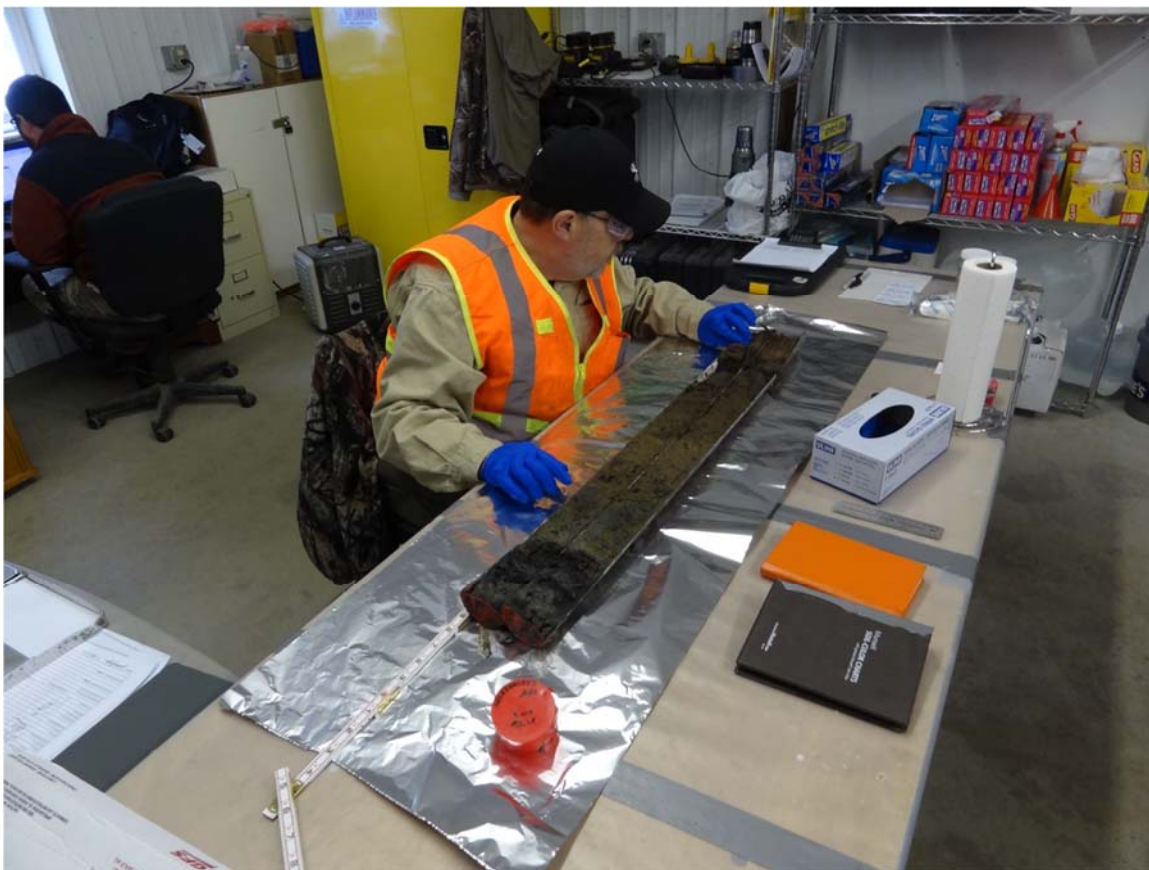
13. C3.2 Pole Barn observed core logging operations.

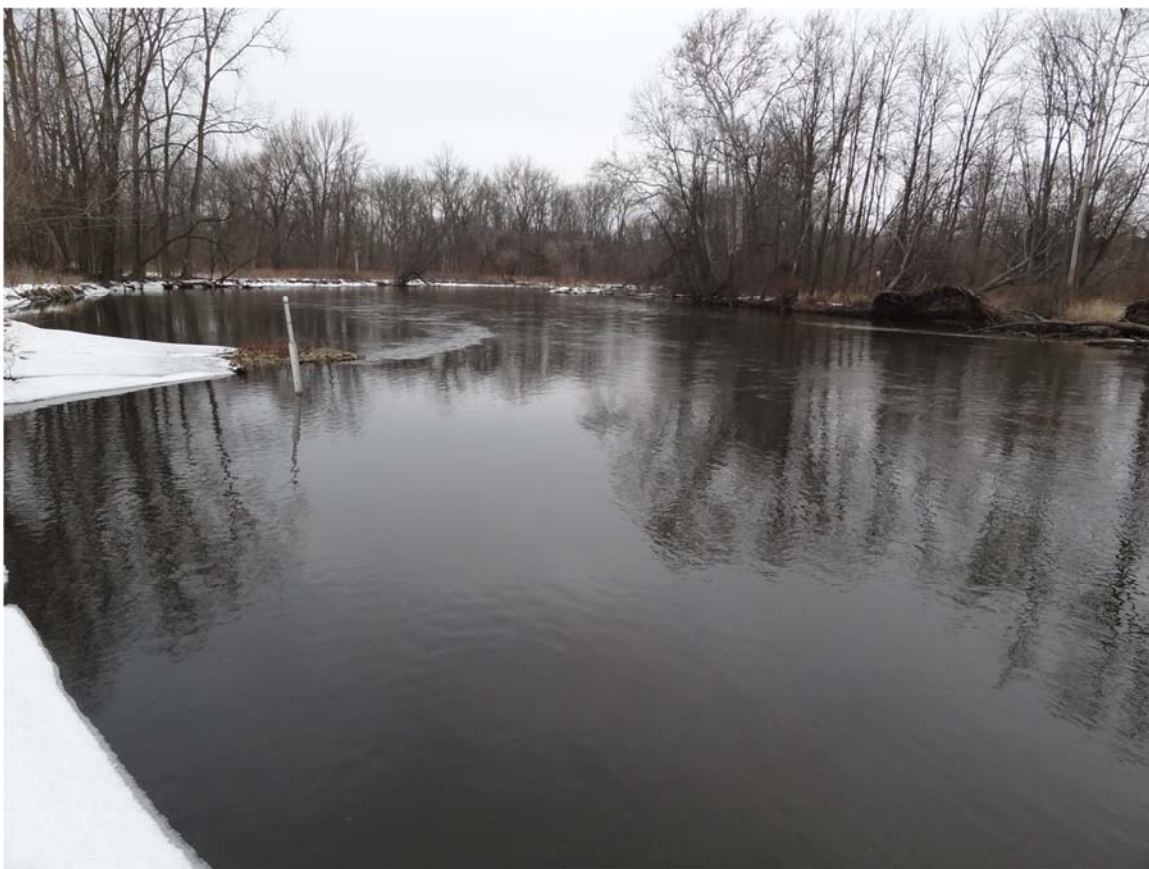
14. C3.2 Boat Launch river icing conditions.

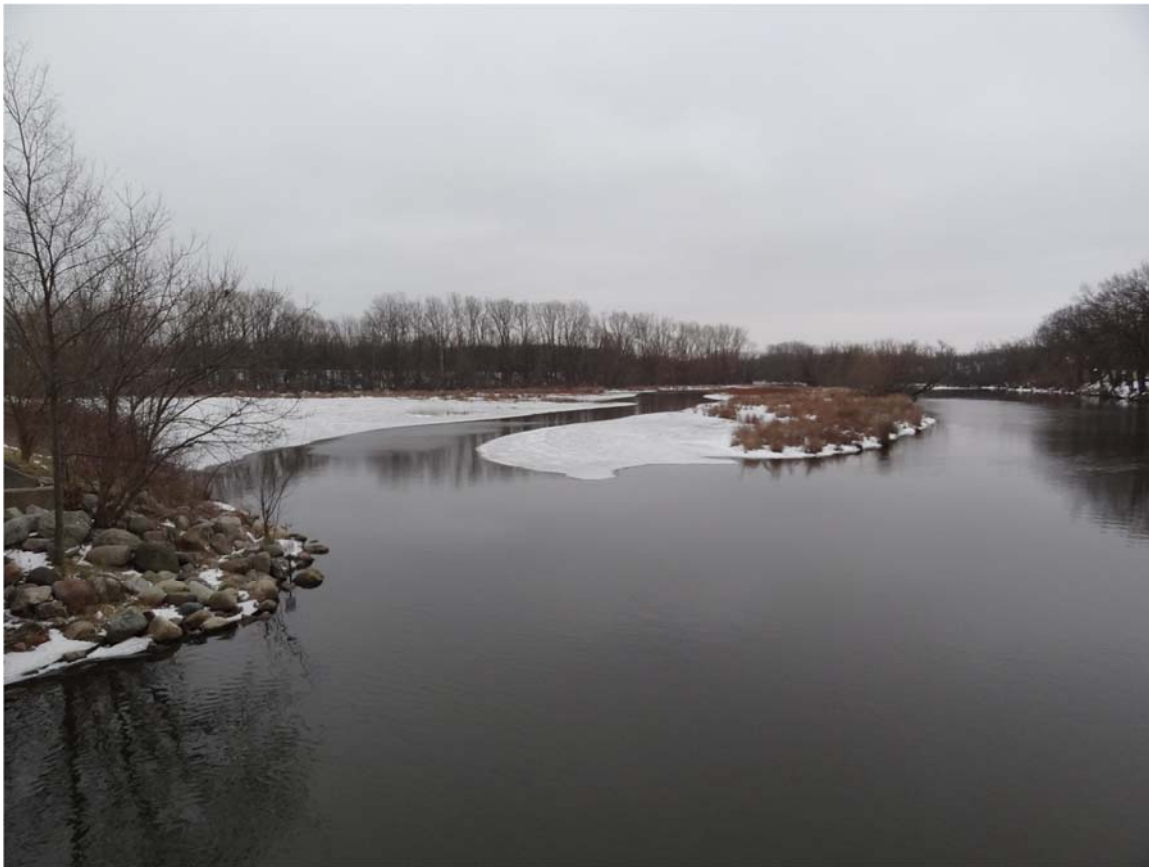
15. MP15.25 South Mill Pond observed river icing conditions.

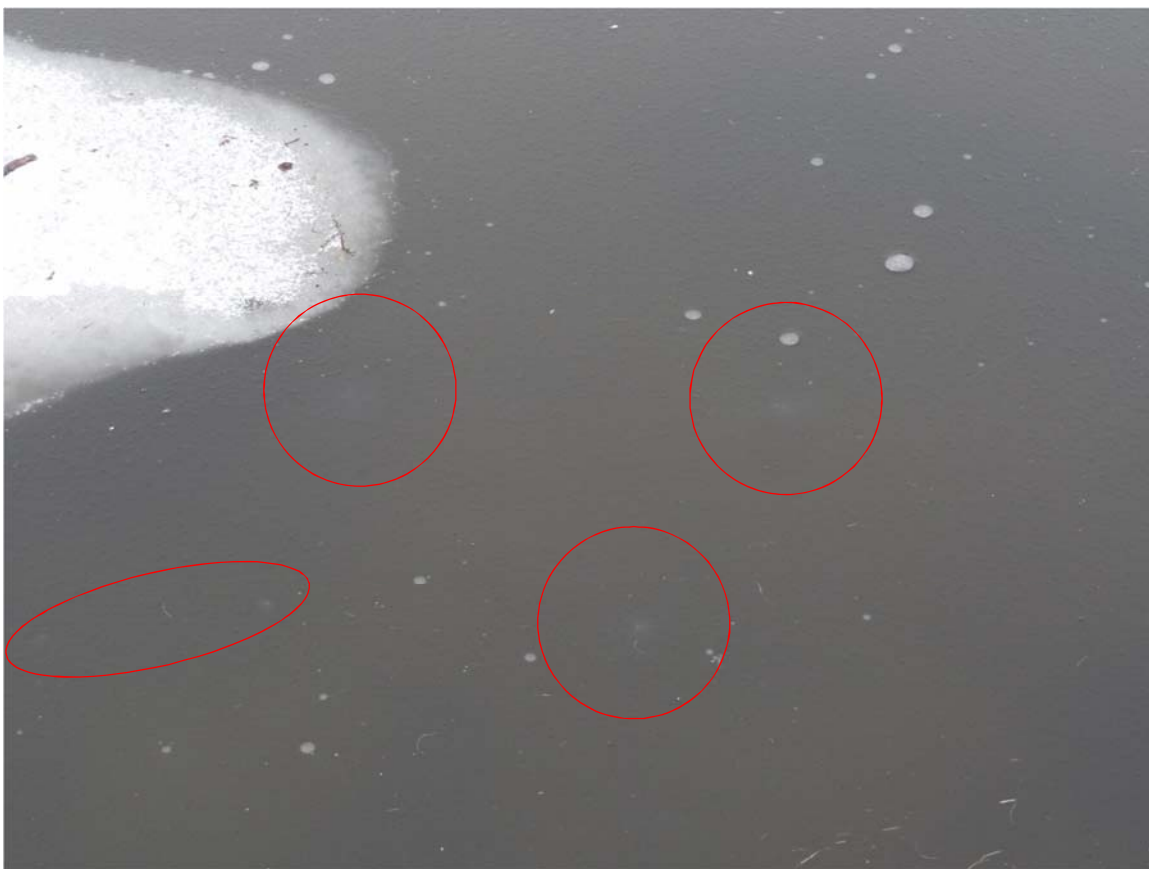
16. MP15.25 South Mill Pond observed sheen frozen in the ice.

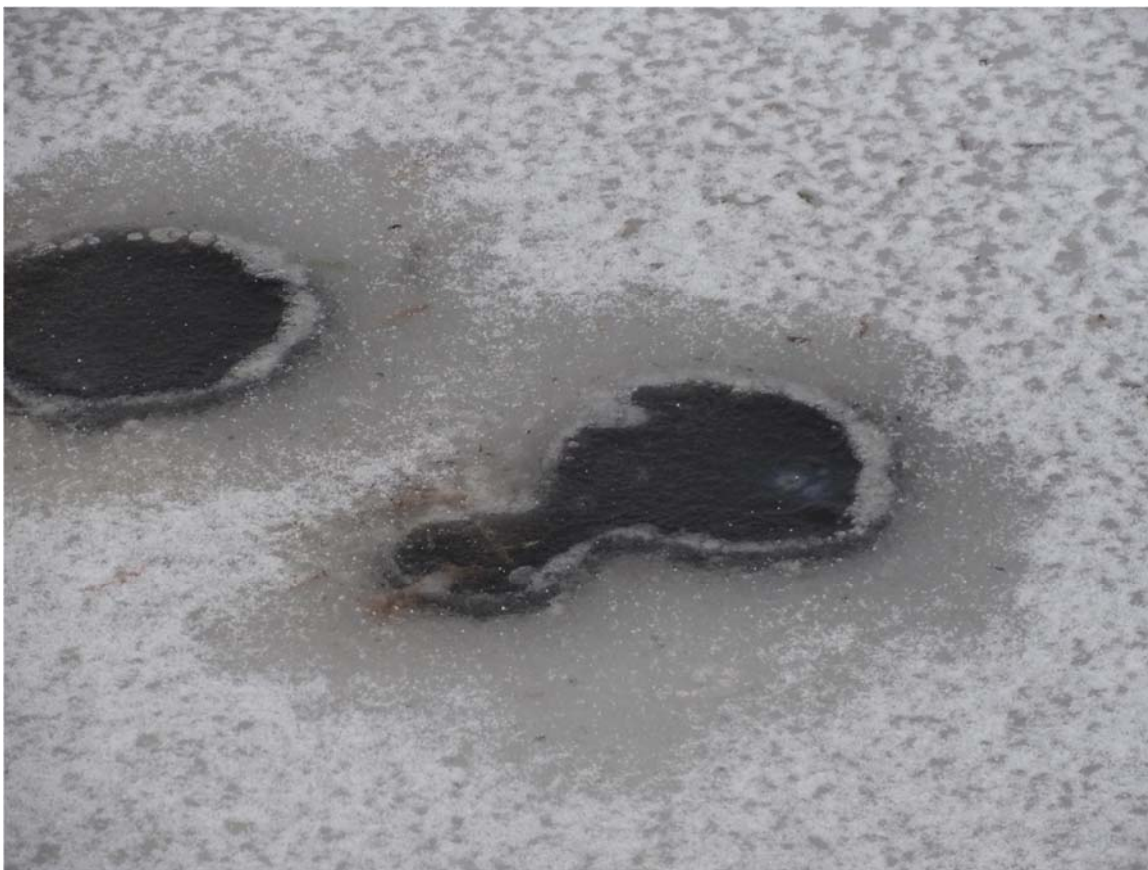
17. MP15.25 South Mill Pond observed sheen and tar globs frozen in the ice.

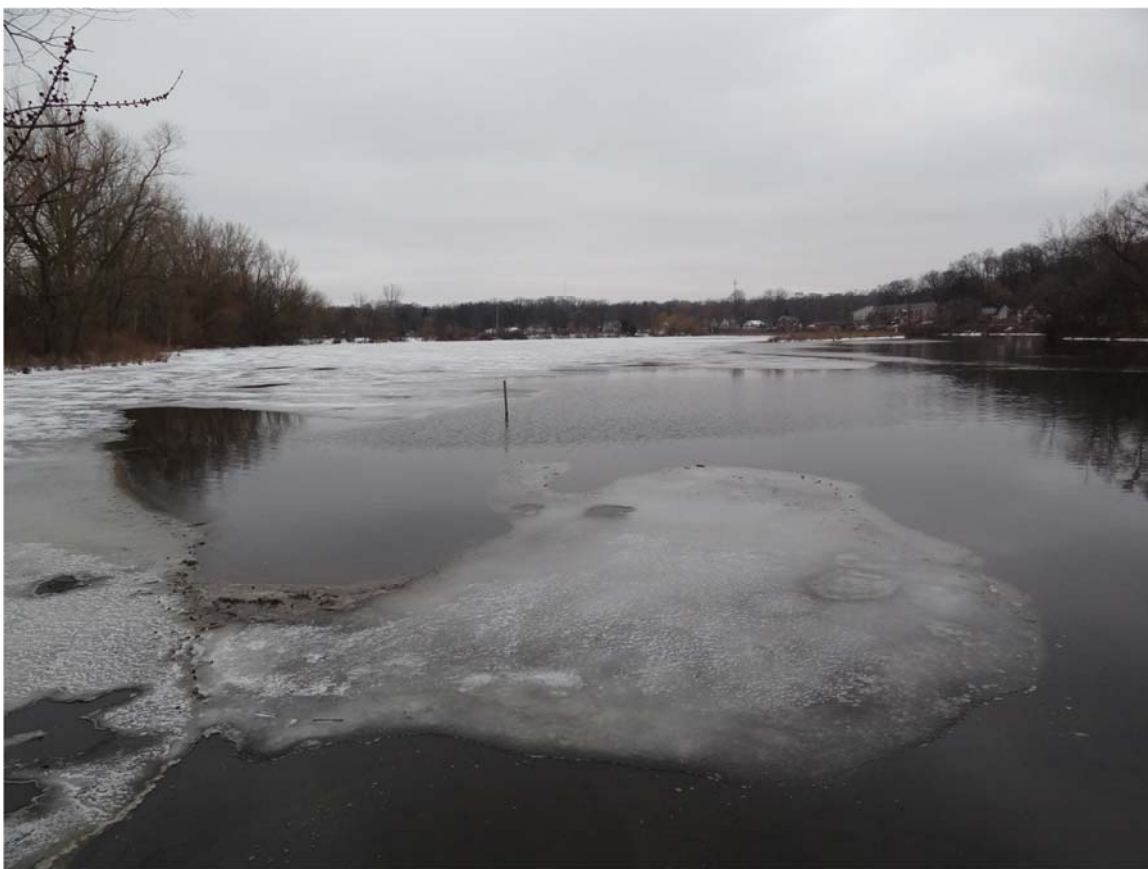
18. MP15.75 North Mill Pond river icing conditions.

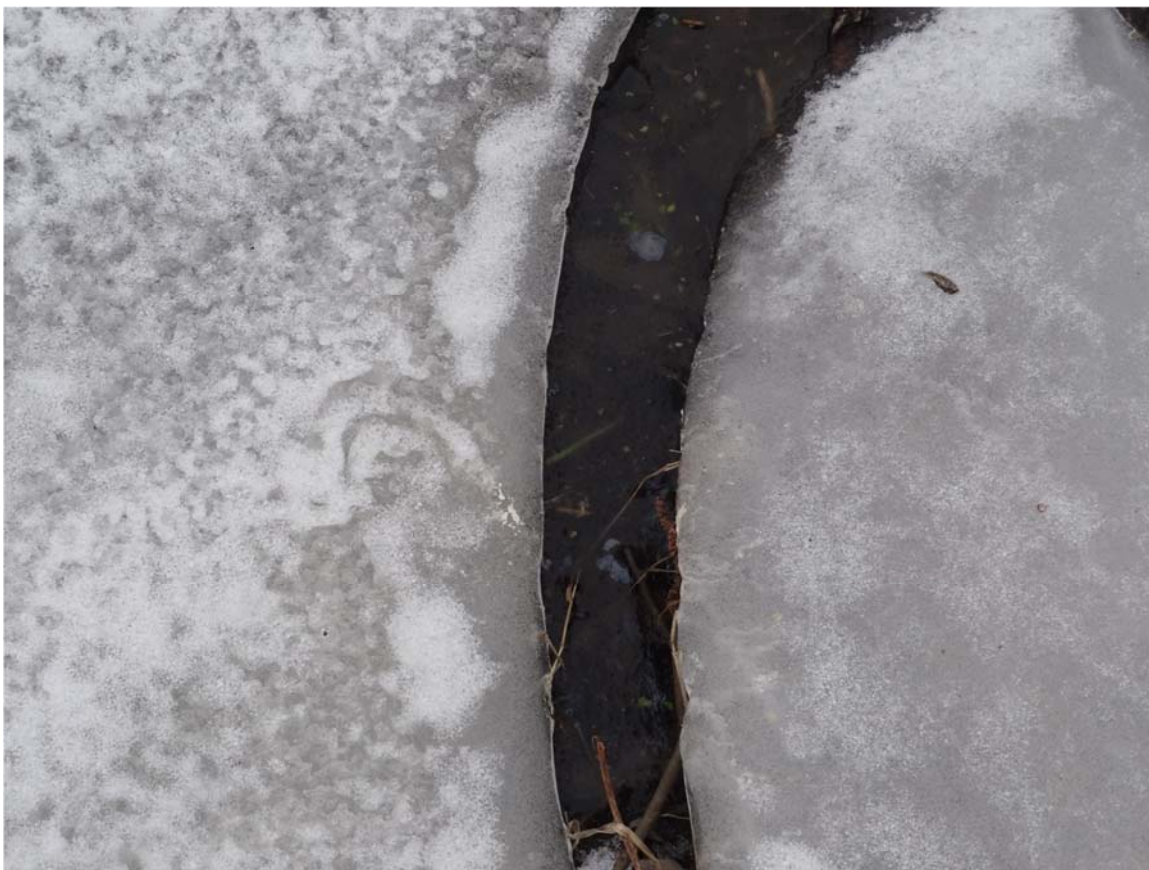
19. MP15.75 RDB observed sheen and tar globs frozen in the ice.

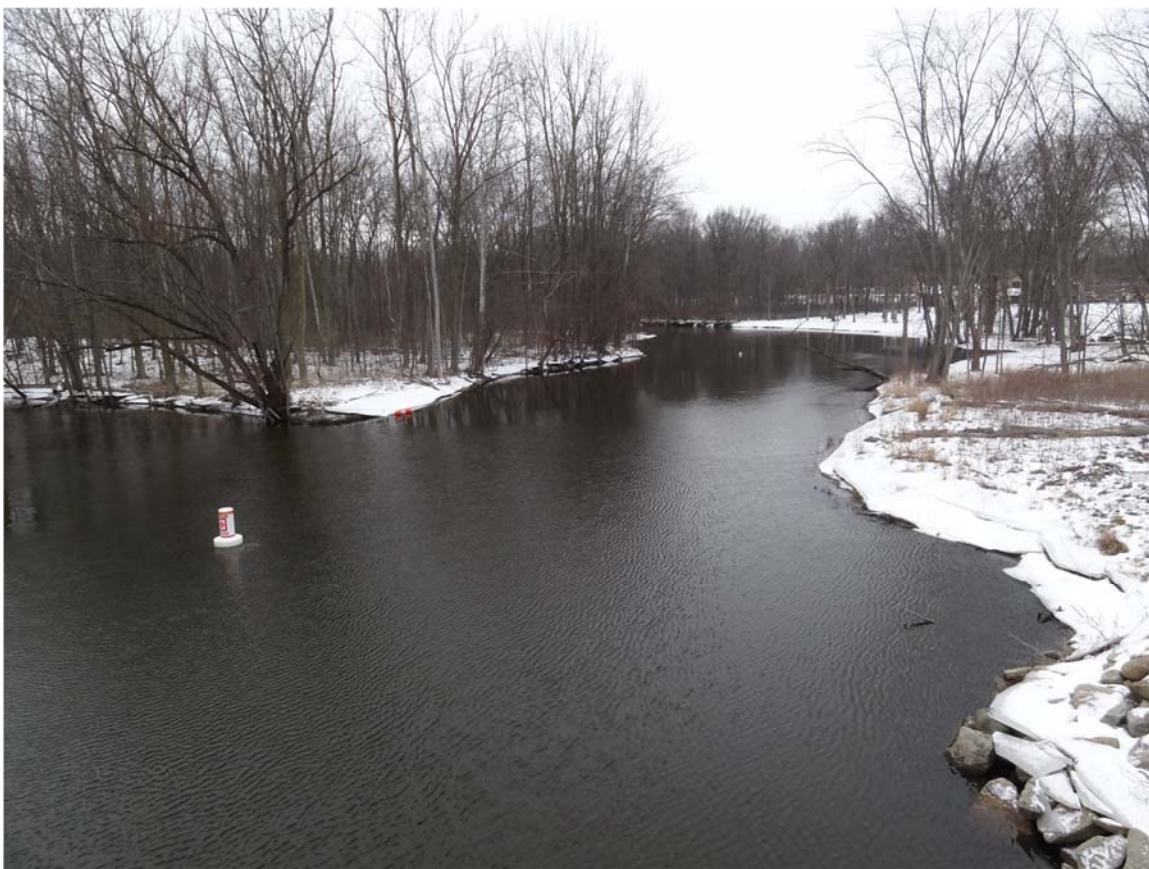
20. MP21.5 River icing conditions.

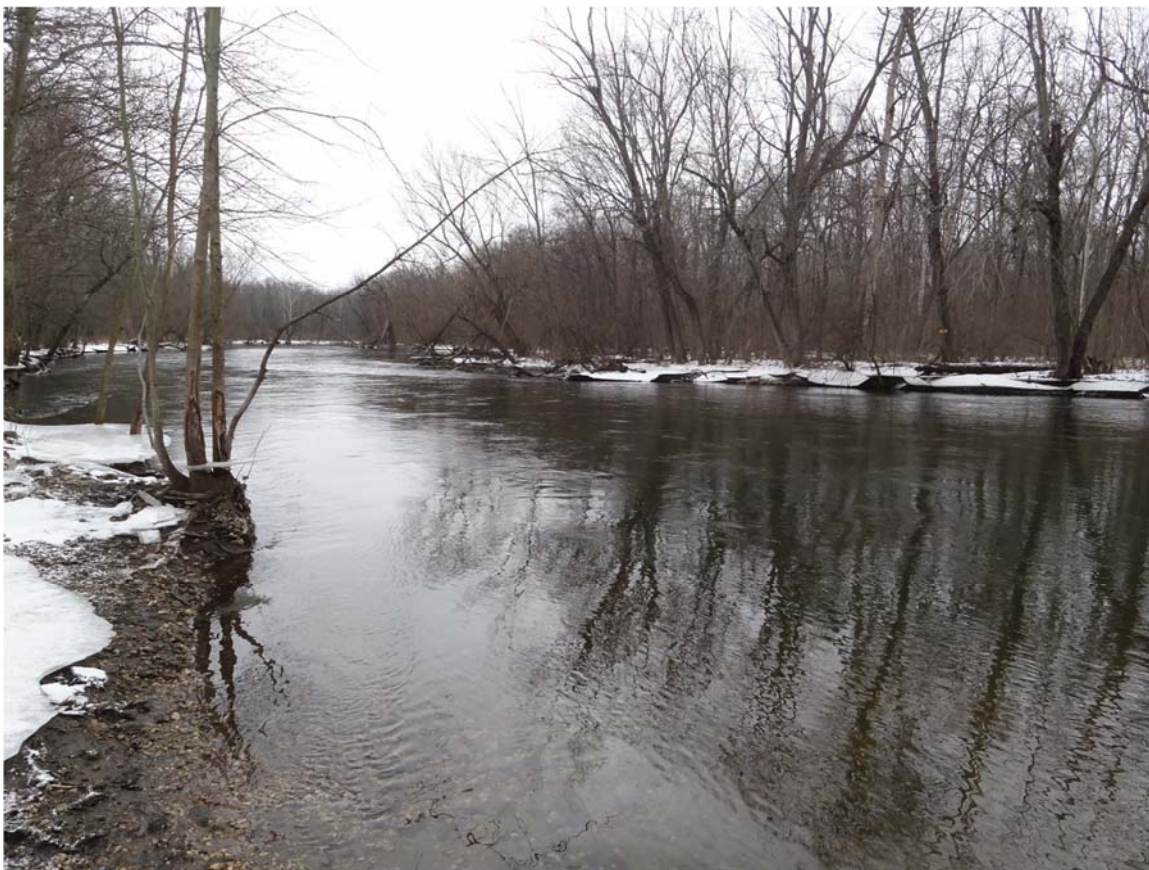
**21. D2 Boat Launch River icing conditions.**

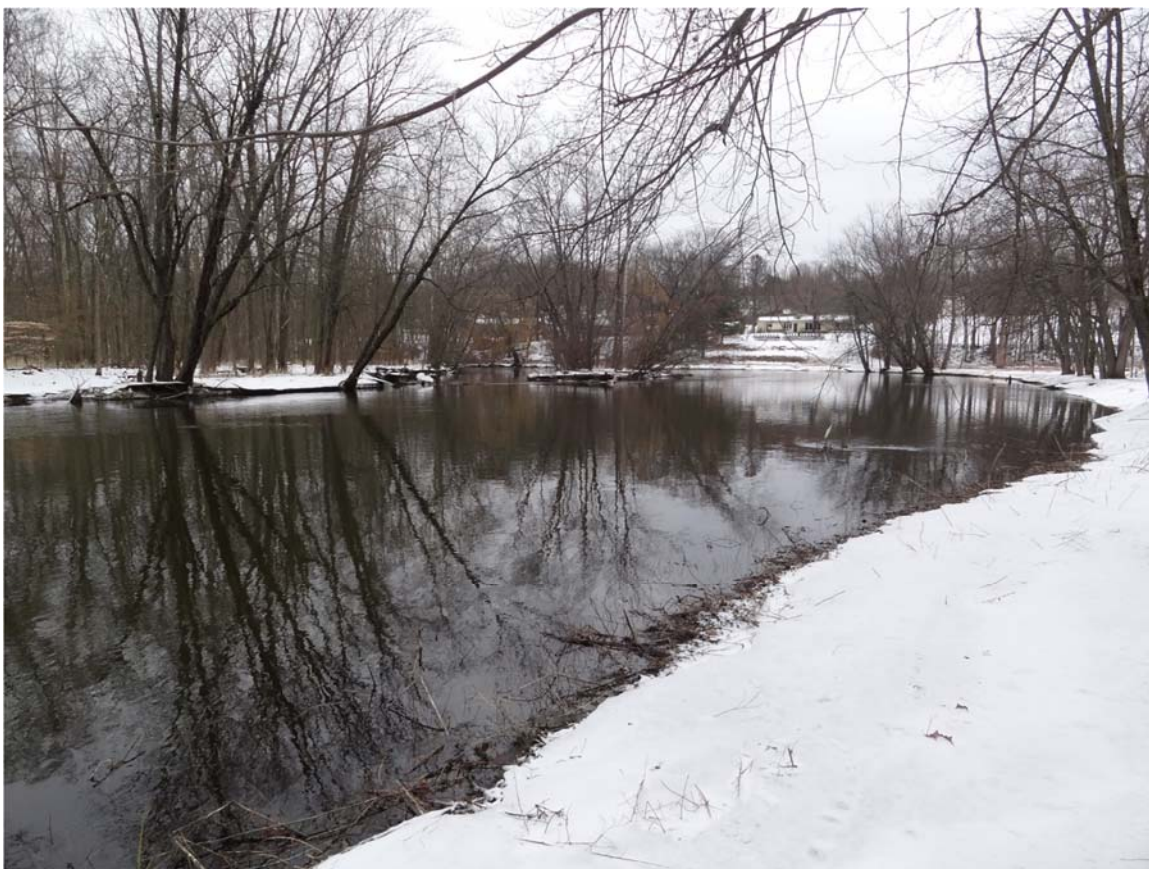
**22. E0.5 Boat Launch Shady Bend Campground river icing conditions.**

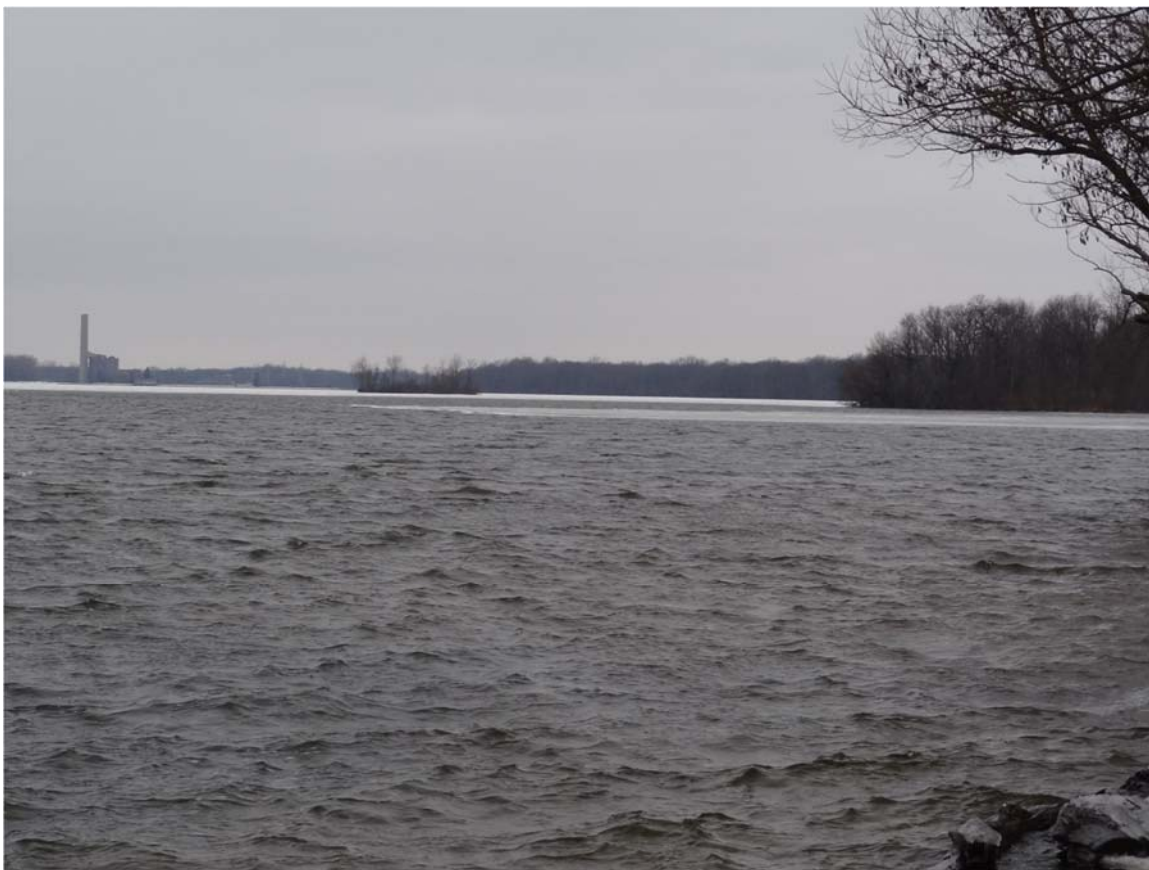
23. Morrow Lake observed icing conditions.
