# Situation Photo Log

Tuesday, February 12, 2013

Kalamazoo River / Enbridge Spill

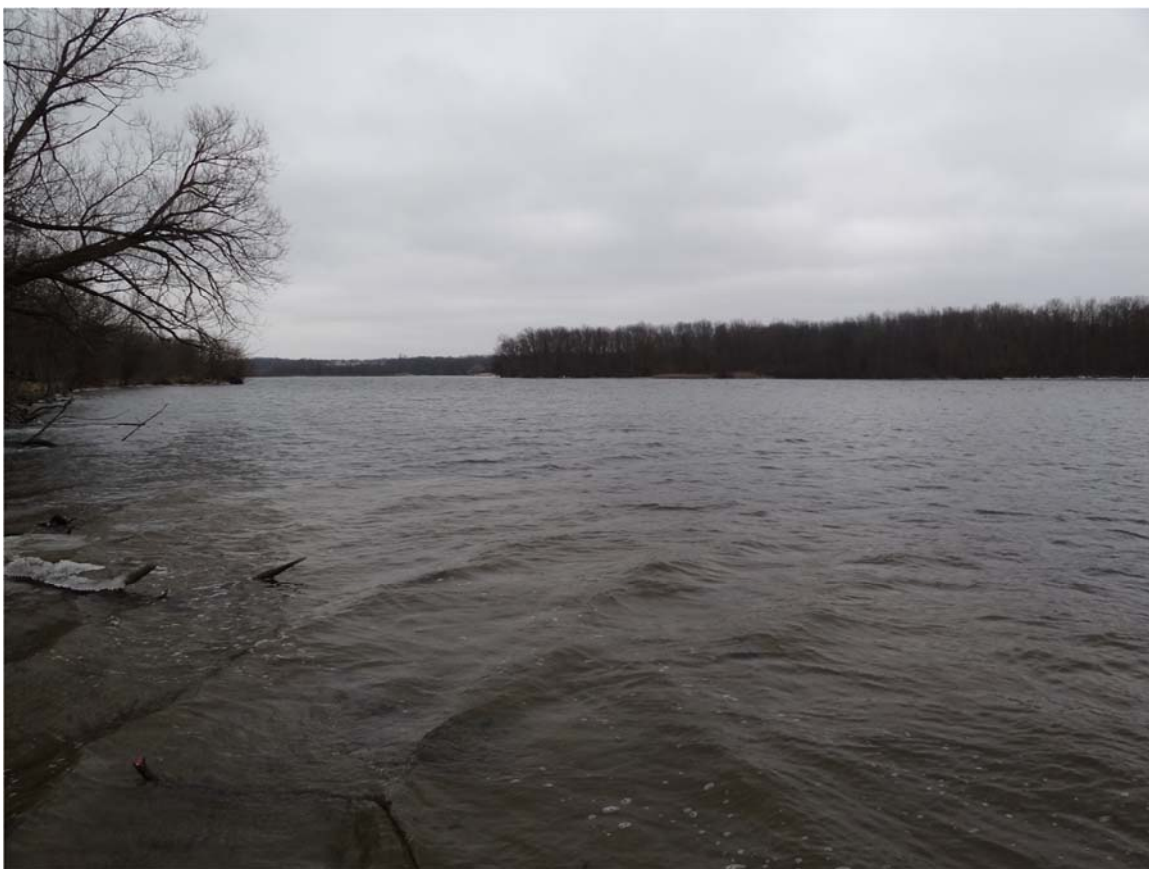
24. Morrow Lake Neck /Morrow Lake Delta River icing conditions.

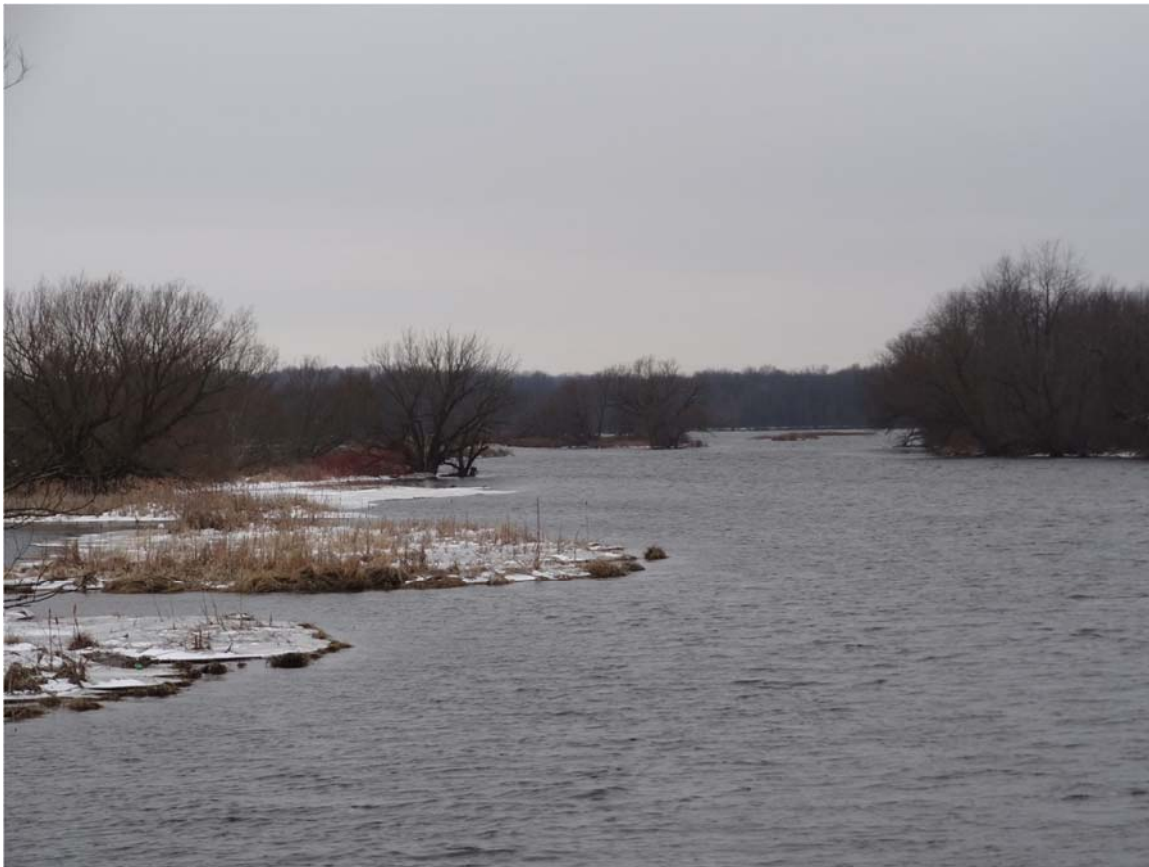
25. Morrow Lake Delta river icing conditions.

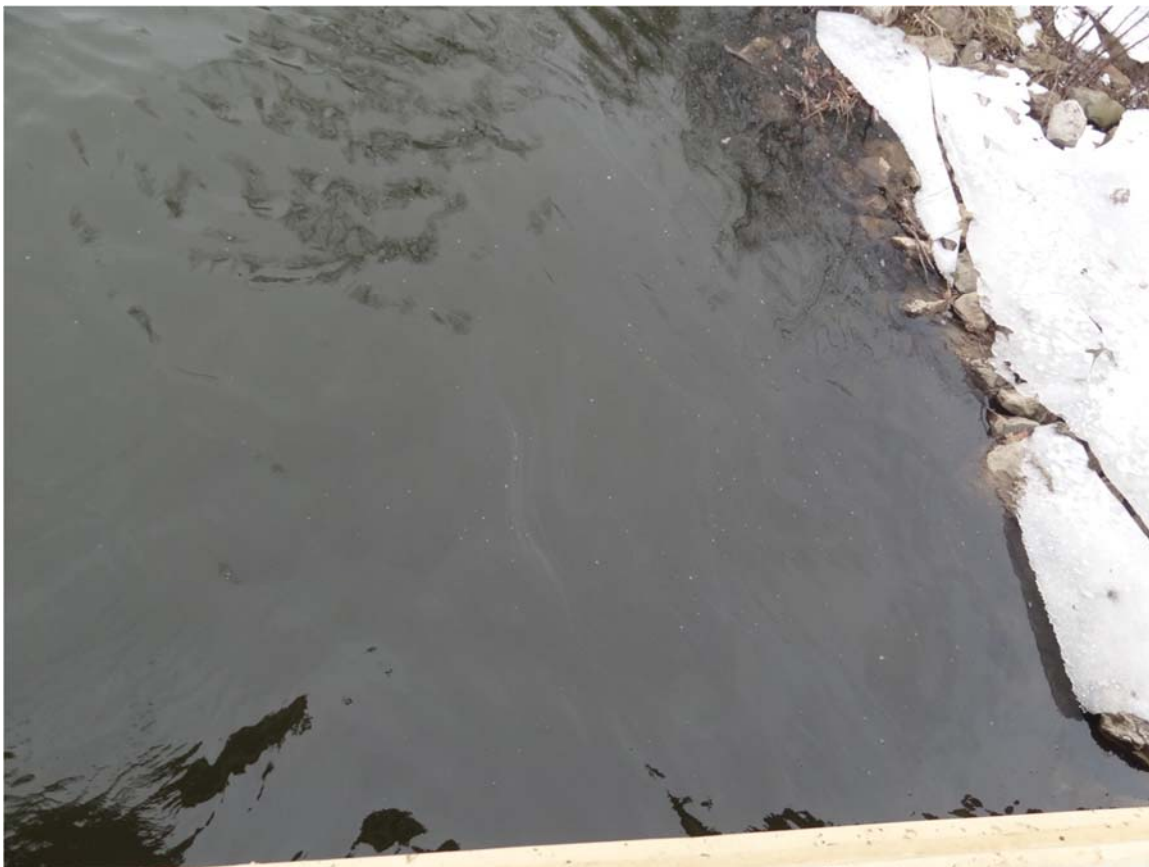
26. MP36.5 35<sup>th</sup> Street Bridge RDB observed sheen.

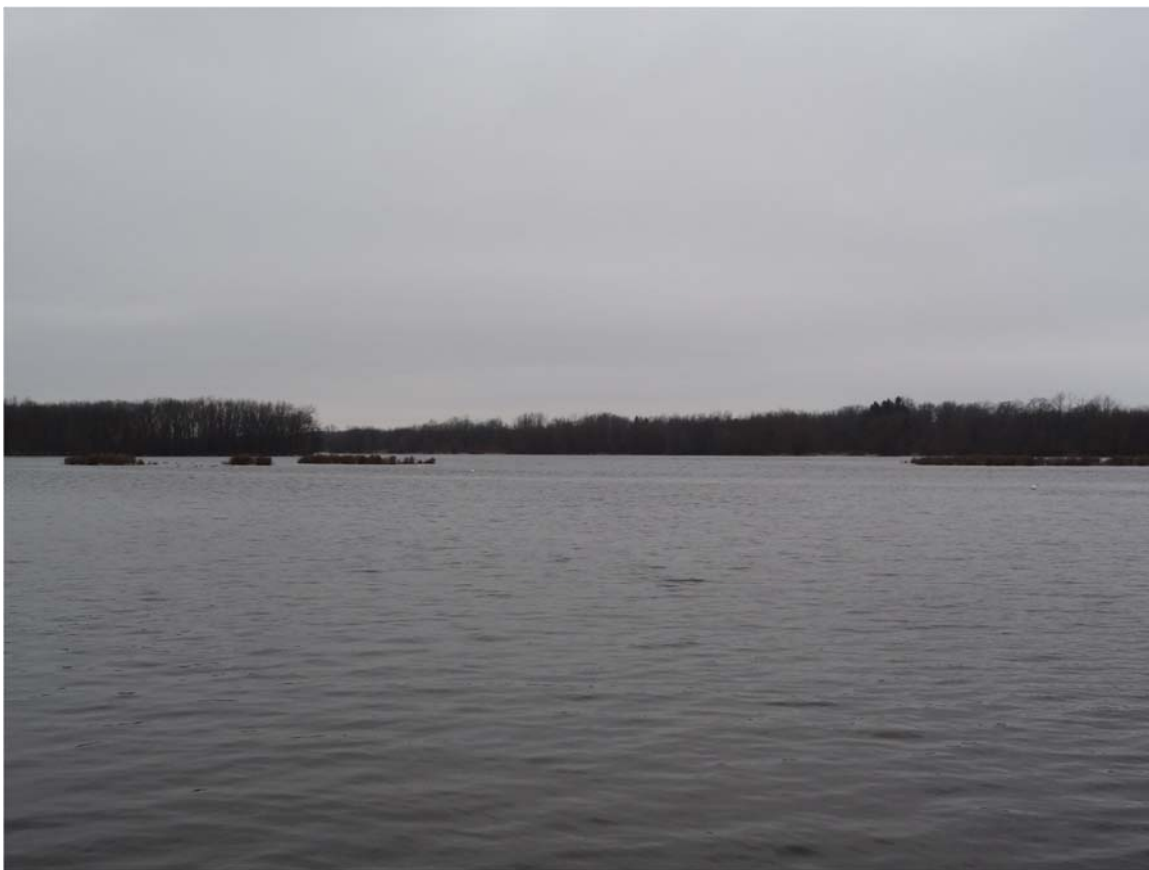
27. Morrow Lake Delta icing conditions.

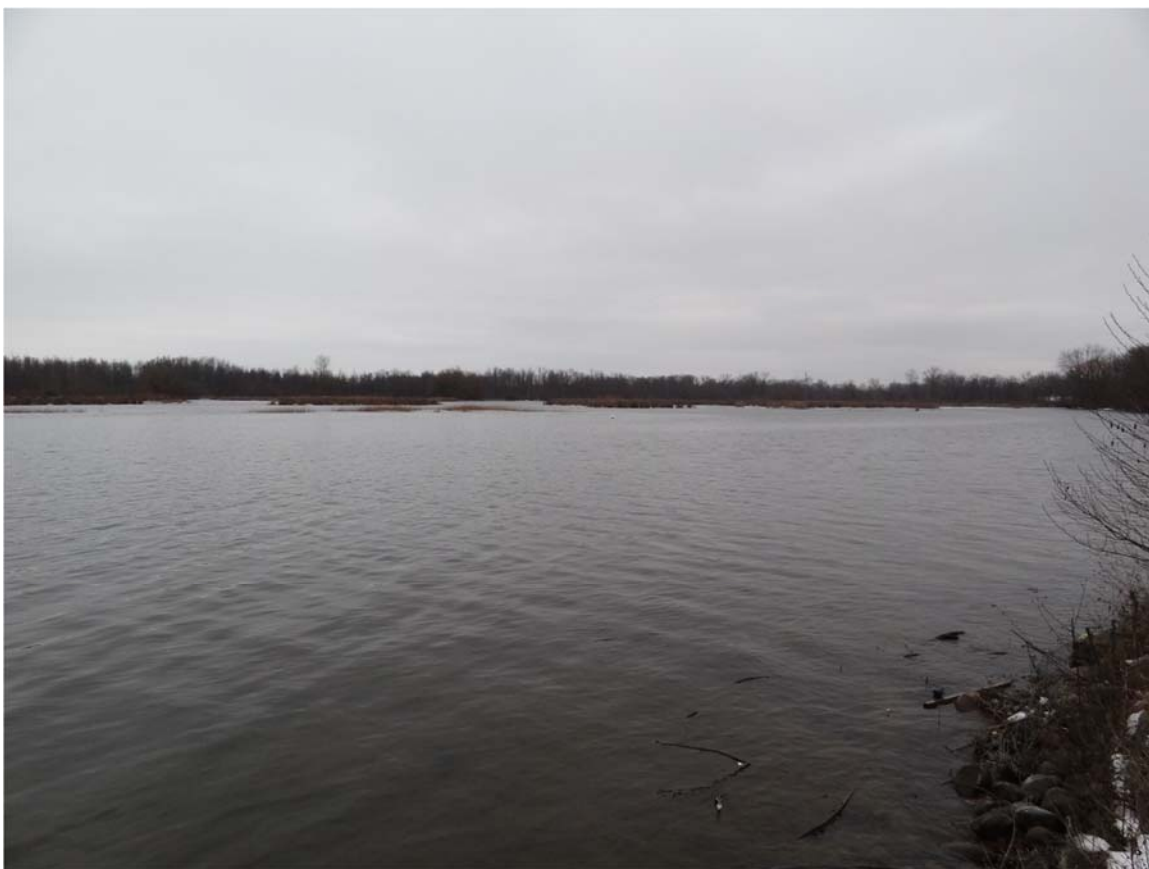
28. Morrow Lake Delta icing conditions.

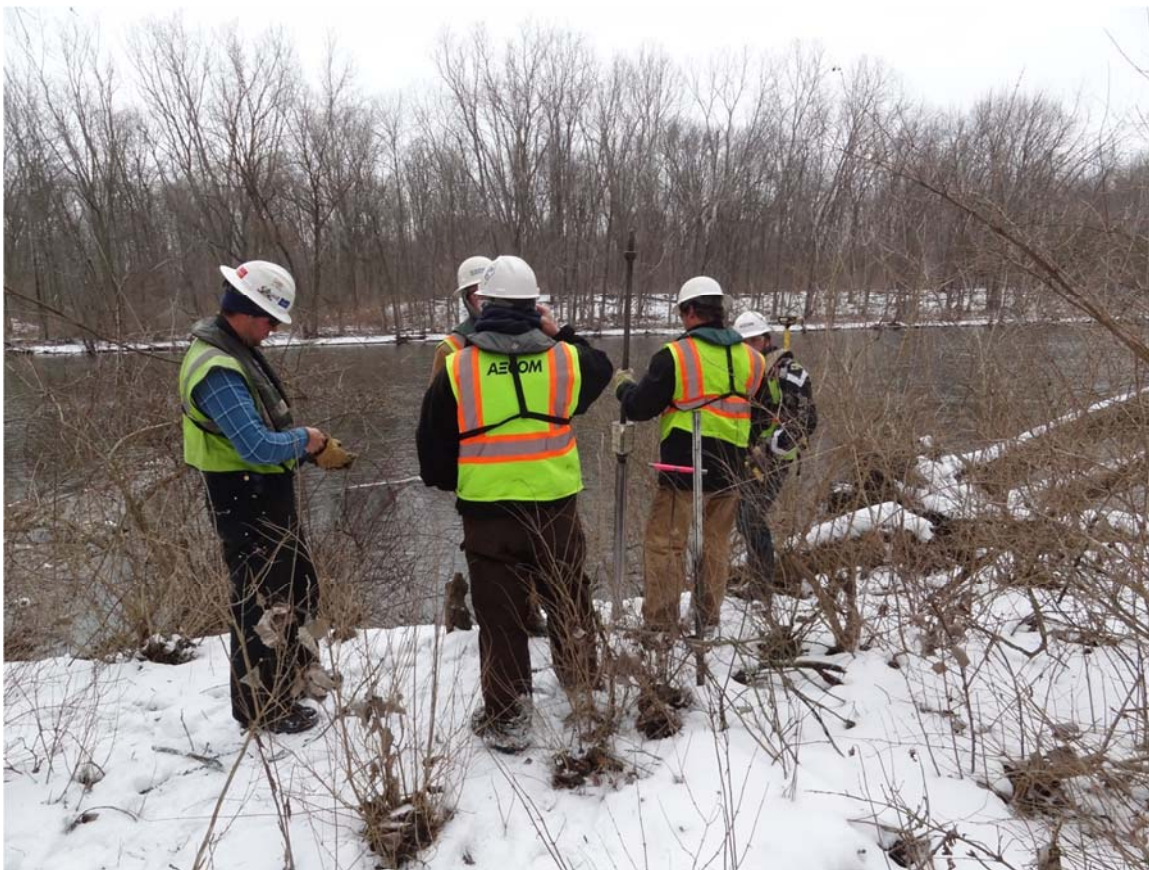
29. MP21.40 LDB observed the RI crew.

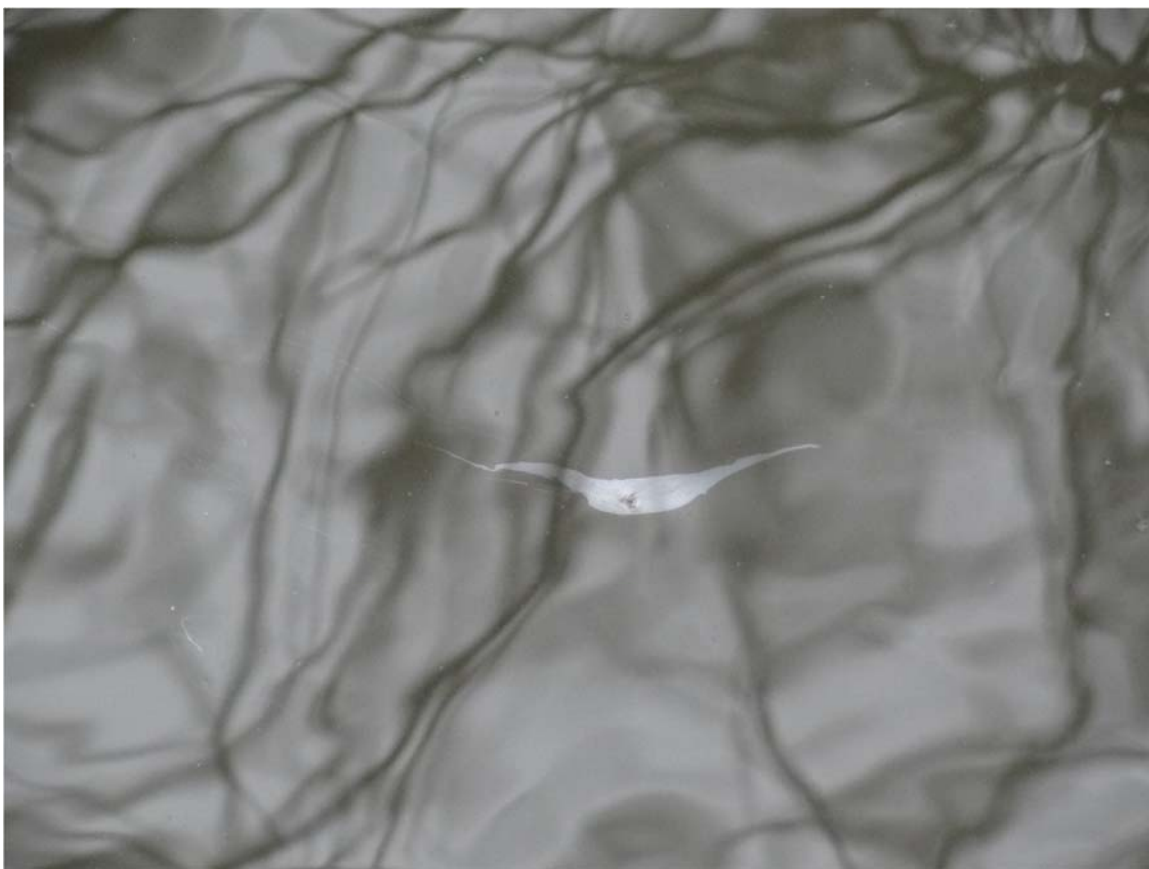
30. MP21.4 LDB observed tar glob and sheen.

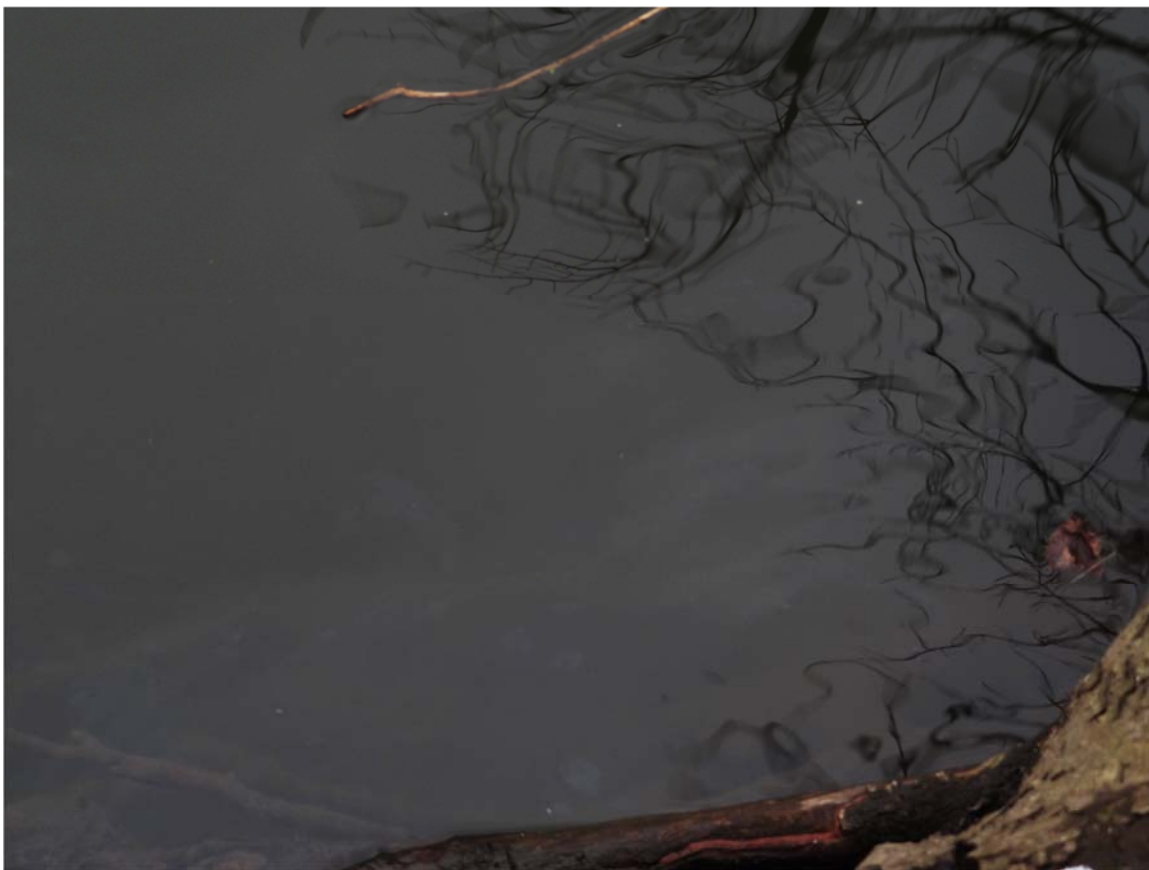
31. MP21.4 LDB observed tar glob and sheen.

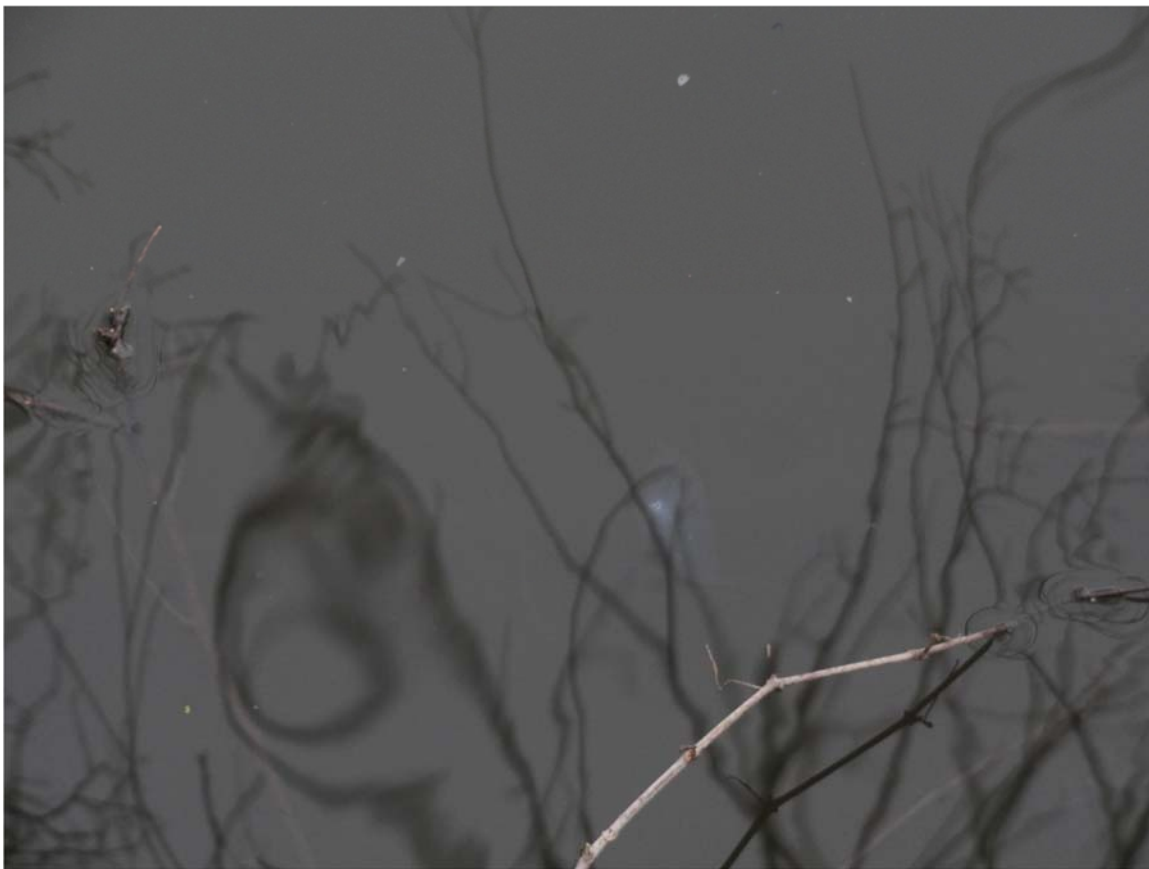
32. MP21.4 LDB observed tar glob and sheen.

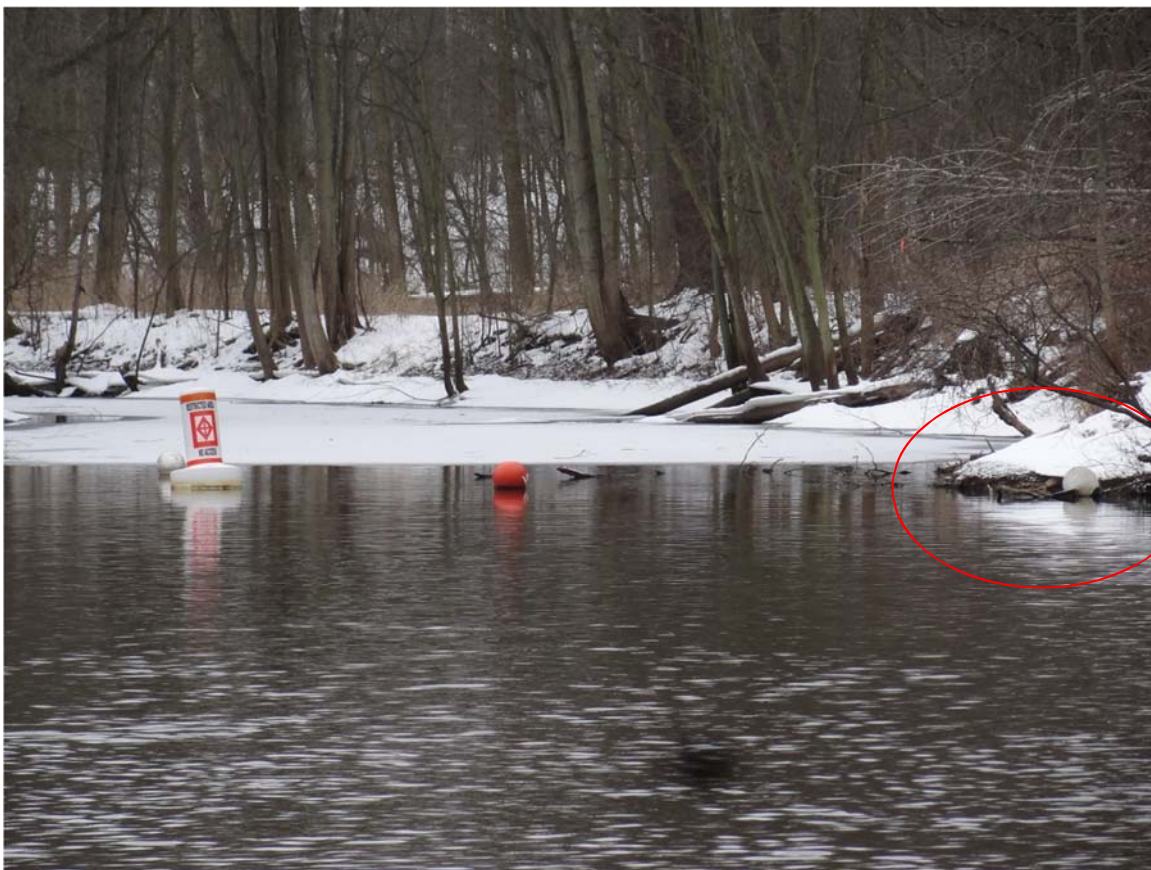
33. MP19.25 Sediment Trap observed CSD buoy moved.
