Situation Photo Log

Wednesday, February 13, 2013

Kalamazoo River / Enbridge Spill

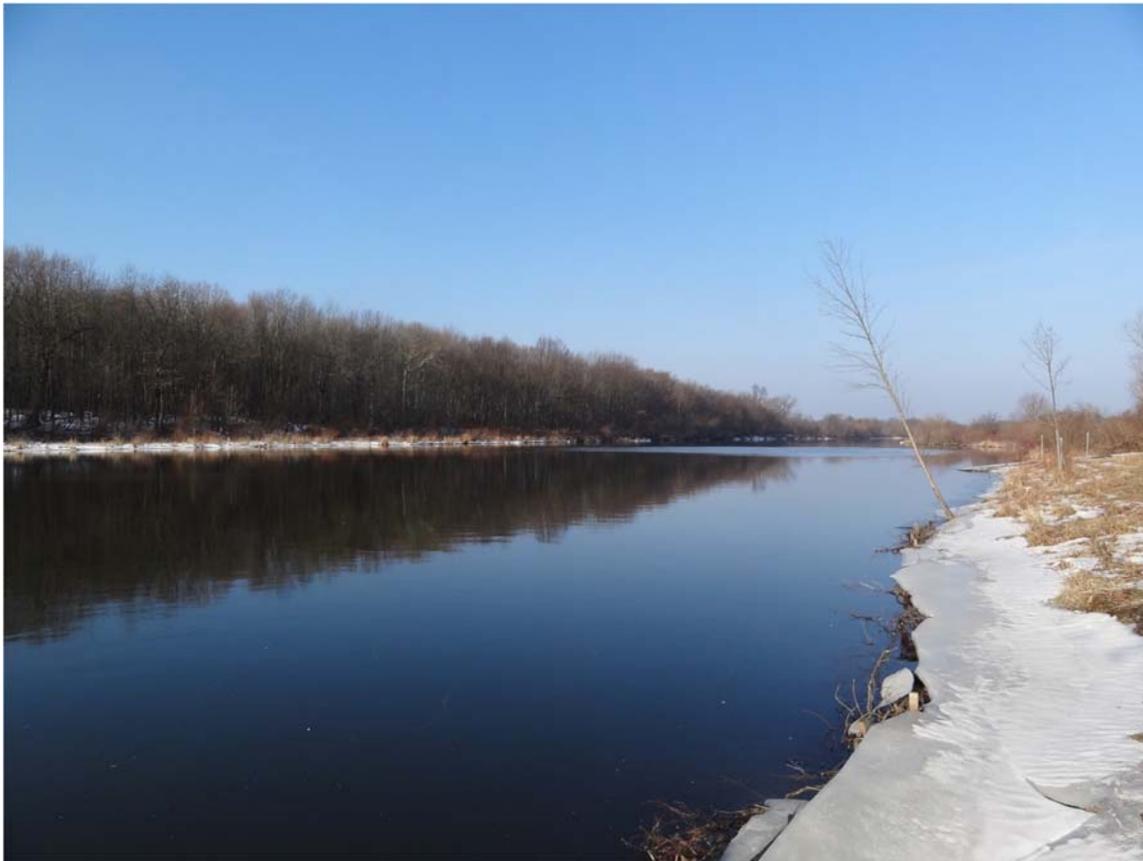
1. C0.4 Boat launch river icing conditions.

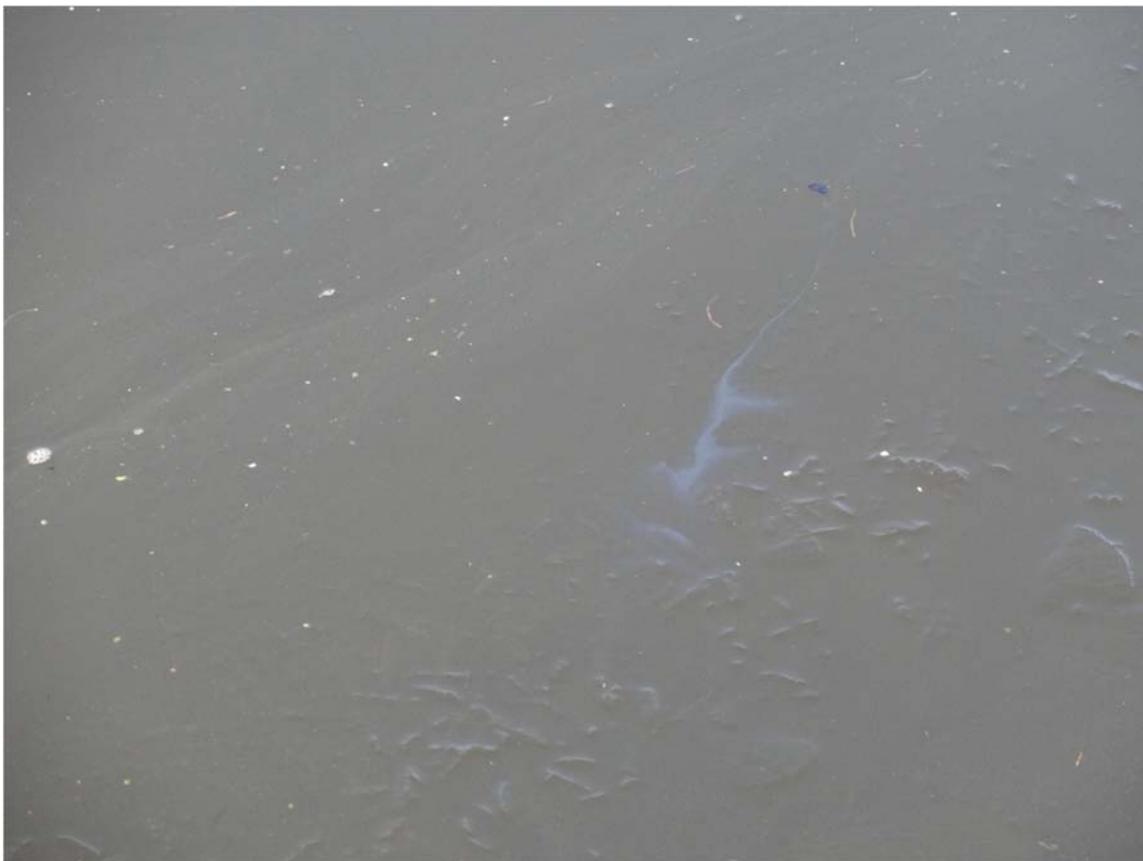
2. C0.4 Boat observed sheen within the ice.

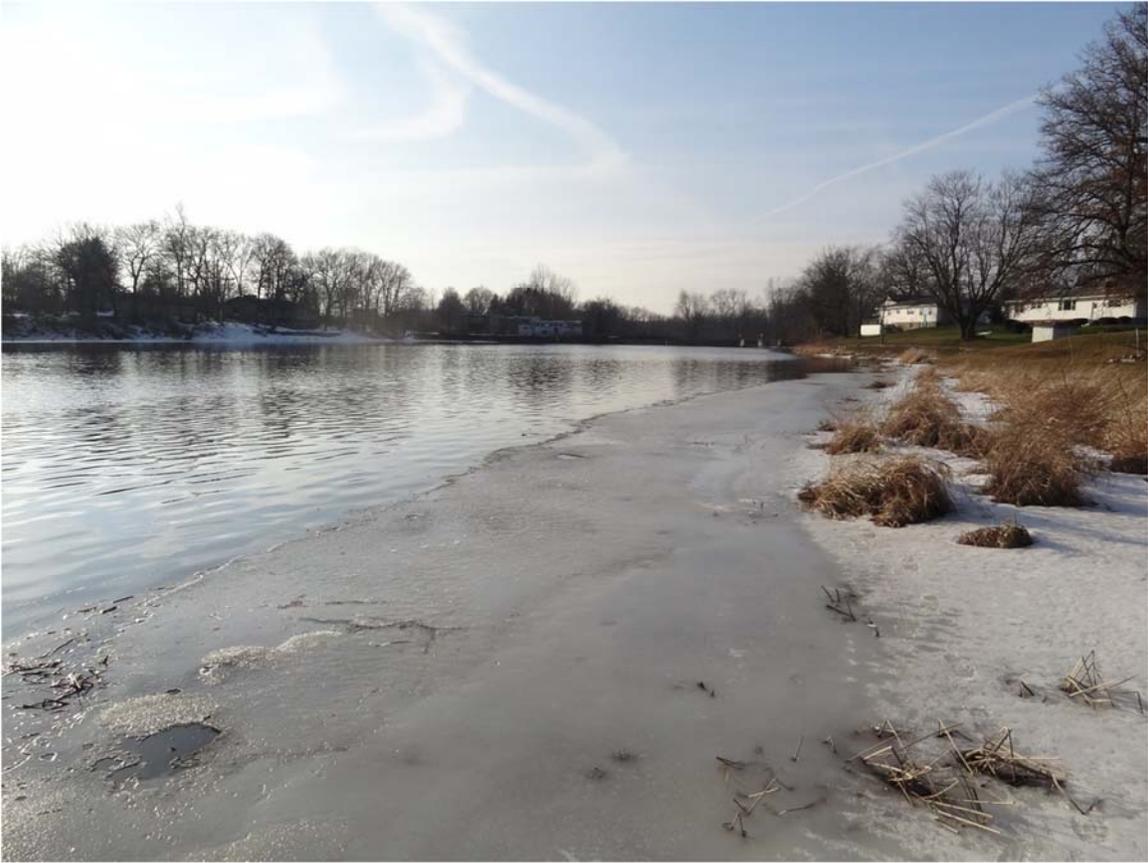
3. MP5.75 Ceresco Dam Impoundment River icing conditions.

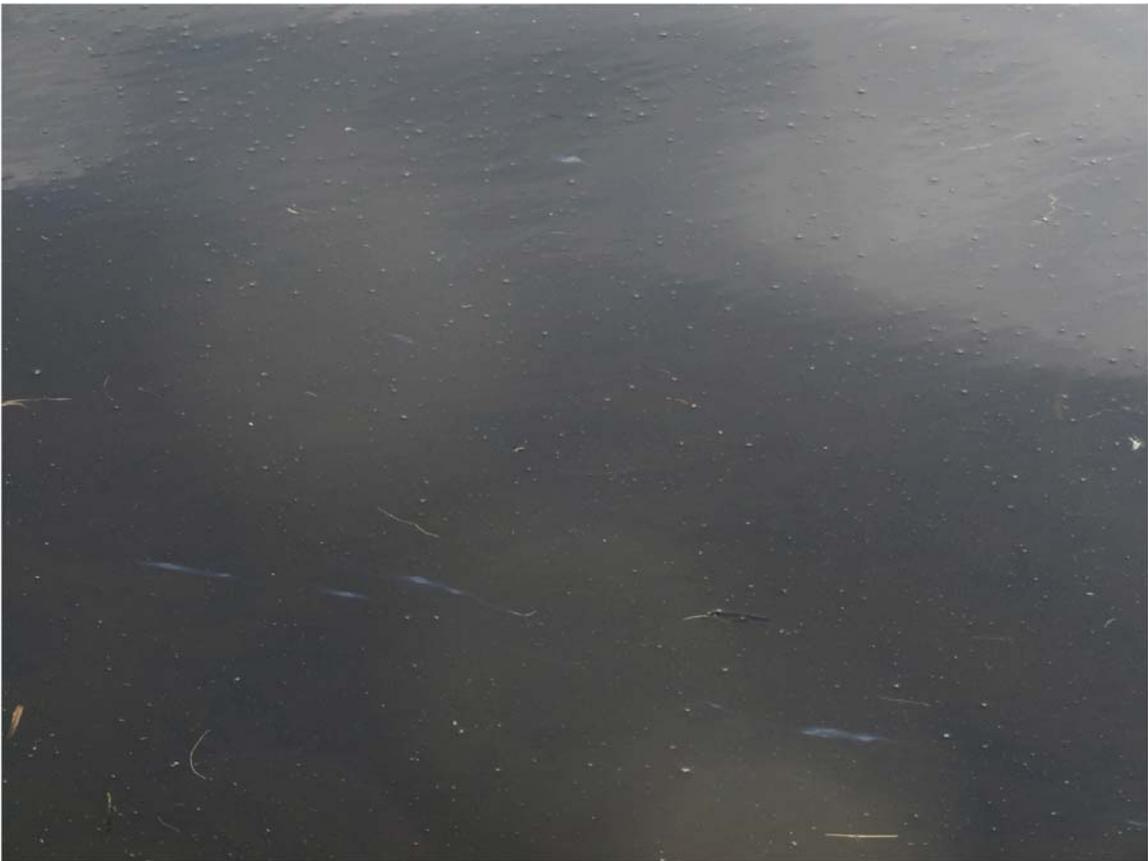
4. MP5.70 RDB observed sheen and tar globs.

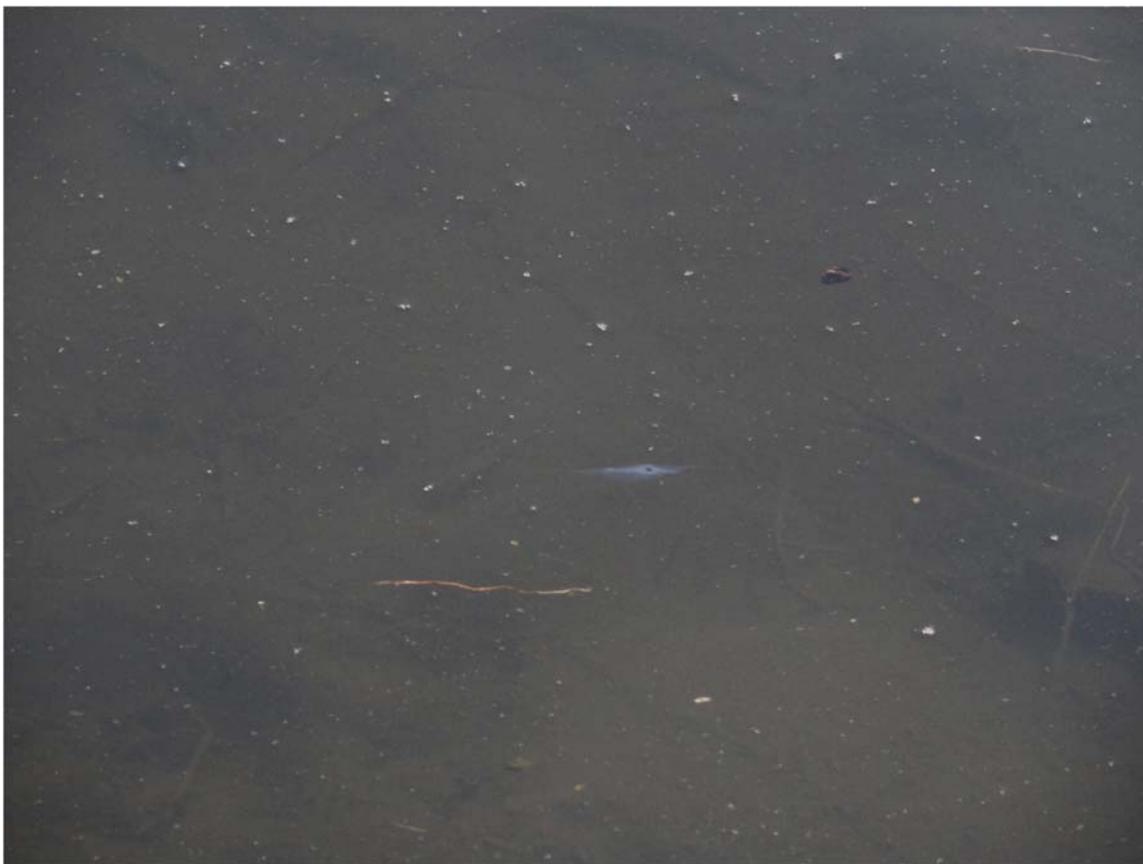
5. MP5.75 RDB observed sheen and tar globs.

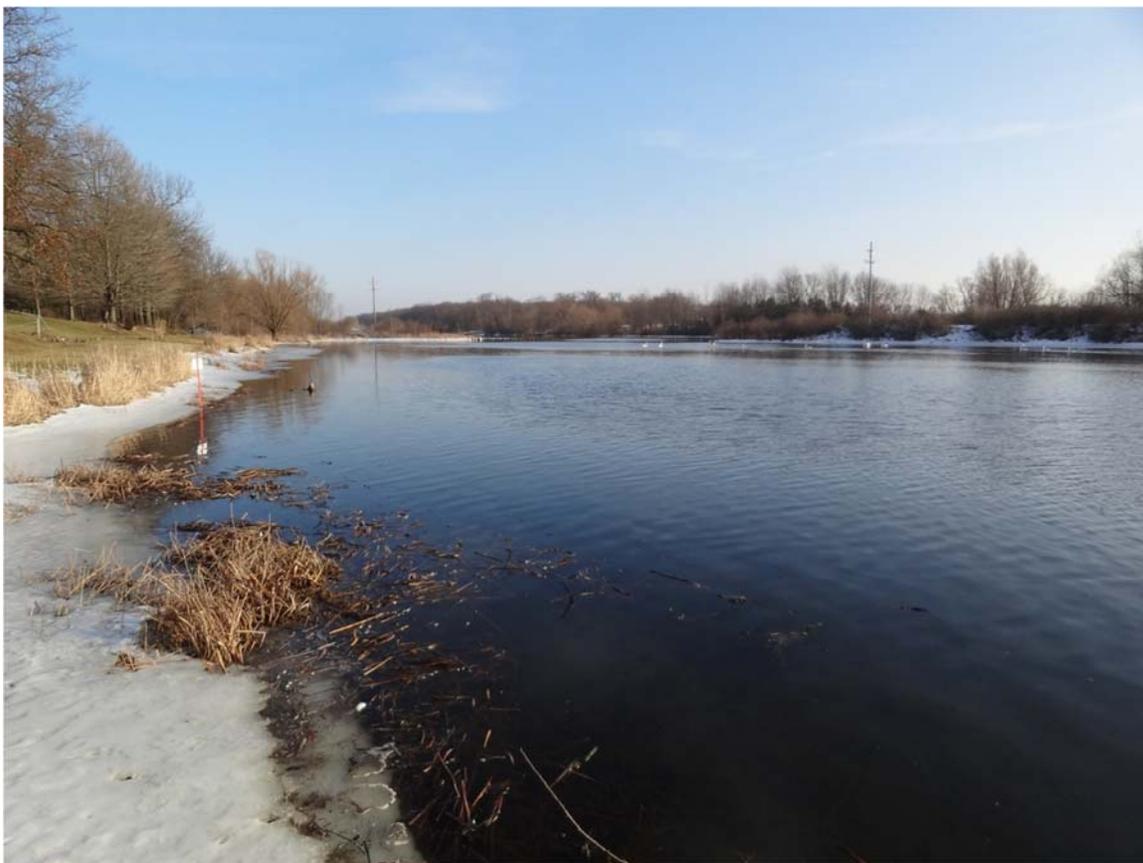
6. Ceresco Dam Impoundment River icing conditions.

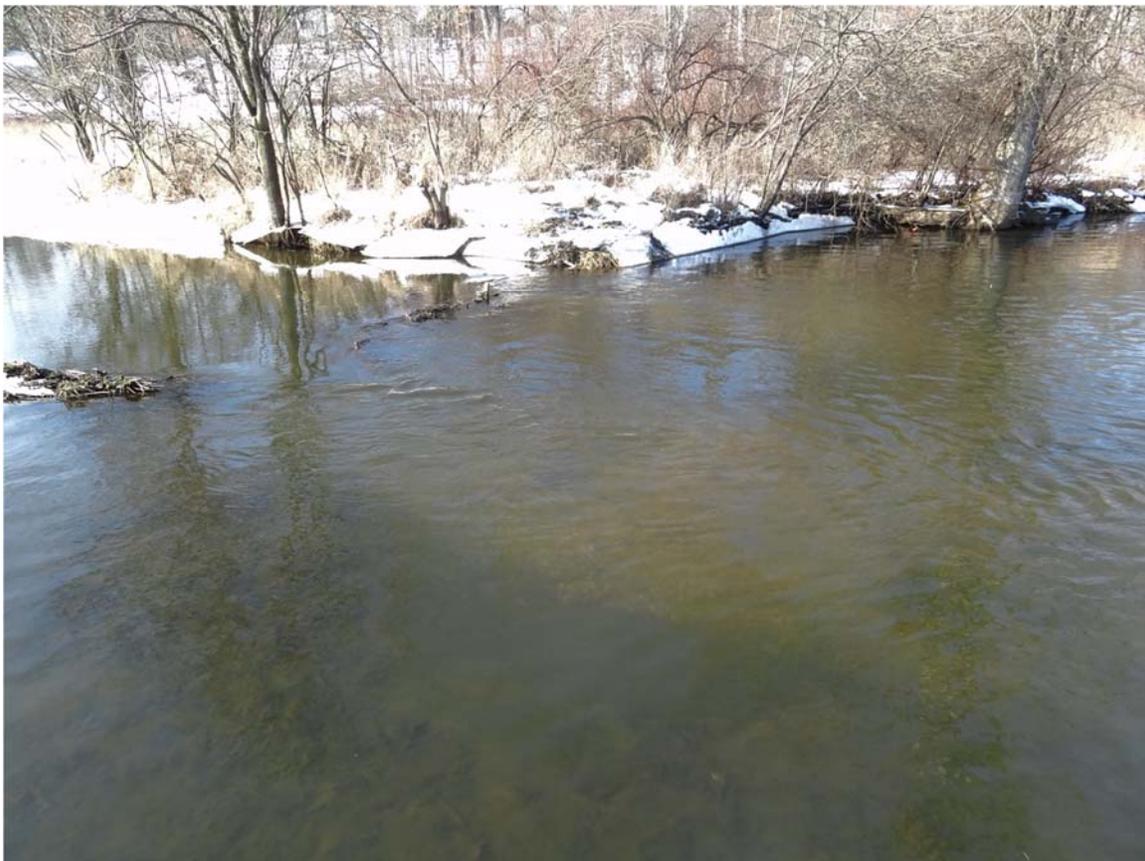
10. MP10.75 Sediment trap conifer tree structure compromised.

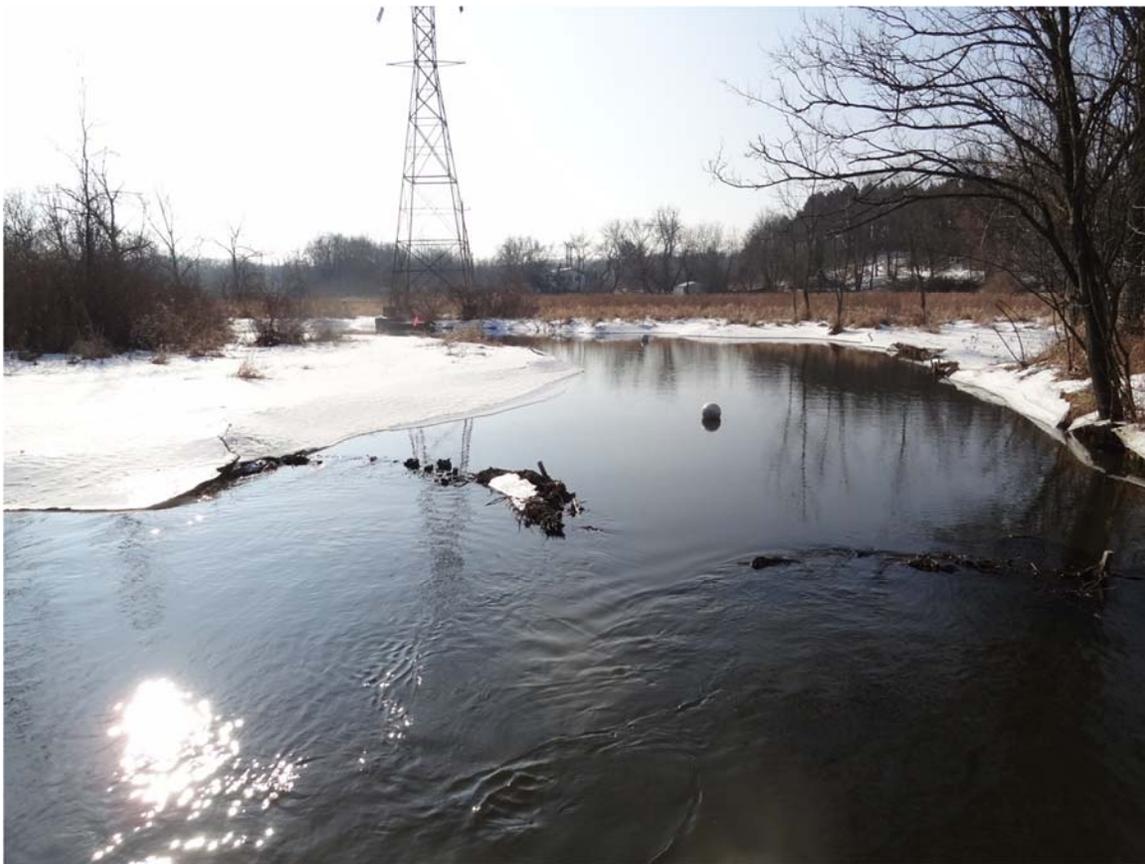
11. MP10.75 Sediment trap conifer tree structure compromised.

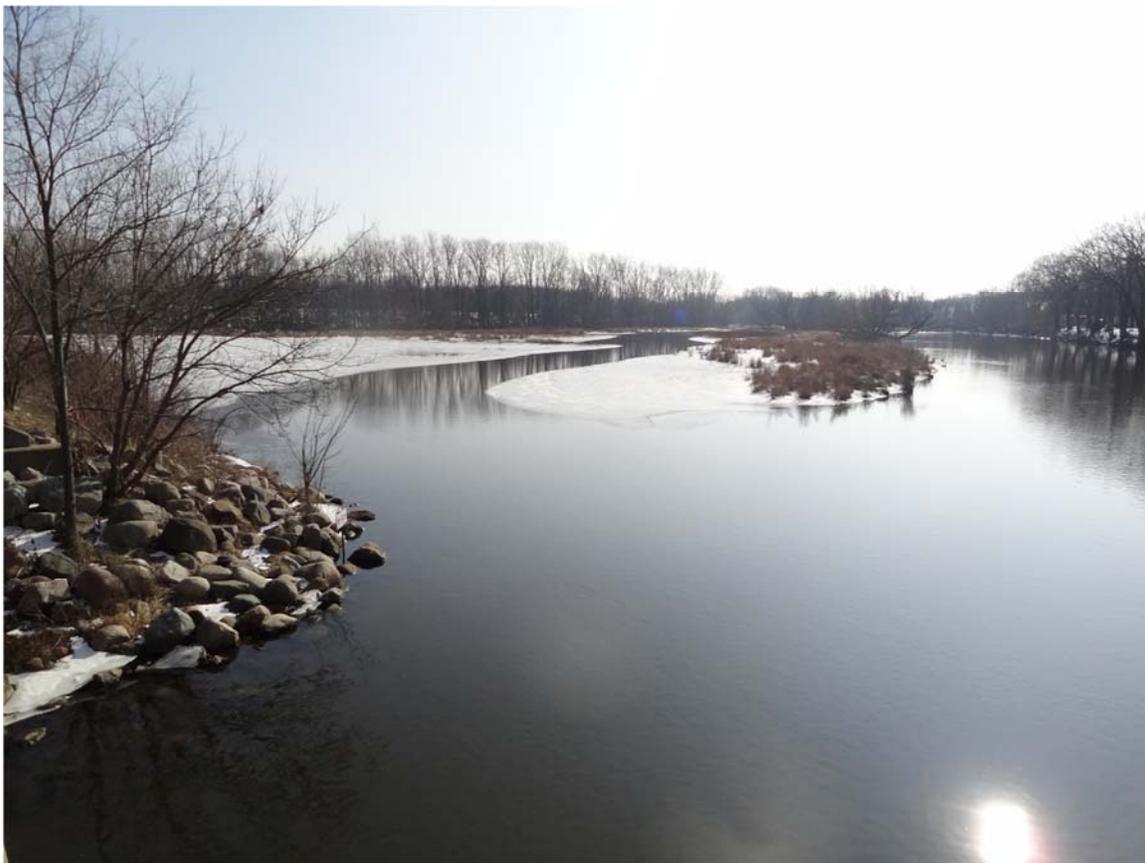
12. MP15.25 South Mill Pond river icing conditions.

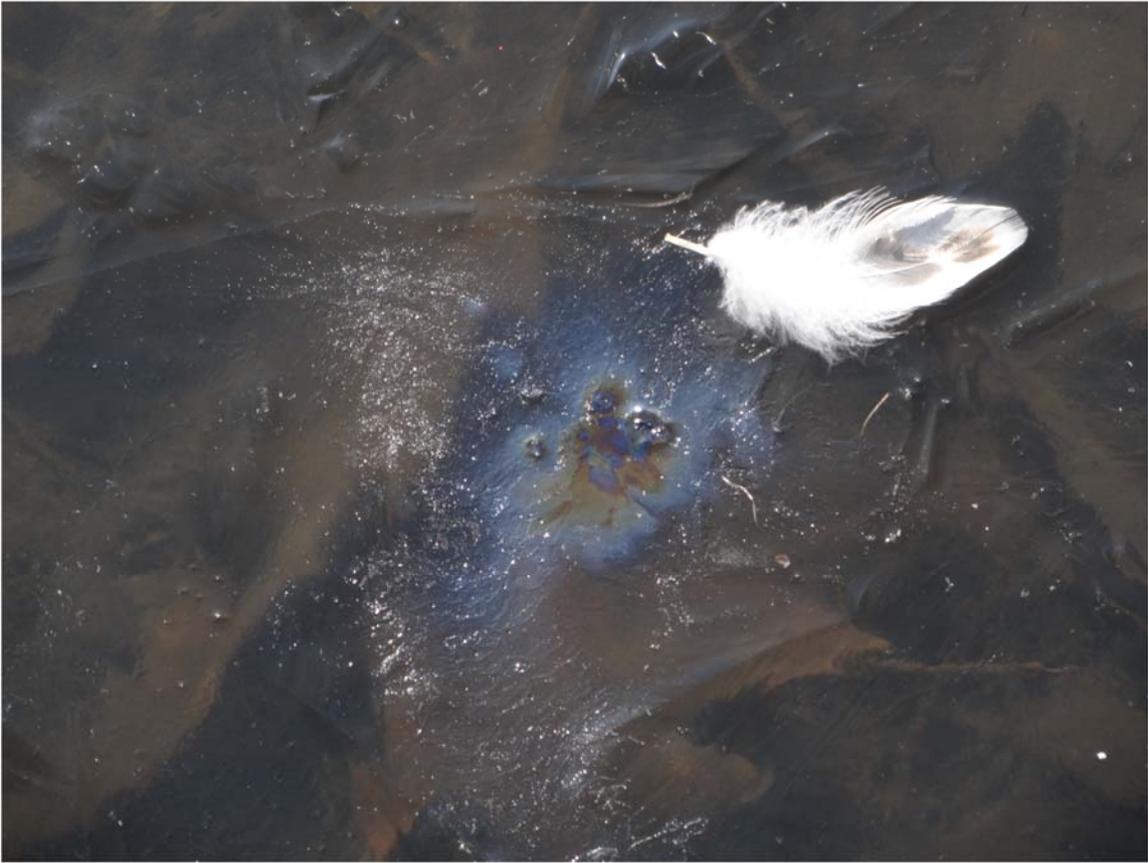
13. MP15.25 South Mill Pond observed sheen and tar globs frozen in the ice.

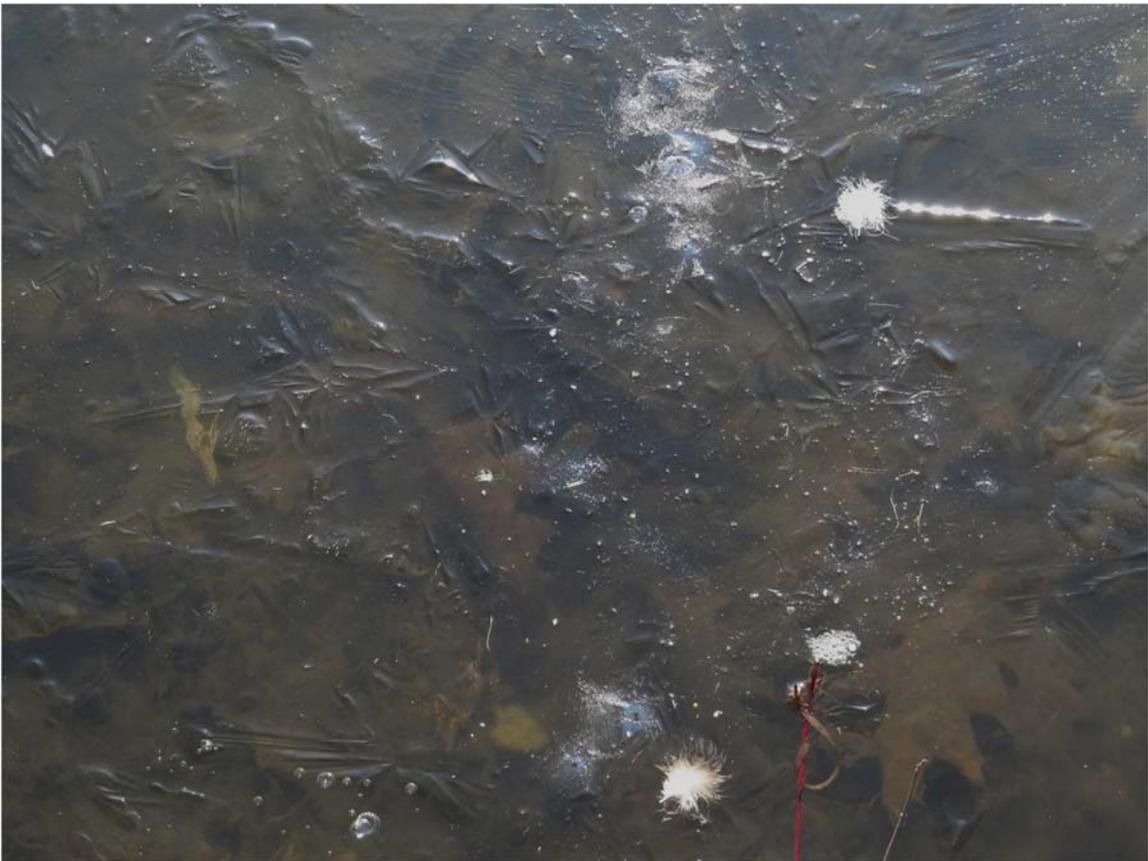
14. MP15.25 South Mill Pond observed sheen and tar globs frozen in the ice.

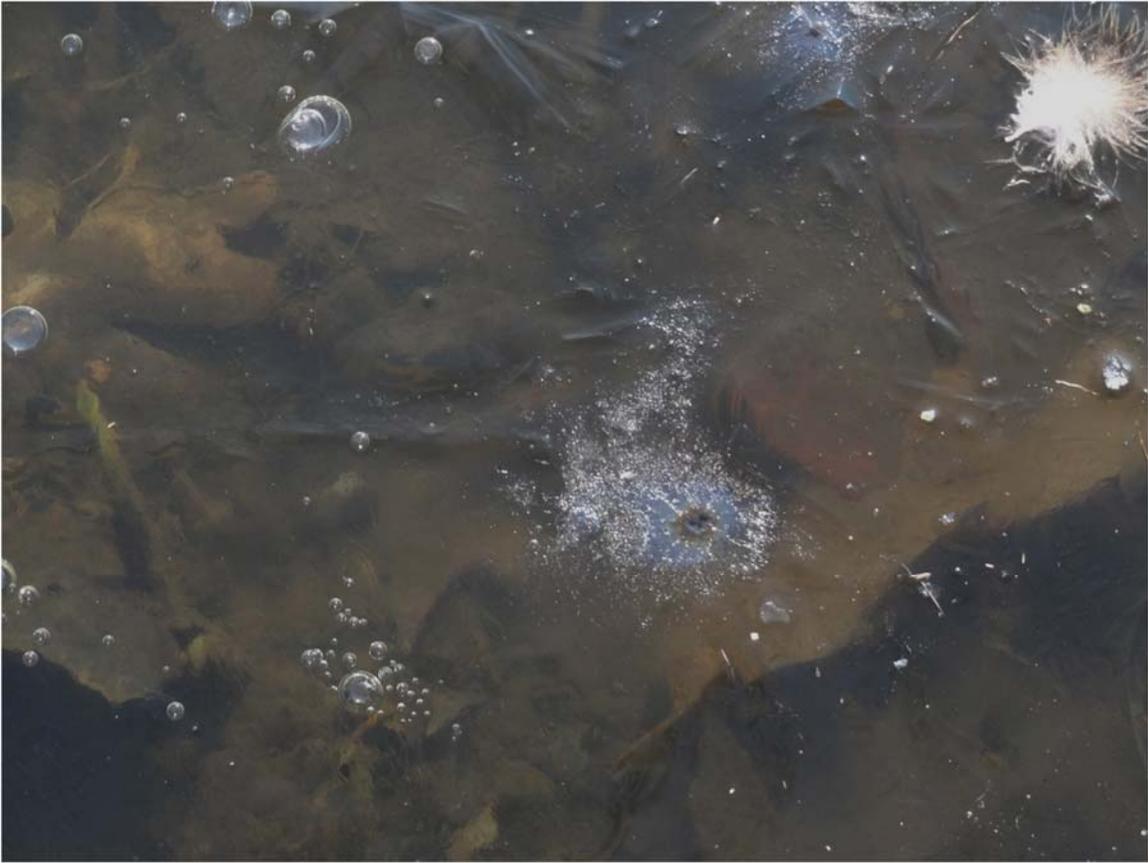
15. MP15.25 South Mill Pond observed sheen and tar globs frozen in the ice.

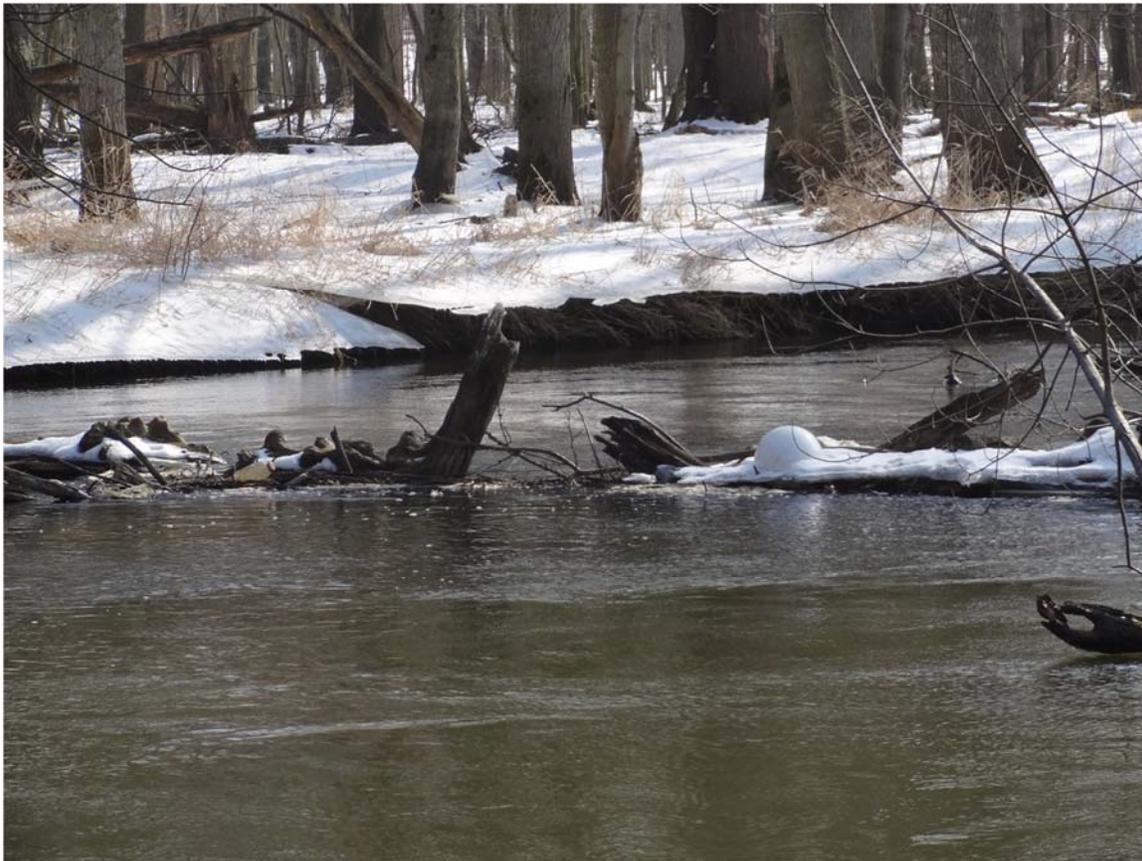
17. MP26.0 Sediment trap CSD buoy observed at MP28.25.

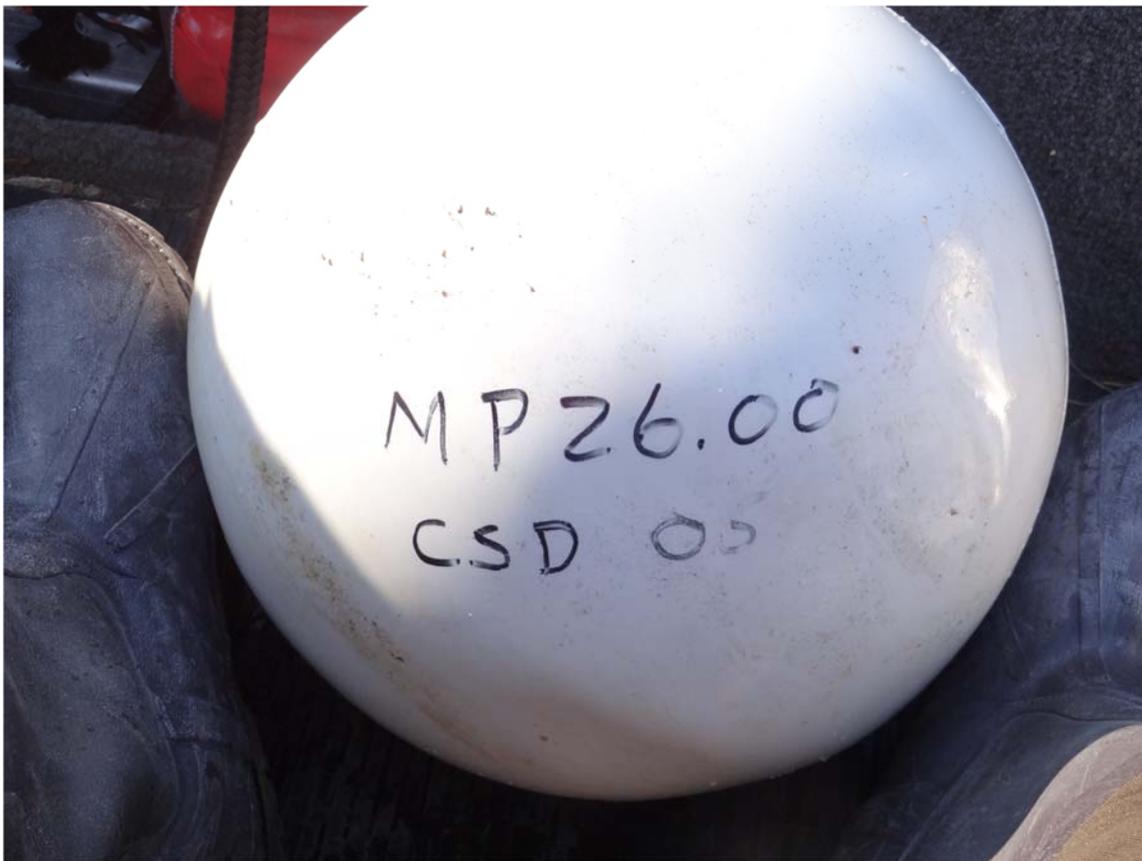
18. MP26.0 Sediment trap CSD buoy observed at MP28.25.

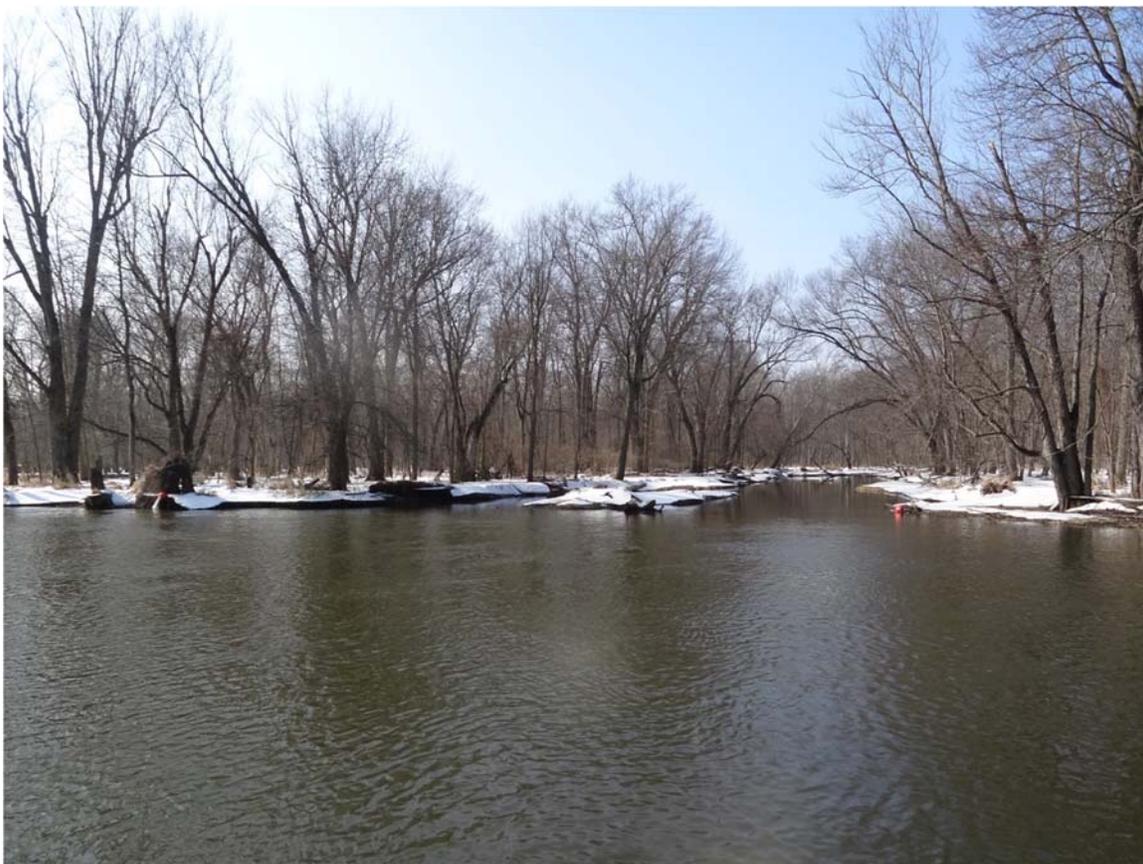
19. MP28.25 Sediment trap upstream observed the navigational buoys dislodged and the can buoy missing.

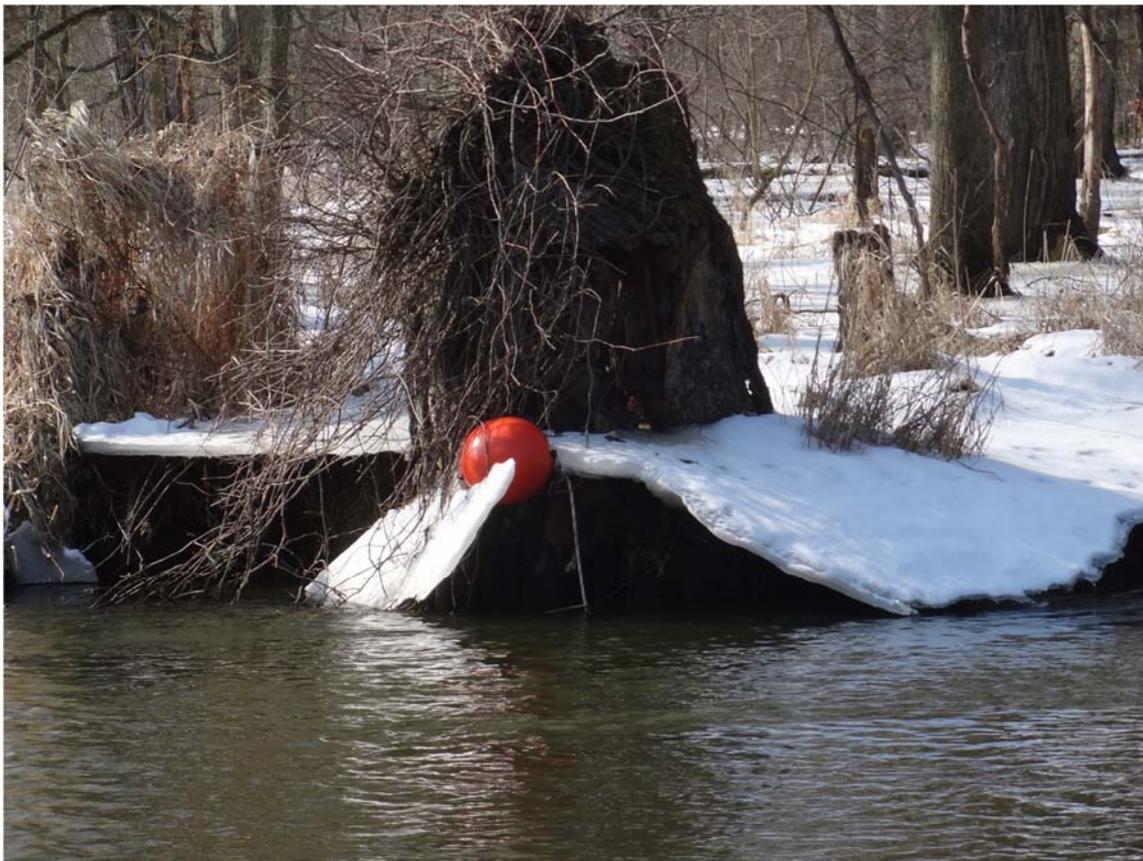
20. MP28.25 Sediment trap observed the navigational buoys dislodged.

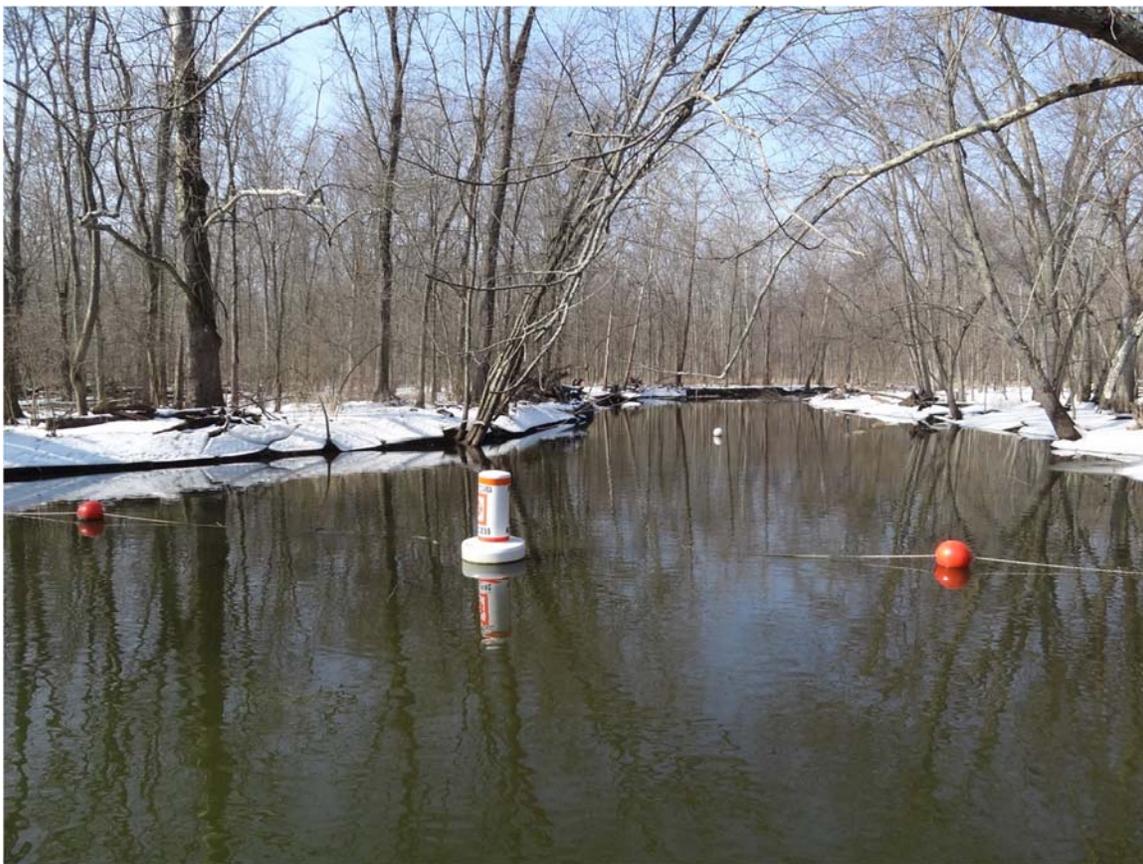
21. MP28.25 Sediment trap observed the downstream side of the sediment trap buoys intact.

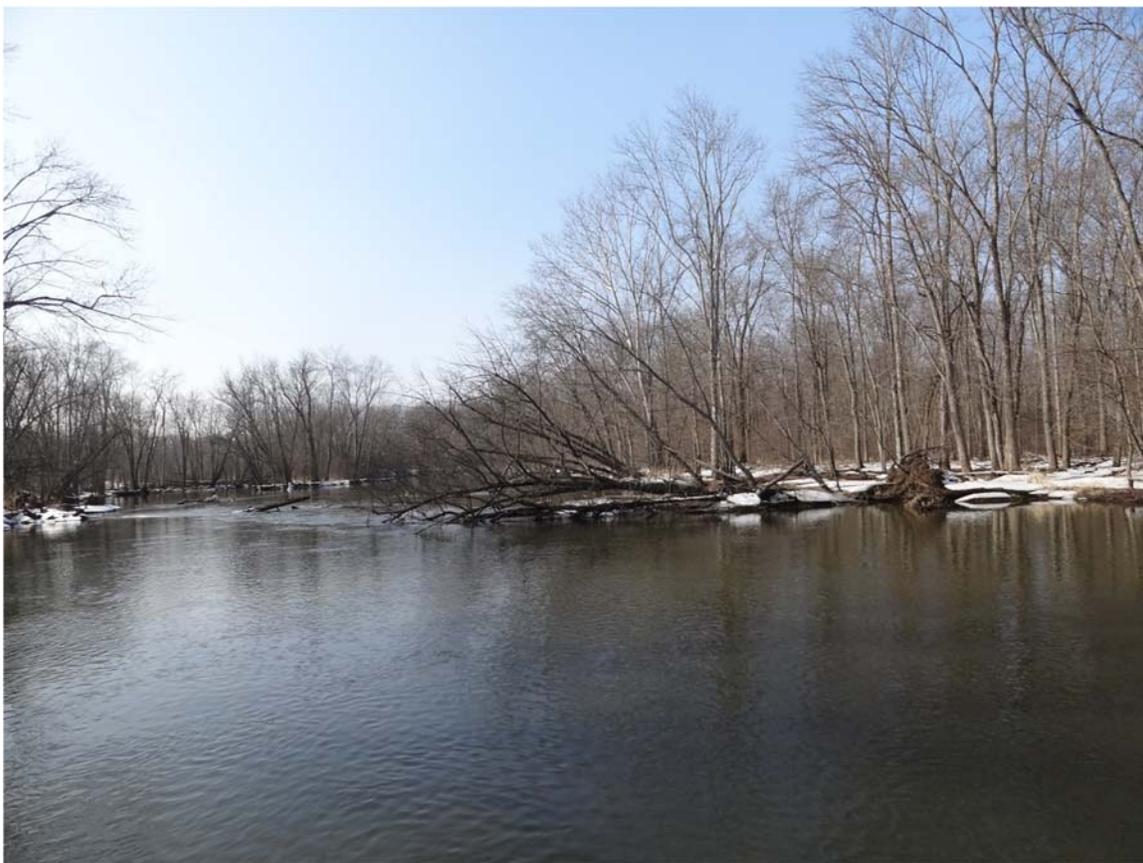
22. MP28.45 observed a new river navigational hazard.

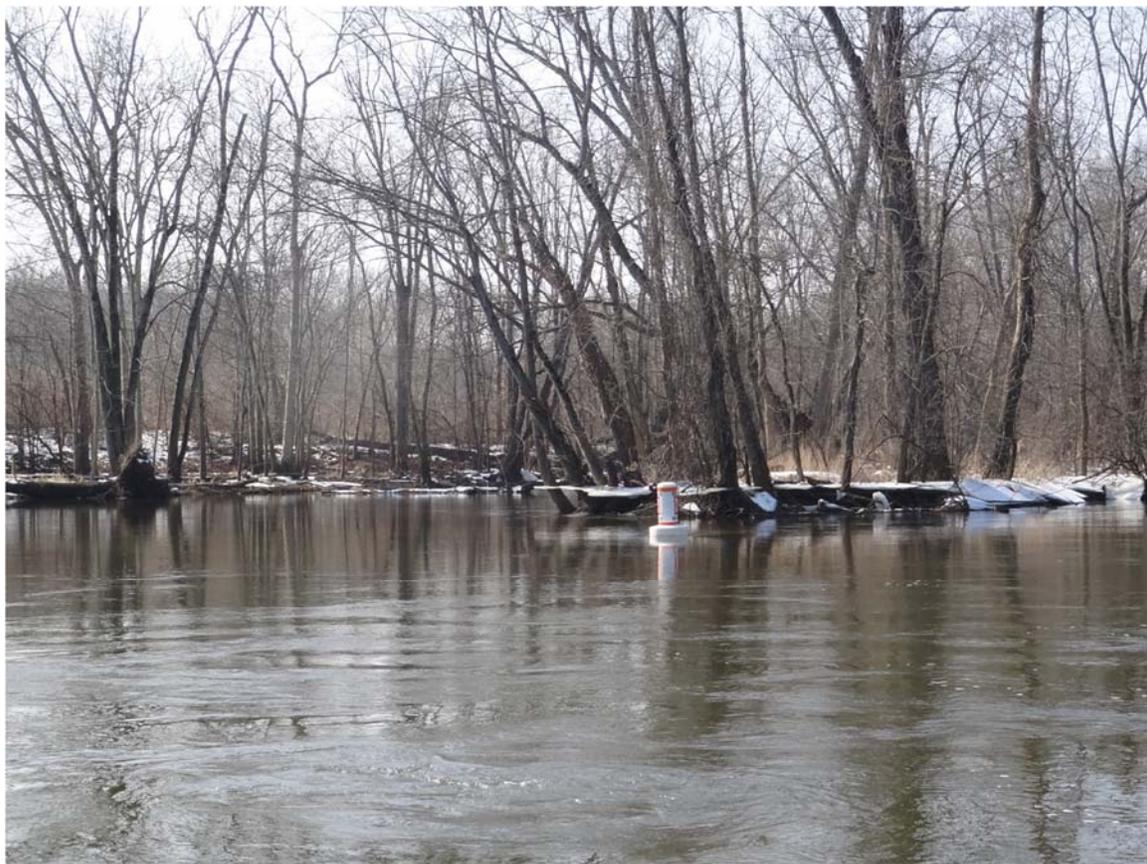
23. MP28.25 Can buoy located at MP28.5.

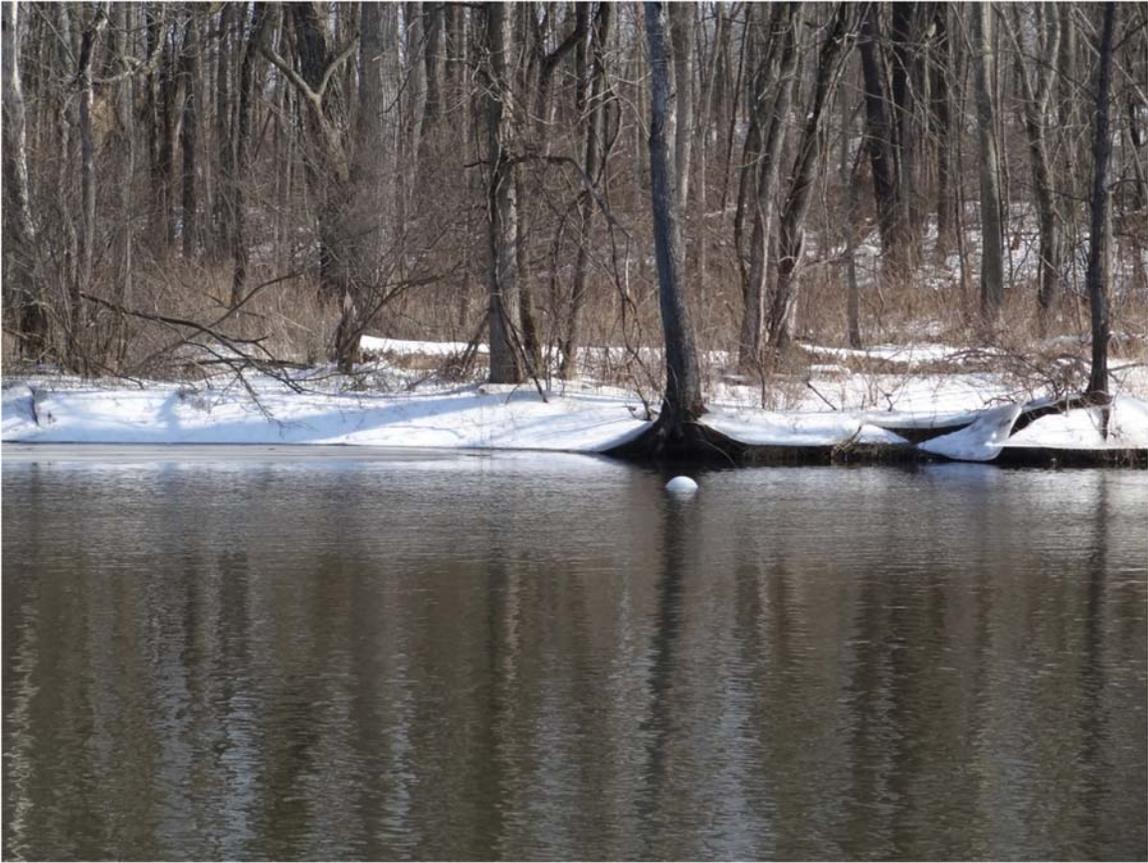
25. MP30.8 Sediment trap observed the CSD buoy partially submerged.

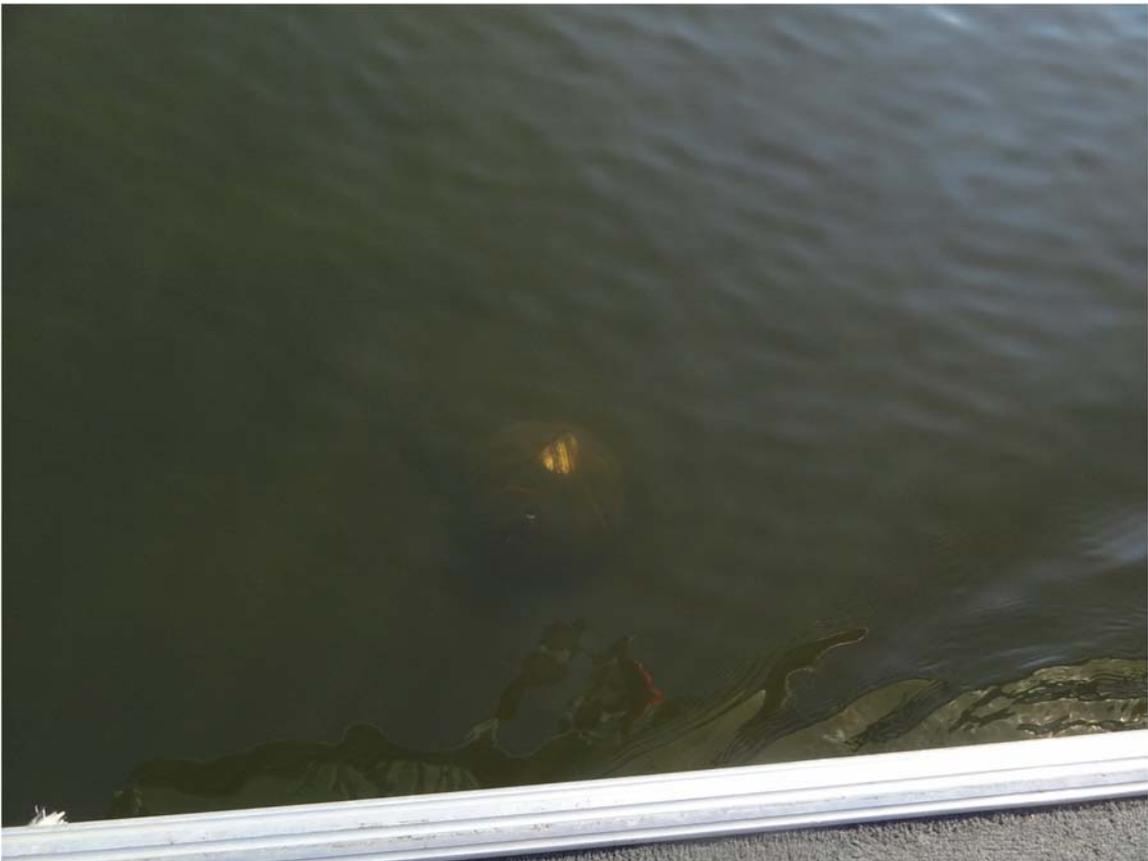
26. MP30.8 Sediment trap observed with what appear to be bullet holes in the submerged CSD buoy.

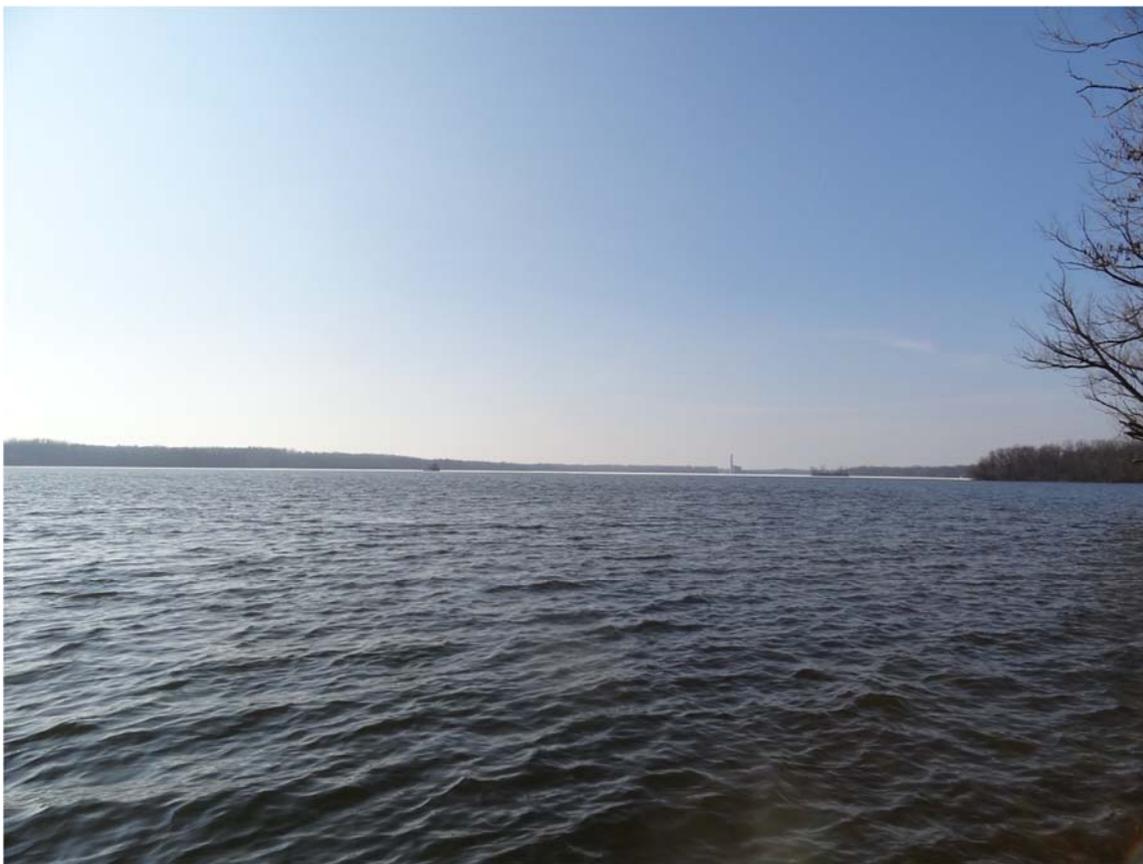
27. Morrow Lake icing conditions.

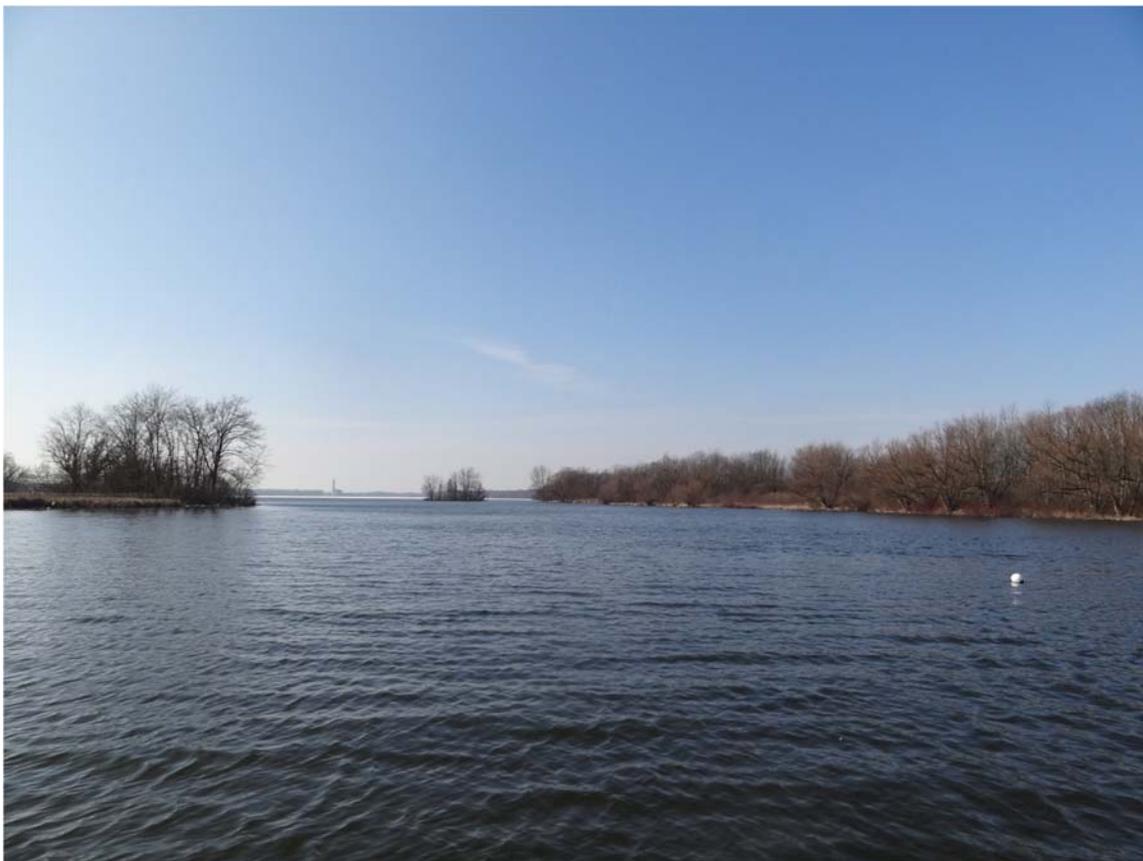
28. Morrow Lake Delta CDS observed displaced and located near the Morrow Lake Neck.
