Situation Photo Log

Wednesday, February 13, 2013

Kalamazoo River / Enbridge Spill

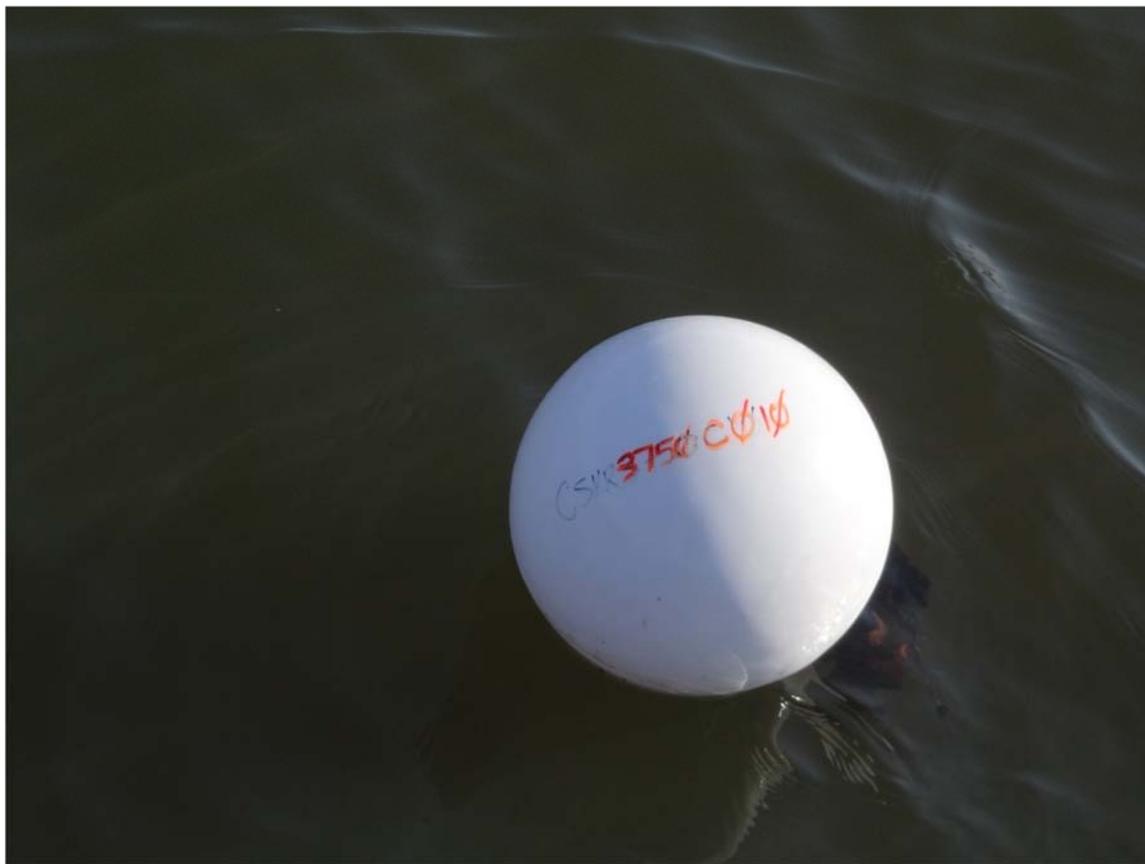
29. Morrow Lake Delta CDS observed displaced and located near the Morrow Lake Neck.

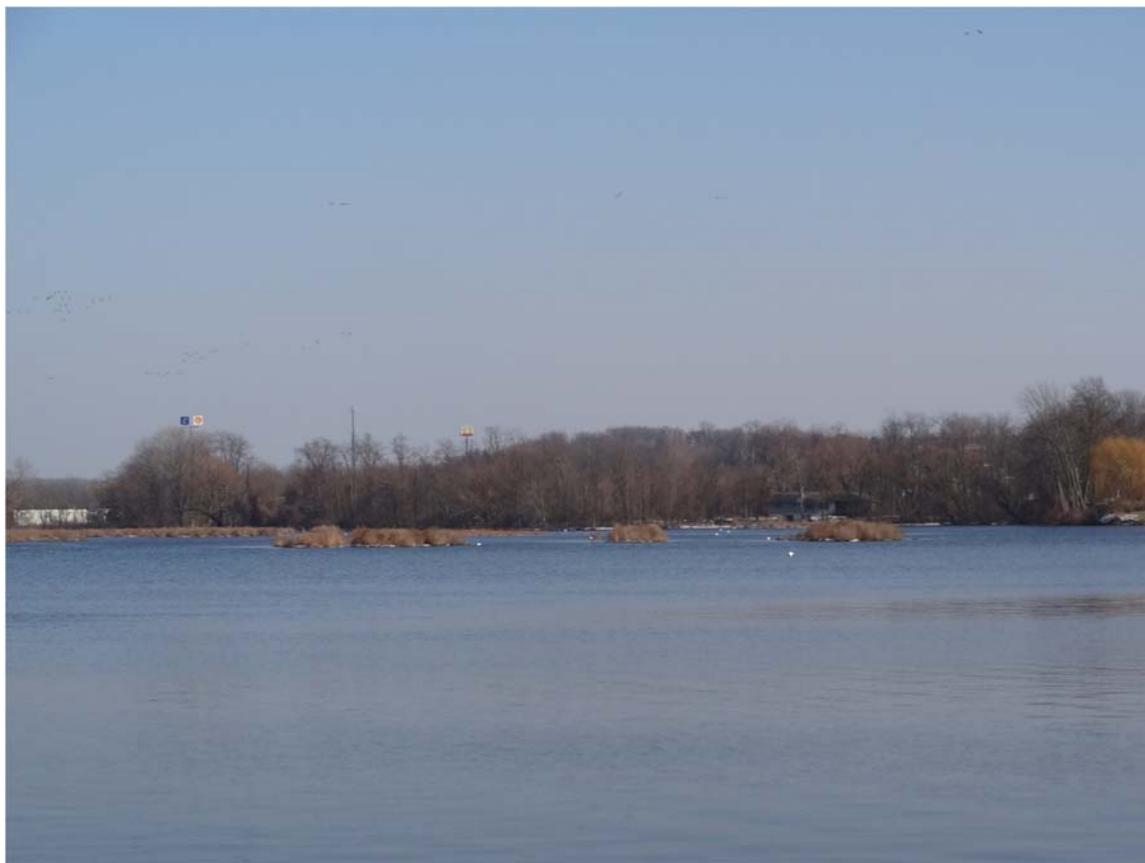
30. Morrow Lake Delta CSD sampling buoys locations.

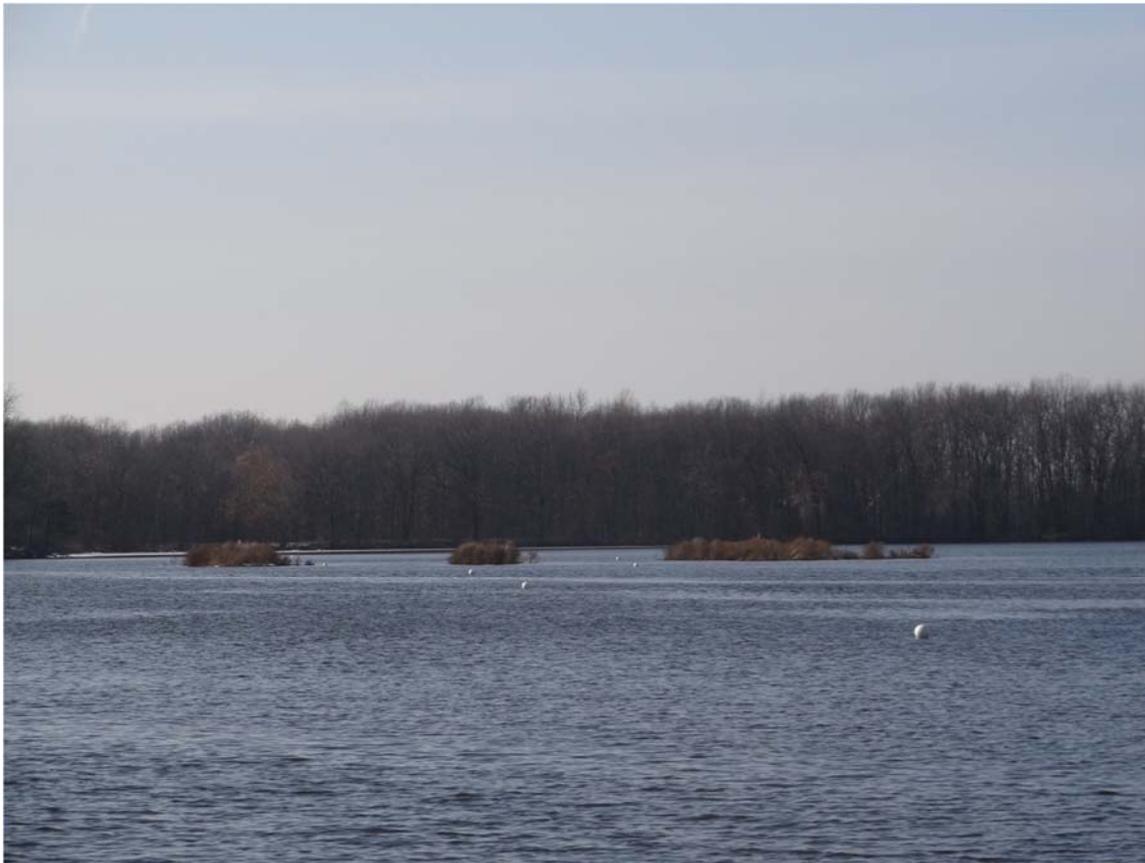
31. Morrow Lake Delta CSD sampling buoys locations.

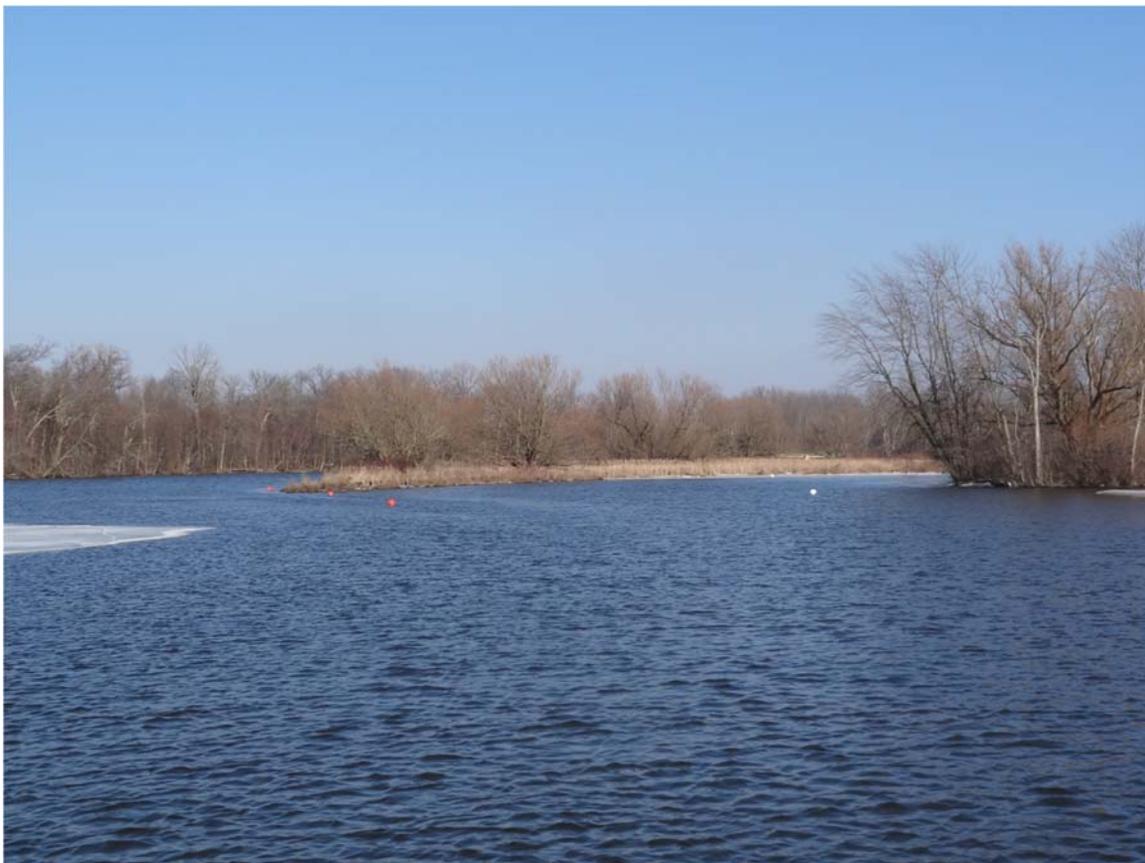
32. Morrow Lake Delta A navigational buoys observed dislodged.

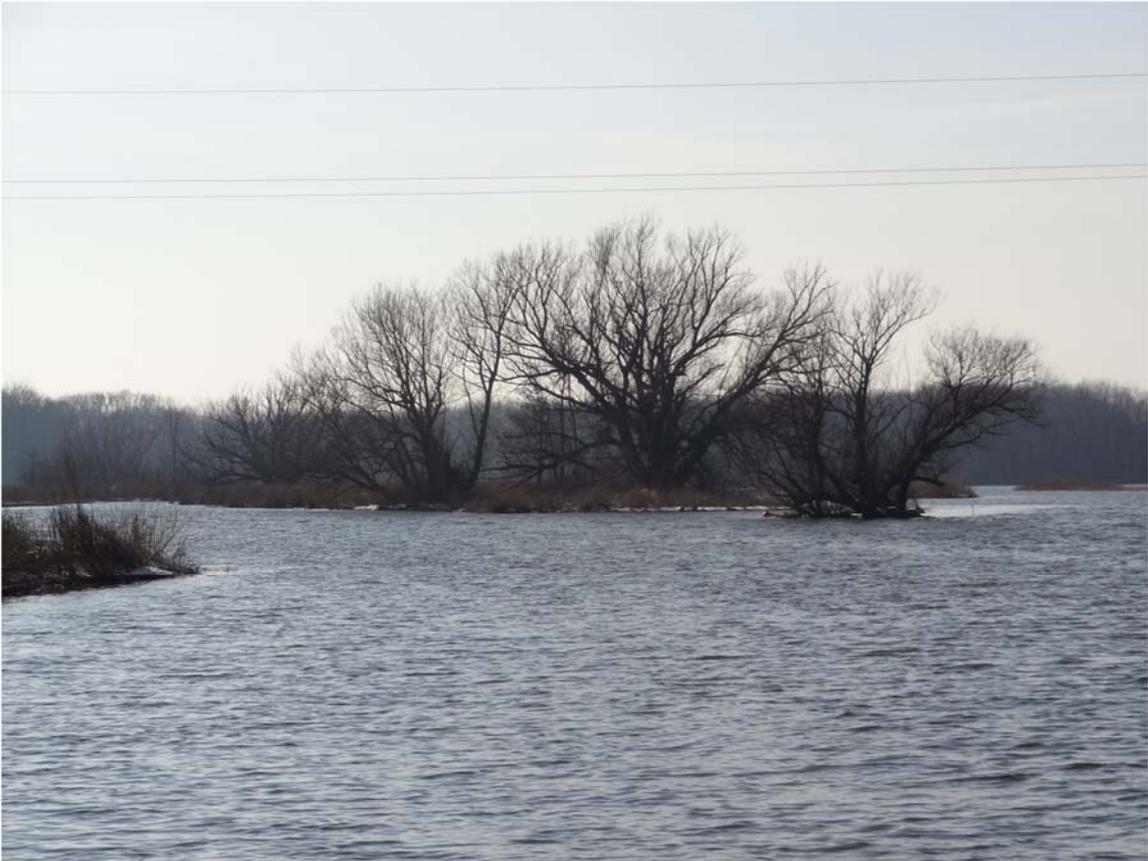
33. Morrow Lake Delta navigational buoys observed dislodged.

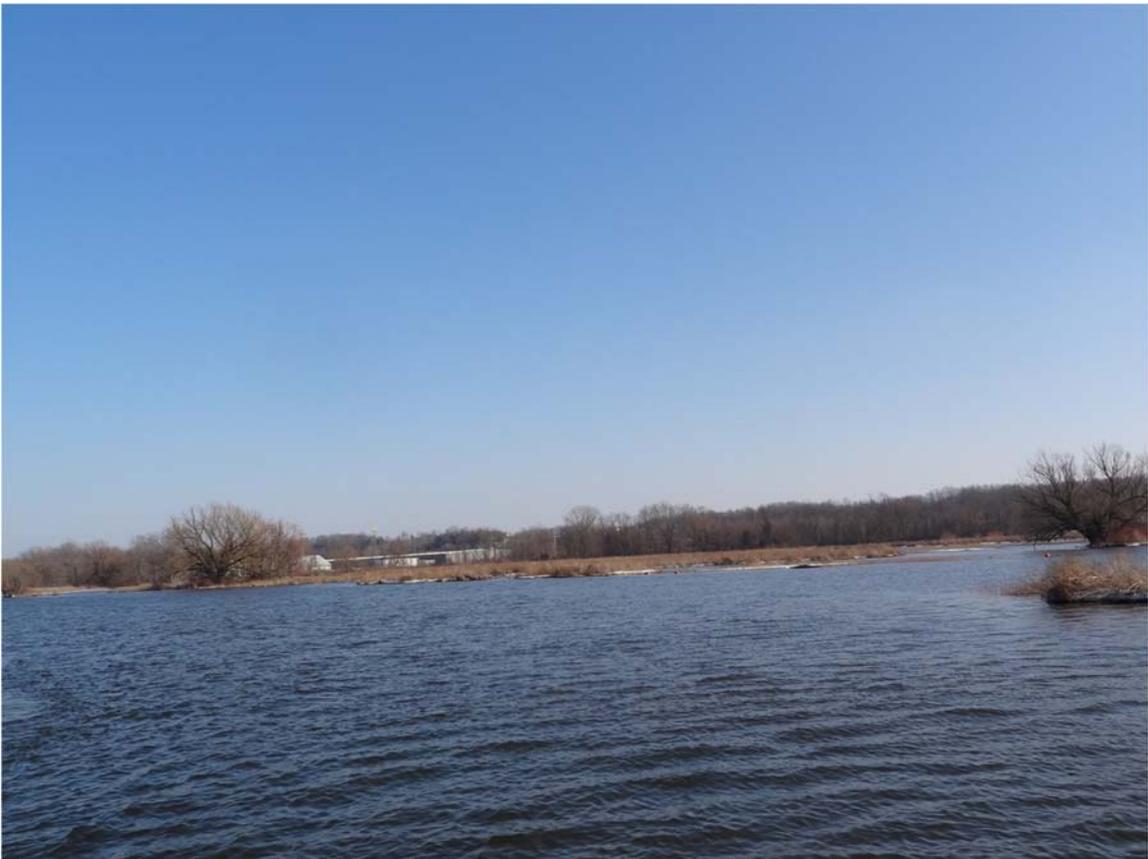
34. Morrow Lake Delta navigational buoys observed dislodged.

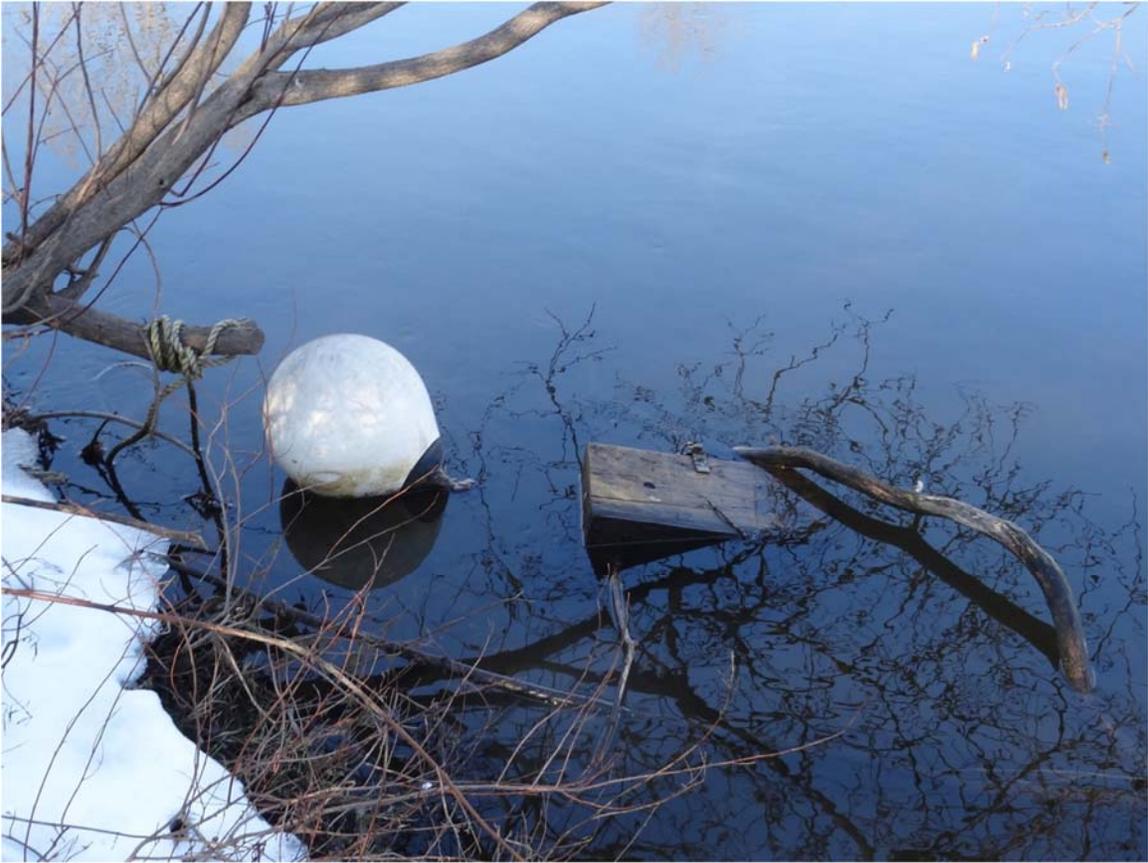
37. MP19.25 CSD observed relocated.
