Situation Photo Log

Saturday, February 16, 2013

Kalamazoo River / Enbridge Spill

Prepared by:
Matthew Haak
START-USEPA
Situation Unit

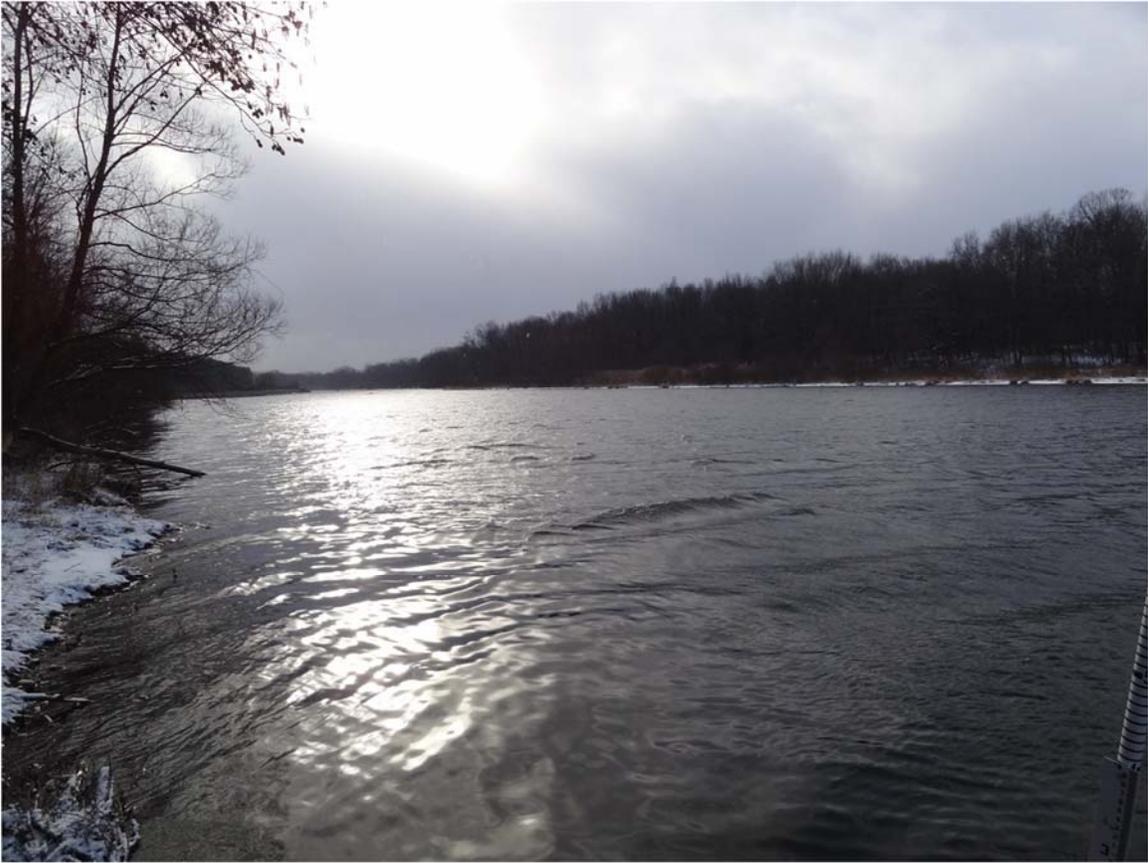
1. C0.4 Boat launch river conditions observed.

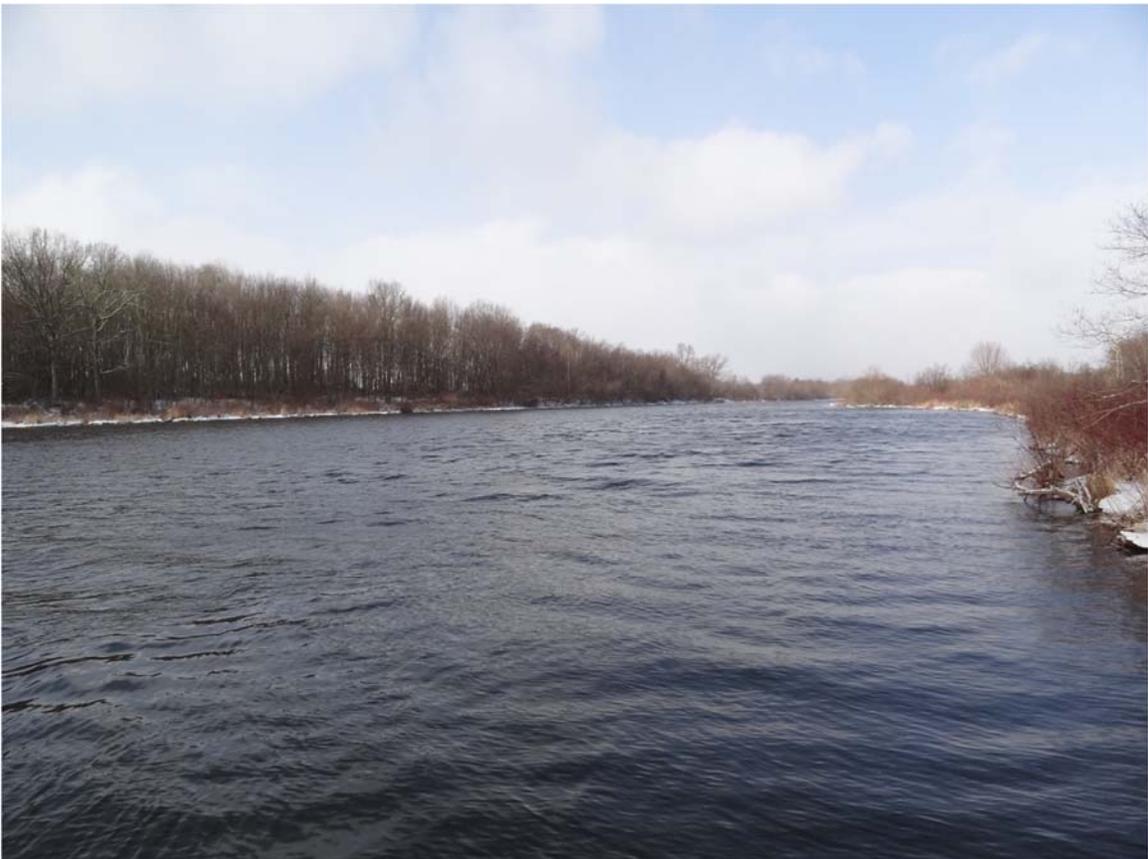
2. C0.4 Boat launch river conditions observed.

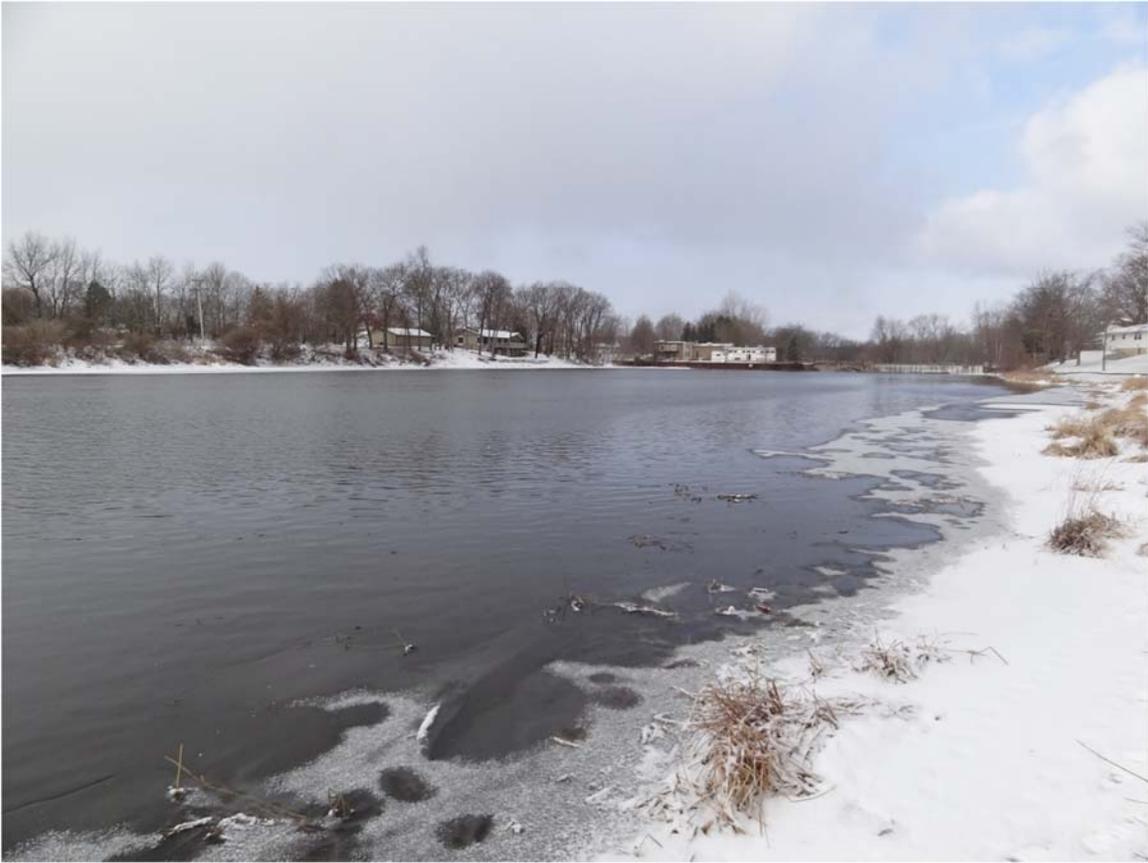
3. Ceresco Dam impoundment river conditions observed.

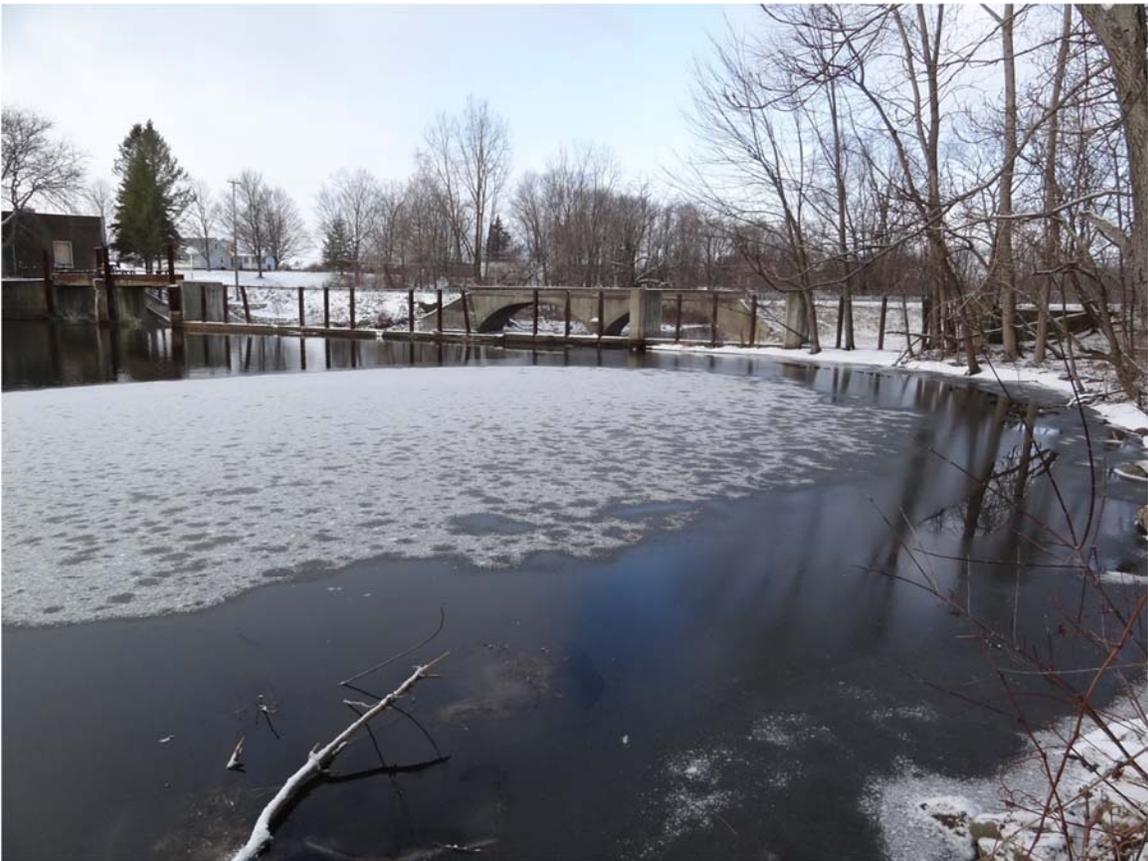
4. MP5.89 Ceresco Dam river icing conditions observed.

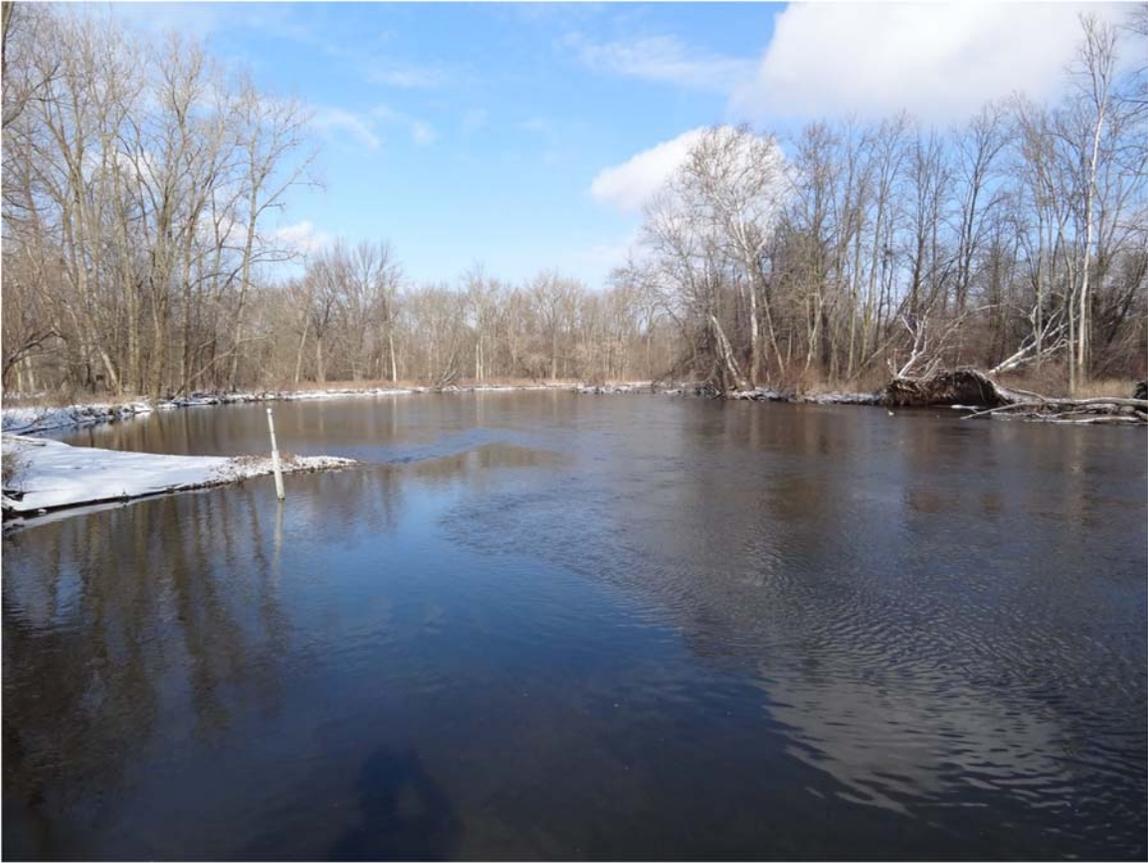
5. C3.2 Boat launch river conditions observed.

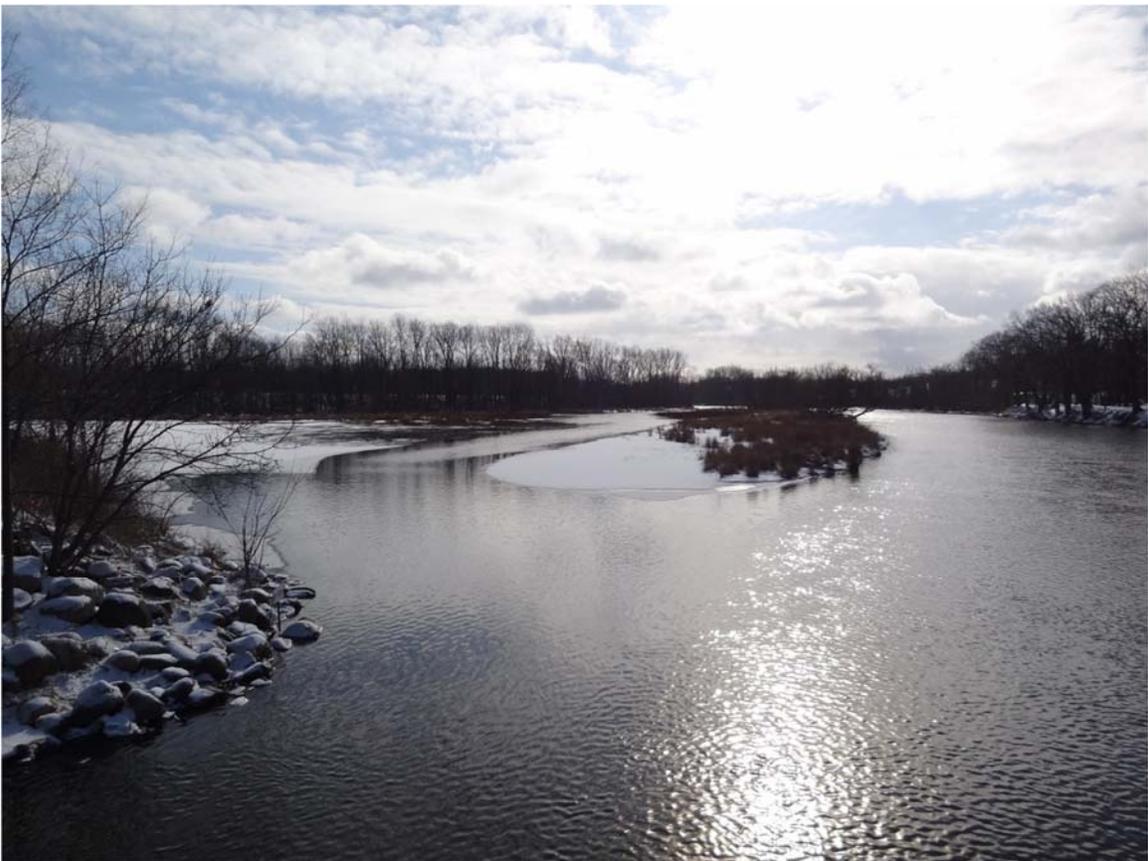
6. MP15.25 South Mill Pond river icing conditions observed.

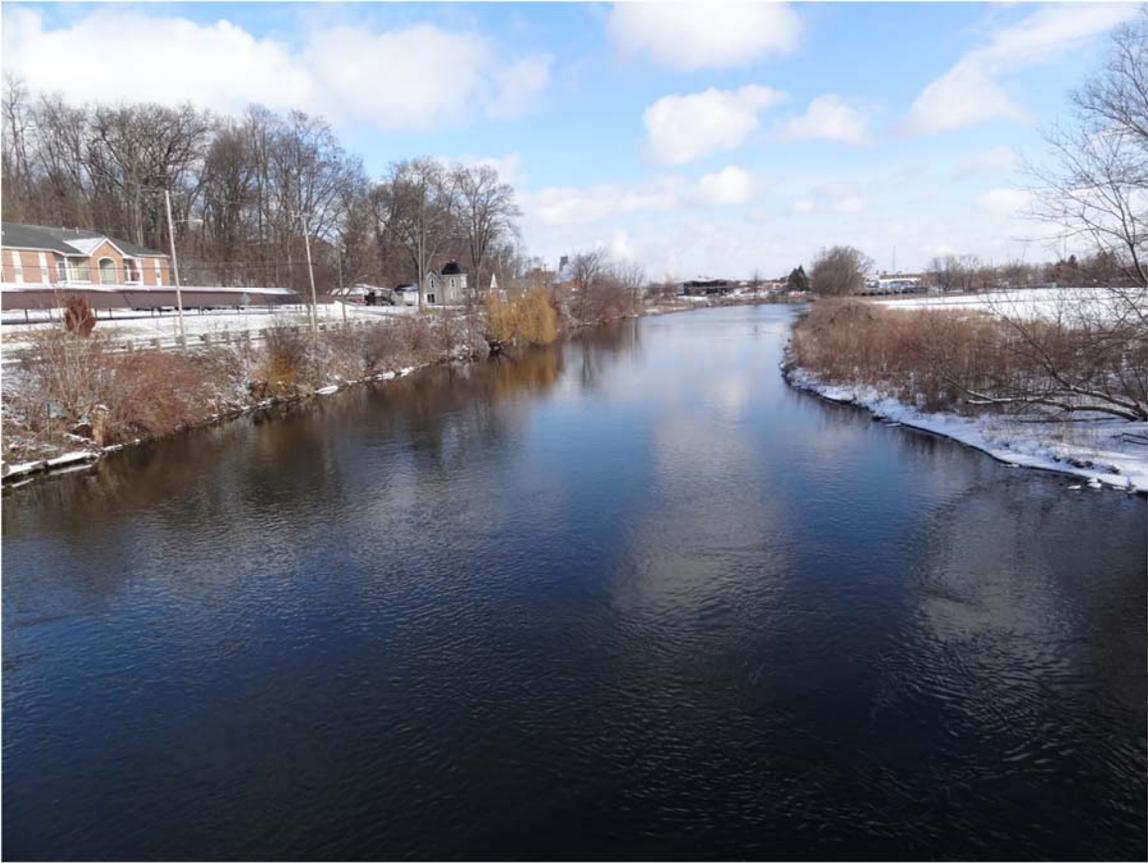
7. MP15.25 river conditions observed.

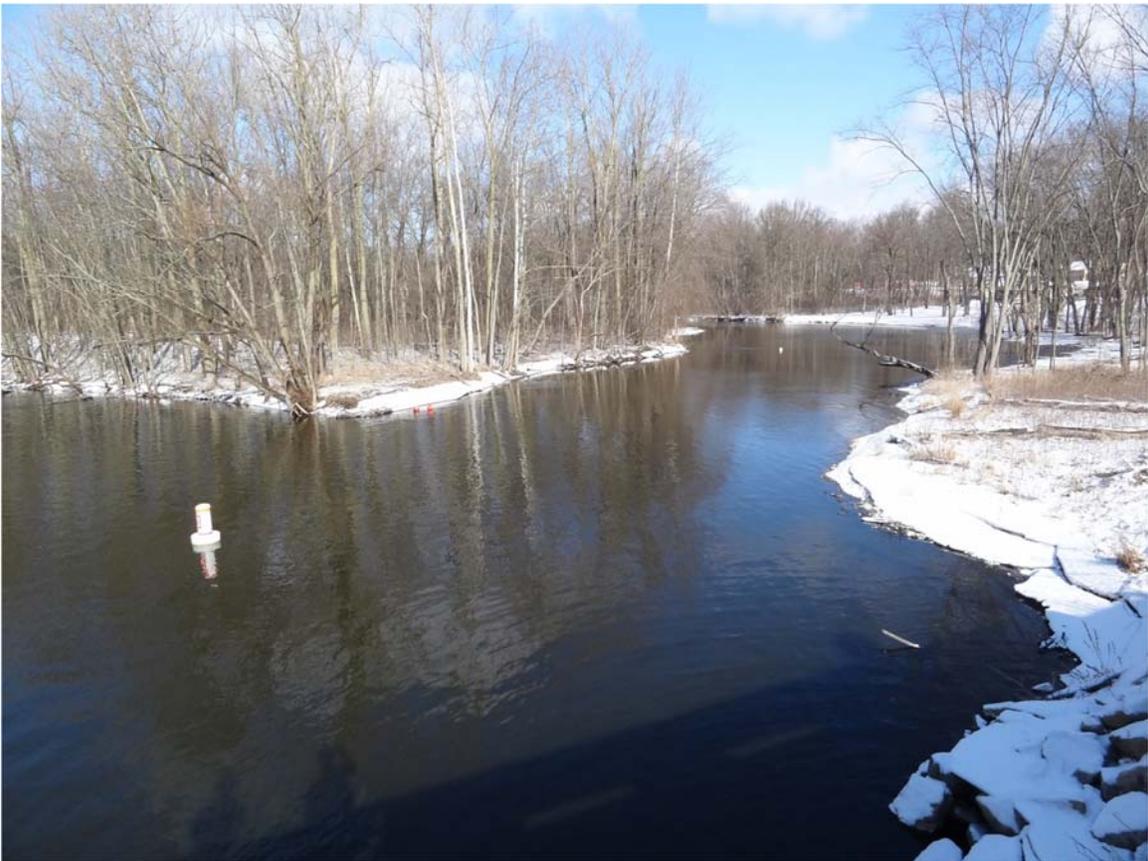
8. MP21.5 Sediment Trap river conditions observed.

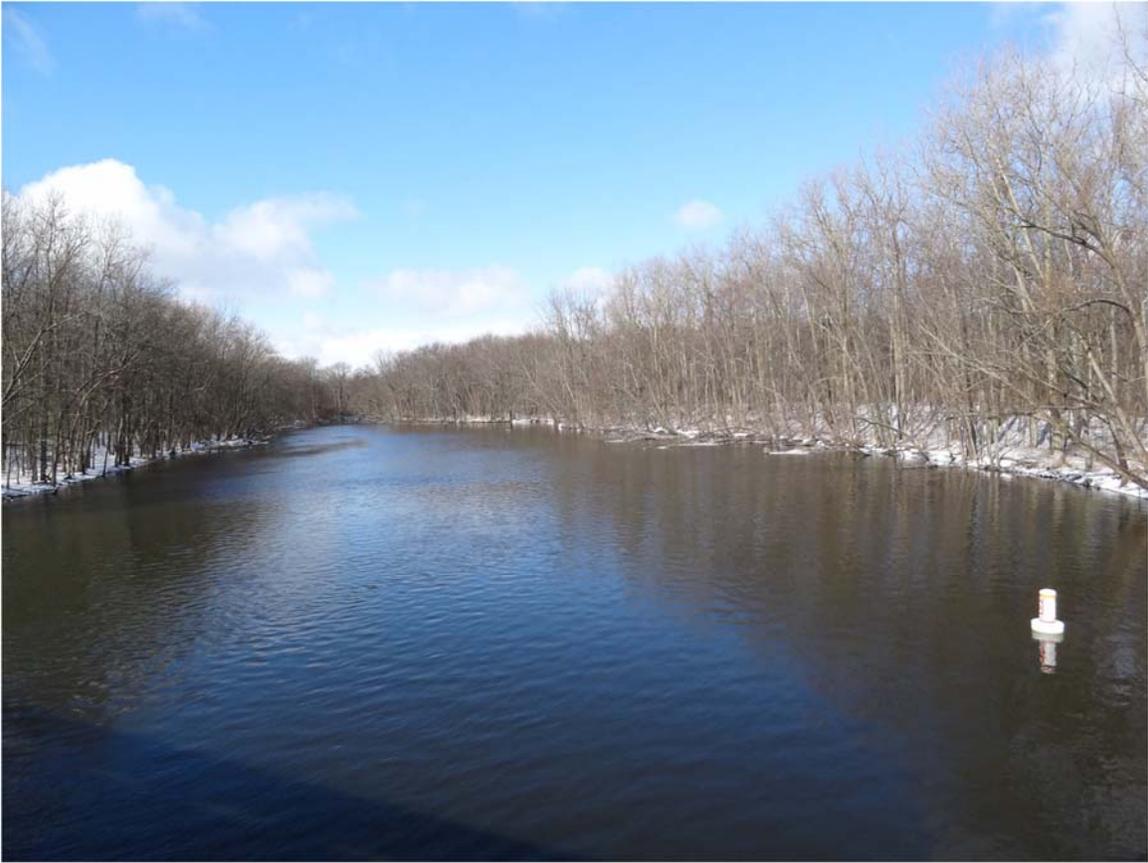
9. MP21.5 river conditions observed.

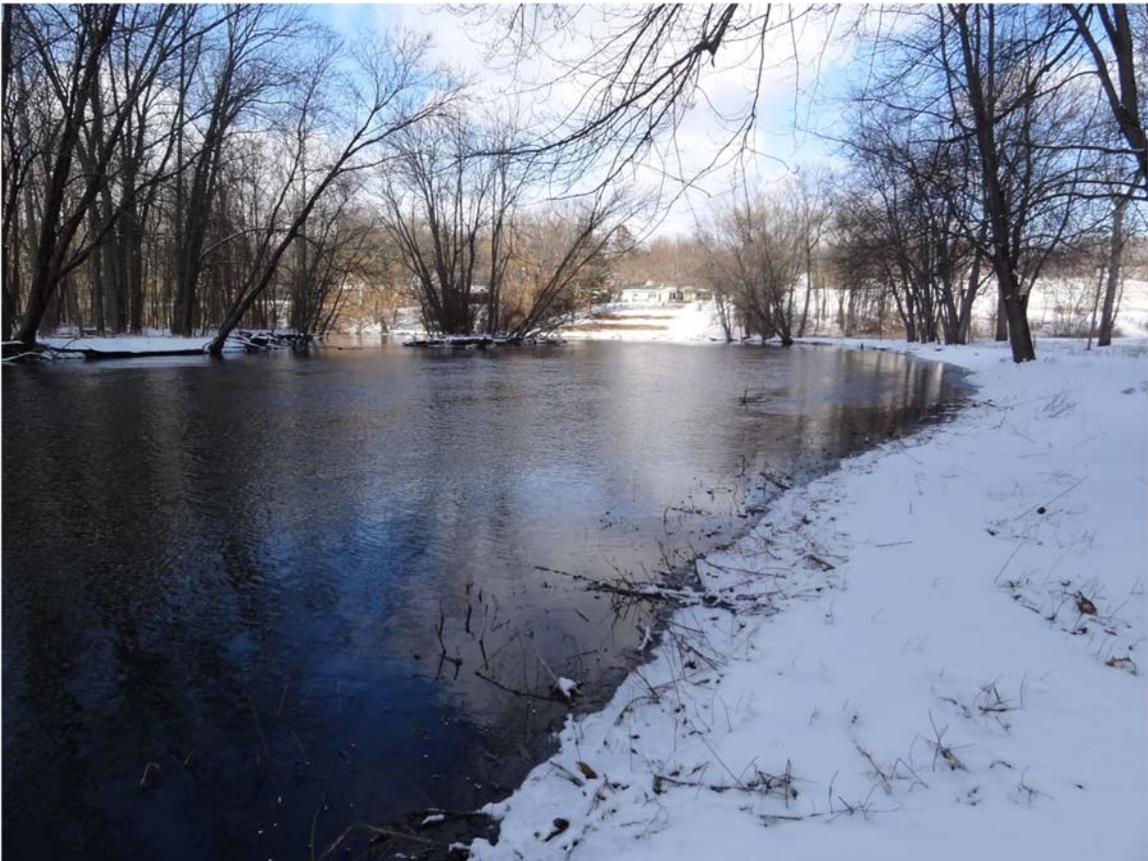
10. MP27.0 Shady Bend Campground river conditions observed.

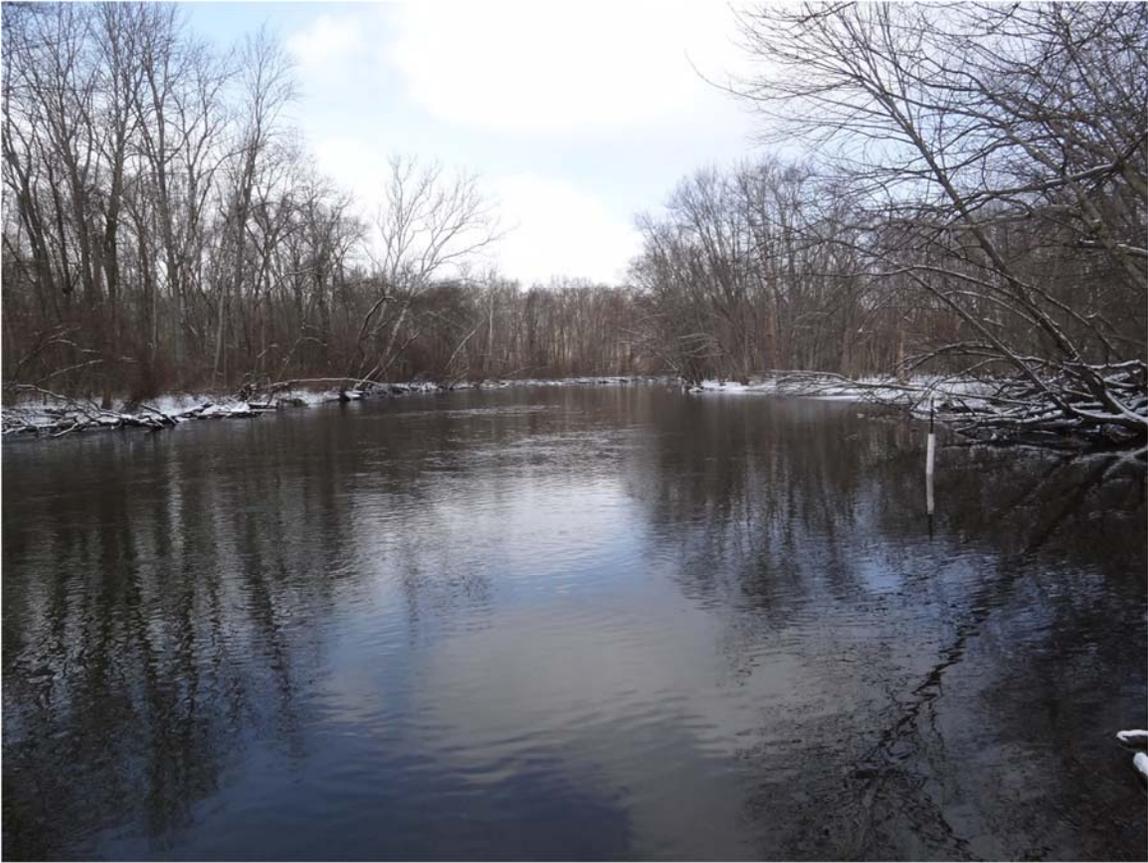
11. E2 Boat launch river conditions observed.

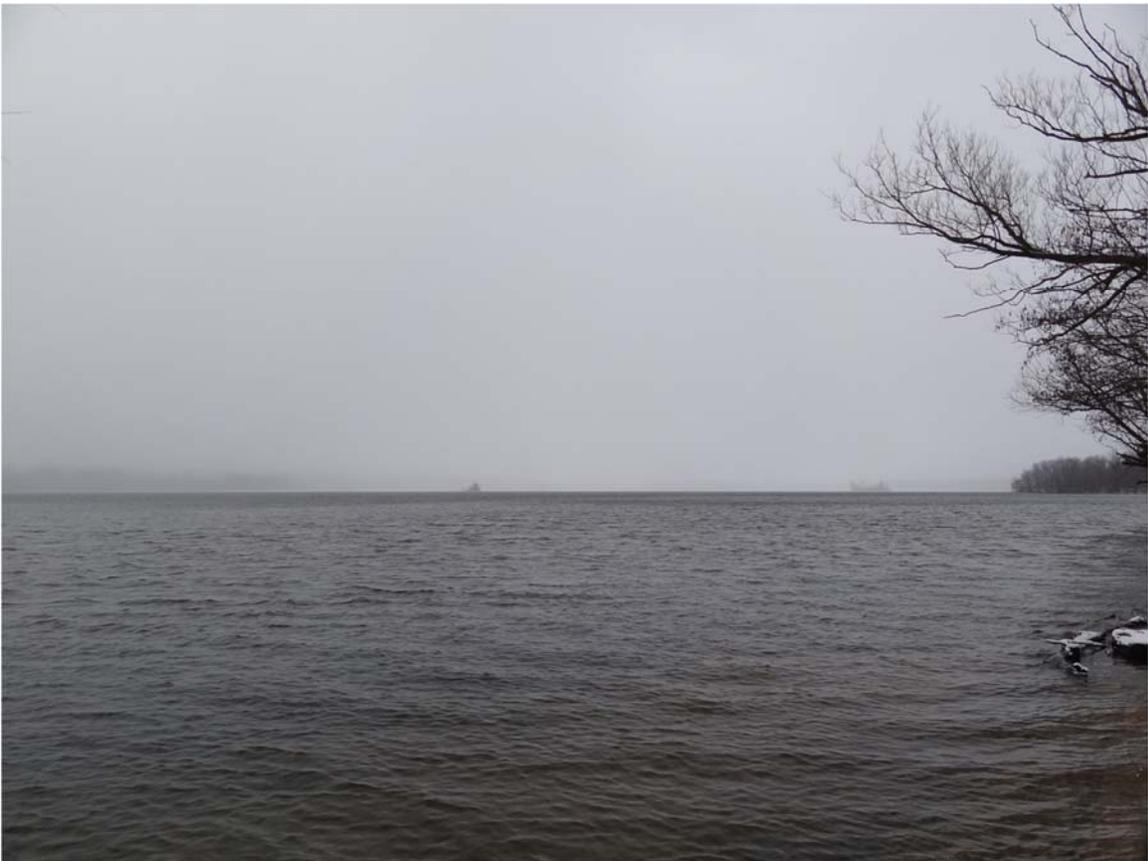
12. Morrow Lake icing conditions observed.

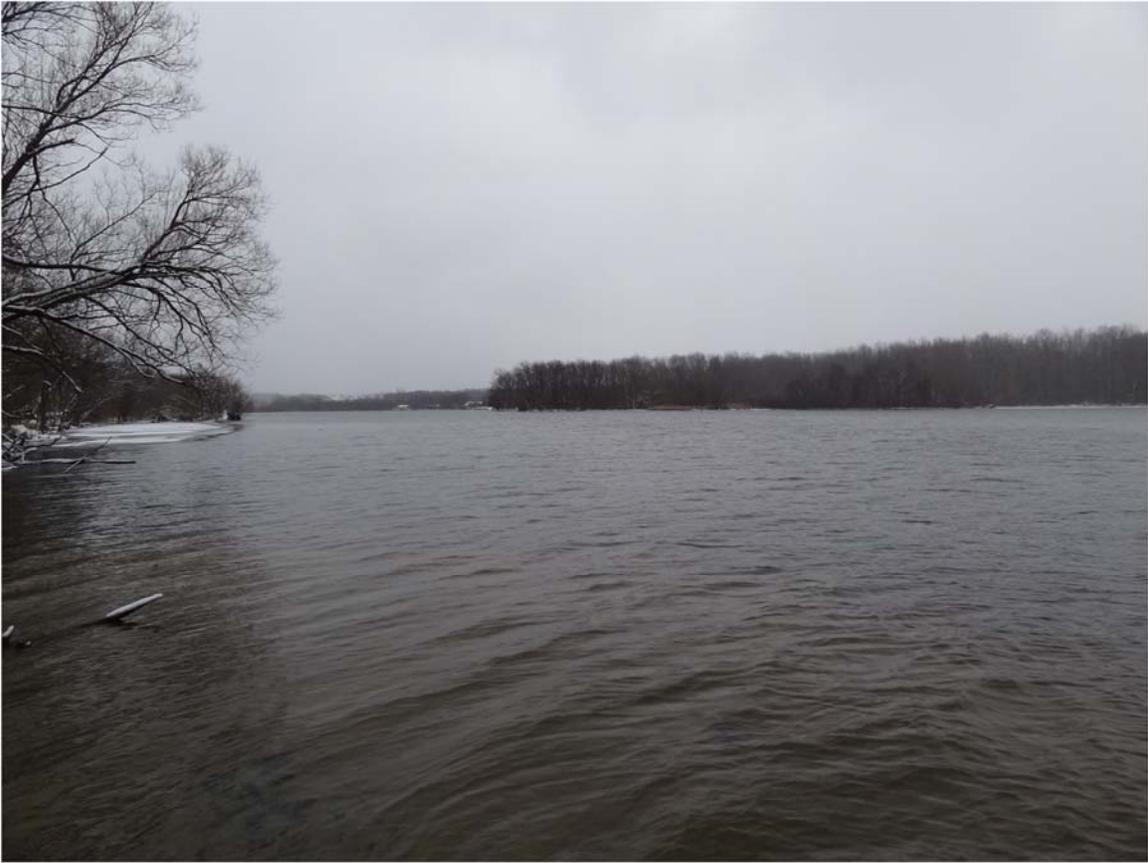
13. Morrow Lake Delta Neck river icing conditions observed.

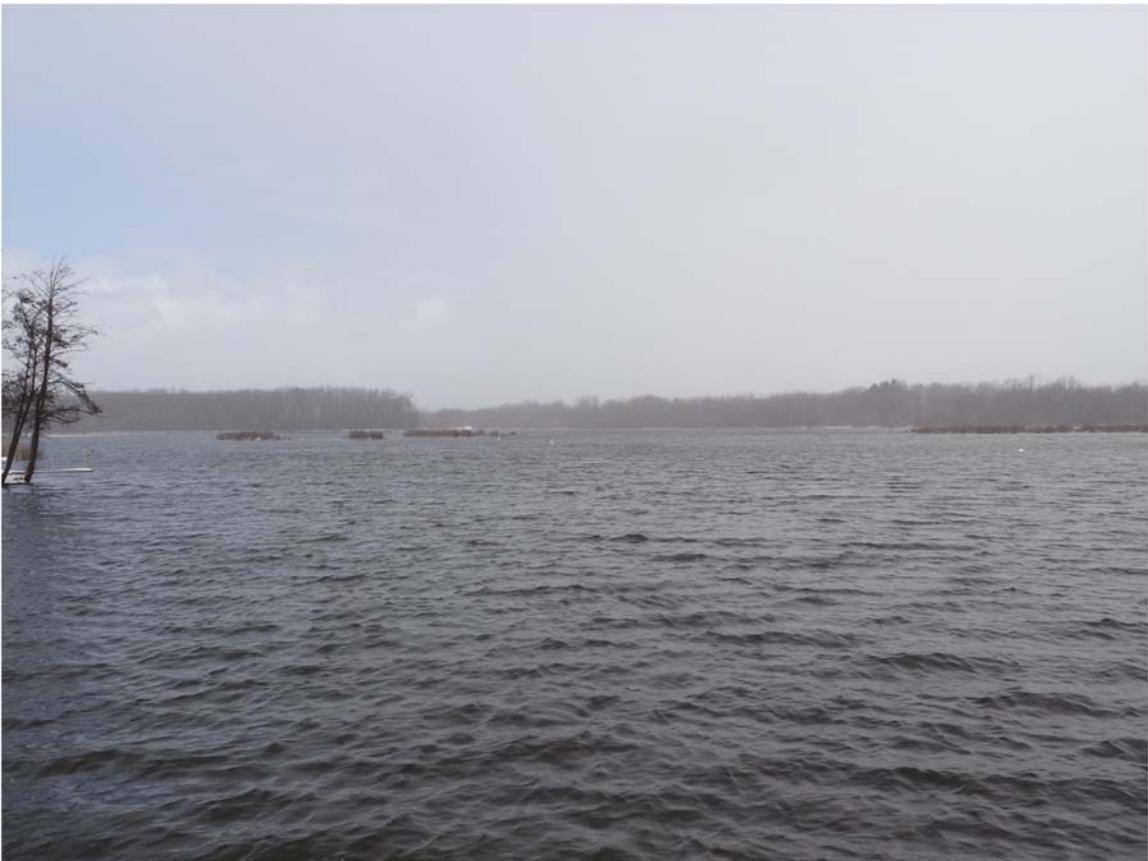
14. Morrow Lake Delta river conditions.

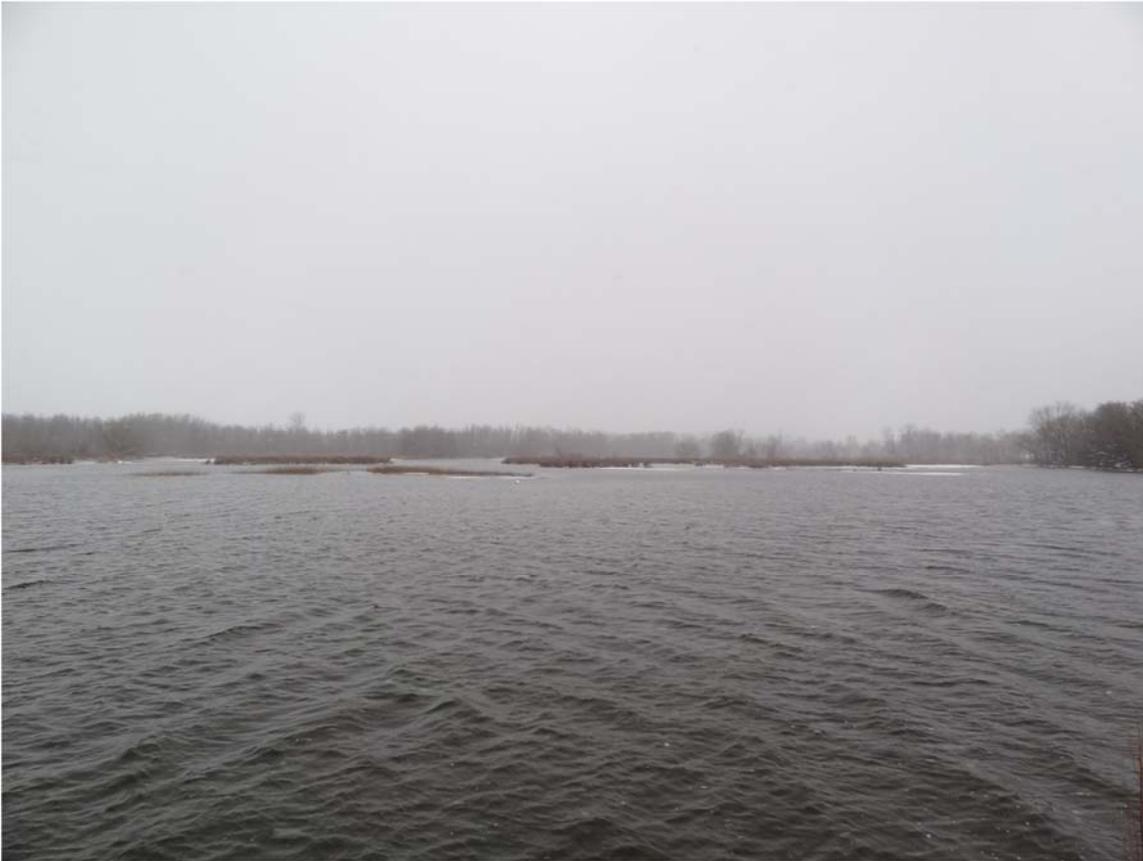
15. Morrow Lake Delta river conditions.

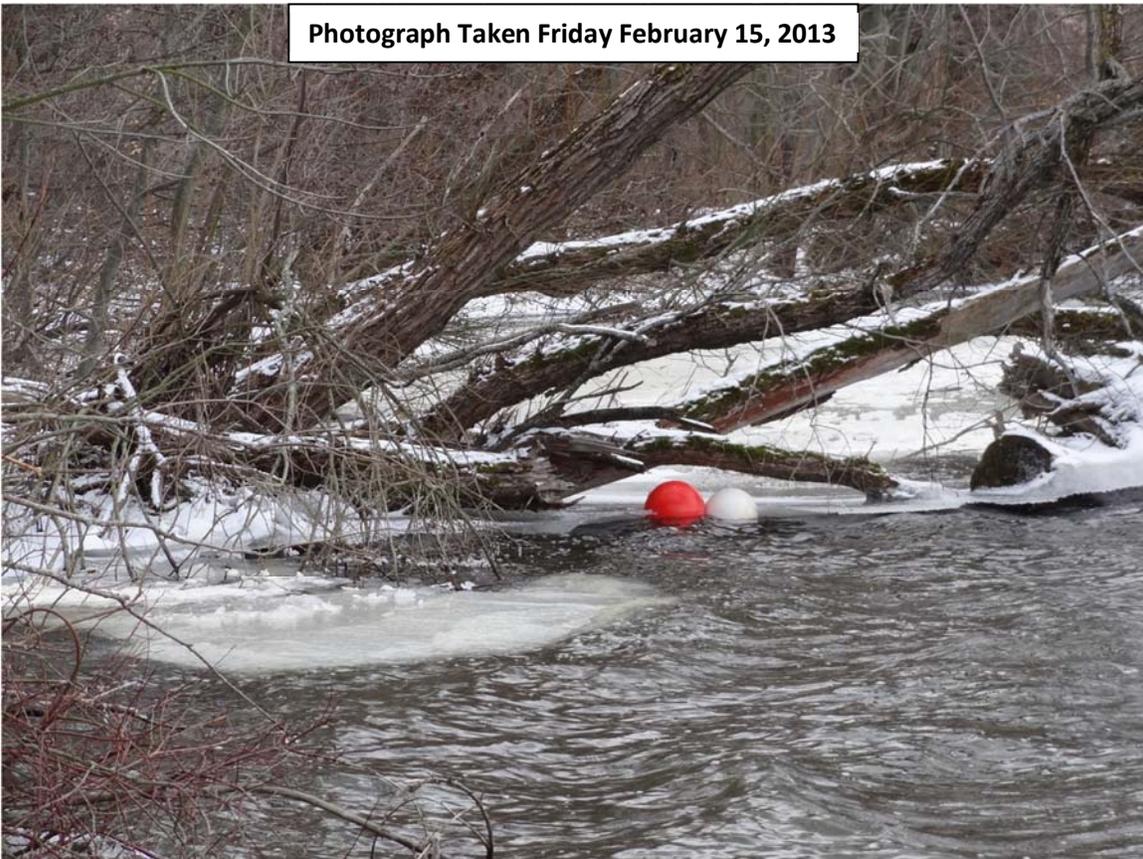
16. Buoys from Rowe Island previously observed during an overflight were located and removed.

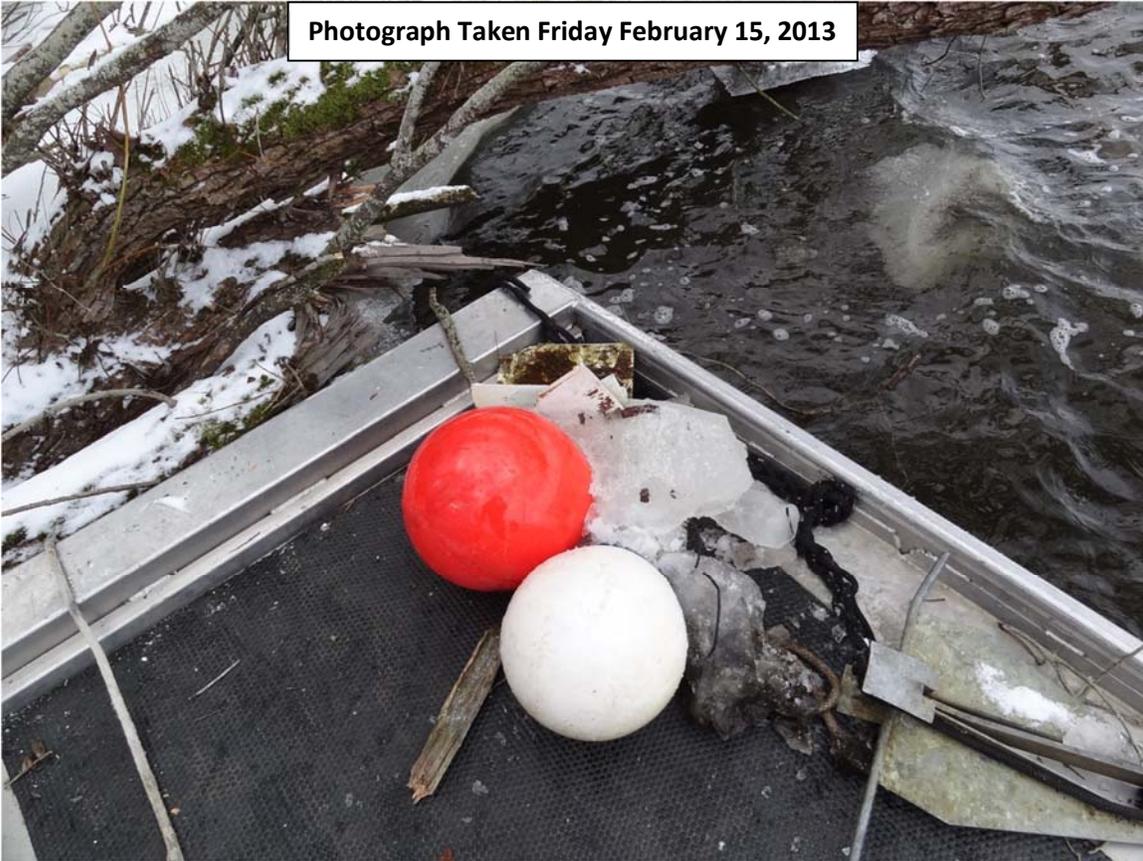
17. Buoys from Rowe Island previously observed during an overflight were located and removed.
