# Situation Photo Log

Monday, February 18, 2013

Kalamazoo River / Enbridge Spill

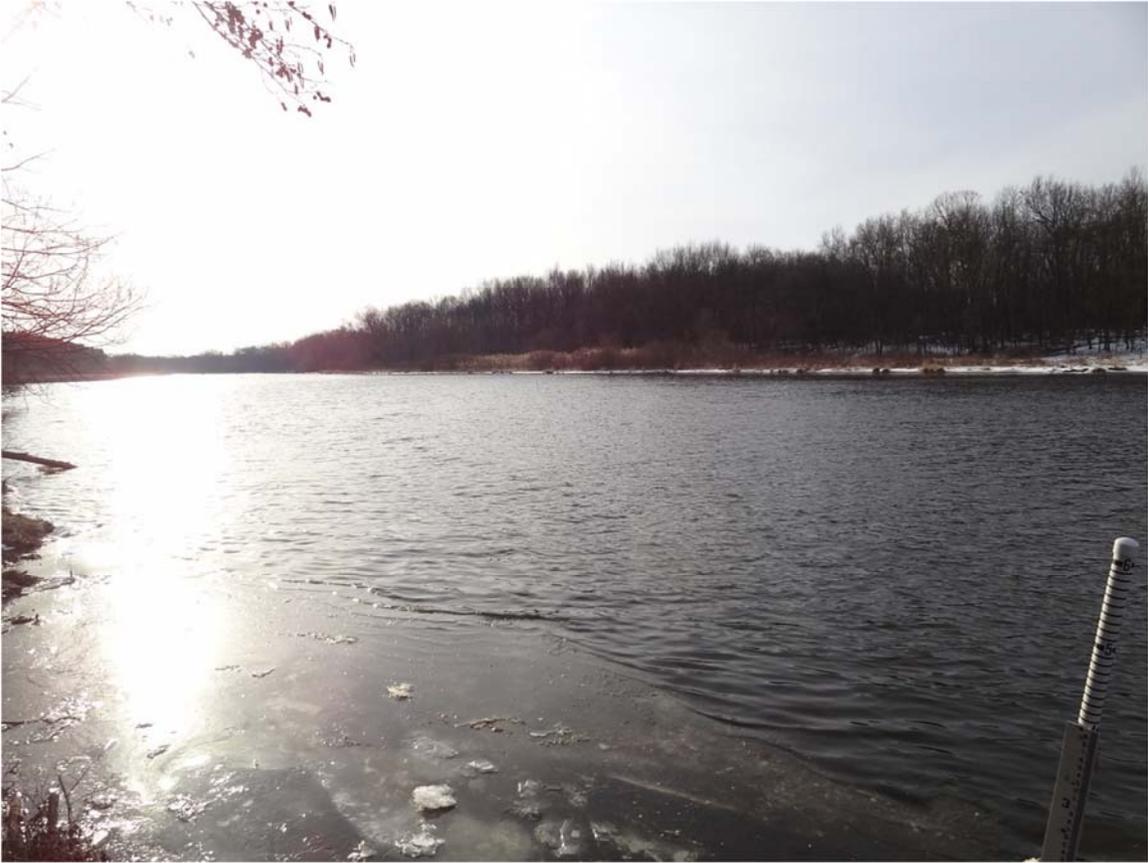
1. C0.4 Boat launch river conditions observed in the morning.

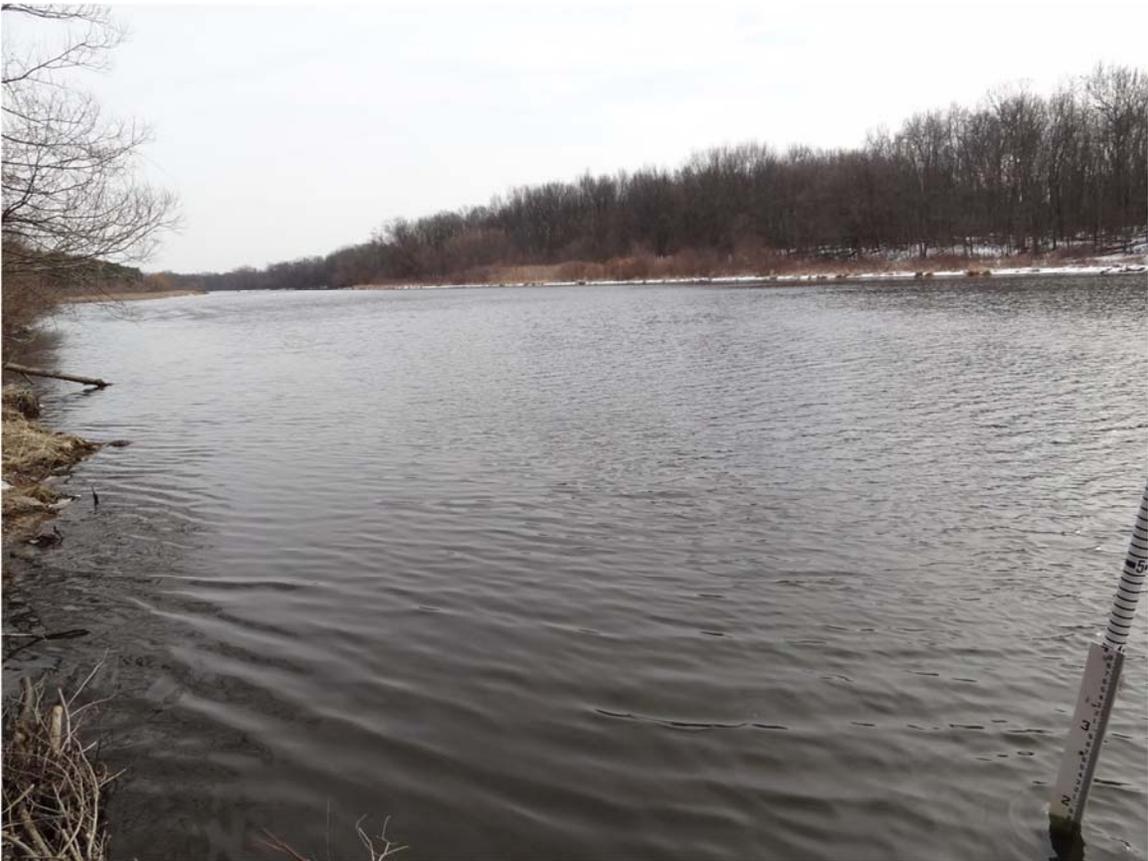
2. C0.4 Boat launch river conditions observed in the afternoon.

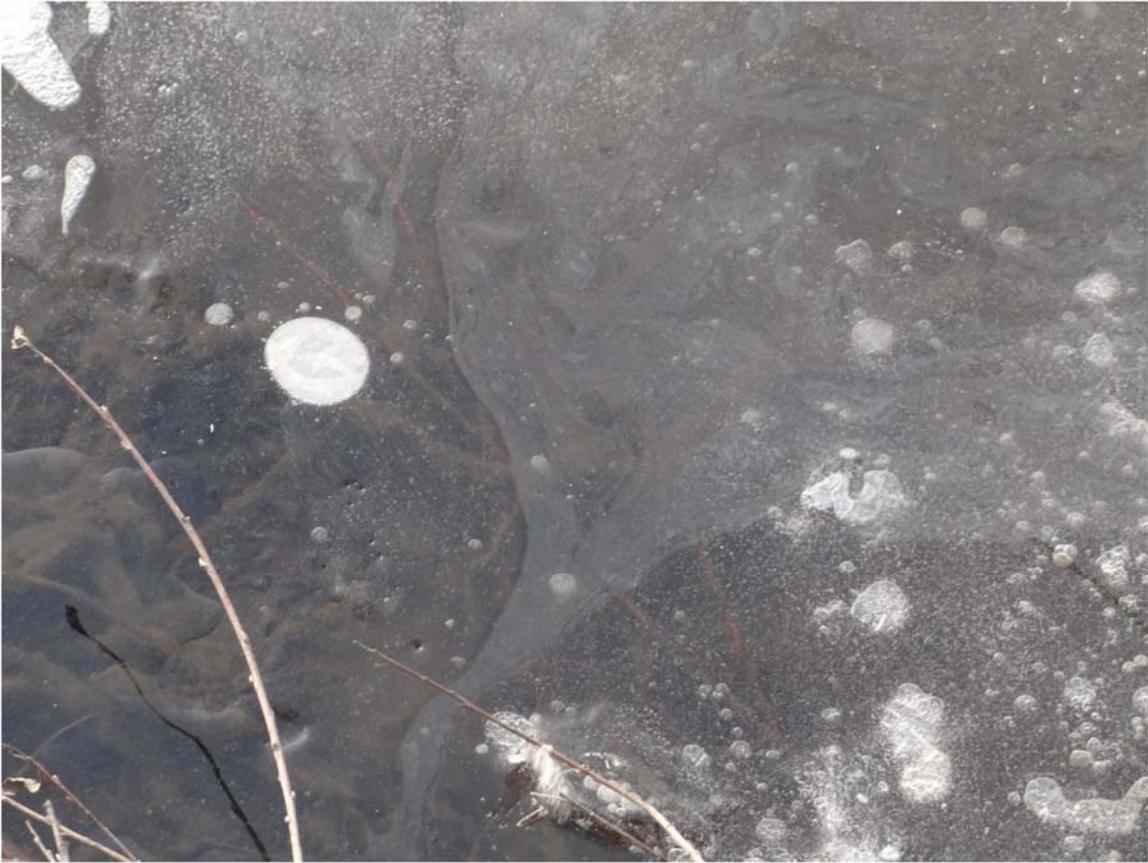
3. C0.4 Boat Launch seen observed within the ice.

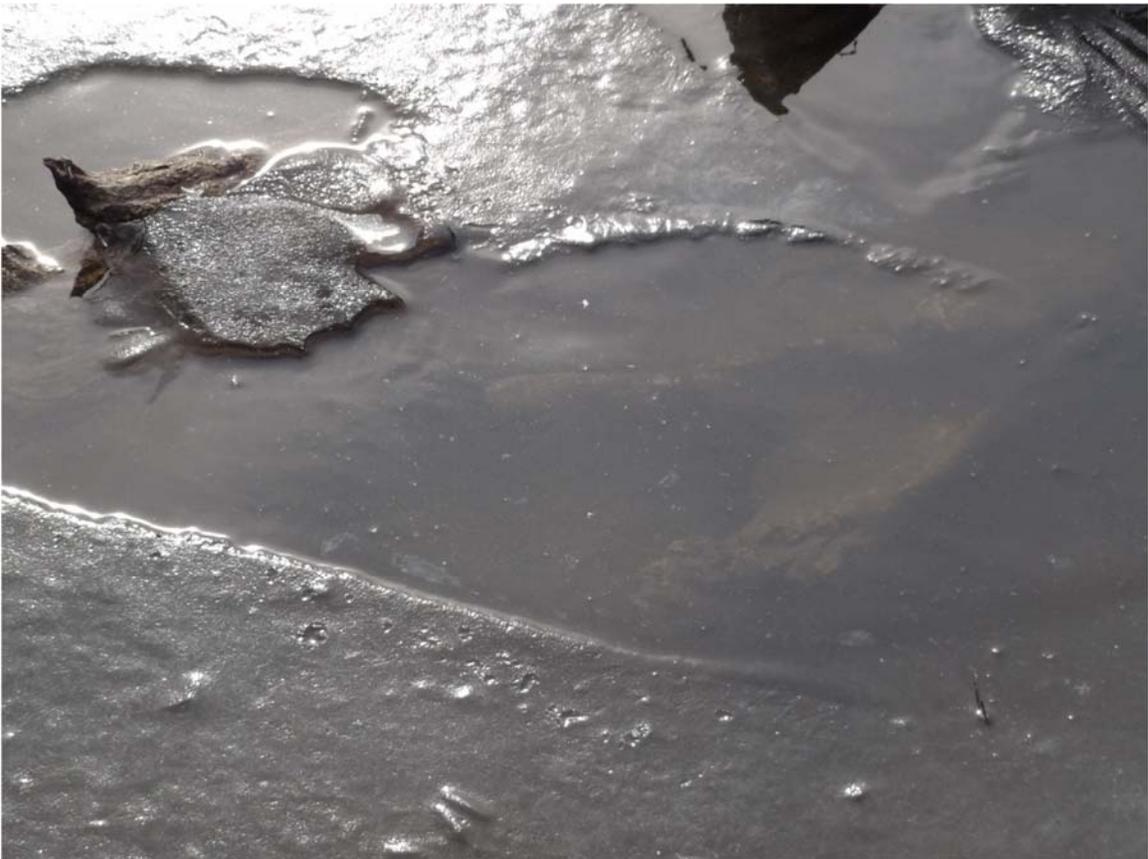
4. MP5.75 RDB seen observed within a pool of melted ice.

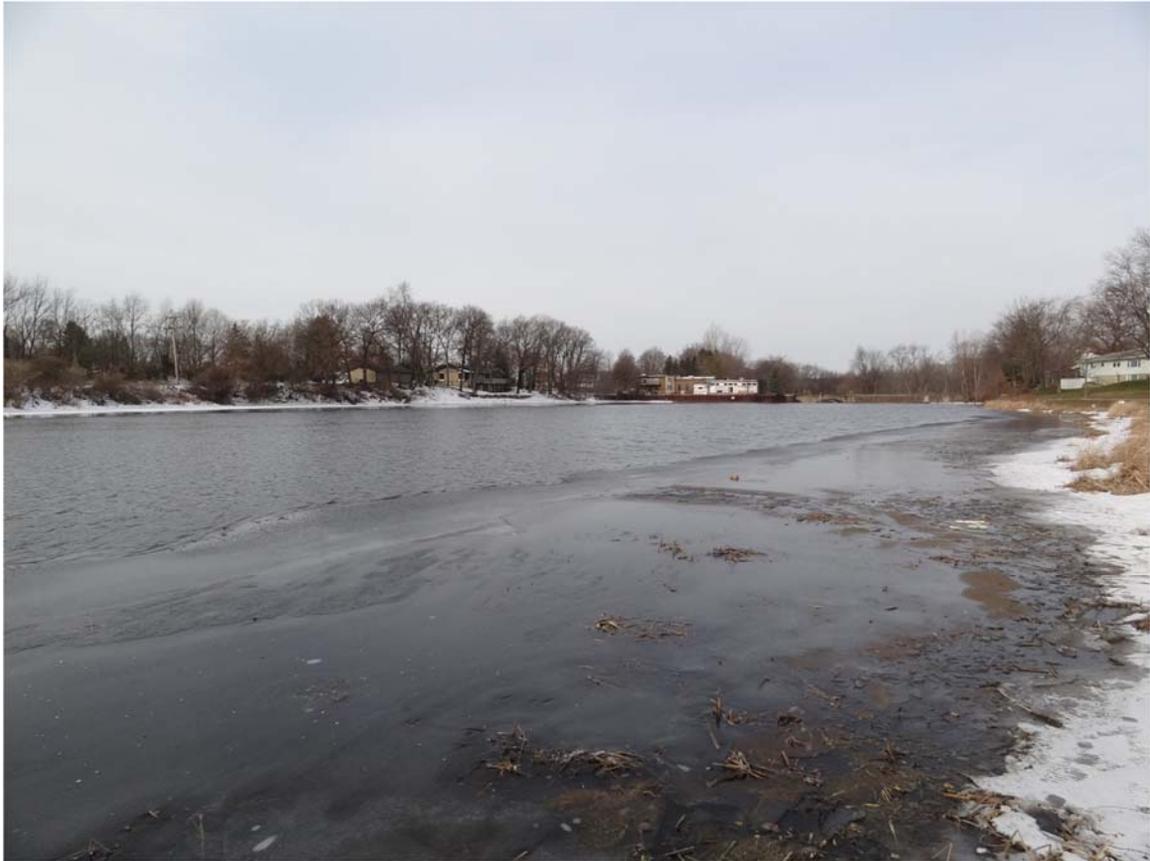
5. MP5.75 Ceresco Dam impoundment river icing conditions observed in the morning.

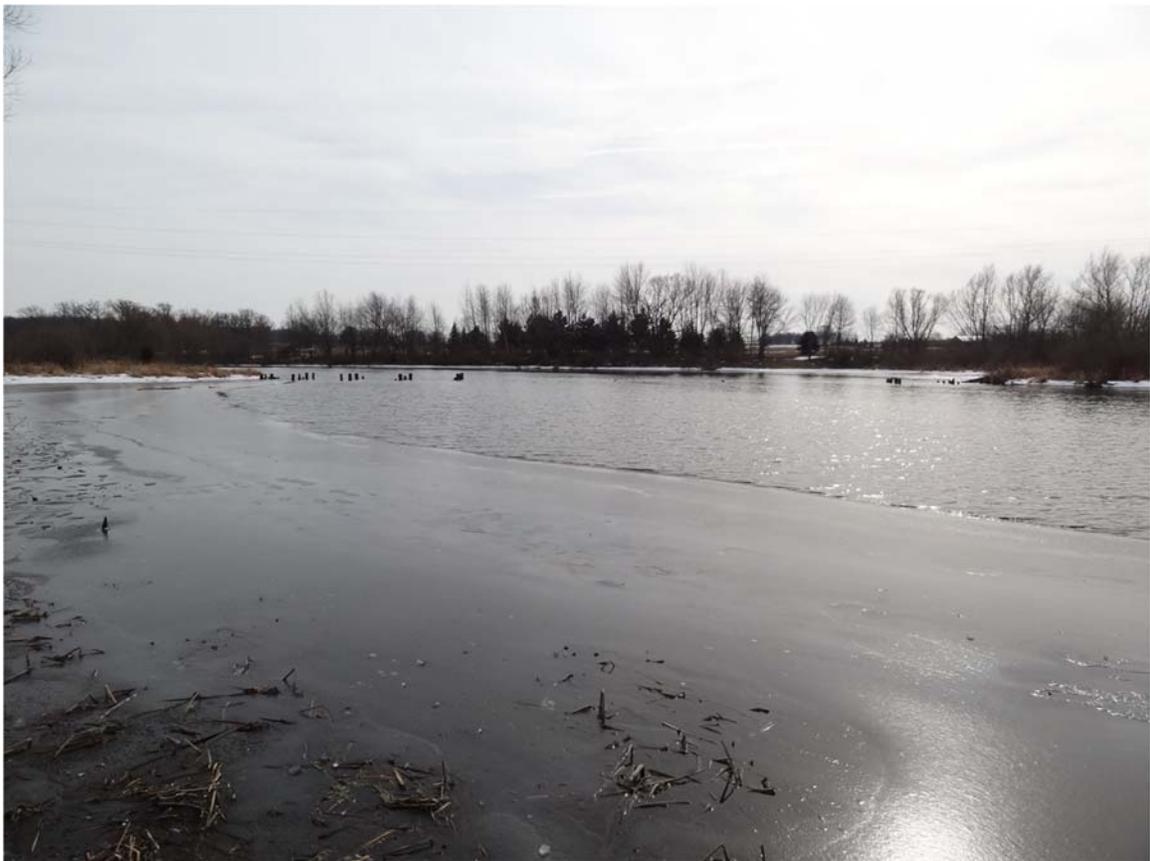
6. MP5.75 Ceresco Dam impoundment river icing conditions observed in the afternoon.

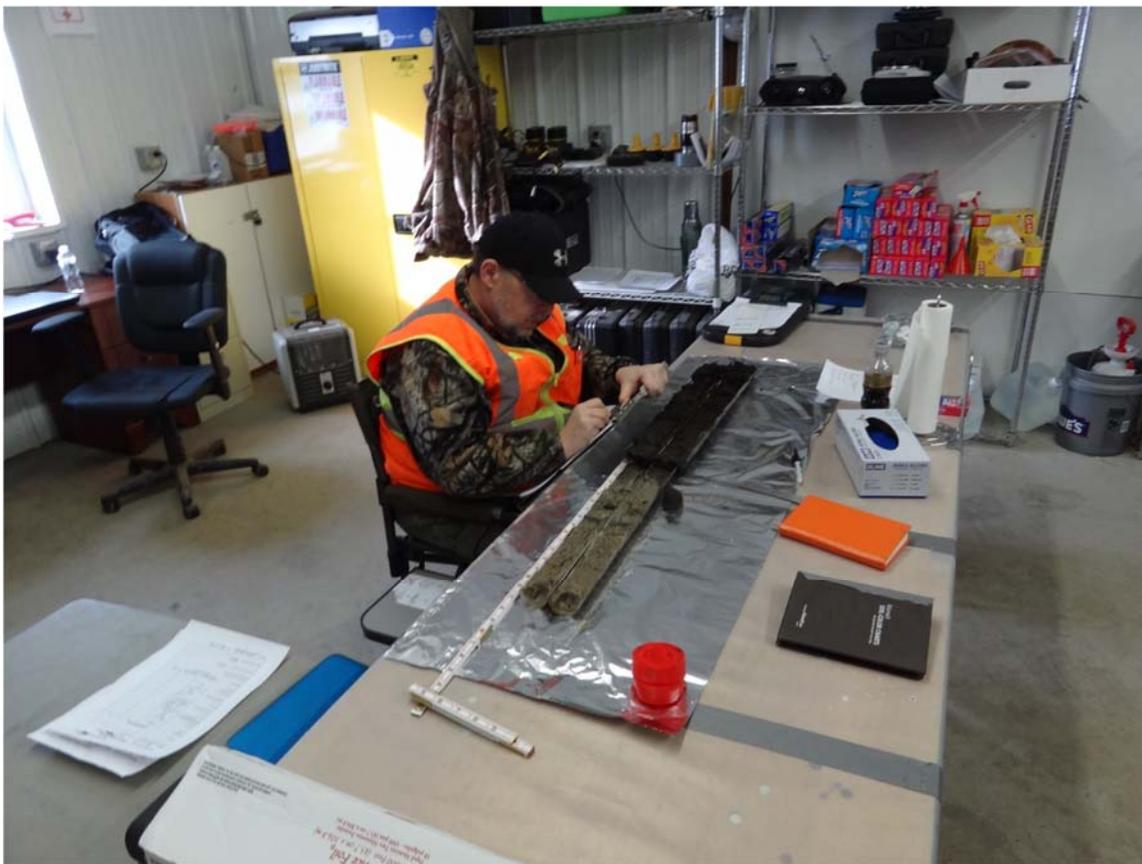
7. C3.2 Pole Barn observed core logging.

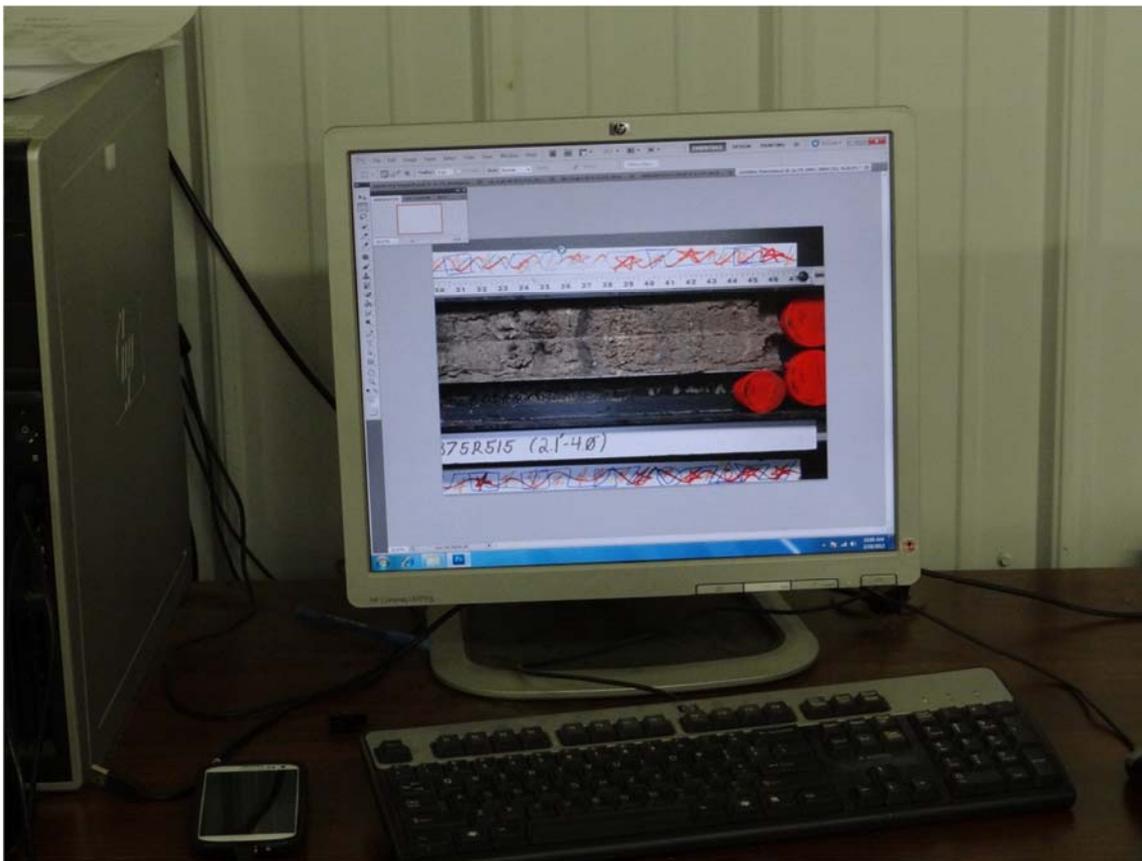
8. C3.2 Pole Barn observed core logging.

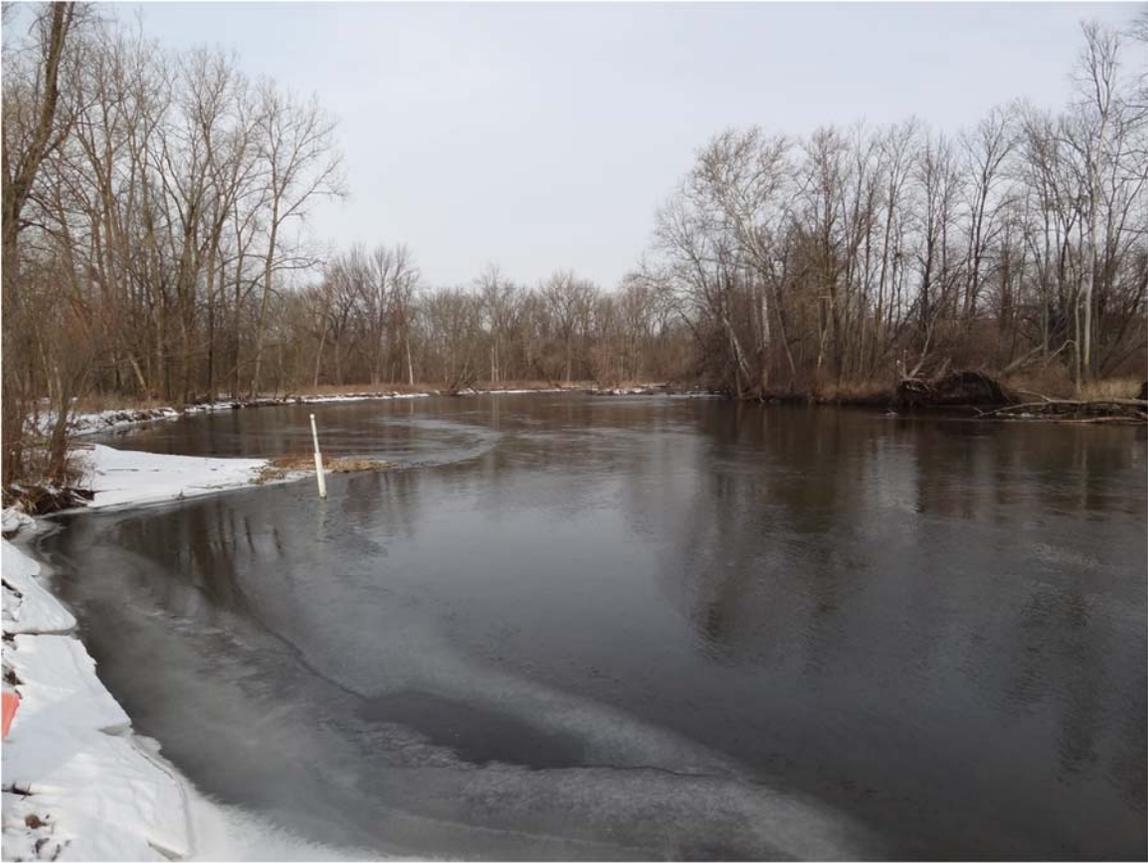
9. C3.2 Observed river icing conditions.

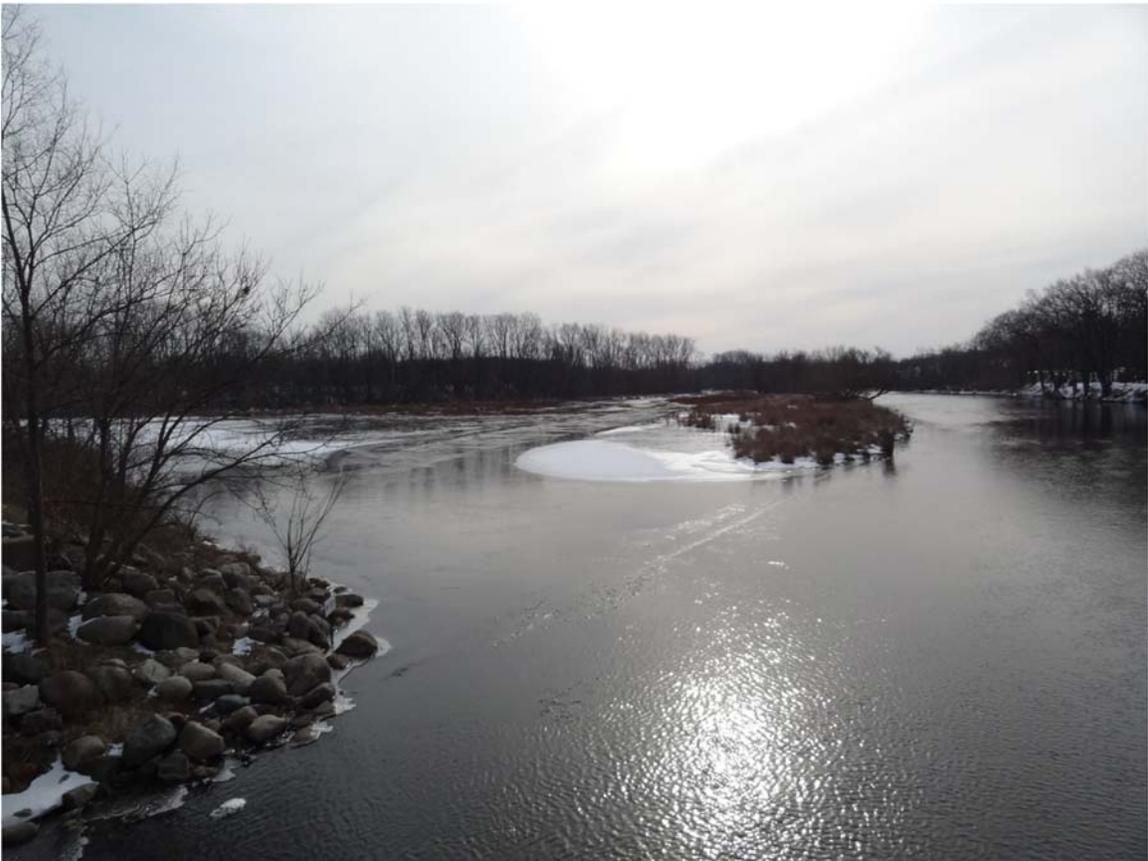
10. MP15.25 South Mill Pond observed river icing conditions.

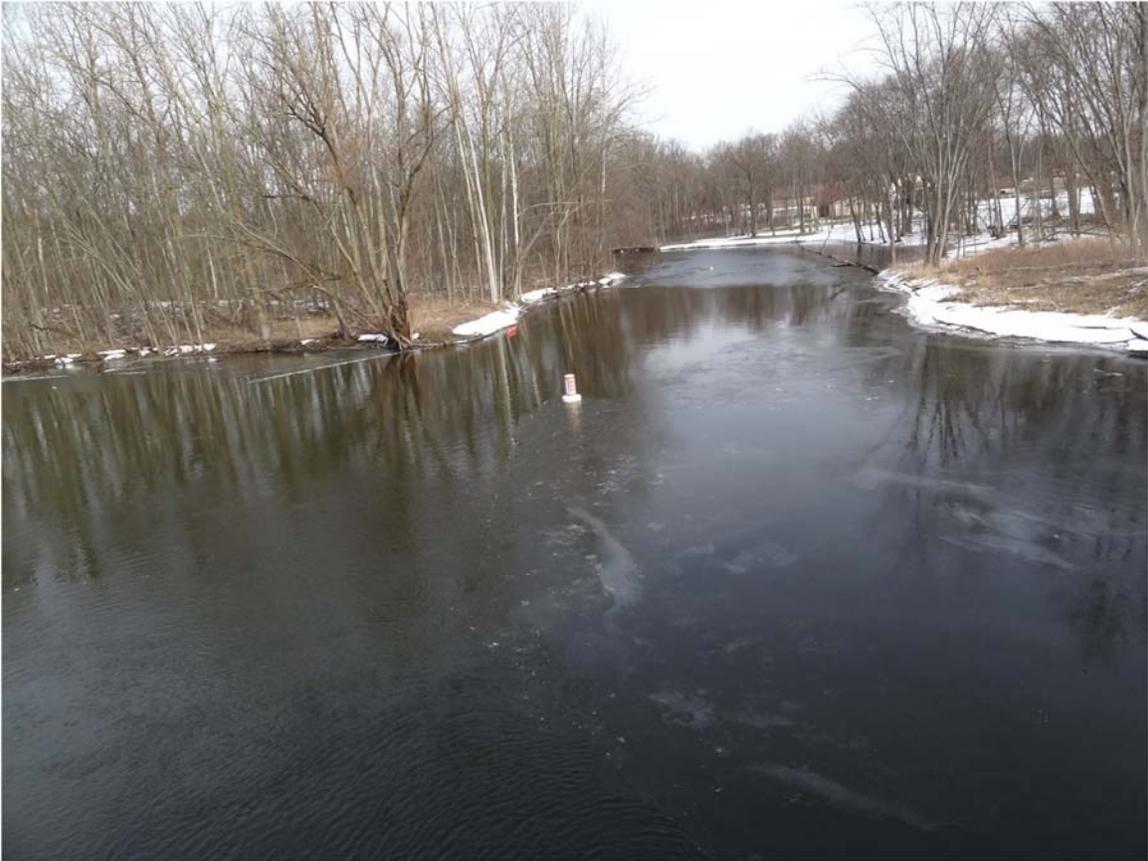
11. MP21.5 Sediment trap observed river icing conditions.

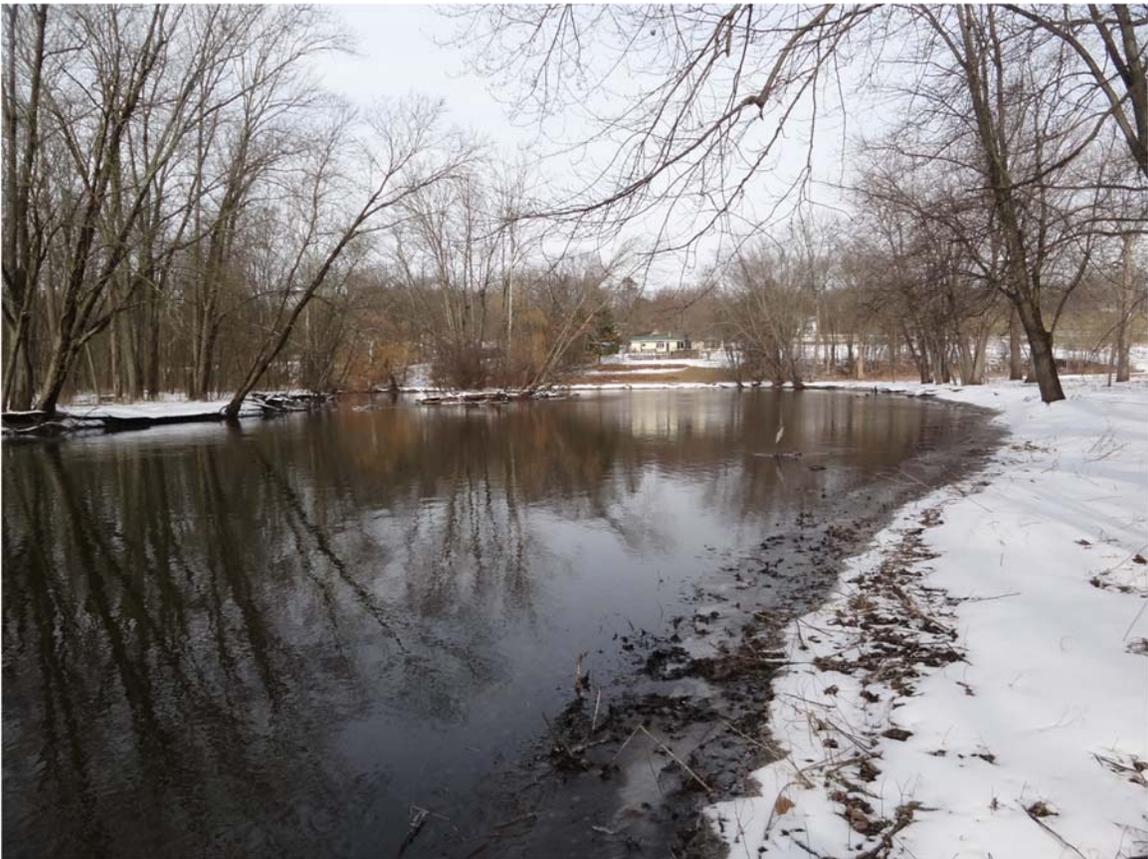
12. MP27.0 Shady Bend Campground observed river conditions.

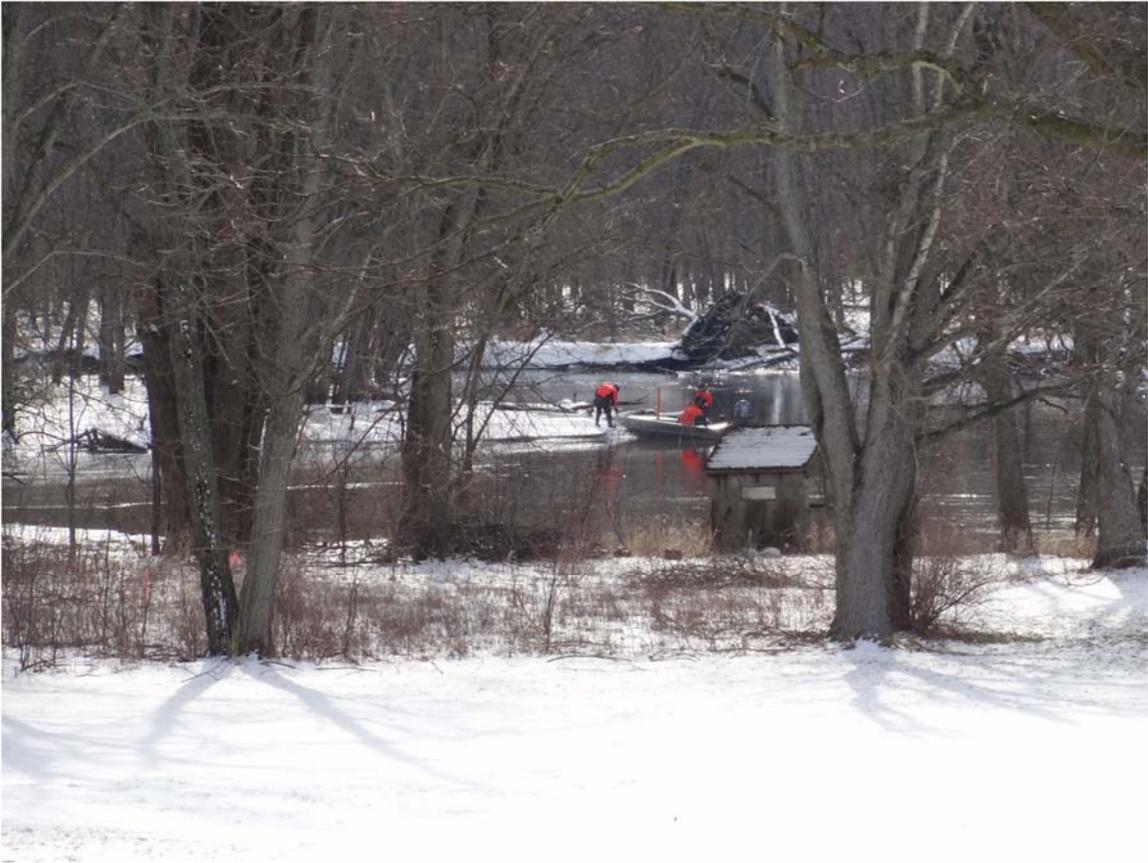
13. MP26.0 Sediment trap observed the CSD sampling crew.

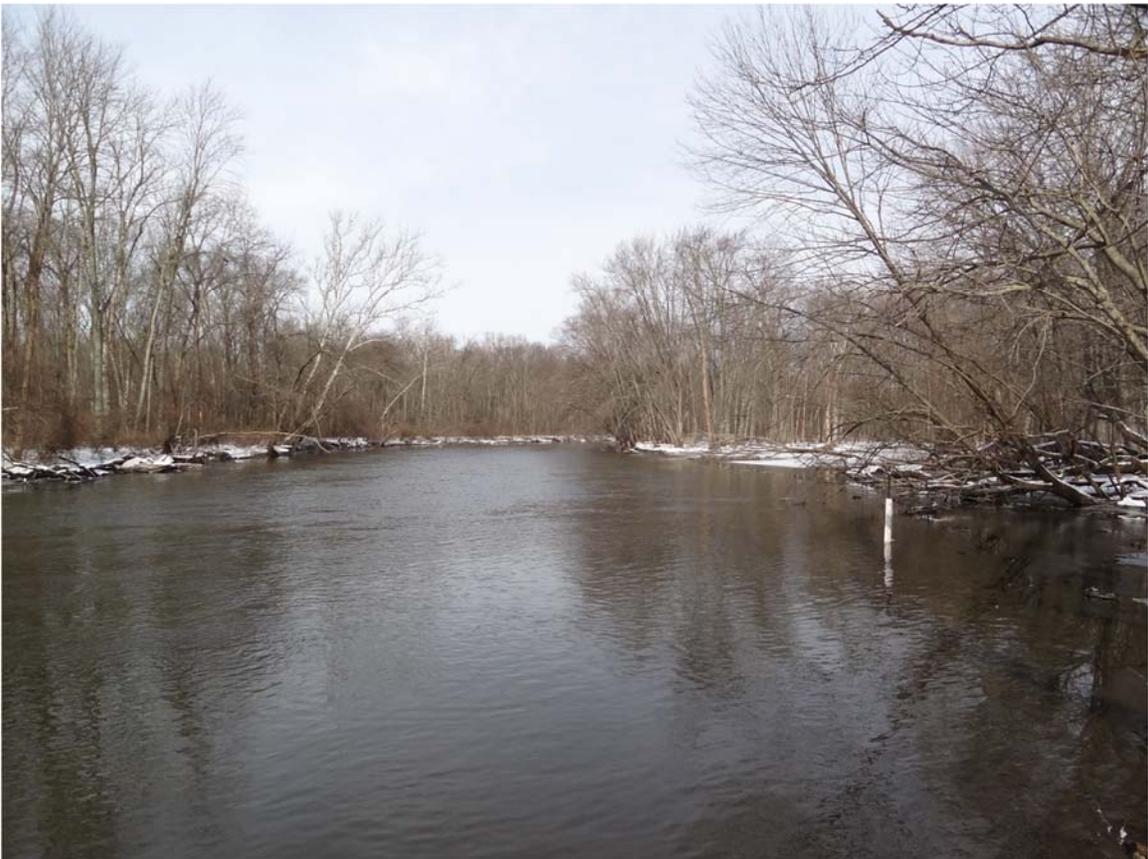
14. E2 Boat launch observed river conditions.

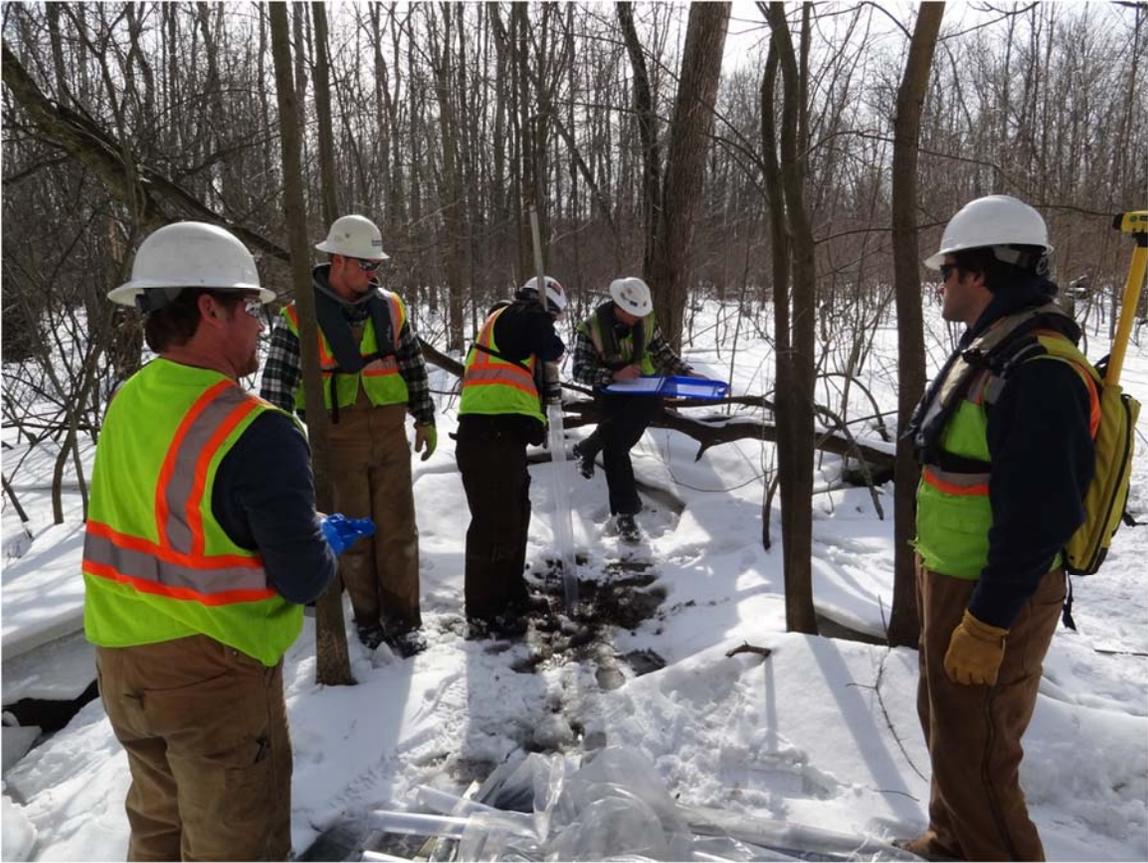
15. MP28.5 RDB observed the RI crew.

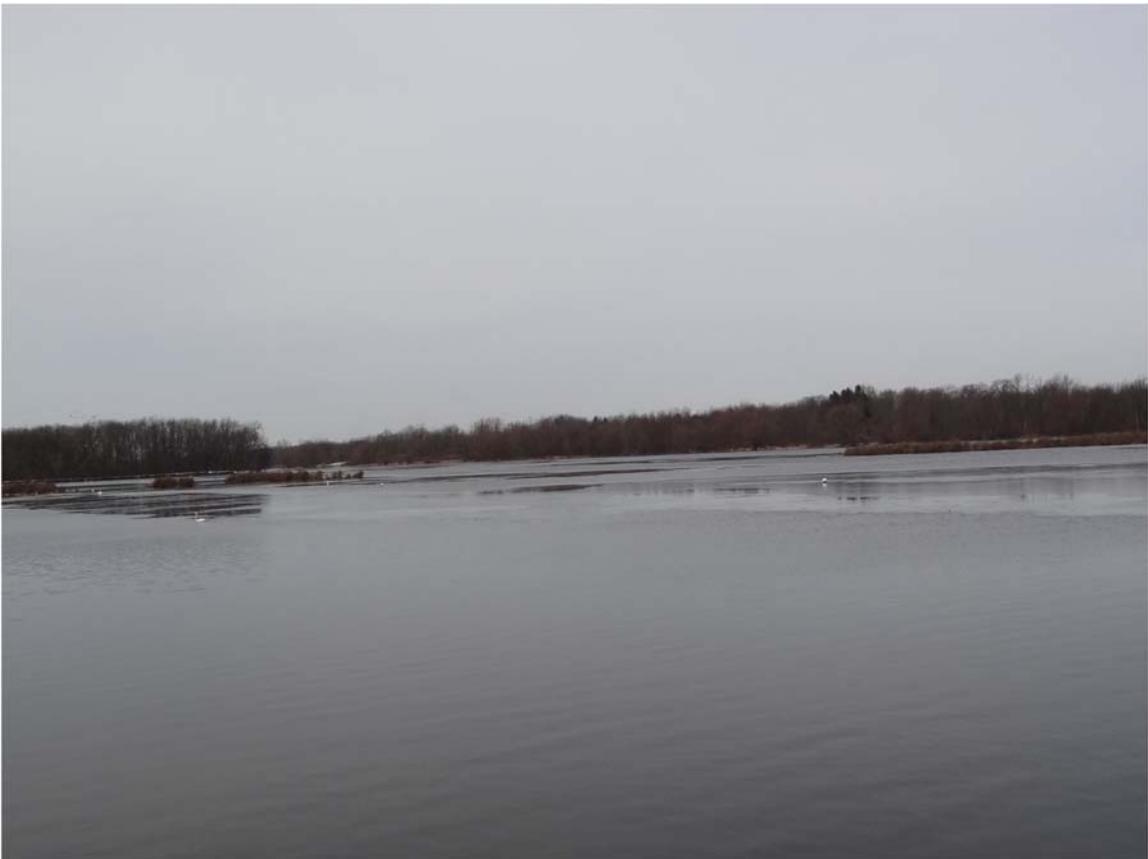
16. Morrow Lake Delta icing conditions observed.

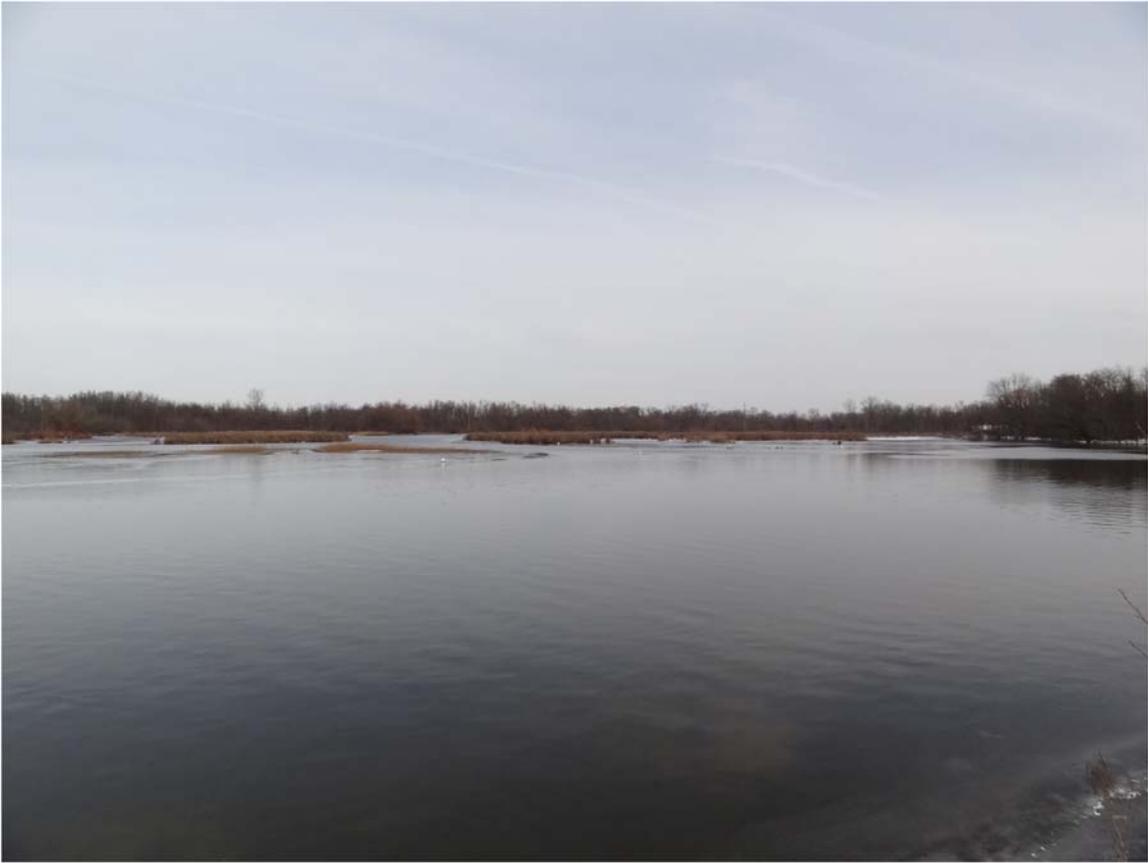
17. Morrow Lake Delta icing conditions observed.

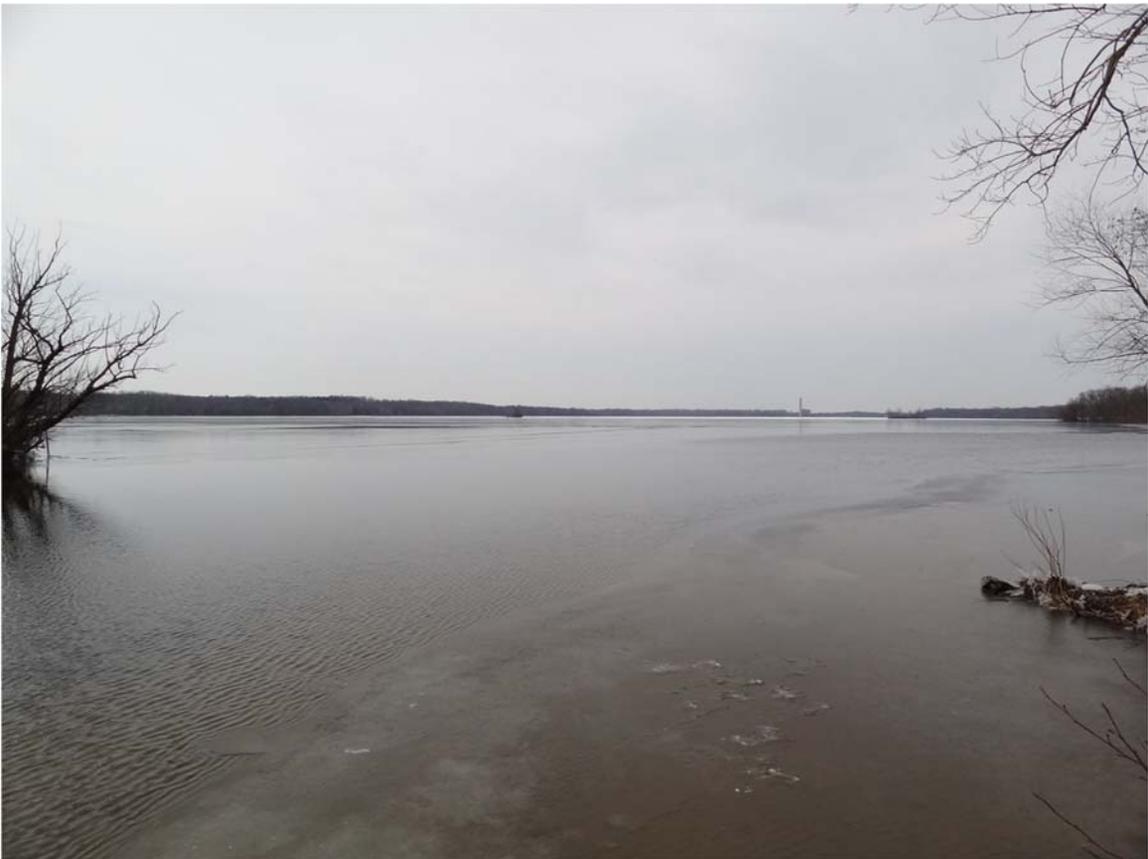
18. Morrow Lake icing conditions observed.

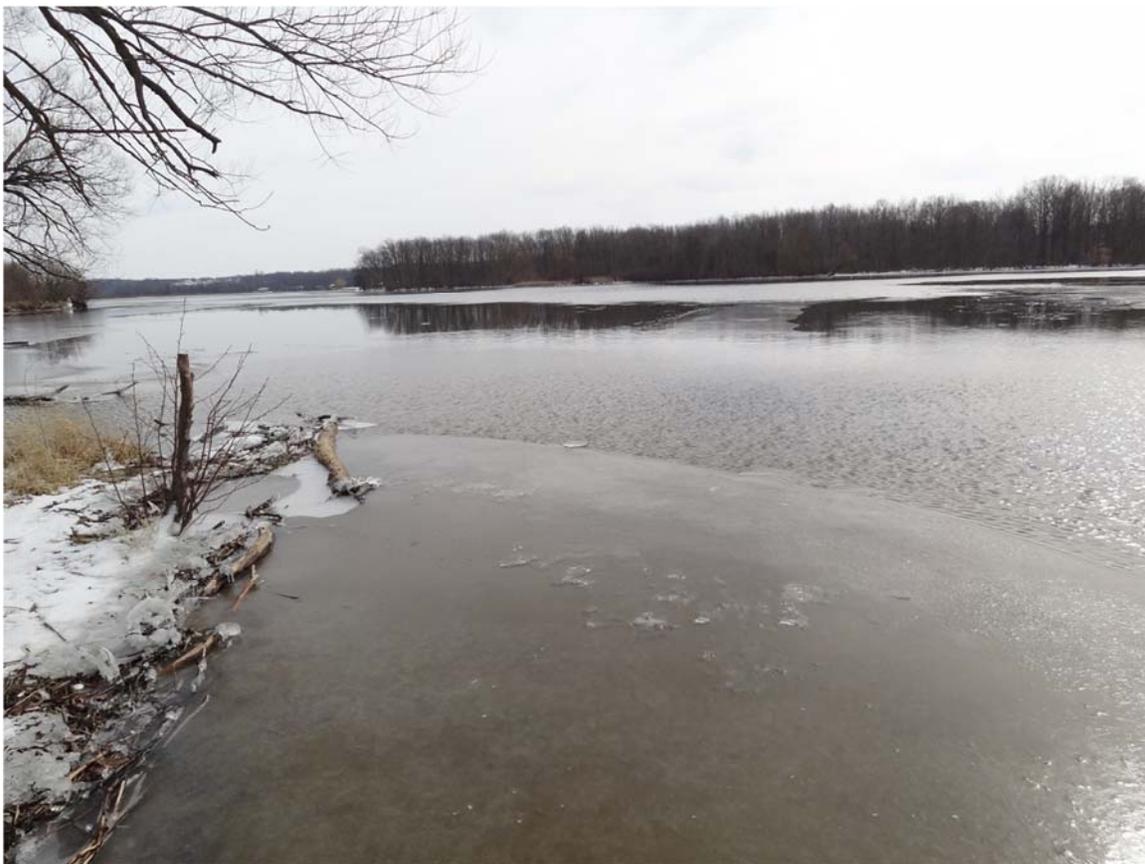
19. Morrow Lake Delta Neck icing conditions observed.

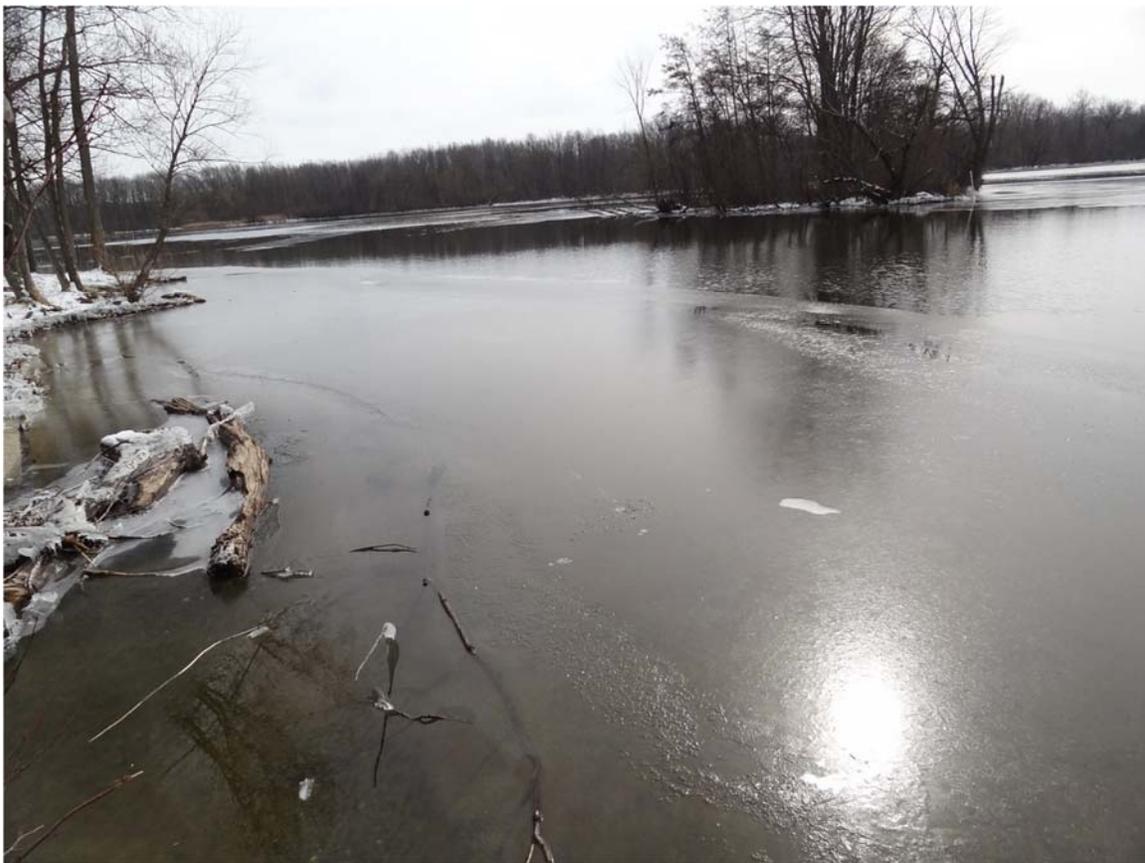
20. Morrow Lake E4 boat launch icing conditions observed.
