# Situation Photo Log

Wednesday, February 20, 2013

Kalamazoo River / Enbridge Spill

Prepared by:  
Matthew Haak  
START-USEPA  
Situation Unit Leader

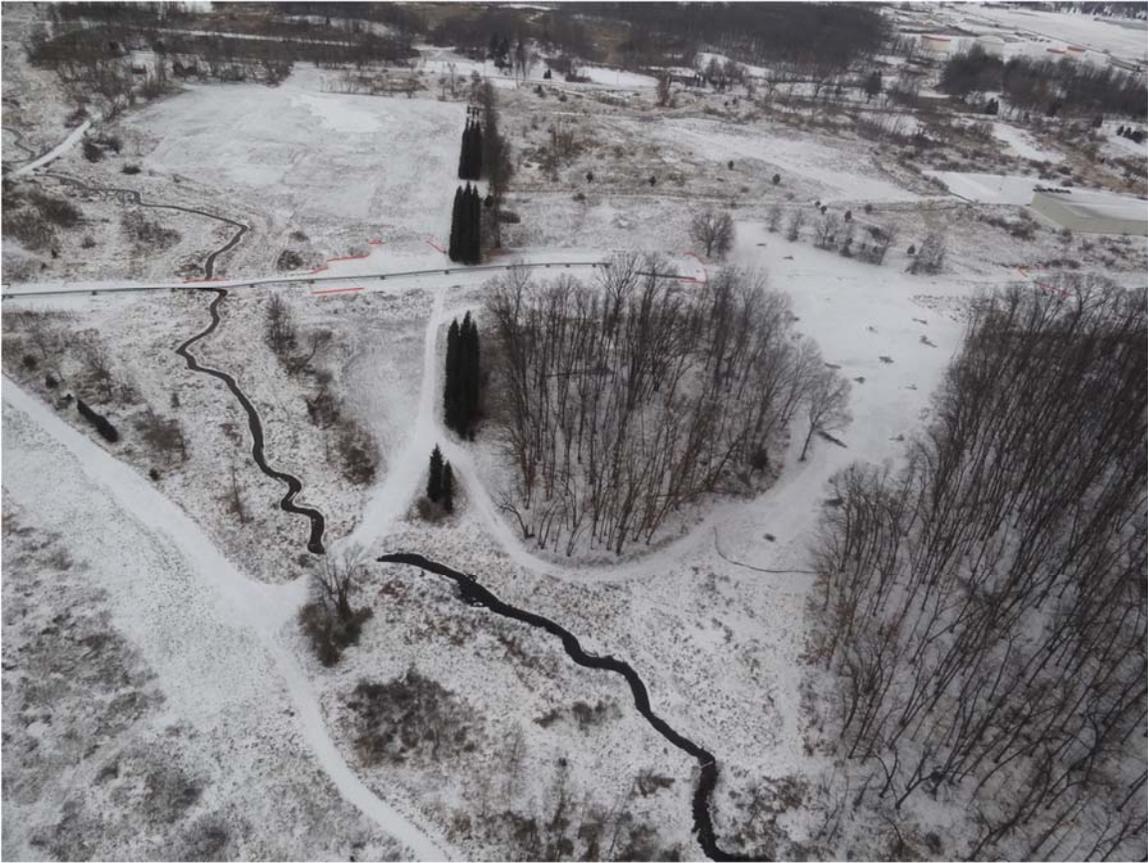
1. Source Area and Talmadge Creek overview.

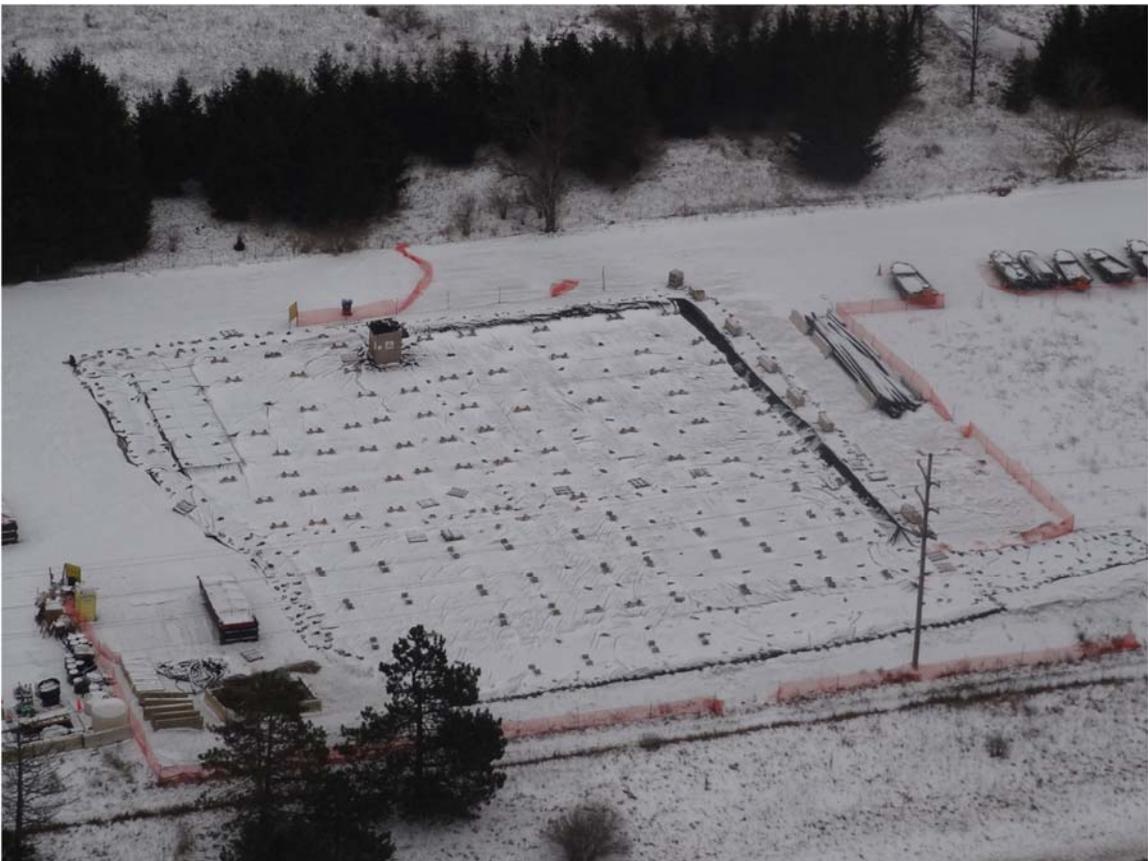
2. Frac Tank City observed Cells A/B winterized.

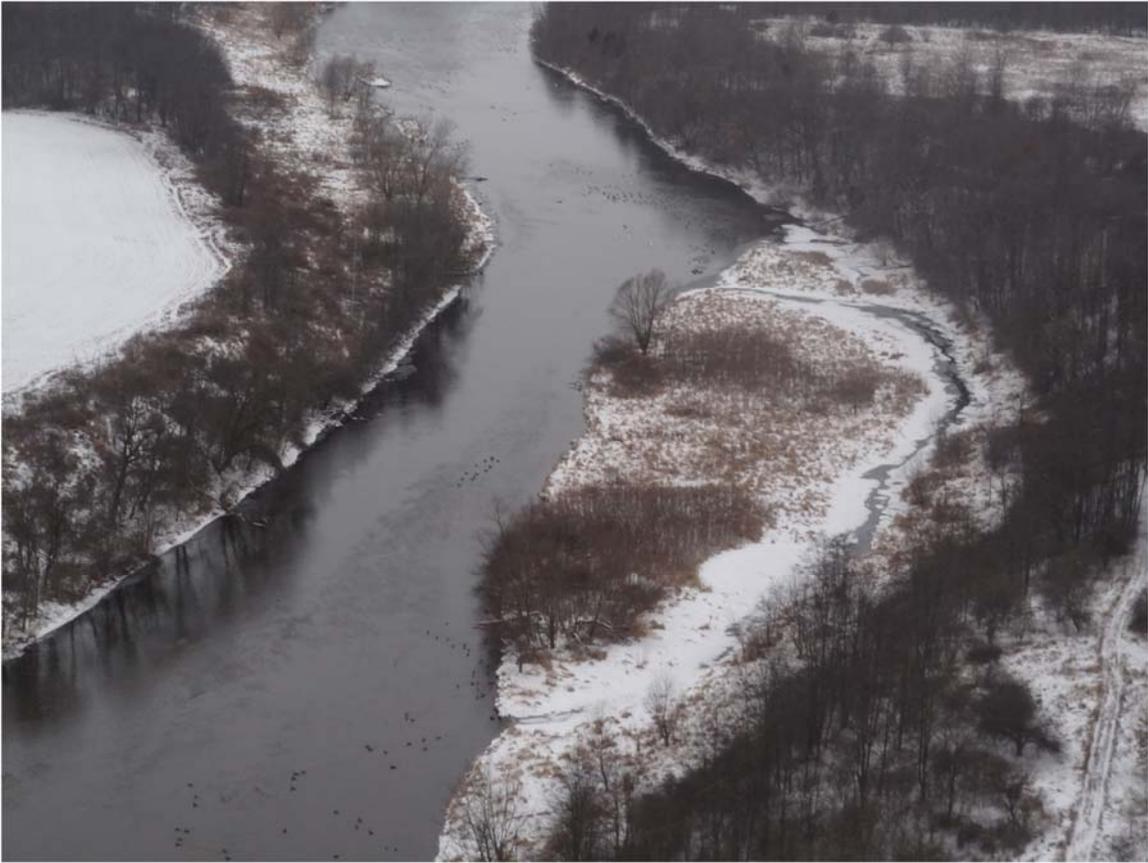
3. MP3.75 observed river icing conditions.

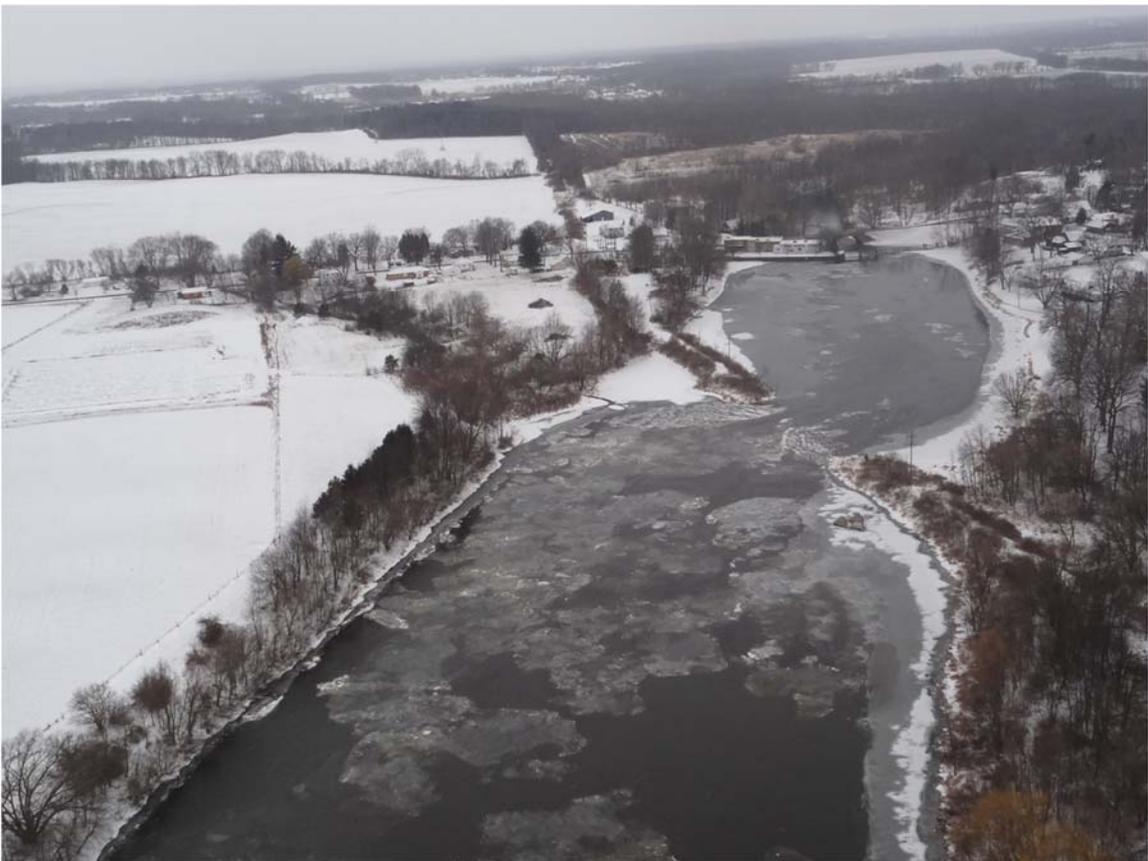
4. Ceresco Dam impoundment river icing conditions.

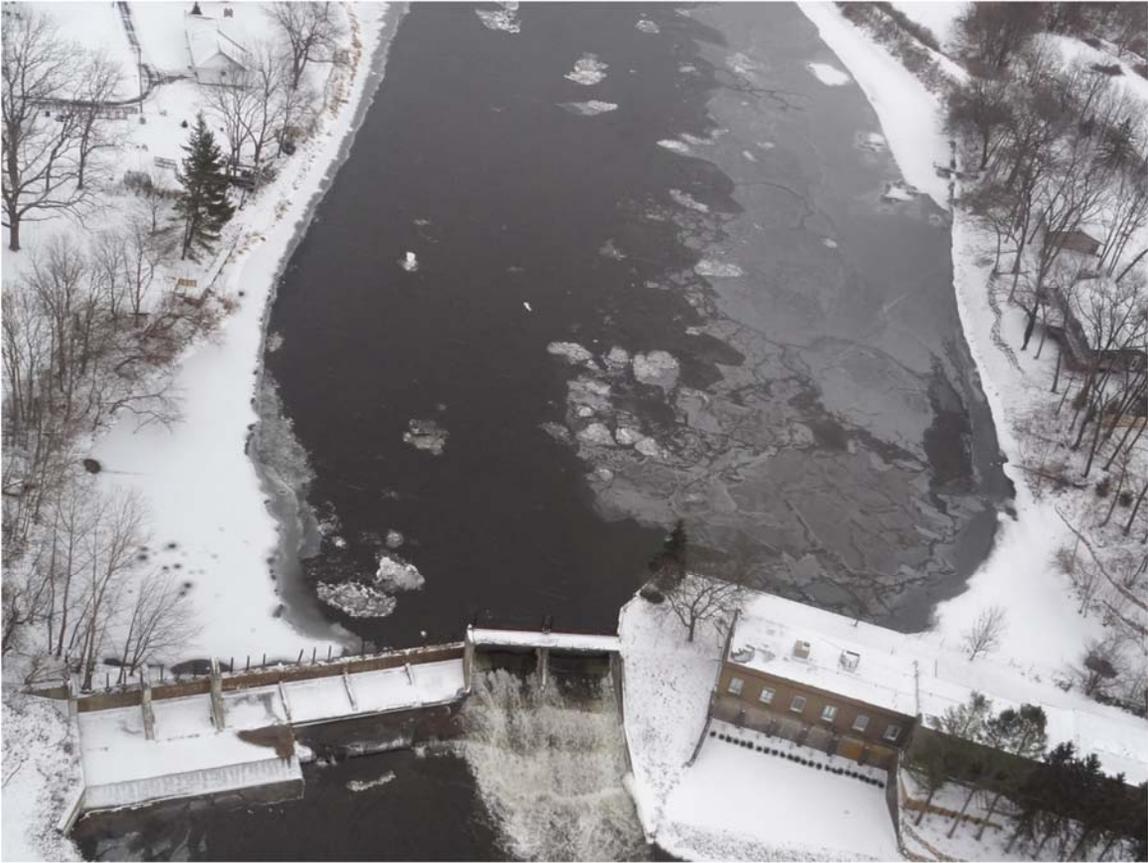
5. Ceresco Dam impoundment river icing conditions.

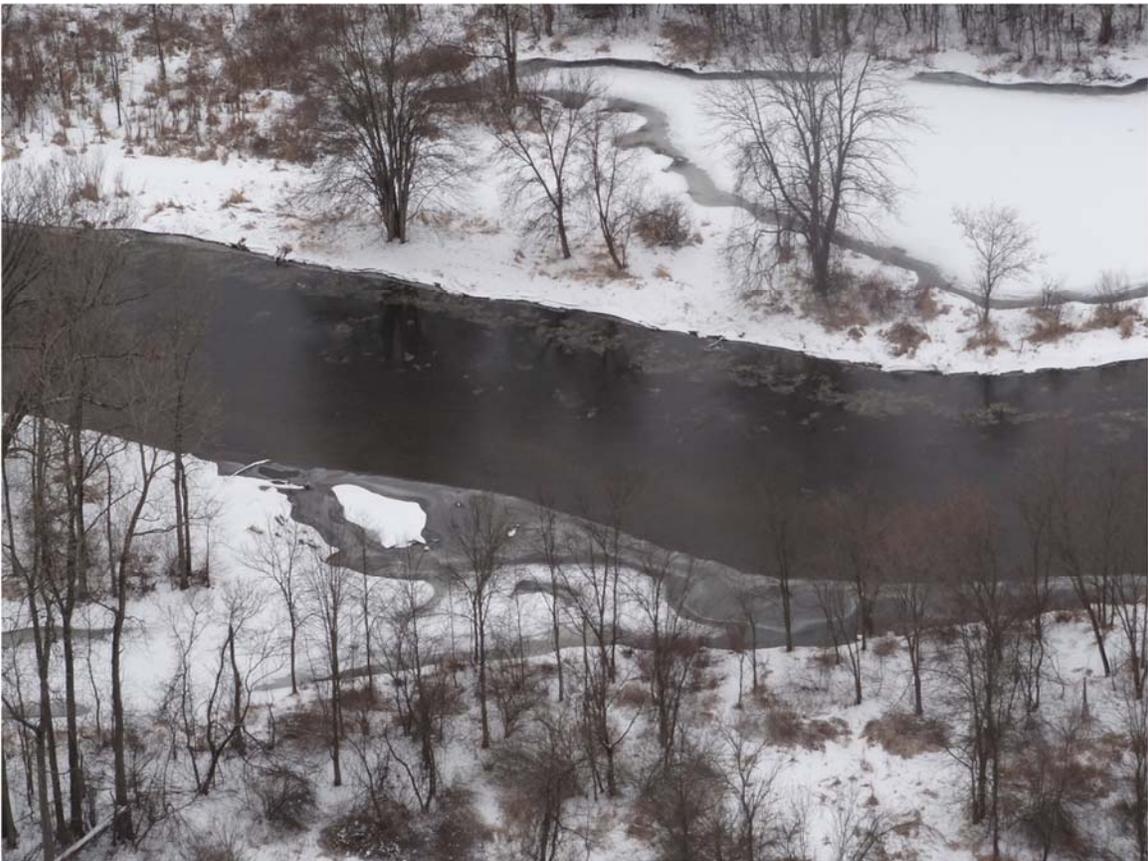
6. MP10.4 RDB Sediment trap ice conditions.

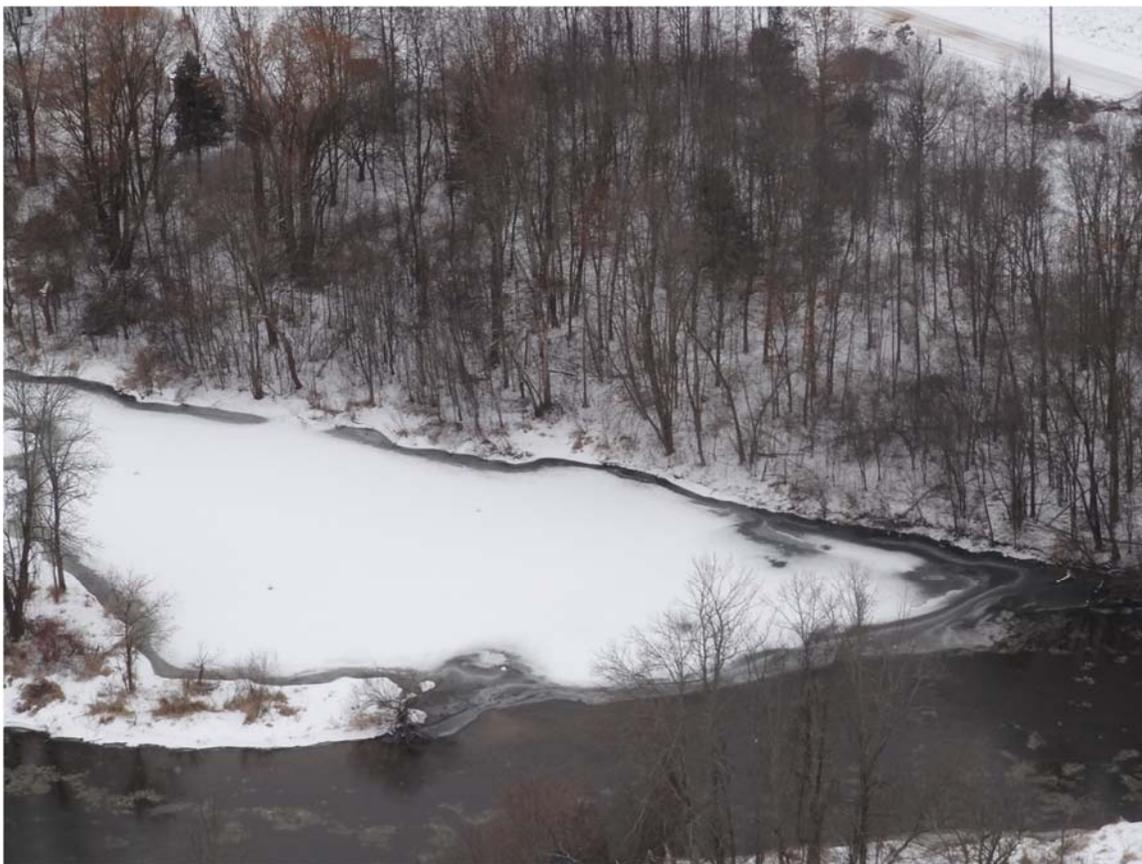
7. MP10.5 LDB Sediment trap ice conditions.

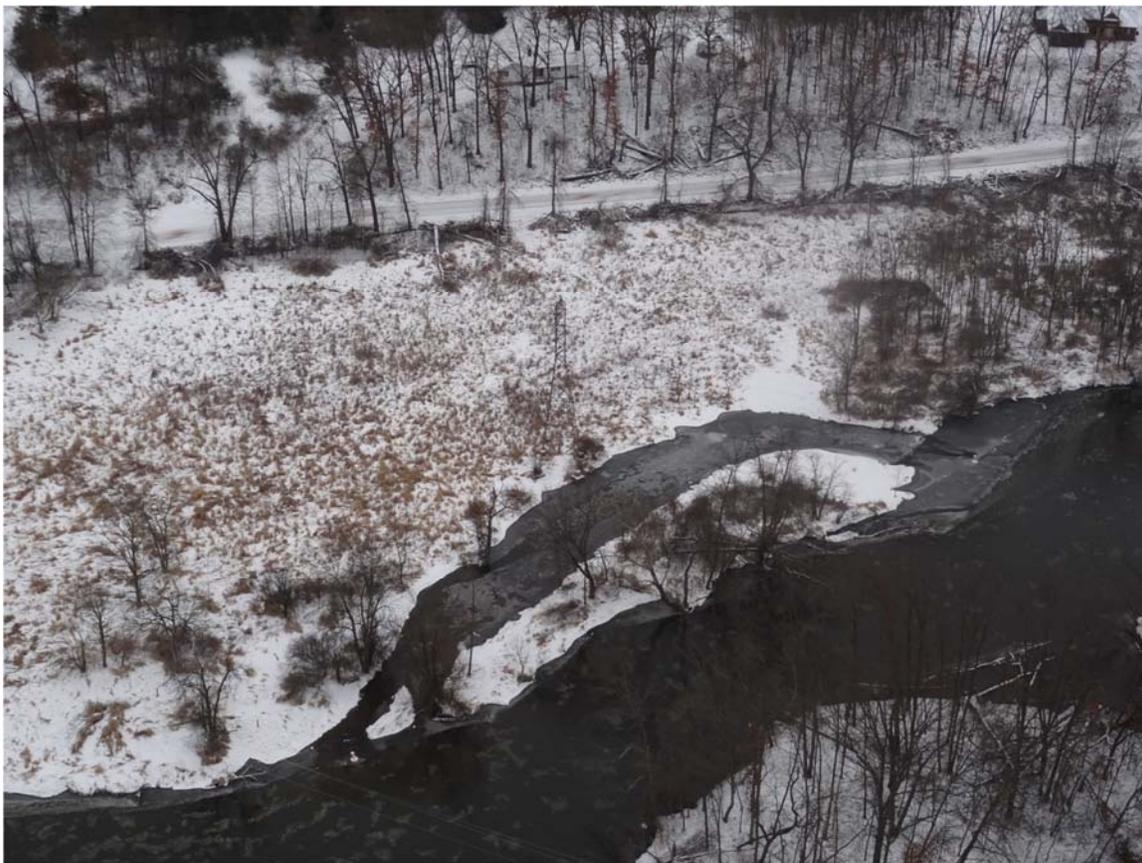
8. MP10.75 Sediment Trap river icing conditions observed.

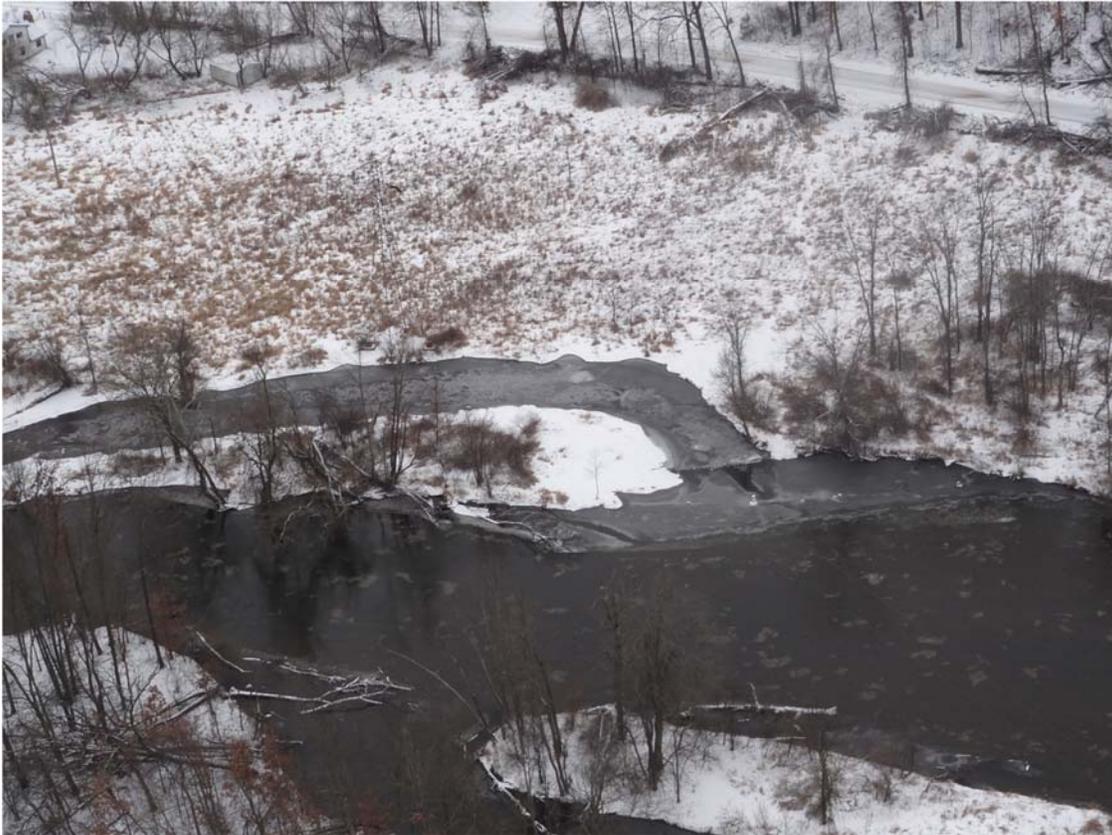
9. MP10.75 Sediment Trap river icing conditions observed.

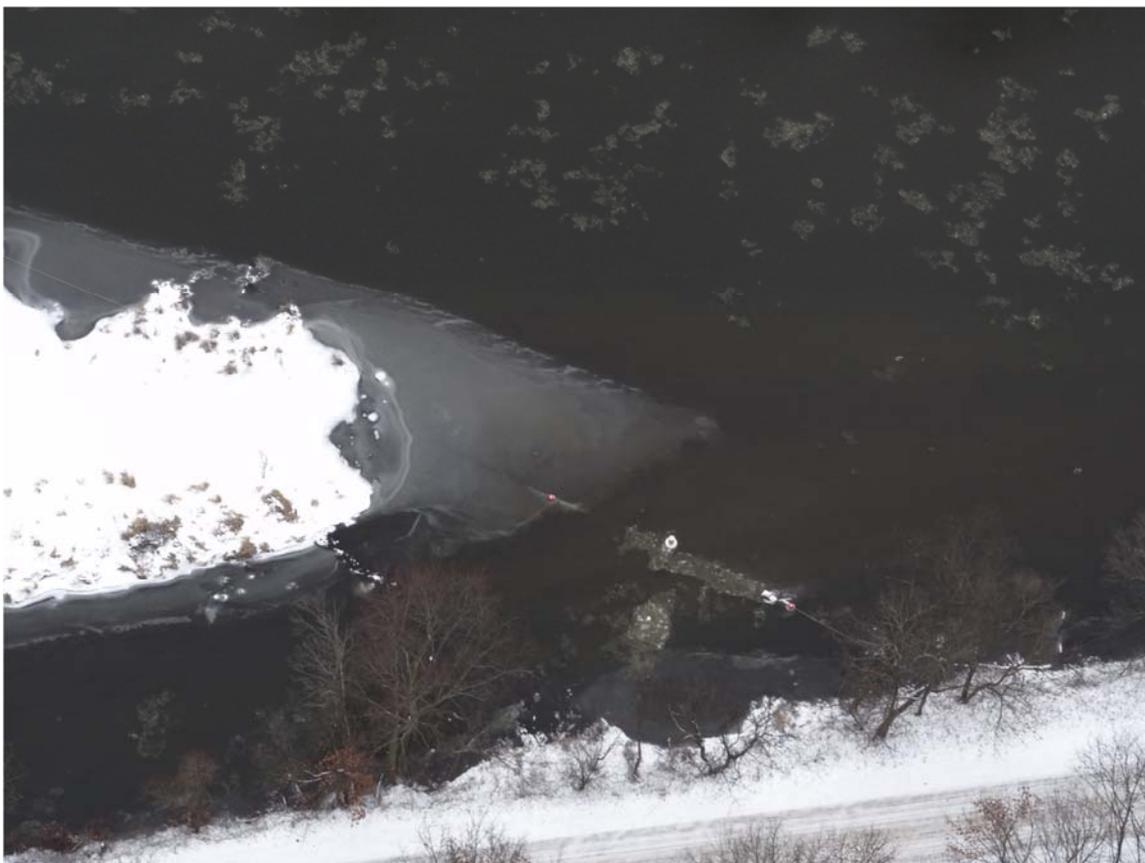
12. Downstream end of the MP14.75 Sediment trap river icing conditions.

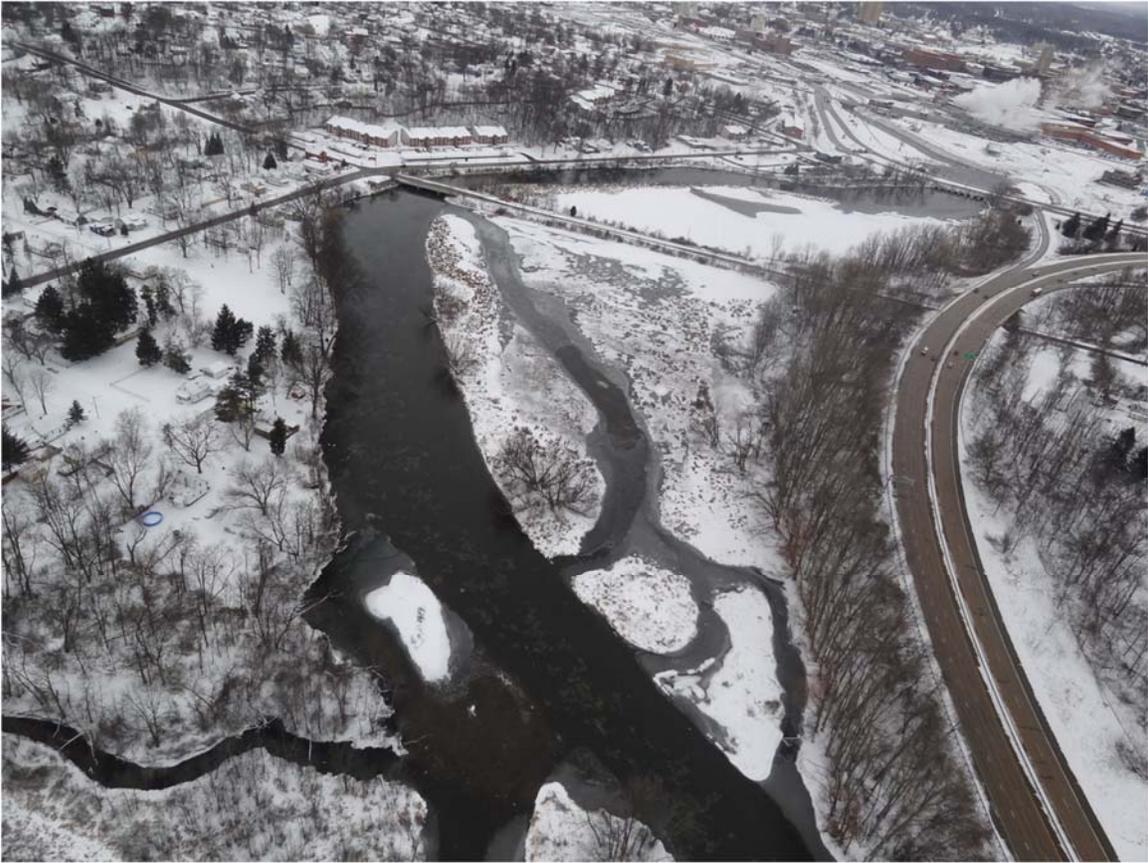
13. North and South Mill Pond river icing conditions.

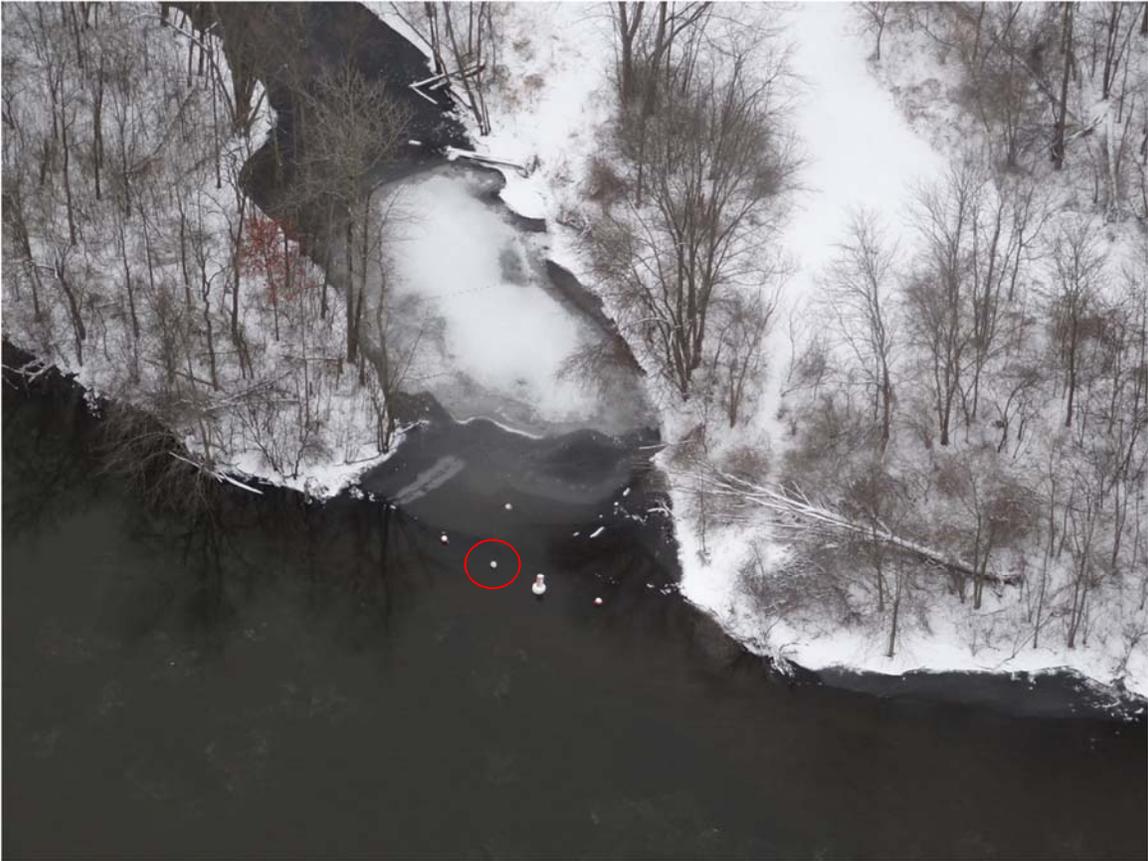
15. MP19.25 Downstream end of the sediment trap. CSD buoy and sampler have been repositioned.

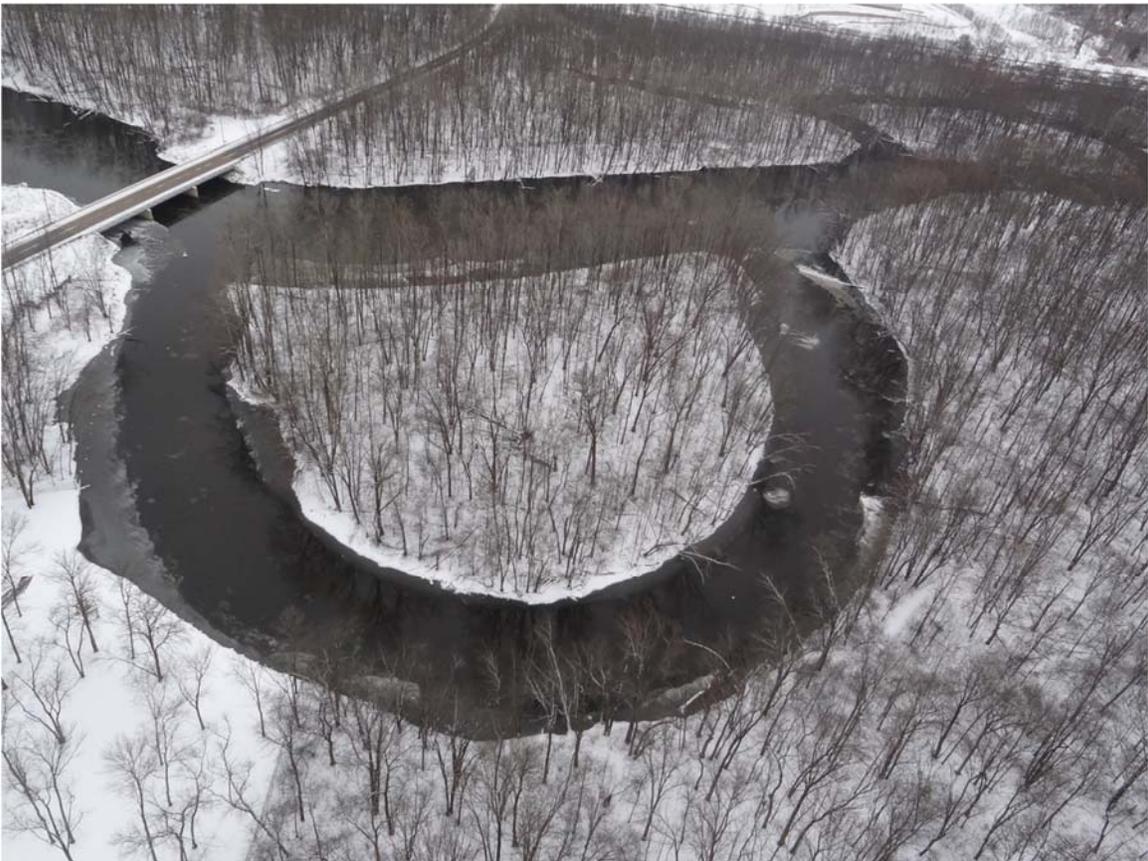
16. MP21.5 Sediment trap river icing conditions observed.

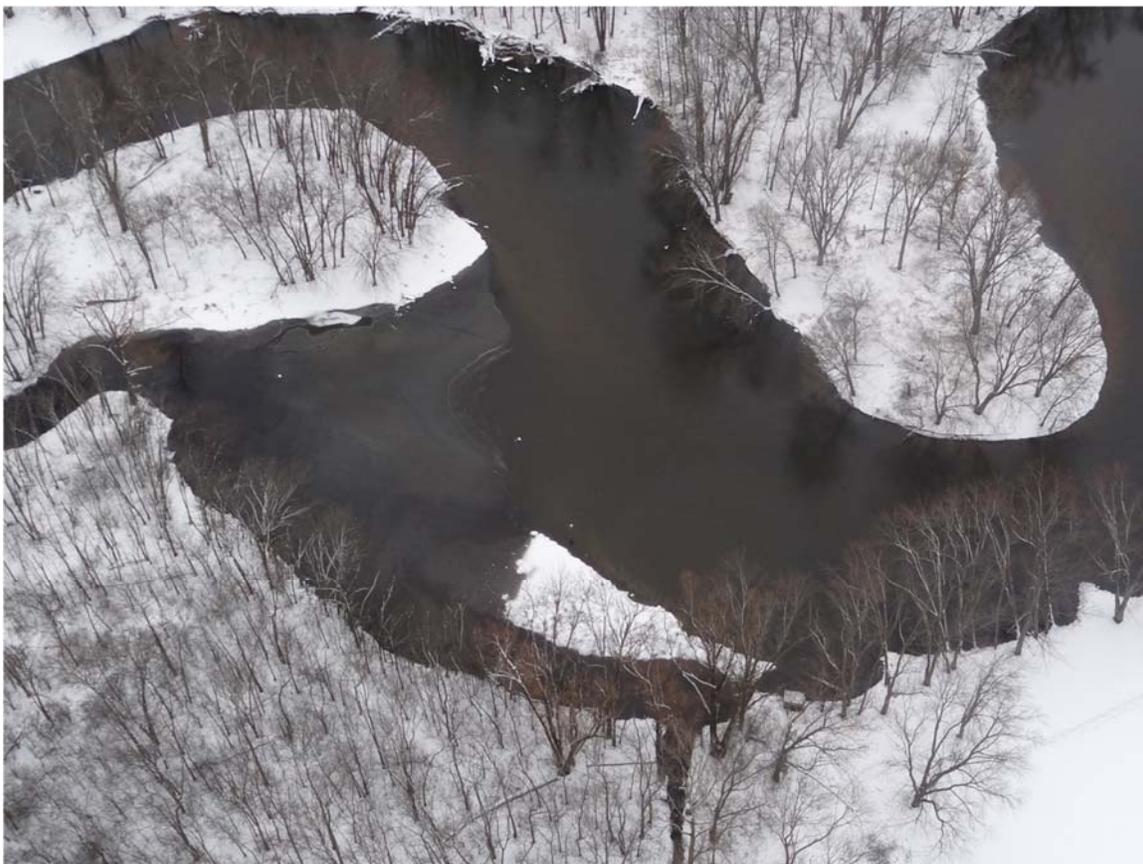
17. MP26.0 Sediment Trap river icing conditions observed.

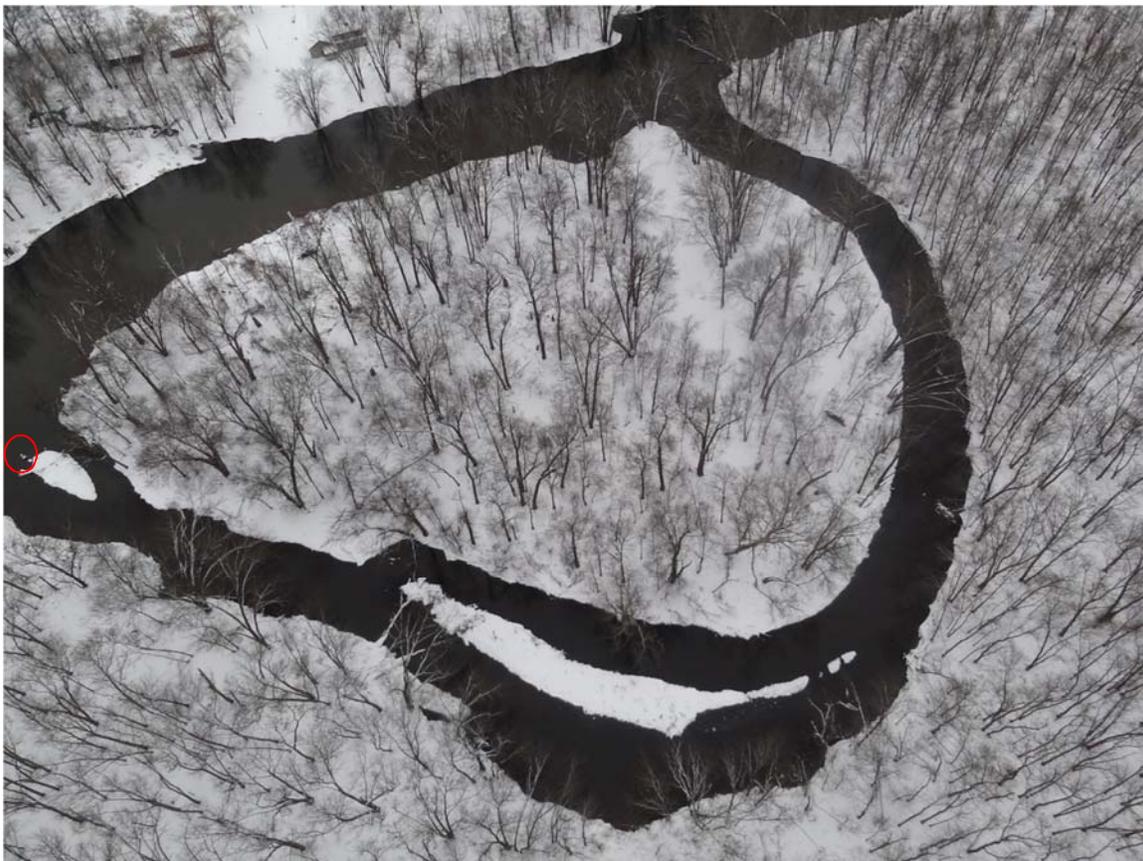
18. MP28.25 Sediment trap. The can buoy on the upstream end of the sediment trap has been repositioned.

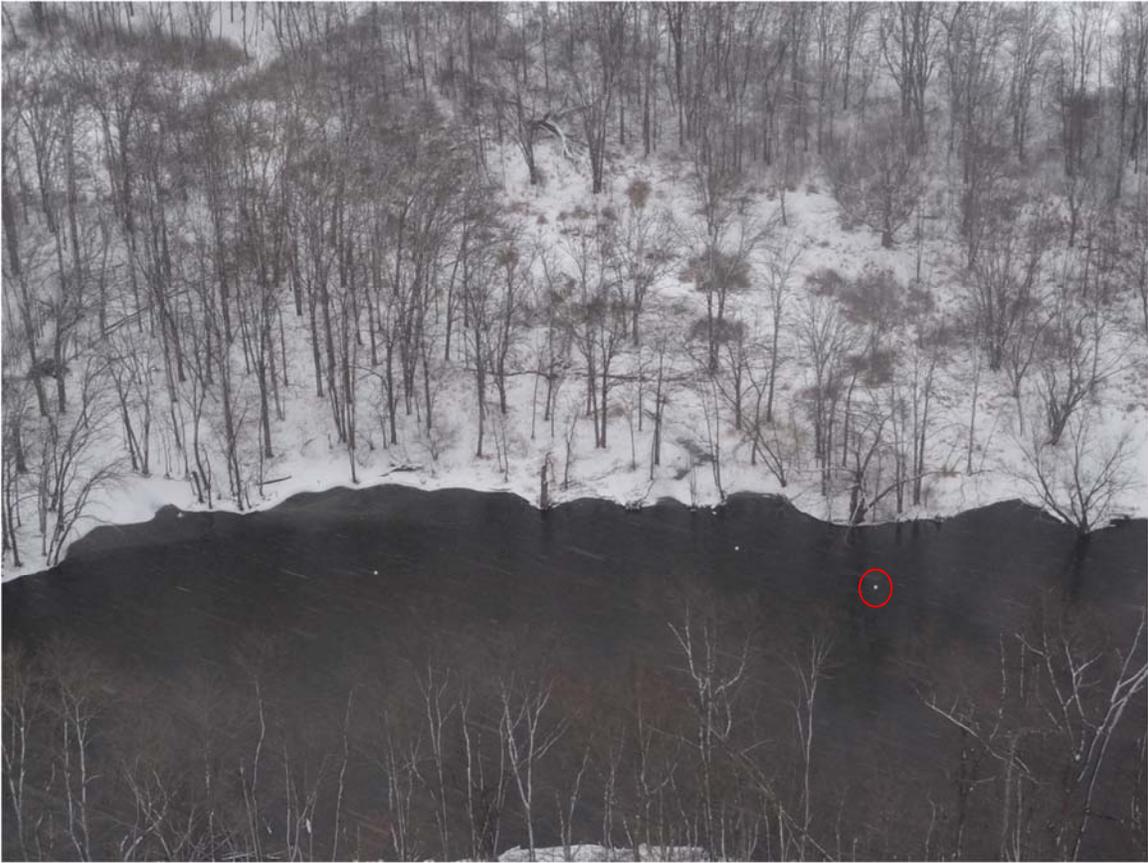
21. MP33.0 B Sediment trap. The CSD sampler and buoy has been repositioned to its original location.

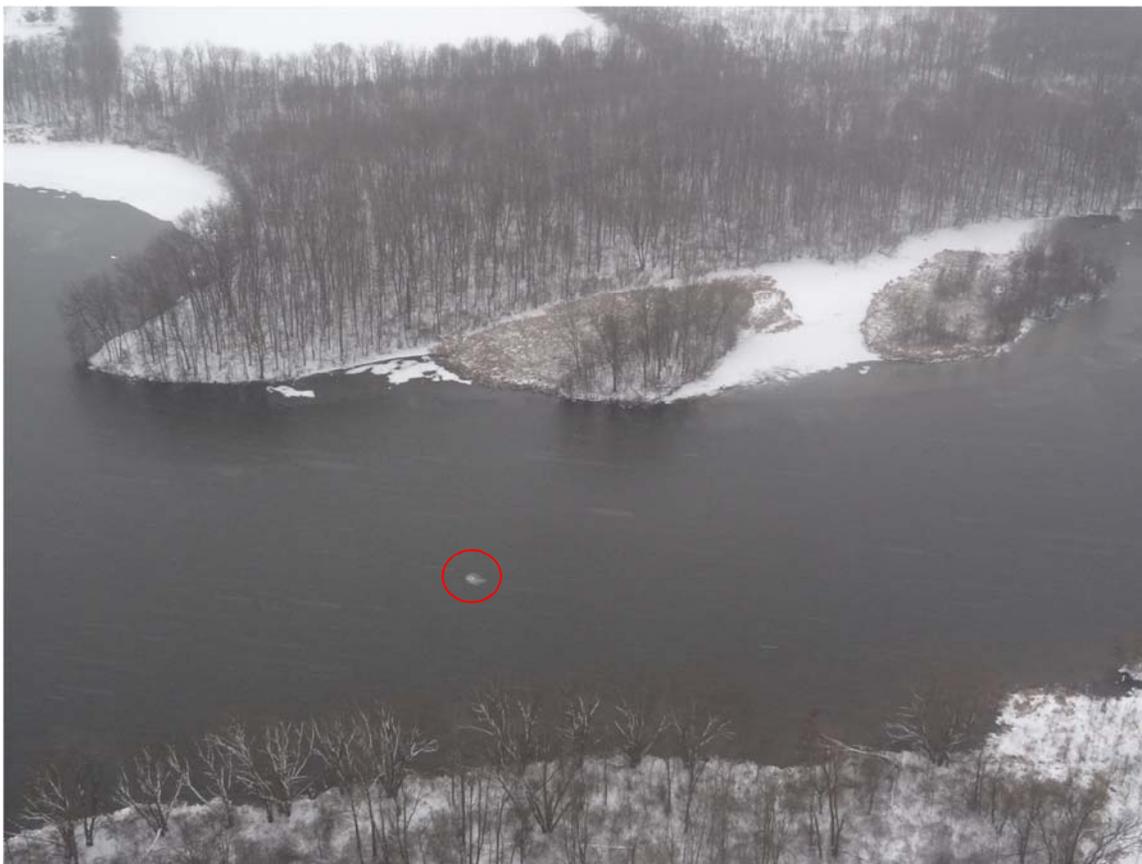
25. Morrow Lake Delta Neck observed the CSC buoy moving further into the neck towards the lake.

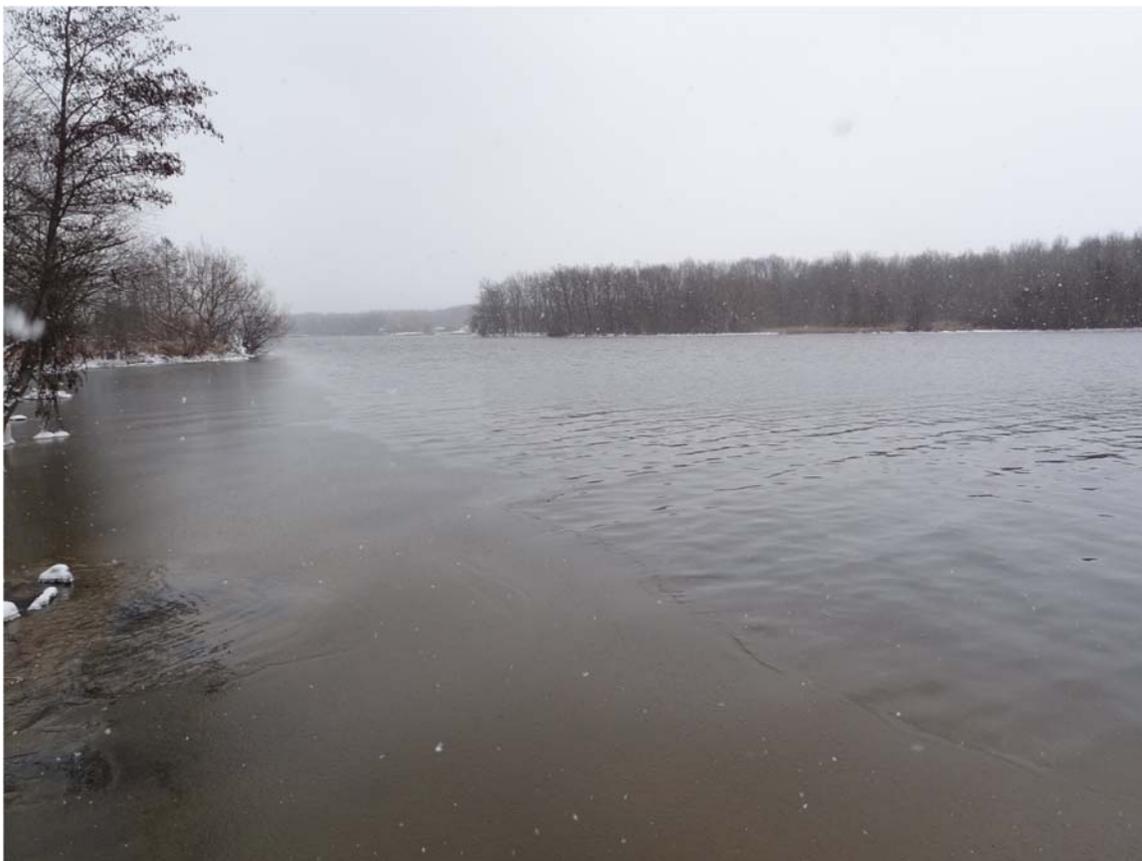
26. Morrow Lake Delta Neck buoy could not be located from the ground.

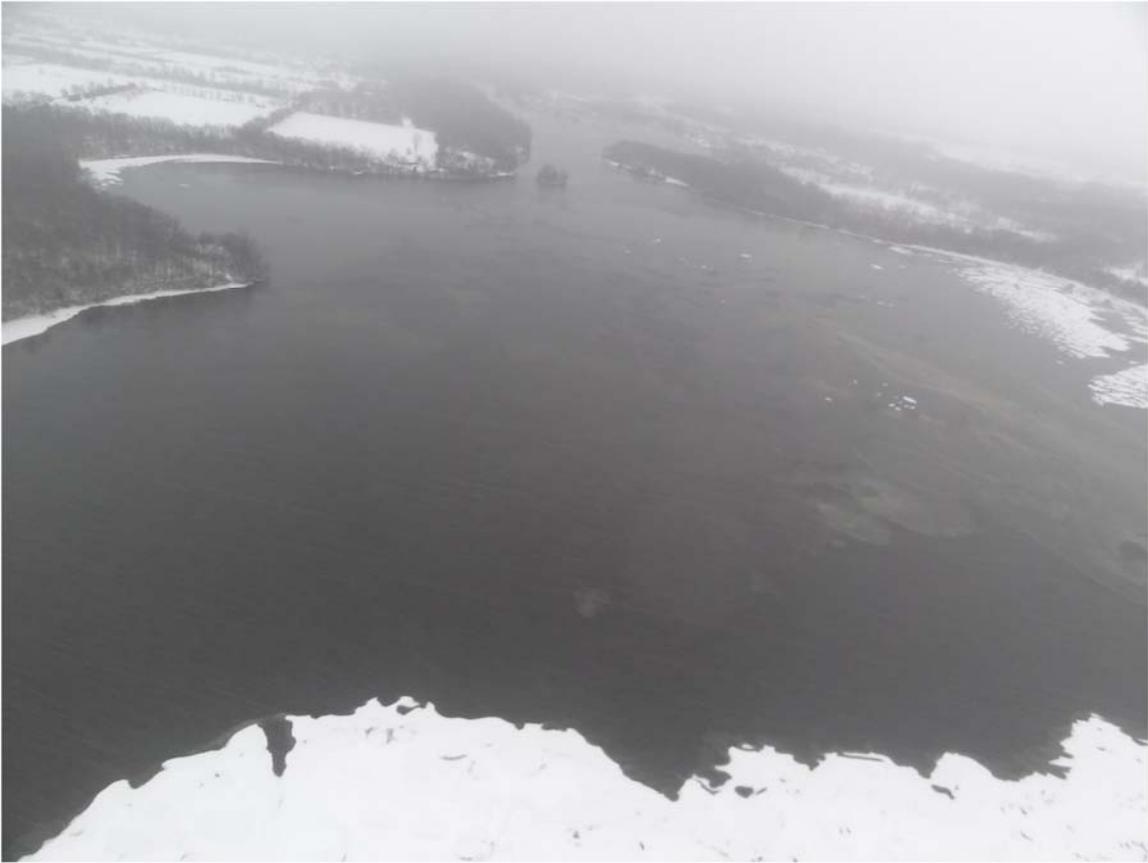
27. Morrow Lake icing conditions.

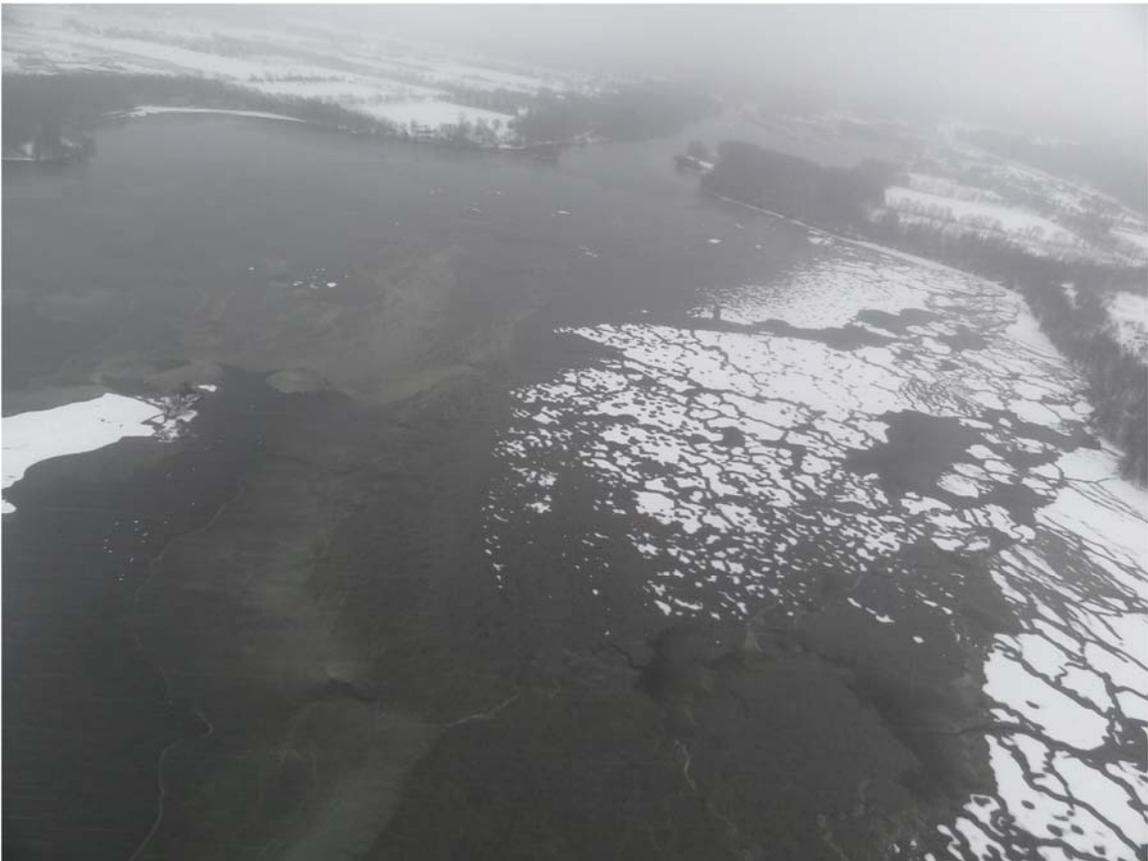
28. Morrow Lake icing conditions.
