U.S. ENVIRONMENTAL PROTECTION AGENCY
POLLUTION/SITUATION REPORT
Kalamazoo River/Enbridge Spill - Removal POLREP-SITREP

Subject: SITREP # 41
Kalamazoo River/Enbridge Spill
Z5JS
Marshall, MI
Latitude: 42.2395273 Longitude: -84.9662018

Date: 9/4/10

Reporting Period: 1900 hours 9/3/10 to 1900 hours 9/4/10

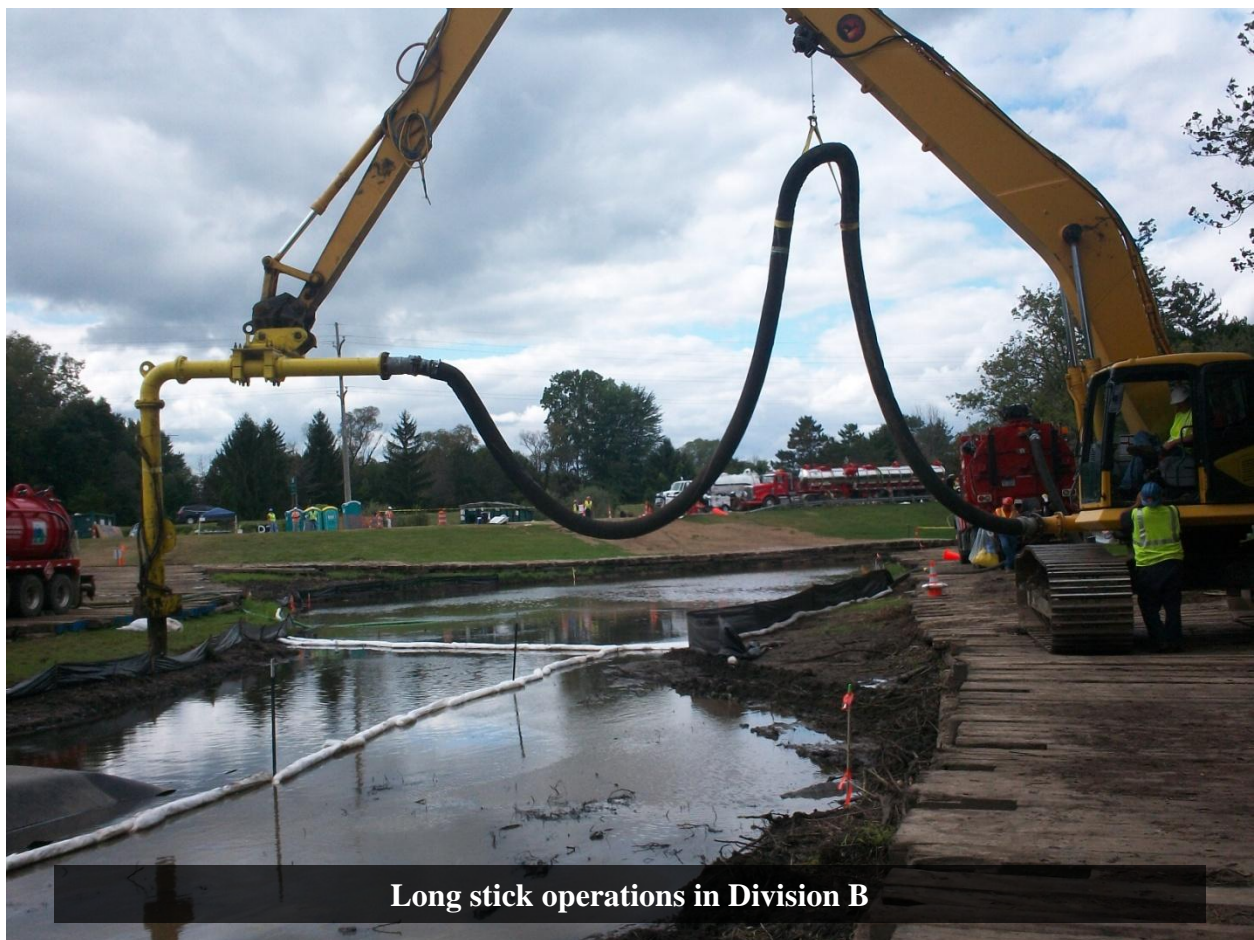
Long stick operations in Division B
