U.S. ENVIRONMENTAL PROTECTION AGENCY  
POLLUTION/SITUATION REPORT  
Kalamazoo River/Enbridge Spill - Removal POLREP-SITREP

**Subject:** SITREP # 42  
Kalamazoo River/Enbridge Spill  
Z5JS  
Marshall, MI  
Latitude: 42.2395273 Longitude: -84.9662018

**Date:** 9/5/10

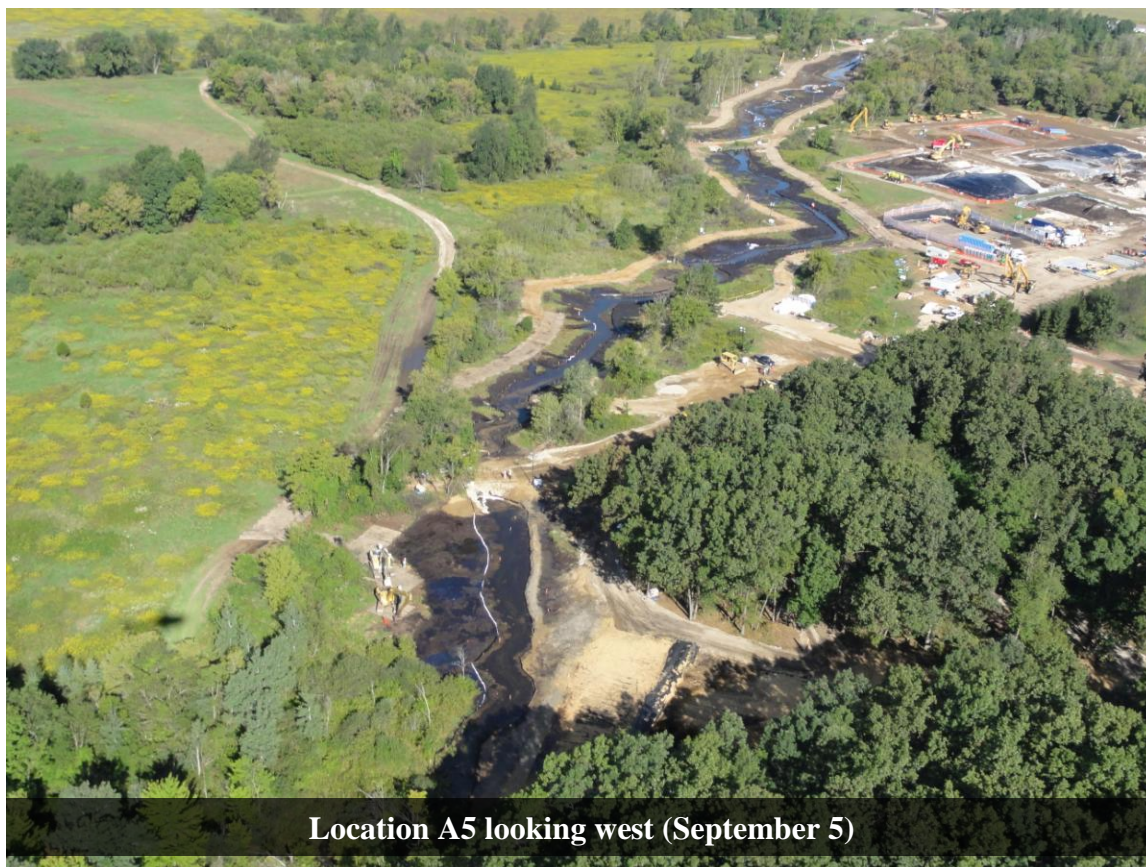
Location A5 looking west (September 5)

- Changes in sheen:
  - Absence of oil and sheen in Division A1 through A4.
  - Presence of sheen along southern shoreline of Talmadge Creek at Location A5.

- Some standing water was observed on the ground cover in Locations A1 through A4.
  - Heavy activity and significant equipment at Location A5.
  - Removal of bladder installed yesterday at Location A6.
