U.S. ENVIRONMENTAL PROTECTION AGENCY
POLLUTION/SITUATION REPORT
Kalamazoo River/Enbridge Spill - Removal POLREP-SITREP

Subject: **SITREP # 51**
 Kalamazoo River/Enbridge Spill
 Z5JS
 Marshall, MI
 Latitude: 42.2395273 Longitude: -84.9662018

Date: 9/15/10

Reporting Period: 1900 hours 9/13/10 to 1900 hours 9/14/10

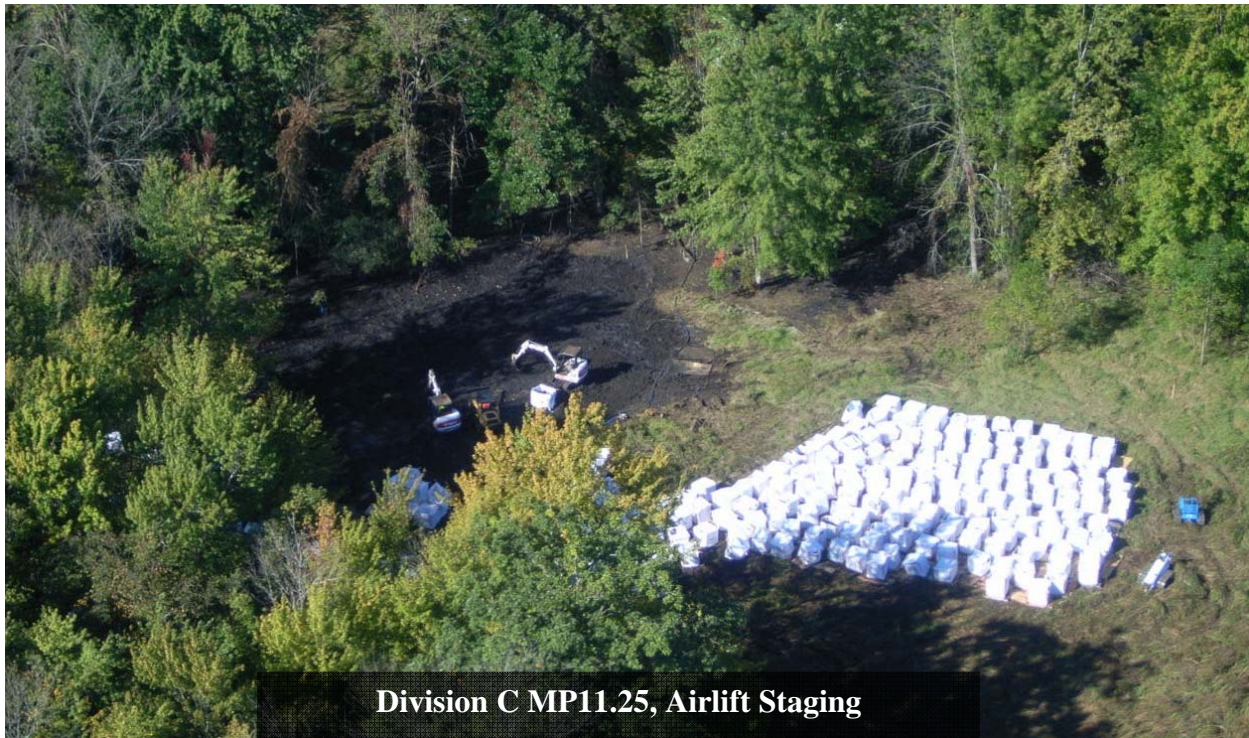
Division C MP11.25, Airlift Staging

- Observed the island at MP8.25 that has been cordoned off due to H&S concerns. No changes or activity noted.
 - Peninsula MP11.25 excavation continues. Super sacks are being staged and ready for airlifting off the peninsula.
