**GROUNDWATER CONTAMINATION AND SINKHOLE COLLAPSE
INDUCED BY LEAKY IMPOUNDMENTS
IN SOLUBLE ROCK TERRAIN**

By Thomas J. Aley
James H. Williams
James W. Massello

1972

MISSOURI GEOLOGICAL SURVEY AND WATER RESOURCES

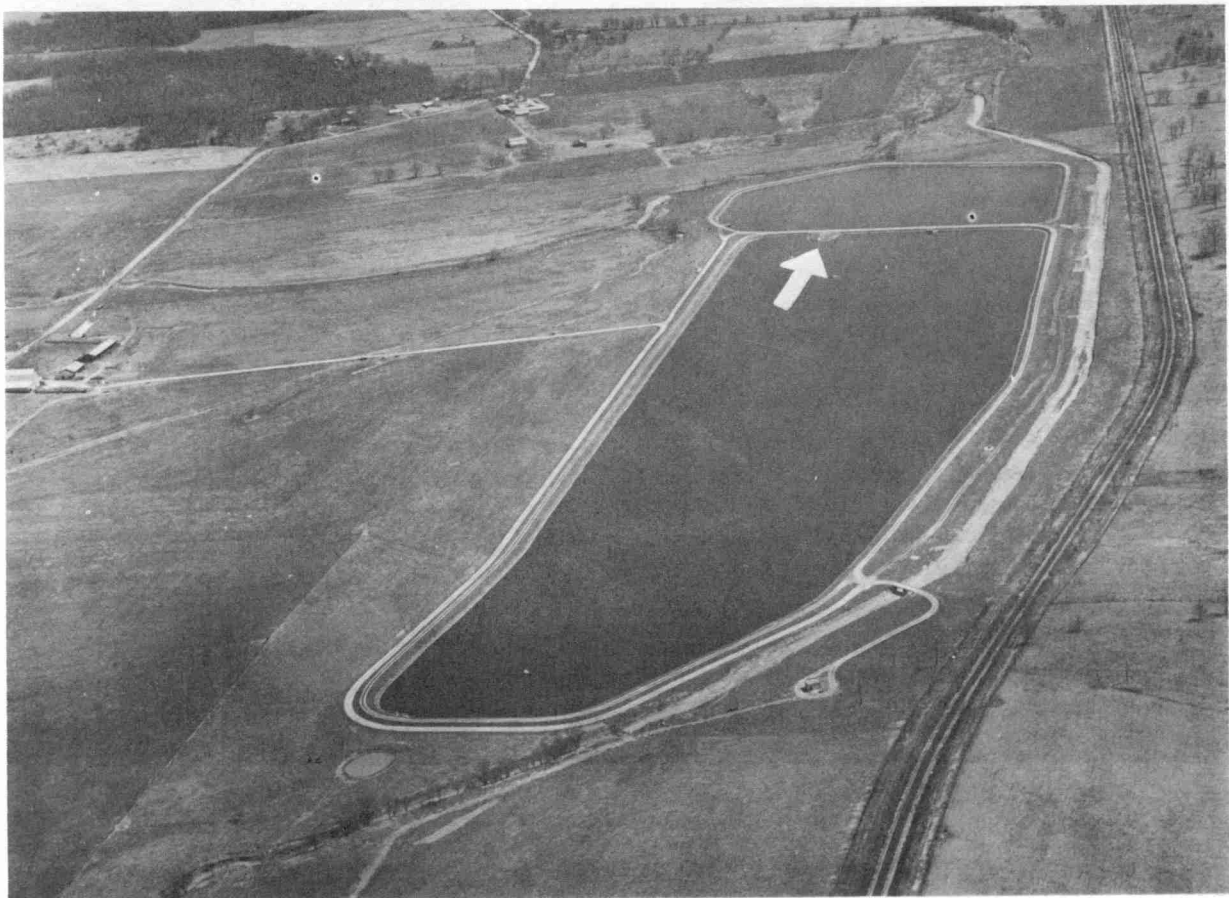
Figure 2

Collapse within sewage lagoons has also occurred at West Plains, Howell County, Missouri (fig. 2). The

Aerial view of the West Plains sewage lagoon as it appeared in 1971. The area which collapsed in 1966 is shown by the arrow. Photo by Jerry D. Vineyard.

The lagoon system was constructed in 1964 and reached full operation in 1966. The smaller cell, which occupies about seven acres, collapsed in two points in 1964. The larger of these collapses was about 17 feet in diameter and probably 10 to 20 feet deep; the sinks were plugged with cement, clay, and bentonite and reportedly no longer leak.

about 136 acre-feet of effluent at the time of collapse; all the water drained out within 52 hours. Mr. Pace, City of West Plains, reports that the collapse and leakage created a vortex of such size that he was unwilling to get close to it with a boat. This is hardly surprising; the average leakage rate for the 52 hours was 29 cubic feet per second.

The 1966 collapse at the West Plains lagoon was about 34 feet in diameter, and probably 10 to 20 feet deep. This hole was filled with clay and bentonite to the level of the dike wall and the lagoon was returned to use. Mr. Renfrow, formerly Assistant City Engineer of West Plains, reported that he walked about 4 miles of the Howell Creek channel below the lagoon collapse, but found no evidence of lagoon water. There were no reports of well contamination

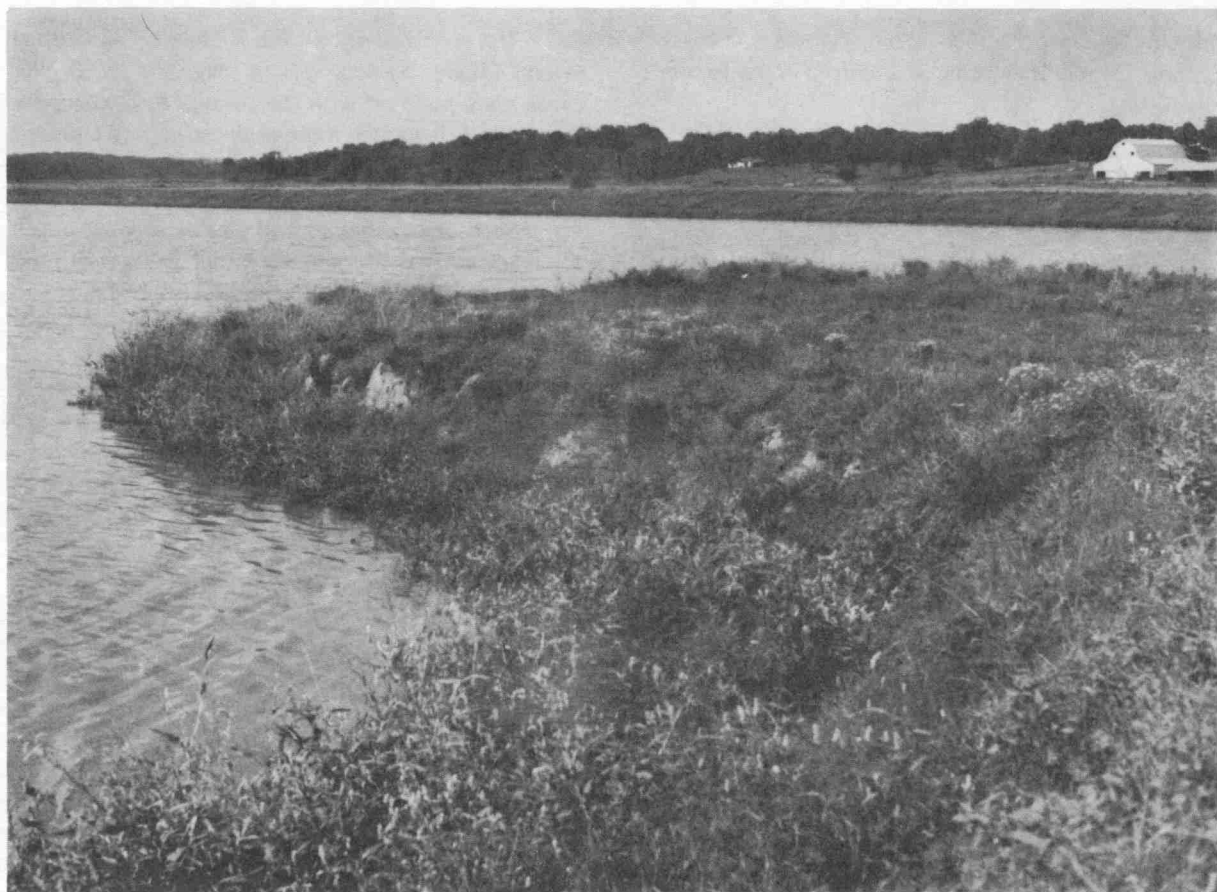
Figure 3

The large cell of the West Plains sewage lagoon. A catastrophic sink occurred in 1966 beneath the peninsula shown in the foreground. Subsequent to the collapse the sink was filled with clay and bentonite and the lagoon was returned to use. Photo by James W. Massello.

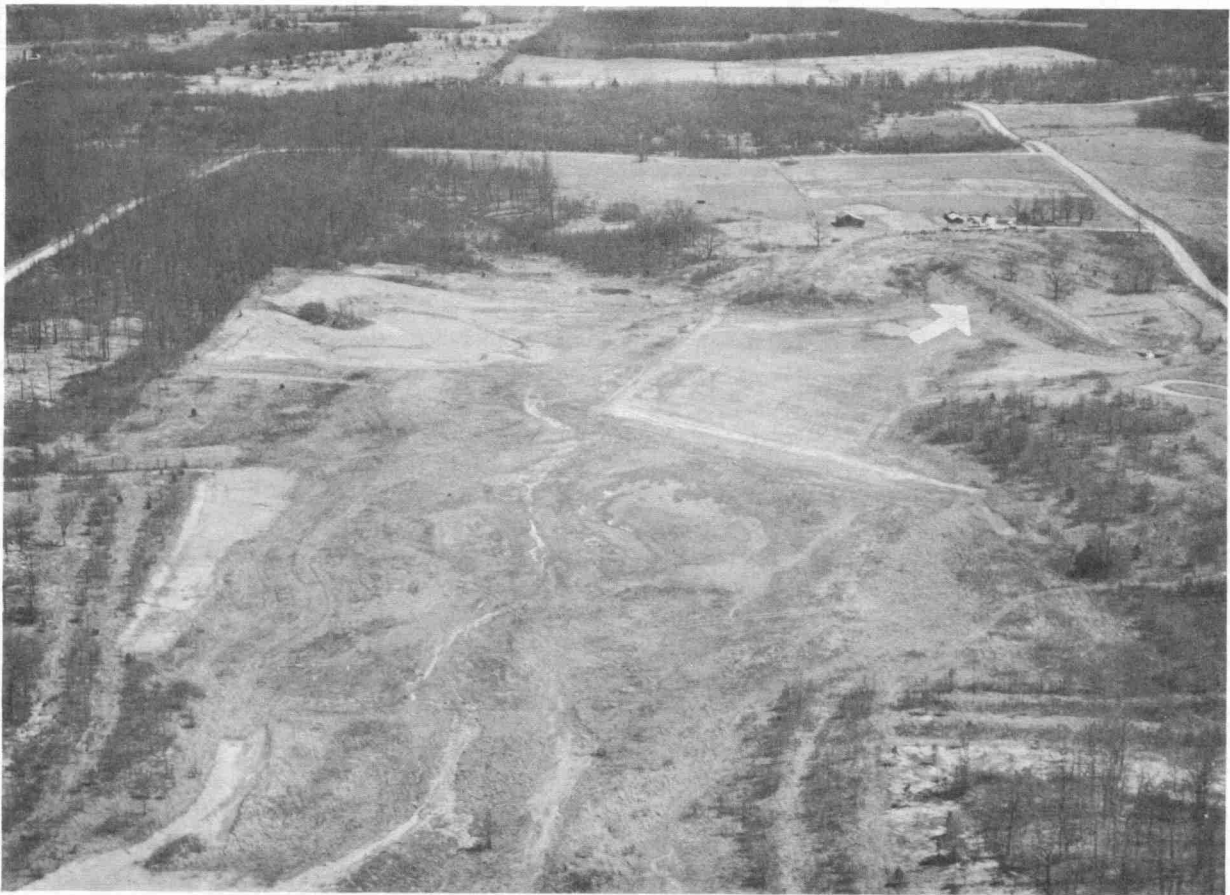
Figure 4

impoundment held a substantial volume of water. Unfortunately, a sinkhole suddenly formed in the floor of the impoundment and drained all the water from the reservoir. Substantial efforts were made to stop the leakage, but they have failed. Personnel of the Missouri Geological Survey report seeing flows of 10 cubic feet per second disappearing underground within the impoundment area.

Aerial view of a portion of the planned impoundment area of the Dean W. Davis Reservoir near Pomona. The arrow indicates the dam. A catastrophic sink formed within 75 yards of the dam and totally drained the impoundment overnight. Extensive attempts to seal the impoundment were unsuccessful. Photo by Jerry D. Vineyard.

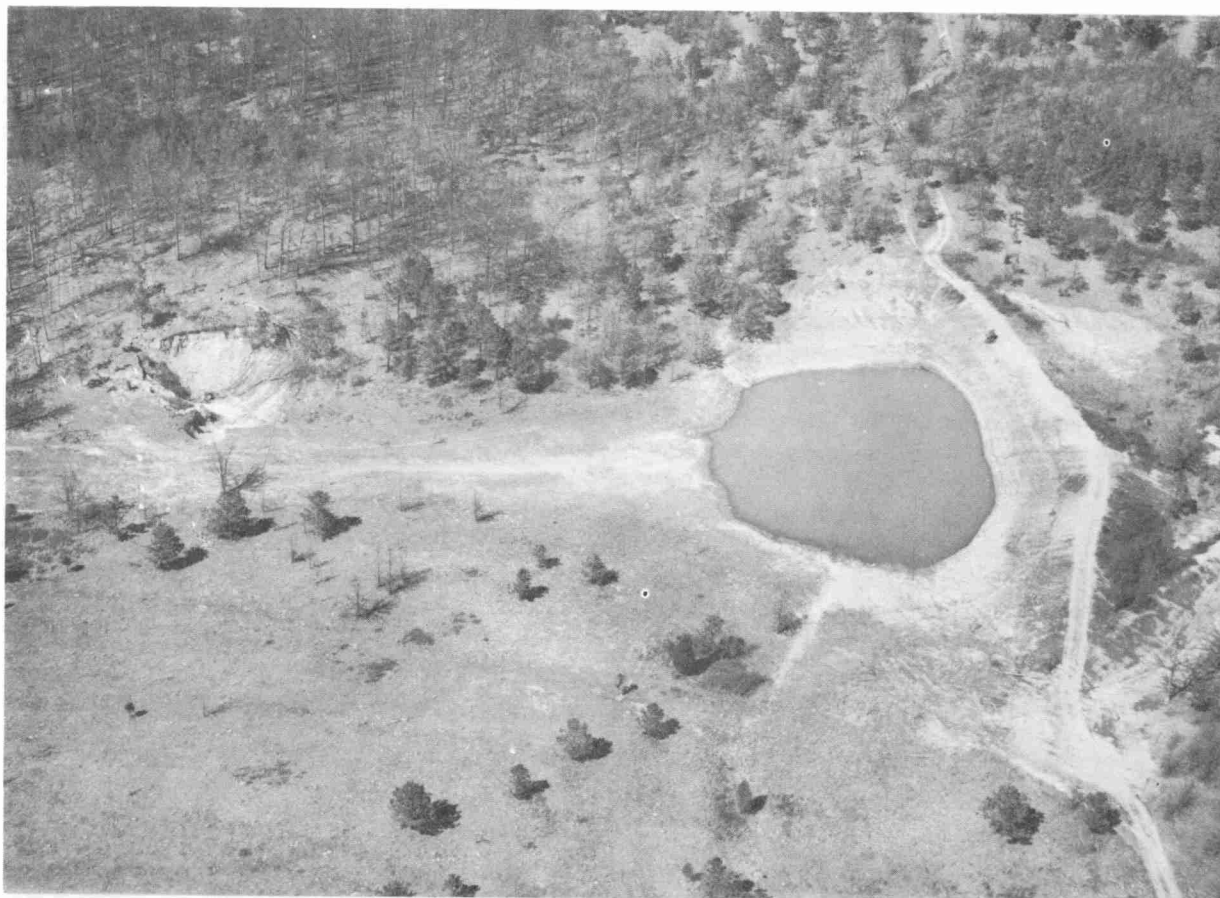
Figure 5

A most spectacular group of collapses induced by construction of an impoundment is found at Norton Dam, 2 miles south of Winona in Sec. 30, T. 27 N., R. 3 W., Shannon County, Missouri (fig. 5). The dam was built on an intermittent stream tributary to Pike Creek. The impoundment site is underlain by deep Roubidoux residuum; there are no bedrock exposures near the impoundment site.

The Norton Dam has been unsuccessful in producing a permanent lake. During storm periods the impoundment will temporarily fill, but the water level falls rapidly to about the original stream

Aerial view of Norton Dam and a portion of the impoundment area. The largest of the four catastrophic sinkholes induced by this impoundment is shown above, in the left-center of the photo. The other three sinkholes lie upstream of the area pictured. Photo by Jerry D. Vineyard.

We are convinced that the Norton impoundment led to the formation of the sinks. The dam has had four effects on water regimens in the valley. The first effect has been to spread flood water over the entire valley floor. The second effect, since the impoundment site leaks, is to induce recharge of groundwater from the impoundment area. This recharge tends to be localized in the more permeable areas, which in turn tends to move fine materials into underlying solution channels and voids. The third effect of the dam has been to make the residuum in

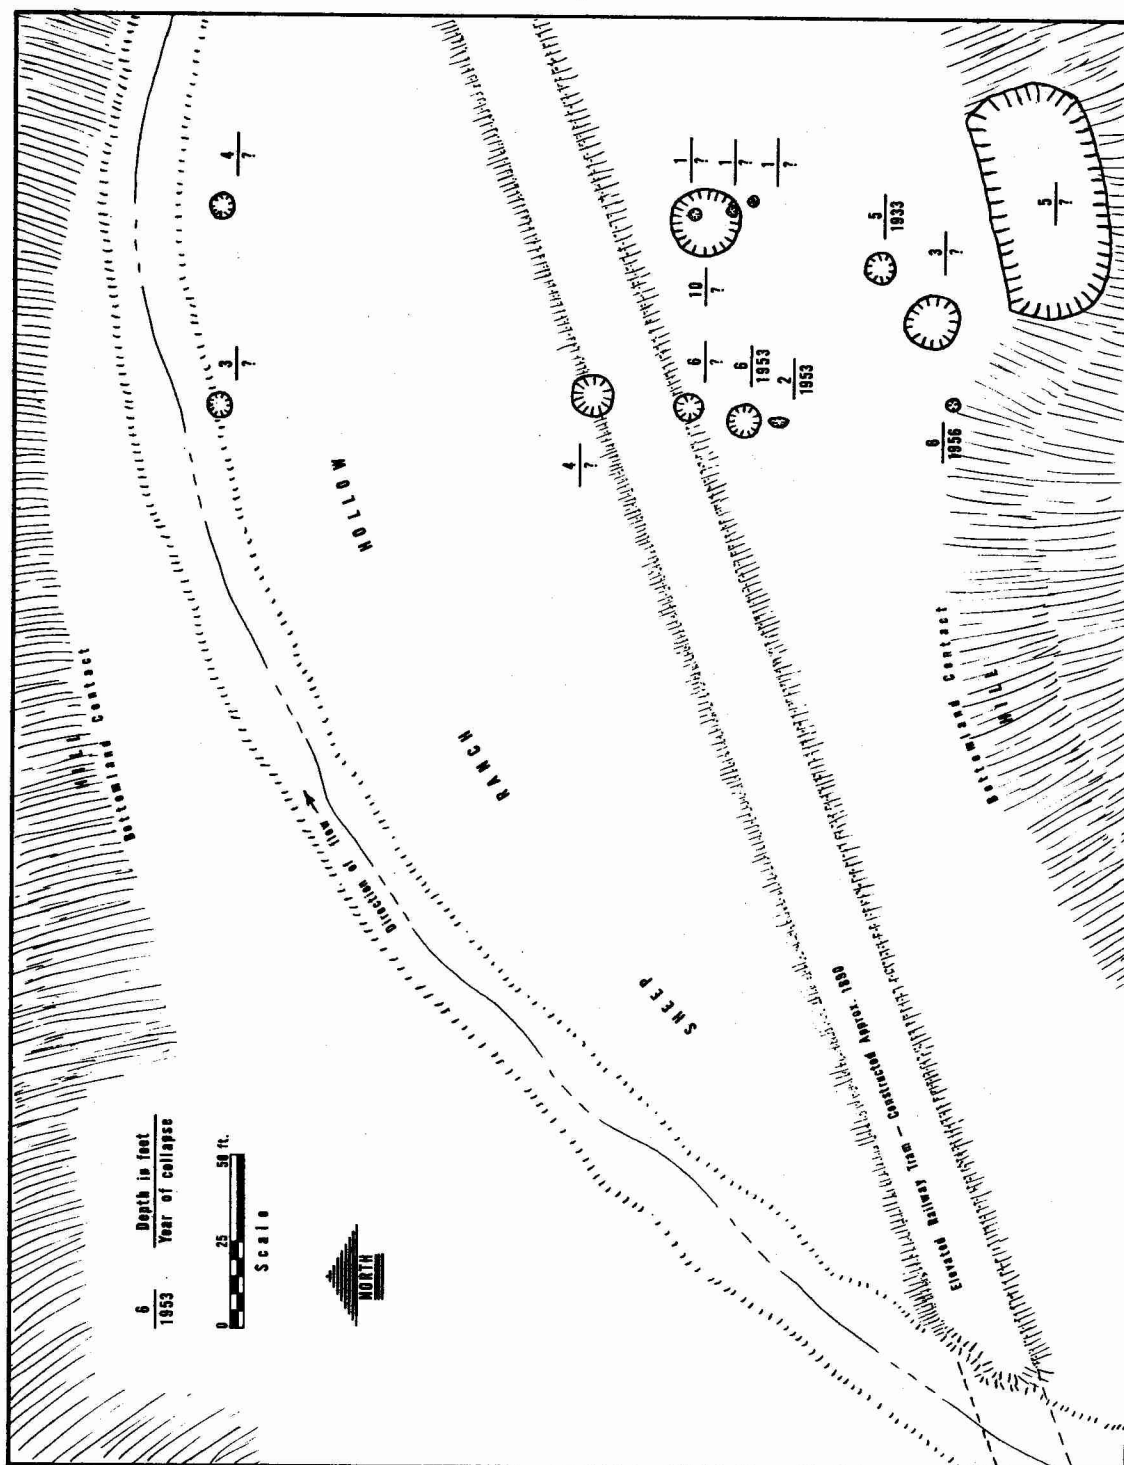
Figure 6

The catastrophic sinkhole collapses which have occurred in Sheep Ranch Hollow (fig. 6) provide an

Sinkhole collapses in Sheep Ranch Hollow induced by construction of a logging tramway in about 1890. Sinkhole sizes were measured in January 1971. (Illustration courtesy of Mark Twain National Forest)

The sinks are found in two clusters within a ten-acre area. The illustration (fig. 6) shows only the downstream cluster consisting of 13 sinks of recent origin. The upstream cluster includes five recent sinks. Not all of the sinks formed immediately after construction of the tramway. One formed in 1933, two

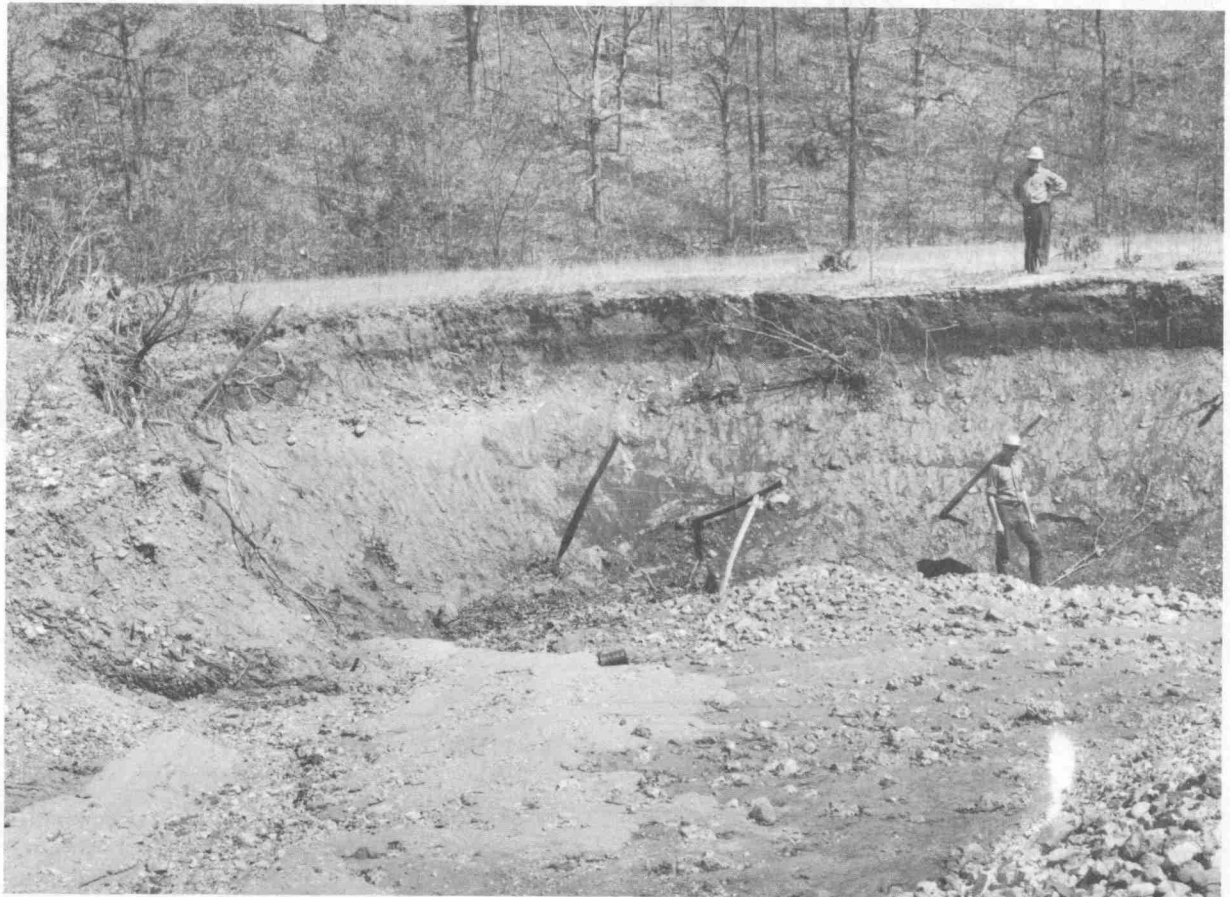
Figure 8

The sink was visited about two weeks after it formed, and at that time it was about 25 feet in diameter, 60 feet deep, and nearly cylindrical in shape. By 1968 (fig. 8) stream gravels had nearly filled the sink; in a few years most, if not all, of the topographic expression of the sink will have disappeared.

Sycamore Creek Sink two years after its formation. The sinkhole has been nearly filled with sand and gravel transported by Sycamore Creek. Photo by James W. Massello.

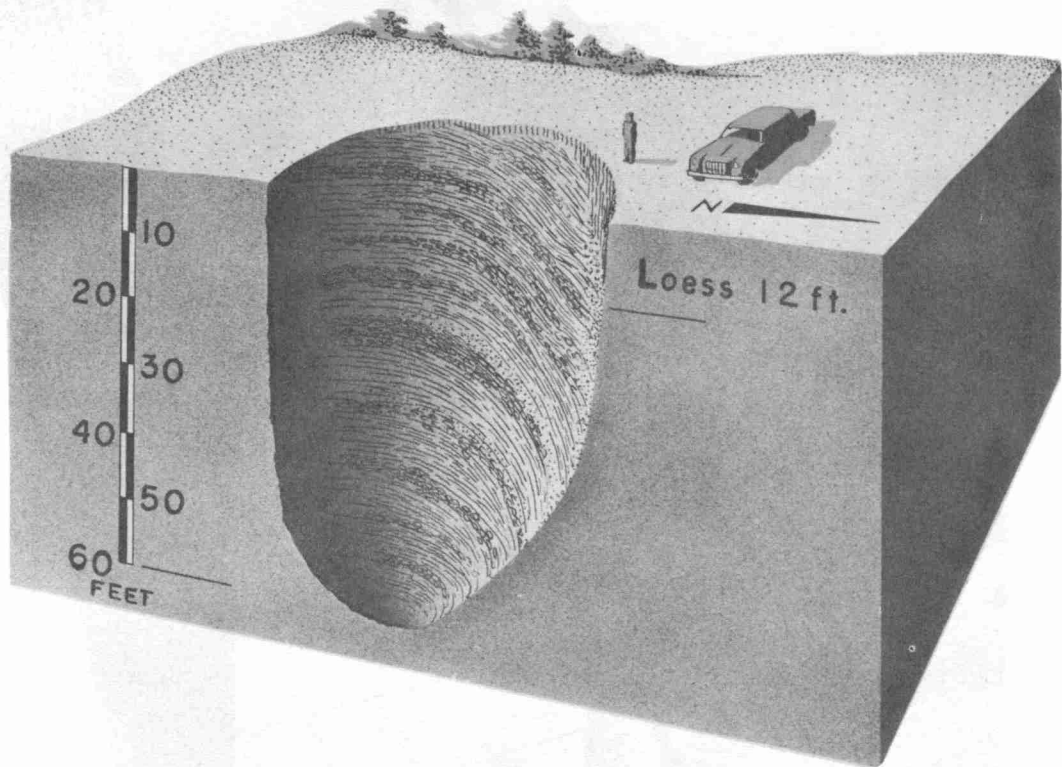
Figure 9

When the sink was first visited on April 10, 1964 it was 42 feet in diameter and 60 to 65 feet deep. The sink was cylindrical and had 10 to 15 feet

of water in the bottom (fig. 9). Vineyard and Williams (1964) suggested that the sinkhole collapse may have been triggered by the Alaskan earthquake of March 27, 1964.

Block diagram of a collapse sink that formed near Lebanon, Mo. contemporaneously with the Alaskan earthquake in March 1964. Apparent bedding is in residuum of the Roubidoux Formation. Drawing by Douglas R. Stark.

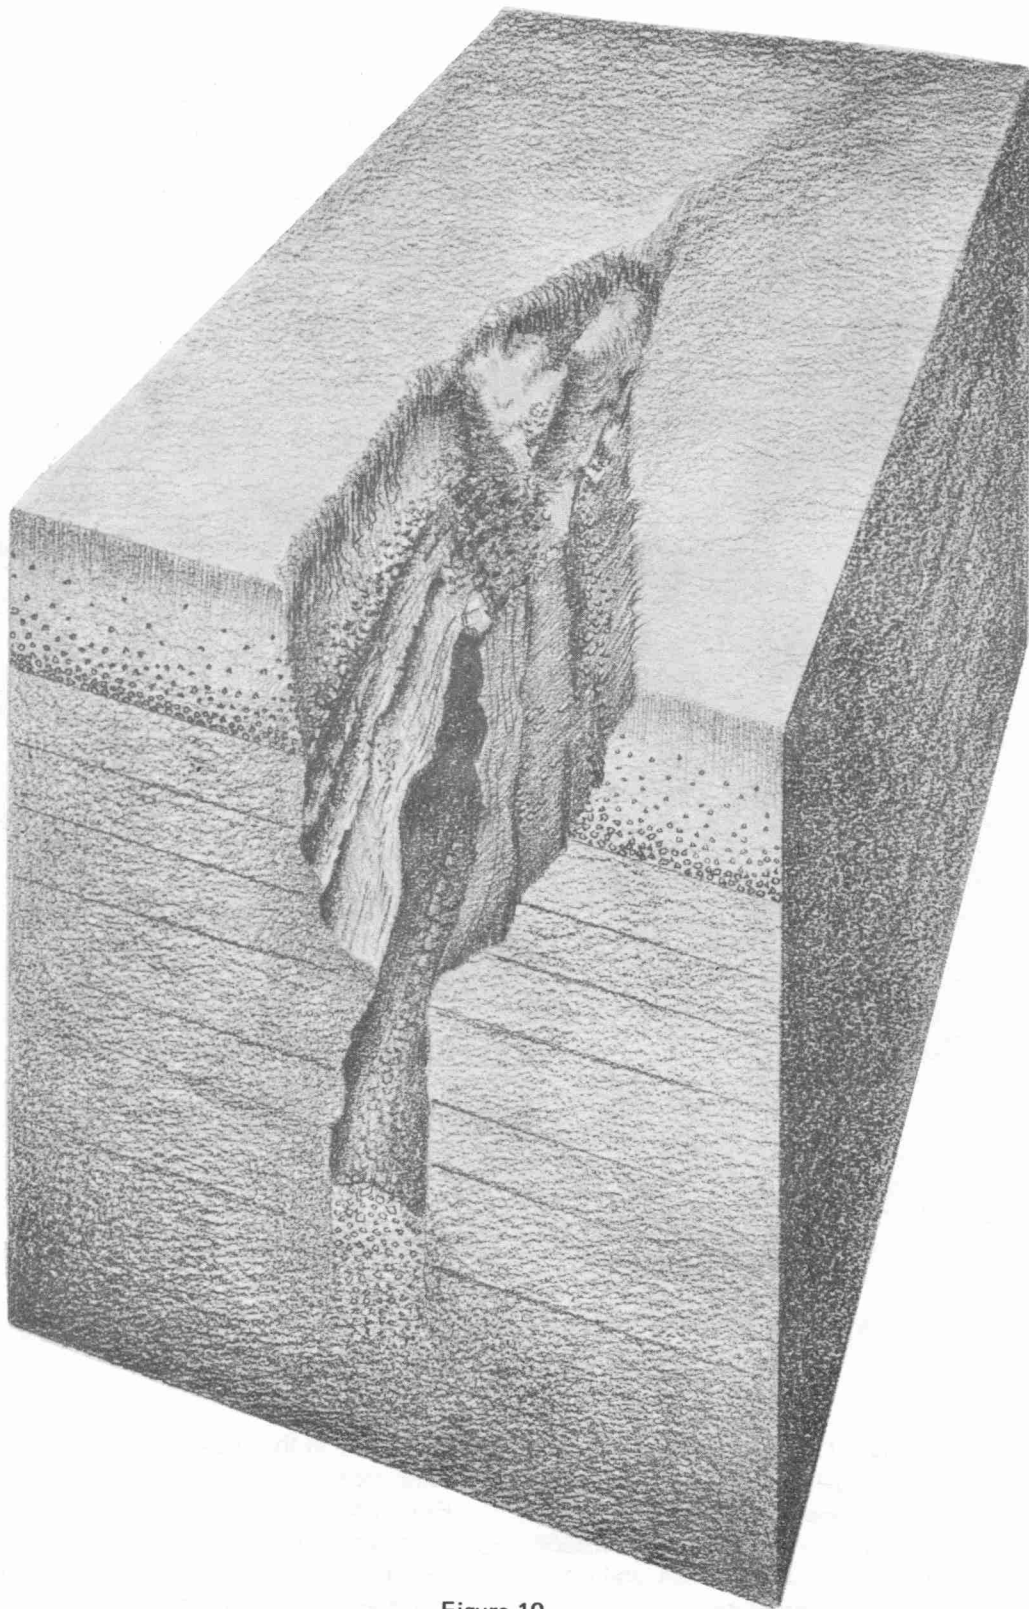
Figure 10

A third example of sinkhole collapse apparently unrelated to man's activities is the Racetrack Ridge collapse near Rueter, Taney County, Missouri, in Sec. 8, T. 22 N., R. 17 W. The sink formed in the 1960's and is about 80 feet long, 40 feet wide, and 60 feet deep. Its orientation is identical with the trend of the losing stream beneath which it has formed (fig. 10). The sink is in an area with shallow soils and numerous rock outcrops assigned to the Jefferson City-Cotter

formation; in this regard it differs from most of our other case histories, with the exception of those at Farmington. Although bedrock is exposed on the sides of the sink, there is no bedrock exposed at the ends of the sink. The senior author has explored several caves in the vicinity which also have residuum ceilings. The caves are typically narrow, vertical passages 2 to 20 feet wide and up to 60 feet high. The Racetrack Ridge sink is apparently an unroofed cave of this type.

Racetrack Ridge collapse. This sinkhole was formed by the collapse of residuum into a solutional void in the bedrock. A portion of the original void still exists and can be entered from the bottom of the sink for about 20 feet. Drawing by Douglas R. Stark from photos by Thomas J. Aley.

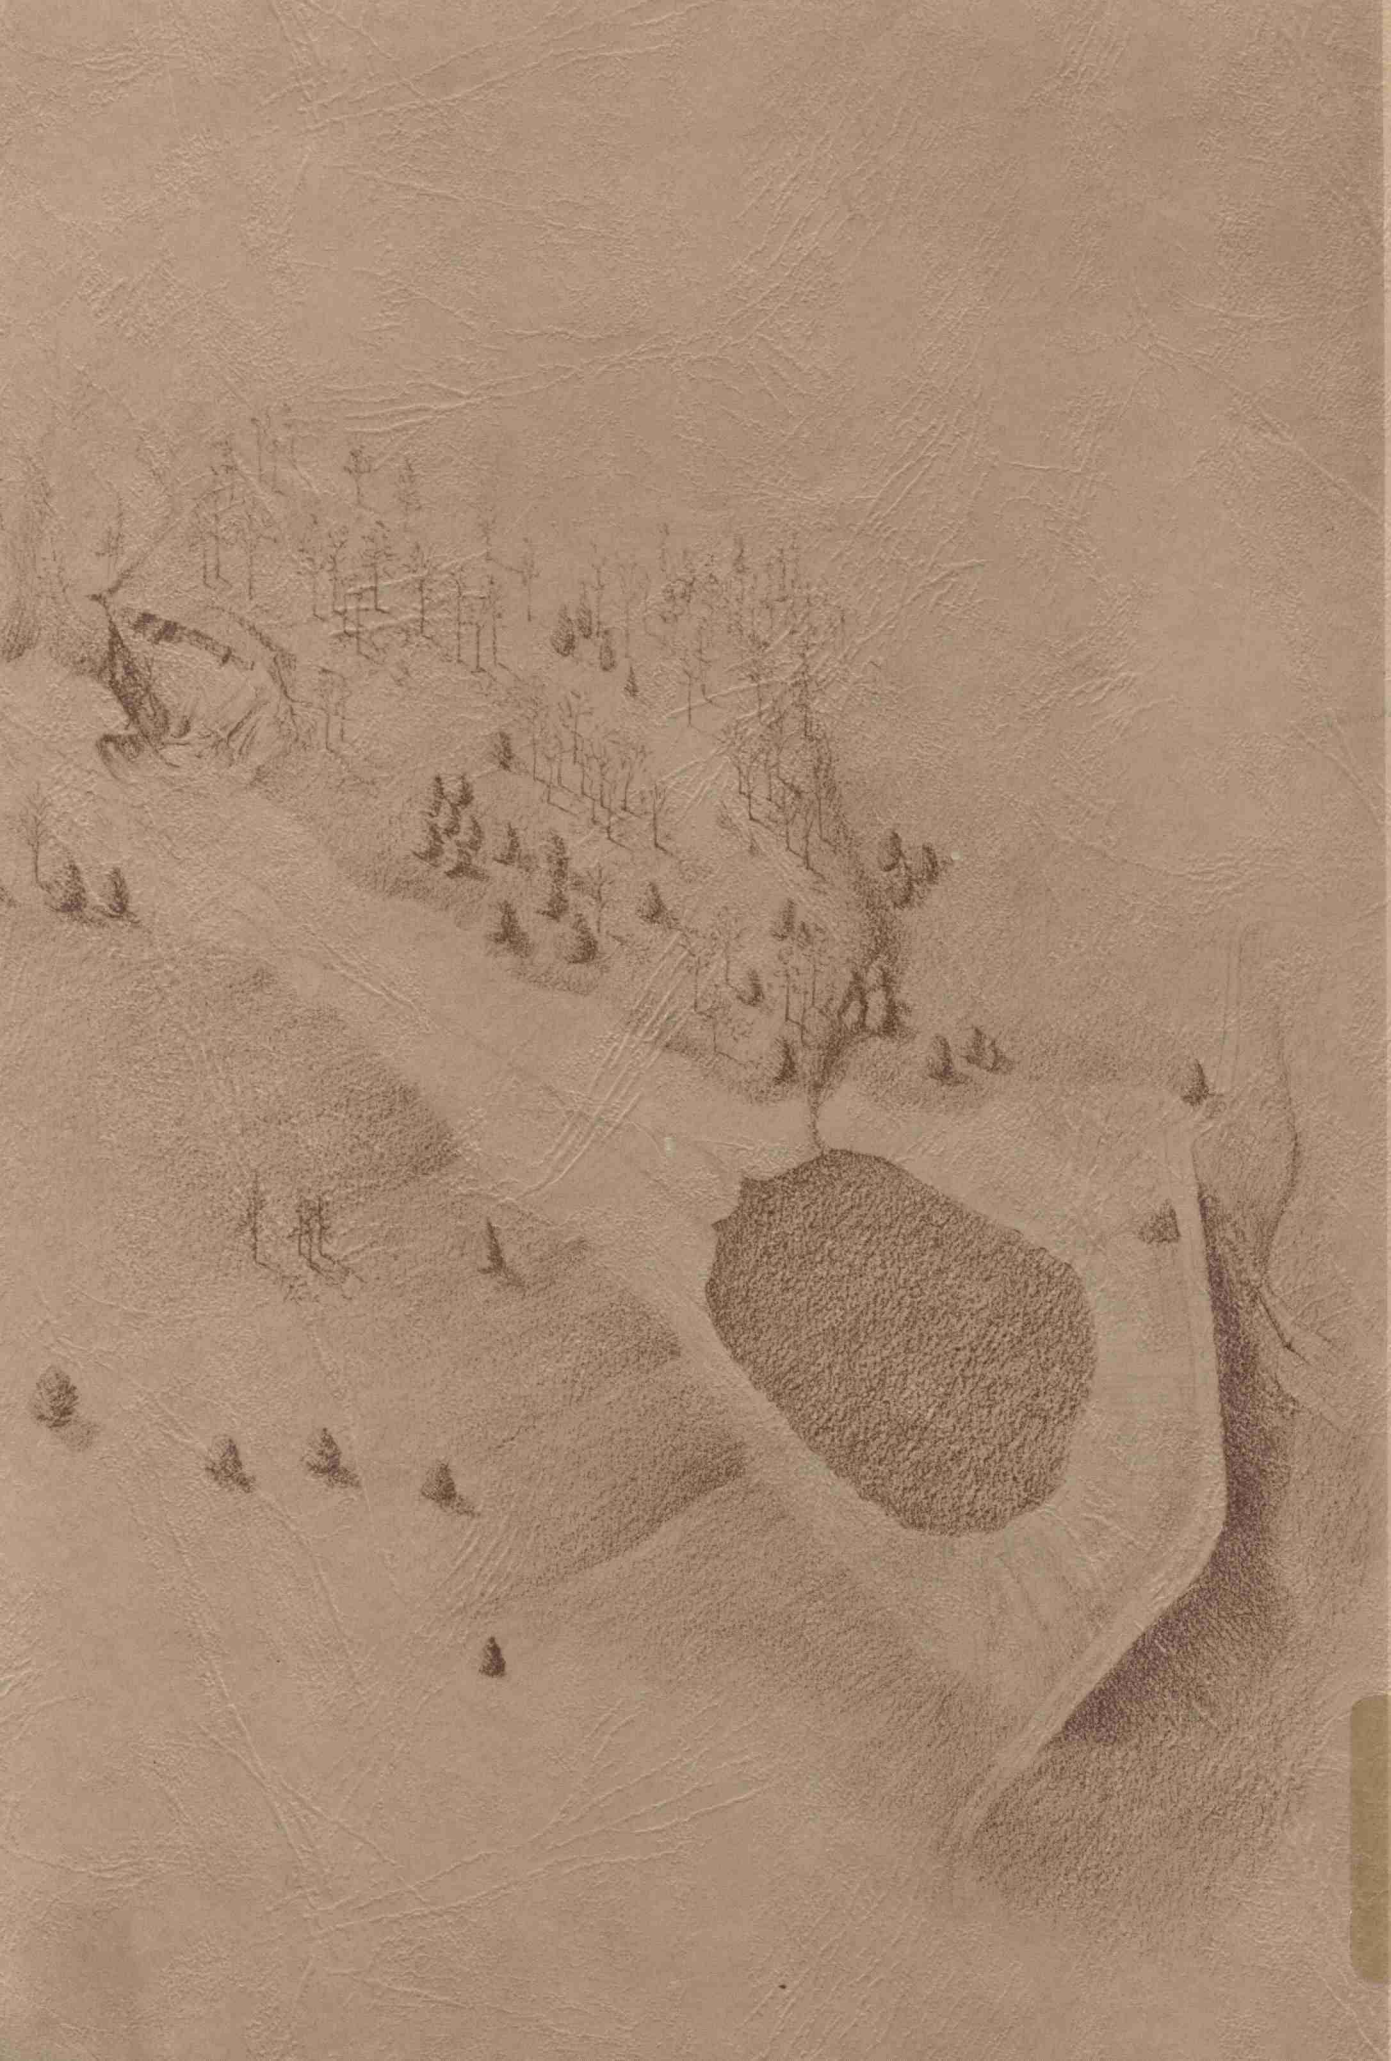
COVER: The largest of four catastrophic sinkholes caused by Norton Dam is shown on the left of the cover illustration. Three other sinkholes lie upstream. Drawing by Douglas R. Stark.
