**SITE PHOTOGRAPHS**  
**REMEDIAL ACTION FOR OPERABLE UNIT 1**  
**GROUND WATER AND SURFACE WATER**  
**TAR CREEK SUPERFUND SITE, OTTAWA COUNTY, OKLAHOMA**

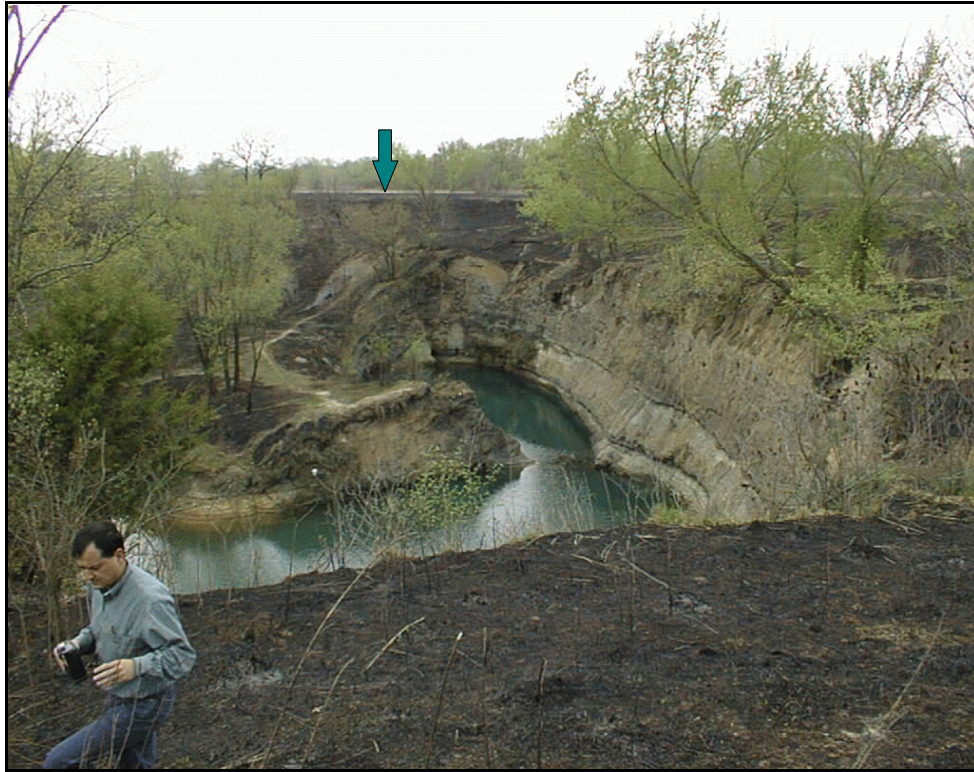
**Roof Collapse Into the Mine Workings in Kansas - The arrow points to the top of the dike designed to direct the flow of Tar Creek away from the collapse structure.**

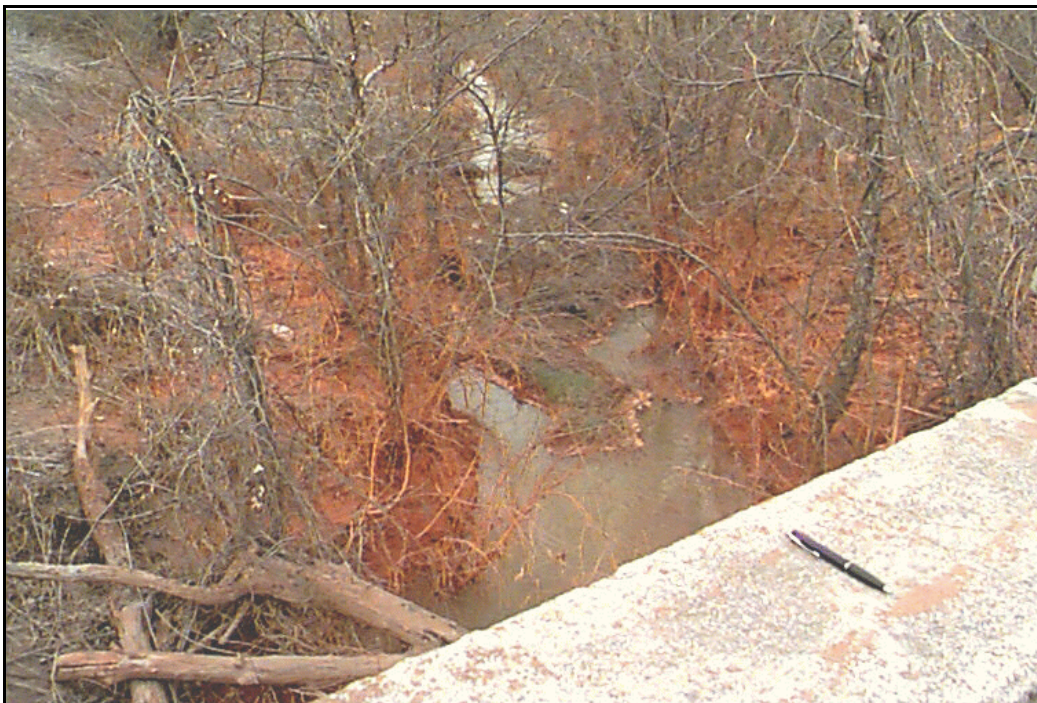
**Acid Mine Drainage - The acid mine water is draining into Tar Creek at Douthat Bridge (approximately 1.5 miles southeast of Cardin, OK). Note the reddish iron oxide staining on the vegetation and banks of the creek.**
