Section 17 Projects: Old Church Rock Mine and Downwind Structures

Navajo Superfund Program - Site Assessment

Scoping Survey done by Navajo Superfund Program March 2007

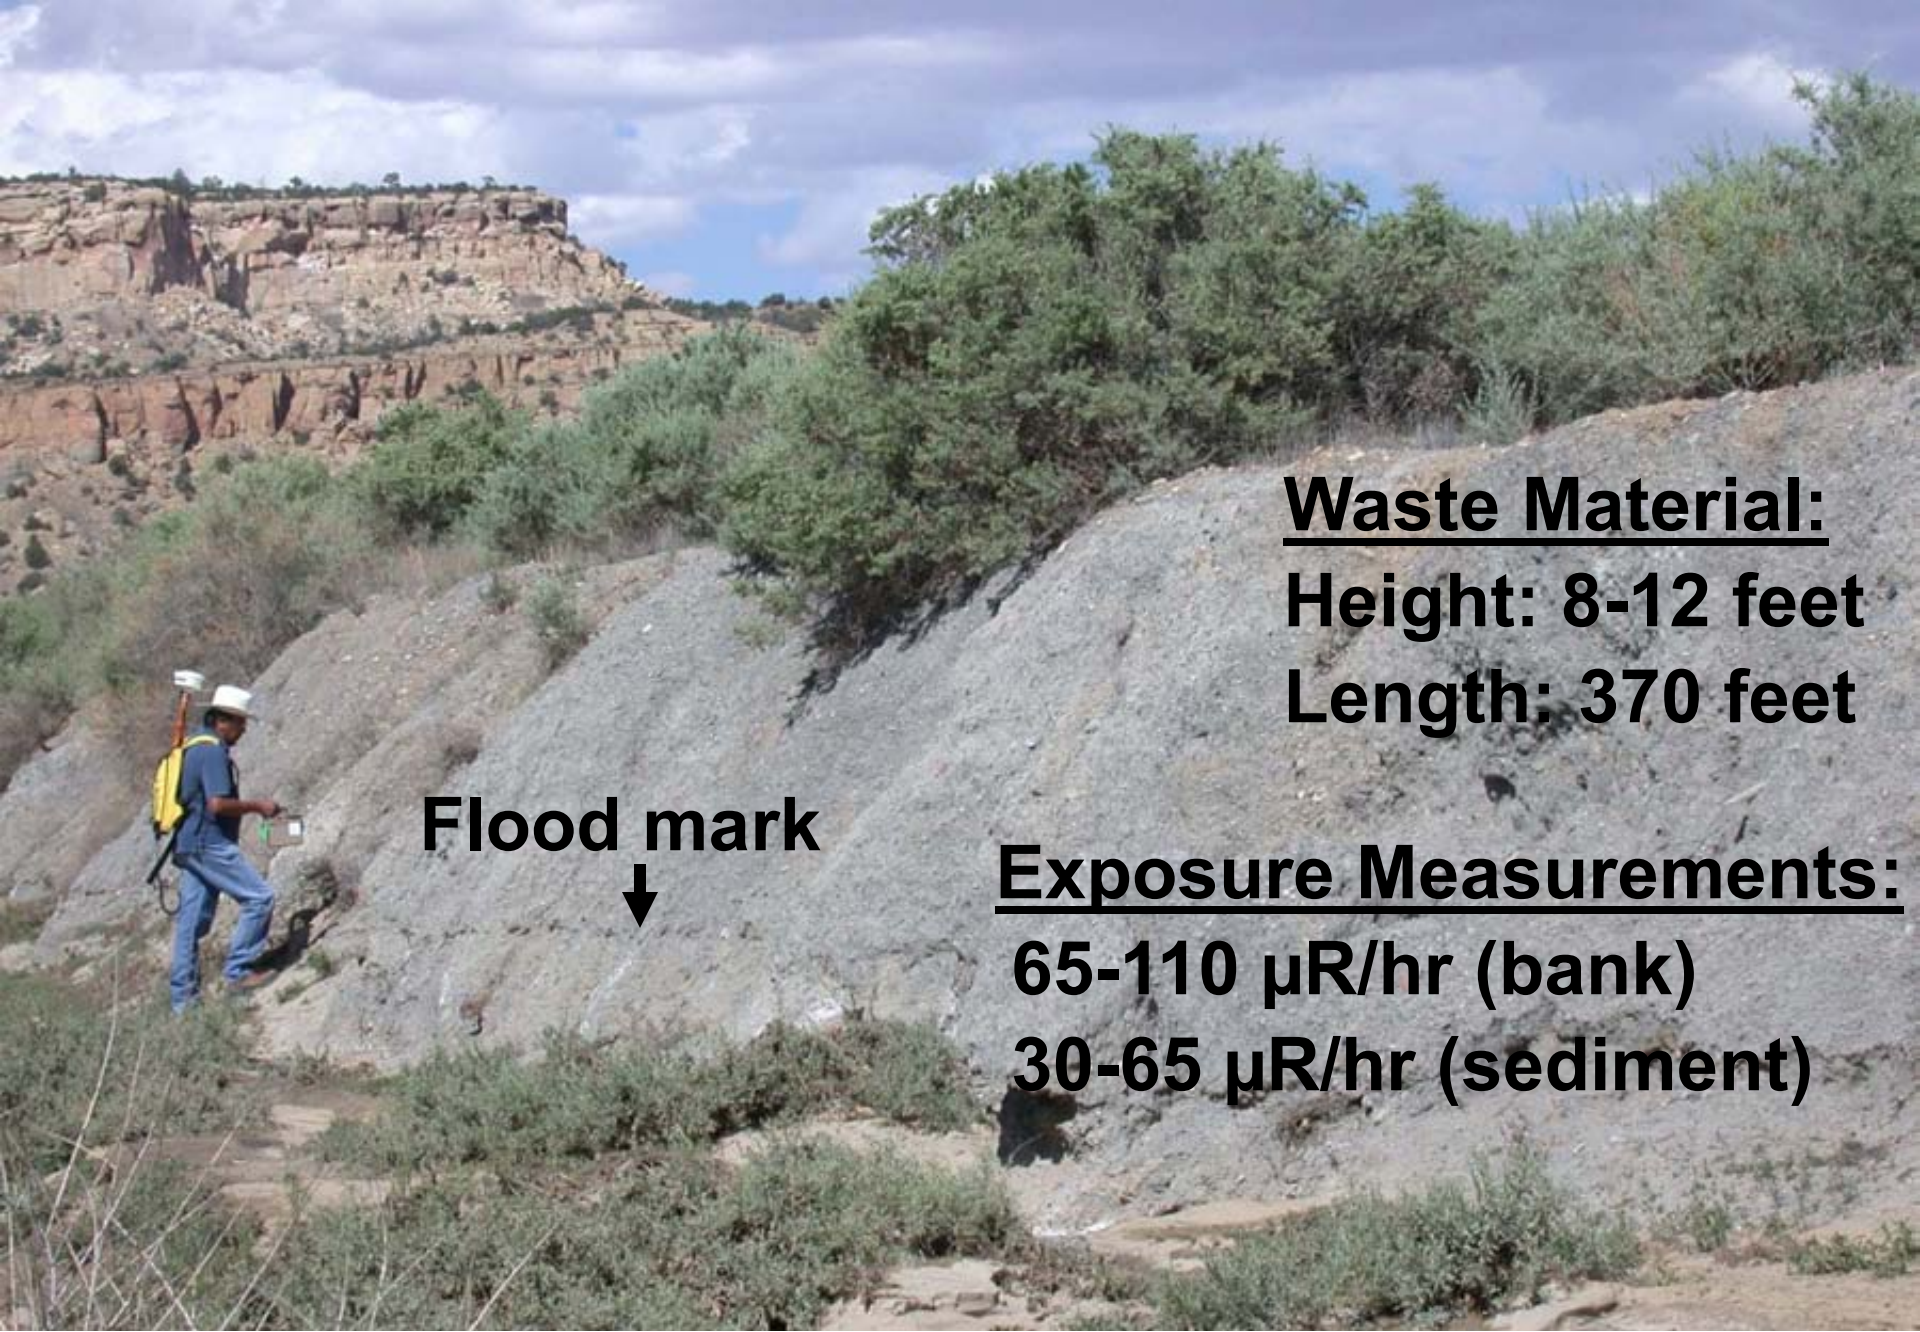
August 2, 2006

Waste Material:
Height: 8-12 feet
Length: 370 feet

Flood mark
↓

Exposure Measurements:
65-110 $\mu\text{R/hr}$ (bank)
30-65 $\mu\text{R/hr}$ (sediment)

Background=12-15 microRoentgens per hour ($\mu\text{R/hr}$)

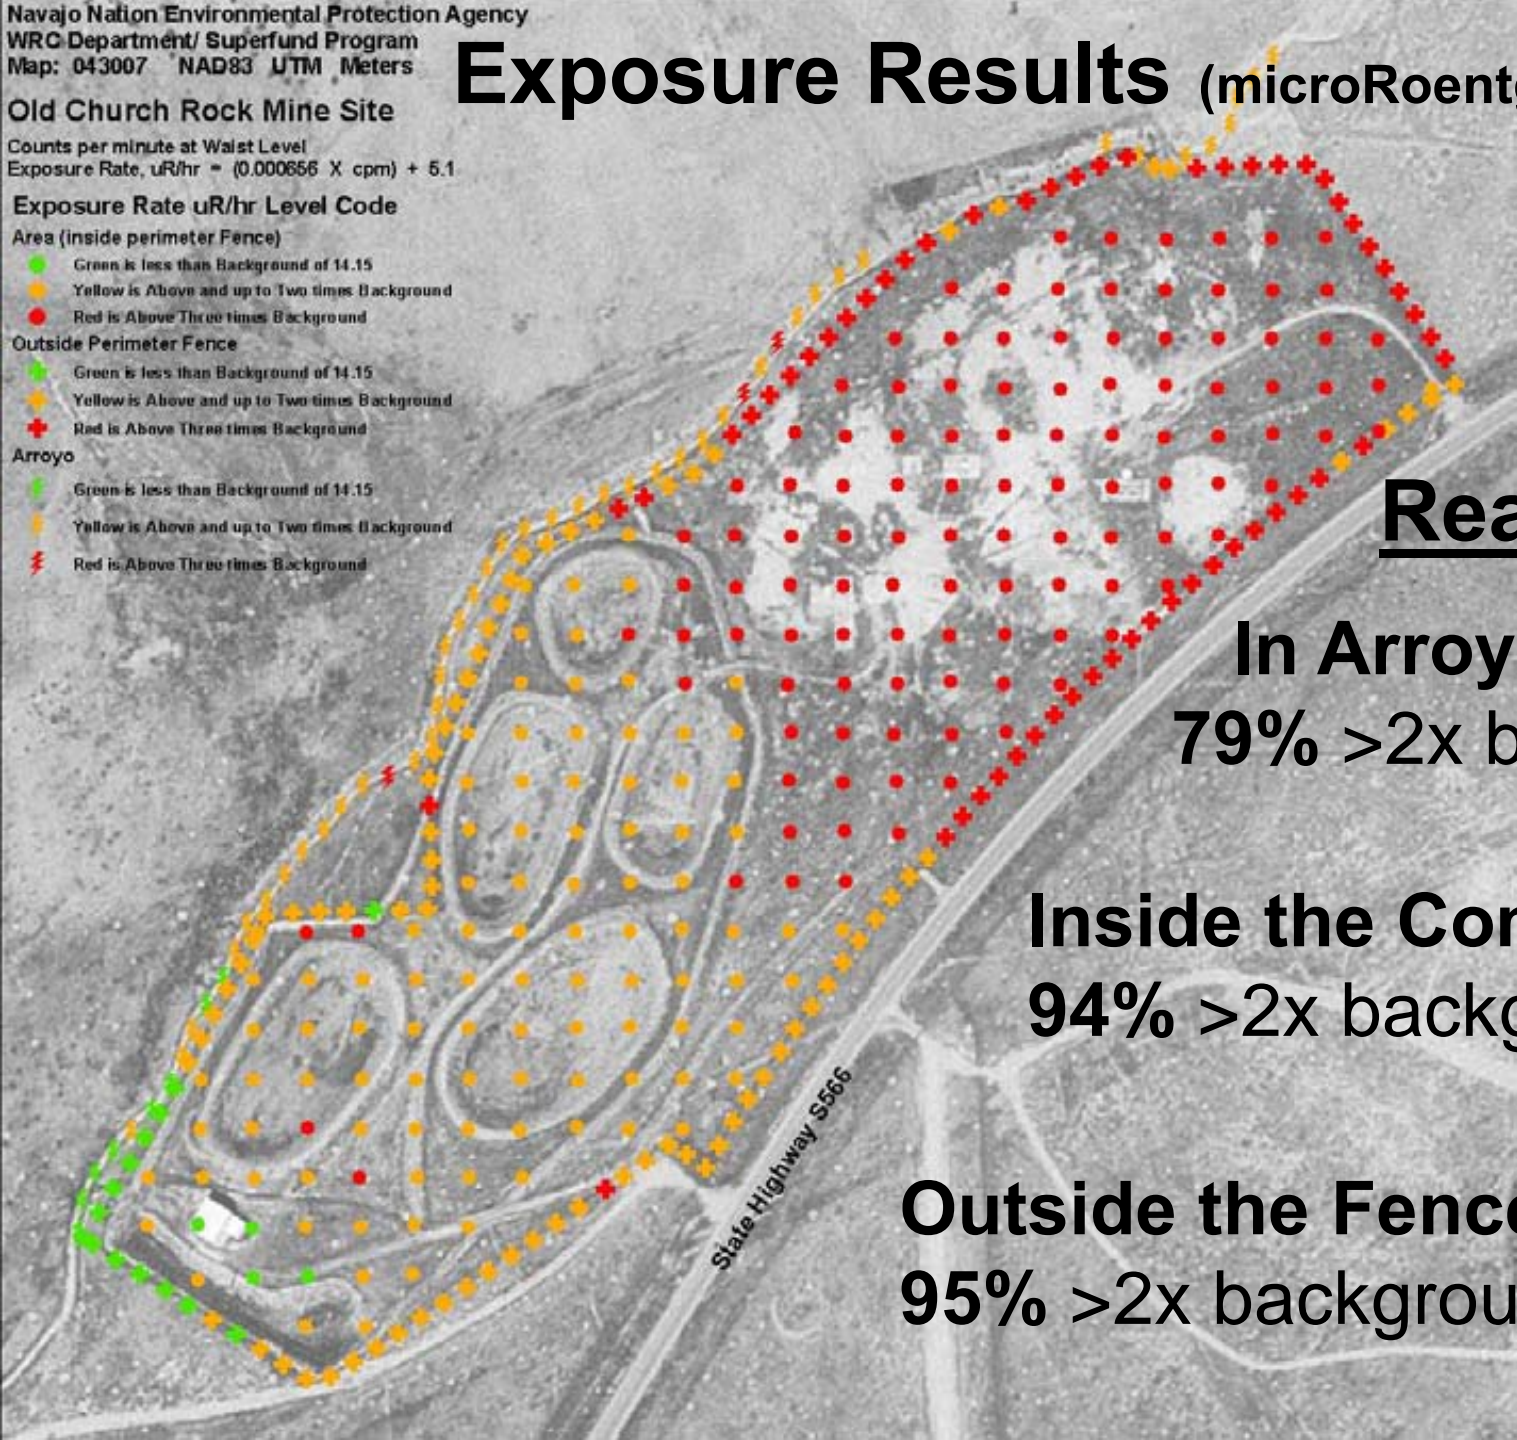
Exposure Results (microRoentgens per hour)

Readings:

In Arroyo

79% >2x background

Inside the Compound

94% >2x background

Outside the Fence Line

95% >2x background

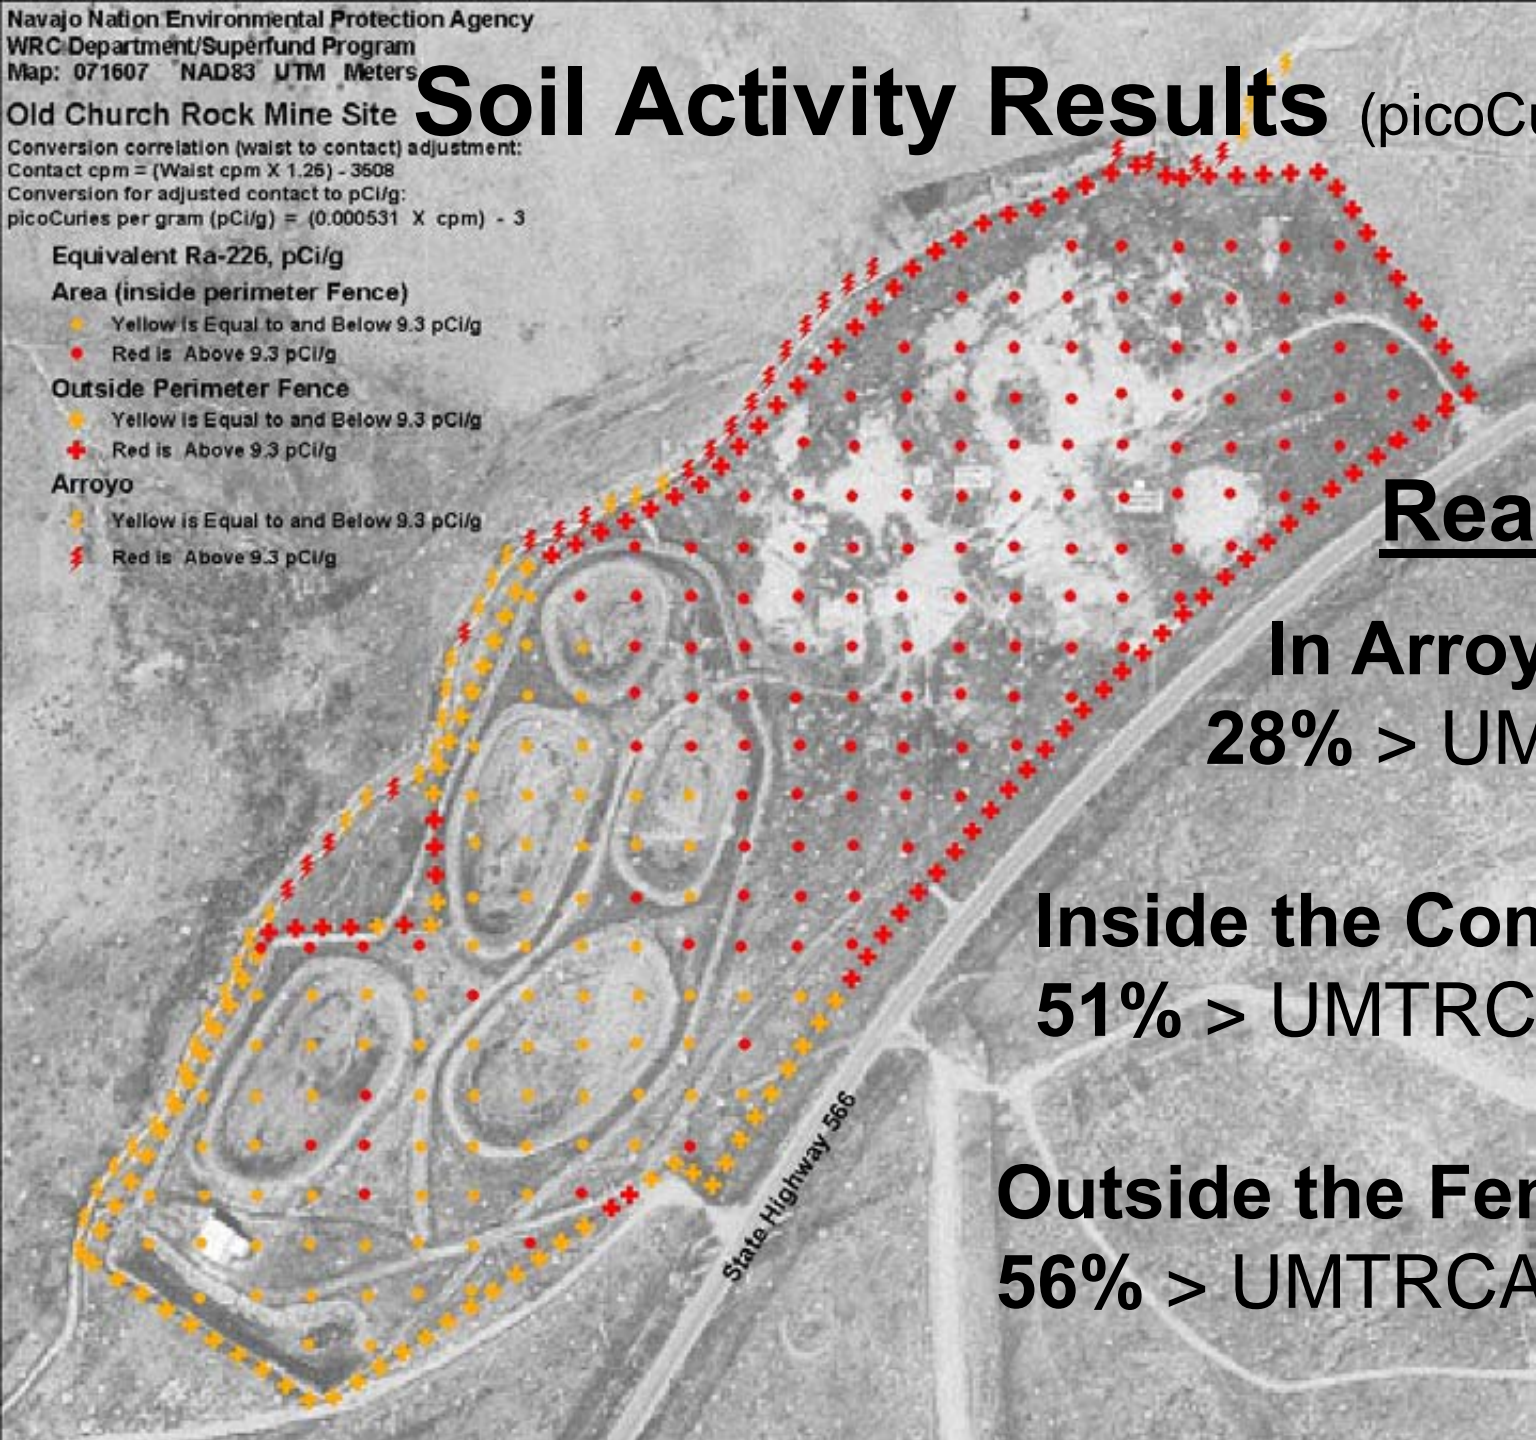
Soil Activity Results (picoCurie per gram)

Readings:

In Arroyo
28% > UMTRCA std.

Inside the Compound
51% > UMTRCA standard

Outside the Fence Line
56% > UMTRCA standard
